STORMWATER MANAGEMENT PLAN FOR THE TOWN OF ENOSBURGH AND VILLAGE OF ENOSBURG FALLS

FINAL REPORT

Stone Project ID 112475-W

March 1, 2013

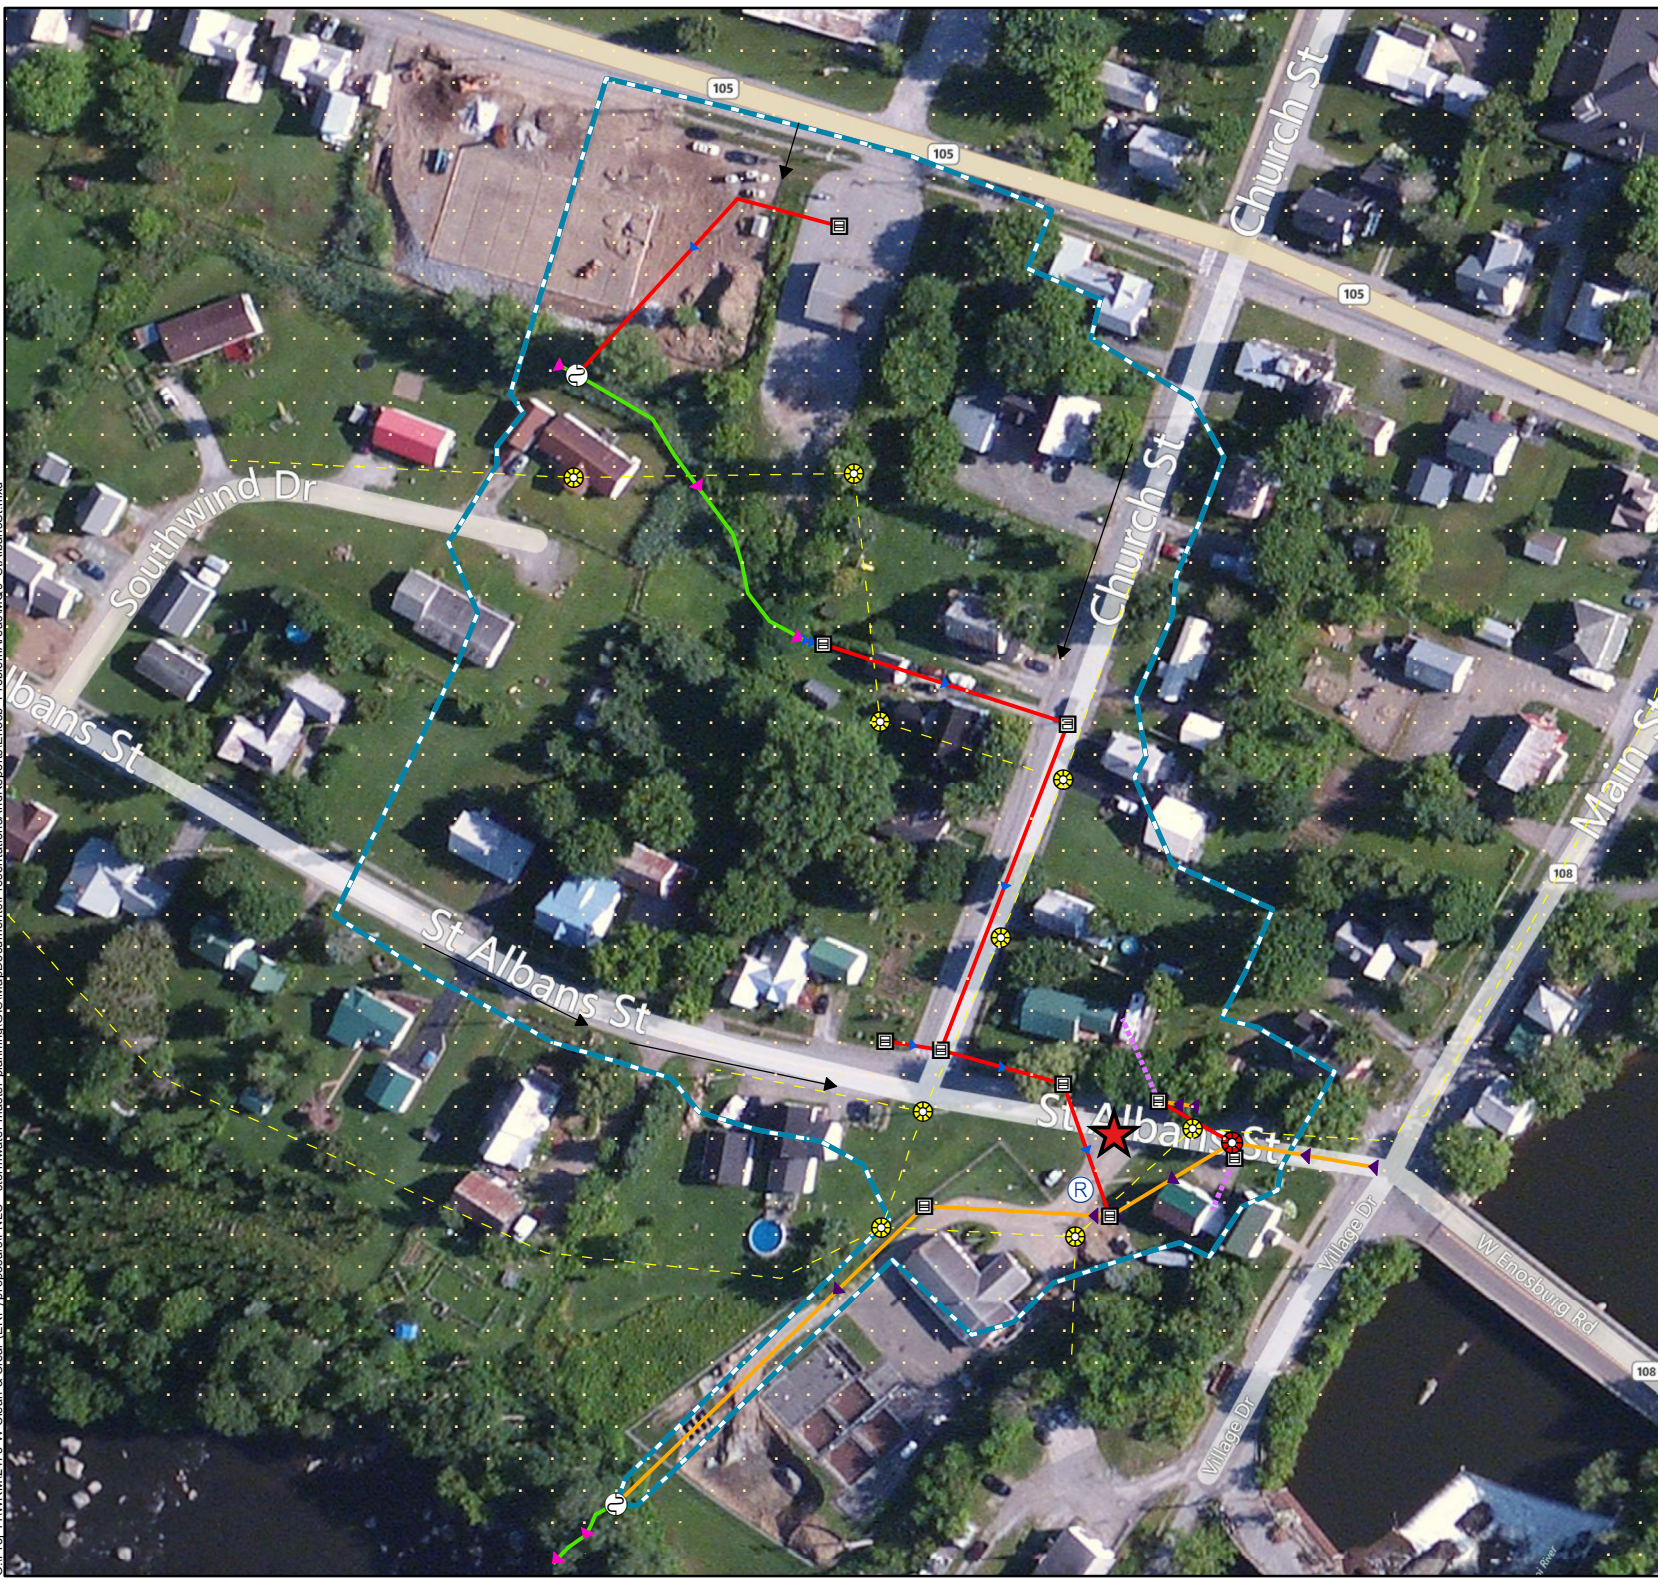
MQ-9

Treatment Opportunity:
Stormwater runoff from impervious surfaces surrounding the Village wastewater treatment facility discharges directly to Missisquoi.

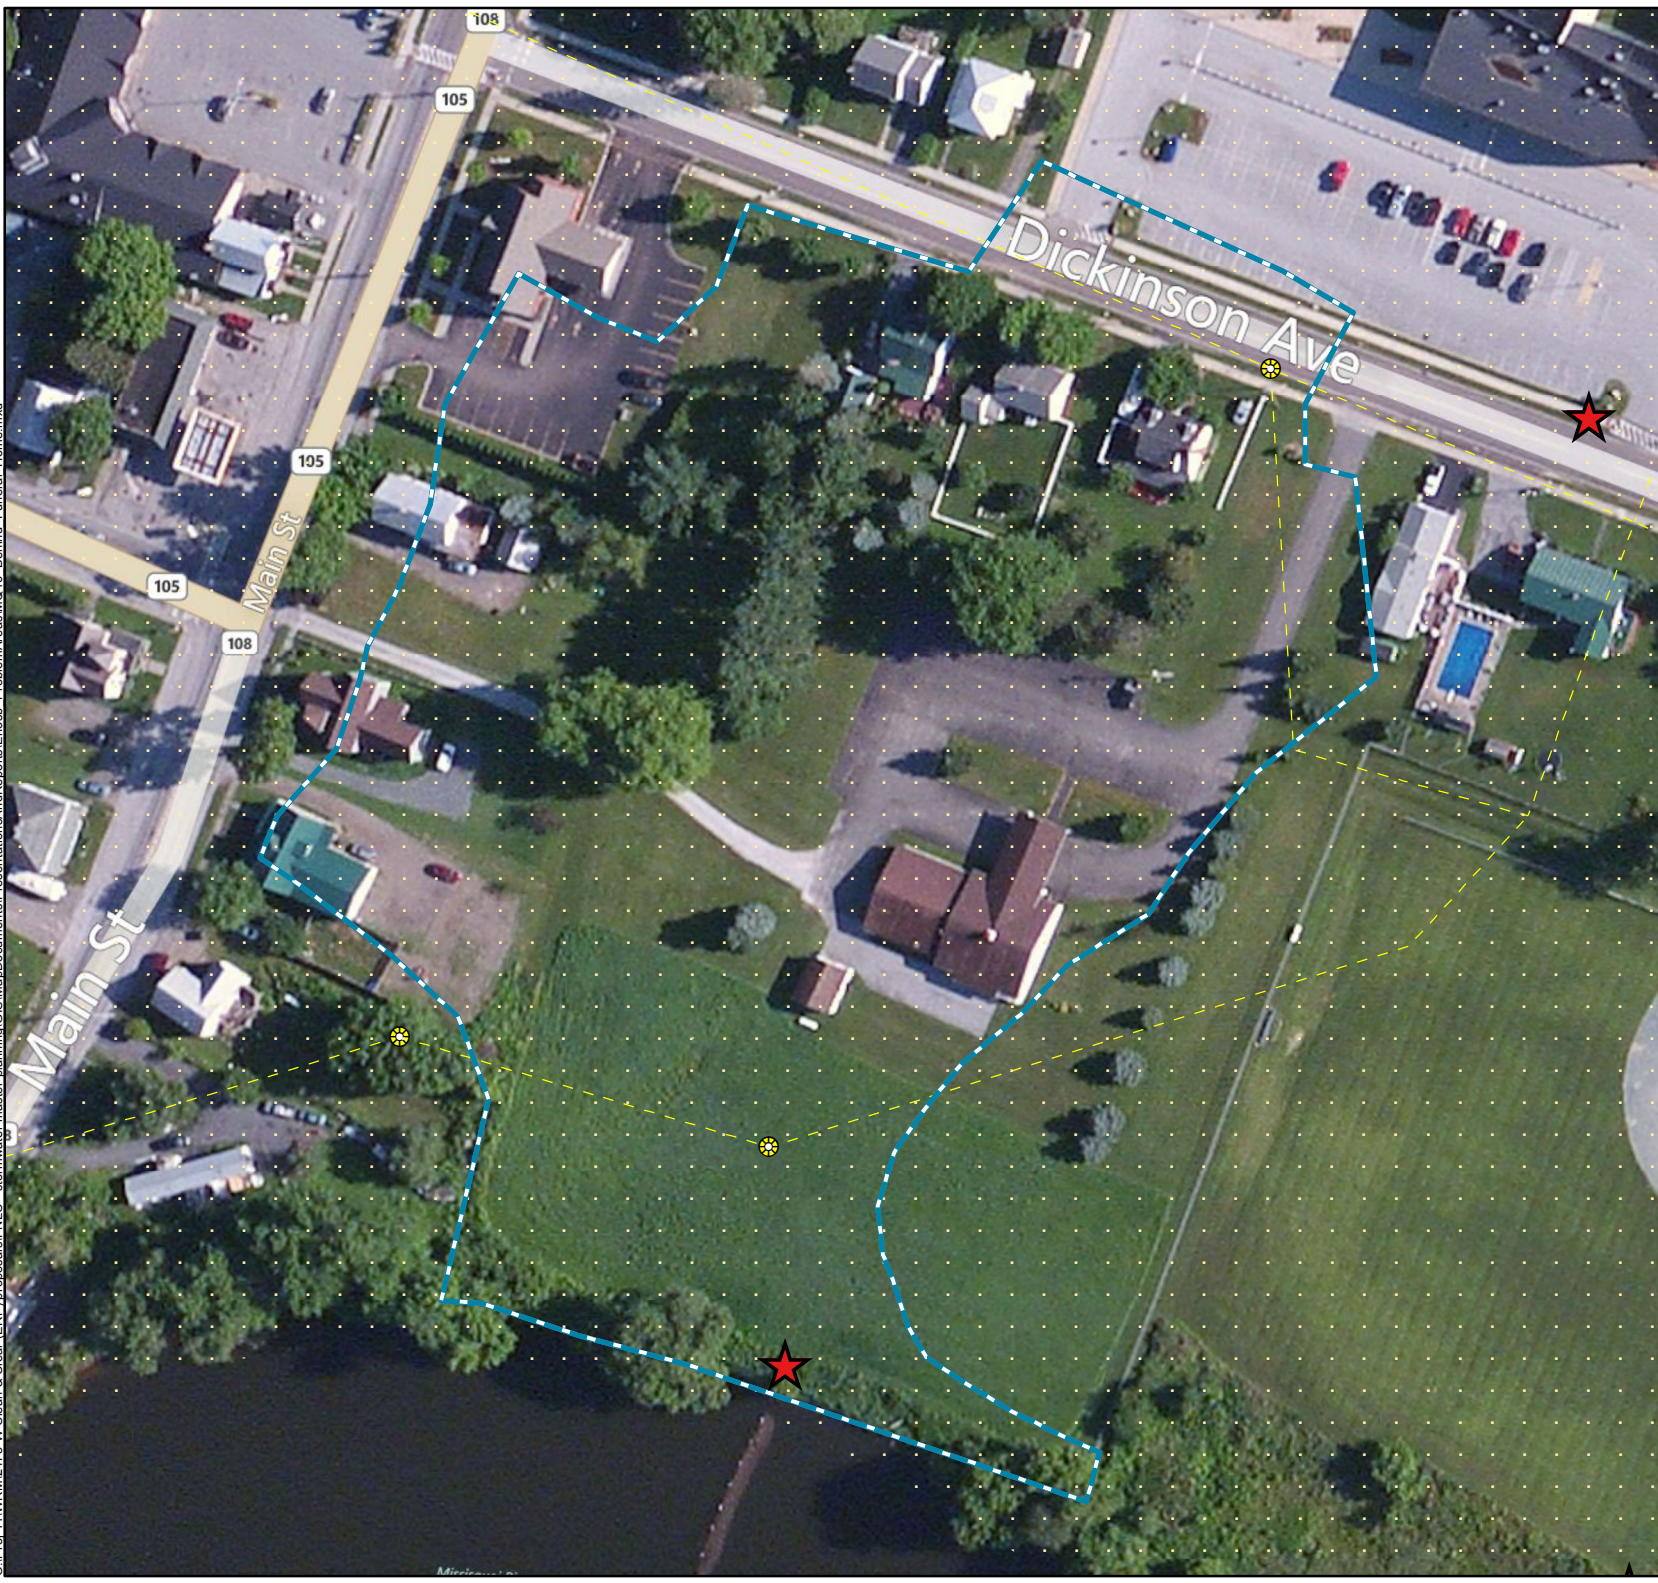
MQ-11

Signs of erosion at outfalls coming from Bismark St. Small stream of water coming through outfall even though there had been no rain for at least a week. High amount of water possible in area, signs of erosion in rip rap that was previously placed at the outfall. Bank erosion observed where water discharges from outfall and into drainage ditch. Space exists for a stormwater treatment measure to be installed near the rail trail between the two outfalls.

Treatment Opportunity:
Active erosion caused by flows from two storm sewer outfalls.

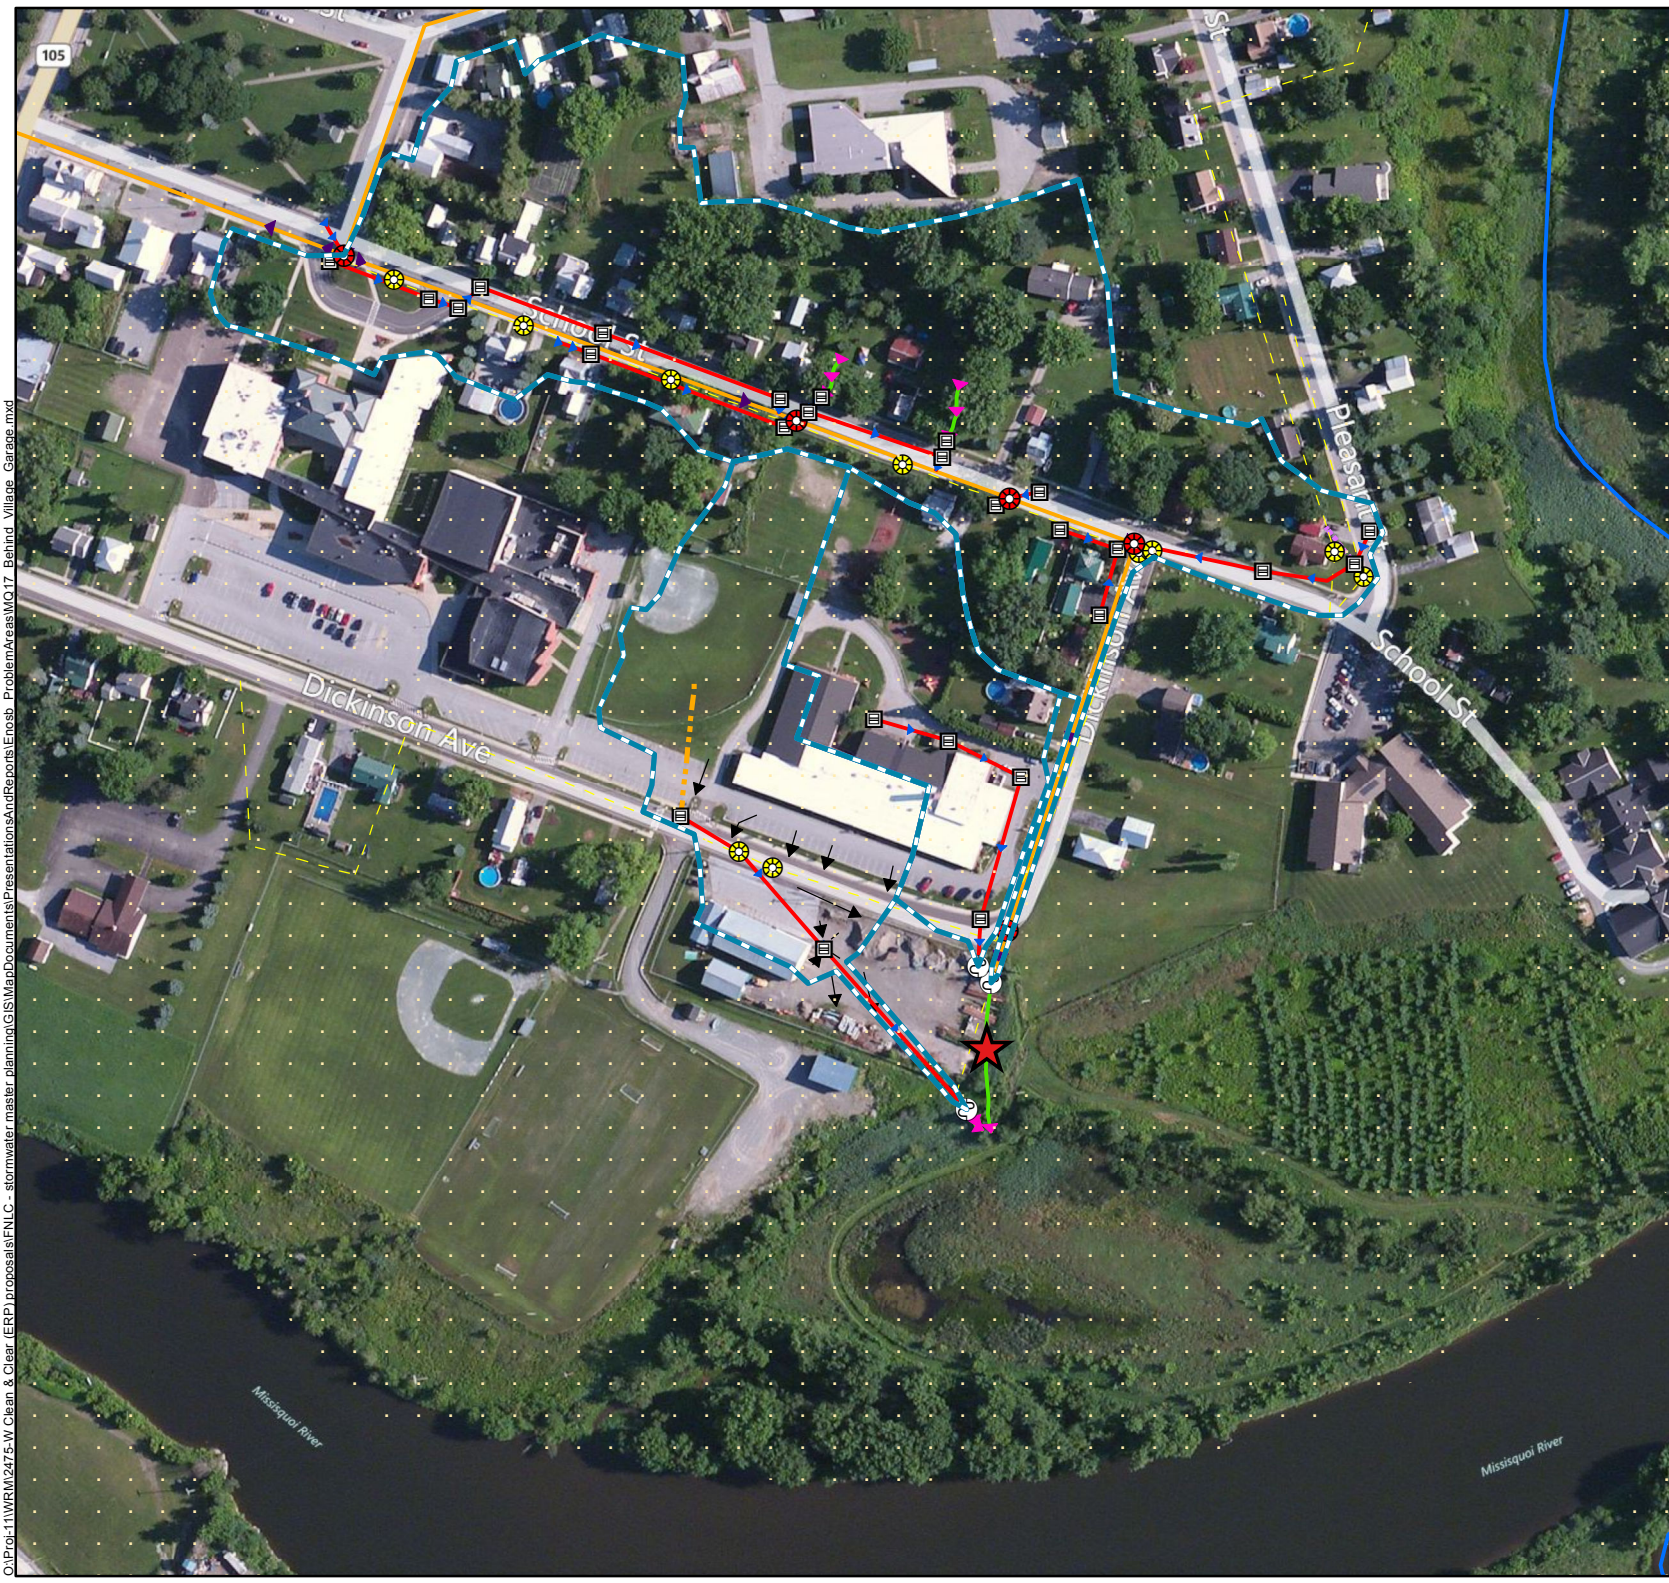
Problem Area ID: MQ-16	Latitude: 44.903173	Longitude: - 72.805325
Watershed: Missisquoi River		
Location: Riparian areas along Missisquoi River, above the falls/dam		
Problem Type: Bank Erosion		
Identification Source: Town/Village Feedback		
Ownership: Unknown		
Classification Level: 3		
Problem Description:	Bank erosion and dumping of yard debris observed behind Spears Funeral Home.

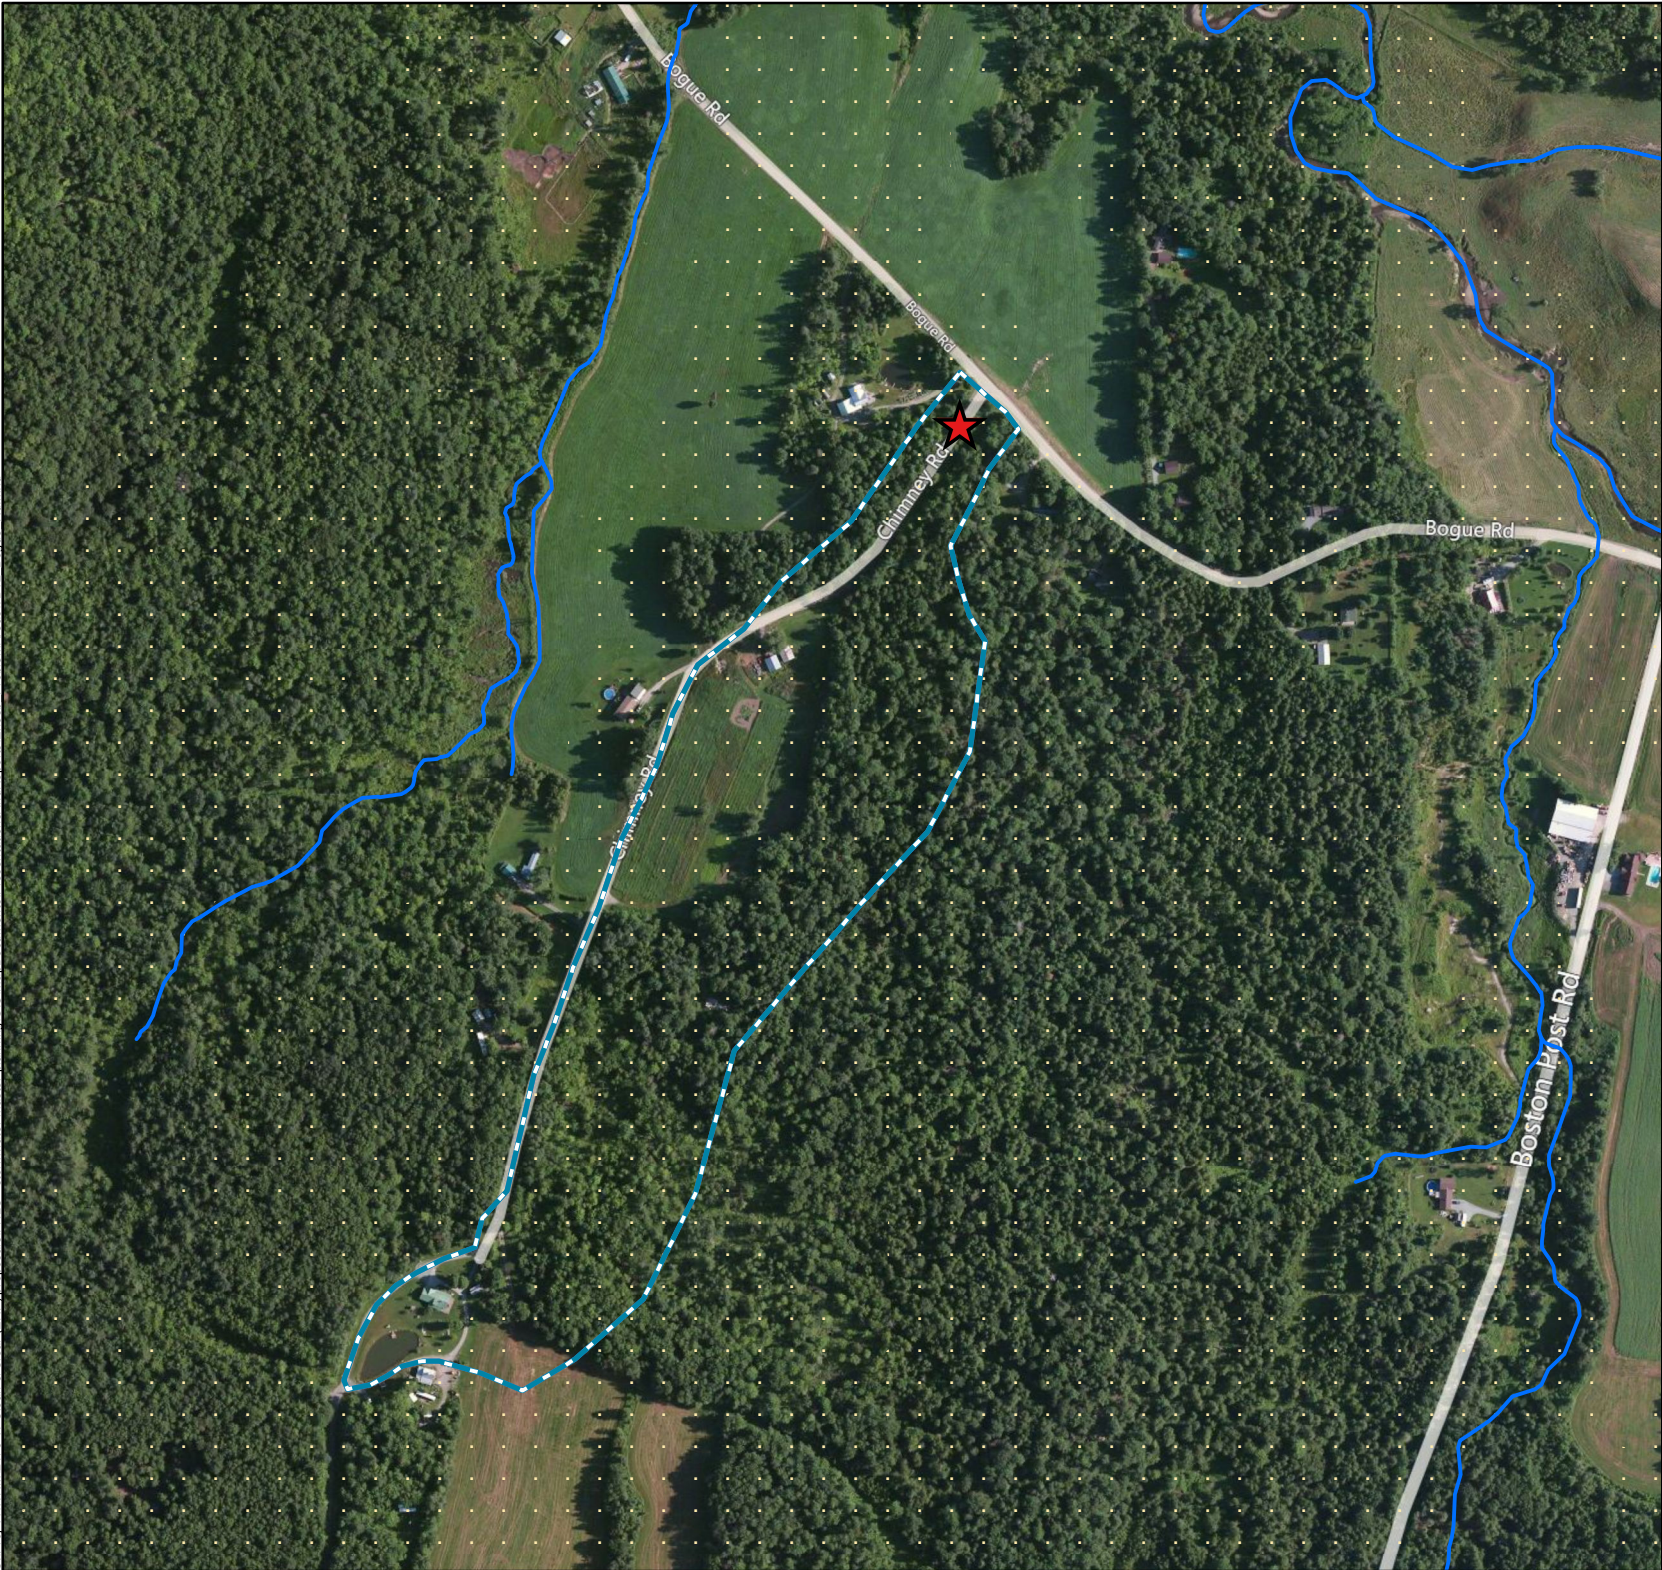
TB-7

Description of Observed Conditions:
<p>Erosion from Town Garage parking lot and salt shed flows directly into Tyler Branch (Photo1). Town has tried to address the issue by placing jersey barriers along the sand pile and access road. While this has helped reduce the amount of sand being washed directly into Tyler Branch, it has caused the stormwater to concentrate and is causing erosion along foundation of salt shed downhill to stream. Entire town lot is sloped downhill toward stream. Sand pile is outside and above salt shed. No nearby land farther away from the stream is owned by the Town.</p>

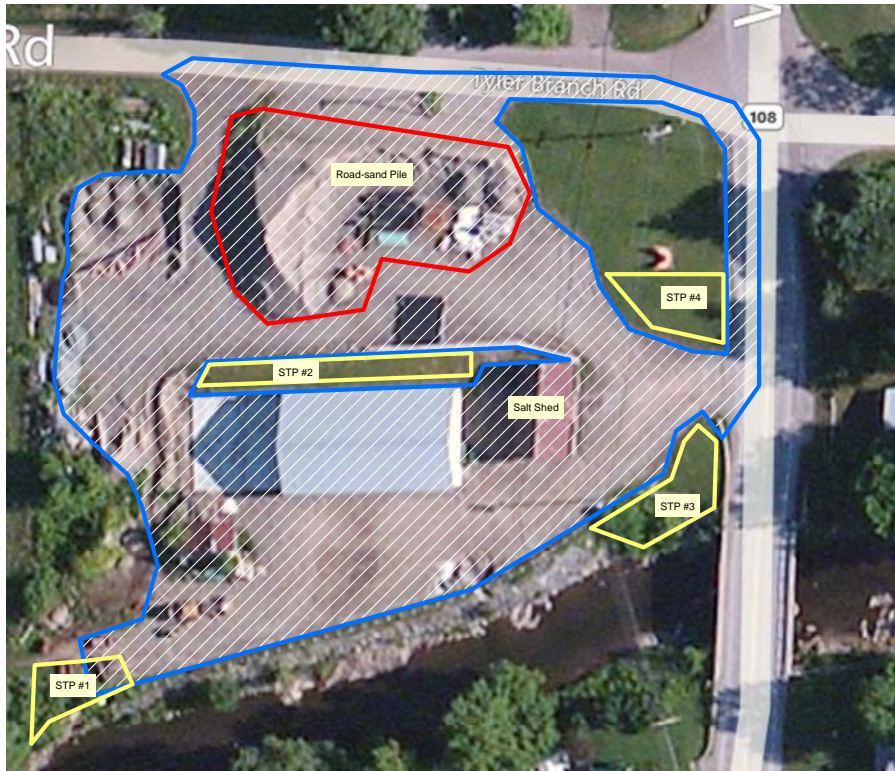
Figure 1. The Enosburg town road maintenance facility includes 1.5 acres of treatable impervious surface (outlined in blue). Potential STP locations are outlined in yellow.

The Enosburg Town road maintenance facility includes 1.5 acres of treatable impervious surface. The site comprises 0.2 acres of roof top and 1.3 acres of compacted gravel utilized for parking, equipment storage, and winter road-sand stockpiling. The road-sand stockpile is a persistent source of sediment. A significant amount of material is mobilized and washed off site during every rain event (see Figure 2).

Covering the road-sand stockpile is the best way to prevent the erosion of material. Recently, the town was awarded grant for approximately \$50,000 for this specific purpose. An engineer's cost estimate, however, approximated the total cost for a suitable structure to be \$250,000.

Locating a stormwater treatment practice (STP) at the southwest corner of the property (labeled STP #1 in Figure 1 and Figure 3) could reduce stormwater and sediment loads to Tyler Branch. An asphalt swale or similar practice may be needed to convey a wider range of flows to STP #1. Including the other STPs shown (STP#2-4) would reduce the burden on STP #1. This could help to reduce the size required for STP #1 and improve effluent water quality.

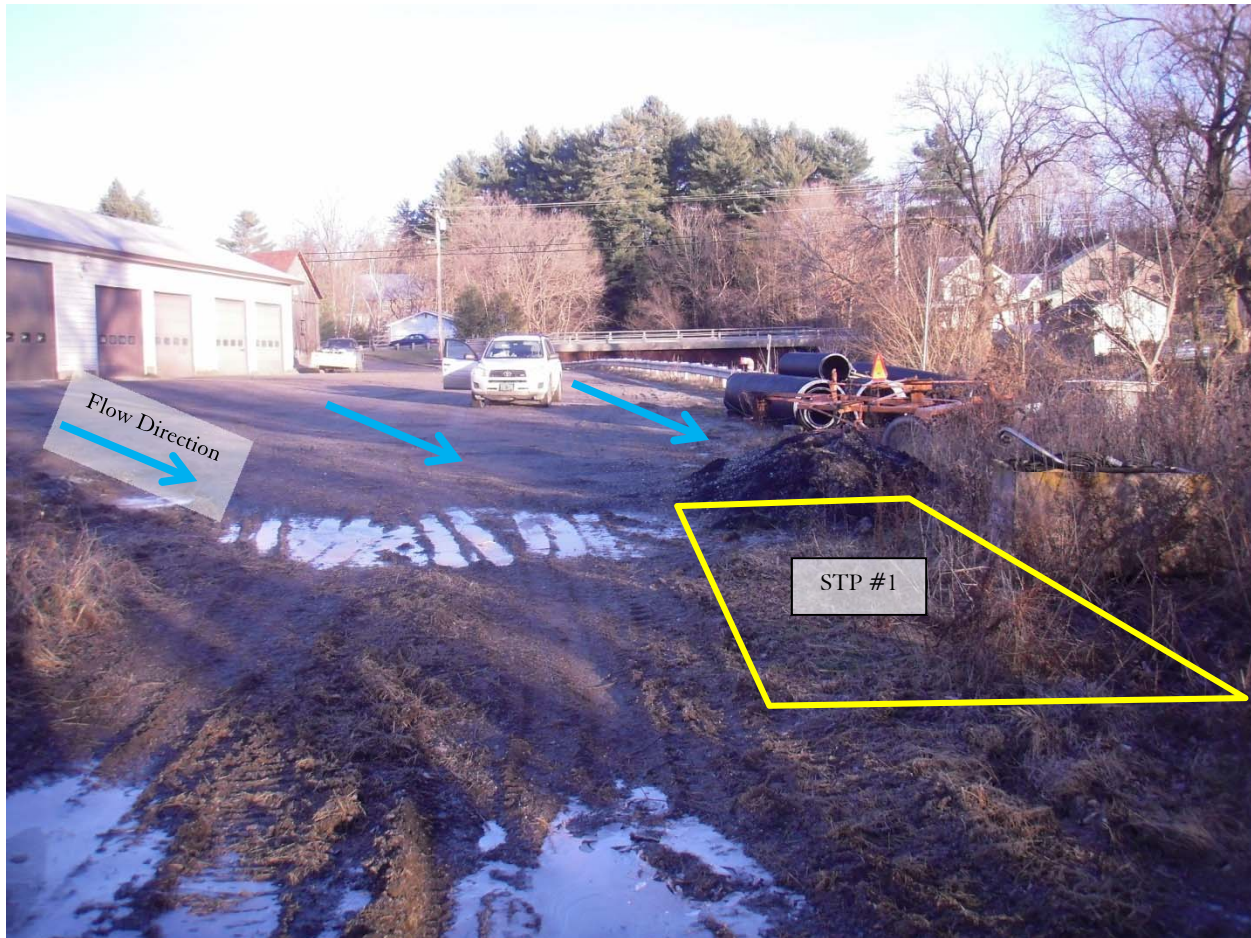
Figure 3. Stormwater that currently flows, southwest across the property could be captured and treated in an STP in the southwest corner of the property.

Soils at STP #1 are reported as Ondawa variant silt loam (HSG B). This soil would support infiltration practices. However, an underdrain should be included in the design. The remainder of the site is reported to be Buxton silt loam (HSG C). This soil type would not allow adequate percolation for effective infiltration practices. STPs in these locations must include some sort of underdrain structure to prevent pooling beyond the intended retention time. The most important feature of STPs at this site will be the removal of sediment. Pre-treatment forebays and regular maintenance will be crucial for ensuring successful stormwater treatment.

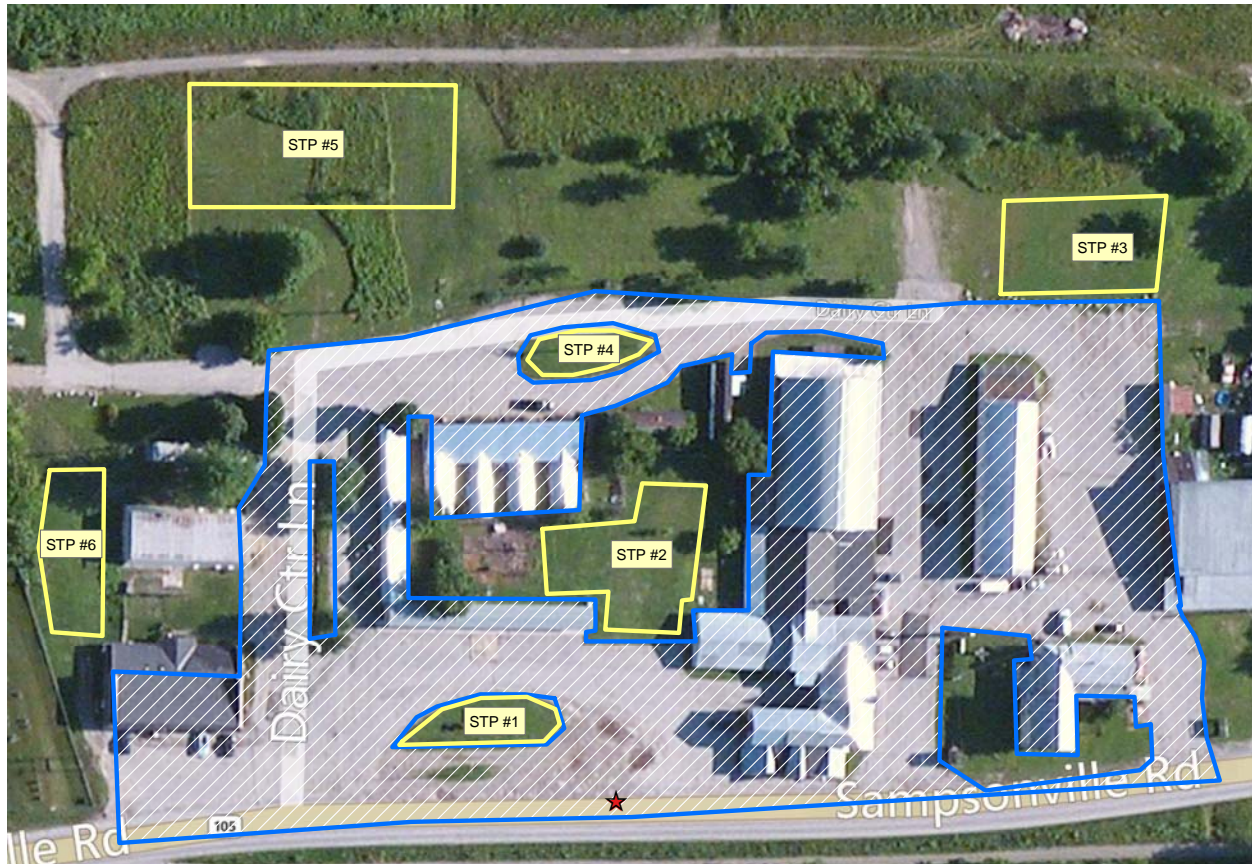
Figure 4. 3.6 acres of treatable impervious area has been identified (highlighted in blue) at The Dairy Center. A number of STP location options exist (highlighted in yellow).

The Dairy Center is a five acre development that includes a bowling alley, restaurant, and lodging. This complex on Rt. 105 includes a large expanse of buildings and asphalt pavement. Approximately 3.6 acres of treatable impervious area has been identified on the property including a number of rooftops and a significant amount of asphalt pavement. The property is immediately across the road from the Missisquoi River.

A number of possible STP locations have been identified and are shown in Figure 4. Examples of two potential STP layouts are provided in Figure 5 and Figure 6.

The NRCS reports soils at the Dairy Center to be Missisquoi loamy sand (HSG A). Infiltration would likely be effective at all potential STP sites. The asphalt pavement at the Dairy Center is expansive. Stormwater impacts could be greatly reduced by “de-paving” the existing pavement and replacing with vegetation or stormwater treatment practices. Pervious pavement may also be an option to reduce stormwater runoff given the flat topography and well-drained soils underlying the parking lot.

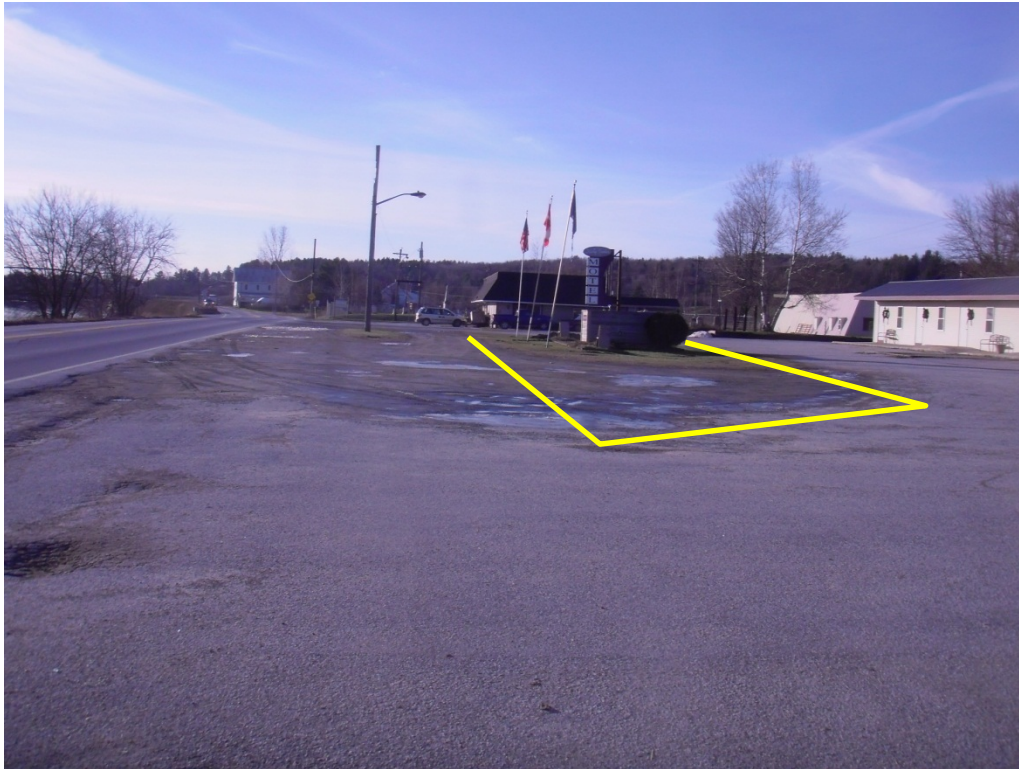
Figure 5. A stormwater treatment practice in the parking median at the Dairy Center could be an effective option with minimal impact on the parking lot traffic patterns.

Figure 5 shows a depression in the pavement at the complex entrance along Rt. 105. GIS analysis shows that stormwater currently flows toward the existing landscaped area where the flags and sign are located. A portion of the deteriorating pavement could be replaced with an STP. This STP would reduce stormwater and pollutant loads to the Missisquoi River while beautifying this highly visible property.

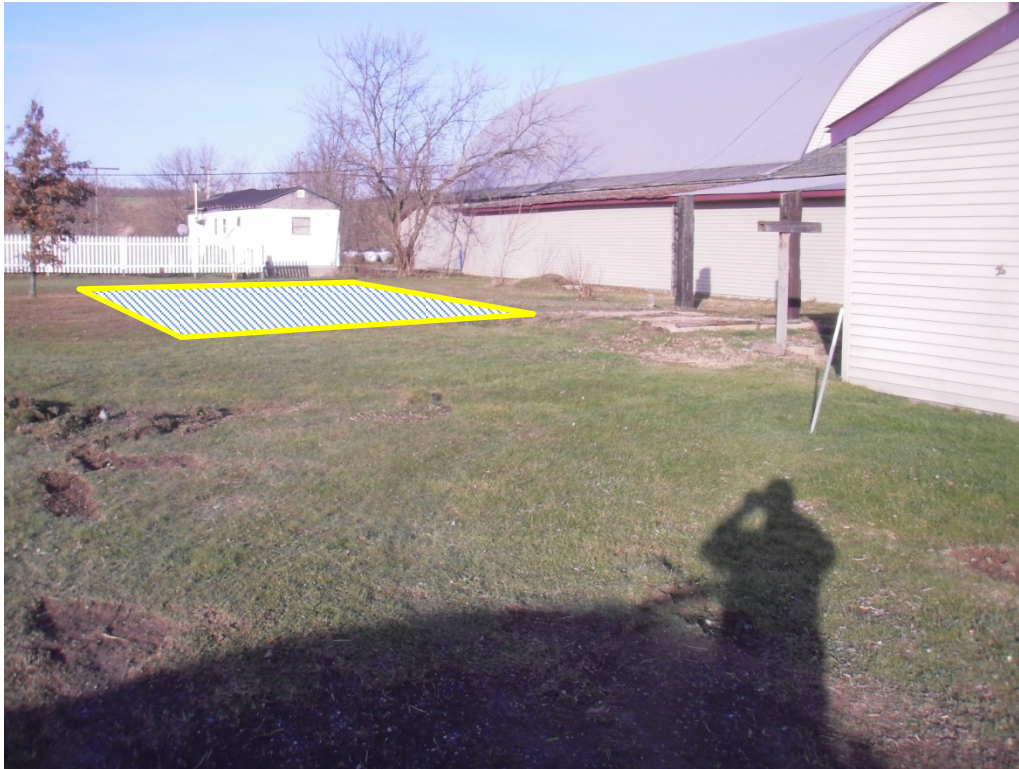
Figure 6. Roof runoff could be captured and infiltrated through an STP place in the complex courtyard.

Figure 6 shows a section of the complex courtyard. Roof runoff could be captured in a simple STP which would promote infiltration. Again, this STP would improve stormwater runoff conditions while blending with the existing landscaping aesthetic.

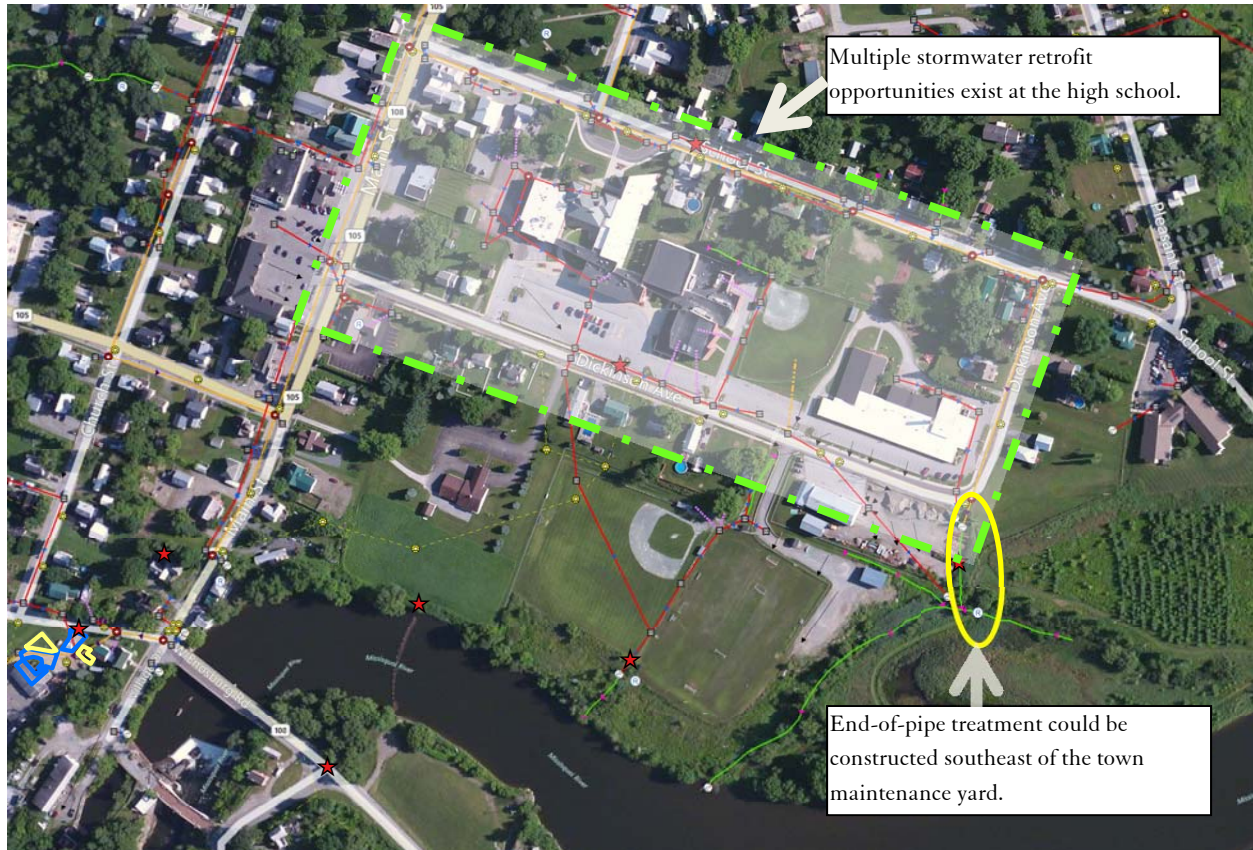
Figure 7. The Enosburg school campus and surrounding Dickinson Avenue neighborhood includes multiple stormwater improvement opportunities.

Stormwater from the Enosburg school campus and much of the surrounding Dickinson Avenue neighborhood is collected in a storm sewer and discharged, untreated, at two locations in the floodplain of the Missisquoi River. Stormwater then drains directly to the Missisquoi River via vegetated swales. This neighborhood includes a large amount of impervious area in the form of rooftops and asphalt pavement.

A two-pronged approach is recommended to treat stormwater from the Enosburg school campus and Dickinson Avenue neighborhood.

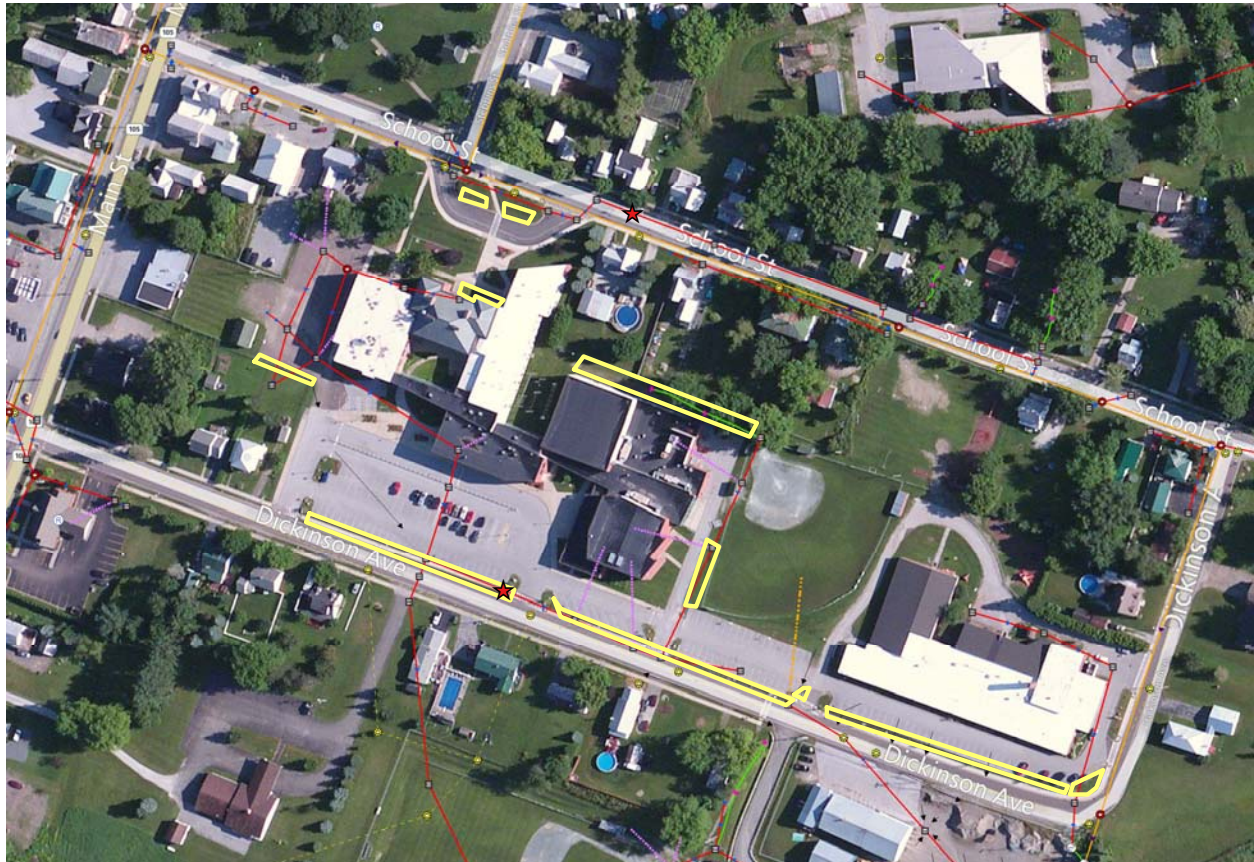
Figure 8. Numerous stormwater retrofit opportunities exist at the Enosburg Falls school property.

Retrofits at the storm sewer inlets could treat stormwater runoff close to the source. The retrofit opportunities that were identified during field investigation are highlighted in Figure 8. It is expected that more opportunities could be identified during a design-level inspection of the campus.

The NRCS reports soils at the school to be Enosburg loamy fine sand, and Eldridge loamy fine sand. As HSG C soil types, both are less than adequate to support infiltration practices. All STPs should include underdrains to assure stormwater is discharged at a satisfactory rate. These retrofits should be relatively straightforward given the proximity of existing stormwater infrastructure at all identified sites.

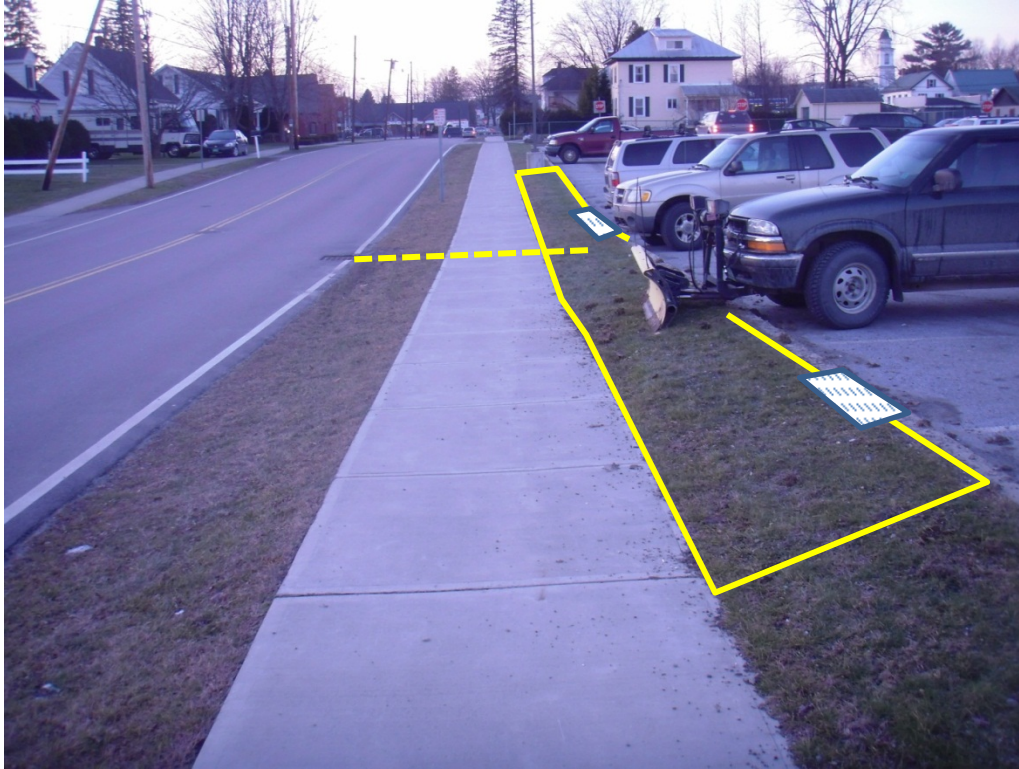
Figure 9. Curb cuts could intercept stormwater runoff from the parking lot as shown. Water could be treated in an infiltration or filter trench within the existing green strip.

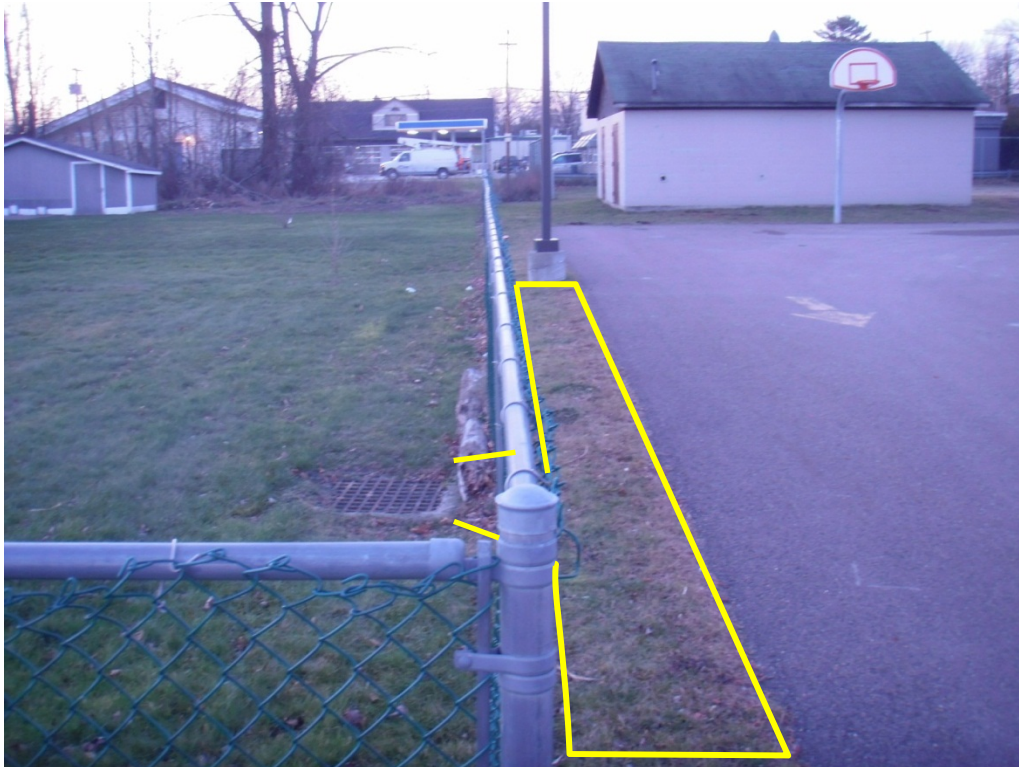
Figure 10. Parking lot runoff could be captured and detained in a small filtration trench or vegetated swale before being discharged to the existing catch basin.

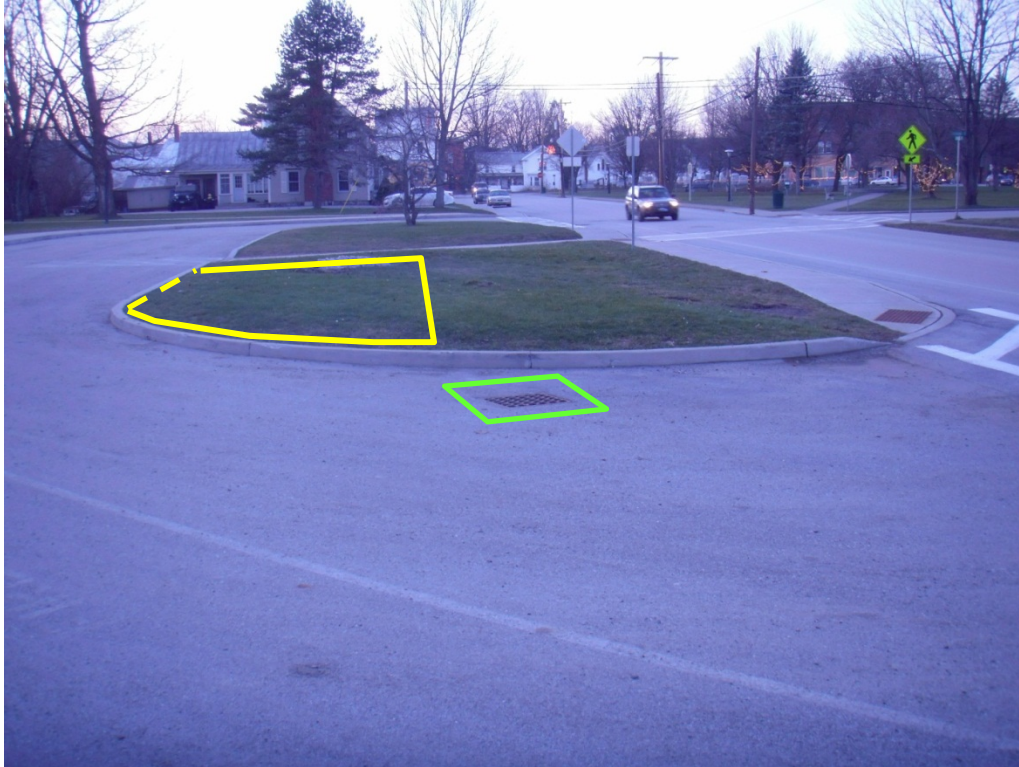
Figure 11. Stormwater currently flows from the left of the photo and then along the curb to the catch basin (highlighted in green). A curb-cut retrofit STP within the existing parking island could intercept and treat runoff.

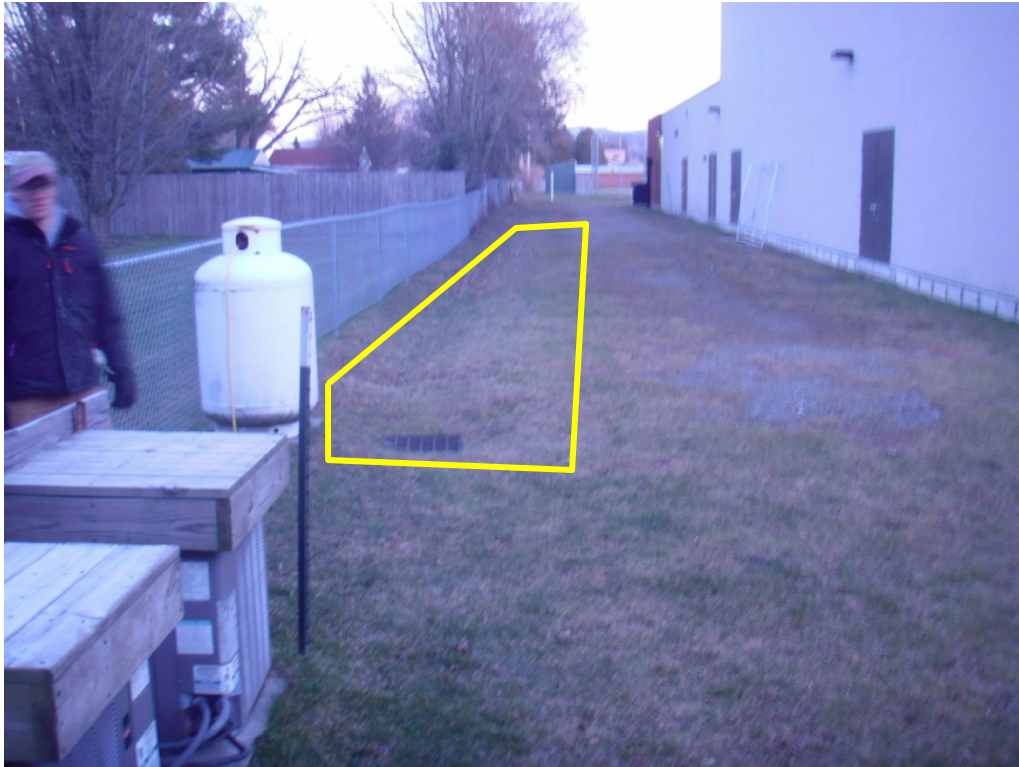
Figure 12. A catch basin to the rear of the high school could easily be retrofitted with a stormwater STP such as a bioretention swale to capture and detain roof runoff.
