STORMWATER MANAGEMENT PLAN FOR THE TOWN OF ENOSBURGH AND VILLAGE OF ENOSBURG FALLS

FINAL REPORT

Stone Project ID 112475-W

March 1, 2013

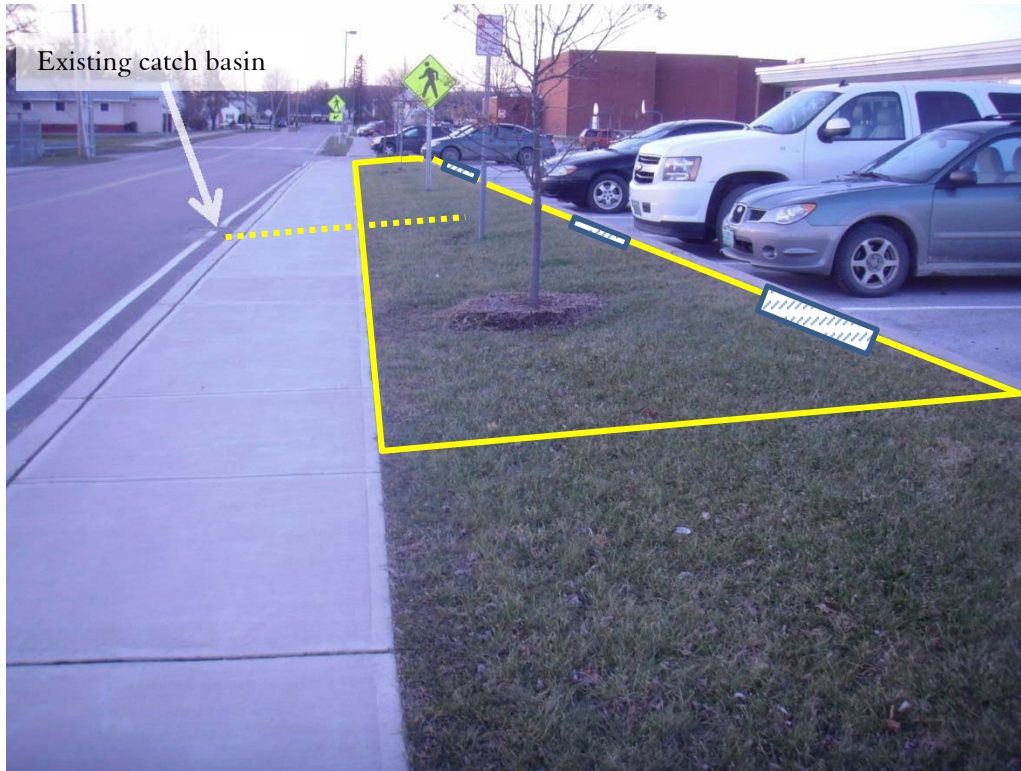
Figure 13. This green strip in front of the elementary school could be modified to treat stormwater. Curb cuts would intercept stormwater from the parking lot. Water could then be treated in the greenstrip before being discharged to the existing storm sewer via an underdrain system.

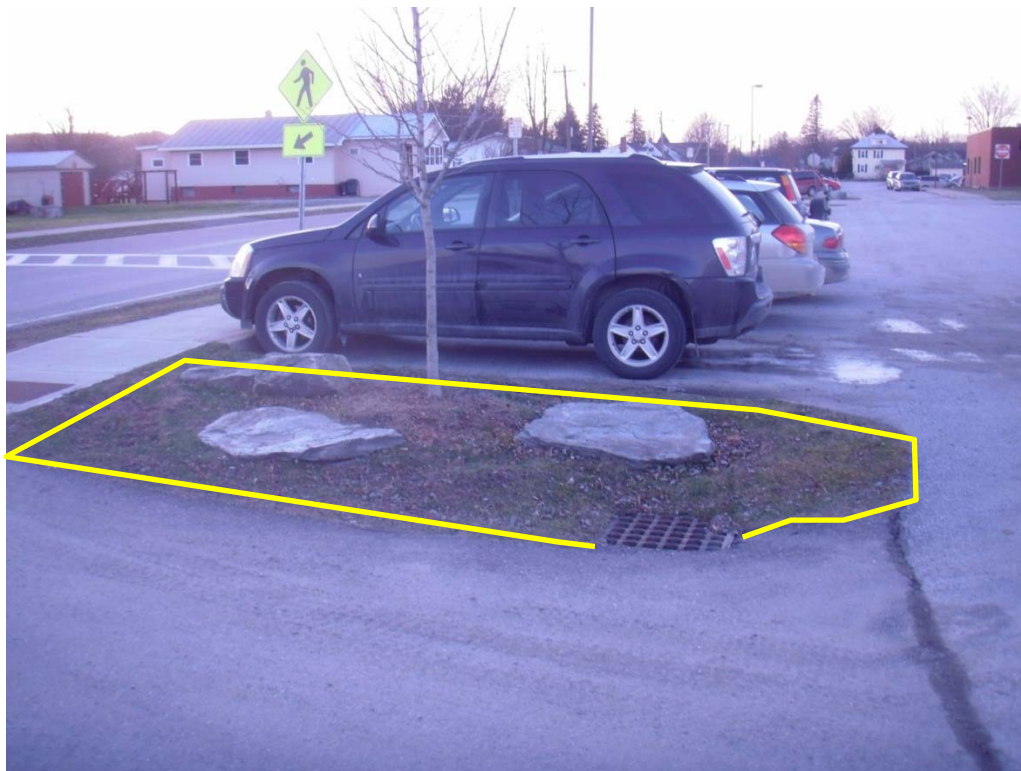
Figure 14. This parking island could be utilized to treat stormwater with a simple retrofit design creating a small bioretention basin.

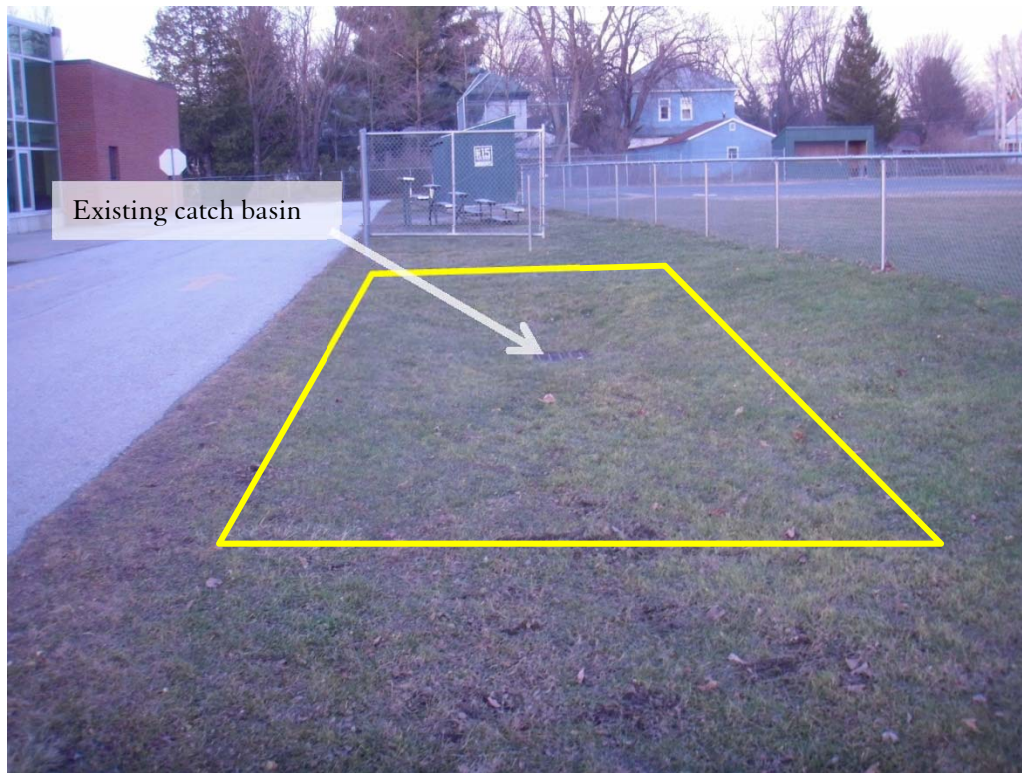
Figure 15. Another example of an existing catch basin that could be modified to provide stormwater treatment in a bioretention basin or similar practice.

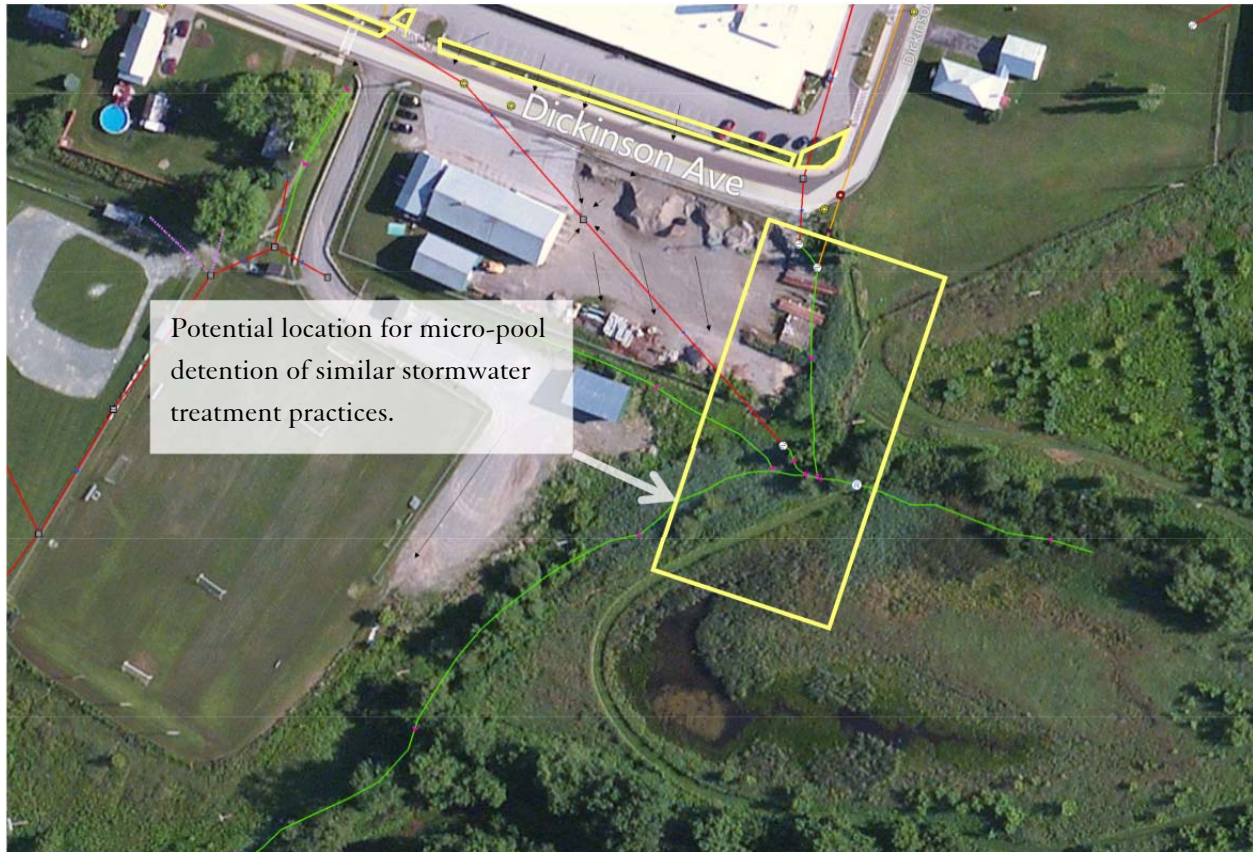
Figure 16. Possible location of proposed STP southeast of the Enosburg Falls road maintenance yard.

The storm sewer line that drains the elementary school portion of the campus and the School Street neighborhood (north of the school) discharges southeast of the maintenance garage. A large amount of space exists near the outfall that could be utilized for a stormwater treatment practice such as a micropool extended detention pond. An example of this type of treatment practice is provided in Figure 17. The village Public Works Director has indicated plans for a significant construction project at the garage in 2013. There could be considerable synergy between this retrofit project and the planned work at the garage. However, if the only feasible locations for an end-of-pipe structure are in the 100-year floodplain, they would not be permissible or eligible for grant-based implementation funding.

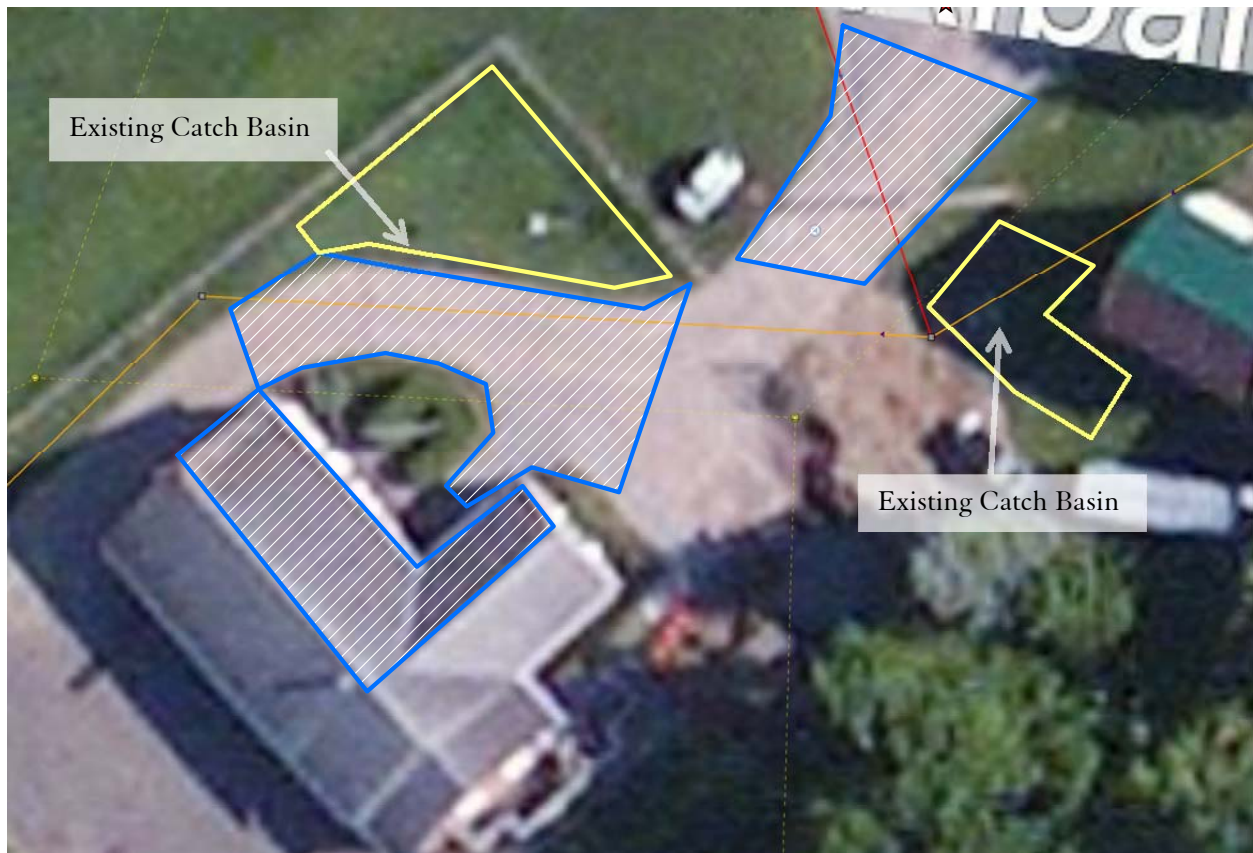
Figure 18. Two STPs could be built around two well-located catch basins at the wastewater treatment plant.

The Enosburg Falls Waste Water Treatment Plant property on St. Albans Street has two catch basins that could be easily retrofitted to treat stormwater. Runoff from portions of two building roofs and two sections of the asphalt drive could be captured and slowly released to the existing stormwater infrastructure through retrofit-bioretention basins. 1/10 of an acre of treatable impervious surface was identified. Figure 19 and Figure 20 show conceptual locations for the proposed STPs. The USGS reports soils at these locations to be Eldridge loamy fine sand. This soil type (HSG C) drains slowly when thoroughly wet. For this reason, infiltration practices are not expected to be effective.

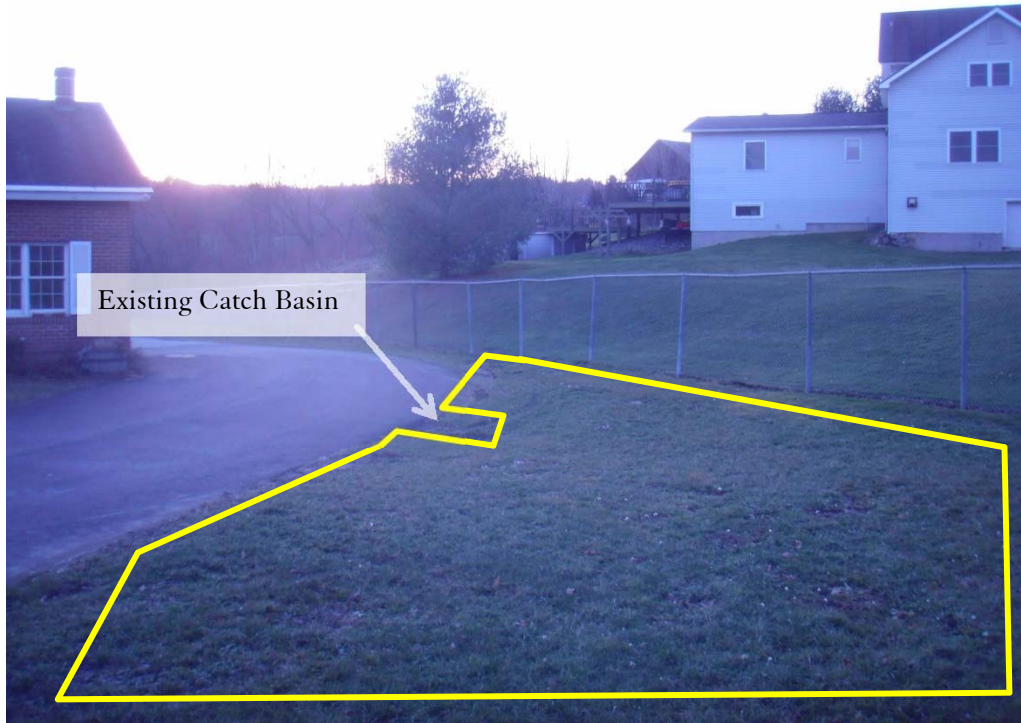
Figure 19. The location of this catch basin makes retrofitting a appealing option.

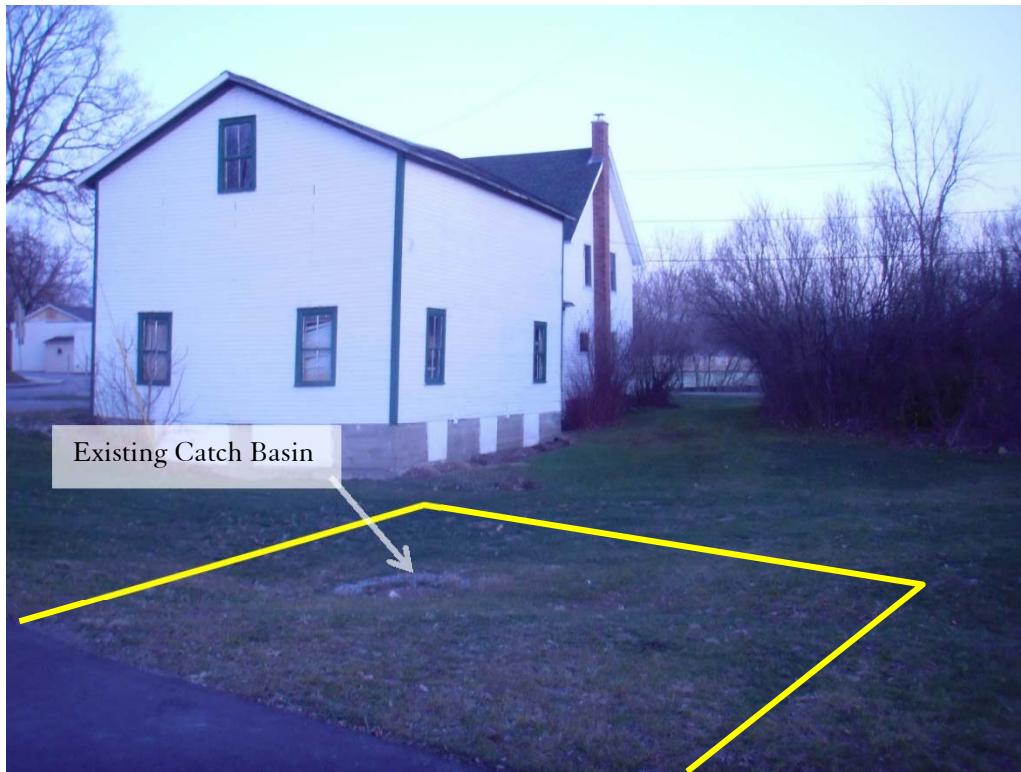
Figure 20. This catch basin located behind the Enosburg Falls village office provides a good retrofit opportunity.
