# Deer Brook Gully Restoration Town of Georgia, Vermont

**17-084**

**Stone Environmental, Inc.**  
535 Stone Cutters Way  
Montpelier / VT 05602  
gbolin@stone-env.com  
603.273.9253

# Deer Brook Gully Restoration, Town of Georgia, Vermont

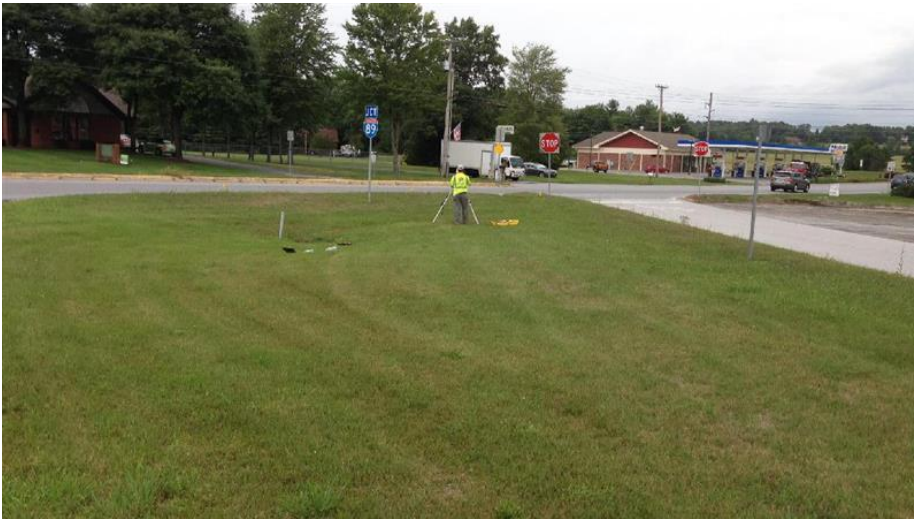
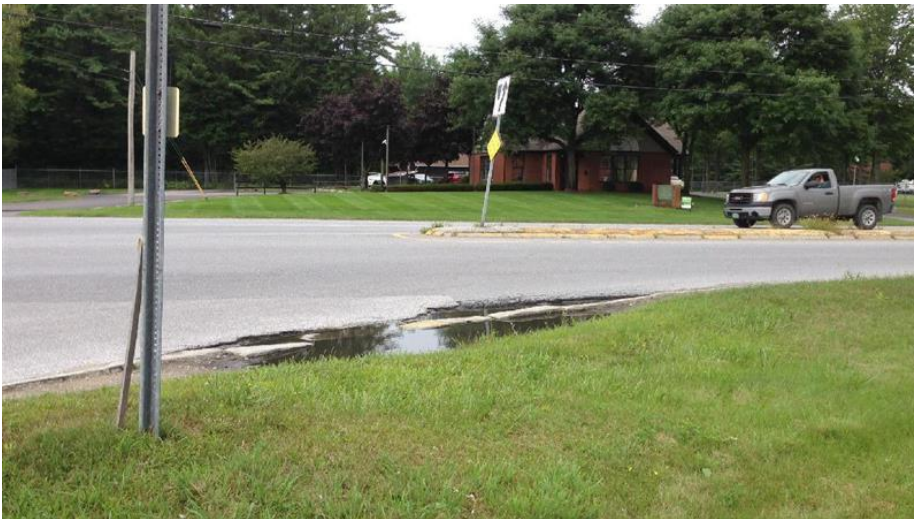
ID# 2, Image 1

<b>ID#: 2</b>																			
<b>Name:</b> Rte 7 - 104A Intersection Island																			
<b>Concept Description:</b> Use existing green space to capture runoff from closed drainage system in water quality/storage retrofit. Green space may be expanded towards Interstate Auto as a result of intersection upgrade. Pavement in front of Interstate Auto may also be removed.																			
<b>Notes/Feasibility:</b> Within the VTrans ROW; utility conflicts include gas.																			
<b>GENERAL SITE INFORMATION</b>	<b>RETROFIT DETAILS</b>																		
<b>Site Contact Info:</b> VTrans	<b>Project Candidate:</b> Yes, high-priority																		
<b>Ownership:</b> Public	<b>New BMP / Retrofit Existing:</b> New BMP																		
<b>Land Use Type:</b> Commercial, Transport-Related (roadway or ROW)	<b>Proposed Retrofit Practice(s):</b> Bioretention or constructed gravel wetland																		
<b>Existing BMP on Site?</b> No	<b>Non-Structural Other:</b>																		
<b>Is site a hotspot?</b> No	<b>Maintenance Burden:</b> Low																		
<b>Sources/pollutants:</b> Sediment, Nutrients, Metals (Cu, Zn, Pb - transportation)

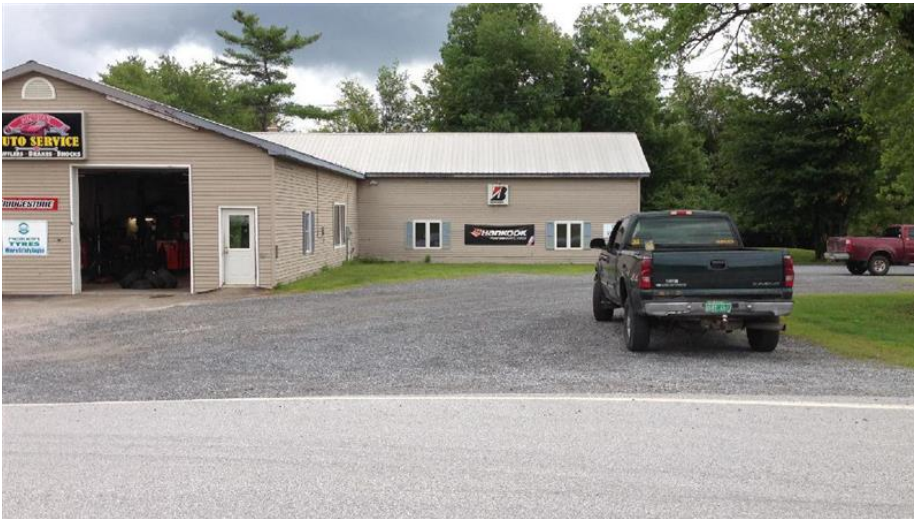
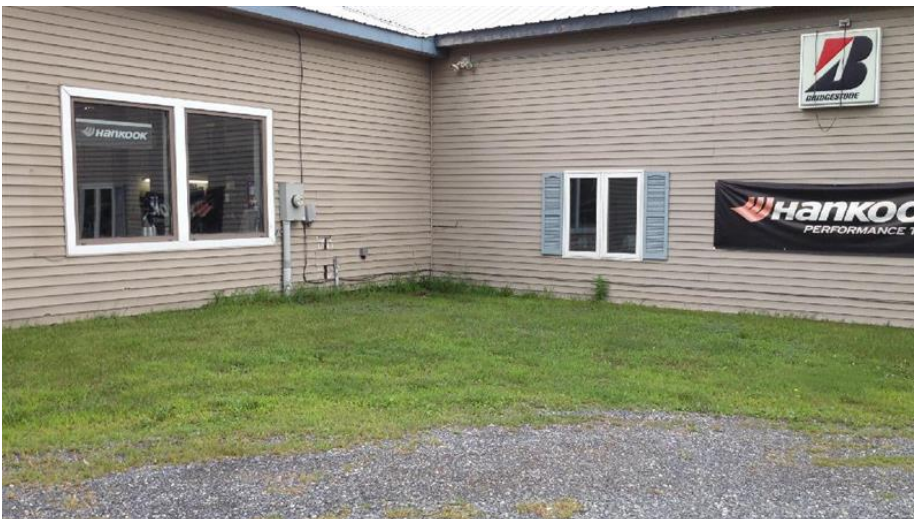
ID# 3, Image 1

<b>ID#: 3</b>																			
<b>Name:</b> Interstate Auto Rain Garden																			
<b>Concept Description:</b> Capture rooftop runoff from portions of Interstate Auto building in a small rain garden. A small portion of the gravel driveway may also be made to drain to this practice.																			
<b>Notes/Feasibility:</b> Utility conflicts may include gas and electric.																			
<b>GENERAL SITE INFORMATION</b>	<b>RETROFIT DETAILS</b>																		
<b>Site Contact Info:</b>	<b>Project Candidate:</b> Ok																		
<b>Ownership:</b> Private	<b>New BMP / Retrofit Existing:</b> New BMP																		
<b>Land Use Type:</b> Commercial	<b>Proposed Retrofit Practice(s):</b> Rain garden																		
<b>Land Use Detail:</b>	<b>Non-Structural Controls:</b>																		
<b>Existing BMP on Site?</b> No	<b>Non-Structural Other:</b>																		
<b>Is site a hotspot?</b> Yes	<b>Maintenance Burden:</b> Medium																		
<b>Sources/pollutants:</b> Sediment, Nutrients, Metals (Cu, Zn, Pb, e.g., transportation)

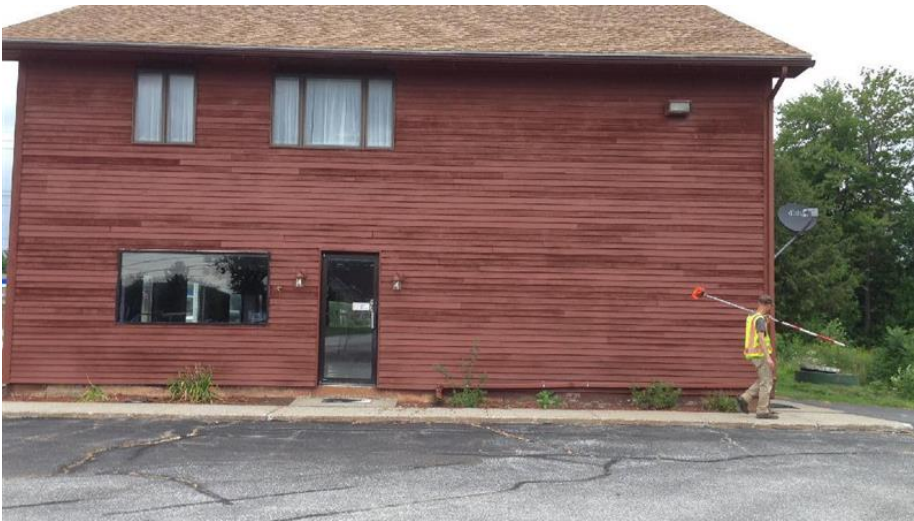
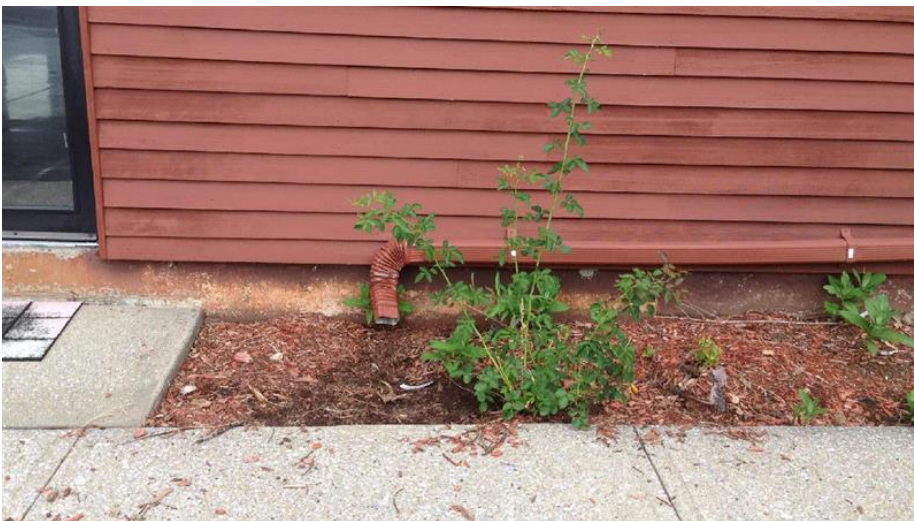
ID# 4, Image 1

<b>ID#: 4</b>																			
<b>Name:</b> Office Roof Disconnection #1																			
<b>Concept Description:</b> Direct existing gutter and downspout to dry well or expanded rain garden to manage runoff from half of the pitched roof.																			
<b>Notes/Feasibility:</b> Existing septic drywell in backyard, and limited pervious area, substantially constrain this opportunity. Property is currently vacant.																			
<b>GENERAL SITE INFORMATION</b>	<b>RETROFIT DETAILS</b>																		
<b>Site Contact Info:</b>	<b>Project Candidate:</b> Ok																		
<b>Ownership:</b> Private	<b>New BMP / Retrofit Existing:</b> New BMP																		
<b>Land Use Type:</b> Commercial	<b>Proposed Retrofit Practice(s):</b> Rain garden, dry well																		
<b>Land Use Detail:</b> Office and apartment	<b>Non-Structural Controls:</b>																		
<b>Existing BMP on Site?</b> No	<b>Non-Structural Other:</b>																		
<b>Is site a hotspot?</b> No	<b>Maintenance Burden:</b> Low																		
<b>Sources/pollutants:</b> Sediment, Nutrients

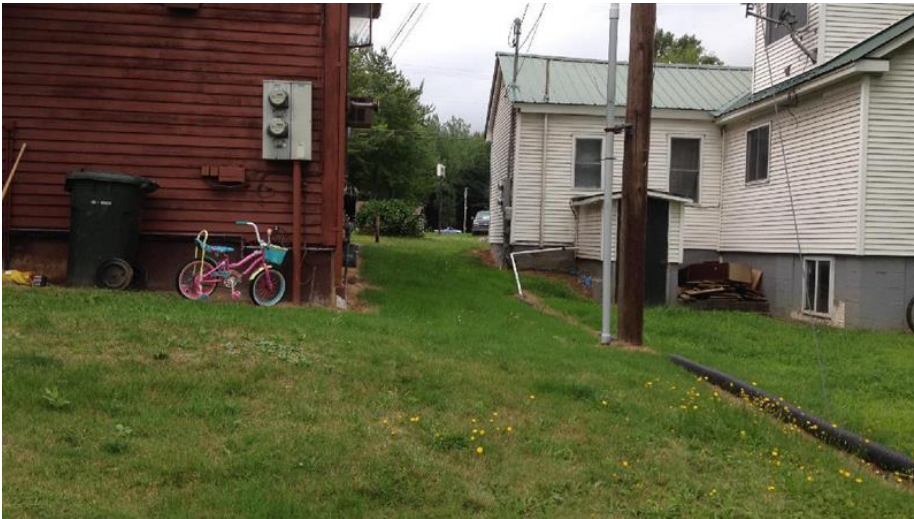
ID# 5, Image 1

<b>ID#: 5</b>																			
<b>Name:</b> Office Roof Disconnection #2																			
<b>Concept Description:</b> Confirm outlet of existing downspout to roof leader. If it currently outlets to gully, propose disconnection via overland flow, rain garden, or dry well.																			
<b>Notes/Feasibility:</b> Existing septic dry well in backyard significantly constrains opportunity and available space.																			
<b>GENERAL SITE INFORMATION</b>																			
<b>Site Contact Info:</b>	<b>RETROFIT DETAILS</b>																		
<b>Ownership:</b> Private	<b>Project Candidate:</b> Ok																		
<b>Land Use Type:</b> Commercial	<b>New BMP / Retrofit Existing:</b> New BMP																		
<b>Land Use Detail:</b>	<b>Proposed Retrofit Practice(s):</b> Rain garden, dry well																		
<b>Existing BMP on Site?</b> No	<b>Non-Structural Controls:</b>																		
<b>Is site a hotspot?</b> No	<b>Non-Structural Other:</b>																		
<b>Sources/pollutants:</b> Sediment, Nutrients	<b>Maintenance Burden:</b> Low																		
<b>Soils:</b> A/D

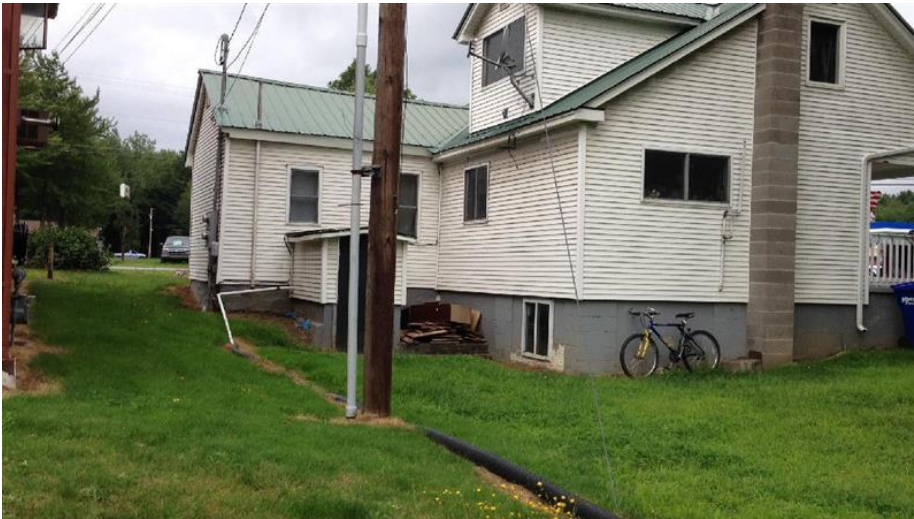
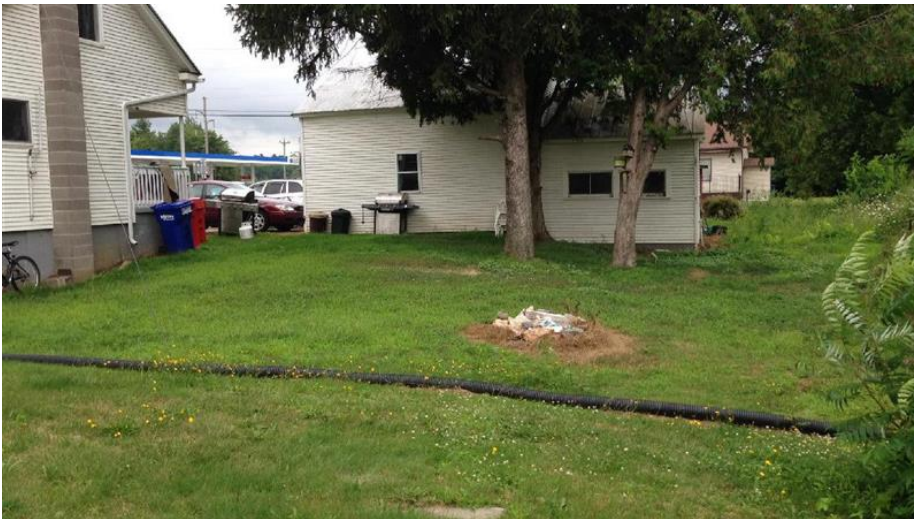
ID# 6, Image 1

<b>ID#: 6</b>																			
<b>Name:</b> Roof Runoff and Sump Disconnection																			
<b>Concept Description:</b> Roof runoff from majority of abutting residences, and line from sump pump, drain through the backyard to head of gully. Opportunity to redirect runoff to a small rain garden in backyard.																			
<b>Notes/Feasibility:</b> Location of septic system unknown. Overhead electric may further constrain available space. Sump drainage currently runs through 6 inch corrugated plastic pipe to gully rim.																			
<b>GENERAL SITE INFORMATION</b>																			
<b>Site Contact Info:</b>	<b>RETROFIT DETAILS</b>																		
<b>Ownership:</b> Private	<b>Project Candidate:</b> Ok																		
<b>Land Use Type:</b> Single Family Residential (< 1 ac. lots)	<b>New BMP / Retrofit Existing:</b> New BMP																		
<b>Land Use Detail:</b> Single family homes	<b>Proposed Retrofit Practice(s):</b> Rain garden																		
<b>Existing BMP on Site?</b> No	<b>Non-Structural Controls:</b>																		
<b>Is site a hotspot?</b> No	<b>Non-Structural Other:</b>																		
<b>Sources/pollutants:</b> Sediment, Nutrients	<b>Maintenance Burden:</b> Medium																		
<b>Soils:</b> A/D

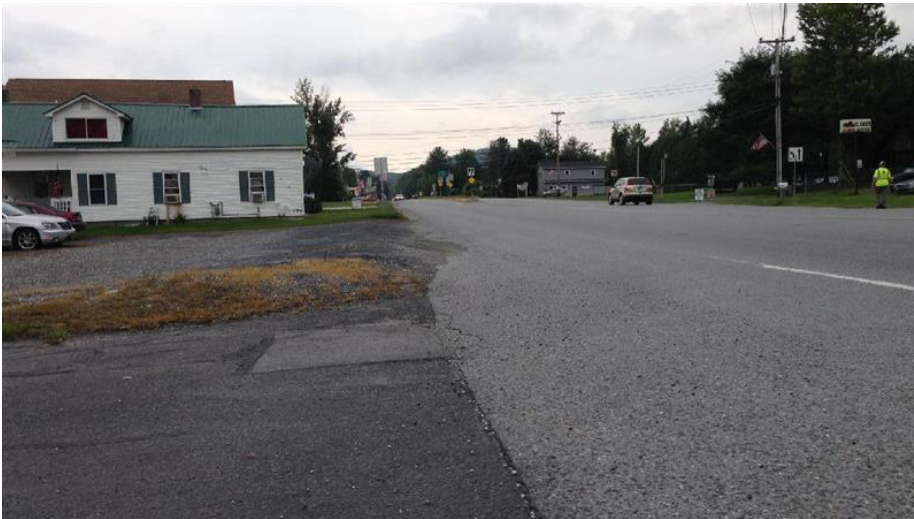
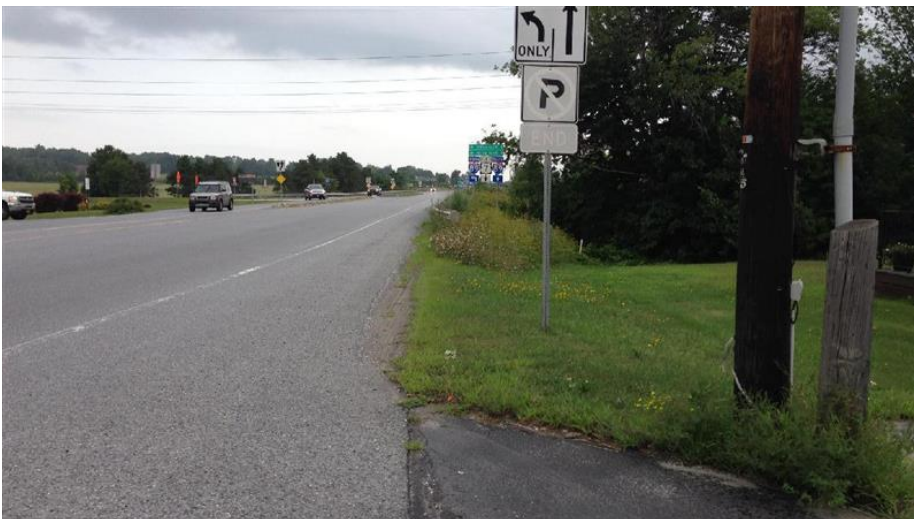
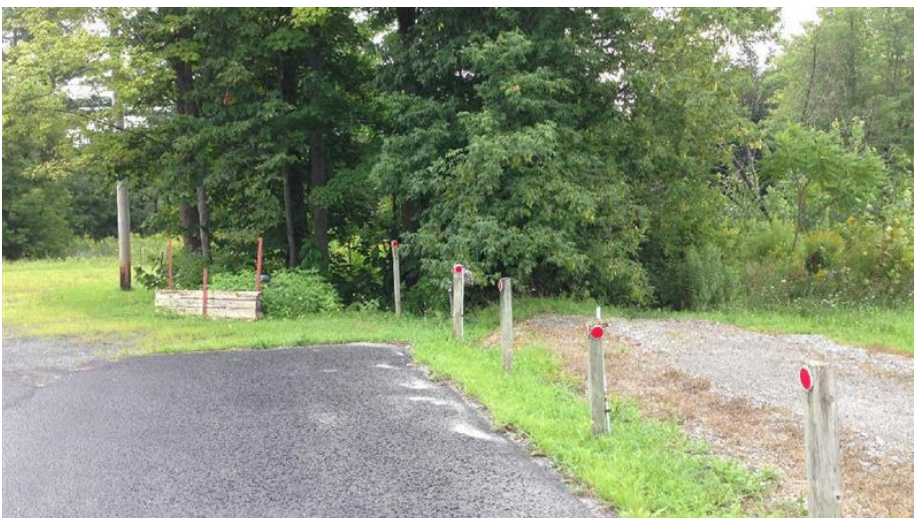
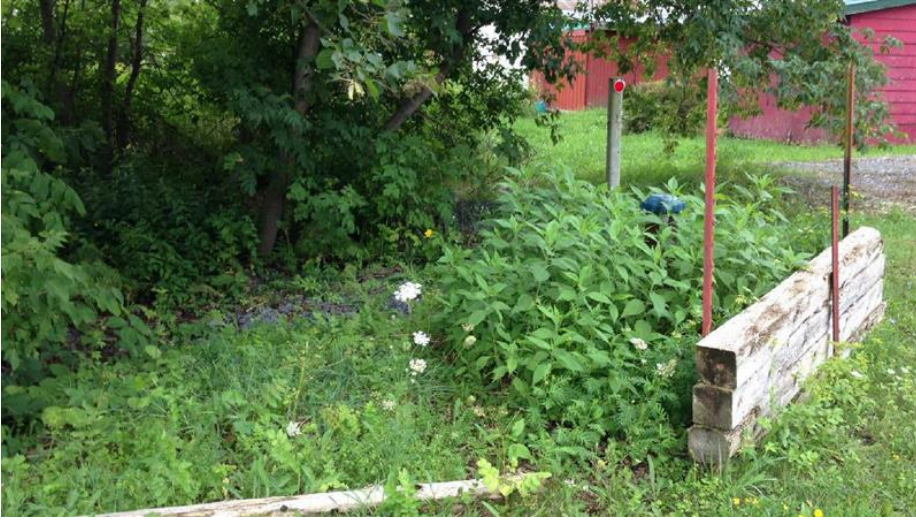
ID# 7, Image 1

<b>ID#: 7</b>																			
<b>Name:</b> 1193 Rte 7 Detention																			
<b>Concept Description:</b> Create a detention basin, subsurface gravel wetland, or other combination water quality and storage retrofit either in narrow green space or where trees are at head of contributing channel to gully. Immediately west of major, recent slope repair by private owner.																			
<b>Notes/Feasibility:</b> Existing drilled well is right next to stone lined channel leading to gully. Overhead electric also a possible conflict. There may be an opportunity to redirect runoff to flat former parking area in back of building. Septic system location unknown.																			
<b>GENERAL SITE INFORMATION</b>																			
<b>Site Contact Info:</b>	<b>RETROFIT DETAILS</b>																		
<b>Ownership:</b> Private	<b>Project Candidate:</b> Yes																		
<b>Land Use Type:</b> Commercial	<b>New BMP / Retrofit Existing:</b> New BMP																		
<b>Land Use Detail:</b> Office and parking; road	<b>Proposed Retrofit Practice(s):</b> Constructed gravel wetland																		
<b>Existing BMP on Site?</b> No	<b>Non-Structural Controls:</b>																		
<b>Is site a hotspot?</b> No	<b>Non-Structural Other:</b>																		
<b>Sources/pollutants:</b> Sediment, Nutrients, Metals (Cu, Zn, Pb, e.g., transportation)	<b>Maintenance Burden:</b> Low																		
<b>Soils:</b> A

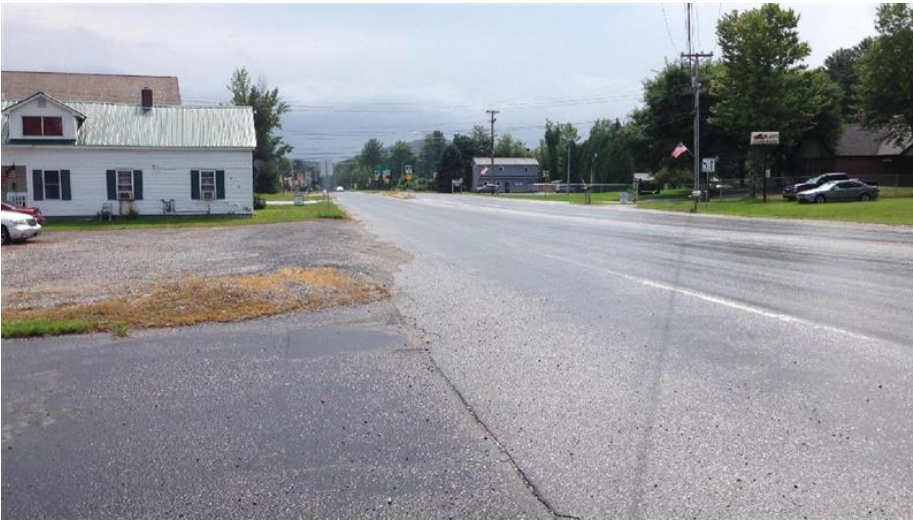
ID# 8, Image 1

<b>ID#: 8</b>																			
<b>Name:</b> 1193 Rte 7 Alternate Retrofit																			
<b>Concept Description:</b> As part of intersection upgrade, consider installing a catch basin with offline water quality treatment – or deep sump catch basin at minimum – and connect to site 2 or at least to closed drainage, instead of upgrade proposed at site #7.																			
<b>Notes/Feasibility:</b> Utility conflicts include overhead electric and telecom. Connection of this area to the closed drainage would at minimum mitigate erosion and instability immediately west of recent private slope stabilization work. Additional water quality or volume management could occur at #2 location.																			
<b>GENERAL SITE INFORMATION</b>																			
<b>Site Contact Info:</b> VTrans	<b>RETROFIT DETAILS</b>																		
<b>Ownership:</b> Public	<b>Project Candidate:</b> Yes																		
<b>Land Use Type:</b> Commercial, Transport-Related (roadway or ROW)	<b>New BMP / Retrofit Existing:</b> New BMP																		
<b>Land Use Detail:</b> Roadway	<b>Proposed Retrofit Practice(s):</b> Deep sump catch basin, Vault																		
<b>Existing BMP on Site?</b> No	<b>Non-Structural Controls:</b>																		
<b>Is site a hotspot?</b> No	<b>Non-Structural Other:</b>																		
<b>Sources/pollutants:</b> Sediment, Nutrients, Metals (Cu, Zn, Pb, e.g., transportation)	<b>Maintenance Burden:</b> Medium																		
<b>Soils:</b> C/D

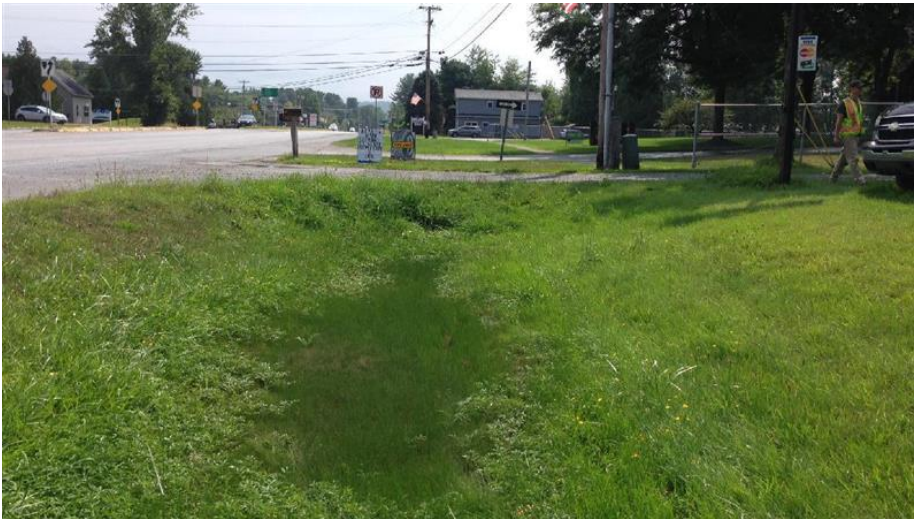
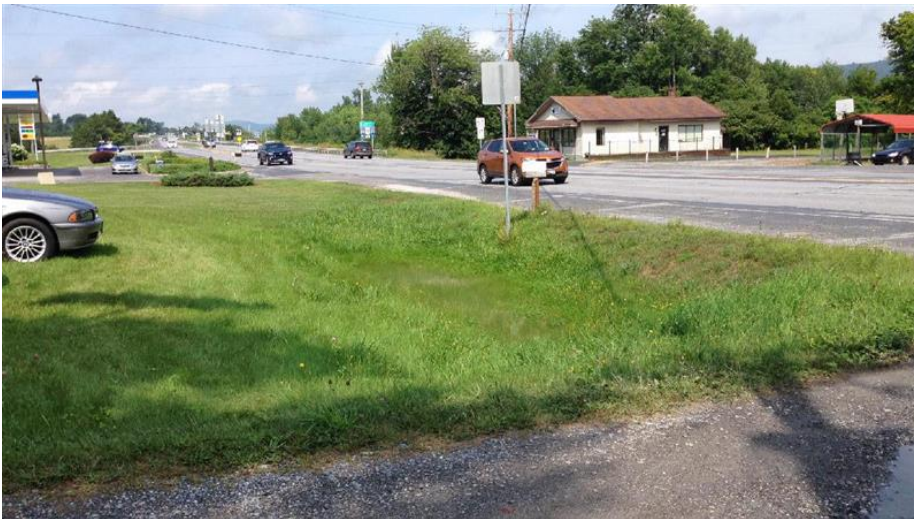
ID# 9, Image 1

<b>ID#:</b> 9																			
<b>Name:</b> Blake's Auto Service Retrofit																			
<b>Concept Description:</b> Consider a small gravel wetland or bioretention practice in deep swale next to Route 7. Generally low-priority.																			
<b>Notes/Feasibility:</b> Very small drainage area and little contributing impervious.																			
<b>GENERAL SITE INFORMATION</b>																			
<b>Site Contact Info:</b> VTrans	<b>RETROFIT DETAILS</b>																		
<b>Ownership:</b> Public	<b>Project Candidate:</b> Ok																		
<b>Land Use Type:</b> Commercial, Transport-Related (roadway or ROW)	<b>New BMP / Retrofit Existing:</b> New BMP																		
<b>Land Use Detail:</b>	<b>Proposed Retrofit Practice(s):</b> Constructed gravel wetland																		
<b>Existing BMP on Site?</b> No	<b>Non-Structural Controls:</b>																		
<b>Is site a hotspot?</b> No	<b>Non-Structural Other:</b>																		
<b>Sources/pollutants:</b> Sediment, Nutrients, Metals (Cu, Zn, Pb, e.g., transportation)	<b>Maintenance Burden:</b> Medium																		
<b>Soils:</b> A/D

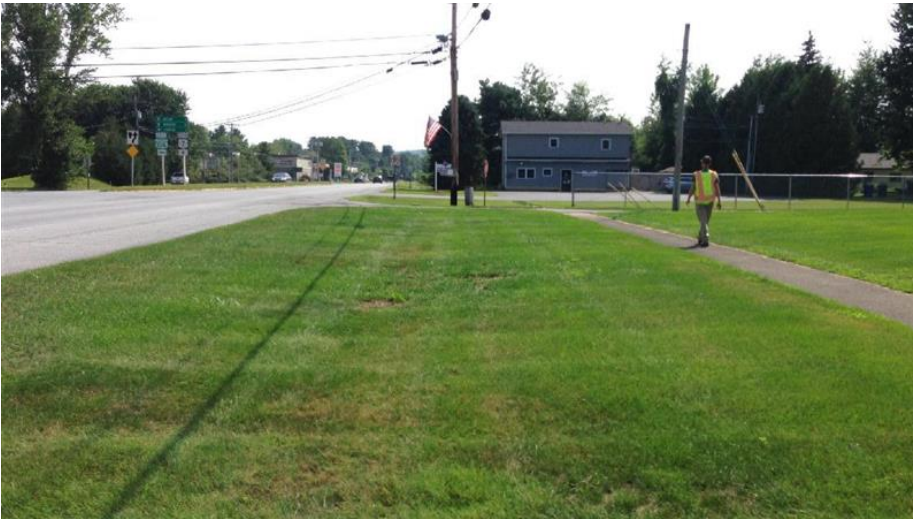
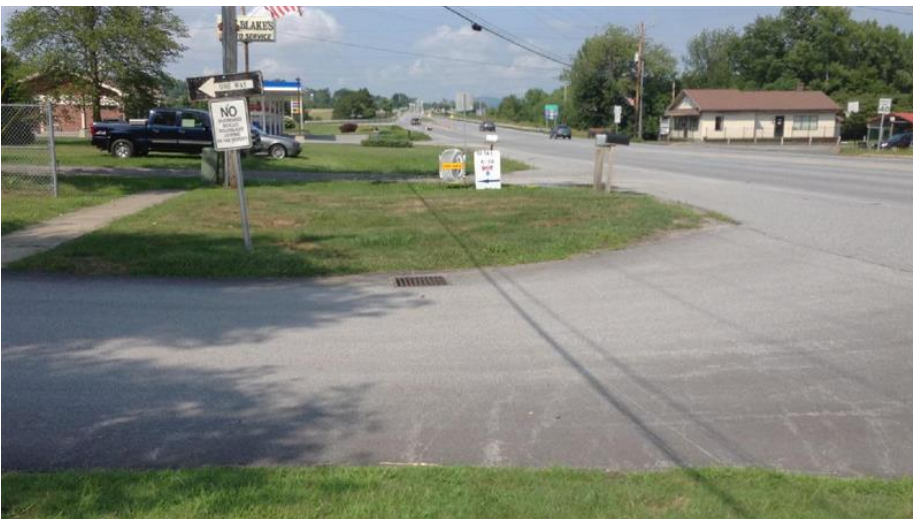
ID# 10, Image 1

<b>ID#: 10</b>																			
<b>Name:</b> Peoples Trust Company Storage & WQ Retrofit																			
<b>Concept Description:</b> Daylight culvert between catch basin and manhole and implement a storage and/or water quality practice in ROW. Sufficient area likely exists to manage more than the Water Quality Volume, providing relief at gully head/system outlet.																			
<b>Notes/Feasibility:</b> Ample green space in the ROW; historically it is likely a swale existed here. Electric and telecom are overhead; gas lateral is a likely conflict. Not clear whether intersection improvements would reduce available ROW space for stormwater management.																			
<b>GENERAL SITE INFORMATION</b>																			
<b>Site Contact Info:</b> VTrans	<b>RETROFIT DETAILS</b>																		
<b>Ownership:</b> Public	<b>Project Candidate:</b> Yes																		
<b>Land Use Type:</b> Commercial, Transport-Related (roadway or ROW)	<b>New BMP / Retrofit Existing:</b> New BMP																		
<b>Existing BMP on Site?</b> No	<b>Proposed Retrofit Practice(s):</b> Constructed gravel wetland																		
<b>Is site a hotspot?</b> No	<b>Non-Structural Other:</b>																		
<b>Sources/pollutants:</b> Sediment, Nutrients, Metals (Cu, Zn, Pb, e.g., transportation)	<b>Maintenance Burden:</b> Low																		
<b>Soils:</b> A/D

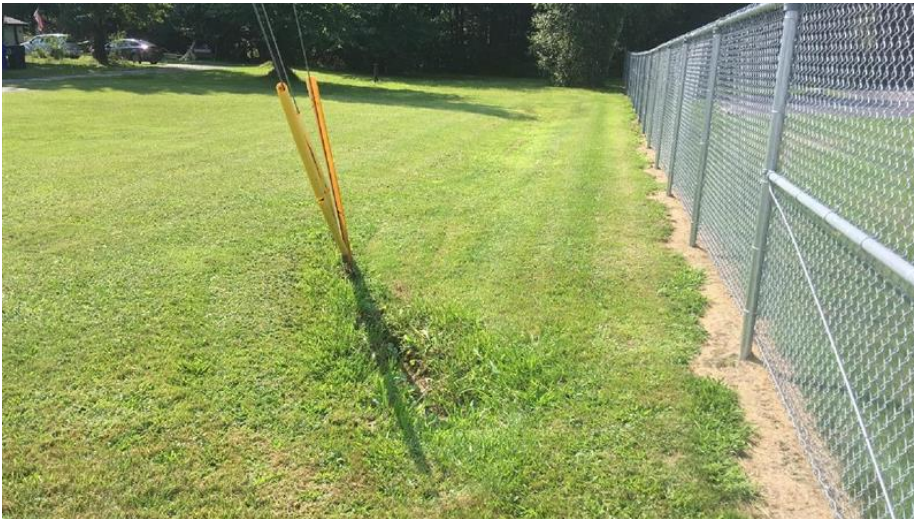
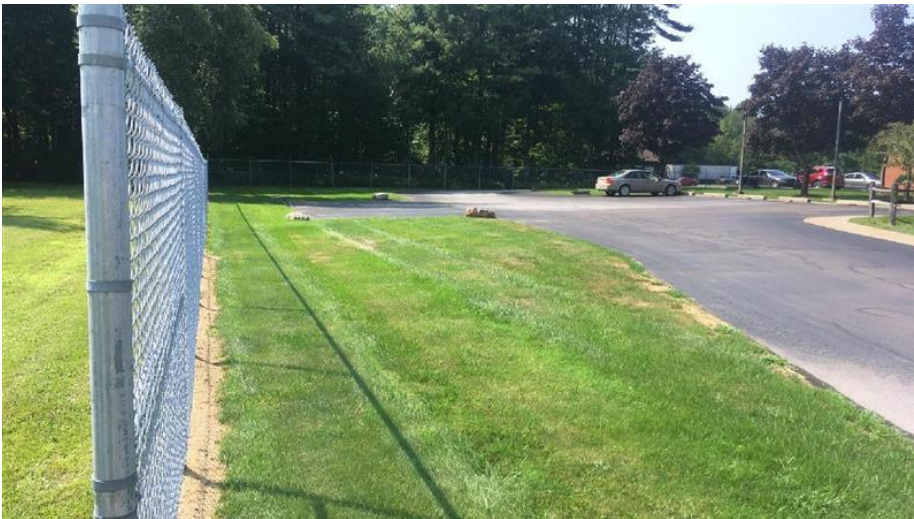
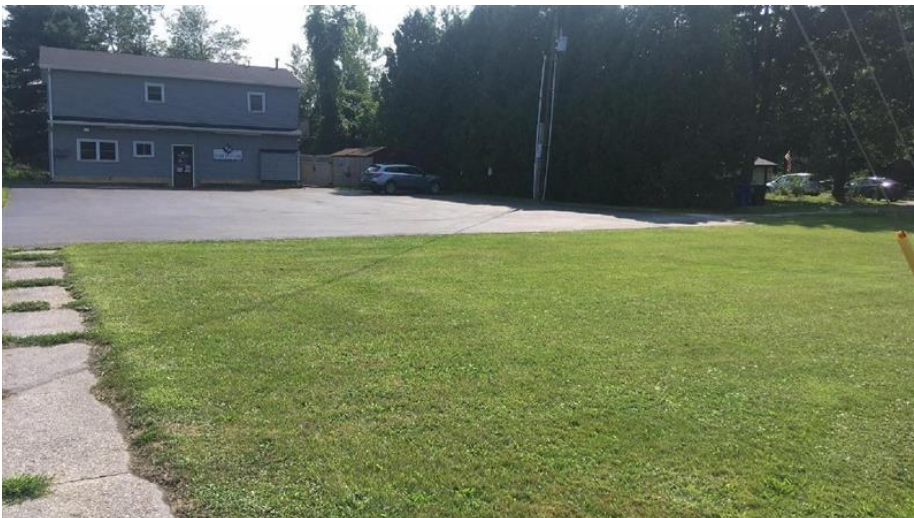
ID# 11, Image 1

<b>ID#: 11</b>																			
<b>Name:</b> Hair Designs Swale Improvements																			
<b>Concept Description:</b> Increase swale geometry to store runoff and improve water quality. Drainage from bank parking lot and grass lawn is conveyed to this swale. Owner reported flooding issues at CB4 during large events. Consider bioretention or gravel wetland. Owner also potentially open to low-maintenance practice in roadway swale.																			
<b>Notes/Feasibility:</b> 6" CMP not visible in CB4, suspected to be buried via accumulated sediment in catch basin. Yard floods, limited infiltration. Septic replacment area between parking lot and fence. Tenants well is visible from CB4. Another well exists in woods.																			
<b>GENERAL SITE INFORMATION</b>																			
<b>Site Contact Info:</b>	<b>RETROFIT DETAILS</b>																		
<b>Ownership:</b> Private	<b>Project Candidate:</b> Yes																		
<b>Land Use Type:</b> Commercial, Single Family Residential (<1 ac. lots)	<b>New BMP / Retrofit Existing:</b> Existing BMP																		
<b>Land Use Detail:</b>	<b>Proposed Retrofit Practice(s):</b> Constructed gravel wetland																		
<b>Existing BMP on Site?</b> Yes	<b>Non-Structural Controls:</b>																		
<b>Is site a hotspot?</b> No	<b>Non-Structural Other:</b>																		
<b>Sources/pollutants:</b> Sediment, Nutrients	<b>Maintenance Burden:</b> Low																		
<b>Soils:</b> A/D

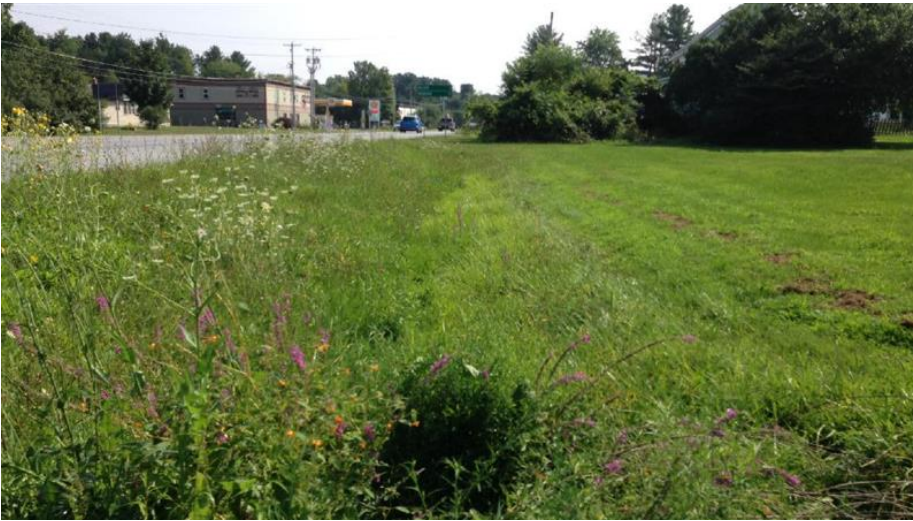
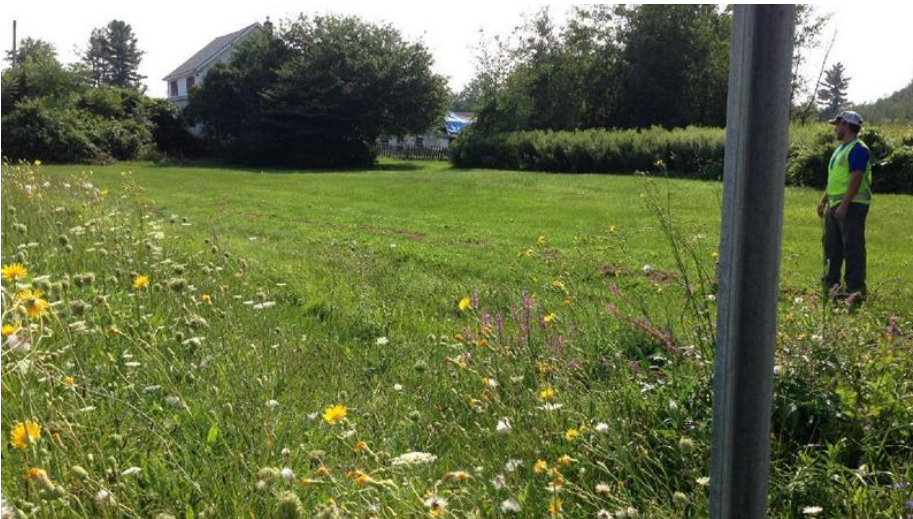
ID# 12, Image 1

<b>ID#: 12</b>																			
<b>Name:</b> Rte 7 Retrofit #1																			
<b>Concept Description:</b> Implement gravel wetlands or storage retrofit in existing swale next to Route 7. Sufficient area is available to manage more than the WQv, and potentially above the HCv/CPv, providing peak flow reduction benefit as well as water quality treatment.																			
<b>Notes/Feasibility:</b> No apparent utility conflicts. The west side of US Rte 7 in this area drains to this swale.																			
<b>GENERAL SITE INFORMATION</b>																			
<b>Site Contact Info:</b> VTrans	<b>Project Candidate:</b> Yes, high-priority																		
<b>Ownership:</b> Public and private	<b>New BMP / Retrofit Existing:</b> New BMP																		
<b>Land Use Type:</b> Single Family Residential, Commercial, Roadway/ROW	<b>Proposed Retrofit Practice(s):</b> Constructed gravel wetland																		
<b>Land Use Detail:</b>	<b>Non-Structural Controls:</b>																		
<b>Existing BMP on Site?</b> No	<b>Non-Structural Other:</b>																		
<b>Is site a hotspot?</b> No	<b>Maintenance Burden:</b> Low																		
<b>Sources/pollutants:</b> Sediment, Nutrients, Metals (Cu, Zn, Pb, e.g., transportation)

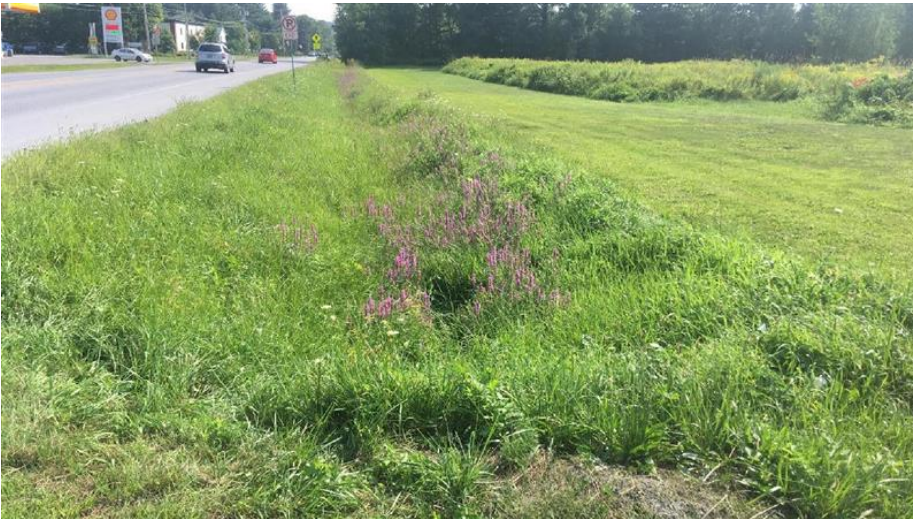
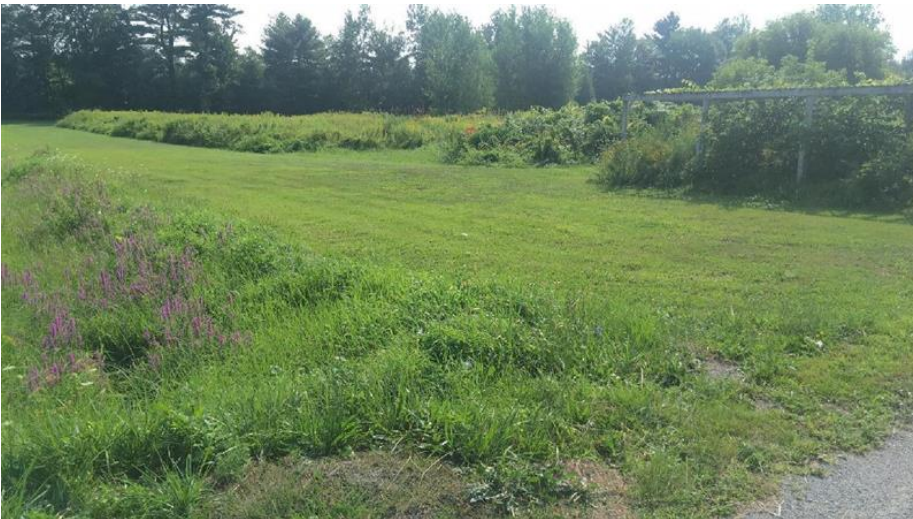
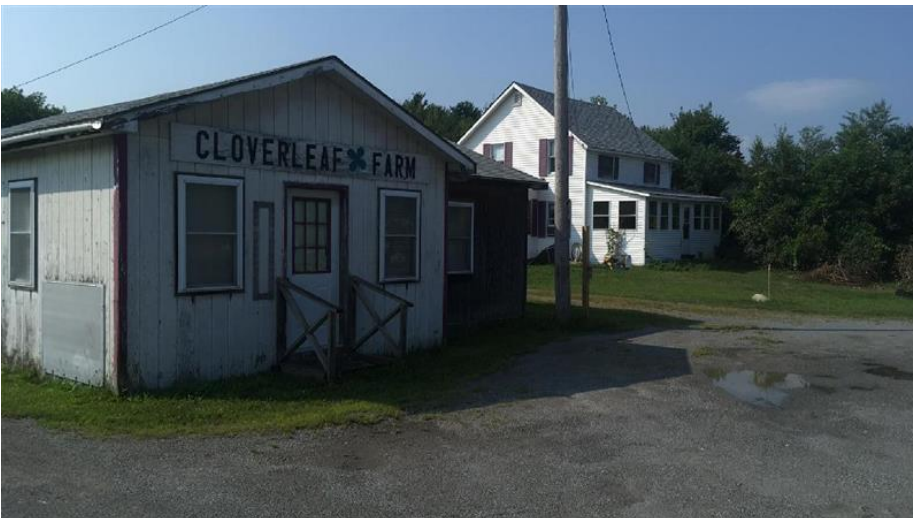
ID# 13, Image 1

<b>ID#: 13</b>																			
<b>Name:</b> Rte 7 Retrofit #2																			
<b>Concept Description:</b> Potential gravel wetland in swale. Moderate head anticipated along length of basin. Captures flow from road and field. Sufficient area exists to manage well more than the WQv from contributing impervious, and potentially more than CPv, providing peak flow reduction benefits at system outfall/head of gully.																			
<b>Notes/Feasibility:</b> This swale is also connected to swale system at Georgia Eye Center (which has substantial connected impervious with almost no space for treatment on site). Despite HSG A in soil survey, conditions observed during site visit indicate limited to no infiltration should be expected.																			
<b>GENERAL SITE INFORMATION</b>	<b>RETROFIT DETAILS</b>																		
<b>Site Contact Info:</b> VTrans	<b>Project Candidate:</b> Yes																		
<b>Ownership:</b>	<b>New BMP / Retrofit Existing:</b> Existing BMP																		
<b>Land Use Type:</b> Single Family Residential (> 1 ac. lots), Commercial, Agricultural	<b>Proposed Retrofit Practice(s):</b> Constructed gravel wetland																		
<b>Land Use Detail:</b>	<b>Non-Structural Controls:</b>																		
<b>Existing BMP on Site?</b> Yes	<b>Non-Structural Other:</b>																		
<b>Is site a hotspot?</b> No	<b>Maintenance Burden:</b> Low																		
<b>Sources/pollutants:</b> Sediment, Nutrients, Metals

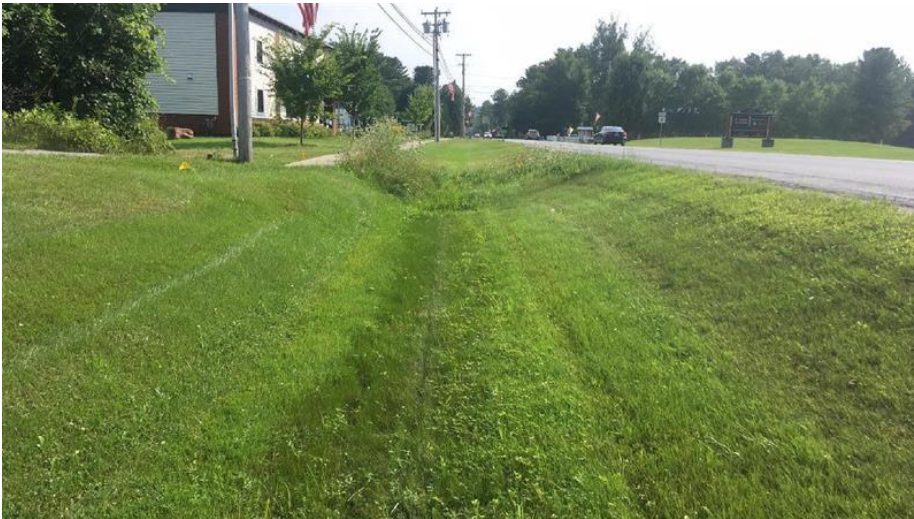
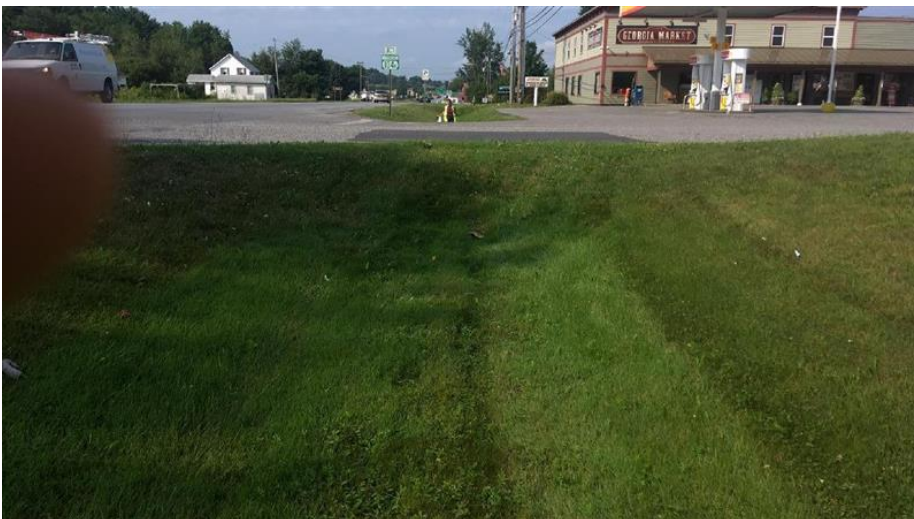
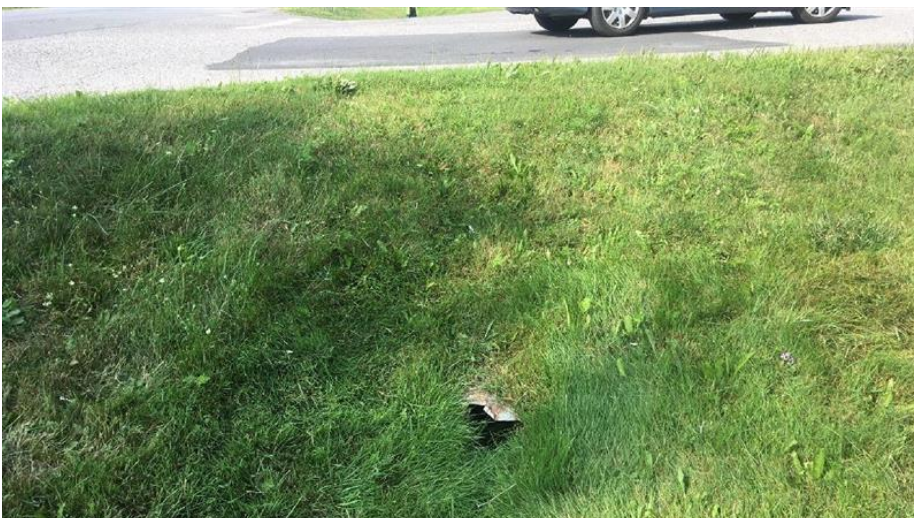
ID# 14, Image 1

<b>ID#: 14</b>																			
<b>Name:</b> Rte 7 Retrofit #3																			
<b>Concept Description:</b> Potentially retrofit existing swale outlet pipe at Georgia Market entrance with stand pipe that has low flow channel and high flow discharge, to create more volume storage. Upsize existing driveway culvert. Sufficient area exists to manage substantially more than the WQv and CPv, providing peak flow attenuation in addition to water quality treatment.																			
<b>Notes/Feasibility:</b> Existing pipe under entrance is 12" CMP that is half buried by sediment at both ends. Entrance has caved in and compromised pipe on downstream end.																			
<b>GENERAL SITE INFORMATION</b>	<b>RETROFIT DETAILS</b>																		
<b>Site Contact Info:</b> VTrans	<b>Project Candidate:</b> Yes																		
<b>Ownership:</b>	<b>New BMP / Retrofit Existing:</b> Existing BMP																		
<b>Land Use Type:</b> Commercial	<b>Proposed Retrofit Practice(s):</b> Bioswale, gravel wetland, culvert repair or replacement																		
<b>Land Use Detail:</b>	<b>Non-Structural Controls:</b>																		
<b>Existing BMP on Site?</b> Yes	<b>Non-Structural Other:</b>																		
<b>Is site a hotspot?</b> No	<b>Maintenance Burden:</b> Low																		
<b>Sources/pollutants:</b> Sediment, Nutrients
