Deer Brook Georgia, Vermont

Georgia Industrial Park,
Deer Brook Watershed

Georgia Stormwater
Management Planning

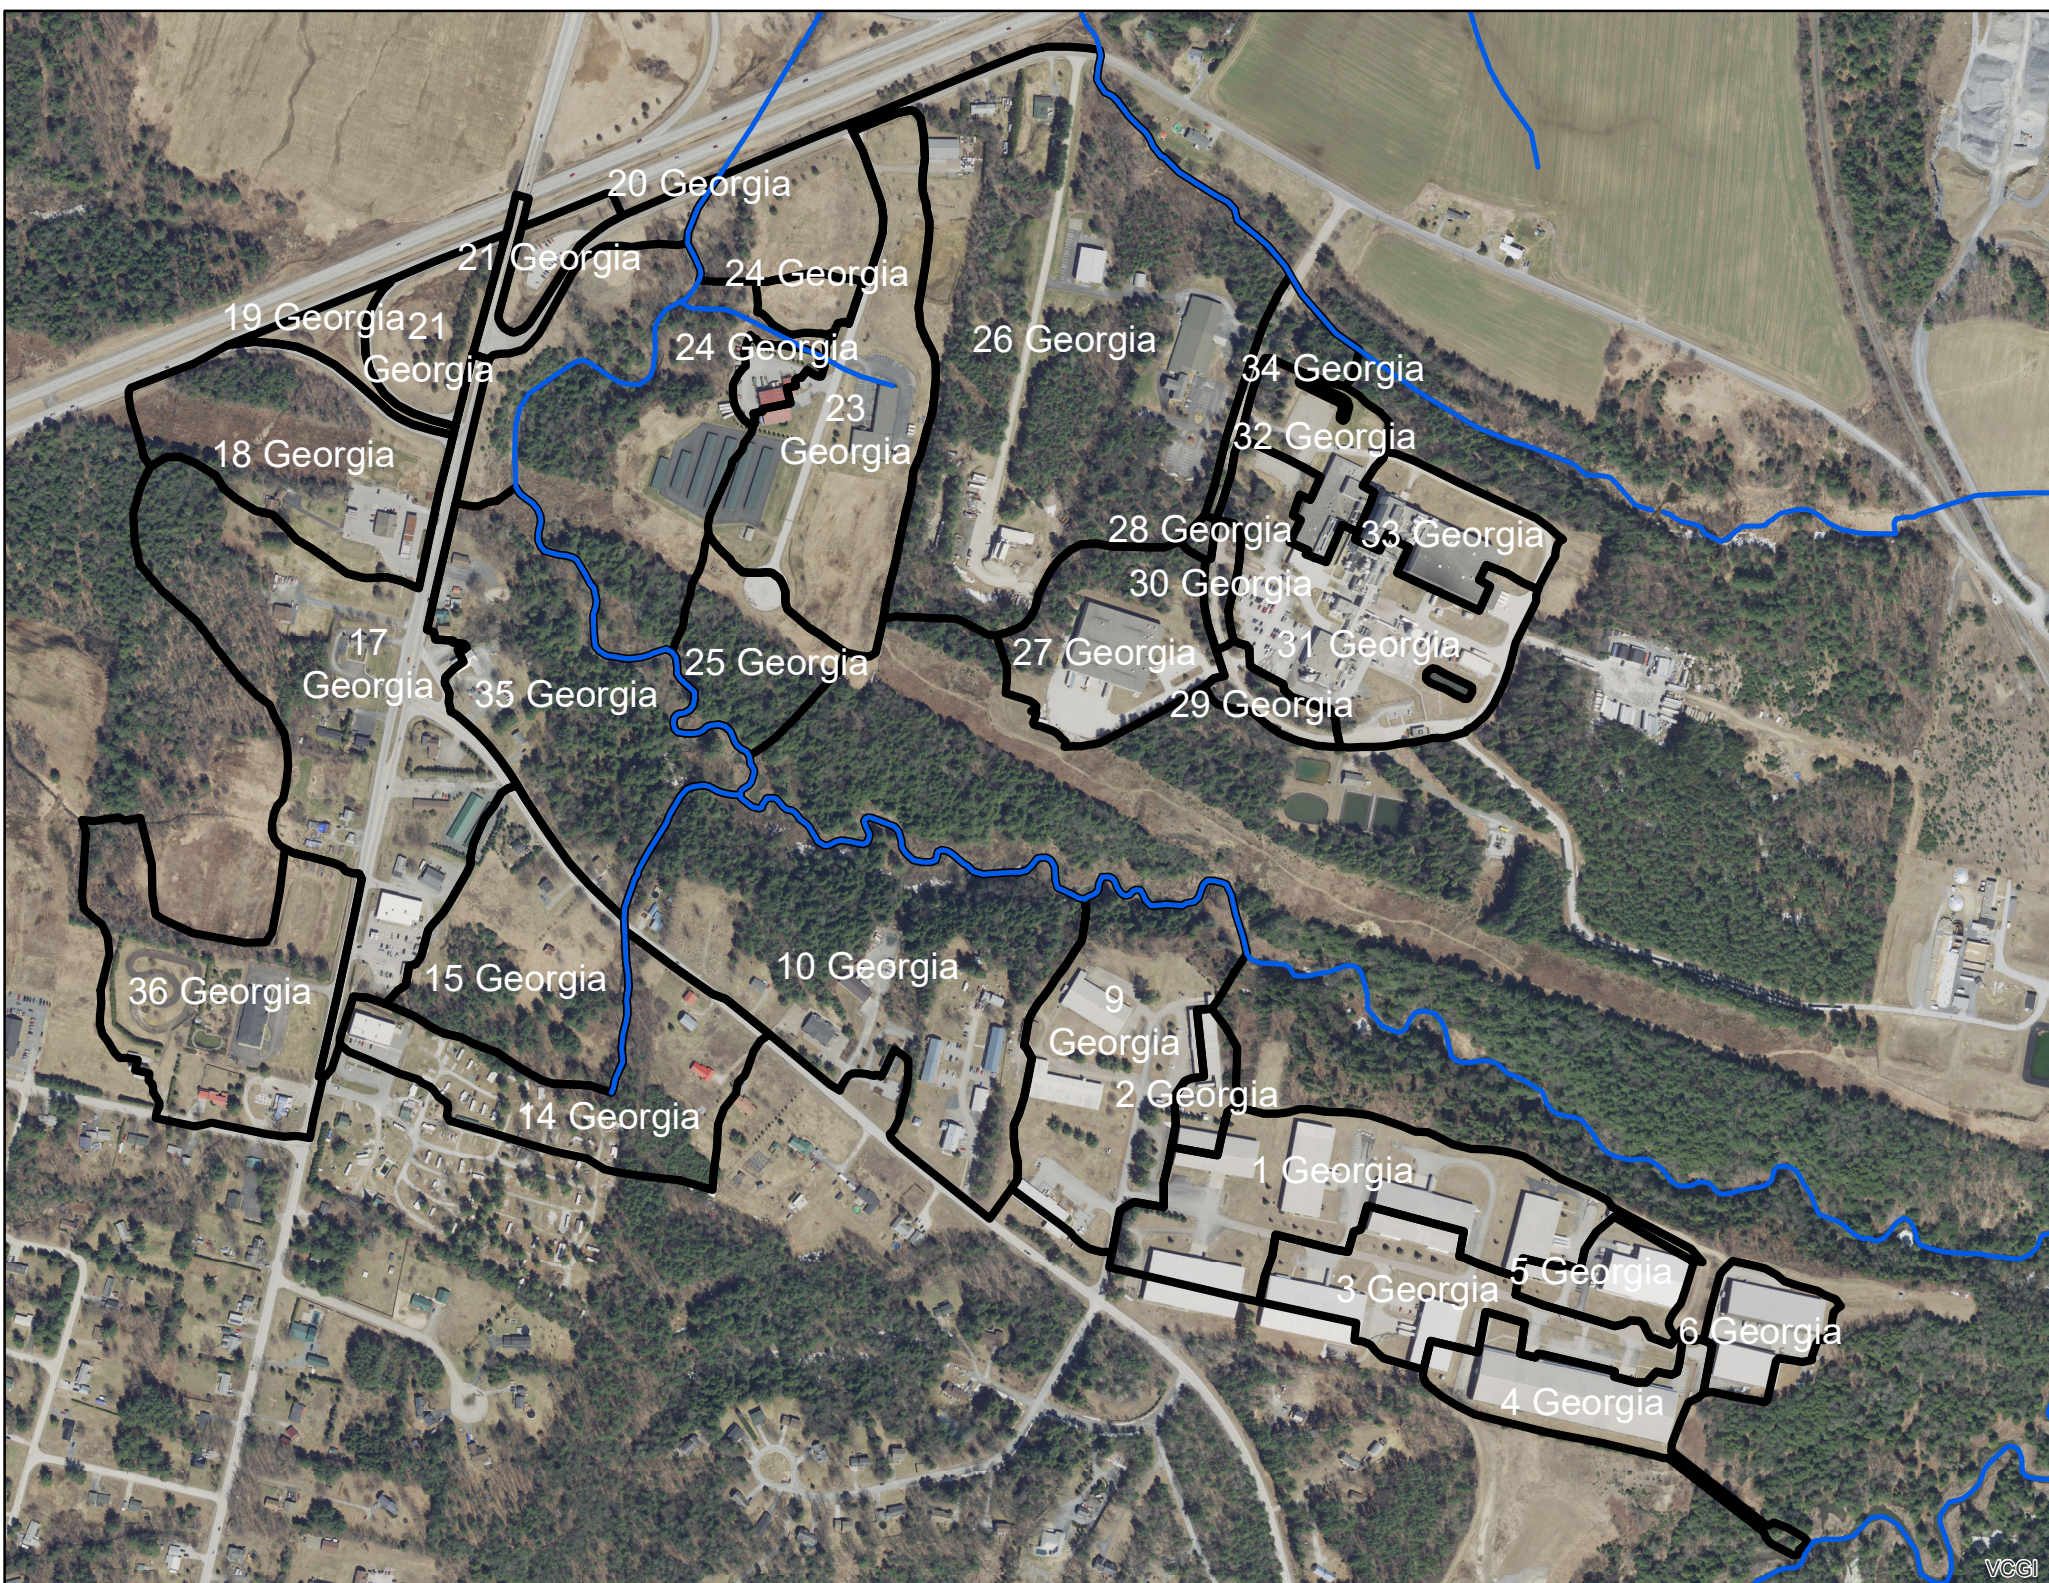
Public Lands in blue
and Stormwater
Drainages in red in
Lower Deer Brook
Watershed

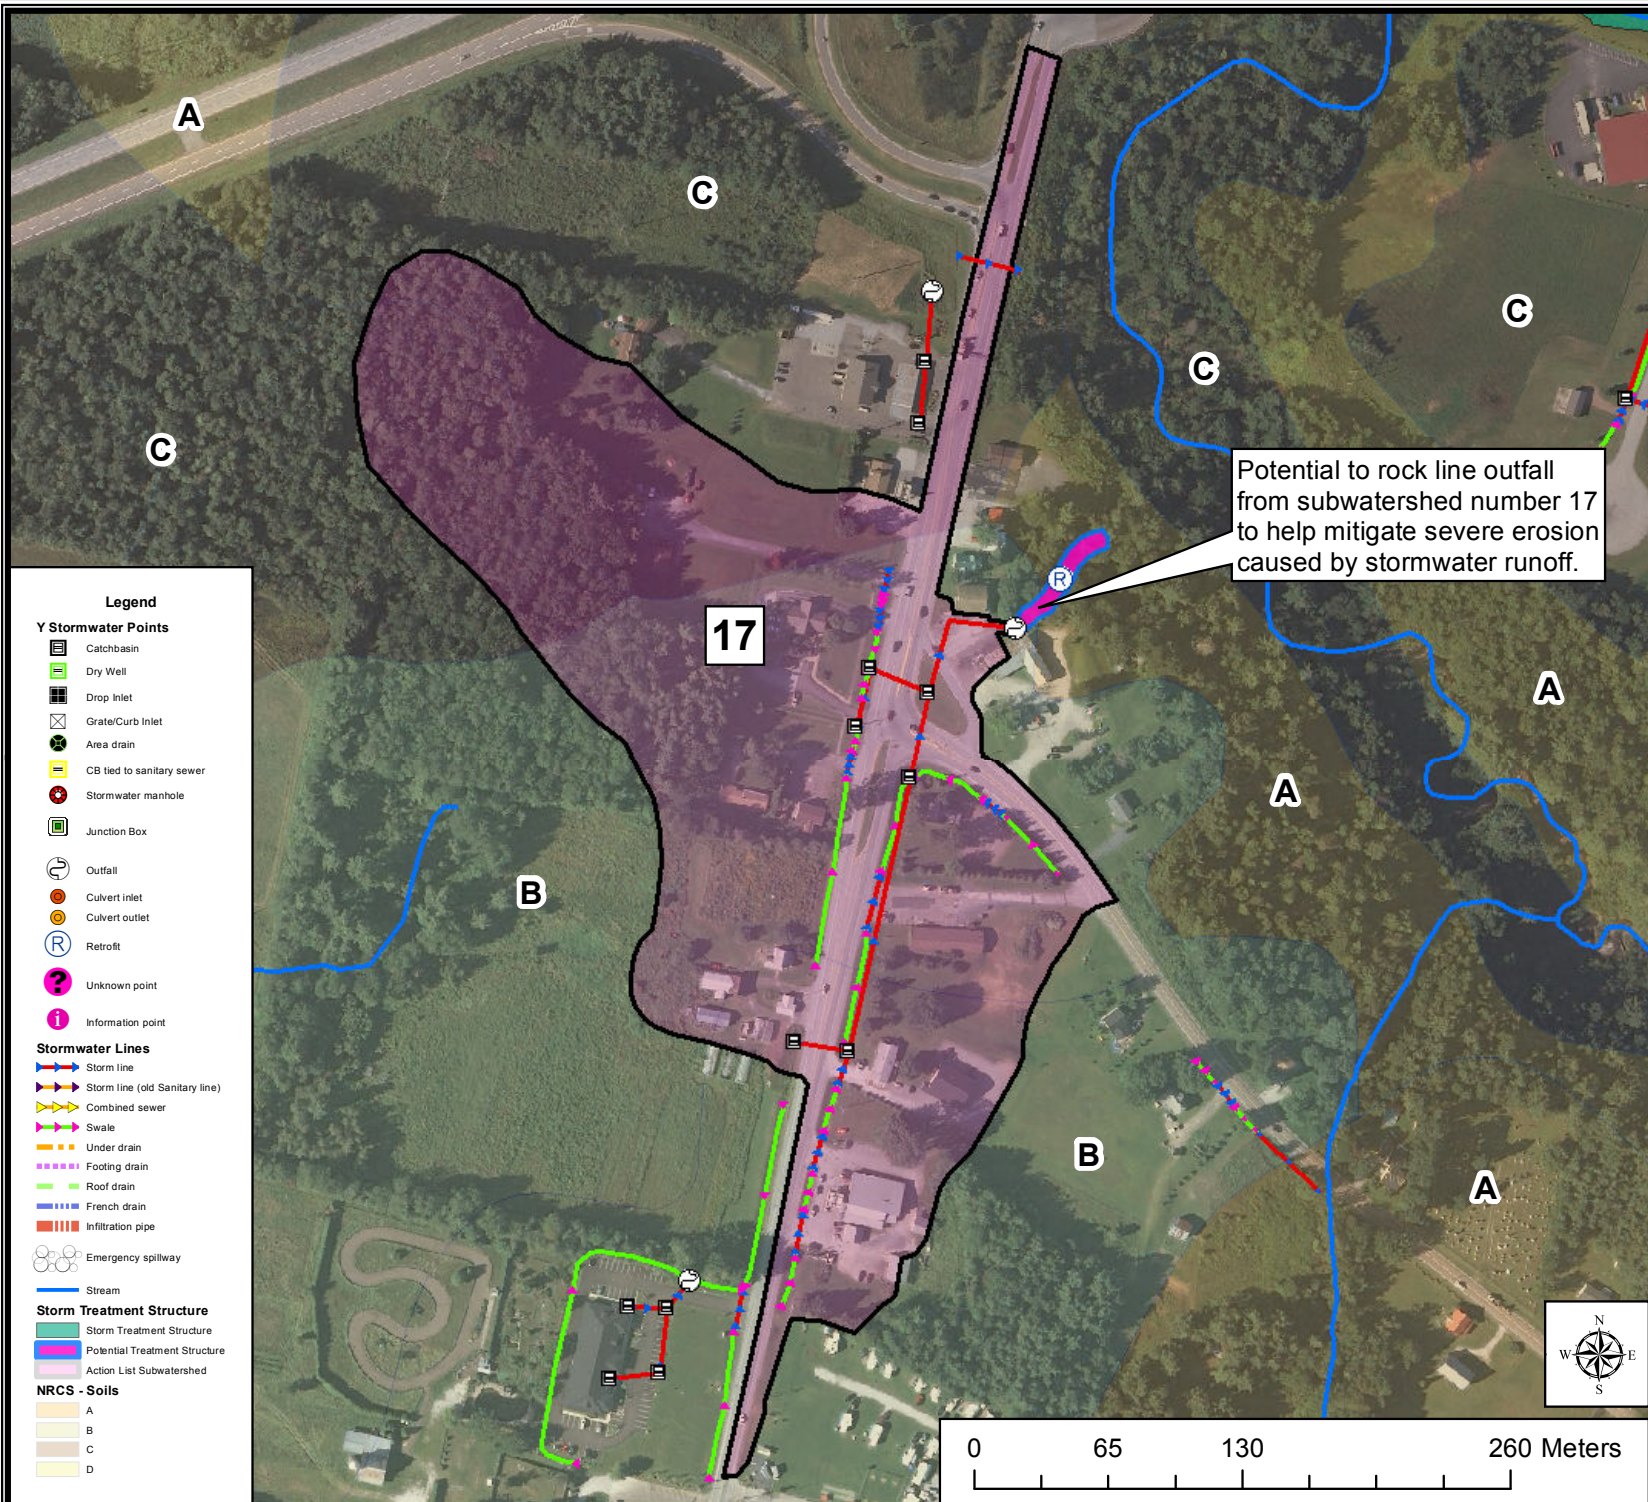
Action List 1
Subwatershed: 17

This map shows high priority subwatersheds which are ranked by connectedness, percent of impervious cover, field observations, and potential retrofit measures and locations.
