Project: AB-2 **Problem Area Summary**

Project: AB-3		Problem Area Summary
Lake Segment	Malletts Bay Direct	
Location	Allen Drive	
Land Ownership	Town ROW/Private	
BMP Type	Subsurface Infiltration	
Drainage Area/Impervious	1.18 / 0.90 acres	
% Impervious	76	
Estimated Project Cost	\$33,800	
P Efficiency (\$/lb removed)	\$26,400	
Project Priority	Moderate

Project: BB-2		Problem Area Summary
Lake Segment	Malletts Bay Direct	
Location	Woodcrest Cir	
Land Ownership	Town	
BMP Type	Subsurface Infiltration	
Drainage Area/Impervious	5.15 / 1.47 acres	
% Impervious	29	
Estimated Project Cost	\$35,000	
P Efficiency (\$/lb removed)	\$29,400	
Project Priority	High

Project: BB-4		Problem Area Summary
Lake Segment	Malletts Bay Direct	
Location	Hemlock Rd	
Land Ownership	Private	
BMP Type	Subsurface Infiltration	
Drainage Area/Impervious	1.38 / 0.20 acres	
% Impervious	15	
Estimated Project Cost	\$10,000	
P Efficiency (\$/lb removed)	\$28,300	
Project Priority	High

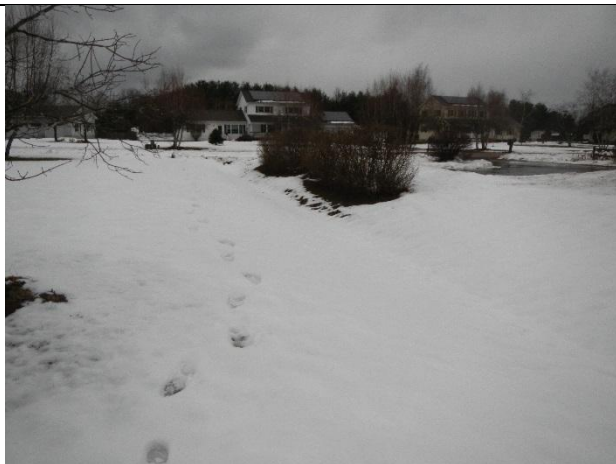
Site Description: All paved surfaces and portions of roofs drain to grassed ditches along the road. A cross-culvert directs all runoff to a grassed swale leading to the pond.

Photo 1: Swale from road to pond

BMP Description: Widen the swale and install check dams to increase water storage volume to infiltrate most of the WQv.

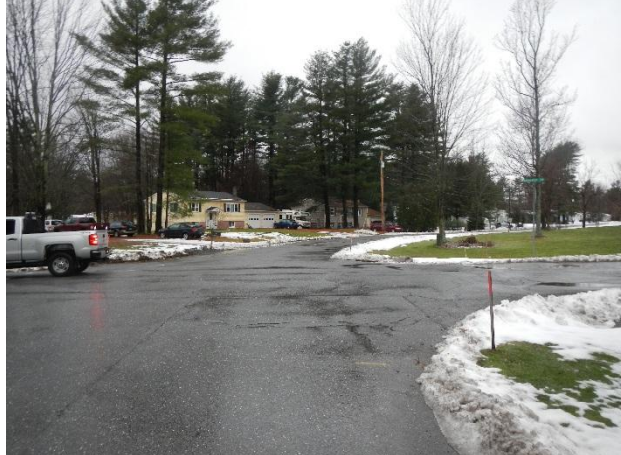
Site Description: A pair of dry wells (DW) located at Griswold and Woodcrest have an outlet pipe draining south to a new catch basin north of Hemlock Rd. This basin and three dry wells located at Woodcrest and Hemlock all connect to a pair of dry wells on Hemlock Rd. The DW south of Hemlock is old and appears to be non-functioning. This dry well has an overflow culvert to a swale south of the houses, the culvert is likely plugged or crushed, restricting flow. All existing dry wells take direct runoff with no pre-treatment.

Photo 1: 3 dry wells at Hemlock/Woodcrest

BMP Description: All 6-7 of the dry wells in the existing drainage network should be drained and cleaned. We expect that several of these should be replaced. Pre-treatment (deep sump catch basin) should be incorporated into any dry well replacements, or retrofits if possible. A large new dry well should replace the catch basin north of Hemlock Road. The overflow pipe from the 3 dry wells should be routed to the newer existing dry well north of Hemlock Road. The outlet pipe to the south should be cleaned or replaced.

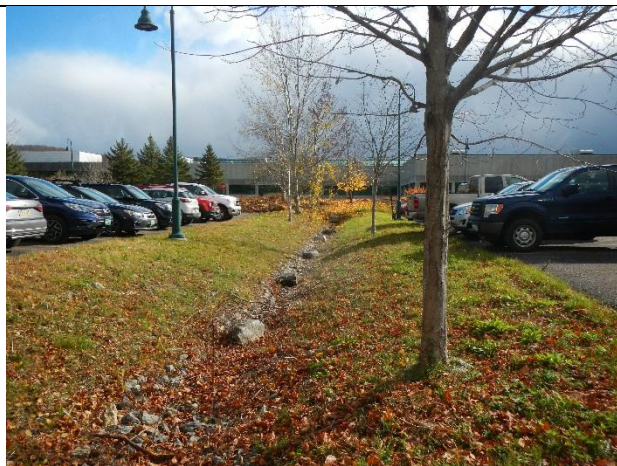
Site Description: Three grassed and stone lined swales are located between employee parking areas. All three appear to receive additional runoff from catchbasins along the main road. The swales all drain to culverts located at grade and outlet northwest to a wetland area. Curb cuts and sheetflow convey runoff from the parking areas to the swales with no visible erosion.

Photo 1: Stone lined swale between parking lots

BMP Description: Retrofit the outlet of each swale to increase ponding volume and retention time. Additional check dams will be necessary to maximize treatment volume. Each swale could be regraded to increase volume. Plantings or reduced mowing are recommended to improve nutrient removal.

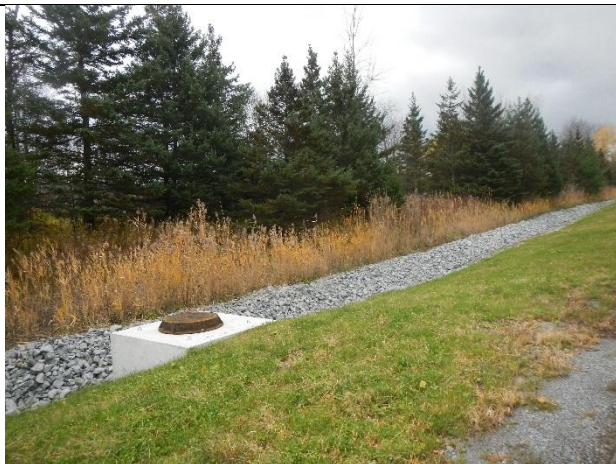
Site Description: The large parking area drains to a steep grassed bank and into an oversized stone lined swale flowing southwest along the railroad tracks. The swale empties into a vegetated ditch along the west side of the railroad tracks.

Photo 1: Northeast end of stone swale and outlet structure with overflow from wet pond.

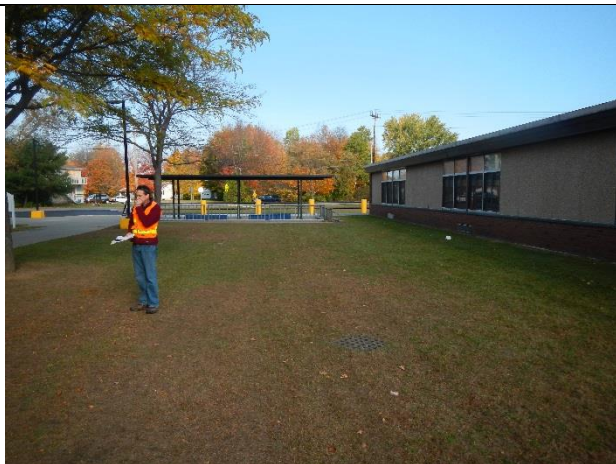
Site Description: Two catchbasins receive runoff from rooftop and paved sidewalk areas. Both basins are connected to the main drainage network (project MSD-2). Both basins are in highly visible locations, 4a is in the grassed area along the main entrance to the school.

Photo 1: Catchbasin by main entrance (4a)

BMP Description: Install small rain garden features in a depression around each existing catchbasin. New rain garden features at each catch basin will increase sediment and nutrient retention and provide some additional infiltration. Minor modifications to the catchbasin may be necessary.

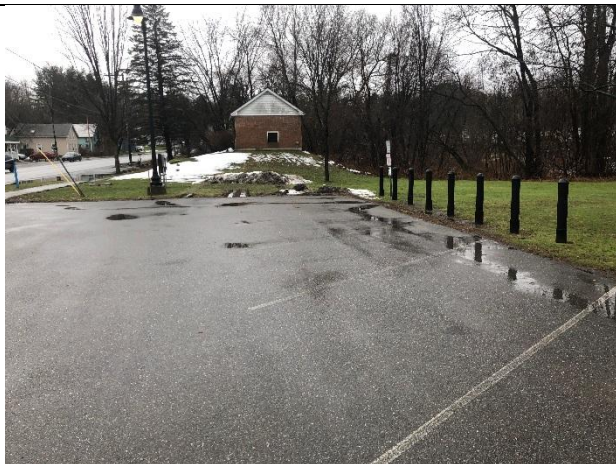
Site Description: The parking area for the River Street Park and a small portion of Route 7 drain to a grassed area off the southwest corner of the parking area. Runoff sheet flows directly to the perennial stream and into the River.

Photo 1: Runoff draining to southwest corner of parking area

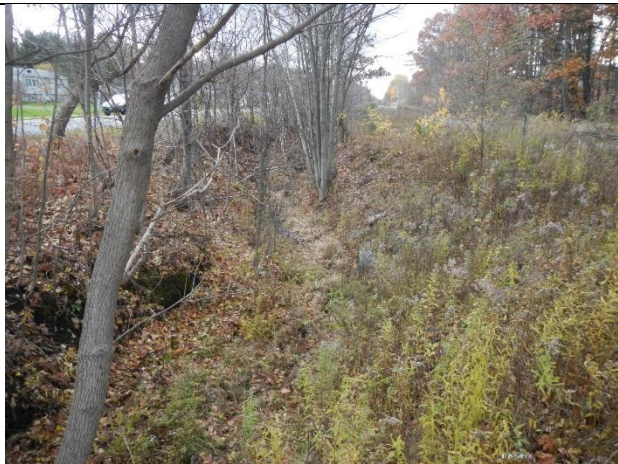
Site Description: A long vegetated swale between Railroad St and the railroad is mapped as having a small perennial stream channel. The swale slope is relatively flat with emergent wetland vegetation in the southern portion. The norther portion has more slope and steep forested banks. The swale crosses under the railroad and empties into a forested wetland.

Photo 1: Incised channel and steep banks from the swale outlet under the railroad tracks

BMP Description: Install earthen/stone check dams to create a series of small wet ponds along the swale. The outlet culvert could be outfitted with an outlet control device to increase ponding depth and volume.

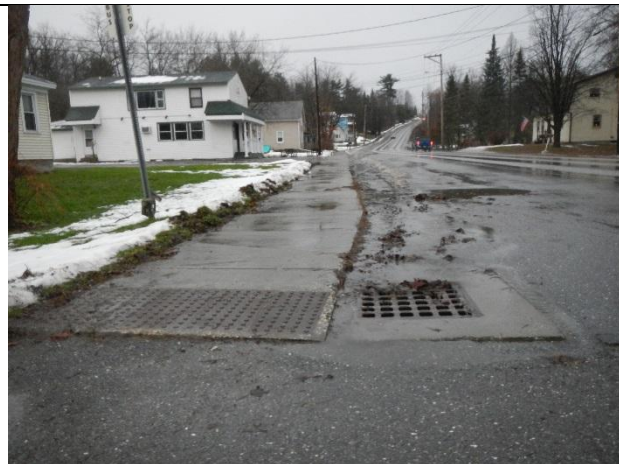
Site Description: Catch basins and drain lines along the east side of Route 7 collect runoff from a large area of impervious surfaces and drain to two smaller perennial streams, emptying directly into the River. The roadway has a wide shoulder along the east side.

Photo 1: Wide shoulder and catch basin looking south from Cherry St

BMP Description: Install tree box filters or other rain garden type structures along the road shoulder. Treatment features should receive surface runoff and incorporate overflow drainage into the existing storm line. **Additional subsurface detention could be incorporated to increase treatment and infiltration volume.**

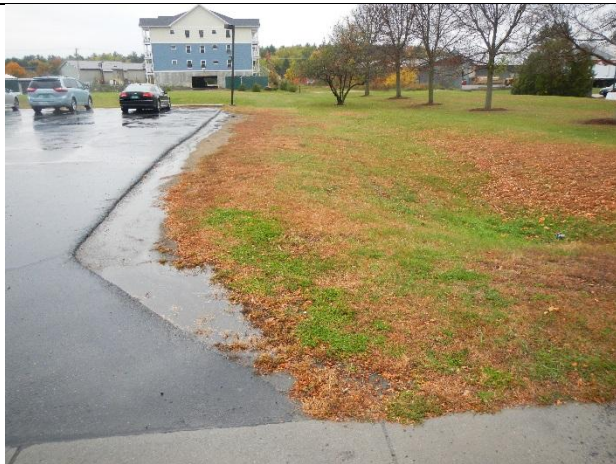
Site Description: The elevated grassed area along the north side of the parking entrance is preventing parking lot runoff from reaching a dry well. Runoff flows along the edge of the pavement and drains to Centre Dr. The existing dry well receives some runoff from the surrounding grassed area. Some erosion is visible along the edges of the pavement.

Photo 1: Grassed basin looking north from Route 7 **Photo 2:** Fabric filter installed under catch basin grate

BMP Description: Regrade the grassed area north of the parking lot to allow for sheetflow to the existing dry well.

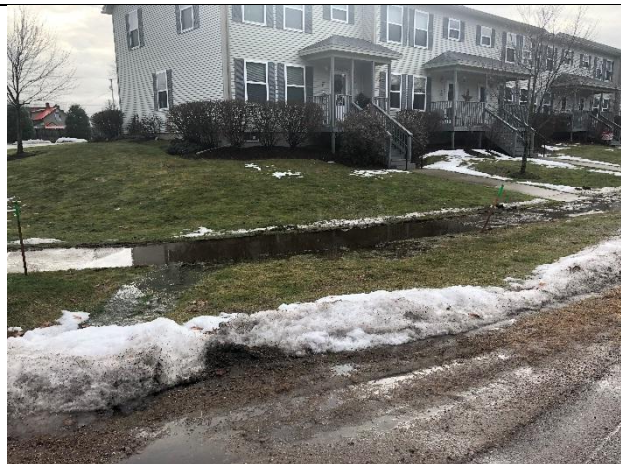
Site Description: A gully has formed where a cross culvert and roadside ditch drain to a small perennial stream. Checkerberry street has inadequate drainage with significant ponding along the southern side during runoff events. Nancy Drive has limited areas of grassed shoulder, runoff primarily flows down the roadway.

Photo 2: Runoff ponding on sidewalk along Checkerberry.

BMP Description: Install 2-3 small catchbasins and cross culverts along the south side of Checkerberry to improve drainage. Install grassed ditches along Nancy Dr. Improve grassed ditches northwest on Checkerberry. Install a flow control structure at the culvert inlet under the storage facility entrance to increase ponding volume in the existing ditch/wetland area. Stabilize the gully area as needed.

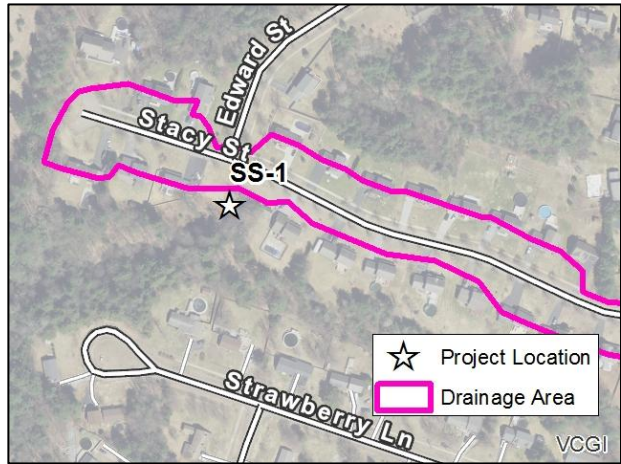
Site Description: The road surfaces and some of the houses and driveways along Stacy Street drain to a simple storm drainage system with a single outlet pipe south of the Edward St intersection. The runoff from this neighborhood has caused a very large gully to form.

BMP Description: Replace existing catch basins with dry wells and install a new underground infiltration practice between the roadway and the gully. May be possible to reroute some of the runoff north into the Edward St drainage system, if this will not cause additional water quality issues.

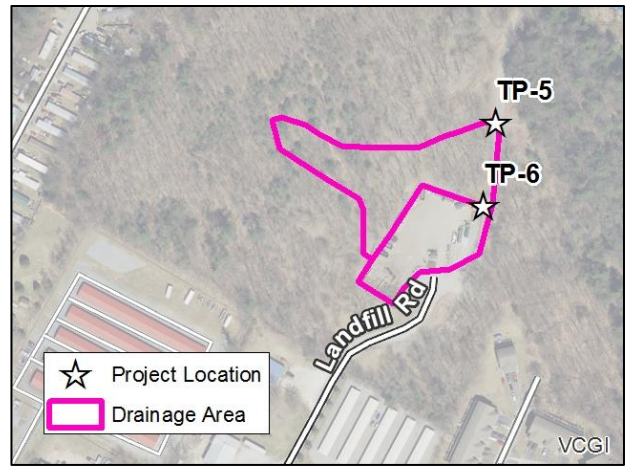
Site Description: An unmapped/unclassified road continuing north from the transfer station is maintained by the Town as an access to the sand and gravel storage areas by the capped landfill. The road drops at approximately 10-11% slope for a 300 ft length to the wetland complex. The road surface is poorly crowned with rill erosion and the west ditch has several areas of minor gully erosion.

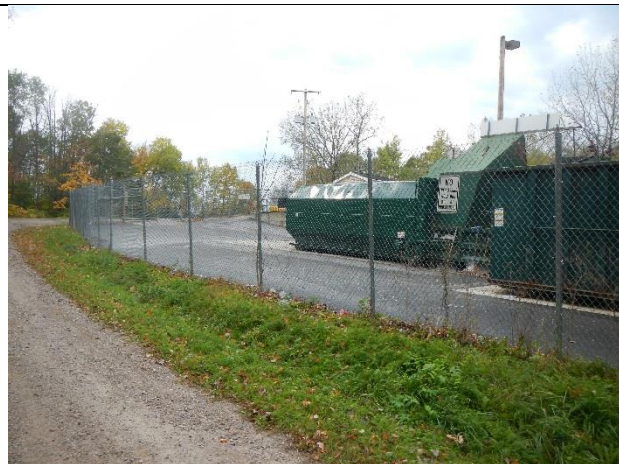
Site Description: The Town transfer station drains the northeast corner and flows into a road ditch. The ditch drains north down the steep slope emptying into a large wetland complex. Some erosion was visible where the runoff exits the transfer station.

Photo 1: Transfer station

BMP Description: Stabilize flow path where runoff leaves the transfer station and stabilize receiving ditch. Install a cross-culvert under the gravel road, with a grassed swale at the culvert outlet. Construct a small pre-treatment forebay and an underground infiltration gallery.

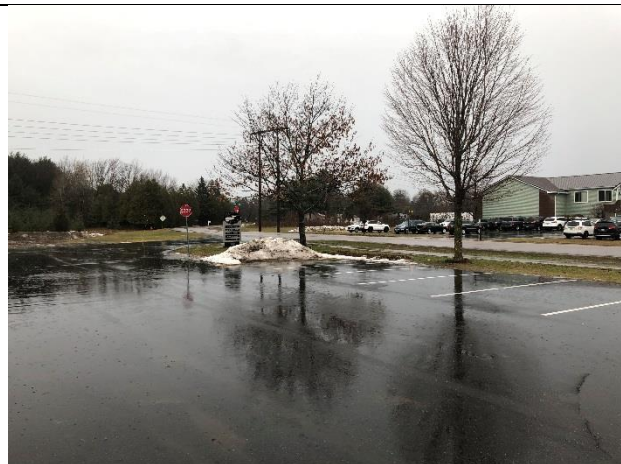
Site Description: A portion of the main parking area for the Milton municipal complex drains to a grassed area between Park Place and Bombardier Rd.

Photo 1: Grassed area receiving runoff from portion of parking lot
