STORMWATER MANAGEMENT PLAN FOR SWANTON TOWN AND VILLAGE

FINAL REPORT

Stone Project ID 112475-W
February 21, 2013

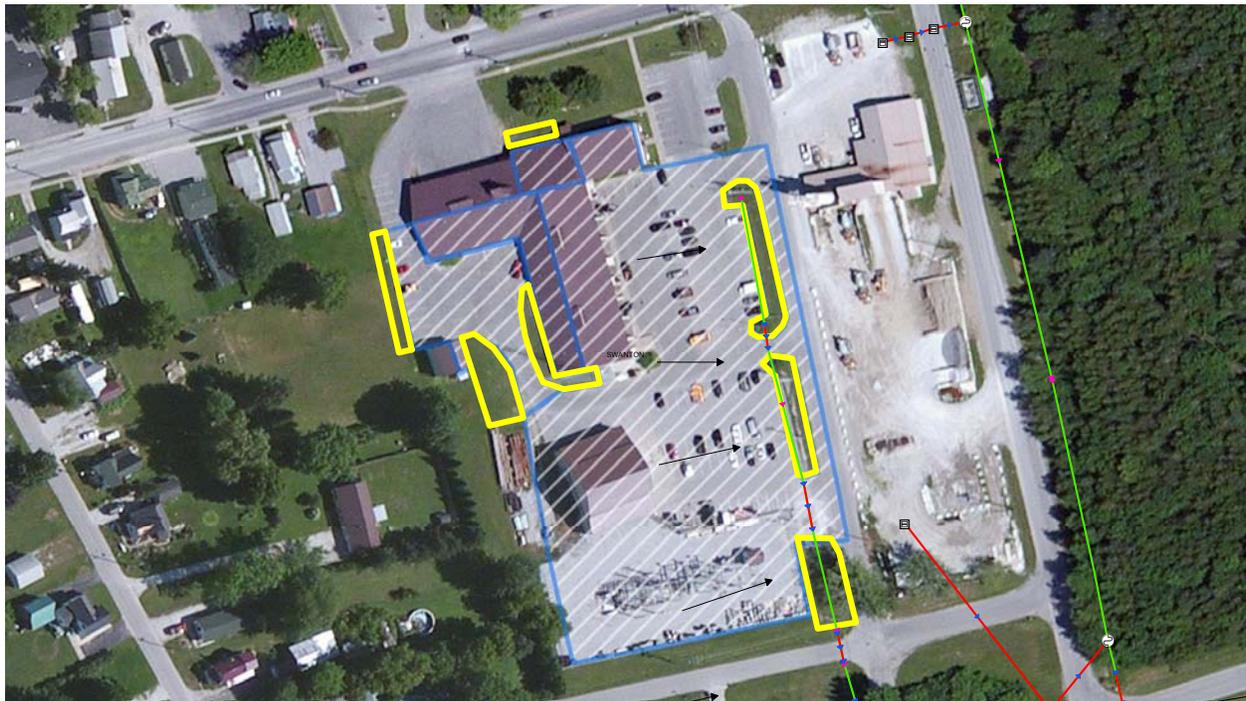
Stormwater from three acres of impervious surface at the Swanton Village Municipal Complex could be routed to potential stormwater treatment practices (STPs) located as shown yellow in Figure 1. Areas of impervious surface that are considered to be treatable are highlighted in blue in Figure 1. Predominant soil types are Windsor loamy fine sand (HSG A) with a deep water table, meaning there is potential to soak away a large amount of stormwater that is currently draining from this property.

Figure 1. Swanton Village Municipal Complex: Treatable impervious areas are highlighted in blue, while locations for potential treatment practices are highlighted in yellow.

The existing swales along Elm St. could be retrofitted to provide relatively simple, yet effective infiltration-based STPs. The presence of underground utilities in the area will need to be fully and carefully investigated as part of any design.

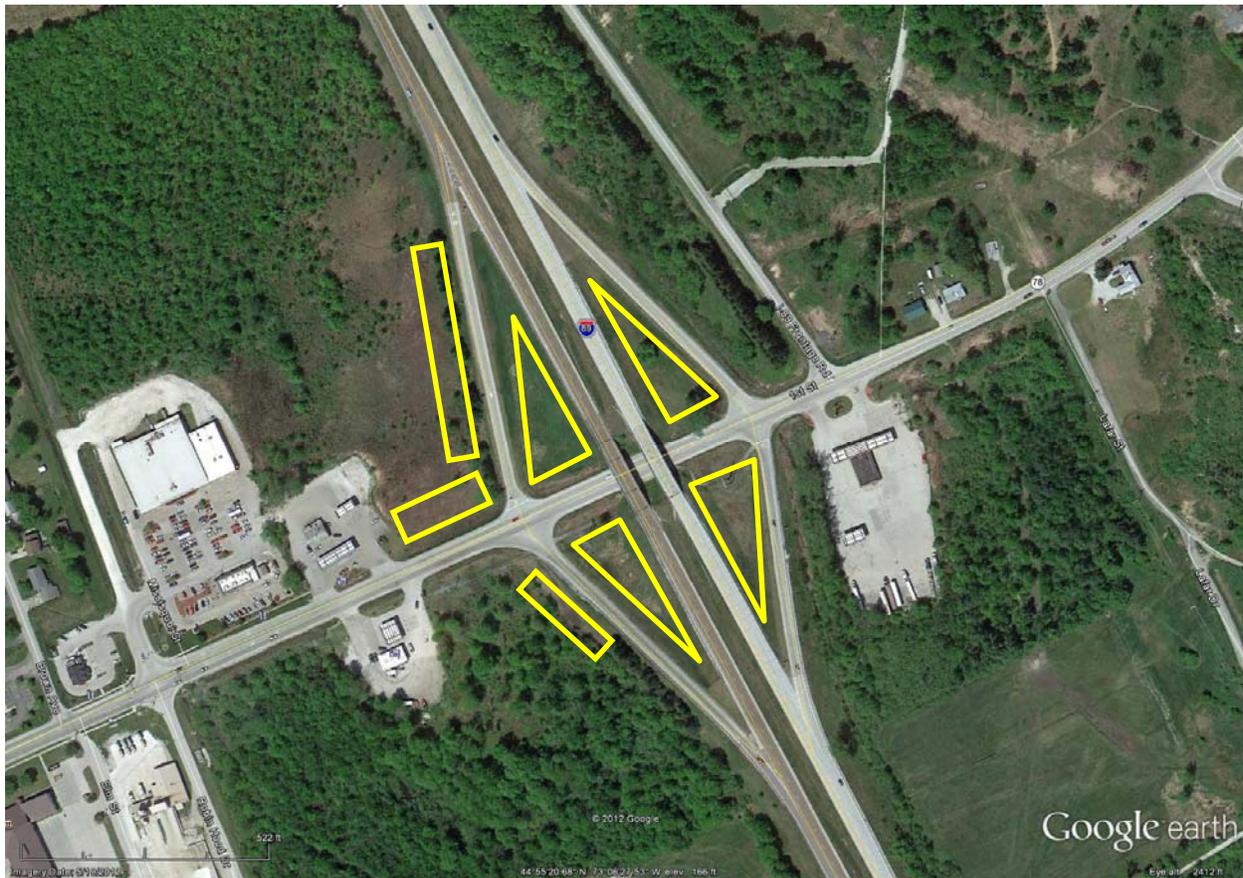
Green space within and adjacent to the I-89 Exit 21 interchange could accommodate the construction of stormwater treatment practices. The diamond interchange at Exit 21 includes a stormwater conveyance system that drains the highway. The 30-acre subwatershed includes 3.8 acres of impervious surface. The large amount of open space and existing conveyance structures simplify design and construction efforts required to implement a stormwater treatment practice at this location. A storm water treatment practice similar to that which was recently constructed in the highway median at I-89 Exit 20 could be effective here.

The most suitable practices are likely to be bioretention and filtration systems that include an underdrain. Soils are reported by the USGS to be Georgia stony loam and Massena stony loam, Hydrologic Soil Group (HSG) C with high water tables. These characteristics mean that infiltration cannot be expected to be a suitable treatment practice. Additionally, roadway subsoil strength can be affected by saturated soils. The proximity of the roadway further supports the need for non-infiltration-based systems.

Figure 2. I-89 (Exit 21)-VT RT 78 Interchange. Potential sites for stormwater treatment practices highlighted in yellow.

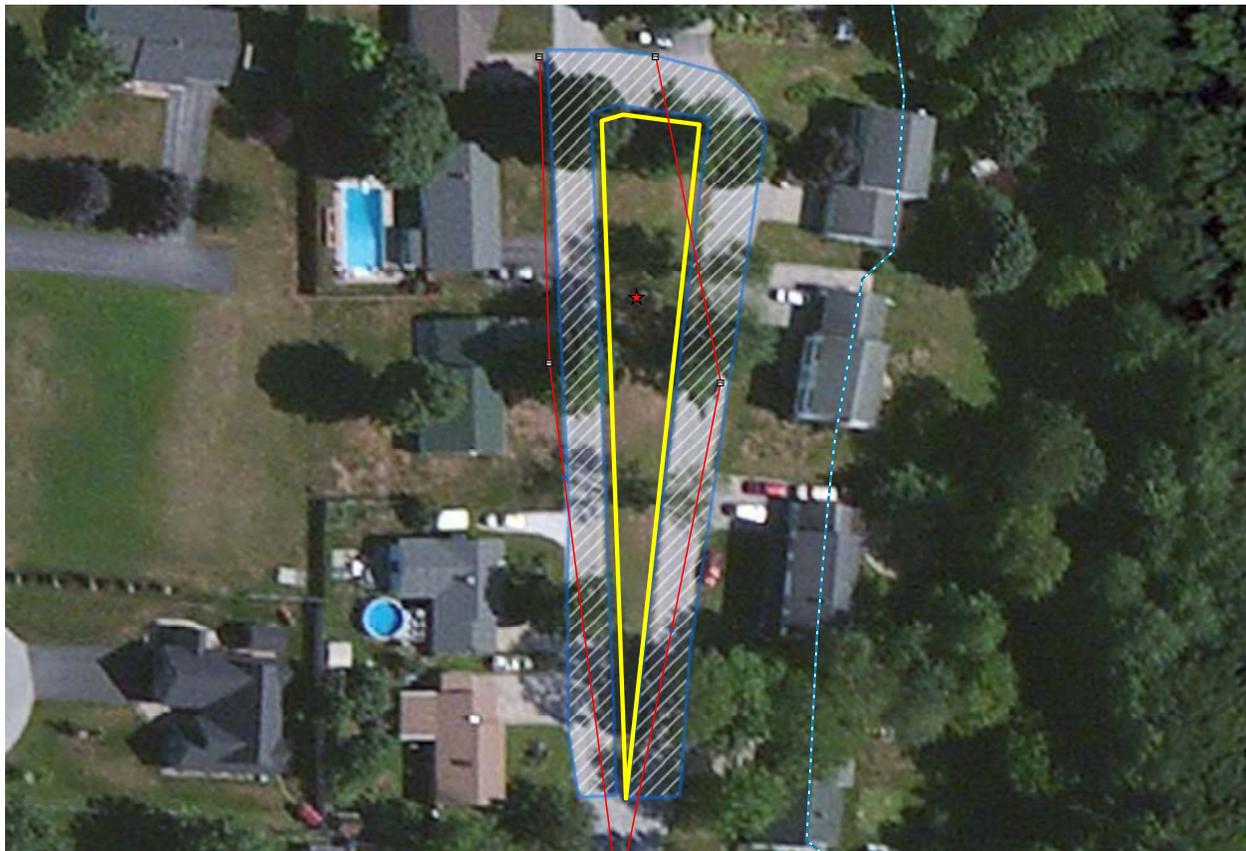
Taylor Drive is a residential street with a large cul-de-sac that includes a median that is well-suited for stormwater treatment. Currently, water drains from the street and some of the adjacent residential lots toward the cul-de-sac where it is collected in catch basins along the existing curb.

The reported soil types in the area are Windsor loamy fine sand (HSG A) with a deep water table. This means that infiltration practices could be used to soak away a large portion of stormwater runoff from this neighborhood. Curb cuts could allow stormwater to drain to a potential stormwater treatment practice within the green space at the center of the cul de sac.

Figure 3. The Taylor Drive cul-de-sac offers ample treatment opportunity (shown in yellow). The contributing impervious area is outlined in blue.

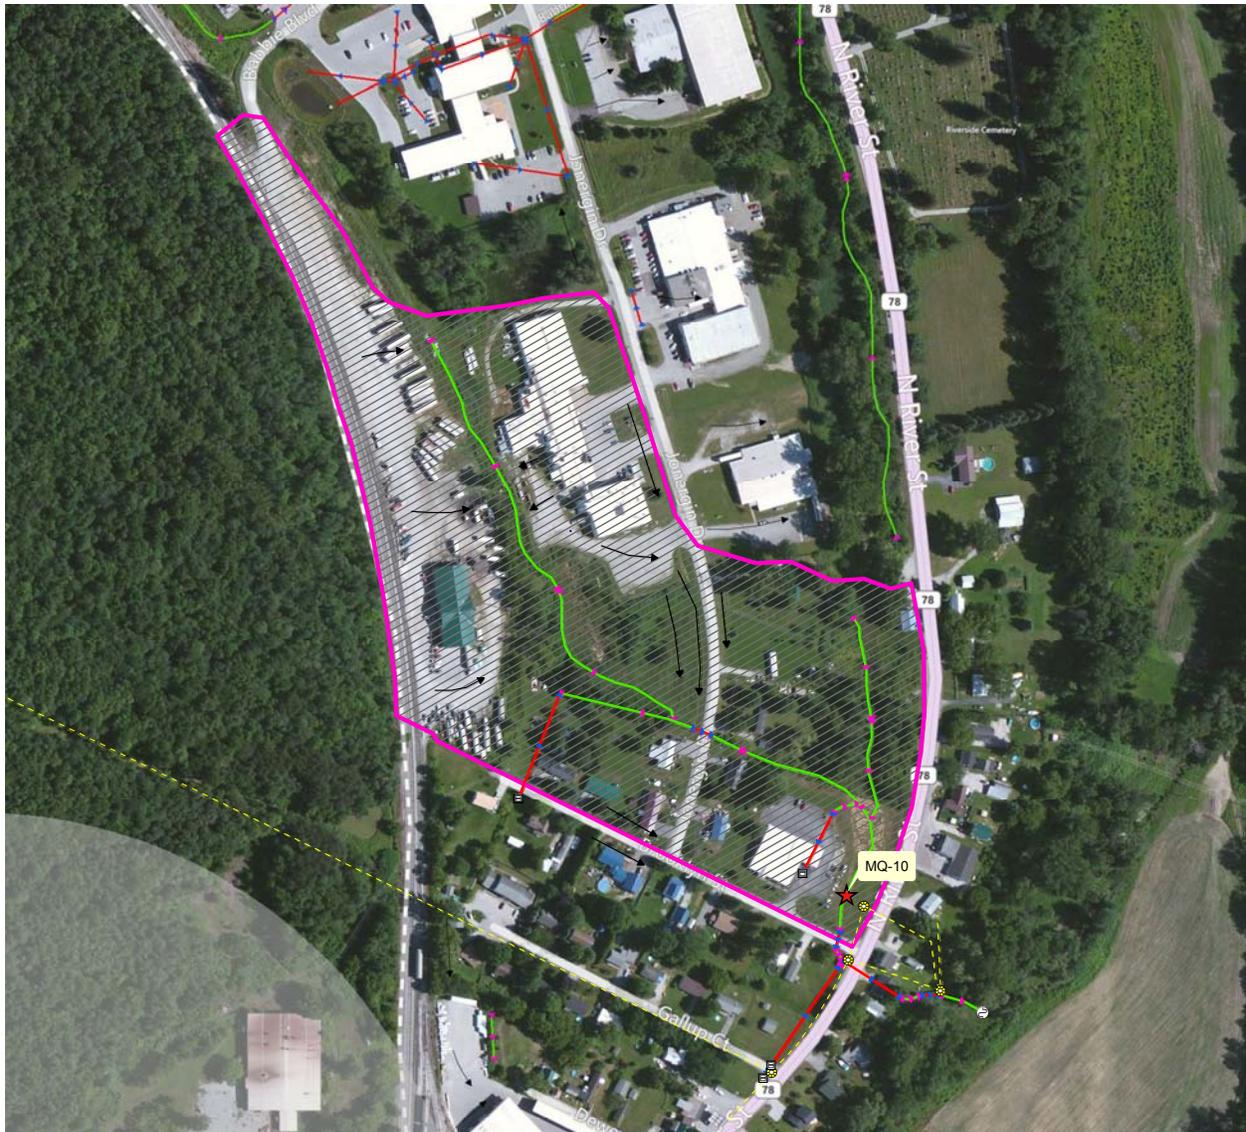
Stormwater runoff from approximately 22 acres drains to a culvert at the corner of Route 78 and Brooklyn Rd., where the Fournier business is located. This 22-acre subwatershed includes 7.1 acres of impervious surface (approximately 3.6 acres of roof tops and asphalt, and 3.5 acres of compacted gravel surface). Stormwater from this subwatershed appears to receive no treatment before being routed through two culverts under Route 78 and discharged to the Missisquoi River.

Figure 4. Subwatershed draining to a culvert at the southeast corner of the Fourniers Door and Window business at the corner of Rt. 78 and Brooklyn St.

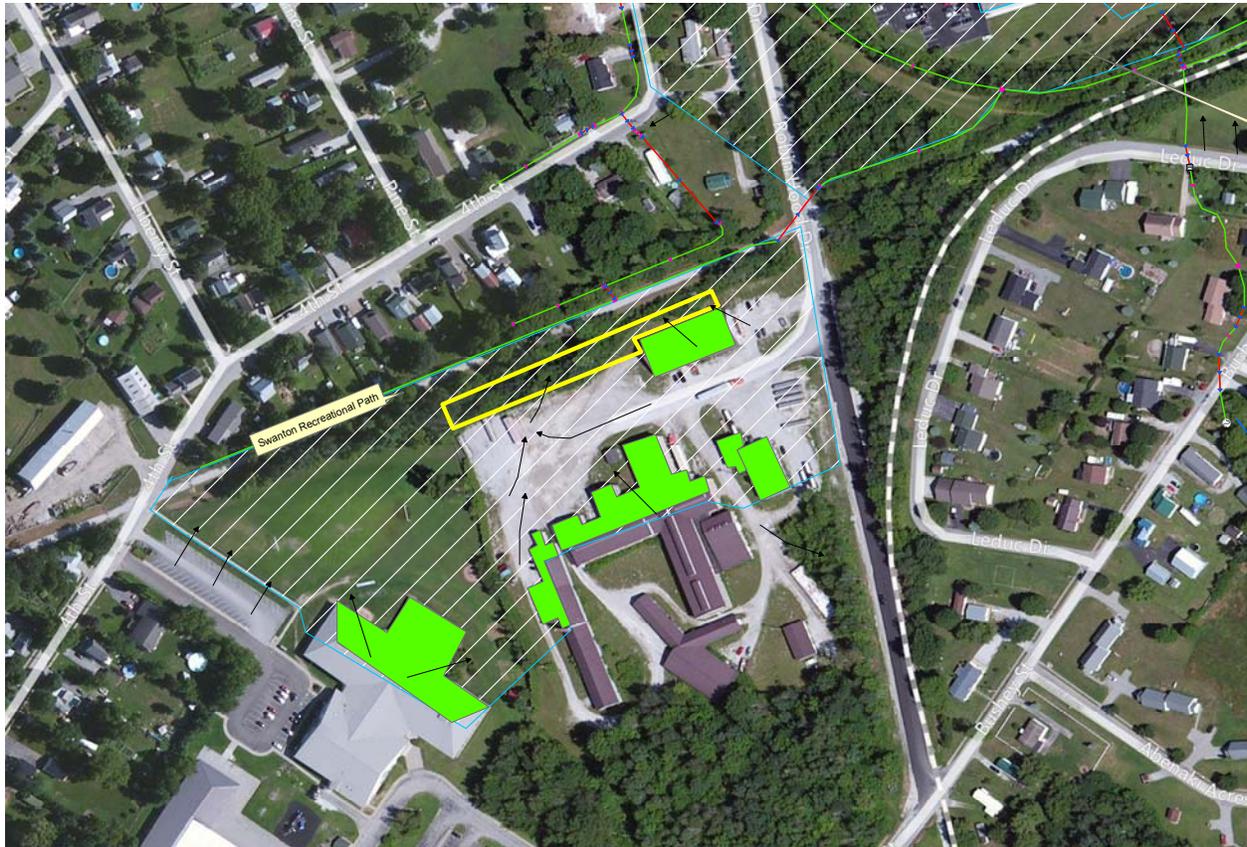
Potential stormwater treatment opportunities exist along the Swanton Recreation Path near Robinhood Drive. The subwatershed contains portions of the Swanton Elementary School and former Robinhood Ammunition plant property. The 10.5 acre subwatershed includes 3.2 acres of impervious surface (1.4 acres of roof tops and 1.8 acres of compacted gravel). The remainder of the subwatershed consists primarily of athletic turf on the school property. Athletic fields are often highly compacted and can have low infiltration rates. Stormwater drains north to a swale that flows to the northeast along the south side of the recreation path. From the end of this swale, stormwater flows through approximately 0.5 miles of storm sewer and open channel conveyance to the Missisquoi River.

Figure 5. Drainage area at and around Swanton Elementary School: location for potential STP shown in yellow. Portions of rooftop that drain toward the potential STP are highlighted in green.

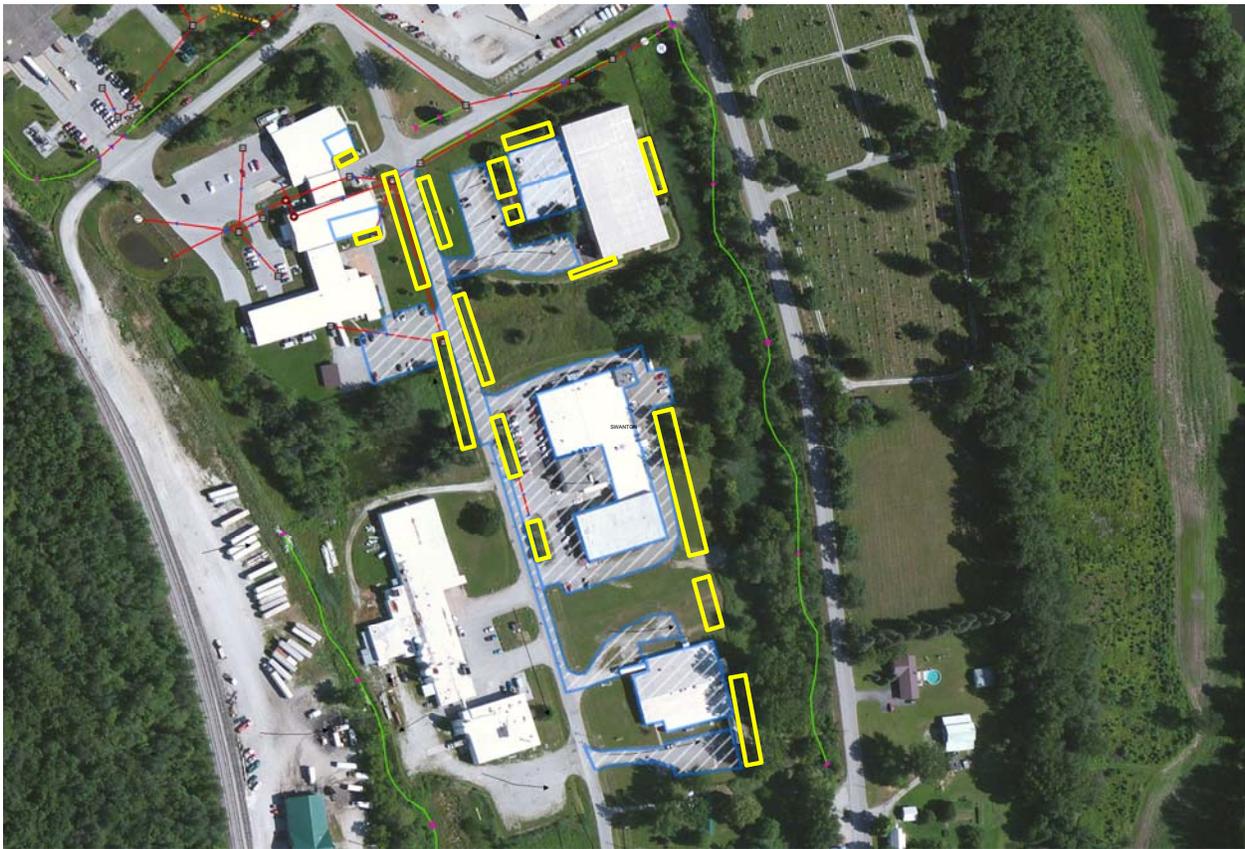
The industrial area along Jonegrin Dr. and Babbie Blvd. includes a significant amount of impervious area; 3.9 acres within the subwatershed have been identified as potentially treatable. Stormwater runoff from this subwatershed makes its way to the Missisquoi River with no retention and little, if any, treatment. Many options have been identified for location of STPs as shown by the yellow highlight in Figure 6. Stormwater from a large segment of the industrial development near Jonegrin Dr. and Babbie Blvd. is untreated and drains to the Missisquoi River. Massena stony loam and Raynham silt loam are the predominant soil types in this area. Both soils are reported to be HSG C with a shallow water table. Infiltration practices will not be a likely option. However, many opportunities exist for retrofitting the existing stormwater infrastructure with filtration-type treatment practices.

Figure 6. Stormwater from a large segment of the industrial development near Jonegrin Dr. and Babbie Blvd. is untreated and drains to the Missisquoi River.

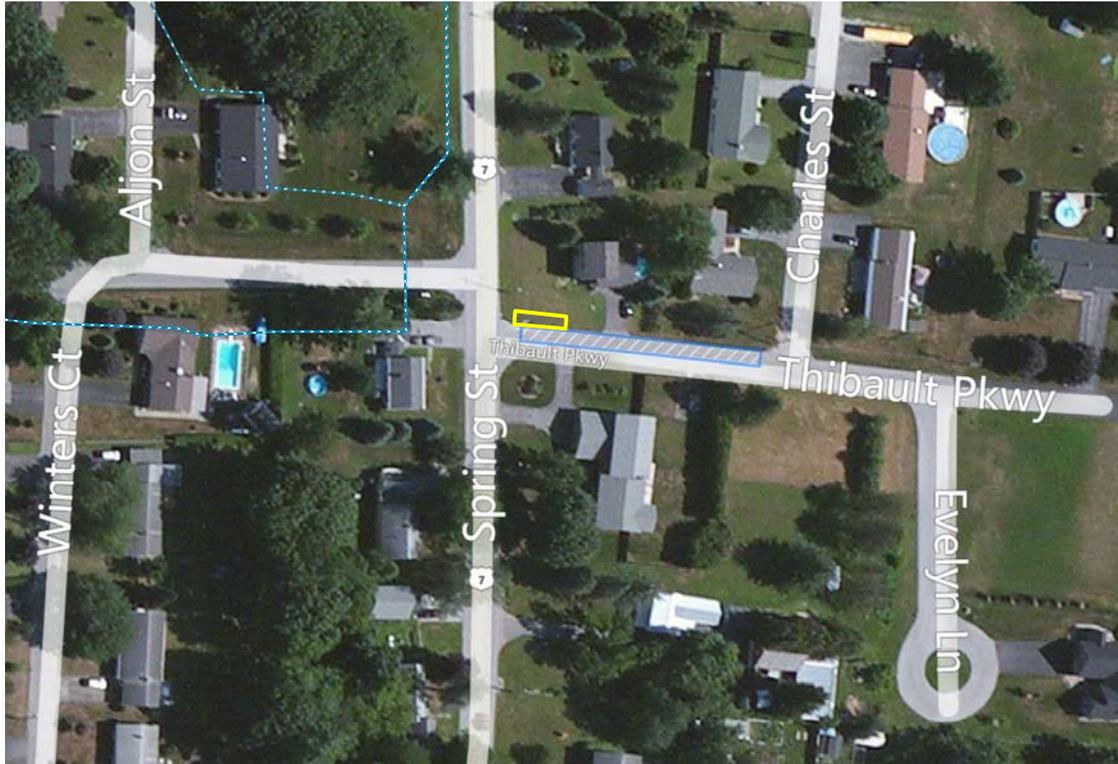
A catch basin adjacent to Thibault Parkway could be retrofitted and utilized as part of an STP, such as a simple rain garden. Site conditions, including Windsor loamy fine sand (HSG A) and a deep water table, would enable detention and infiltration of a significant portion of stormwater runoff from 0.04 acres of impervious surface draining to the existing catch basin.

Figure 7. Stormwater treatment opportunity at corner of Thibault Parkway and Spring Street

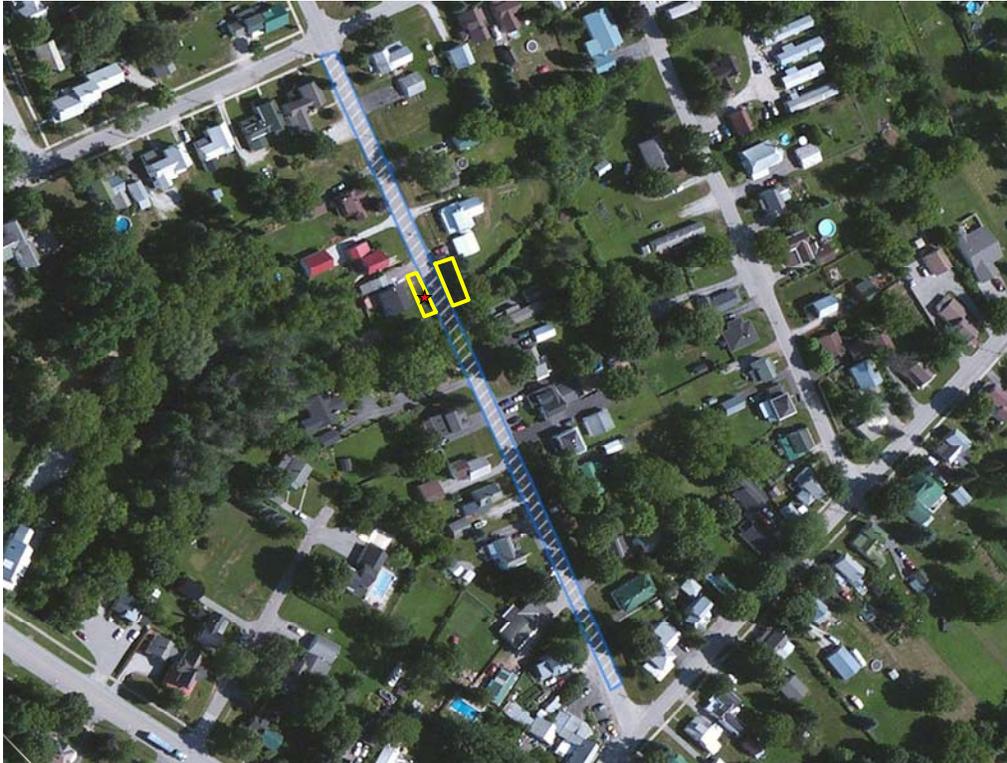
Two existing catch basins on Greenwich Avenue between 2nd St. and Platt St. are well-situated to be utilized as part of stormwater treatment practice. Approximately 0.4 acres of Greenwich Ave. drains toward the center of the block where stormwater is collected by two existing catch basins on either side of the street. The predominant soil type is reported to be Windsor loamy fine sand (HSG A) with a deep water table. This means that there is potential to soak away a large portion of the stormwater draining from this neighborhood. The existing catch basins could then act as overflow relief for an infiltration-based STP.

Figure 8. Greenwich Ave. drains to two existing catch basins near the middle of the block where two STPs could be located.

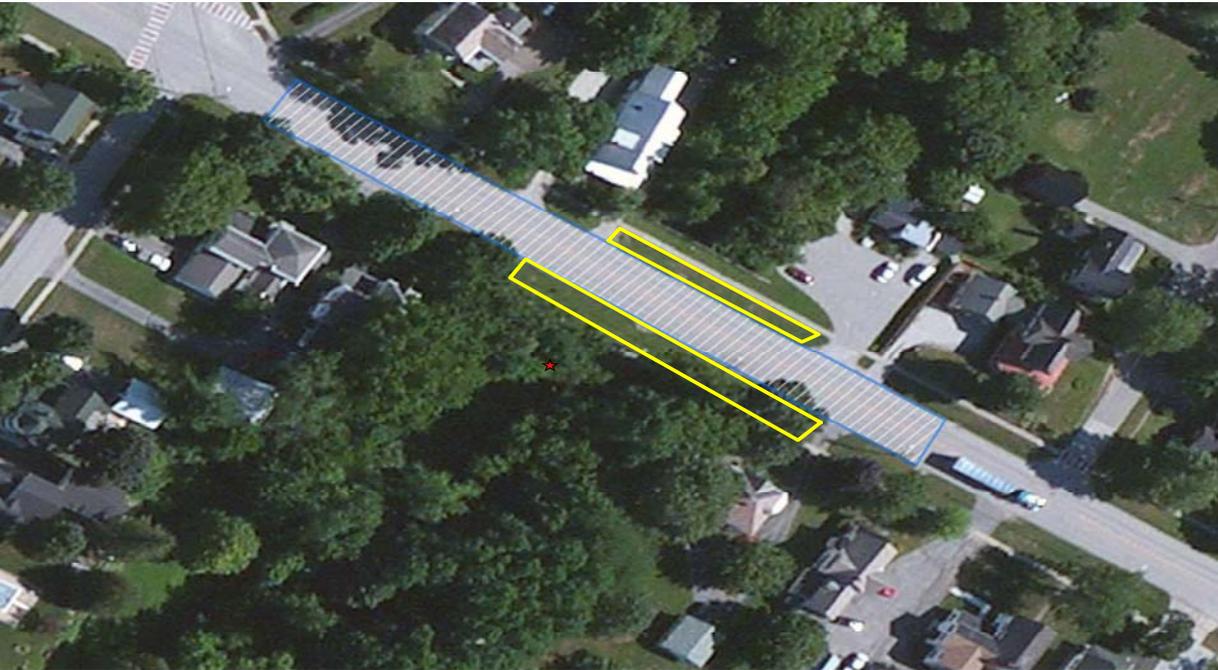
Stormwater runoff from 0.3 acres of Grand Ave., between Farrar St. and Furman Place, could be treated before draining to existing catch basin in the green strip. Stormwater drains toward the center of the block from both directions. Catch basins between the street and sidewalk collect stormwater on either side of Grand Ave. The predominant soil type is Windsor fine sand (HSG A) with a low water table. Given the well-drained soils and position of existing catch basins, stormwater from this section of Grand Ave., could be treated with an infiltration-based STP.

Figure 9. Grand Ave. stormwater could be treated with infiltration practices located between Farrar St. and Furnam Pl.

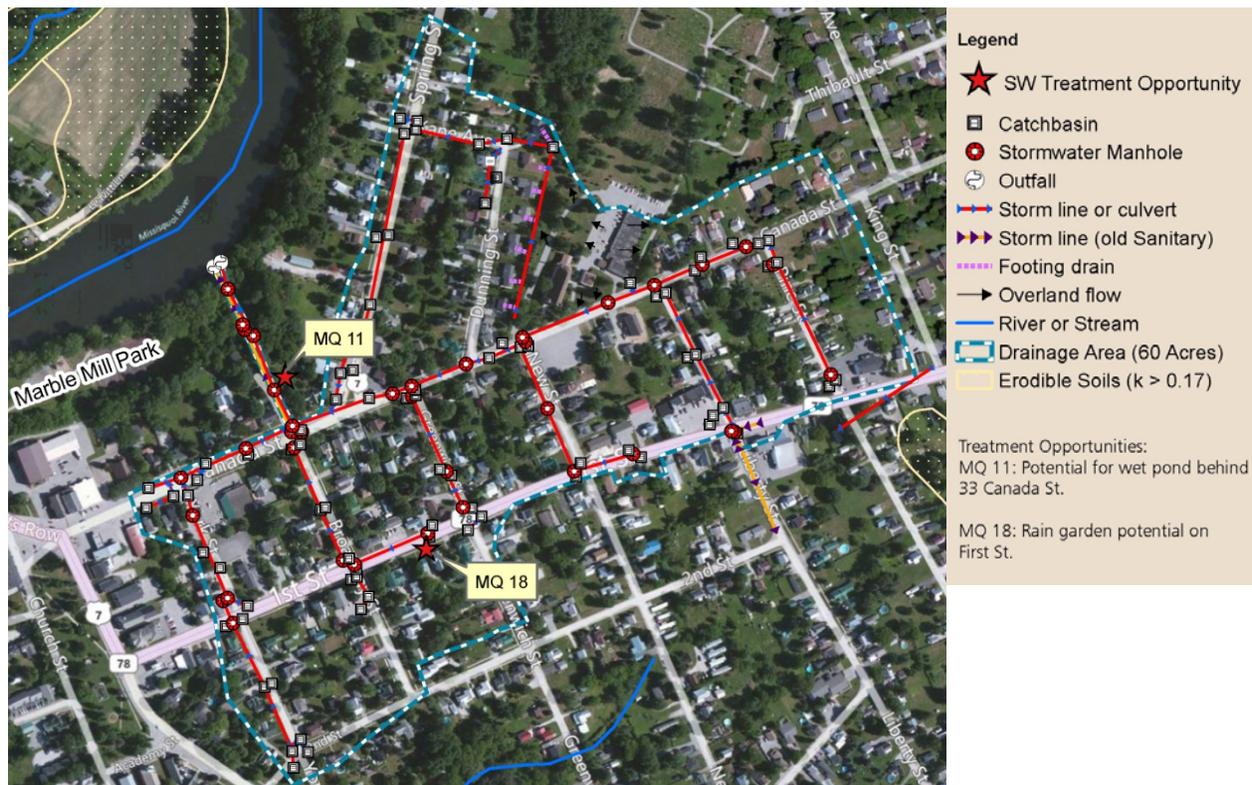
A significant portion of the stormwater runoff from the closed drainage system in Swanton Village is piped to Marble Mill Park, where it is discharged without treatment to the Missisquoi River. The area of the park near this outfall also contributes untreated runoff to the Missisquoi, including active erosion in the road and path leading to the park, runoff from the parking lot, and a washout leading from the park to the river’s edge near the outfall. The Village previously worked with the Northwest Regional Planning Commission to obtain grant funding from VT DEC to develop a comprehensive solution for stormwater management at Marble Mill Park, and a design has been prepared. Unfortunately the Village has faced a number of challenges in seeing the design implemented, including concerns raised over any construction activity within the 100-year floodplain of the Missisquoi, and nothing has been built to date.

Figure 10. Marble Mill Park problem area, with areas of identified issues highlighted in red.

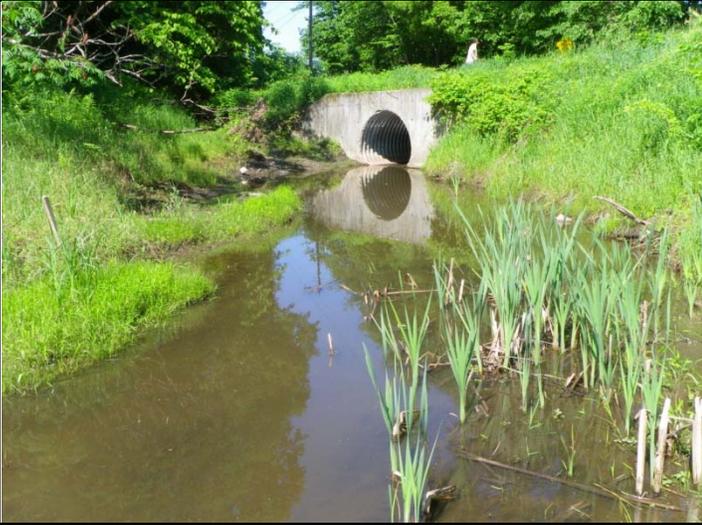
Photo 1. Culvert Entrance (C1)	Photo 2. Ponding downstream of culvert C2

C1- 5' corrugated culvert inside concrete armor wall. Poor alignment is causing left bank to erode as stream is forced to turn to enter culvert (Photo 1). C2- Large pool forming at outfall, exacerbated by large (20-25') grass island in channel (Photo 2). A large tree is growing adjacent to the culvert. Culvert entrance is tilted upwards (Photo 3, below) causing water to pool at entrance and possibly undermine the culvert.

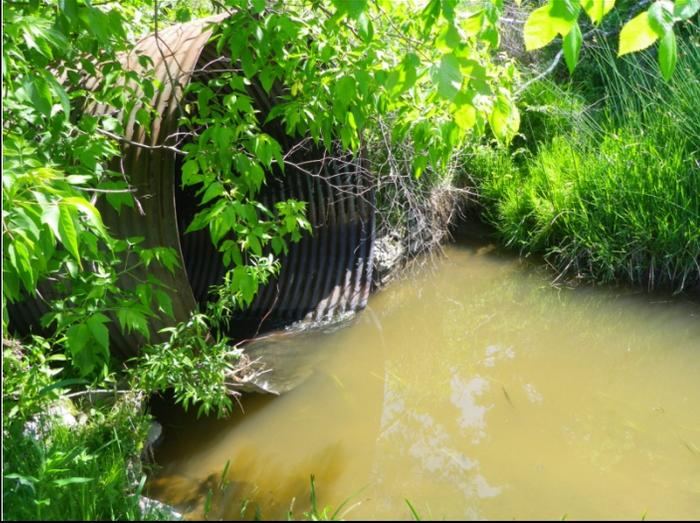
Photo 3. Poorly set culvert

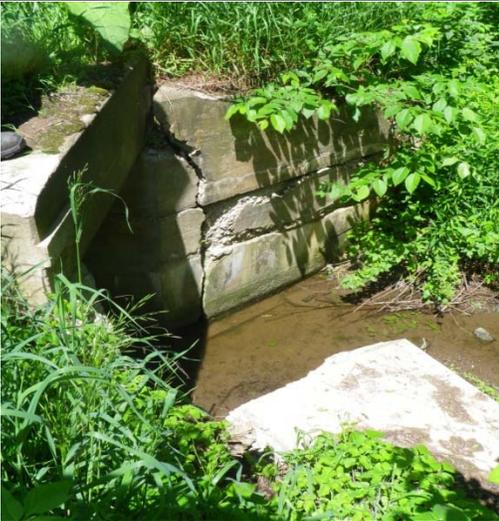
Photo 1. Deteriorated concrete armor	Photo 2. Straightened stream flowing downhill to culvert

Description of Observed Conditions:
 South side of concrete armor has fallen into stream. Some evidence of erosion present. Two drainage ditches and a stream merge directly at bridge crossing. Stream has significant slope and could see heavy flows during rain events.

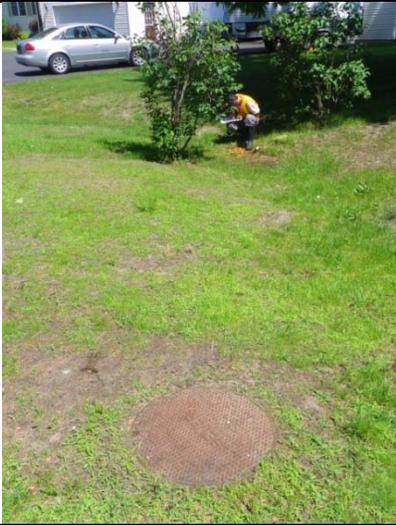
<p>Photo 1. Catch basin (in background) seem to be working and flowing throughout neighborhood</p>	<p>Photo 2. Evidence of ponding water and localized erosion</p>

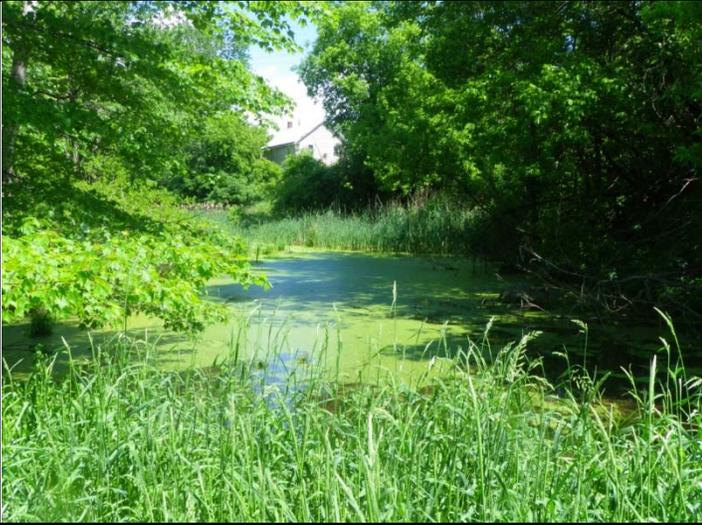
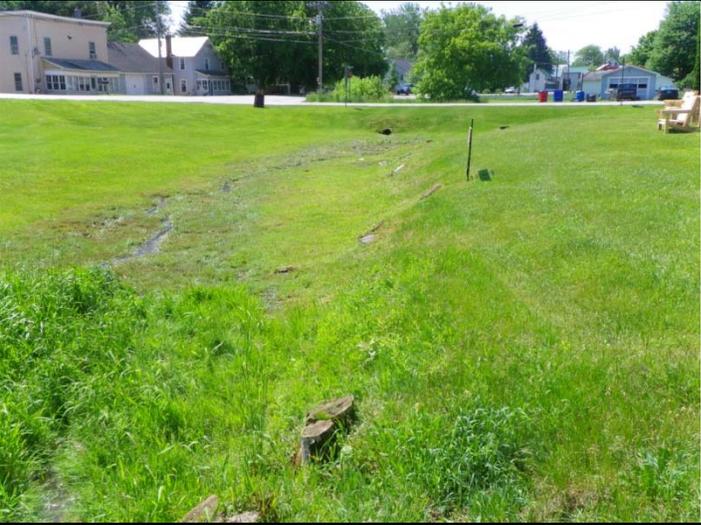
Photo 1. Existing pond	Photo 2. Swale between pond and culvert

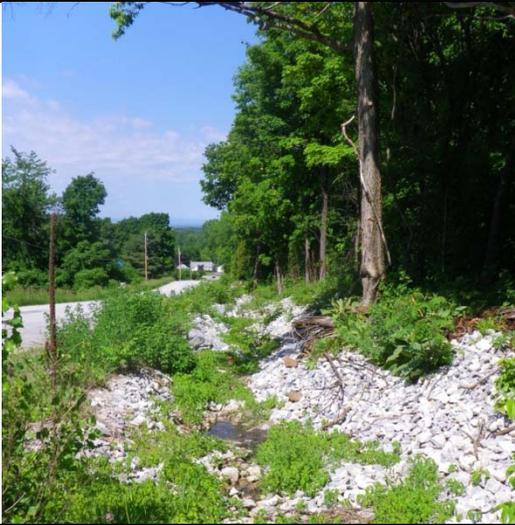
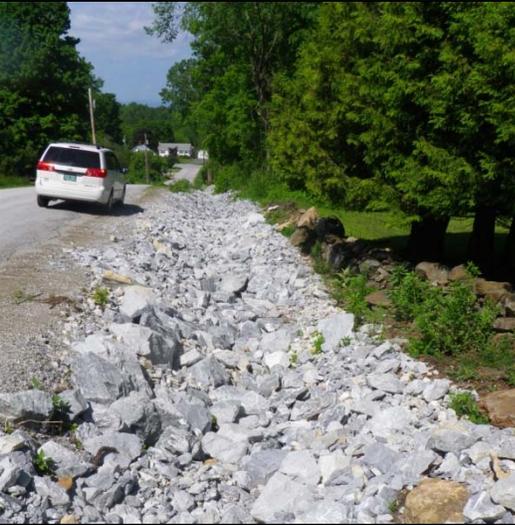
Road Name: <u>Bachand Rd</u>		
Problem Type: <u>Local Drainage</u>		
Identification Source: <u>Town Feedback</u>		
Ownership: <u>Local</u>		
Classification Level: <u>2a</u>		
Problem Description:		
Roadside ditch erosion on Bachand Rd.

Photo 1. Upper portion of road	Photo 2. Lower section of road

Description of Observed Conditions:
<p>After years of significant erosion during high flow events, the town installed rip rap in roadside ditch to ease water flow down the hill. Residents report no problems this year. There may be an opportunity to use check dams or similar measures to further slow flow, if warranted.</p>

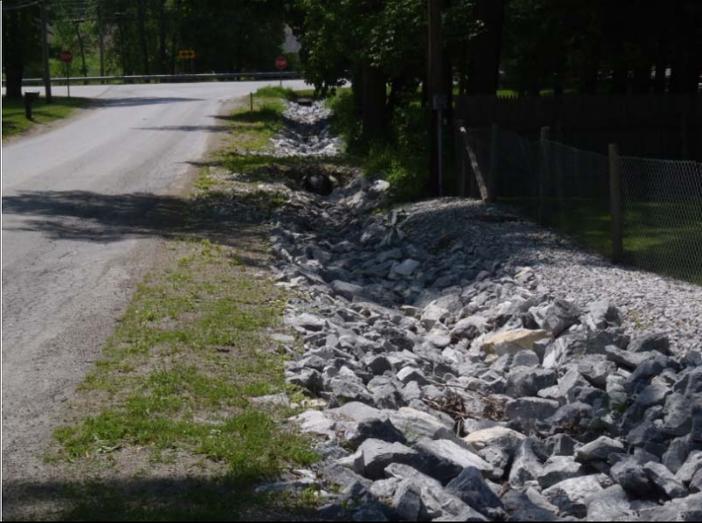
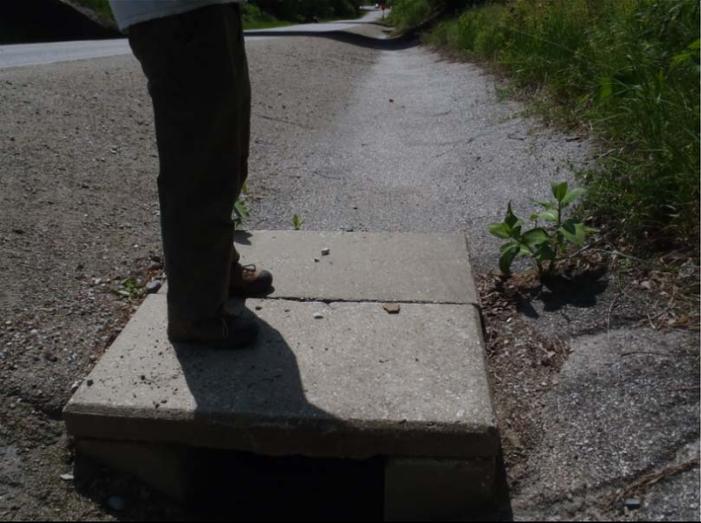
Watershed:	Hungerford Brook													
Road Name:	Woods Hill Road													
Problem Type:	Local Drainage													
Identification Source:	Town Feedback													
Ownership:	Local/State													
Classification Level:	2a													
Problem Description:	Woods Hill Road at I-89: erosion in roadside ditch along steep section of roadway (some work done already).

Photo 1. Rip rap	Photo 2. Drop inlet

Rip rap has been placed in the ditch along the north side of road west of I-89; asphalt ditch runs below both directions of I-89. Several drop inlets exist in the ditch and the drainage system ends east of I-89 at a drop inlet. No damage visible. There may be an opportunity to use check dams or similar measures to further slow flow, if warranted.

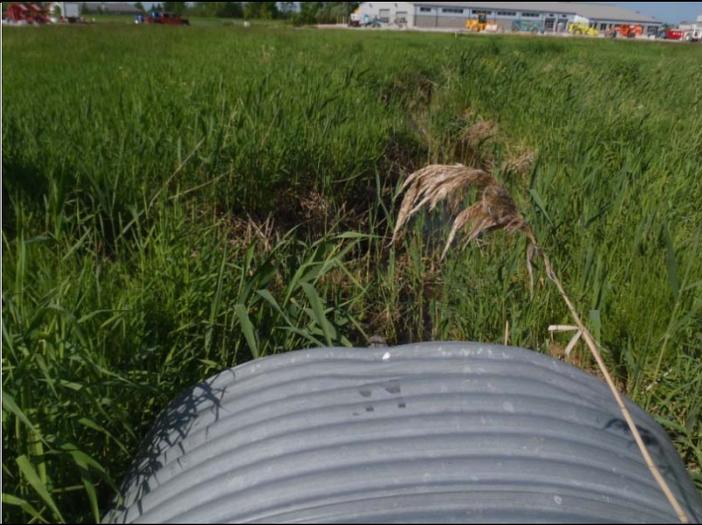
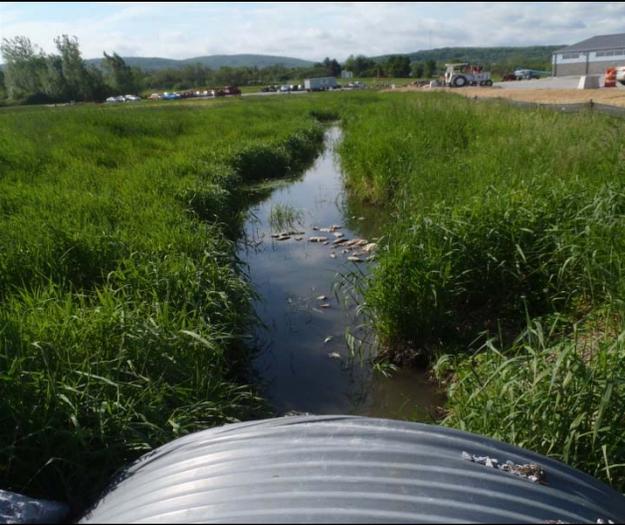
Photo 1. Paquette Rd. looking towards I-89	Photo 2. Paquette Rd. looking towards industrial park

Description of Observed Conditions:
The Town of Swanton wishes to encourage and concentrate future development at the Exit 20 interchange. Upstream segments of Stevens Brook are considered “stormwater impaired;” strategies need to be investigated that both address current stormwater concerns and take proactive steps to guard against the cumulative impacts of future development in order to ensure that these tributaries are not added to the State’s list of impaired waters.

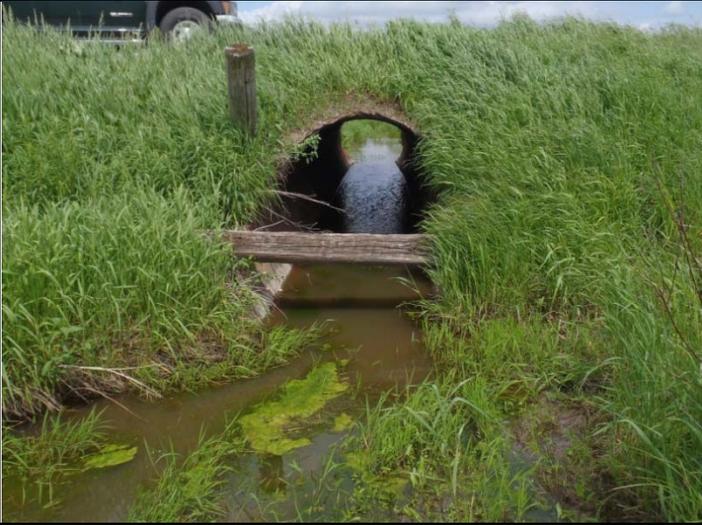
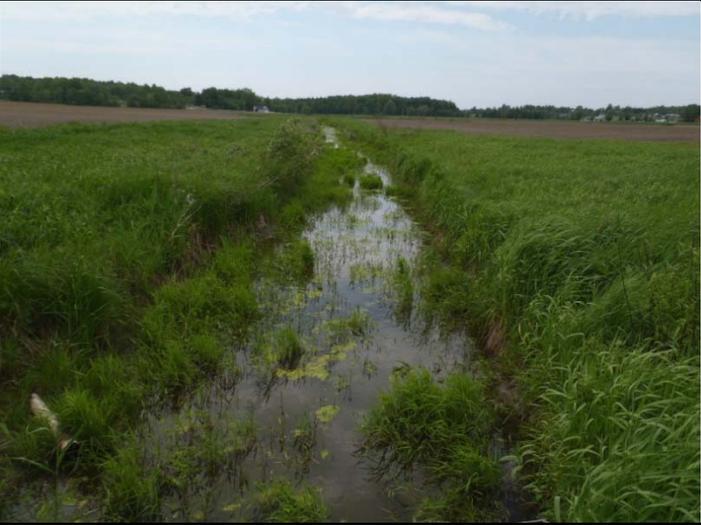
Photo 1. Culvert C1	Photo 2. Channel straightening, upstream of C1

C1- Extensive channeling between the two fields, no visible signs of erosion. C2- Bridge crossing; pooling upstream of bridge, channel is not aligned with the bridge. C3- 6' corrugated metal culvert, with 4" of flow. Culvert is perched with deterioration in the bottom middle of culvert evident; undercutting of culvert occurring as well.

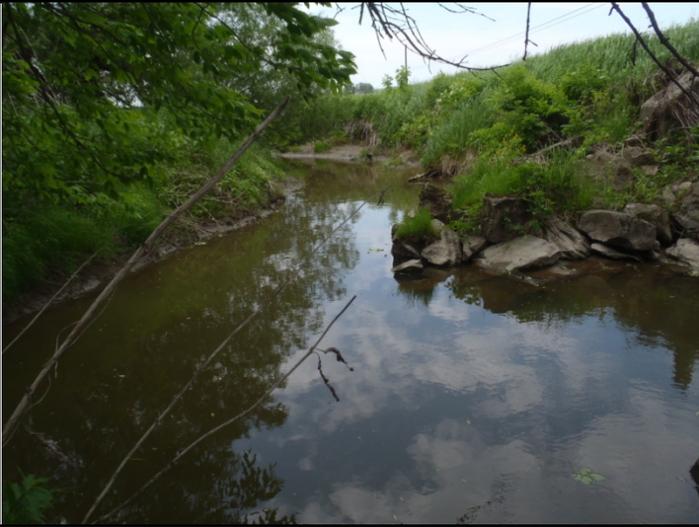
Photo 3. Pooling upstream C2

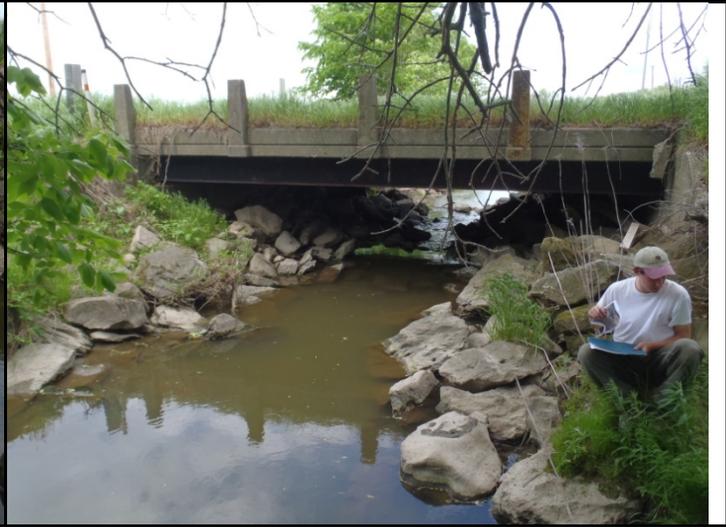
Photo 4. Bridge crossing C2

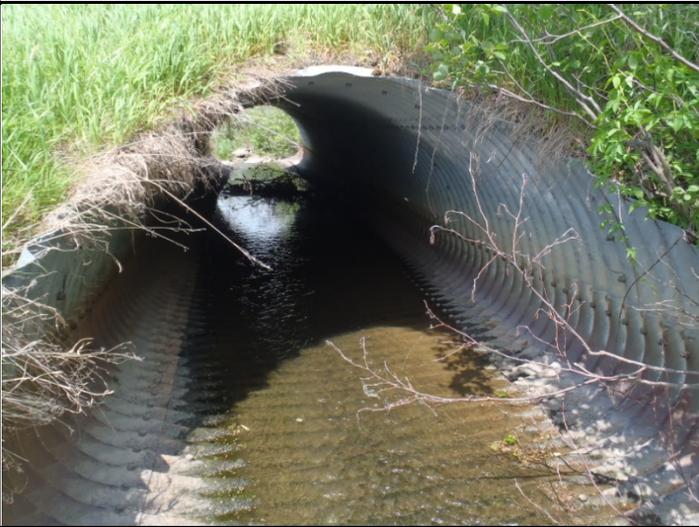
Photo 5. Culvert C3

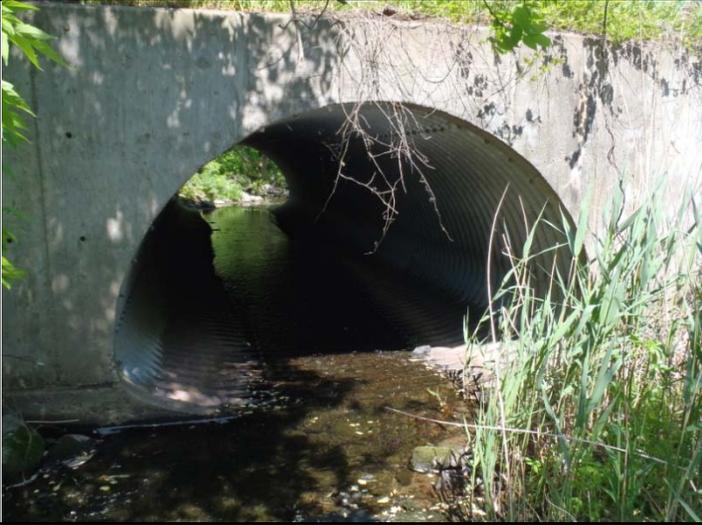
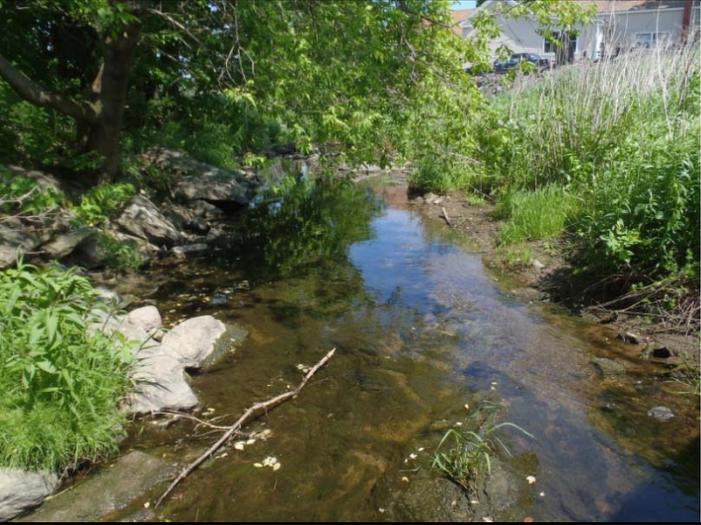
Photo 1. Metal lined concrete bridge	Photo 2. House on bank

Description of Observed Conditions:
7' tall, crushed metal culvert lining a concrete tunnel. 4" of flow, no significant erosion. Fish passage is possible. Evidence of direct livestock (cow) access directly downstream of culvert, floodplain constricted by road crossing and homes encroaching on the riparian area

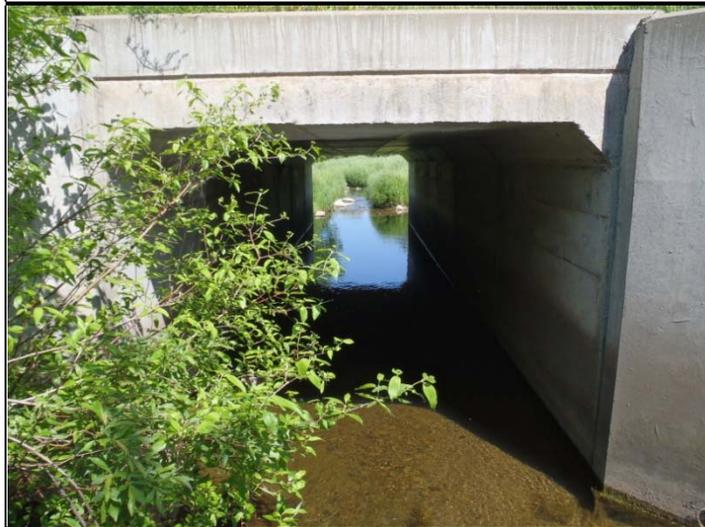
Problem Description:			
Numerous concerns identified, including: loss of floodplain, direct access by cows, lack of vegetative buffer, channelization and straightening in reaches.			
Date of Field Data Collection: <u>5/25/2012</u>			
Field Photos

Photo 1. Concrete Tunnel

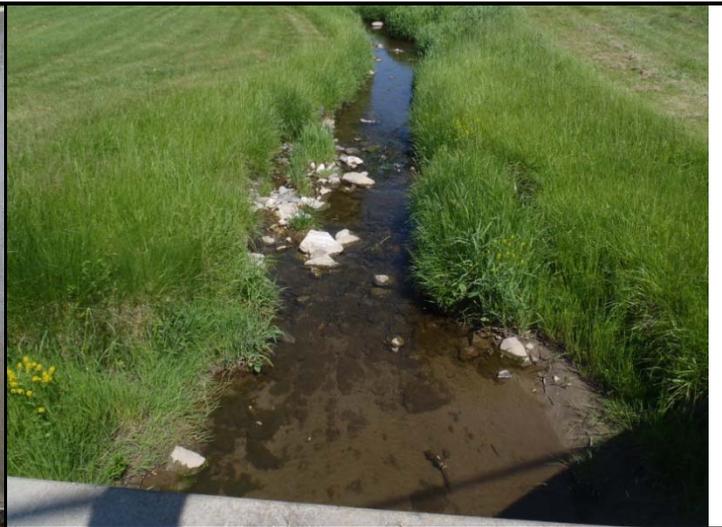
Photo 2. Grass buffers

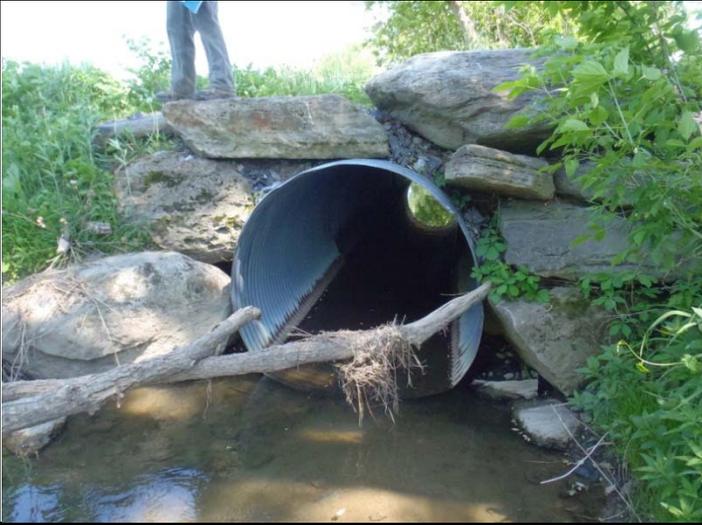
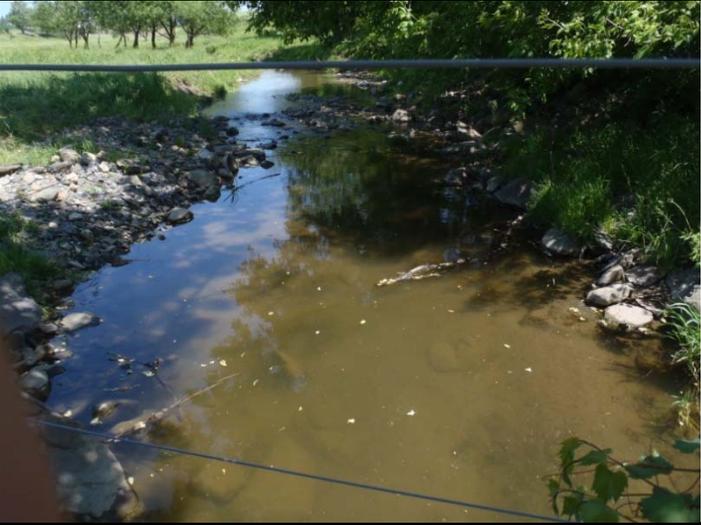
Photo 1. C1- Culvert	Photo 2. Cow access near C1 culvert

C1- Corrugated metal 5' culvert. Evidence of direct animal (cow) access on the north-side of the stream. C2- concrete bridge on farm road. 4' high, 15' across. Erosion present downstream; more signs of cow access. C3-concrete bridge is too small and constricts flow; erosion is present. Structure is also damaged, cinder blocks in stream. C4- rocky tunnel with extensive damage; pooling at outlet and erosion downstream. C5- Brook bypassing culvert. Major erosion and pooling at culvert. 36" culvert too small for stream flow.

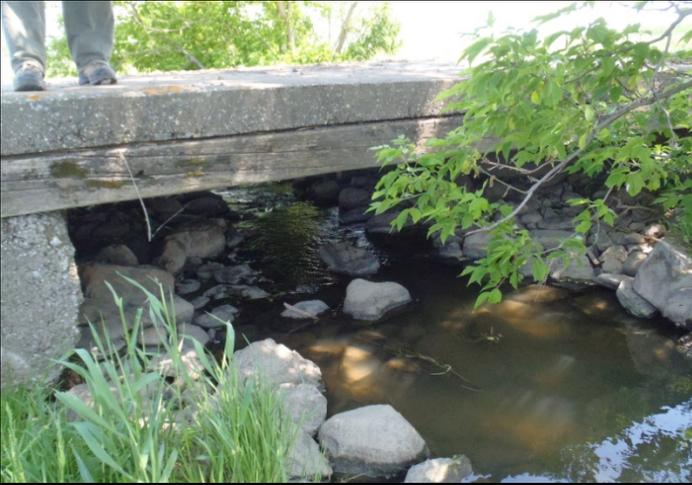
Photo 3. Concrete bridge C2

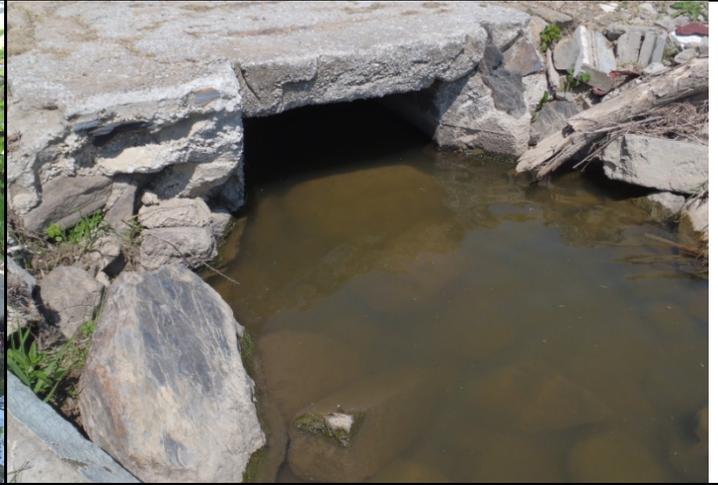
Photo 4. Small Concrete bridge C3

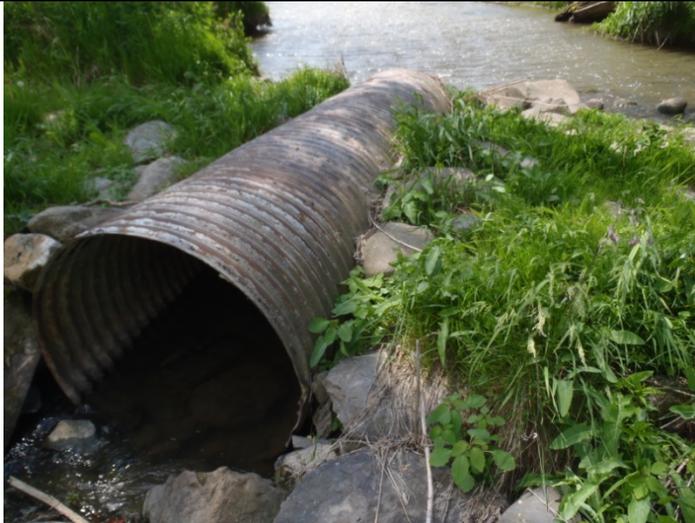
Photo 7. Undersized culvert C5
