STORMWATER MANAGEMENT PLAN FOR SWANTON TOWN AND VILLAGE

FINAL REPORT

Stone Project ID 112475-W
February 21, 2013

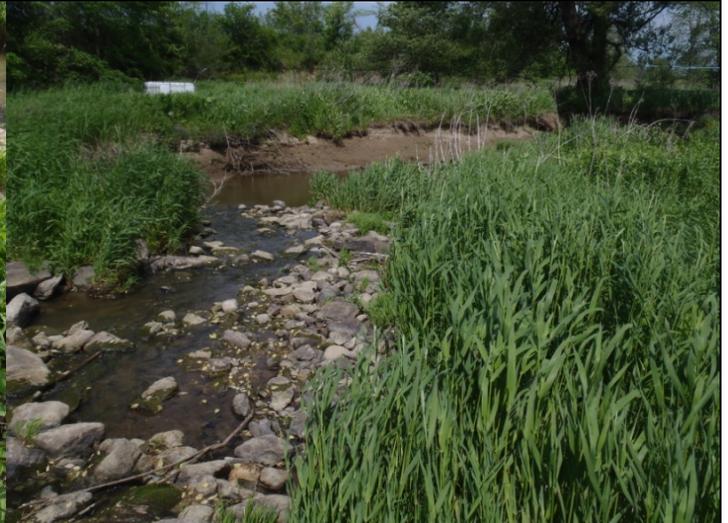
C1- Corrugated metal 5' culvert. Evidence of direct animal (cow) access on the north-side of the stream. C2- concrete bridge on farm road. 4' high, 15' across. Erosion present downstream; more signs of cow access. C3-concrete bridge is too small and constricts flow; erosion is present. Structure is also damaged, cinder blocks in stream. C4- rocky tunnel with extensive damage; pooling at outlet and erosion downstream. C5- Brook bypassing culvert. Major erosion and pooling at culvert. 36" culvert too small for stream flow.

Photo 8. Cow access near C5

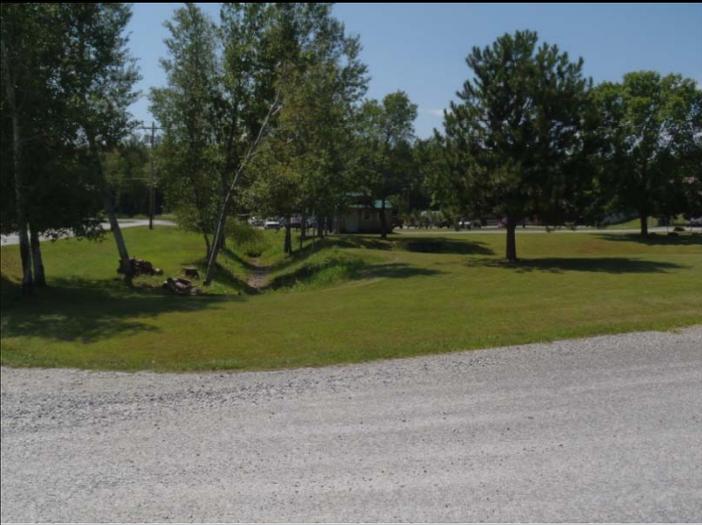
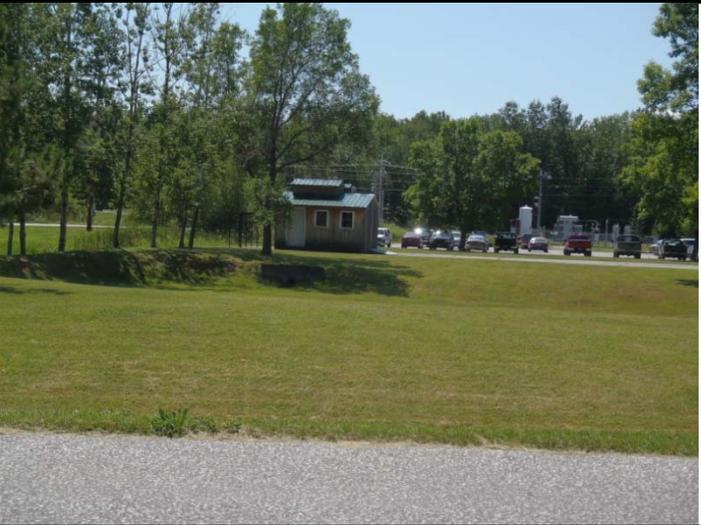
Missisquoi River													
Road Name:	Jonergin Dr.													
Problem Type:	Local Drainage													
Identification Source:	Town Feedback													
Ownership:	Private													
Classification Level:	3													
Problem Description:	Stagnant water in Jonergin Dr. ditches, causes discolored discharges during heavy storms.

Photo 1. Grass swale east of Leader Evaporator	Photo 2. Lawn/dry pond east of Leader Evaporator

Description of Observed Conditions:
No stagnant water observed, likely due to recent dry conditions. Dry pond and/or grass swale retrofits may be possible to improve stormwater treatment.

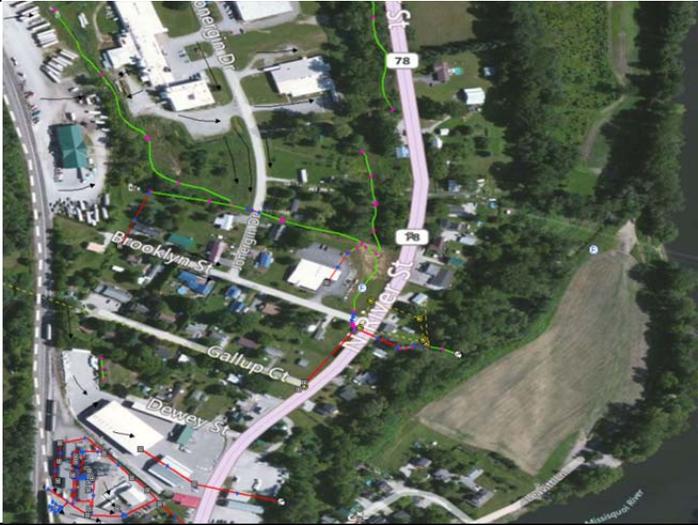
Problem Description:		
Goose Point, village owned parcel with potential for stormwater mitigation from industrial area.

Photo 1. Stormwater infrastructure in Goose Pt area

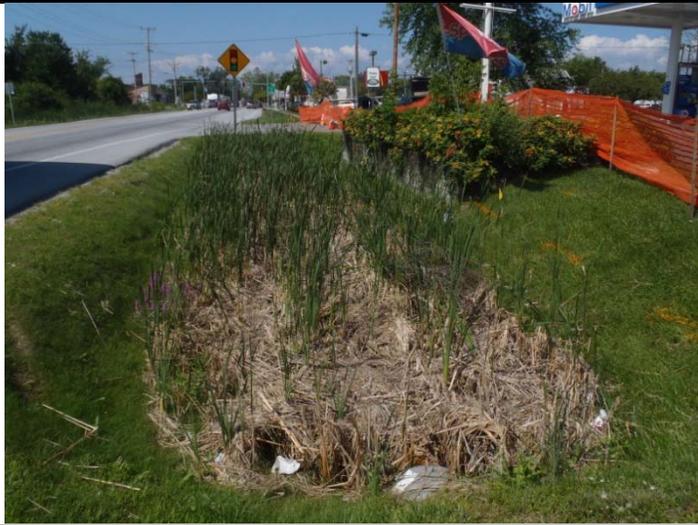
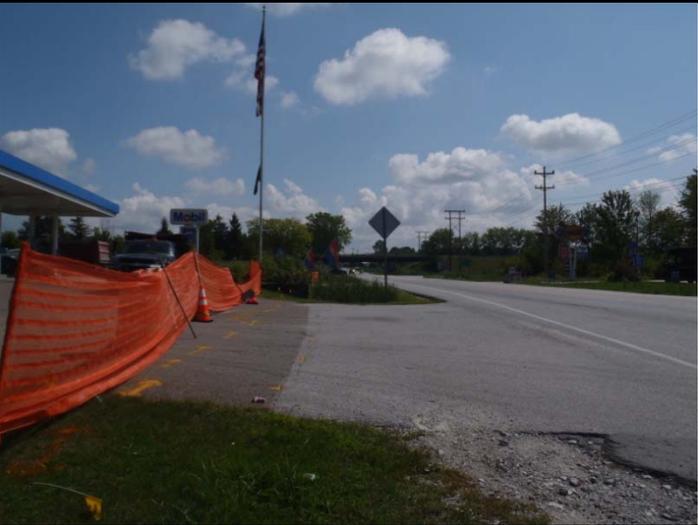
Photo 1. Existing swale/wetland in front of Mobil	Photo 2. Looking east to drainage area

Description of Observed Conditions:
<p>Could retrofit existing wet swale to enhance treatment. Existing wetland plants currently provide some filtration. A gas line present to the immediate north of the swale may prohibit widening, but swale could potentially be dug deeper. Proximity to Route 7 could make construction challenging.</p>

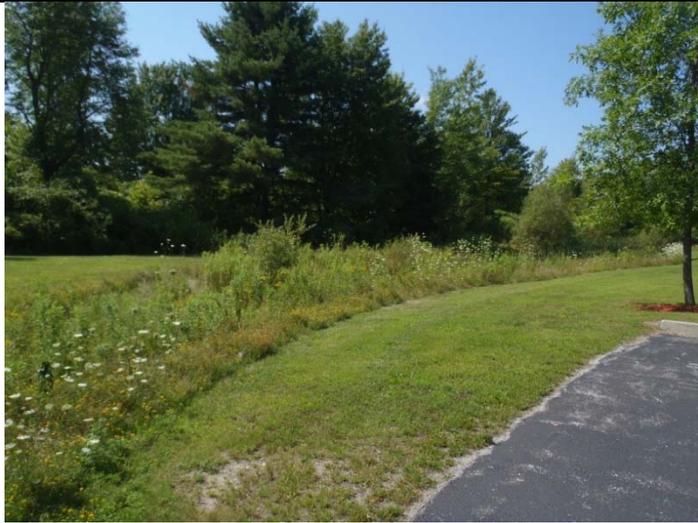
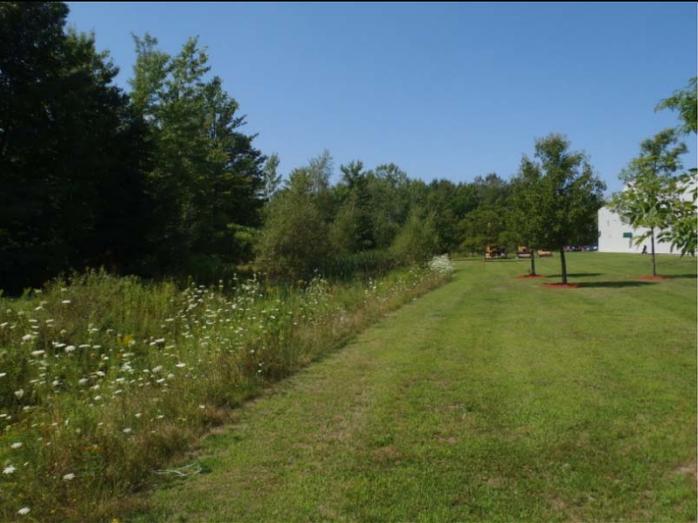
Photo 1. SE corner of VT Precision looking to the west	Photo 2. Same as Photo 1, longer extent

Description of Observed Conditions:
Large area of impervious surface feeding directly into swale system. Depending on landowner interest, system could be retrofitted to improve treatment; large “campus” may offer other opportunities for low-impact type retrofits.

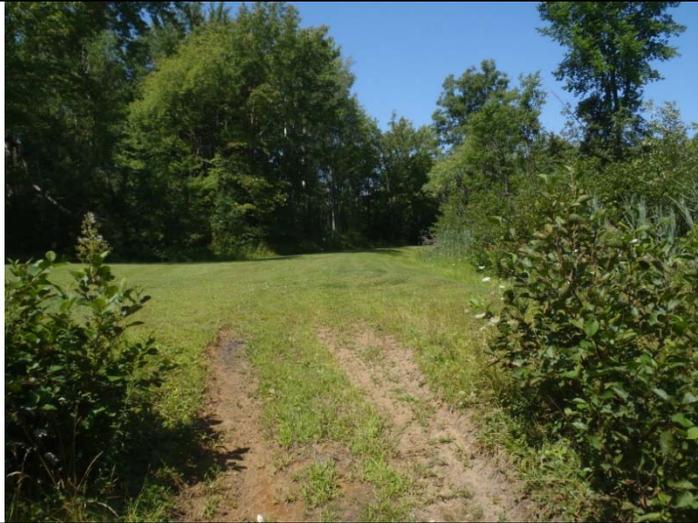
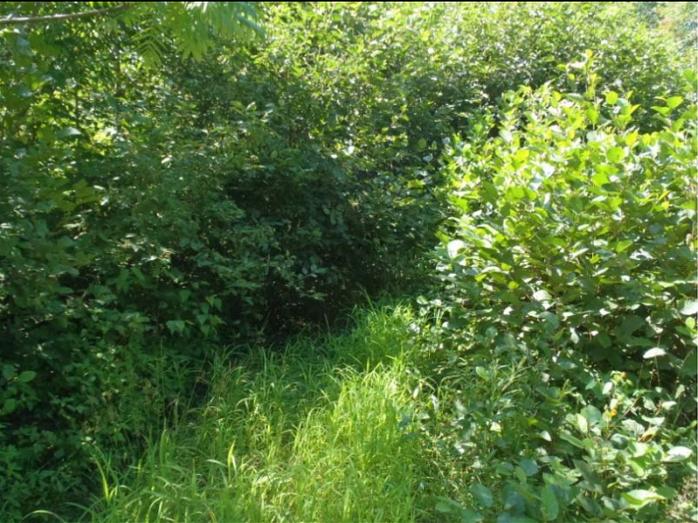
Photo 1. Looking NW to potential treatment area	Photo 2. Looking west from swale junction

Problem Description:		
Two swales meet in the meadow visible to the lower left in the above photo, draining Elm St, 4 th St, and the entirety of Robinhood Drive.

Description of Observed Conditions:
Potential exists to install a treatment practice in the meadow, treating the stormwater before it crosses the Rail Trail and Leduc Drive. Landowner interest/willingness is unknown.

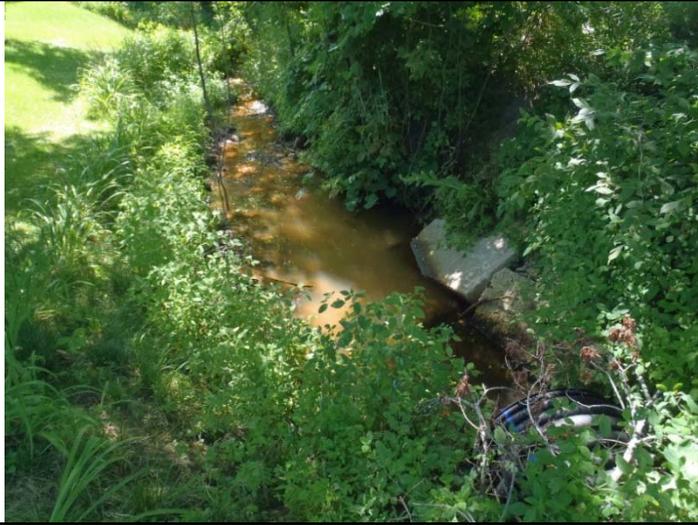
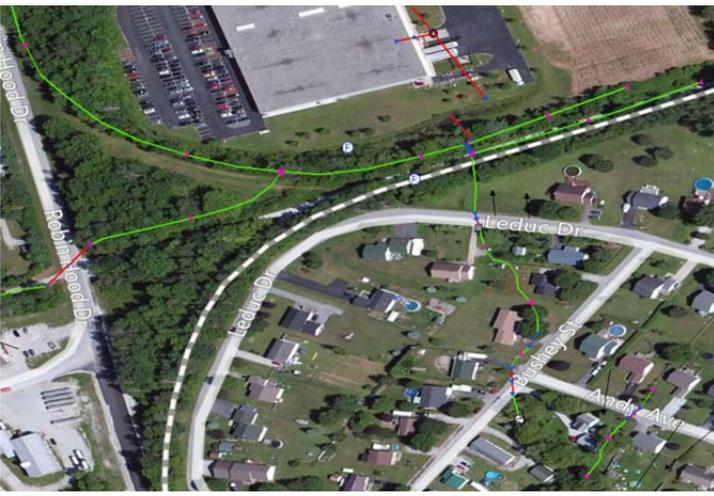
Photo 1. Outfall from culvert under Bushey Ave.	Photo 2. Existing stormwater infrastructure

Road Name: Bushey Ave		
Problem Type: Local Drainage		
Identification Source: Collin Smythe, VTDEC mapping project		
Ownership: Private		
Classification Level: 3		
Problem Description:		
<p>Outfall of sections of the rail trail, Elm St, and Robinhood Drive. Base flow during summer, low flow conditions suggests that conveyance may be a stream in addition to stormwater ditch, although waterway is entirely culverted through the Bushey Ave area.</p>

Description of Observed Conditions:
<p>Potential exists to slow stormwater and/or enhance treatment in the swale near Precision Lane. Water at outfall appeared to have an orange tint, but fish and frogs visible, suggesting that oxygen is present.</p>

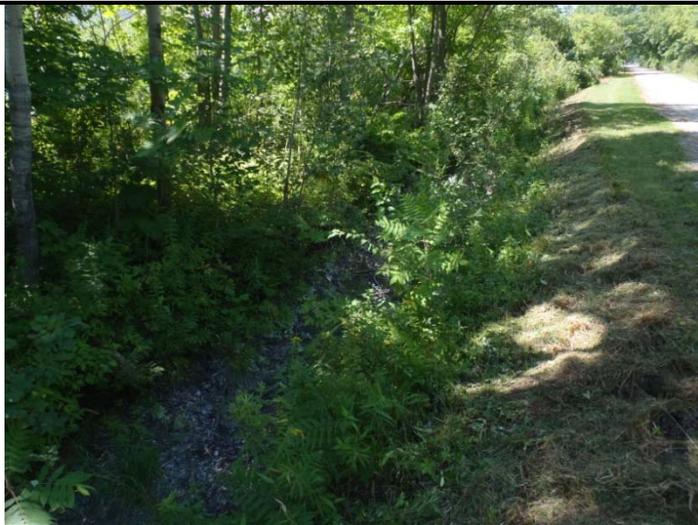
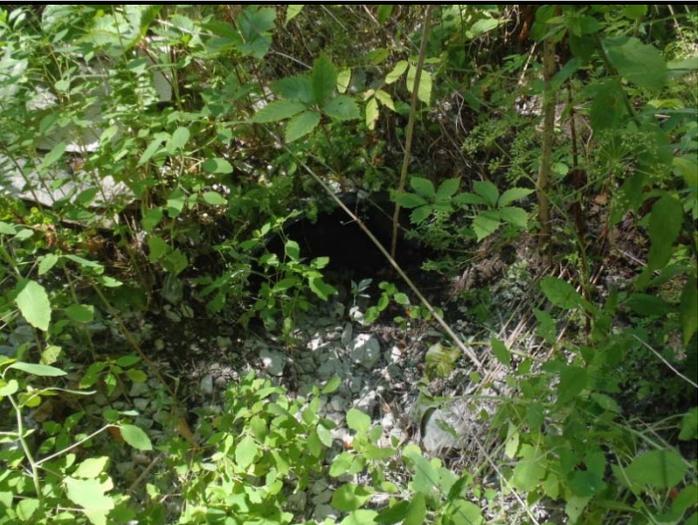
Photo 1. Ditch on SW corner of intersection	Photo 2. Under-road culvert NW corner of intersection

Road Name: Robinhood Dr.		
Problem Type: Local Drainage		
Identification Source: VT DEC		
Ownership: Public (Town)/Private		
Classification Level: 3		
Problem Description:	Erosion in culvert and swale system around the intersection of Robinhood Dr. and the rail trail.

Description of Observed Conditions:
Ditch condition suggests high volume of water during storm events, likely clogging culvert in Photo 2. A system of check dams could be used to reduce the energy of stormwater as it moves through the system, in addition to abating further erosion. Other retrofits might be possible depending on landowner interest and ROW constraints.

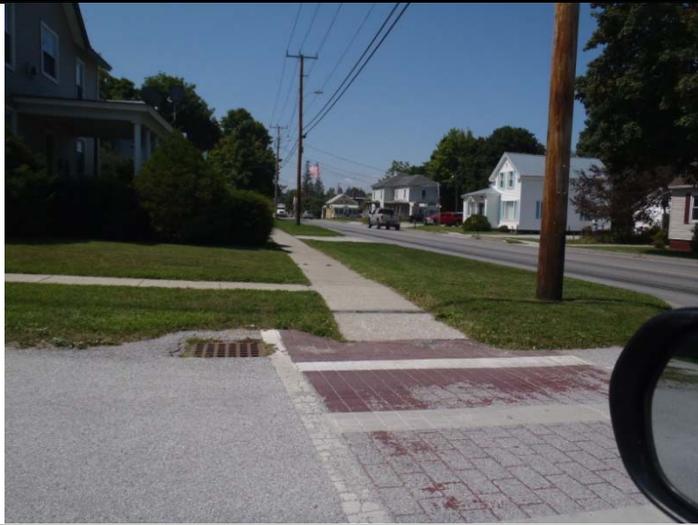
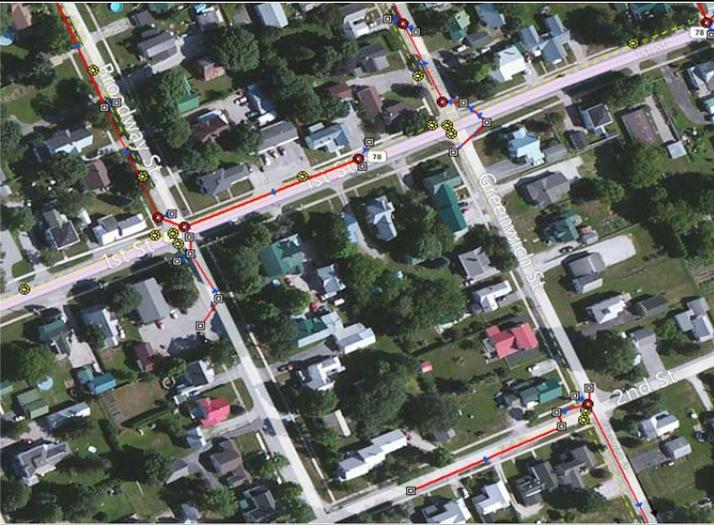
Photo 1. SW corner of First and Greenwich	Photo 2. Stormwater infrastructure

Road Name: First St.		
Problem Type: Local Drainage		
Identification Source: SWMP evaluation		
Ownership: Private		
Classification Level: 3		
Problem Description:		
Untreated/unmanaged stormwater runoff throughout the Village.

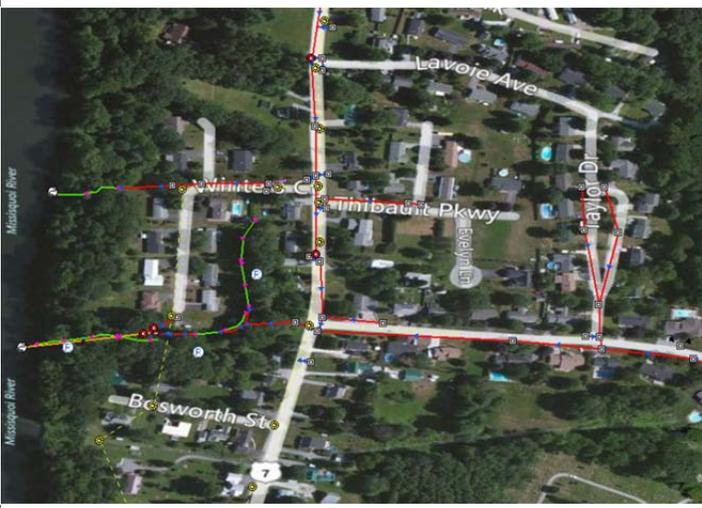
Photo 1. Stormwater infrastructure

Downspout disconnection and/or infiltration area potential on Taylor Dr.

Description of Observed Conditions:
<p>Several roof gutter systems outfall onto driveways and flow into stormlines on Taylor Dr. Substantial green space in center of loop may offer opportunity to disconnect these downspouts from the stormline system and direct runoff to a soak away area.</p>

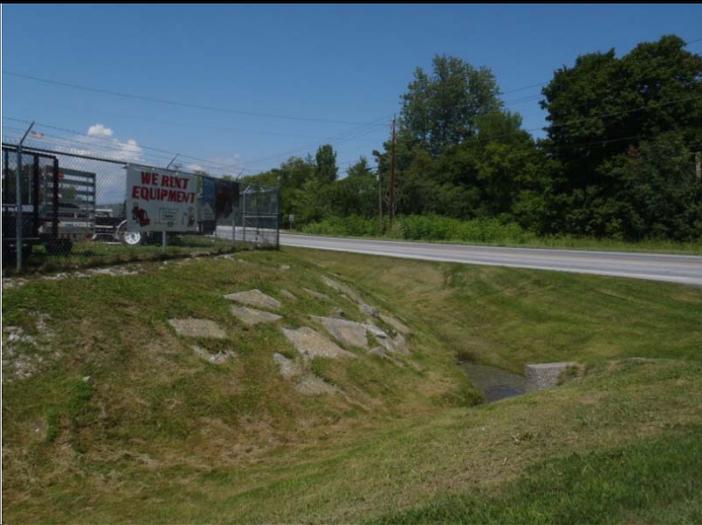
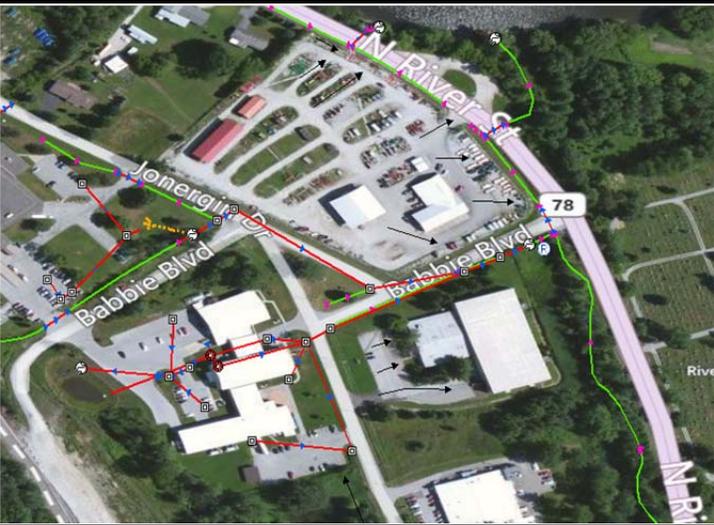
Photo 1. Grass swale SW of Fournier's dealership	Photo 2. Stormwater infrastructure

Road Name: Route 78 N		
Problem Type: Local Drainage		
Identification Source: Collin Smythe, VTDEC mapping project		
Ownership: Private		
Classification Level: 3		
Problem Description:		
Grassed swale SW along Route 78 provides limited treatment before discharging directly to the Missisquoi River.

Description of Observed Conditions:
Water from culvert under Town Highway 61 flows through this swale, then under Route 78 to outfall in the Missisquoi. Potential retrofit opportunities include converting the area to a wetland to slow/treat stormwater runoff. Landowner interest/willingness is unknown.

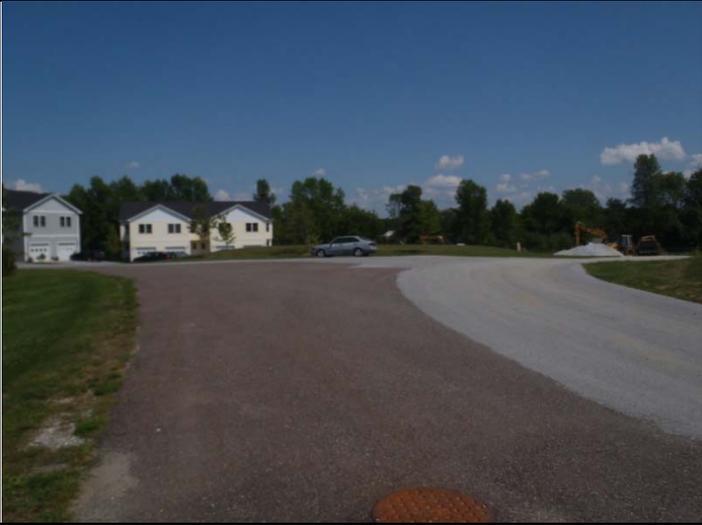
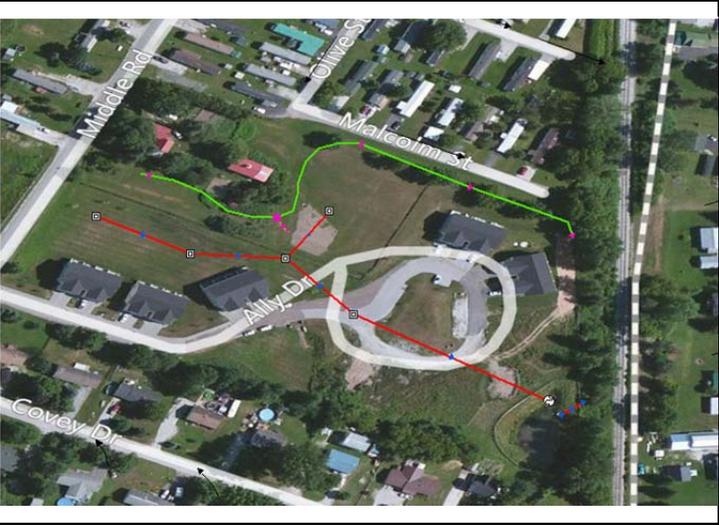
Photo 1. Ally Dr, looking east toward cul-de-sac	Photo 2. Stormwater infrastructure

Missisquoi River													
Road Name:	Ally Dr.													
Problem Type:	Local Drainage													
Identification Source:	Town Plan													
Ownership:	Private													
Classification Level:	2a													
<p>New development on Ally Drive has created disproportionately large amount of impervious area, including road layout and driveways.</p>

Ally Drive development has a great deal of pavement, as seen in Photo 1 and the aerial image above. The need for stormwater treatment practices can often be minimized by employing so-called "better site design" techniques; full implementation of better site design techniques may necessitate changes in land use and development regulations.

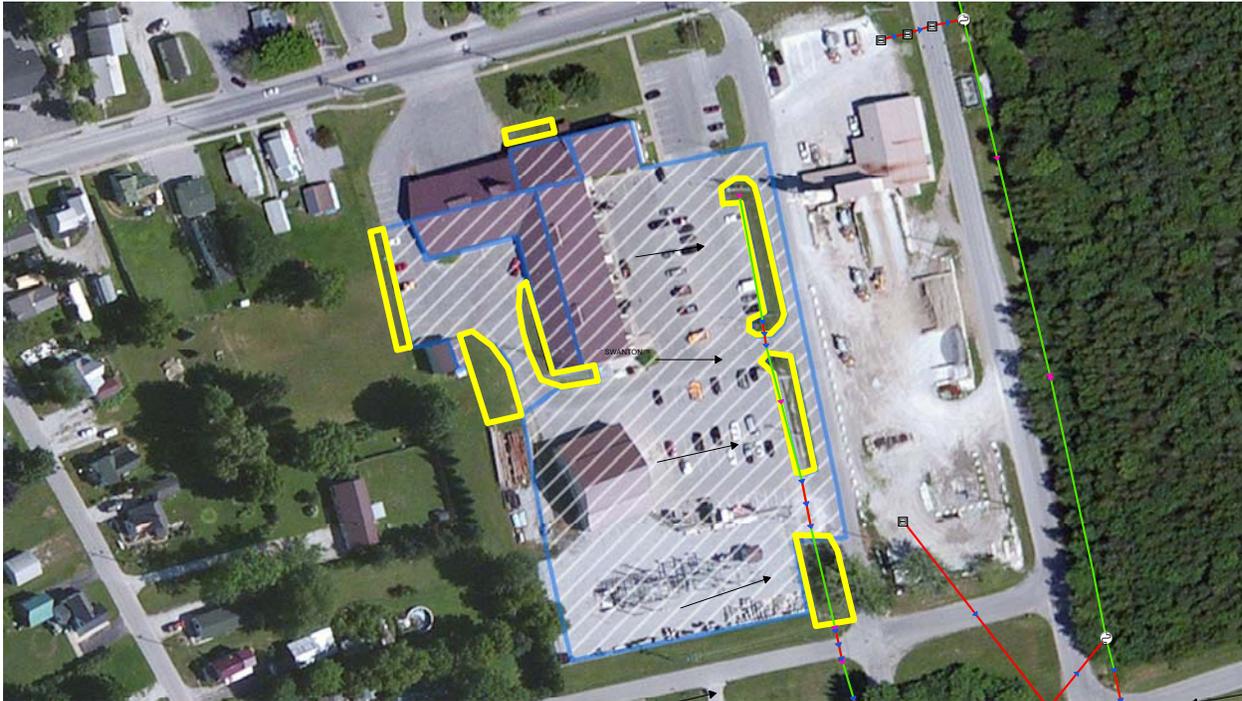
Figure 1. Swanton Village water office, fire department, and road maintenance garage: Treatable impervious area highlighted in blue and locations for potential treatment practices highlighted in yellow.

Stormwater from three acres of impervious surface at the Swanton Village Municipal Complex and adjacent electrical substation could be routed through potential stormwater treatment practices (STPs) located as shown in yellow in Figure 1.

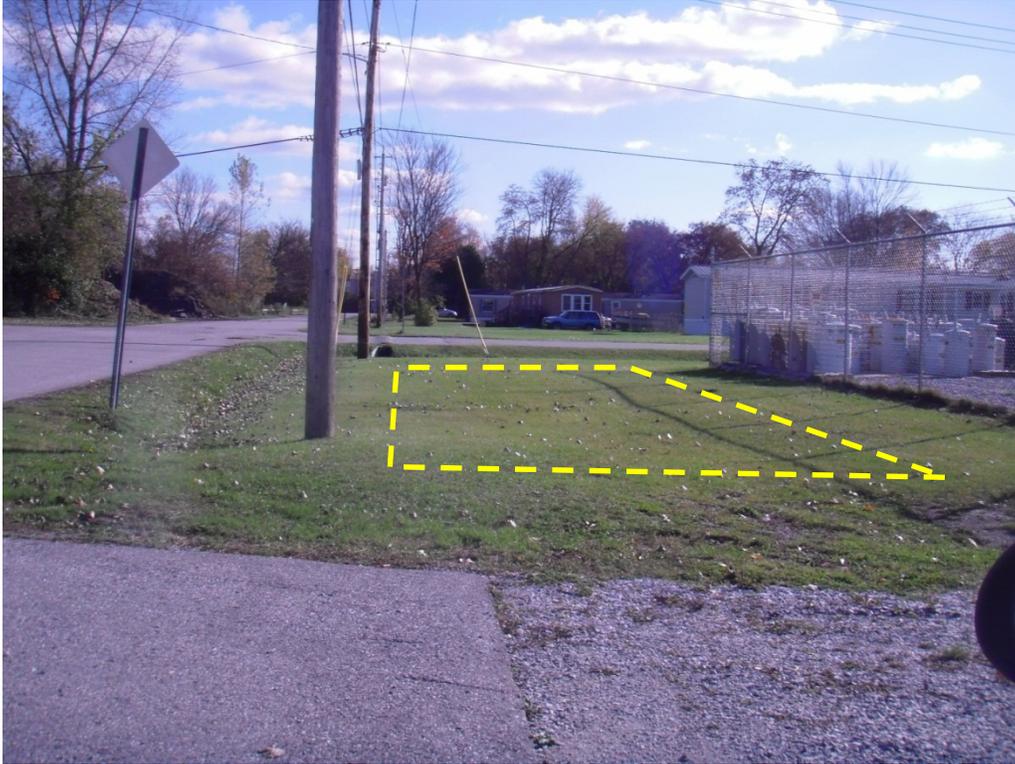
Figure 4. A large unused portion of greenspace in front of the electrical substation could be utilized to treat stormwater runoff from the substation and adjacent town properties.

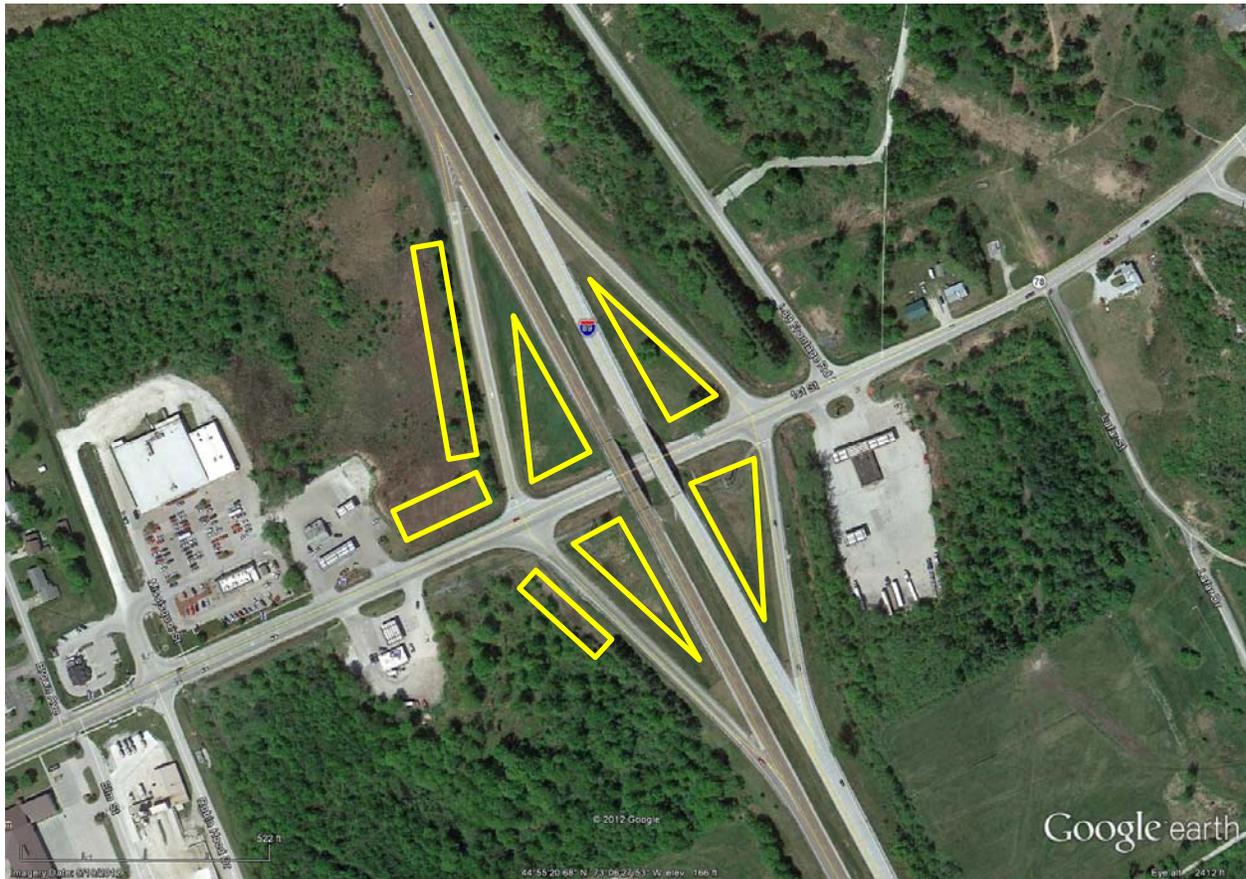
Figure 5. I-89 (Exit 21)-VT RT 78 Interchange. Potential sites for stormwater treatment practices highlighted in yellow.

Green space within and adjacent to the I-89 Exit 21 interchange could accommodate the construction of stormwater treatment practices. The diamond interchange at Exit 21 includes a stormwater conveyance system that drains the highway. The 30-acre subwatershed includes 3.8 acres of impervious surface. The large amount of space and existing conveyance structures simplify design and construction efforts required to implement a stormwater treatment practice at this location. A storm water treatment practice similar to that which was recently constructed in the highway median near I-89 Exit 20 could be effective here.

The most suitable practices are likely to be bioretention and filtration systems that include an underdrain. Soils are reported by the USGS to be Georgia stony loam and Massena stony loam, Hydrologic Soil Group (HSG) C with high water tables. These characteristics mean that infiltration cannot be expected to be a suitable treatment practice. Additionally, roadway subsoil strength can be affected by saturated soils. The proximity of the roadway further supports the need for non-infiltration-based systems.

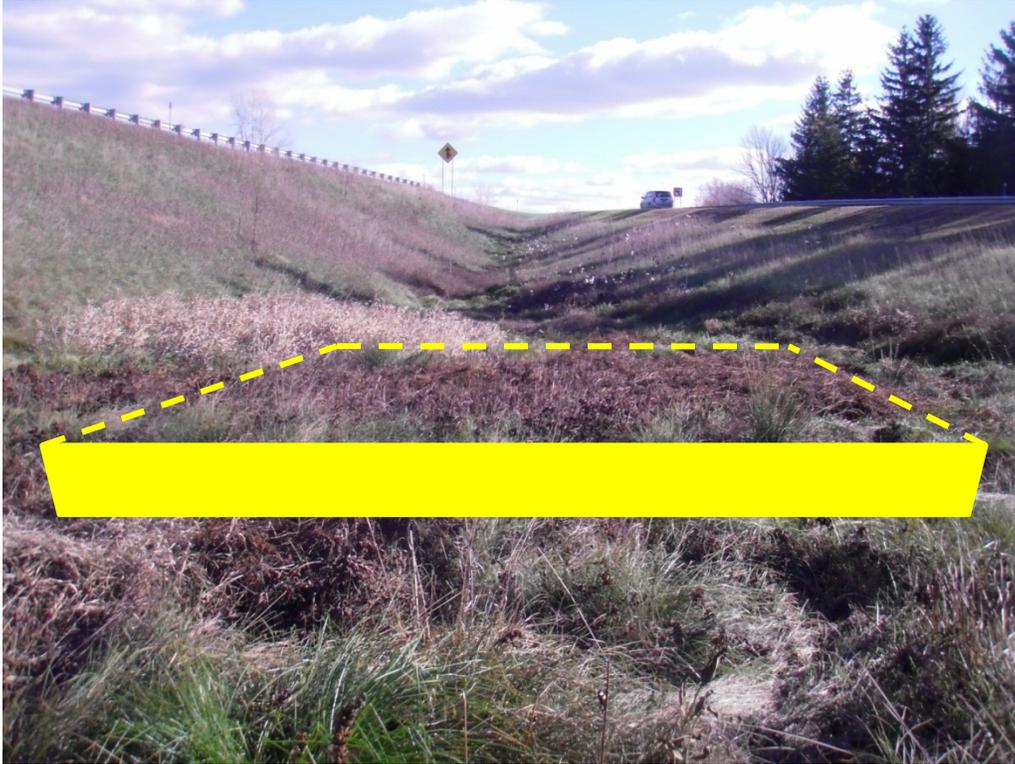
Figure 6. Conceptual example of STP installation within interchange diamond.

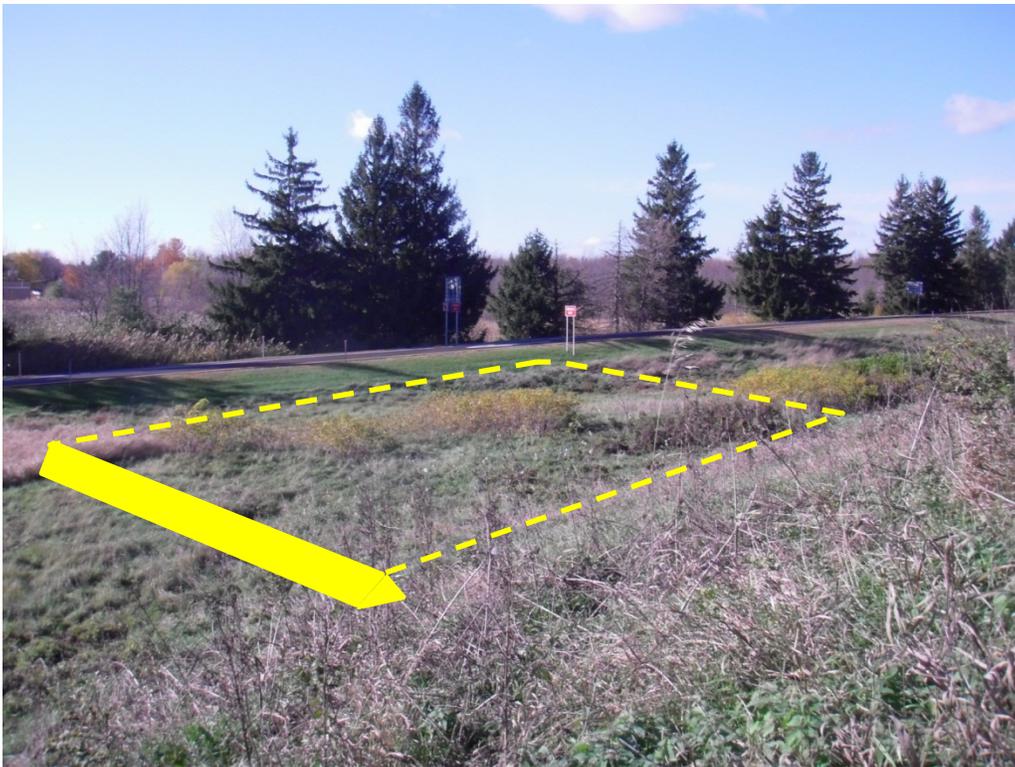
Figure 7. Another view of a conceptual STP layout within the I-89 Exit 21 interchange diamond.

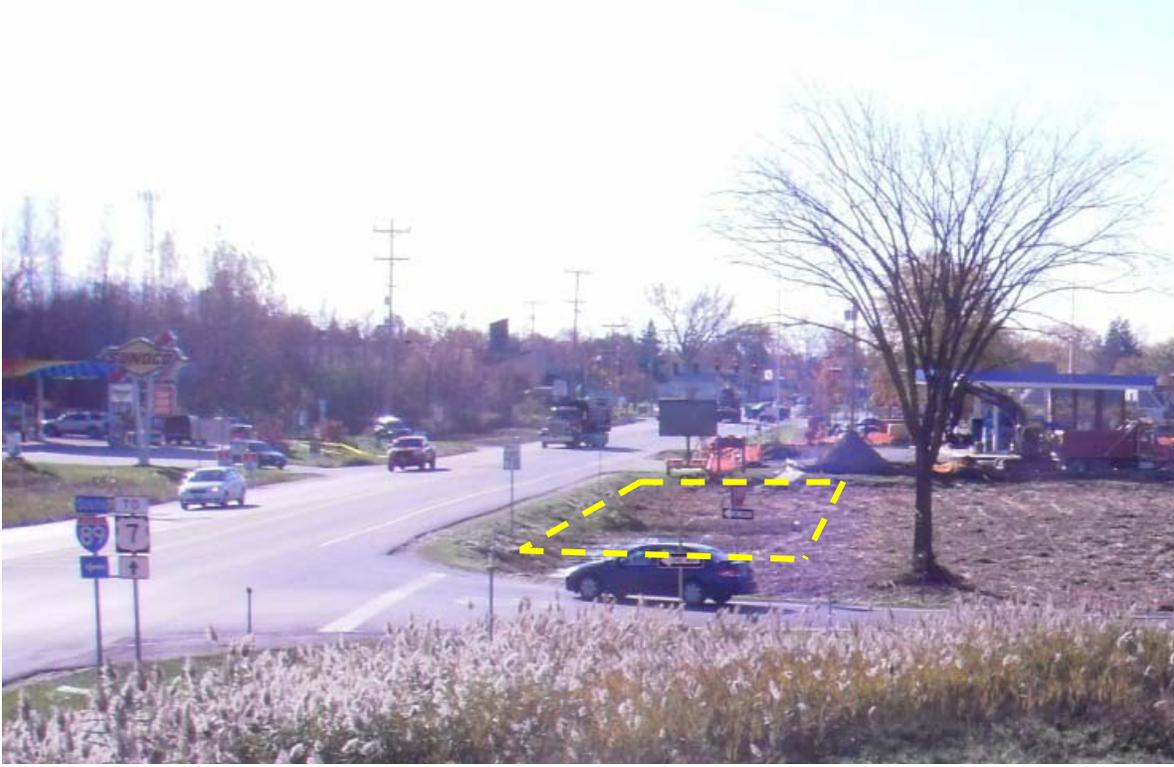
Figure 8. Conceptual location of STP outside of the I-89/Exit 21 interchange.

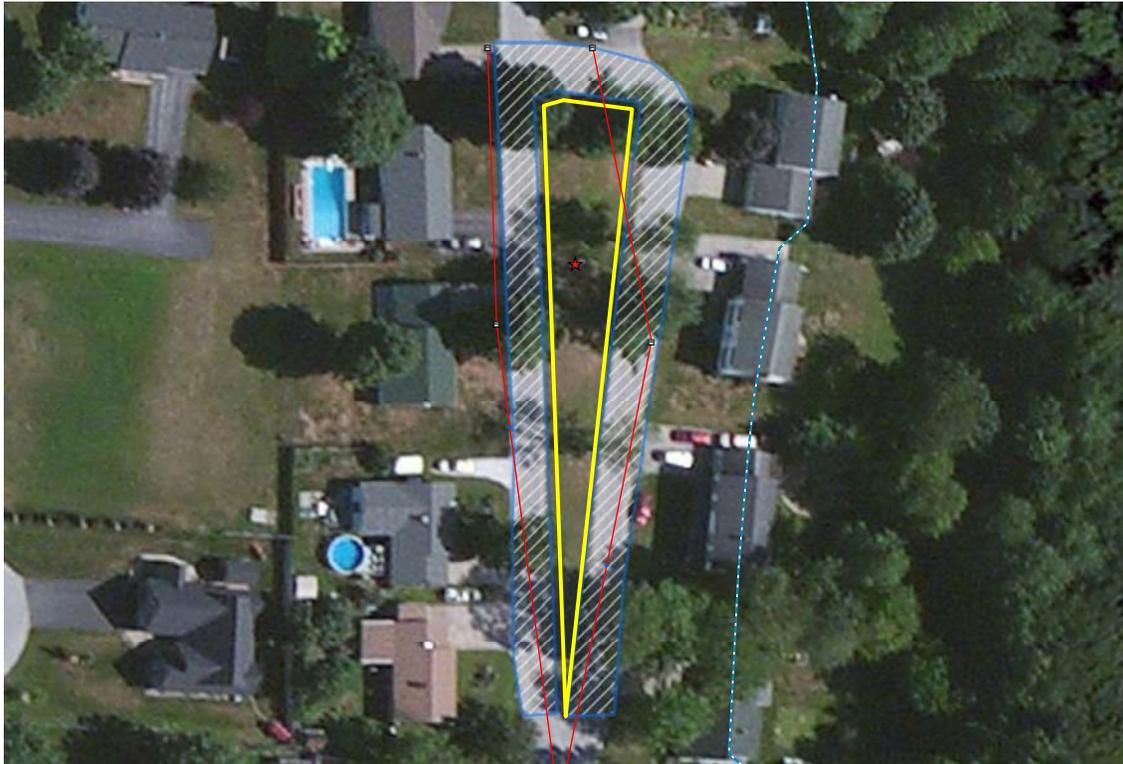
Figure 9. The Taylor Drive cul-de-sac offers ample treatment opportunity (shown in yellow). The contributing impervious area is outlined in blue.

Taylor Drive is a residential street with a large cul-de-sac that includes a median that is well-suited for stormwater treatment. Currently, water drains from the street and some of the adjacent residential lots toward the cul-de-sac where it is collected in catch basins along the existing curb.

The reported soil types in the area are Windsor loamy fine sand (HSG A) with a deep water table. This means that infiltration practices could be used to soak away a large portion of stormwater runoff from this neighborhood. Curb cuts could allow stormwater to drain to a potential stormwater treatment practice within the green space at the center of the cul de sac. The existing catch basins are located such that they could act as overflow relief for the proposed stormwater treatment practices. Figure 10 through Figure 12 show conceptual locations for the STPs and associated curb cuts.

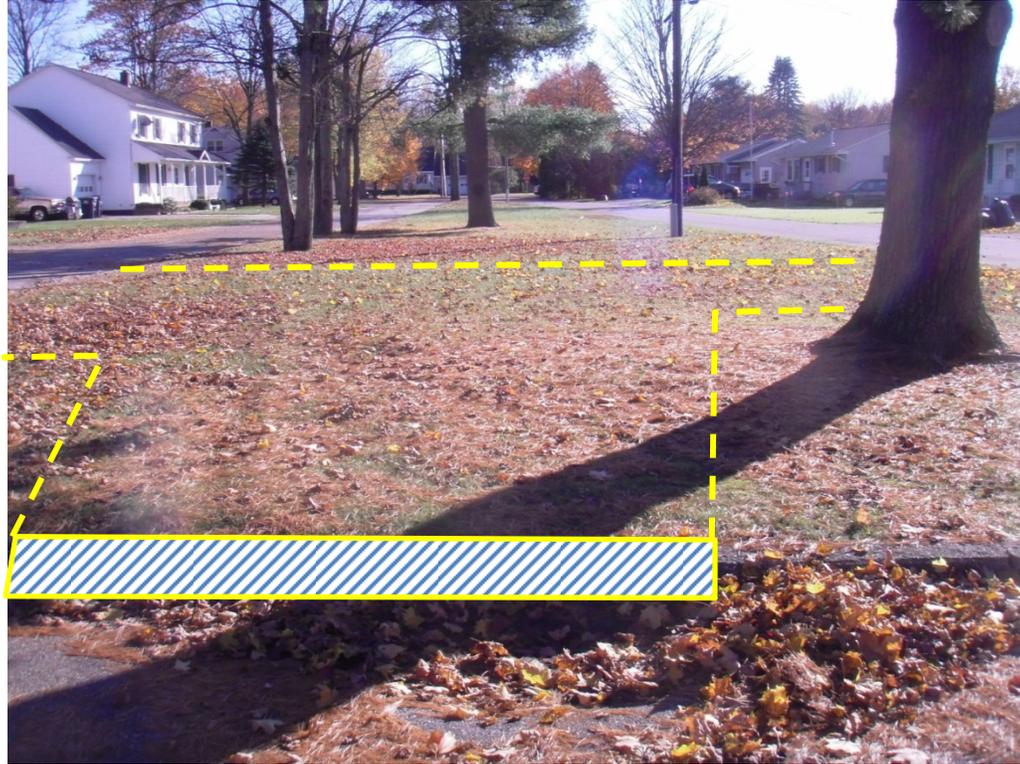
Figure 10. The green space within the cul-de-sac provides a great opportunity for infiltration practices with curb cut inlets.

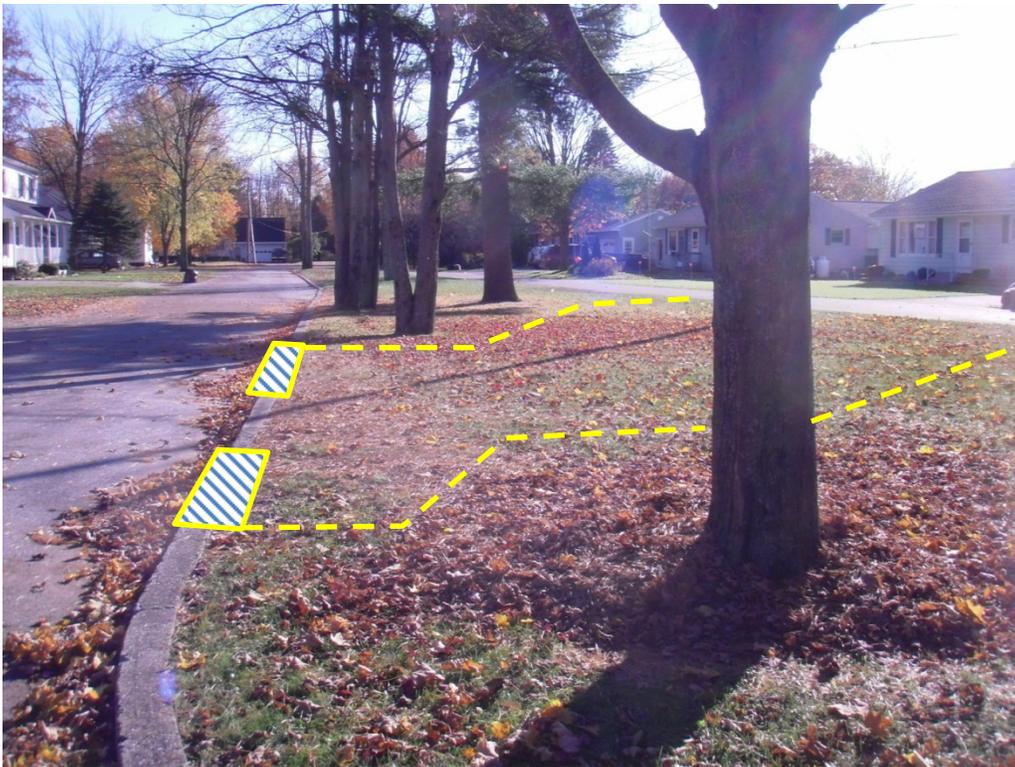
Figure 11. Curb cuts along street would allow stormwater to drain to STPs inside the cul-de-sac. In high flow events, water would back up and drain to existing catch basins.

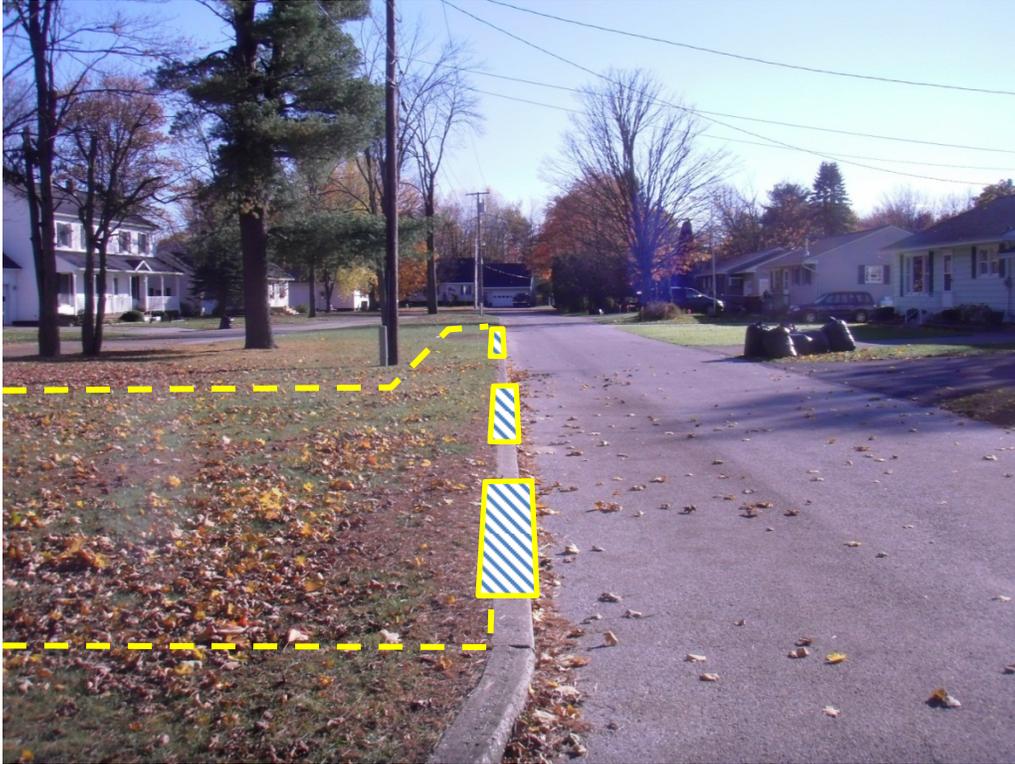
Figure 12. Curb cuts on the east side of the Taylor Dr. cul-de-sac would allow stormwater runoff to access proposed STPs.

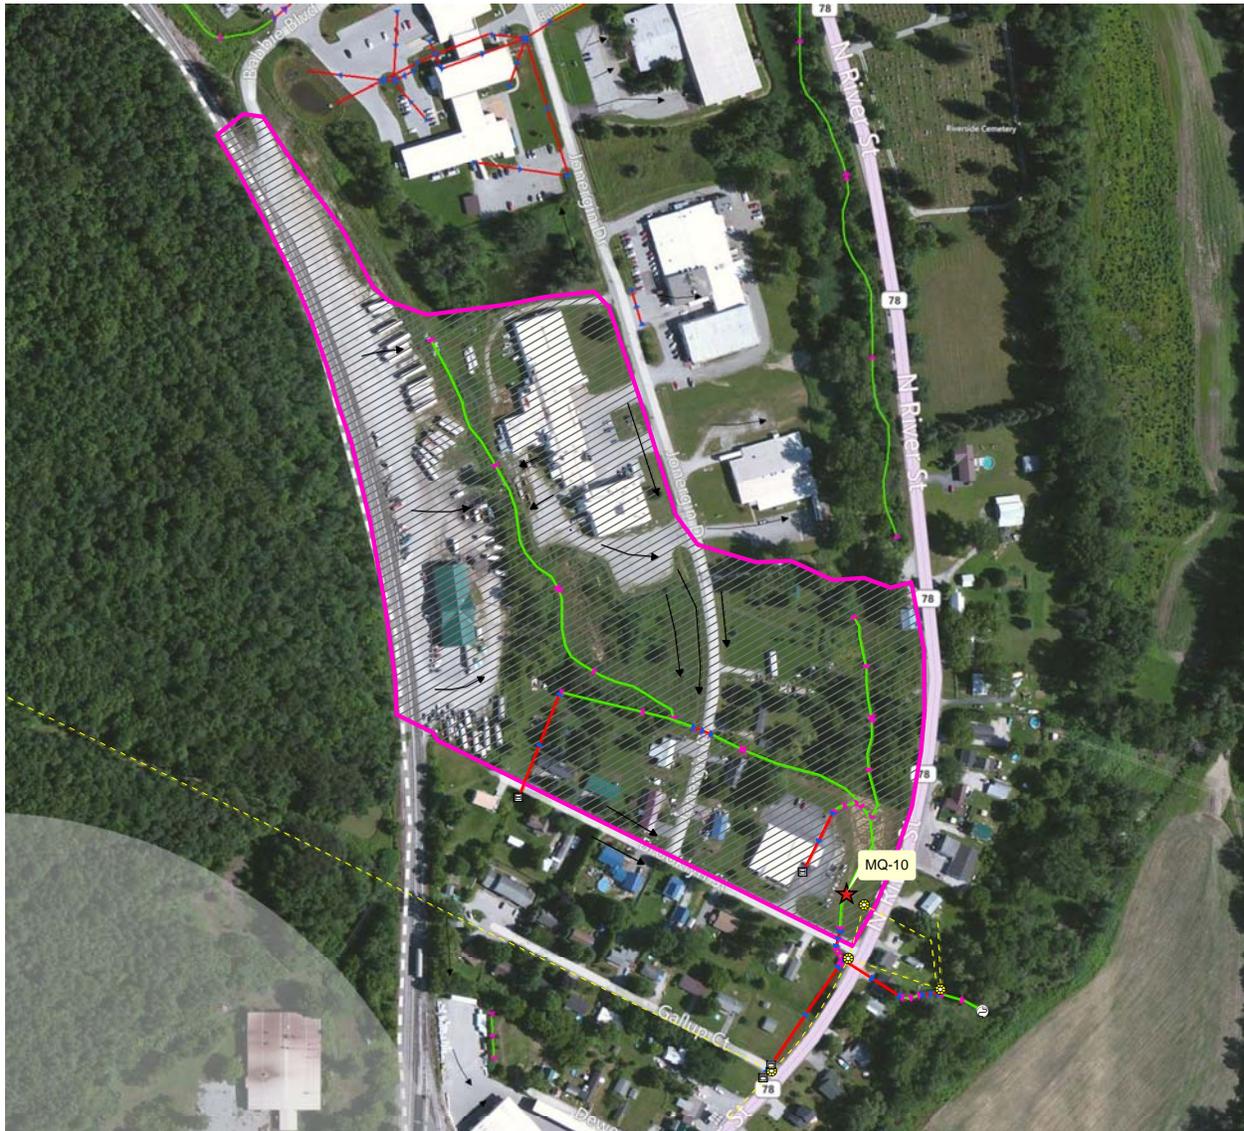
Figure 13. Subwatershed draining to a culvert at the southeast corner of the Fourniers Door and Window business at the corner of Rt. 78 and Brooklyn St.

A significant stormwater treatment opportunity exists near the Fourniers Door and Window property. Stormwater runoff from approximately 22 acres drains to a culvert at the corner of Route 78 and Brooklyn Rd., where the Fournier business is located. This 22 acre subwatershed includes 7.1 acres of impervious surface (approximately 3.6 acres of roof tops and asphalt, and 3.5 acres of compacted gravel surface). Stormwater from this subwatershed appears to receive no treatment before being routed through a culvert under Route 78 and discharged to the Missisquoi River.

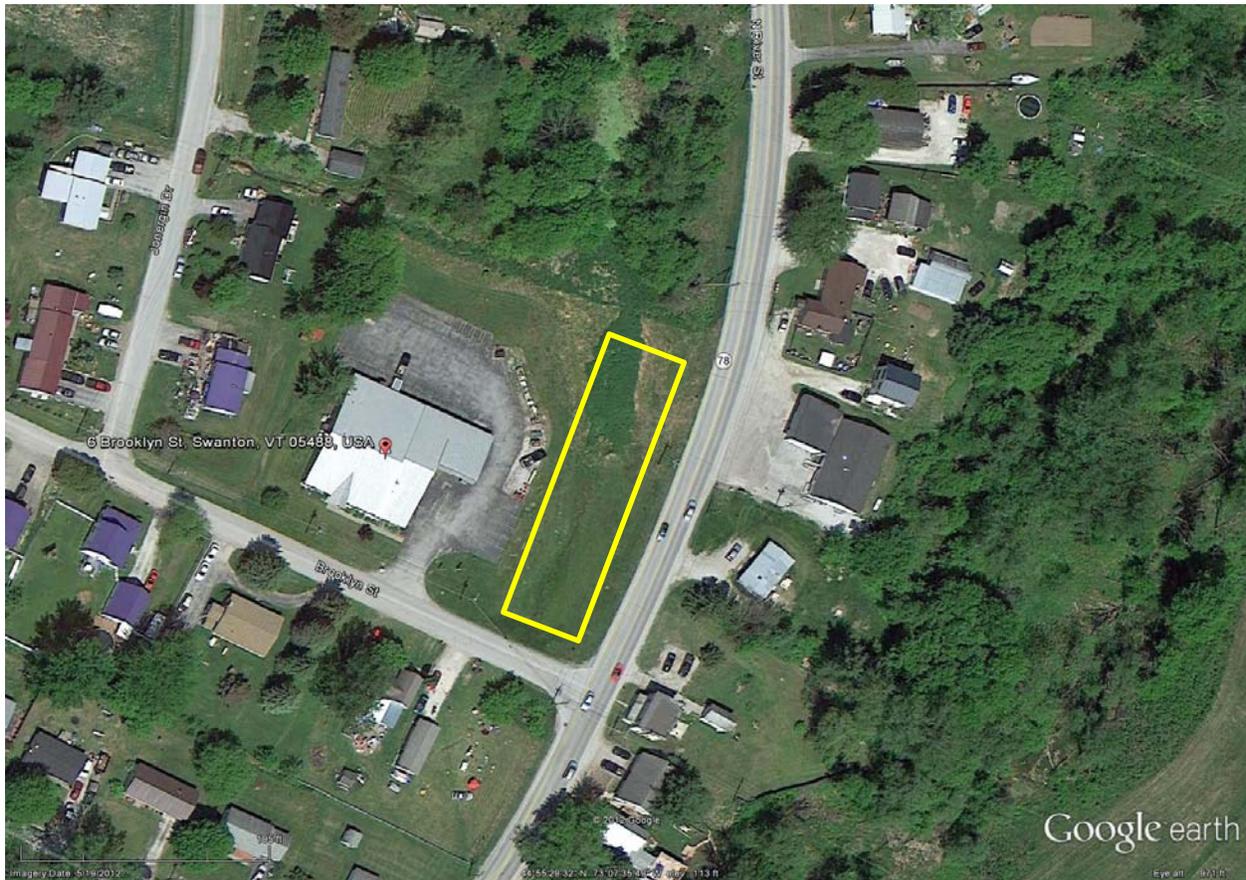
There is a large swale on the east side of the Fournier property that extends 250 ft. upslope, north of an existing 24" culvert. Stormwater drains from upslope properties via this swale and picks up runoff from the Fournier property before flowing south through the culvert under Brooklyn St. Approximately 0.5 acres of

open space shown in yellow in Figure 14, appears to be a suitable location for a stormwater treatment practice.

Figure 14. STP opportunity at Brooklyn St. and Route 78 (N. River St.) near Fourniers Door and Window.

Given the existing topographic conditions, a bioretention basin or small treatment wetland would be most appropriate for this property. Alteration of the existing land form would be minimal. The presence of poorly drained soils (HSG D) would necessitate an underdrain system. A practice such as bioretention or constructed-wetland treatment system would detain and slowly release water while removing sediment and solids through settling and filtration. A conceptual location for the proposed STP is shown in Figure 15.

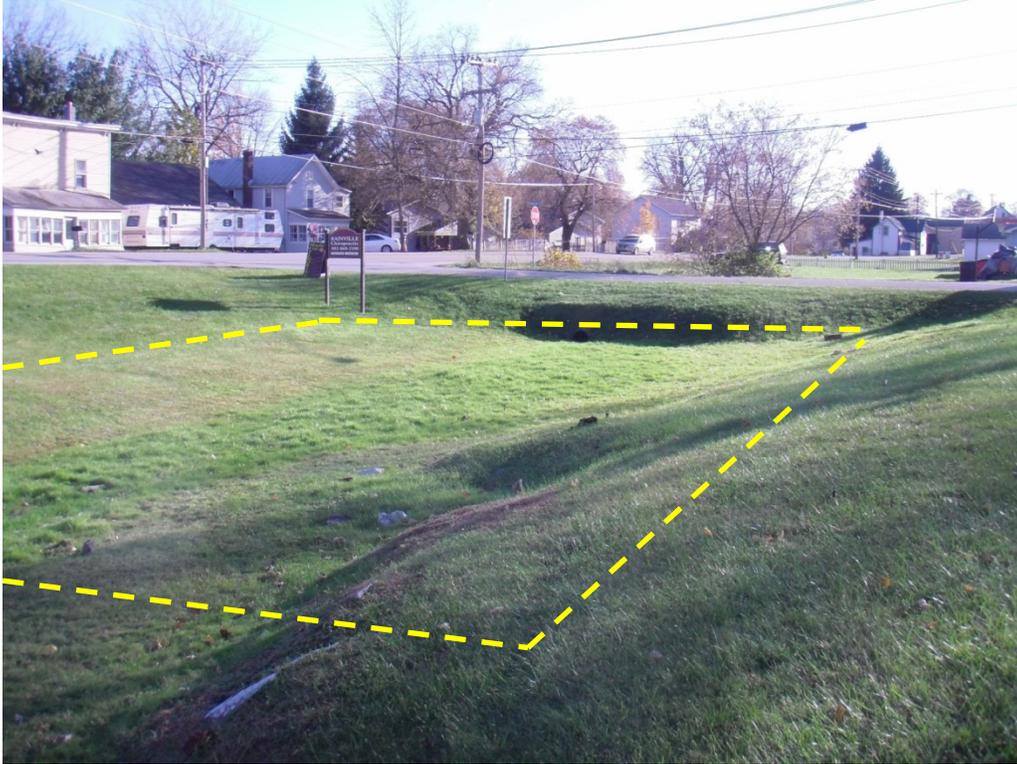
Figure 15. Location for potential treatment at Brooklyn St. and VT Rt. 78 near Fourniers Door and Window business.
