STORMWATER MANAGEMENT PLAN FOR SWANTON TOWN AND VILLAGE

FINAL REPORT

Stone Project ID 112475-W
February 21, 2013

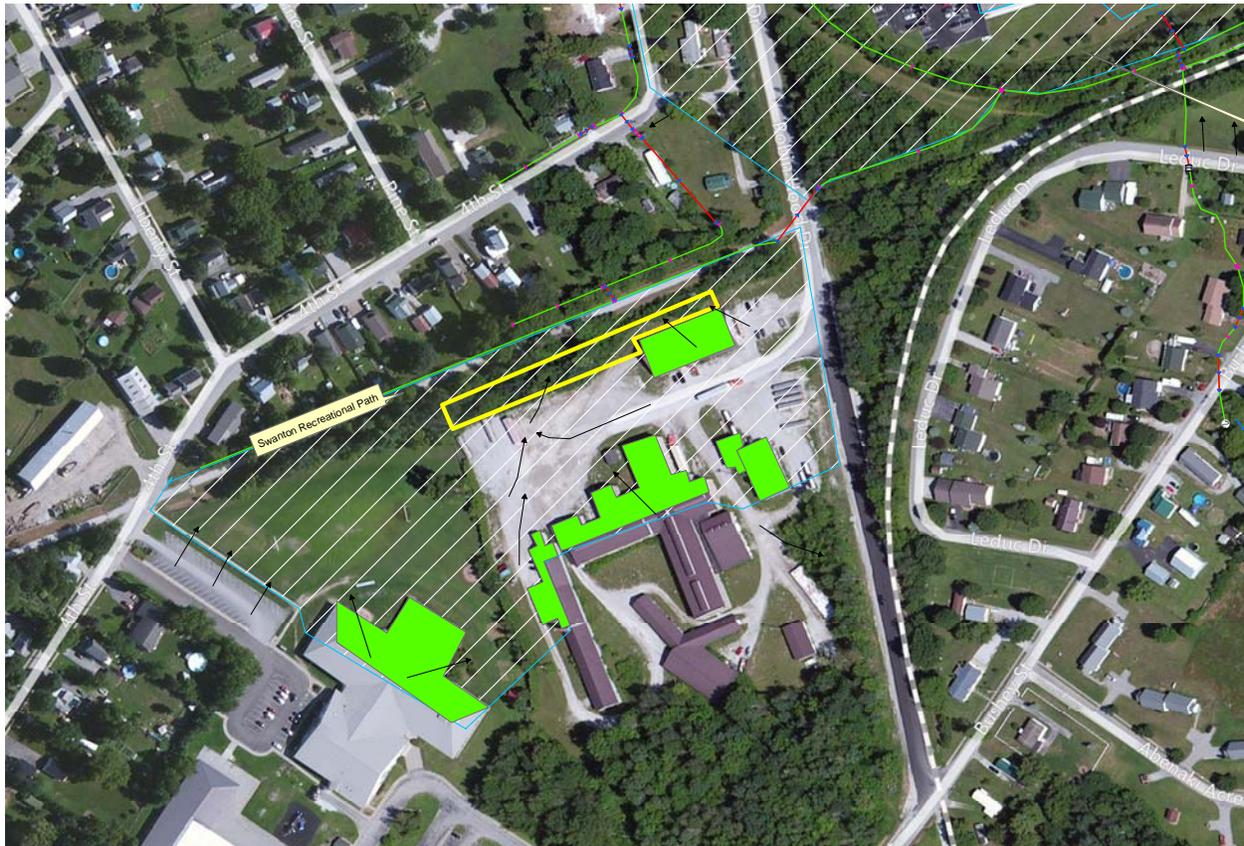
Figure 16. Drainage area at and around Swanton Elementary School: location for potential STP shown in yellow. Rooftop areas that drain to the potential STP are shown in green.

Potential stormwater treatment opportunities exist along the Swanton Recreation Path near Robinhood Drive. The subwatershed contains portions of the Swanton Elementary School and former Robinhood Ammunition plant property. Stormwater drains north to a swale that flows to the northeast along the south side of the recreation path. From the end of this swale, stormwater flows through approximately 0.5 miles of storm sewer and open channel conveyance to the Missisquoi River

The 10.5 acre subwatershed includes 3.2 acres of impervious surface (1.4 acres of roof tops and 1.8 acres of compacted gravel). The remainder of the subwatershed consists primarily of athletic turf on the school property. Athletic fields are often highly compacted and can have low infiltration rates.

A detention and filtration practice, such as a bioretention basin, could be effective in treating runoff from these properties. A conceptual location for an STP is highlighted in yellow in Figure 16 and Figure 17. The prevailing soil type is Deerfield loamy fine sand (HSG B) with a moderately high seasonal water table. This means that infiltration features could improve treatment by soaking away a portion of the treated runoff. Still, an underdrain system is recommended to ensure proper drainage throughout the year.

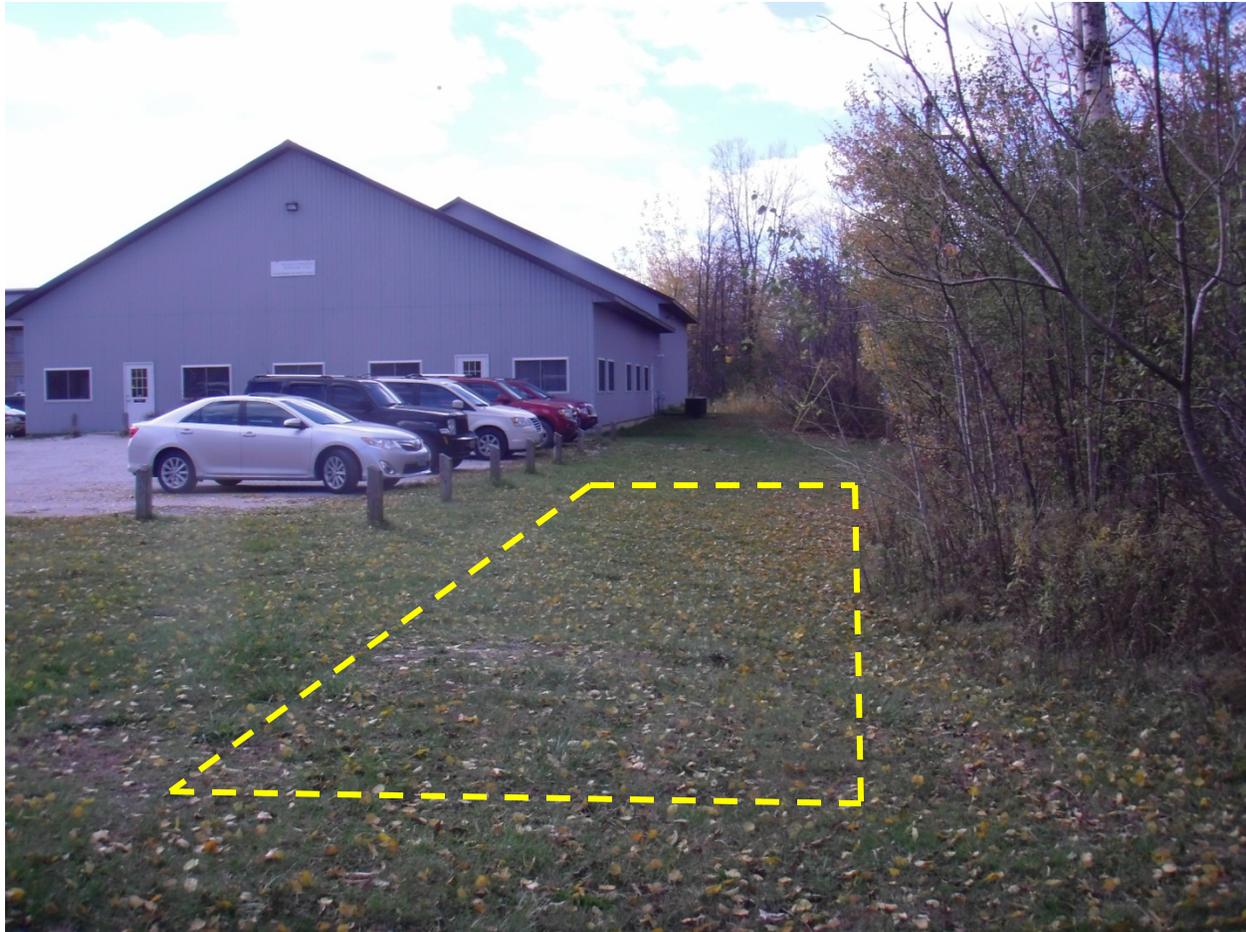
Figure 17. Proposed location for stormwater treatment at the former Robinhood Ammunition property.

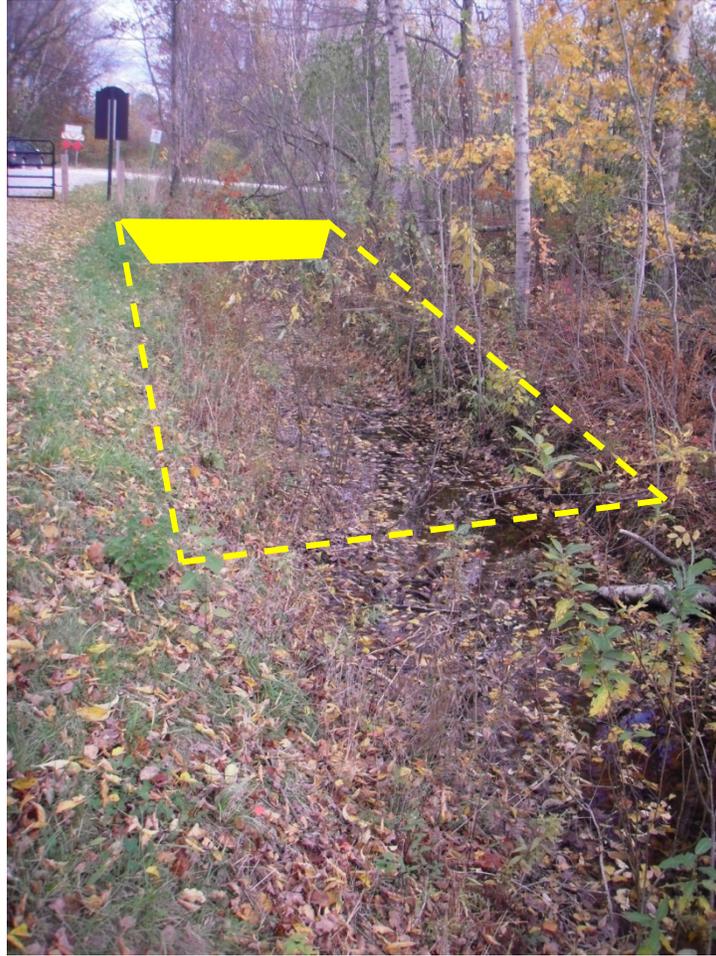
Figure 18. The existing swale along the recreation trail could be modified to improve stormwater treatment.

Additionally, or as an alternative, it may be possible to modify the existing swale along the recreation path to enhance stormwater treatment (see Figure 18). Beyond improving water quality, installing an STP at this location will improve the aesthetic conditions along the recreation path, while providing an educational opportunity. The proximity of Swanton Elementary School and the recreation path would mean that an STP at this location could be accessible by student groups and visible to recreation path users. Interpretive signage could be used to inform users of the recreational path about water quality, stormwater treatment practices, and the benefits to the community and local environment.

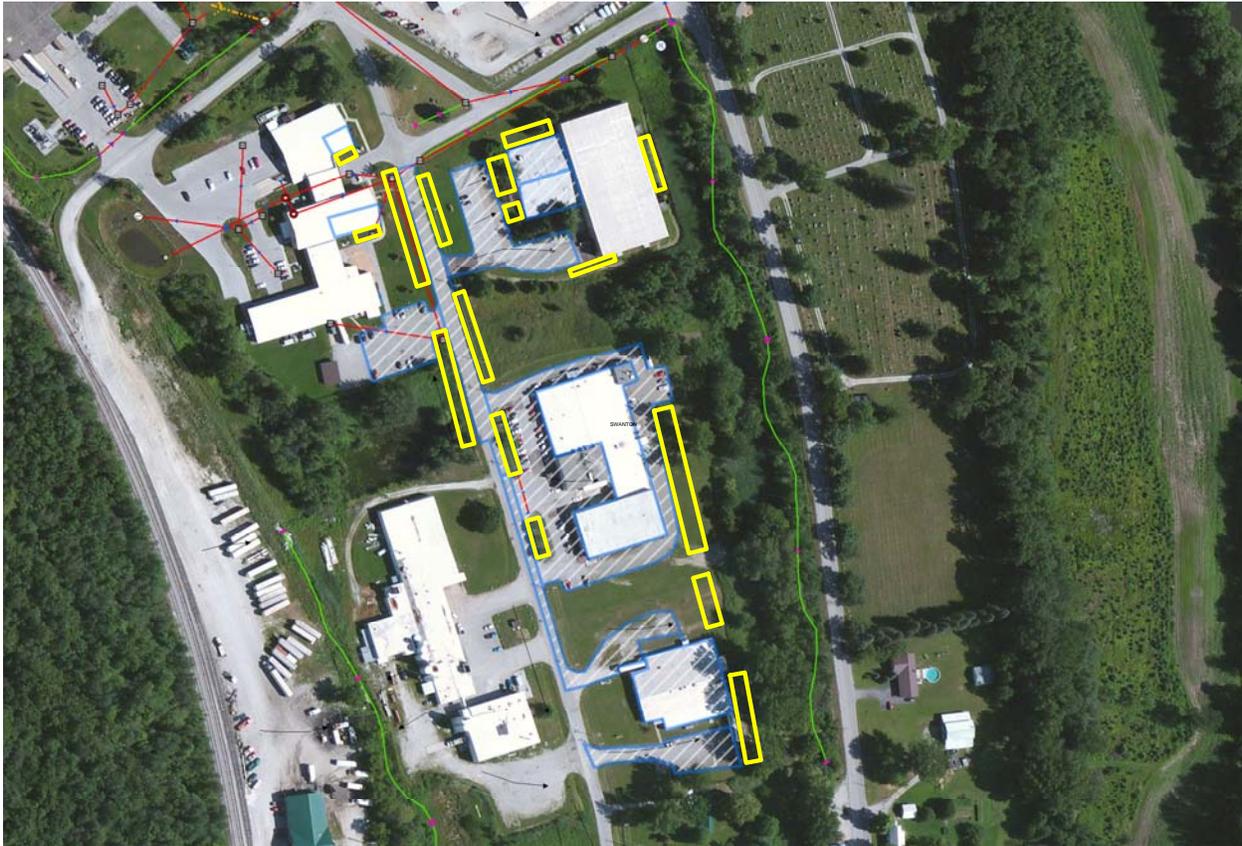
Figure 19. Stormwater from a large segment of the industrial development near Jonegrin Dr. and Babbie Blvd. is untreated and drains to the Missisquoi River. Treatable impervious area is highlighted in blue and potential locations for STPs highlighted in yellow.

The industrial area along Jonegrin Dr. and Babbie Blvd. includes a significant amount of impervious area; 3.9 acres within the subwatershed have been identified as potentially treatable. Stormwater runoff from this subwatershed makes its way to the Missisquoi River with no retention and little, if any, treatment. Many options have been identified for location of STPs as shown by the yellow highlight in Figure 19. Stormwater from a large segment of the industrial development near Jonegrin Dr. and Babbie Blvd. is untreated and drains to the Missisquoi River. Treatable impervious area is highlighted in blue and potential locations for STPs highlighted in yellow.

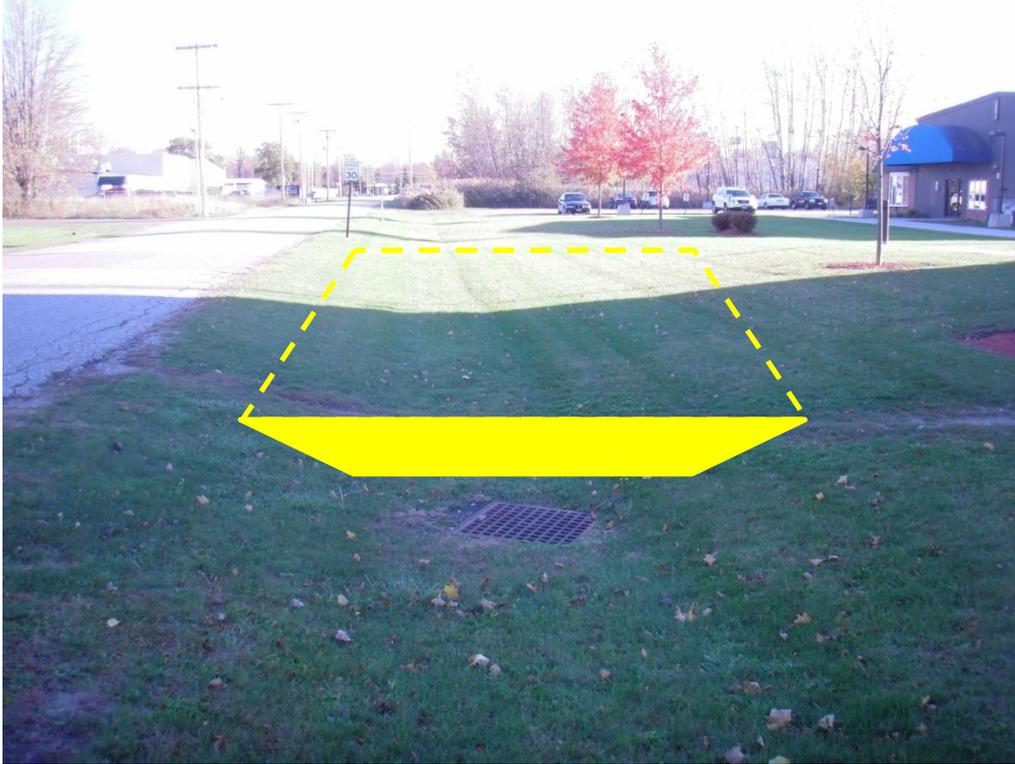
Massena stony loam and Raynham silt loam are the predominant soil types in this area. Both soils are reported to be HSG C with a shallow water table. Infiltration practices will not be a likely option. However, many opportunities exist for retrofitting the existing stormwater infrastructure with filtration-type treatment practices (see Figure 20).

Figure 20. Existing catch basins in front of the Mylan Technologies building and neighboring property could easily be retrofitted with filtration practices.

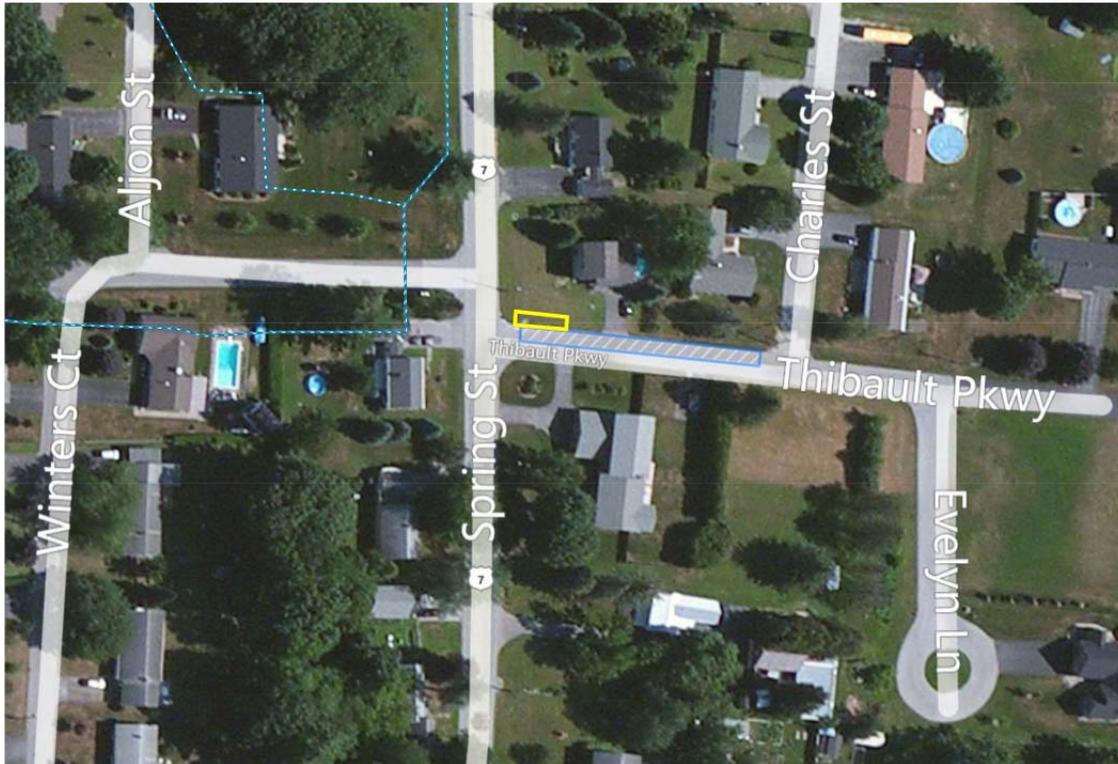
Figure 21. Stormwater treatment opportunity at corner of Thibault Parkway and Spring St.

A catch basin adjacent to Thibault Parkway could be retrofitted and utilized as part of an STP, such as a simple rain garden. Site conditions, including Windsor loamy fine sand (HSG A) and a deep water table, would enable detention and infiltration of a significant portion of stormwater runoff from 0.04 acres of impervious surface draining to the existing catch basin.

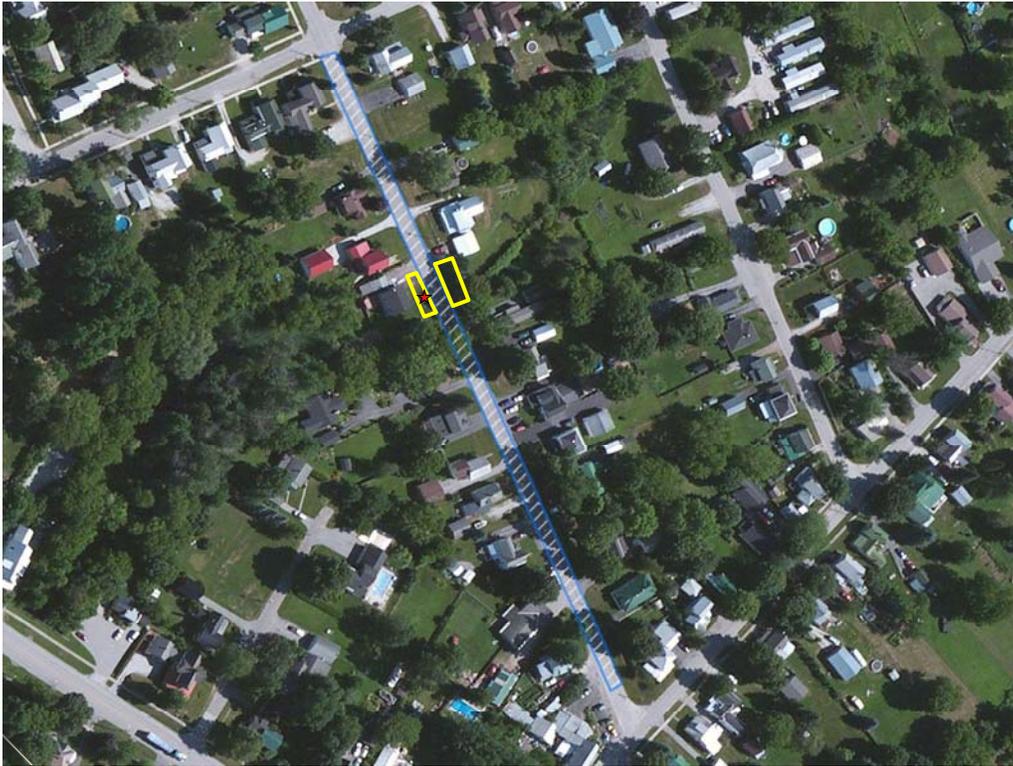
Figure 23. Greenwich Ave. drains to two existing catch basins near the middle of the block where two STPs could be located.

Two existing catch basins on Greenwich St. between 2nd St. and Platt St. are well-situated to be utilized as part of stormwater treatment practice. Approximately 0.4 acres of Greenwich Ave. drains toward the center of the block where stormwater is collected by two existing catch basins on either side of the street.

The predominant soil type is reported to be Windsor loamy fine sand (HSG A) with a deep water table. This means that there is potential to soak away a large portion of the stormwater draining from this neighborhood. The existing catch basins could then act as overflow relief for an infiltration-based STP.

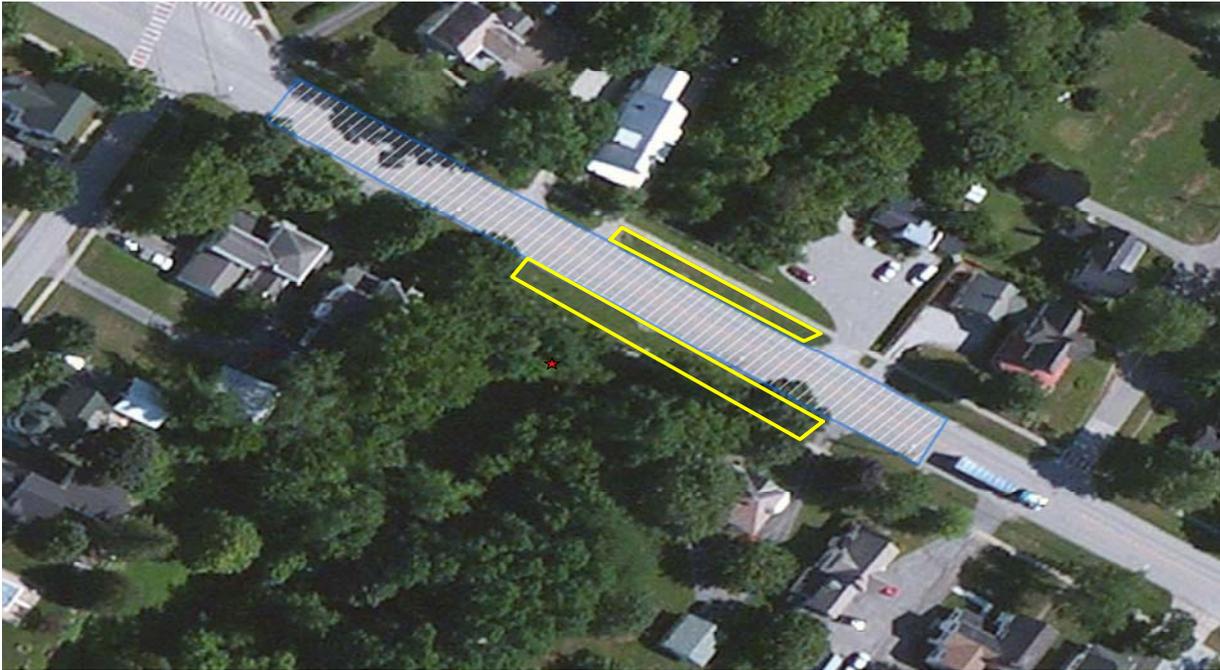
Figure 25. Grand Ave. stormwater could be treated with infiltration practices located between Farrar St. and Furnam Pl.

Stormwater runoff from 0.3 acres of Grand Ave., between Farrar St. and Furman Place, could be treated before draining to existing catch basin in the green strip. Stormwater drains toward the center of the block from both directions. Catch basins between the street and sidewalk collect stormwater on either side of Grand Ave. The predominant soil type is Windsor fine sand (HSG A) with a low water table.

Given the well-drained soils and position of existing catch basins, stormwater from this section of Grand Ave., could be treated with an infiltration-based STP (see Figure 26 and Figure 27). Water would infiltrate the underlying soils, or otherwise be slowly released with sediment removal occurring through settling and filtration.

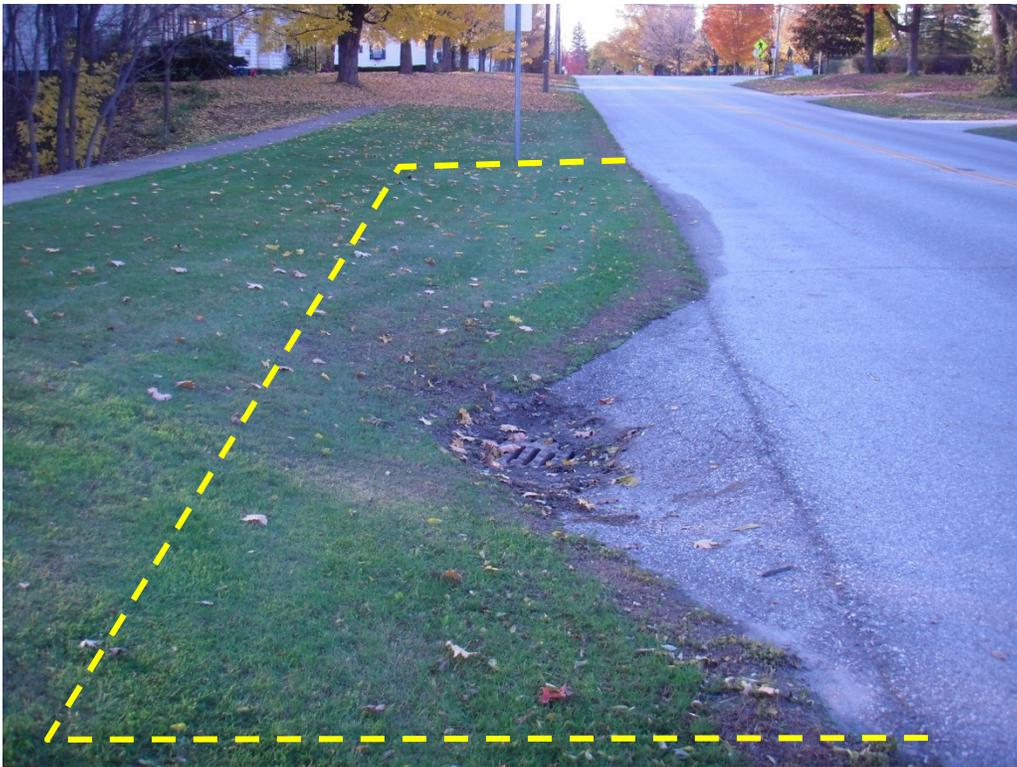
Figure 27. Catch basin on north side of Grand Ave. that could be modified as part of an STP.

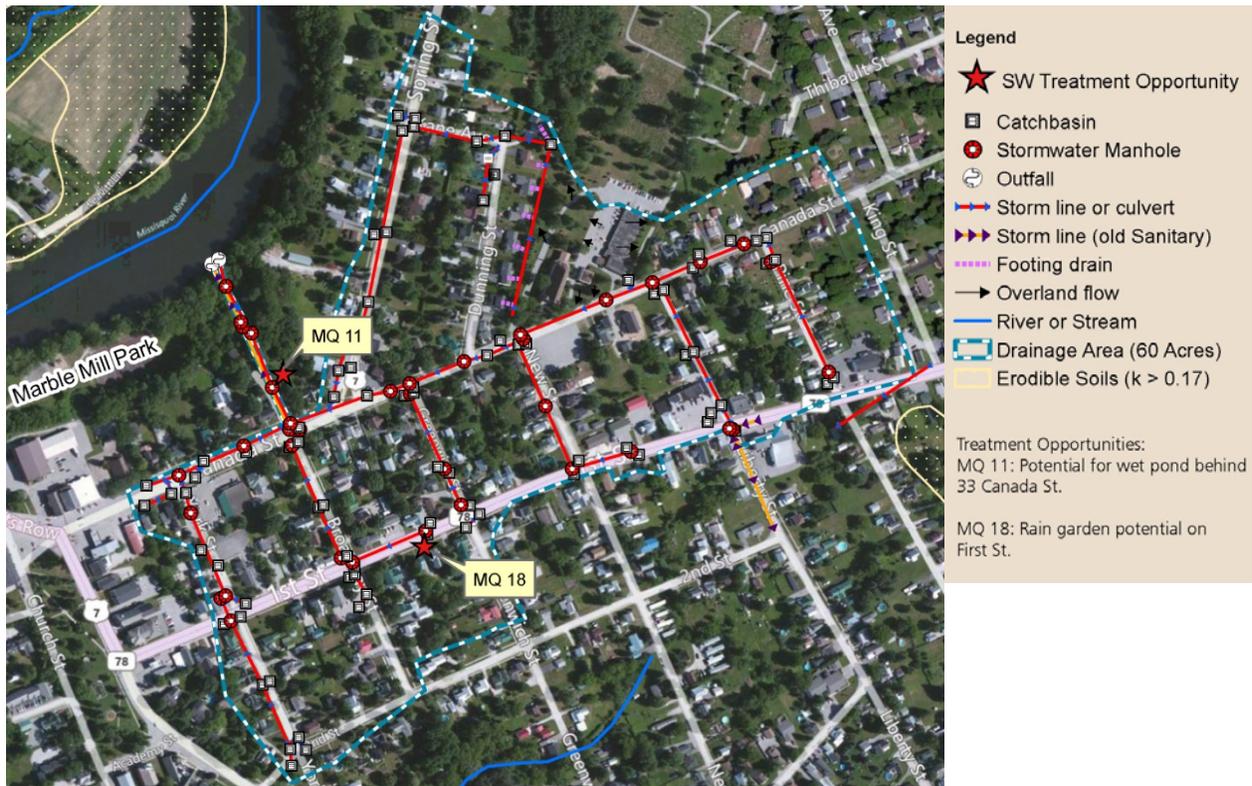
A significant portion of the stormwater runoff from the closed drainage system in Swanton Village is piped to Marble Mill Park, where it is discharged without treatment to the Missisquoi River. The area of the park near this outfall also contributes untreated runoff to the Missisquoi, including active erosion in the road and path leading to the park, runoff from the parking lot, and a washout leading from the park to the river's edge near the outfall. The Village previously worked with the Northwest Regional Planning Commission to obtain grant funding from VT DEC to develop a comprehensive solution for stormwater management at Marble Mill Park, and a design has been prepared. Unfortunately the Village has faced a number of challenges in seeing the design implemented, including concerns raised over any construction activity within the 100-year floodplain of the Missisquoi, and as a result nothing has been built to date.

Figure 28. Marble Mill Park problem area.
