TOWN OF WILLISTON TOWN-WIDE WATERSHED IMPROVEMENT PLAN - PHASE 2

FINAL REPORT

Stone Project ID 12-055
September 10, 2013

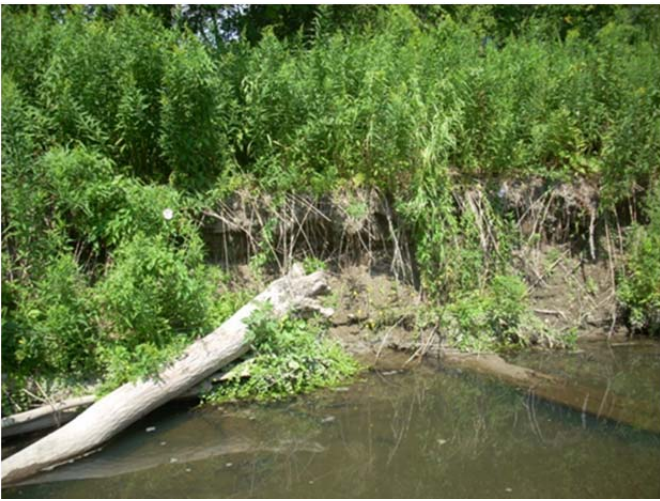
Description of Observed Conditions:
 Aggradation has caused new (braided) channel to form; visible erosion on outer bank. Large riparian buffer zone, including some woody vegetation, present.

Photo 1. Visible erosion/undercutting of bank	Photo 2. Evidence of aggradation

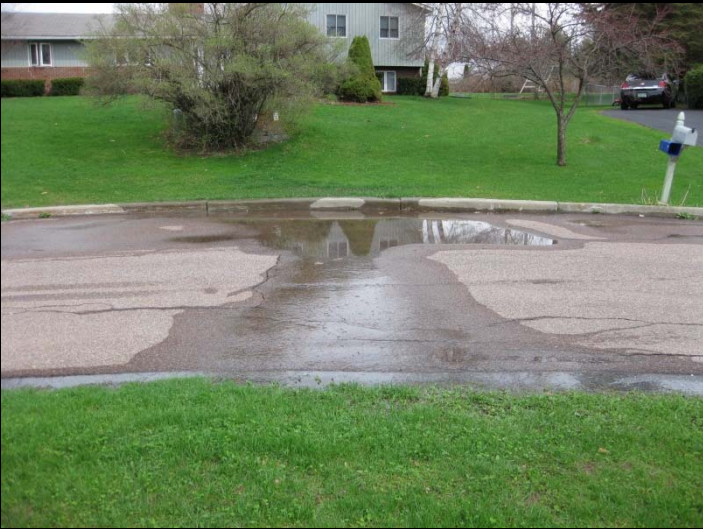
Update 6/18/2013: Opportunity on cul-de-sac for rain garden. CB on west side of street, directly in front of #49 Palmer Ct. emitting sewage smell. Sediment is being deposited along curb line on either side of street.

Photo 1. Stormwater runoff flowing into the cul-de-sac from surrounding residential properties.

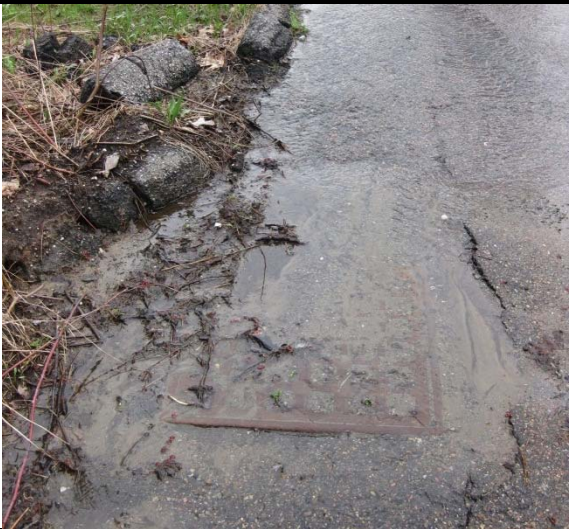
Updated 6/18/2013: Catch basins at bottom of hill remain full. CBs uphill are clear. Gully erosion continues in wooded area. May be another community outreach opportunity for curb cuts with rain gardens on residential properties.

Photo 1. Catch basin clogged with sediment.	Photo 2. Erosion of the gravel cul-de-sac.

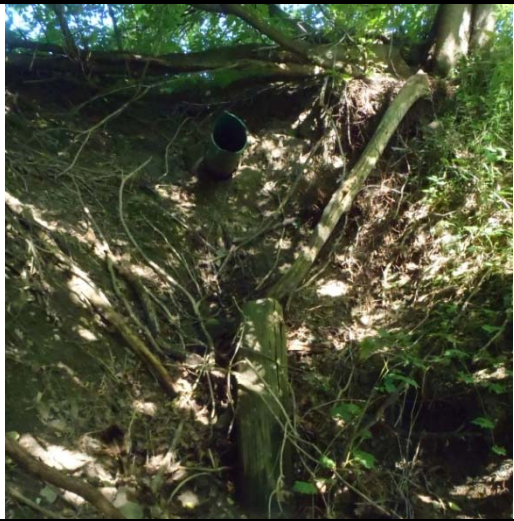
12" plastic outfall with broken end. Bank around outfall has failed and about 4' of pipe is exposed. Outfall drop is 4-5' to ground causing erosion issues. Major gully erosion present as water approaches Allen Brook. Sediment build up in Allen Brook, grass and weeds are growing on top of sediment causing a false bank to form in brook.

Photo 1. Failed bank and pipe outfall

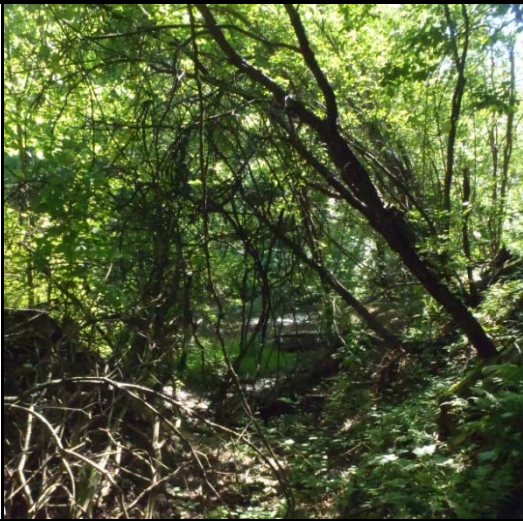
Photo 2. Channel forming as water travels to Allen Brook

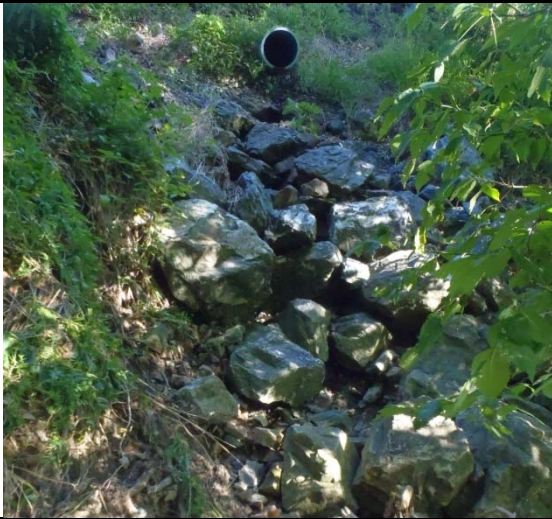
12" plastic outfall; riprap has been placed below outfall - outfall drop is ~1'. Erosion is present in a few areas around riprap. Major sediment build up at intersection with Allen Brook. Large amounts of storm debris evident in brook.

Photo 1. Erosion left of riprap

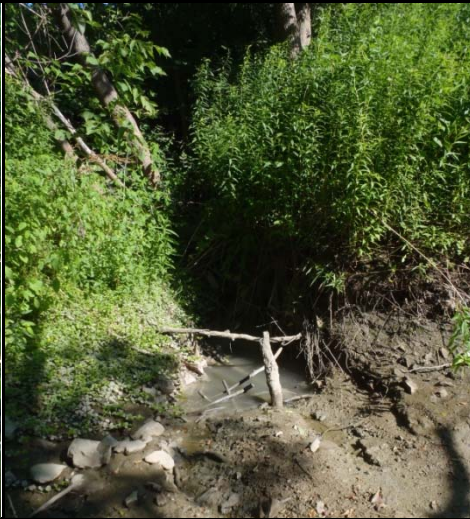
Photo 2. Sediment in Allen Brook

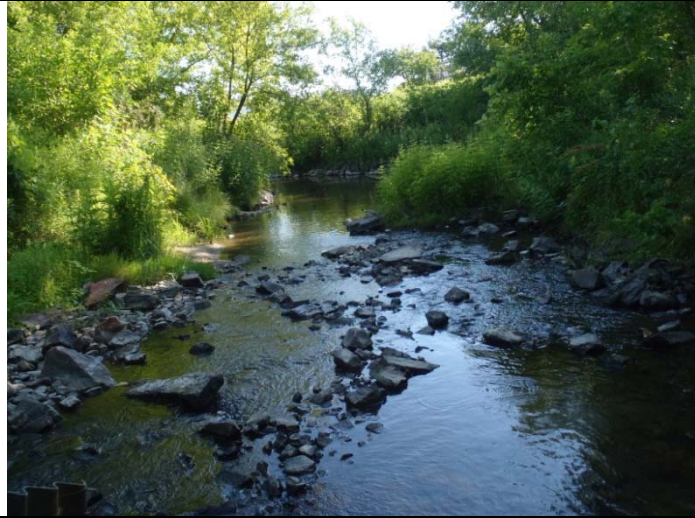
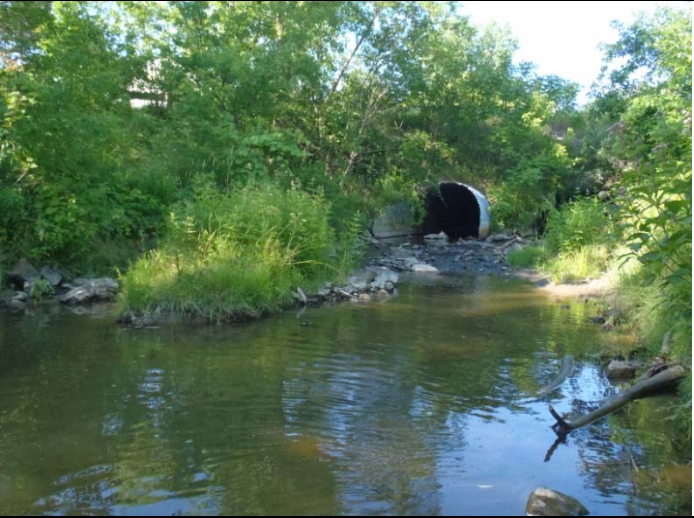
Description of Observed Conditions:
Sediment “delta” and scour pool forming at outfall of double-barrel culverts. Scour pool is developing at outfall. Culvert is less than bankfull width.

Photo 1. Looking downstream from culvert outfall	Photo 2. Culvert outfall

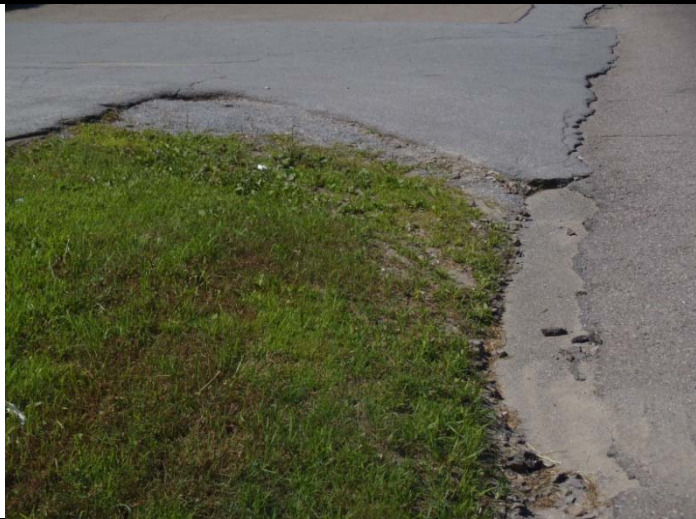
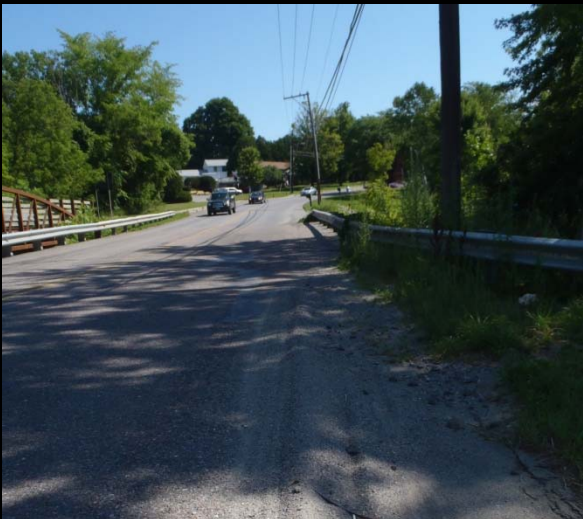
Description of Observed Conditions:
 Erosion is present between entire length of parking lot and Industrial Ave. Minor pavement trenching is present. Significant sediment accumulation on bridge that spans Allen Brook near north end of parking lot.

Photo 1. Erosion on Industrial Ave.	Photo 2. Sediment on bridge above Allen Brook

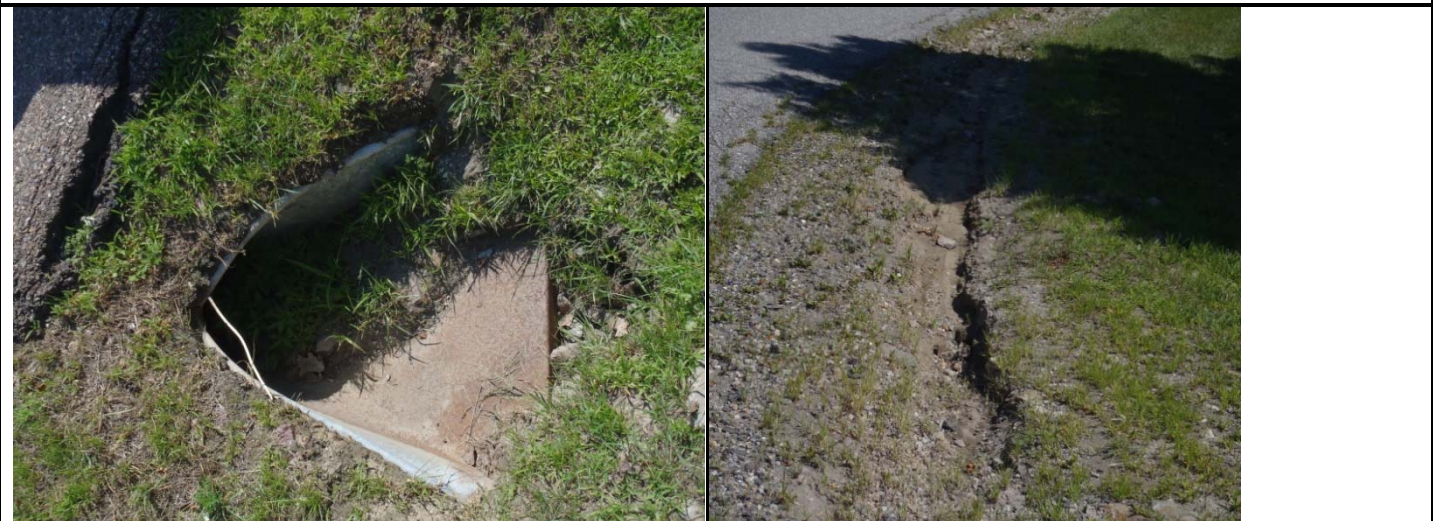
Erosion in drainage ditches on west side of Avenue D; excess flows have begun to undermine. Check dams have been installed to slow water rate as it approaches culvert. Gullying present on the east side of road at bend in Avenue D. Some evidence of hillside cutting and erosion on bank from parking lot run-off at Production Advantage.

Photo 1. Culvert, beginning to be undermined

Photo 2. Curve side trenching

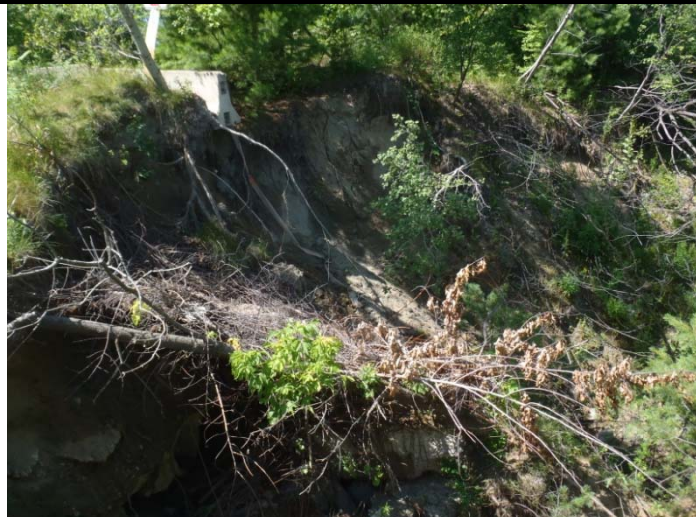
Major erosion and bank failure. Landslide extends several hundred feet down into old sand pit. Run-off from road could be contributing to erosion around outfall.

Photo 1. View from top of slide

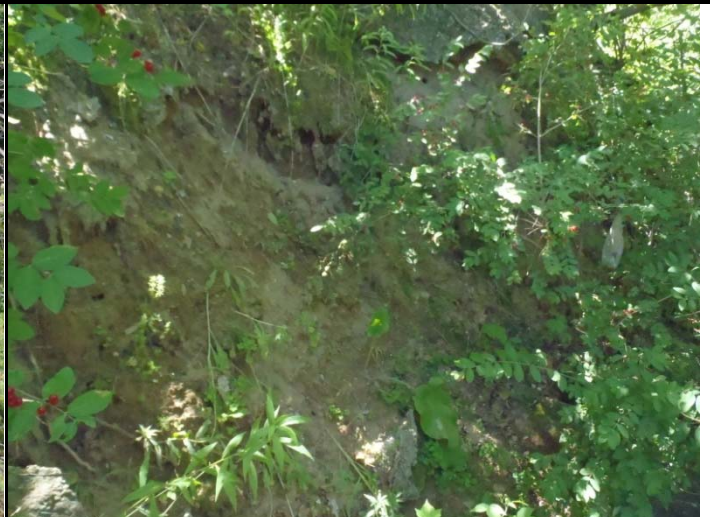
Photo 2. Further down in slide

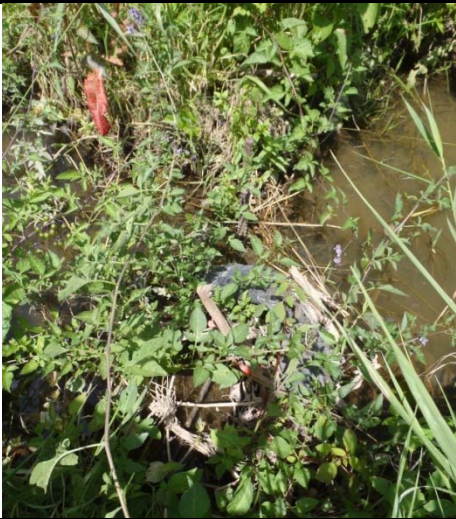
Description of Observed Conditions:
 Ponding of water before entering marsh area. Pond is 8' by 12' about 8" deep. Signs of small dam/blockage at one point with rebar in stream; obstruction has been breached.

Photo 1. Ponding of water	Photo 2. Remnants of blockage

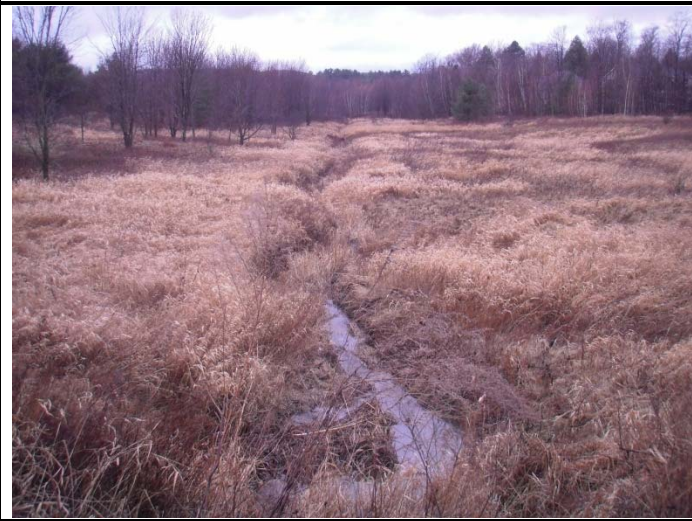
Photo 1. Stream in wetland area

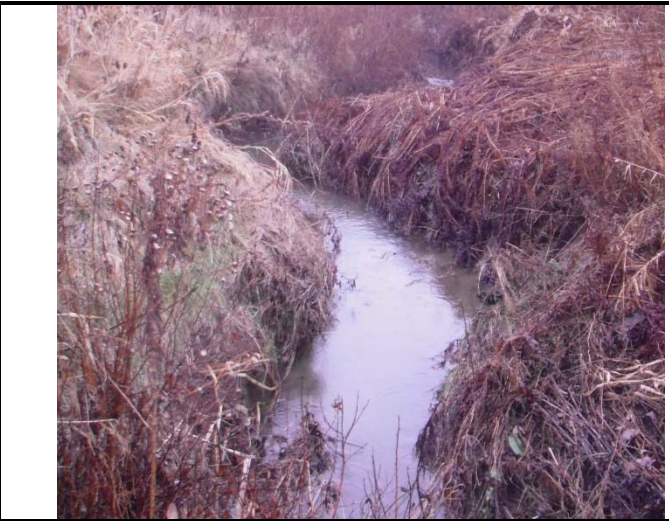
Incised banks are constantly failing. Conditions worsen as stream progresses down channel. Large amount of development in the watershed.

Photo 2. Erosion of stream banks.

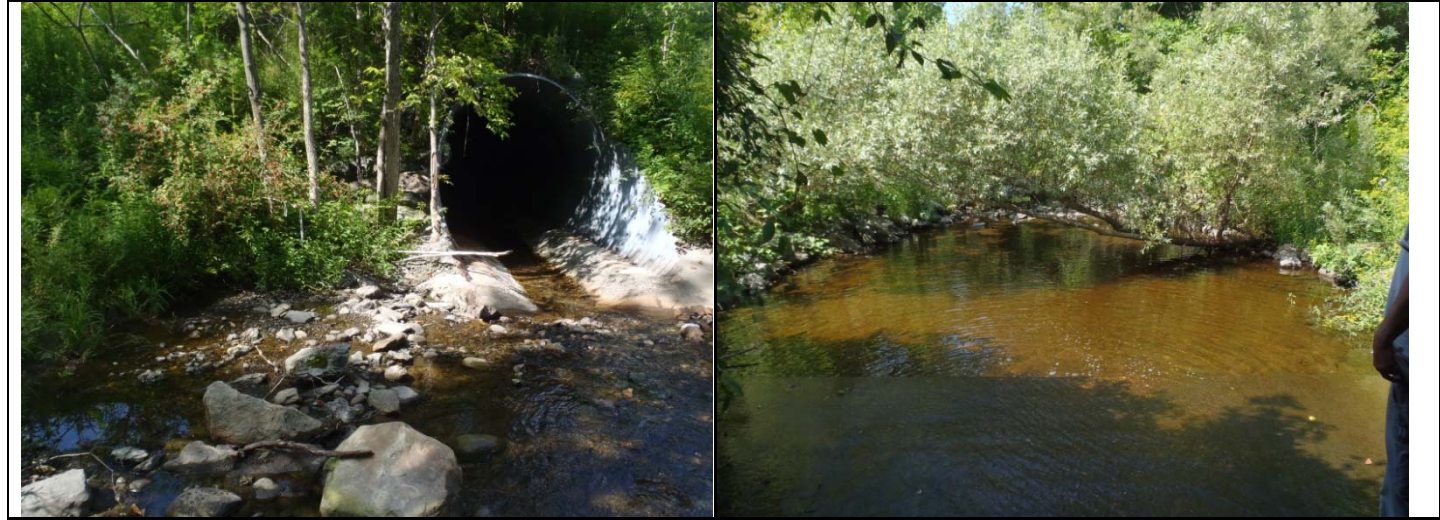
Photo 1. **Photo 2.**

Description of Observed Conditions:
 Upstream, brook makes an “S” as it approaches culverts. Bank scouring at the entrance to culvert. Between N/S lanes of 89 small scour pool is present. Scour pool at North bound outfall with 6” headcut from concrete box culvert.

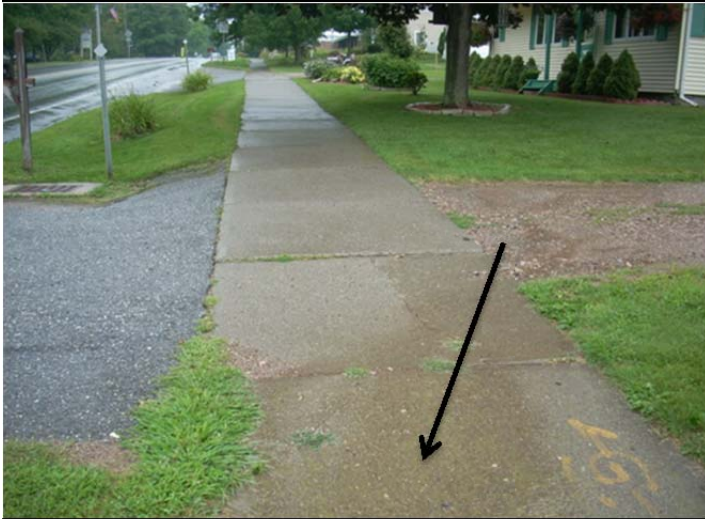
Photo 1.

Stormwater pipe flows from French drain underground to catch basin. French drain is a 6" plastic pipe and stormwater pipe is 12". Signs of erosion and water bypass at French drain outlet causing water to flow into driveway and onto sidewalk and street.

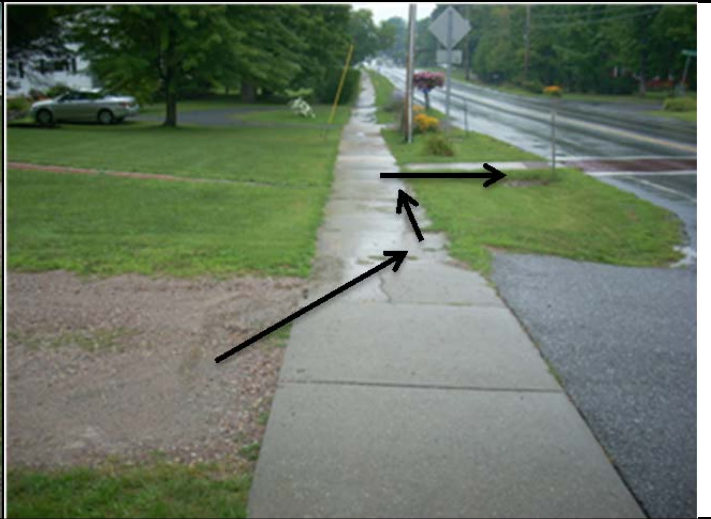
Photo 2. Looking down to street

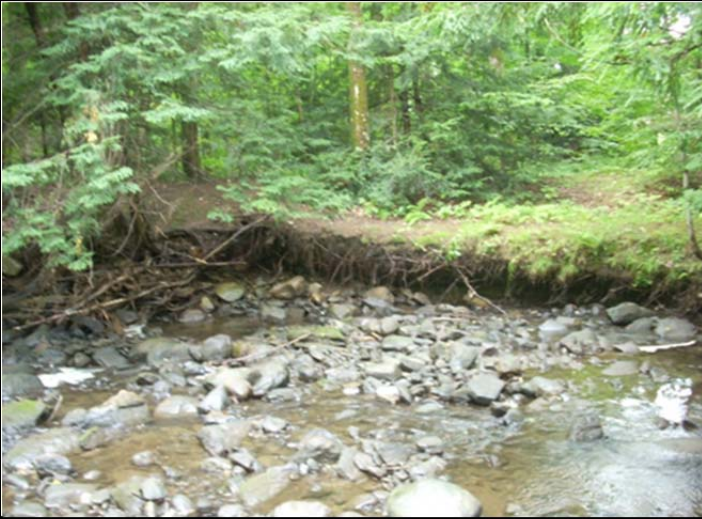
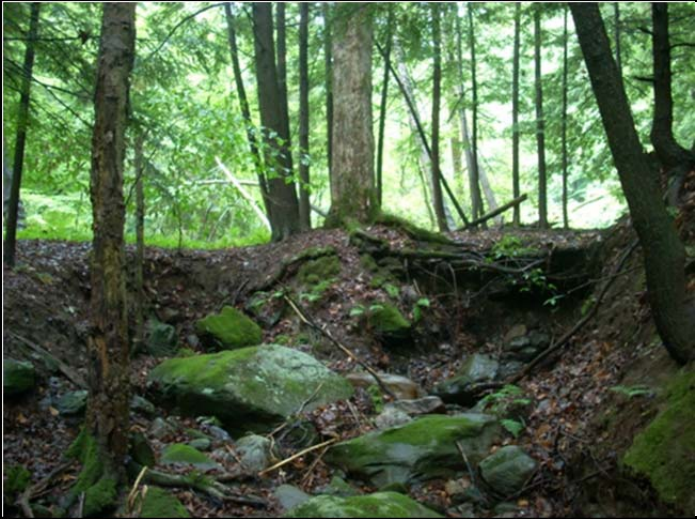
Description of Observed Conditions:
Areas of streambank erosion and small undercuts and bank collapses were observed. One area where water has jumped bank was also noted.

Photo 1. Streambank has been undermined	Photo 2. Localized bank collapses

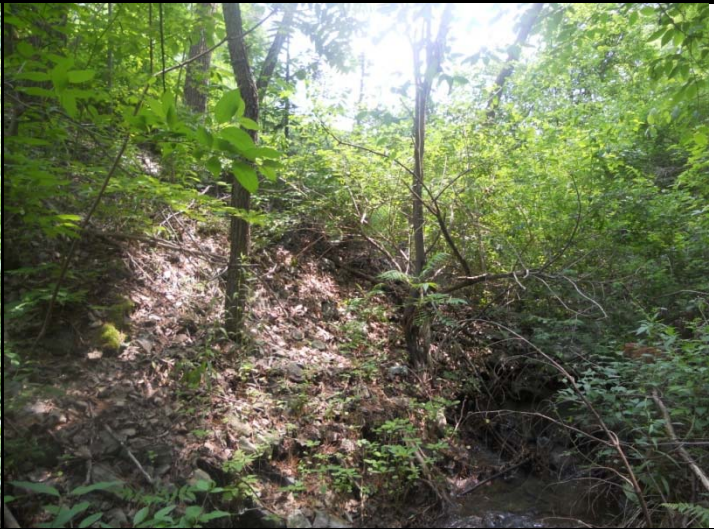
Steep banks line both side of the unnamed tributary to Muddy Brook; minor erosion along toe of bank evident throughout the area. One small headcut was found in the unnamed tributary.

Photo 2. Steep bank leading into tributary

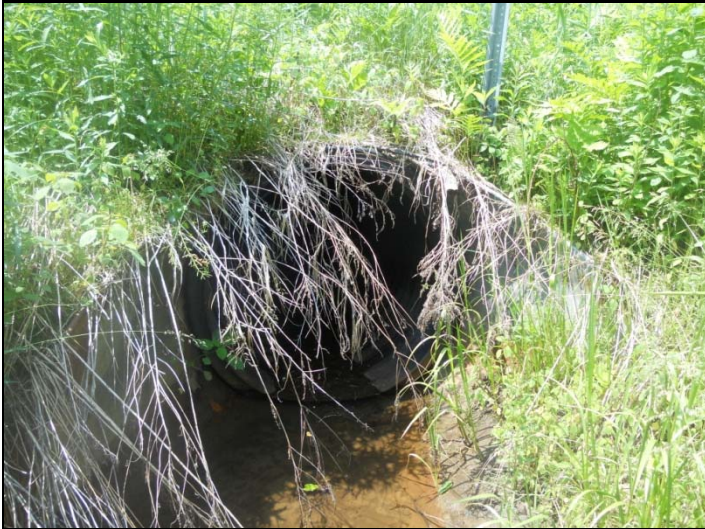
36" black plastic corrugated culvert carries unnamed tributary under Marshall Ave. Culvert is undersized and is causing erosion upstream and downstream. A headcut has formed downstream of the Marshall Avenue crossing. The headcut does not appear to be migrating rapidly upslope, but increasing urbanization in the upslope watershed may make the stabilization of this feature a higher priority.

Photo 1. Existing 36" plastic culvert

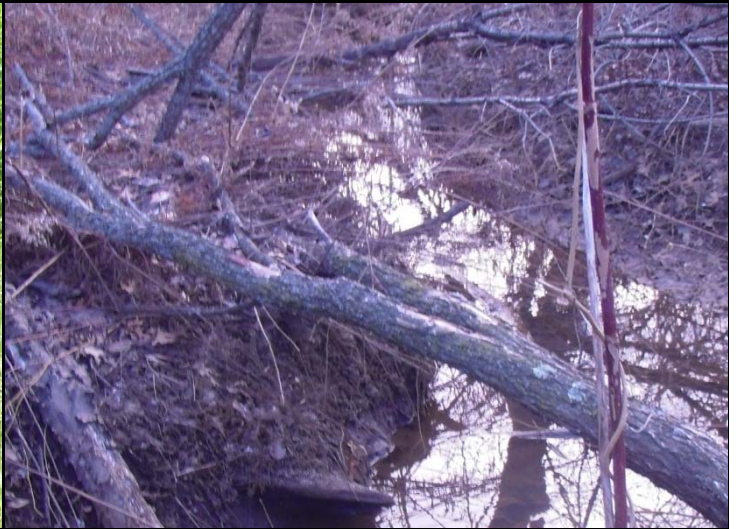
Photo 2. Incised channel

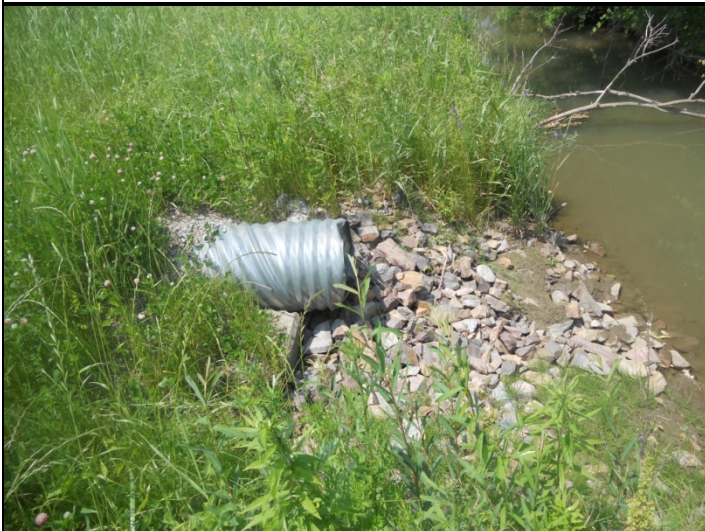
Six drains from northbound lanes and three pipes from southbound lanes of I-89 discharge directly into Muddy Brook. Southbound drains causing erosion and trenching into Muddy Brook. New riprap was recently placed around culvert in question

Photo 1. Recent riprap around culvert

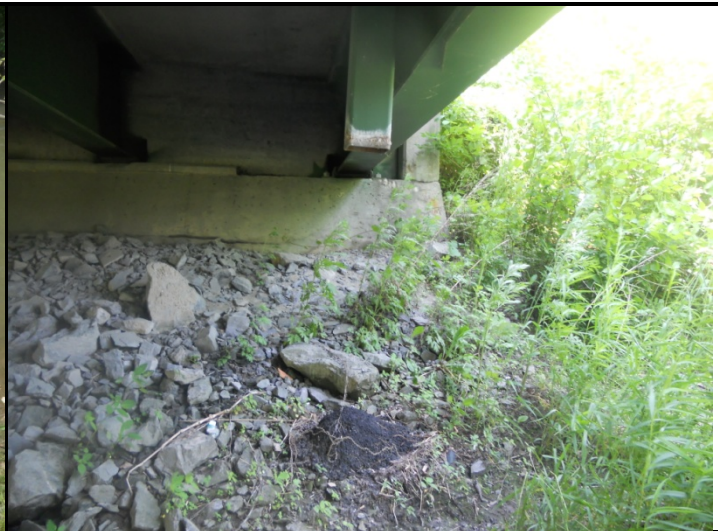
Photo 2. Highway drainage

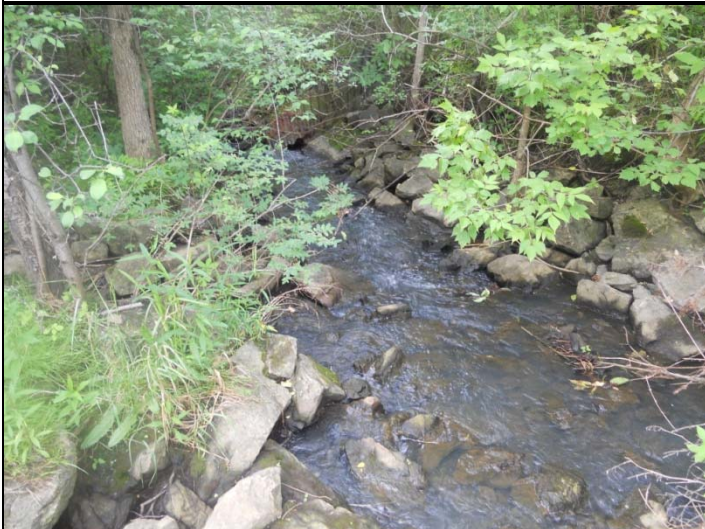
Update 6/18/2013: Very steep bank on east side of South Brownell road, above culvert. Elm trees (primary tree growth in area) appear to have been infected by Dutch Elm Disease. Once the trees are gone, the bank will be at greater risk of erosion. Pre-emptive tree planting may protect bank.

Photo 1. Downstream view towards culvert

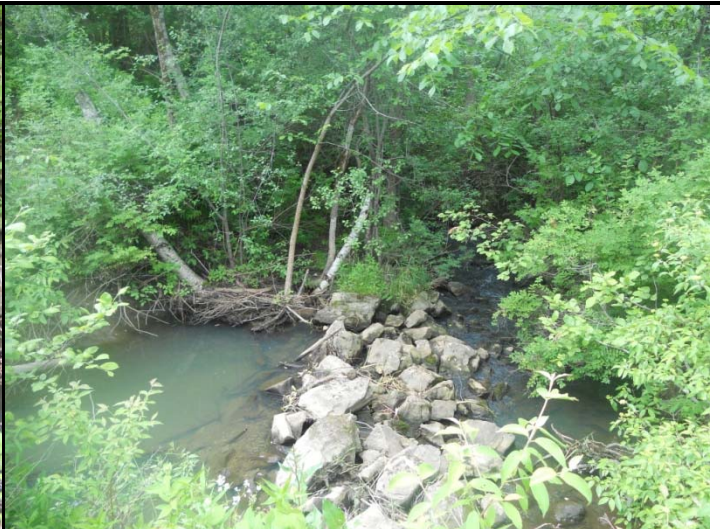
Photo 2. Upstream rock weir causing pooling

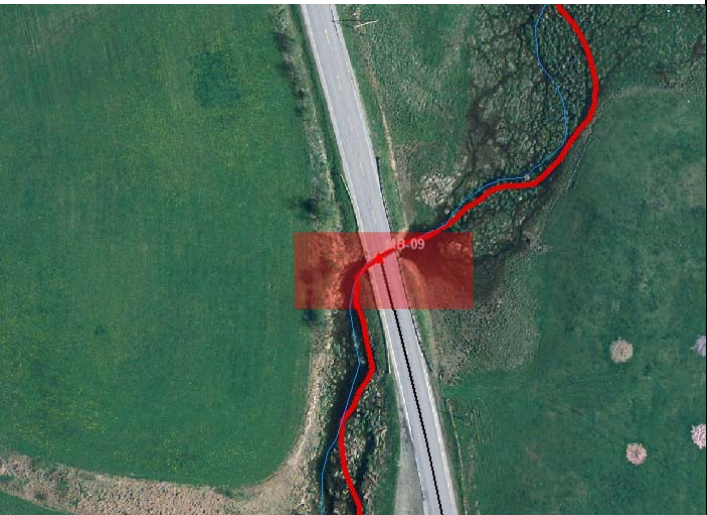
Problem Area ID: MB-09	Latitude: 44.410058 ° N	Longitude: 73.152236 ° W
Watershed: Muddy Brook Location: Route 116/Hinesburg Rd, 0.25 mi south of Cheeseactory Rd. Problem Type: Channel Erosion Identification Source: Muddy Brook SGA Ownership: Public (VTrans) Classification Level: 1

Description of Observed Conditions:
 Stream originates in large pond/marsh area. Stream makes 90° turn before passing under bridge; minor scouring was observed at bend. Existing bridge is causing minor scour upstream of the structure. The existing bridge is 36% of bankfull channel width.

Prioritization Ranking Factors							
Relative Impact	Frequency	Current Conditions	Urgency	Impact to Public Infrastructure	Realistic to Fix	Non-stormwater related	Larger/Systemic Problem
2	1	2	2	Yes	No	No	No
Relative Impact: Bridge alignment appear okay; possible bank armor needed to protect against erosion.

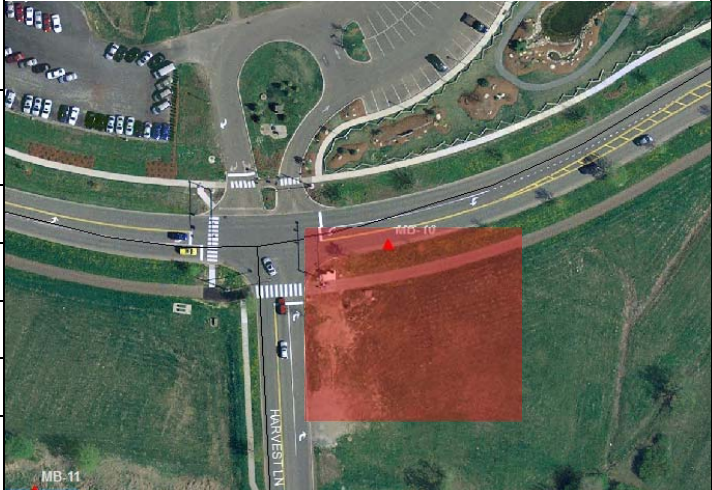
Problem Area ID: MB-10	Latitude: 44.445367 ° N	Longitude: 73.120968 ° W
Watershed: Muddy Brook Location: Marshall Ave. just east of Harvest Ln. Problem Type: Local Drainage Identification Source: SWMP Field Assessment Ownership: Private Classification Level: 1

Description of Observed Conditions:
 Marshall Avenue and the adjacent sidewalk flood as the Muddy Brook floodplain overflows across private property. Town Public Works Department contacted the developer who cleaned the culvert; more observations are needed to ensure problem has been fully addressed.

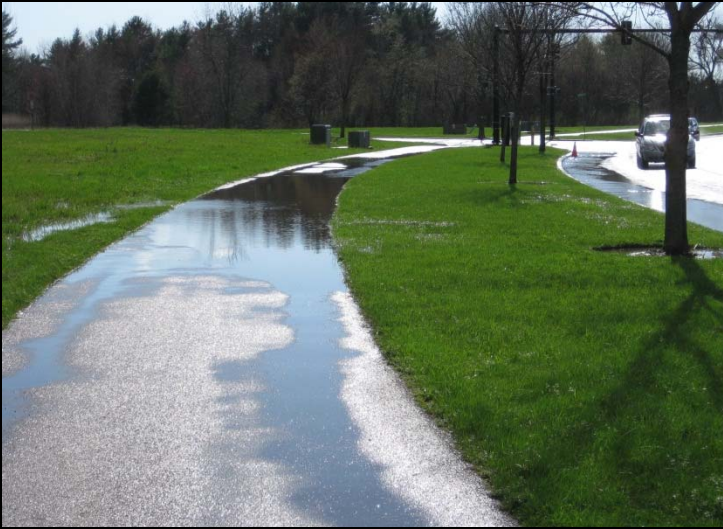
Photo 2.

Prioritization Ranking Factors							
Relative Impact	Frequency	Current Condition	Urgency	Impact to public infrastructure?	Realistic to fix?	Impacts beyond water resources?	Part of larger systemic problem?
2	2	1	2	Yes	No	Yes	Yes
Relative Impact: Intersection and roads are in floodplain for the stream.

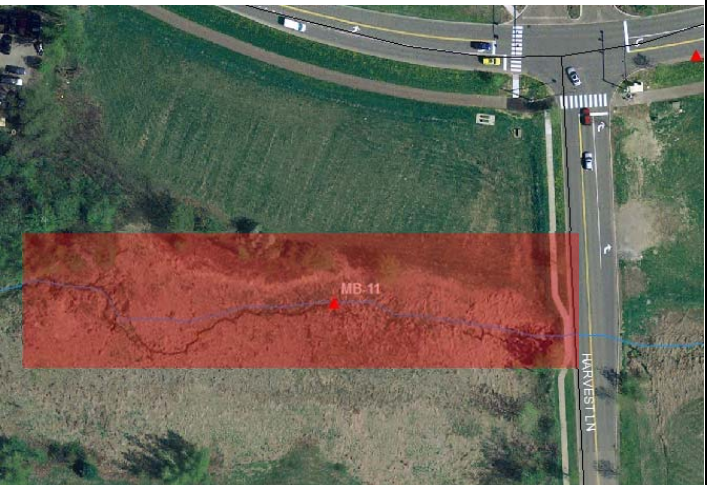
Description of Observed Conditions:
 Stream bed is eroding. Primary headcut measures 2.8' feet with a steady 3" flow falling. The downstream erosion is about 15' wide and extends into floodplain.

Prioritization Ranking Factors							
Relative Impact	Frequency	Current Condition	Urgency	Impact to public infrastructure?	Realistic to fix?	Impacts beyond water resources?	Part of larger systemic problem?
3	2	2	2	No	No	No	Yes
Relative Impact: Small nick-point/headcut has resulted in significant localized erosion; left unchecked erosion likely to continue to migrate upstream.

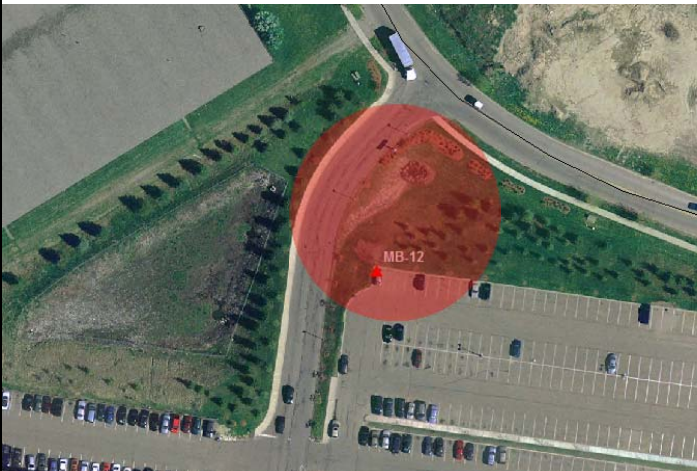
Problem Area ID: MB-12	Latitude: 44.442633 ° N	Longitude: 73.121009 ° W
Watershed: Muddy Brook

Catch basin is slightly elevated or pavement/ground around the basin has settled and sunk in corner of parking lot. Water is flowing next to basin straight into the curb and then over and down the bank towards the Wal-Mart drive. Trenching is visible on west side of drive. Water is seeping from hillside between two basins, unsure of this source as it had been dry for a few days before observations.

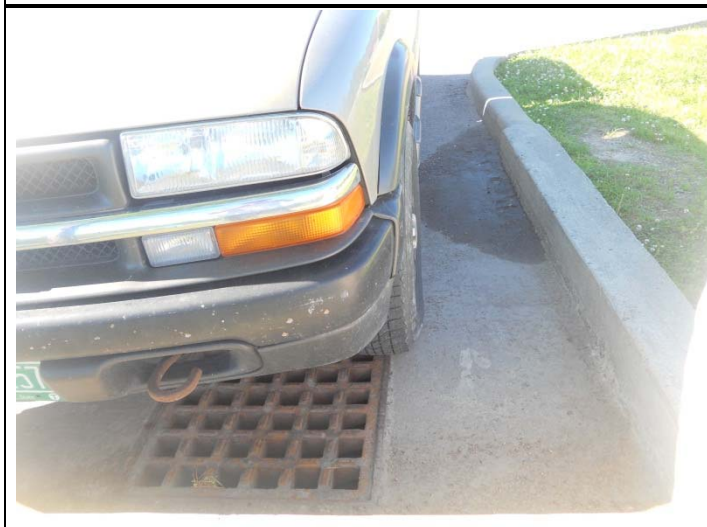
Photo 1. Water seeping from ground

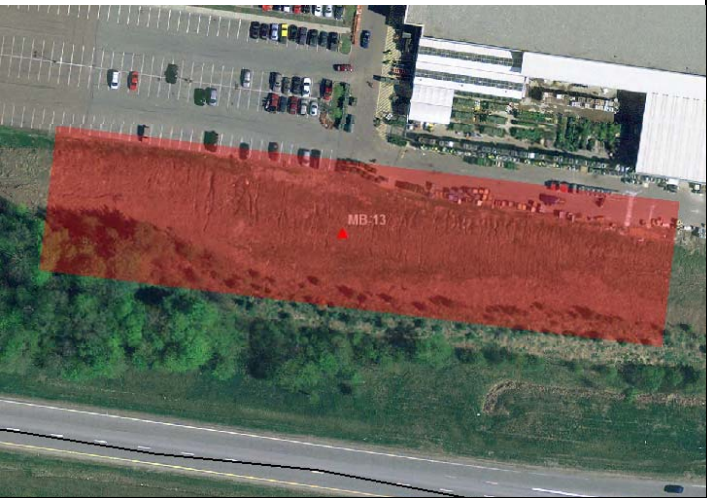
Problem Area ID: MB-13	Latitude: 44.440538 ° N	Longitude: 73.119519 ° W
Watershed: Muddy Brook Location: Near southwest corner of Home Depot building Problem Type: Overland Erosion Identification Source: SWMP Field Assessment Ownership: Private Classification Level: 2

Description of Observed Conditions:
 Gully erosion is occurring along the entire cut slope due, at least partially, to poor stabilization. Some are wet with minor water run-off. Rip-rap is in place on bank behind Wal-Mart with a couple trees lying on their sides. Unsure if the rip rap is from original construction or an attempt to abate on-going erosion.

Prioritization Ranking Factors							
Relative Impact	Frequency	Current Condition	Urgency	Impact to public infrastructure?	Realistic to fix?	Impacts beyond water resources?	Part of larger systemic problem?
2	2	1	2	No	No	No	Yes
Relative Impact: On-going erosion and mass failure attributable to previous construction activities. This may be addressed through ANR permit enforcement.

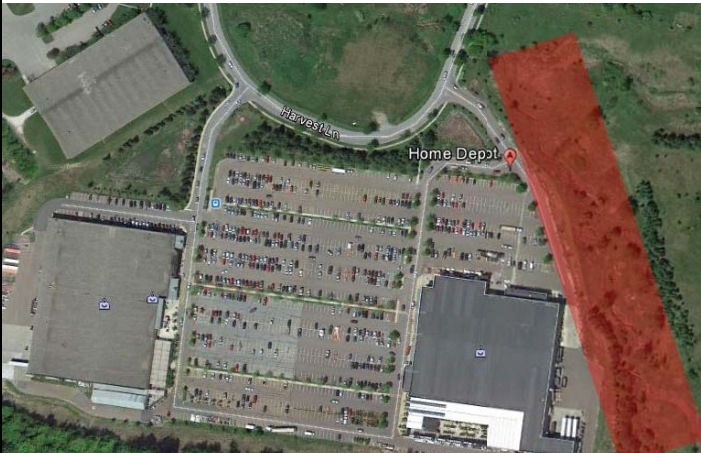
Description of Observed Conditions:
 Severe bank erosion is present along most bends of reach. Major bank under cutting occurring, particularly along the bank that separates stream from Home Depot parking lot, only about 6' of bank left. Could be cause of sediment build up in MB 14, as it is just upstream of culvert.

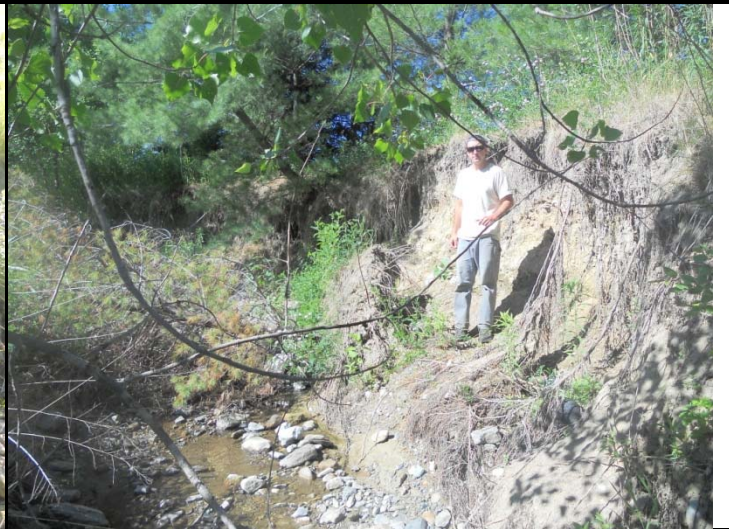
Photo 2. Bank between Home Depot and Stream

Relative Impact: Large amounts of erosion in stream causing downstream sediment build up and possible complete bank failure to Home Depot parking lot. Bank between stream and parking lot is severely eroded.

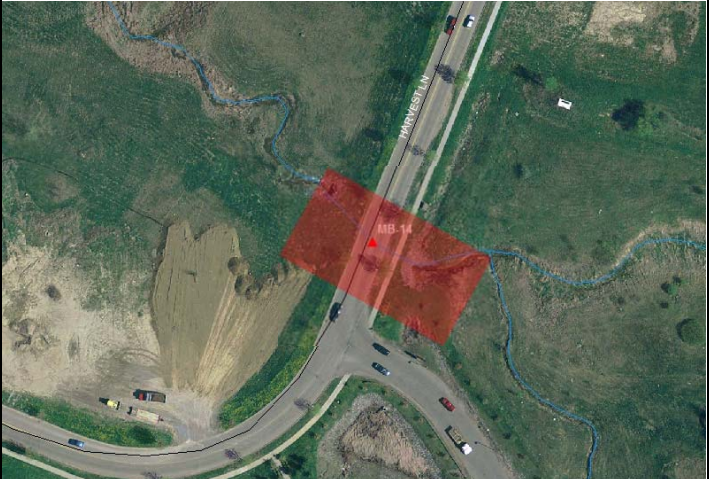
Problem Area ID: MB-15	Latitude: 44.443329 ° N	Longitude: 73.118874 ° W
Watershed: Muddy Brook Location: Harvest Lane, near entrance to Home Depot Problem Type: Erosion Identification Source: Muddy Brook SGA Ownership: Public (Town) Classification Level: 3

Description of Observed Conditions:
 Sediment built up at outfall of culvert, which is causing pooling in the culvert and very slow moving water at outfall. Large amounts of sediment downstream of culvert altering flow of water. Town Public Works Department contacted the developer who cleaned the culvert; more observations are needed to ensure problem has been fully addressed.

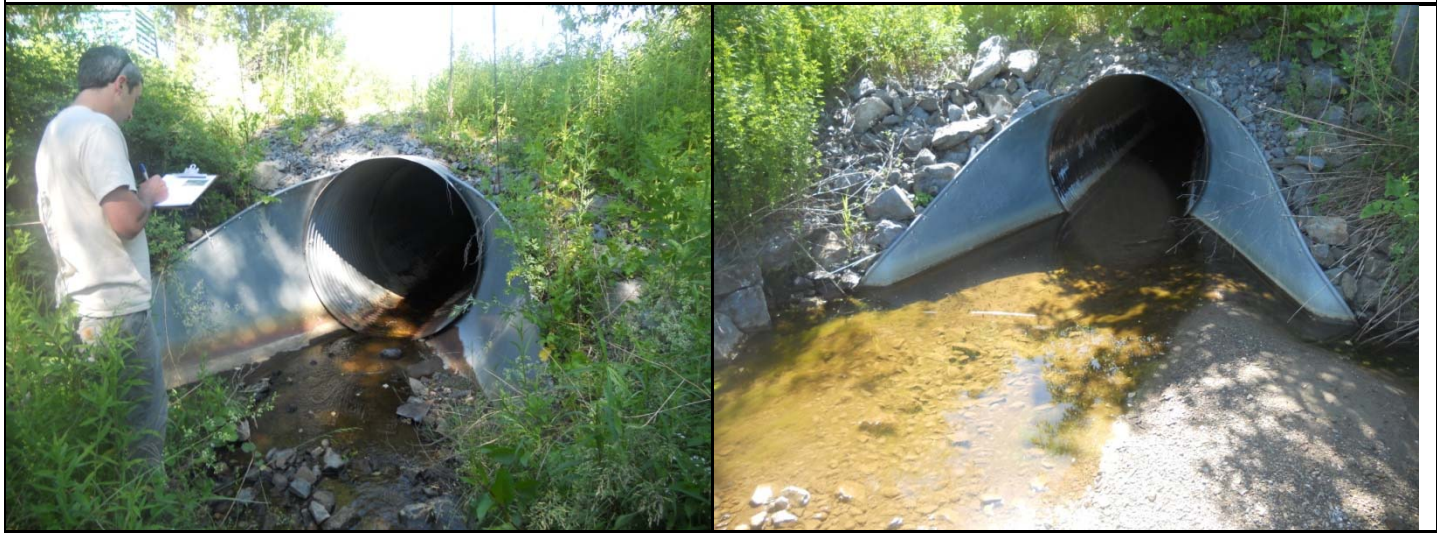
Photo 1. Looking downstream **Photo 2.** Looking upstream

Prioritization Ranking Factors							
Relative Impact	Frequency	Current Condition	Urgency	Impact to public infrastructure?	Realistic to fix?	Impacts beyond water resources?	Part of larger systemic problem?
2	2	2	1	Yes	Yes	Yes	Yes
Relative Impact: Upstream erosion from Home Depot site (see MB-15) causing sediment to build up near/in culvert.

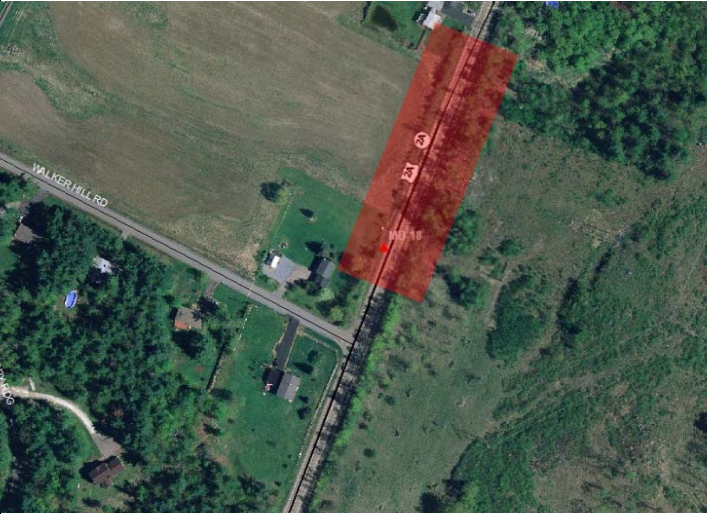
Problem Area ID: MB-18	Latitude: 44.431129 ° N	Longitude: 73.119568 ° W
Watershed: Muddy Brook Location: VT 2A, northeast of Walker Hill Rd. Problem Type: Local Drainage Identification Source: Resident Questionnaire Ownership: Public (VTrans, Town) Classification Level: 3

Majority of the issues appear to be on the southeast side of 2A; road-side ditches are eroding road shoulders. Drainage ditch crosses 2A at #3283 with 24" plastic culvert. Culvert is ½ full of sediment and debris. Hydraulic capacity of culvert decreased from aggraded material.

Relative Impact: Drainage ditches along road needs repair; culvert needs to be cleaned out. Slope of culvert or source of backwater should be investigated to determine reason for aggradation.

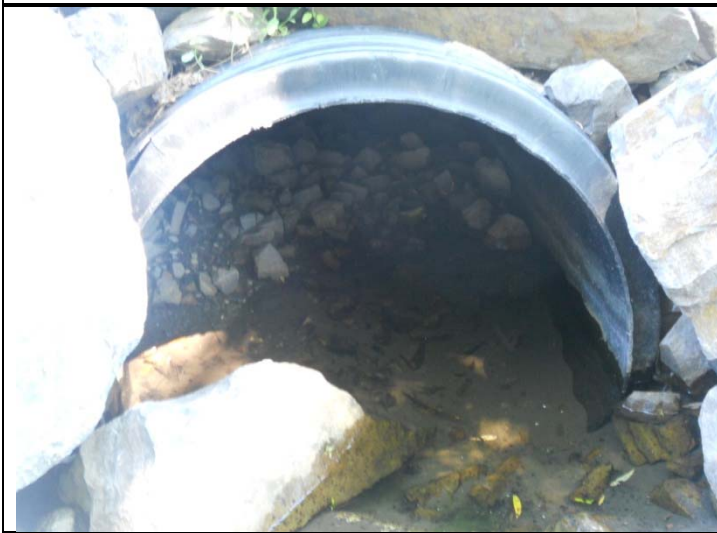
Photo 1. Aggradation in culvert.

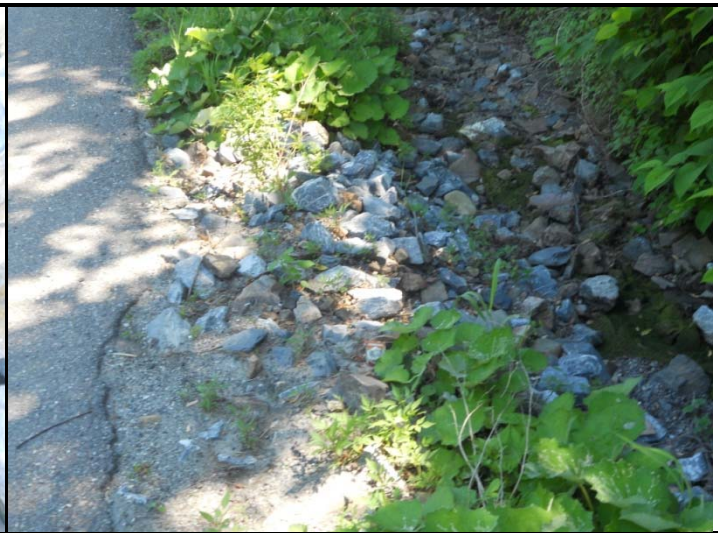
Photo 2. Road side erosion

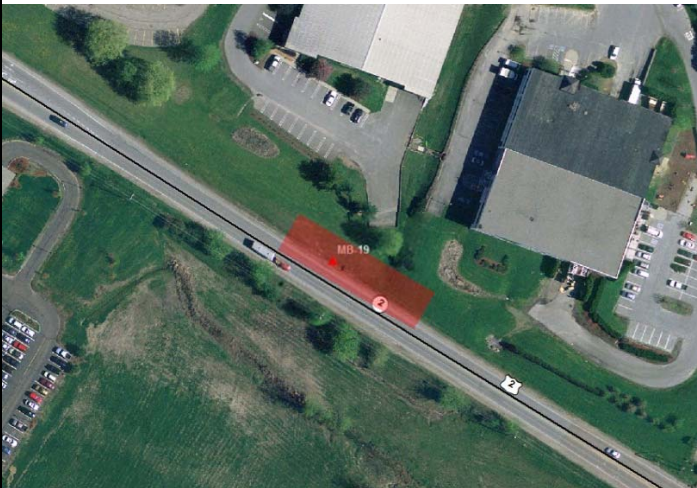
Problem Area ID: MB-19	Latitude: 44.451607 ° N	Longitude: 73.115406 ° W
Watershed: Muddy Brook Location: Rt. 2 (Williston Rd) 0.1 mi. southeast of Harvest Ln Problem Type: Local Drainage Identification Source: SWMP Field Assessment Ownership: Public (VTrans, Town) Classification Level: 3

Evidence of road run-off is present on sidewalk. Trenching has formed between road and green belt.

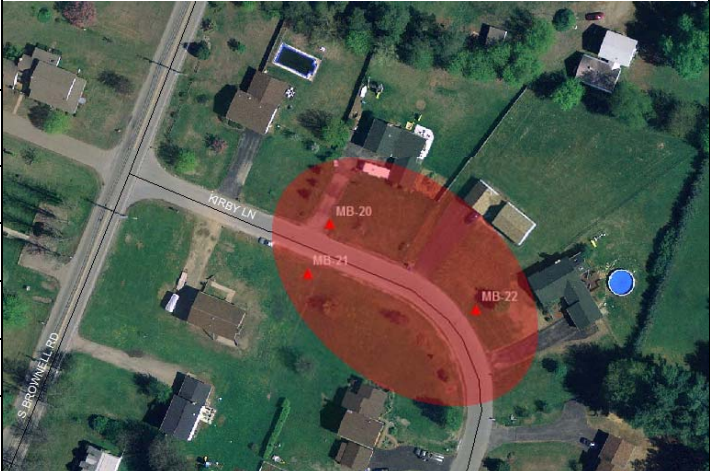
Problem Area ID: MB-20	Latitude: 44.453336 ° N	Longitude: 73.123286 ° W
Watershed: Muddy Brook

Catch basin / dry well does not drain and causes localized flooding.

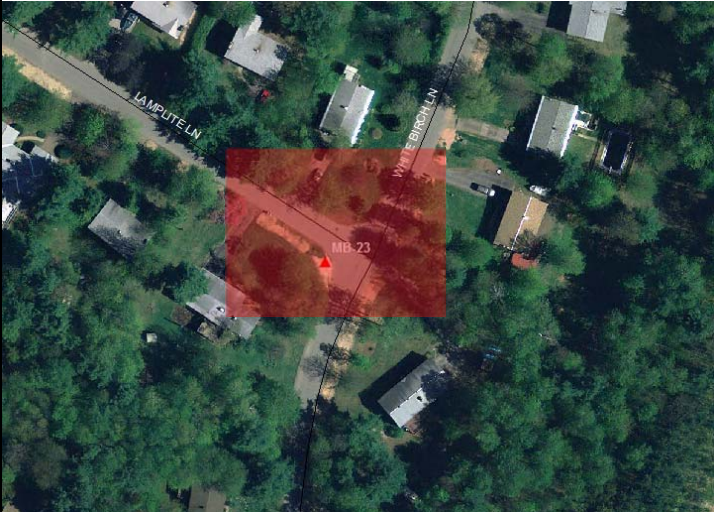
Problem Area ID: MB-23	Latitude: 44.456809 ° N	Longitude: 73.118364 ° W
Watershed: Muddy Brook Location: Lamplite Lane and White Birch Lane. Problem Type: Local Drainage Identification Source: Public Works Department Ownership: Public (Town) Classification Level: 2

Description of Observed Conditions:
 Catch basin appears to be clear of debris, difficult to determine exact cause of flooding.

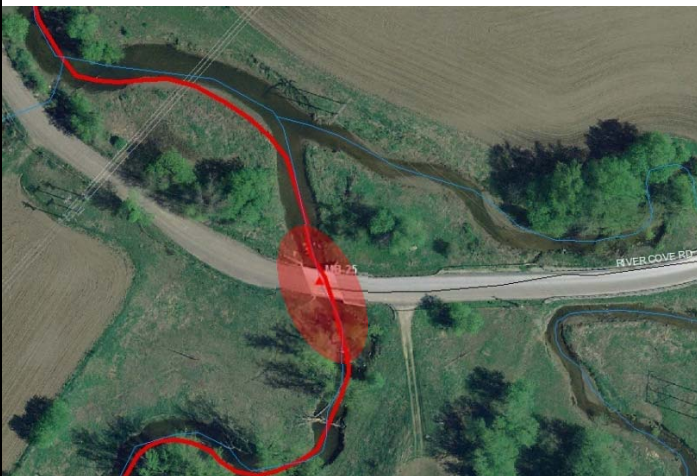
Problem Area ID: MB-25	Latitude: 44.472759 ° N	Longitude: 73.134958° W
Watershed: Muddy Brook Location: River Cove Road, 1.2 mi., west of VT 2A Problem Type: Erosion Identification Source: Muddy Brook SGA Ownership: Public (Town) Classification Level: 3

Sediment build up occurring downstream of bridge. Small, 1' head cut just upstream of bridge. Signs of bank erosion on both upstream and downstream edges, majority is on west side. Existing bridge is causing significant upstream and downstream erosion; existing bridge is 52% of bankfull width.

Relative Impact: On-going in channel erosion as brook continues to adjust to increased stormwater flows and constriction caused by undersized bridge.

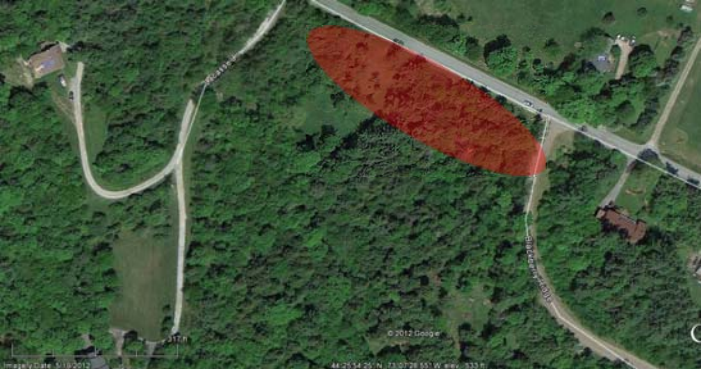
Problem Area ID: MB-26	Latitude: 44.472759 ° N	Longitude: 73.134958° W
Watershed: Muddy Brook Location: SW corner of Walker Hill Rd. and Blackberry Ridge. Problem Type: Channel Erosion Identification Source: VT DEC (Pease) Ownership: Public/Private Classification Level: 3

Description of Observed Conditions:
 4-5-foot headcut forming downstream from culvert under Blackberry Ridge; streambank is actively eroding.

Prioritization Ranking Factors							
Relative Impact	Frequency	Current Condition	Urgency	Impact to public infrastructure?	Realistic to fix?	Impacts beyond water resources?	Part of larger systemic problem?
2	2	2	3	No	Yes	No	Yes
Relative Impact: Headcut will eventually move up to culvert, endangering bank stability.

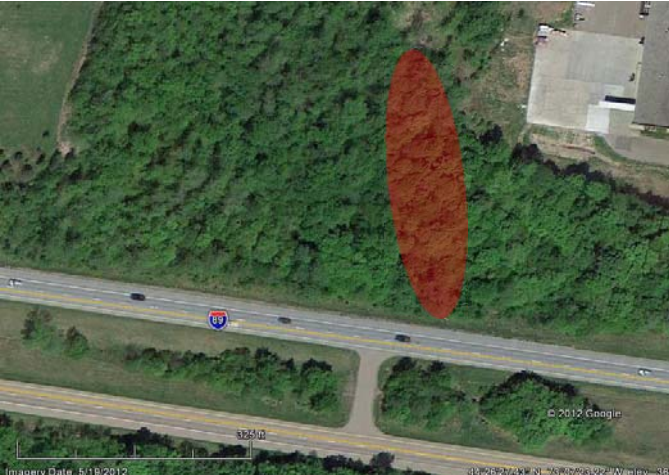
Problem Area ID: MB-27	Latitude: 44.472759 ° N	Longitude: 73.134958° W
Watershed: Muddy Brook Location: I-89 drainage, SW of Wal-Mart Problem Type: Channel Erosion Identification Source: VT DEC (Pease) Ownership: Public (VTrans)/Private Classification Level: 2

Description of Observed Conditions:
 Streambank erosion downstream of culvert. Access to floodplain ~100ft downstream.

Prioritization Ranking Factors							
Relative Impact	Frequency	Current Condition	Urgency	Impact to public infrastructure?	Realistic to fix?	Impacts beyond water resources?	Part of larger systemic problem?
2	1	2	2	No	No	No	Yes
Relative Impact: Some stabilization measures have been implemented. Rip-rap has failed in places and bank erosion continues.

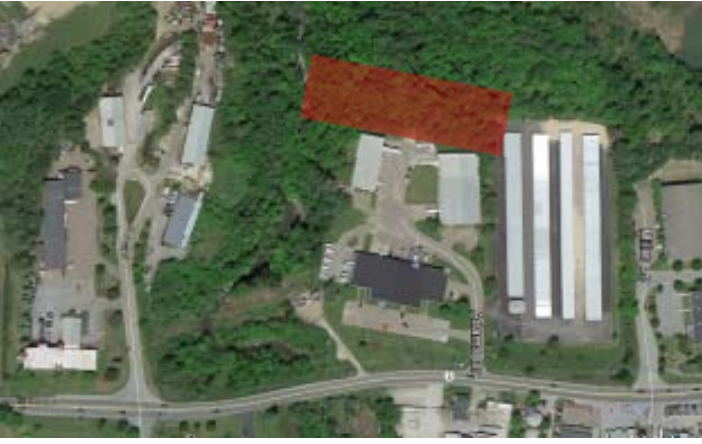
Problem Area ID:	MB-28	Latitude: 44°27'37.93"N	Longitude: 73° 8'4.70"W
Watershed:	Muddy Brook

Large gully (40' width, 30' depth) at outfall from stormwater system at Extra Storage LLC (28 Adams Drive, stormwater discharge permit # 4148-9010.R). The bank around the outfall has been armored with stone. Repair of gully will be extremely costly and technically challenging. Stormwater should be addressed upstream.
