TOWN OF WILLISTON TOWN-WIDE WATERSHED IMPROVEMENT PLAN - PHASE 2

FINAL REPORT

Stone Project ID 12-055
September 10, 2013

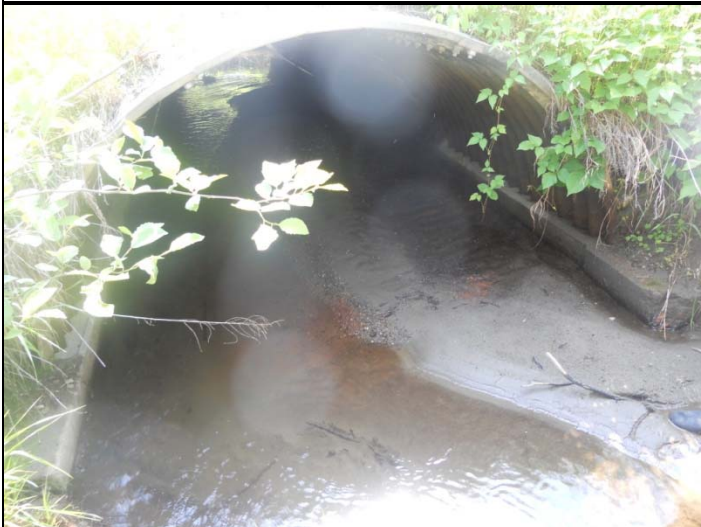
Update 6/18/2013: Culvert at northern private driveway is set with concrete barrier on either side, and is significantly undersized causing stream erosion on the downstream side. The stream appears to have shifted near the culvert at Ridge Rd. and has begun to erode an area that is not armored with riprap.

Photo 1. Culvert under Ridge Road

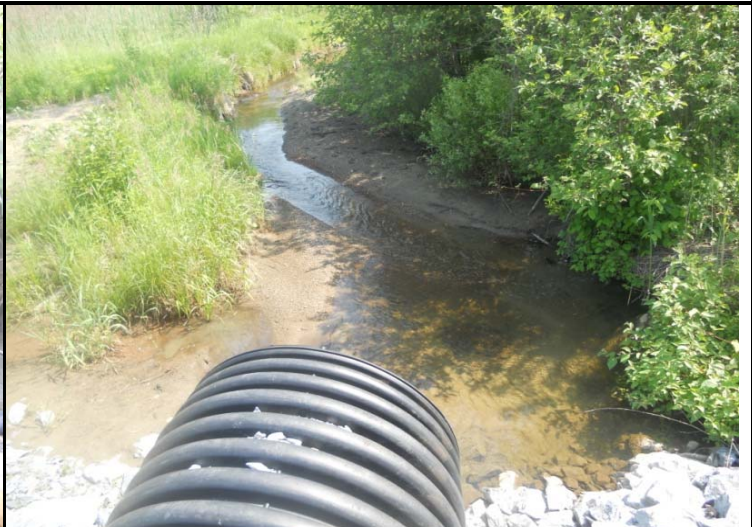
Photo 2. Culvert under private drive

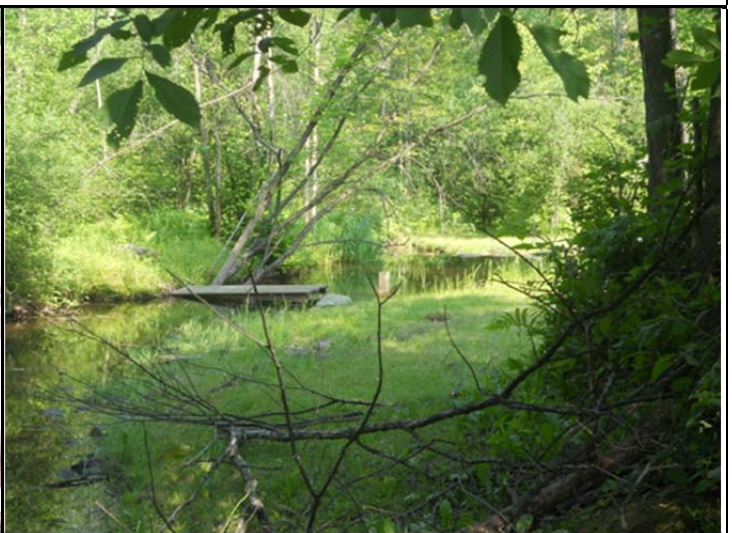
In this area, Sucker Brook is being impacted by residential encroachment (and the attendant stormwater runoff) and unnatural structures placed in and across the channel. Specific observed problems include eroding streambanks and channel incision.

Photo 2. Foot bridge and "abutment"

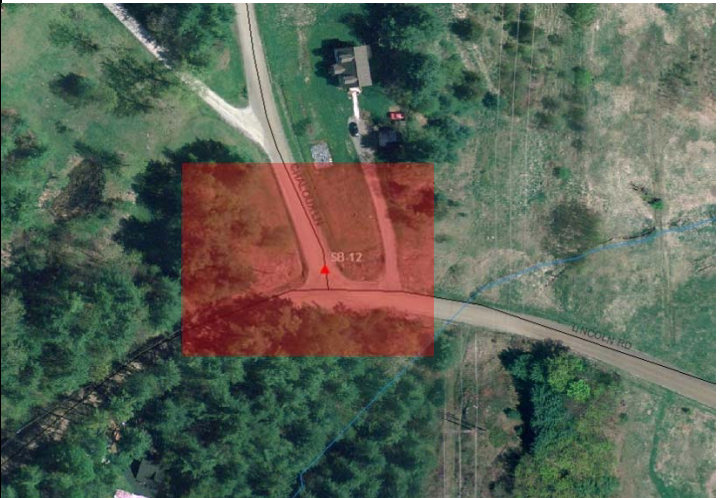
Problem Area ID: SB-12	Latitude: 44.403875° N	Longitude: 73.130124° W
Watershed: Sucker Brook Location: Near intersection of Chaloux Lane with Lincoln Road Problem Type: Local Drainage Identification Source: Public Works Ownership: Public (Town)/Private Classification Level: 3

Prioritization Ranking Factors							
Relative Impact	Frequency	Current Condition	Urgency	Impact to public infrastructure?	Realistic to fix?	Impacts beyond water resources?	Part of a larger or systemic problem?
2	2	2	2	Yes	Yes	No	Yes
Relative Impact: Current drainage patterns lead to erosion during moderate and large runoff events.

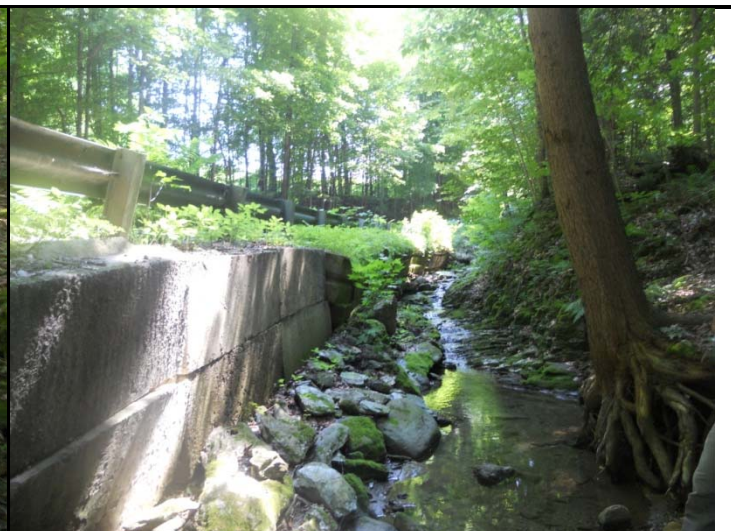
Photo 2.

Update 6/18/2013: Public Works reports that Spring 2013 flooding exacerbated this condition; repair is underway.

Relative Impact: Failing retaining wall is impacting road surface and exacerbating erosion along road.

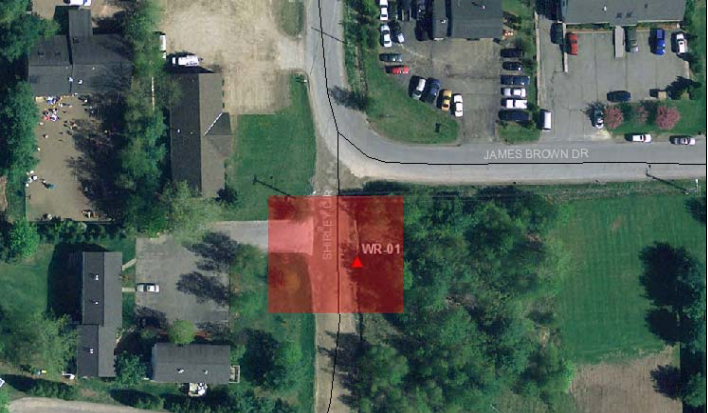
Problem Area ID: WR-01	Latitude: 73.117346 N	Longitude: 44.475213 W
Watershed: <u>Winooski River</u>

Update 6/25/2013: Shirley Circle, south of the driveway leading to the western parking lot for the apartment building, appears to have recently lain stone and the adjacent ditch appeared to have recently been re-trenched. The section of Shirley Circle to the north of that driveway remains in poor condition, with large ruts and potholes and standing water from the previous day's storms. A large pile of gravel has been placed in the road to prevent through traffic.

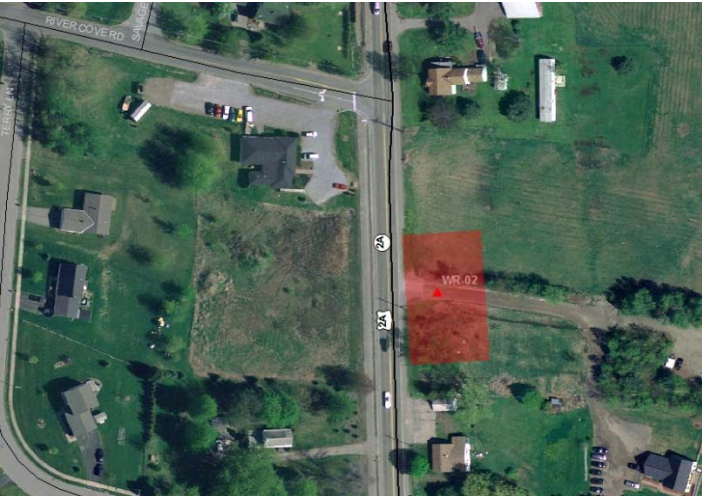
Problem Area ID: WR-02	Latitude: 73.112286 N	Longitude: 44.471829 W
Watershed: Winooski River Location: Route 2A, just south of the intersection with River Cove Rd Problem Type: Local Drainage Identification Source: Reported by resident Ownership: Private Classification Level: 1

New stone driveway in place. New 12" corrugated plastic culvert installed with 1/2" of flow moving from wetland adjacent to drive into what appears to be a 6" plastic pipe running underground into the woods. May be an issue if large amounts of water begin to flow through culvert. Second culvert is new 8" corrugated plastic helping to ease drainage. Some iron staining present. Disturbed areas have not been fully stabilized with seed and mulch.

Relative Impact	Frequency	Current Conditions	Urgency	Impact to Public Infrastructure	Realistic to Fix	Non-stormwater related	Larger/Systemic Problem
1	2	1	1	No	No	No	No
Relative Impact: Localized erosion attributable to poor site stabilization; larger culvert likely to address original concern.

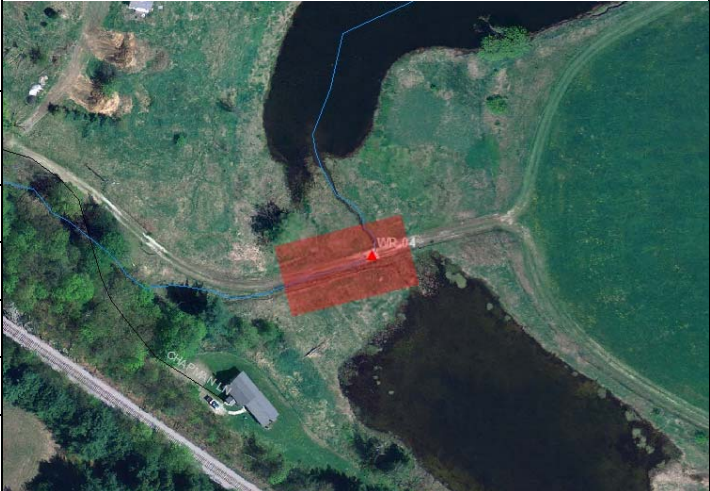
Problem Area ID: WR-04	Latitude: 73.034995 N	Longitude: 44.462254 W
Watershed: <u>Winooski River</u>

Stream running parallel to farm road on south side. Road on both sides of existing culvert lower, causing drainage issue and ponding. Attempts made by landowner to channel water off of road do not seem to be working.

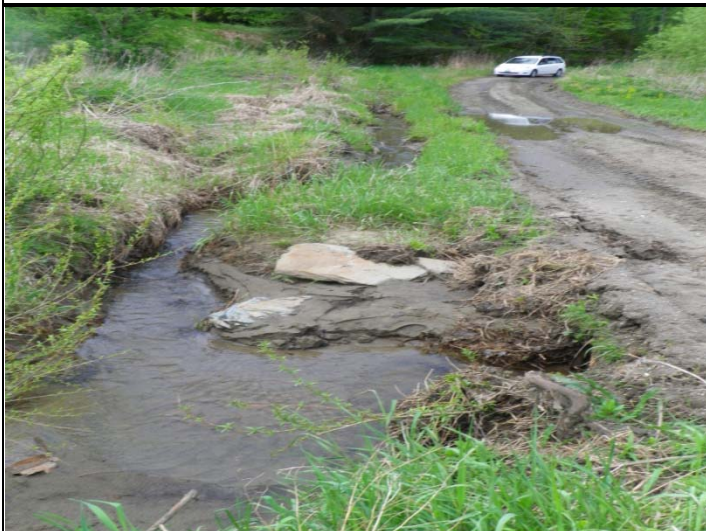
Photo 1. Straightened stream flowing to culvert

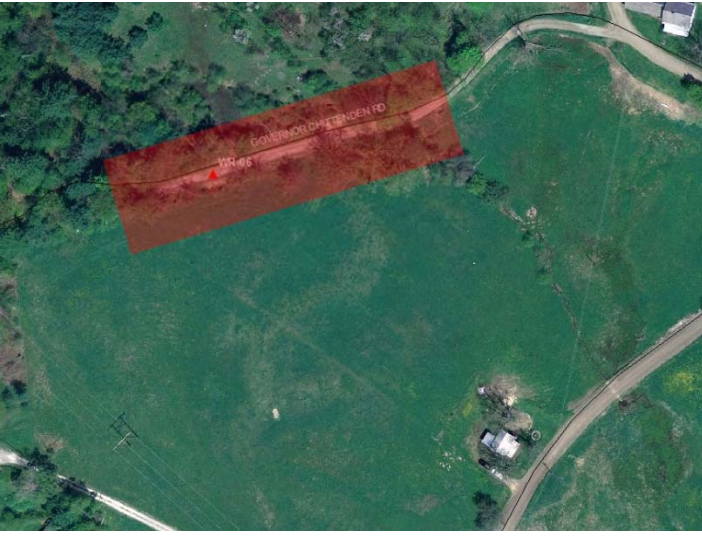
Description of Observed Conditions:
 Lack of roadside conveyance facilities and proper road crown/cross slope is causing runoff to erode the dirt/gravel roadway. Multiple in-road gullies beginning to form, as road is not crowned/sloped so as to reliably shed water. Undermining of tree and roots along north-side of road.

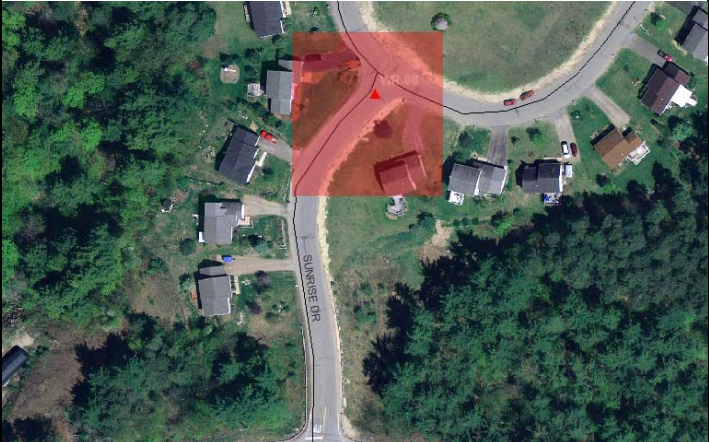
Problem Area ID: WR-08	Latitude: 73.045167 N	Longitude: 44.435489 W
Watershed: Winooski River

Catch basins positioned in lawns away from road. Storm water flows down edge of road causing gullying and road decay. Town remedy of cold patch working in areas it was installed but it appears that the material was not extended all of the way downhill. All storm water flows to catch basin at center of circle, causing some road damage. Water drains from the catch basin via an 8" corrugated metal pipe which discharges to a drainage ditch in the back of development.

Update 6/18/2013: Lots of loose gravel material observed along road, but little evidence of sand transport in around the cul-de-sac. Area has no topsoil layer. Grass on the slopes of cul-de-sac (the septic leach field for the subdivision) is sparse. No sediment observed in CBs. Another opportunity for community outreach with rain gardens.

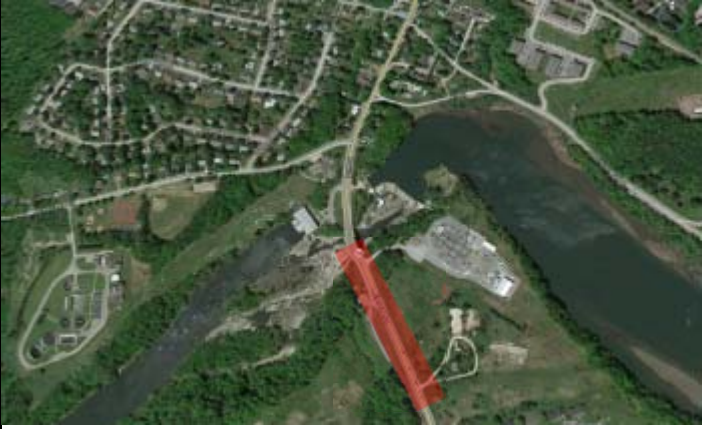
Problem Area ID:	WR-10	Latitude: 44°25'59.02"N	Longitude: 73° 3'59.07"W
Watershed:	Winooski River

Vegetated swale adjacent to south-bound Rt. 2A is mounded on the road-side, inhibiting water from entering. Runoff instead flows along the shoulder causing some erosion. Sediment from road and shoulder is depositing in the northern end of the Overlook Park lot, and also flowing down the recreation path leading directly to the Winooski River. Puddles near the river bank had sheen layer, indicating road/parking lot runoff.

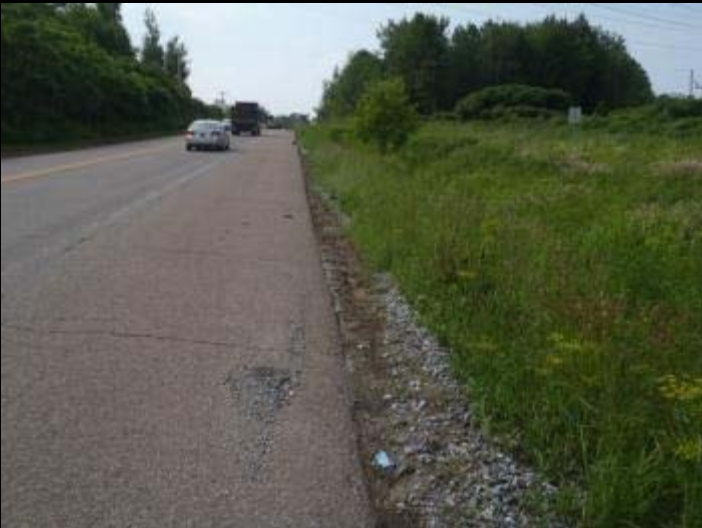
Photo 1. Berm above swale does not allow water entry from road

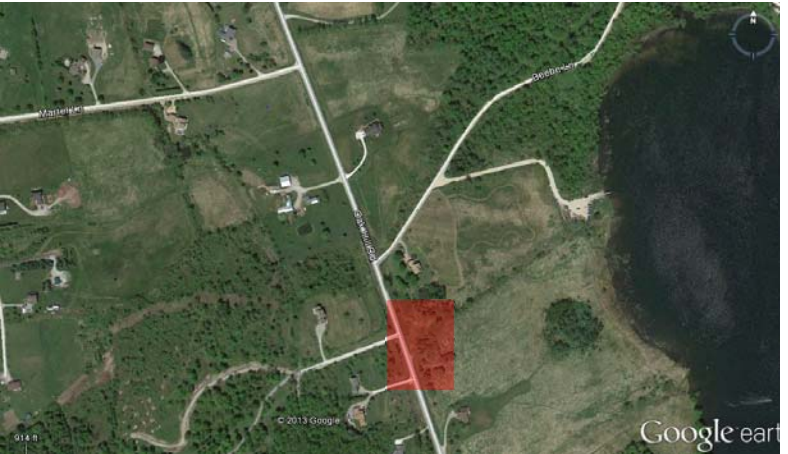
Problem Area ID:	LI-01	Latitude: 44.374836°	Longitude: 73.116677 ° W
Watershed:	Lake Iroquois

Description of Observed Conditions:
<p>Culvert appears to serve large drainage area and is undersized. The ditch along the Western side Oak Hill Rd. is incised. The bank above the culvert outfall (east side of Oak Hill Rd.) has degraded and the road edge is beginning to collapse. The bank has been armored with stone. Road barrels at the site indicate that the Town is aware of the problem.</p>

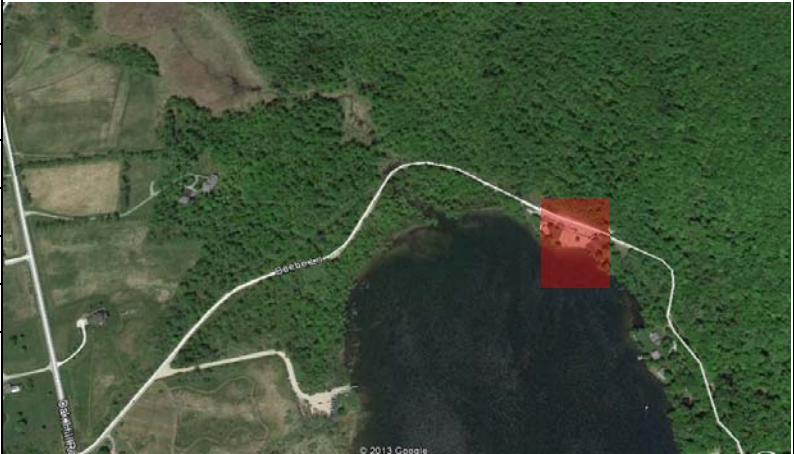
Problem Area ID:	LI-02	Latitude: 44.379228°	Longitude: -73.085752°
Watershed:	Lake Iroquois

Description of Observed Conditions:
<p>Beach is at 25-35% grade. According to resident, new sand is brought in each spring to replace sand that has slumped into the lake. There are stormwater managements opportunities around the beach and parking lot. It may be necessary to reduce the elevation and install a retaining wall at of the back of the beach.</p>

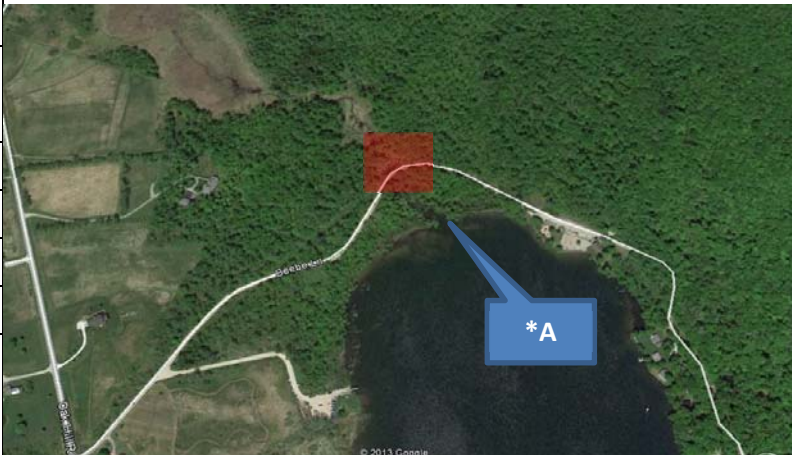
Problem Area ID:	LI-03	Latitude: 44.380320°	Longitude: -73.089183°
Watershed:	Lake Iroquois

Description of Observed Conditions:
<p>Culvert under Beebe Ln is undersized. Upstream from culvert is marsh area with tributaries from several directions.</p> <p>Daniel Sharpe of the Lake Iroquois Association monitors the mouth of the stream (*A) and has noted high turbidity. Marsh appears to be eroding and may be the source of sediment load.</p>

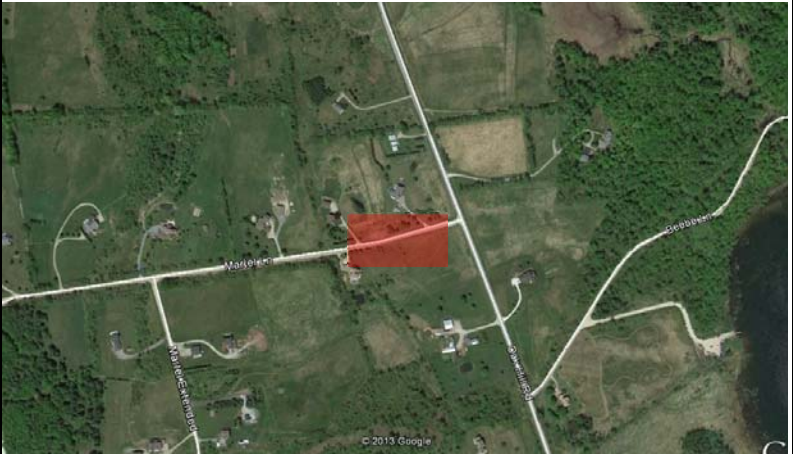
Problem Area ID:	LI-04	Latitude: 44.378467°	Longitude: -73.097289°
Watershed:	Lake Iroquois

Description of Observed Conditions:
<p>Road surface condition is very poor. Ditch along southern edge of Martel Rd. is incised and actively degrading. There are large sediment deposits near the road, presumably from the road surface.</p> <p>The eastern-most 300ft of Martel Rd. falls within the Town of Williston. The western portion of the road (uphill, and source of much of the sediment load) is the Town of St. George.</p>

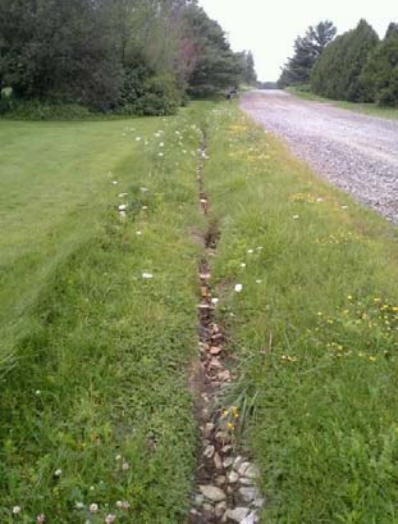
Photo 1. Incised ditch (facing west towards St. George)	Photo 2. Incised ditch and sediment deposit (facing east towards Oak Hill Rd.)
