**BLOOD BROOK WATERSHED
CORRIDOR PLAN
NORWICH, VT**

March 27, 2008

Prepared by:
Daniel Ruddell, Elisabeth McLane, Anna Mulligan,
Staff Scientists, and
Ben Machin, Principal
Redstart Consulting

Prepared for:
Two Rivers-Ottawaquechee Regional Commission,
Town of Norwich Conservation Commission, and
Vermont Agency of Natural Resources/
Department of Environmental Conservation
River Management Program

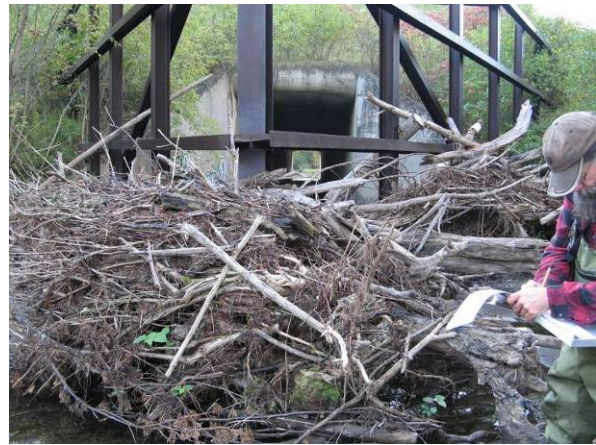
Figure 5. This debris catcher is located at the mouth of a 70-foot-long box culvert that runs underneath Rte. 5 at the downstream end of reach M03 on the Blood Brook mainstem, where floodwaters nearly overtopped the embankments in 1973 (Fig. 6).

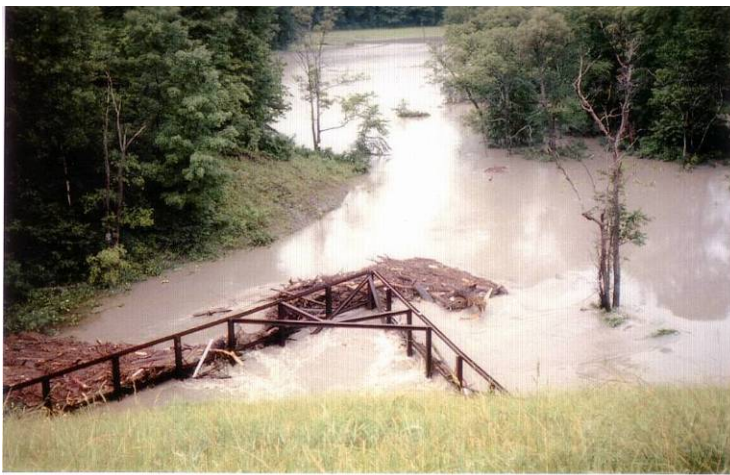
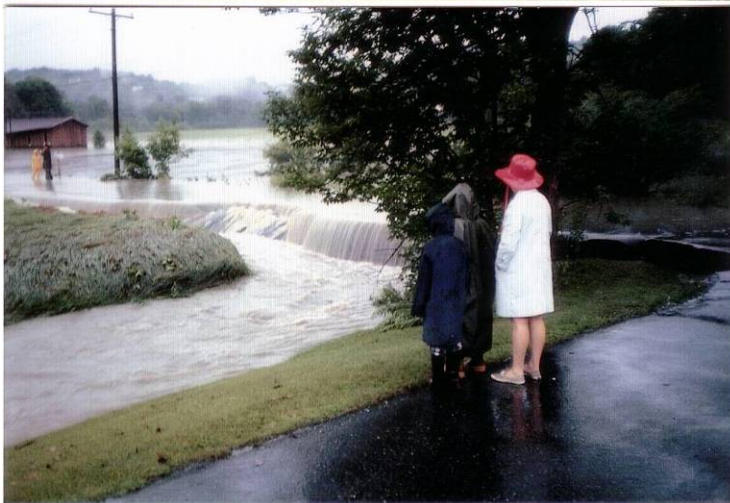
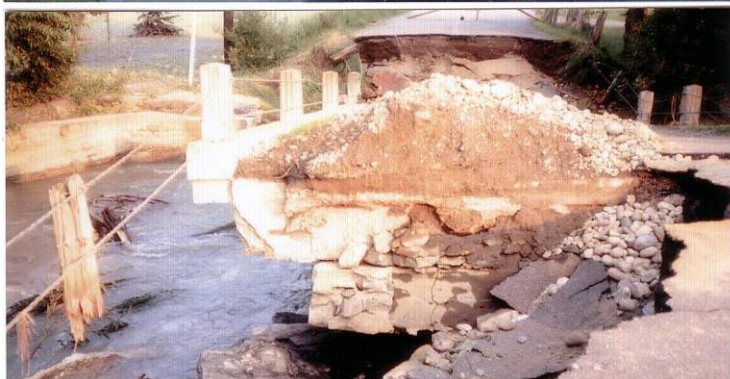
There are no continuous-record stream gages in the Blood Brook drainage basin. The nearest gage of this type is the one found downstream on the Connecticut River mainstem at West Lebanon, NH, which spans the years 1912-2007 but records the drainage of a 4,092-square-mile area and sits below a major hydroelectric dam at Wilder that highly regulates flows and masks flood levels. The dam went into full operation in 1950, but major floods were recorded before then by the gage, in 1913, 1922, 1927, 1936 and 1938. The 1927 flood exceeded the 500-year discharge in many watersheds in Vermont and had extensive impacts in a wide area of the region (Johnson 1928). Even with dam regulation, high flow levels were recorded on the Connecticut in 1973 (Fig. 4). The 1973 flood was felt strongly in Norwich, where the Blood Brook mainstem nearly overtopped Rte. 5 where a high embankment completely blocks the floodplain at the base of reach M03 (Figs. 5, 6) and took out several bridges (notably at Beaver Meadow Rd. on reach M04; Fig. 6).

Figure 6. Photos from 1973 show floodwaters rising up the embankments at Rte. 5 (also shown in Fig. 5) , as well as the damage caused at the Beaver Meadow Rd. bridge just north of the Norwich village center (photos courtesy of Andy Hodgdon).

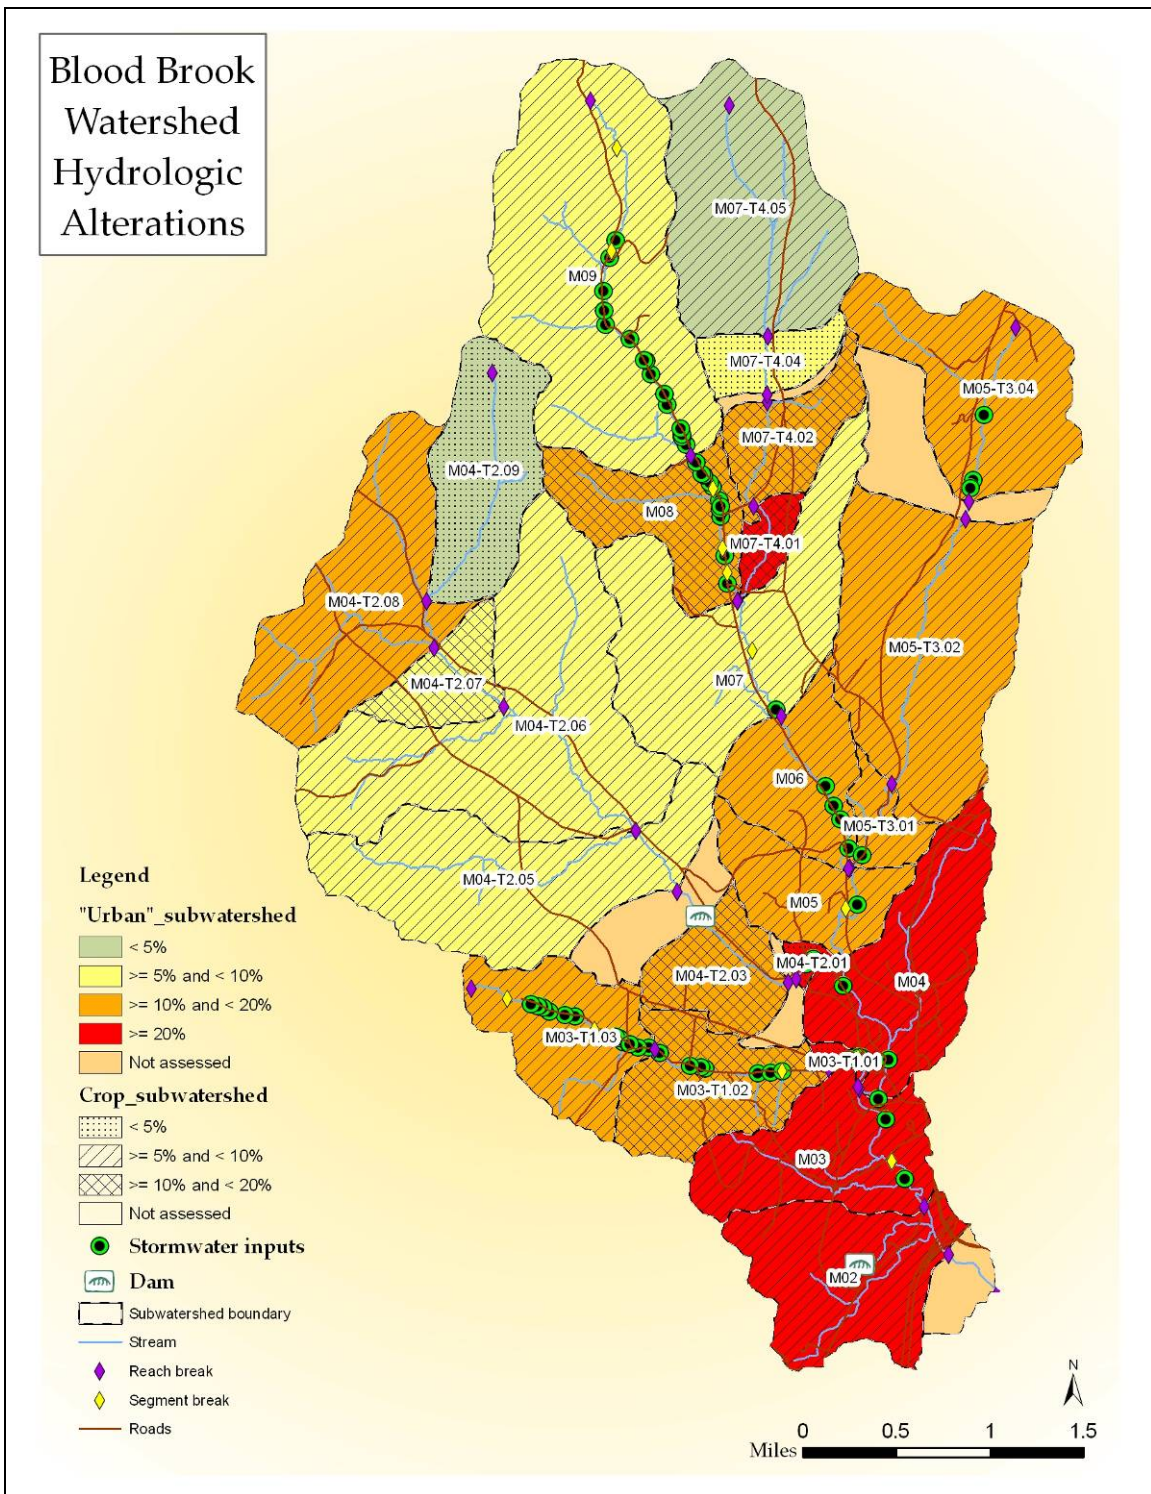
While intensified hydrologic impacts tended to diminish with reforestation, channel enlargement indicated by both current and historical channel incision as well as current widening were noted in Phase 2 data collection for the Blood Brook watershed. Although Phase 1 assessment generally indicated greater than 75% forest cover in the upper portions of the watershed, this figure dropped significantly in a number of sections of the watershed where development and agricultural use were higher. In addition, upper portions of the Blood Brook mainstem and Bragg Brook are receiving significant stormwater inputs to the stream (Fig. 9). Analysis of hydric soils overlaid with current crop and developed land uses (Figure 2, Sec. 3.1.3) also indicates likely impairment of wetland attenuation of precipitation inputs in the Blood Brook watershed, although lack of baseline historical data makes it difficult to quantify and establish impact thresholds for this parameter. Intensively cultivated crop land can generate considerable inputs of overland runoff as well as sediment when exposed during significant precipitation events. Phase 1 and 2 geomorphic assessment also indicated that many roads and crop lands have been ditched over time, further contributing to intensified hydrologic inputs to streams (Fig. 9).

Figure 9. Hydrologic alterations map for the Blood Brook corridor planning area. Labels denote the entire subwatershed draining to the stream reach indicated by the label. Subwatersheds ‘Not assessed’ were excluded from Phase 1 analysis due to the influence of wetlands and impoundments.

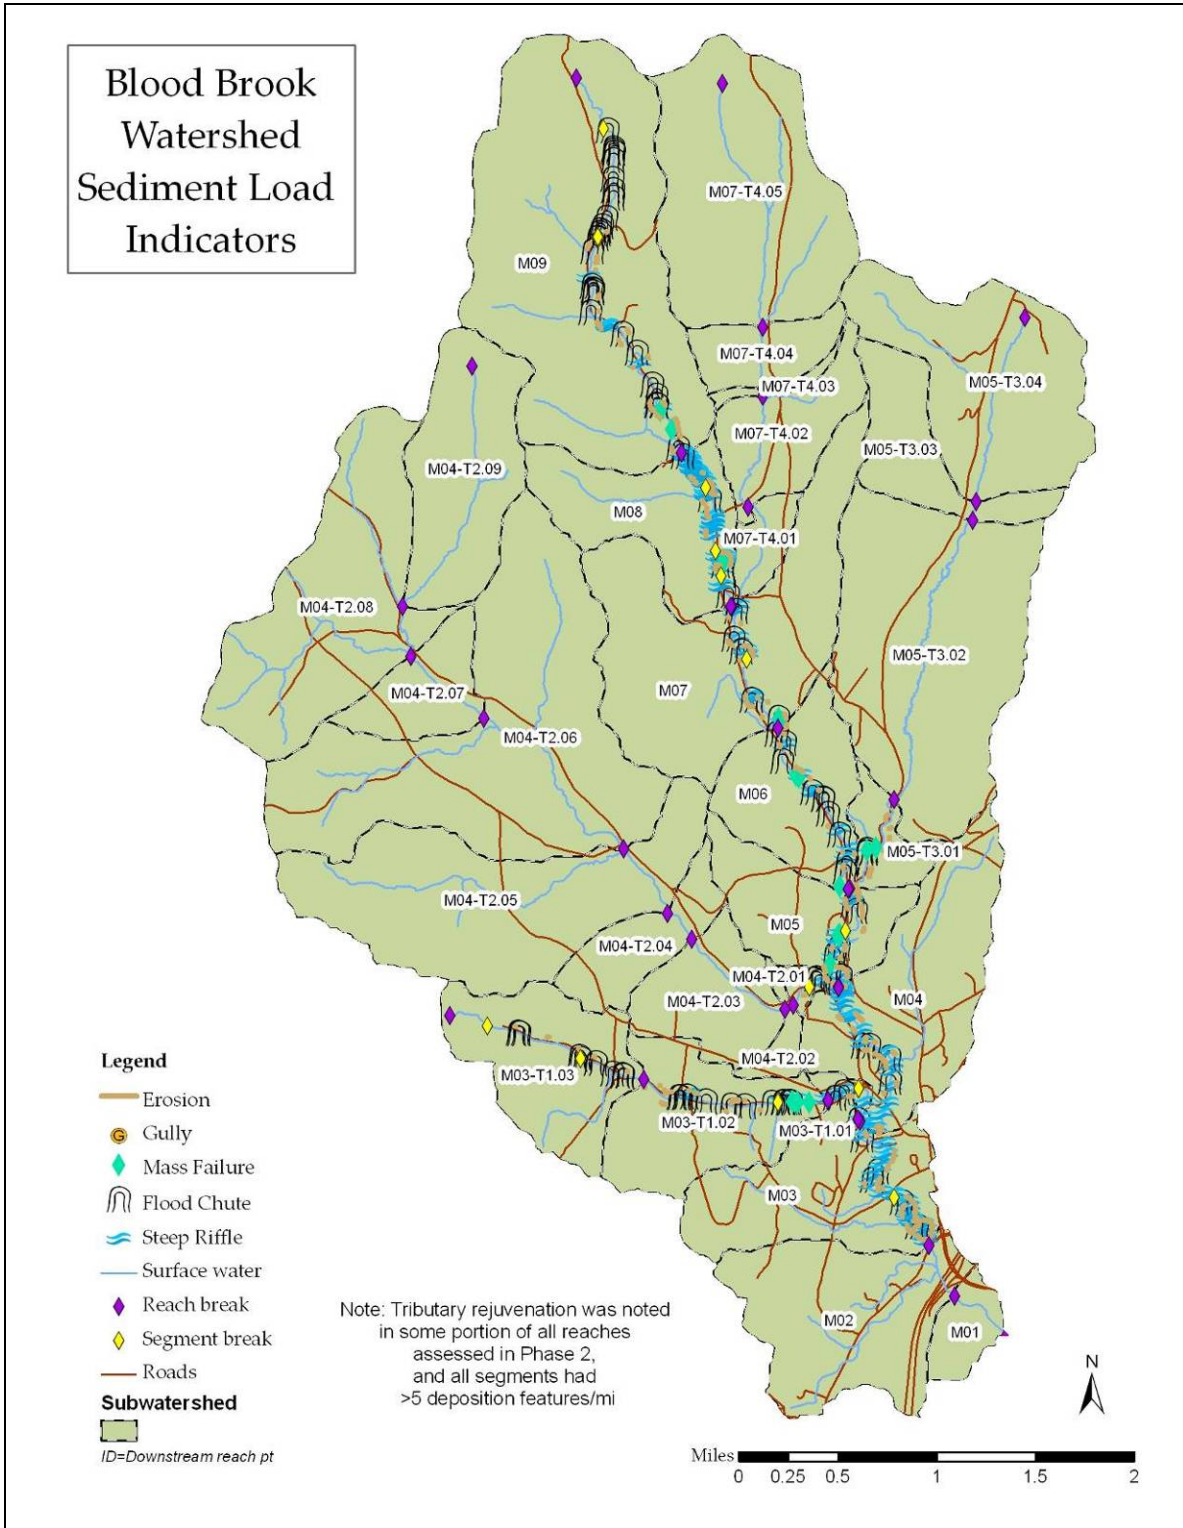
Important implications of this sediment regime in the Blood Brook basin include elevated erosion levels in reaches undergoing adjustments related to increased stream power, plus a high likelihood for channel avulsions and similar planform changes (e.g., flood chute access and formation) in high water events as well as heavy deposition (and thus further

possibilities for changes in channel direction) when stream power decreases at constrictions such as bedrock outcrops and undersized culverts and bridges.

Figure 12. Watershed-scale sediment load indicators for the Blood Brook corridor planning area. Labels denote the entire subwatershed draining to the stream reach indicated by the label. Symbols only appear on reaches included in the Phase 2 analysis.

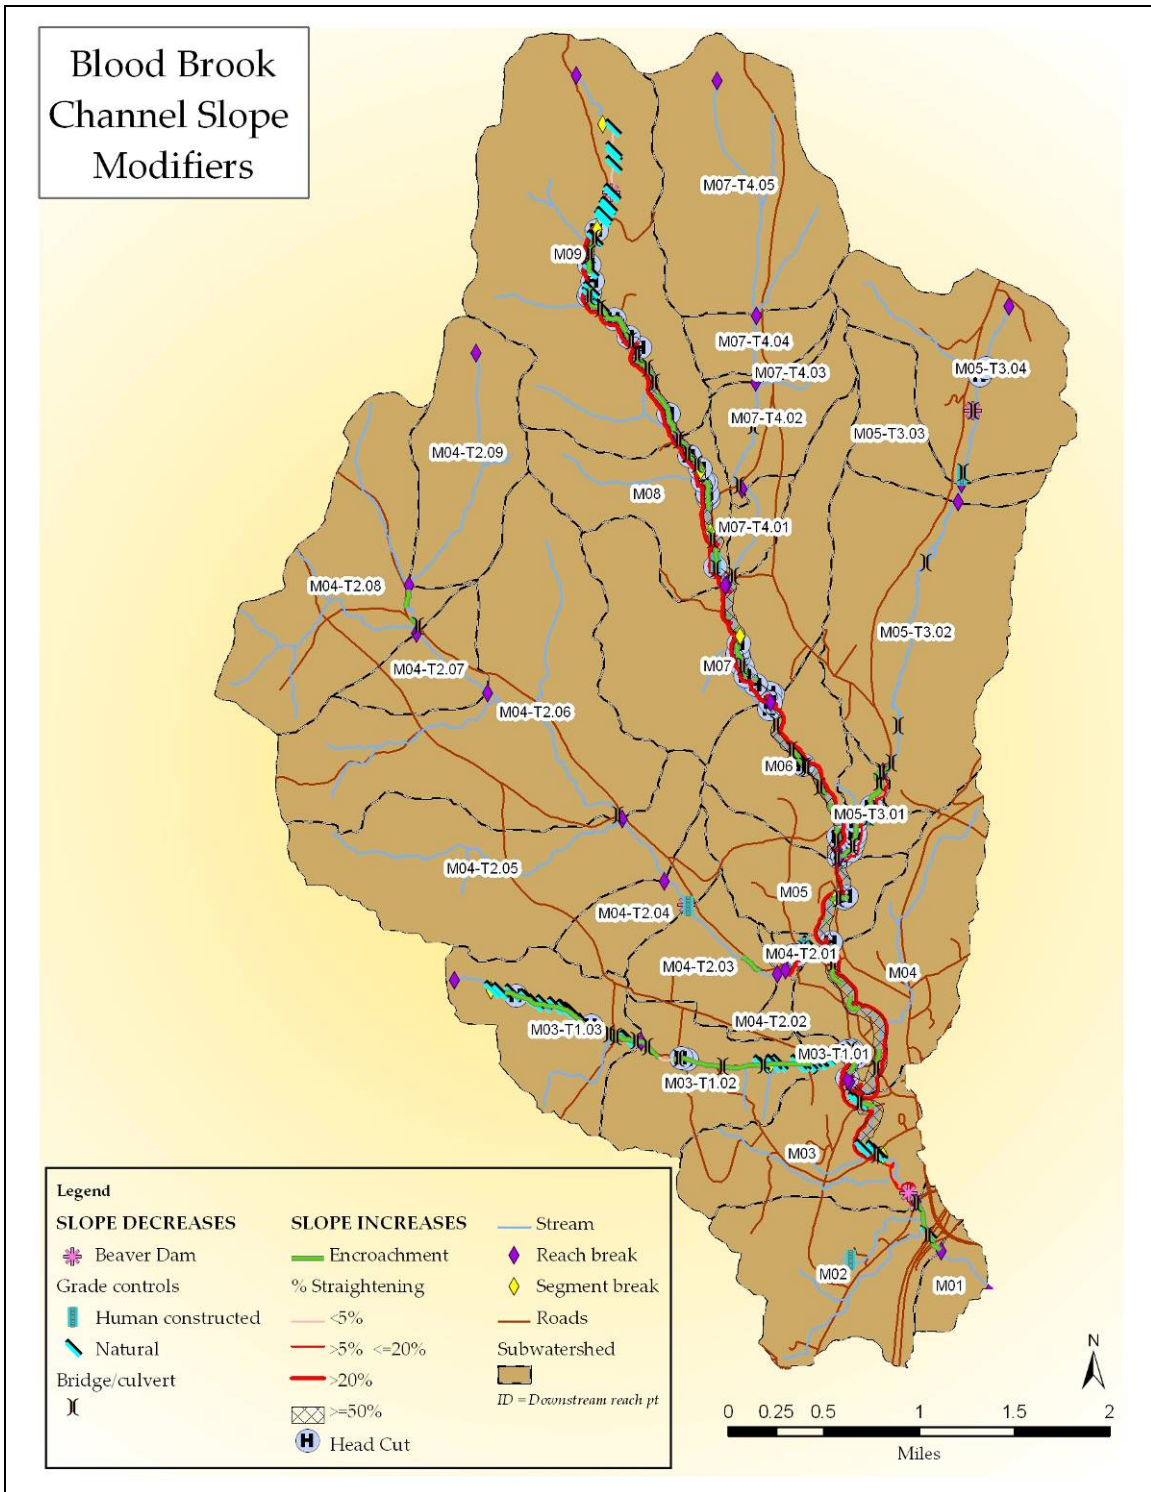
In areas with erodible boundary materials channel straightening can lead to slope increases through bed erosion in particular (exacerbated if there is a loss in floodplain access due to increased downcutting), and plays a significant role in enhancing sediment transport capacity as a result of the increased slope and depth at flood stage. Tributary rejuvenation noted in all Project reaches (Fig. 12) indicates that these streams have incised. Tributary rejuvenation generally suggests increased sediment contributions from tributaries as downcutting proceeds upstream, a process often evidenced in the presence of headcuts or localized nickpoints. These indicators of active incision processes can occur along lower reaches as well, and numerous headcuts (most of these were nickpoints rather than deeper headcuts) were noted in Phase 2 assessment along the Blood Brook mainstem (above reach M05) and Bragg Brook in particular. In this type of sediment regime, the enhanced transport capacity due to slope increases further contributes to stress in reaches downstream: instead of storing some of the increased load, the straightened reaches are now conveying sediment until a constriction or significant decrease in slope is encountered. These slope decreases often build on themselves as further deposits accrue in these same areas during high flow events, and undersized bridges and culverts are frequently focal points for this type of deposition.

Dams and beaver ponds also present slope decreases in the stream, but depending on their location may exacerbate the dynamics contributing to slope increases. This appears to be the case in the Project area, as these structures are primarily located in the upstream portions of the watershed and appear to be contributing to “sediment starving” (see subsection 5.1.2, Watershed sediment regime stressors) that actually increases stream power downstream.

Figure 13. Reach-scale stressors: Channel slope modifiers maps for the Blood Brook corridor planning area.

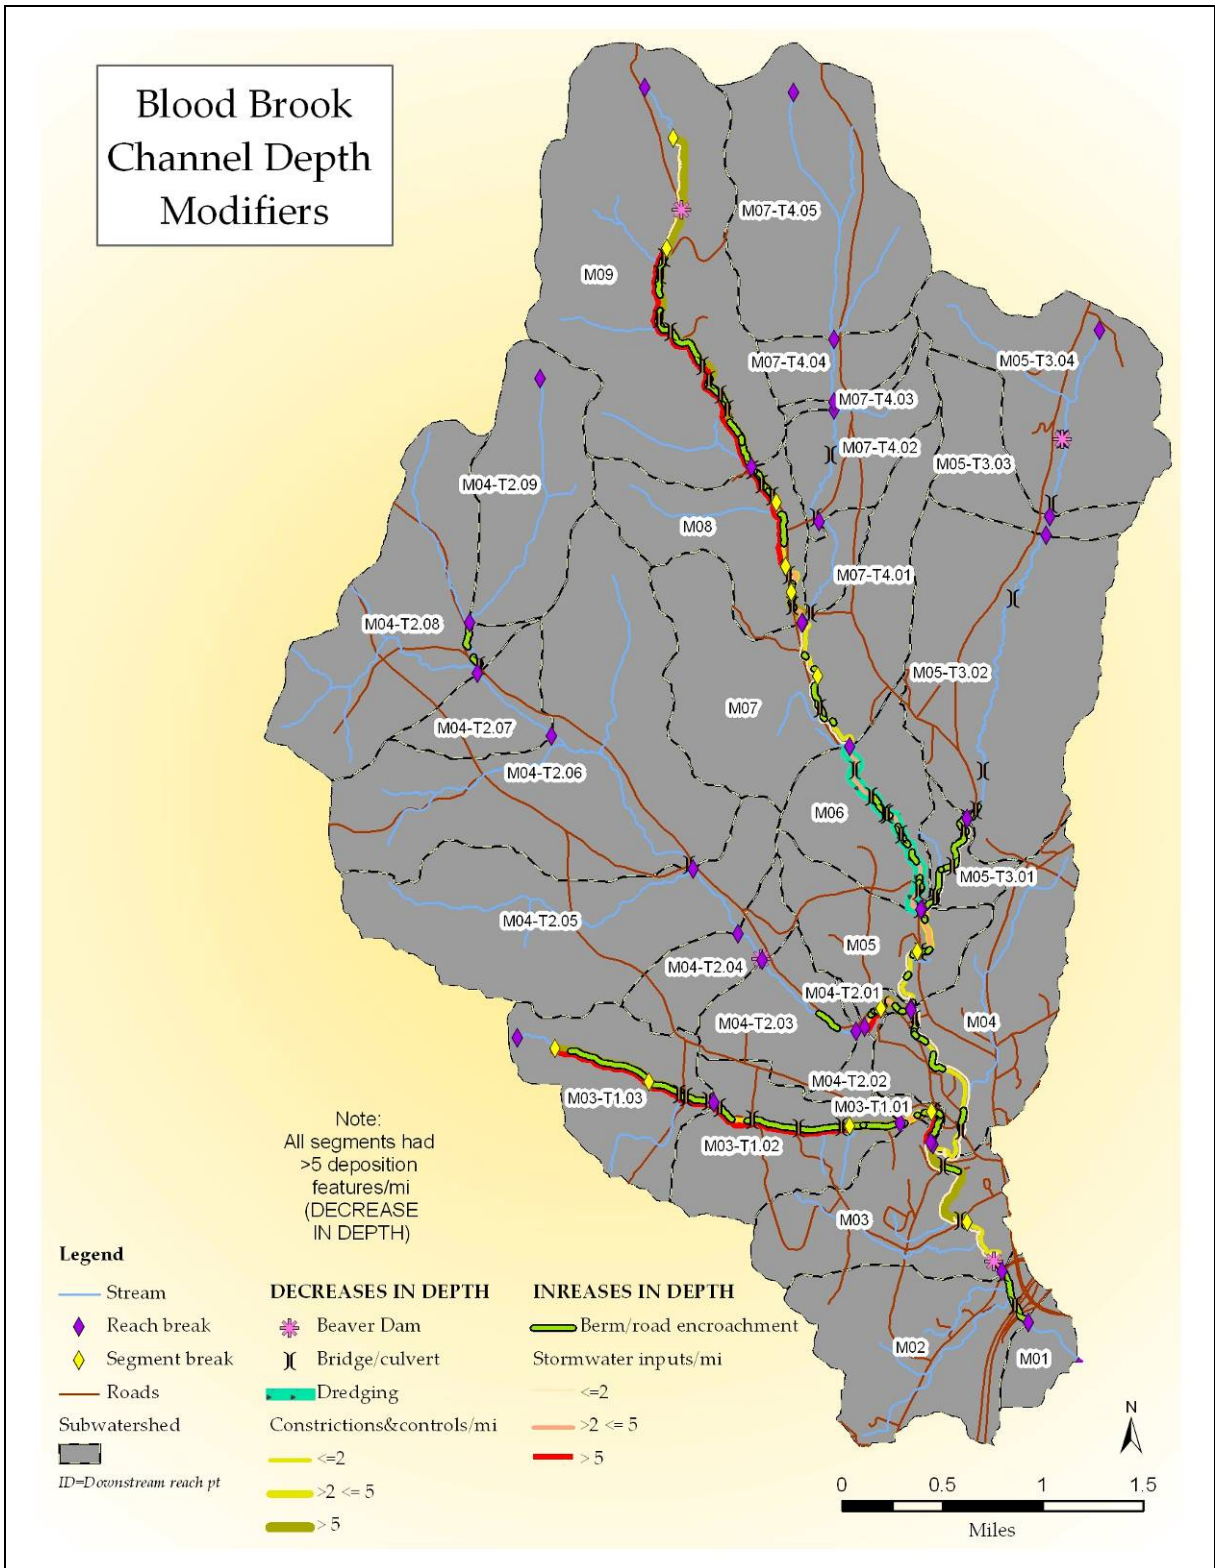
Figure 17. Reach-scale stressors: Channel depth modifiers maps for the Blood Brook corridor planning area.

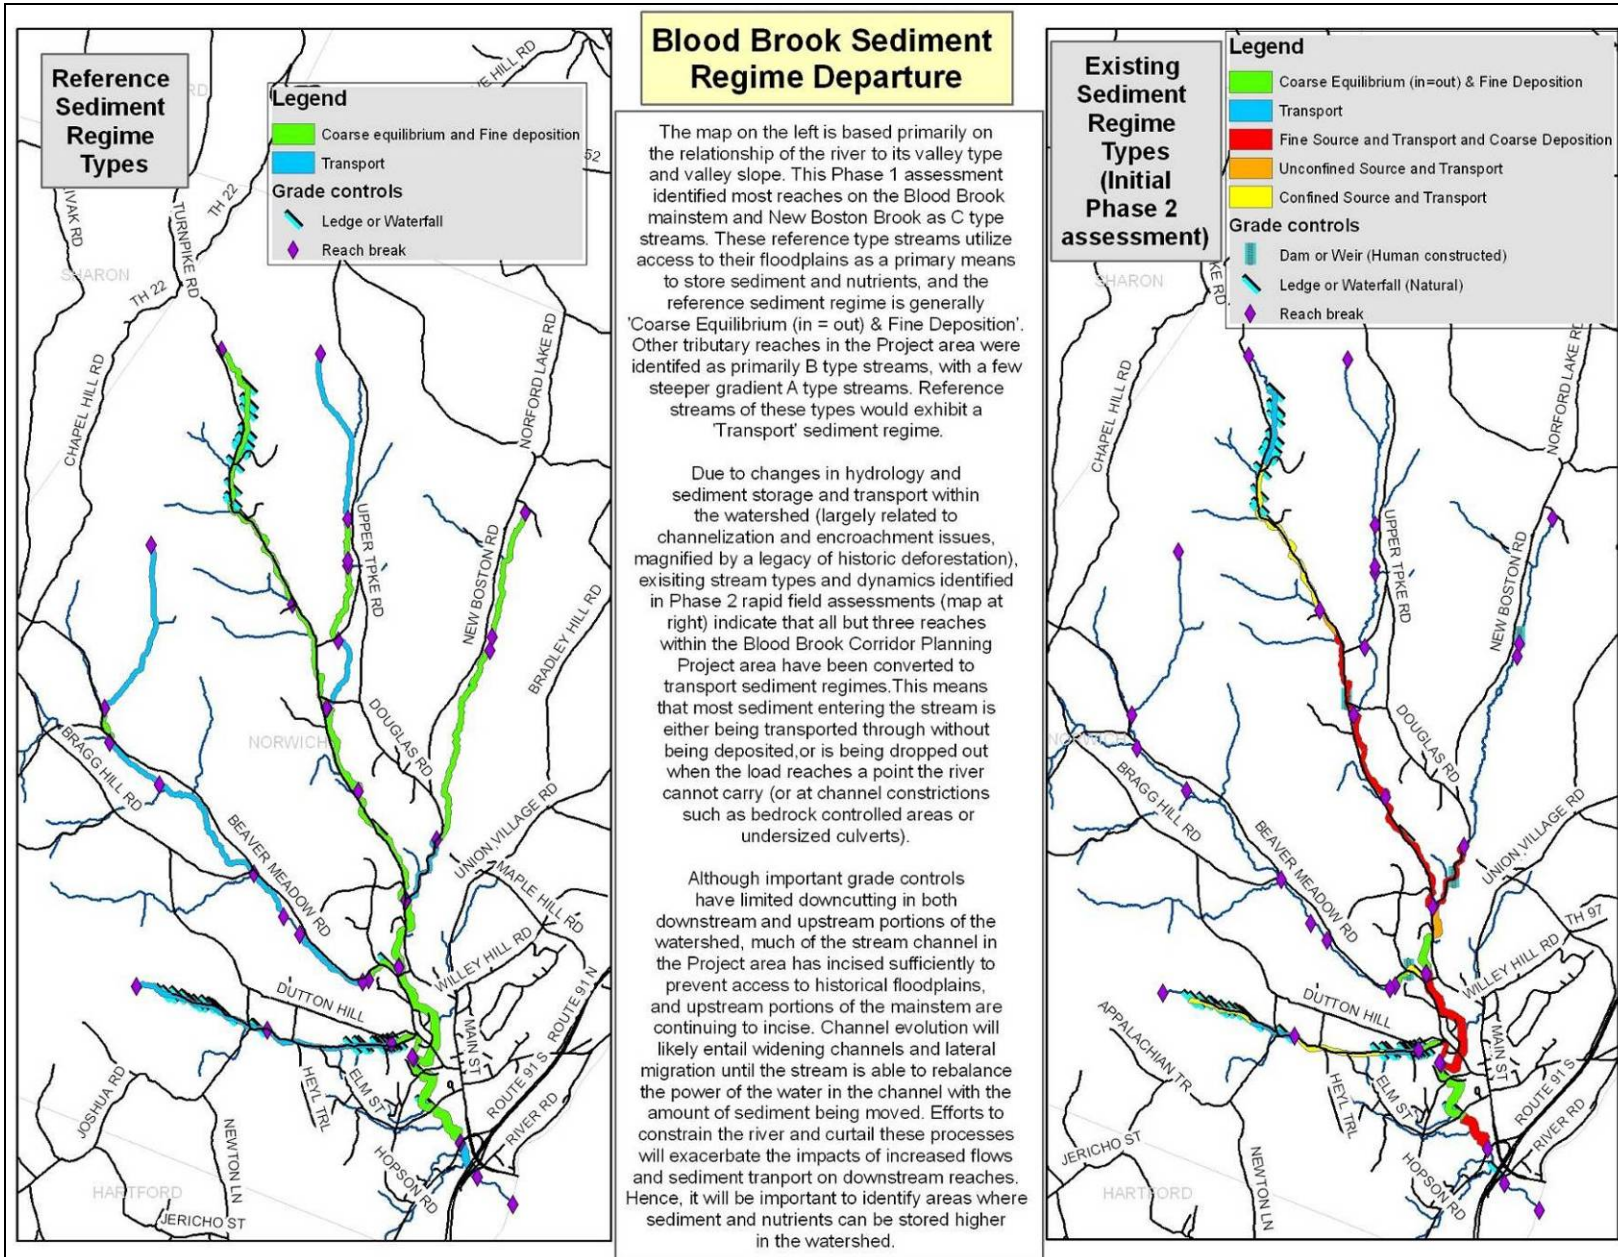
Phase 2 measurements found incision (downcutting) of both a current and historical nature throughout the Blood Brook corridor planning Project area, indicating limited access (and potential ongoing loss) of the streams to historical floodplains in many reaches in conjunction with extensive straightening and channelization that have served to increase stream power. The reference sediment regime in the Project area has thus been converted to one in which the majority of reaches in the Project area function as transport reaches, with coarse deposition occurring primarily when stream power is reduced or sediment load exceeds the carrying capacity of the stream (Fig. 20).

Figure 20. Sediment regime departure in the Blood Brook corridor planning Project area.

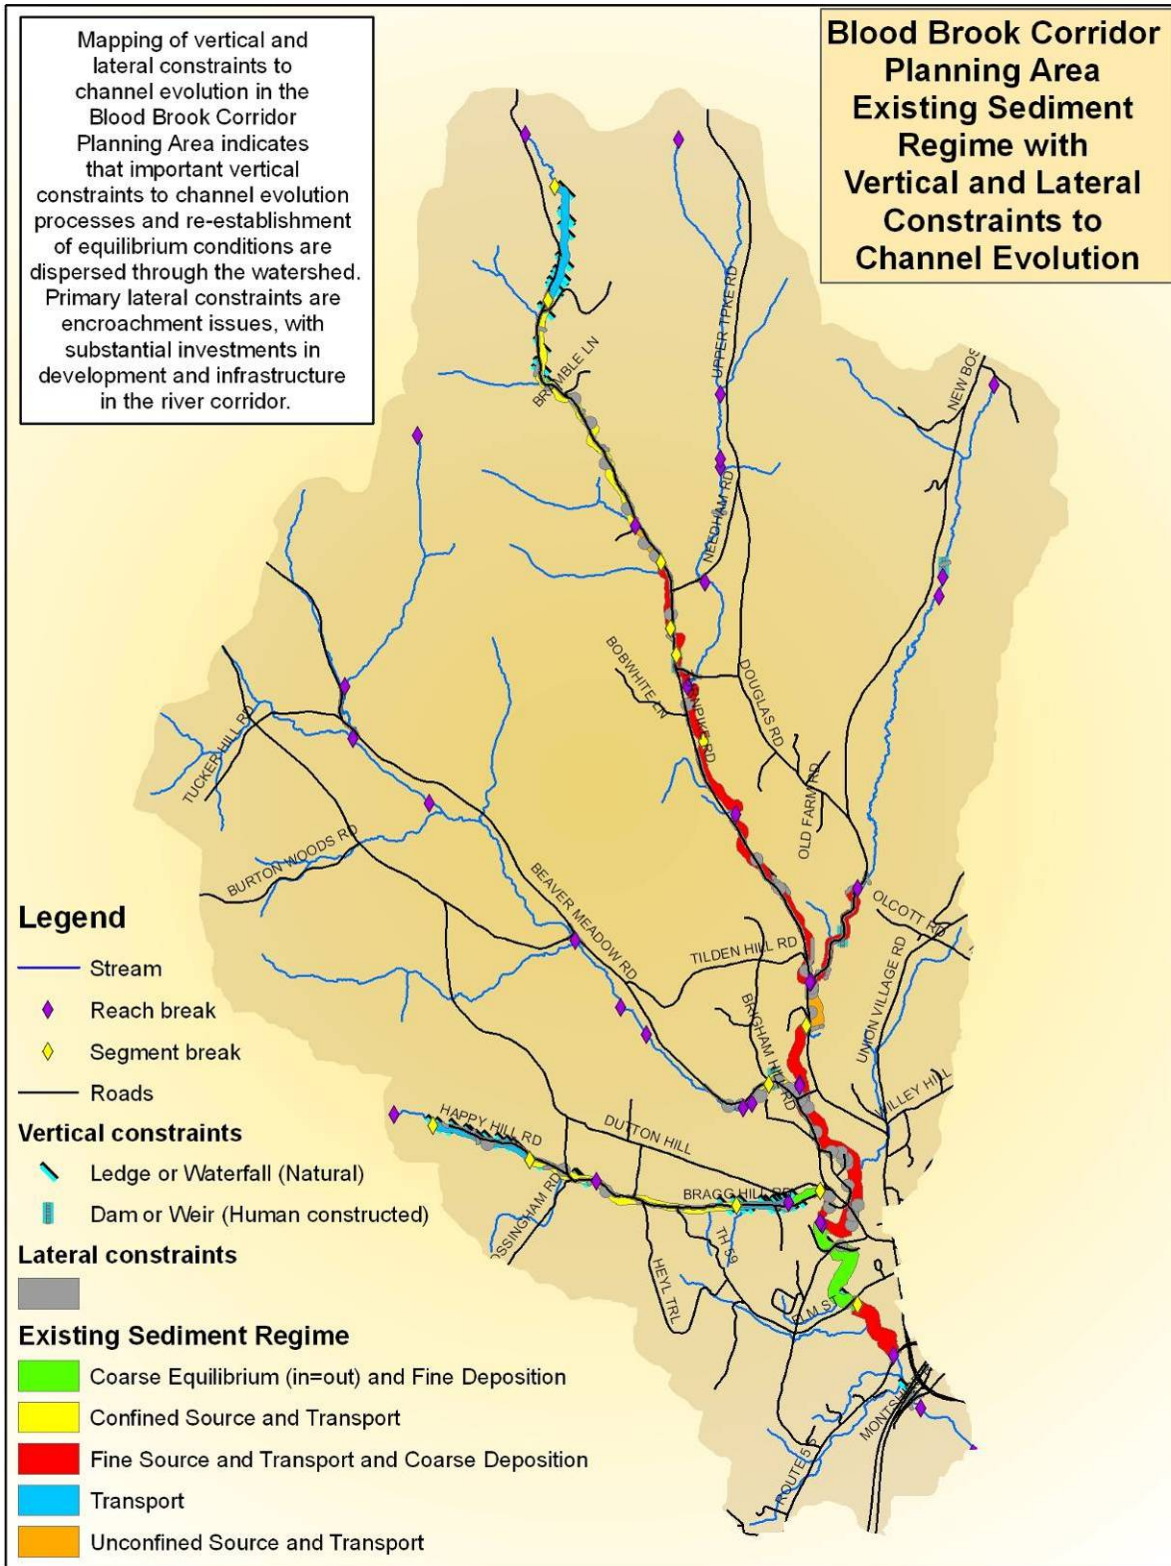
Natural lateral constraints occur in the form of bedrock and ledge outcrops on both mainstem and tributary reaches, but the most significant constraints to channel evolution in the Project area are associated with human-built encroachments (Fig. 22). The extensive nature of these constraints in the Project area increases the importance of identifying and protecting attenuation assets that don't conflict with such land uses. Failure to do so will increase flooding impacts, both in channel-forming annual high flows as well as larger flood events, on downstream reaches.

The important vertical constraints to channel evolution that occur in the form of waterfalls and ledge grade controls in the Project area (Fig. 22) provide vital functions in limiting incision of the bed that would further limit floodplain access and increase stream power. Log check dams (weirs) that have been placed below the Norwich Pool and on the Blood Brook mainstem just above the junction of Turnpike and Upper Turnpike Rds provide similar functions, and may play an important role in allowing the stream to utilize its own sediment inputs to begin to rebuild floodplains at a lower elevation. Such structures require frequent maintenance, however, and should be considered temporary structures at best. In addition, it should be noted that in areas where vertical constraints are present the likelihood of lateral evolution is increased.

Figure 22. Map of existing sediment regime in conjunction with vertical and lateral constraints to channel evolution in the Blood Brook corridor planning Project area.

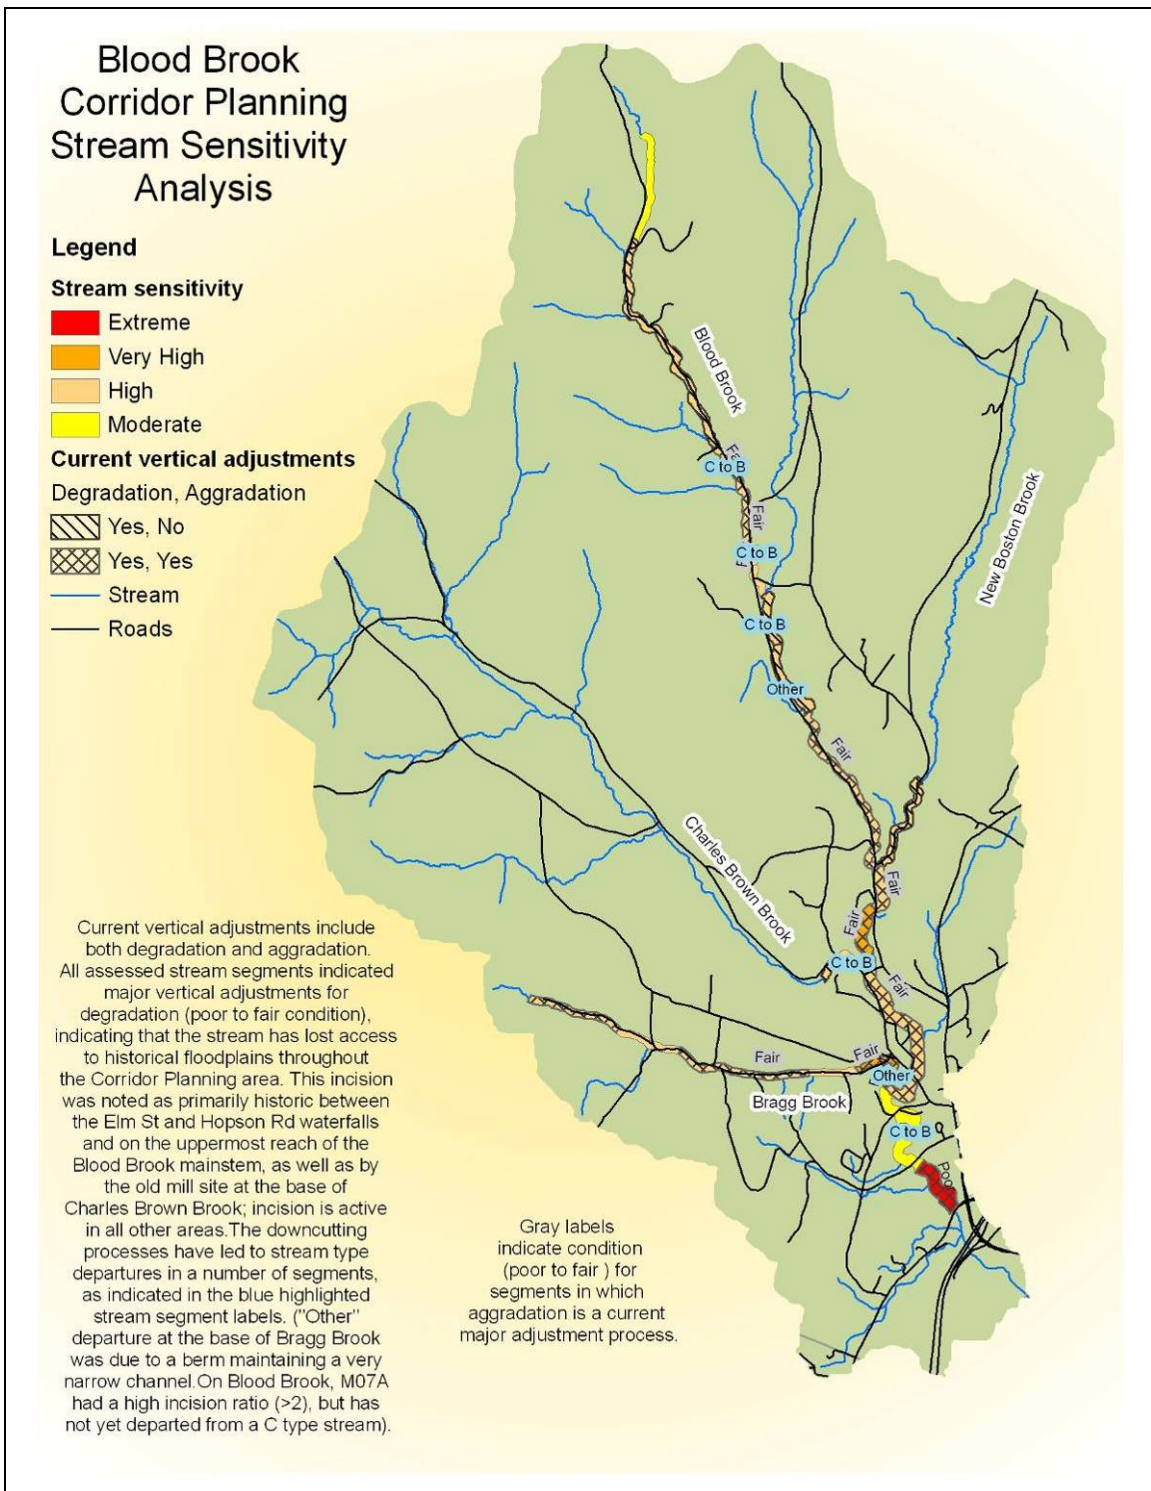
Figure 23. Stream sensitivity map for the Blood Brook corridor planning Project area.

Extreme sensitivity was indicated in segment M03A (most downstream segment of the Blood Brook mainstem), as well as Very High ratings in both segments of reach M03-T1.01 at the downstream end of Bragg Brook and segment M05A (Blood Brook mainstem between Moore Ln. and Turnpike Rd. near Sun Lion Dr.). The value of these segments as attenuation assets (Table 7) in addition to these elevated sensitivity ratings are indicators that protection of the stream corridors in these areas offers a critical, cost-effective approach to stream restoration with optimal benefits in terms of overall watershed dynamics, safety and property protection.

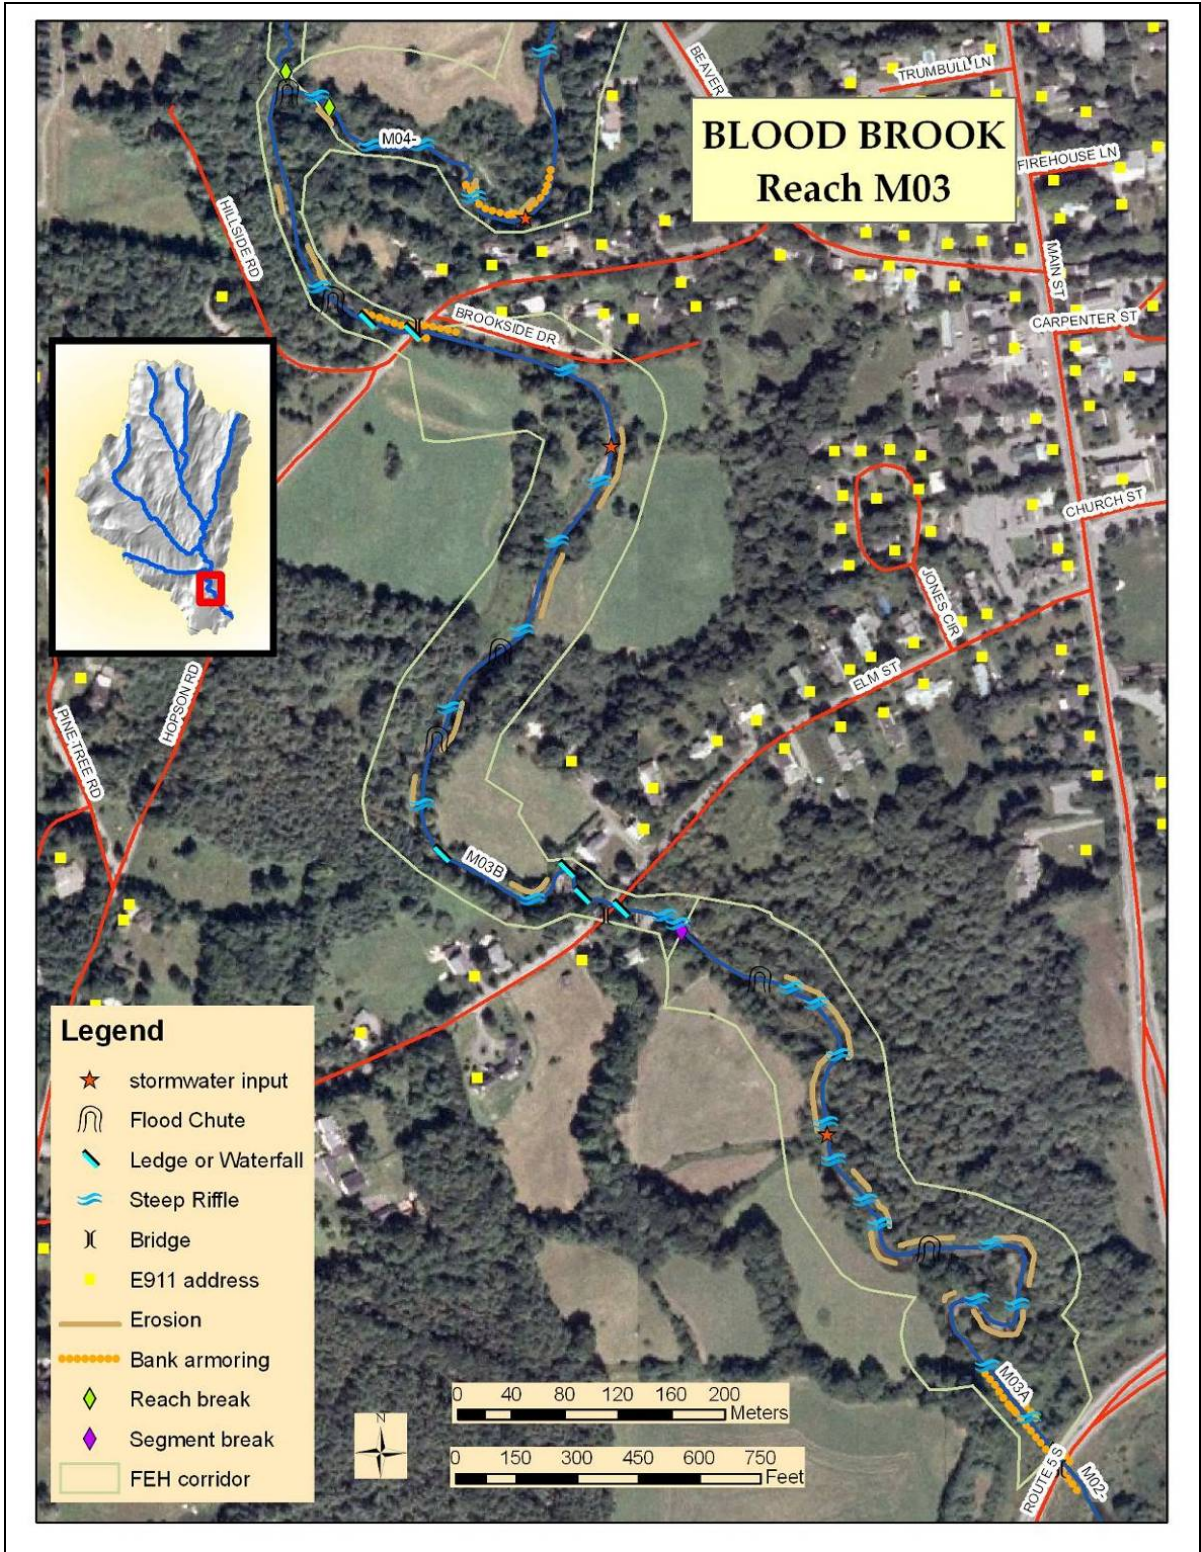
Reach M03 is the farthest-downstream reach within the Project area, extending 5,600 ft. (1.1 mi.) between a large debris catcher maintained by state road crews at the entrance to a culvert beneath Route 5 on the downstream end and the confluence with Bragg Brook, below Hillside Cemetery, at the upstream end (Fig. 24). The reach was segmented for Phase 2 assessment, with significant differences in stream dynamics largely attributable to two series of grade controls present in the upstream segment (M03B), while M03A has highly erodible boundary conditions and diminished stream buffers in portions of the segment.

Figure 24. Reach map for Blood Brook mainstem reach M03.

Establishment and maintenance of a protected river corridor in both segments would be beneficial to the stability and habitat condition of the stream, helping to accommodate stream meander geometry and provide access to critical floodplain. River corridor protection has been initiated, with conservation easements limiting development already in place along portions of the right bank in the downstream segment (M03A). Buffer revegetation (utilizing low-cost stock and a significant setback from current bank location, due to vertical instability and high likelihood of channel widening and/or lateral migration) may be a good candidate for funding opportunities through the Conservation Reserve Enhancement Program (CREP) administered by the Natural Resources Conservation Service, which will provide financial incentives for farmers willing to establish adequate buffers and corridor protection.

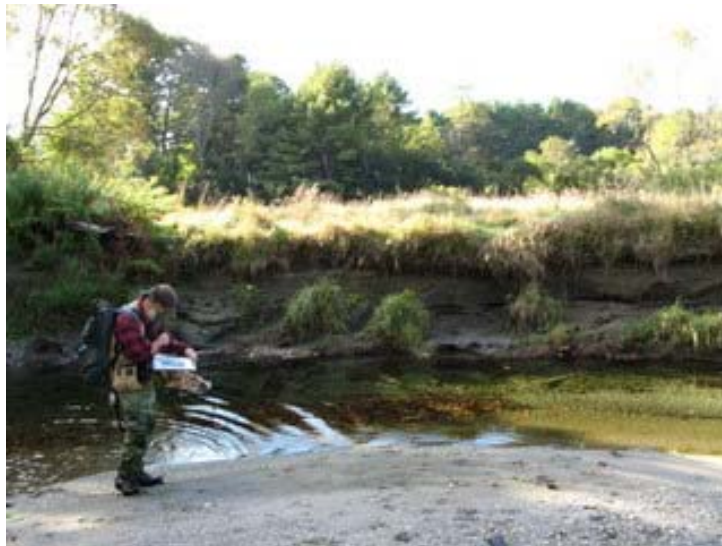
Buffer width generally exceeded 100 ft. on the left bank in segment M03A, although invasive species (primarily honeysuckle and buckthorn) dominated the near bank and buffer vegetation on both sides and was also significant in the understory of the forest that represented the dominant left bank riparian corridor use. Hayfields represented the dominant land use in the right bank riparian corridor, and buffer width on this side was predominantly 51-100 ft. but dropped to less than 5 ft. in portions of the segment. These diminished buffers would be the areas that may be particularly appropriate for Conservation Reserve Enhancement Program projects (Fig. 25).

Figure 25. Although river corridor protection has been initiated in segment M03A, diminished buffers may present opportunities for project implementation with potential partners such as the Conservation Reserve Enhancement Program.

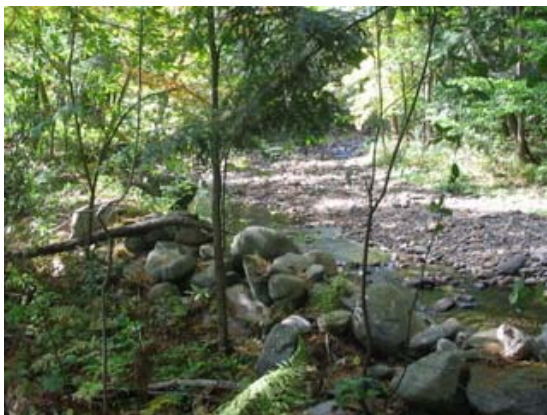
It appears that some of the stone removed from the bed was also used to plug an old flood chute (or possibly the former stream channel) in the lower portion of segment M05A, possibly to divert the channel away from the edge of a nearby hayfield (Fig. 30). Removing this plug could potentially allow greater floodplain access for the stream with a minimum of damage, as the area below it is largely wooded at this point and has no substantial development on the mainstem above the mouth of Charles Brown Brook.

Figure 30. Windrowed stone was used to plug the head of a flood chute in the downstream portion of segment M05A.

While this might help to attenuate moderate flood levels, this flood chute would likely be accessed at higher level discharges anyway. The straighter course of this channel might actually serve to shorten meander length and thus increase rather than decrease stream power in the short term if it is accessed on a regular basis; it would not necessarily hasten a return to equilibrium conditions. The wooded riparian zone in this section does represent a highly valuable attenuation asset, however, emphasizing a need for corridor protection.

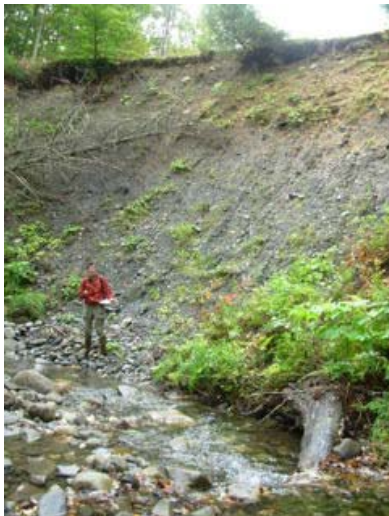
Sediment inputs from mass failures both in this reach (Fig. 33) and farther upstream contribute to significant aggradation in this reach, and widening and attempted lateral migration were noted in Phase 2 assessment. Headcuts documented in the reach are thus likely to quickly wash out, given the high bed load of the system, but may need to be monitored in the event of a flood. Ledge grade controls in the upper third of the reach should also help limit upstream migration of headcuts.

Figure 33. Mass failures in reach M06 are providing sediment that will contribute to channel evolution processes as the stream attempts to reestablish floodplains and meanders.

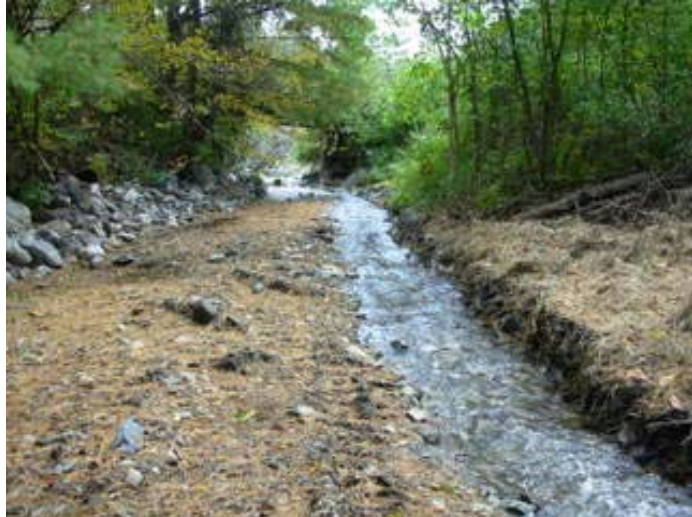
Figure 34. Recent dredging just upstream of a private bridge replacement project in Reach M06.

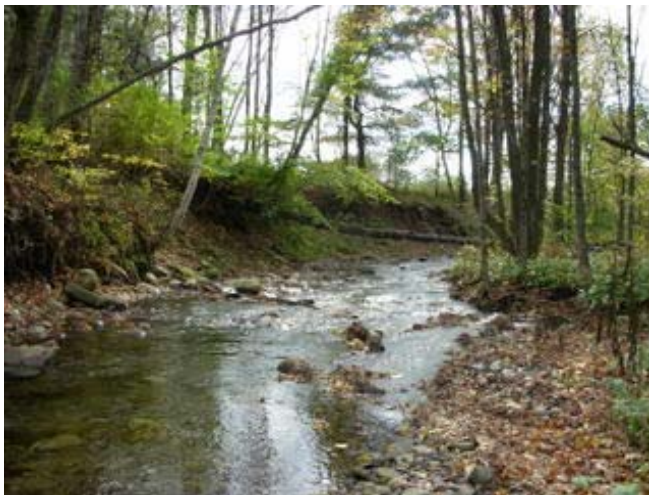
The incision ratio in this segment M07B was lower than in the downstream segment (1.7 as opposed to 2.0), but the stream had already lost access to floodplain historically in this section. There were still some signs of active degradation, but aggradation and channel widening (Fig. 37) were the more dominant processes in the upstream segment, and a

Figure 37. Channel widening and aggradation were dominant processes in the alluvial soils along segment M07B.

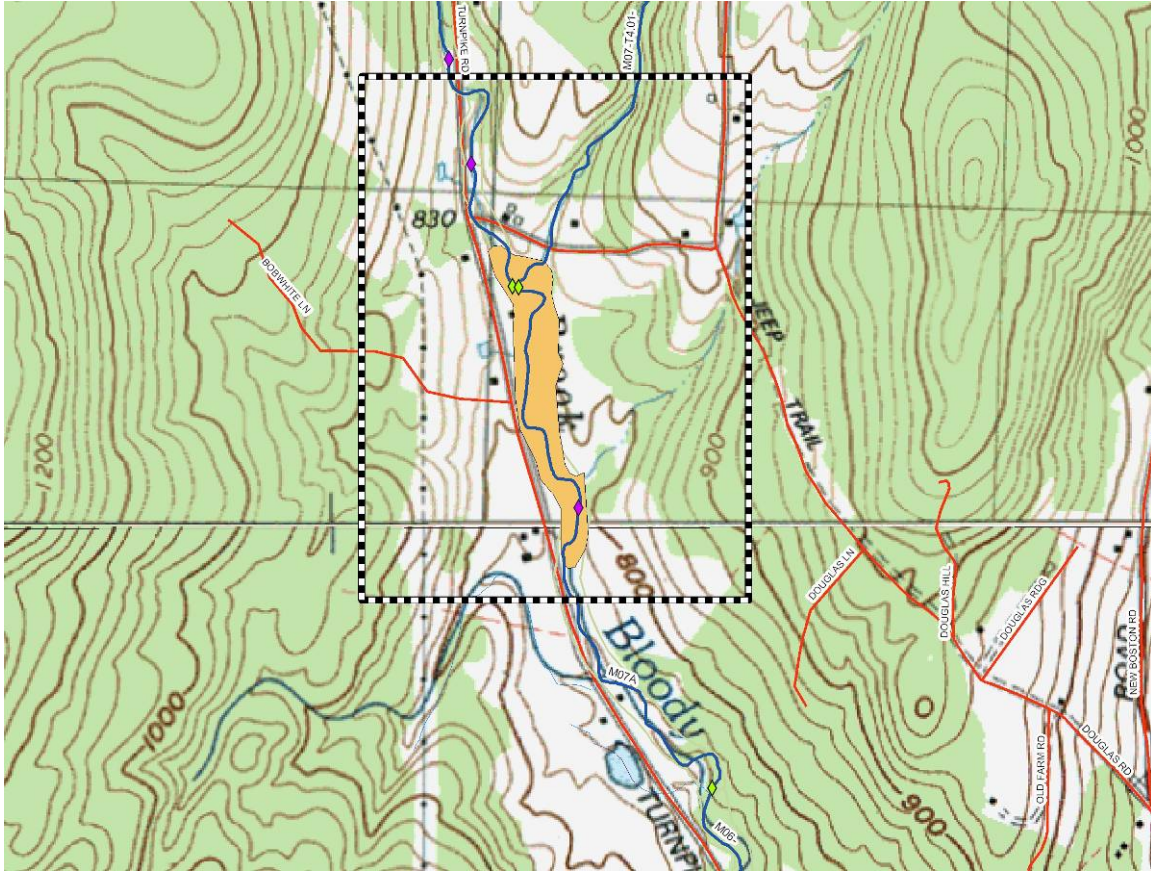
streams above the upstream portion of this segment (Fig. 38) suggests that there is at least significant sedimentation occurring, and/or that it has occurred historically, here. This situation would lead to a naturally unstable portion of the stream channel, with significant shifts in location probable over time; river corridor protection is thus a high priority.

Figure 38. Alluvial soils (indicated by orange solid polygon at center) and steep valley walls bounding convergent streams just above segment M07B suggest the presence of an alluvial fan in this area that would lead to a naturally unstable and shifting portion of the stream channel.
