**BLOOD BROOK WATERSHED
CORRIDOR PLAN
NORWICH, VT**

March 27, 2008

Prepared by:
Daniel Ruddell, Elisabeth McLane, Anna Mulligan,
Staff Scientists, and
Ben Machin, Principal
Redstart Consulting

Prepared for:
Two Rivers-Ottawaquechee Regional Commission,
Town of Norwich Conservation Commission, and
Vermont Agency of Natural Resources/
Department of Environmental Conservation
River Management Program

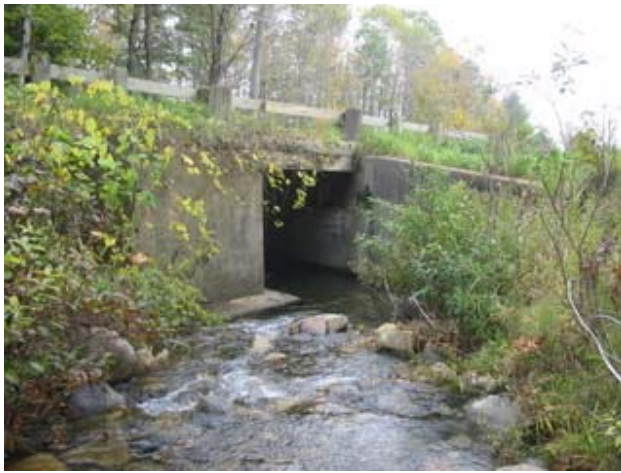
<http://docs.unh.edu/VT/strf96se.jpg> and <http://docs.unh.edu/VT/strf44se.jpg>) indicates that the stream has likely been maintained against the left valley wall over time. Although the bridge is sized at 67% of reference channel width, the angle of this bridge and its arrangement with an adjoining driveway form both a channel and a flood-prone

constriction to the stream and make this structure a concern in a flood event, as well as a contributor to significant deposition above the structure due to the constriction. As with the squashed culvert in segment M08A, however, replacement of the structure may well initiate changes in bed elevation and/or bank stability and would require consideration of property protection. Channel bed stabilization may be less of an issue in this section of the stream, as it is relatively far away from upstream roads and structures.

Figure 42. Bridge alignment and the presence of a driveway above the right bank (right side of this photo) combine to form both a stream channel and a flood-prone constriction in segment M08B.

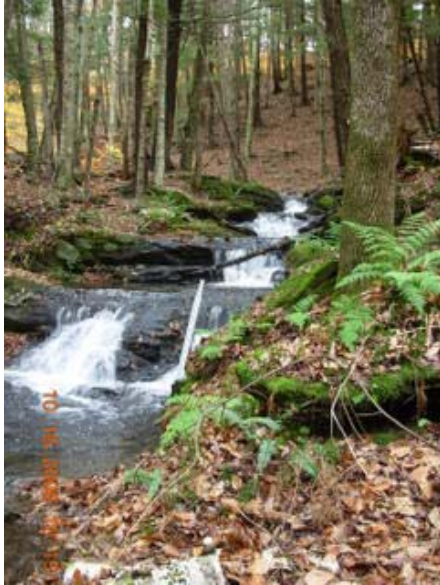
Segment M09B was rated in good condition on rapid geomorphic, and reference on rapid habitat, assessment scores, and it offers a benchmark in this watershed for buffers in a healthy condition, as well as excellent possibilities for protecting the relatively intact corridor from encroachment and development to avoid potential land use conflicts and erosion hazards. The presence of bedrock and ledge grade controls naturally limits upstream migration of bed degradation processes (Fig. 48). There is one old abutment in the segment that presents a channel, but not a flood-prone, constriction. This structure could be removed but that would likely entail little change in stream conditions or channel equilibrium.

Figure 48. Segment M09B was rated in good condition on the Rapid Geomorphic, and reference on the Rapid Habitat, Assessment in Phase 2.

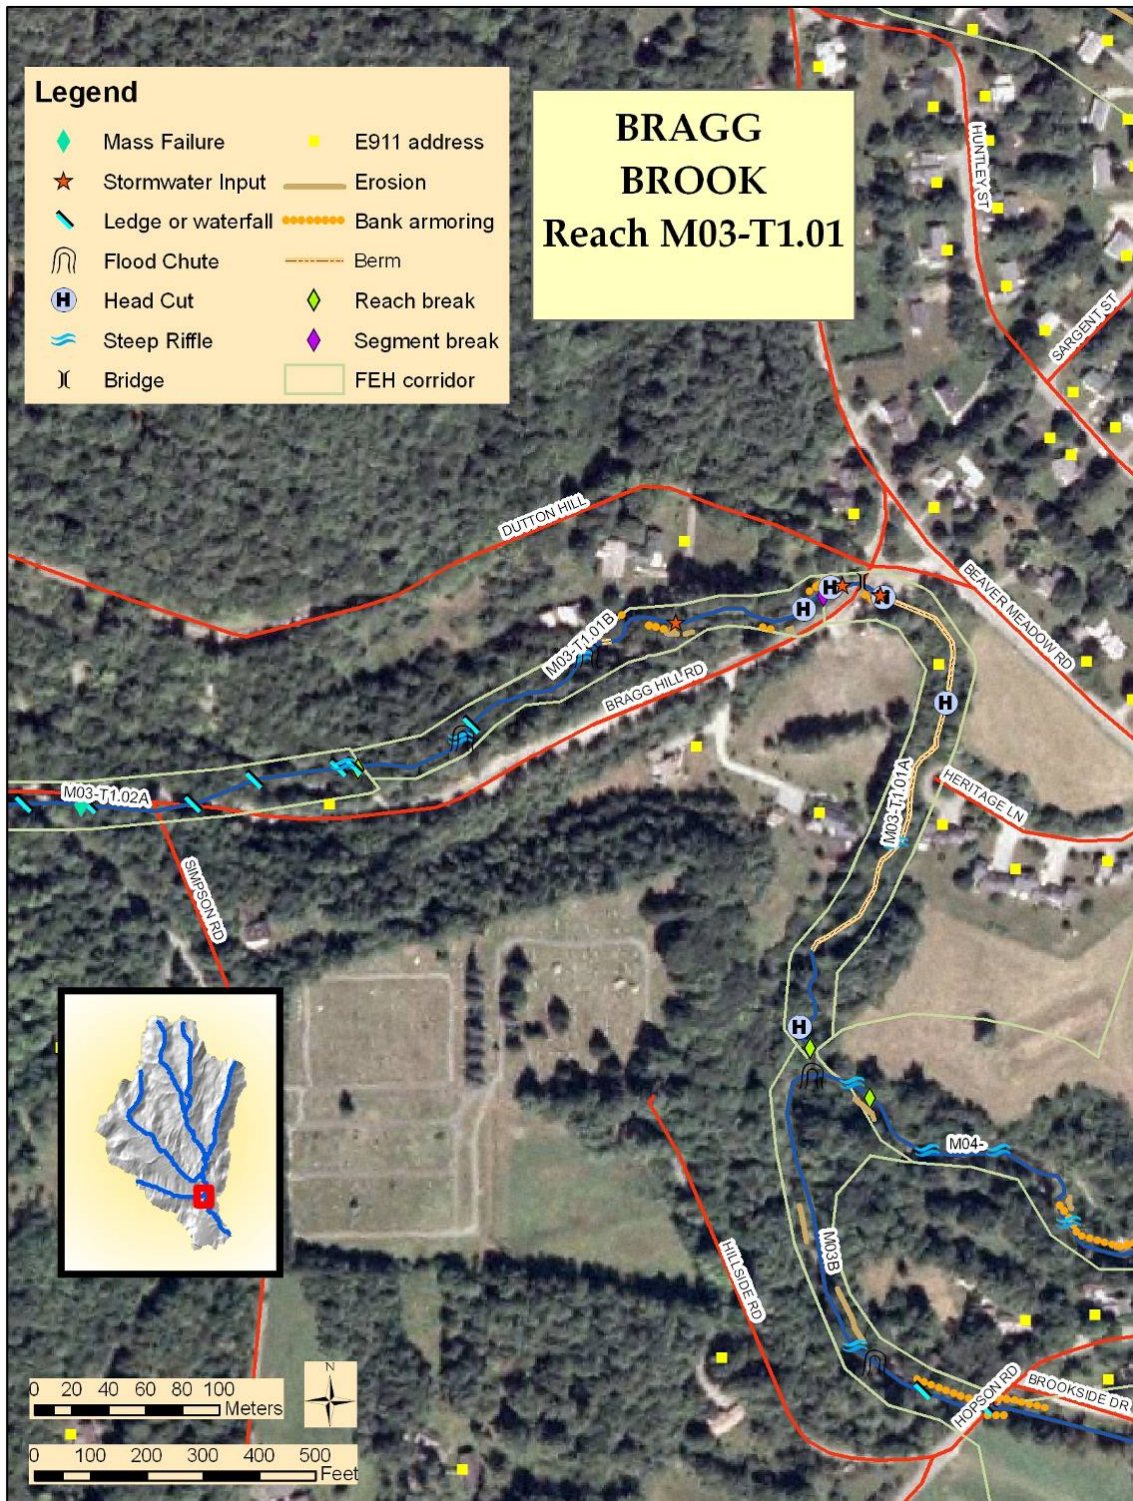
Figure 49. Reach map for Bragg Brook reach M03-T1.01.

valley roughly 375 ft. downstream of Simpson Rd. (Fig. 49). The reach was divided into two segments during Phase 2 field assessment.

Headcuts were noted in reach M03-T1.01A, indicating that the stream is degrading, but an incision ratio of 1.5 and an entrenchment ratio of 2.7 indicate some floodplain access. Straightening and confinement of the stream channel in M03-T1.01A contributed to the breakdown of reference streambed features; those characteristics, combined with subsequent deposition, classify most of the segment as having a plane bed and diminished aquatic habitat. With sediment from mass failures and erosion farther upstream still moving through the stream channel, as well as natural grade controls present upstream, headcuts and nickpoints are likely to wash out or be checked from further upstream migration. Headcutting should be monitored, however: primary issues would be threats to infrastructure and further loss of floodplain access. The top section of this segment had a buffer only 5-25 ft. in width, and sometimes less, on the left bank. The most-downstream section of the segment was less developed and had a forested buffer exceeding 100 ft. on both sides. Potential exists for the removal of portions of the berm in the lower segment's forested area to regain some floodplain access. This is downstream of residential developments, should not have an impact on town infrastructure, and may restore some of the vital floodplain access that this lower portion of Bragg Brook has lost. The septic

The Bragg Hill Rd. bridge near the top of the segment is sized at 62% of bankfull width, but the alignment of the structure with the stream channel reduces the effective width and contributes to this structure being both a channel and floodplain constriction, indicating potential structure risk and/or channel avulsion in a flood event. Replacement of the structure could initiate changes in bed elevation and/or bank stability, however, and may require consideration of property protection and possible channel bed stabilization; ideally this would be coordinated with floodplain restoration measures downstream of the structure.

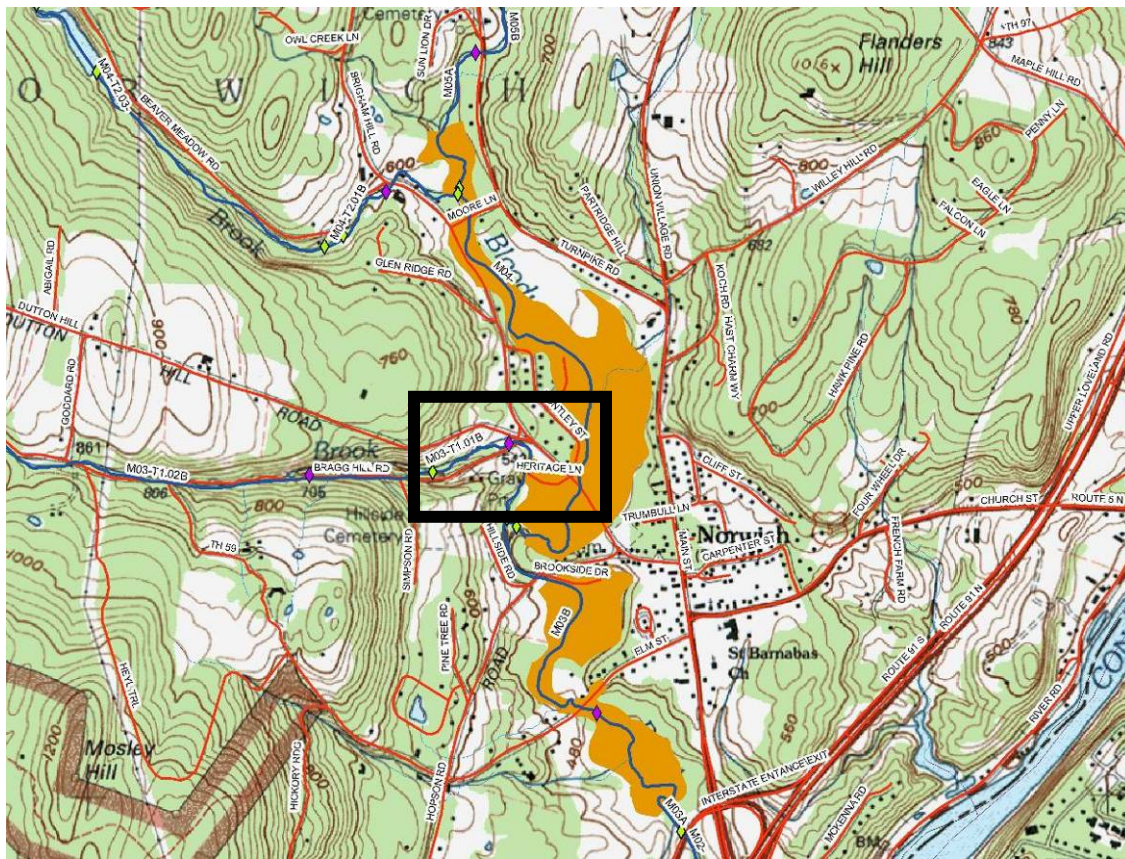
Figure 51. Alluvial soils (indicated by orange solid polygon at center) and steep valley walls above convergent streams in the downstream portions of the Project area suggest the presence of an alluvial fan in this area. The base of Bragg Brook (reach M03-T1.01, within the bounding rectangle) has been disconnected from this former floodplain by the berm pictured in Fig. 50.

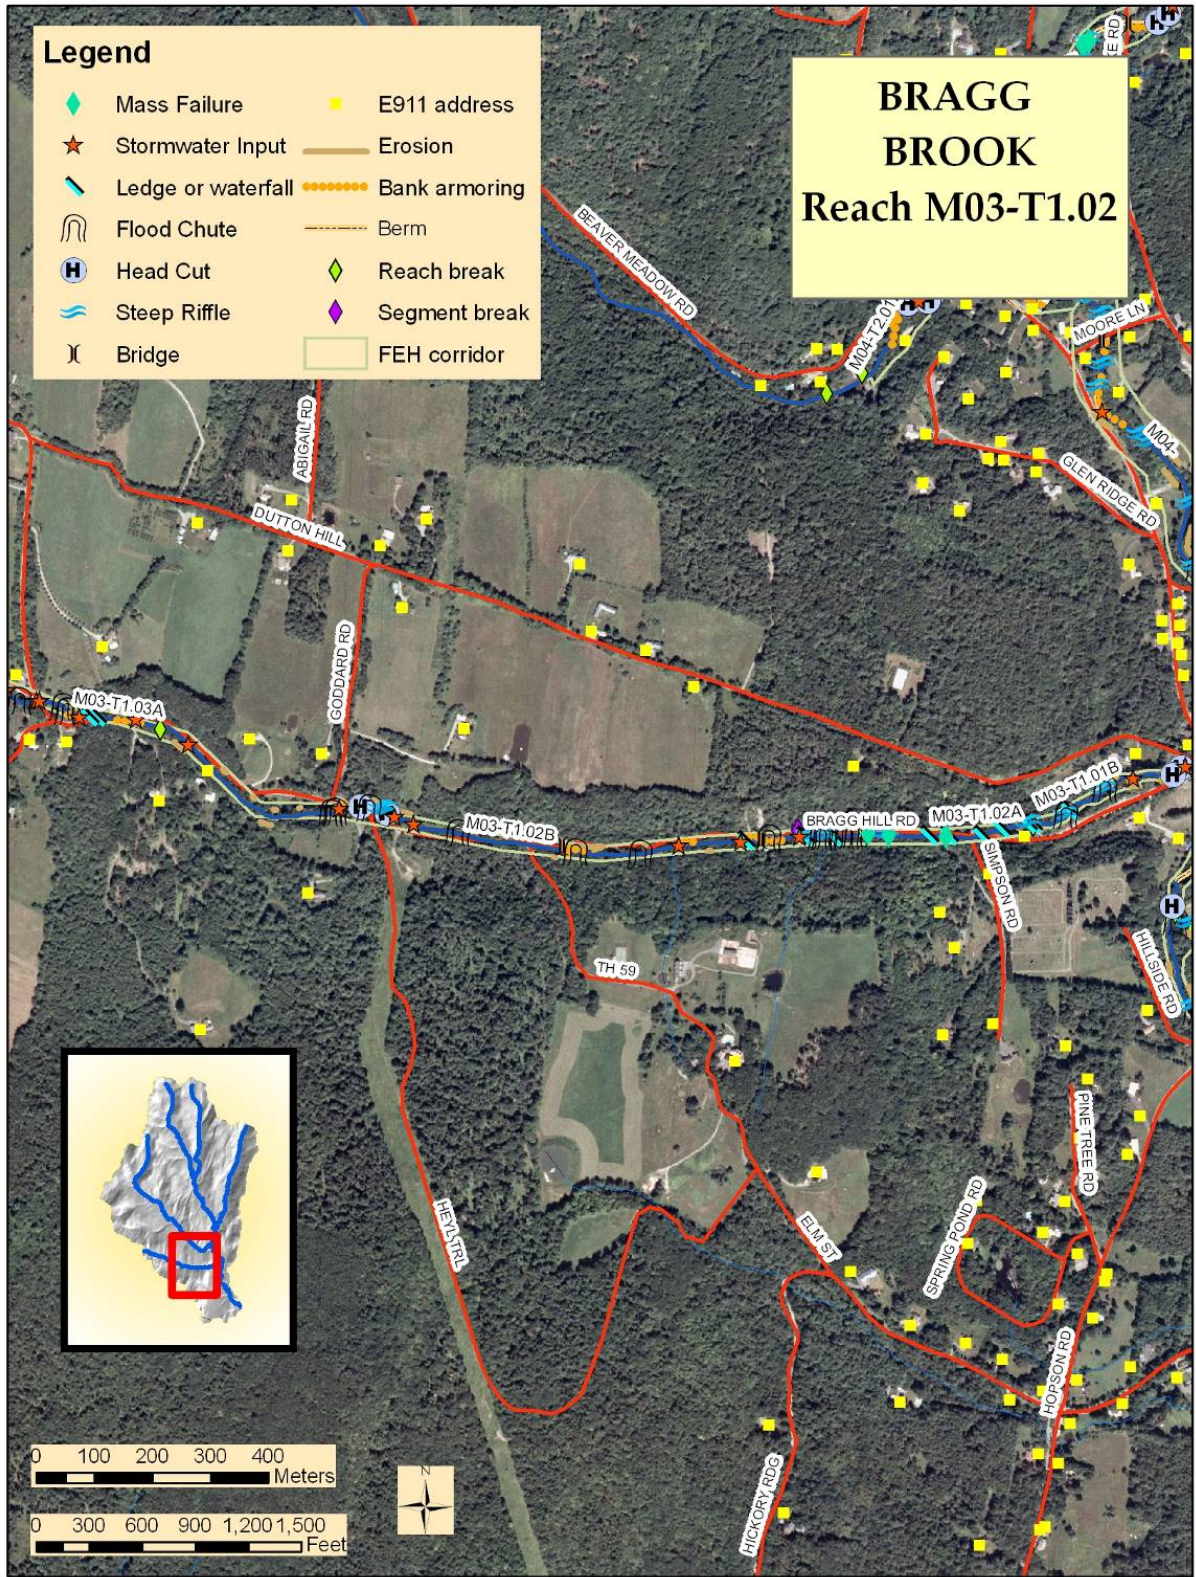
Figure 52. Reach map for Bragg Brook reach M03-T1.02.

Reach M03-T1.02 extends just past a new bridge put in upstream of 369 Bragg Hill Rd. during mid-October, 2006 (Fig. 52). It drains 1.17 square miles and has a channel length of 5,210 ft. (0.99 mi.). The entire reach was typed as a B channel with cobble-dominated substrates and a relatively steep gradient (>4%), and it was divided into two segments during Phase 2 assessment. The lower segment (M03-T1.02 A, 1,350 ft. or 0.26 mi.) was dominated by ledge grade controls and was largely in reference condition, except for sediment inputs from mass failures on its steep left corridor. These mass failures appear related to a one-time break in a water line leading from town wells near the Connecticut River to a 3-million-gallon holding tank on Dutton Hill Road, upslope of this reach, in the late 1970s (pers. comms., Andy Hodgdon, Norwich Road Foreman, December 2006 and January 2007). The largest mass failure extended upslope 70 feet and was approximately 15-20 feet deep (Fig. 15, Sec. 5.1.3a).

Although the slopes above segment M03-T1.02A have largely stabilized, the large flow increase and sediment inputs related to the water line rupture appear to be impacting Bragg Brook significantly. Waterfall and ledge grade controls immediately upstream of the mass failures were likely a saving grace for upper portions of the stream, limiting rapid upstream migration of headcuts at the time of the rupture. A relatively low incision ratio of 1.2 in segment M03-T1.02A indicates that the series of ledge grade controls downstream also provided a measure of stability for the channel bed there. Field assessments also noted a number of flood chutes associated with these grade controls, however, likely indicating higher erodibility of the banks in relation to the bed in these areas. These conditions indicate potential for channel avulsions in high-water events, as well as lateral migration related to localized increases in deposition above these grade controls at both low- and high-flow levels.

The upstream segment (M03-T1.02B) had a relatively high incision ratio of 2.0. This may be related to adjustment processes occurring in response to the water line break downstream, with headcuts migrating upstream as the stream tried to match the lowered elevation of the streambed downstream. There are waterfall and ledge grade controls above the entry point of the discharge, however, which would serve to limit such migration. Incision in this reach may also be related to stressors including six stormwater inputs noted in the segment, localized flow increases and sediment reduction below three culverts and one bridge noted as channel constrictions, and frequent encroachment from Bragg Brook Rd., which comes right to the streambank in several areas (Fig. 53).

Both segments of reach M03-T1.02 are natural transport reaches, and the steep gradient and confined valley setting mean that the stream is not likely to exhibit a high degree of lateral migration under reference conditions. Primary recommendations for these areas are corridor protection to prevent or mitigate flood hazards and maintenance or establishment of wooded buffers whenever possible.

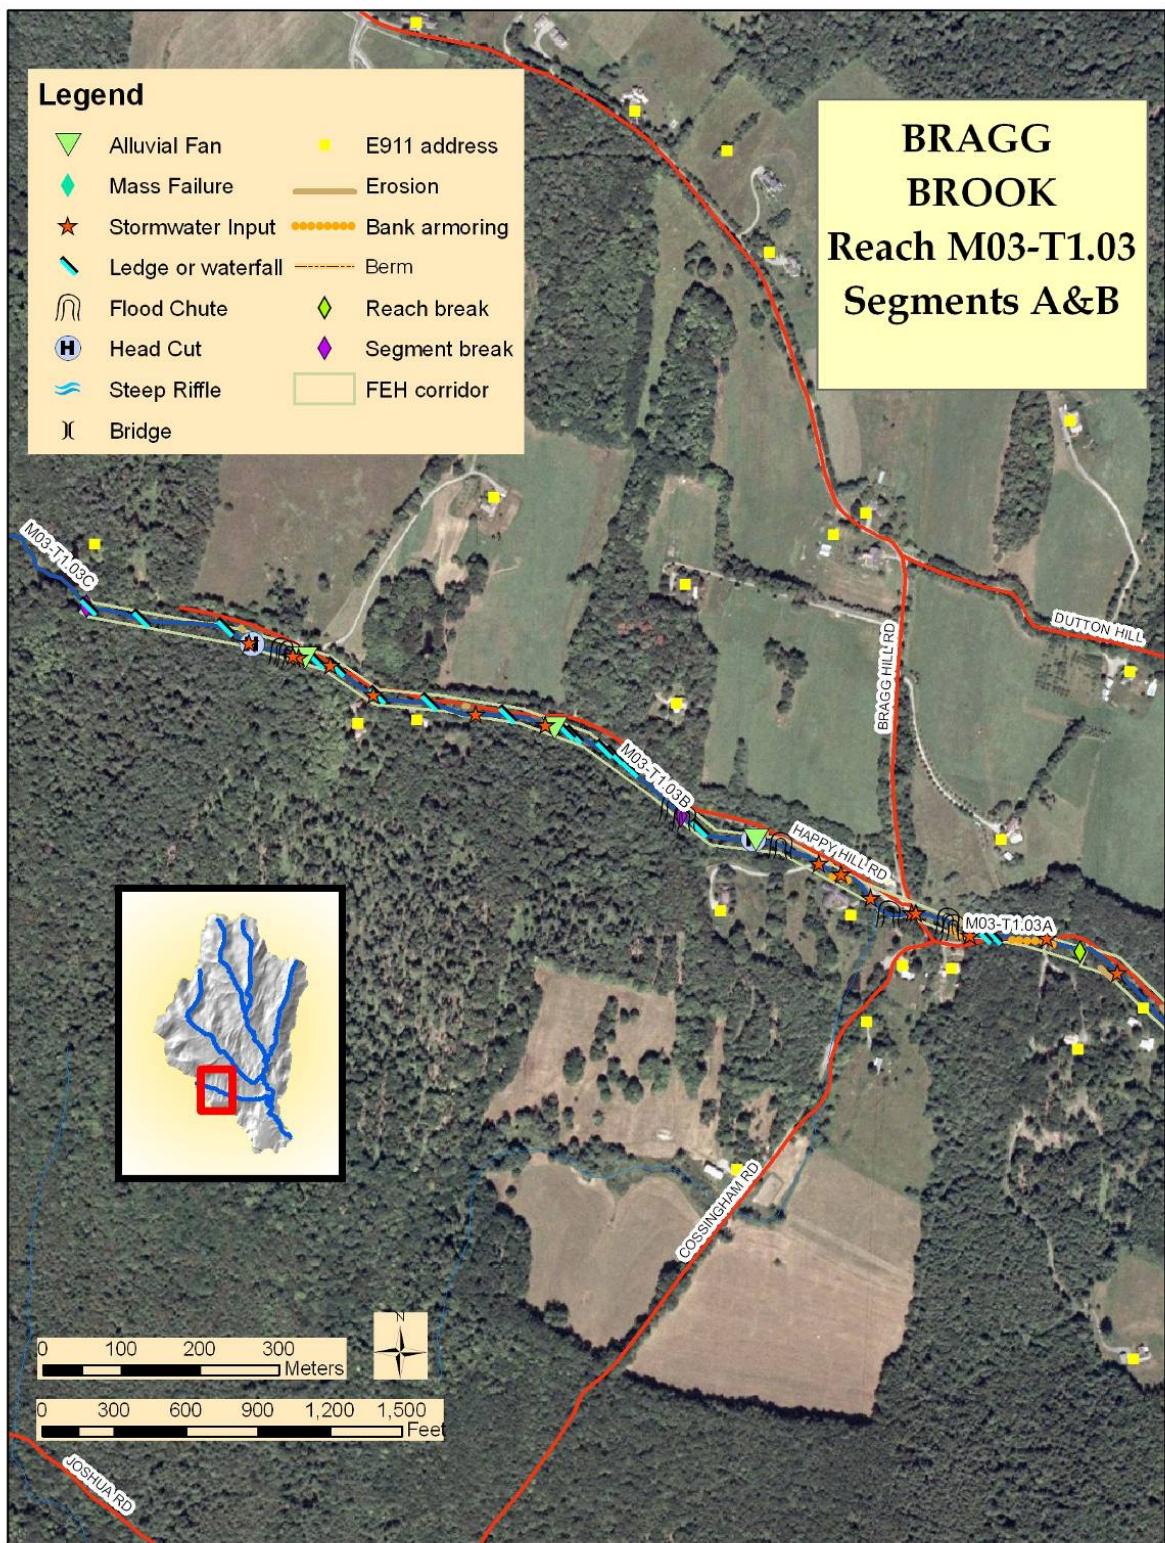
Figure 56. Reach map for Blood Brook mainstem reach M03-T1.03, segments A and B (segment C was excluded from full Phase 2 analysis due to the influence of wetlands and impoundments).

Reach M03-T1.03 extends 5,780 ft (1.09 mi) from 369 Bragg Hill Rd to the head of the Bragg Brook watershed (Fig. 56), and drains a watershed of 0.59 square miles. It was broken into three segments during Phase 2 assessment: M03-T1.03A is 1,868 ft (0.35 mi); M03-T1.03 B includes 2,714 ft (0.51 mi); and M03-T1.03 C covers 1,198 ft (0.23 mi). The downstream segment (M03-T1.03 A) is characterized by human development and diminished buffers and is highly recommended for river corridor protection planning and limitation of further encroachment. This segment is a highly sinuous, slightly entrenched C (or possibly E)-channel in some places, though road encroachment contributes to overall characterization as primarily a moderately entrenched B type. The middle segment (M03-T1.03 B) has a less developed setting with frequent ledge and waterfall grade controls. This segment alternates between a B-type and a steeper, entrenched A-type channel. The upper segment (M03-T1.03 C) is dominated by impoundments and was not further evaluated, in accordance with Phase 2 protocols (VTANR 2007d).

Downstream segment M03-T1.03 A was dominated by gravel substrates in a riffle-pool setting at cross-section locations, contributing to its designation as a subreach with different stream dynamics than the upstream portions. Small areas of moderate slope (<2%) and significant deposition (appearing as small alluvial fans) occur periodically in the segment, alternating with steeper sections that are often bedrock-controlled. Indications are that this area can play some role as an attenuation asset for sediment storage and flow moderation, despite the narrowly confined valley setting. However, an incision ratio of 1.8 indicates downcutting, and encroachments were severe along more than 20% of the segment (Fig. 57), restricting access to floodplain and limiting these functions. Five flood chutes and tributary rejuvenation were noted. Nickpoints noted in the reach are likely related to this downcutting, but are in close proximity to grade controls and would be checked from upstream migration. Buffers were noted as predominantly <5 ft on the left bank and <25 ft on the right bank along the segment, with subdominant buffers of 26-50 ft on both banks. Joint projects in 2007 (along Blood Brook) between town road crews and Vermont Youth Conservation Corps workers, in coordination with TRORC and the Better Backroads program, may have applicability for roadside plantings if maintenance or repairs are scheduled along this segment. Maintenance with hard armoring increases the stream power and transport capacities of the segment and limits the extent of available floodplain, processes that are augmented by 7 stormwater inputs documented in the segment. Five culverts and one bridge in segment M03-T1.03A were noted as floodprone constrictions, and four of the culverts were noted as channel constrictions. The newest town installations were a 6-foot bridge and a 10-ft box culvert, significant upgrades from the culverts they replaced; remaining culverts are sized from 2 – 3.5 ft.

Segment M03-T1.03B is largely bedrock-controlled, and an incision ratio of 1 indicates minimal downcutting in this portion of the stream. The reference sediment regime in this portion of the reach is a transport type, and buffers were relatively intact but somewhat diminished with a 26- to 50-ft buffer width dominant on the left bank and subdominant on the right bank; the right bank dominant buffer exceeds 100 feet. Seven stormwater inputs were documented in this segment, in addition to the seven noted in the next downstream segment, suggesting there are elevated hydrologic inputs being transferred downstream. Encroachment was noted along >20% of the channel, suggesting an increase

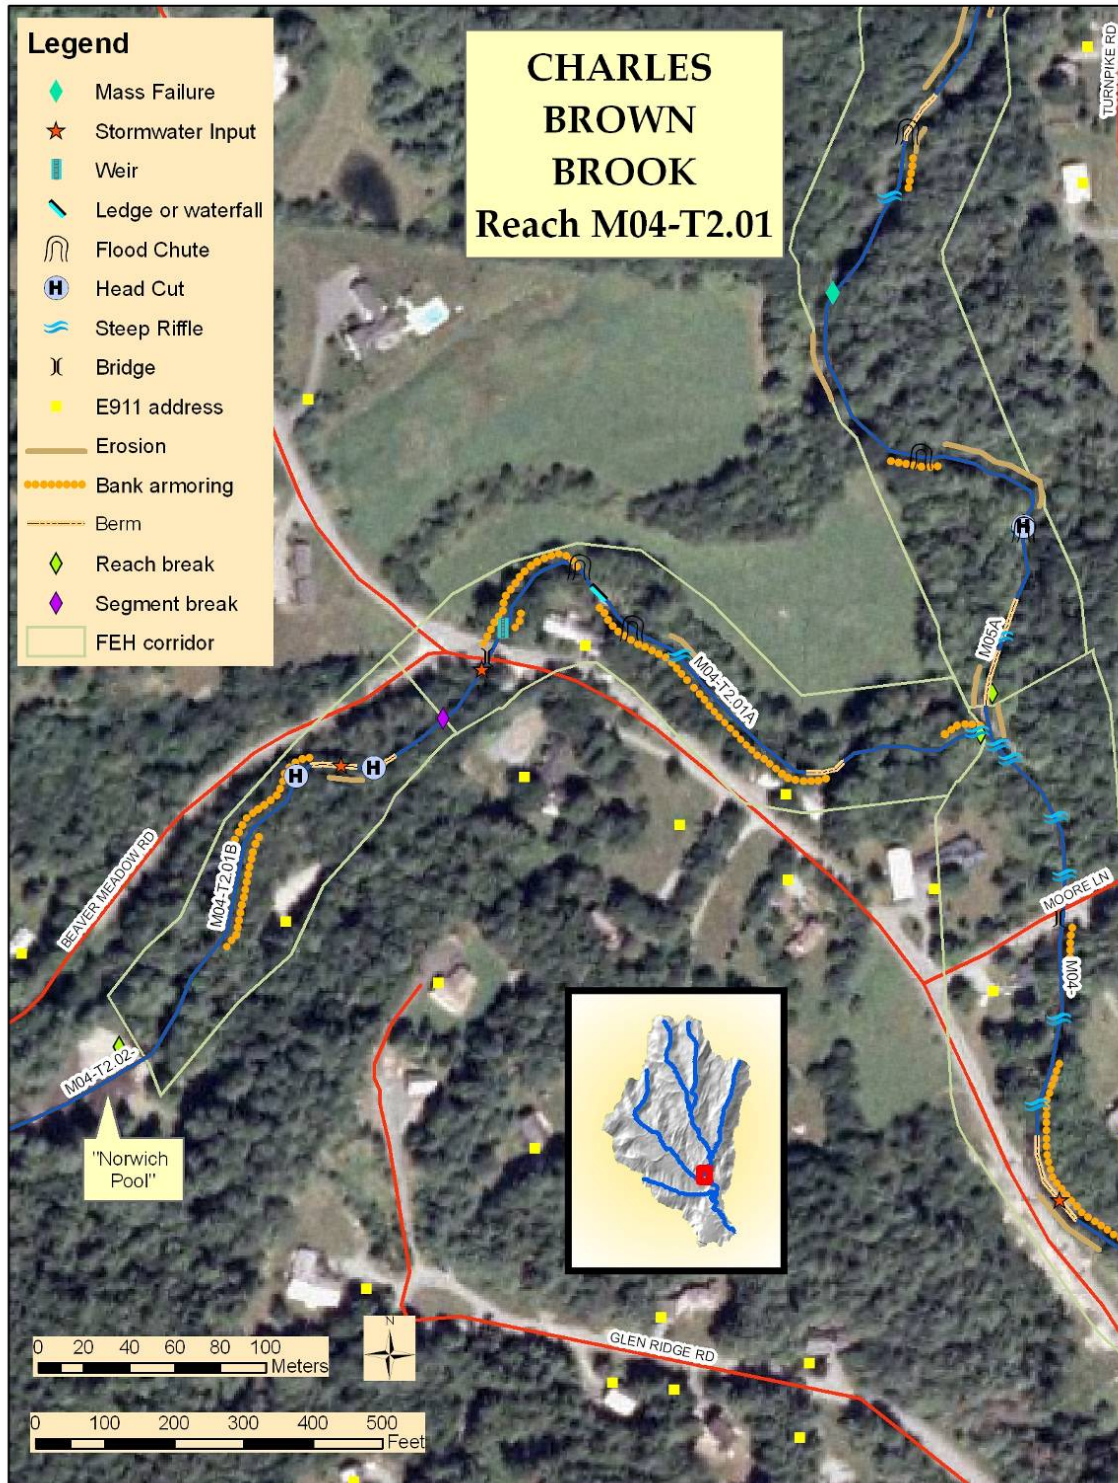
Figure 58. Reach map for Charles Brown Brook Reach M04-T2.01.

Reach M04-T2.01 is the most downstream section of Charles Brown Brook, beginning at its confluence with Blood Brook and continuing upstream to the dam below the Norwich Pool. This short reach drains 5.64 square miles. It is only 1,760 ft (0.33 mi) long, but was segmented into two subreaches because of reference stream type differences (Fig. 58). The segments also differed in corridor encroachment and grade control characteristics. The lower subreach, M04-T2.01A, was typed as a B channel dominated by cobble substrates, while the upstream segment, M04-T2.01B, was characterized as a C channel with a cobble substrate.

Segment M04-T2.01A extends roughly 1040 ft (0.20 mi) upstream to just above a bridge on Beaver Meadow Rd. A 10-foot waterfall accounts for the large majority of elevation change in this segment, and the rest of the segment is a c subslope (<2 %). An old mill foundation and significant walling of the channel below this indicate that the artificial valley created by this confinement is of a long-standing historical nature, and the segment was designated a subreach with a modified Bc cobble riffle-pool reference type. A plane bed structure noted in fieldwork is likely to be related to adjustment processes

subsequent to bulldozing both above the waterfalls and below this segment (on the Blood Brook mainstem) following the 1973 flood, as well as the store and release regime at the Norwich Pool impoundment in the next reach upstream.

The upper segment (M04-T2.01B) had better buffers, with 50-100 widths dominant on the right bank and subdominant on the left bank, but road encroachment on the left bank meant the dominant buffer on that side was less than 25 feet. Store and release damming of the Norwich Pool upstream, along with lack of natural grade controls, contributes to periodic sediment starving of this segment and then larger inputs of sediment and water when the impoundment is flushed out seasonally. This segment was bulldozed after the dam had breached following the 1973 flood as well (pers. comms., former selectboard member Linda Cook, August 2006 and Town Road Foreman Andy Hodgdon, December 2006). It is difficult to identify exactly how these factors affect channel dimensions and adjustment processes, but an incision ratio of 1.2 indicates that loss of floodplain through downcutting has likely been limited by the installation of a check dam just downstream of this segment (Fig. 58) and/or mitigated by aggradation following periodic flushing of the pool. Plane bed features noted in the segment are likely due to a combination of these factors and the bulldozing, which left many coarser bed sediments windrowed along the banks, creating a berm off the right bank in the midsection of the segment and contributing to bank armoring in the upstream portion of the segment. The sum effect of channelization appears to be increased stream power and sediment transport, with the bulk of impacts transferred downstream. The maintenance of the Pool and the substantial development and infrastructure off the right bank downstream indicate that equilibrium conditions may be more easily achieved by protecting and accessing the floodplain downstream of this section of the stream. Encroachment from Beaver Meadow Rd off the left bank appears to restrict potential access to floodplain downstream and offers a focus area for project implementation.

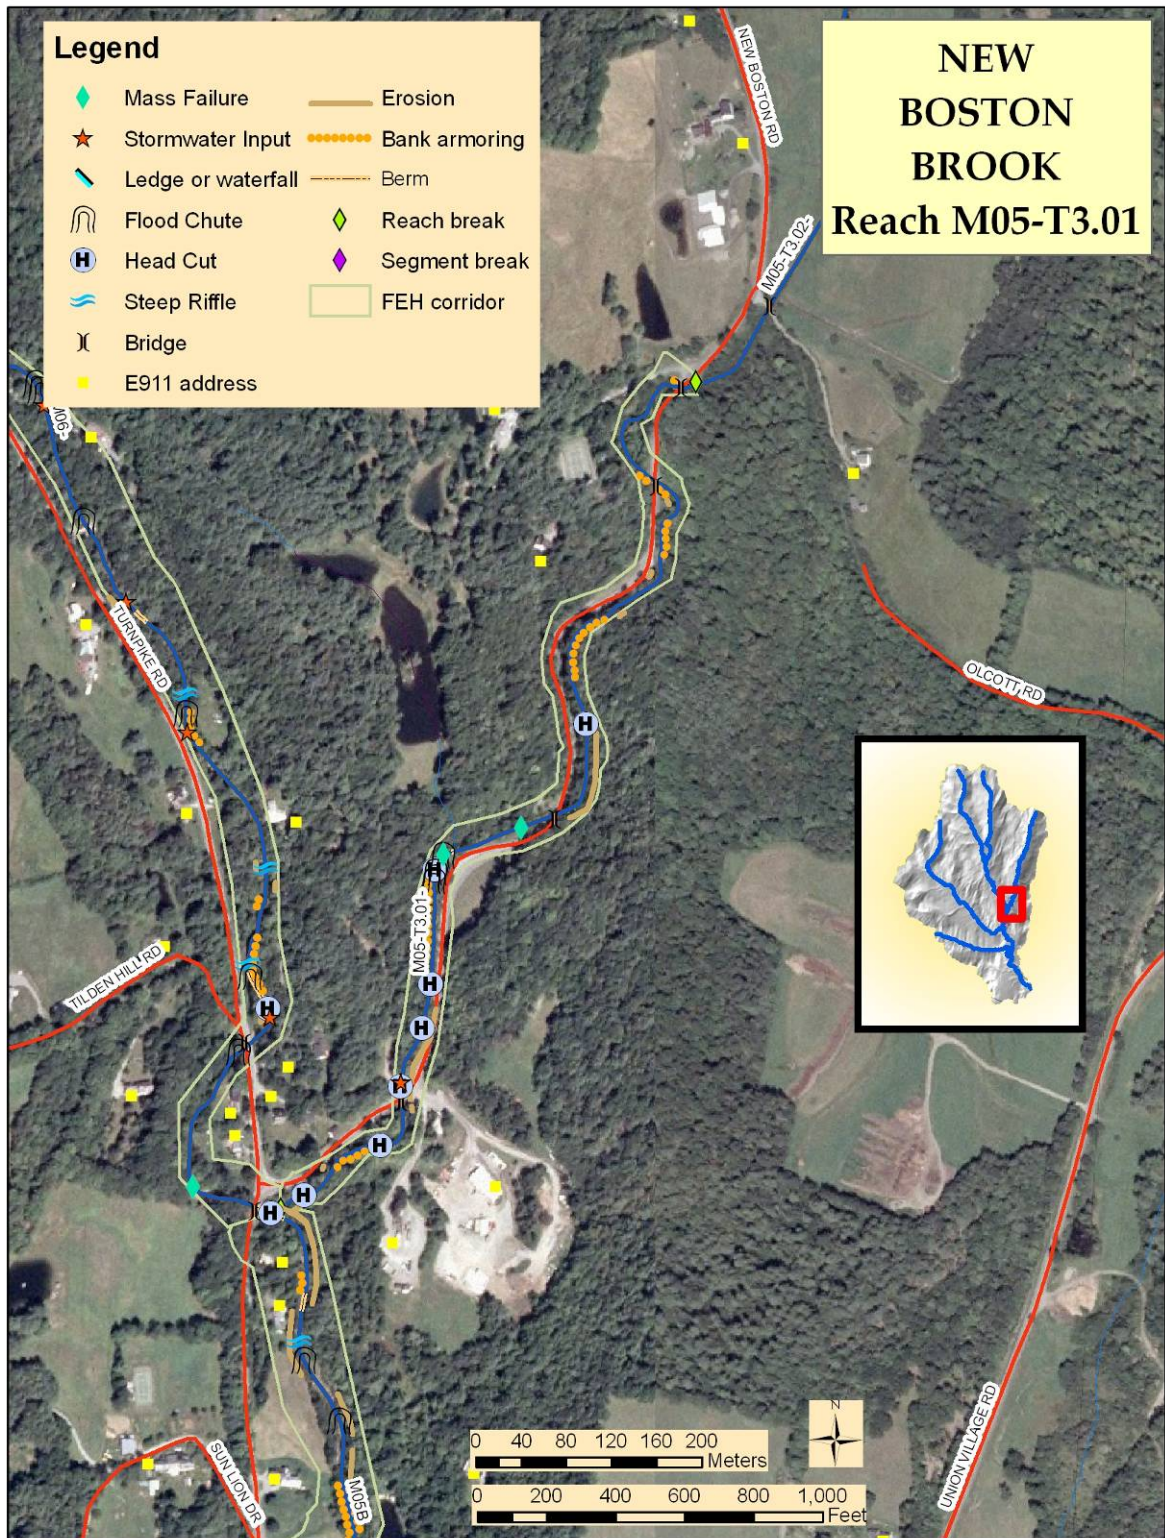
Figure 60. Reach map for New Boston Brook Reach M05-T3.01.

This reach extends from the confluence of New Boston Brook and Blood Brook and continues upstream to the top of what is known as the “crooked half mile” on New Boston Road (Fig. 60). This reach drains 2.79 square miles, is 3302 feet (0.63 mi) in length, and was left unsegmented during assessment. It was characterized by a narrow valley confinement, but classed as a C_b type stream (b subscript for 2-4% slope, steeper than a typical C stream), due to its access to the narrow floodplain. The stream is moderately to severely encroached upon by New Boston Road, and an unusual situation arises from the fact that the valley and floodplain have been somewhat broadened by road construction. At the top of the reach, the landscape broadens into a wide valley. Extensive wetlands and multiple impoundments constructed by both humans and beavers upstream of this reach are likely retain many sediments that might otherwise become part of the sediment load of this reach; the reduction of sediment load may be contributing to increased stream power in this reach. Although there is access to the floodplain in this reach, it is very narrow; concerns have more to do with retaining access to the floodplain upstream of this reach and minimizing impacts transferred out of this area to downstream reaches.

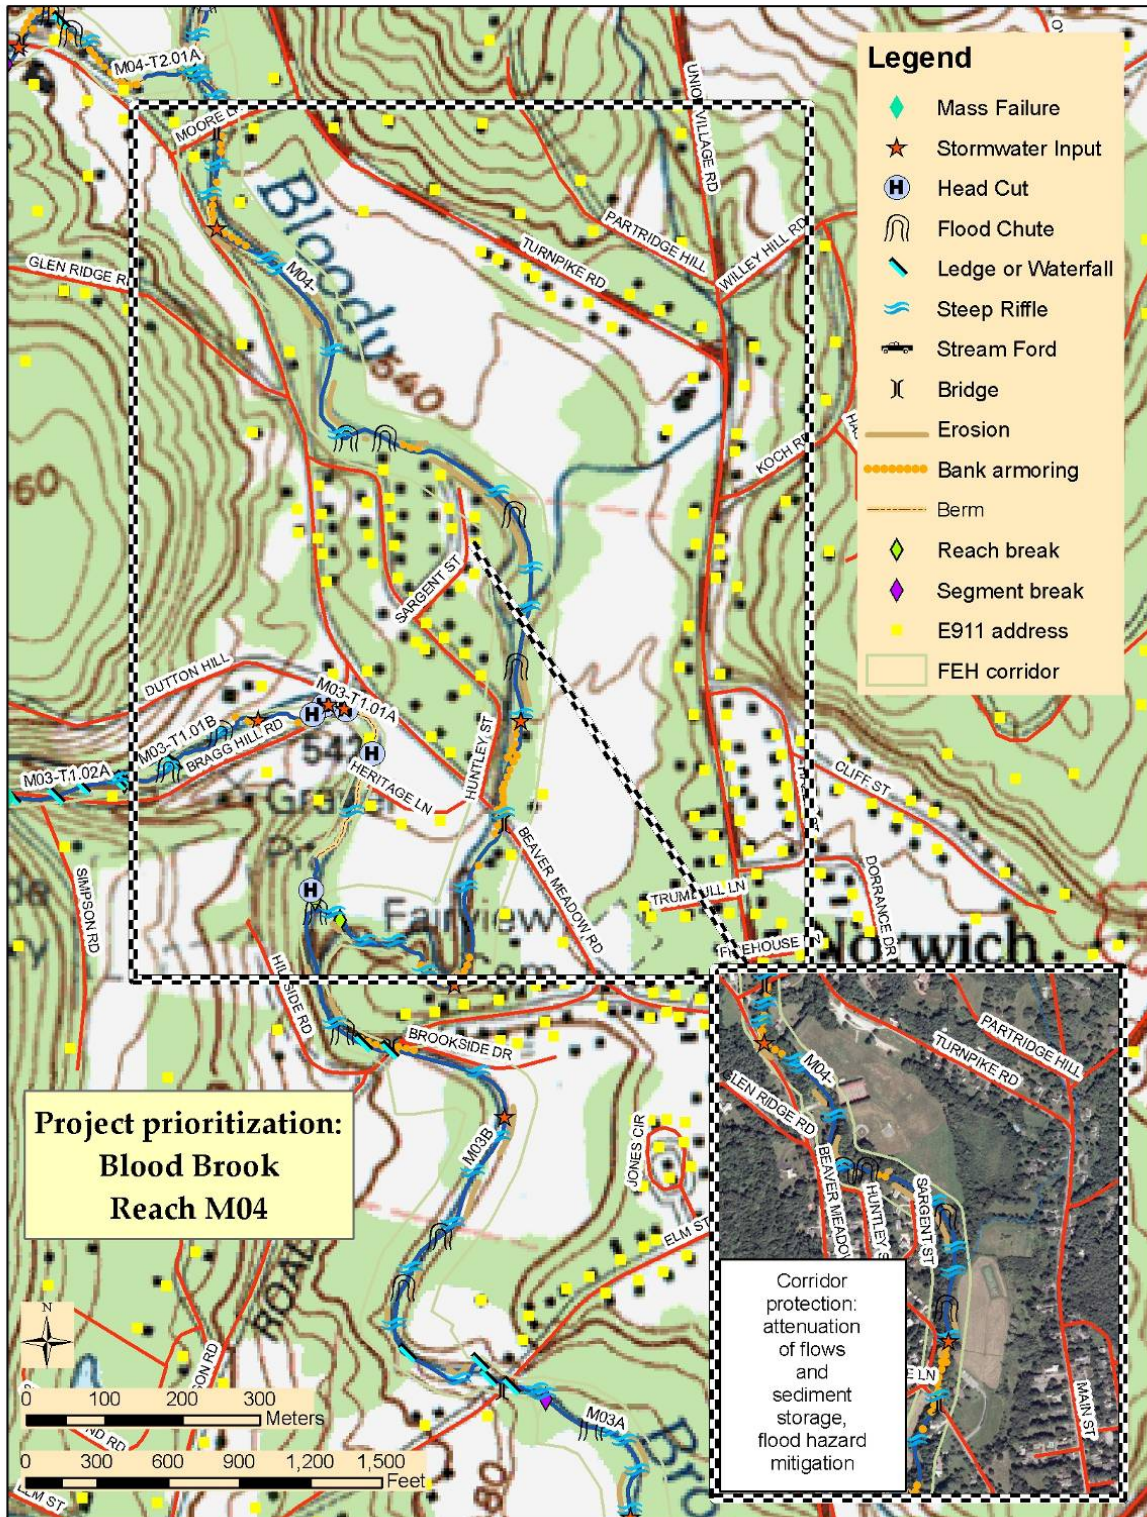
Figure 63. Project prioritization: Segment M04, Blood Brook by Norwich playing fields and Huntley Meadows

2	M04 Fair – High (Fig. 63)	Still has floodplain access	Passive; protect corridor	Feasible	Flood mitigation for downtown	Easement transactions	Land use conversion minimal; Flood insurance	Town of Norwich, abutting landowners

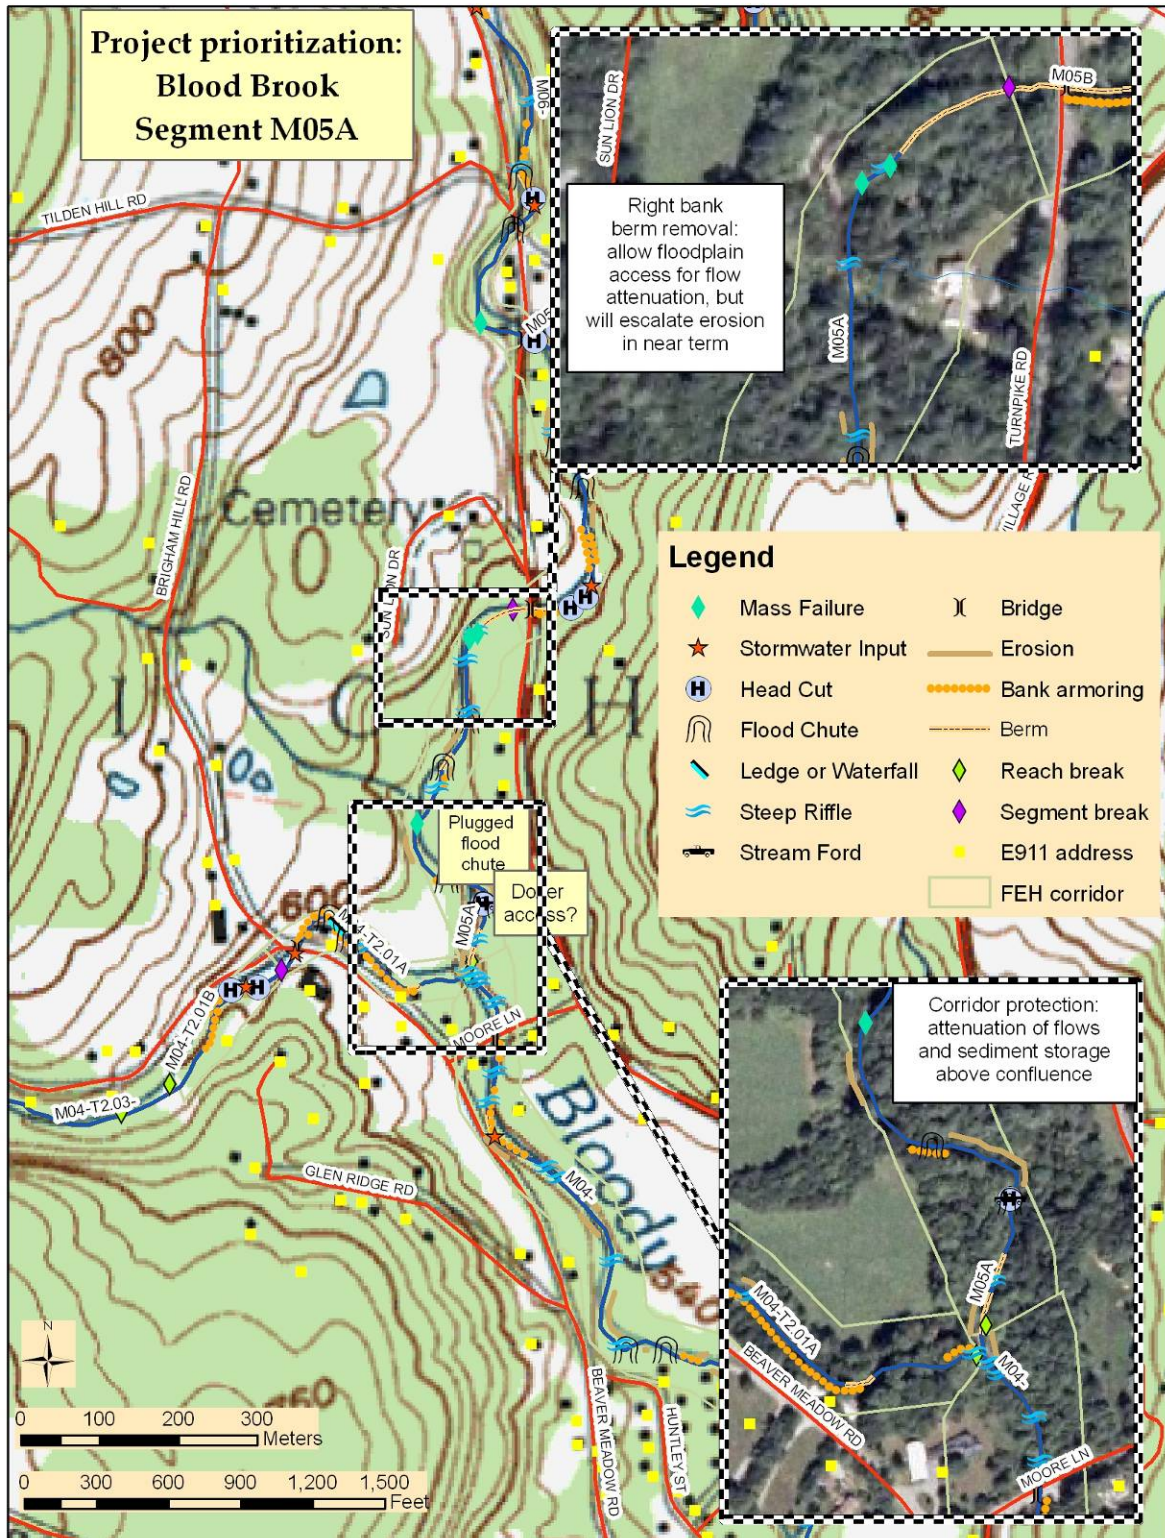
Figure 65. Project prioritization: Segment M05A, Blood Brook from Moore Ln. to Sun Lion Rd.

Project #	Reach/ Segment Condition-Sensitivity	Site Description including Stressors and Constraints	Project or Strategy Description	Technical Feasibility & Priority	Other Social Benefits	Costs	Land Use Conversion & Landowner Commitment	Potential Partner Commitments
4	M05A Poor –Very High (Fig. 65)	Bulldozed and windrowed after '73 flood, effectively bermed Corridor encroachments: development off banks and downstream	Corridor protection, especially hayfield in floodplain above Charles Brown confluence; remove windrow on right bank upstream, place larger stone back in stream	Feasible, but impacts on downstream development need careful assessment; high priority for watershed dynamics but implementation tricky		Easement transactions or compensation on ag lands; removal of berm, replacement of stone in stream	Permit further erosion at mass failures off right bank on upstream end; buffer augmentation and flood hazards on ag lands	Investigate CREP, EQIP and similar options, Town of Norwich, VT ANR-RMP

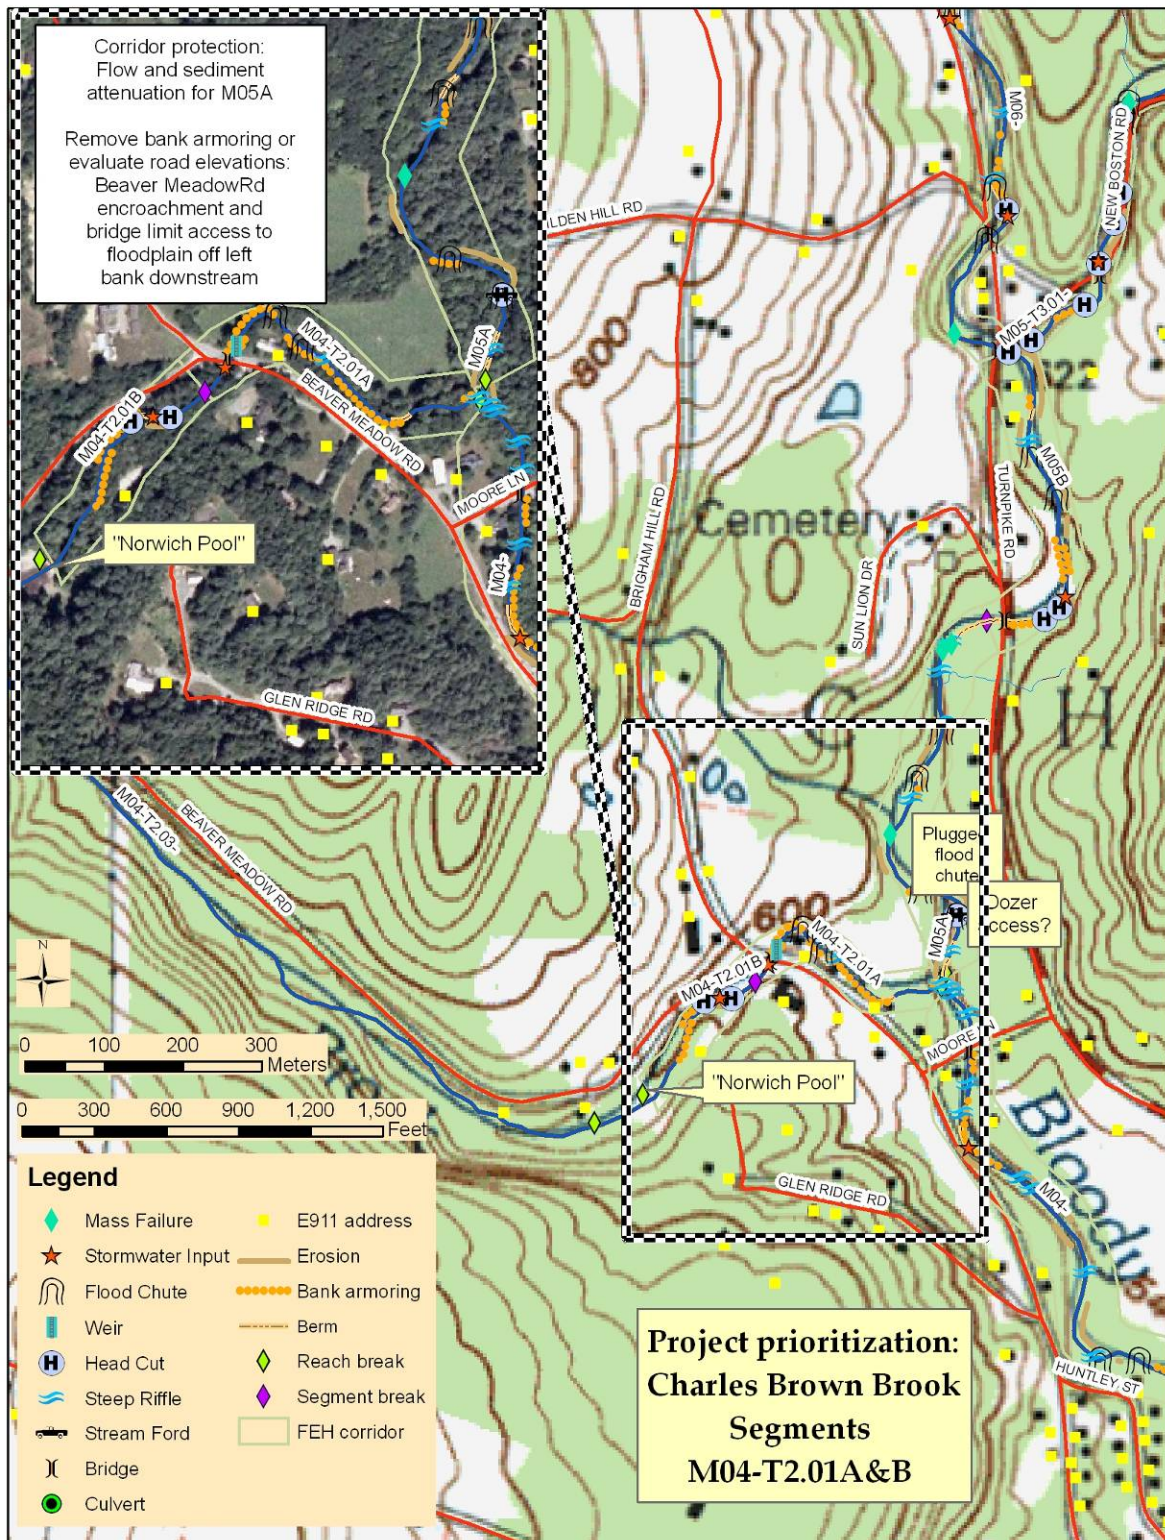
Figure 66. Project prioritization: Segments M04-T2.01A&B, Charles Brown Brook from Blood Brook confluence to Beaver Meadow Rd. downstream of the Norwich Pool

Project #	Reach/ Segment Condition-Sensitivity	Site Description including Stressors and Constraints	Project or Strategy Description	Technical Feasibility & Priority	Other Social Benefits	Costs	Land Use Conversion & Landowner Commitment	Potential Partner Commitments
5	M04-T2.01A&B Fair – High (both segments) (Fig. 66)	Beaver Meadow Rd encroachment and bridge limits access to floodplain off left bank downstream	Ensure access to left bank floodplain in flood flows: a) if bridge outflanks and b) remove LB armoring below bridge and restore floodplain access/meanders	Needs detailed elevation analysis off left bank of bridge at Beaver Meadow Rd; high priority, attenuation for M05A	May offer some property protection or damage mitigation for downstream properties in flood	Elevation analysis, grade changes if necessary; removal of armoring; easement transactions, compensation on ag	Buffer augmentation and flood hazards on ag lands	Investigate CREP, EQIP and similar options, Town of Norwich, VT ANR-RMP
