**BLOOD BROOK WATERSHED
CORRIDOR PLAN
NORWICH, VT**

March 27, 2008

Prepared by:
Daniel Ruddell, Elisabeth McLane, Anna Mulligan,
Staff Scientists, and
Ben Machin, Principal
Redstart Consulting

Prepared for:
Two Rivers-Ottawaquechee Regional Commission,
Town of Norwich Conservation Commission, and
Vermont Agency of Natural Resources/
Department of Environmental Conservation
River Management Program

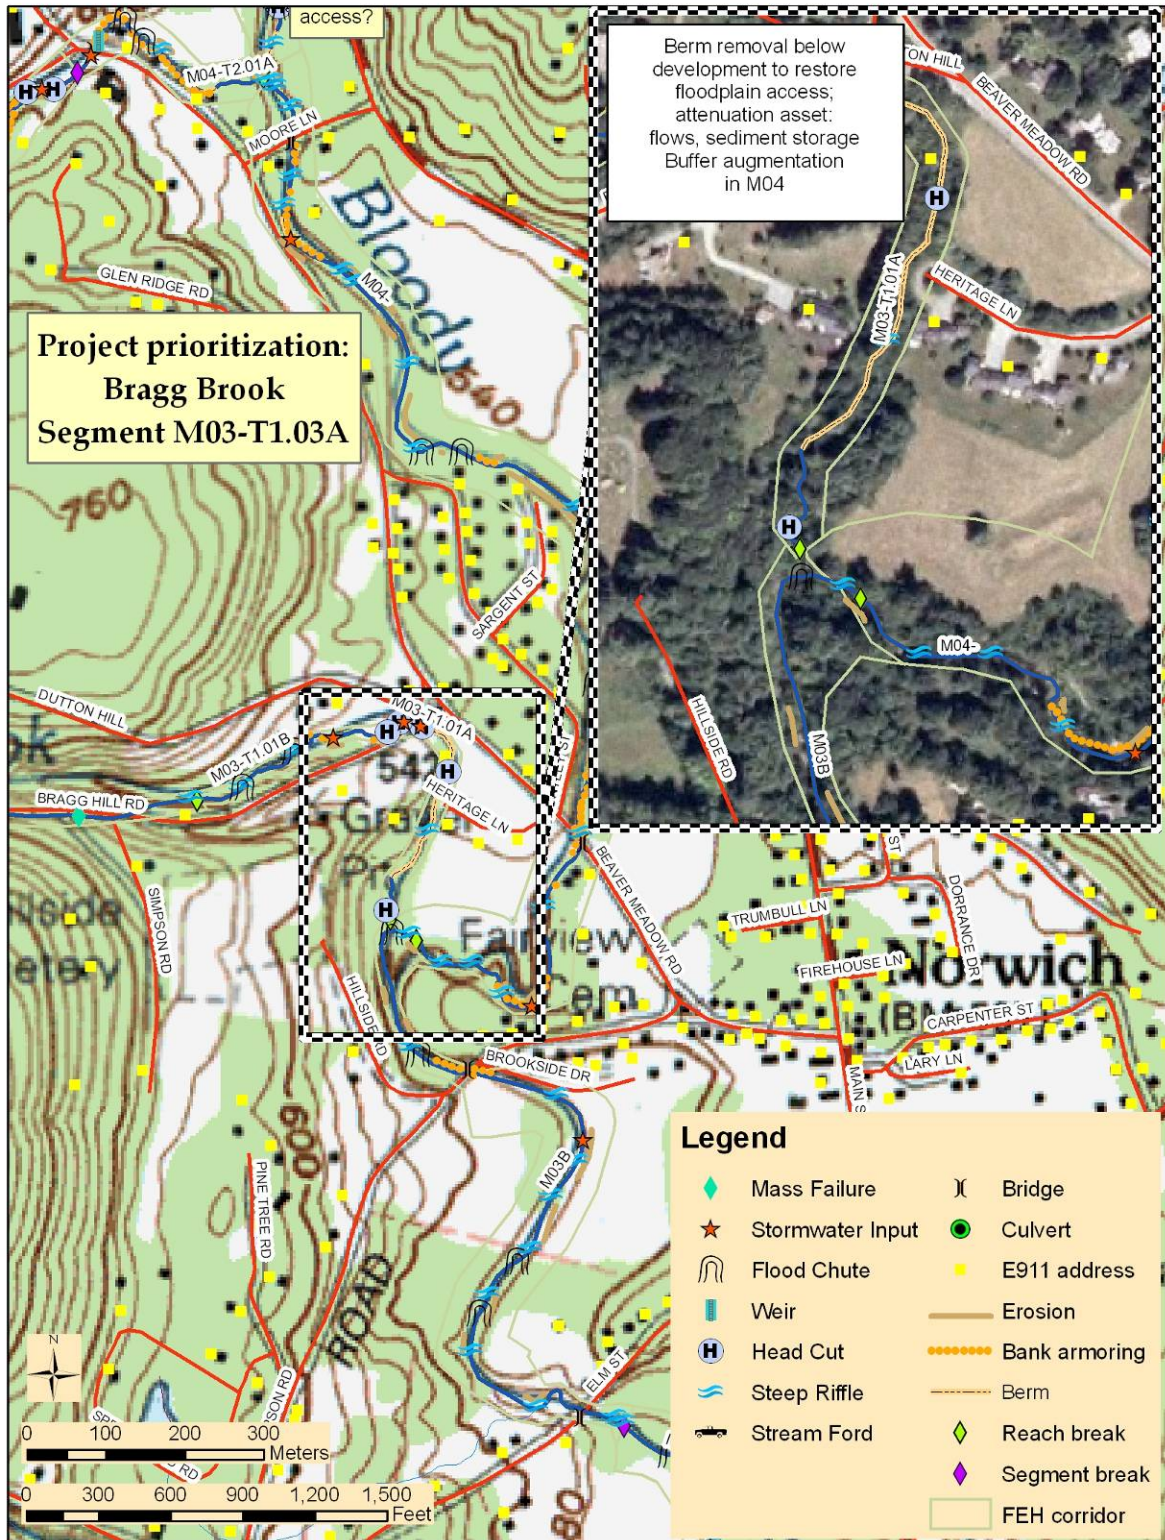
Figure 67. Project prioritization: Segment M03-T1.01A, Bragg Brook below Heritage Ln.

6	M03-T1.01A Fair – Very High (Fig. 67)	Cut off from likely historic floodplain; straightening, encroachment May impact Heritage septic in flood	Remove berm below potential development impacts	Feasible; limited floodplain gain, enters watershed low	Could tie to trail system	Berm removal	Buffer augmentation on upstream end and near confluence with Blood Brook mainstem	NCC (trail system), Heritage Condo assoc.

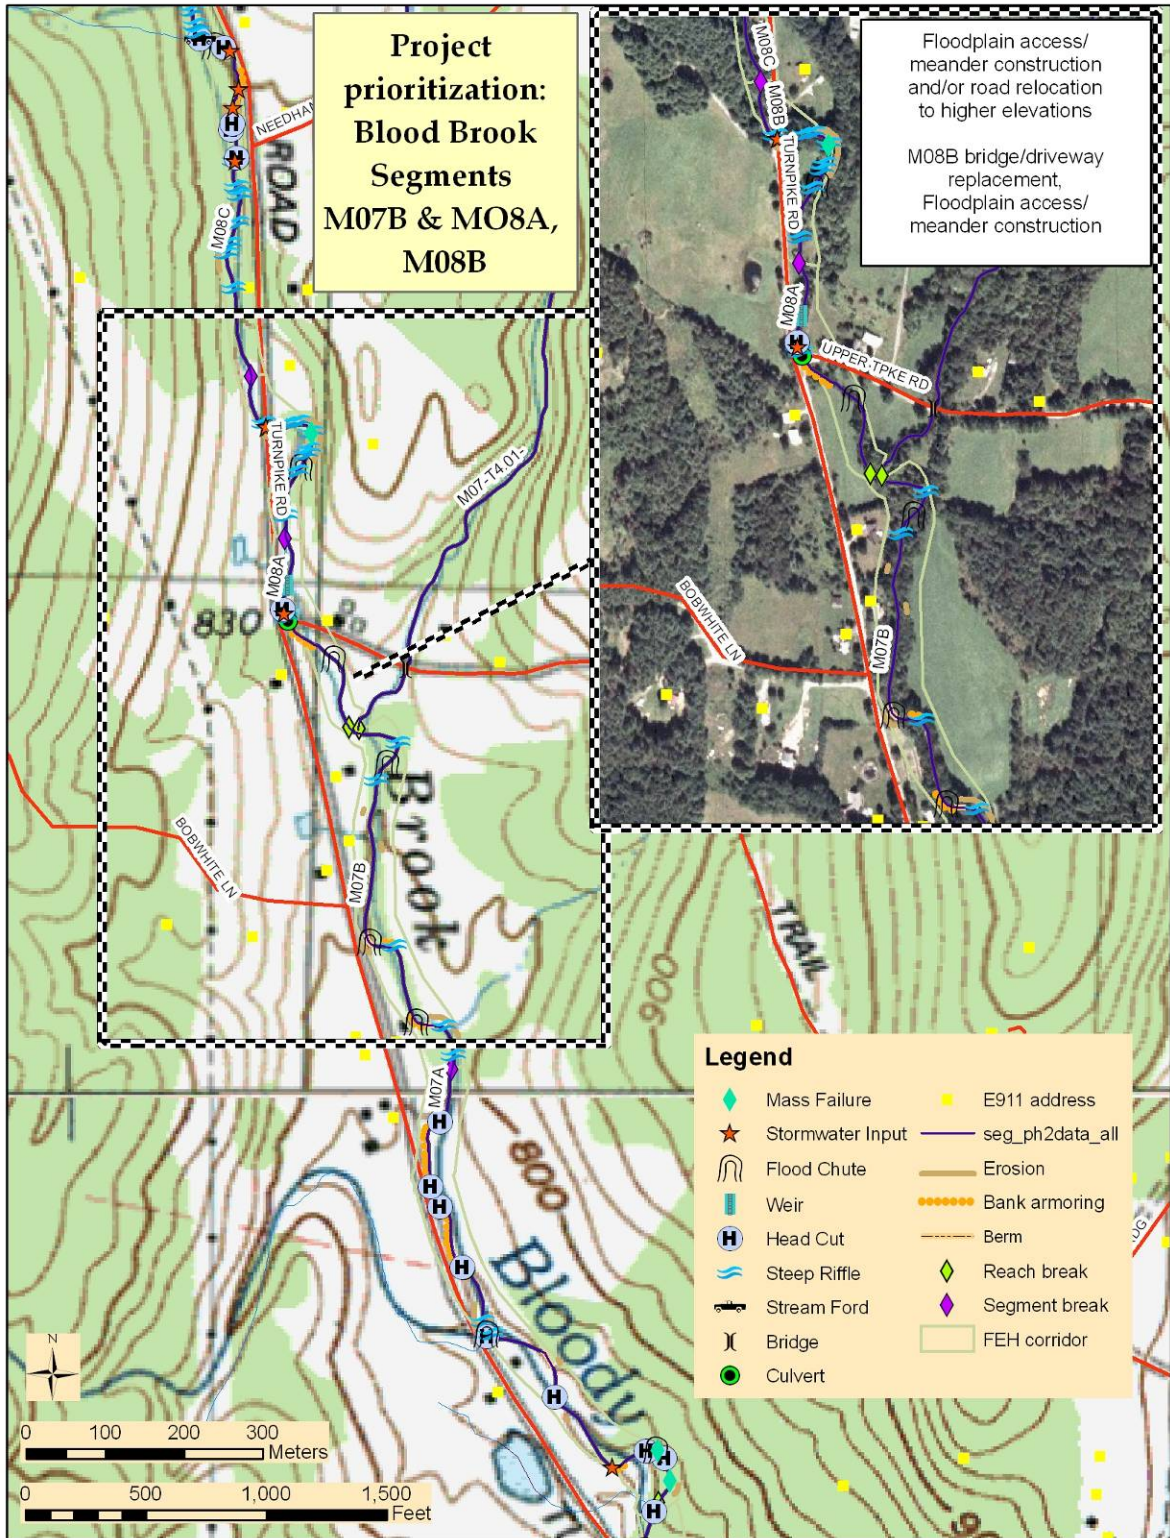
Figure 70. Project prioritization: Segment M07B & M08A, segment M08B, Blood Brook downstream of Bobwhite Ln. to bridge 1000 feet upstream of Upper Turnpike Rd.

Project #	Reach/ Segment Condition-Sensitivity	Site Description including Stressors and Constraints	Project or Strategy Description	Technical Feasibility & Priority	Other Social Benefits	Costs	Land Use Conversion & Landowner Commitment	Potential Partner Commitments
9	M08A & M07B Fair – High (both segments) (Fig. 70)	Possible alluvial fan, inherent stream instability Road, development and ag use encroachments	Floodplain access/ meander construction and/ or road relocation to higher elevations outside corridor	Costly, may be difficult to implement and soil/slope capabilities need to be assessed Mid range priority, may rise with repeated conflicts; high priority for watershed dynamics	May offer reduced maintenance costs in long term; high risk of repeated flood impacts	High; needs cost/ benefit analysis in relation to high risk of repeated flood impacts Possible easement and/or compensation costs	Site engineering and earthworks, buffer establishment and maintenance (buffers could be done independently)	Town of Norwich, VTANR-RMP

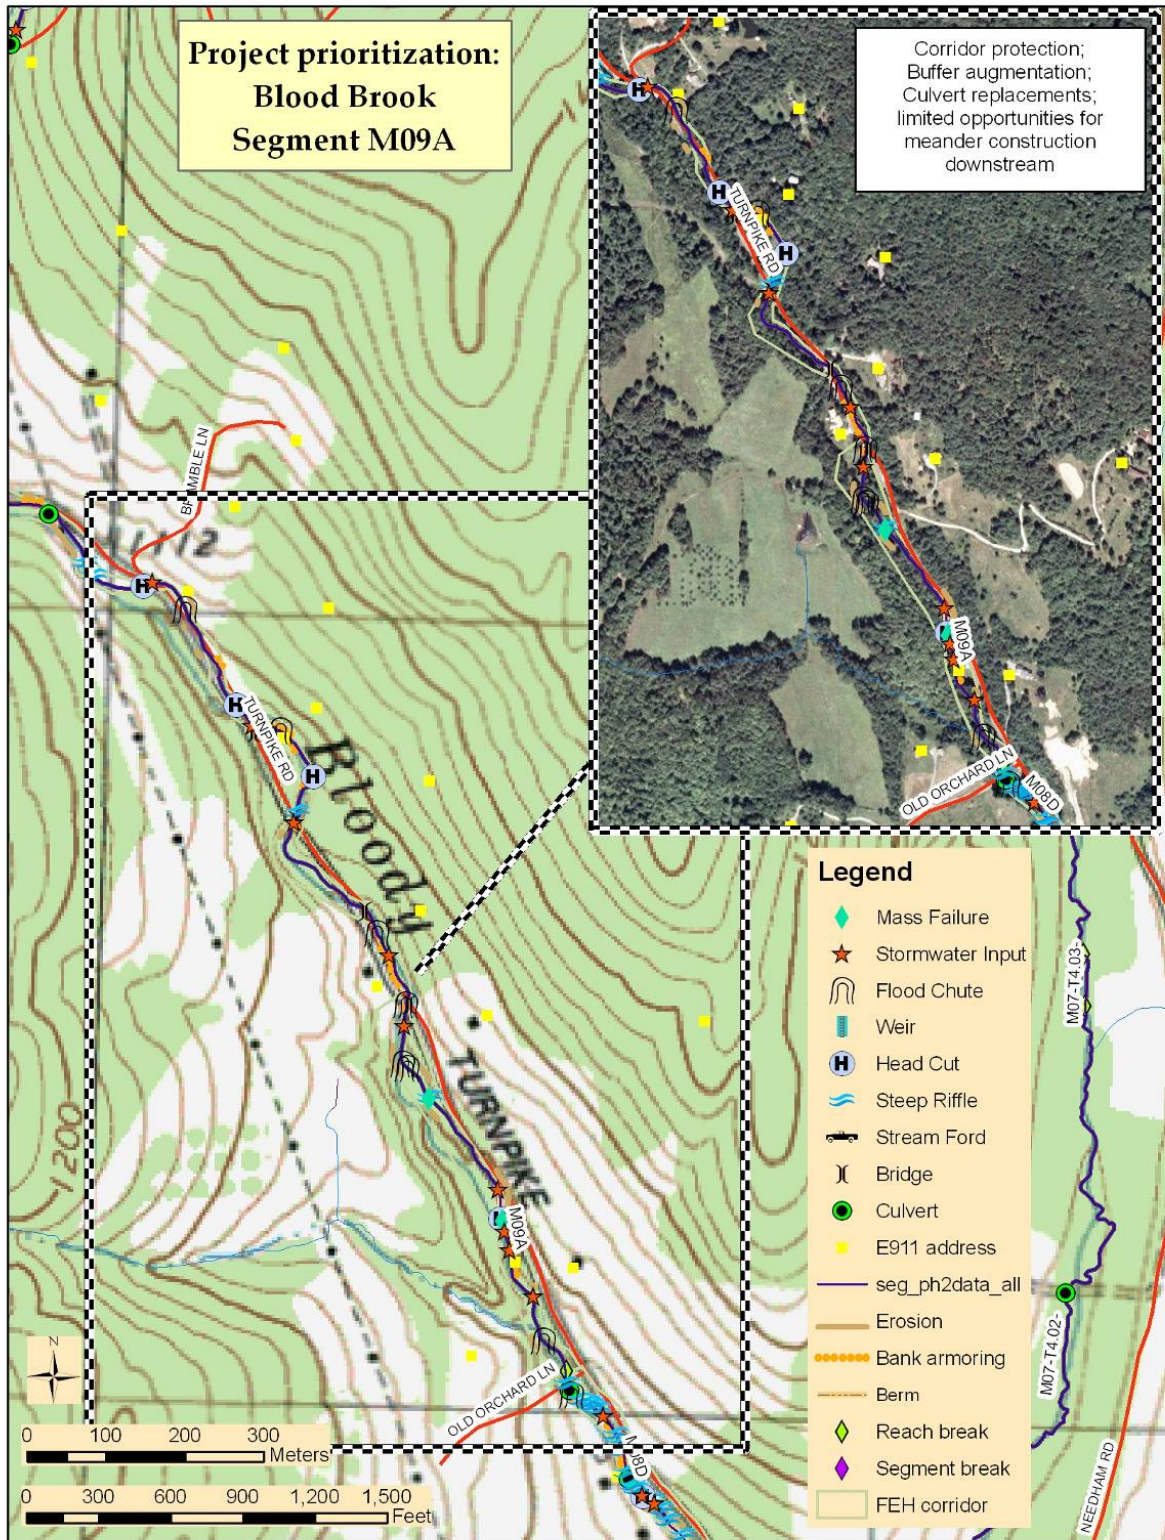
Figure 71. Project prioritization: Segment M09A, Blood Brook, Old Orchard Ln. to Bramble Ln.

Project #	Reach/ Segment Condition-Sensitivity	Site Description including Stressors and Constraints	Project or Strategy Description	Technical Feasibility & Priority	Other Social Benefits	Costs	Land Use Conversion & Landowner Commitment	Potential Partner Commitments
11	M09A Fair – High (Fig. 71)	Increased hydrologic inputs; road, development encroachments, bulldozing and straightening	Floodplain access/ meander development, buffer augmentation	Buffers feasible; other pieces more difficult: numerous encroachments in a narrow valley; valuable for attenuation high in watershed		Planting stock; other pieces could be largely passive but would likely entail flood hazard risks for roads, culverts, driveways; monitoring for headcuts
