**Phase 1
Stream Geomorphic Assessment
Blood Brook Watershed
Norwich, Vermont**

**Prepared by
The Two Rivers-Ottawaquechee Regional Commission
September 2006**

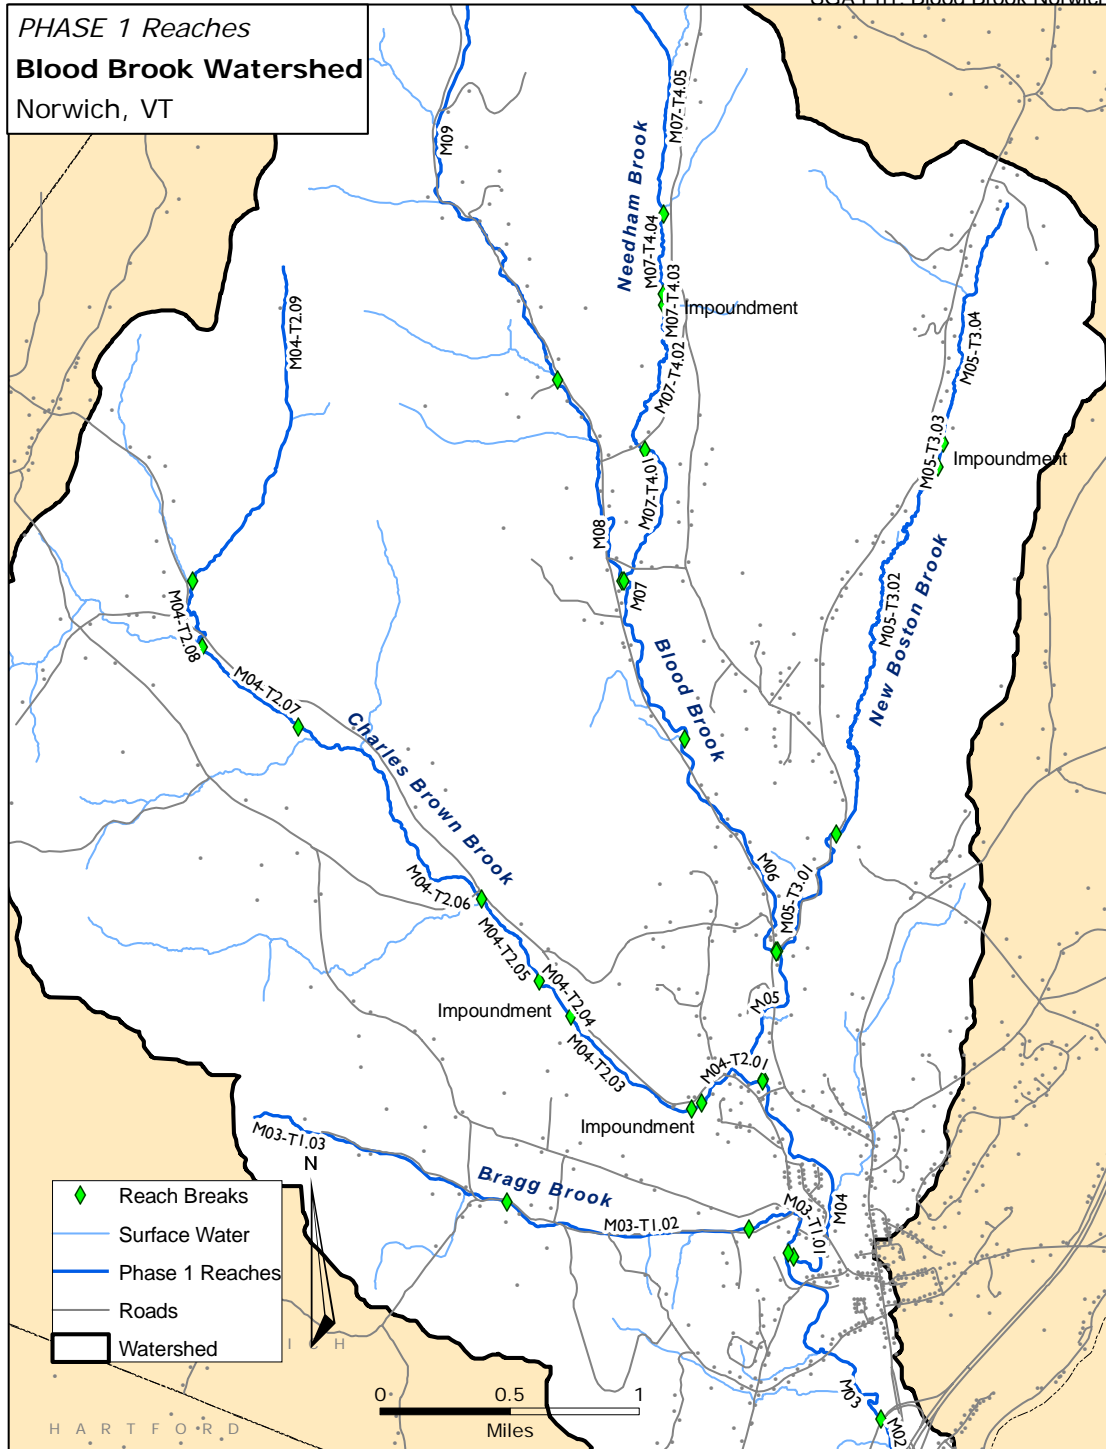
Figure 1 – Study reaches

The Blood Brook was divided into 30 reaches for the Phase 1 Assessment, totaling 14.2 river miles in length. The following is a description of each reach, including the reach locations generated from SGAT. Figure 1 shows the location of study reaches used in the Phase 1 Assessment. Each point represents the downstream end of the reach. Phase 1 reaches are defined according to significant tributary intersections and valley confinement. The three tributaries were selected because of they had largest drainage area of the mainstem tributaries.
