**Phase 2 Stream Geomorphic Assessment  
Blood Brook Watershed  
Town of Norwich  
Windsor County, Vermont**

February 27, 2007

Prepared by:  
Daniel Ruddell, Elisabeth McLane, Staff Scientists, and  
Ben Machin, Principal  
Redstart Consulting

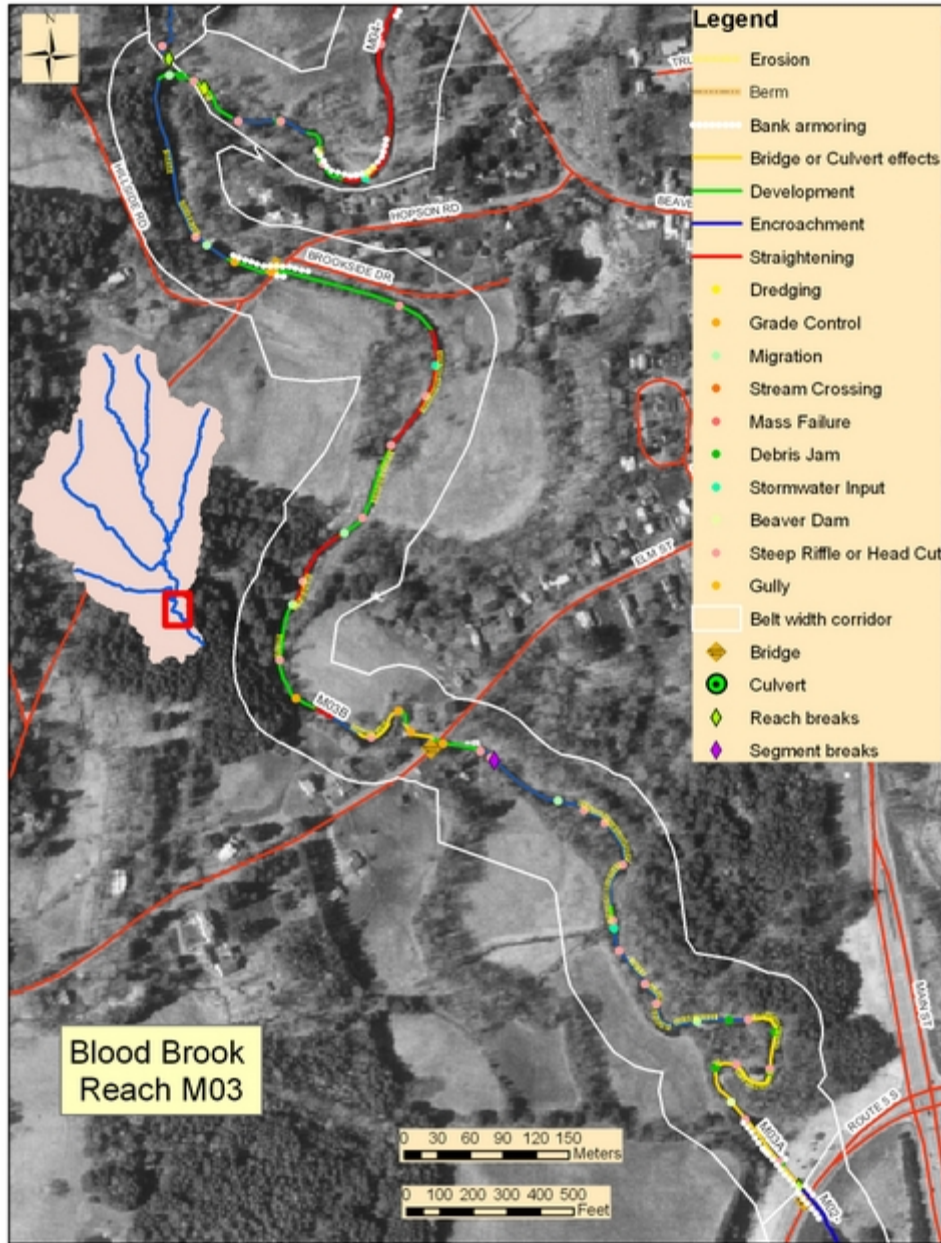
**Figure 3. M03 reach map. Erosion in Fig. 4 is at the head of a bend leading into the major dogleg in the downstream segment M03A, shortly before the stream passes through a long culvert underlying the massive embankments of Rte. 5 at the tail end of the reach. Waterfalls at Elm St. (Fig. 5) and above Hopson Rd. were dominant features in the upstream segment M03B.**

Hay fields represented the dominant land use in the right bank riparian corridor, and buffer width on this side was predominantly 51-100 ft. but dropped to less than 5 ft in portions of the segment. This was most notable on 100 ft of the outside bend leading to the dogleg in this segment (Fig. 4). Due to the non-cohesive nature of the bank materials in this section, this area was identified as a potential neck-cutoff and is strongly recommended for river corridor protection and buffer revegetation.

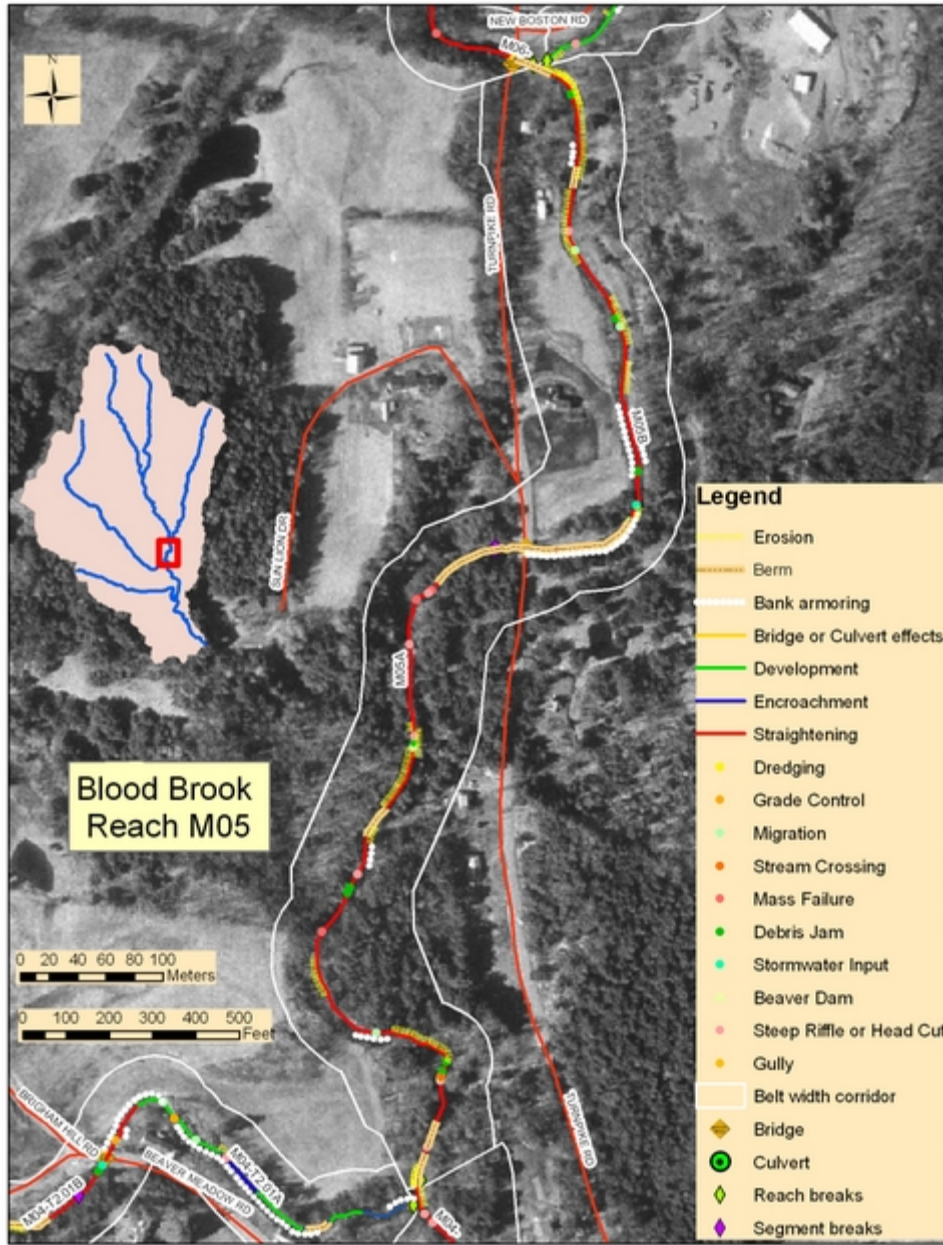
**Figure 7. Map of Reach M05 includes significant erosion, two mass failures, and bank armoring and revetments placed to control erosion throughout the reach. Lowest section of segment M05A contains a plugged flood chute east of the hayfield above the confluence with Charles Brown Brook that has restricted stream access to some of the historical floodplain.**

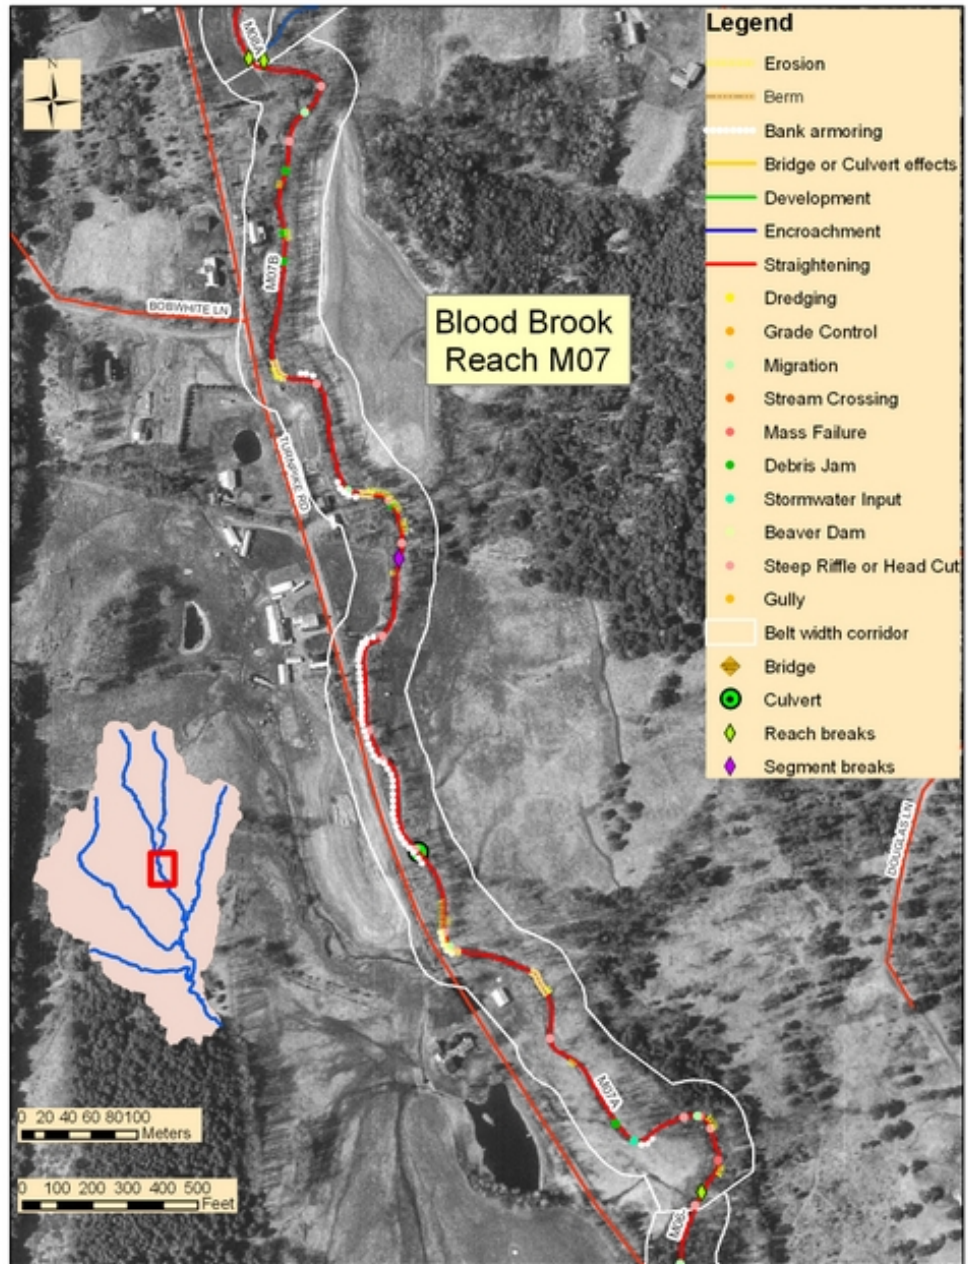
Figure 12. Reach map for M07.

M07 drains 5.54 sq. mi. and was divided into two segments of 2,570 and 1,809 feet. The segments differed in buffer and levels of encroachment as well as human-caused differences in stream type. The lower segment (M07A) was a C-type stream dominated by cobble substrates and had a weak riffle-pool bed form. This segment showed frequent encroachment in the river corridor from development and roads, and vegetated buffers were lacking in much of the reach. This section of stream had been straightened in the past and there were distinct indications of degradation (Fig. 13). The upper segment (M07B) was a B-type stream due to historic degradation that has caused a loss of floodplain access. There were still some signs of active degradation, but aggradation and channel widening were the more dominant processes.

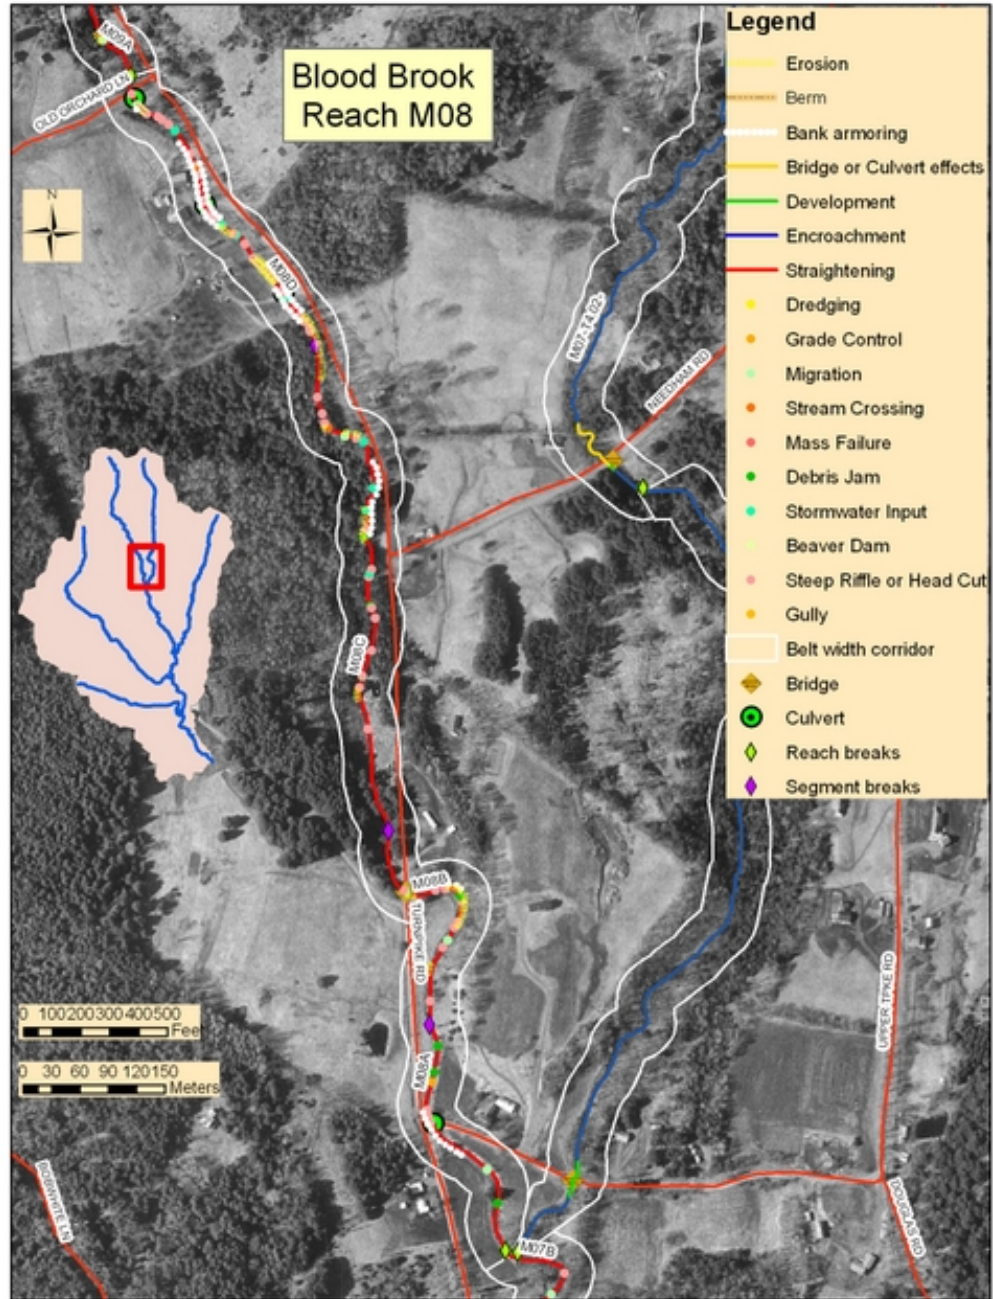
**Figure 15. Map for Reach M08 on the Blood Brook mainstem indicates frequent road encroachment and numerous culverts within the reach.**

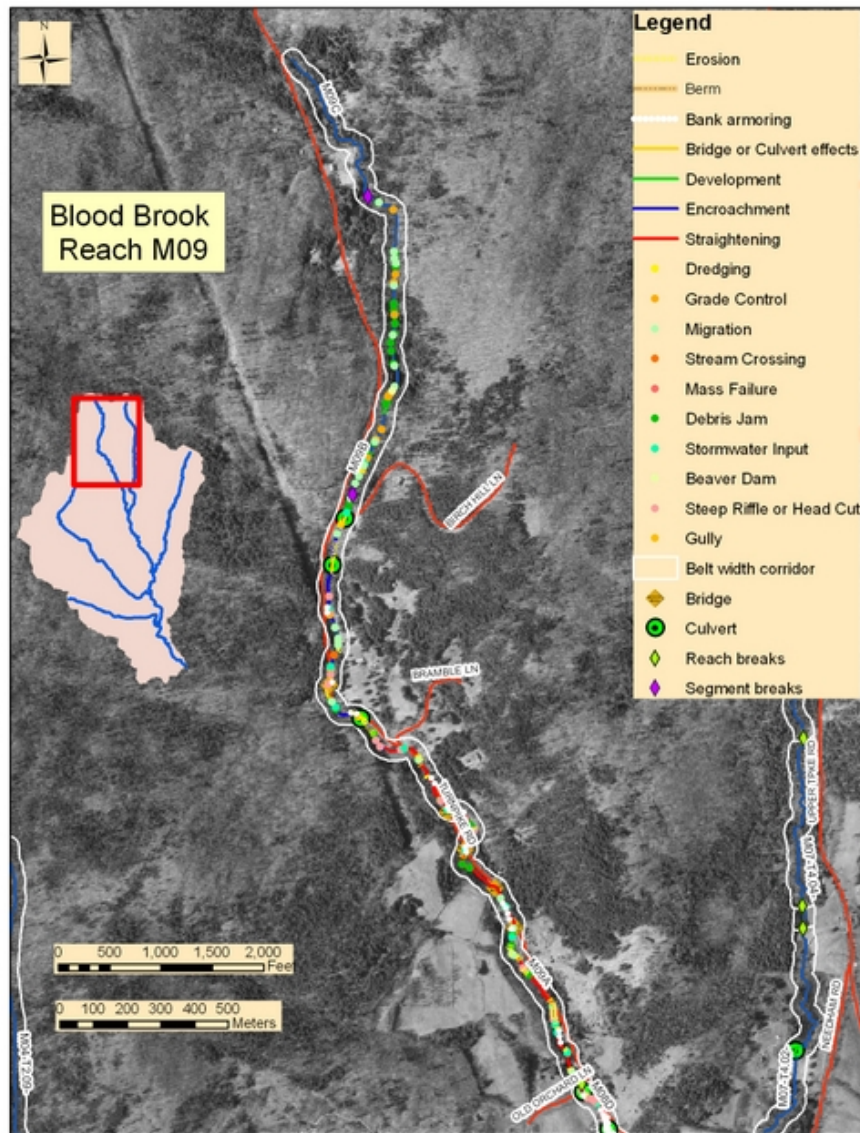
**Figure 21. Reach M09 features reference conditions in segment M09B and an abandoned beaver impoundment in the headwaters of Blood Brook. M09A on the downstream end has a number of road encroachments and numerous culverts and shows some signs of incision.**

*Potential project identification – ReachM09:* The primary issues in the lower segment of this reach were road encroachment and channel constrictions, and high priority should be given to river corridor protection and limiting further encroachment. Additional projects for this area could focus on the replacement of undersized culverts (over time) and limiting migration of headcuts and bed degradation, as well as the potential for allowing buffers to regenerate in areas of housing encroachment. Please refer to the general discussion of development of a stream corridor protection plan included in Section 7 – Recommendations within the main body of this Blood Brook Watershed Phase 2 report for further discussion of these issues.

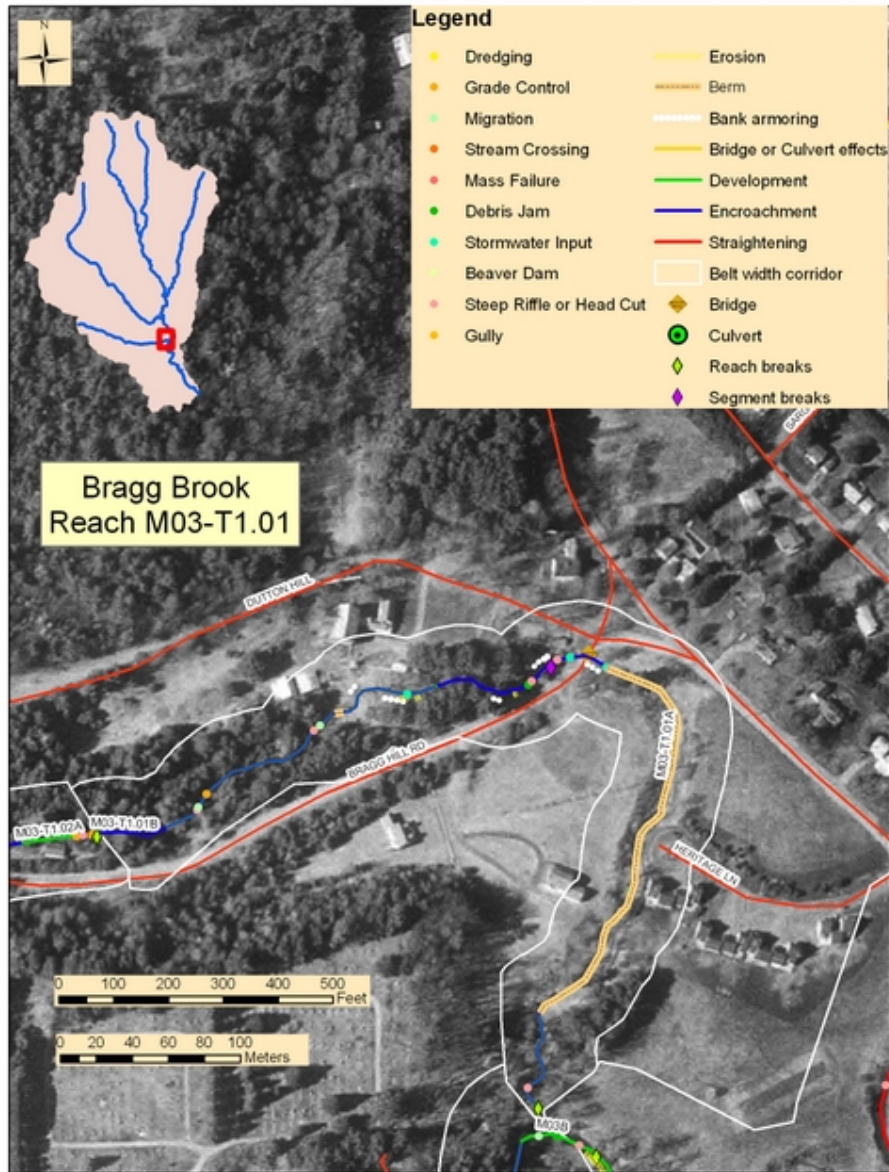
**Figure 23. Reach map for M03-T1.01.**

The lower segment (M03-T1.01A) was characterized by significant human manipulation and development, particularly on the left bank where a 790 foot berm prevents the stream from reaching its floodplain even in very high water (Fig. 24). A small housing development was located approximately mid-segment on this left bank. The right bank was characterized by steep slopes with a couple houses that only slightly impact the stream belt-width corridor.

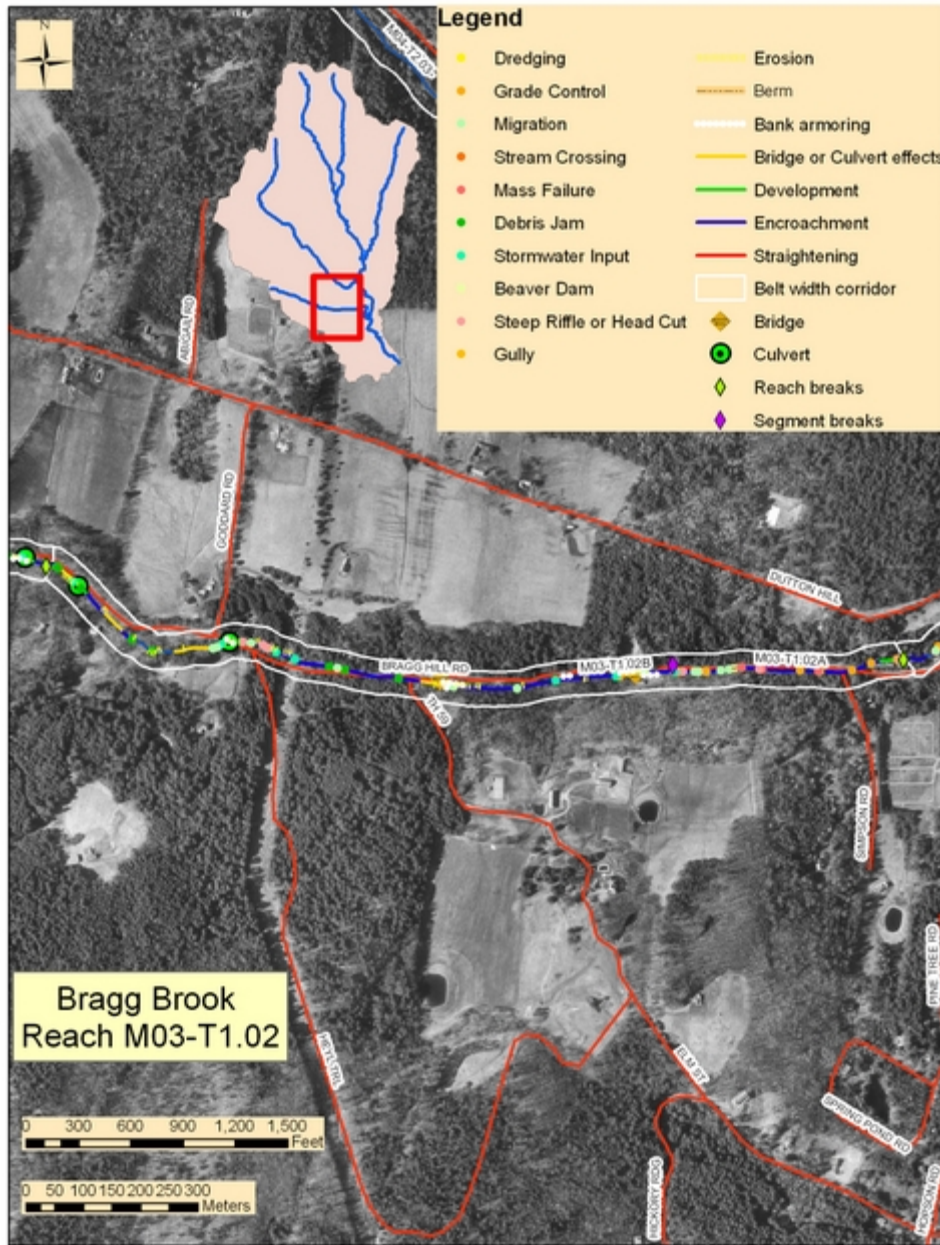
**Figure 25. Reach map for M03-T1.02. This reach is recommended for further assessment of bankfull discharge due to significant impacts on stream dynamics.**

The lower segment (M03-T1.02 A) was dominated by ledge grade control and was largely in reference condition except for sediment inputs from mass failures on its steep left corridor. These mass failures appear related to a one-time break in a water line leading from town wells near the Connecticut River to a 3 million gallon holding tank on Dutton Hill Road, upslope of this reach, in the late 1970s (pers. comms., Andy Hodgdon, Norwich Road Foreman, December 2006 and January 2007). This area of erosion could also be termed a gully. It extended upslope 70 feet, and was approximately 15-20 feet deep (Fig. 26).

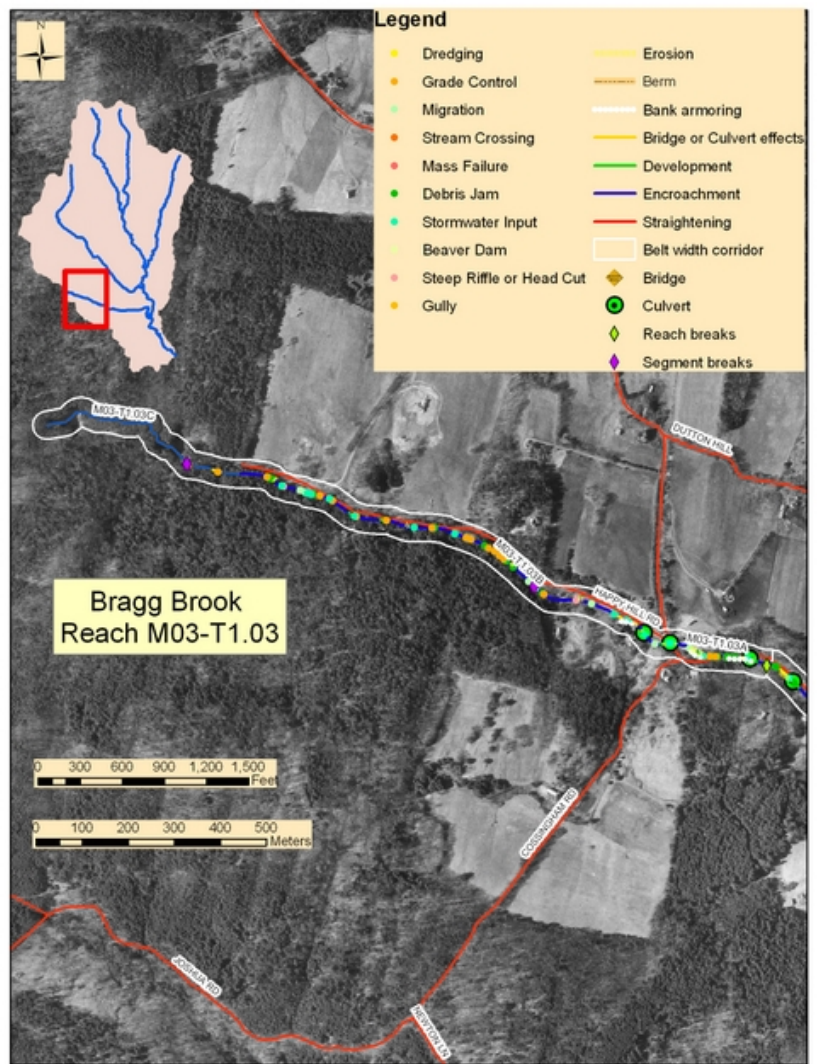
Figure 27. Reach M03-T1.03 was divided into three segments.

The entire reach had a B-type channel overall, but the lower segment (M03-T1.03 A) was dominated by gravel substrates in a riffle-pool setting, while the middle segment was dominated by cobble substrates in a step-pool setting. For these reasons, M03-T1.03 A was designated a subreach. Both segments contained channel restrictions in the form of culverts and bridges. The bridge in the lower segment had been recently replaced; alignment was good and sizing was roughly 75% of bankfull width .

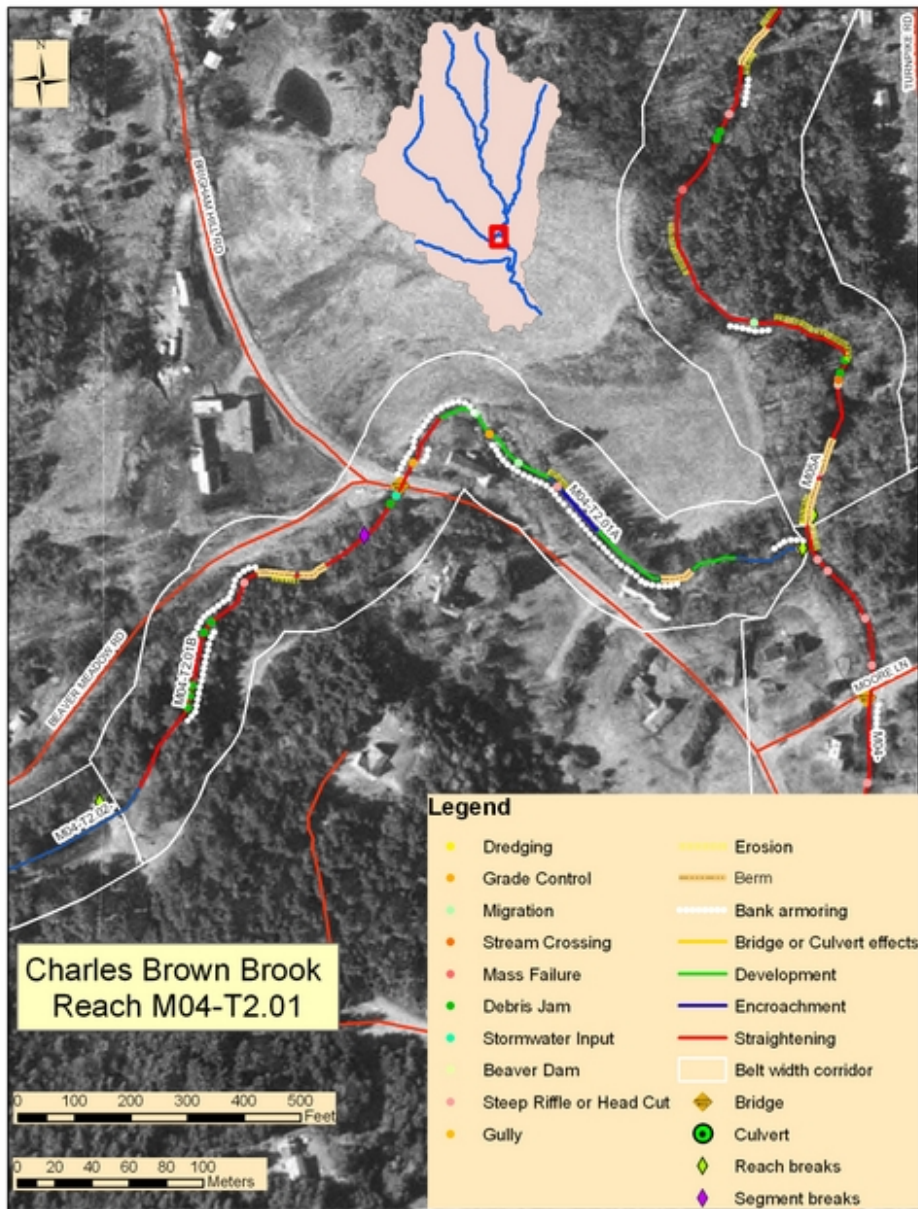
Figure 29. Reach map for Charles Brown Brook Reach M04-T2.01.

The lower subreach (M04-T2.01A) was characterized by somewhat extreme corridor encroachment and a dramatic waterfall grade control (Fig. 30). It was typed as a Rosgen Bc channel dominated by cobble substrates in a plane bed channel structure, in contrast to the preliminary Phase 1 B cobble step-pool typing. The waterfalls account for the large majority of elevation change in this segment, and the rest of the segment is a c subslope (<2 %). An old mill foundation and significant walling of the channel below this indicate that the artificial valley created by this confinement is of a long-standing historical nature, and the segment was designated a subreach with a modified Bc cobble riffle-pool reference type. The plane bed structure is related to adjustment processes in relation to bulldozing both above the waterfalls and below this segment (on the Blood Brook mainstem) following the 1973 flood.

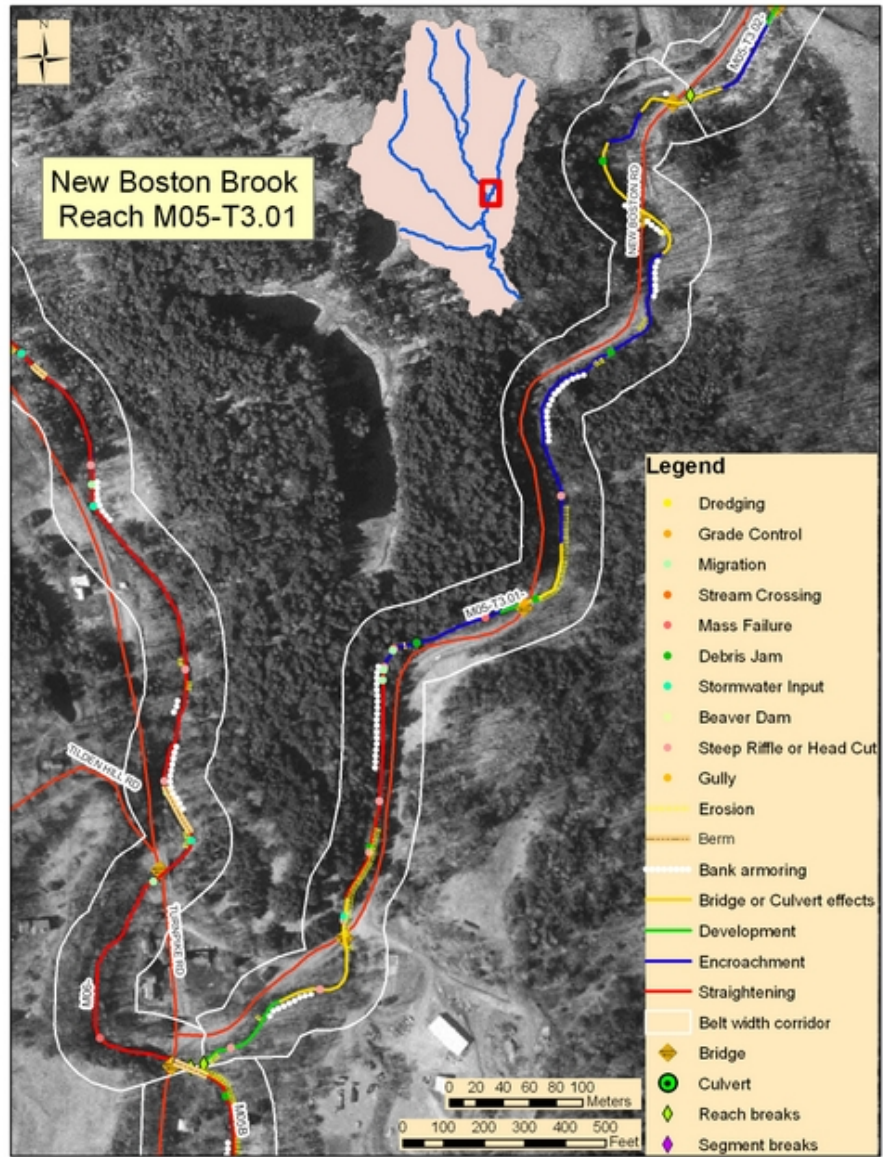
Figure 32. Reach M05-T3.01 is known locally as “the crooked half-mile”.

continues upstream to the top of what is known as the “crooked half mile” on New Boston Road (Fig. A-32). At the top of the reach, the landscape broadens into a wide valley. This reach drains 2.79 square miles, is 3302 feet in length, and was left unsegmented. It is characterized by a narrow valley, and the stream was moderately to severely encroached upon by New Boston Road. There were many road crossings within the reach, including one bridge and three culverts. They all represented some channel constriction. An old abutment within the reach was a significant channel constriction but not a floodprone constriction, as it would flood during major flood events.

*Potential project identification – Reach M05-T3.01:* General discussions of infrastructure protection and development of a stream corridor protection plan included in Section 7 – Recommendations within the main body of this Blood Brook Watershed Phase 2 report are highly relevant in this area. Flood prone height is above the grade of the road in many places within this reach. The valley has been somewhat broadened by road construction,

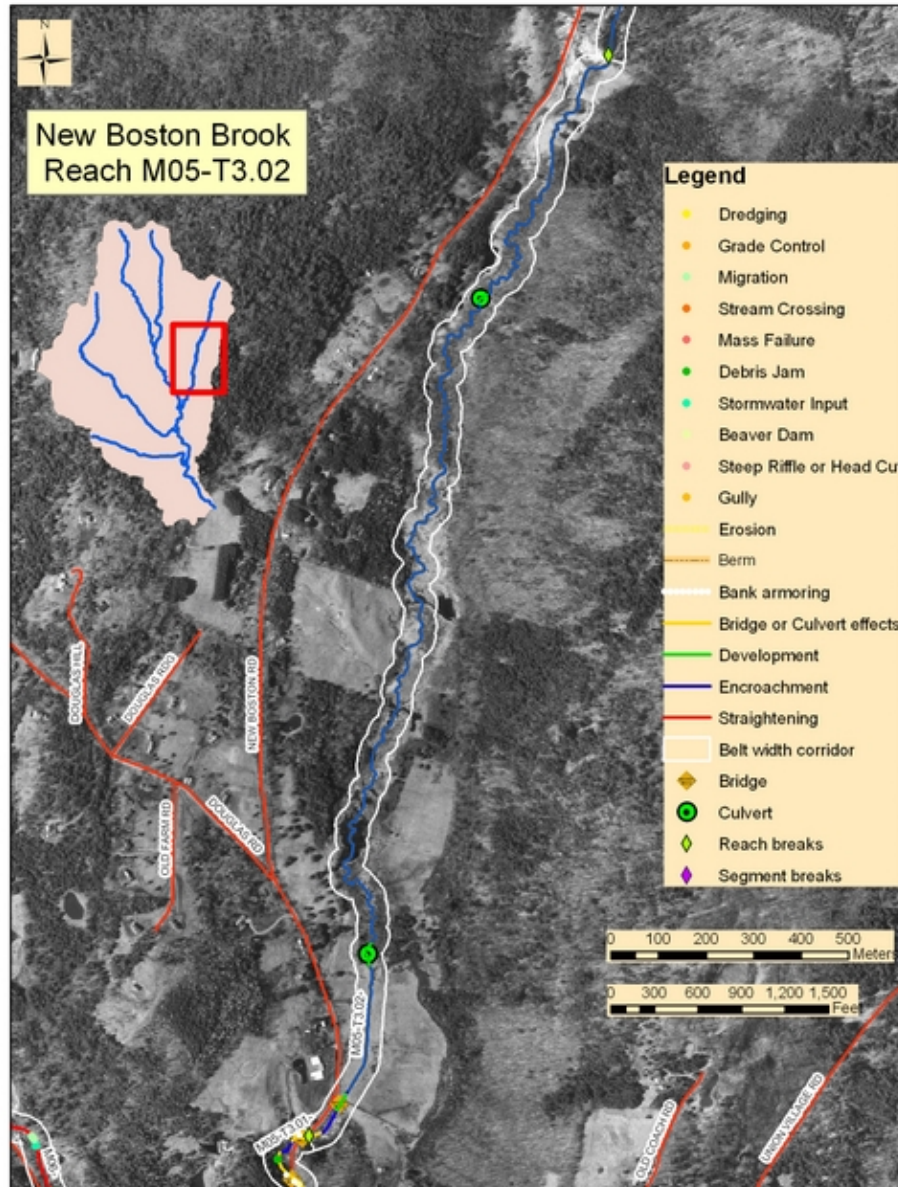
Figure 34. Reach M05-T3.02 on New Boston Brook.

Reach M05-T3.02 begins close to New Boston Rd. just upstream of a bridge near 177 and 190 New Boston Rds. and diverges from the road soon thereafter, extending along the bottom of a broad valley to the downstream end of an impoundment close to 688 New Boston Rd. (Fig. 34). This reach consists largely of shrub wetlands varying from 100-300 ft. in width and showed evidence of beaver activity; this activity presents challenges for maintenance of the bridge at the lower end of the reach in particular. Due to the extensive influence of the wetlands the reach was documented with photos but not further assessed.

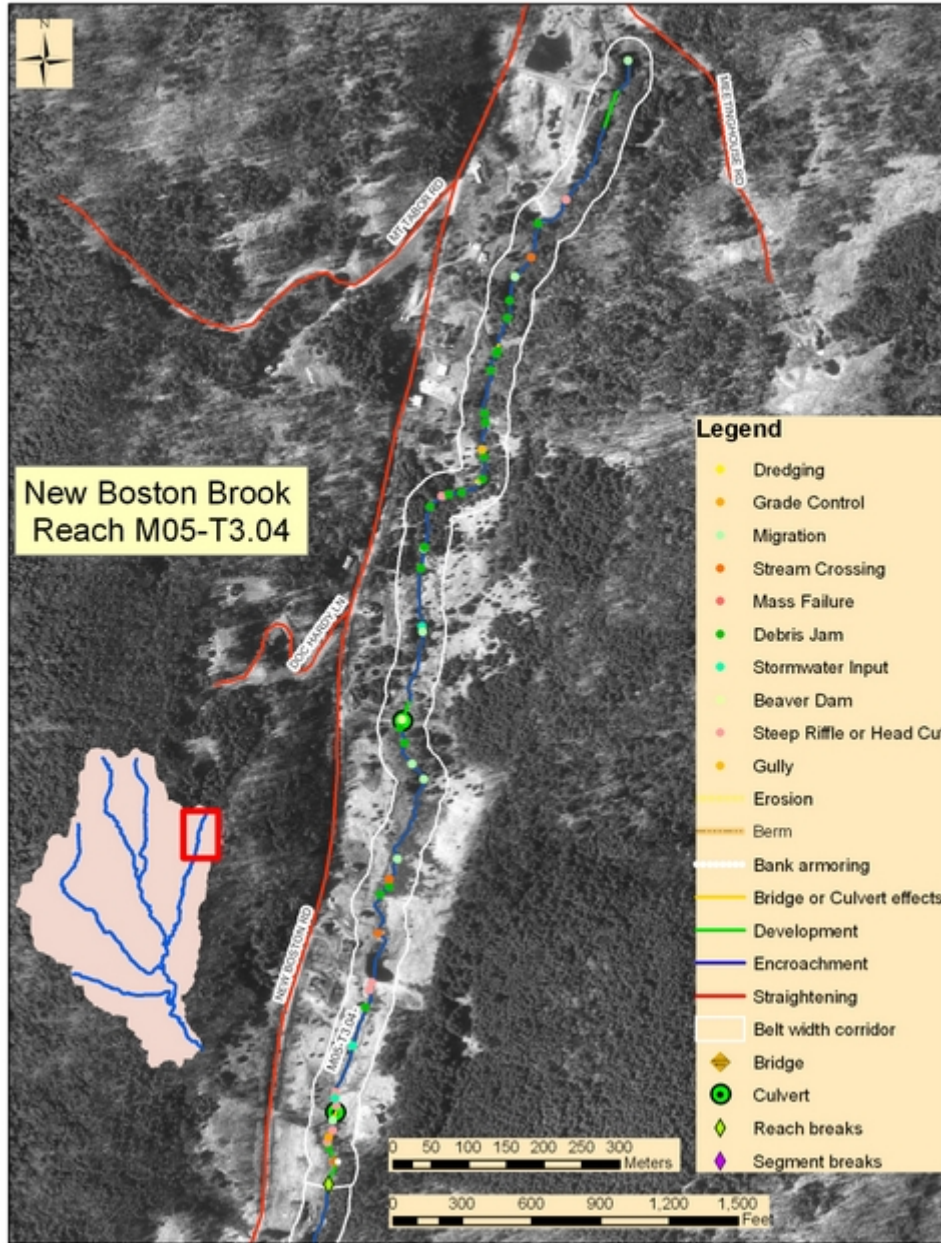
M05-T3.04 extends from the upstream end of an impoundment near 734 New Boston Rd. to just below Meetinghouse Rd.; it is a reach heavily influenced by four impoundments (Fig. 35). One of these is a beaver impoundment, and beavers remain active within the reach. The other three are constructs that appear to be largely human-maintained at this point but may have capitalized on previous beaver efforts, as the reach is located in a broad valley with extensive wetlands. Due to the influence of these impoundments and wetlands, the reach was mapped and documented with photographs but not further assessed.

**Figure 35. Reach M05-T3.04, like much of New Boston Brook, has extensive areas of shrub wetlands and numerous impoundments maintained by both humans and beavers.**
