# Mill River

## Phase 2 Stream Geomorphic Assessment

### Rutland County, Vermont

December 31, 2007

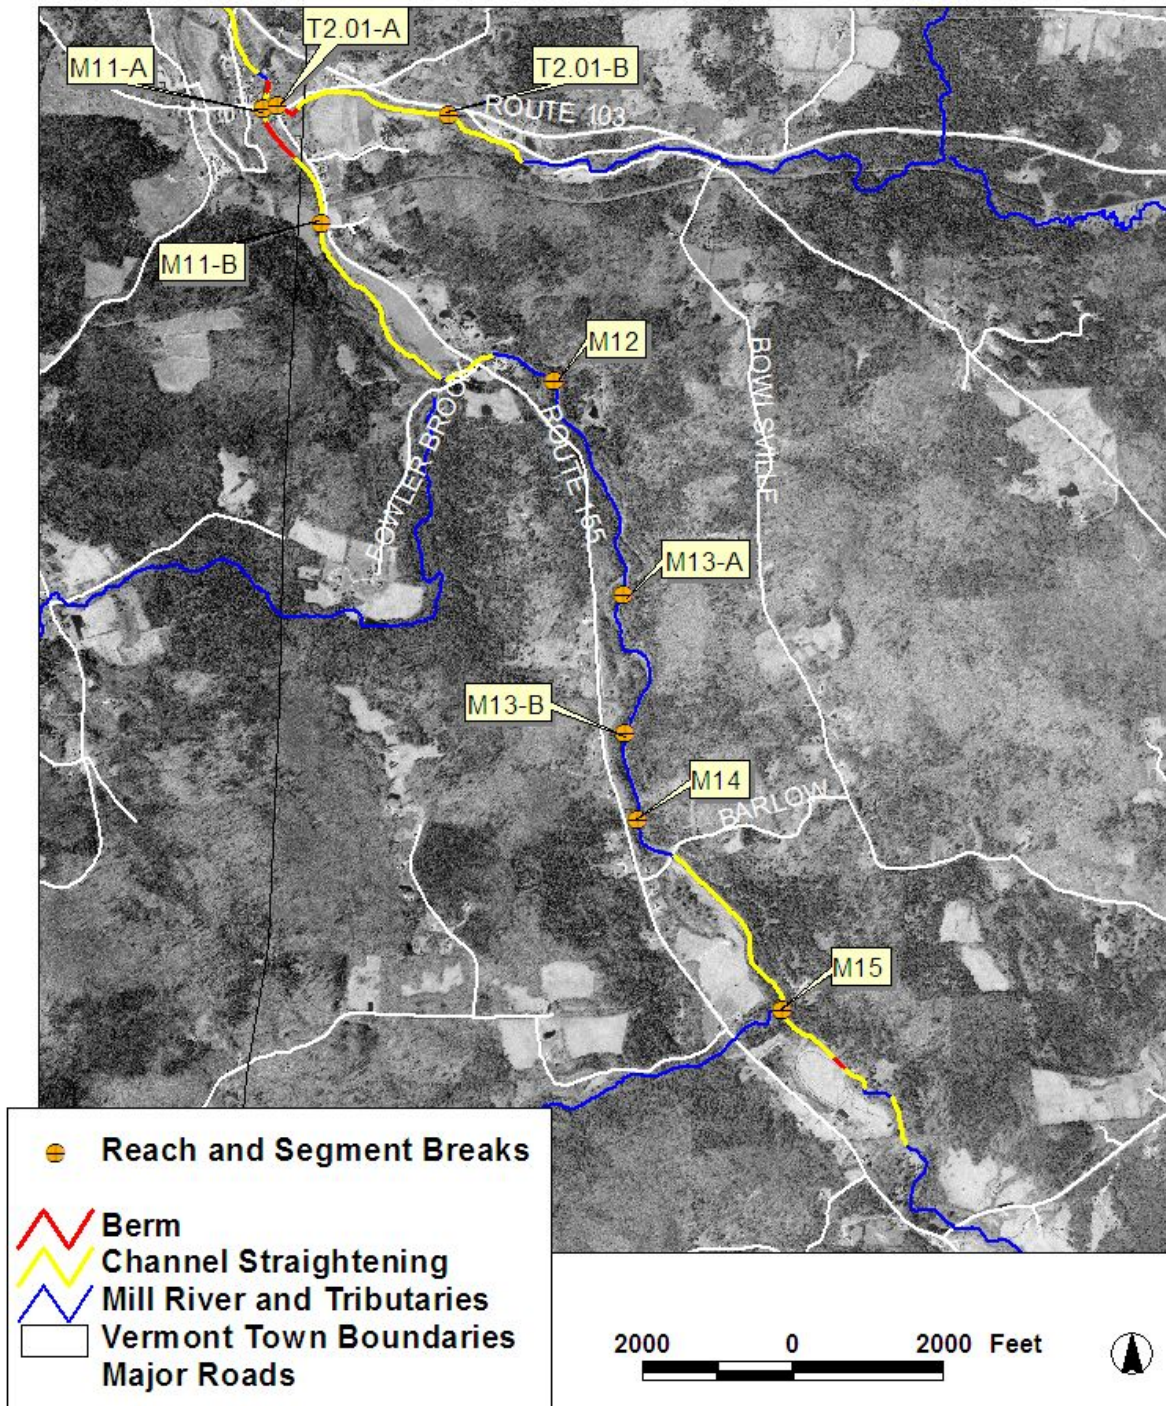
Figure 6: Overview of reaches M11 through M15 (including T2.01), and channel straightening and berming.

*The first section of river (illustrated in Figure 6) begins in Mount Holly and flows northerly towards East Wallingford Village. The valley alternates between very broad and narrow and land use changes from predominately agricultural and forested to commercial and residential in East Wallingford. Major significant impacts in this section include: removal of riparian vegetation, channel straightening, dredging, berming, channel armoring, and floodplain encroachment.*

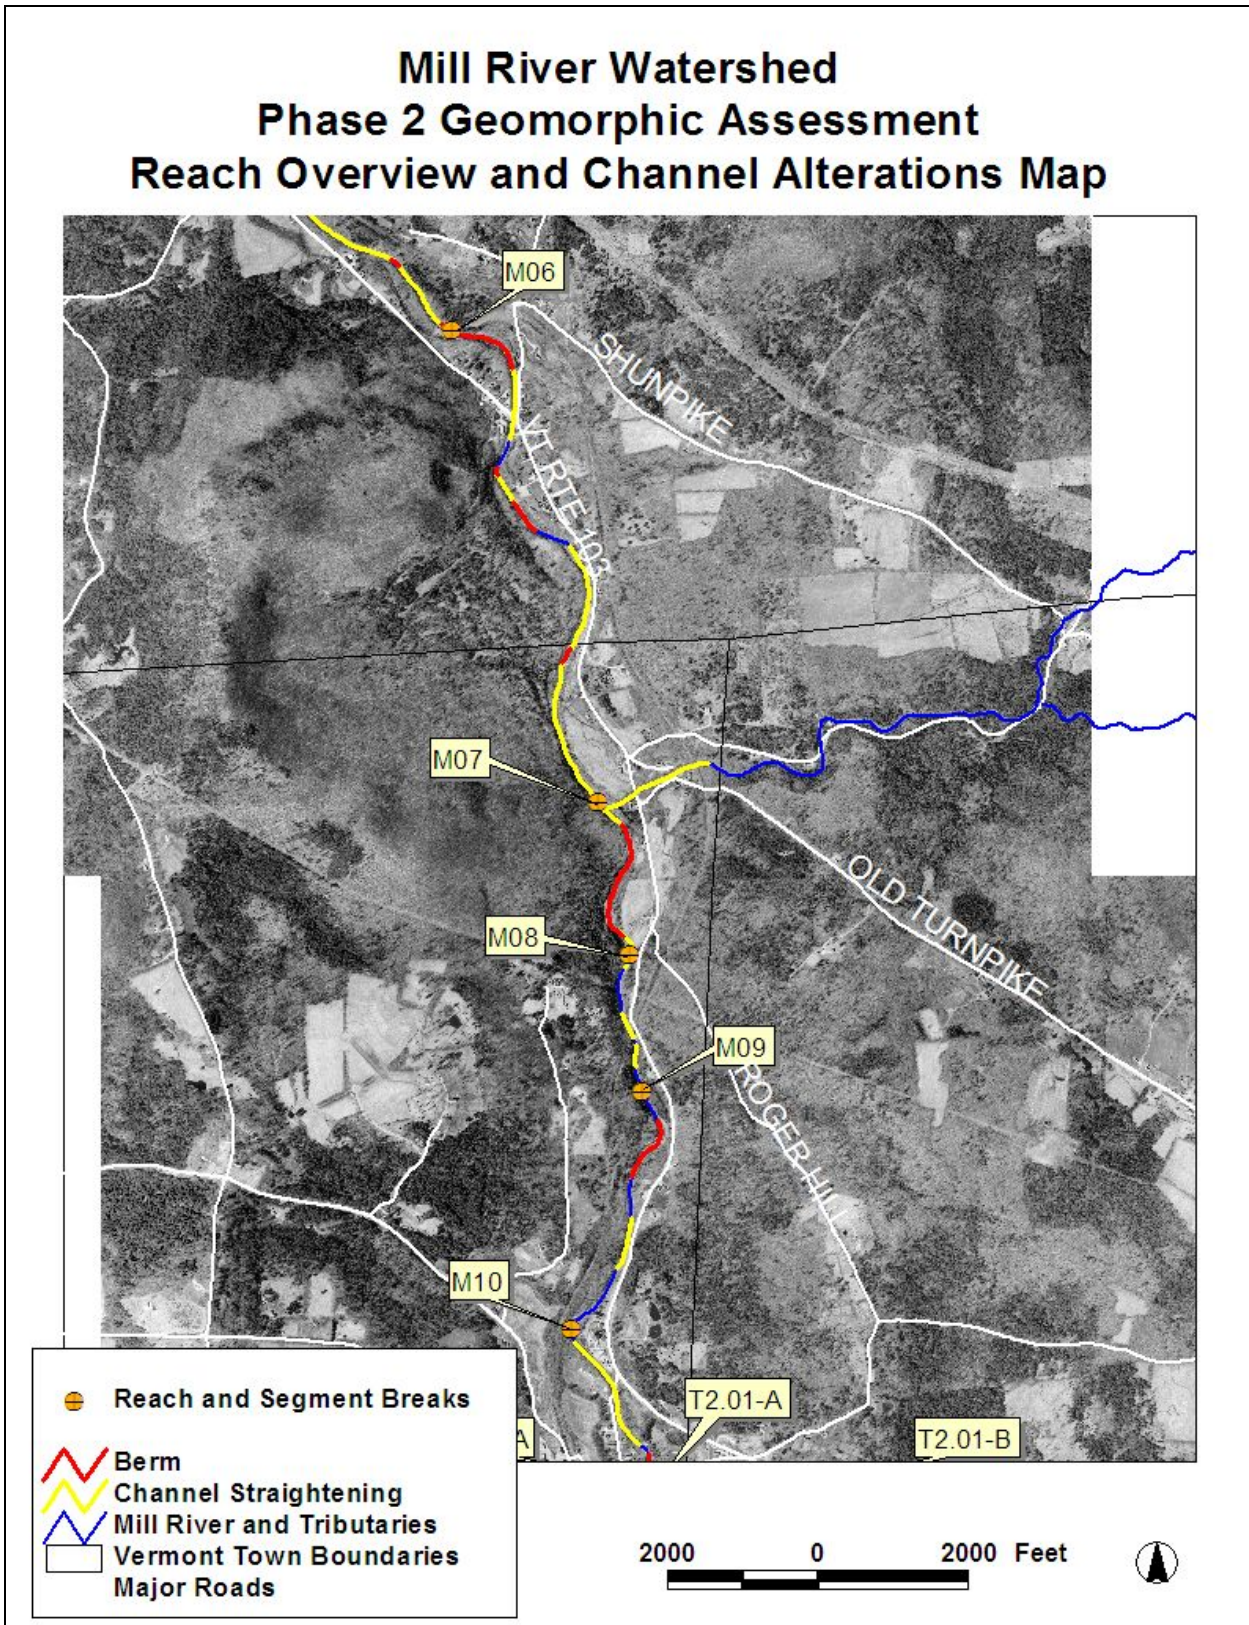
Figure 16: Overview of reaches M06 through M10 and channel straightening and berming.

*The second section of river (illustrated in Figure 16) begins below East Wallingford Village and continues downstream to Cuttingsville. The valley alternates between very broad and narrow and the land use changes from commercial and residential in East Wallingford to agricultural and then back to development in Cuttingsville. Major significant impacts in this section include removal of riparian vegetation, channel straightening and dredging, berming, channel armoring, and floodplain encroachment.*

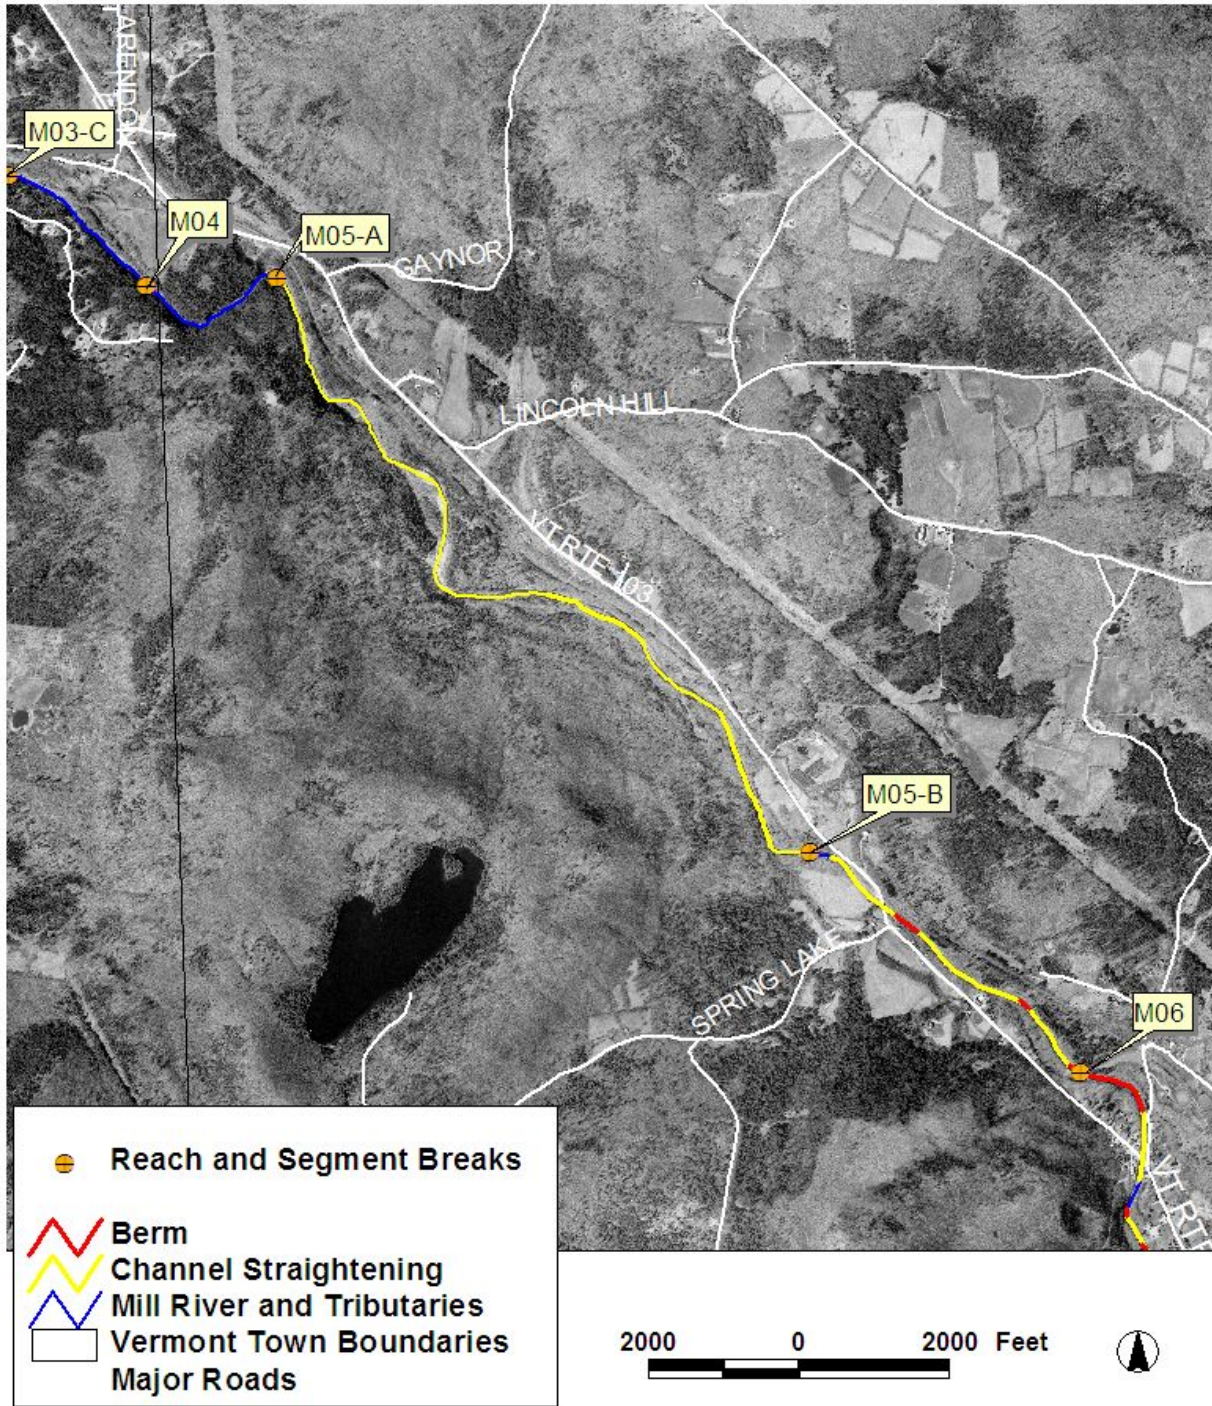
Figure 22: Overview of reaches M03-C through M06 and channel straightening and berming.

*The third major section of river (illustrated in Figure 22) begins just downstream of Cuttingsville Village. From here down to the upper Clarendon Gorge, the Mill River flows through a broad valley. Major significant impacts in this section include removal of riparian vegetation, channel straightening and dredging, corridor encroachment and an undersized bridge.*

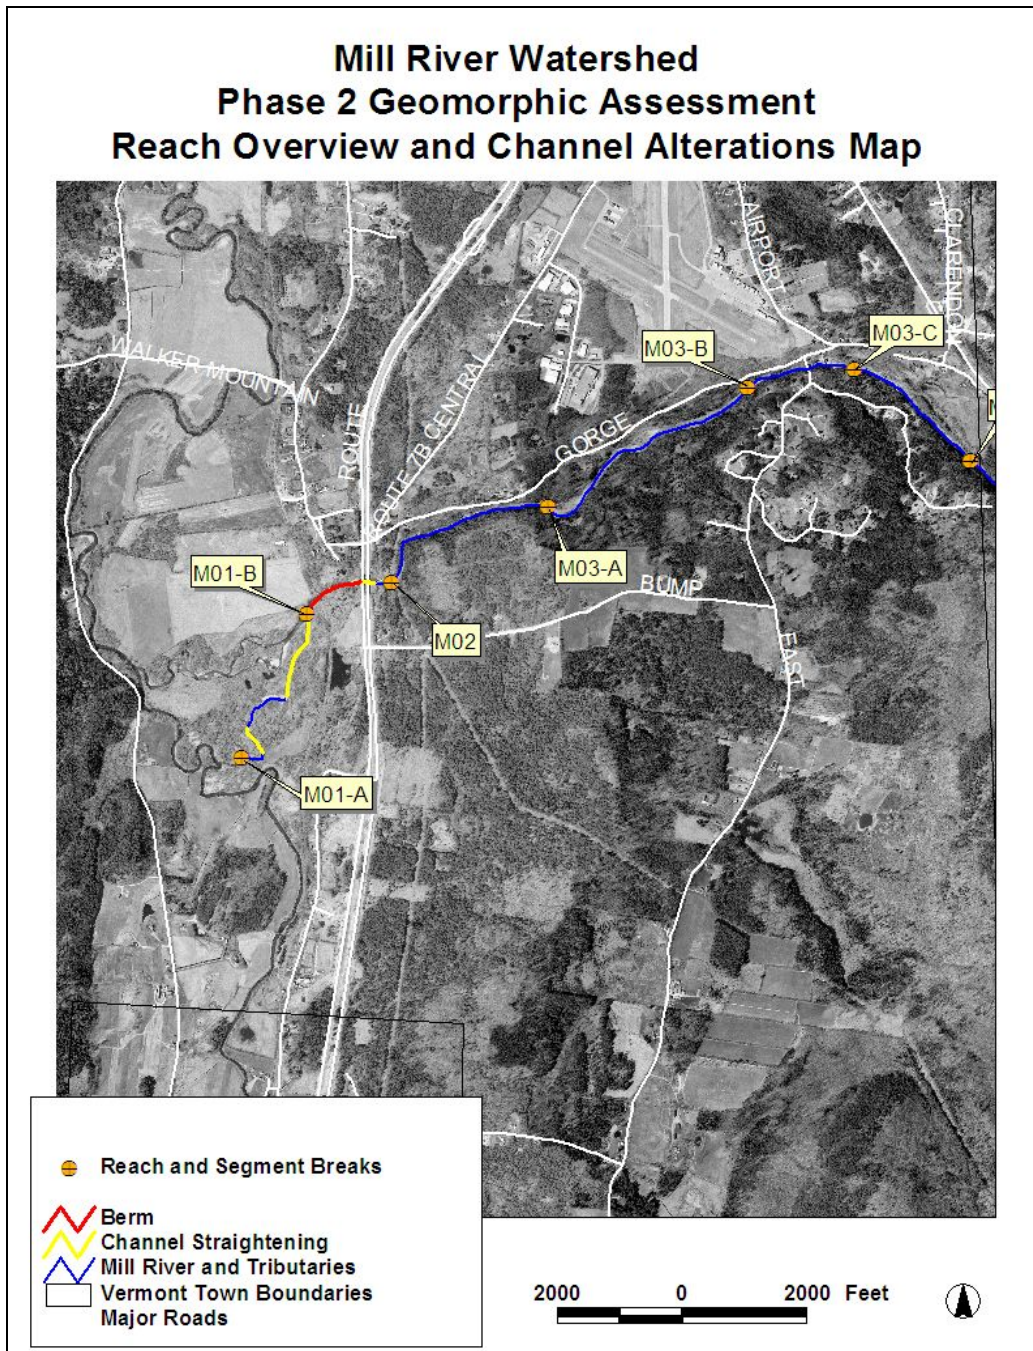
Figure 26: Overview of reaches M01 through M03 and channel straightening and berming.

The final section of river (illustrated in Figure 26) begins below the Upper Clarendon Gorge (near the Kingsley Covered Bridge) in the town of Clarendon. From here down to the confluence with the Otter Creek, the Mill River flows through a few bedrock dominated reaches bordered by state and federally owned wooded landscapes before spilling onto the much broader Otter Creek valley bottom. Major significant impacts in this section include removal of riparian vegetation, channel straightening, dredging, and several undersized bridges.

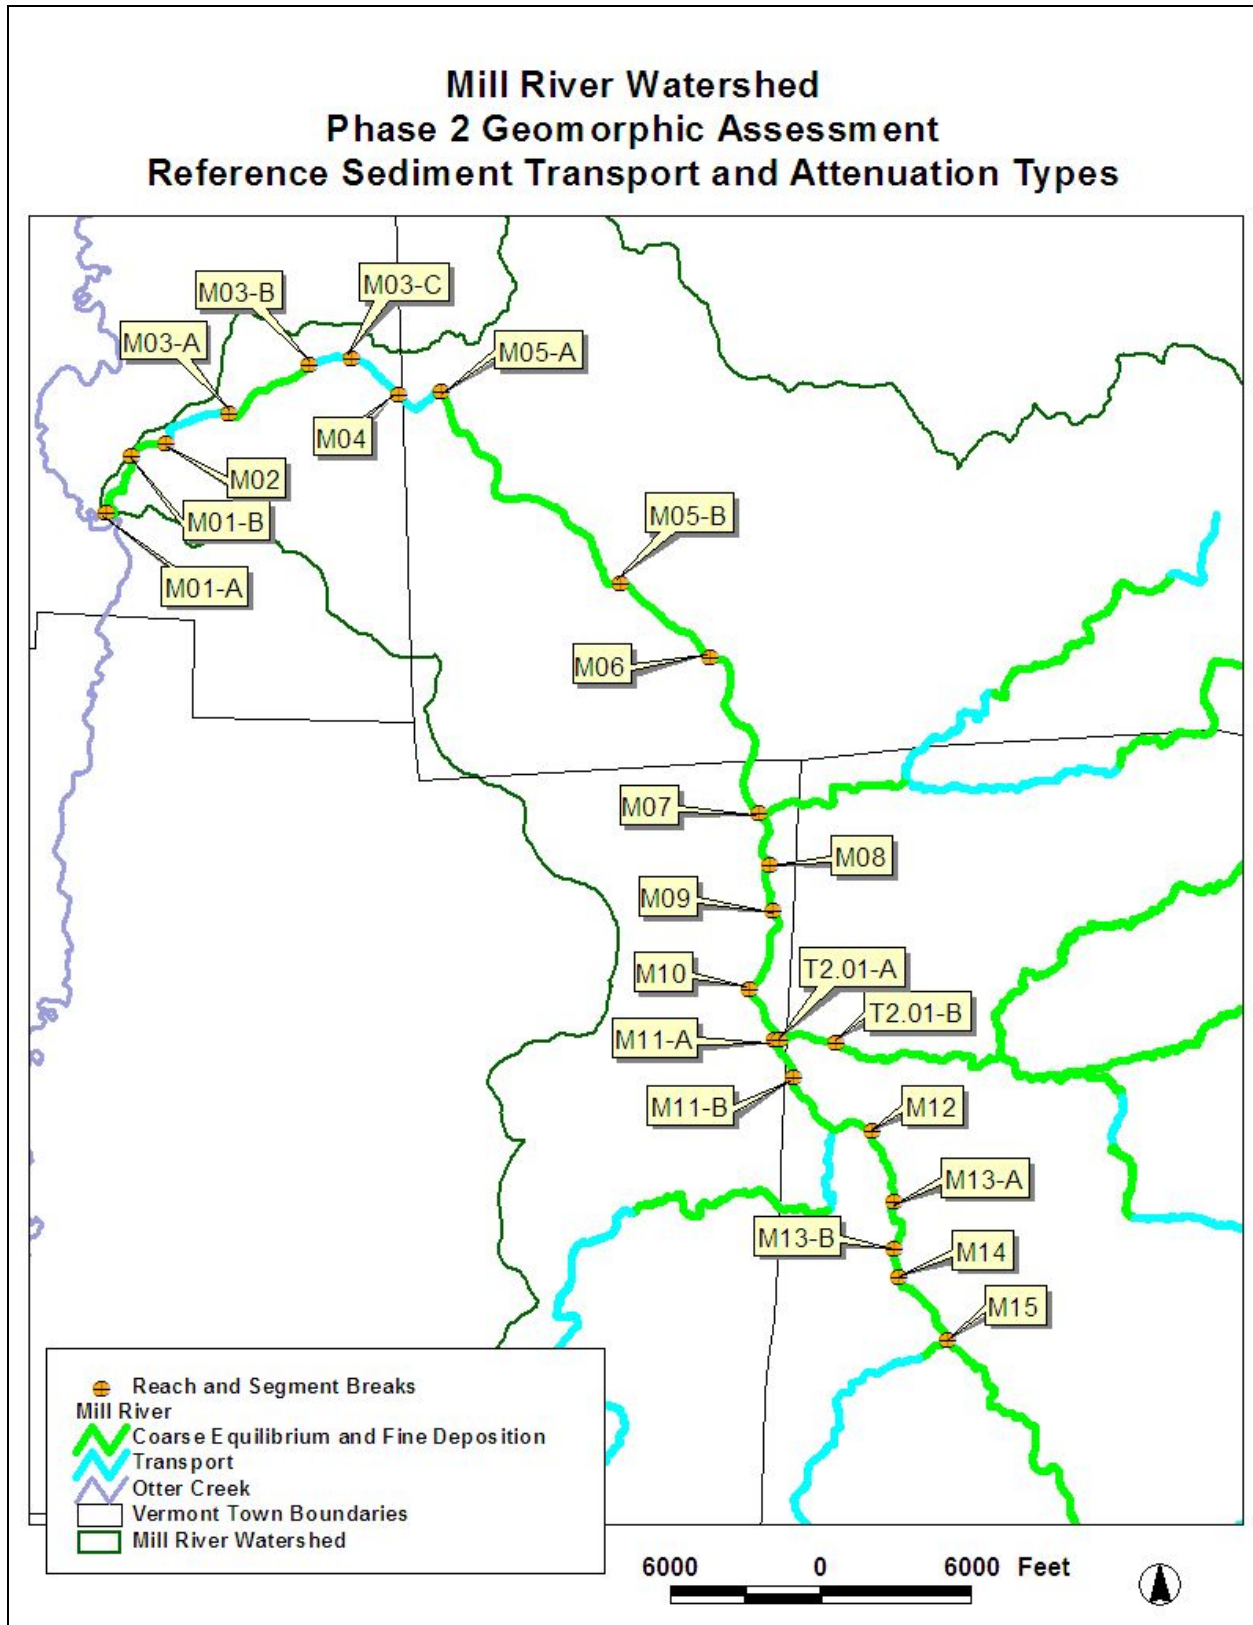
Figure 36. Sediment Transport and Attenuation under reference conditions.

Figure 36 indicates that nearly the entire main stem of the Mill River had the capacity to store fine sediments in the floodplain and to transport the normal balance of gravels, cobbles, and the occasional boulder downstream at a rate that was in balance with the inputs coming from the highest sources in the watershed thus leading to long term stability. Analysis of Figure 37, the current sediment regime map, indicates that numerous reaches in the upper Mill River watershed are sources of both fine and course materials. In areas where course deposition is occurring in the upper watershed this deposition may be at occurring at a high rate (leading to numerous mid channel bars and channel migration and conversely the human response

which has been the dredging of this accumulating material) such as in reaches M11-B and M06.

The excessive degree of departure in the upper watershed presents two situations downstream. First, the downstream reaches may be moving towards excessive aggradation of material (such as in reach M05-A) and therefore a high degree of lateral channel adjustment and bar building. Second, the storage capacity of these downstream reaches is a key asset to the watershed and the receiving watershed, the Otter Creek (and eventually Lake Champlain). Finally, analysis of these maps reveals that restoration of attenuation capacity in the upper reaches of the watershed, especially above the village locations of East Wallingford and Cuttingsville, may be helpful to restoring some of the overall equilibrium of the Mill River watershed.

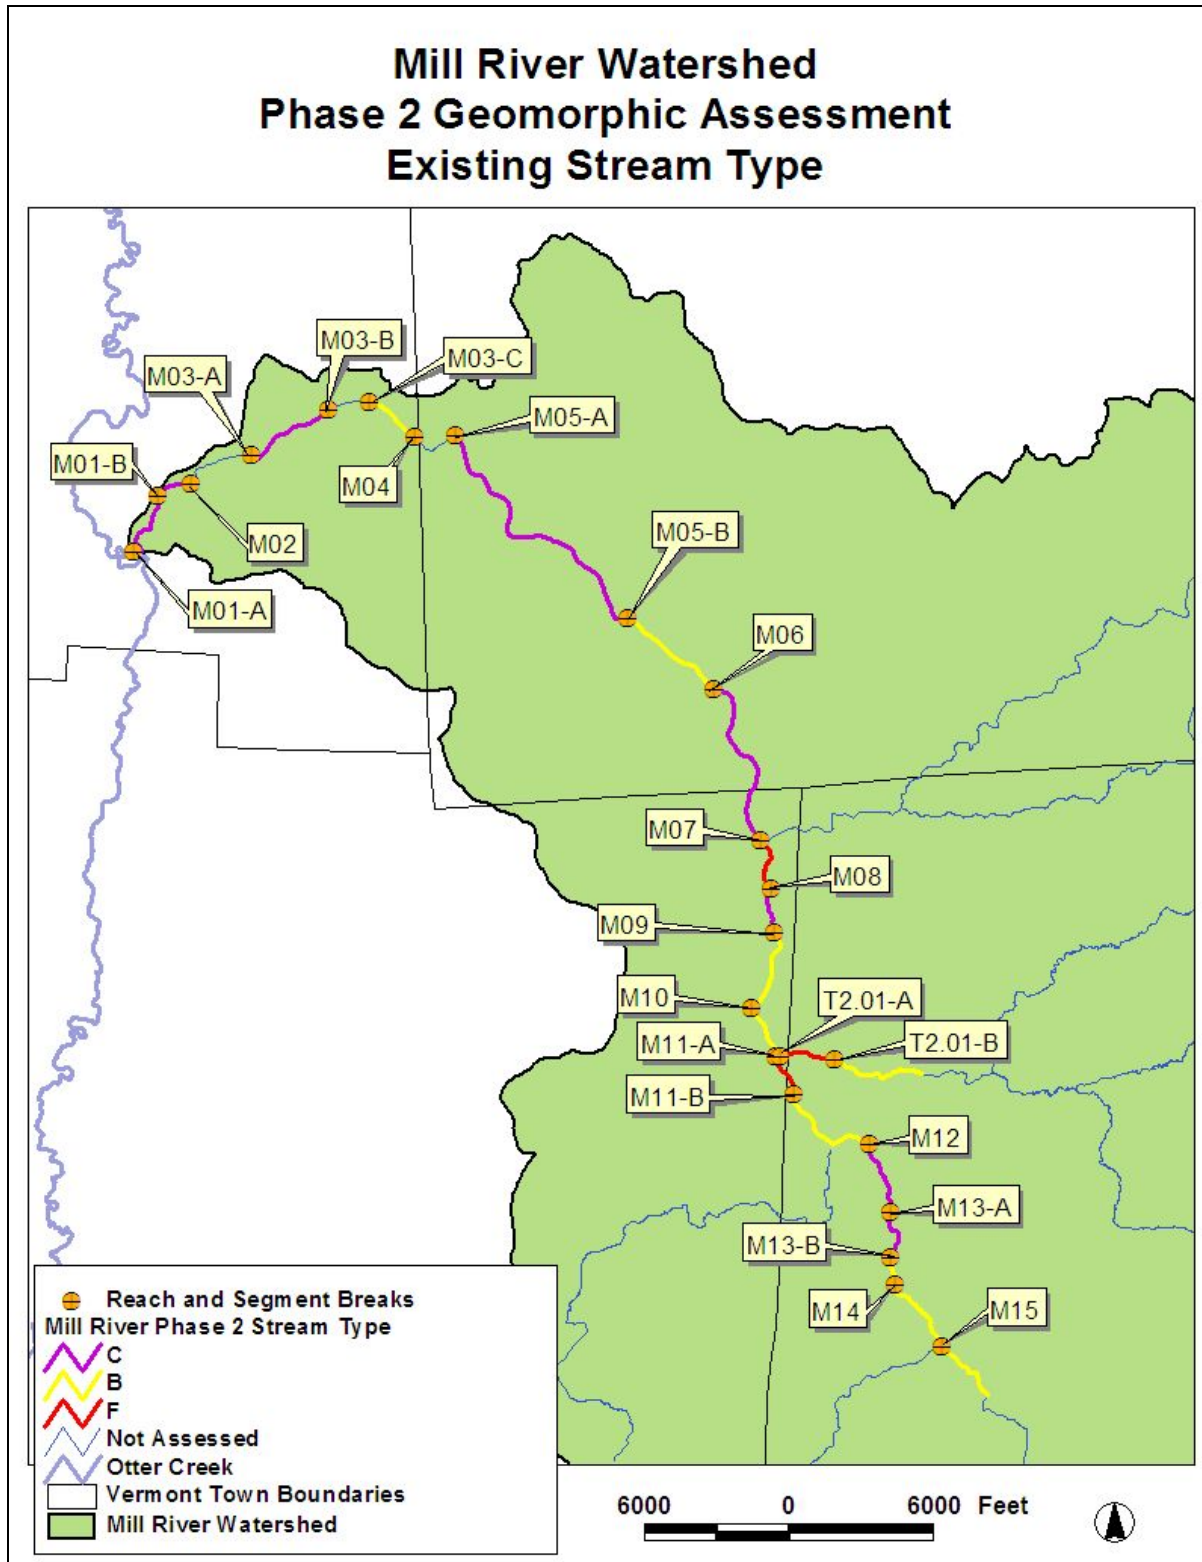
Figure 38. Phase 2 Existing Stream Types

Figure 38 is a map presenting the existing stream types found in the Mill River watershed. Most of the reaches are Rosgen (1996) "C" channels by reference. C channels have wide valleys and moderate to gentle gradients. B channels have moderate to steep slopes and have narrower valleys than C channels. The stream sensitivity of these reaches, categorized according to ANR protocol, is depicted in Table 5 and in Figure 39. For the most part the Phase 2 purposefully studied reaches that would be expected to exhibit a higher sensitivity and be undergoing active adjustments. It is not surprising therefore that all of the study area reaches were defined as having high, very high, or extreme sensitivity. The exception being the bedrock controlled reaches M04, M03-B, and M02 which have a greater resistance to rapid adjustment due to the underlying bedrock and lateral constraints.
