Fluvial Erosion Hazard Mapping and Phase 2 Assessment Report

For the Municipalities of
Georgia, Highgate and Saint Albans City

~Northwest Regional Planning Commission~
February 2008

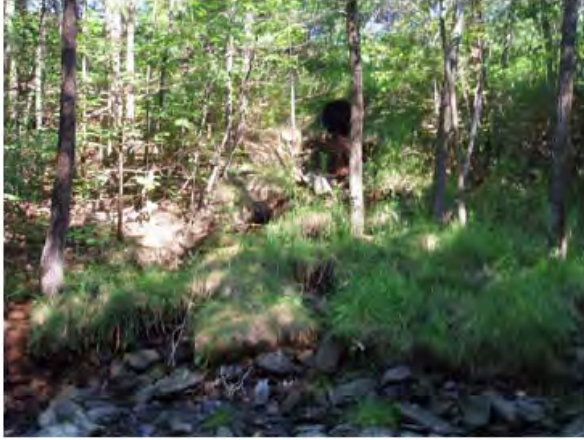
Urbanization is most prevalent in the southern portion of Deer Brook, in the areas of M01, M02 and M03, and Phase 1 data indicates that a majority of the Deer Brook watershed is impacted by greater than 20% urban land use, which is likely a predominant stressor on the watershed (see Hydrologic Alterations Map for Deer Brook). While reaches M01 and M02 are located within the commercial district, the buffer is greater than 100 feet and the stream is somewhat protected from the encroachments by very steep valley walls. Most of M02 and some of M01 is adjacent to the Georgia Industrial Park (though it is outside the corridor). Overall, it appears that urbanization is indeed a dominant stressor to the Deer Brook Watershed. Stormwater impacts (increased flows and an increase of sediment input) resulting from this urbanization are most prevalent in the downstream reaches (See Figure 2).

Figure 2: Deer Brook M02- Stormwater Input

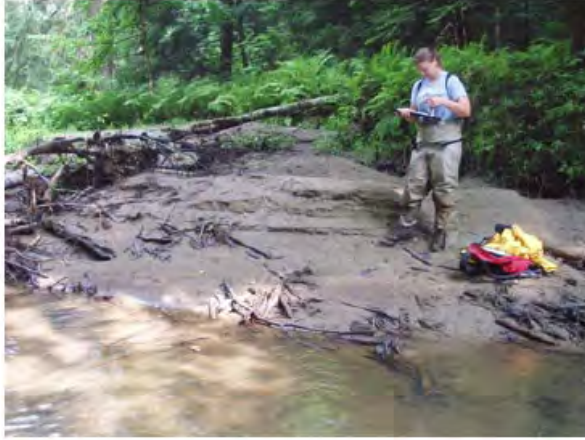
In general, the sediment supply has increased throughout the watershed, and is most prevalent in the two ends of the mainstem: M5S3.01, where erosion and mass wasting are occurring in response to historic straightening; M02, where the reach is adjusting to several sources of sediment input from the adjacent urban land use and includes several mass failure locations; and M01, where a large accumulation of very fine sediment was observed on the bed (See Figures 7 and 8).

Figure 8: Deer Brook M02- Silt Accumulation

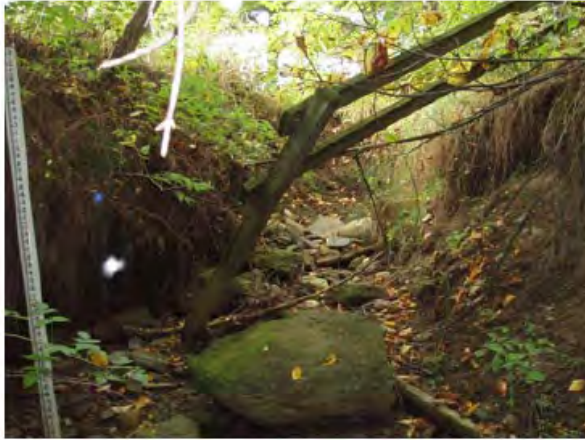
On the Mill River mainstem, some of the stream segments were observed to have significant erosion or mass failure including: M01C, M01D, M03, M04A, and M08. In addition, several of the small tributaries were observed to have significant erosion including M2T2.01, M2T2.02A, M2T2.02B, M2T2.2S1.2S2.01A and B, M2T2.2S1.2S2.02A and B, M2T2.2S1.03, and M2T2.06C (See Figure 9). The erosion observed in these segments is considered to be a response to several different stressors (including straightening, increased flows, agricultural inputs, etc). In addition, three gullies, which add a significant amount of sediment to the stream, were observed throughout the assessed area: M2T206C, M2T2.2S1.2S2.02A, and M2T2.02B (See Figure 10). Rejuvenating tributaries were also observed in segments M01E, M2T2.06C, M7S2.01A, and M2T2.2S1.2S2.01B. These rejuvenating tributaries add sediment to the segment as the elevated tributary stream bed degrades to meet the elevation of the receiving segment.

Figure 10: Mill River M2T2.2S1.2S2.02A- Gully

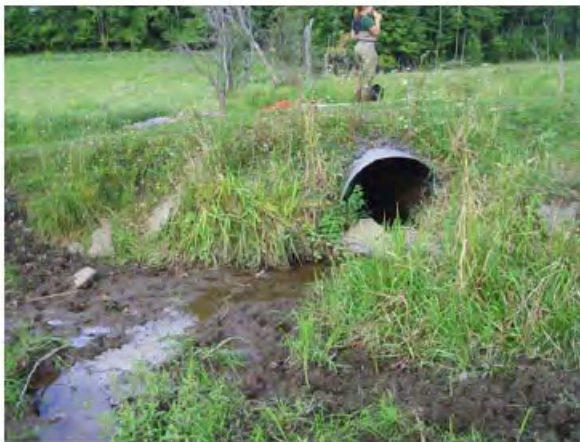
observed in M06B and M5S1.01B, which has caused localized erosion and compaction (See Figure 14).

Figure 14: Stonebridge Brook M5S1.01- Animal Access to Stream

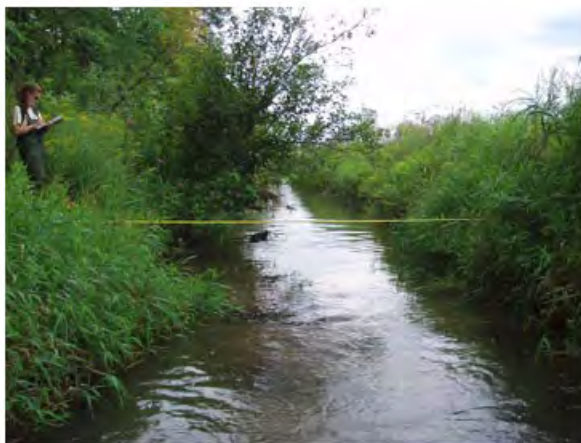
In general, stream power has increased throughout most of the Mill River watershed. Development and agricultural land use activities have resulted in an increased channel slope of most of the assessed reaches within Mill River watershed. The increased slope is an adjustment that is primarily in response to historic straightening, and/or road and development encroachments in-reach or upstream. The affects of channel straightening were most prevalent in the smaller tributaries in the southern portion of the watershed, mostly in agricultural areas, where several headcuts and some rejuvenating tributaries were observed (See Figure 15). Significant deposition above bridges and culverts was observed. Natural bedrock grade controls were observed throughout M01 as well as M04B, which are likely acting to hamper the effects of bed incision and bank instability resulting from the increased channel slope (See Figure 16). Human constructed grade controls, in the form of weirs, were observed in M04B and M05, in the vicinity of stream crossing structures. These weirs locally reduce channel slope; however, overall the watershed-wide stressors trump these two areas.

Figure 15: M07B- Straightening

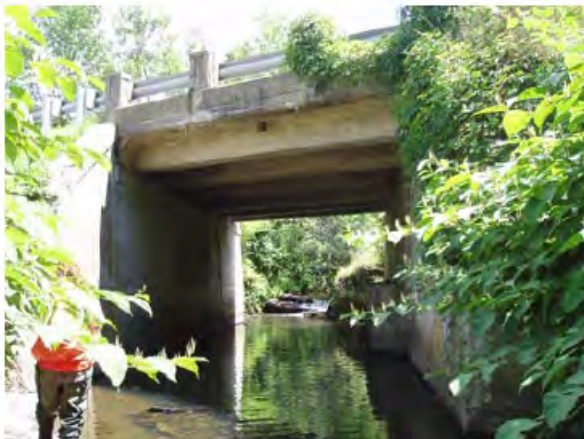
There are several natural bedrock grade controls acting as vertical and lateral constraints to the Mill River streams. Most of these major grade controls, consisting of waterfalls and ledge outcrops, are located in M01 and M04. There are also a few human made grade controls, in the form of weirs, located in M04B and M05 in the vicinity of stream crossings. The watershed is significantly impacted by several bridges and culverts to accommodate road crossings. Some of these structures, namely those on Ethan Allen Highway and other major roads, are considered floodplain encroachments due to their elevation constructed above the stream – not sure this makes sense (See Figure 19). These structures and the associated urban development will have significant impacts on the Mill River and its tributaries as agricultural land is converted to residential development in this area.

Figure 19: Mill River M05- Ethan Allen Highway Box Culvert

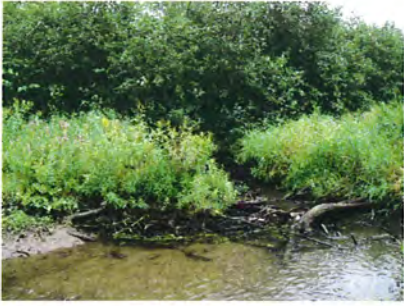
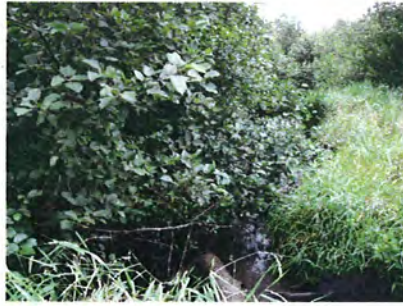
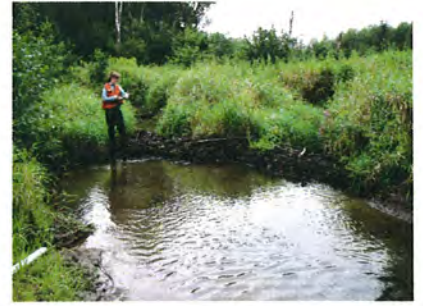
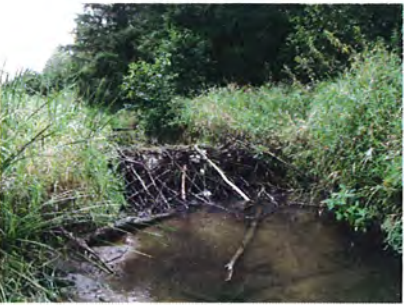
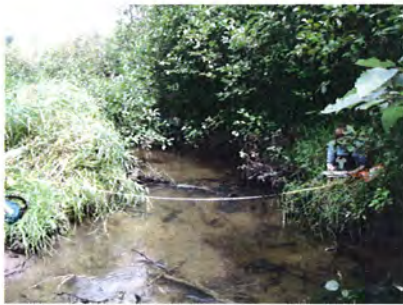
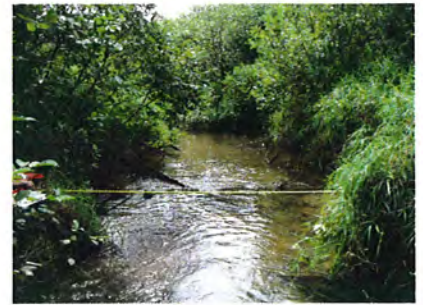
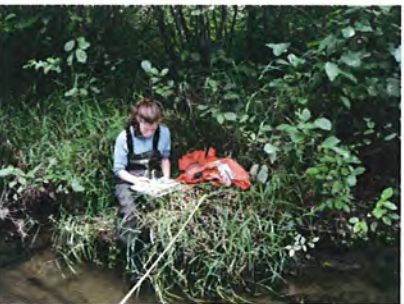
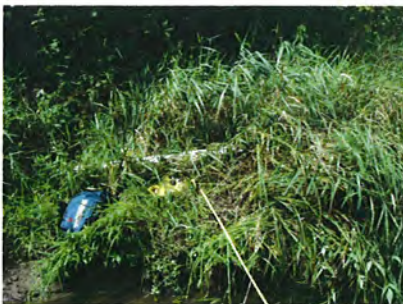
In M02A, aggradation was the major adjustment process observed, which was evident as an increase in fine sediment accumulations at constrictions, forming multiple unvegetated bars. The majority of the corridor is forested in the segment; however, moderate to high erosion was noted, and multiple mass failures were observed in bare areas, most consistently on the right valley wall, which is extremely steep. The Georgia Industrial Park is located immediately adjacent to the right valley wall, and is likely responsible for a portion of the sediment input causing aggradation in this segment. The RGA score for M02A was 0.50 (fair), with the stream in Stage III of evolution, and with very high sensitivity.

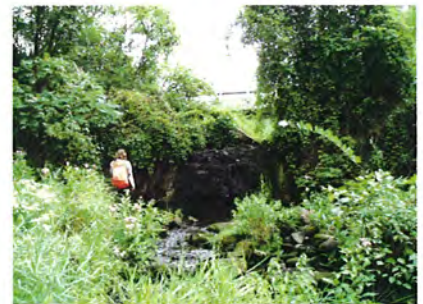
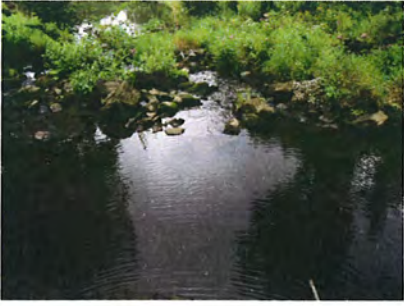
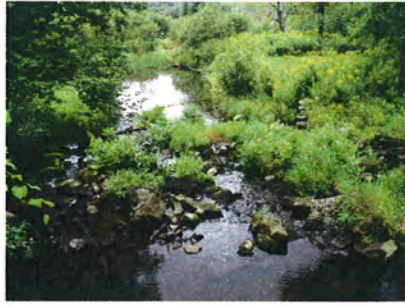
In M02B, less aggradation and widening were noted, and the substrate was dominated by gravel. The incision ratio (1.1) indicates minor incision. One single active headcut was observed downstream of a stormwater input and may be the result of increased flows during episodic events. Minimal bank erosion and some aggradation were observed. The RGA score for M02B was 0.69 (good), with the stream just beginning Stage III of evolution, and with high sensitivity.
