# Joiner Brook River Corridor Plan

**Bolton, Vermont  
February 21, 2009**

Prepared by: Bear Creek Environmental, LLC

Prepared for: Town of Bolton, Vermont

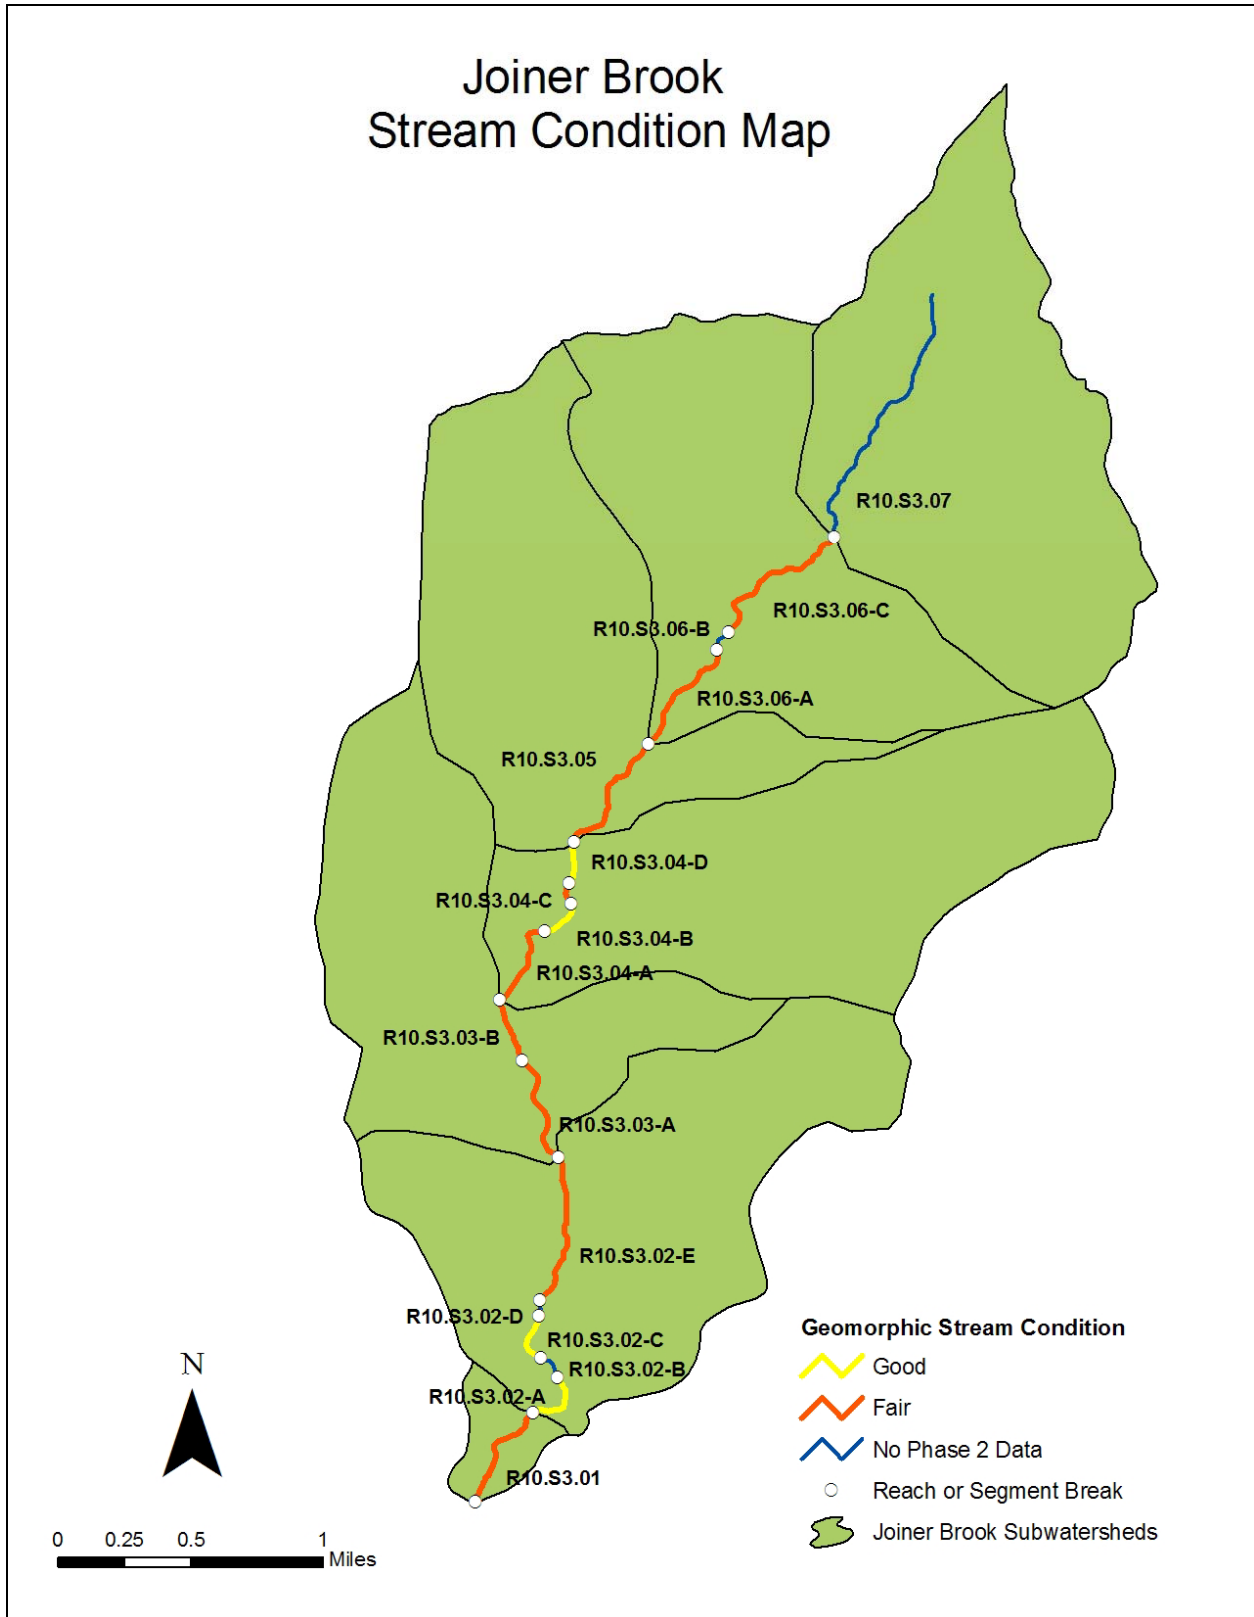
Figure 7. Reach condition map for the Phase 2 Geomorphic Assessment

The geomorphic condition for each Phase 2 reach is determined using the rapid geomorphic assessment (RGA) protocol, and is based on the degree of departure of the channel from its reference stream type (Vermont Agency of Natural Resources, 2007b). The reference stream type for each of the Phase 2 reaches was previously identified in Table 2. The six reaches of Joiner Brook that were assessed were further broken down into 16 segments based on different reference stream types. Of these 16 segments, Phase 2 RGAs were conducted on 13 segments, the remaining 3 segments were only partially assessed as they exist in bedrock gorges. Of the 13 segments where RGAs were evaluated, 4 segments rated in the good category and 9 segments rated in the fair category. Figure 7 illustrates the geomorphic condition of the streams in relation to the watershed.

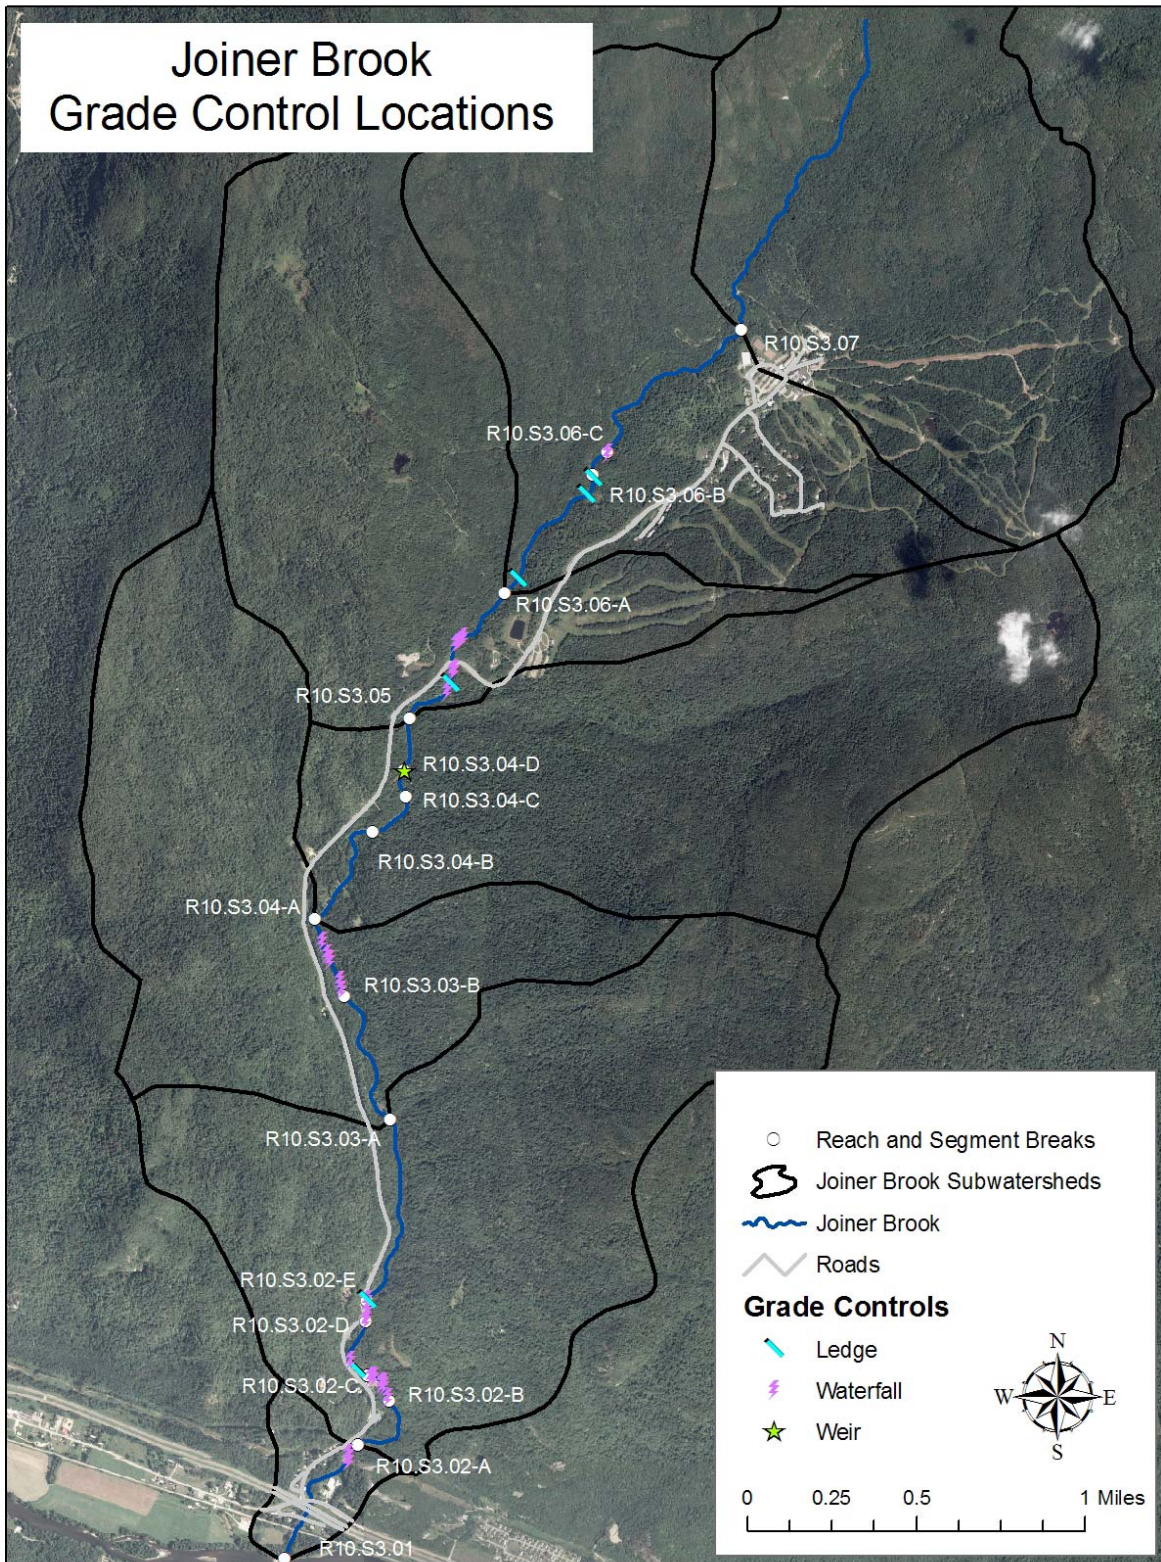
Figure 9. Grade Controls Locations on Joiner Brook

through a widening process to create a floodplain at a lower elevation. Segment R10S3.04-C is located just below Bolton Valley Resort's snowmaking weir and has likely historically incised as a result of being sediment starved due to the weir. The numerous grade controls (see Figure 9) along the entire length of Joiner Brook have likely helped to control incision along the length of the river. Two segments (R10.S3.04-B and R10.S3.04-D) were noted to be in stage I of the "F" stage model indicating these segments are stable and are not significantly aggrading or degrading. A cascade with large boulders at the top of R10.S3.04-B appears to be acting to hold the elevation of the bed. Multiple bedrock grade controls in R10S3.05 are contributing to vertical stability in R10.S3.04-D.

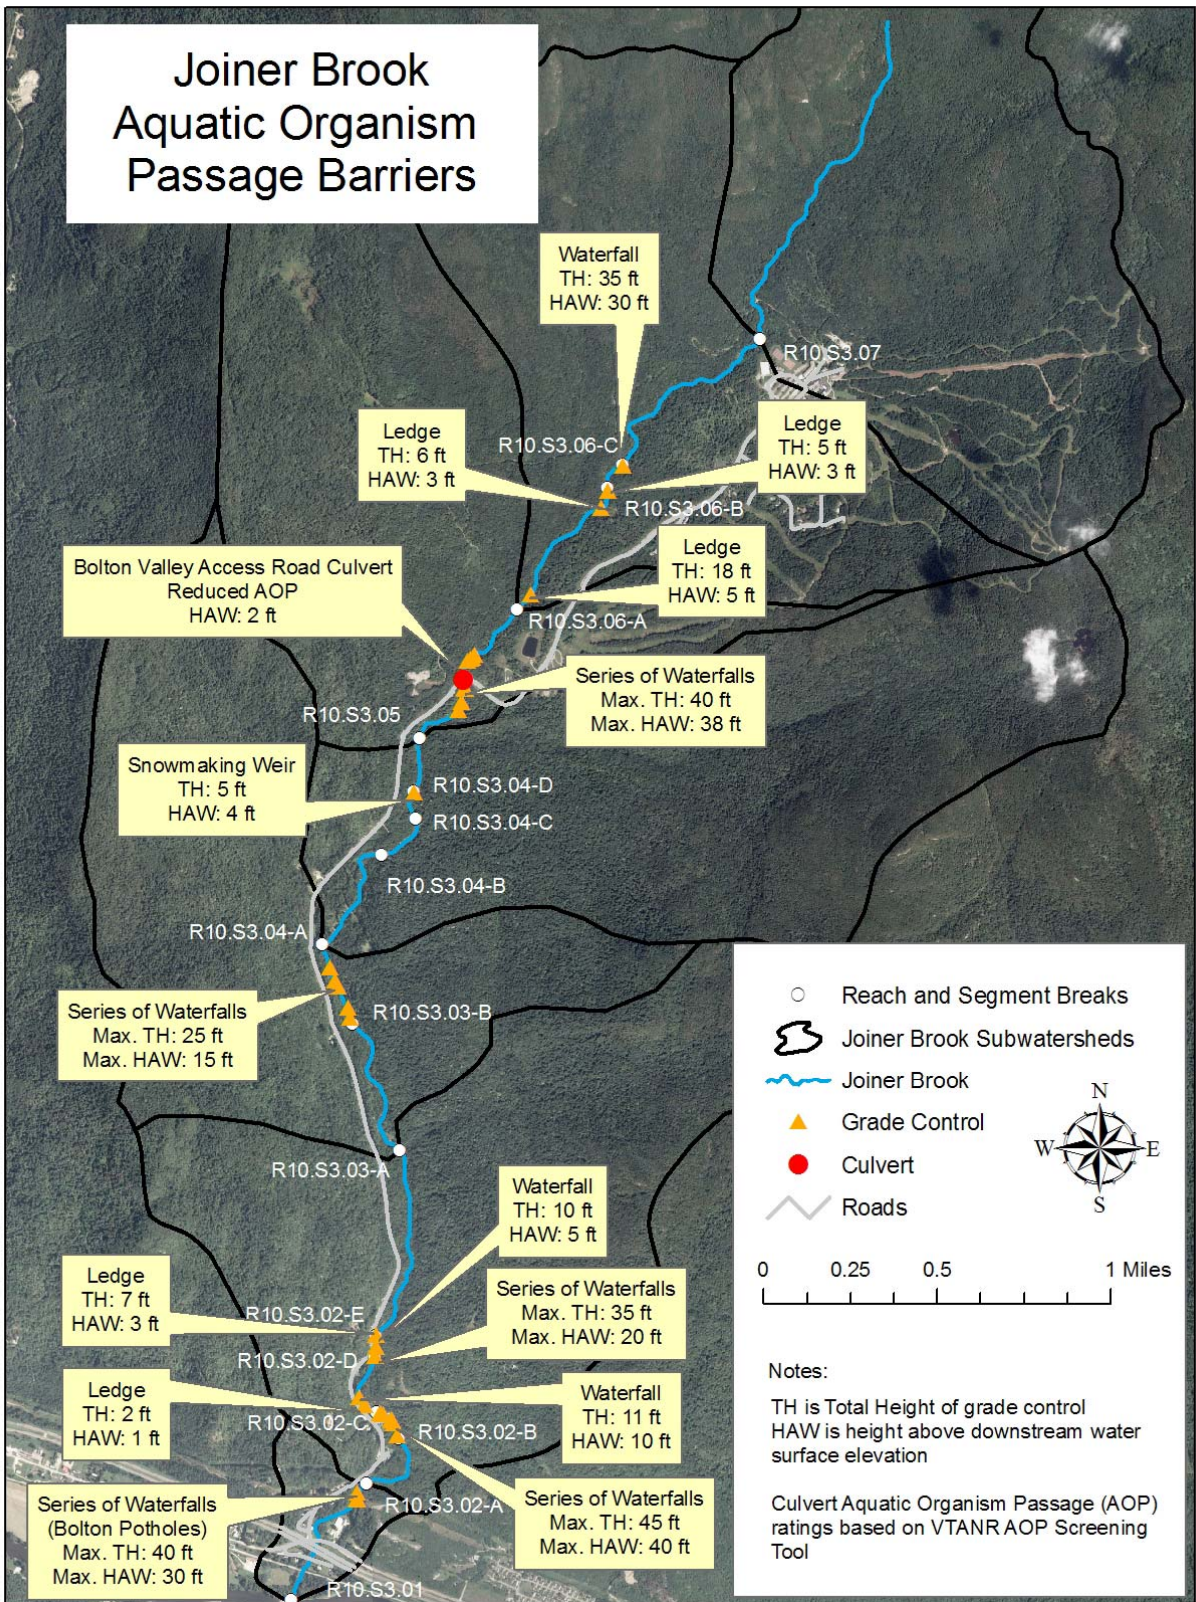
Figure 13. Aquatic organism passage barriers map

Natural and manmade obstructions are impeding passage of aquatic organisms throughout the study area. Figure 13 shows where there are culverts or natural barriers that are obstructions. Large waterfalls (higher than 10 feet) were found in segments R10.S3.01, R10.S3.02-B, R10.S3.02-C, R10.S3.02-D, R10.S3.02-E, R10.S3.03-B, R10.S3.05, R10.S3.06-A and R10.S3.06-B. Given the natural barriers to aquatic organism passage (e.g. waterfalls) the artificial barriers (culverts) are probably not the primary factor impeding fish passage on the Joiner Brook mainstem.

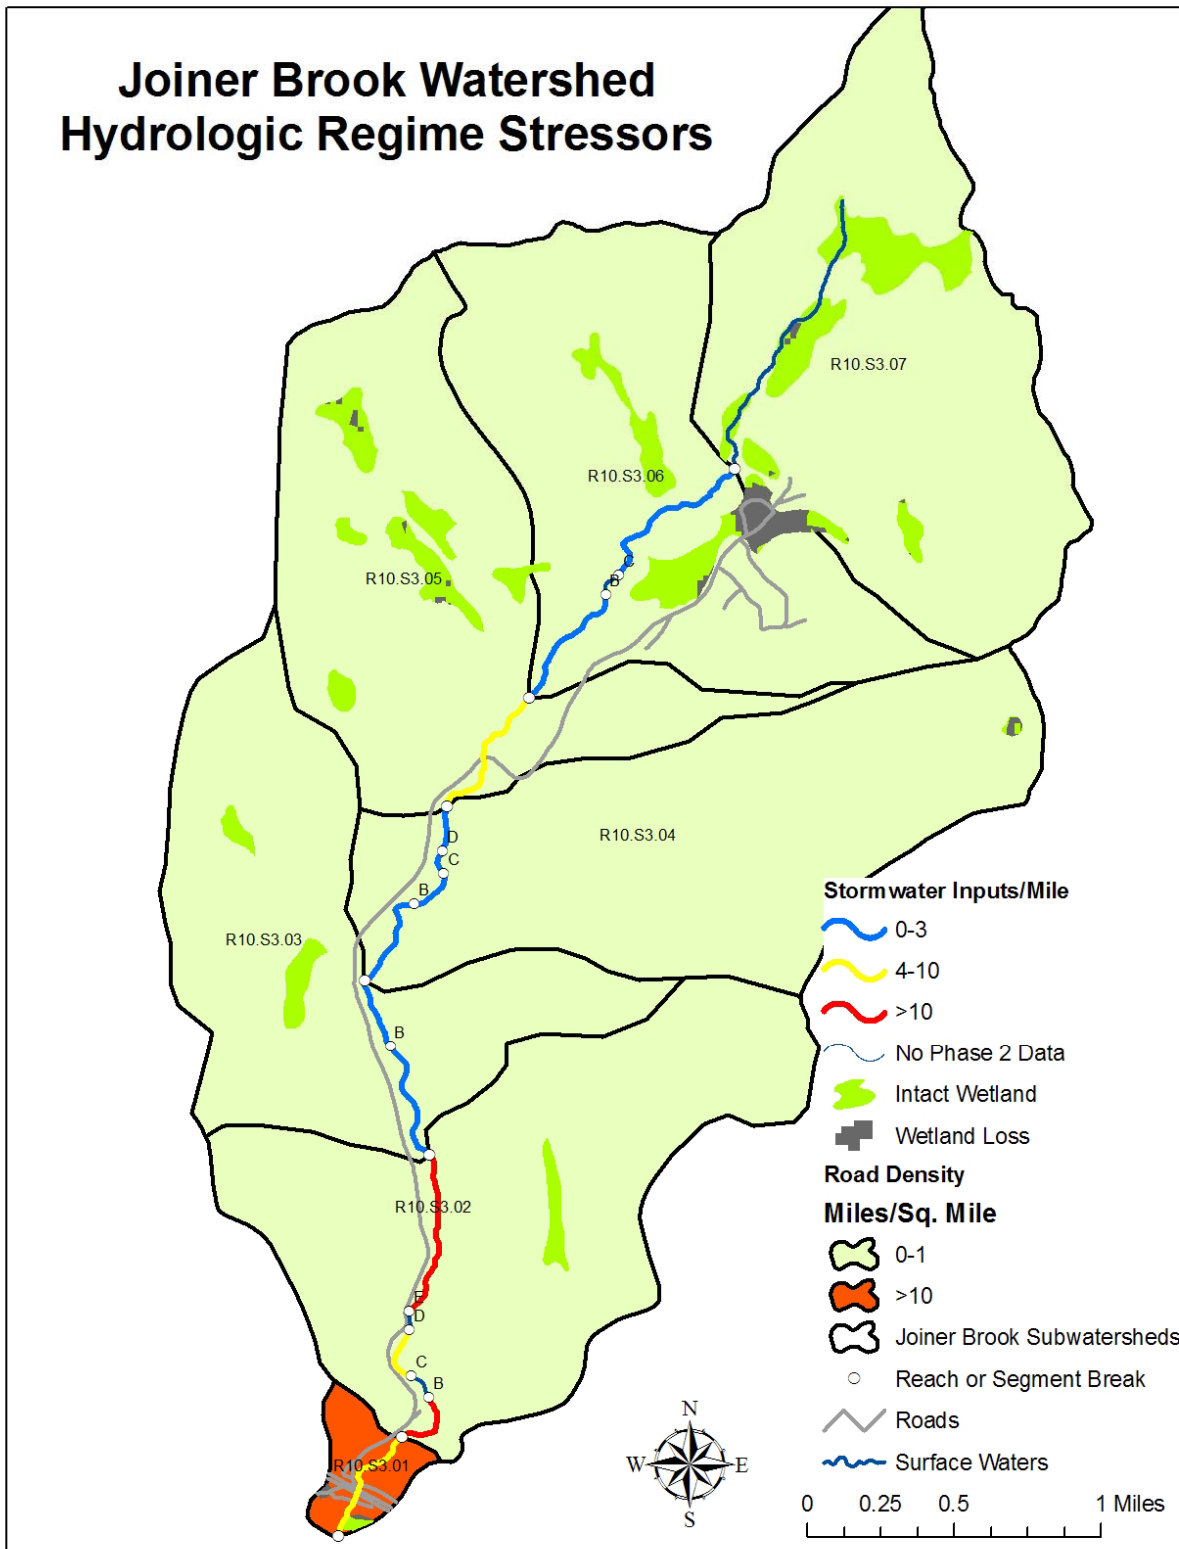
Figure 16. Land use map showing road density, stormwater influence, existing wetlands and lost wetlands.

The Joiner Brook watershed has a modest network of roads as shown in Figure 16. Only one subwatershed within the study area has a road density greater than 10 miles per square mile (R10.S3.01). According to Foreman and Alexander (1998), increased peak flows in streams may be evident at road densities of 3.2 miles/ square mile. All

other subwatersheds within the study area have road densities less than one mile per square mile. Numerous stormwater inputs from the Bolton Valley Access Road were mapped in the field. These stormwater inputs are responsible for increasing peak flows and for contributing sediment to Joiner Brook. Figure 16 shows segments in red where stormwater inputs per mile exceeded 10. This may contribute to localized increased flows resulting both from increased runoff and stormwater ditching in the lowest subwatershed.

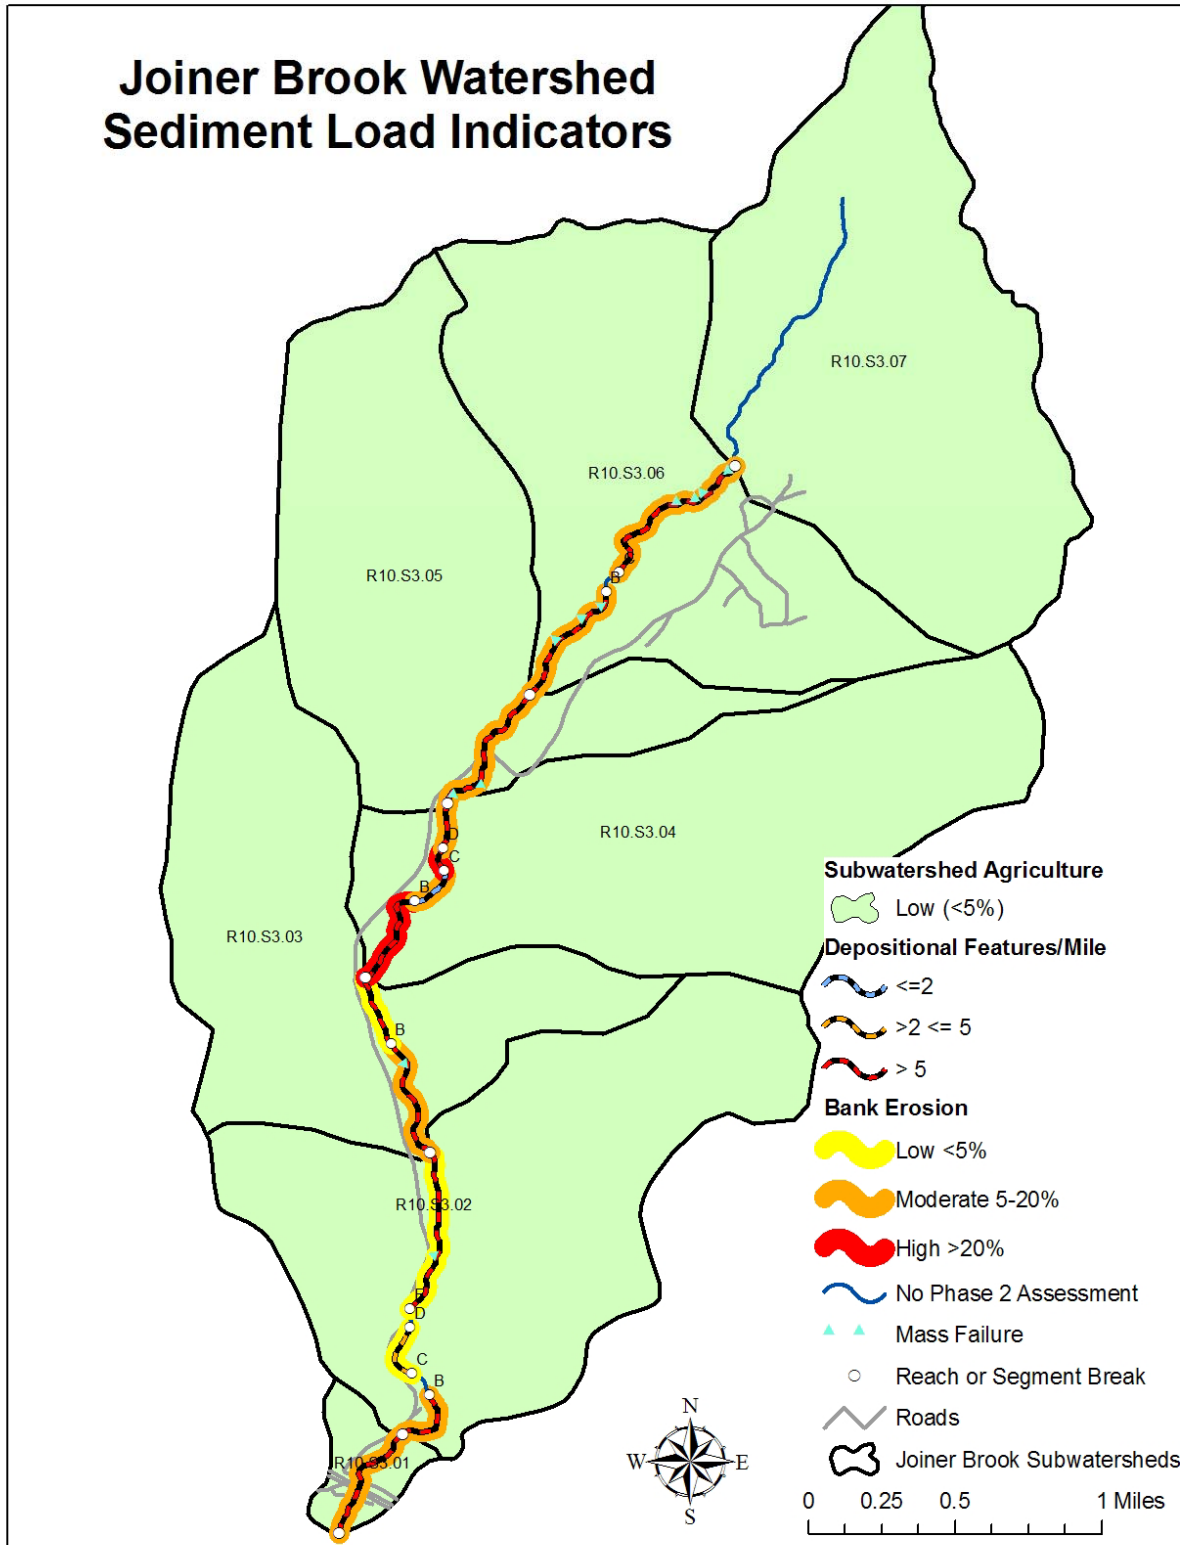
**Figure 17. Sediment load indicators map showing cumulative subwatershed percent agriculture, depositional features per mile, bank erosion and mass failures.**

The sediment regime is the quantity, size, transport, sorting and distribution of sediments. The sediment regime may be influenced by the proximity of sediment sources, the hydrologic regime, and the specific morphology of the valley, floodplain, and stream. The Sediment Load Indicators Map (Figure 17) shows the distribution of sediment load indicators in the Joiner Brook watershed at the watershed scale. The dominant watershed land cover/land use within the Joiner Brook watershed is forest. All of the six reaches evaluated in the study area had less than 5 percent cumulative watershed land cover/land use quantified as crop and/or urban. Bank erosion and mass failures contribute to sediment inputs along Joiner Brook. Bank erosion is defined as “an area of raw and barren soil where the vegetation does not have the ability to hold the soil and/or the soil has slumped or fallen into the channel”. Mass failures can occur when “a perennial stream erodes into or undercuts a high erodible landform, such as glacial lacustrine terrace” (Vermont Agency of Natural Resources, 2007b).

Mass wasting sites were common during the Stream Geomorphic Assessment and were mapped in five segments. Eleven mass failures were mapped within the thirteen assessed Joiner Brook segments. The total length of mass failures on Joiner Brook is approximately 984 linear feet (4 percent of the total channel length of reaches R10.S3.01 through R10.S3.06). These mass failures represent a significant source of sediment within the Joiner Brook watershed. Localized areas of bank erosion and depositional features (steep riffles, mid channel bars, delta bars, flood chutes, and/or avulsions) are prevalent. As shown below in Figure 17, the majority of the segments on Joiner Brook have moderate bank erosion (5-20 percent of the length) and/or high depositional features (> 5 per mile).

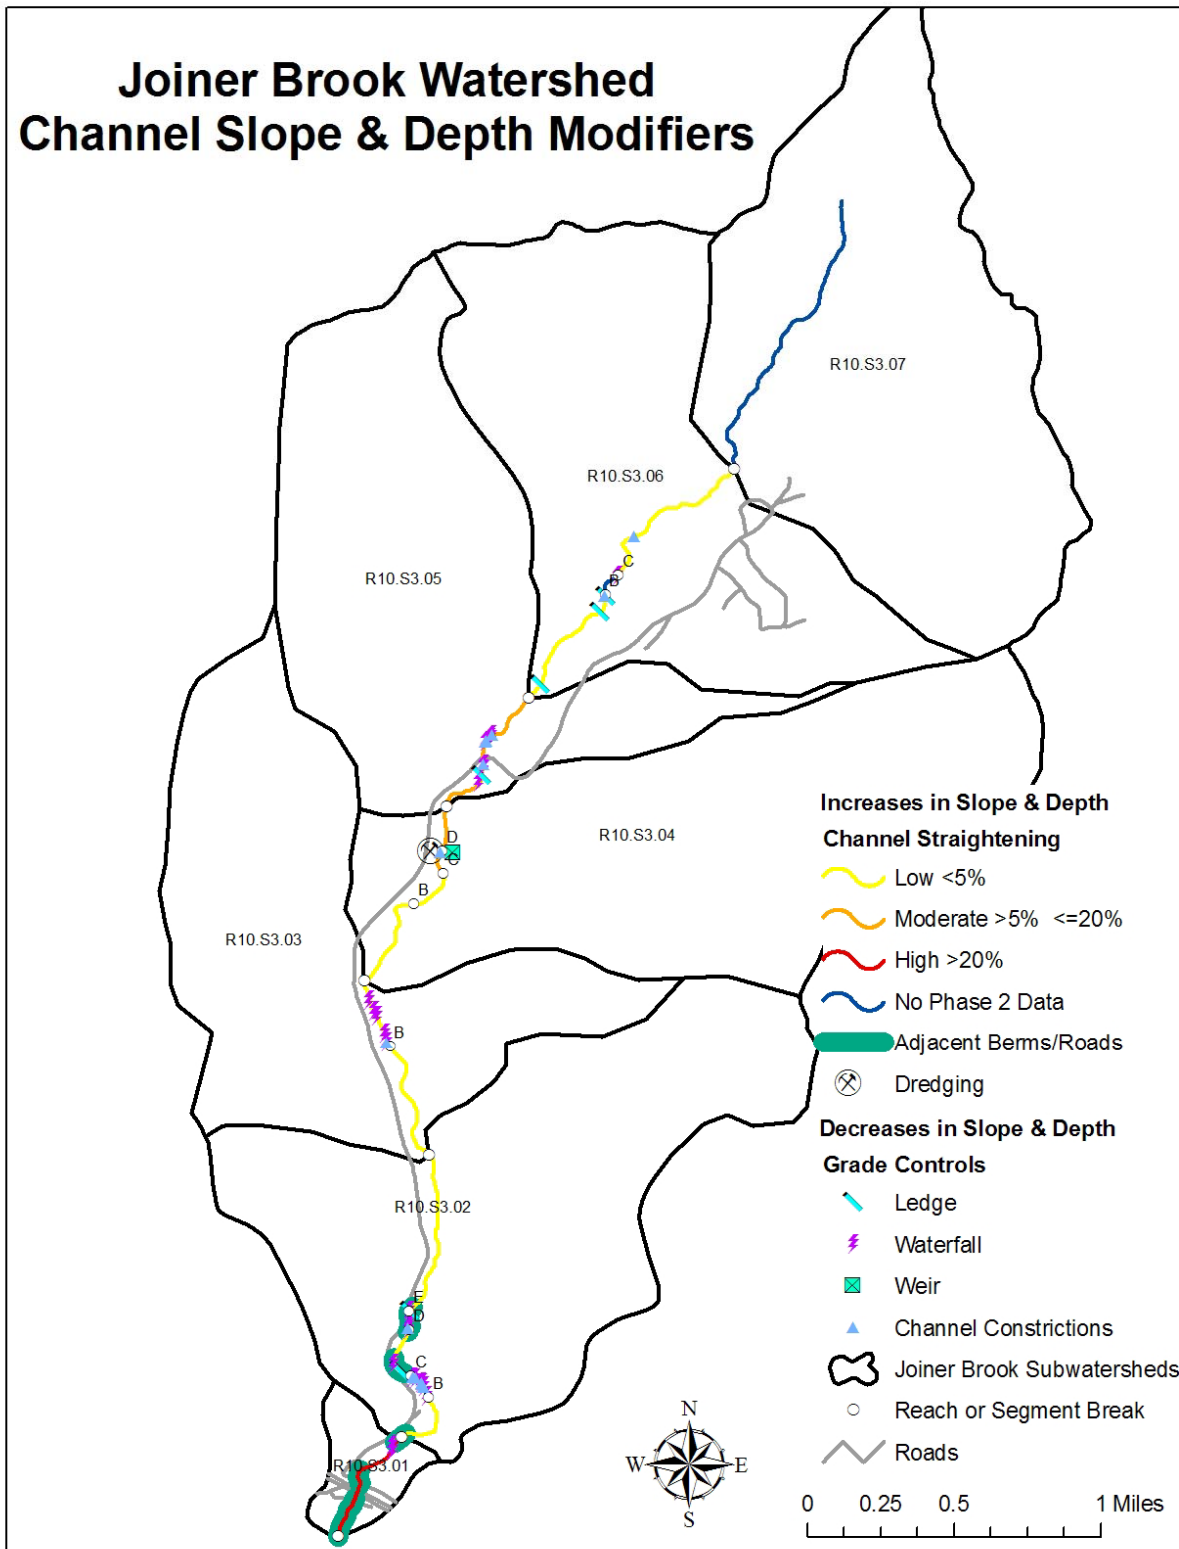
Figure 18. Channel slope and depth modifiers map showing stressors contributing to increases in slope and depth and stressors contributing to decreases in slope and depth.

Results from the Joiner Brook watershed indicate that primary stressors include straightening of the channel along with road and development encroachments (see Figure 18). Development in the upper reaches of the watershed has contributed to the loss of wetlands and increased runoff. Jeffrey Cueto, Vermont Department of Environmental Conservation, was contacted regarding historic dredging at Bolton Valley Resort's snowmaking water withdrawal. According to Mr. Cueto, some historic dredging at the snowmaking weir likely occurred, but nothing is on record with the DEC within the past 10 years. Historic dredging also likely occurred where the channel was straightened and bermed near the mouth of Joiner Brook.

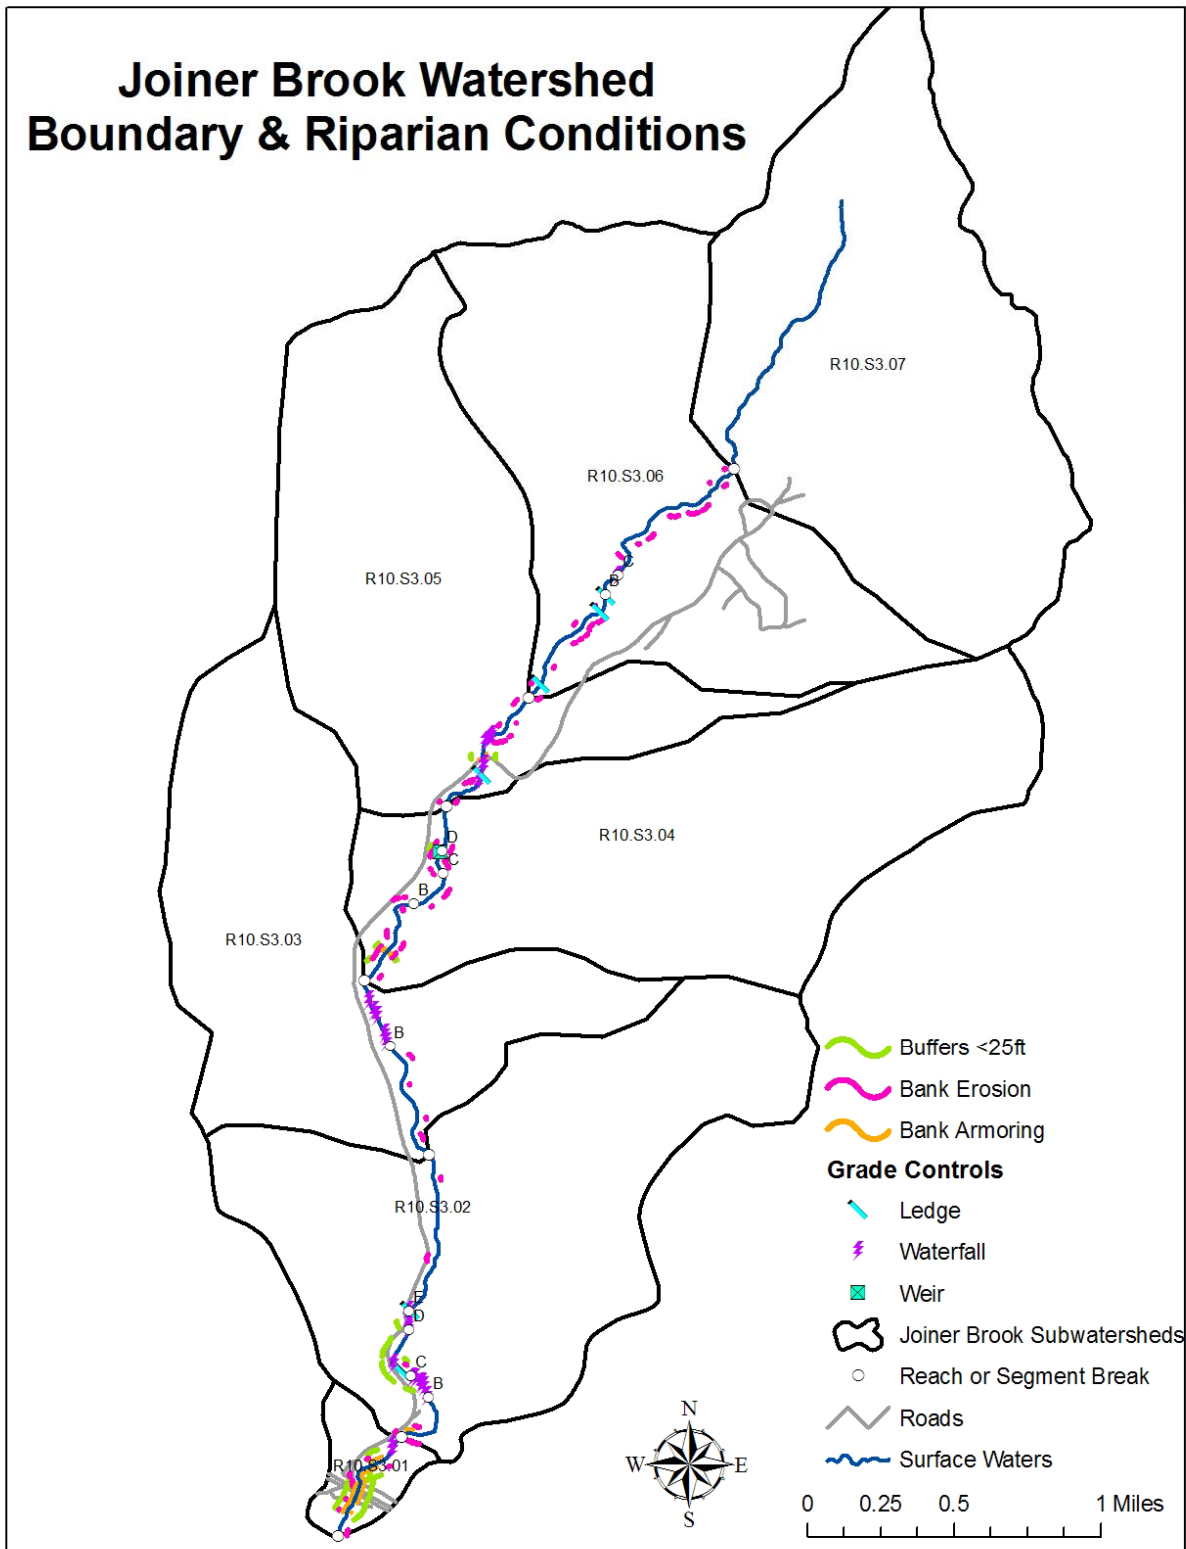
Figure 19. Boundary and riparian conditions map showing areas of buffers less than 25 feet, bank erosion, bank armoring and grade controls.

Riparian buffers provide many benefits. Some of these benefits are protecting and enhancing water quality, providing fish and wildlife habitat, providing streamside shading, and providing root structure to prevent bank erosion (see Figure 19). Most of Joiner Brook had sufficient riparian buffers. Three segments at the lower end of the watershed (R10.S3.01, R10.S3.02-B, and R10.S3.02-C) had 40 percent or more of the reach with little or no buffer on at least one bank. These stream reaches which lack a high quality riparian buffer are at a significantly higher risk of experiencing high rates of lateral erosion. Four segments have stream banks that are stabilized with rip rap or hard bank armoring where they are adjacent to human constructed infrastructure (R10.S3.01, R10.S3.02-A, R10.S3.04-A, and R10.S3.05).
