# Waterbury, Vermont Middle Winooski River Corridor Plan

December 15, 2015

Prepared by:  
Bear Creek Environmental, LLC  
149 State Street, Suite 3  
Montpelier, Vermont 05602

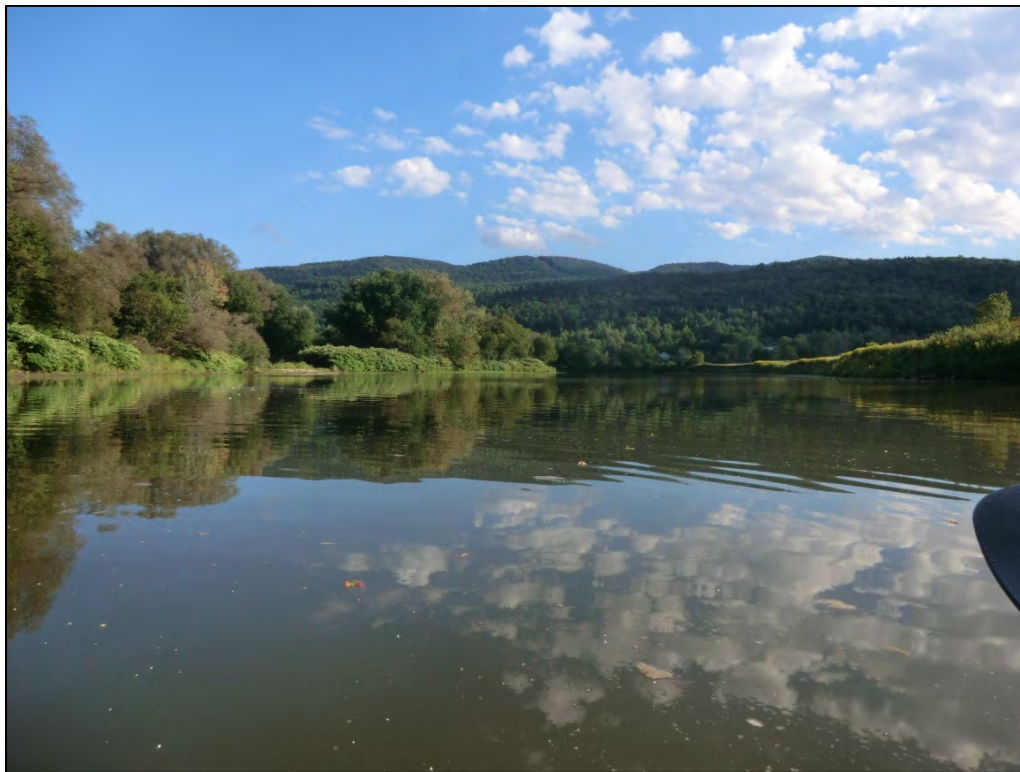
This reach was not divided into segments during assessment. It begins just above the Bolton Falls Dam and continues upstream for 2.3 miles to above the confluence of the Little River. This entire reach is affected by the large dam at Bolton Falls, which impounds the river and has a backwatering effect of over two miles. At the time of assessment, there were no riffles present in R12 due to the flow regulation at the dam. Impacts and habitat features were recorded during field work, but a full assessment was not done on this reach due to its impounded nature. Based on qualitative field observations, the Winooski River in R12 appears to have good access to its floodplain. The New England Central Railroad cuts across the southern floodplain, while US Route 2 encroaches upon the northern side of the river. Riparian buffers are lacking along nearly the entire reach due to the presence of agricultural fields. Most of this reach appears to have been historically straightened due to the placement of I-89, Route 2, and the railroad. Bank erosion and armoring are scattered along both banks in R12.

**Figure 5.9.** R12 is impounded and lacks bed features due to the presence of the Bolton Falls Dam.

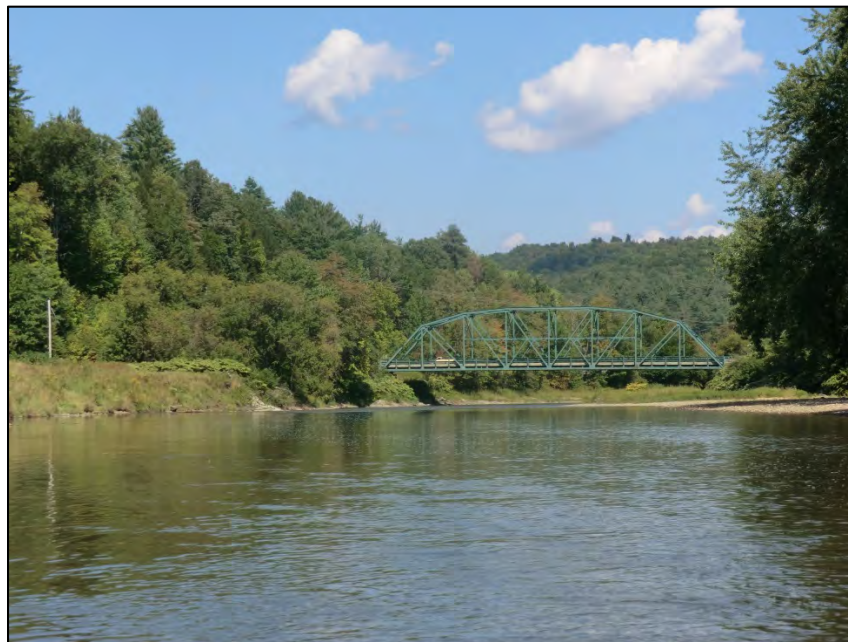
Reach 13 on the Winooski River begins just above the Little River and continues upstream for nearly four miles to above Waterbury Village near the Waterbury Ice Center. The reach was not divided into any segments during assessment. The Winooski River is extensively encroached upon by development in R13. Waterbury Village is located on the northeastern bank of the river, River Road in Duxbury is on the south western bank, and US Route 2 is on both banks. The river appears to have been historically straightened to accommodate this development for most of the length of R13. This straightening likely caused moderate channel incision, which has led to a loss of some floodplain access and a stream type departure. In response, the channel has widened and will likely continue to widen before building a juvenile floodplain. The banks of the river are frequently eroding in R13, but have been armored in areas of infrastructure. Several large flood chutes in this reach indicate that the river is moving laterally, however surrounding development limits that movement. Stormwater inputs are common in R13 due to its urbanized surroundings. The river is in **fair** geomorphic condition due to historic incision, active widening, and limitations to planform adjustment due to surrounding developed land. It is also in **fair** habitat condition as a result of poor bank and buffer vegetation, lacking woody debris, and altered channel morphology.

Figure 5.10. Development is prevalent along the Winooski River in R13 (Winooski Street Bridge pictured).

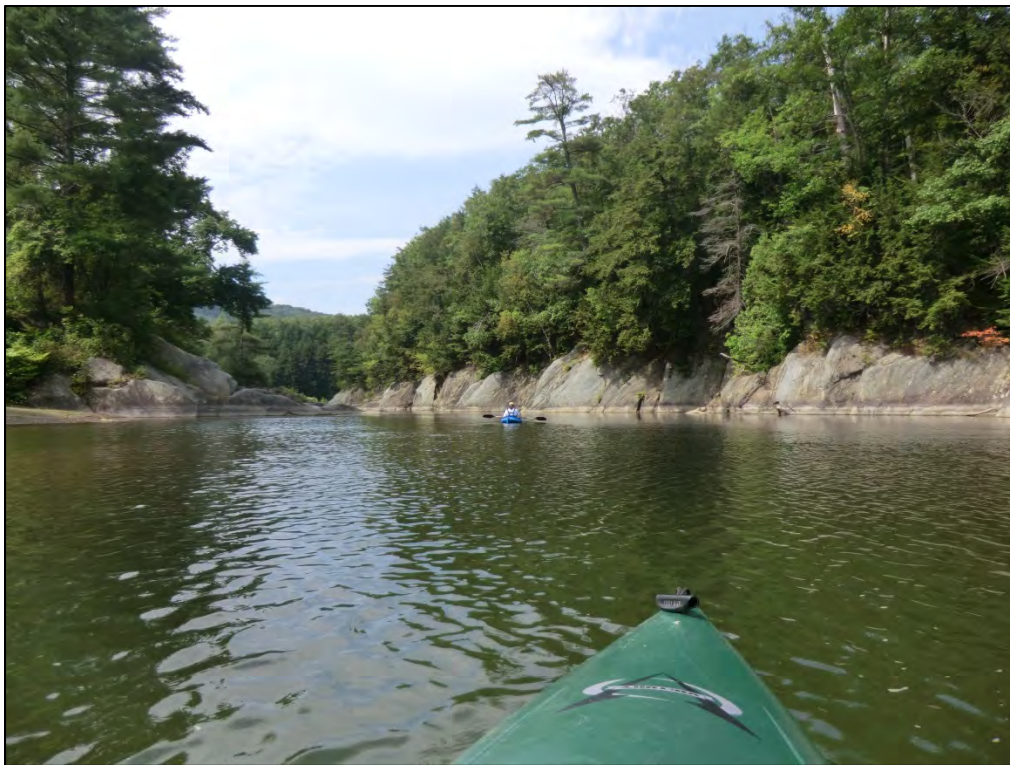
The upstream-most reach on the Winooski River included in this assessment is R14. It is just over 3 miles long and extends from just above Waterbury Village to just below the confluence of the Mad River in Middlesex/Moretown. The river has a steeper slope in this reach than in the surrounding reaches, and bedrock is prevalent along the banks. The river valley is naturally narrow, but has been further narrowed due to the placement of Route 2, the New England Central Railroad, and I-89. In R14, the river has incised slightly, but bedrock outcrops may be preventing further downcutting. The channel has not widened in comparison to the reaches below it. Small areas of bank erosion are present, as well as small areas of riprap. Several large flood chutes and three islands are present in R14 in areas where bedrock is not present. Buffers are comprised of nice floodplain forests where the river flows away from development. Geomorphic condition is **fair** in R14 due to incision and planform change. Habitat condition is also **fair** as a result of lacking woody debris and areas of poor bank vegetation.

**Figure 5.11.** Bedrock is abundant on the bed and banks of the Winooski River in R14.

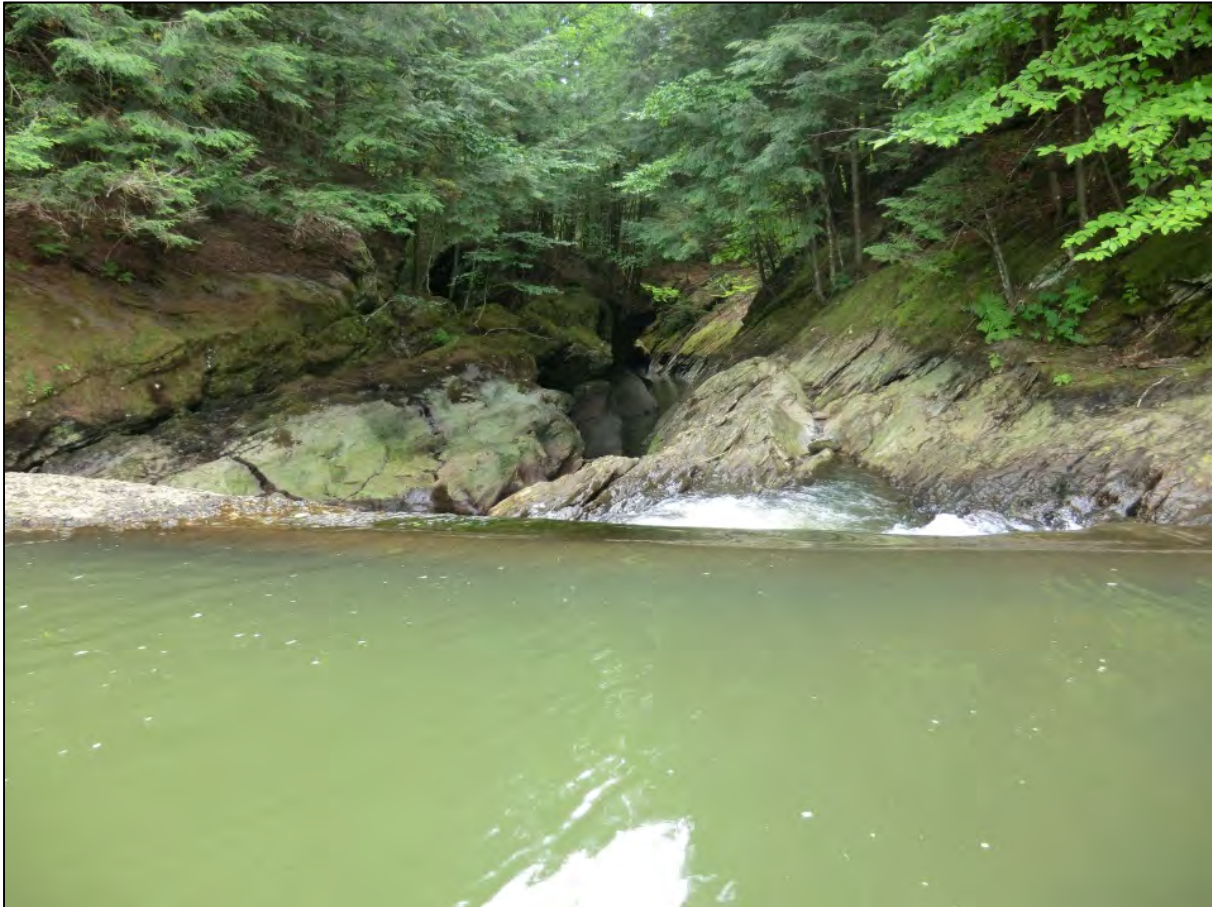
This segment is a 2,000 foot bedrock gorge. At the top of the gorge there is an old concrete run-of-river dam. Due to the nature of the channel, M2.03-B was not fully assessed and was placed in **good** geomorphic condition based on administrative judgement.

**Figure 5.15.** Looking downstream into bedrock gorge and old dam in M2.03-B.

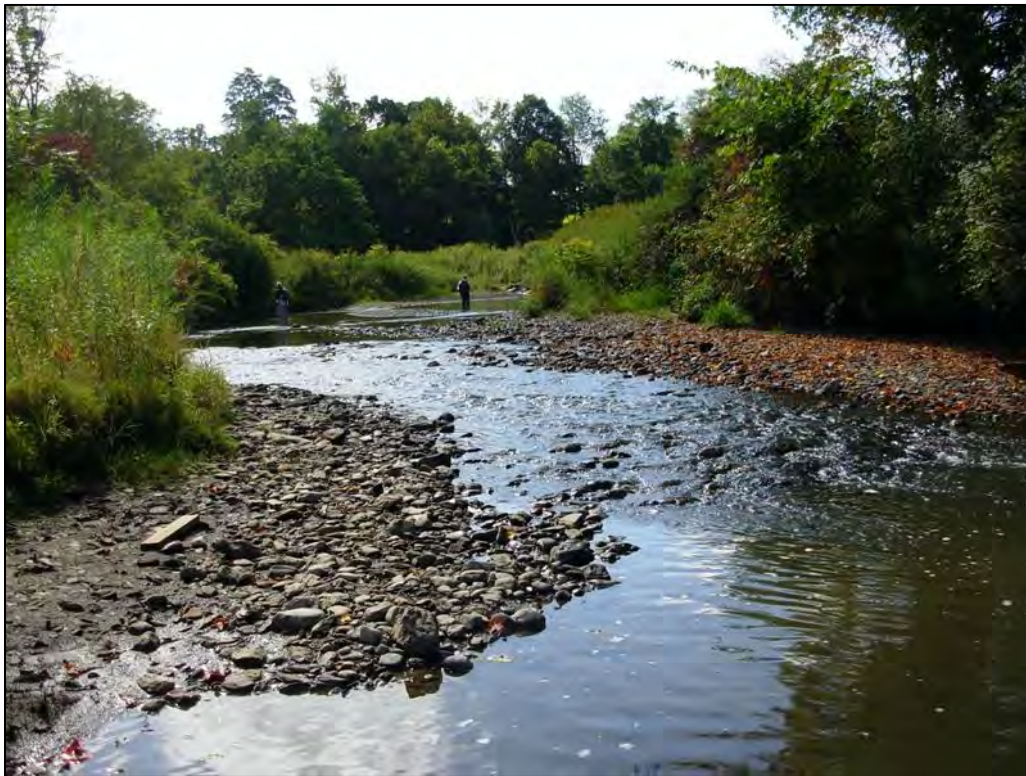
The second segment on Graves Brook assessed in 2010 begins between the Armory Drive and I-89 bridges and continues upstream for 2,700 feet to just above the bridge on the I-89 Waterbury exit. It appears that all of R13.S1.01-B was historically straightened due to the placement of roads and development. The brook has undergone moderate incision here and is aggradational. Some areas are widening and changing planform via flood chutes. Bank revetments are abundant in R13.S.01-B, preventing widening in several locations. The brook flows under the interstate through three bridges in this segment. Despite some incision, floodplain access remains intact. Due to historic channel management around development and the brook’s geomorphic responses, R13.S1.01-B is in **fair** geomorphic condition. It is also in **fair** habitat condition because woody debris is lacking and bank and buffer vegetation are frequently impacted.

**Figure 5.19.** R13.S1.01-B is more aggradational and wider than surrounding segments.

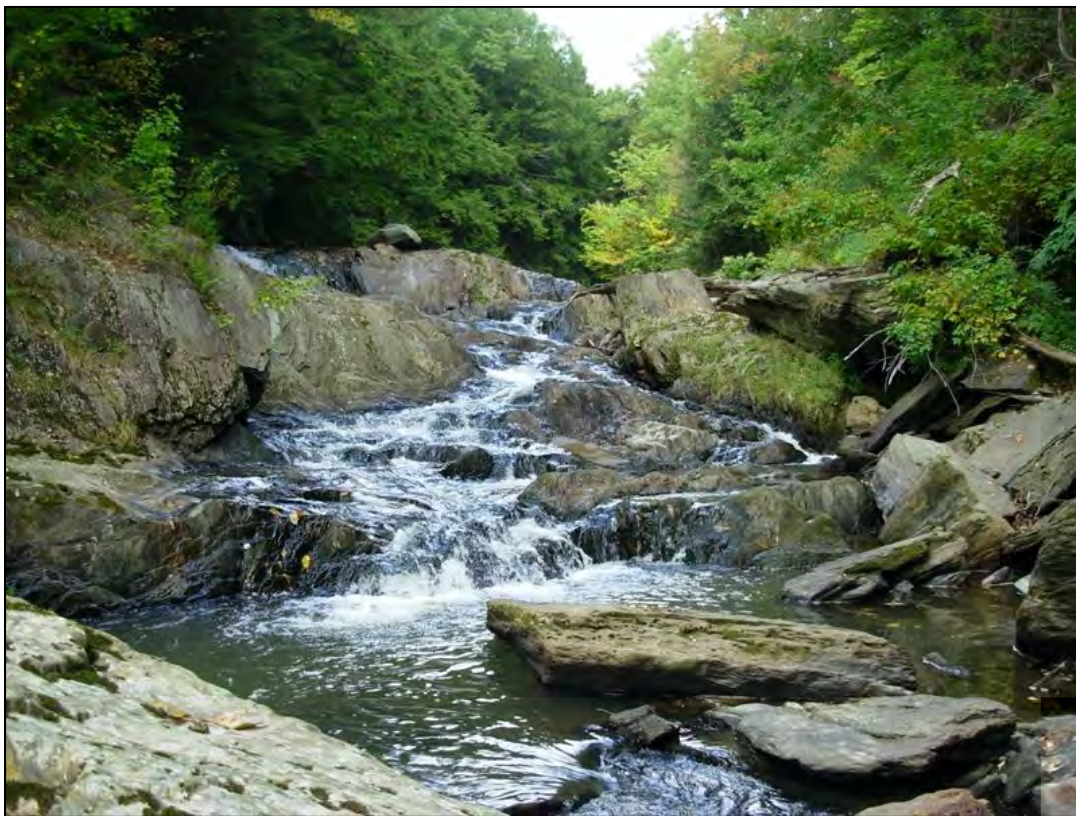
The downstream-most segment on reach two of Graves Brook is a bedrock gorge, beginning just above the I-89 bridges and continuing upstream nearly 1,000 feet to just below the Stowe Street crossing where bedrock becomes less dominant in the channel. This segment was not fully assessed during 2010 because it is bedrock controlled and very stable. Graves Brook flows through a confined valley and has minimal human impacts. Bank erosion and one mass failure are present in short sections where bedrock does not dominate the stream banks.

**Figure 5.20.** R13.S1.02-A is a bedrock gorge and is very stable.

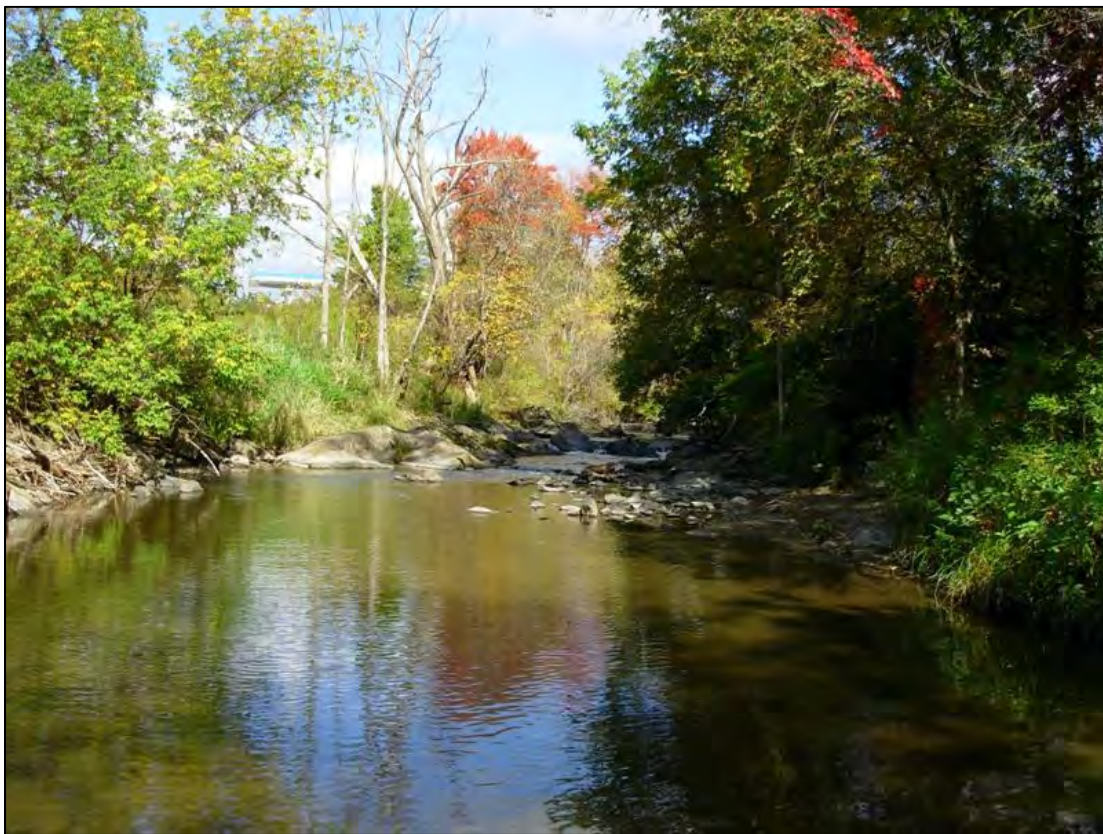
The second segment on reach two of Graves Brook flows through a confined valley for 1,200 feet from the Stowe Street Bridge to just upstream of where Thatcher Brook flows into Graves Brook. Much of this segment was historically straightened due to surrounding development. The floodplain was filled in to construct roads, which has obscured the degree of channel downcutting in this segment. R13.S1.02-B is afforded some vertical stability due to the presence of abundant bedrock just downstream and one bedrock grade control within the segment. Riprap is common along both banks, which may be preventing widening in areas. R13.S1.02-B is in **fair** geomorphic condition as a result of historic channel alteration. It is also in **fair** habitat condition because woody debris is lacking, floodplain connectivity has been altered, and banks and buffers are not consistently vegetated.

**Figure 5.21.** Graves Brook is entrenched in R13.S1.02-B due to historic floodplain filling.

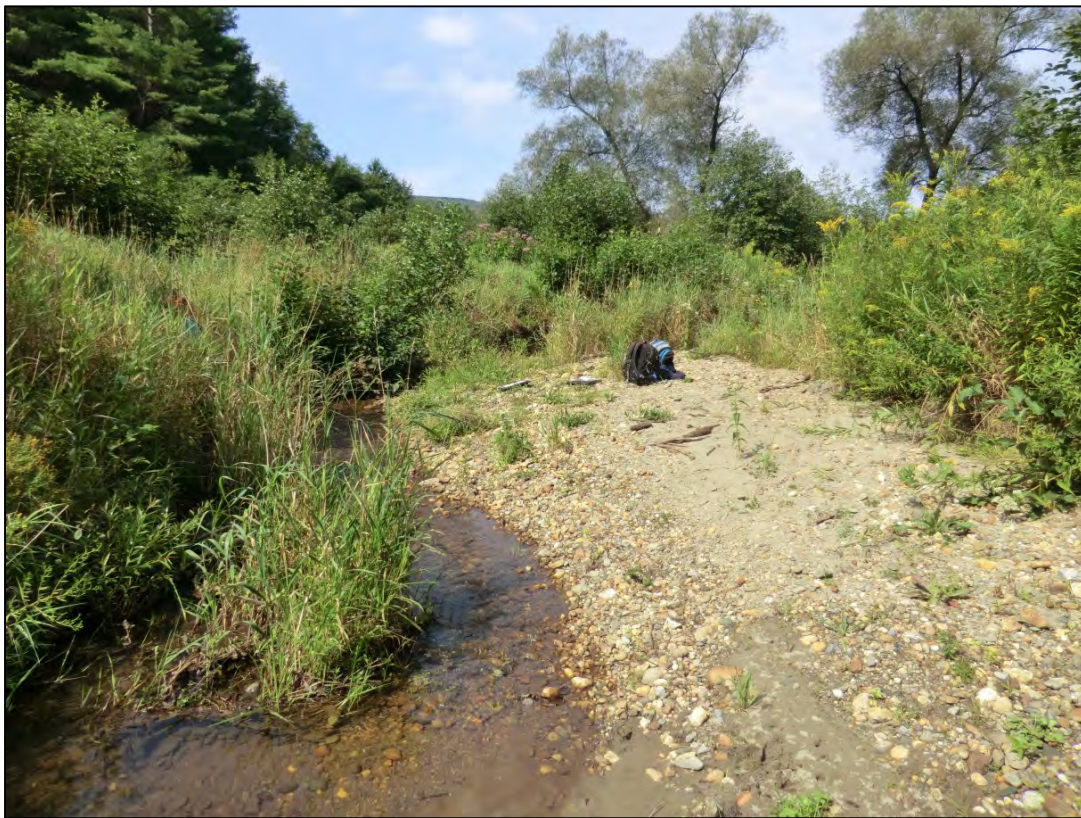
The middle segment on Graves Brook is characterized by a very broad river valley. Stream banks and buffers are well vegetated, with the exception of the upstream end in the vicinity of the Waterbury Country Club golf course. There are two beaver dams in the segment causing some localized impoundment. The segment is 3,873 feet long, and begins where roads no longer encroach upon the river corridor. This segment has undergone minor incision, but is experiencing major aggradation, widening and planform change. Abundant erosion is present and numerous large bars are forming a juvenile floodplain. Aggradation may be due in part to a drop in slope from the upstream segment. Planform adjustment is common via flood chutes, neck cut offs, and one channel avulsion. This segment is in **fair** geomorphic condition as a result of the aforementioned processes and **good** habitat condition in part due to well vegetated banks and buffers and abundant large woody debris.

Figure 5.23. Abundant aggradation and juvenile floodplain being built on large bar in R13.S1.03-B

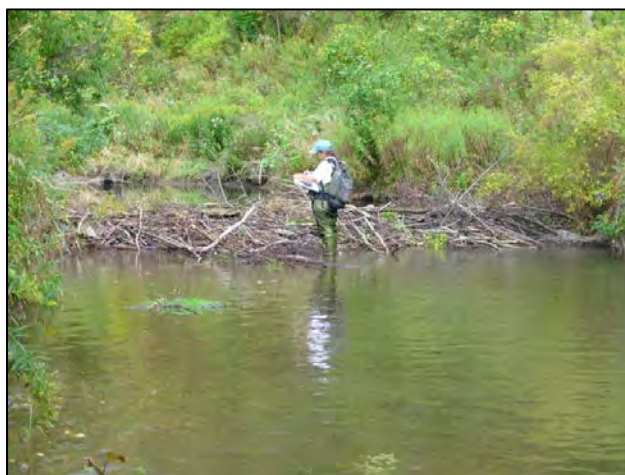
The first segment on reach one of Thatcher Brook is just over 1,900 feet in length, beginning at the mouth and continuing upstream to the base of the bedrock gorge. Beaver activity is prevalent in this segment, and beaver dams are causing frequent channel adjustment. Over two-thirds of this segment appears to have been historically straightened, which has led to slight historic incision. The stream channel is in the process of widening, aggrading, and adjusting planform. Bank erosion is common along both banks as the stream widens and moves laterally. R13.S1.02-S1.01-A is in **fair** geomorphic condition due to these active adjustments. It is also in **fair** habitat condition due to lacking pool habitat and unstable banks.

Figure 5.25. Beaver activity is common in R13.S1.02-S1.01-A.

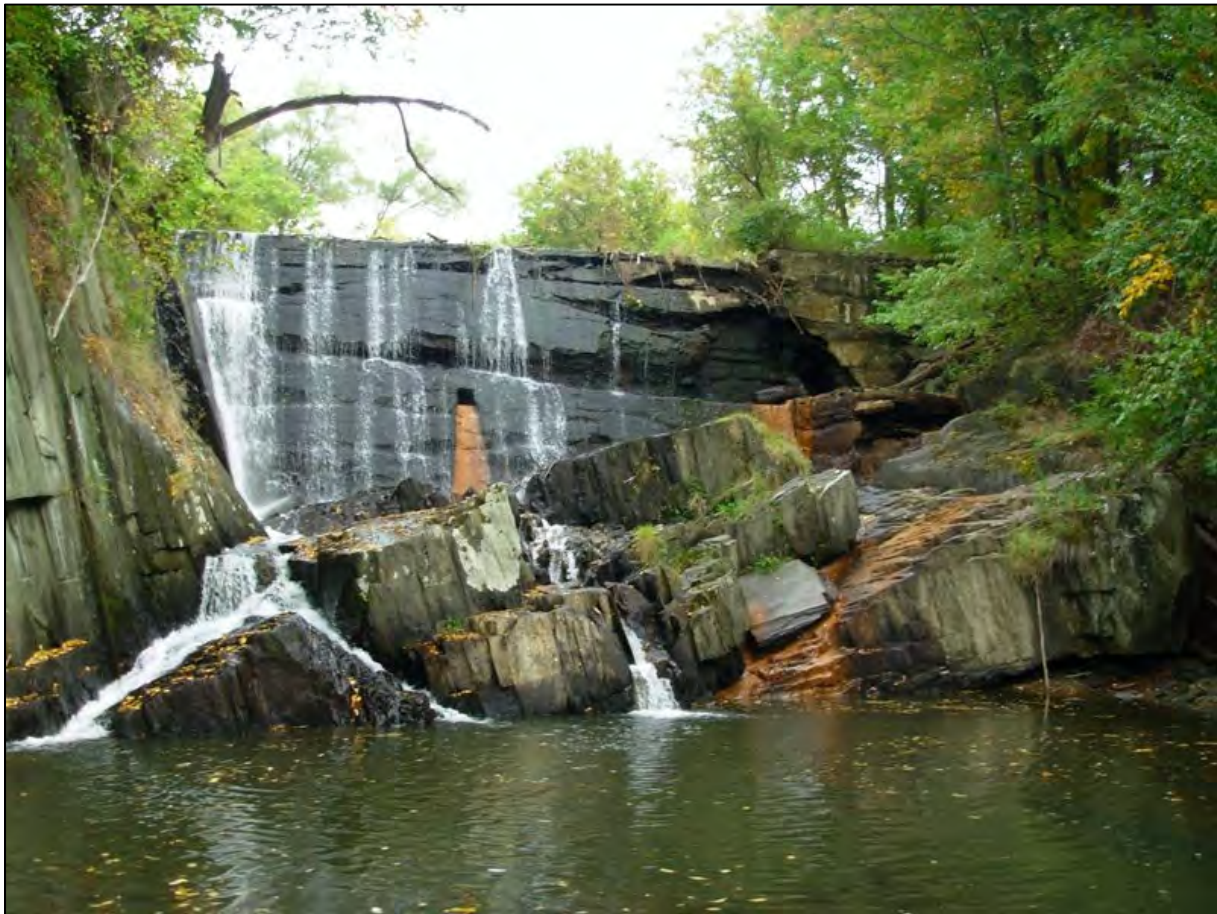
The second segment on Thatcher Brook is approximately 1,400 feet in length, beginning behind Shaw’s and continuing upstream to almost 500 feet above the Laurel Lane stream crossing. This segment was not fully assessed during 2010 because the lower portion flows through a bedrock gorge and the upper portion is impounded by a historic dam at the top of the gorge. In the upper portion of the segment, roads and development encroach on the river corridor, and the stream has been straightened in a few areas.

**Figure 5.26.** R13.S1.02-S1.01-B flows through a bedrock gorge that has two dams in it.

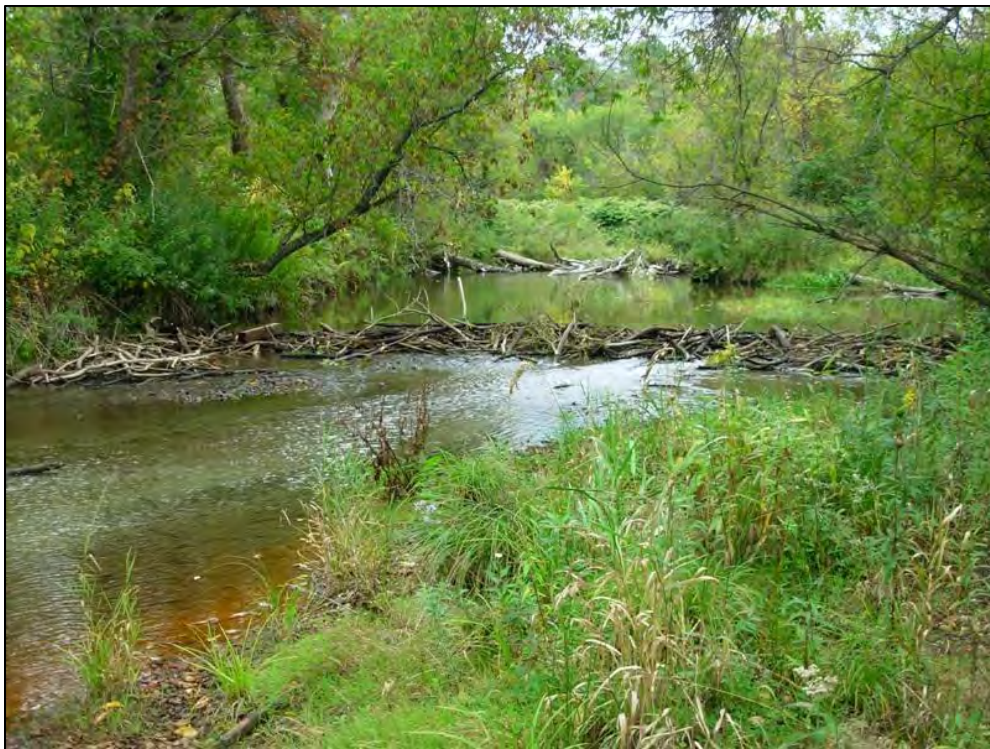
Segment C on reach one of Thatcher Brook is nearly 2,000 feet in length and flows along Route 100 in Waterbury Center. Similarly to downstream, R13.S1.02-S1.01-C is affected by beaver activity. Just over half of this segment appears to have been historically straightened along Route 100. Despite this, Thatcher Brook does not appear to have incised in this section. The dams and bedrock outcrops downstream afford vertical stability to this segment, and are likely deterring downcutting. Aggradation is major in segment C and is causing some planform adjustment. Beaver dams, which are scattered throughout the segment, are exacerbating lateral movement. Bank erosion is common along both banks and may be associated with these adjustments. Riprap is present where the brook flows directly along Route 100, toward the downstream end of the segment. R13.S1.02-S1.01-C is in **fair** geomorphic condition as a result of the major active adjustment occurring here. It is also in **fair** habitat condition due to a lack of diverse bed features and impacted bank and buffer vegetation.

**Figure 5.27.** R13.S1.02-S1.01-C is a meandering wetland channel with current beaver activity.

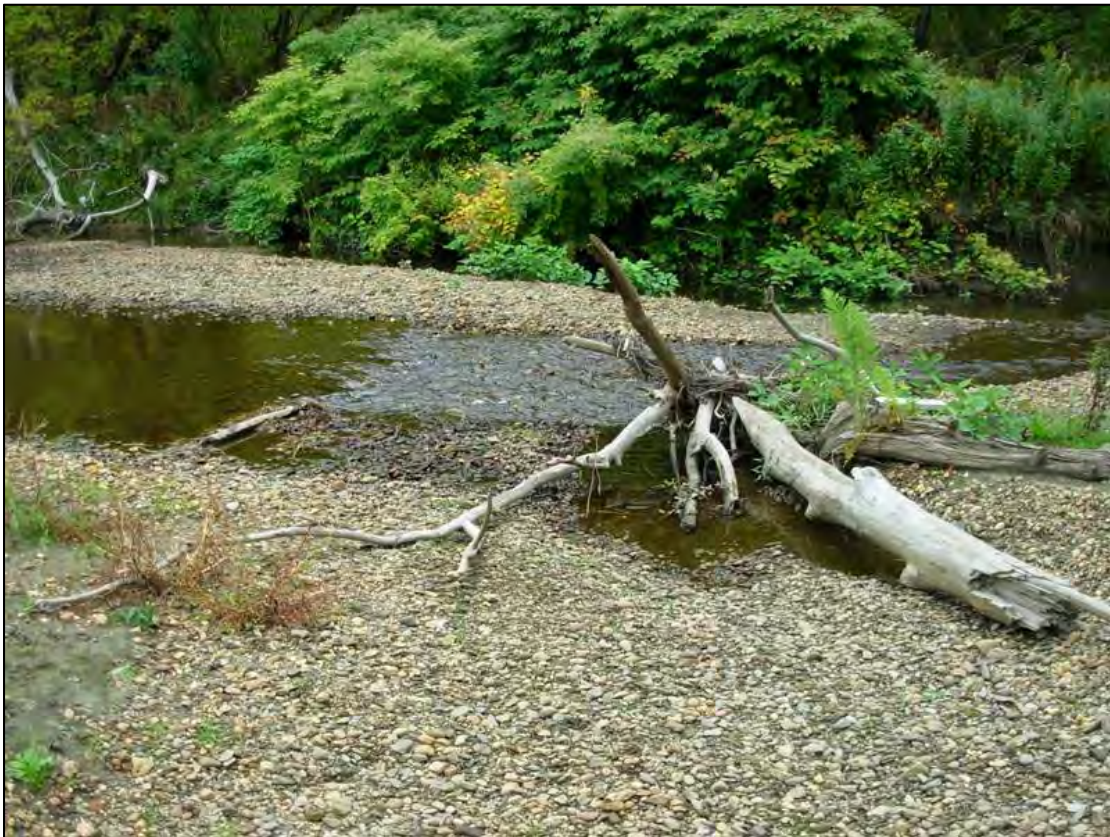
The upstream-most segment on reach one of Thatcher Brook is approximately 1,400 feet in length, flowing between Route 100 to the west and Country Club Road to the east and ending just above the bridge on Guptil Road. Approximately half of the segment was subjected to historic straightening due to surrounding development, which likely sparked slight historic incision. Major aggradation is present in R13.S1.02-S1.01-D and the channel is in the process of widening. Thatcher Brook is undergoing planform adjustment in this segment via several flood chutes and one avulsion. Segment D is in **fair** geomorphic condition due to historic incision and major active aggradation and planform adjustment. Similarly, the segment is in **fair** habitat condition because bed cover is lacking and substrate is very small.

**Figure 5.28.** Depositional features are abundant in segment D of reach one of Thatcher Brook.

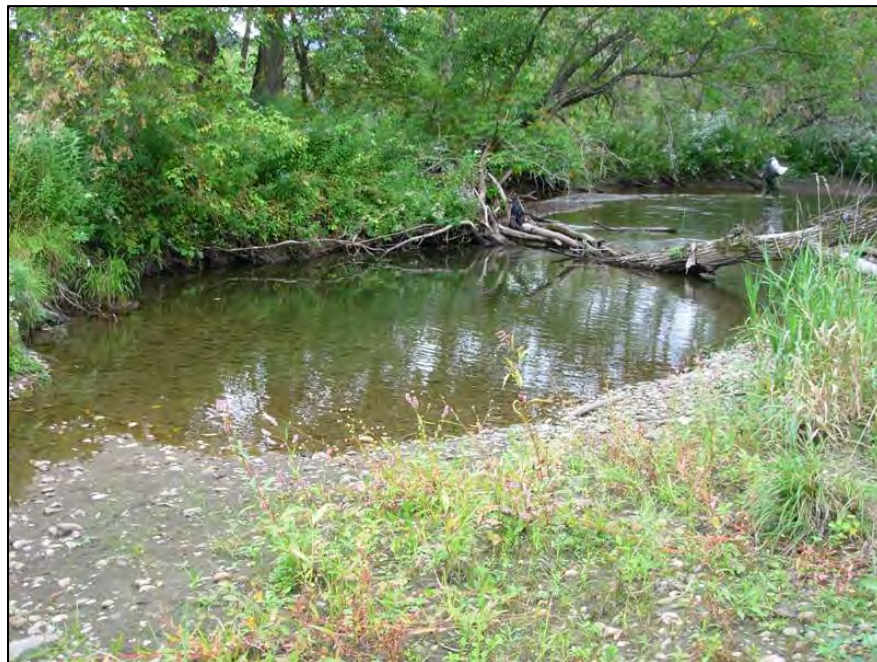
The second reach on Thatcher Brook flows away from Route 100 through wetlands, residential, and agricultural land. It was not divided into any segments during the 2010 assessment. The segment is just over 4,600 feet in length, beginning near the intersection of Guptil Road and Route 100 and ending upstream between the Guptil Road and Kneeland Flats Road bridges. R13.S1.02-S1.02 is characterized by a meandering wetland channel with a mostly natural planform. Historic straightening appears to have occurred in the vicinity of the two bridges within this reach. The brook has undergone slight historic incision and has begun to widen in this area. Floodplain access throughout R13.S1.02-S1.02 is excellent, and it retains a natural riffle-pool bedform. Bank erosion is scattered along both banks, as is bank armoring. The sinuous planform of Thatcher Brook within this reach has led to major planform adjustment including several flood chutes and channel avulsions. Debris jams appear to be exacerbating lateral adjustment in this area. R13.S1.02-S1.02 is in **fair** geomorphic condition as a result of all the aforementioned adjustments. The reach is in **good** habitat condition due to its natural planform and excellent diversity of streambed features.

**Figure 5.29.** Woody debris is abundant in R13.S1.02-S1.02.

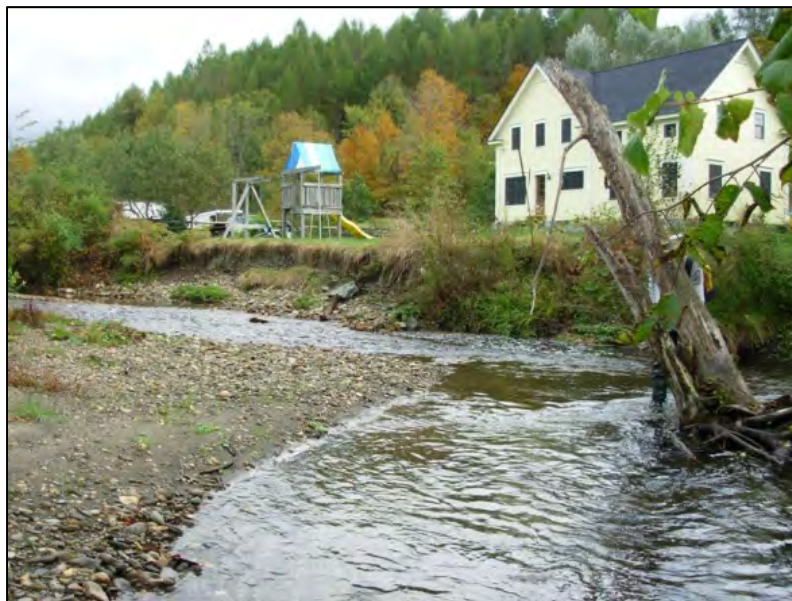
This segment is characterized by a very broad valley with a C stream type that has been almost 100 percent historically straightened. The segment begins at the confluence of Unnamed Tributary 2 and continues to approximately 1,000 feet downstream of the Guptil Road Bridge. Development and encroachment from Guptil Road is common along the eastern bank lending to abundant armoring and pasture with no buffer is common along the western bank. Approximately halfway up the segment there is an animal ford across two pastures. Depositional features are abundant including mid-channel bars. The channel has experienced moderate incision, is widening and a new floodplain is being built up in some areas. Riparian buffers are poor in many locations due to pastures and development. Habitat and geomorphic conditions are both **fair** in this segment due to the processes and lack of riparian buffers and adequate bank vegetation.

**Figure 5.31.** River corridor encroachment and lack of riparian buffer in R13.S1.02-S1.04-A.

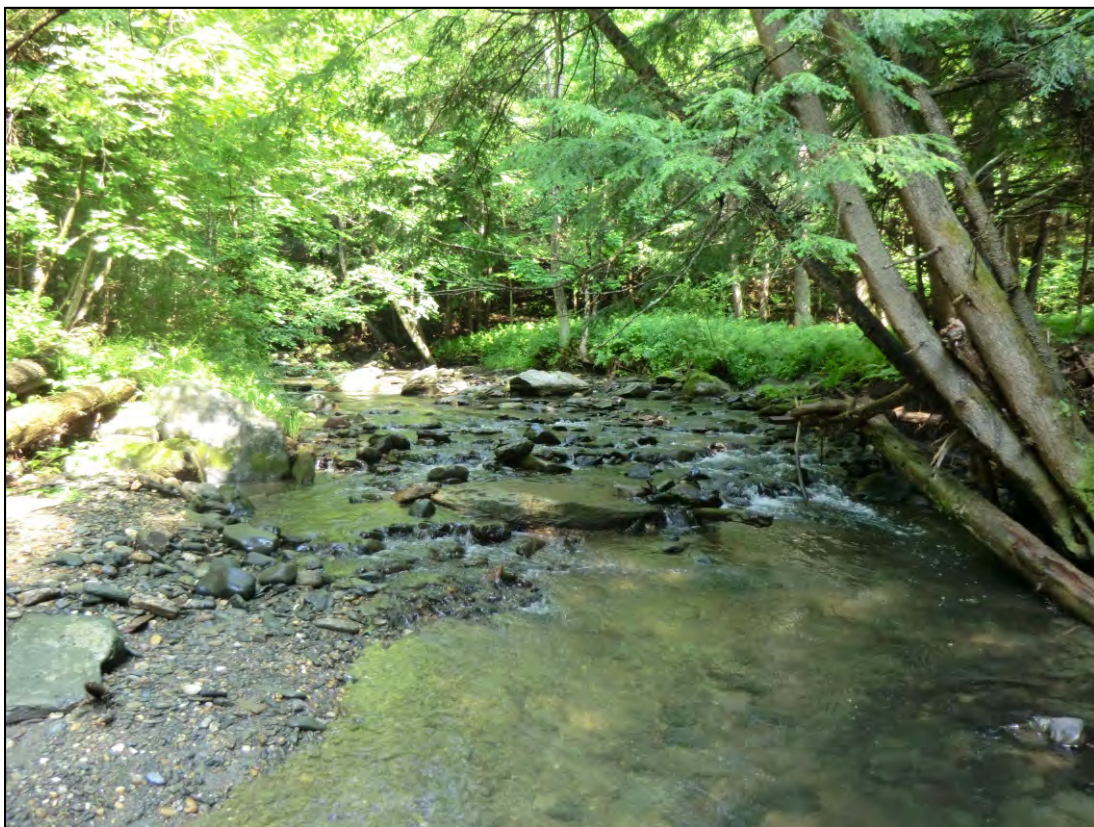
This segment begins approximately 1,100 feet northeast of the intersection of Guild Hill Road and Maple Street and continues upstream for about 1,500 feet. Overall, planform is mostly natural and undisturbed in R13.S1.02-S1.06-B, and the brook has been very minimally straightened. Thatcher Brook has incised moderately in this section but retains access to its floodplain. It is currently in the process of widening, and bank erosion is common along both banks. Major planform adjustment is occurring in this segment, which has led to the formation of two islands. Short sections of braiding occur where the brook is aggrading. Due to the channel incision and planform adjustment, the segment is in **fair** geomorphic condition. Well forested riparian buffers, vegetated banks, abundant large woody debris, and a well-defined bedform have resulted in a **good** habitat condition in R13.S1.02-S1.06-B.

**Figure 5.37.** Typical channel in R13.S1.02-S1.06-B.

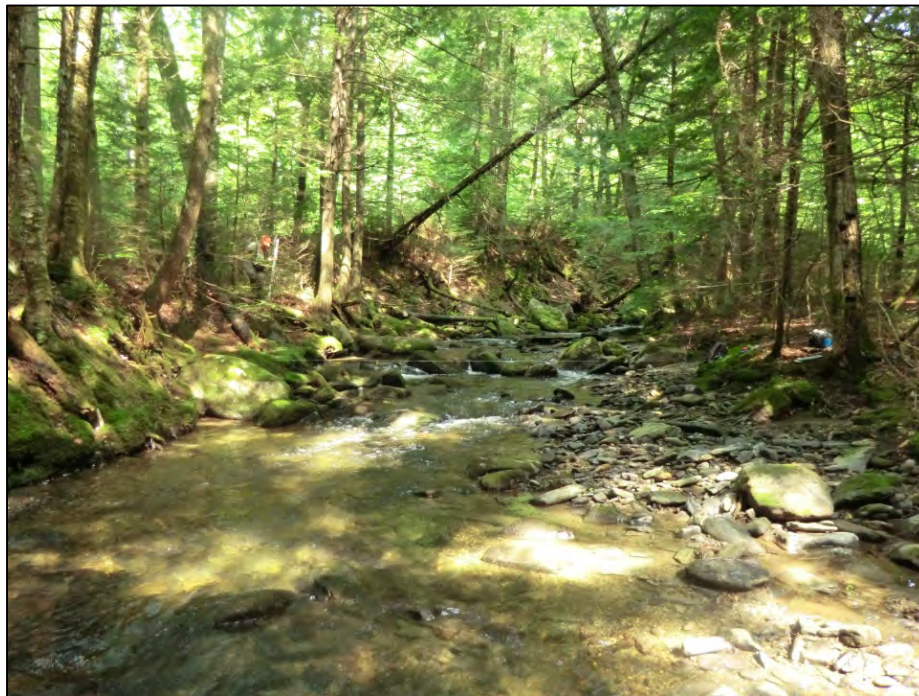
This segment is 2,960 feet in length, beginning just above the confluence with tributary R13.S1.02-S1.07-S1. The brook flows through a densely forested area for the whole segment, with no development. Overall, the channel has incised and not yet widened but there are locations with good floodplain access. Some areas have more planform adjustment than others via flood chutes, neck cut offs, and bifurcation around islands. Mass failures and small areas of bank erosion are present as well, but overall the banks are stable and mossy. The geomorphic condition of this segment is **fair** due mostly to the channel degradation and localized planform adjustment. However, the segment is in **good** habitat condition due to well forested banks and buffers, abundant woody debris in the channel, excellent substrate cover, and a well-defined step-pool habitat.

Figure 5.39. Well forested banks and buffers in R13.S1.02-S1.08-A.

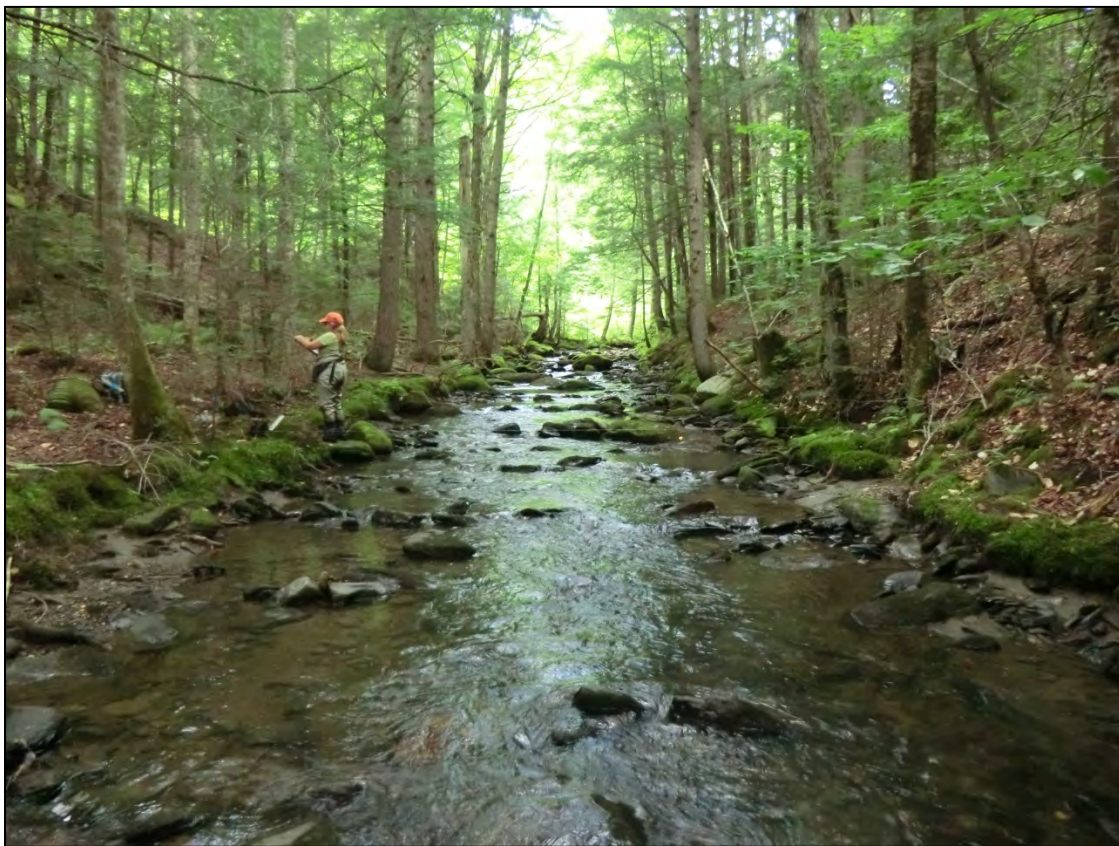
Conditions in this segment are very similar to downstream: well forested riparian habitat with no development along the valley wall. The segment comprises the top 1,250 feet of the reach and begins where the valley width becomes narrower. Valley confinement is variable with some areas semi-confined and some very broad. If not for the extreme incision in this segment, it would be in great condition. Although the degree of incision was extreme in the vicinity of the cross section location, there are areas where incision was not as severe and there was better floodplain access. The channel has not yet widened and there is minor bank erosion resulting in very stable and mossy banks except for two locations where there are mass failures. The segment is in **fair** geomorphic condition due to channel incision but in **good** habitat condition as a result of stable banks and undisturbed riparian habitat.

Figure 5.40. Mossy and stable stream banks in R13.S1.02-S1.08-B.

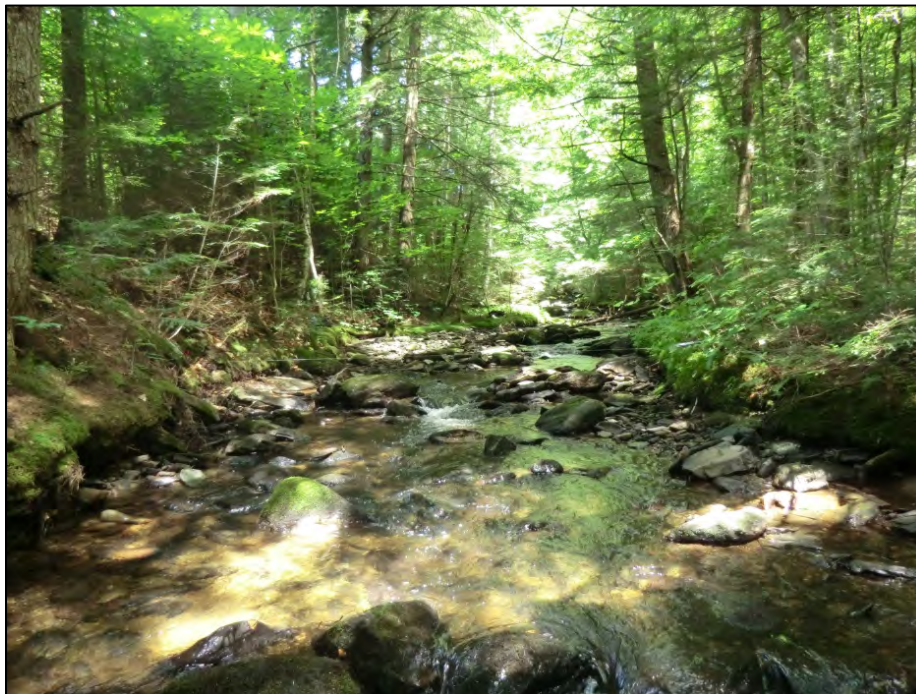
The most downstream segment in reach 9 of Thatcher Brook has characteristics similar to the reach 8. Segment A is 1,340 feet long and flows through densely forested land. The valley is very broad on average but it is narrower toward the upstream end of the segment. Where the valley opens up significantly is where the next segment begins. The downstream section has experienced some planform adjustment around two islands. This segment has incised but retains its reference stream type and access to its floodplain. The channel has not widened and bank erosion is minimal. Overall, Thatcher Brook is in **good** geomorphic condition in this segment despite moderate channel incision. It also is in **good** habitat condition due to undisturbed riparian habitat and stable, well-vegetated banks.

Figure 5.41. R13.S1.02-S1.09-A has well forested banks and buffers.

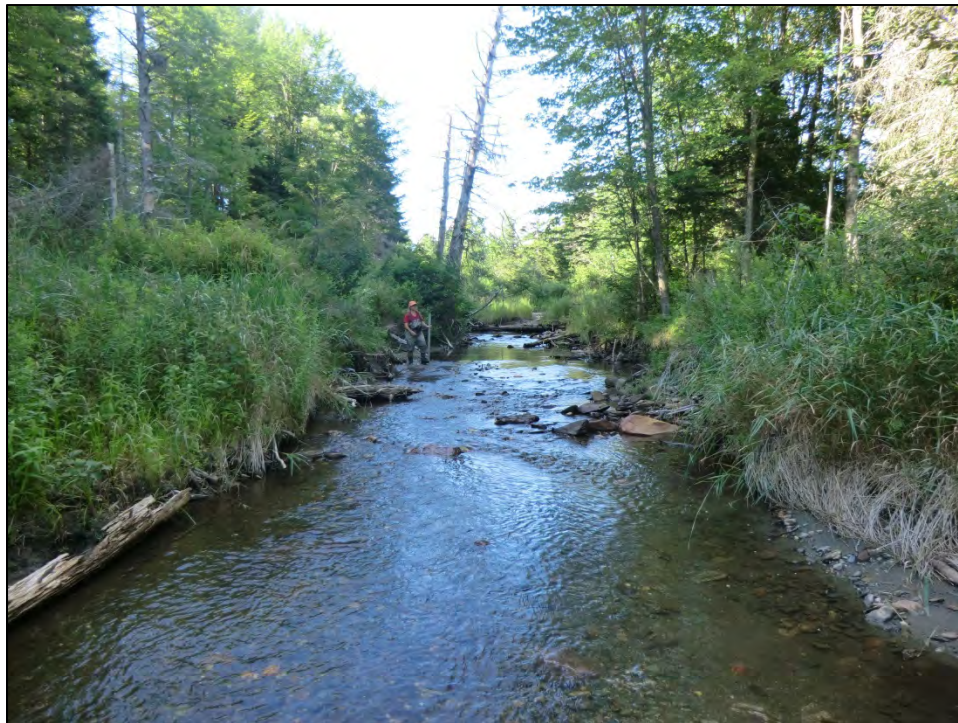
The next segment is characterized by a wetland channel through a very broad valley. The segment begins where the valley opens way up and there is a hay field in the western riparian corridor. The channel continues for approximately 1,100 feet and ends just upstream of a road crossing at a beaver dam, which has created a wetland. Flow out of the wetland is split and results in three culverts at the road crossing. The split flow is reconnected downstream of the crossing. This segment is also incised but only slightly and widening is minor. Aggradation is a major process in this segment and is perhaps a natural condition as the segment is a transition zone between the wetland upstream and the steeper forested section downstream. Many flood chutes indicate major planform change, but this is natural for this type of system. Segment R13.S1.02-S1.09-B is in **fair** geomorphic condition due to the channel incision, aggradation and planform adjustment. However, the habitat condition is **good** as a result of well vegetated banks and buffers, good hydrologic characteristics through wetland drainage and abundant large woody debris.

Figure 5.42. Thatcher Brook in R13.S1.02-S1.09-B is a wetland channel.

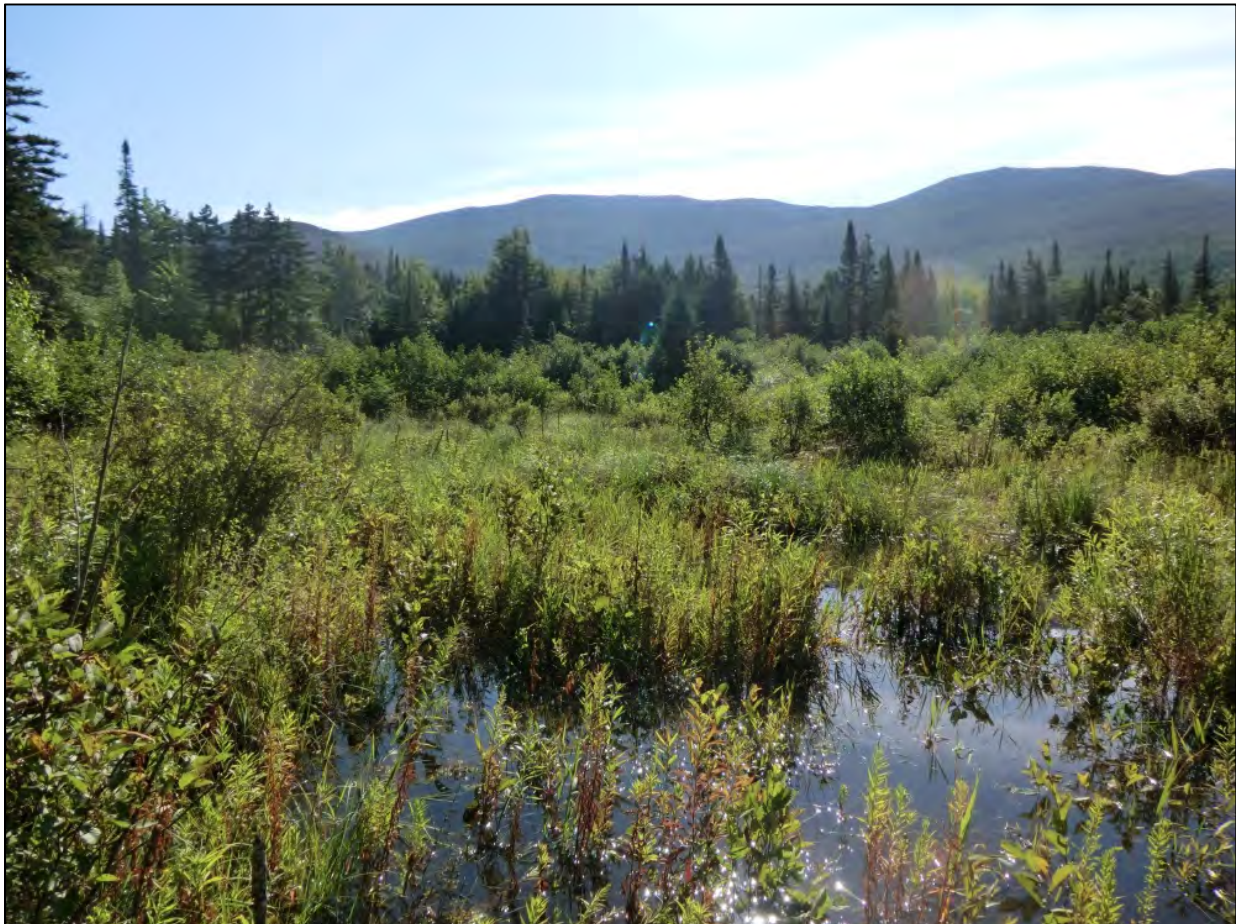
This segment is approximately 300 feet long and was not assessed because it is an impounded wetland. A beaver dam at its downstream end just above a driveway crossing is causing the impoundment.

**Figure 5.43.** Segment R13.S1.02-S1.09-C is a wetland.

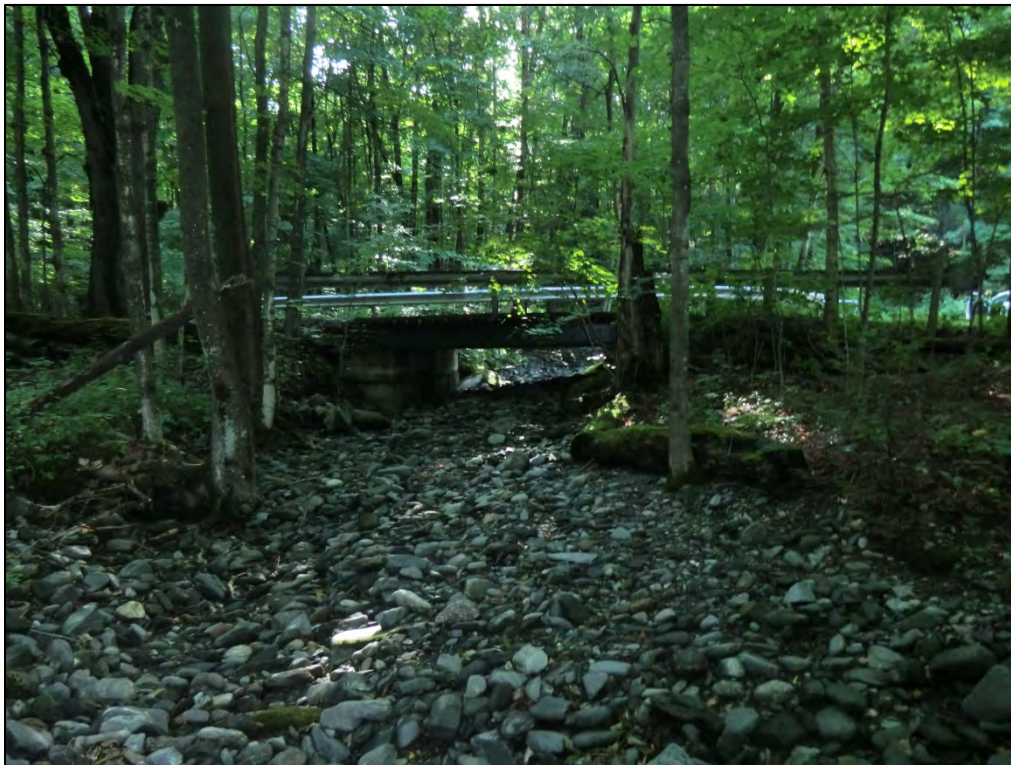
The upstream-most segment on Thatcher Brook is approximately 1,700 feet long and begins at the top of the wetland and continues until just above the Waterworks Road crossing. The riparian conditions are well vegetated and there is little erosion, but the main impact of this segment is flow regulation from the upstream water withdrawal by the Town of Waterbury. At the first visit to this segment, the streambed was completely dry at the upstream end. When BCE returned to the stream to assess the segment, there was flow in the channel. The stream has undergone minor channel incision and retains its reference stream type and access to its floodplain except for one location where the channel material has been windrowed creating a berm. R13.S1.02-S1.09-D is in **fair** geomorphic condition as a result of historic incision, major aggradation and planform adjustment. Despite the impacted flow regime in the upstream end of the segment, overall it is in **good** habitat condition due to stable well vegetated banks and buffers and abundant large woody debris.

Figure 5.44. Dry streambed in R13.S1.02-S1.09-D.
