# Waterbury, Vermont Middle Winooski River Corridor Plan

December 15, 2015

Prepared by:  
Bear Creek Environmental, LLC  
149 State Street, Suite 3  
Montpelier, Vermont 05602

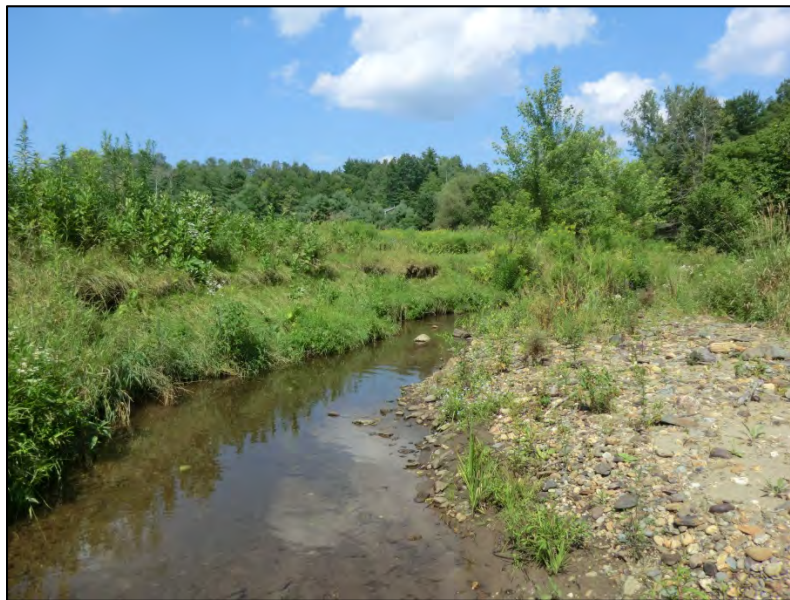
The downstream-most segment on reach one of the first unnamed tributary to Thatcher Brook is an *alluvial fan*, which forms as the channel slope drops and river valley widens from the upstream bedrock gorge to meet Thatcher Brook. It is a dynamic area where abundant aggradation and planform change naturally occur. The segment is short, extending from the confluence with Thatcher Brook upstream about 700 feet to the start of a bedrock gorge. The stream channel has incised historically and is in the process of widening. Due to these adjustments, R13.S1.02-S1.02-S1.01-A is in **fair** geomorphic condition. It is also in **fair** habitat condition as a result of lacking pool habitat, eroding stream banks, and lacking forested buffer.

Figure 5.45. R13.S1.02-S1.02-S1.01-A is an alluvial fan with abundant aggradation.

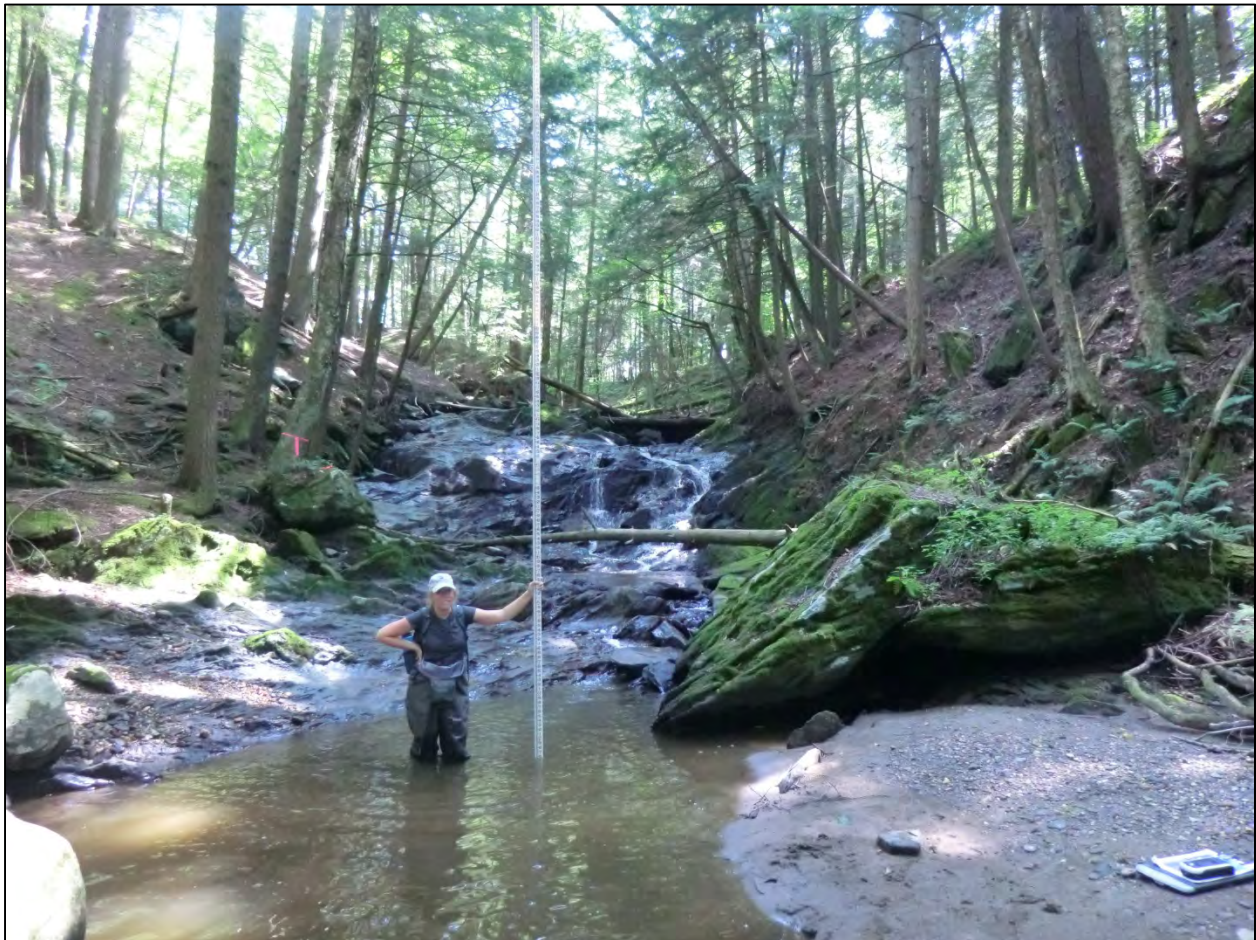
The second segment on reach one of Unnamed Tributary 1 is nearly 500 feet in length. It was not fully assessed because it is a bedrock gorge. There are three large bedrock grade controls present in this segment and abundant bedrock lining the valley walls. The stream channel is stable, but bank erosion is occurring where bedrock is not present on the banks. Based on qualitative field observations, the segment was estimated to be in **good** geomorphic condition.

Figure 5.46. R13.S1.02-S1.02-S1.01-B is a bedrock gorge and was not fully assessed.

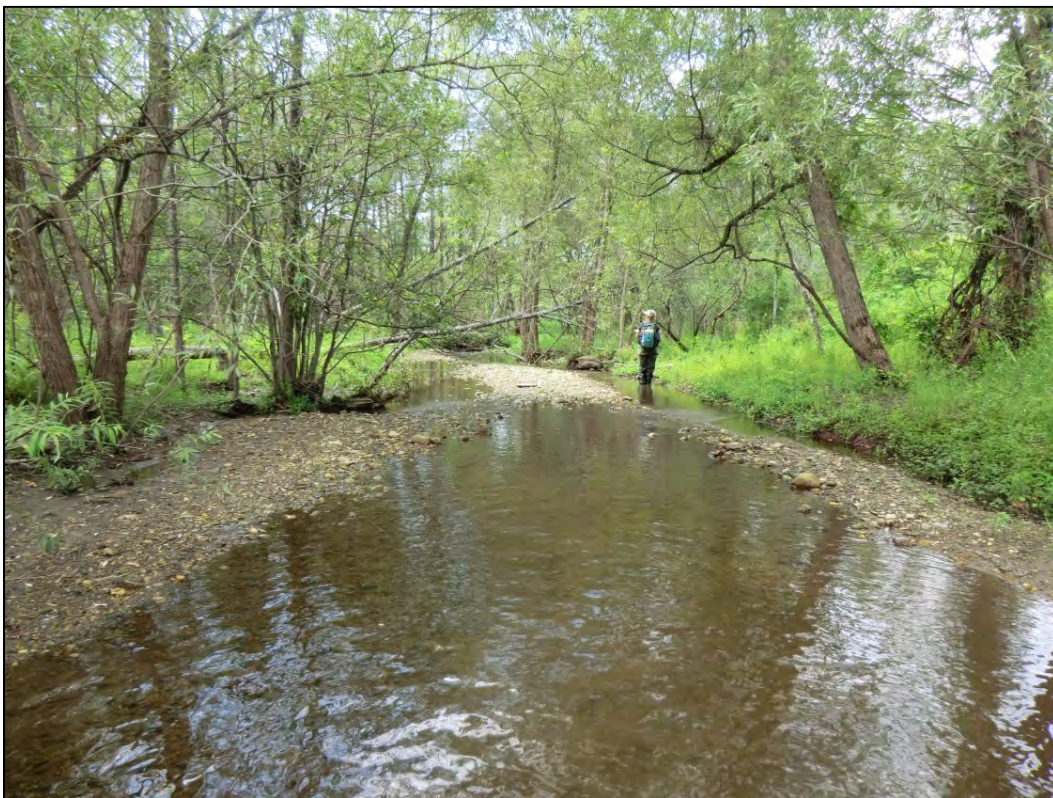
The next most upstream segment on Unnamed Tributary 1 to Thatcher Brook is about 2,700 feet in length, extending from the upper end of the bedrock gorge upstream to slightly above the Twin Peaks Road stream crossing. This section of the stream has incised historically and is actively adjusting planform via flood chutes, but has not widened much. Areas within this segment have majorly aggraded and bank erosion is scattered throughout. One short section was recently windrowed and bermed to protect a landowner’s lawn. Segment C mostly flows undisturbed through the woods, though the upstream end is more residential. Geomorphic condition is **fair** because of historic incision and active planform adjustment. R13.S1.02-S1.02-S1.01-C is in **good** habitat condition, as it has ample woody debris to provide in-channel cover and well forested banks and buffers.

Figure 5.47. Segment C flows through the woods in Waterbury Center and is largely undisturbed.

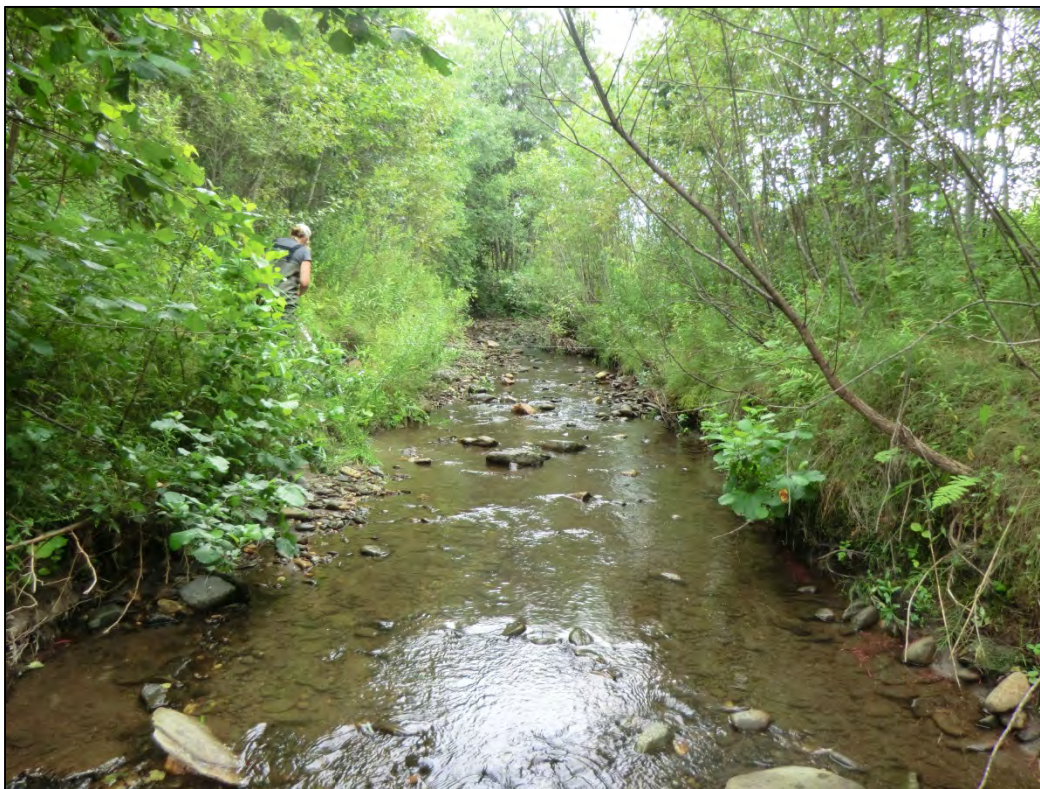
**Figure 5.48.** Segment C flows through the woods in Waterbury Center and is largely undisturbed.

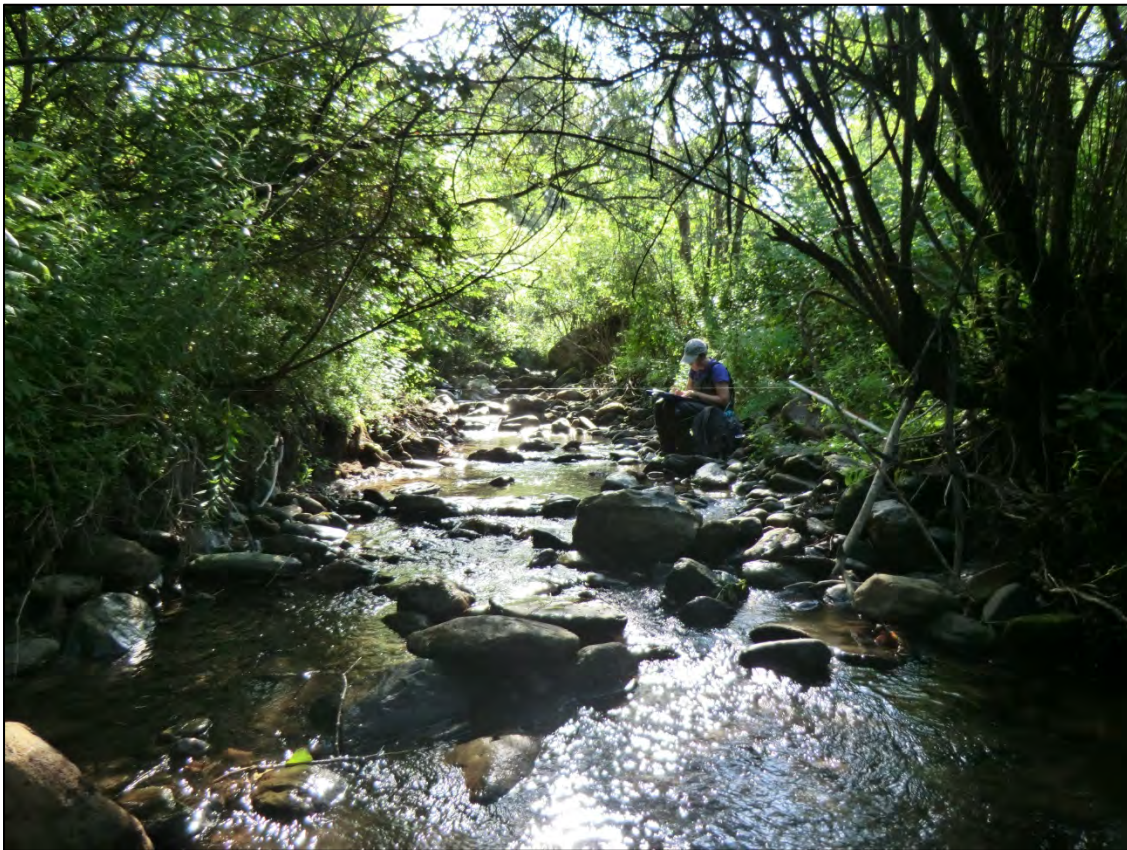
*R13.S1.02-S1.02-S1.01-F*

Segment F on R13.S1.02-S1.02-S1.01 is characterized by a narrow channel flowing through shrubby wetlands. The channel has a natural planform in this segment, except for where it was straightened at the downstream-most end where it crosses under Perry Hill Road. The segment is approximately 1,200 feet in length, beginning just below the Perry Hill Road crossing and continuing upstream. The stream channel in R13.S1.02-S1.02-S1.01-F has incised very slightly but has not widened and has great floodplain access. Bank erosion is common along this sinuous stretch of stream. Its undisturbed planform and good floodplain access cause it to be in **good** geomorphic condition. R13.S1.02-S1.02-S1.01-F is in **fair** habitat condition because it is lacking in channel woody debris, there are few pools, and the banks are unstable in areas.

**Figure 5.50.** Segment F is a naturally narrow channel flowing through a shrubby wetland.

<b>R13.S1.02-S1.02-S1.01-F Data Summary</b>		<b>Reference</b>	<b>Existing</b>
Length: 1,245 ft Drainage Area: 2.8 sq. mi. Evolution Stage: F-II Sensitivity: High	Confinement	Very Broad	Very Broad
	Stream Type	E	E
	Entrenchment Ratio	> 2.2	8.1
	Incision Ratio	< 1.2	1.2
	Dominant Bed Material	Gravel	Gravel
	Dominant Bedform	Riffle-Pool	Riffle-Pool
<b>Major Stressors:</b>	<b>Erosion, Mass Failure</b>

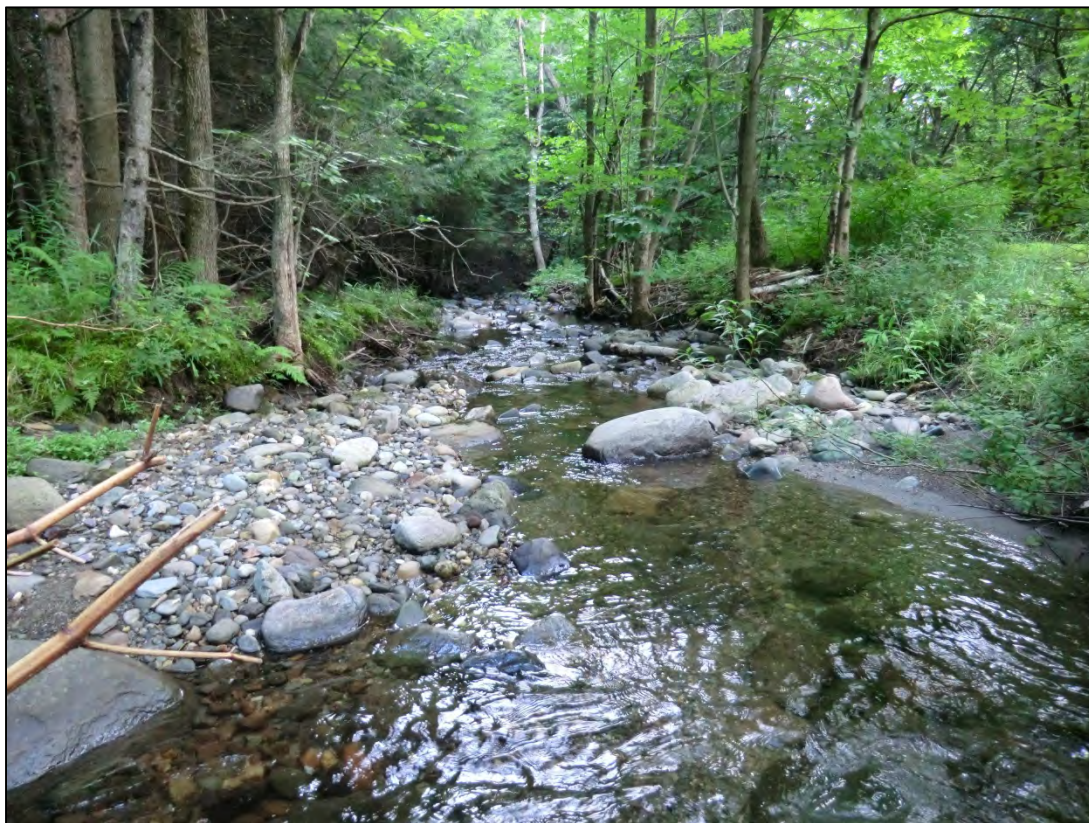
*R13.S1.02-S1.02-S1.01-G*

This segment is the uppermost segment included in this study on the first unnamed tributary to Thatcher Brook. It is approximately 1,200 feet in length and flows in the woods behind houses on the south side of Kneeland Flats Road. R13.S1.02-S1.02-S1.01-G is steeper than the downstream segments (other than B) and is undisturbed. Its planform is natural and it has not incised or widened. Floodplain access is excellent. Areas of minor erosion exist on both banks and one short mass failure is present on each side of the stream. Surrounding lands are primarily forested with short sections of agricultural land and residential land closer to Kneeland Flats Road. R13.S1.02-S1.02-S1.01-G is in **good** geomorphic condition due to its stability and undisturbed nature, as well as excellent floodplain access. The segment is also in **good** habitat condition, as large woody debris is abundant in the channel, there is a diversity of bed features, and the banks and buffers are well forested.

**Figure 5.51.** R13.S1.02-S1.02-S1.01-G flows through forested land and is stable and undisturbed.

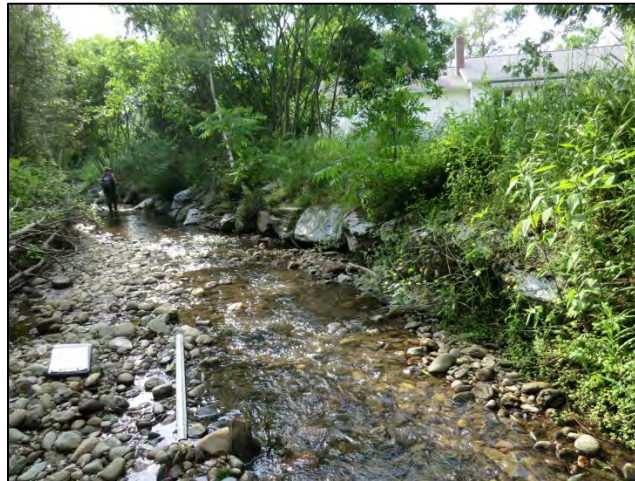
#### *R13.S1.02-S1.03-S1.01-A*

The downstream-most segment on this tributary begins at the confluence with Thatcher Brook and continues upstream to about 900 feet above the bridge on Guptil Road. It flows through residential land and was historically straightened for about half of its length. This section of the stream has not incised or widened and retains excellent floodplain access. Aggradation is abundant in this segment, as is bank armoring, especially in the vicinity of the bridge and directly above it. The section above the bridge is used as pasture land and cows have access to the stream. Bank erosion is minimal in R13.S1.02-S1.03-S1.01-A. A short section at the confluence with Thatcher Brook appears to have been windrowed. This segment is in **fair** geomorphic condition as a result of historic straightening and the encroachment of development. It is also in **fair** habitat condition due to lacking woody debris, poor diversity of bed features, and impacted buffer zones.

Figure 5.52. Riprap and development are common in R13.S1.02-S1.03-S1.01-A.

<b>R13.S1.02-S1.03-S1.01-A Data Summary</b>		<b>Reference</b>	<b>Existing</b>
Length: 1,162 ft	Confinement	Very Broad	Very Broad
Drainage Area: 2.3 sq. mi.	Stream Type	C	C
Evolution Stage: F-I	Entrenchment Ratio	> 2.2	12.1
Sensitivity: High	Incision Ratio	< 1.2	1.0
	Dominant Bed Material	Gravel	Gravel
	Dominant Bedform	Riffle-Pool	Riffle-Pool
<b>Major Stressors:</b>	<b>Straightening, Encroachments, Animal Grazing, Revetments</b>

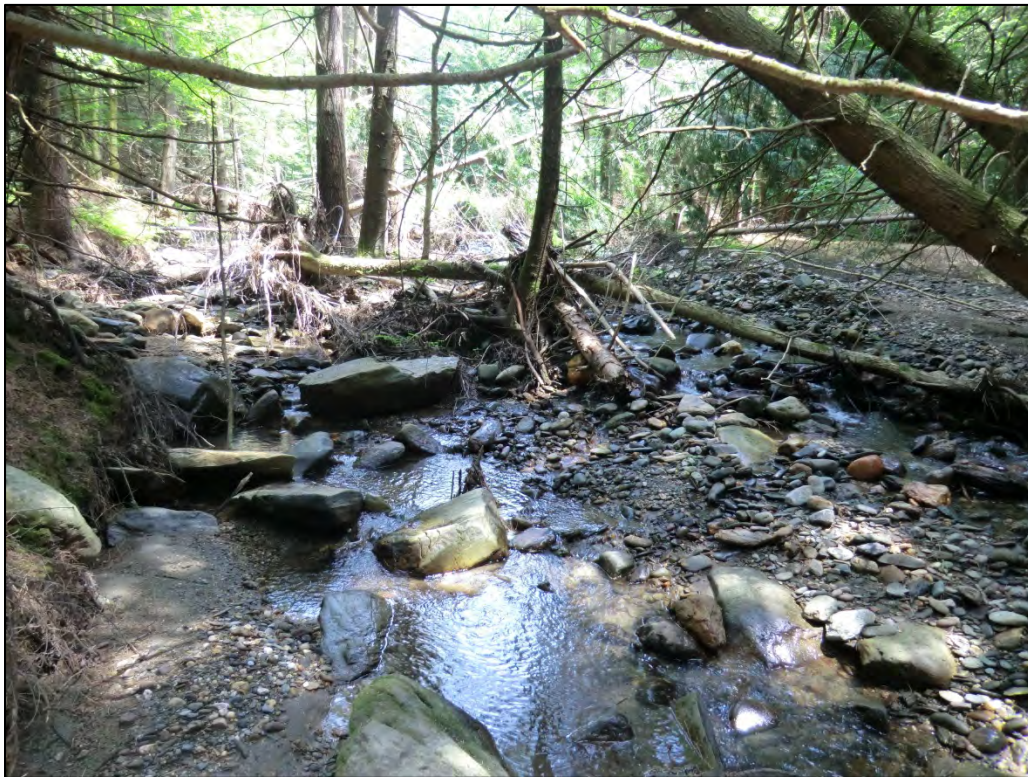
R13.S1.02-S1.03-S1.01-C is the upstream-most segment on reach one of this tributary. It flows through the woods and has a natural planform and minimal human impacts. The stream channel has incised and is beginning to widen and adjust planform. During Tropical Storm Irene, the channel avulsed, taking a new course, and created multiple large flood chutes. The channel is braided in one location under low flow conditions. Stormwater inputs are present in this segment, and one large, unstable gully is delivering substantial amounts of sediment to the stream channel from adjacent developed land. This sediment contributes to the major aggradation observed in this segment. Debris jams are also exacerbating planform adjustment as the channel moves around them. Bank erosion is common in R13.S1.02-S1.03-S1.01-C as the channel adjusts. This segment is in **fair** geomorphic condition due to active adjustment and **good** habitat condition as a result of ample woody debris, diverse bed features, and well forested banks and buffers.

Figure 5.54. Deposition and woody debris are common in the stream channel of R13.S1.02-S1.03-S1.01-C.

R13.S1.02-S1.03-S1.01-C Data Summary		Reference	Existing
Length: 2,850 ft Drainage Area: 2.3 sq. mi. Evolution Stage: F-IV Sensitivity: Very High	Confinement	Very Broad	Very Broad
	Stream Type	B	B
	Entrenchment Ratio	1.4 – 2.2	2.0
	Incision Ratio	< 1.2	1.5
	Dominant Bed Material	Gravel	Gravel
	Dominant Bedform	Riffle-Pool	Riffle-Pool
<b>Major Stressors:</b>		<b>Stormwater Inputs, Gully, Erosion, Mass Failure</b>

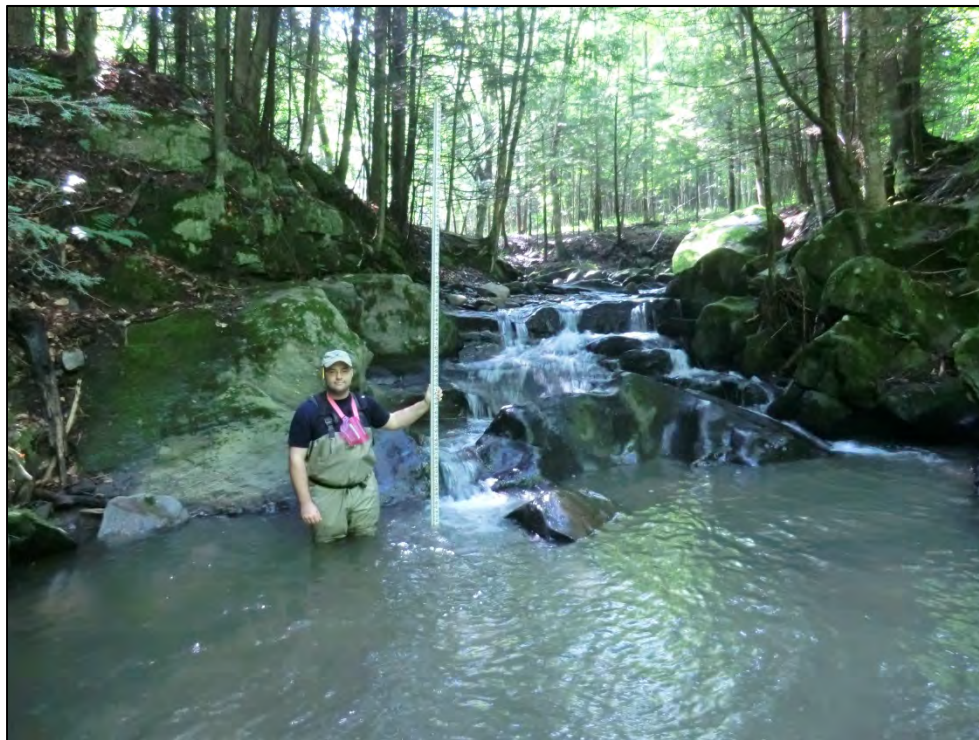
*R13.S1.02-S1.03-S1.02-A*

The downstream-most segment on reach two of the second unnamed tributary to Thatcher Brook is characterized by a narrow river valley with abundant bedrock outcrops. There are four bedrock grade controls present in this segment, which have likely prevented channel incision. This segment is very stable and the channel has not undergone widening overall. Bank erosion and mass failures are present in some areas where bedrock is not dominant on the banks and/or valley walls. The stability of this segment and its overall lack of adjustment have caused it to be in **good** geomorphic condition. It is also in **good** habitat condition as a result of good cover on the streambed and well forested banks and buffers.

Figure 5.55. Bedrock outcrops are common in R13.S1.02-S1.03-S1.02-A and afford vertical stability to the channel.

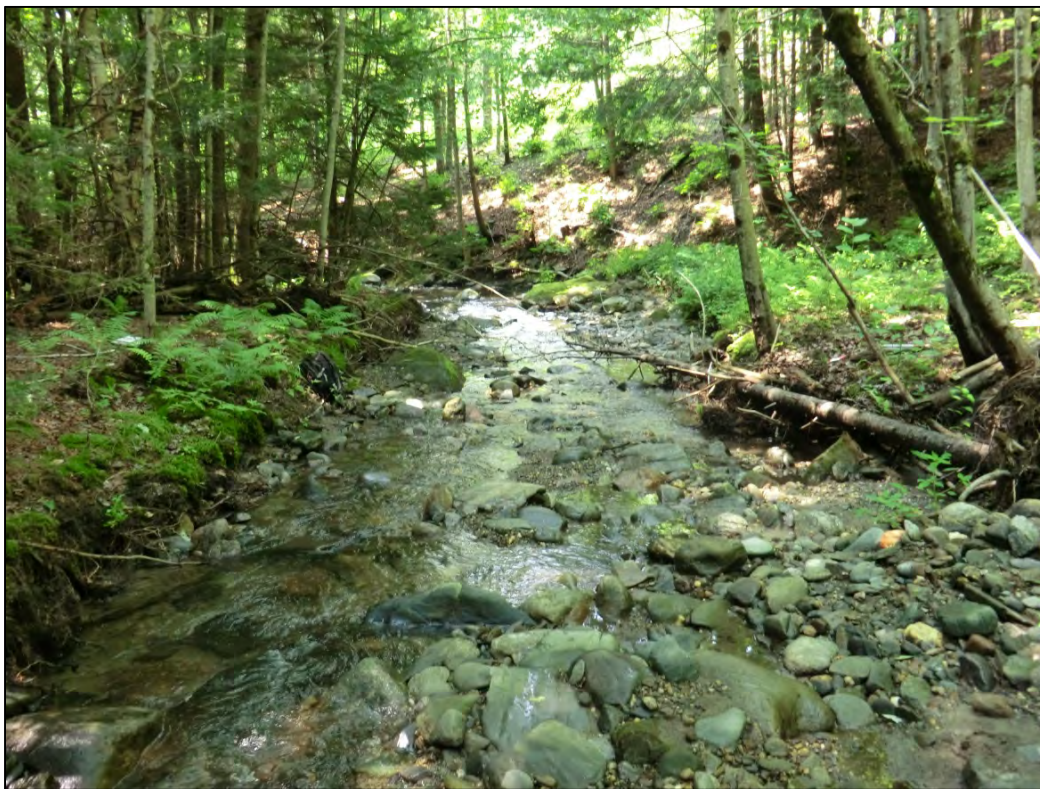
*R13.S1.02-S1.03-S1.02-B*

The second segment on reach two of this tributary is 1,800 feet in length, beginning just below the stream crossing on Shaw Mansion Road and ending in the woods between Shaw Mansion Road and Ripley Road where a large tributary enters. This section of stream has incised, but has not widened. Bedrock outcrops are present toward the upstream end of this segment and are holding the grade and deterring further incision. Bank erosion is scattered throughout the segment and one mass failure is present along the southern valley wall. The culvert under Shaw Mansion Road is significantly undersized and is likely contributing to localized geomorphic instability. The stream is adjusting laterally via several flood chutes. For these reasons, R13.S1.02-S.03-S1.01-B is in **fair** geomorphic condition. This segment is in **good** habitat condition because of its well-defined bedform, good floodplain connectivity, and forested banks and buffers.

**Figure 5.56.** R13.S1.02-S1.03-S1.02-B has well forested banks and buffers.

<b>R13.S1.02-S1.03-S1.02-B Data Summary</b>		<b>Reference</b>	<b>Existing</b>
Length:	1,798 ft	Very Broad	Very Broad
Drainage Area:	1.8 sq. mi.	$C_b$	$C_b$
Evolution Stage:	F-II	> 2.2	5.0
Sensitivity:	High	< 1.2	1.7
		Dominant Bed Material	Gravel
		Dominant Bedform	Riffle-Pool
<b>Major Stressors:</b>	<b>Undersized Culvert, Erosion, Mass Failure, Stormwater Inputs</b>

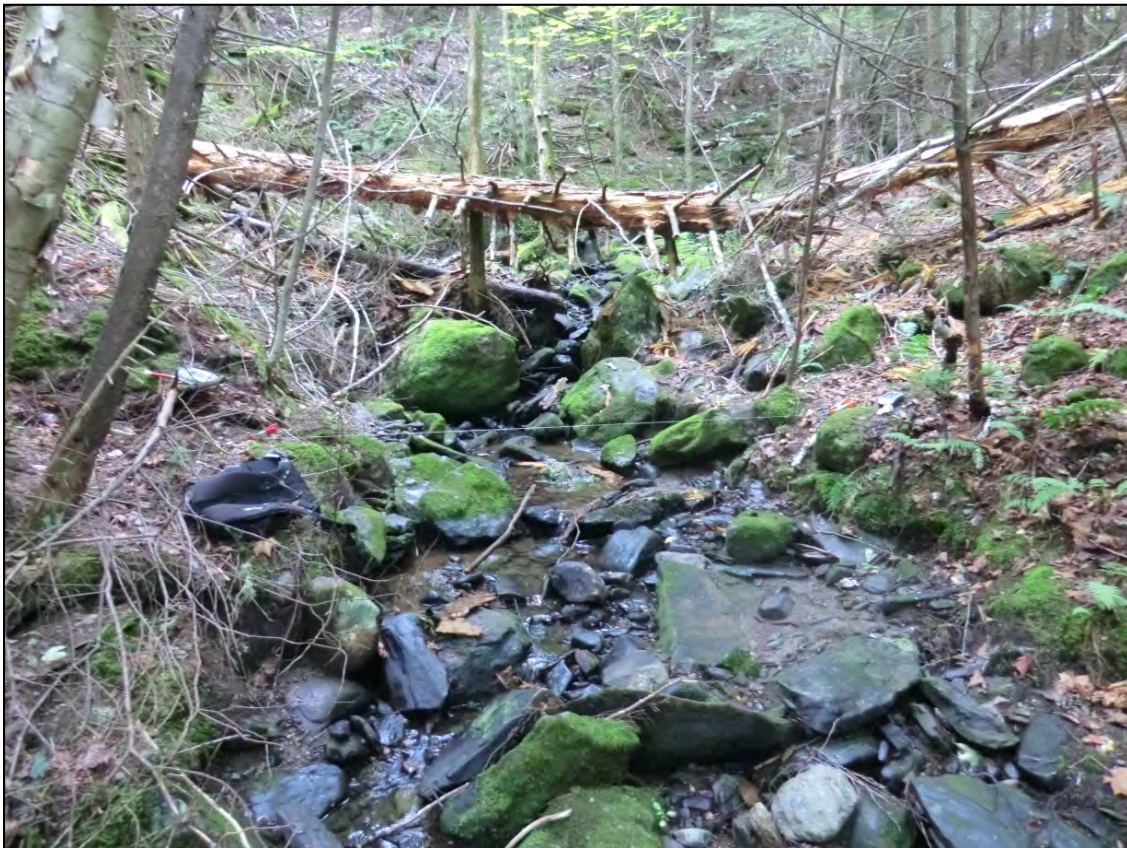
*R13.S1.02-S1.03-S1.02-D*

Segment D on reach two is approximately 1,200 feet in length, beginning just above the culvert under Ripley Road and continuing upstream to where the forest canopy opens into a wetland complex. This segment is characterized by having a steep channel slope and a natural planform. R13.S1.02-S1.03-S1.02-D has incised very slightly, but has not widened. Small flood chutes are present in this segment where it is adjusting laterally. The stream’s drainage area is very small at the upstream end of this segment, but a tributary enters within this segment and contributes more flow to the channel. This segment is in **good** geomorphic condition because it has not majorly incised, widened, or changed planform. It is also in **good** habitat condition, as there are diverse bed features and well forested banks and buffers.

**Figure 5.58.** The stream channel in R13.S1.02-S1.03-S1.02-D is small and steep for most of the segment.

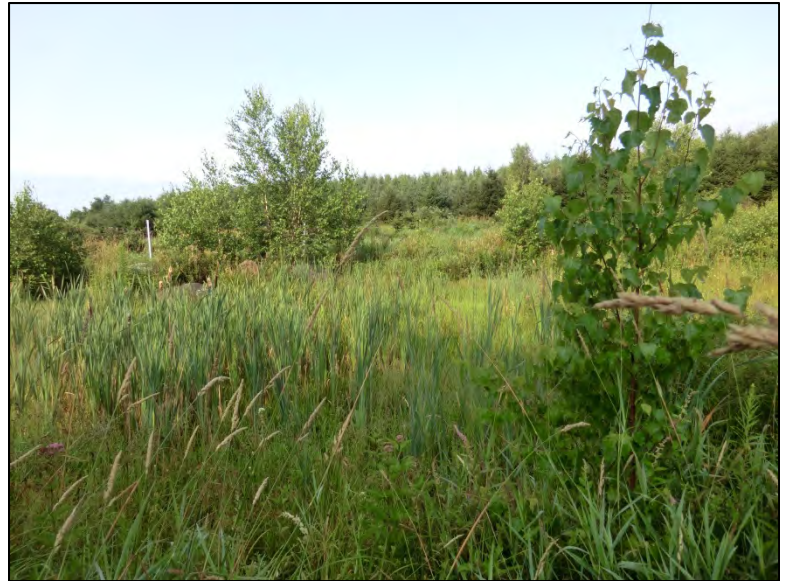
The upstream-most segment on the Unnamed Tributary 2 to Thatcher Brook included in this study was not fully assessed due to a lack of flowing water. The upstream end of the segment is a wetland complex, which empties into a man-made pond. The pond is piped out under a trail and becomes the flowing channel of this stream. Surrounding land in this segment is wetland and agricultural.

**Figure 5.59** The upstream end of segment R13.S1.02-S1.03-S1.02-E is a wetland complex.

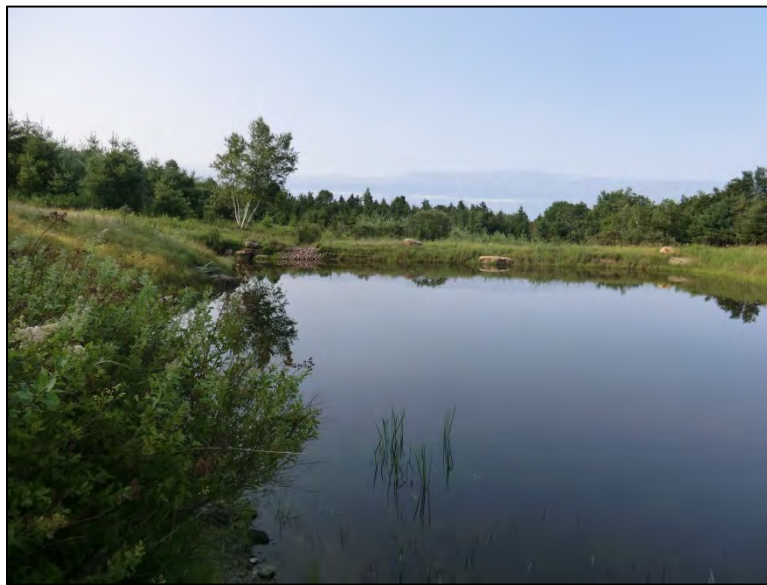
**Figure 5.60.** R13.S1.02-S1.03-S1.02-E is a man-made pond for part of its length.

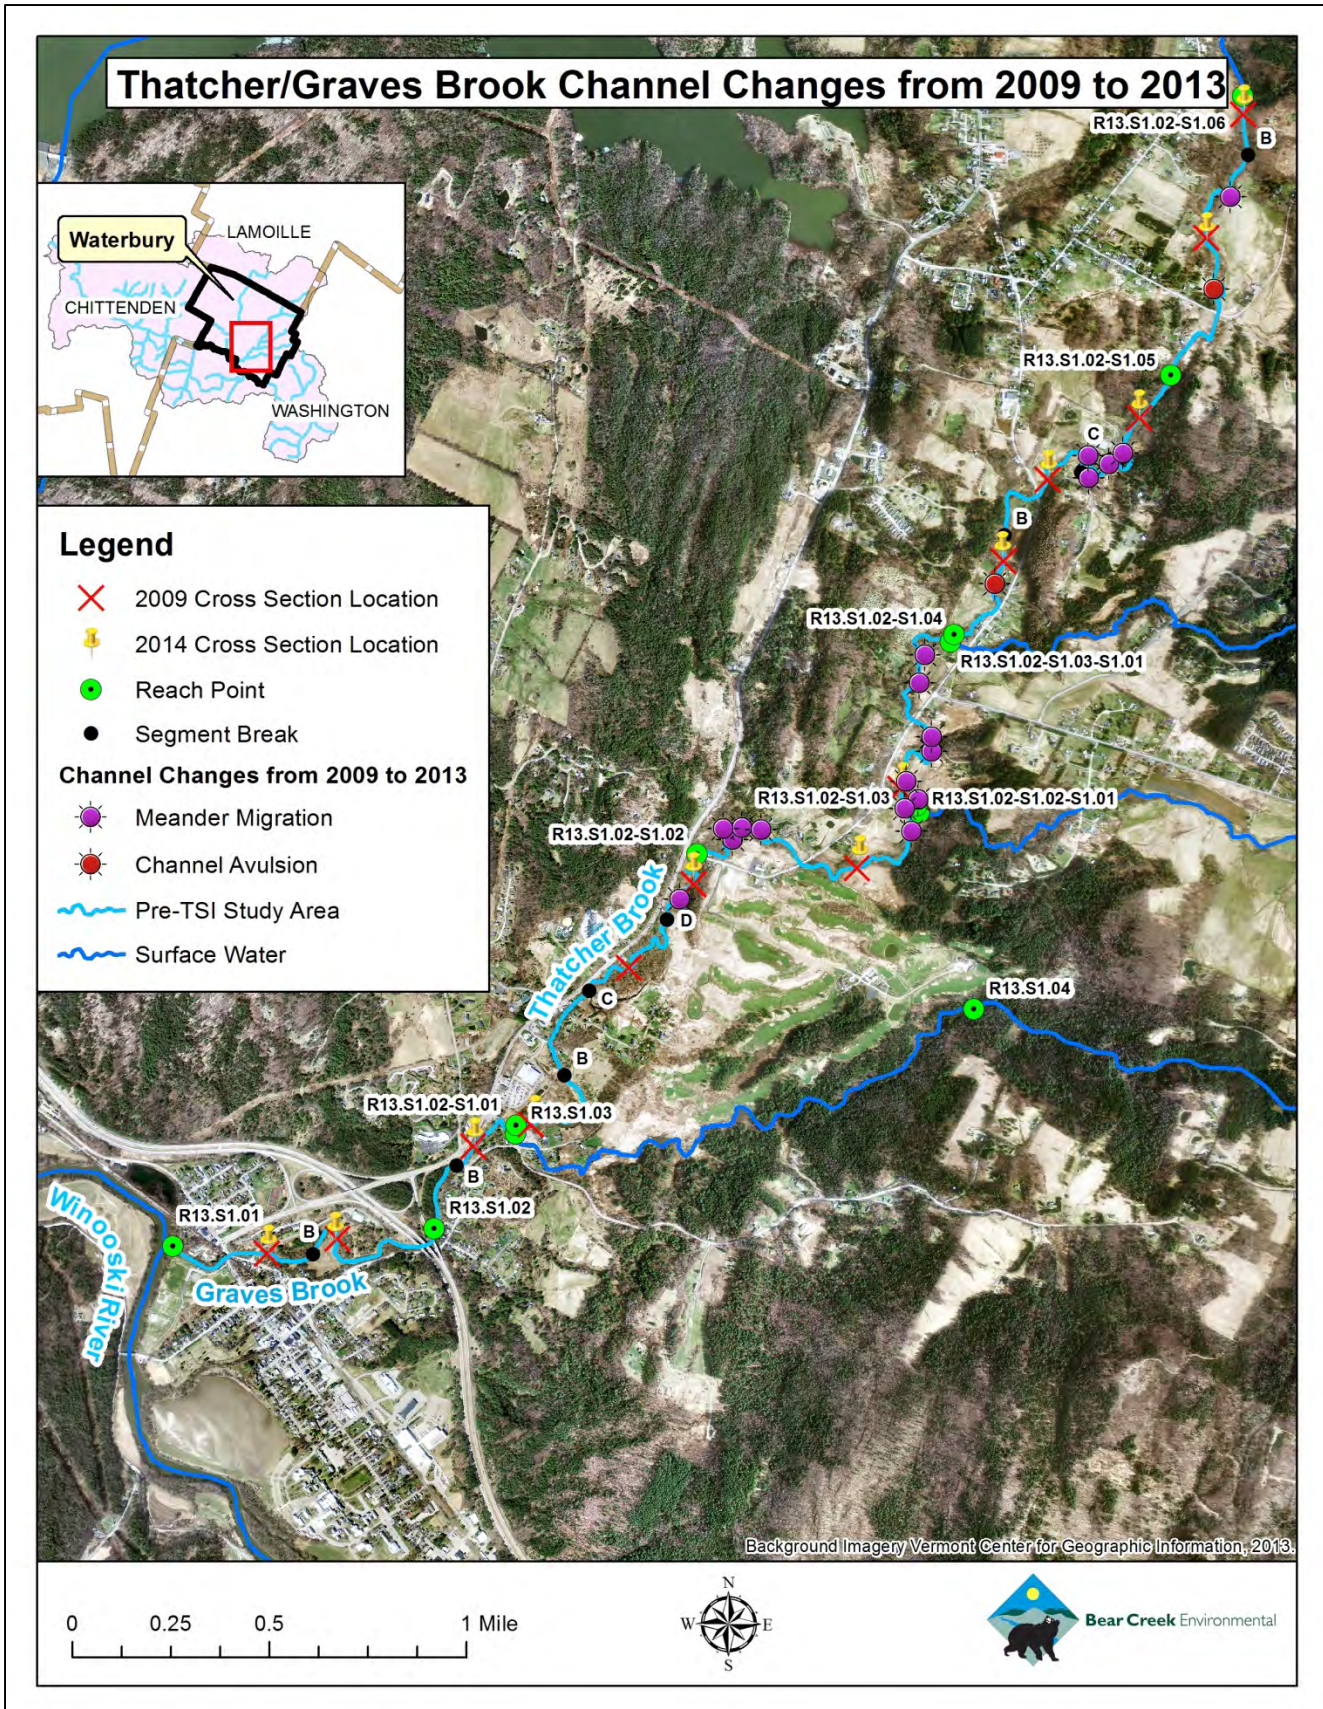
Figure 3. Channel changes in Thatcher and Graves Brook from 2009 to 2013.

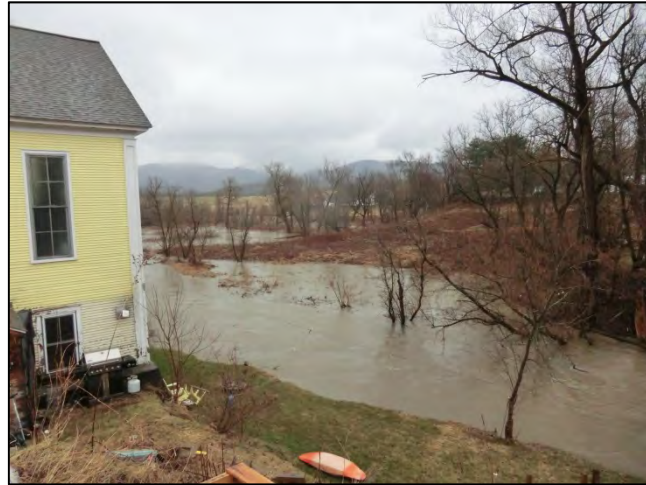
**Figure 4.** Floodwater attenuation in wetlands along Thatcher Brook.

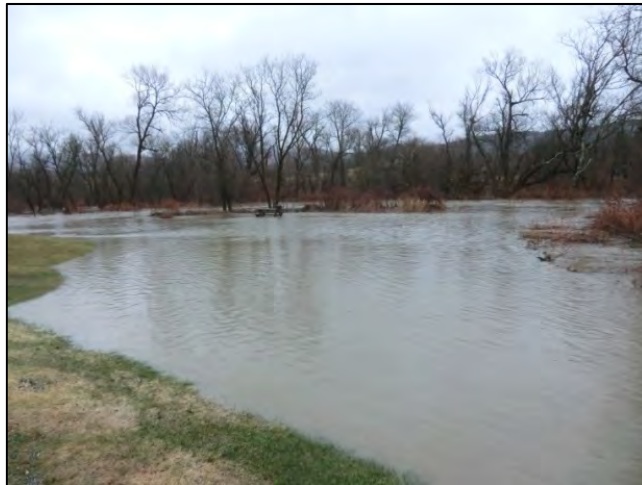
**Figure 5.** Water disperses energy out onto the floodplain in many areas along Thatcher Brook.

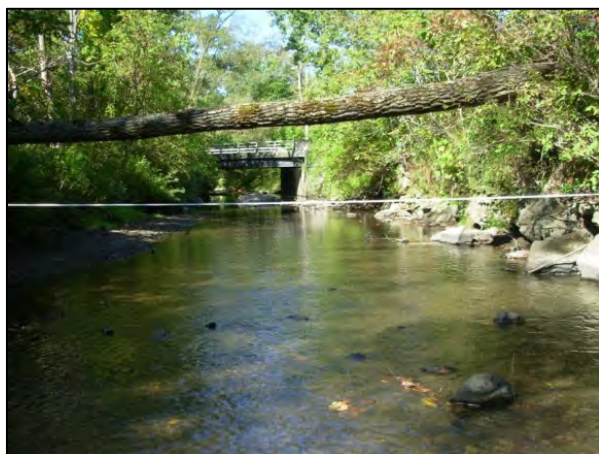
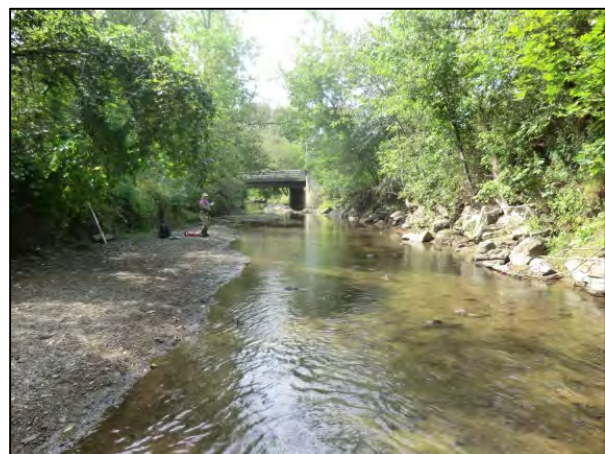
<b>Table 1: Comparison of 2009 and 2014 Cross Sections at R13.S1.01-A</b>					
<b>River Scientist Team</b>	<b>Cross Sectional Area</b>	<b>Bankfull Width</b>	<b>W/D Ratio</b>	<b>Entrenchment Ratio</b>	<b>Incision Ratio</b>
Redstart (2009)	146.8	35.3	8.5	3.39	1.8
BCE (2014)	151.4	36.6	8.8	3.17	1.8
Percent change	3.1%	3.7%	3.5%	-6.5%	0%
Comments: Cross sections very similar. No significant change due to TSI. Left valley wall differs due to 2014 cross section extending to railroad bed. 2009 cross section ended at road. Bedform in 2014 was more of a run and not a riffle.

**Figure 7.** Cross section R13.S1.01-A in 2009 (left) and in 2014 (right)

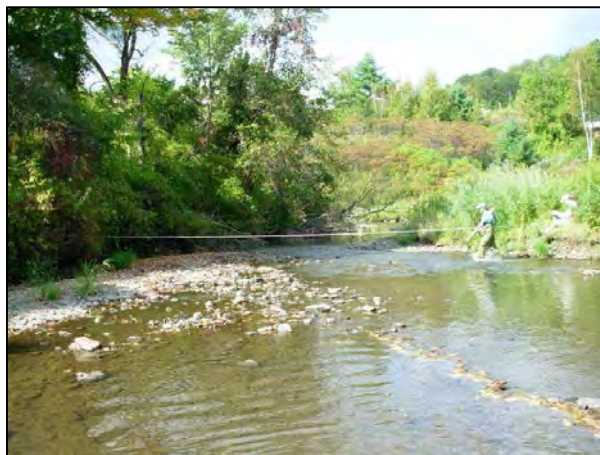
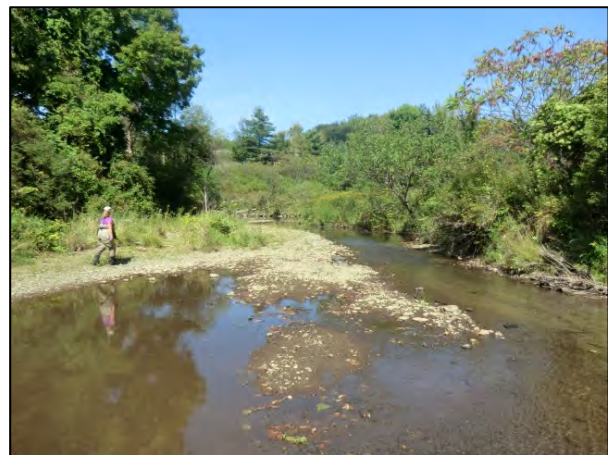
Comments: 2009 cross section location is now a pool. 2014 cross section was surveyed just upstream (about 35 feet) of 2009 cross section location, which may account for the difference in left terrace elevation. Channel has slightly widened. No more undercut on left bank and left bank has slumped. More aggradational in 2014 possibly due to TSI (See Figure 9).

**Figure 9.** Cross section R13.S1.01-B in 2009 (left) and in 2014 (right)

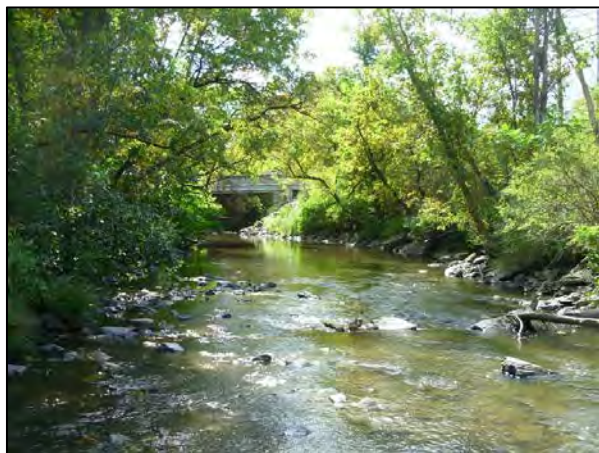
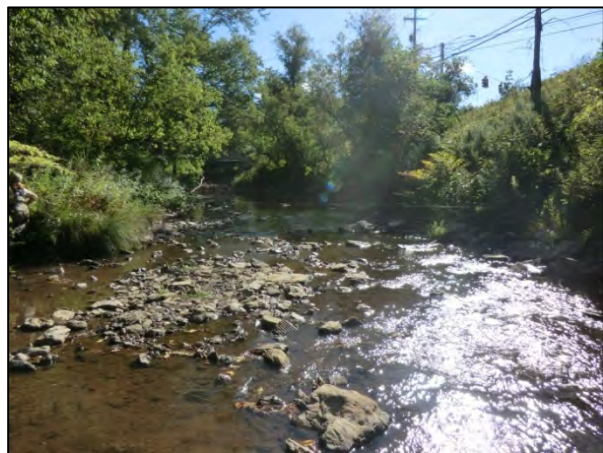
Comments: Cross sections very similar from 2009 to 2014. Channel may have widened based on increased w/d ratio.

**Figure 11.** Cross section R13.S1.02-B in 2009 (left) and in 2014 (right)

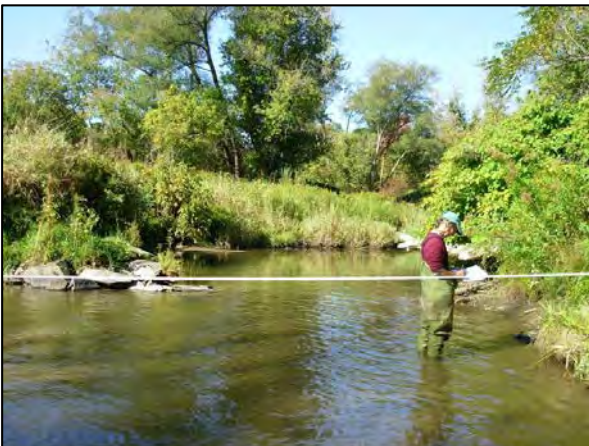
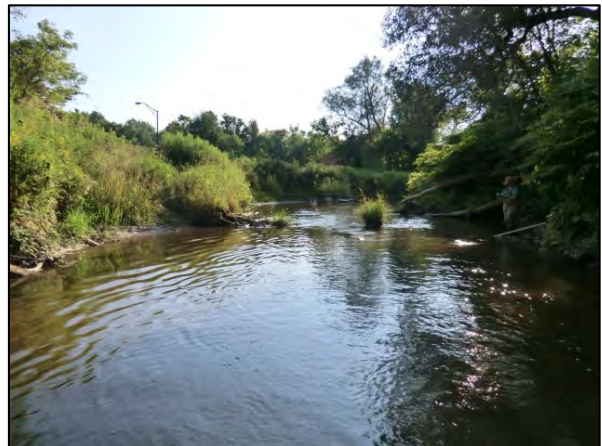
Comments: Cross sectional area for 2014 was lower than 2009, but consistent with upstream cross sectional areas. Cross section in 2014 was measured just 45 feet upstream of 2009 cross section due to bank slump in 2009 location (indicating channel widening). This resulted in different valley widths. Bankfull width in 2014 cross section was the same as 2009 cross section. Width to depth ratio in 2014 showed “C” stream type.

**Figure 13.** Cross section R13.S1.02-S1.01-A in 2009 (left) and in 2014 (right)

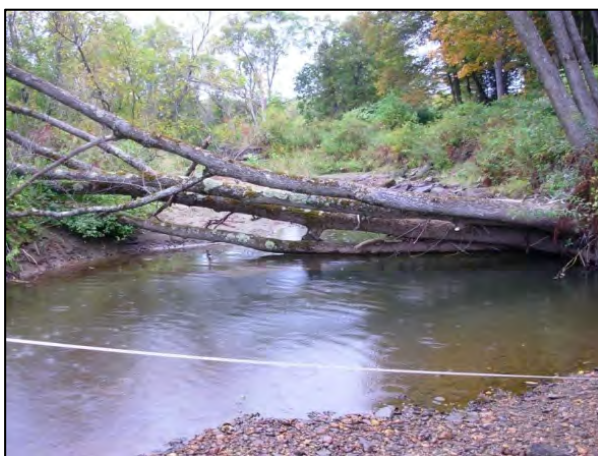
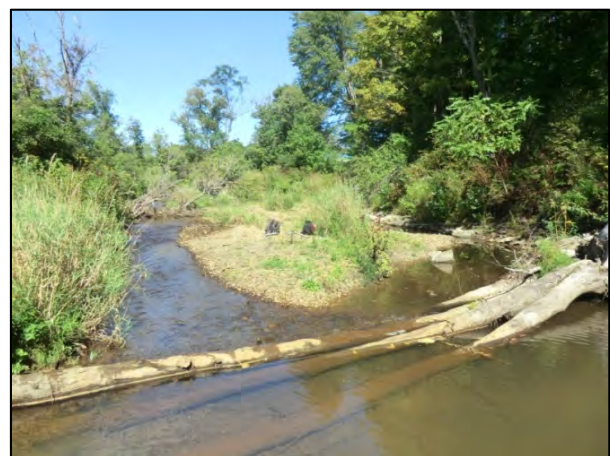
<b>Table 5: Comparison of 2009 and 2014 Cross Sections at R13.S1.02-S1.01-D</b>					
<b>River Scientist Team</b>	<b>Cross Sectional Area</b>	<b>Bankfull Width</b>	<b>W/D Ratio</b>	<b>Entrenchment Ratio</b>	<b>Incision Ratio</b>
Redstart (2009)	95.9	37.4	14.6	6.9	1.5
BCE (2014)	121.7	47.1	18.3	5.0	1.5
Percent change	26.9%	25.9%	25.3%	-27.5%	0%
Comments: Cross sectional area was higher in 2014 than 2009. The 2014 cross section was measured just upstream (about 20 feet) of the 2009 cross section due to channel changes. The fallen tree and large pool were present in the 2009 location (Figure 15). Channel may have experienced widening based on increased w/d ratio.

**Figure 15.** Looking upstream at cross section R13.S1.02-S1.01-D in 2009 (left) and 2014 (right).

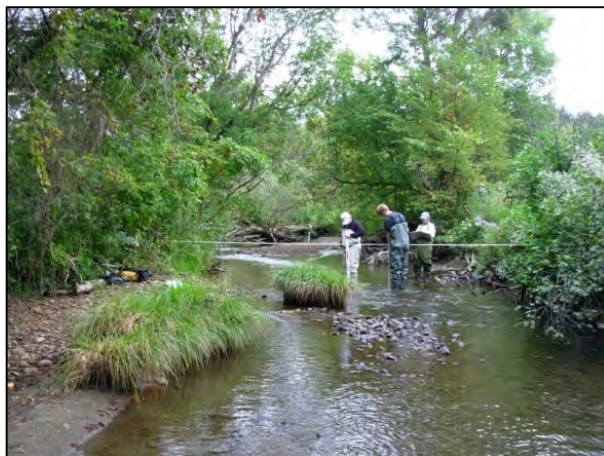
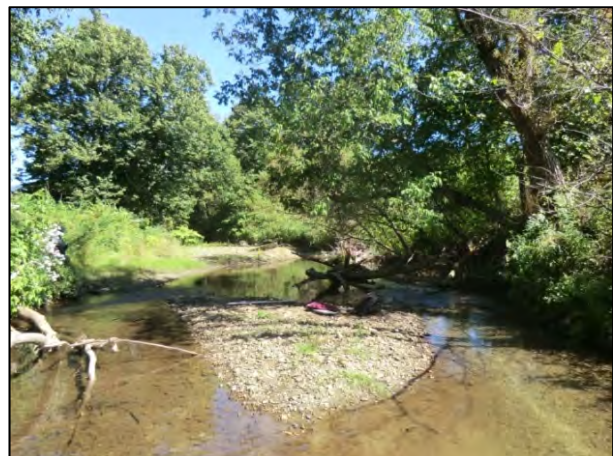
Comments: Cross sectional area for 2014 was higher than 2009. Depositional features in 2014 were larger than in 2009, and new debris noted in channel in 2014; both most likely due to TSI (See Figure 17). Both teams noted that bankfull was hard to find in the field. Redstart used a “low new bench” for determining the bankfull elevation, while Bear Creek used the tree line. This likely accounts for differences in the bankfull cross sectional areas measured.

**Figure 17.** Cross section R13.S1.02-S1.02 in 2009 (left) and 2014 (right).

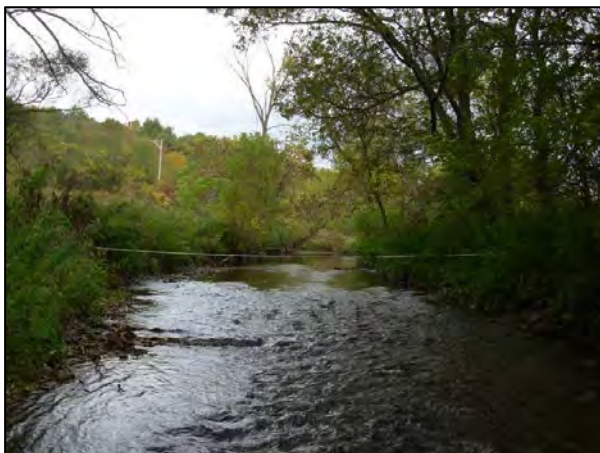
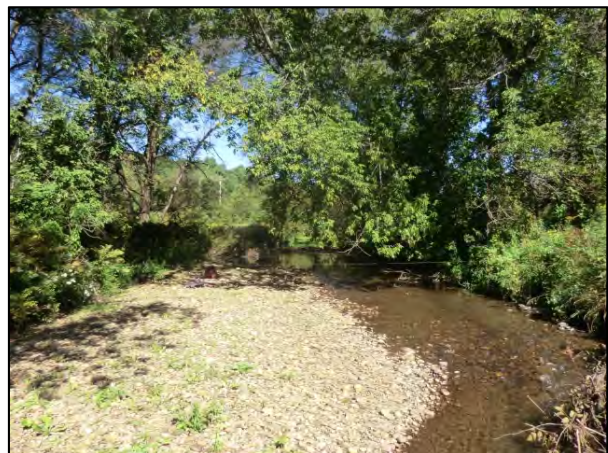
<b>Table 7: Comparison of 2009 and 2014 Cross Sections at R13.S1.02-S1.03</b>					
<b>River Scientist Team</b>	<b>Cross Sectional Area</b>	<b>Bankfull Width</b>	<b>W/D Ratio</b>	<b>Entrenchment Ratio</b>	<b>Incision Ratio</b>
Redstart (2009)	97.1	38.2	15.0	16.5	1.0
BCE (2014)	91.9	40.2	17.6	14.3	1.1
Percent change	-5.4%	5.2%	17.3%	-13.3%	10%
Comments: 2014 cross section was surveyed just downstream (about 40 feet) of 2009 cross section due to new beaver dam. Channel still has good floodplain access. More aggradational than in 2009 (Figure 19).

**Figure 19.** Cross section R13.S1.02-S1.03 in 2009 (left) where there is now a beaver dam and in 2014 (right) – more aggradational.

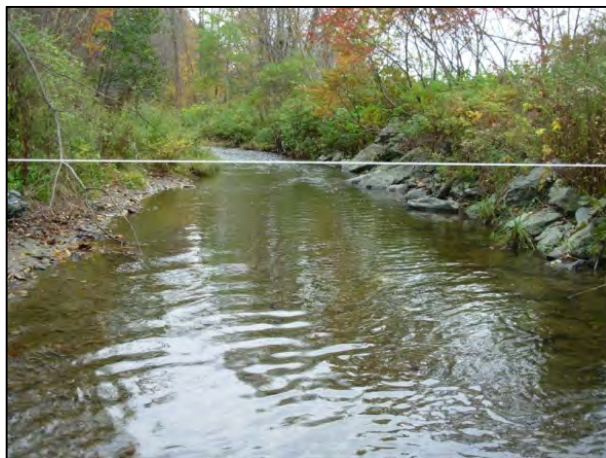
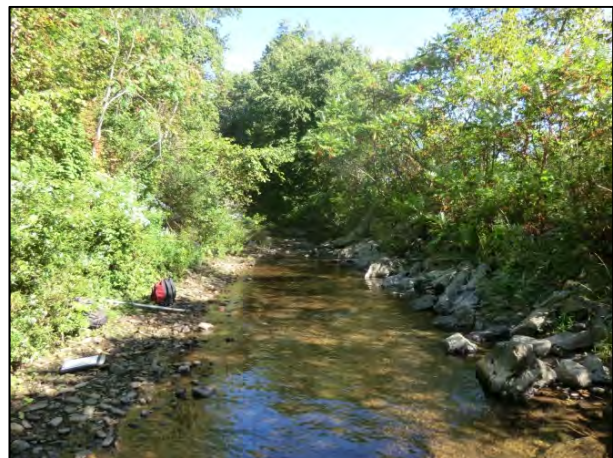
<b>Table 8: Comparison of 2009 and 2014 Cross Sections at R13.S1.02-S1.04-A</b>					
<b>River Scientist Team</b>	<b>Cross Sectional Area</b>	<b>Bankfull Width</b>	<b>W/D Ratio</b>	<b>Entrenchment Ratio</b>	<b>Incision Ratio</b>
Redstart (2009)	91.4	31.9	11.1	11.9	1.5
BCE (2014)	67.4	27.3	11.1	6.5	1.9
Percent change	-26.3%	-14.4%	0%	-45.4%	21.1%
Comments: Cross sectional area lower in 2014 than 2009, but consistent with upstream cross sectional areas measured in 2014.

**Figure 21.** Cross section R13.S1.02-S1.04-A in 2009 (left) and 2014 (right).

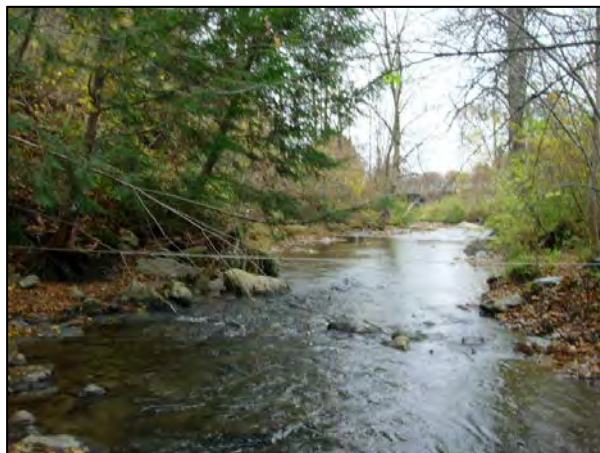
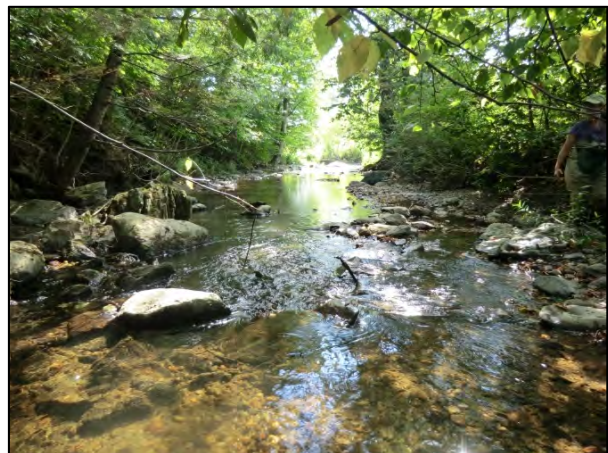
<b>Table 9: Comparison of 2009 and 2014 Cross Sections at R13.S1.02-S1.04-B</b>					
<b>River Scientist Team</b>	<b>Cross Sectional Area</b>	<b>Bankfull Width</b>	<b>W/D Ratio</b>	<b>Entrenchment Ratio</b>	<b>Incision Ratio</b>
Redstart (2009)	74.8	32.5	14.1	8.5	1.8
BCE (2014)	63.7	27.8	12.1	2.9	1.9
Percent change	-14.8%	-14.5%	-14.2%	-65.9%	5.6%
Comments: Cross sections similar. No significant changes from TSI except for some fallen debris from left bank.

**Figure 23.** Cross section R13.S1.02-S1.04-B in 2009 (left) and 2014 (right).
