# Waterbury, Vermont Middle Winooski River Corridor Plan

December 15, 2015

Prepared by:  
Bear Creek Environmental, LLC  
149 State Street, Suite 3  
Montpelier, Vermont 05602

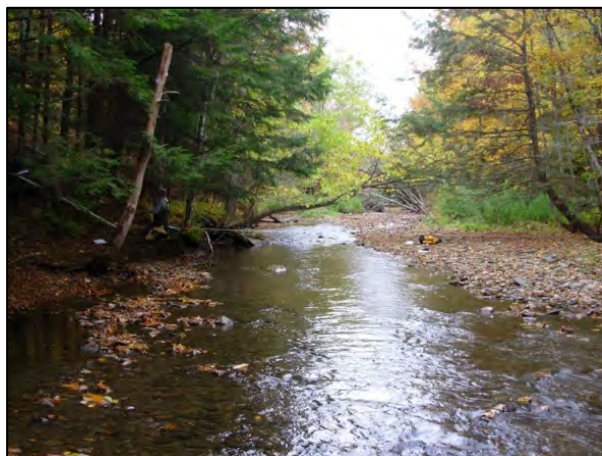
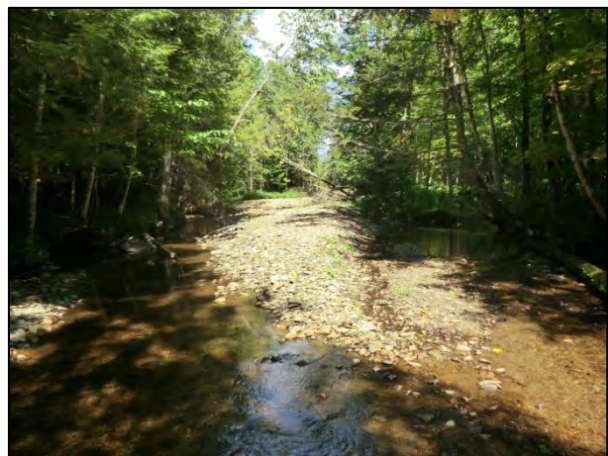
<b>Table 10: Comparison of 2009 and 2014 Cross Sections at R13.S1.02-S1.04-C</b>					
<b>River Scientist Team</b>	<b>Cross Sectional Area</b>	<b>Bankfull Width</b>	<b>W/D Ratio</b>	<b>Entrenchment Ratio</b>	<b>Incision Ratio</b>
Redstart (2009)	79.0	49.4	30.9	4.1	1.5
BCE (2014)	71.5	52.3	38.3	3.6	1.7
Percent change	-9.5%	5.9%	23.9%	-12.2%	13.3%
Comments: Left side of channel deeper in 2014. Flood chute observed in left floodplain in 2014. Bar shifted from left to right in channel.

**Figure 25.** Cross section R13.S1.02-S1.04-C in 2009 (left) and 2014 (right).

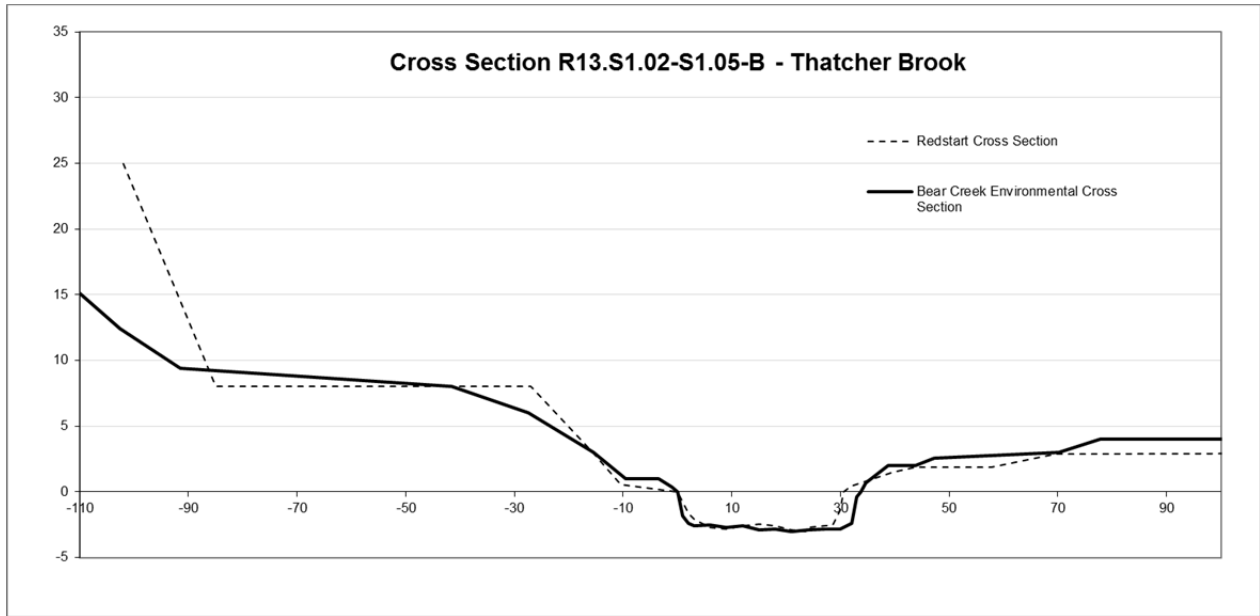
**R13.S1.02-S1.05-B**

**Figure 28.** 2009 and 2014 Cross sections done by Redstart and BCE, respectively in Segment R13.S1.02-S1.05-B.

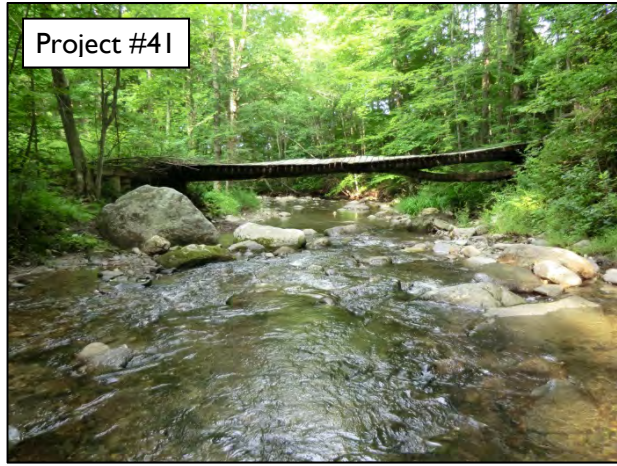
Project #41 R13.S1.02-S1.06-B (Refer to Map 6)	Structure Replacement/Removal	Remove Bridge	Thatcher Brook	Waterbury	Across from 371 Barnes Hill Road	Low

Old wooden trail bridge with no abutments. Low clearance and in unstable condition.
Project #42 R13.S1.02-S1.09-B (Refer to Map 6)	Structure Replacement/Removal	Replace Culvert	Thatcher Brook	Waterbury	At private drive crossing near 1930 Barnes Hill Road	High

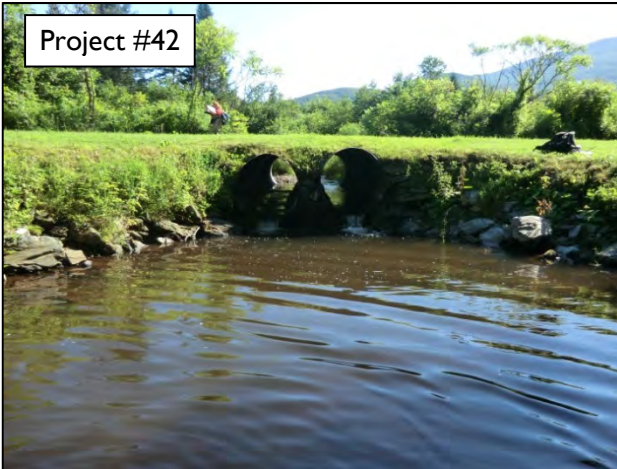
Project #42

Flow downstream of wetland is split into two channels that go through three culverts. Culverts are very undersized and there is no aquatic organism passage. Beaver dam upstream. Replace with adequately sized structure with no freefall drop.
Project #43 R13.S1.02-S1.09-D (Refer to Map 6)	Structure Replacement/Removal	Remove Bridge	Thatcher Brook	Waterbury	Approximately 900 feet downstream of Waterworks Road crossing	Low

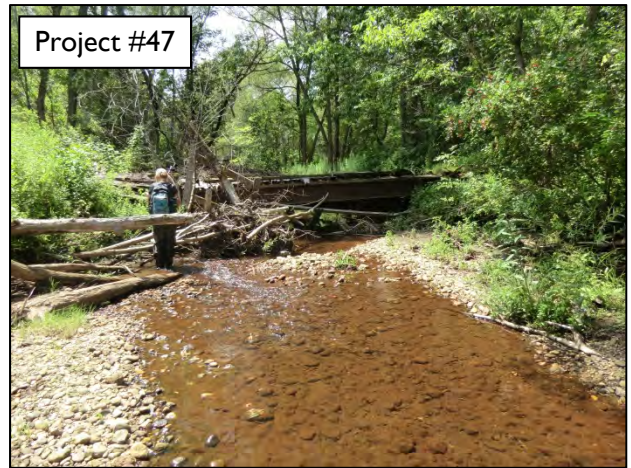
Project #47 R13.S1.02-S1.02-S1.01-C (Refer to Map 7)	Structure Replacement/Removal	Remove Destroyed Bridge	Unnamed Tributary 1 to Thatcher Brook	Waterbury	On VAST trail about 900 feet downstream of culvert under Twin Peaks Road	High

There is a destroyed snowmobile bridge (iron and wood) causing sediment and debris accumulation in the stream channel. The bridge could affect water quality and channel stability, and could wash downstream and cause damage to infrastructure/property if not removed.

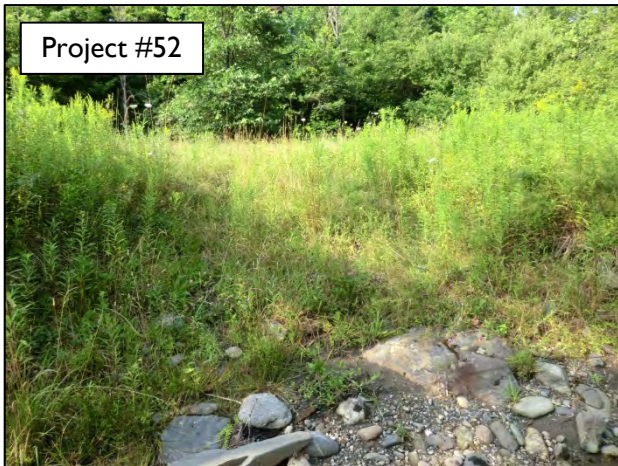
Project #52 R13.S1.02-S1.02-S1.01-G (Refer to Map 7)	Floodplain Improvement and Conservation	Riparian Buffer Planting	Unnamed Tributary 1 to Thatcher Brook	Waterbury	About 1,300 feet upstream of Perry Hill Road crossing	Low	●	●	○	○	Riparian buffer is lacking on northern bank for approximately 150 feet due to an agricultural field. Project may be eligible for CREP, but is a small planting area.
Project #53 R13.S1.02-S1.02-S1.01-G (Refer to Map 7)	Structure Replacement/ Removal	Remove or Replace Bridge	Unnamed Tributary 1 to Thatcher Brook	Waterbury	On VAST trail about 1,800 feet upstream of Perry Hill Road crossing	Moderate	○	○	●	●	A snowmobile bridge on the VAST trail is in poor condition and is partially collapsing. The bridge is a safety issue if it is currently in use, and if it is not in use, it should be removed as it is undersized and failing.
Project #54 R13.S1.02-S1.03-S1.01-A (Refer to Map 7)	Structure Replacement/ Removal	Replace Bridge	Unnamed Tributary 2 to Thatcher Brook	Waterbury	Bridge on Guptil Road almost 800 feet northeast of intersection with Kneeland Flats Road	High	○	○	●	●	Bridge is slightly undersized and is in poor condition. Riprap around the bridge has all fallen into the stream and a large amount of sediment has accumulated beneath the bridge, causing it to have a very low clearance. It could be easily overtopped and damaged during high flows.
