# **Little River Corridor Plan**

**Stowe, Waterbury, Morristown, Worcester,  
Bolton, Underhill and Cambridge, Vermont**  
**June 28, 2010**

Prepared by:  
Bear Creek Environmental, LLC  
297 East Bear Swamp Road  
Middlesex, Vermont 05602

Prepared for:  
The Lamoille County Planning Commission  
632 LaPorte Road  
Morrisville, VT 05661

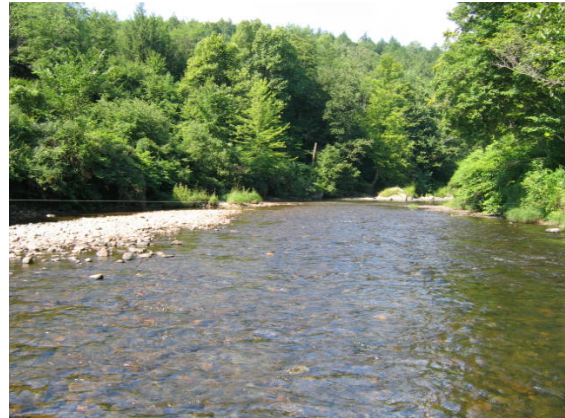
Many side bars, one mid-channel bar, two point bars, one diagonal bar, and one steep riffle were noted in the reach indicating that this reach is depositional (Figure 7.8). Reach M09 is a gravel dominated "C" channel in the F-III stage of channel evolution. The RGA scored "fair" due to extreme historic degradation and major widening and aggradation. Planform adjustment is a minor process. Channelization along Moscow Road, exposed substrates, deposition, bank erosion, and a narrow buffer width on the north bank are all factors that contributed to a RHA score of "fair".

**Figure 7.8. Side bars in Reach M09**

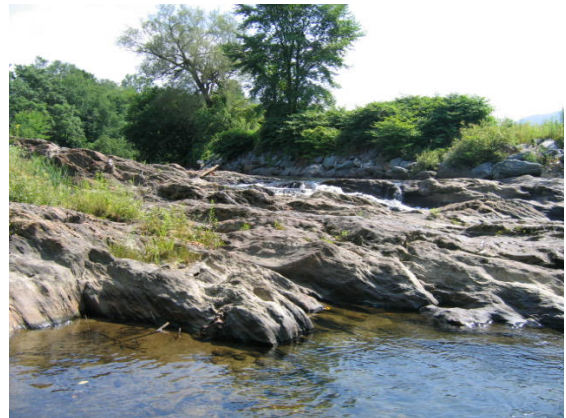
Reach M10 begins on the downstream end where there are bedrock grade controls (Figure 7.9) and commercial development within the corridor. The reach is 1,180 feet in length. The valley confinement is broad and there is no human-caused change in valley confinement. The corridor of reach M10 has considerable development along it with 60 percent of the north side developed and approximately 40 percent development on the south side. Straightening has occurred along approximately three-quarters of the reach and the reach has been armored for about half its length with rip-rap along both banks.

**Figure 7.9. Bedrock grade control in Reach M10**

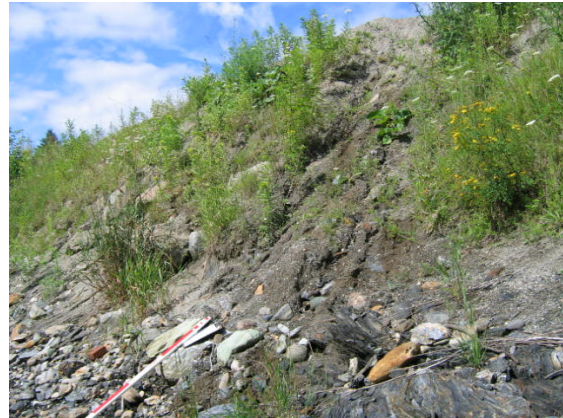
There is a bedrock grade control and an old dam (Figure 7.22) acting as a grade control in segment 15-A. The old dam is acting as a channel constriction and causing fine sediment to settle out upstream. The municipal sand storage is located on the western bank and there is significant bank erosion in the vicinity of this facility (Figure 7.23). The relocation of sand stockpiles and stormwater improvements are recommended at this site. A berm adjacent to the river could be removed as part of regrading of the parking lot; however, this berm is located above the floodprone elevation and removal will not result in improved floodplain access. A second parcel of land owned by the Town of Stowe, the wastewater treatment facility, abuts the northern bank of the Little River in segment M15-A and B.

**Figure 7.23. Bank erosion and lack of woody vegetation in the vicinity of the municipal sand storage facility**

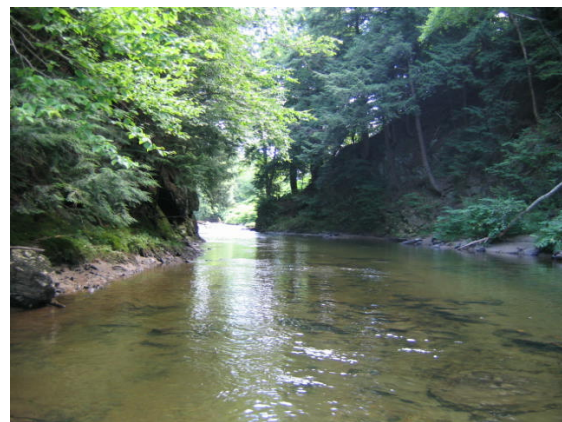
Segment M15-B is 559 feet long and is contained within a bedrock gorge (Figure 7.24). Due to the bedrock grade controls, Segment M15-B was not fully assessed. Since Segment M15-B is in a narrowly confined bedrock gorge with decent riparian buffers, it is presumed to be in reference condition. The western corridor is well forested, but the eastern corridor contains residential and commercial land use outside the valley wall.

**Figure 7.24. Reference condition of bedrock gorge in Segment M15-B**

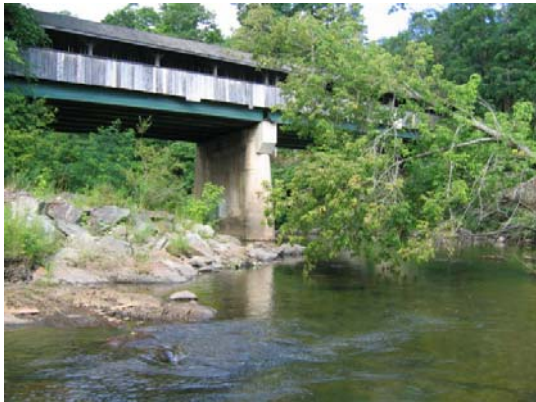
Segment M15-D begins where the Route 108 Bridge crosses (Figure 7.25). The valley opens up and the channel is less entrenched making it a gravel dominated “C” stream in stage III of the F channel evolution model. The presence of three large point bars, one side bar, and one mid-channel bar indicates M15-D is more depositional than the downstream segments in M15 (Figure 7.26). The west side of the river has a buffer less than 25 feet along 80 percent of its length from the presence of mowed lawn for commercial purposes. Erosion is minimal to moderate due to the presence of rip-rap on both banks.

**Figure 7.25. Route 108 bridge at downstream end of Segment M15-D**

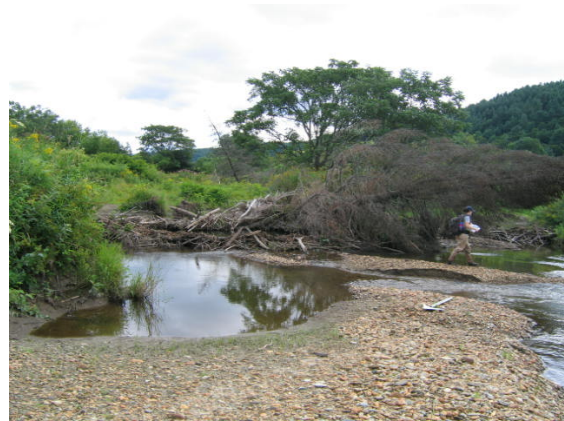
Reach M16 was separated into three segments to capture the characteristics of a beaver dam influenced sub-reach, M16-B. Differences in substrate size and depositional features were also factors in segmenting the reach. All three segments have beaver dams (Figure 7.27), but M16-B is most affected by the beaver dams.

**Figure 7.27. Beaver dam and deposition in M16-A**

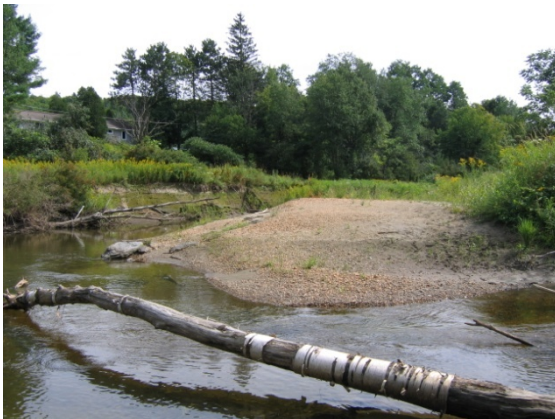
The lower segment, M18-A, begins about one-half mile downstream of the Little River Farm Road crossing and is 2,350 feet in length. The segment is currently undergoing major aggradation (Figure 7.31), major planform adjustment with minor widening. Planform adjustment was evident from the two avulsions which have cut off meander bends to form new channels.

**Figure 7.31. A large unvegetated gravel bar showing the major aggradation in**

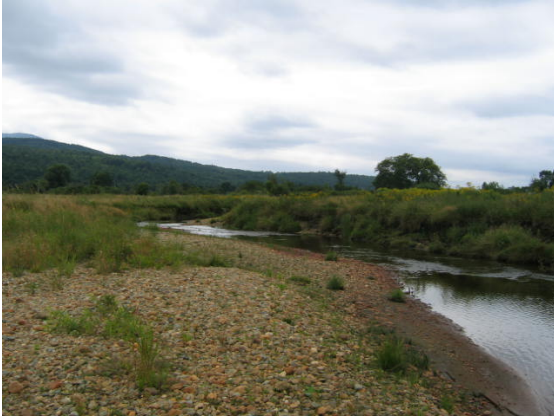
Reach M19 was divided into two segments due to changes in valley width and incision. The downstream segment (M19-A) is more incised than the upstream segment (M-19-B). The upstream valley is wider than downstream, although both segments still have very broad valleys. Both segments are gravel dominated “C” riffle-pool channels in stage F-III of channel evolution. M19 is very depositional with twenty steep riffles and numerous bars. (Figure 7.33).

**Figure 7.33. Large point bar in M19-A**

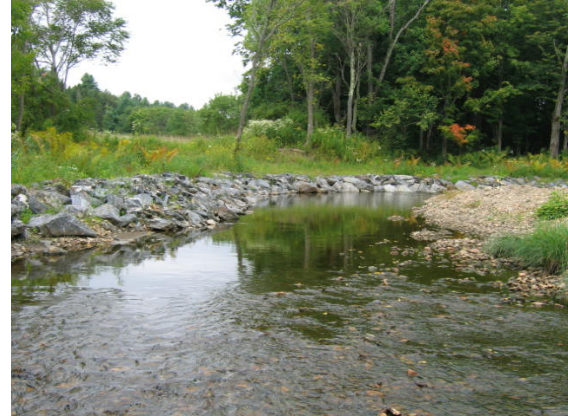
The percentage by length of erosion is greater in Segment M19-A indicating more widening than in Segment M19-B, although some of the outside bends in M19-B are eroding. Segment M19-B also has rip-rap armoring on its banks especially in the vicinity of Tansy Hill Road Bridge (Figure 7.34), while downstream there is none. This bridge is causing a channel and floodprone constriction. Just upstream of Tansy Hill Road Bridge, there is evidence of gravel mining. Dominant land use in M19-B is hay within the eastern corridor and forested in the western corridor. A berm, 225 feet in length, was observed just downstream of Tansy Hill Road Bridge in segment M19-B. Removal of this berm is not feasible given its purpose is to protect an adjacent pond.

**Figure 7.34. Rip-rap along bank upstream of Tansy Hill Road Bridge in M20**

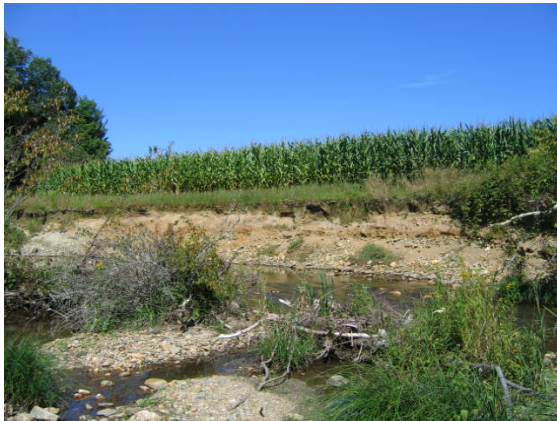
The dominant buffer category is greater than 100 feet on both banks, but there are some areas where the buffer is less than 25 feet. Some of these areas with limited buffer are experiencing major erosion within the vicinity of crop fields (Figure 7.35). Forest is the dominant land use within the corridor in this reach, but the subdominant is crop in the eastern corridor and residential in the western corridor. CREP may be an appropriate management option for the upstream end of the reach.

**Figure 7.35. Severe erosion and lack of riparian buffer along east bank in Reach M20**

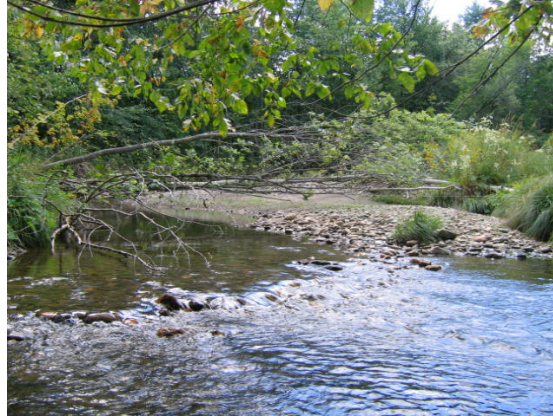
Segment M21-A has not incised and therefore follows the D channel evolution model. With the presence of steep riffles and diagonal bars among other depositional features (Figure 7.36), this reach is currently undergoing major aggradation. The combination of channel alteration and sediment deposition has resulted in major planform adjustment. Minor widening is occurring from the moderate to high erosion on both banks.

**Figure 7.36. Steep riffle and point bar within Segment M2I-A.**

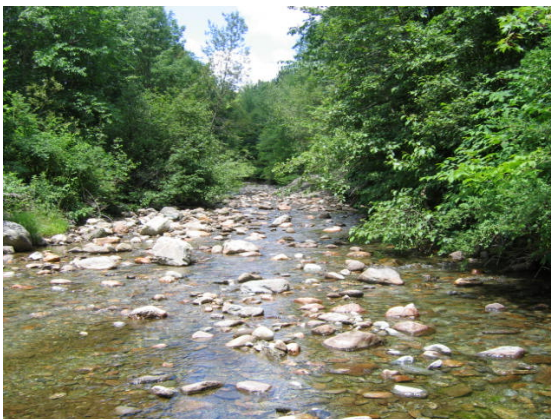
Reach T4.03 was broken into two segments due to differences in valley width, planform and slope, and depositional features. The stream type for both segments T4.03-A and T4.03-B is a cobble dominated “Cb” channel (Figure 7.43). Both segments are in stage III of the F channel evolution model. T4.03 is located along Nebraska Valley Road, which encroaches on the river corridor. Straightening has occurred on approximately one-quarter and one-half of the length of segments T4.03-A and T4.03-B, respectively, with windrowing having also taken place in segment T4.03-A.

**Figure 7.43. Cobble dominated “Cb” channel in Reach T4.03**

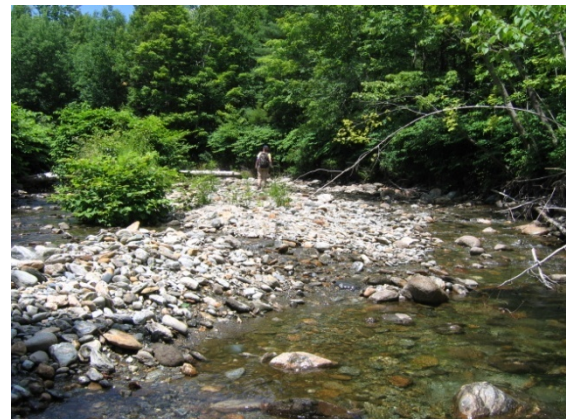
Segments T4.03-A and T4.03-B have historically incised, with greater incision in T4.03-B. Geomorphic processes in T4.03-A include minor historic incision and widening, major aggradation, and major planform adjustment. T4.03-B shows major historic incision and aggradation, while widening and planform adjustment are minor. Aggradation was evident from many steep riffles and diagonal bars along with other depositional features (Figure 7.44). The RGAs for both segments in T4.03 were scored in the “fair” category. The RHA was scored “fair” for T4.03-A and “good” for T4.03-B. In general, the RHA scored lower for T4.03-A primarily due to banks vegetated with invasive species, bank erosion, and lack of substrates for fish cover and epifaunal colonization.

**Figure 7.44. Steep riffle and mid-channel bar showing major aggradation in Segment T4.03-A**

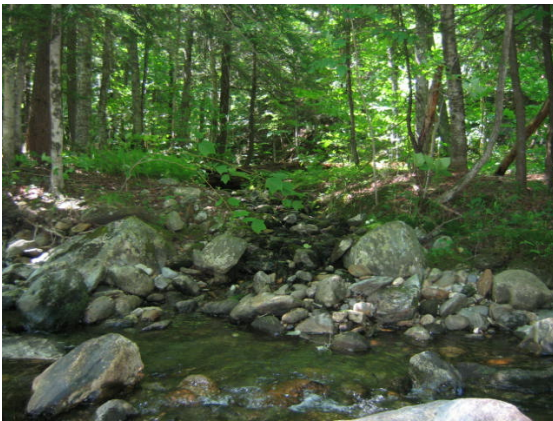
Major historic incision and planform adjustment are evident in T4.04 by the presence of rejuvenating tributaries (Figure 7.45), four flood chutes, six islands (Figure 7.46), and one channel avulsion. Widening and aggradation are minor in T4.04. The RGA scored “fair”. Reach T4.04 has a diversity of velocity/depth patterns and stable banks. The habitat condition came out as “good”.

**Figure 7.45. Rejuvenating tributary in Reach T4.04**

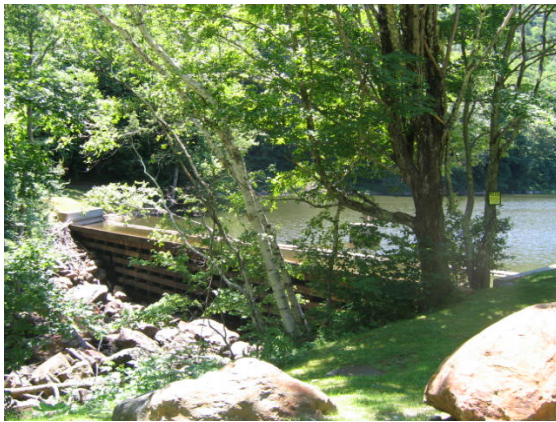
Reach T4.05 is 1,925 feet long and is well forested along both banks. The reach begins at the confluence with an unnamed tributary (T4.04SI) and continues upstream to the dam at Lake Mansfield. Although T4.05 is well forested and has wide buffers, it has been impacted by the dam at Lake Mansfield (Figure 7.47). The dam has caused the reach to be sediment starved and to incise to an extreme degree (incision ratio of 2.0). The extreme historic incision has led to a stream type departure from a cobble dominated “C” channel to a

**Figure 7.47. Lake Mansfield Trout Club dam at upstream end of T4.05**

Nebraska Valley Road encroaches upon the eastern corridor for 360 feet at the upstream end. The buffers for this reach are very well forested with a dominant width of greater than 100 feet and subdominant 51-100 feet just at the upstream end where Nebraska Valley Road encroaches upon the corridor. Large trees along the banks are holding soil in place, thereby resulting in little bank erosion. The dominant land use within both corridors is forest. The subdominant corridor land use is residential due to the road. Nebraska Valley road crosses Miller Brook again with a bridge that is constricting both the channel and the floodplain (Figure 7.48). Two berms, each approximately 150 feet in length, are located downstream of the Nebraska Valley Road Bridge. The reason for placement of these berms is not known. The removal of the berm on the east side of the channel is not recommended given the remote, forested location and the mature tree growth on the berm. The berm on the west side of the channel needs further investigation for removal feasibility.

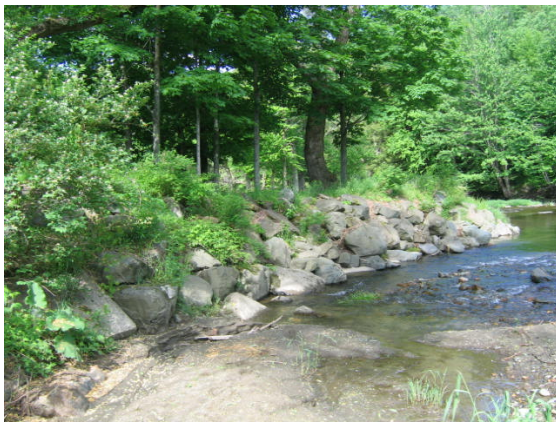
Approximately 70 percent of Reach T6.01 has been heavily bermed and about one-third has been armored with rip-rap and hard bank on the southern bank (Figure 7.49). Due to the armoring, there is little bank erosion on the southern bank. However, there is bank erosion along one-third of the northern bank. Roads and development encroach upon the corridor for approximately 60 percent of the channel length. Straightening has occurred along 80 percent of the reach. Gold Brook has also been dredged from its mouth up to VT 100. There is a bridge at the crossing at VT 100 causing both a channel and a floodprone constriction. The upstream part of this reach has a higher slope than near the mouth and includes a bedrock grade control (Figure 7.50).

**Figure 7.49. Rip-rap along southern bank in Reach T6.01**

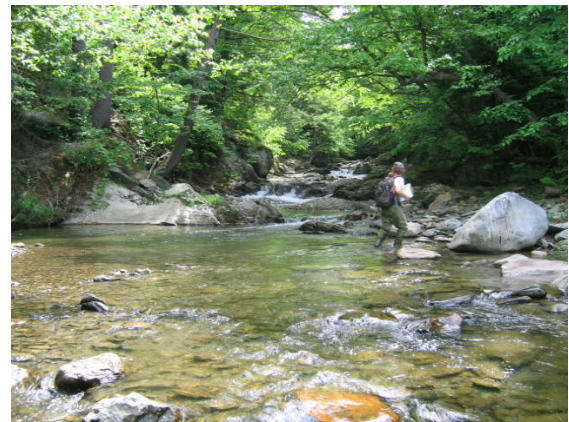
**Figure 7.50. Bedrock grade control in upper part of Reach T6.01**

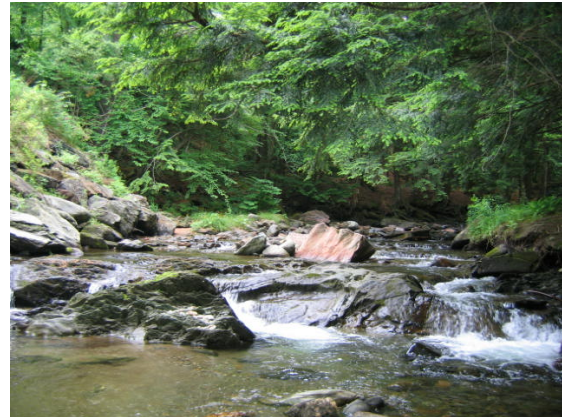
Reach T6.02 starts upstream of VT 100 and continues for about one-half mile. Reach T6.02 is a “B” type step-pool stream with no historic incision. There are many bedrock grade controls throughout Reach T6.02, thereby preventing downcutting of the bed (Figure 7.51). The bedrock in T6.02 is also causing channel constrictions in four locations.

**Figure 7.51. Bedrock grade control in Reach T6.02 preventing incision in this segment**

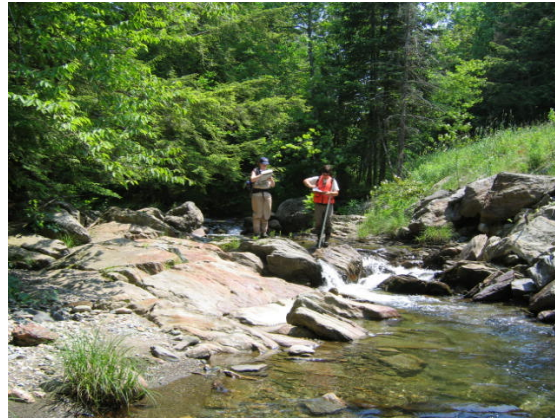
Segment T6.03-A is one-quarter mile long and begins where the southern side has road encroachment, buffers less than 25 feet, and is straightened and armored. A 180 foot long berm exists between Gold Brook and Gold Brook Road. This berm should be investigated further to analyze the feasibility for removal. The bedrock grade control in T6.03-A is preventing incision in this segment (Figure 7.52).

**Figure 7.52. Bedrock grade control in Segment T6.03-A**

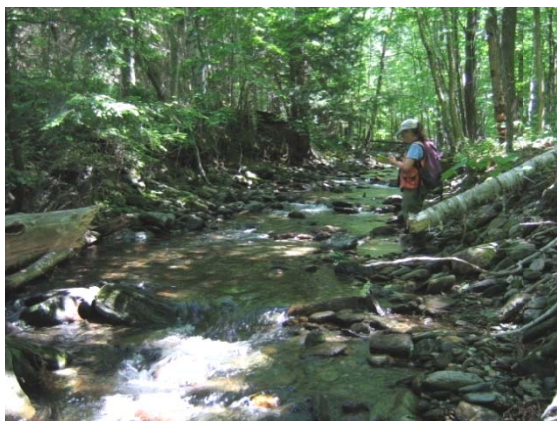
There has been a human caused change in valley width in both segments due to North Hollow Road. Approximately one-half of T6.06-A is straightened with possible windrowing, but T6.06-B is not straightened. Except for areas where development and North Hollow Road encroaches the corridor, the buffers are wide and well vegetated. There are several grade controls and bedrock constrictions (Figure 7.59).

**Figure 7.58. Typical channel in Segment T6.06-A**

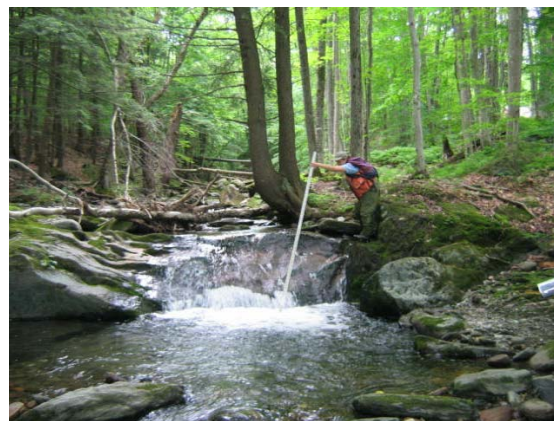
**Figure 7.59. Bedrock grade control and channel constriction in T6.06-B**

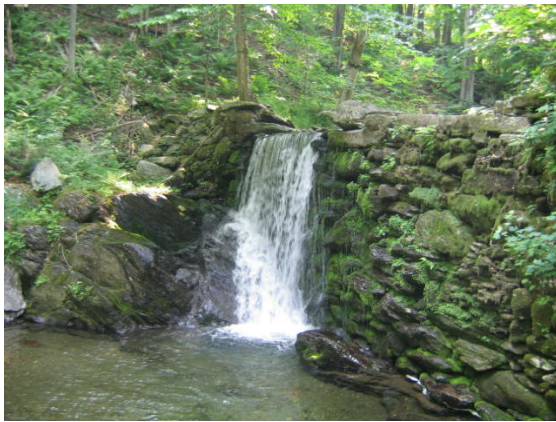
length. Channel straightening has occurred along about one-half of T6.07. There are many bedrock constrictions and grade controls including an old rock dam at the downstream end which is a fish passage issue and has caused significant scour just downstream (Figure 7.61). Two mass failures within T6.07 are providing a sediment source for the channel (Figure 7.62).

Compared to other reaches in Gold Brook, T6.07 has been severely incised (ratio of 2.41) and the stream type has departed from a “Ba” stream to a “Fa” stream in stage F-II. The severe historic incision is a result of the extensive channel straightening and alterations associated with the old dam.

**Figure 7.61. Old rock dam grade control in T6.07**

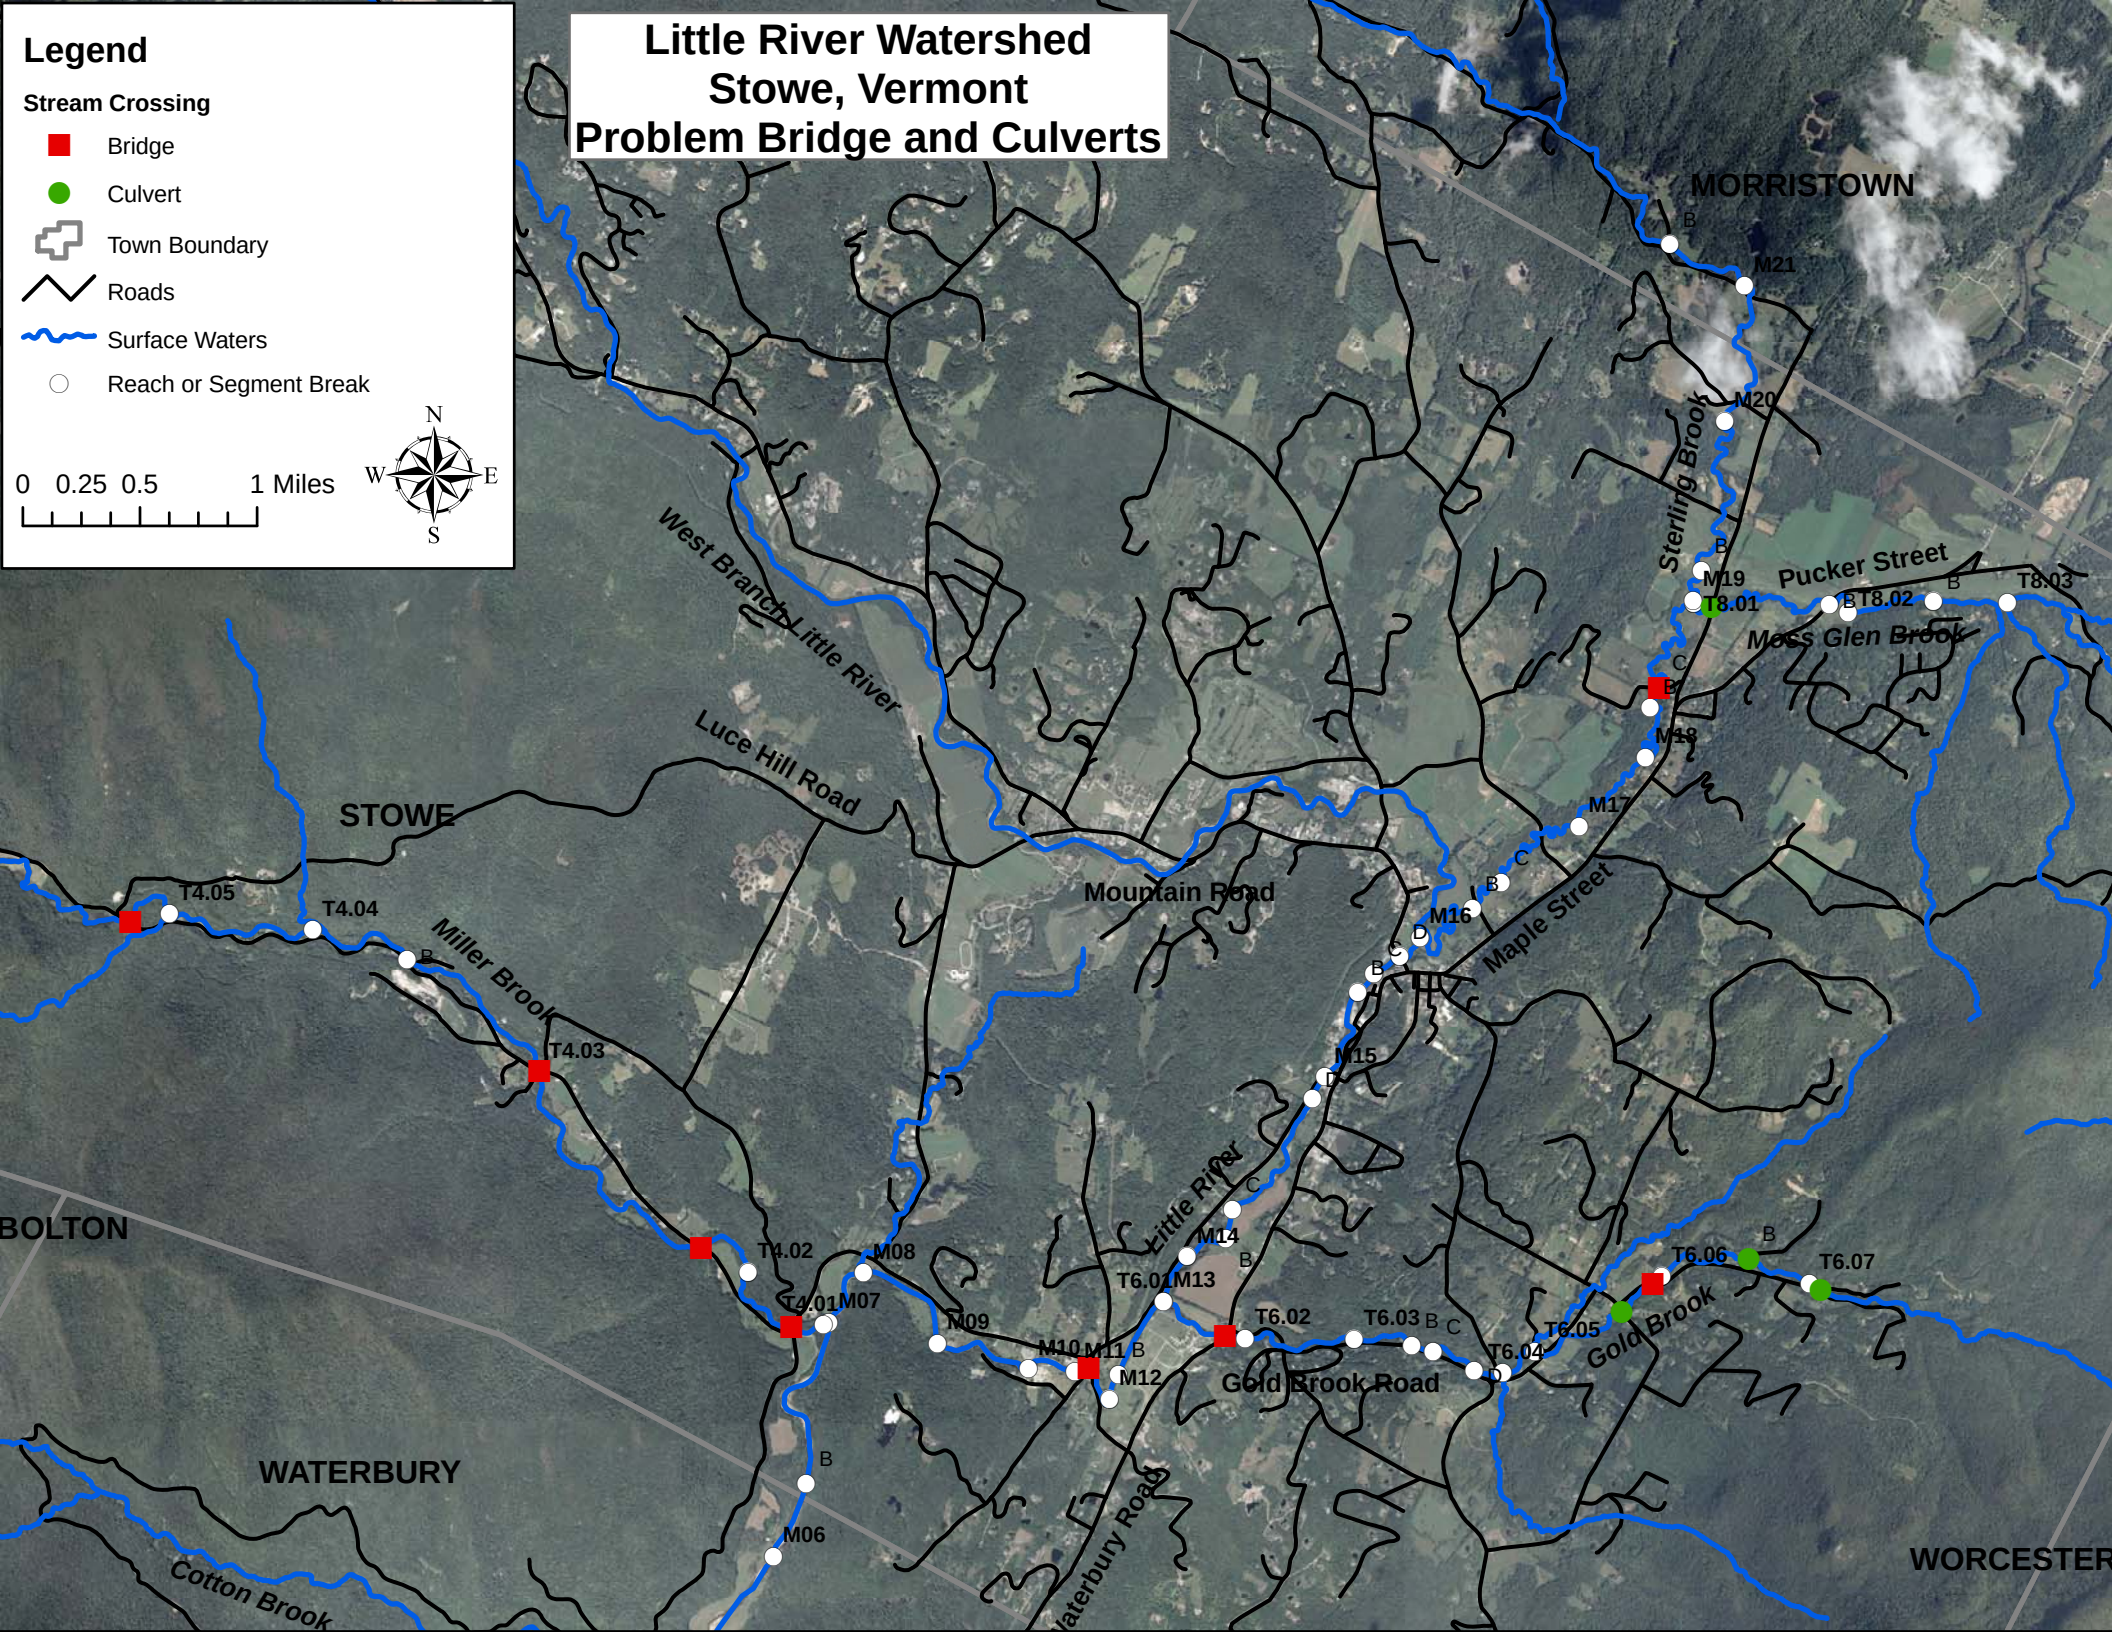
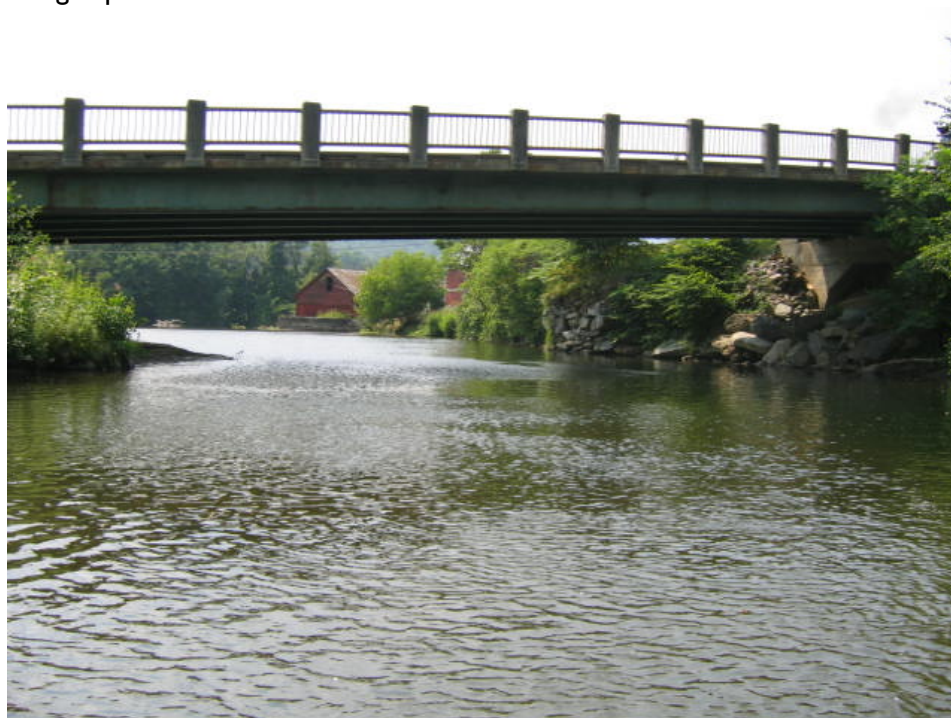
**Little River Mainstem  
Moscow Road  
Reach M11**

| Project # Segment | Type of Project | Site Description Including Stressors and Constraints | Project or Strategy Description | Technical Feasibility and Priority | Other Social Benefits | Costs | Land Use Conversion | Potential Partners |
|---|---|---|---|---|---|---|---|---|
| #3<br><br>Moscow Road crossing<br><br>M11 | Active Restoration | The Moscow Road bridge was found to be partially compatible using the geomorphic screening tool. Scour and alignment are issues with the bridge. | Bridge Replacement | Moderate priority | Improved geomorphic stability | High cost for replacement | Unknown | Town of Stowe, VANR, LCPC |

Road Width: 34 feet  
Bridge Clearance: 30 feet  
Bridge Span: 94

**Geomorphic Compatibility – Partially Compatible**

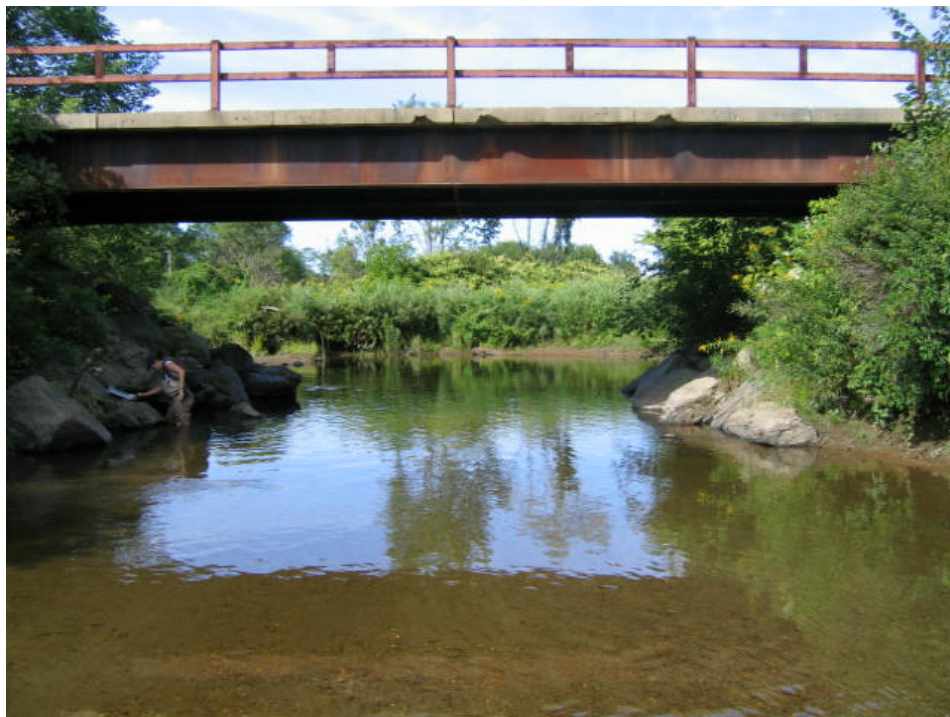
**Little River Mainstem  
Little River Farm Road  
Reach MI8-B**

| Project # Segment | Type of Project | Site Description Including Stressors and Constraints | Project or Strategy Description | Technical Feasibility and Priority | Other Social Benefits | Costs | Land Use Conversion | Potential Partners |
|---|---|---|---|---|---|---|---|---|
| #6<br><br>Little River Farm Road crossing<br><br><br><br><br><br><br><br><br><br>M18-B | Active Restoration | The Little River Farm Road bridge was found to be partially compatible using the geomorphic screening tool. There is scour above and rip-rap within the structure. An impending channel avulsion and major deposition was noted upstream of the bridge on May 5, 2010, when the reach was visited by BCE. | Bridge Replacement | Moderate priority; given the impending channel avulsion upstream, a more detailed analysis is recommended for this structure, | Improved geomorphic stability | High cost for replacement | Unknown | Town of Stowe, VANR, LCPC |

Road Width: 20 feet  
Bridge Clearance: 10 feet  
Bridge Span: 26

**Geomorphic Compatibility – Partially Compatible**

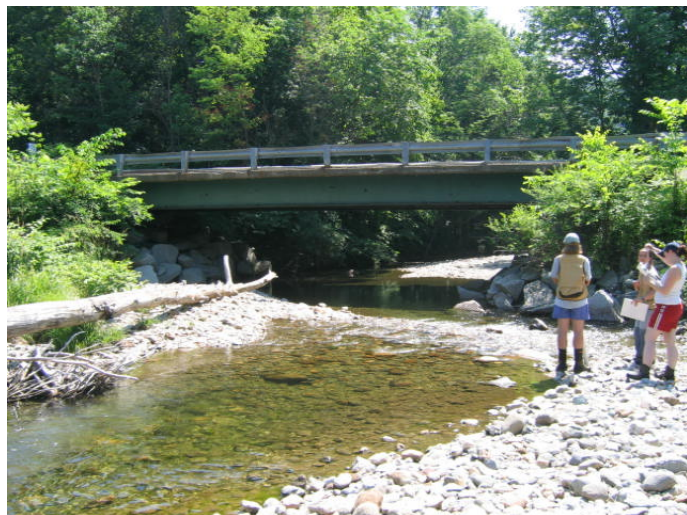
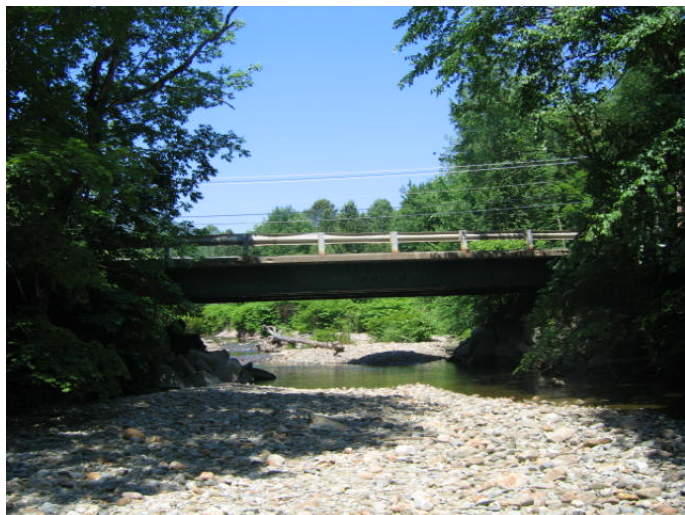
Bridge Clearance: 30 feet

Bridge Span: 35

**Geomorphic Compatibility – Partially Compatible**

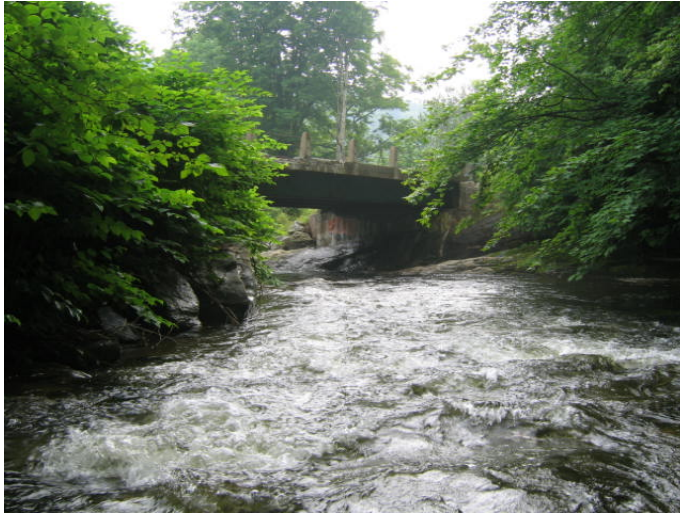
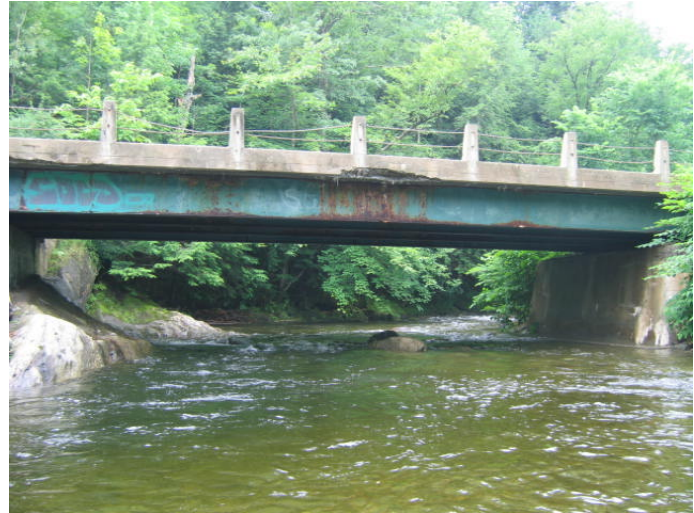
Bridge Clearance: 30 feet

Bridge Span: 42

**Geomorphic Compatibility – Partially Compatible**

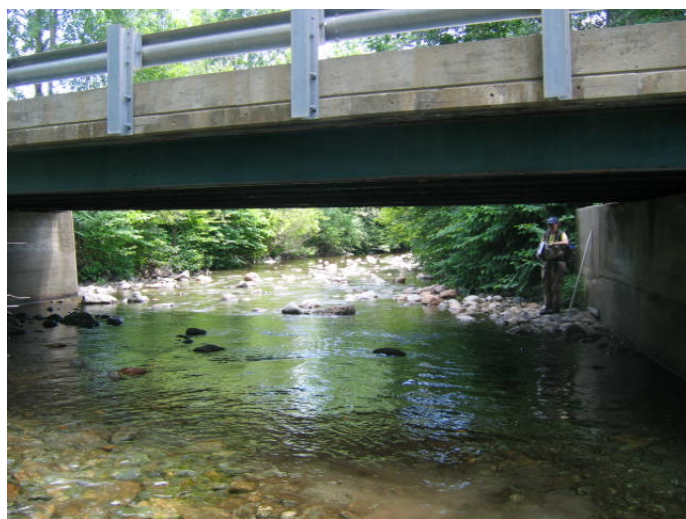
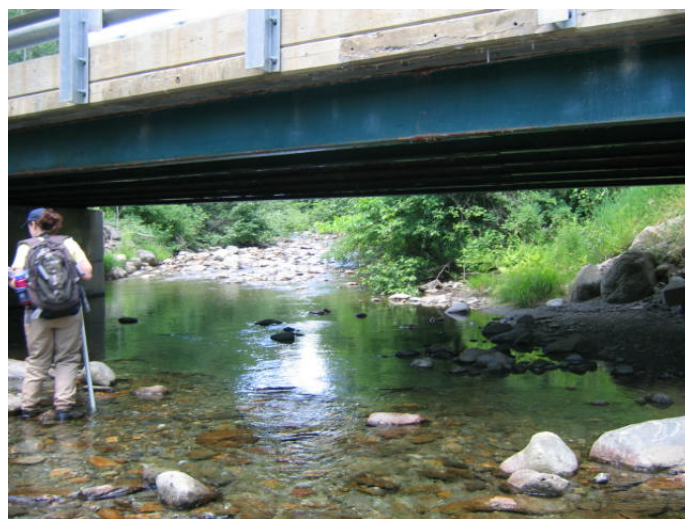
**Miller Brook  
Nebraska Valley Road  
Reach T4.03-A**

Road Width: 26 feet  
Bridge Clearance: 7 feet  
Bridge Span: 36

**Geomorphic Compatibility – Partially Compatible**

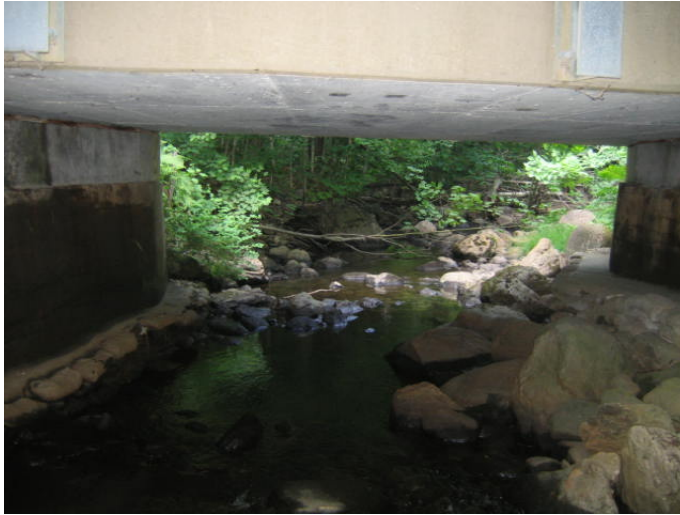
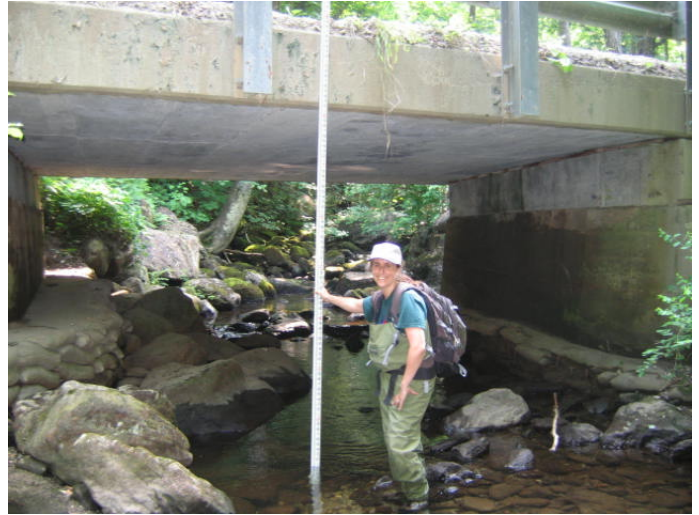
**Miller Brook  
Nebraska Valley Road  
Reach T4.05**

Road Width: 20 feet  
Bridge Clearance: 7 feet  
Bridge Span: 13.4

**Geomorphic Compatibility – Partially Compatible**

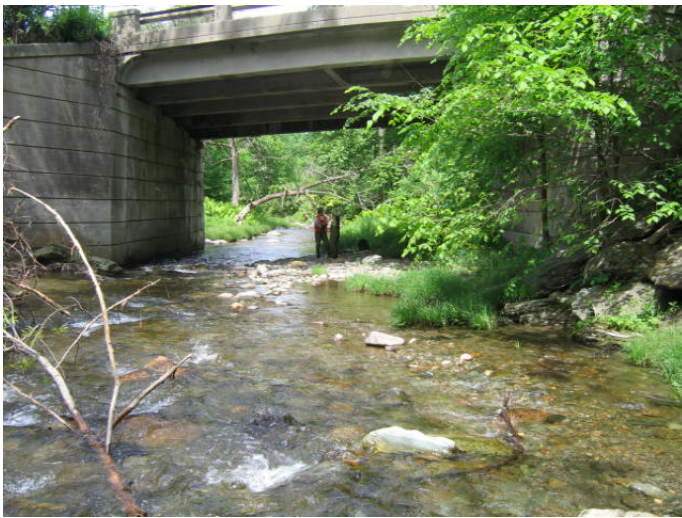
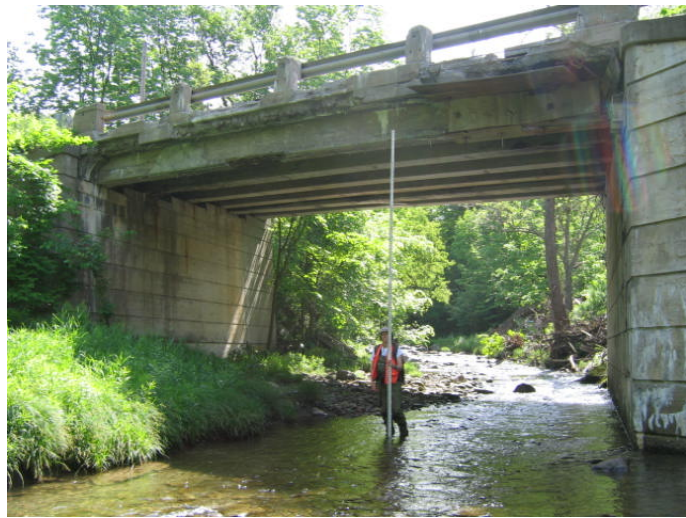
Bridge Clearance: 18 feet

Bridge Span: 32

**Geomorphic Compatibility – Partially Compatible**

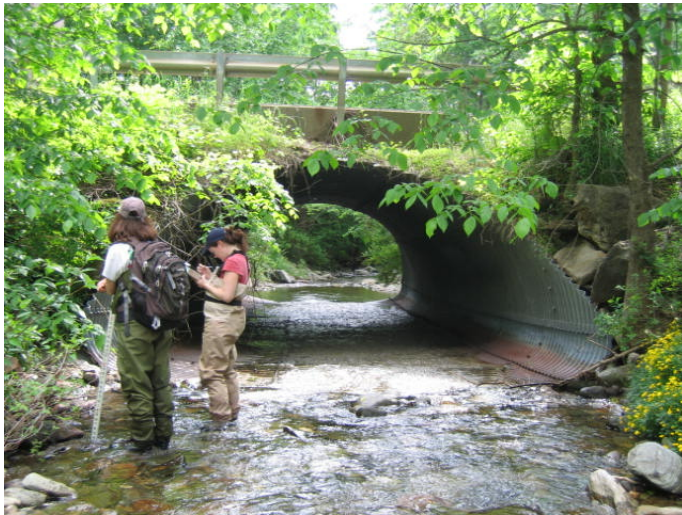
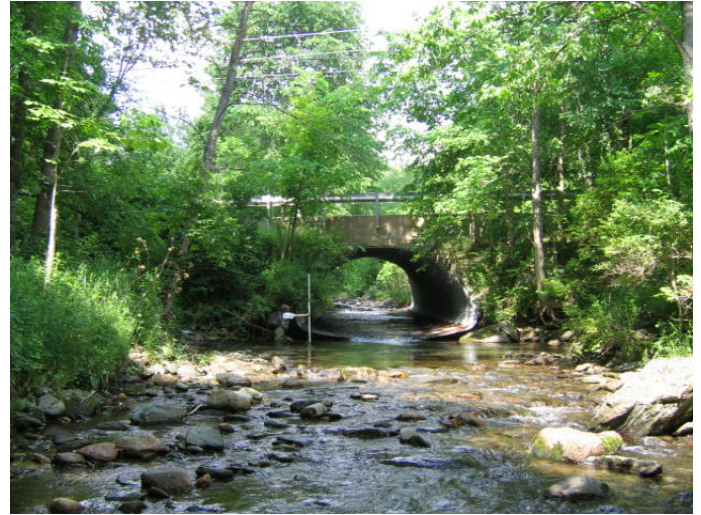
**Gold Brook  
Upper Hollow Road  
Reach T6.05**

Culvert Length: 38 feet  
Culvert Height: 10 feet  
Culvert Width: 17

Outlet – invert is freefall

**Geomorphic Compatibility – Fully Compatible**

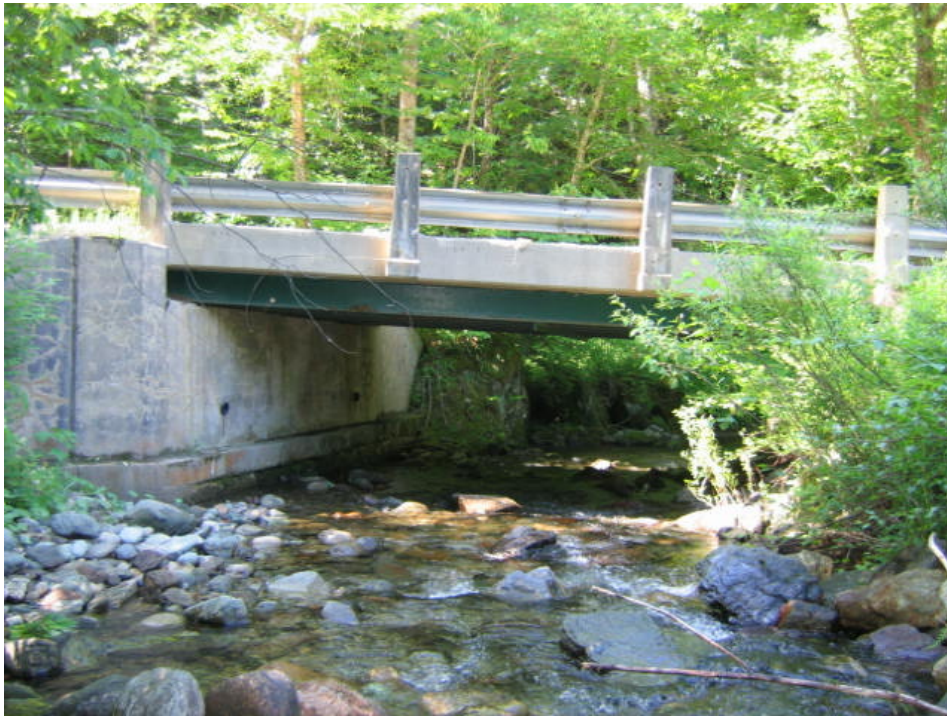
**Gold Brook  
North Hollow Road  
Reach T6.05**

Road Width: 20 feet  
Bridge Clearance: 7 feet  
Bridge Span: 18

**Geomorphic Compatibility – Mostly Incompatible**

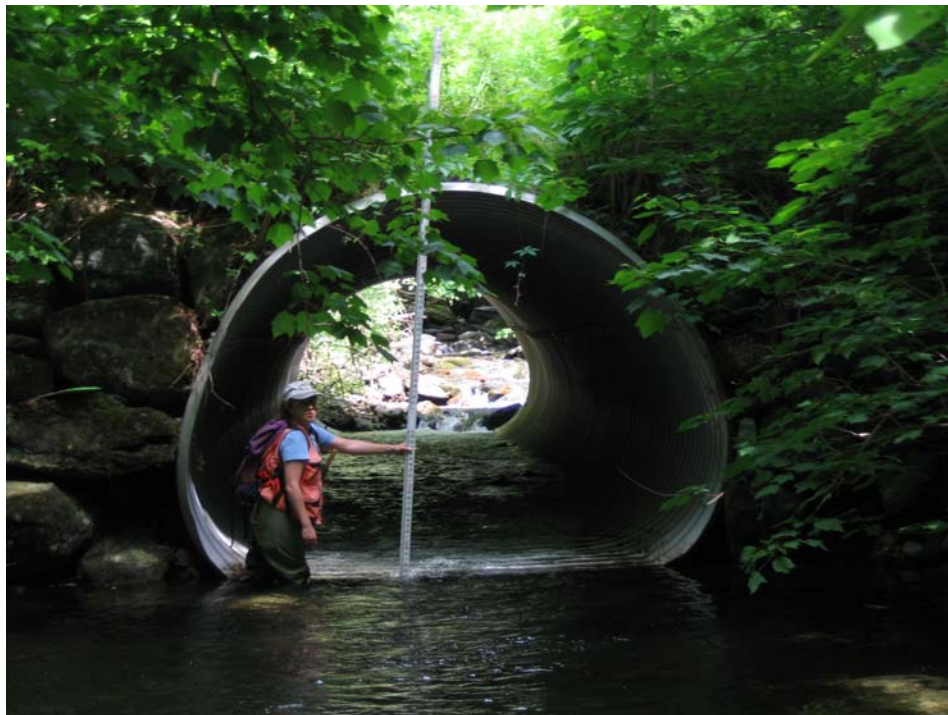
**Gold Brook  
Bryan Road  
Reach T6.06-A**

Culvert Length: 50 feet  
Culvert Height: 7 feet  
Culvert Width: 9.5

**Geomorphic Compatibility – Mostly Compatible**

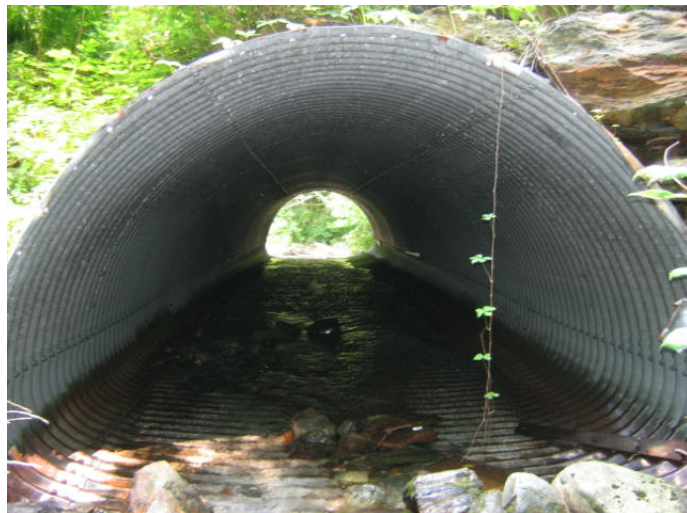
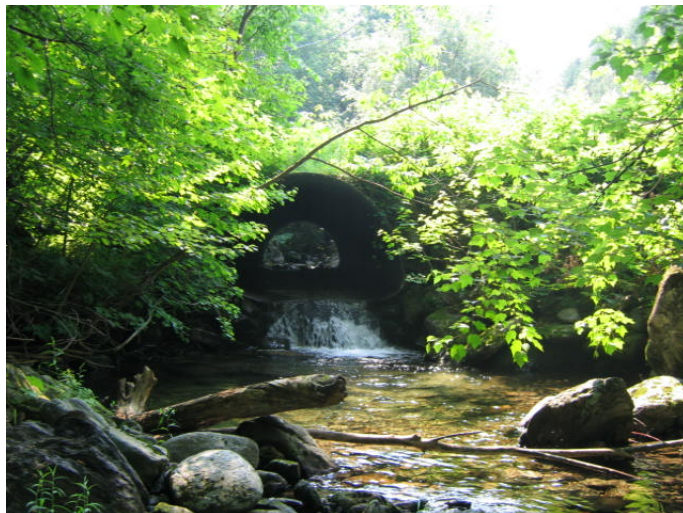
**Gold Brook  
North Hollow Road  
Reach T6.07**

Culvert Length: 50 feet  
Culvert Height: 8 feet  
Culvert Width: 11

Outlet - Cascade

**Geomorphic Compatibility – Mostly Compatible**

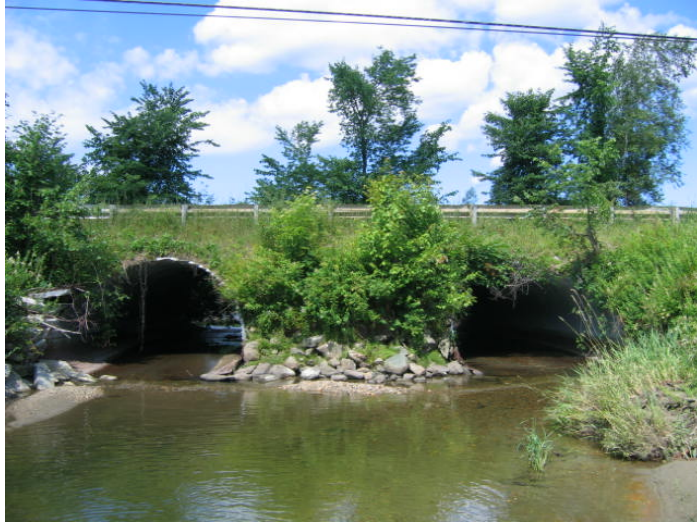
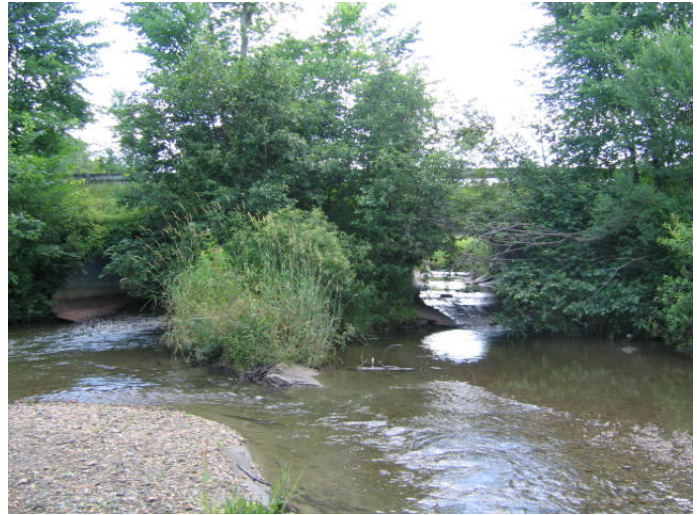
Culvert Height (left): 6 feet Culvert Height (right): 6 feet

Culvert Width (left): 7 feet Culvert Width (right): 7 feet

Outlet – at grade

**Geomorphic Compatibility – Mostly Incompatible**
