**Phase 2 Stream Geomorphic Assessment  
Black River Watershed  
Rutland & Windsor Counties, Vermont**

**Addendum 1: Patch Brook & Buffalo Brook Tributaries  
Towns of Plymouth, Reading, Mount Holly, Ludlow**

**October 2010**

**South Mountain Research & Consulting**

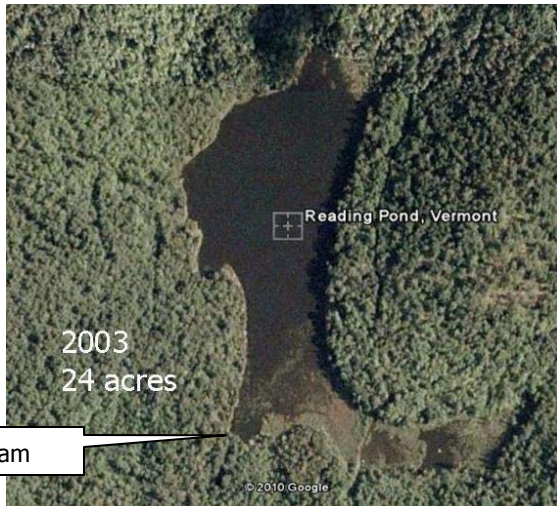
The sudden breaching of Reading Pond dam resulted in a significant volume of water being released to the Reading Pond Brook and lower reaches of the Buffalo Brook. As observed in September of 2009, the southern shore line of Reading Pond is now located more than 700 feet to the north of its former position. The aerial extent of this pond has been reduced by approximately 10 acres (Figures 10-a & -b). It is likely that volumes of fine and coarse sediments were released from behind the dam as the pond drained (Figures 10-c, 10-d, 10-e). Today, the southern extent of the former pond has begun to revegetate (Figure 10-f).

(a) Reading Pond prior to 2006 dam breach.

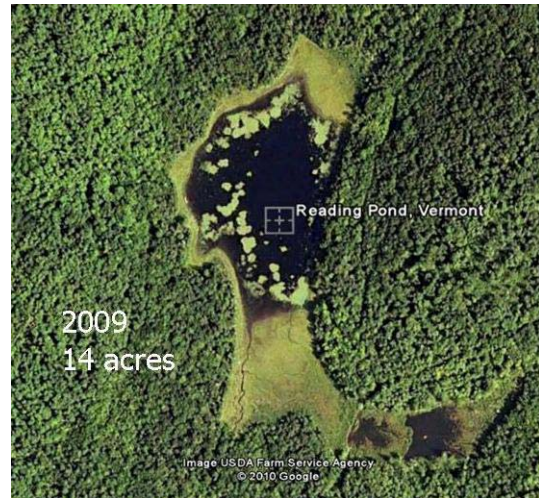
(b) Reading Pond after 2006 dam breach.

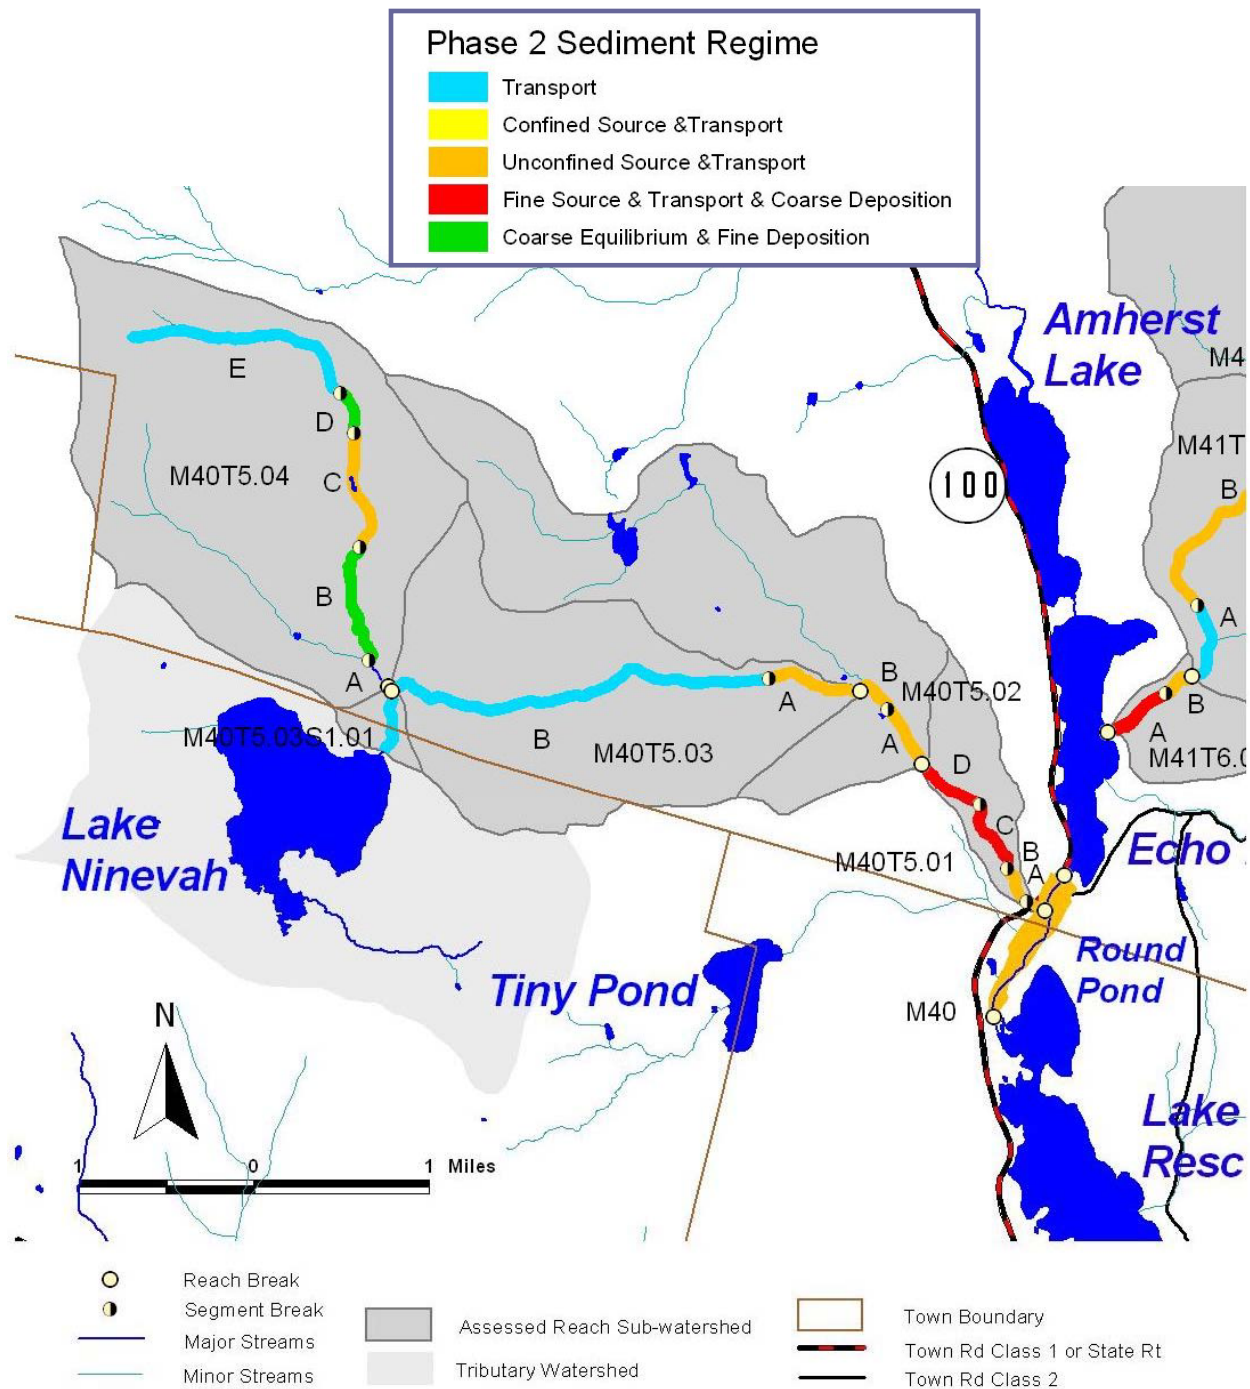
**Figure 17-b. Phase 2 (Existing) Sediment Regime Map  
Assessed Reaches of the Patch Brook & Black River main stem.**

Figures 17-b and 18-b display the **existing** sediment regimes that are hypothesized based on Phase 2 assessment results and the departure analysis previously described. The contrast in coding of the reaches between the Phase 1 (Reference) Sediment Regime figures and these Phase 2 (Existing) Sediment Regime figures illustrates the degree of departure from reference that is inferred.

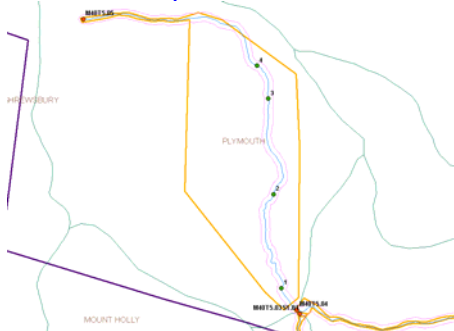
- Do I have the correct valley wall verification data for this reach? It looks unnatural in shape, does not fit reported valley wall dimensions, and crosses the streamline mid-reach. Also, lower end does not even include downstream reach point. See screenshot below where gold line polygon is ph. 2 valley wall. Valley walls were not able to be delineated along most of the reach, because the VHD coverage defining the position of the Patch Brook main stem was considerably different than the actual channel position measured in the field with a GPS (see Figure 1 a on next page). Mapped valley wall positions would have crossed the channel in a number of locations, causing SGAT to generate errors when trying to delineate corridors using these valley walls. Should I delete this reach from the valley wall shape file? Or is there a different way that this reach should be treated?

SP: If possible, it would best to have the actual valley wall location portrayed in the shapefile. SGAT can be amended to account for the correct streamline if the corridor ever needs revision or setback/FEH options are explored. OK. Revised ph2 valley width shape file has been delivered via email attachment to this QA response, as well as stored on the updated Project CD #1. Please be aware that the actual channel position is an estimate only; it is more accurate than the channel position shown by the VHD, but it is not necessarily highly accurate. I would be uncomfortable with this approximate channel position (and the valley wall shape file developed from it) being used to depict fluvial erosion hazards. The GPS I used typically had an accuracy of +/- 17 to 20 ft on the assessment date. The channel width of the Patch Brook measured in this headwater setting ranged from 9 to 14.7 feet wide. Channel position was recorded every 50 or so feet along the traverse at meander cross-over points or prominent meanders (or other FIT features). Valley wall positions (generally high terraces on either side of the channel) were identified at a given distance from each channel waypoint, measured perpendicular to the channel. These segments are located within the Calvin Coolidge State Forest, suggesting that future development surrounding the channel is less likely than on non-state-forest lands. The upstream drainage area of the reach (1 sq mile) is smaller than would typically warrant mapping of FEH boundaries –instead this reach would likely be treated with a buffer of default width.

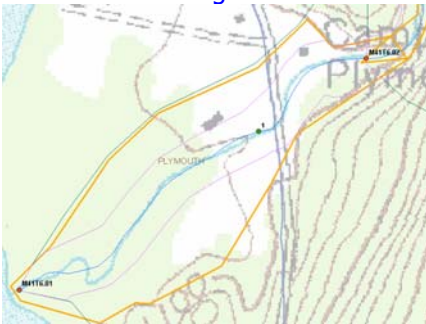
- Does valley wall shapefile need to be updated? When I measure segment B in GIS, I get more than 180' (reported in step 1.5). I'm not sure what happened here. I also get a larger value for valley width in Segment B. I took a closer look and revised the valley walls slightly (new valley wall shape file is stored on the Project CD). Average valley width for Segment B is 290. Revised valley width in Ph2 St 1.5; confinement changed from Broad to Very Broad.

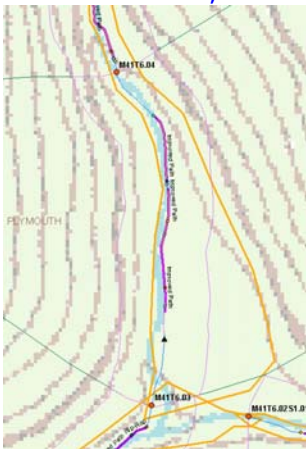
- Again, am I looking at correct valley wall file? When I measure segment B in GIS, I get more than 80' (reported in step 1.5). The valley wall varies in width from 55 ft near the upstream end of the reach to 270 feet near the downstream end of the reach at the confluence of Reading Pond Brook. Taking an average of six evenly-spaced valley width measurements in GIS, I get 160 feet. I have replaced the valley width in Phase 1 St 2.9 and Phase 2 St 1.5 with 160 ft. Confinement type revised to Broad. Reference stream type unchanged. Cross section plot appears to show 240'. Yes, at that location along the reach, I would agree. Are you counting path/forest road as change in valley width? No.

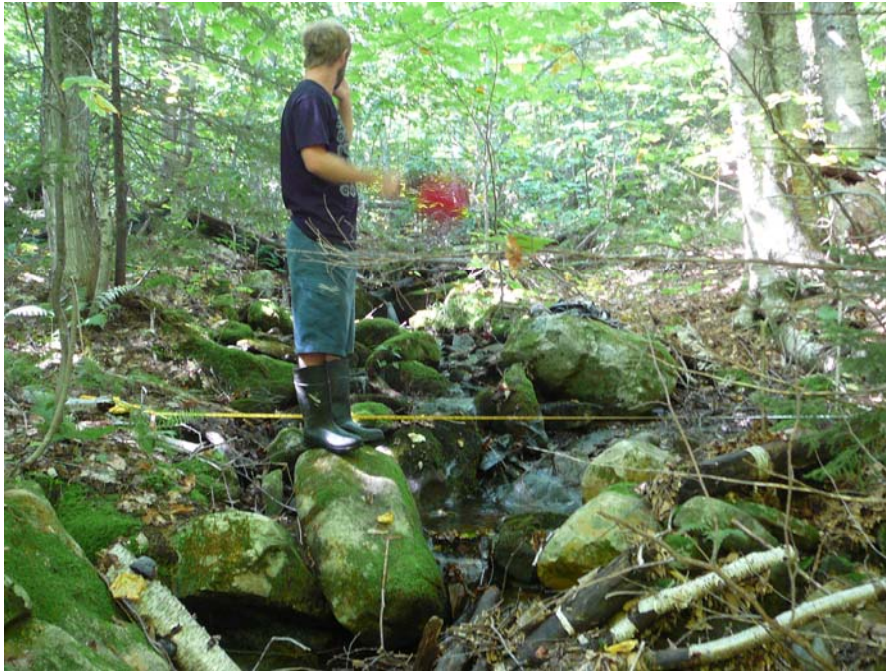
Step 6. Floodplain Modifications

6.1 Berms & Roads - old:      **1,465.1 ft.**      **16.4**  
     One Side      Both Sides  
     Road:      **0.0 ft.**      **0.0 ft.**  
     Railroad:      **0.0 ft.**      **0.0 ft.**  
     Berm:      **0.0 ft.**      **0.0 ft.**  
     Improved Path:      **1,465.1 ft.**      **0.0 ft.**  
 6.2 Development:      **0.0 ft.**      **0.0 ft.**  
 6.3 Channel Bars: **Multiple**  
 6.4 Meander Migration: **Multiple**  
 6.5 Meander Width:      **N/A** Ratio: **0.0**  
 6.6 Wavelength:      **N/A** Ratio: **0.0**

7.1 Bank Erosion: **3043.89**      ft  
 7.2 Bank Height: **3**      ft  
 7.3 Ice/Debris Jam Potential: **Debris**

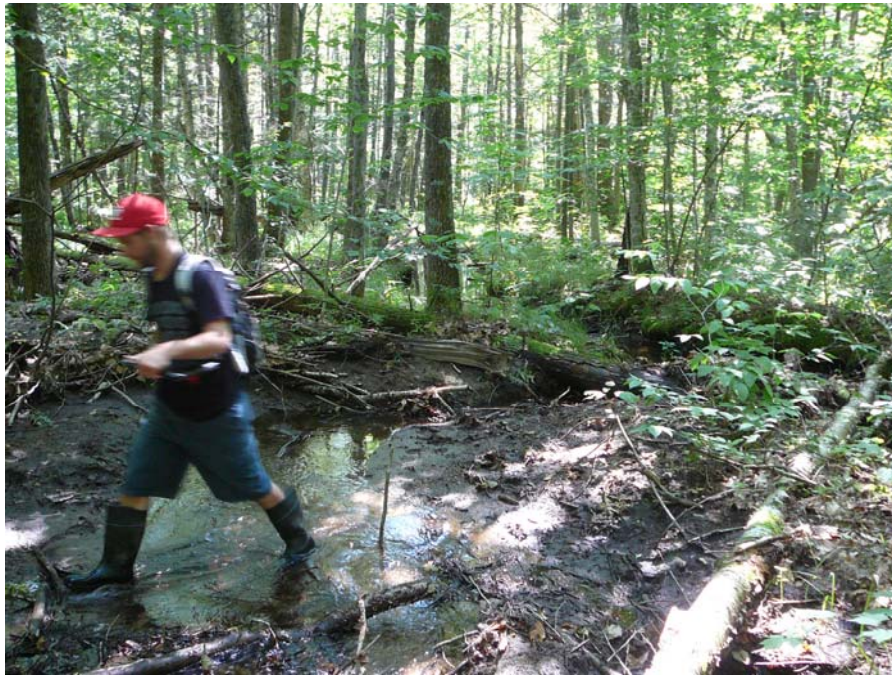
Segment D is a subreach of somewhat lesser gradient in an unconfined setting, with typical valley widths ranging from 100 feet to more than 200 feet. Good floodplain connection. Like the upstream segment E, bed substrates are dominated by very coarse gravels, but Segment D is characterized by fewer boulders and more cobbles. Minor aggradation and planform adjustment (mid-channel bars, point and side bars, one flood chute). A natural reduction in valley confinement and gradient (from approximately 10% in Segment E to 4.4% in Segment D) may be contributing to the minor degree of aggradation and planform adjustment. Lateral and vertical adjustments are probably moderated by the dense, young-growth forest cover, and erosion resistance of glacial till parent material in the bed and banks of the channel. Also, limited degree of sediment from upstream sources. Lots of LWD recruitment and a frequent spacing of channel-spanning debris jams. Woody material contributes to pool formation. Generally closed canopy – offering shading and ample organic material and detritus.

Figure 3. View downstream, M40T5.04 Segment D, Patch Brook; 3 September 2009

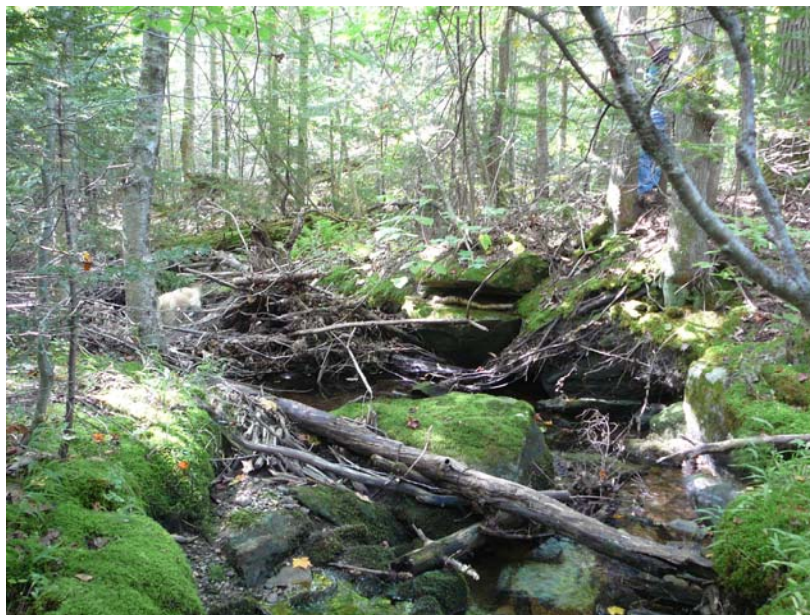
*Figure 5. View upstream, M40T5.04 Segment C, Patch Brook; 11 September 2009*

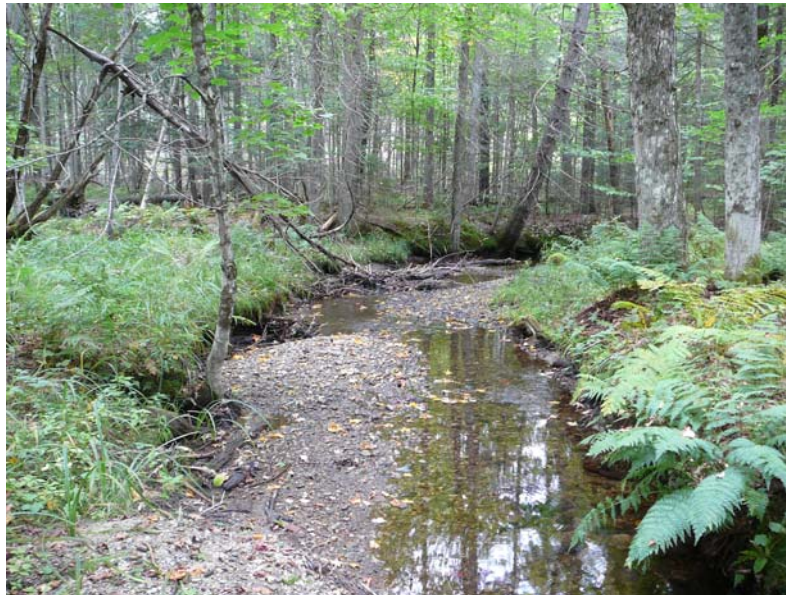
Young-growth forest surrounds the channel in Segment B. Generally closed canopy. Lots of LWD recruitment and a frequent spacing of channel-spanning debris jams. Entrained woody material contributes to pool formation.

Figure 6. View downstream, M40T5.04 Segment B, Patch Brook; 11 September 2009

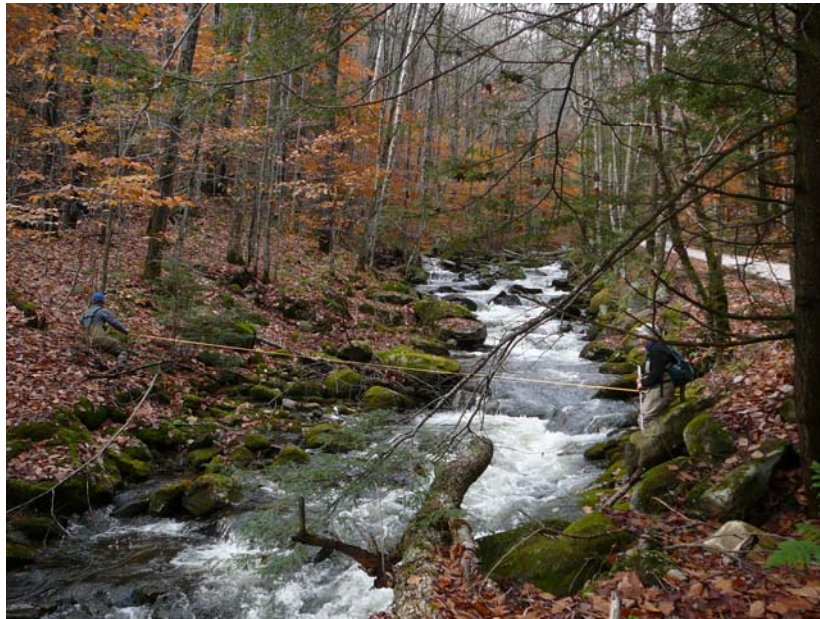
Segment B comprises the upstream 7,623 feet of reach M40T5.03. While the very upstream end of the segment has a somewhat wider valley width and lesser gradient (slightly less than 4%), the segment is generally a reference Ba-S/P channel. Over the years, Patch Brook Road has been maintained to encroach within this valley, and is elevated above the brook (cut into the left valley wall) at heights generally ranging from 6 to 15 feet (or 3 to nearly 8 times the bankfull depth of the channel). In one location mid-segment, where the height of the road is approximately 3.5 times the bankfull depth, presence of a short berm (between the road and the channel) and left-bank armoring suggests that the river may have avulsed in a past flood to wash out a section of the Patch Brook Road and temporarily occupy a small floodplain on the far side of the road. Encroachment by the road has resulted in human-modification of the valley width, such that the floodplain is now generally less than two channel widths (i.e., Narrowly-Confined). The natural valley width, prior to the road, was probably not much wider (between 1.5 to 2.5 times the channel width, or Narrowly-Confined to Semi-Confined valley type). No significant change in the reference stream type (Ba-S/P) is inferred as a result of the road encroachment.

Figure 7. View upstream, M40T5.03 Segment B, Patch Brook; 29 October 2009

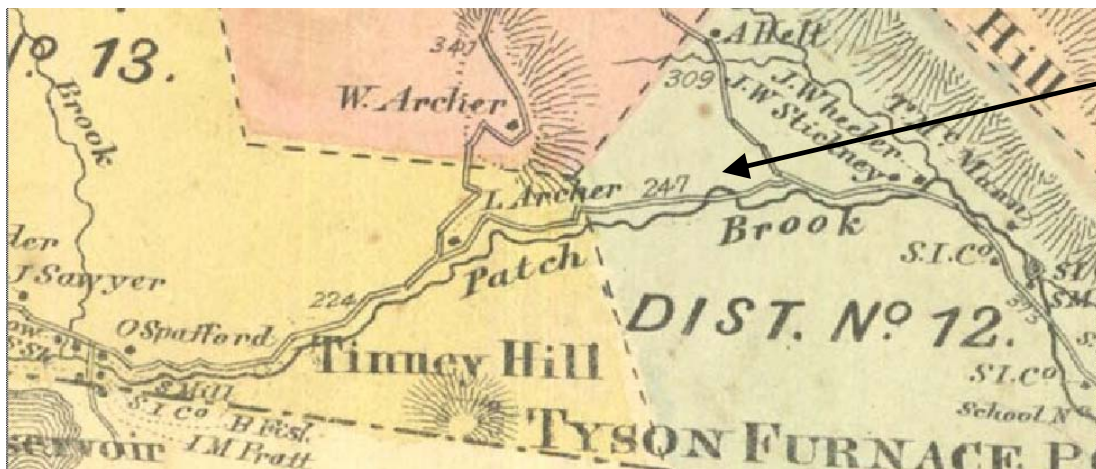
The Beers Map (1869) shows that the Patch Brook Road once crossed the Patch Brook in two locations just upstream of the Dublin Road intersection. Specific evidence of former crossings or the previous road alignment was not able to be located in the field.

Figure 8. Beers Map (1869) indicates that Patch Brook Road once crossed the Patch Brook in two places.

The present map view of the road is more linear than depicted on this historic map also, suggesting that the road alignment has been somewhat straightened over the years. A few sections of rip-rap armoring were indexed along the reach where the road encroaches on the channel.

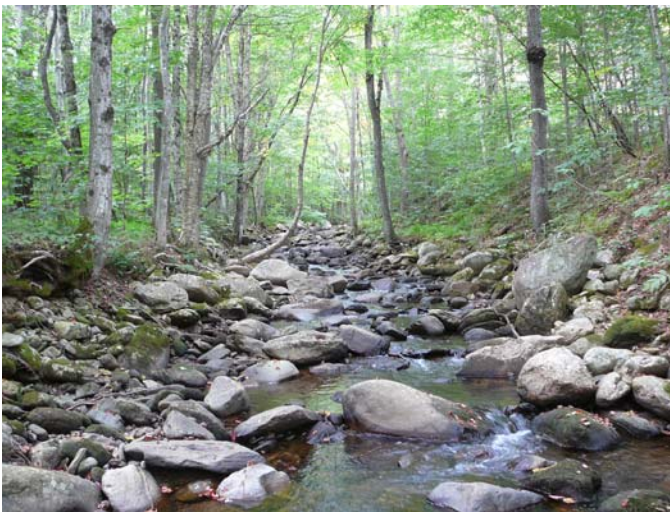
Historic incision and historic planform adjustment (straightening) are inferred. Historic incision may have developed in response to historic channelization and/or channel management in response to the large flood events of 1927 or 1973. Historic incision may also have been associated with the historic mill dam operations, and/or water withdrawals to the canal. The channel is inferred to be persisting in early stage III of channel evolution, with widening moderated by the coarseness of the bed and bank material of glaciofluvial origin and the well-developed, though young-growth, forested buffers. Historic straightening of the channel has enhanced the natural transport function of this semi-confined channel with relatively steep valley gradient. There is little evidence of aggradation.

*Figure 14. View upstream,  
M40T5.01 Segment D,  
Patch Brook; 10 September 2009*

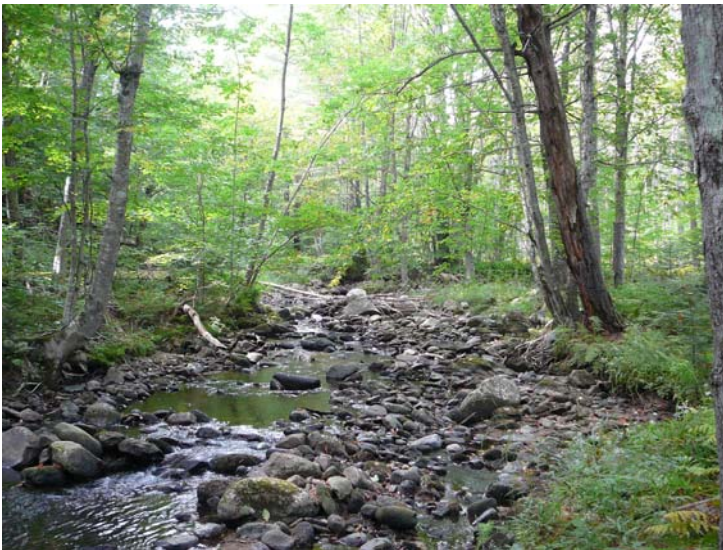
Presence of active flood chutes, and channel bifurcations around tree islands is more prevalent. Despite the steep gradient, a few signs of localized aggradation were noted, including a point bar and side bar. Evidence of breached debris jams and one intact debris jam was also noted, suggesting active recruitment of LWD. The channel has a degree of connection to a narrow floodplain in select locations.

The cross section for Segment C captured a flood chute and reflected the higher width/depth ratio and greater degree of floodplain connection that is characteristic of the segment. Bed and bank sediments are generally somewhat smaller in size than upstream segment D, but cobble is still the dominant grain size. Generally, a plane bed form, with weak step/pool form developing.

*Figure 15. View upstream, M40T5.01 Segment C, Patch Brook; 10 September 2009*

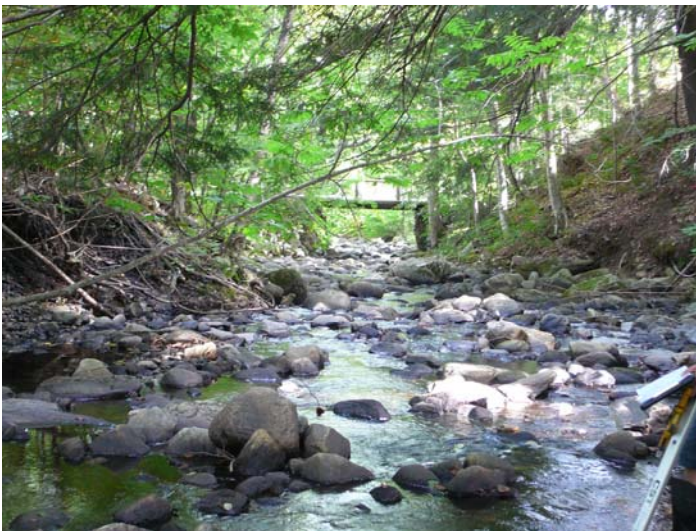
short distance further downstream, the river joins a high terrace along the RB. The LB corridor has a long history of development including the former Tyson Furnace. Fill material likely encroaches along the LB in vicinity of the present day Tyson Library building. A laid-up stone wall reinforces the LB on approach to Library Road bridge crossing. The 16-foot span between stone wall abutments of this bridge is undersized (48%, 57%, respectively) compared to the measured bankfull width (33.3 feet) and reference bankfull width (28 ft) of this channel.

A cross section was completed approximately 175 feet upstream of the Library Road bridge. If the terrace immediately adjacent to the channel on the LB is considered the Recently Abandoned Floodplain, an incision ratio of 3.7 is calculated. The degree of actual incision may be overstated (although there is a long history of extensive floodplain and channel modifications in this vicinity). It is likely that the current vertical displacement of the channel from the LB floodplain results from a combination of historic incision (associated with channelization, and possibly dredging) and historic encroachments involving fill, regrading of the floodplain, road building and berms. More recently, this area has probably been modified and regraded during flood response activities following the 1973 and 1927 floods, at a minimum.

*Figure 16. View downstream to Library Road bridge, M40T5.01 Segment B, Patch Brook; 10 September 2009*

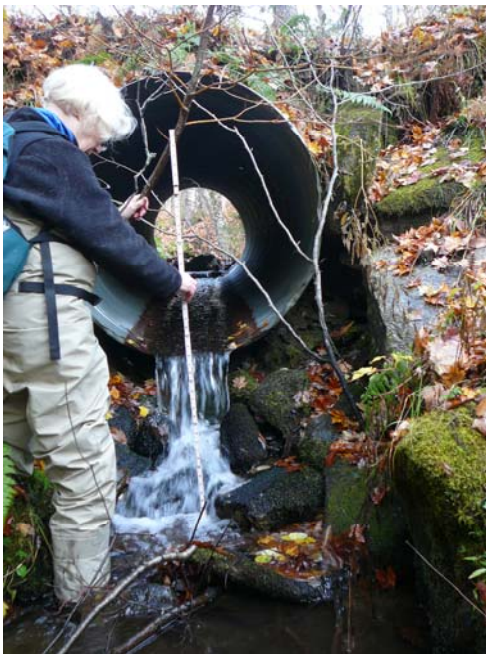
A forest road (and VAST trail) leads west from the terminus of Reading Pond Road and crosses the reach near the upstream end, approximately 0.4 mile west from the junction. This culvert (3.9 ft wide) is 49% of the reference bankfull width (8 ft) for the channel. The structure invert is perched approximately 2 feet above the channel bed (Figure 18).

*Figure 18. View upstream through culvert under forest road at upstream end of reach M41T6.06, Buffalo Brook, 22 October 2009*

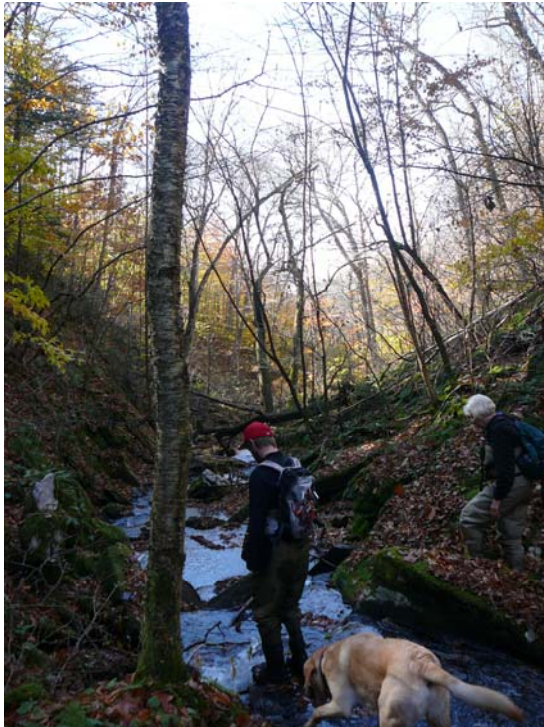
The segment has a short section (250 feet long) of C4b-riffle/pool channel at very upstream end in vicinity of tributary confluence, which was too short to segment. Channel quickly transitions from the confluence area to the bedrock gorge.

*Figure 19. View downstream Segment B, reach M41T6.05, Buffalo Brook, 22 October 2009*

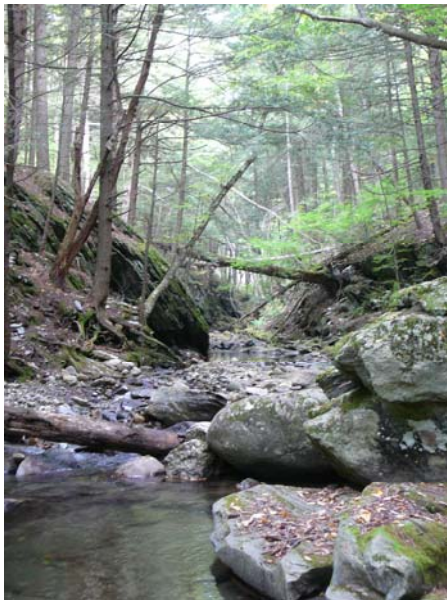
Bedrock gorge. Tall bedrock walls, Semi-confined.  
(As the bedrock walls become steeper and more closely confine the channel in this downstream Segment A, the roads on either side of the channel climb the valley wall and remain somewhat distant from the channel).

*Figure 24. View upstream at base of bedrock gorge which comprises Segment A of reach M41T6.02, Buffalo Brook, 18 September 2009*
