**Restoring Water Quality in the Lake Memphremagog Basin:  
River Corridor Plan for the Black River**

**Melissa Dyer, Jayson Benoit, and Matt Goclowski**

**March 2011**

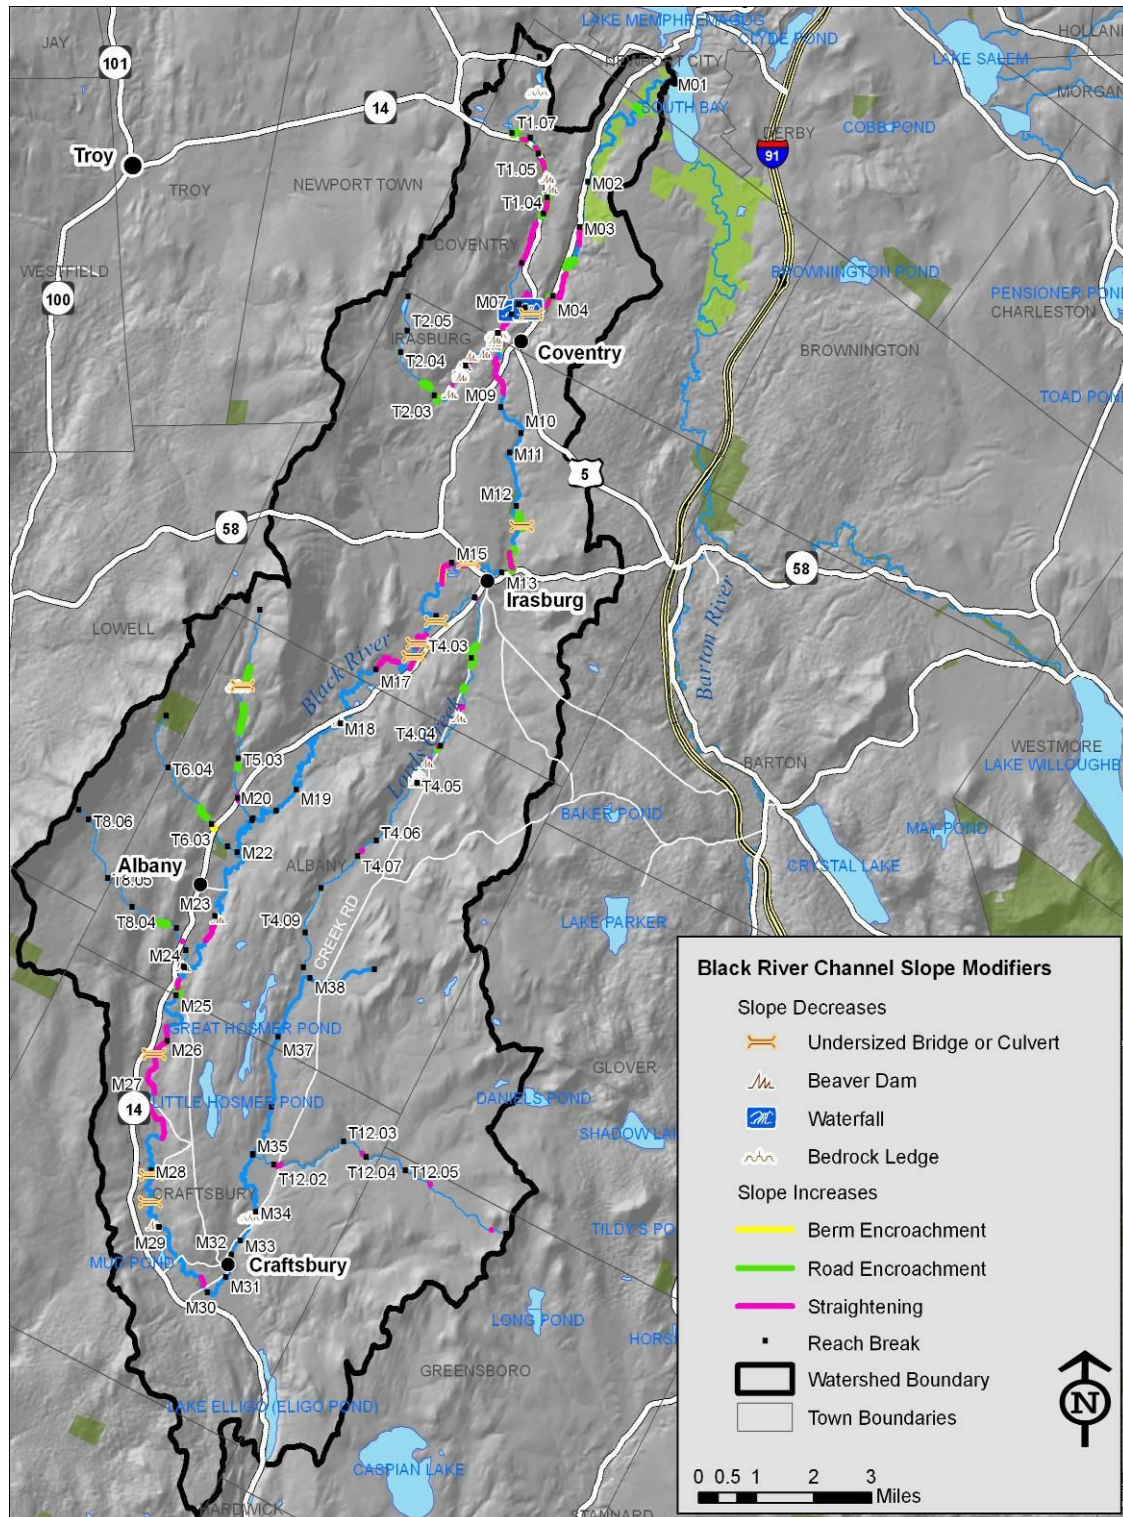
**Figure 8.** Slope modifiers along the Black River mainstem and assessed

these features were mapped if they fell within the Black River's corridor between Coventry and Craftsbury (M03-M29), or along the assessed tributaries. Undersized bridges and abutments were found throughout the river's length but were mainly concentrated (and had their greatest impact) on Reach M16, southwest of Irasburg. Several of these constrictions caused areas of bank erosion and sediment deposition immediately upstream, but most caused large areas of scour and deposition downstream, as a result of the velocity gained by water flowing through the narrow passages. Natural grade controls were concentrated in the Coventry area, where two waterfalls and one ledge were located. One ledge was also located in the upper watershed in Craftsbury.

Additionally, three active beaver dams were found along the slow, meandering portion of the river between Craftsbury and Irasburg, along with many more breached dams and debris jams.

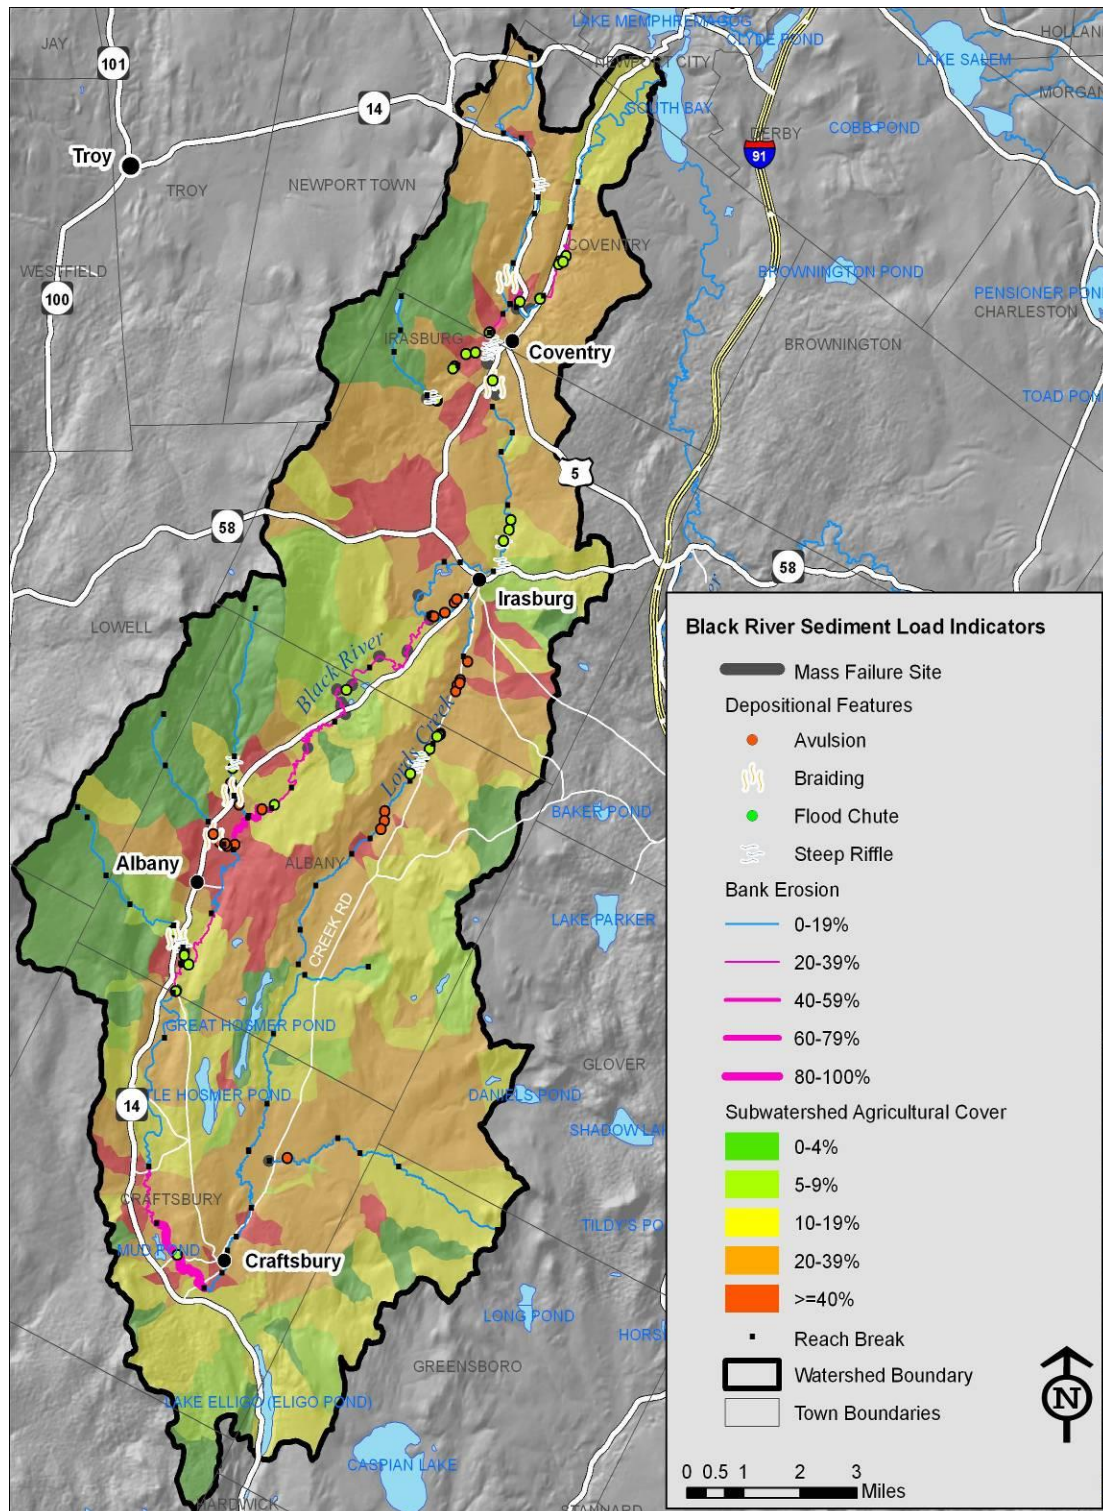
**Figure 9.** Sediment load indicators along the Black River.

In addition to sources of sediment to the river channel, depositional features and channel adjustments are also displayed in Figure 9 for Reaches M03 through M29 and the assessed tributaries. These features can serve as indicators of a river's sediment load as it adjusts to high sediment inputs, and include steep riffles, channel avulsions, braiding, and flood chutes. Our data show that most of the Black River reaches are exhibiting signs of a large sediment load. The two reaches with the most depositional features per mile are Reaches M04, located upstream of the Route 5 crossing in Coventry, and M23, located upstream of the Rogers Branch confluence.

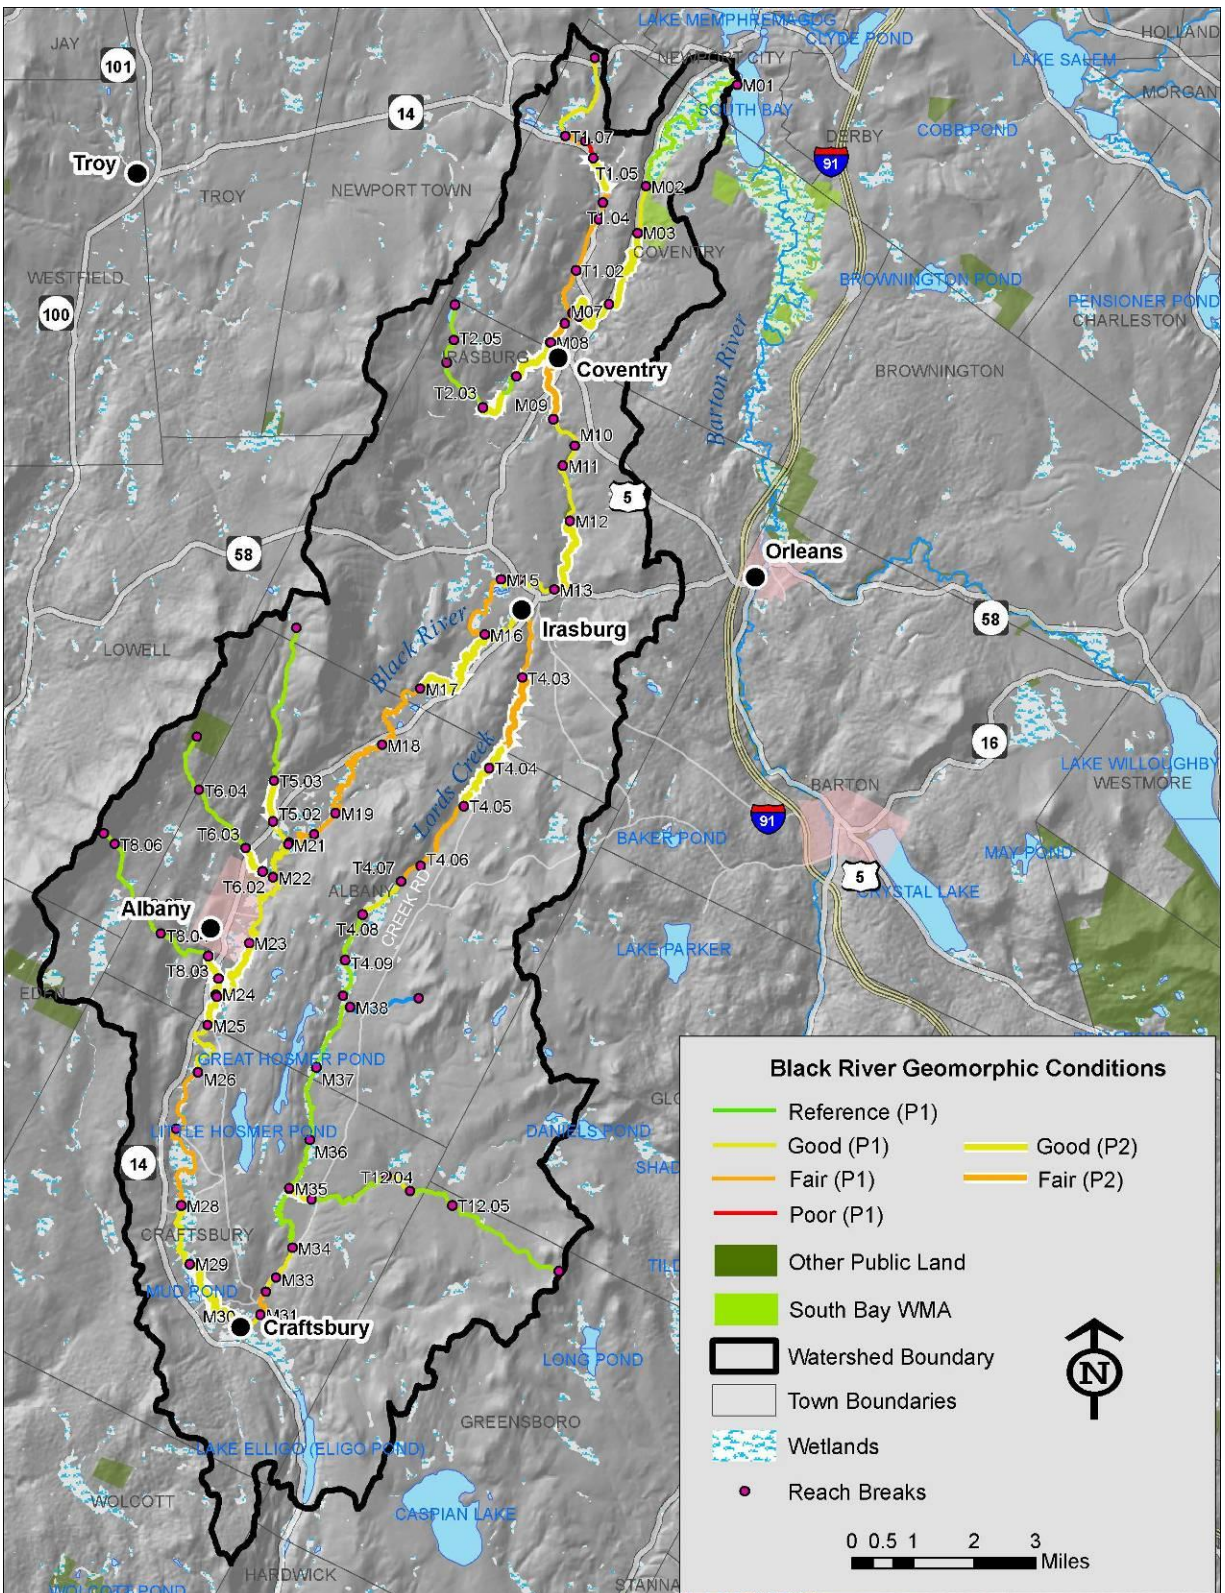
**Figure 13.** Map of geomorphic conditions found during Phase 1 and 2 assessments .

Along the Black River, our Phase 1 assessments identified 10 river-miles (20% of the total assessed miles) as in reference condition. These reaches were stable, well-connected with their floodplains, and lacked significant alterations to the channel or floodplains. The mainstem reaches in good condition totaled 14 miles (29%) and were less stable than the reference reaches. Finally, 22 miles (45%) were in fair condition and three miles (6%) were in poor condition; these reaches having higher impacts due to historic channel alteration - such as straightening - or current land use activities (generally agriculture).

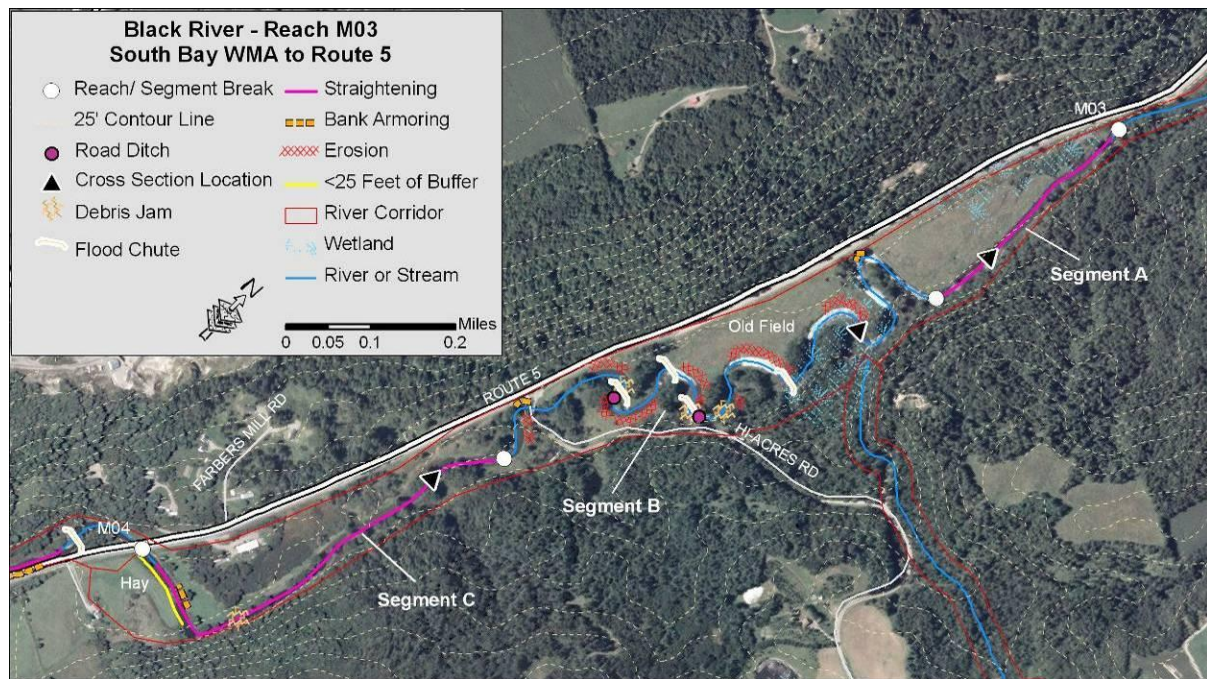
**Figure 14:** Results for Black River Reach M03.

Reach M03 (Figure 14) parallels Route 5 for its entire length, beginning near the Route 5 bridge a short distance downstream of Coventry village and ending 1.8 miles downstream as the river flows close to the highway. Half of this reach is within South Bay WMA, starting from Hi-Acres road and continuing downstream. The reach was segmented after initial surveys, due to historic straightening in the beginning and ending segments. Segment A is at the lower end of the reach. In segment C the river is shallow and flows straight mainly along the valley wall (right bank). The landscape along the left corridor consists of scattered silver maple trees with an ostrich fern understory along the fringes of

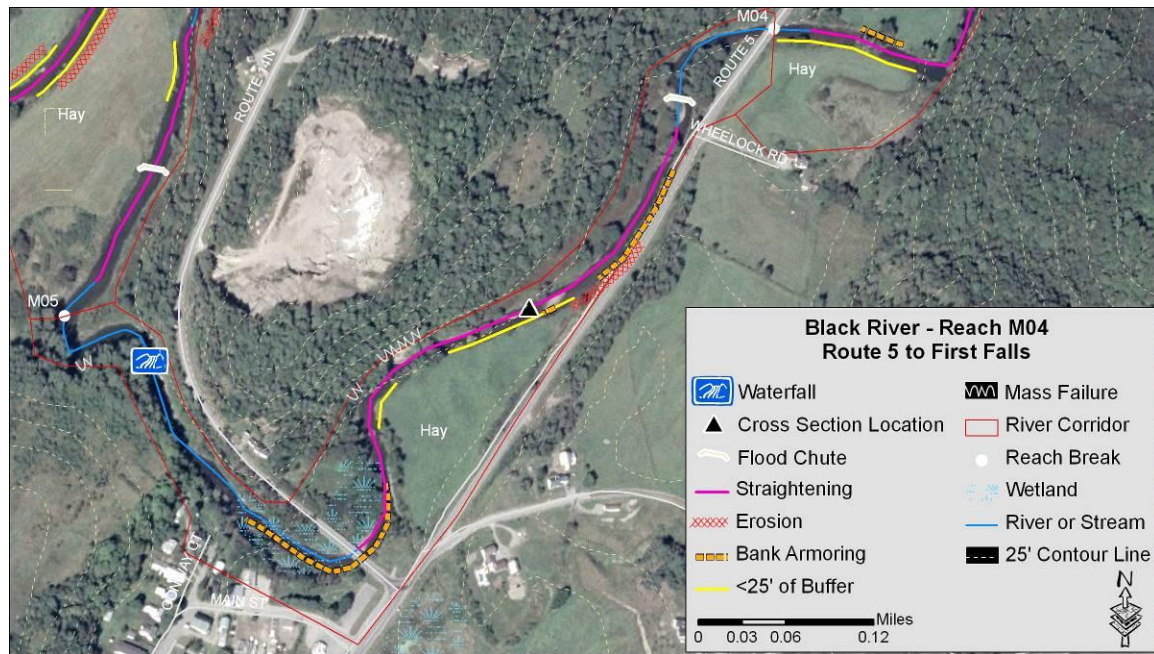
**Figure 16:** Phase 2 results for Black River reach M04.

Reach M04 (Figure 16) begins at the second of two waterfalls in Coventry and ends at the Route 5 crossing, approximately 0.5 miles downstream of the intersection of Route 14 and Route 5. This 0.8 mile reach is initially a swift, cobble-bed river near the 11-foot waterfall (Figure 17) but transitions to a slower river with a sandy bed. The channel shows many signs of historic alteration, with approximately 40% straightened and 25% lined with rip-rap. The areas that were rip-rapped are deep and slow flowing, but the areas lacking rip-rap are shallow and contain very soft, new sediment deposition. These areas are also wide, and contain mid-channel bars – indicating that the river’s planform will change, though probably quite slowly.

Aquatic habitat is in fair condition. The reach flows along a hay field for about half its length. This area lacks natural riparian vegetation, as the field is mowed close to the river and there is little shade and few sources of debris. Elsewhere, the river flows through floodplain forest with large silver maples, occasional box elder, and an ostrich fern understory. A small portion of this field is eroding due to sediment deposition mid-

channel. Sediment deposition is common along the non-armored streambeds. Much of the channel bed consists of uniform, freshly-deposited sands and silts. Management of this reach should consider the historic straightening and current aggradational nature of the reach, and that the river is slowly attempting to regain natural meanders in this area.

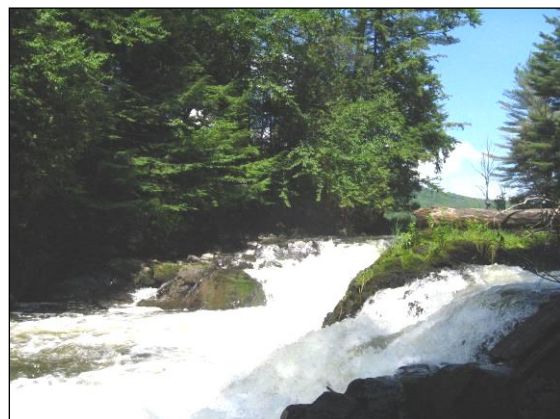
**Figure 17:** Waterfall at upstream end of Reach M04.

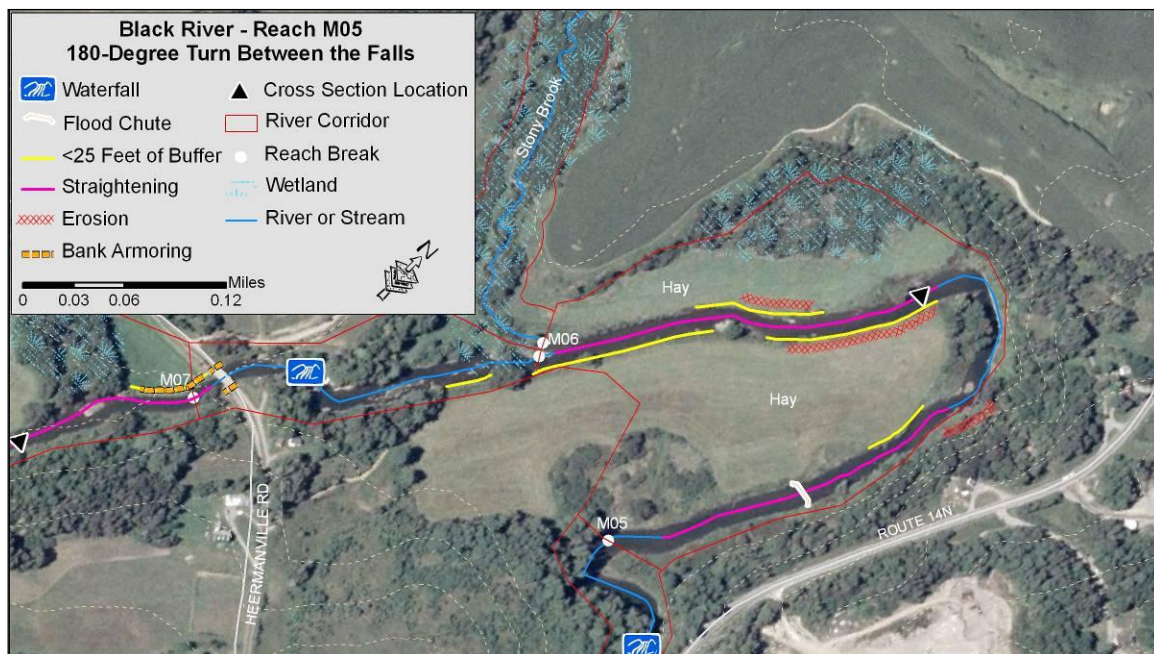
**Figure 18:** Results for Black River Reach M05.

Reach M05 (Figure 18) follows an interesting path after its origin at Stony Brook, flowing first straight toward the steep valley wall, then making a 180-degree turn while continuing to flow against the valley wall. Furthermore, the river makes this sharp bend prior to hitting the steep valley wall; however the water was too deep and murky during our visit to determine if this section had been armored to protect the hillside. Because it flows straight through an unconfined valley, most of the reach was likely straightened for agricultural purposes long ago, and it now lacks the natural sinuosity one would expect in this landscape. Reach M05 is not in reference geomorphic condition because of the

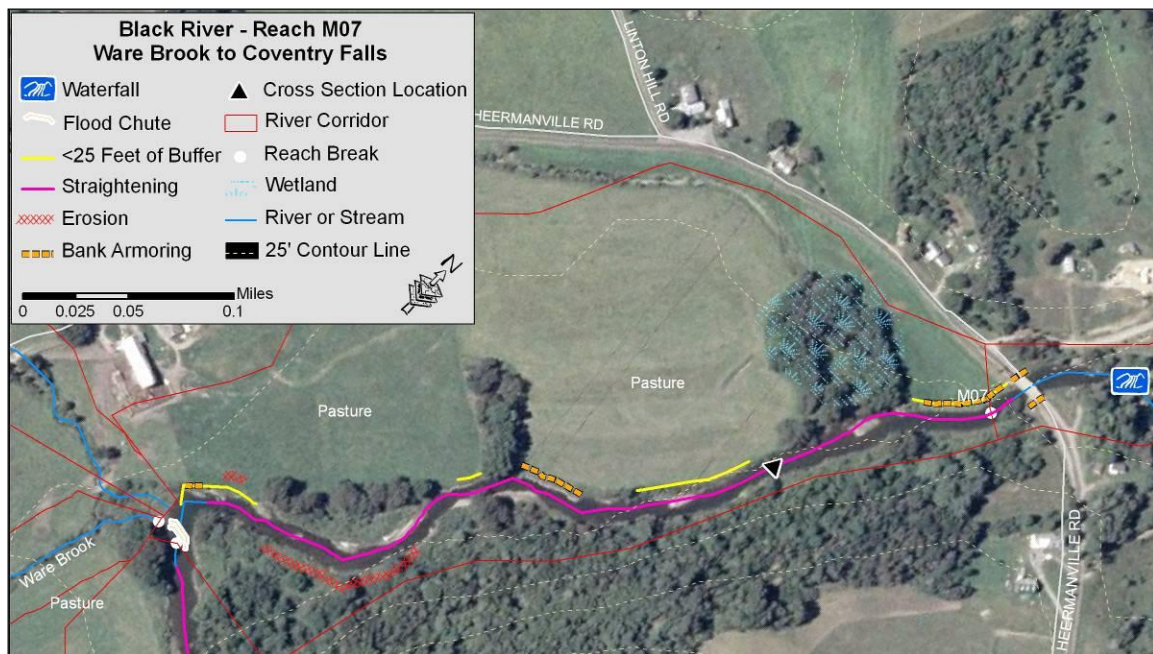
Reach M07 (Figure 20) is 0.4 miles in length and flows between Ware Brook and Coventry Falls - a 7-foot waterfall occupying a brief but interesting constriction of the river valley. This reach has been artificially straightened in the past, as evidenced by its straight path through a wide and flat valley. Both historic (failed) and existing rip-rap is present, and both riverbanks exhibit signs of old erosion that has since stabilized. The reach is incised (incision ratio 1.6); a cross sectional measurement of the channel was taken at a lower terrace formed by an eroded riverbank that had stabilized (Figure 21). Because of the significant man-made alterations to the channel, and subsequent downcutting of the channel bed, the reach has been rated in fair geomorphic condition.

**Figure 20:** Results for Black River Reach M07.

Habitat is also in fair condition; as the reach is clearly receiving and reacting to fine sediment deposition. The dominant substrate of coarse gravels is approximately 35% embedded with finer silts and sands. Additionally, the channel bed is characterized by uniform plane-bed features, rather than the diverse riffles and pools that would naturally occur in this setting. As a result, portions of the streambed are fairly wide and shallow. Riparian vegetation is intact along the entire right corridor, and the upstream portion of the left corridor (Figure 22), but is lacking downstream. Instead, herbaceous vegetation dominates the left side, particularly where fences are placed close to the riverbank.

Future management actions should include **re-establishing a riparian buffer along the left bank** and **fence set-back**. A **corridor easement coupled with buffer planting** here would allow the river to re-establish natural meanders gradually while also improving habitat conditions.

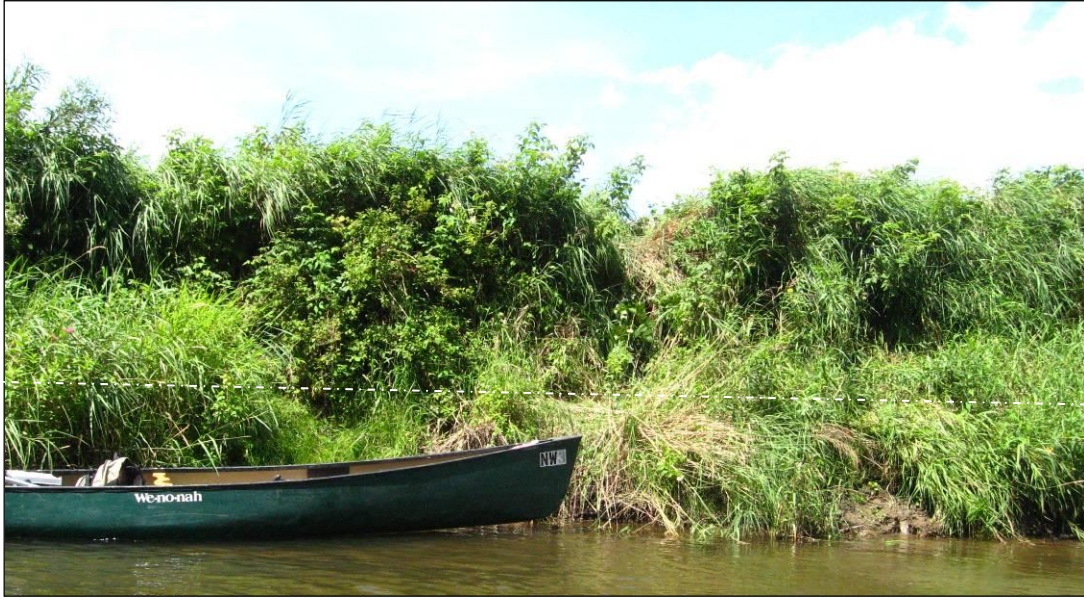
*Figure 21: New, vegetated terrace (dashed line) used to determine the bankfull height on Reach M07.*

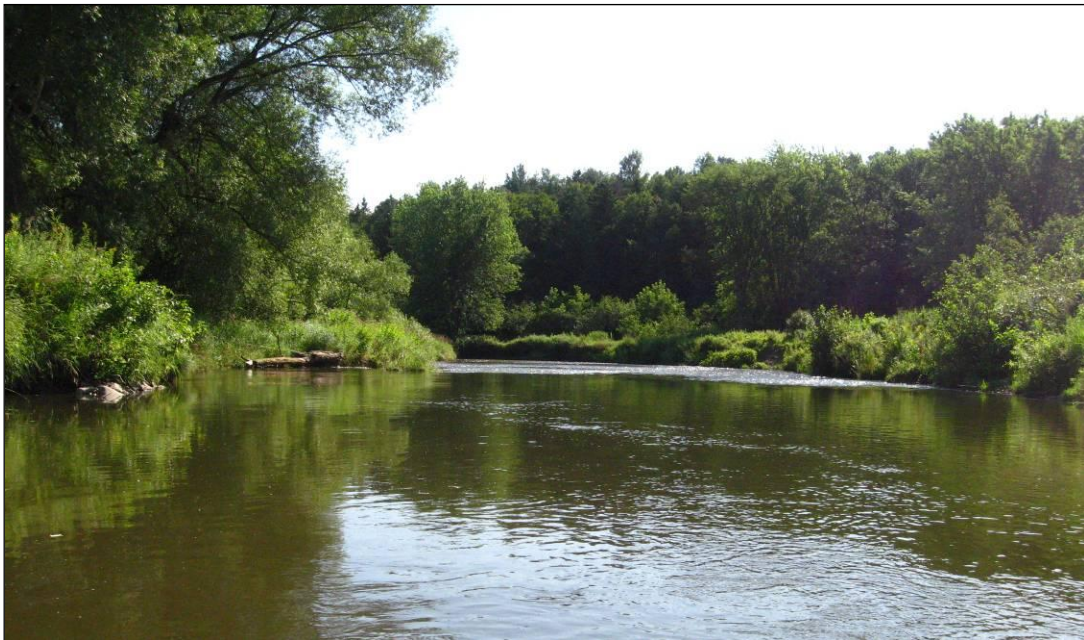
*Figure 22: The upstream portion of Reach M07, depicting the healthy riparian corridor in this area.*

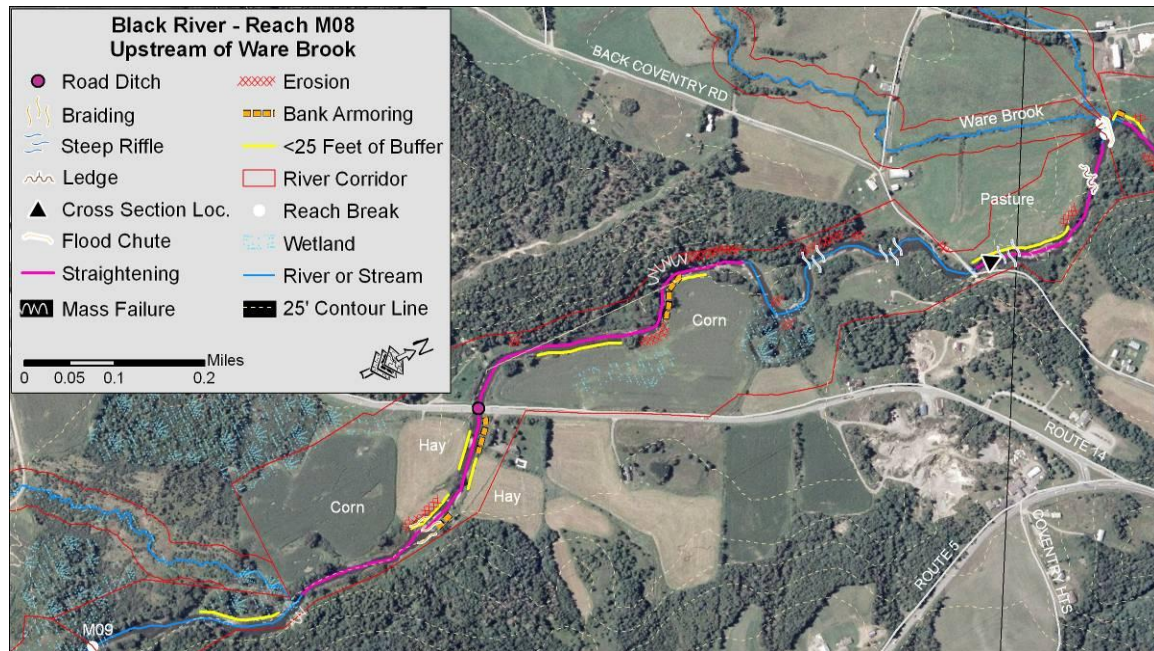
**Figure 23.** Results for Black River Reach M08.

Reach M08 begins at the Ware Brook confluence and ends near the terminus of an interesting narrow and forested valley. This reach totals 1.5 miles in length and is a transition between the two miles of confined, transport-type reaches with gentle rapids upstream and the slow, sand-dominated reach downstream. As an unconfined section with a gentle slope, Reach M08 serves as a depositional area for the sediment carried from upstream. Several significant sediment sources were identified along these upstream reaches and the upper portion of Reach M08 including; a 4' wide gully, recent logging in the river corridor, a mass failure site, and an eroding logging road. In addition, 59% of the reach was straightened historically to facilitate agriculture along the river. Thus, this portion of the river is attempting to regain natural meanders while simultaneously accepting sediment inputs from upstream and within the reach. This is most obvious at a braided section near the Route 14 crossing, where the river has formed two islands that split the river into three channels. The left riverbanks are collapsing into the river and it is possible that the left channel will become dominant in the future. There is also a flood chute along the left side. This particular location is likely affected because a bedrock outcrop on the right riverbank is slowing flows along the right channel and causing the carried sediment to deposit at this location. Furthermore, the outcrop is preventing erosion along the right bank and causing the left bank to be the most affected.

After the Route 14 crossing, the river continues through a straightened section then, due to an armored riverbank, turns to flow against the valley wall (which is eroding into the river). Further downstream, the river flows at sharp angles into its banks. Three steep riffles, a mid-channel bar, and an island are present. The channel is very wide and shallow in this section (Figure 24), indicating another area of aggradation. The reach is rated in fair geomorphic condition because of its aggradational nature and the anticipated adjustments that the reach will experience as it transitions from a straight channel to a more meandering one.

Reach M08's geomorphic condition and past alterations to the channel affect the condition of its habitat as well, which is rated in fair condition. Pools are uncommon because much of the reach is wide, shallow, and affected by sediment deposition. Trees and other woody riparian vegetation are uncommon overall, though the river flows for a time adjacent to a nicely forested hillside (hemlock, white pine, and yellow birch), and portions of the right corridor include small patches of silver maple forest. Woody debris is rare in the channel, and much of the reach lacks shading vegetation. Scattered purple loosestrife plants are found along the river as well. Management recommendations are to **remove the purple loosestrife** and to **re-establish riparian buffers along the 2,300 feet** of unbuffered bank. **Corridor easements** along the straightened sections would also be beneficial to allow the river to regain its natural meanders.

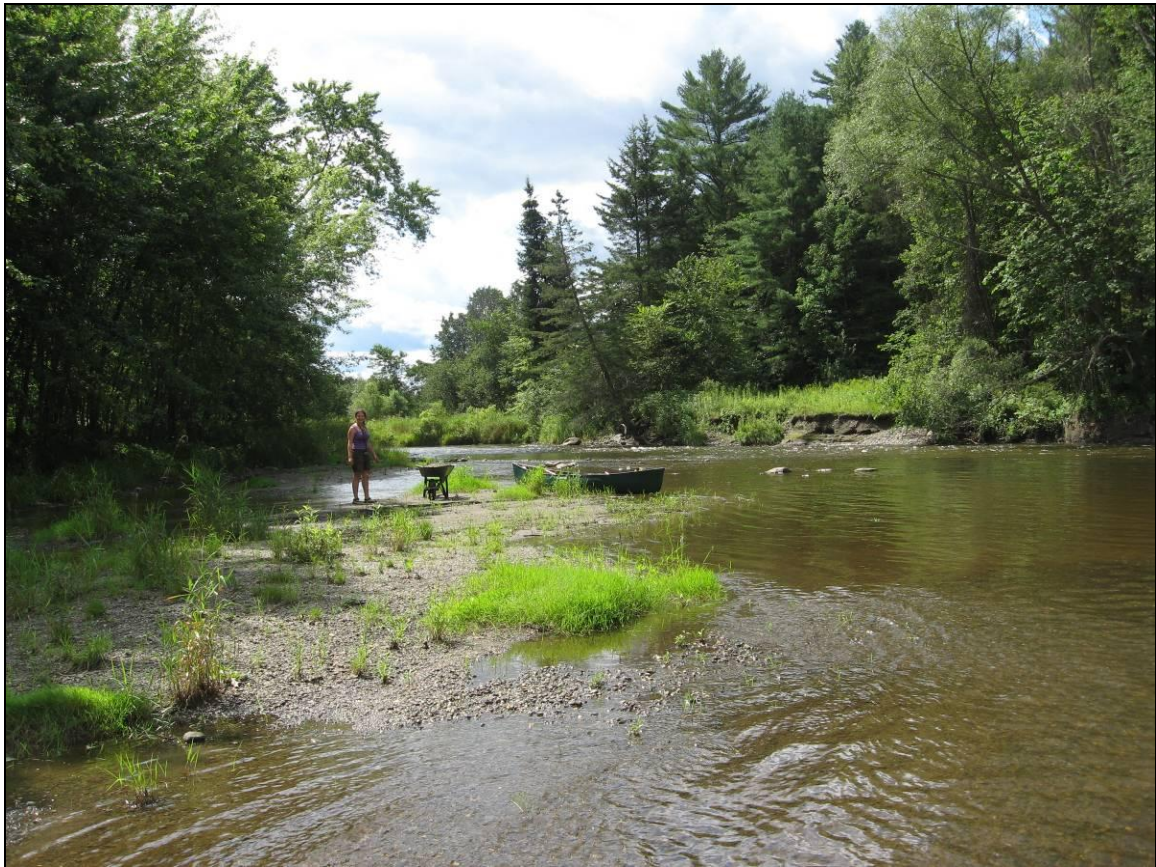
**Figure 24.** Very wide portion of Reach M08, featuring a well-buffered corridor.

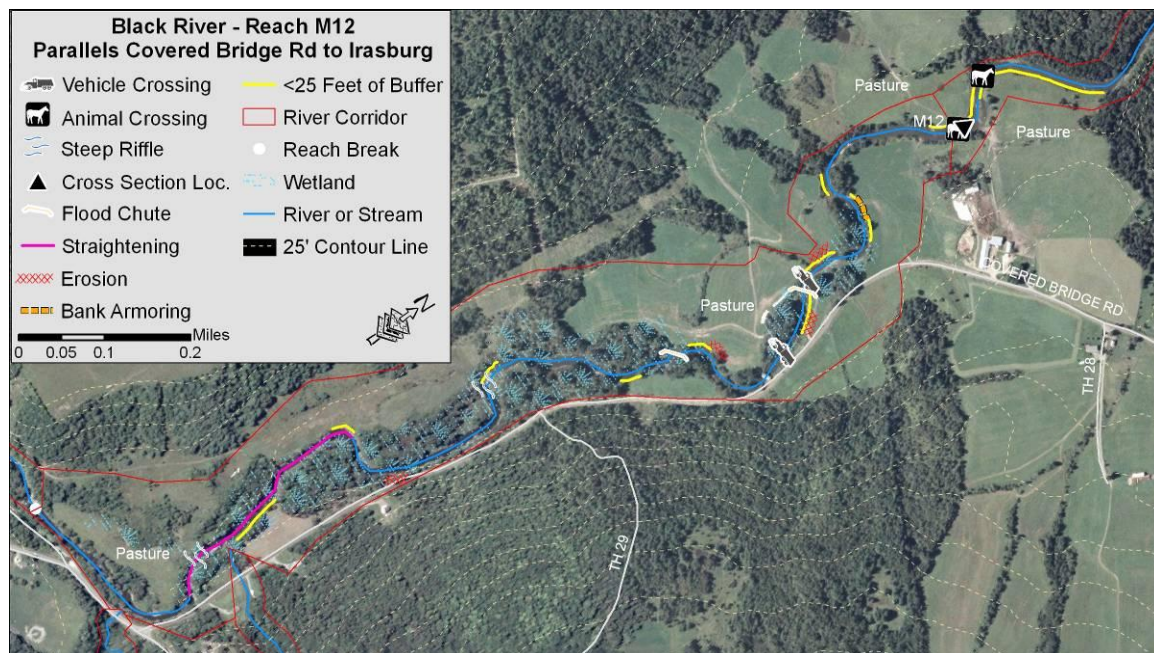
Reach M12 flows alongside the Covered Bridge Road, which is located approximately 0.5 miles west of the center of Irasburg (Figure 25). The reach totals 1.6 miles in length and flows between patches of silver maple floodplain forest and pasture. Located downstream of a narrow and cascading portion of river, it is rated in good geomorphic condition because upstream and in-reach stressors are minimal. Approximately 1,500' of the reach is straightened, but this straightening was completed long ago. A covered bridge that is only 42% of the river's width impacts about 230' of river downstream of the bridge. The bridge impact includes an 8-foot deep scour pool and mid-channel sediment deposition. It appears that the reach is affected by sediment deposition, as multiple indicators of deposition are found. These include three flood chutes, three mid-channel bars, and two steep riffles. A small portion of the river's banks are eroding.

**Figure 25.** Phase 2 results for Reach M12.

Habitat is also in good condition. The majority of the upstream half of the river corridor contains a wide riparian buffer; though **fencing should be set back along parts of the downstream half of the reach and part of Reach M11**. Fencing is adequate along much of the corridor, though some is located closer than 25' from the riverbank. **A wider natural buffer should be re-established** to introduce woody vegetation on the bare exposed riverbanks and to connect the good habitat found upstream with the excellent habitat located in downstream reaches. The upstream portion of M12 contains large

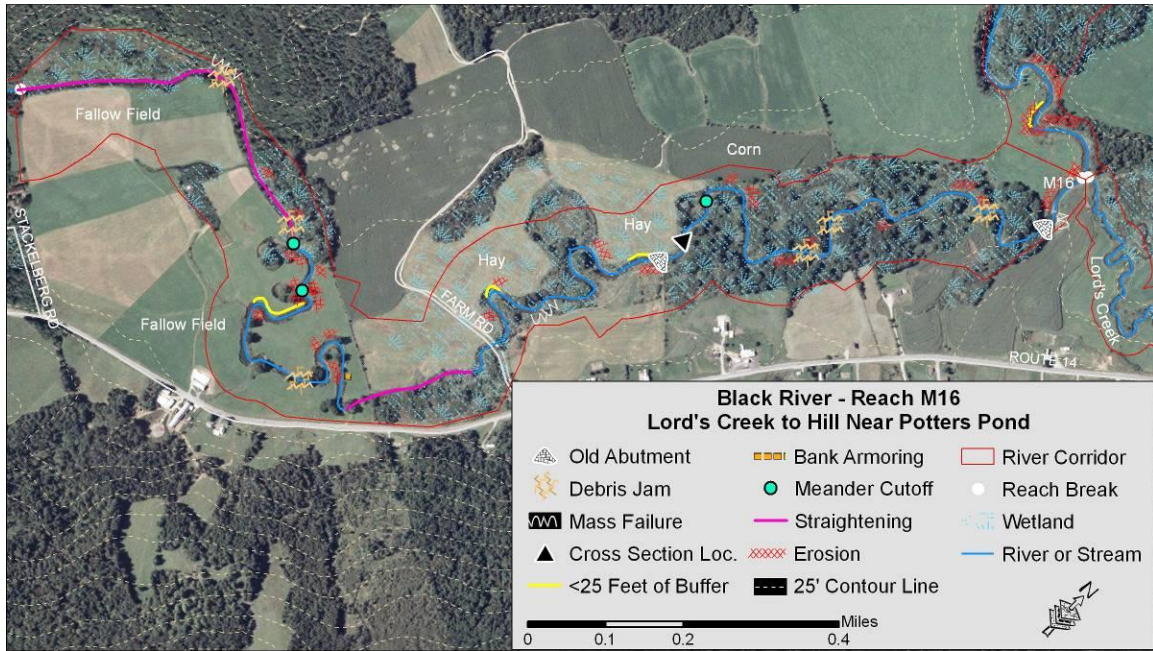
Reach M16 (Figure 27) meanders for 2.6 miles upstream of the Lords Creek confluence through fields and interesting floodplain forests. This reach lies near the start of the wide and gently sloping valley that extends from Irasburg to Craftsbury, where the river meanders through extensive shrub and forested wetlands for approximately 27 miles. Several factors keep Reach M16 from being a reference reach. Approximately 26% of the

reach was straightened to maximize agricultural use in the river corridor. Because most of the fields adjacent to the straightening are no longer utilized, it is likely that the river will re-establish meanders in these areas. Also, two bridges and two old abutments are much narrower than the channel, ranging between 39 and 59% of the channel width. In particular, the abutment near the Lord's Creek confluence appear to be exacerbating erosion of a 15' high bank downstream of the constriction, causing mid-channel deposition and erosion of the left riverbank (Figures 11, 29). **Removal of the abandoned abutments should be at least a long-term goal.** Riverbank erosion is present along the reach in patches - where the riverbanks retain only herbaceous vegetation and in the

*Figure 27. Phase 2 results for Reach M16.*

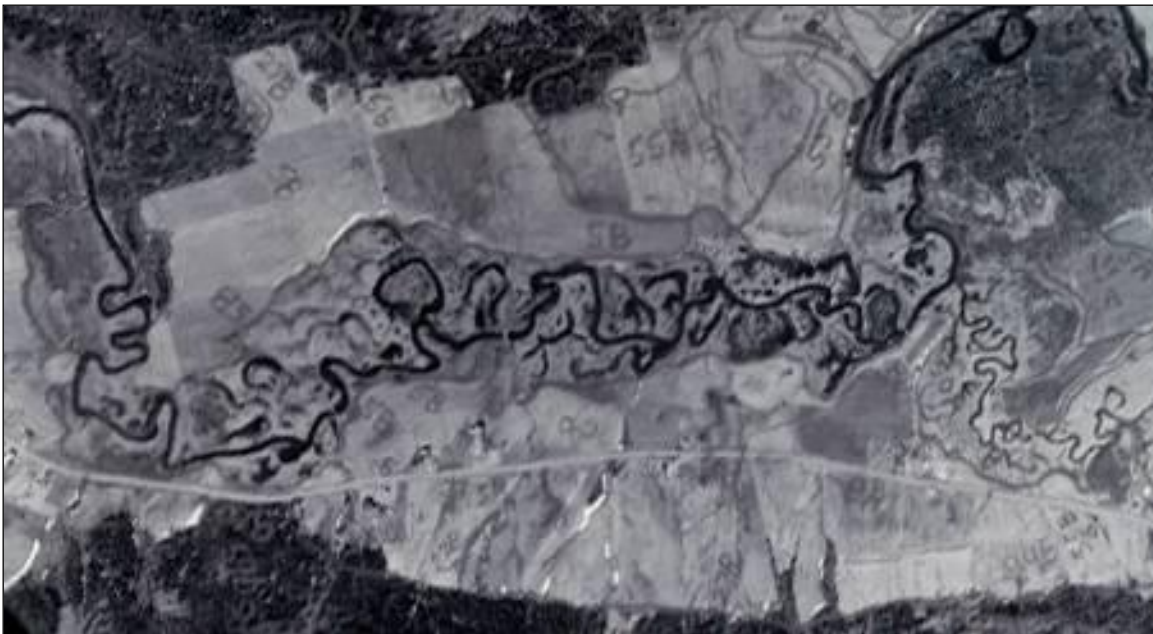
*Figure 28. Reach M16, as photographed in 1962 after leaf drop, showing a mostly unforested corridor and a multitude of old oxbows.*

vicinity of debris jams. Active erosion is present along 20% of the reach, while many banks exhibit old erosion that has since stabilized. Interestingly, despite the meandering nature of the river and the very wet landscape, the corridor was once cleared for agriculture, and was in fact unforested as recently as 1962 (Figure 28). Three meanders have cut off since 1962 and the floodplain forest has re-established upstream of the Lords Creek confluence.

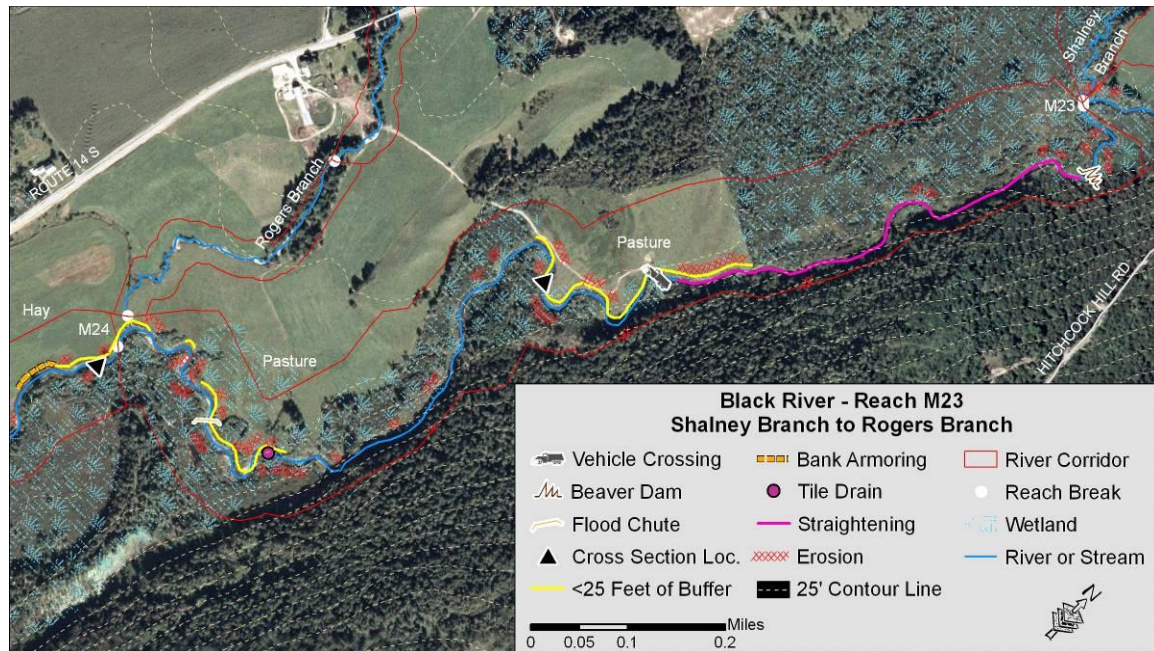
**Figure 30.** Phase 2 results for Reach M23.

Reach M23 (Figure 30) flows for 1.6 miles between the Shalney and Rogers Branches, which originate in the Lowell Mountains. The reach mainly meanders through alder-dominated wetlands and pasture, but also flows along the base of a steep hillside off the right riverbank. Reach M23 is in good geomorphic condition. Thirty percent of the reach is straightened where the river appears pushed against the right valley wall.

Approximately 36% of the river lacks a riparian buffer on the left bank, where the buffer width is less than 5 feet along most of the portions highlighted in yellow in Figure 30.

Habitat is in good condition; with on-going sediment deposition, riverbank instability, historic straightening, and the lack of riparian buffer along the left corridor (Figure 30) keeping it from achieving reference condition. This reach is heavily influenced by beaver activity, with one active dam, one breached dam, and extensive sign throughout. Wood turtles, bobcat and mink sign were also observed. Given the very wet nature of the corridor, the landscape is naturally an alluvial shrub swamp, dominated by speckled alder. The river does flow against the valley wall for a time amid a mixed forest of hemlock, cedar, and deciduous tree species. At times the river flows against bedrock and

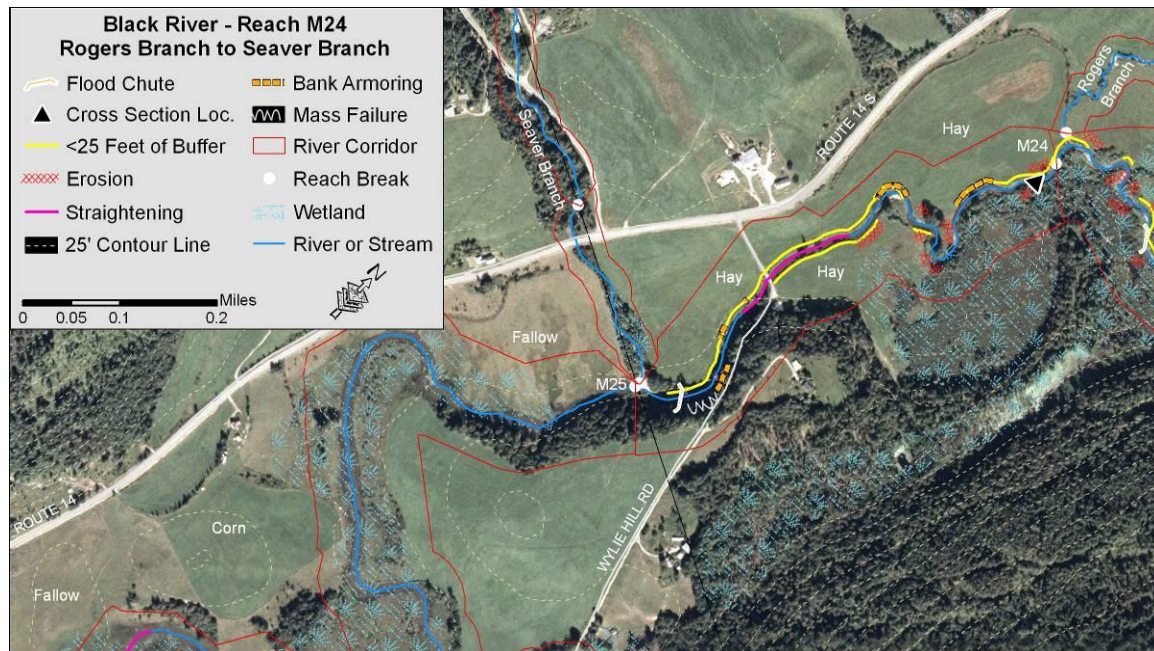
Reach M24 flows for 0.7 miles between the Rogers and Seaver Branches (Figure 32), and is in good geomorphic condition. At the Seaver Branch confluence, deposited sediments are constricting the river's flow, forcing water to accelerate through a narrow channel. From here the river flows against the valley wall, eroding the hillside where it is not armored. After this point, the reach flows straight amid agricultural fields. About 21% of the reach is straightened, and an additional 21% was recently armored to reduce erosion of the hayfield along the left bank. As a result, flows are deflected to a portion of the reach located in the shrub wetland, where eroding riverbanks, an eroding point bar, and a

diagonal bar were observed. At the diagonal bar, river flows are focused directly at a riverbank. This portion of the river will likely change position in the near future.

**Figure 32.** Phase 2 results for Reach M24. A portion of slow, pond-like M25 is also shown.

Habitat is in fair condition, due to the intensive alteration of the river and the adjacent landscape. Many of the hayfields adjacent to the reach were formerly wetlands. Most of the left riverbank and a portion of the right riverbank are mowed to the very edge, eliminating any natural vegetation. Because of the lack of riparian vegetation, important habitat features are absent, such as woody debris in the river and streambank shading. Also, alteration of the channel itself has changed the morphology of the reach by eliminating natural meanders and the diverse pools and streambed features that often accompany a meandering reach. If possible, **riparian buffers should be re-established** and the fields that were formerly wetlands should be converted back to native wetland vegetation, providing a continuous naturally vegetated corridor with adjacent areas and greatly enhancing wildlife habitat along the reach. Several small patches of **Japanese knotweed** (an invasive exotic plant) are present and **should be removed**.

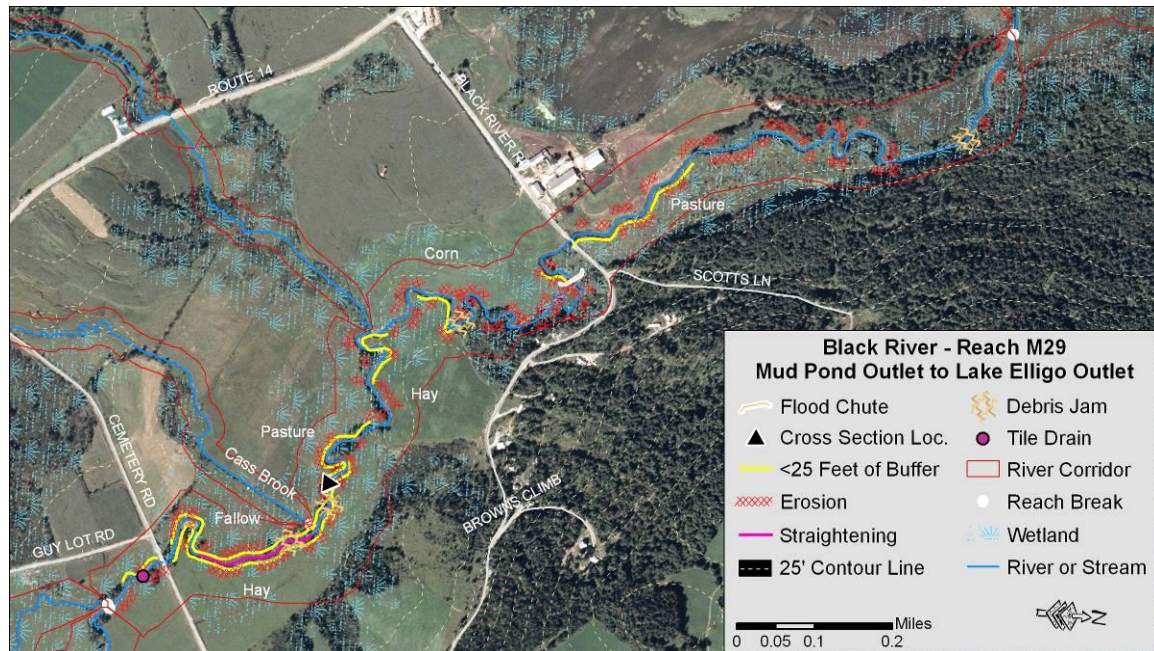
**Figure 33.** Phase 2 results for Reach M29.

Located in Craftsbury, Reach M29 flows for 2.3 miles between the Mud Pond outlet and the Lake Elligo Outlet (Figure 33). A majority of the river valley was formerly wetland, but now exists as wet pasture or has been ditched and is utilized for growing hay or corn. Though direct human-caused modifications to the channel are minimal (mainly straightening along 7% of the reach), impacts from land uses along the corridor are evident. Tributaries entering the reach have been straightened and several field ditches also enter the river. Sediment deposition is occurring at the Lake Elligo outlet and at the Cass Brook confluence. About 82% of the riverbanks between Cemetery Road and Black River Road are eroding due to limited or non-existent bank vegetation along both sides, as is the case along the right bank downstream of Black River Road. Despite these stressors, the reach is in good geomorphic condition. The river is clearly migrating, however the rate is slow - in part due to the slow flows here, and also because of the more stable clays that make up the lower riverbanks.

Because of the intensive adjacent land uses, habitat is only in fair condition. Most of what had been floodplain forest or shrub wetland has since been drained and converted to agricultural fields. Most of the riverbanks, particularly those between Cemetery and Black River Road, are completely devoid of natural vegetation. Though Figure 33 displays areas with <25' of riparian buffer in yellow, most of these areas actually contain
