**Restoring Water Quality in the Lake Memphremagog Basin:  
River Corridor Plan for the Black River**

**Melissa Dyer, Jayson Benoit, and Matt Goclowski**

**March 2011**

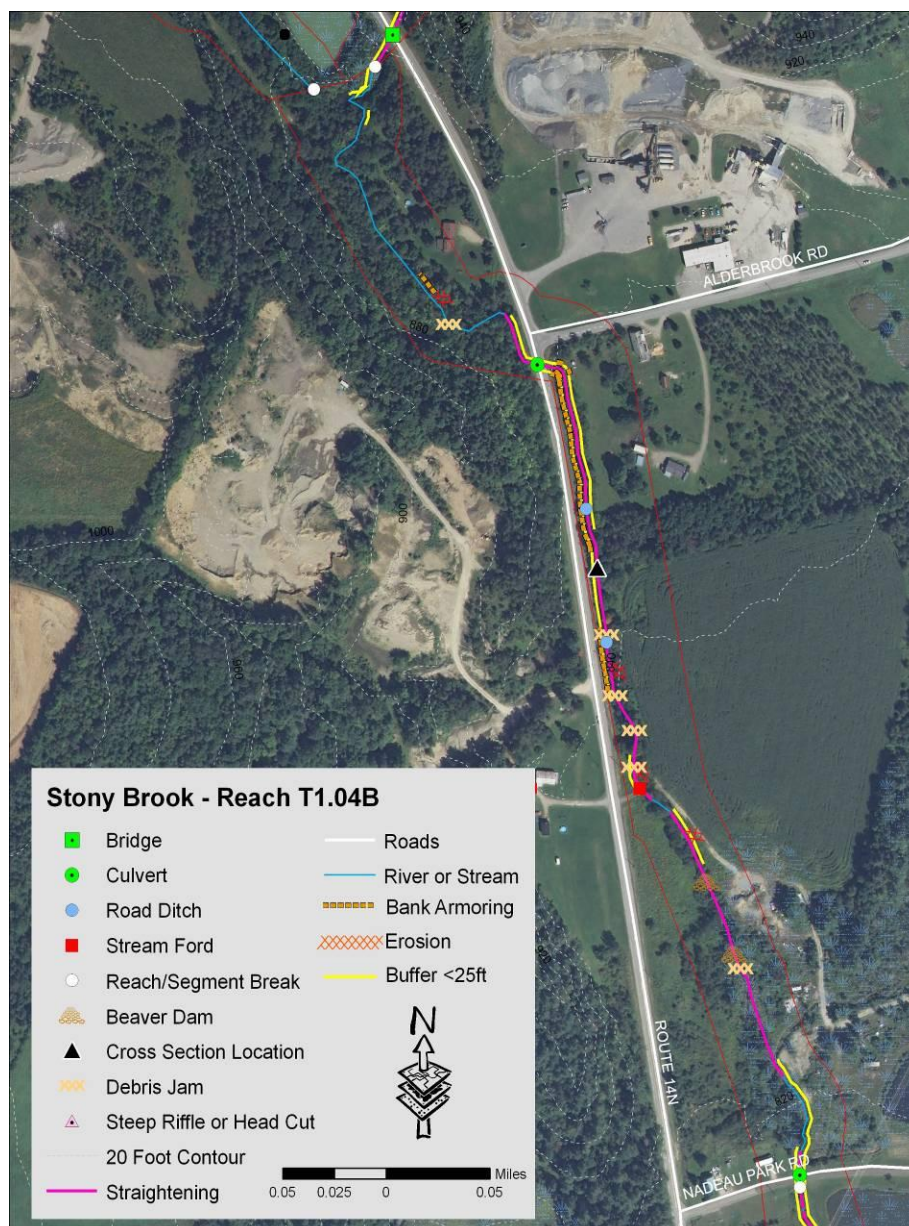
Reach T1.04 on Stony Brook flows for approximately 0.9 miles along VT Route 14 (Figure 35). Segment A includes the portion of the reach located downstream of Nadeau Park Road (~1490 ft) and was not assessed due to restricted access by the property

**Figure 35.** Phase 2 results for Reach T1.04B.

owner. Based on aerial photos and observations from a nearby road, the segment appears to flow through a shrubby wetland. An artificial pond is located adjacent to the stream within the stream corridor, and the pond's dam may serve as minor encroachment to the stream. Route 14N also encroaches on the stream's corridor for a short distance near the downstream end of the segment.

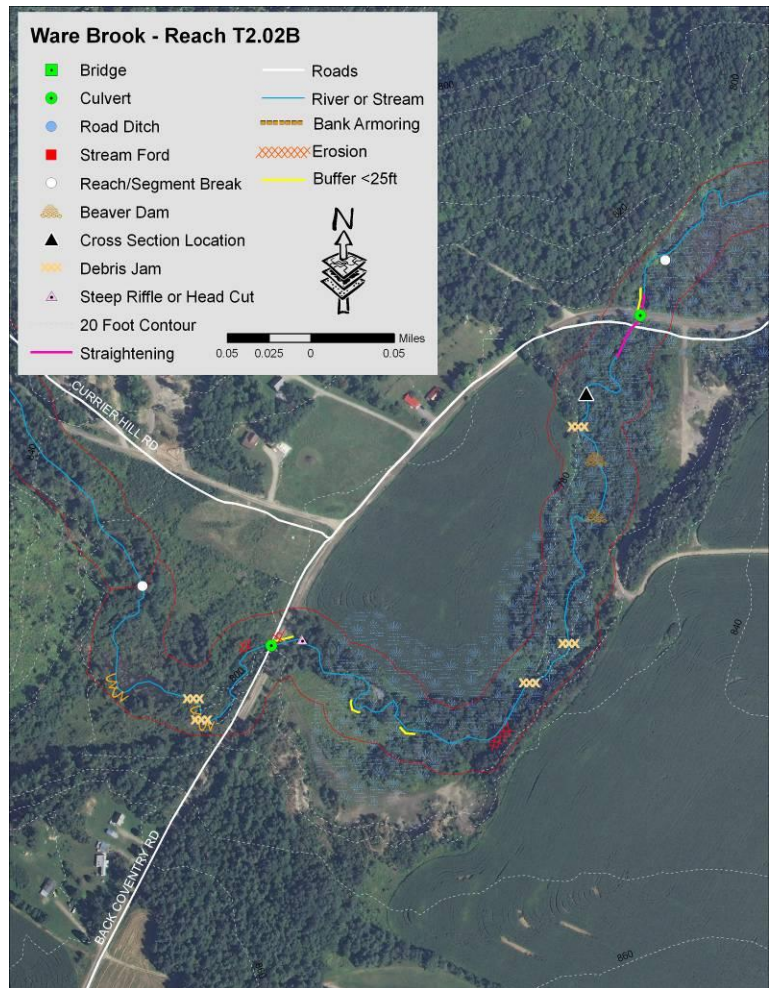
**Figure 37.** Phase 2 results for Reach T2.02B

Segment B extends 4,175 feet, from 275 feet downstream of the lowest Back Coventry Road crossing to 1,000 feet upstream of the upper crossing of this road. The river corridor is forested and development is absent (except for the two road crossings).

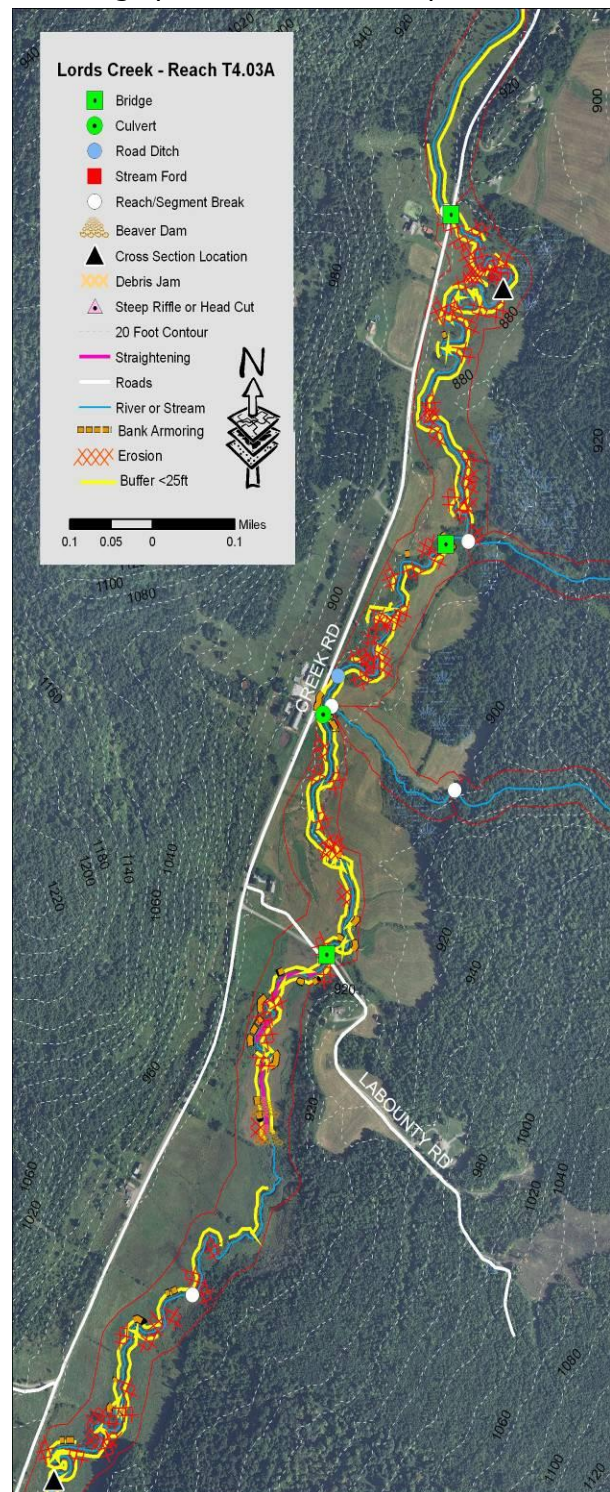
This segment flows almost entirely through cow pasture and hayfields. Buffer width is <25' through most of the reach. Erosion is present on most outside bends and avulsions also occur. There is some evidence of historic channel straightening, but many of the revetments appear to have failed over time. Cows have complete access to the stream in pasture sections and severe bank trampling has resulted. This is most severe in the section downstream of the confluence with T4.03S1.01. **This segment should be considered a high priority site for a buffer planting project and efforts should also be made to restrict cow access to the stream.** The USDA Conservation Reserve Enhancement Program (CREP) offsets the cost to farmers for measures that enhance water quality, and would be a good match for this site.

**Figure 38.** Phase 2 results for Reach T4.03A

A culvert located near the farm buildings about 1,700 feet downstream of Labounty Road serves as a channel constriction, with upstream deposition and downstream scour resulting. This culvert is likely a migration barrier for aquatic organisms during most flow levels, and would be an appropriate **Aquatic Organism Passage retrofit project**. An unusual number (8-10) of dead fish of multiple species (minnows, suckers, and trout- thought to be brown trout) were also encountered in this segment, though the cause of this mortality was unclear.

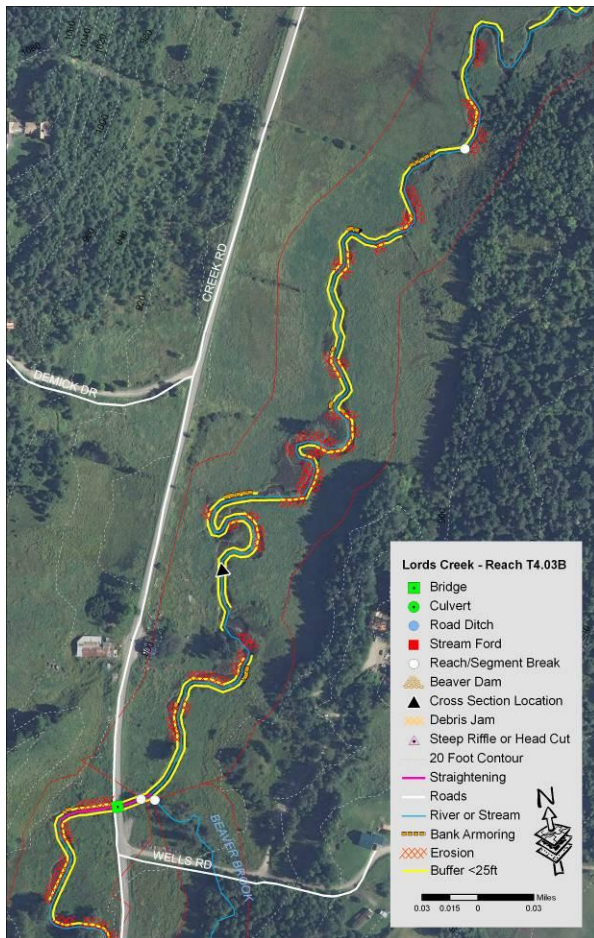
**Figure 39.** Phase 2 results for Reach T4.03B

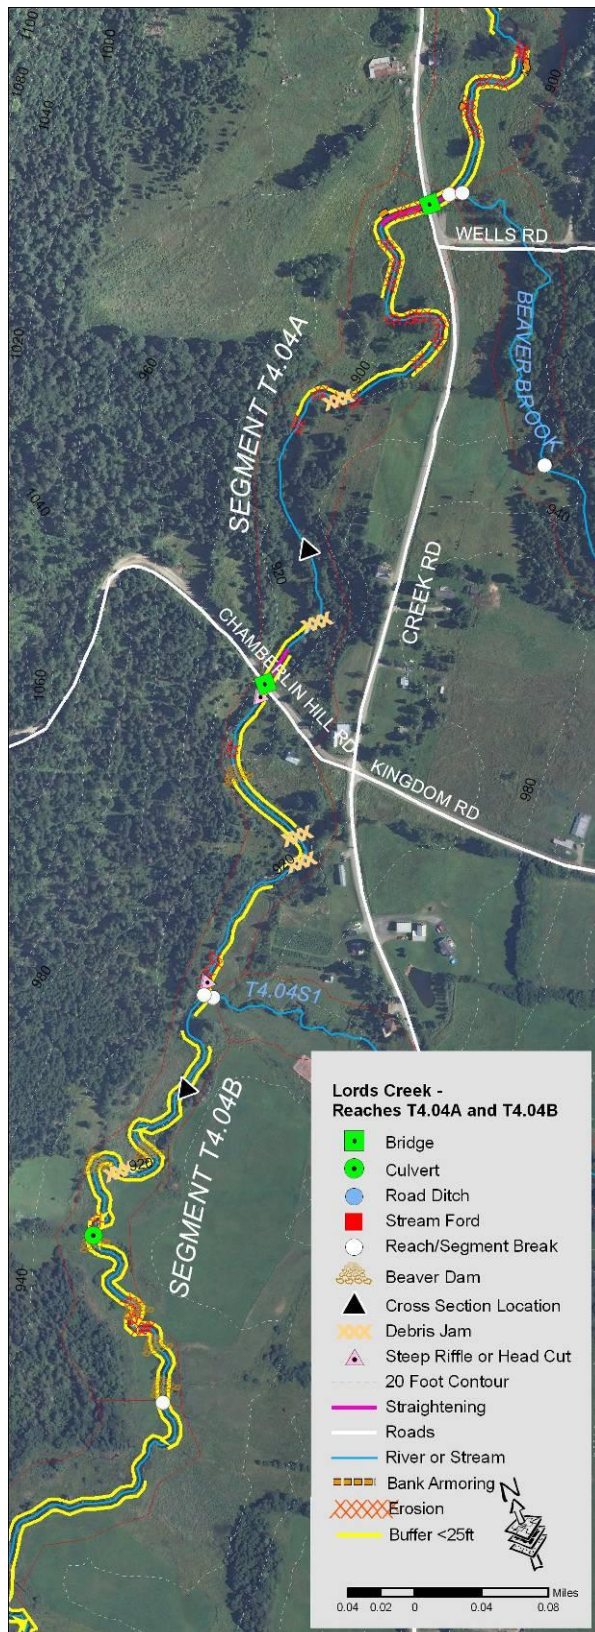
Reach T4.04 was segmented during Phase 2 due to differences in channel dimensions and substrate size between the two sections. Segment A includes 3,551 feet of Lords Creek, from the stream's uppermost crossing of Creek Road to the confluence with stream T4.04S1. This segment flows through cow pasture for 1,000 feet upstream from the Creek Road, and the banks here are very trampled from cows continually accessing the stream channel. This section would benefit greatly from a **buffer planting**, if the cows were also restricted from entering the stream (**fencing**).

Figure 40. Phase 2 results for Reach T4.04A & B

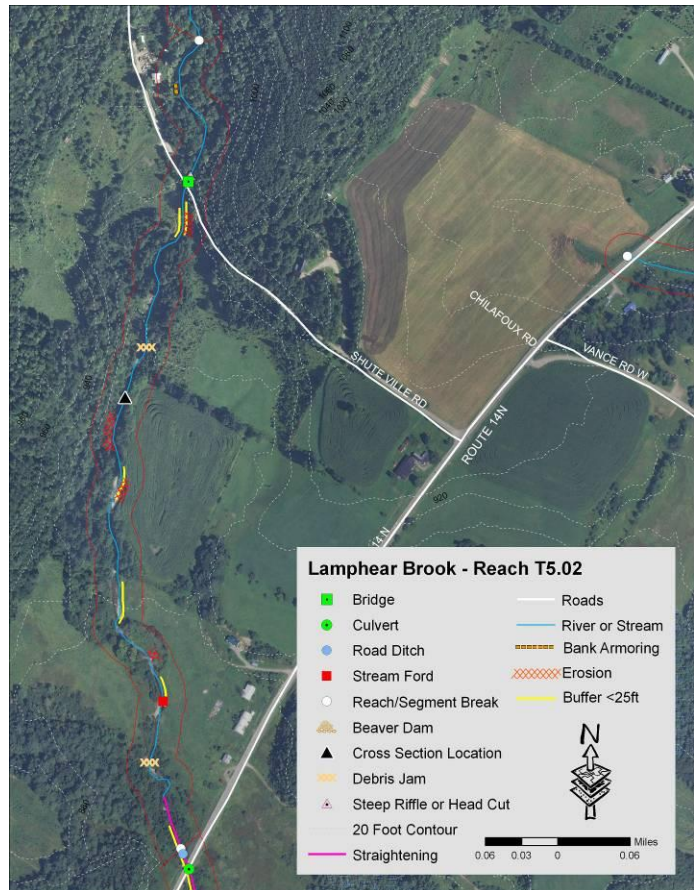
Stream banks are fairly stable through most of the reach, with little erosion evident. Several large bar deposits are present on the inside of meander bends. A large debris jam is located 500 feet upstream of Route 14, and channel braiding has resulted for a short distance downstream.

**Figure 41.** Phase 2 results for Reach T5.02

The culvert at Shuteville Road is a channel constriction that is causing both deposition upstream and a very large scour pool downstream. The stream exits the culvert in a freefall drop, which very likely presents a barrier to the movement of most aquatic organisms during low flows. This culvert would be a good candidate for an **Aquatic Organism Passage retrofit project**.

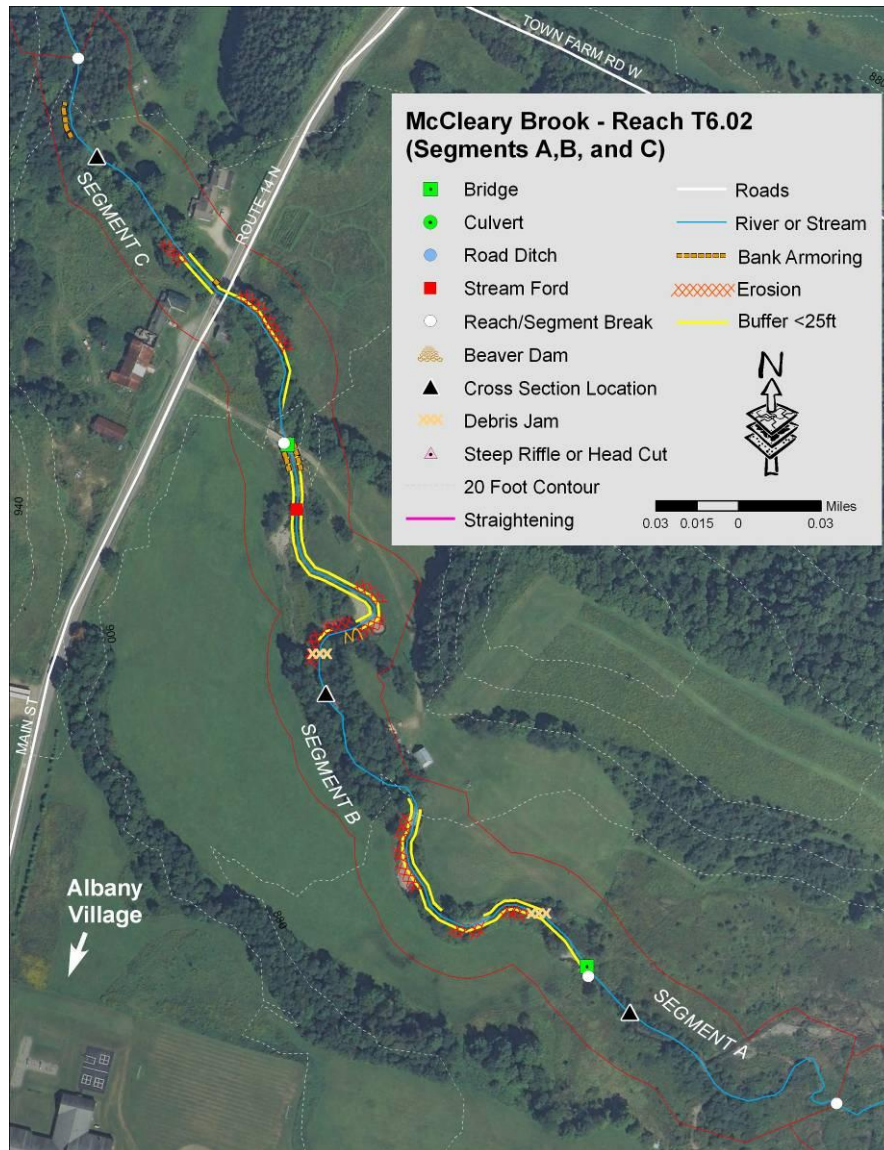
Reach T6.02 was segmented during Phase 2 as a result of widely varying flow conditions. Segment A is 715 feet long and extends from 1,850 feet to 2,565 feet downstream from Route 14. This segment flows through a shrubby wetland and the channel becomes very indistinct. As a result, this segment was not assessed. The stream appears to continue to cross shrubby wetlands on through reach T6.01, to the confluence with the Black River.

**Figure 42.** Phase 2 results for Reach T6.02 (segments A-C)

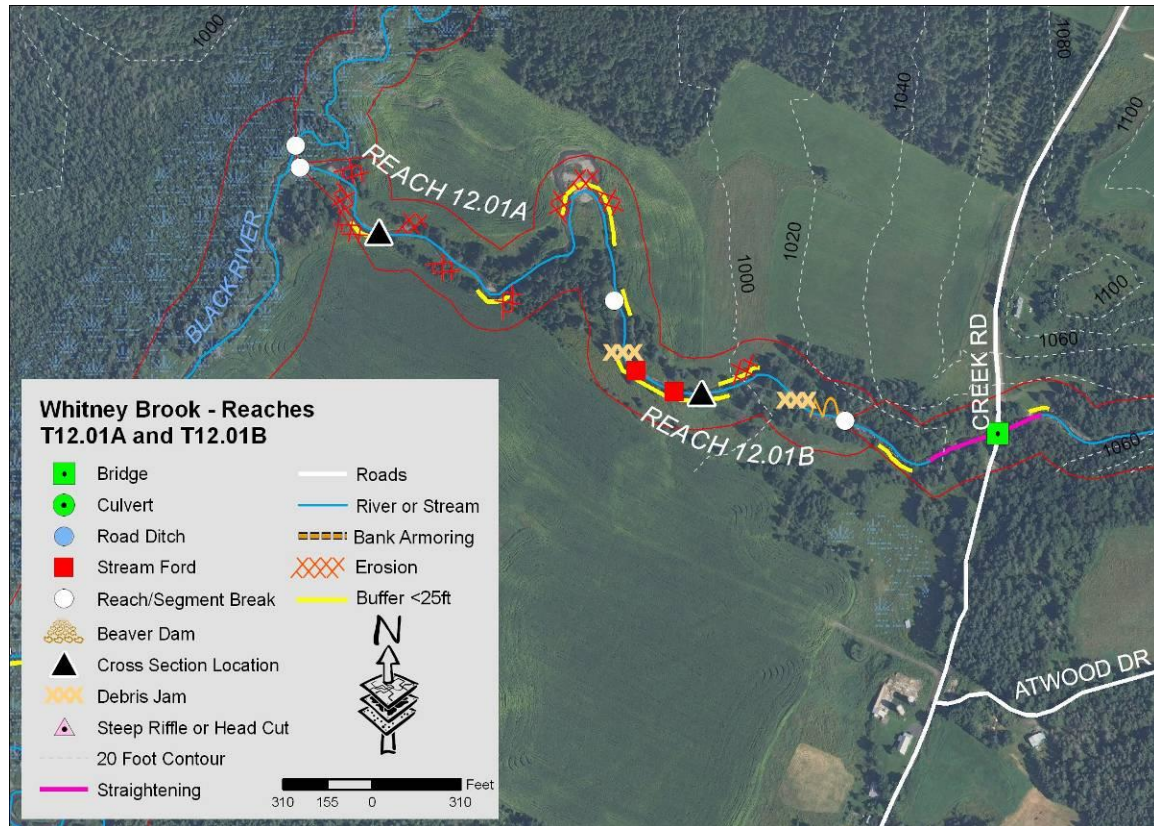
Segment B of Reach T12.01 extends from the upper end of segment A (1,832 feet upstream of the Black River confluence) an additional 1,130 feet upstream, to a point

**Figure 44.** Phase 2 results for Reaches T12.01A and B

roughly 600 feet downstream of the Creek Road. The upper end of this segment has a forested buffer, but this rapidly diminishes downstream as the stream flows between corn and hay fields. There is some erosion on the outside bends in this area, but the banks are fairly stable. **Localized buffer plantings** to increase woody vegetation within the stream corridor would be beneficial here and should be considered a medium priority.
