# **TWEED RIVER WATERSHED CORRIDOR PLAN**

## **WHITE RIVER PARTNERSHIP**

April 18, 2008

Prepared by:  
Daniel Ruddell, Elisabeth McLane, Anna Mulligan,  
Staff Scientists, and  
Ben Machin, Principal  
Redstart Consulting

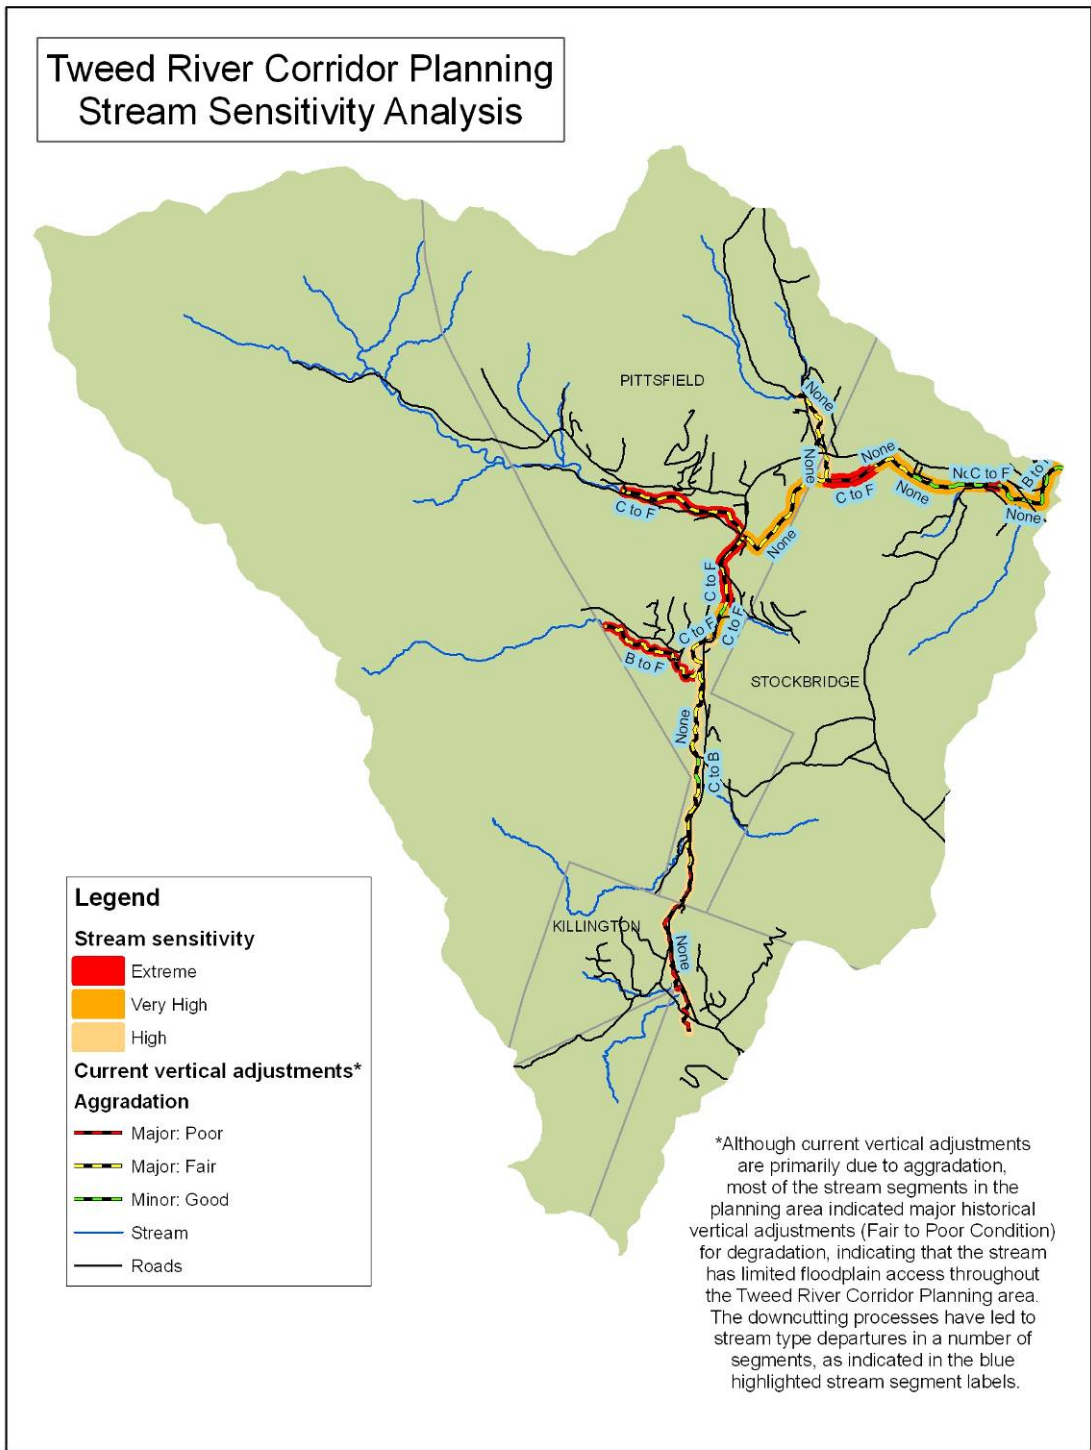
**Figure 17. Sensitivity analysis: Stream sensitivity and current adjustment map for the Upper White River Corridor Project planning area.**

Alteration of sediment and flow regimes have converted all Project area reaches to transport reaches, and erodible boundary conditions (particularly on banks) and high levels of current aggradation in most reaches are indicative of high to extreme sensitivity in all reaches and segments (Fig. 17). Stream type departures (indicating a change from the reference-type channels indicated by Phase 1 analysis) were indicated for 9 of 19 river segments assessed in Phase 2, converting all but one of these to F (highly entrenched and overwidened) stream types. Segment T6.04B indicated a C to B stream type departure (moderately entrenched). This is indicative of the loss of floodplain access, with attendant increased stream power impacts, that is a major contribution to elevated stream sensitivity.

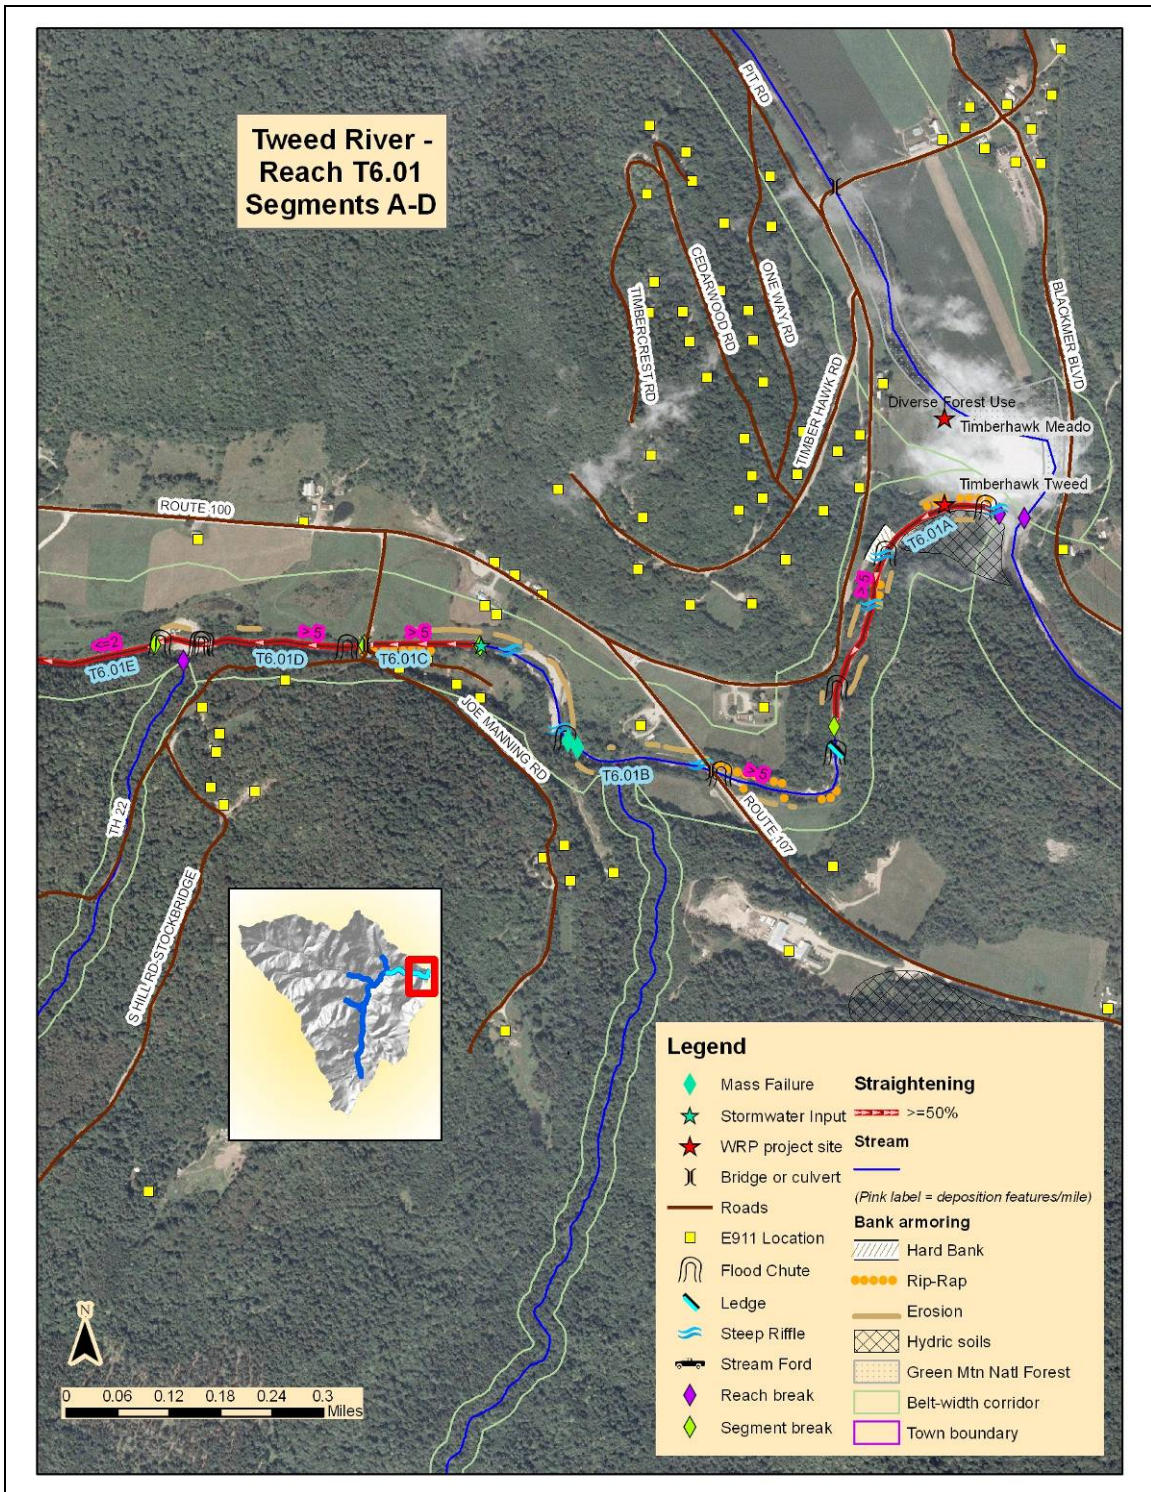
Figure 18. Tweed River reach T6.01, segments A–D.

Segment T6.01A, covering 1415 ft (0.27 mi) from the White River confluence to a popular swimming hole and bedrock outcrop on the upstream end, shows signs of significant historical impacts featuring two breached sluice dams and additional old stone abutments and walls (none of which were identified in Phase 2 assessment as significant current constrictions or grade controls). Phase 2 measurements showed a stream type departure from a Bc channel to a deeply entrenched and overwidened F channel, with an incision ratio of 2.7 indicating lack of floodplain access and extensive bank armoring and erosion as indicators of increased stream power impacts. A semiconfined valley setting is the result of a significant narrowing of valley width by the encroachment of Rte. 100 along the left bank in conjunction with steep valley walls on the right bank, indicating that this segment will likely need to be managed toward a Bc type stream for equilibrium conditions rather than the C type (with Very Broad confinement) originally assigned in the Phase 1 assessment. Bank and buffer vegetation was generally good except in areas where Rte. 100 encroaches heavily on the left bank. Numerous deposition features and multiple flood chutes were indicative of significant aggradation and planform change, although Phase 2 scores indicated only “minor” current adjustments in this segment. Movement of sediment “slugs” through upstream portions of the river suggest that these adjustments may be likely to increase over time, exacerbating erosion impacts in particular, and strongly suggest that even the relatively limited opportunities to attenuate flow and sediment impacts in this segment are important to protect. The WRP implemented the Timberhawk Tweed project in this segment, planting a 400-ft buffer and installing instream fish habitat enhancement structures as part of the project.

Segment T6.01D extends roughly 1400 ft (0.27 mi) from the South Hill Rd. bridge to a large area of aggradation just above a small tributary confluence on the right bank. Road encroachment from South Hill Rd. on the right bank and Rte. 100 on the flanks of the left bank valley has narrowed the valley and floodplain width, and an overwidened channel (with a high width:depth ratio of 35) now exists in a semi-confined setting due to the ratio of this overwidened channel to the narrowed valley. A relatively low incision ratio of 1.4 and retention of access to floodplain may be related to rapid channel evolution featuring high erodibility of the banks in comparison with the bed and lack of constraints to evolution (Phase 2 noted indications that the segment was more armored in the past). Although field assessment did not note an alluvial fan, delta deposits, or tributary rejuvenation from Brown Brook on the upstream end of this segment, substantial deposition at the base of this tributary appears to be augmenting the function of this segment as a highly valuable sediment attenuation asset for upstream reaches in the watershed (Fig. 18). The segment is dominated by the White's hayfields on the left bank, with minimal woody vegetation in a 5- to 25-ft buffer on that bank.

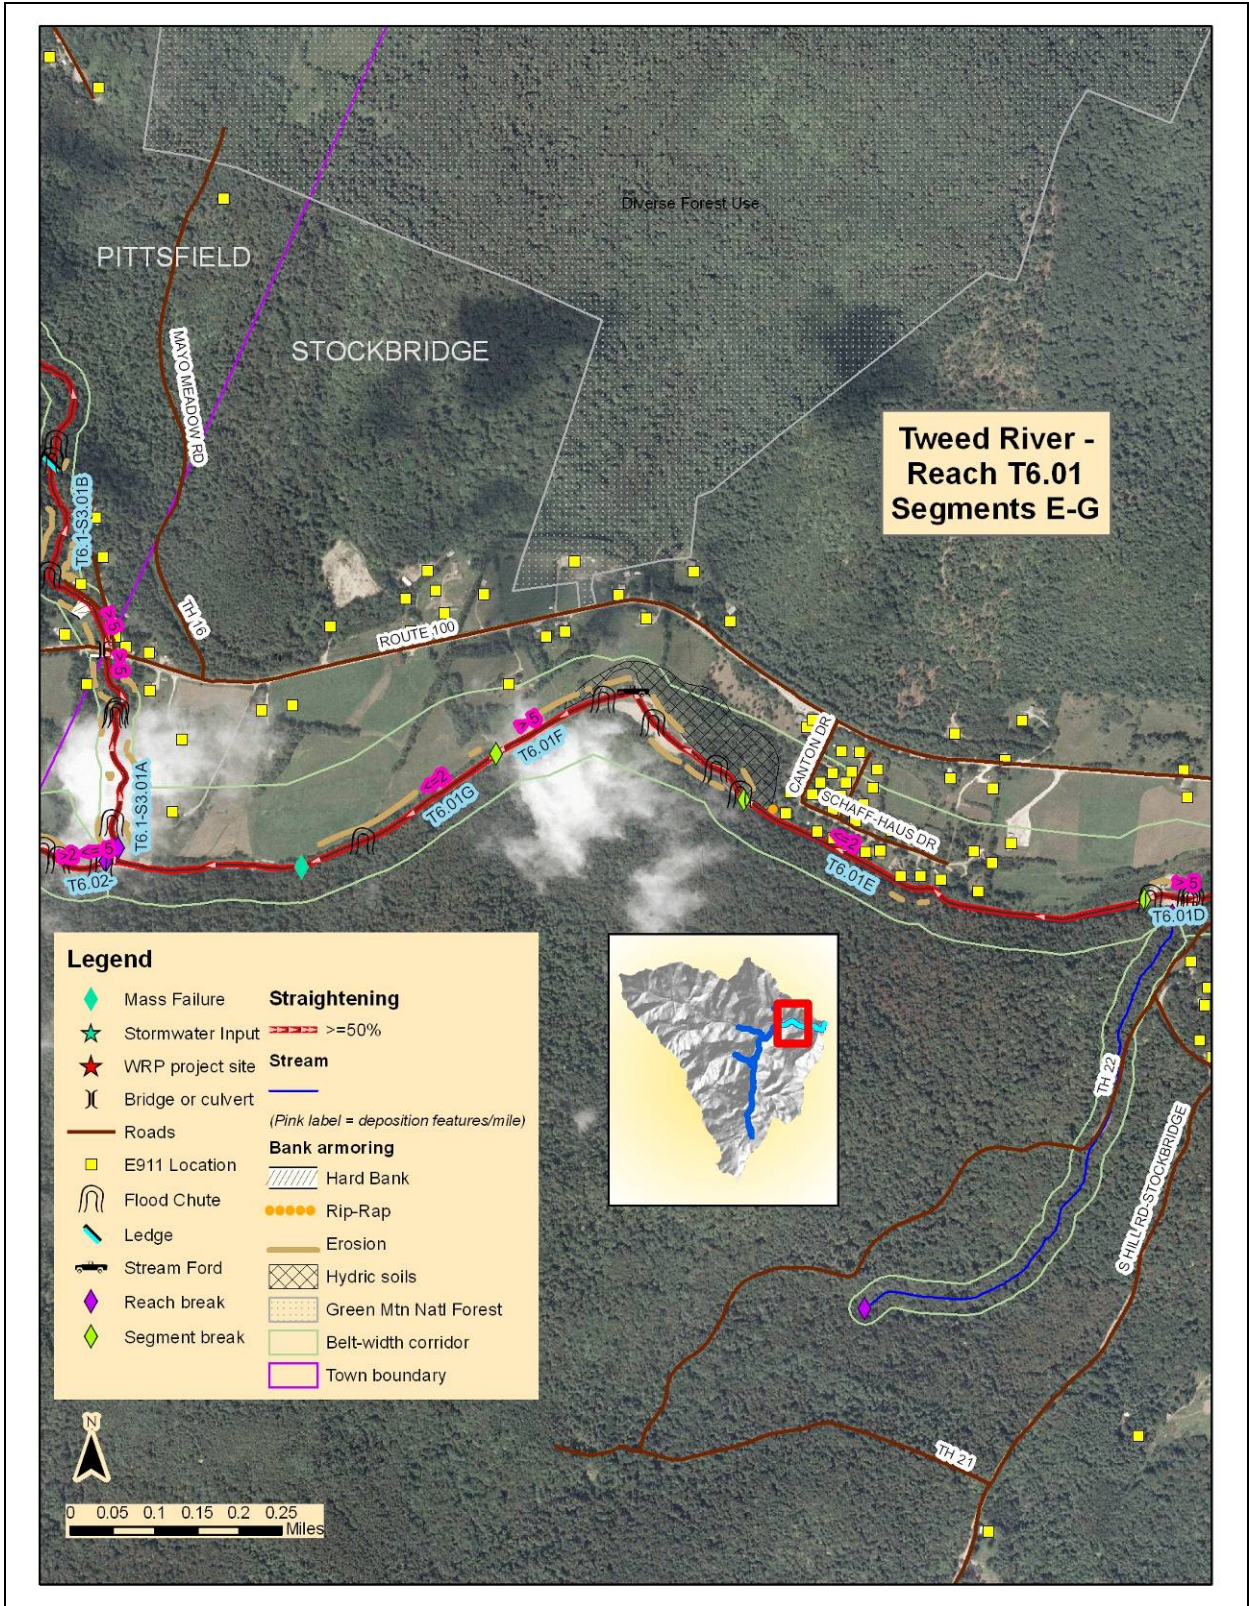
Figure 19. Tweed River reach T6.01, segments E-G.

Segment T6.01E continues upstream 2665 ft (0.5 mi), past the White farm fields to the upstream end of a development dubbed “the A-frame village”, which includes a number of units within the extent of the recently abandoned floodplain (Fig. 19). The stream is still maintained against the valley wall in this portion of the reach, and an incision ratio of 1.9 indicates loss of floodplain access related to the increased stream power of channelization and straightening. Road and development encroachment have helped change the valley confinement from Very Broad to Broad, and the residential land use (as well as some areas of agricultural lands) contributes to the minimal to absent vegetated buffers documented on the left bank of the segment during Phase 2 assessment. The steep slopes above the right bank are forested, with reference buffer conditions, and overall erosion levels in the segment appear low. Lack of distinct depositional features in the segment was surprising given the significant aggradation in the reach overall, as well as assessment scores that indicate the segment is aggrading. Plane bed features were noted throughout the segment (with the exception of bedrock-formed scour pools), leaving questions as to whether the segment has been dredged. Dredging and bar scalping have been practiced extensively in the Tweed watershed, but exact locations are undocumented (pers. comm., Frederick Nicholson, VT River Mgmt. Program Stream Alteration Engineer).

Segment T6.01F extends roughly 2115 ft (0.4 mi) from upstream of the A-frame village to a point where the right valley wall begins to pinch the stream corridor. Although the valley is relatively wide in this portion of the reach, an overwidened channel in conjunction with road and development encroachments that narrow the valley width yield a confinement ratio indicating a Broad valley rather than the reference Very Broad type. This segment marks the first area upstream of the confluence with the White where the Tweed mainstem departs from the right valley wall to any significant extent. During 2006 Phase 2 assessments, a stream ford was being constructed midsegment to access forest lands across the river, and water diversions, channel braiding, and slackwater pools were noted due to the movement of gravel and cobbles for construction. Despite an incision ratio of 2.0, Phase 2 measurements still show a C-type stream with access (though diminished) to floodplain. Heavy erosion was noted on both banks, along with significant aggradation. Channel measurements indicated major overwidening (width/depth ratio of 41.8), and plane bed features were dominant in the reach, with sedimented riffles and multiple flood chutes forming in areas of aggradation. Minimal bank cover (1–25% bank canopy) on both banks was noted, with residential and agricultural land use on the left bank contributing to lack of buffers (0–25 ft) as well. A combination of pasture and forest land on the right bank reduced buffer widths (to 26–50 ft) on that side as well.

Segment T6.01G, the most upstream segment of the reach, covers 2660 ft (0.5 mi) from the point where the valley wall begins to pinch the stream corridor up to the confluence of Guernsey Brook. The stream is back against the valley wall in this segment, and encroachment is again significant enough to change the valley confinement type from Very Broad to Broad. An incision ratio of 1.6 may indicate less recent degradation than in other downstream segments in the reach, with bedrock noted as a dominant material on the right bank, but no channel-spanning grade controls were recorded. The relatively low incision ratio indicates that the recently abandoned floodplain may be accessed more easily in this section of the reach than in some of the other segments. Phase 2 measurements indicated a stream type departure from a C to an F type stream, however, indicating an entrenched and overwidened stream segment that has lost significant access to floodplain. Heavy erosion on the left bank indicates where the majority of widening is occurring, and all distinct depositional features noted in the segment were side bars. A mass failure mid-segment contributes to heavy overall aggradation and plane bed features noted in the segment. Although no headcuts were noted in Phase 2 fieldwork, the high sediment load of fine materials being contributed by the mass failure and tributary rejuvenation from Guernsey Brook are likely to quickly “wash out” distinct signs of degradation.

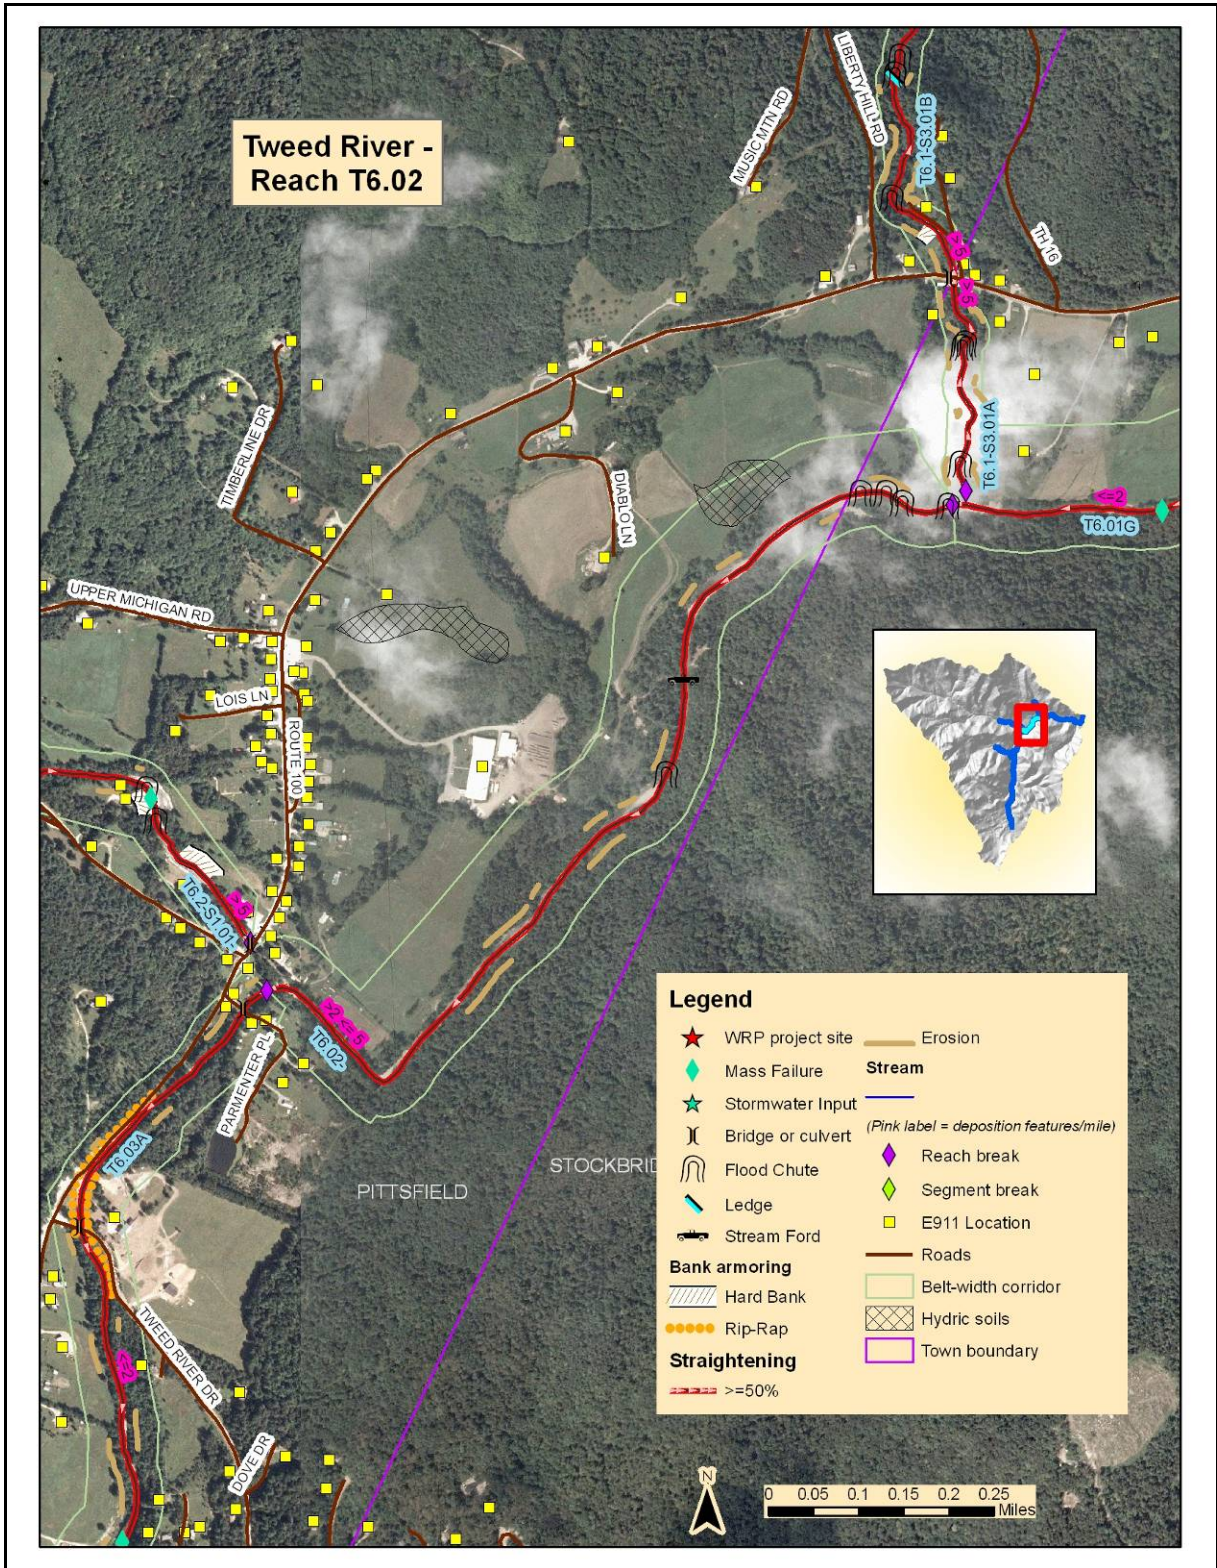
Figure 20. Tweed River reach T6.02.

Reach T6.02 comprises 6195 ft (1.2 mi) of the mainstem Tweed between the Guernsey Brook confluence and the confluence of the West Branch of the Tweed (Fig. 20), and marks the historic extent of the Lumber Railroad along the mainstem, as the railroad continued along the West Branch upstream of this reach. The reach was not segmented during Phase 2 assessment. As with the rest of the river along the old Railroad, this reach is extensively straightened and maintained against the valley wall for much of its length. Impacts of increased stream power due to channelization are evidenced as historical downcutting (incision ratio 1.6) followed by current aggradation, with widening and planform adjustments that feature moderate to extensive areas of bank erosion that are more prevalent on the left bank. Corridor encroachments have a moderate impact but are concentrated in the upstream portion of the reach in Pittsfield village, beginning with outbuildings below the Stanley Tool plant facilities. Phase 2 assessment thus indicated that the Very Broad valley confinement has not been significantly altered except in the short portion of the stream below the confluence of the West Branch, where channelization and the valley wall combine to force the stream into a pair of right angle turns and encroachments are in close proximity to the stream. Despite loss of some floodplain function indicated by the incision ratio, the stream in this reach still accesses sufficient floodplain to function as a C-type stream, with riffle-pool features and a gravel-dominated substrate. A series of flood chutes just upstream of the Guernsey Brook confluence were indicative of planform adjustment and likely indicate the importance of this area as a potential attenuation asset. Buffer vegetation was generally adequate to good, with some developed areas along the left bank lacking vegetated buffers (<25 ft) in the upstream portion of the reach.

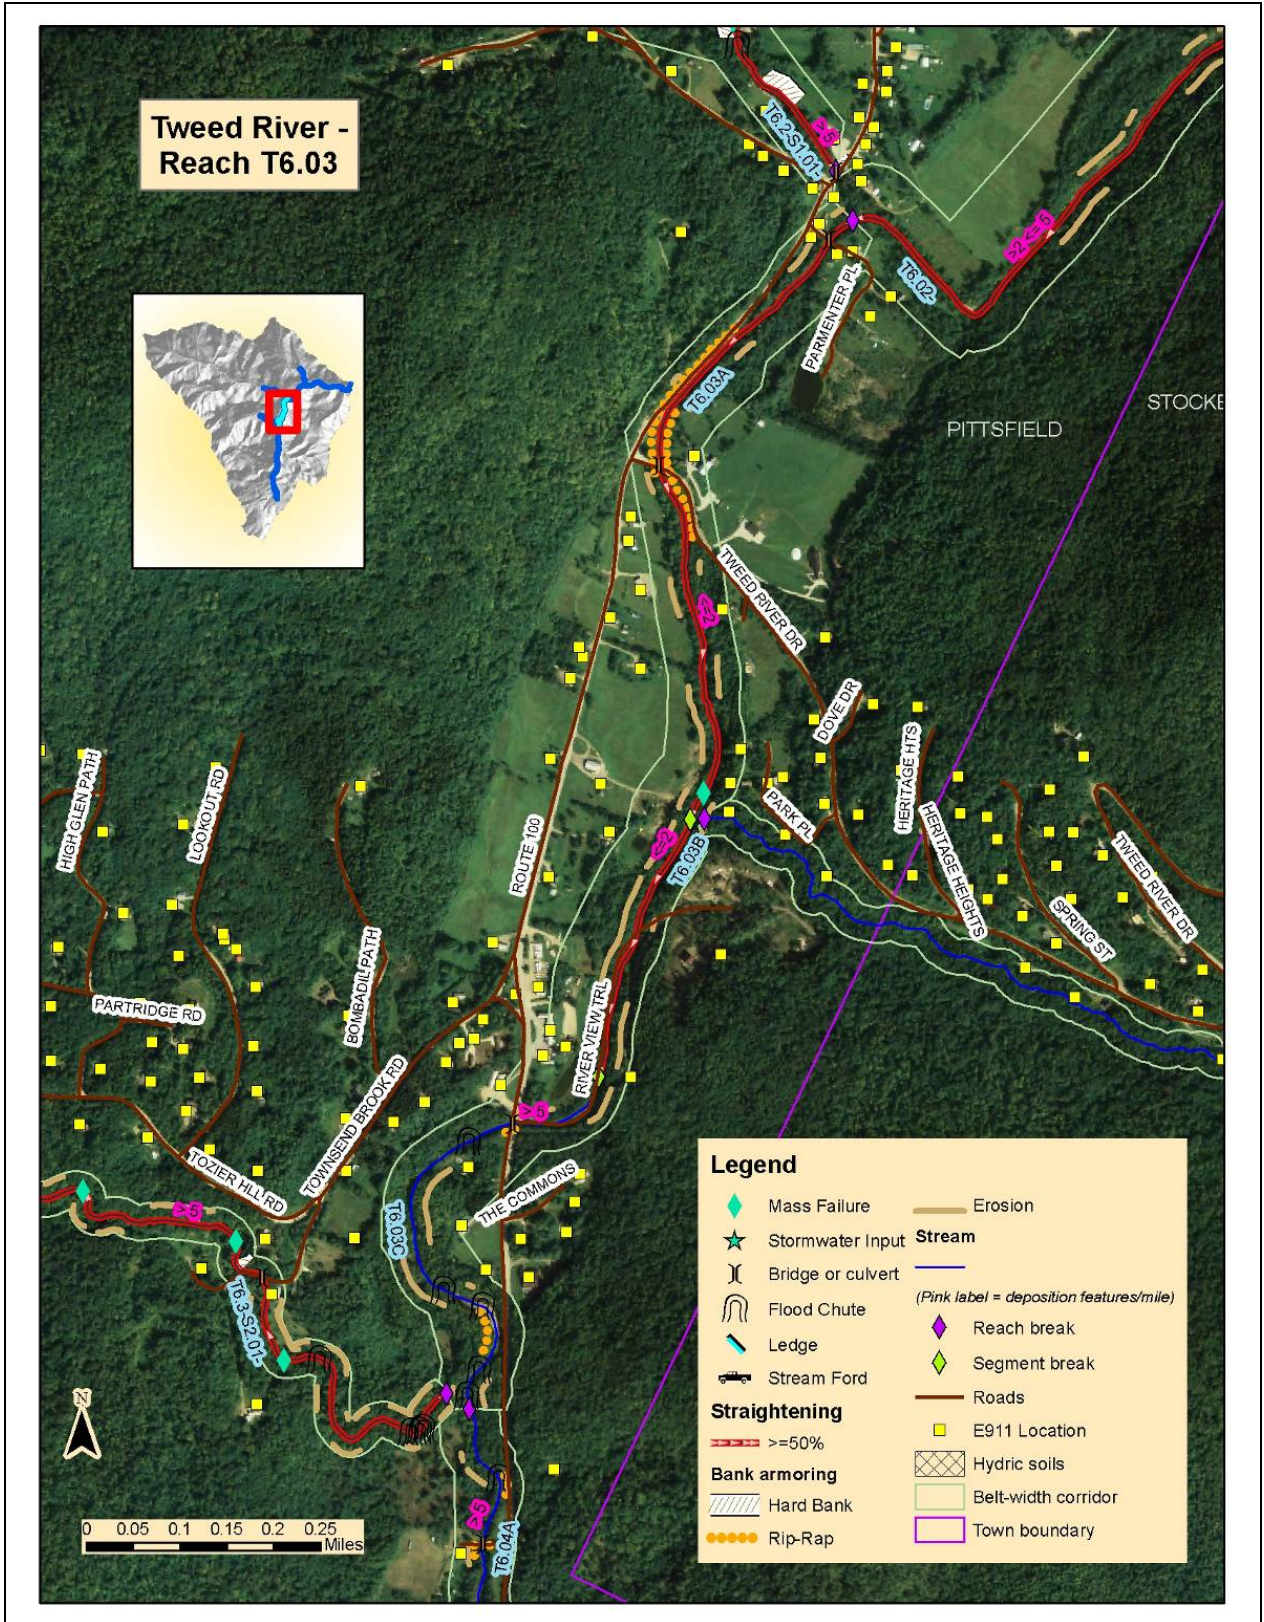
Figure 21. Tweed River reach T6.03 (NAIP 2006 background imagery).

Reach T6.03 covers roughly 8350 ft (1.6 mi) of the mainstem Tweed between the West Branch confluence in Pittsfield village and the confluence of Townsend Brook (Fig. 21). This is the first reach upstream of the historic extent of the Lumber Railroad, and it was broken into three segments during Phase 2 based on differences in flow status, slope, and planform. The two downstream segments are extensively straightened and encroachment is prevalent through all portions of the reach. Road and development encroachment is sufficient to change the valley confinement type from Very Broad to Broad in T6.03C, the furthest upstream segment, and effectively bottlenecks the river between the base of Tweed River Drive and the left bank valley wall in segment T6.03A (Fig. 21). Historical maps (Fig. 3) indicate that the Tweed River Drive encroachment is a long-standing confinement that forces the river across the valley to the opposite wall but it appears likely that the road approach to Route 100 has been relocated farther south, further restricting potential access of the river to former floodplain. Development in the floodplain in the area of Parmenter Place just downstream of this area has increased but appears on historical maps dating to 1917 as well (Fig. 3) and would likely be at risk if the river were to access this floodplain (Fig. 21).

The three segments appeared to be evidencing different stages of channel evolution, with downstream segment T6.03A still in between the downcutting processes that dominate Stage II and the subsequent widening and aggradation processes that evolve during stage III. The upstream segments were further along in stage III, with sediment slugs contributing to heavier current aggradation in T6.03C. Multiple flood chutes below the confluence of Townsend Brook in segment T6.03C and multiple mass failures on Townsend Brook indicate that tributary rejuvenation is contributing significant amounts of sediment in this section of the river that are being moved downstream in high flows (Fig. 21). All three segments were noted as highly entrenched F-type streams in the Phase 2 assessment, a stream type departure from the expected reference C-type channels, and high incision ratios of 2.0 in T6.03A, 2.9 in T6.03B, and 2.7 in T6.03C were noted. The combination of deep incision, overwidened channels, extensive erosion along both banks, and the presence of a long portion of windrowed stone along the banks in segment T6.03A indicate that historical dredging practices may have been prevalent in this portion of the mainstem (dredging has been noted historically in many portions of the Project area, with exact locations undocumented; pers. comm., Frederick Nicholson, VT ANR-RMP Stream Alteration Engineer, November 2007). The combination of these factors indicates that this area may play an important role as an attenuation asset, and it is likely that under current conditions this portion of the watershed marks an area where passive or active project implementation might be reasonably expected to achieve relatively rapid results in comparison with downstream sections where results are likely to be more dependent on previous remediation of upstream impacts before channel evolution processes begin to move toward equilibrium conditions. Opportunities are significantly constrained by existing development, however, and will require careful review for implementation options; midportions of the reach will likely offer the best opportunities.

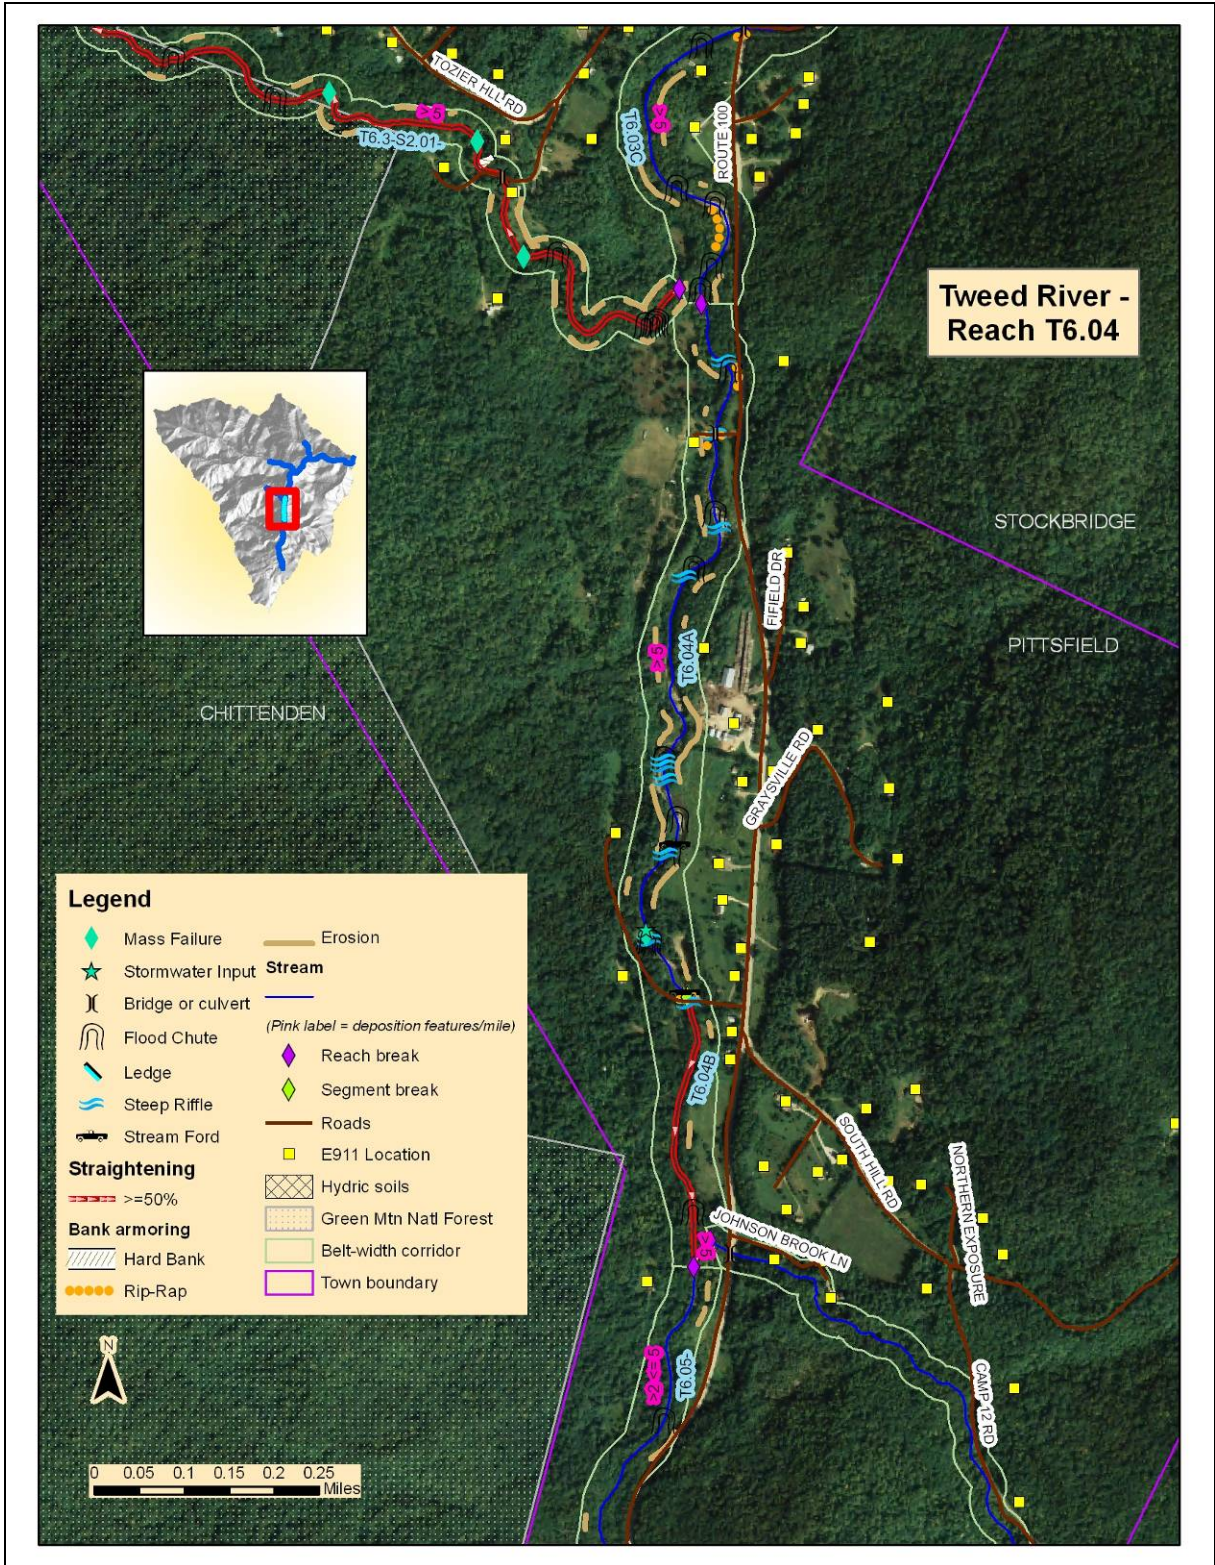
Figure 23. Tweed River reach T6.04 (NAIP 2006 background imagery).

Tweed mainstem reach T6.04 extends roughly 6156 ft (1.17 mi) from the Townsend Brook confluence to just upstream of the Johnson Brook confluence (Fig. 23). The reach was divided into two segments during Phase 2 assessment, with downstream segment T6.04A indicated in stage III channel evolution evidenced by widening, aggradation, and planform change following historic incision. Upstream segment T6.04B was assessed to be in stage II, with fewer indications of channel evolution processes evident. Both segments were noted as B-type streams, a departure from the reference C stream type for both segments.

Segment T6.04A comprises roughly 4500 ft (0.85 mi) in the downstream portion of the reach, extending to just below the bridge at Stonewood Crossing (across the Tweed from

the base of South Hill Rd.; Fig. 23). The segment is characterized by a patchwork of former small fields and pasture, now largely converted to commercial (dominated by Colton Enterprises firewood processing and kiln drying operations) and residential areas with lawns and clearings intermixed with wooded lands along the narrowing upper reaches of the Tweed valley. Historical maps dating to 1893 (<http://docs.unh.edu/VT/rutl93ne.jpg>) indicate that the river has been maintained in a straightened condition alongside Rte. 100 for more than 100 years, and a B- to C-type stream departure resulting from historic incision points out that the stream is now moderately entrenched. Dominant buffer widths on the right bank ranged from 26–50 ft, with a subdominant buffer width of <25 ft in some of the residential and field areas, and extensive erosion noted on both banks was prominent in areas lacking buffers. Encroachment levels of a moderate 5–20% of the segment were noted on each of the banks, but these encroachments are placed and spaced in a manner that makes project implementation challenging. Significant deposition in the segment was marked by numerous very steep riffles (nine steep riffles and eight flood chutes were documented in the segment) and two stream fords contribute to decreases in stream power that augment the depositional processes occurring in the segment. The bridge at Baker’s Road (near the southwest corner of the Stockbridge town boundary; Fig. 23) was noted as both a floodprone and channel constriction, with deposition above and scour below the structure; the effective width for sediment transport is reduced (from a structure width of 32 ft) to 25 ft (roughly 50% of the channel width) by the angle of alignment with the stream. With significant hydrologic changes from stormwater inputs and substantial amounts of ledge and bedrock grade controls further upstream, this segment appears to have the potential to play a vital role as an attenuation asset relatively high in the watershed but is currently limited for such possibilities by corridor encroachments.

Segment T6.04B continues upstream from Stonewood Crossing (across from the base of South Hill Rd.; Fig 23), covering roughly 1600 ft (0.30 mi) to the reach break just above the Johnson Brook confluence. Similar to the downstream portion of this reach, this segment appears to have been maintained in a highly straightened condition for more than 100 years and now evidences significant loss of floodplain access reflected in a B- to C-type stream departure. Unlike the downstream segment, however, this portion of the stream shows less channel evolution in terms of planform adjustment in particular, with very little meander development evident. The segment was thus characterized as being in Stage II channel evolution, and a plane bed form despite significant boulder and cobble stream-bed components both reflects and contributes to the impacts of elevated stream power in this segment, further contributing to the transfer of hydrologic and sediment transport impacts to downstream portions of the watershed. Due to relatively low levels of encroachment, this segment appears to have potential as an attenuation asset, but the stream is moderately entrenched and the valley is narrowed by the presence of Rte. 100 and development just upstream of Stonewood Crossing in particular. Although the segment may have potential for an active restoration project, such a project is not currently recommended due to the high cost of implementation, increase of flood hazard risk downstream, and a relatively low yield of accessible floodplain.

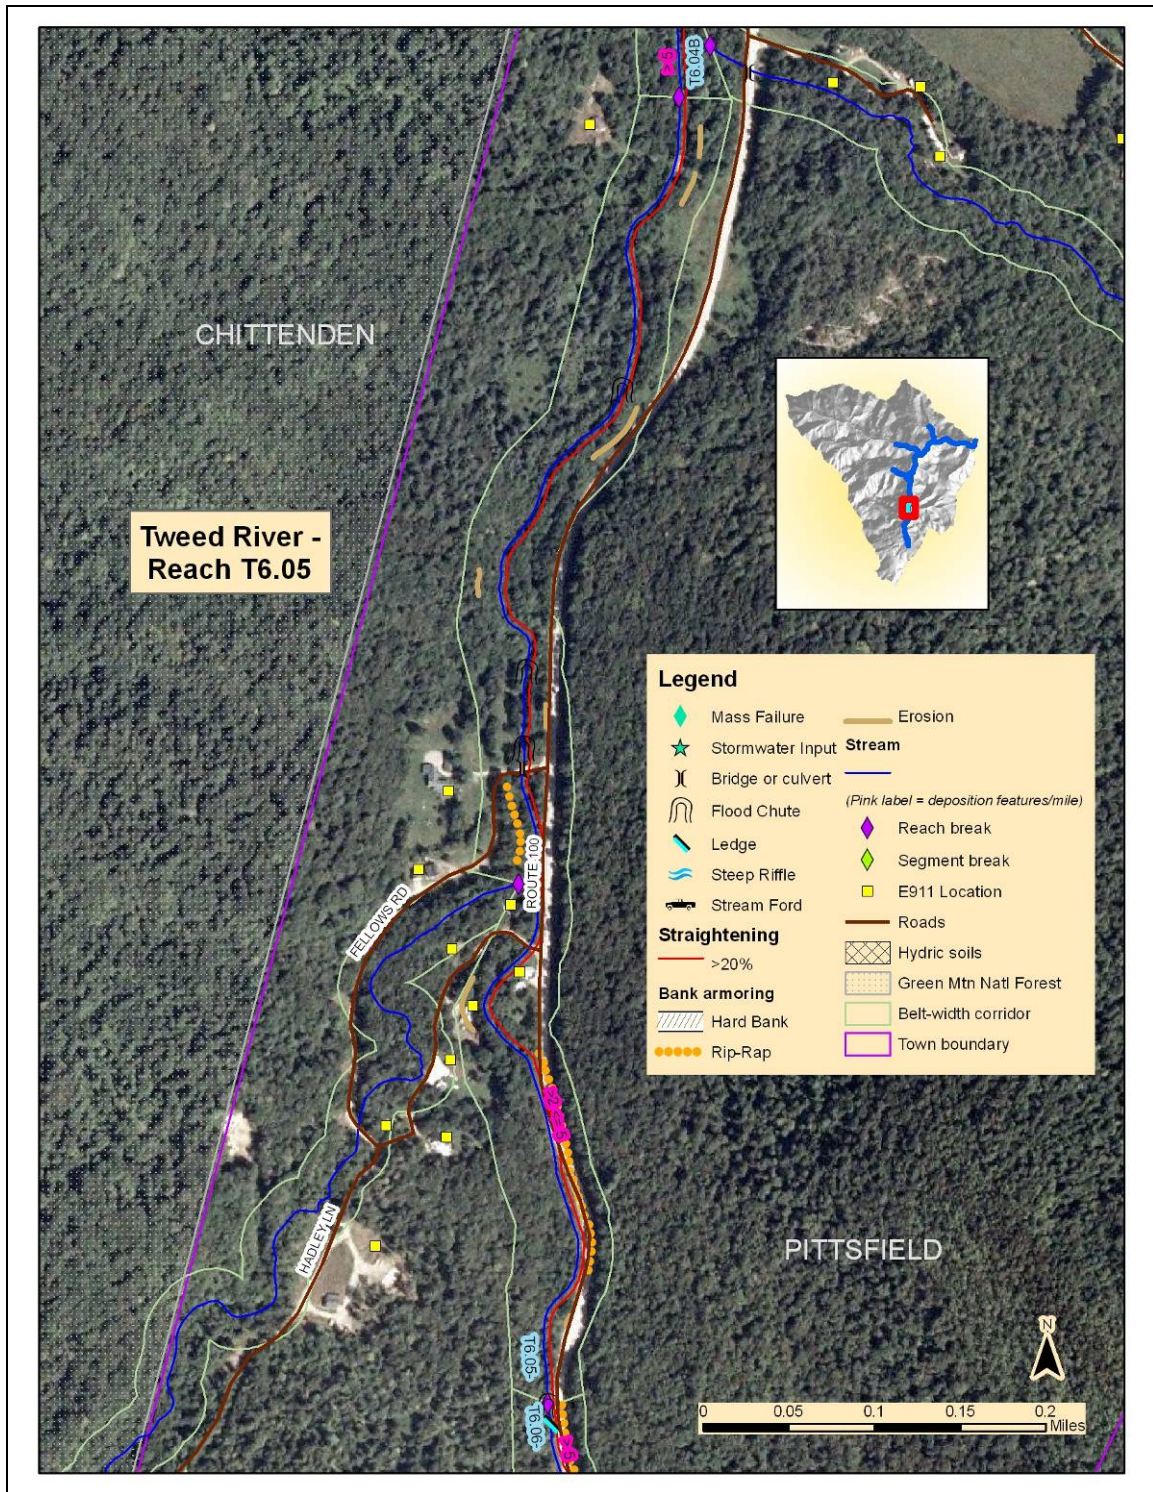
Figure 24. Tweed River reach T6.05 (NAIP 2003 background imagery).

Reach T6.05 includes 4425 ft (0.84 mi) of the Tweed mainstem upstream of the Johnson Brook confluence (Fig. 24) and marks a significant transition in valley confinement, passing from the Broad valley type of reach T6.04 to a Narrow confinement type. Rte. 100 runs right along the stream for much of the reach, and this encroachment narrows the valley sufficiently to change the Broad valley confinement type that the reach would have under reference conditions. As in reach T6.04, historical maps indicate that the stream has been maintained in this straightened condition by the presence of the road for more than 100 years, and roughly 20% of the right bank is riprapped. Unlike reach T6.04, however, the narrow stream in this reach retains sufficient access to floodplain to be classed as a C-type stream due to a lower degree of entrenchment (a higher entrenchment ratio, i.e., floodprone width/bankfull width, of 3.4 in contrast to 2.0 in segment T6.04A and 1.8 in T6.04B). In addition, the downstream portion of the reach is farther from the road, and some meander development or retention is evident; the reach was characterized as straightened in just under half (49.9%) of its extent, in contrast with the 15 of 19 stream segments assessed in Phase 2 that were characterized as >50% straightened. Encroachment was noted in >20% of the reach, largely due to the presence of Rte. 100, since levels of development along the river were lower than in many other portions of the

mainstem. Dominant buffers in reach T6.05 were <25 ft on the right bank, and a subdominant class of <25-ft buffers was noted on the left bank as well.

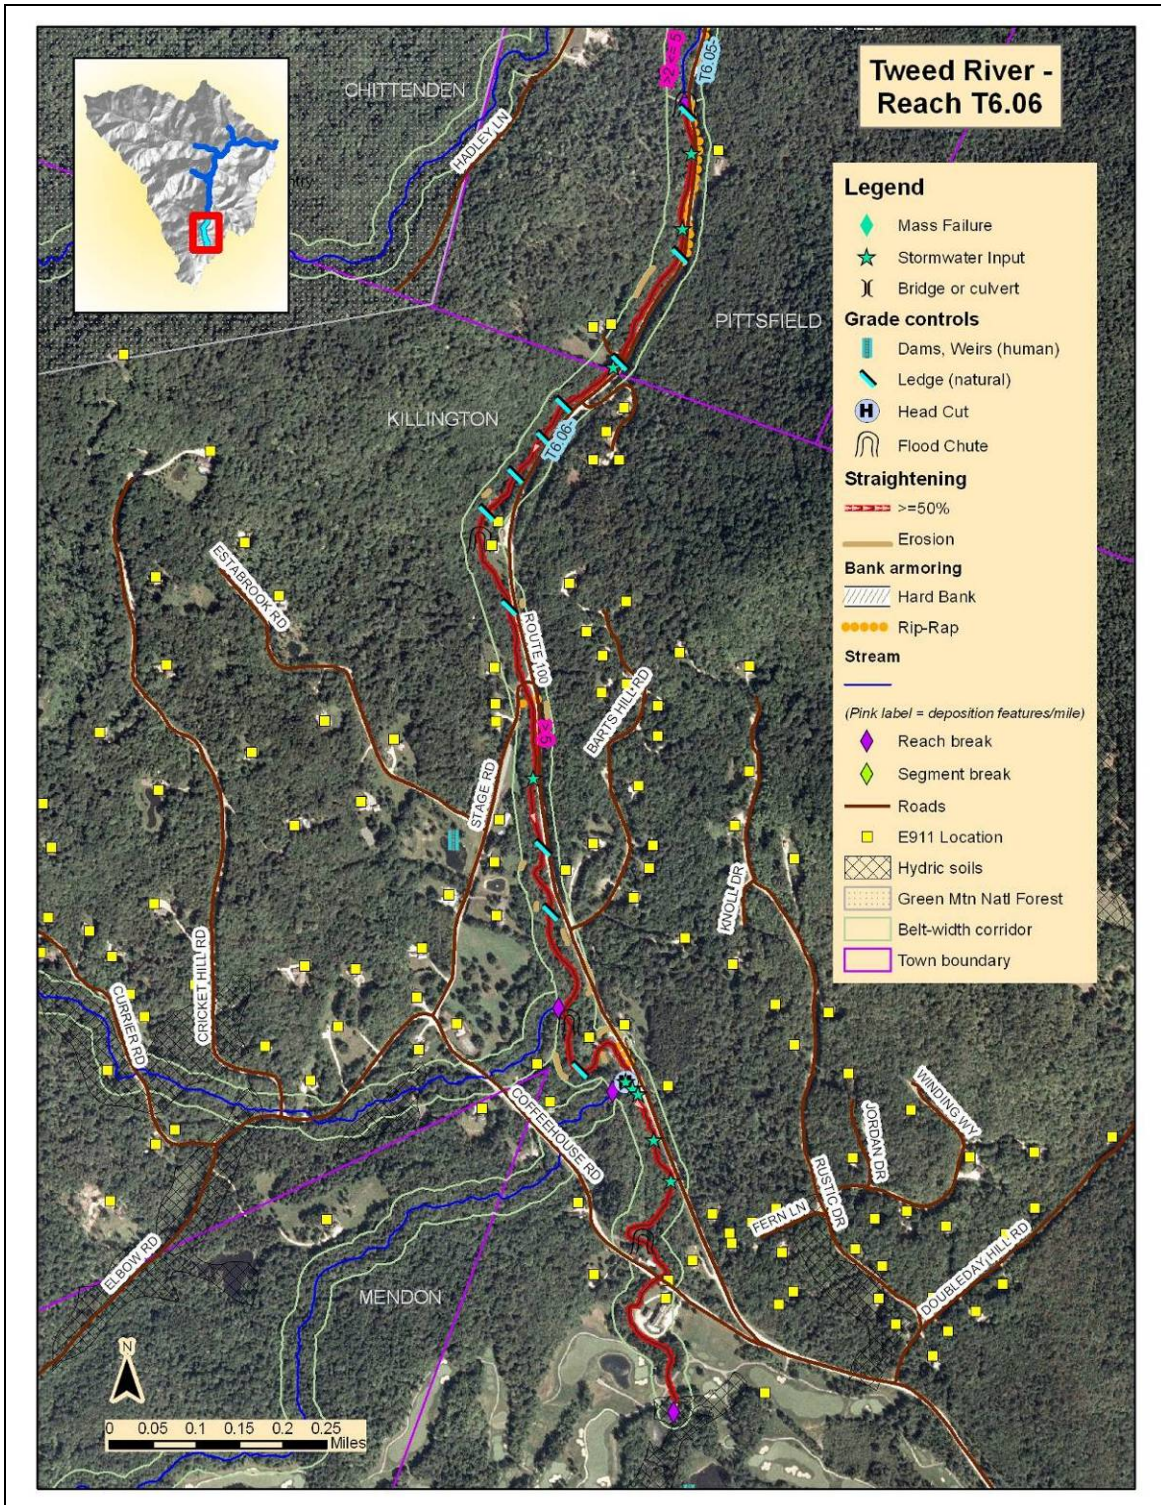
Figure 25. Tweed River reach T6.06 (NAIP 2003 background imagery).

Reach T6.06 was the most upstream reach of the Tweed mainstem assessed in Phase 2 and covers roughly 9875 ft (1.87 mi), ending at a small pond in the Green Mountain National Golf Course (Fig. 25). The reach was characterized by extensive development in the riparian corridor, straightening along Rte. 100 for most of the reach, and exposed bedrock with 12 ledge grade controls documented in the reach. This reach was further characterized as a B-type step-pool system dominated by cobble substrates under both reference and current conditions, but Phase 2 assessment noted that many of the pools were filling with sediments of various sizes. “Urban” land use accounted for >40% of the corridor land use, and encroachment was noted along >20% of the reach. Buffers reflected this level of development, with the right bank buffer having dominant and subdominant widths of <25 ft and 26–50 ft, respectively, and the left bank buffer having dominant and subdominant widths of 26–50 ft and <25 ft, respectively. With bedrock so prominent in the reach, banks are likely to be more erodible than the bed, and channel avulsions are an increased risk in flood conditions. Vegetated buffers can help mitigate these impacts and attenuate the impacts of increased stream power on downstream reaches in high flows. Directing stormwater outlets to well vegetated surfaces, reduction of direct inputs to the stream where possible, maintenance of vegetated buffers (shrubs can sometimes be established in surprisingly difficult conditions), and similar efforts would also help. The Better Backroads (<http://www.vt.nrcs.usda.gov/rc&d/bbcoverpage.html>) program has assisted communities in developing design and implementation guidelines for such efforts.
