# **TWEED RIVER WATERSHED CORRIDOR PLAN**

## **WHITE RIVER PARTNERSHIP**

April 18, 2008

Prepared by:  
Daniel Ruddell, Elisabeth McLane, Anna Mulligan,  
Staff Scientists, and  
Ben Machin, Principal  
Redstart Consulting

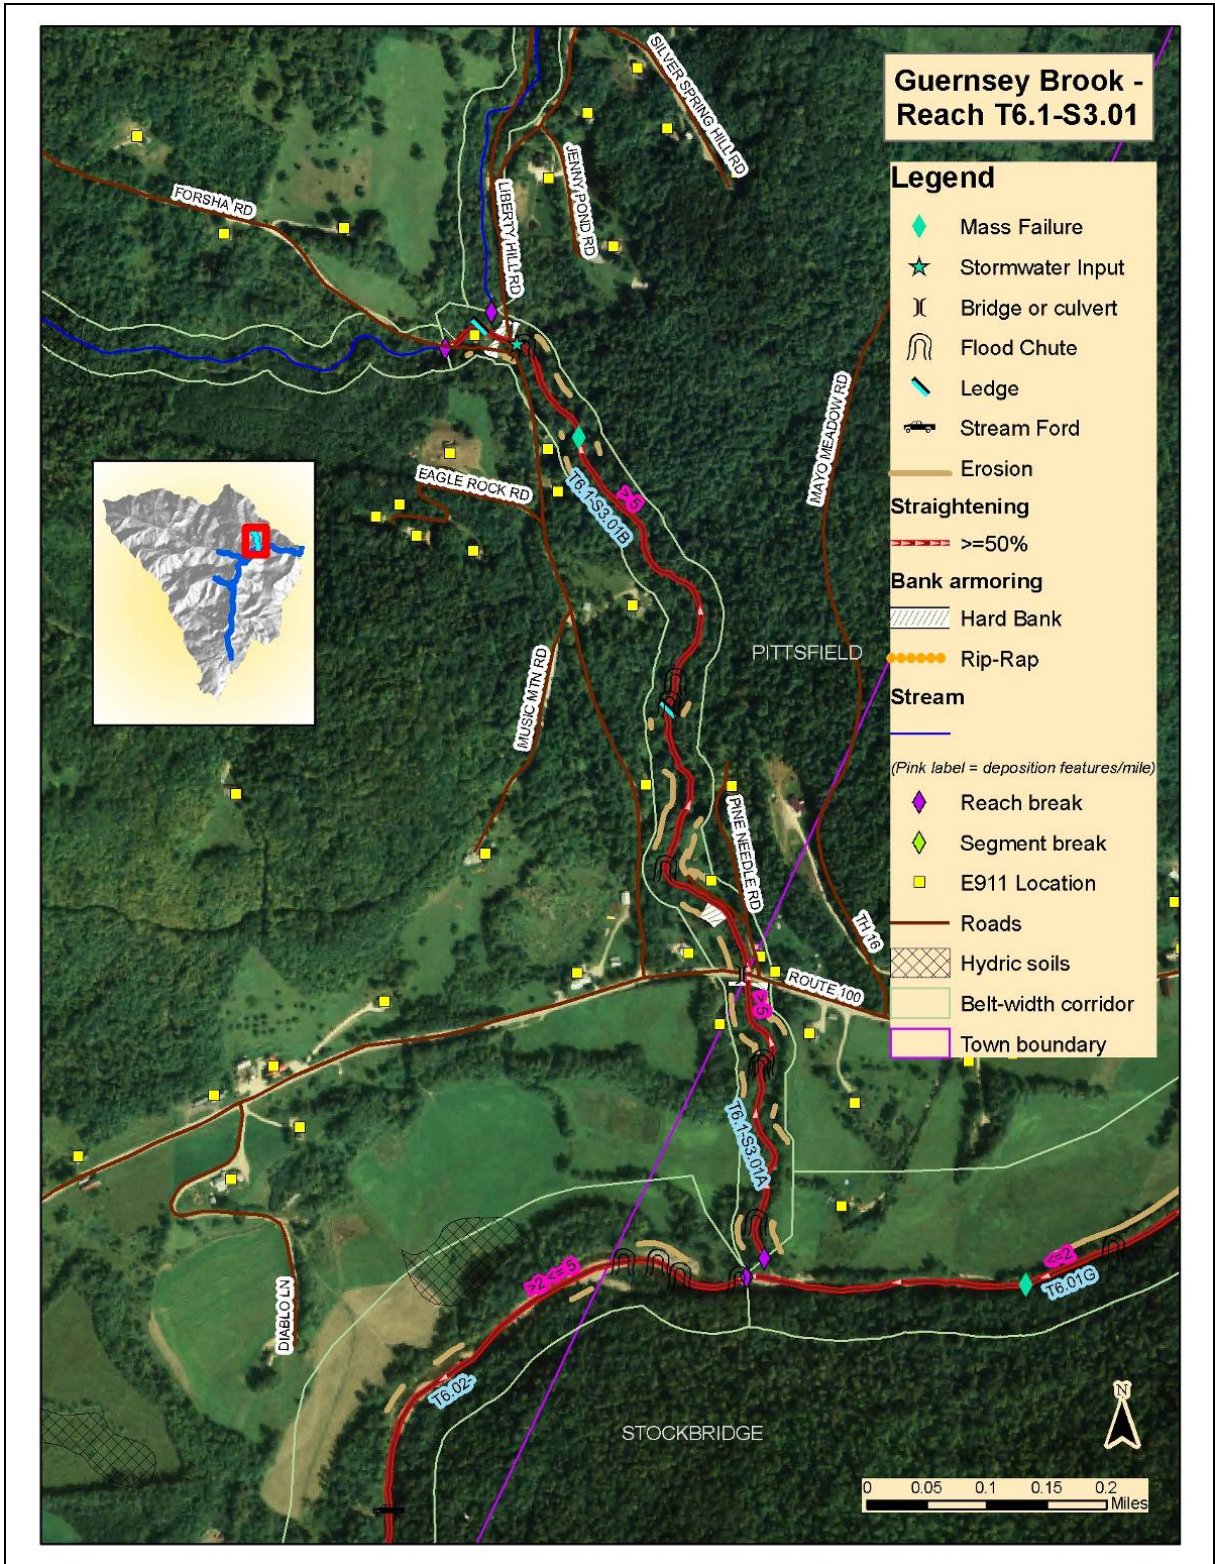
Figure 26. Guernsey Brook reach T6.1-S3.01 (NAIP 2006 background imagery).

Reach T6.01-S3.01 is the most downstream reach of Guernsey Brook, extending roughly 5090 ft (0.96 mi) from its confluence with the mainstem Tweed near the Stockbridge/Pittsfield town line to just upstream of the confluence with an unnamed tributary above the intersection of Forsha Rd. and Liberty Hill Rd. (Fig. 26). The reach was divided into two segments during Phase 2 assessment due to differences in valley width, planform, and slope. Although both segments were characterized as B-type streams, downstream segment T6.1-S3.01A was characterized with a Very Broad confinement type in the valley downstream of Rte. 100, while upstream segment T6.1-

Segment T6.1-S3.01A consists of roughly 1380 ft (0.26 mi) of Guernsey Brook downstream of Rte. 100 (Fig. 26). Historical maps from 1893 (Fig. 3) indicate that the stream may have meandered farther to the west toward the town line, and it appears likely that this portion of the Brook has been straightened through the valuable agricultural lands along the Tweed mainstem riparian corridor. Because Phase 1 assessment included this segment with the upstream portions of the reach, the overall reach was assessed as a B-type stream under reference conditions. The Very Broad valley confinement in this portion of the reach suggests that this portion of the stream may be a C-type stream that has departed from its reference conditions and is now moderately entrenched due to historic incision, although this assessment was not established during Phase 2 fieldwork. Encroachment levels of <5% along this portion of the stream indicate that development conflicts are relatively low, and dominant buffers exceeding 100 ft in width on both banks appear to be critical to the stability of the very highly erodible soils in this area. Dominant vegetation in the buffer on both sides of the stream was herbaceous, however, with subdominant deciduous tree buffers, and the actual bank canopy on both banks was noted as <25%. The left bank had a subdominant buffer width of 26–50 ft noted in the Phase 2 assessment. Erosion was noted along >20% of the banks on both sides of the stream, indicative of channel evolution stage III widening and lateral migration noted in the segment, which reinforces the need for the vegetated buffers to reduce impacts of erosion. This erosion and several flood chutes noted in the Phase 2 assessment indicate attempts of the stream to reestablish meander patterns (planform change) and diffuse stream power through access to a broader floodplain. Maintenance and augmentation of the existing buffers can help these processes to proceed while simultaneously reducing the loss of soils and nutrients in this area, allowing this stream segment to play a vital role in attenuating sediment and hydrologic inputs to the mainstem. In such a scenario, finer sediments are retained and deposited in the floodplain (contributing to fertility) along this segment, while coarser sediments are allowed to proceed further downstream as part of the bed load that will be important in reestablishing equilibrium conditions along the Tweed mainstem. Limiting further development along the base of Guernsey Brook also plays a critical role in allowing this area to fulfill its extremely valuable role in watershed dynamics.

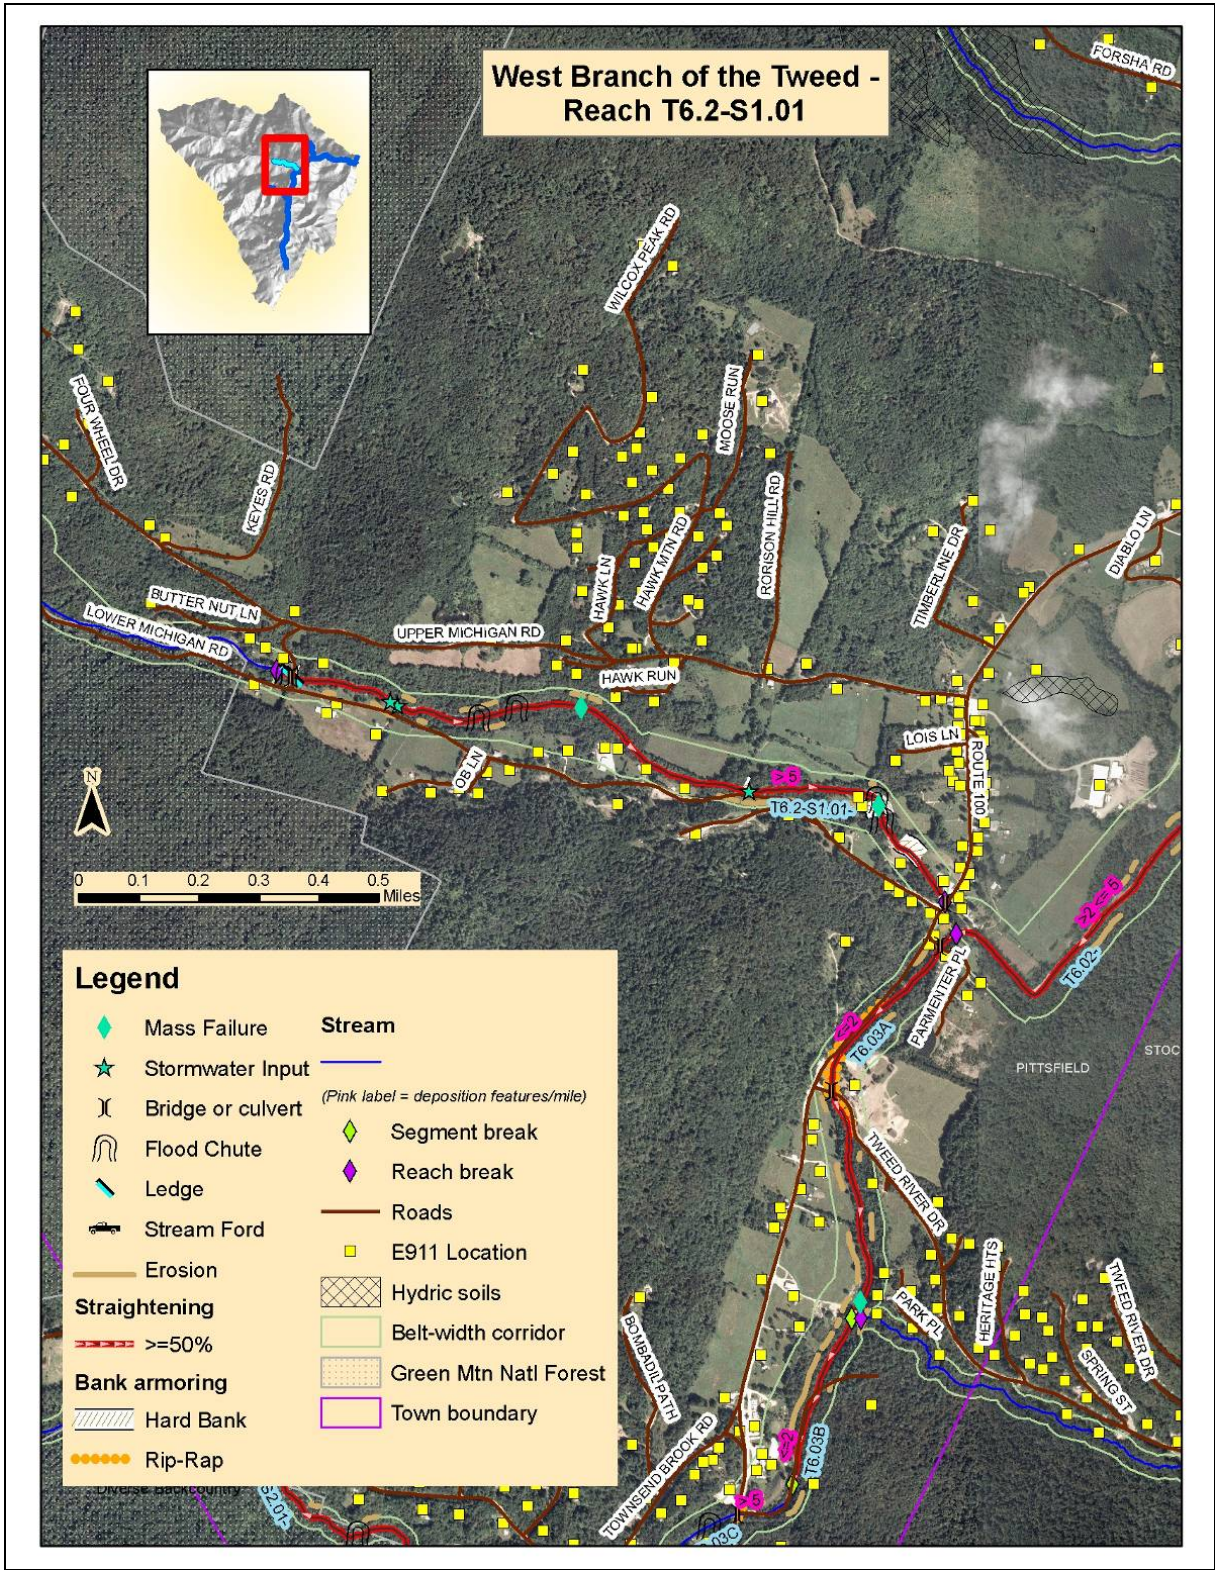
Figure 27. West Branch of the Tweed reach T6.2-S1.01 (NAIP 2003 background imagery).

Reach T6.2-S1.01 is the most downstream reach of the West Branch of the Tweed and covers roughly 6790 ft (1.29 mi), extending from the confluence with the Tweed mainstem in Pittsfield to just upstream of Crossover Rd., which connects Upper and Lower Michigan Roads (Fig. 27). The reach was not segmented during Phase 2 assessment. Similar to the downstream reaches of the Tweed mainstem, this lowest reach of the West Branch was locked into place by the presence of the Lumber Railroad along the left bank, which had its terminus just above the upstream reach break of T6.2-S1.01 (Fig. 3), in conjunction with Lower Michigan Rd. on the opposite bank. The double right-angle bend of the Tweed mainstem just downstream of the confluence with this reach accommodated a freight yard at the end of a rail spur in Pittsfield village, and the West Branch was bermed and snagged to increase the depth and power of the stream in order to move lumber down to this yard from the Michigan and Bayonne Lumber Camps located further up the West Branch (Fig. 3). The 1927 flood caused enough damage to railroad beds to contribute to the eventual closing of all rail lines that were formerly located along the White and its tributaries above Bethel, and the Lumber Railroad was not rebuilt after that time (Johnson 1928). Phase 2 assessment in 2006 indicated berms along only 4% of the reach, but the legacy of berming is still incorporated into the elevated road beds on either side of the mainstem and windrowed stone is evident along midstream portions of the right bank below the Lower Michigan Rd. in particular. The stream in this reach was noted as an entrenched (entrenchment ratio 1.17, incision ratio 2.30) and overwidened F-type channel with plane bed features. With significant development along the reach in addition to the berms and roads, encroachment levels exceed 20% of the reach, and

The extensive straightening of Reach T6.2-S1.01 permitted Pittsfield village to occupy an alluvial fan that forms the floodplain between the West Branch and the Tweed mainstem (Fig. 3; Fig 27). This extensive development makes it unlikely that channelization of this reach will be significantly reduced, and dramatically increases the potential value of planting full-width buffers on the left bank of midportions of the reach above the village for flood hazard mitigation in particular. Despite the extreme sensitivity, widening, and lateral migration documented in the reach, the value of these plantings for protection of the village in a high-water event would suggest that investment in higher-value planting stock, and the extra time and planting techniques that would establish the stock more quickly, would be well spent in the portions of such a buffer that are set back from the stream.

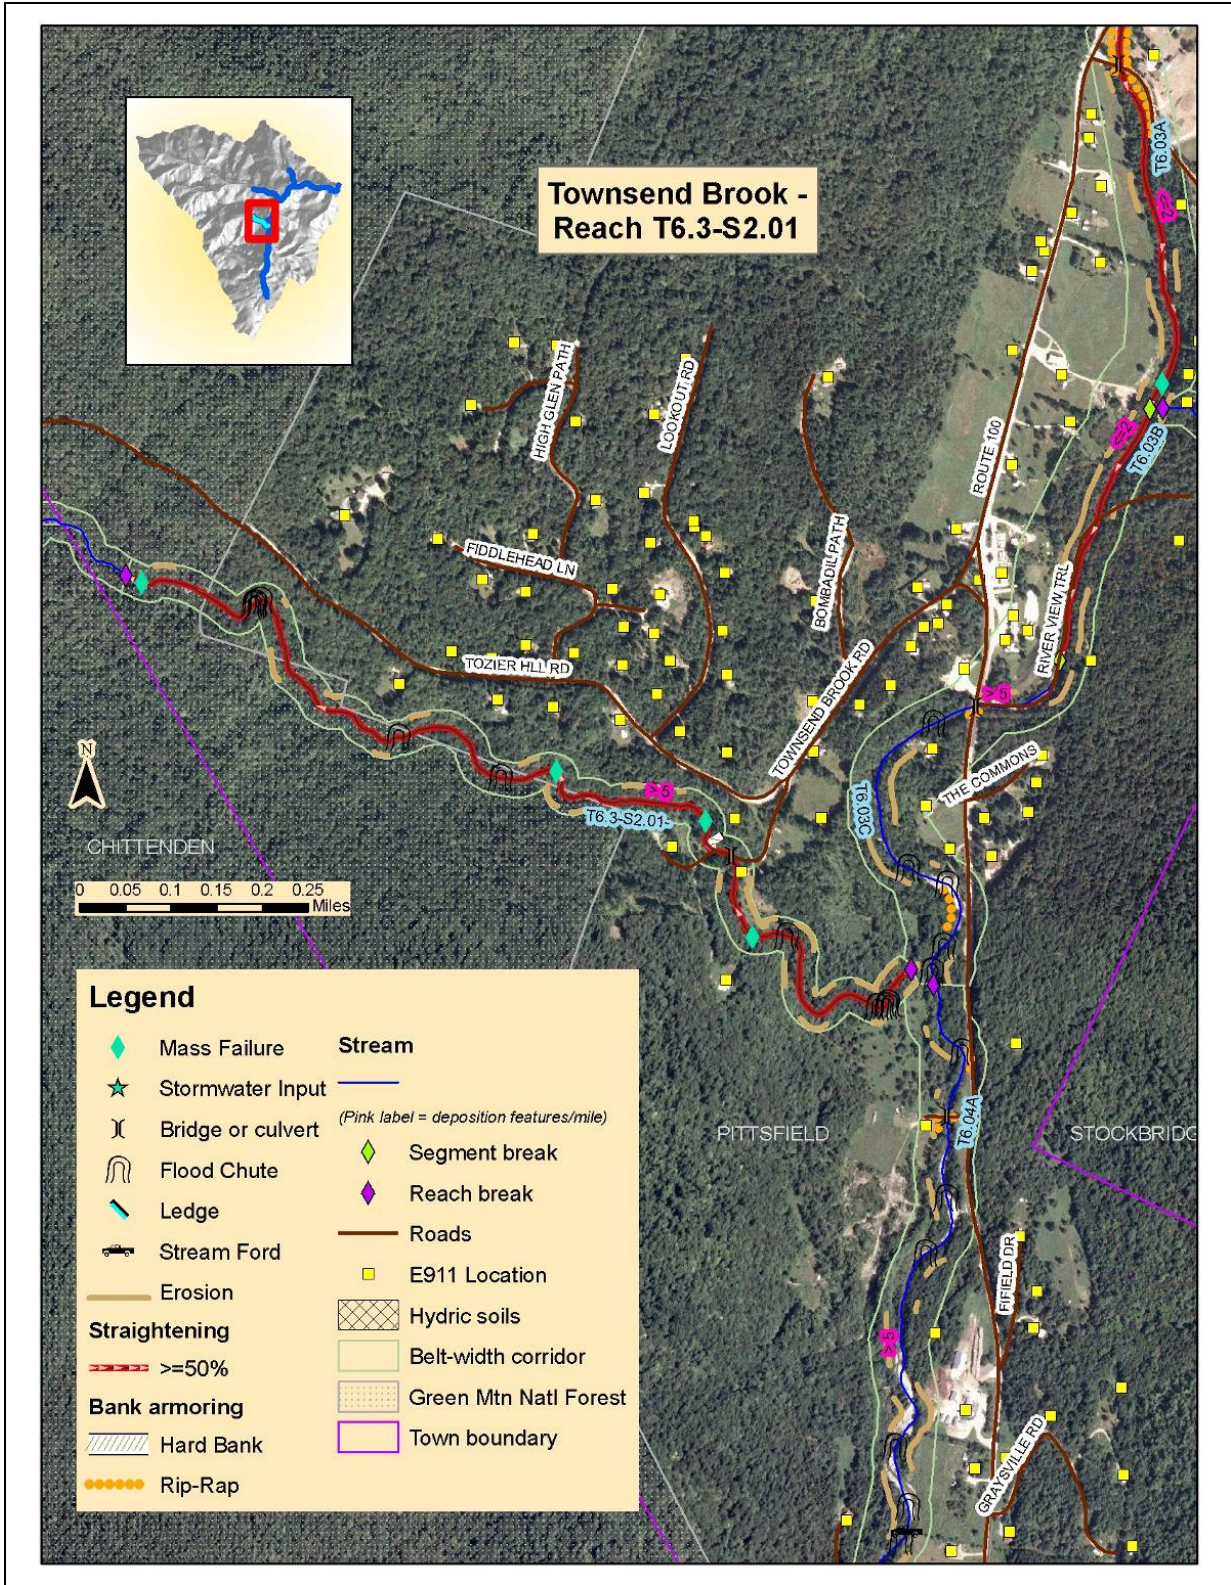
Figure 28. Townsend Brook reach T6.3-S2.01 (NAIP 2003 background imagery).

Reach T6.03-S2.01 comprises the most downstream reach of Townsend Brook and extends roughly 6580 ft (1.25 mi) from the confluence with the Tweed mainstem at the south end of Pittsfield village to where the valley becomes extremely narrow, roughly 200 ft as the crow flies, or 500 ft along the stream from the Pittsfield/Chittenden town line (Fig. 27). Reference conditions for the reach would indicate a B-type step-pool system with a cobble substrate, but Phase 2 fieldwork identified an entrenched (entrenchment ratio 1.16, incision ratio 2.28) F-type stream with gravel-dominated substrate and significant sedimentation of pools in the reach. The subwatershed is largely undeveloped off the right bank of the stream, with much of the land included within the boundaries of the Green Mountain National Forest, but the area off the left bank has been extensively developed. Tozier Hill Rd. parallels the stream along the upstream two-thirds of the reach, and encroachment was noted along >20% of the reach length. Although dominant buffers on the left bank exceed 100 ft, a patchwork of clearings associated with developed areas and four mass failures along the reach have limited dominant buffer widths on the right bank to 26–50 ft and subdominant buffer widths on the left bank to <25 ft; buffers of 51–100 ft were dominant on the right bank. The reach was assessed at stage III channel evolution with the four mass failures, numerous midchannel and island bars, seven flood chutes, and erosion along >20% of the left bank and 5–20% of the right bank all indicating the widening, lateral migration, and planform change associated with that stage of channel evolution.
