# Upper & Middle White River Watershed Corridor Plan

Barnard, Hancock, Pittsfield, Rochester, and  
Stockbridge, Vermont  
July 15, 2015

Prepared by:  
Bear Creek Environmental, LLC  
149 State Street, Suite 3  
Montpelier, Vermont 05602

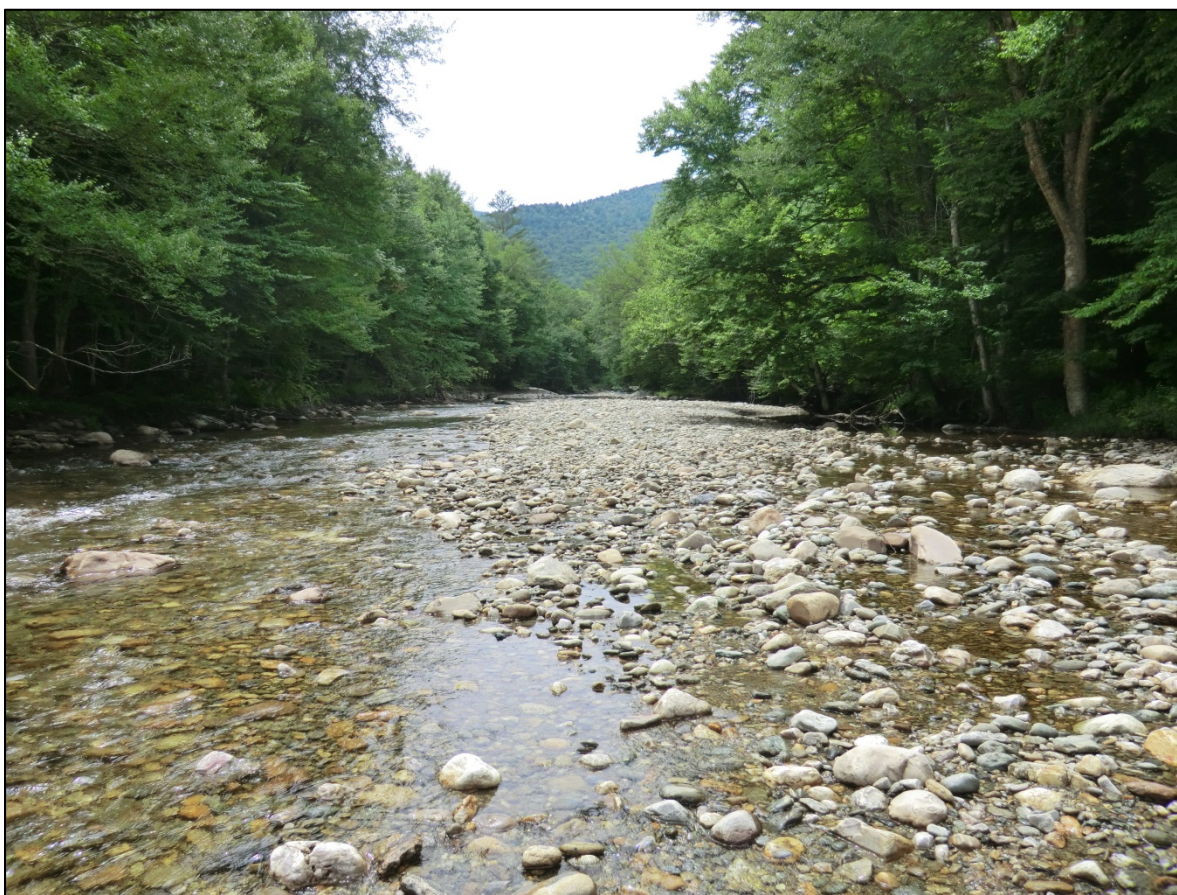
**Figure 5.57.** Typical channel in T7-02B.

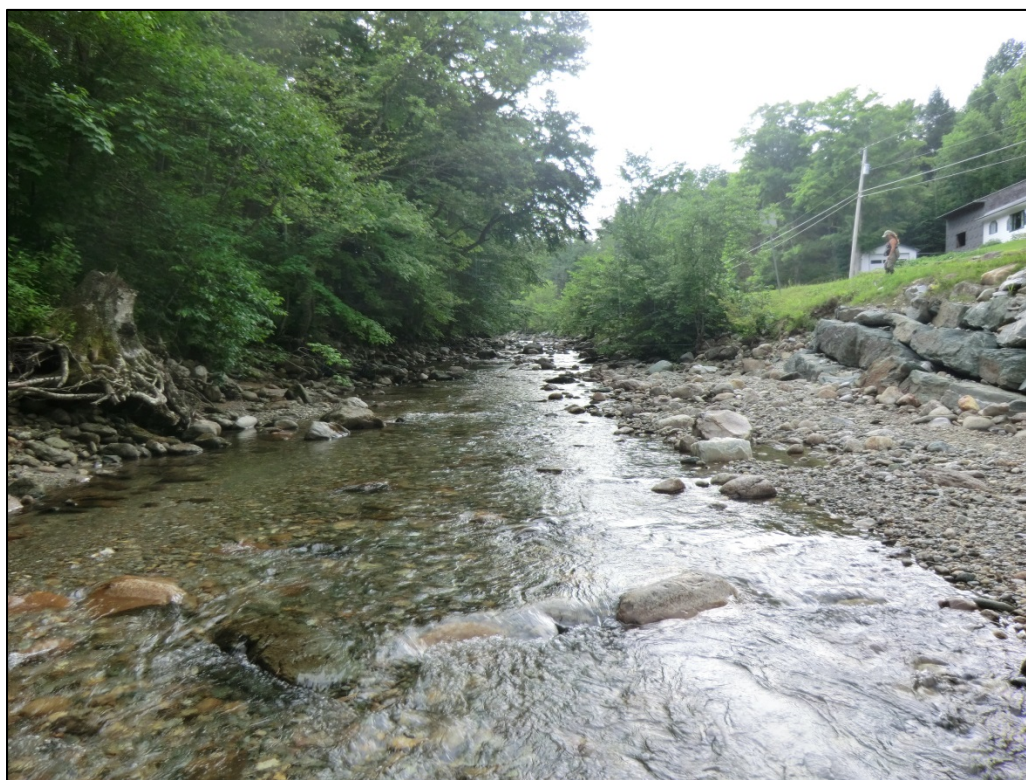
Figure 5.62. T8.01-B was historically straightened along Route 125.

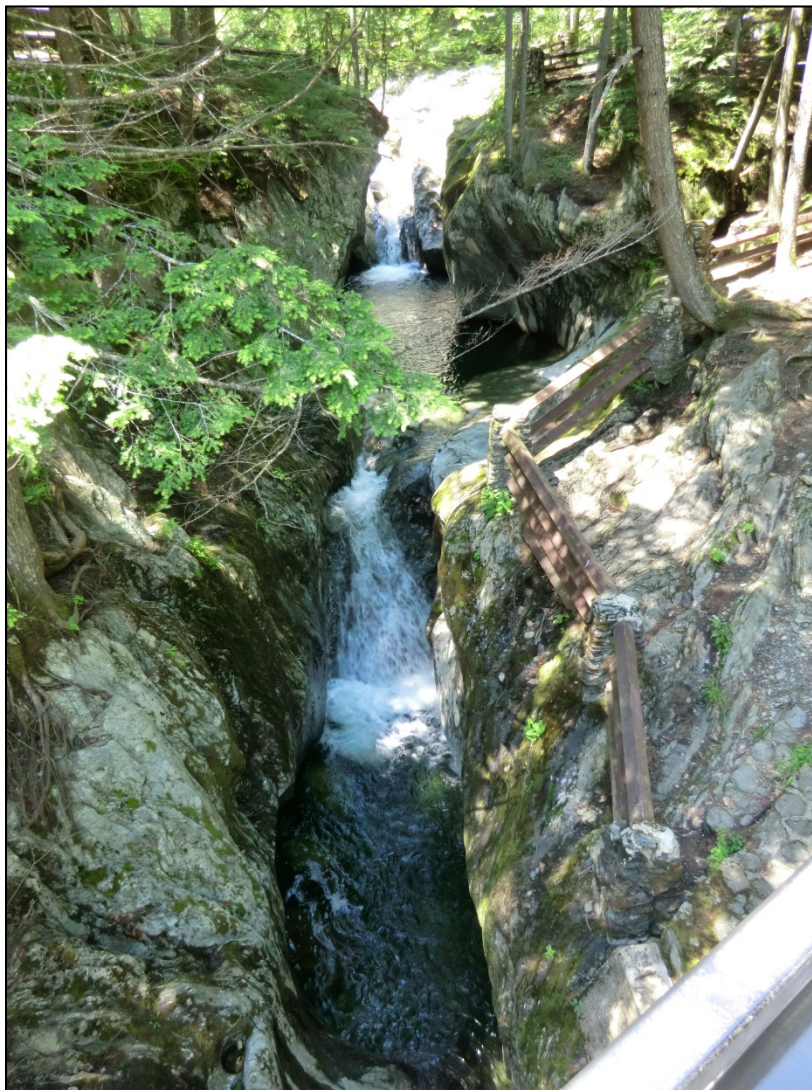
**Figure 5.69.** T8.03-B contains the renowned Texas Falls.
