# **Winhall River Watershed Corridor Plan**

**Winhall, Jamaica, & Londonderry, Vermont**  
**October 27, 2014**

Prepared by:  
Bear Creek Environmental, LLC  
149 State Street, Suite 3  
Montpelier, Vermont 05602

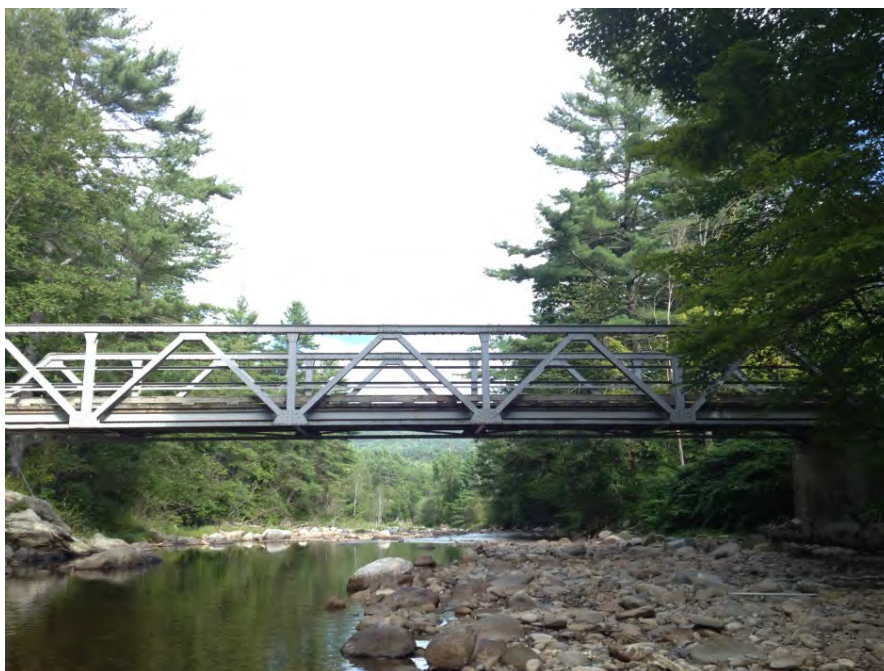
**Figure 5.2.** Stream crossing at the upstream end of T11.01.

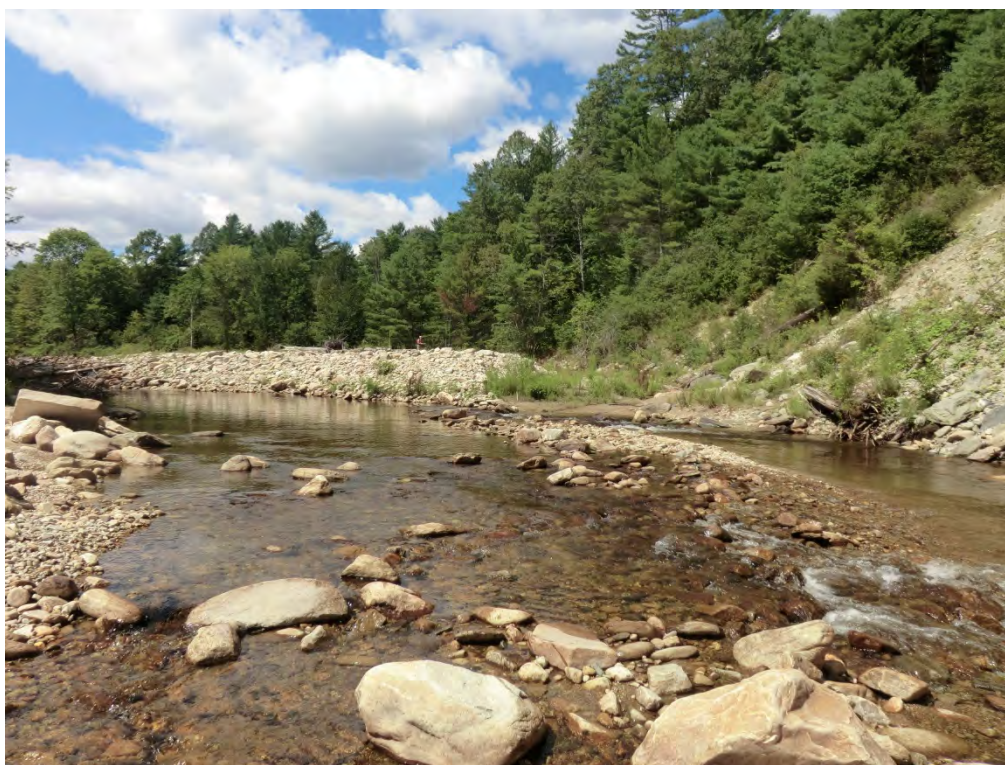
**Figure 5.9** The Winhall River is building a juvenile floodplain through large bars in T11.03-C.

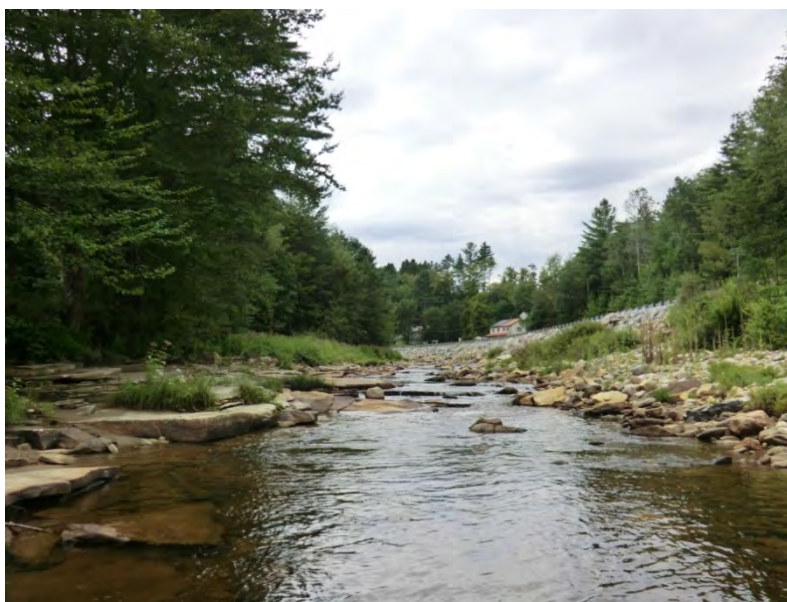
**Figure 5.11.** Bedrock is limiting further incision throughout T11.05-A.

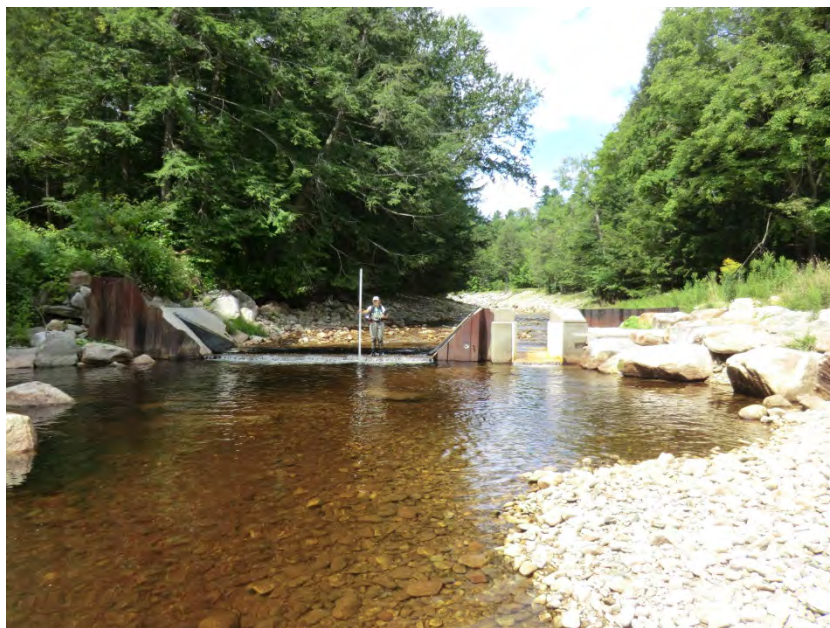
**Figure 5.15.** A weir in T11.07-A is impacting sediment transport throughout the segment.

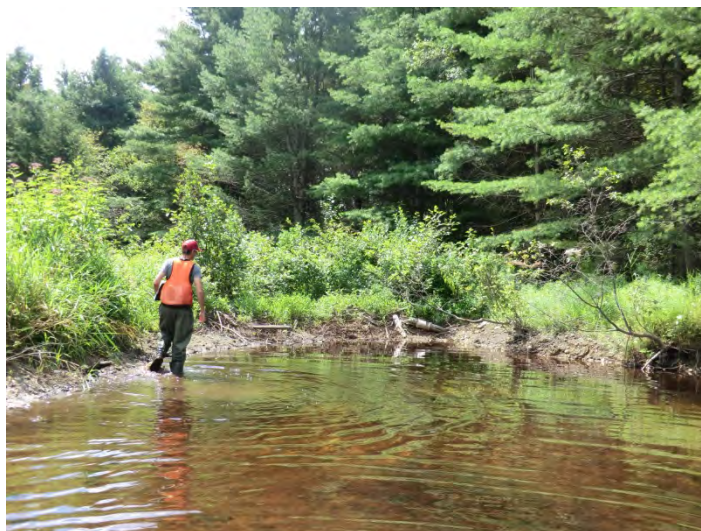
**Figure 5.19.** One of many beaver dams present in T11.S3.01-A.

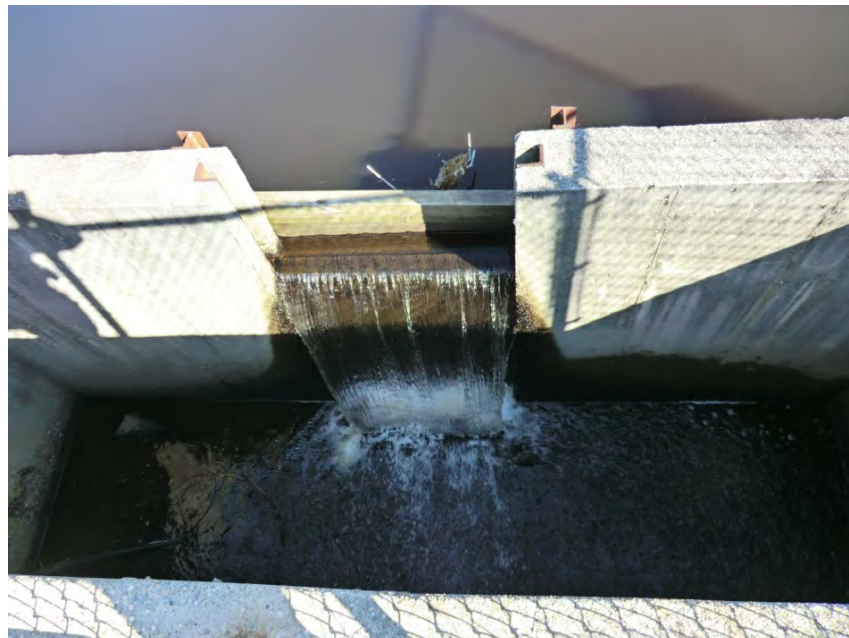
**Figure 5.22.** The dam at the pond outlet likely poses an AOP barrier.

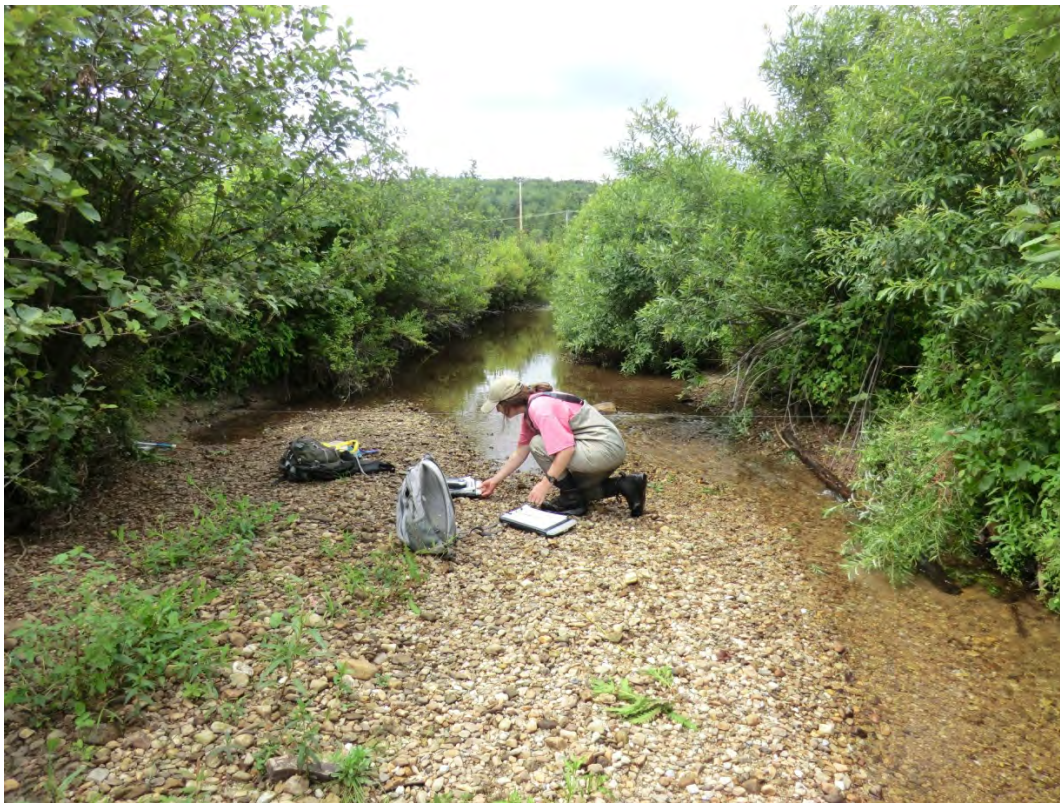
**Figure 5.26.** T11.S4.01-B is actively widening and aggrading.

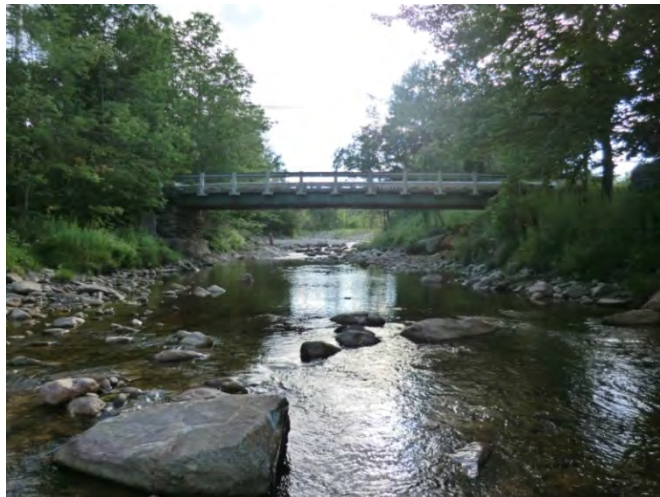
A bridge on Lower Taylor Hill Road in T11.06-A (Figure 5.31) has also been recommended for replacement at a low priority. This bridge was closed to traffic at the time of assessment and had scour around its footers, wingwalls, and abutments. It is a channel constriction because of riprap placed within the structure. The streambed has scoured through the structure.

**Figure 5.31.** Lower Taylor Hill Rd bridge was closed at the time of assessment.

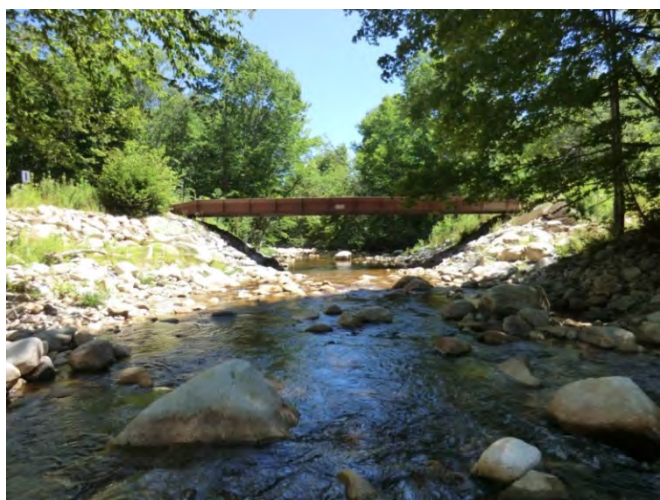
The final stream crossing structure recommended for replacement on the Winhall River is located in segment T11.08-B on Lightfoot Camp Road and is shown in Figure 5.32. This bridge is a channel constriction due to the placement of riprap within the structure. There is also a flood chute that enters the river immediately upstream of the structure, which could pose a risk to it during high flow events. It is recommended for replacement with a low priority.

**Figure 5.32.** Channel constriction on Lightfoot Camp Road

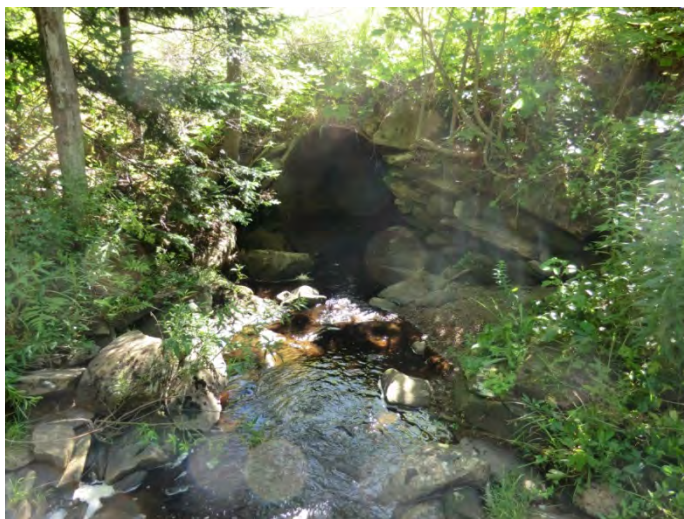
A culvert under Winhall Hollow Road in segment T11.S3.01-E has been recommended for replacement with a high priority. This structure is severely undersized and is not well aligned with the channel. The streambed has scoured below the structure and aggraded above it. Bank scour both above and below the culvert are present (Figure 5.36).

**Figure 5.36.** The culvert under Winhall Hollow Rd is not well aligned.

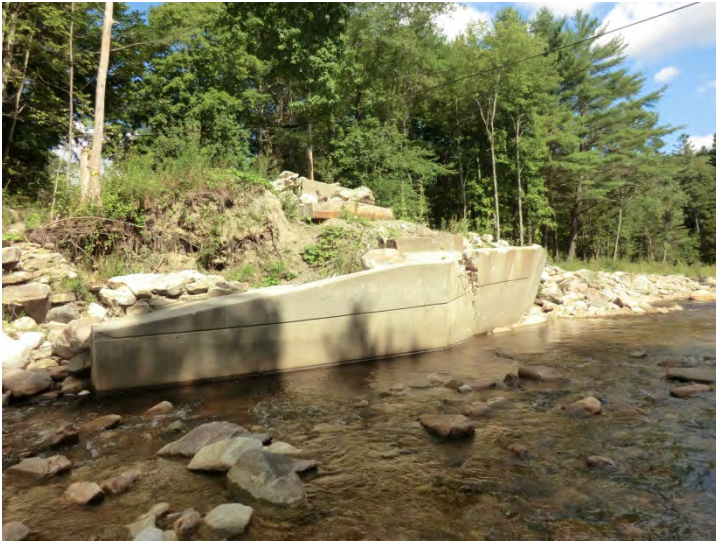
**Project #3 – Remove Old Bridge Abutments**

| <b>Project #<br/>Segment</b> | <b>Type of<br/>Project</b> | <b>Site Description Including<br/>Stressors and Constraints</b> | <b>Project or Strategy<br/>Description</b> | <b>Technical<br/>Feasibility and<br/>Priority</b> | <b>Benefits</b> | <b>Potential<br/>Partners/<br/>Programs</b> |
|---|---|---|---|---|---|---|
| Project #3<br>T11.03-A | Active<br>Restoration | A bridge on Goodaleville Road was destroyed during TSI. The bridge abutments remain in place and are creating a channel constriction in this location. | <b>Remove Old Bridge Abutments</b> | High Priority<br>(Bridge is no longer in existence, but may be replaced in the future) | Improved geomorphic stability | WRC, VANR, CRWC, Town of Jamaica |

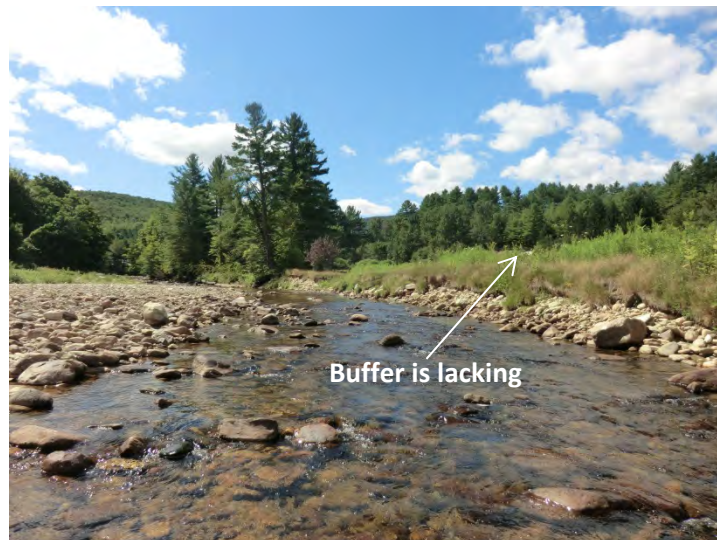
**Project #8 – Streamside Plantings**

| <b>Project #<br/>Segment</b> | <b>Type of<br/>Project</b> | <b>Site Description Including<br/>Stressors and Constraints</b> | <b>Project or Strategy<br/>Description</b> | <b>Technical<br/>Feasibility and<br/>Priority</b> | <b>Benefits</b> | <b>Potential<br/>Partners/<br/>Programs</b> |
|---|---|---|---|---|---|---|
| Project #8<br>T11.03-C & T11.04 | Passive<br>Restoration | Riparian buffer is lacking on the western bank of the Winhall. The bank is actively eroding and contributing sediment to the river. | <b>Streamside Plantings</b> | Moderate Priority | Improved habitat and water quality | Landowners, WRC, VANR, CRWC<br>TFS |

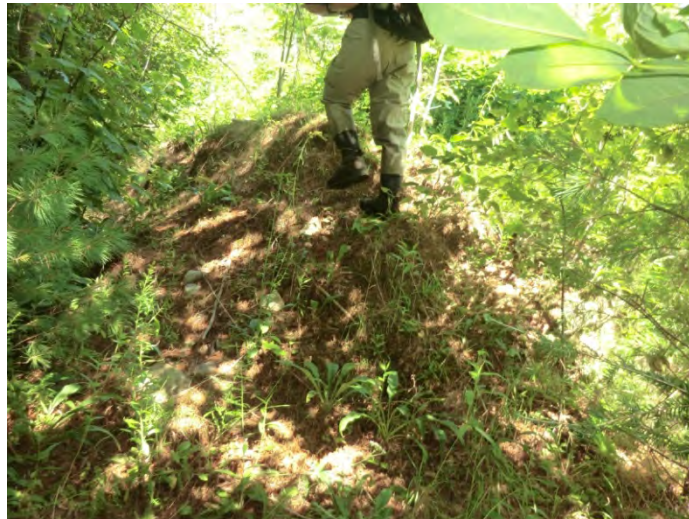
Project #11 – Berm Removal

| Project # Segment | Type of Project | Site Description Including Stressors and Constraints | Project or Strategy Description | Technical Feasibility and Priority | Benefits | Potential Partners/Programs |
|---|---|---|---|---|---|---|
| Project #11<br>T11.04 | Active Restoration | Historic four-foot berm is present along the south side of the stream and is restricting floodplain access. | <b>Berm Removal</b> | Low Priority (Berm is short-lived) | Improved geomorphic stability, habitat, and water quality, attenuation of floodwaters and sediment | Landowners, WRC, VANR, CRWC |

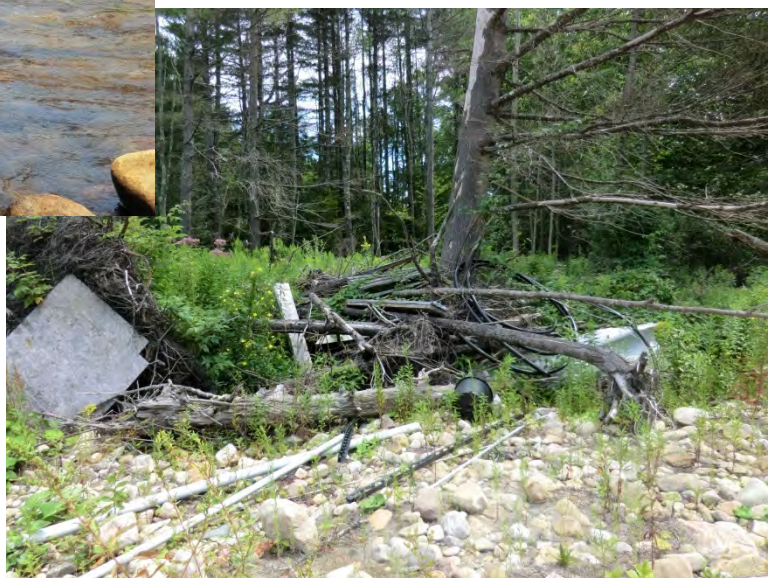
**Project #14 – Arrest Headcut &  
Clean Up Trash on Banks**

| <b>Project # Segment</b> | <b>Type of Project</b> | <b>Site Description Including Stressors and Constraints</b> | <b>Project or Strategy Description</b> | <b>Technical Feasibility and Priority</b> | <b>Benefits</b> | <b>Potential Partners/ Programs</b> |
|---|---|---|---|---|---|---|
| Project #14<br>T11.05-B | Active Restoration | The stream channel in T11.05-B is actively degrading via one small headcut. At the same location, there is trash piled on the north bank of the river. | <b>Arrest Headcut &amp; Clean Up Trash on Banks</b> | Moderate Priority | Improved geomorphic stability, habitat, and water quality | Landowners, WRC, VANR, CRWC |

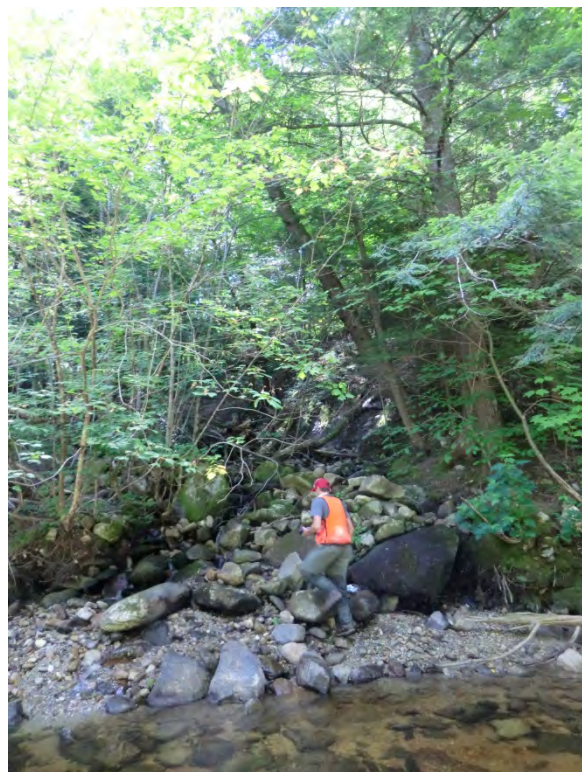
Project #18 –  
Remove Berm &  
Investigate  
Gully

| <b>Project #<br/>Segment</b> | <b>Type of<br/>Project</b> | <b>Site Description Including<br/>Stressors and Constraints</b> | <b>Project or Strategy<br/>Description</b> | <b>Technical<br/>Feasibility and<br/>Priority</b> | <b>Benefits</b> | <b>Potential<br/>Partners/<br/>Programs</b> |
|---|---|---|---|---|---|---|
| Project #18<br>T11.07-B | Active<br>Restoration | A berm exists on the north bank of the Winhall where no infrastructure is present – only an agricultural field. The river could likely access this floodplain if the berm were not present. A gully exists on the south bank and is contributing sediment to the river. The source of the gully is unknown. | <b>Remove Berm &amp; Investigate Gully</b> | Moderate Priority | Improved geomorphic stability, habitat, and water quality; attenuation of floodwaters and sediment | Landowners, WRC, VANR, CRWC |

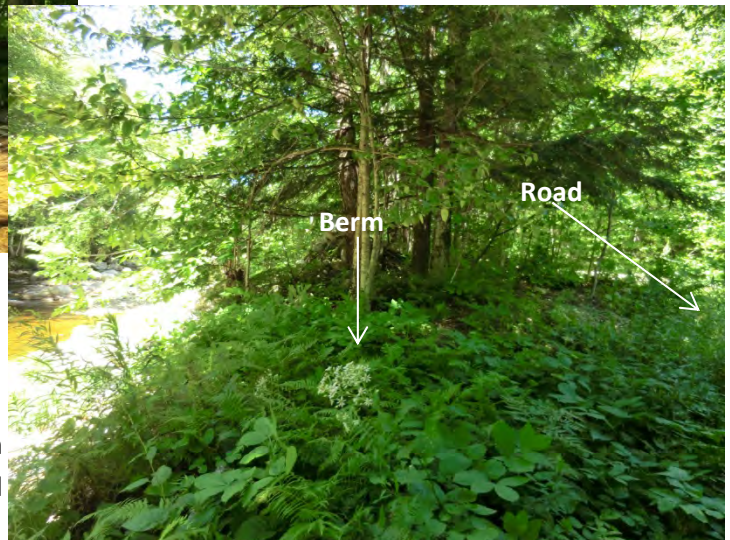
Project #20 – Investigate Berm Removal & Lowering Road

| <b>Table 6. Winhall River Main Stem</b><br><b>Map 6: T11.08</b><br><b>Site Level Opportunities for Restoration and Protection</b><br><b>Winhall, Vermont</b> | | | | | | |
|---|---|---|---|---|---|---|
| Project #20<br>T11.08-B | Active Restoration | The extension of Kendall Farm Road has caused the river to lose access to once-adjacent wetlands. A historic berm along the road has furthered this segment's loss of floodplain access. Access to this wetland could provide important flood water & sediment attenuation. | <b>Investigate Berm Removal &amp; Lowering Road</b> | Low Priority | Improved geomorphic stability, habitat, and water quality; attenuation of floodwaters and sediment | Green Mountain National Forest, WRC, VANR, CRWC, Town of Winhall |
