# River Corridor Plan for the Saxtons River Watershed Windham County, Vermont

September 30, 2010

**Fitzgerald Environmental Associates, LLC.**  
316 River Road  
Colchester, VT 05446

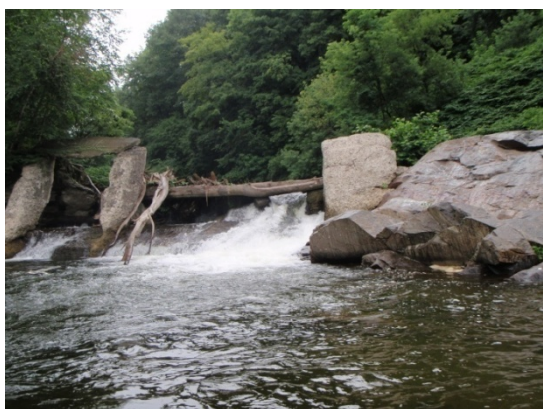
Reach M01 was segmented to highlight the differences in channel form below and above the grade control at the Blake and Higgins dam. Segment A is 0.2 miles in length and begins at the confluence with the Connecticut River about 800 feet downstream of the Route 5 crossing. Some structural components of the Blake and Higgins dam remain intact despite the dam being breached. The dam buttresses are situated on a bedrock outcrop, so it continues to act as a grade control (Figure 4.1). Downstream of the dam the channel is largely influenced by the backwaters of the Connecticut River during high flow events. The channel is widened and has an abundance of mid-channel bars (Figure 4.2). The channel has F-type morphology due to the additional hydraulic forces associated with the Connecticut River backwaters. The width-to-depth (WDR) and entrenchment ratios (ER) are 48.4 and 1.1, respectively. The segment has a braided bedform and predominately gravel with a median particle size of 30mm. The valley setting is narrowly confined, and both valley side slopes are extremely steep.

Figure 4.1 Blake and Higgins dam buttresses on a grade control

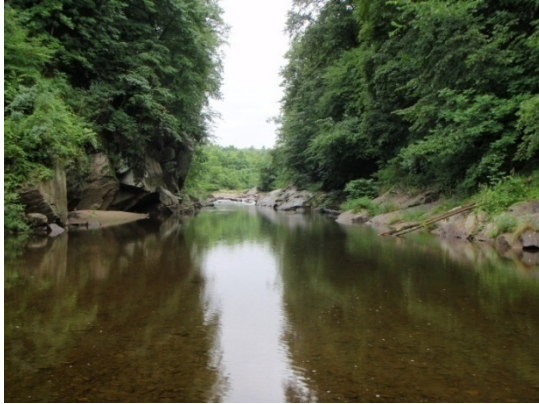
Segment B of reach M01 is 0.1 miles in length and set in a narrowly confined bedrock gorge (Figure 4.3). It was segmented because of the gorge setting and no cross-section was taken because of the stability of the bedrock (Figure 4.4). Administrative judgment was used to determine the geomorphic state (RGA score "good")

Figure 4.3 Upstream view from the dam at the bedrock gorge

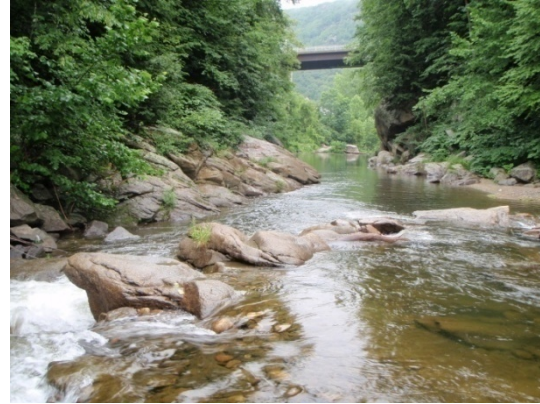
Figure 4.4 Looking downstream at the gorge toward Route 5

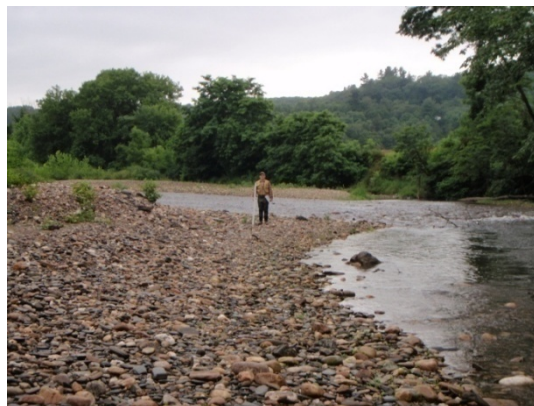
Figure 4.6 Sediment aggradation at steep riffle near M01

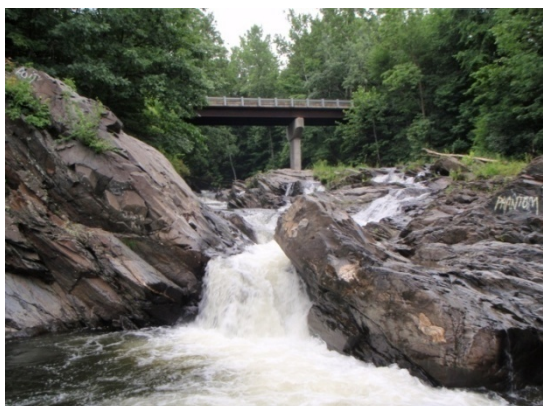
Reach M03 was segmented because of several grade controls that altered the channel morphology upstream of the Covered Bridge Road crossing. Segment A is 0.8 miles in length and extends upstream from the change in confinement at the reach break with M02, up to the segment break just upstream of the Covered Bridge Road crossing. The average channel slope of this segment is about 1.8%, but a lot of the slope change occurs at the three grade controls (including Twin Falls), which account for 41 feet of the elevation differences (Figure 4.7). The segment is semi-confined by its valley and the channel geometry is characteristic of B-type channels ( $WDR = 29.0$ ,  $IR = 1.5$ ,  $ER = 2.2$ ) with a subclass slope of c, because of the low slope. The segment exhibits plane bedform and cobble is the dominant substrate (64%). The median substrate size from the pebble count was 90 mm. One mass failure was observed in the downstream end of this segment. The failure was approximately 81 feet high and 100 feet in length (Figure 4.8).

Figure 4.7 The grade control downstream of Covered Bridge Rd

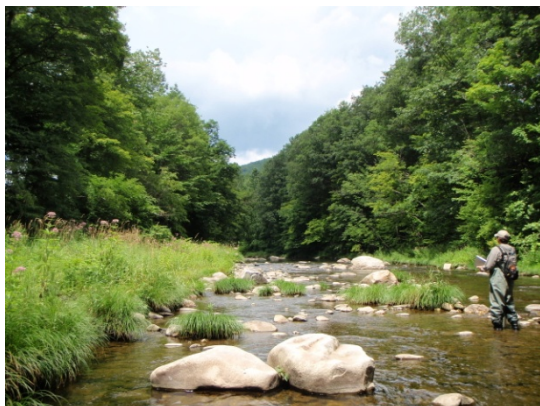
Figure 4.13 Looking upstream at B-Type channel

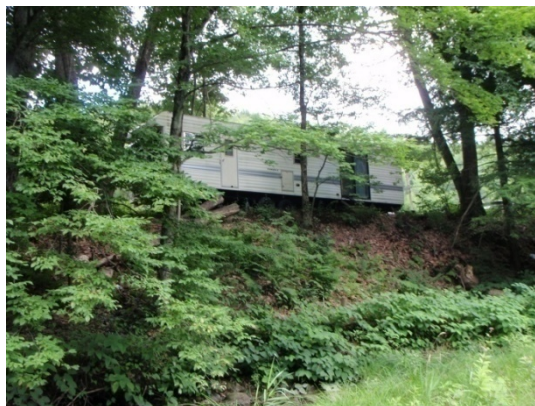
About 30% of the right corridor is developed and the residential buildings found within the corridor could be at risk during extreme events, especially where the valley wall broadens in the upper reach (Figure 4.14). The geomorphic condition is "Fair" and widening is the dominant adjustment process. The channel is in stage III of the CEM because of its moderate widening and incision. The habitat condition has been reduced by the availability of wood (LWD/Mile = 2) and pools (Pools/Mile = 5; RHA score = "Fair"). The buffer and bank condition is adequate for much of the reach keeping the condition "Fair" despite the low woody debris and pool densities.

Figure 4.14 Development on the RB along Route 121

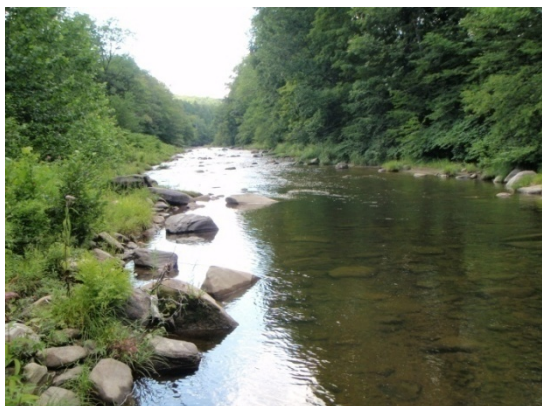
Figure 4.17 Plane bedform with little habitat

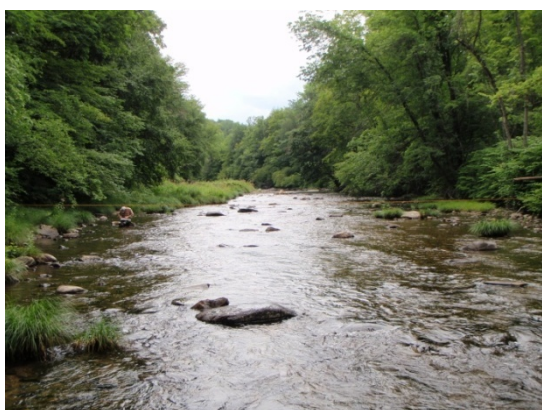
riffle-pool. The dominant substrate observed was cobble (43%) and the median substrate size was 60mm. Channel geometry reflects some widening (WDR = 28.5), with minor incision (IR = 1.6), and C-type entrenchment (ER = 3.2; Figure 4.19). One channel crossing, at McBride Road, seemed to be causing some bank scour and deposition above. The upstream end of the reach on the left bank had reduced buffer width because cattle are allowed to graze up to the channel's edge.

Figure 4.19 Channel geometry indicative of C-type morphology

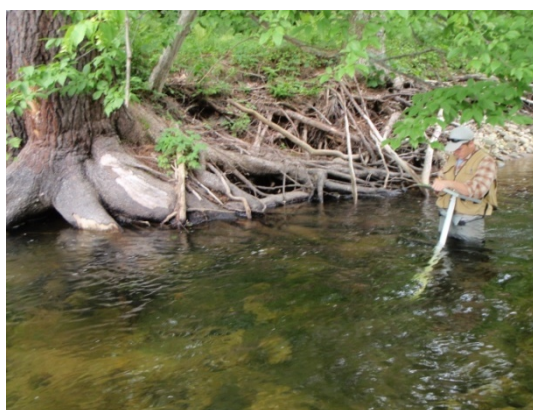
Upstream, in reach M09, channel migration and widening is causing sediment to be transported downstream. Reach M08 is aggrading the coarse substrate from upstream and its channel is also widening (RGA score "Fair"). The channel is currently in stage III of the CEM. M08's habitat condition does not seem to be seriously impacted by the aggrading sediment. However, the excessive widening and lack of woody debris (LWD/mile = 15) is reducing the habitat condition (RHA score = "Fair"). Pools were limited (pools/mile = 10), but several nice habitat features including undercut banks were noted (Figure 4.20).

Figure 4.20 Undercut bank located in area of migration

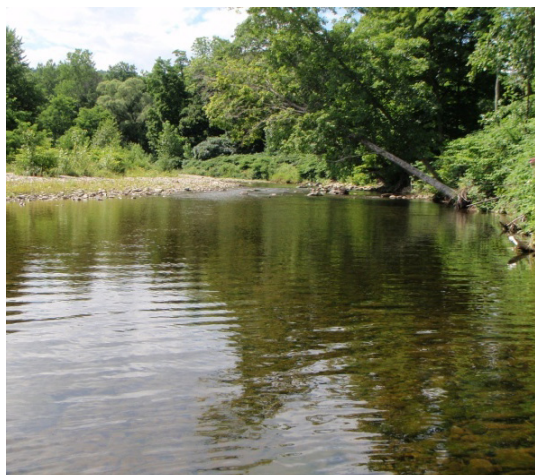
The multiple flood chutes present, along with aggradation and side bar development indicates widening and planform changes. The geomorphic condition is highly unstable and the lack of grade controls has likely led to the advanced stage of the CEM (RGA score = "Fair"; CEM stage = IId, D-model). Some restoration efforts were made on the right bank (Figure 4.21). There, willow plantings and rip-rap were installed to prevent further channel migration and potential avulsions out into the hay field to the southeast. The habitat was influenced by the shallow nature of the channelized flow (Figure 4.22). Pools were limited (pools/mile = 9), and the channel was often too shallow to support a diverse assemblage of aquatic species. Woody debris was quite low (LWD/mile = 17) and the habitat condition seemed to reflect the geomorphic condition (RHA score = "Fair").

Figure 4.22 Wide, shallow channel with little available habitat

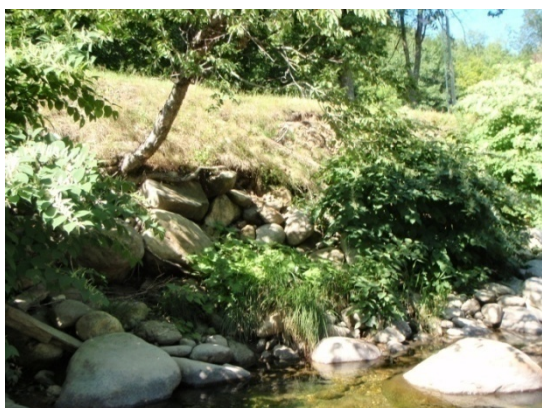
Figure 4.23 Human elevated floodplain in lower reach

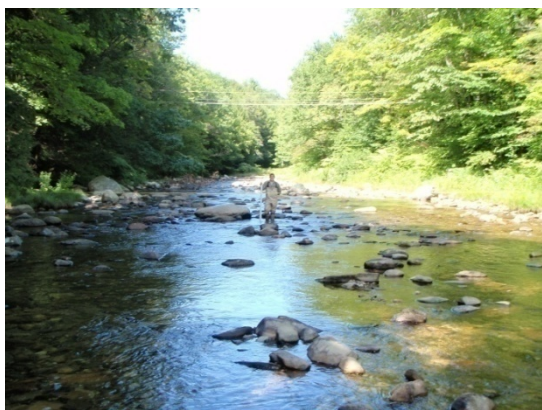
M11 is one mile long and has an average channel slope of 0.9%. The reach begins downstream of the Route 121 crossing near The Dug Road and extends upstream to just downstream of the next crossing of Route 121. The channel exhibits C-type morphology with riffle-pool bedform (Figure 4.25). The width-to-depth ratio of this reach is 25.8, the entrenchment ratio is 2.8, and the incision ratio is 1.4. The substrate is predominately cobble (50%) with some coarse gravel (23%), and the median particle size is 75mm. The riffles and pool sequences are well spaced but the riffles themselves are sedimented by more mobile substrate. The upper and lower sections of this reach are encroached on both sides. The Dug Road and Route 121 encroach upon the lower portion of M11, and an unnamed driveway and Route 121 encroach on the upper part of the reach. The encroachment totals about 47% of the channel's length. Some development and reduced buffer widths were also noted along this reach. A large flood chute was observed along the left bank mid-reach. This feature could have been an old road that got scoured out during a large flow event. The abutments of a historic channel crossing remain downstream of the current Route 121 crossing near The Dug Road. There the channel has several well developed pools that exceeded 4 feet in depth (Figure 4.26).

Figure 4.25 Cross-section looking upstream at C-type geometry Figure 4.26 Deep pool feature downstream of Rt 121 crossing

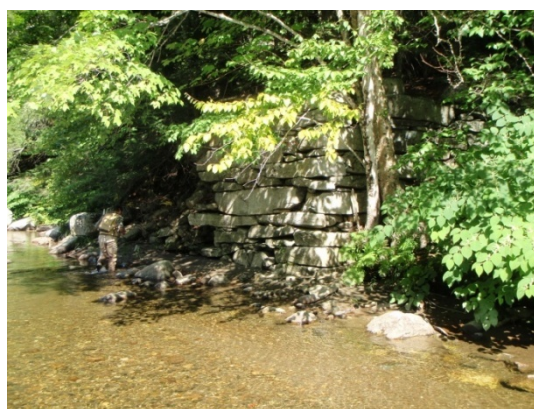
The channel is encroached upon entirely by Route 121, which has led to substantial changes in the natural geomorphic adjustment processes. Incision caused by road encroachment has caused a stream type departure, from C to B<sub>c</sub> due to lack of extensive floodplain (RGA score = "Fair"). The stream is in stage II of the F-model of CEM. Some meandering profile and habitat formation was noted in the lower reach, but extensive historical channel encroachment has led to a simplified form with limited habitat. Fine sediment deposition also reduces the viable habitat (RHA score = "Fair"; Figure 4.28).

Figure 4.28 Fine sediment deposition near Route 121 crossing

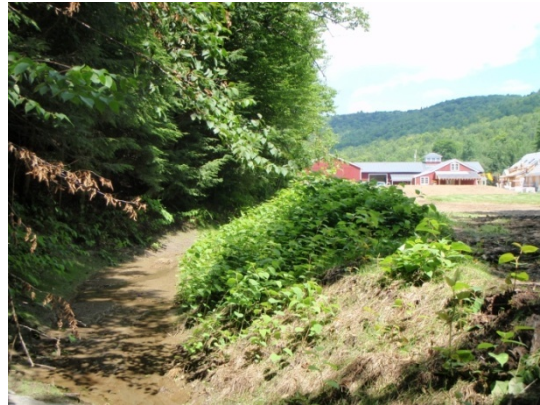
The encroachment has affected the natural channel form significantly, but not as much as it did in M14. M15 still retains a riffle-pool bedform with some regularity in its riffle spacing. The geomorphic condition is "Fair" and the large number of side bar features (13 total) indicates that the channel is beginning to change its planform and is in stage III of the CEM. The alpaca farm in the upper reach has a dredged farm ditch to divert water coming off the steep valley wall into the channel and prevent ponding in the fields (Figure 4.34). This feature could be adding significant amounts of fine

**Figure 4.34** Farm ditch that drains water from steep slope

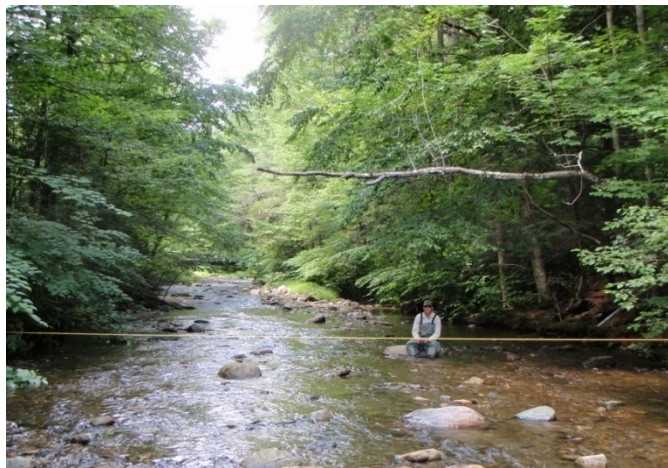
Like M15, M16 also runs along Route 121. The reach begins north of the alpaca farm and extends 0.7 miles upstream to the reach break by a snowmobile bridge. Reach M16 is set in a semi-confined valley. The low slope for this setting (slope = 0.8%) is causing sediment to aggrade and give the channel a plane bedform. The channel exhibits C-type morphology, with a width-to-depth and entrenchment ratio of 21.3 and 1.8, respectively (Figure 4.35). The entire length of the channel is encroached upon by Route 121, which has limited the ability of the channel to shift its planform and redevelop sinuosity. The substrate is predominately gravel (45%) and cobble (42%), with a median particle size of 60mm. Some incision on this reach can be attributed to the encroachment of Route 121 (IR = 1.6). The human elevated floodplain in the form of fill from Route 121 has made the natural floodplain much smaller (HEIR = 2.8).

**Figure 4.35** M16 Cross-section looking upstream

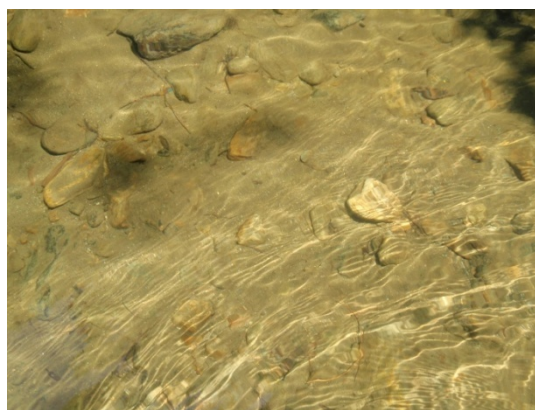
amount of fine sediment depositing upstream with very high embeddedness (Figure 4.36; Figure 4.37). Limited pools (pools/mile = 10) and woody debris (LWD/mile = 12), along with the encroachment reduced the habitat condition (RHA score = "Fair").

**Figure 4.37.** Deposition of fines and high embeddedness

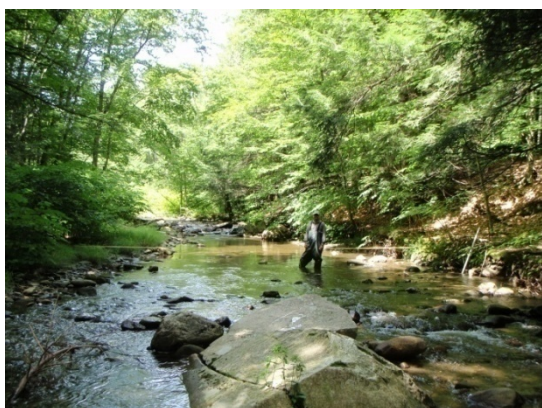
Figure 4.40 M18 cross-section looking upstream.

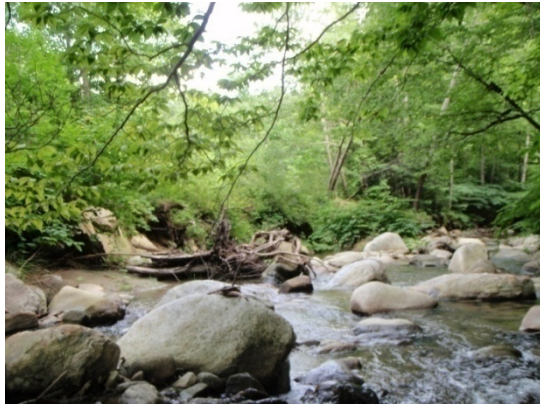
While Phase 2 assessments were underway a stream bank revetment project was completed on 750 feet of channel mid-reach. The land owners were concerned about the banks receding into their field and received the permits necessary to work in the channel. The reach was assessed prior to installation, and then reexamined after rip-rap lined a good portion of both banks. Prior to construction this area had the best habitat in the reach, with deep pools (pools/mile = 22), overhung banks, and woody debris (LWD/mile = 12) that slumped into the channel (Figure 4.43). The habitat features that were present in the reach prior to the revetment project yielded a "Good" RHA score. After the rip-rap was installed most of the quality habitat features were removed and all wood was removed from the channel (Figure 4.44). The current RHA score is not known, but given the extent of rip-rap and pool filling, it is likely that it would score in a lower category. Shifts in planform associated with eroding banks and some minor widening were observed. The reach scored "Fair" for the RGA. Much of the upper reach is controlled vertically by bedrock outcrops, but the majority of the channel is in stage IV of the CEM.

**Figure 4.43** The left bank prior to rip-rapping

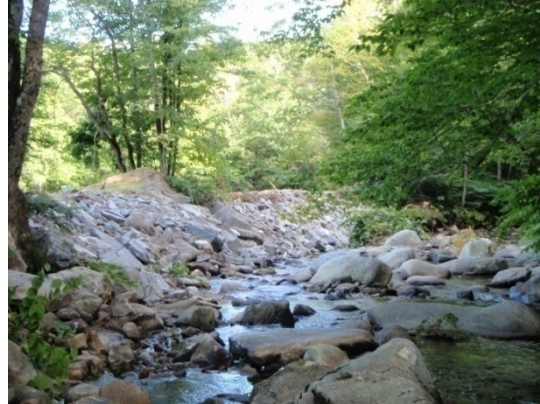
**Figure 4.44** Rip-rap and the removal of vegetation on the LB

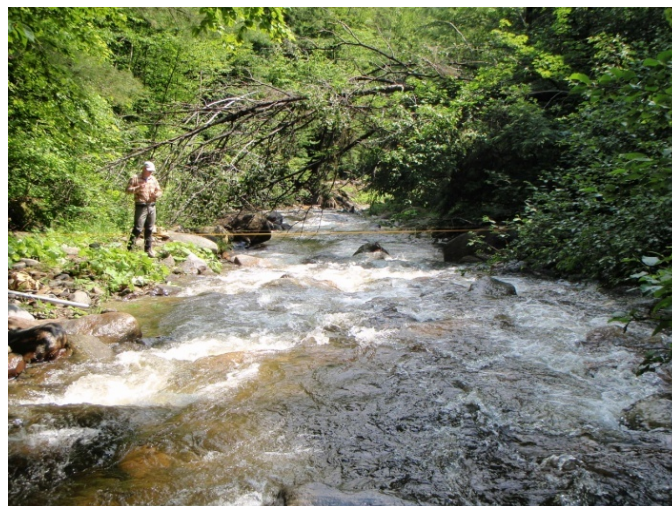
**Figure 4.45** M20-A cross-section looking downstream

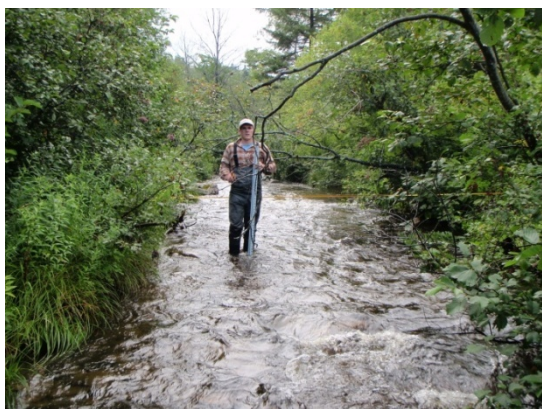
Figure 4.47 M20-B cross-section looking upstream

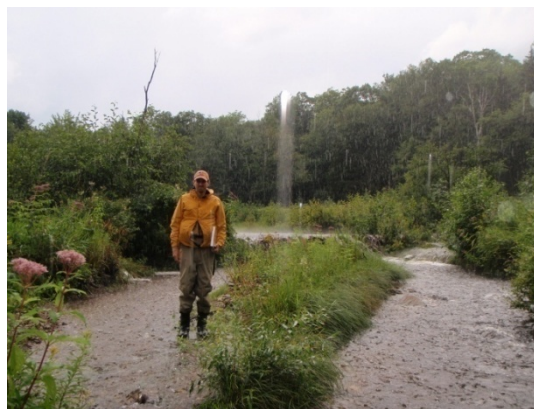
There are two large beaver dams on this reach. The first is located in the portion of the channel that runs between Route 121 and White Road (Figure 4.48). The second can be found in a fairly confined area upstream of the Mercy Lane Crossing. These areas were not segmented because of their short length but both actively trap sediment and change the natural fluvial condition. The major adjustment processes in M20-B are degradation and incision induced by historical channel straightening and road encroachment from Route 121 (RGA score = “Fair”). The historic incision from the road has put this segment in stage II of the CEM. It is unlikely that it will advance any further due to the rip-rap and road encroachment. The woody debris in this segment was less frequent (LWD/mile = 42) but still high compared to downstream reaches. Rt. 121 has cut off meander bends and floodplains that exist on the other side of the road over approximately 30-40% of the segment. The habitat would have been better with more pools (pools/mile = 16) and if the channel was able to take on a more natural meandering profile with the valley (RHA score = “Fair”).

Figure 4.48 Beaver dam downstream of White Road

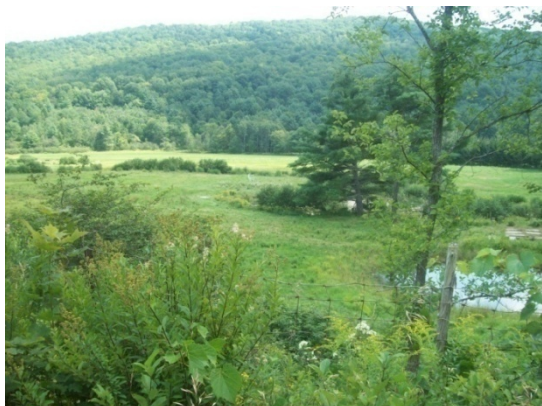
Figure 4.50 Wide alluvial valley of T4.01-A

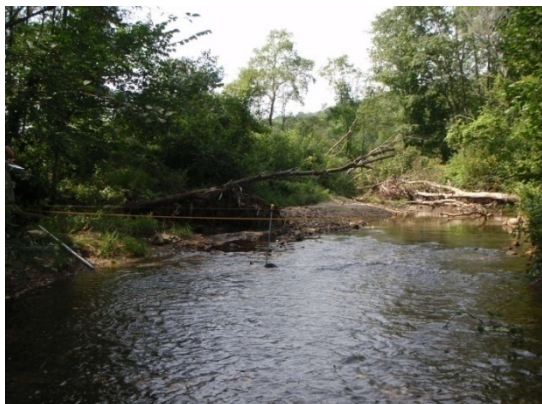
Figure 4.52 Cross-section location looking upstream

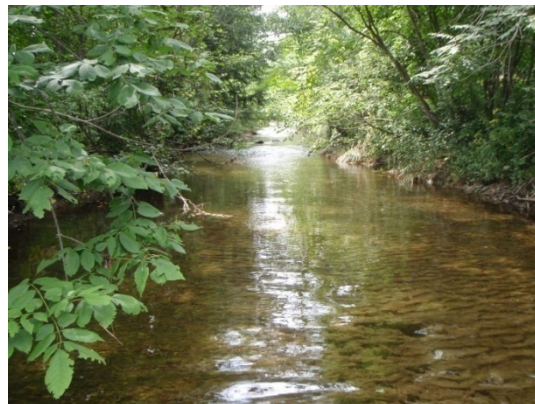
Segment T4.01-B begins at the segment break just upstream of a farm road crossing off Brookline Road and ends at the confluence with tributary Athens Brook (T4.S1.01). The segment is 2.0 miles in length and an average slope of 0.6%. The channel exhibits C-type morphology with a width-to-depth ratio and entrenchment ratio of 12.9 and 15.8, respectively (Figure 4.52). The substrate is predominately gravel (39%) and cobble (34%) with a median particle size of 30mm (gravel). The segment showed signs of minor incision, but not enough to drastically reduce the floodplain connectivity ( $IR = 1.2$ ). Bedform in this segment was predominately riffle-pool, with some areas resembling plane bed because of historic channel straightening and armoring (Figure 4.53).

Figure 4.53 Straightened area along Brookline Road

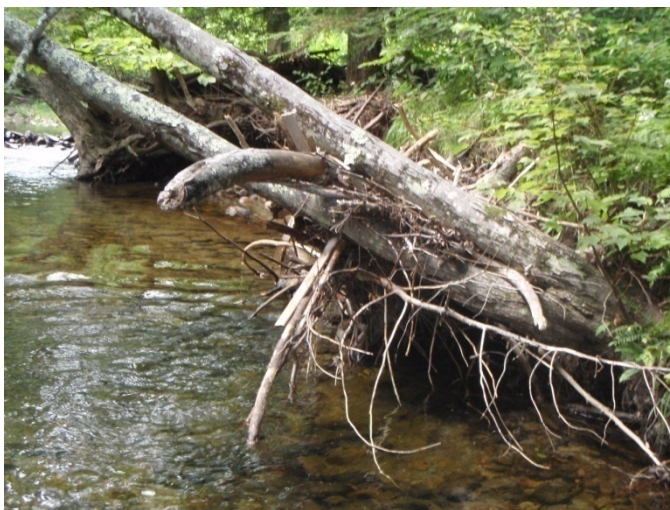
T4.01-B is a dynamic channel with a high bed load, active meander bends, and excellent pool formation (pools/mile = 35). Most pools had good cover over a large portion of the pool area or were in conjunction with undercut banks (Figure 4.54). Existing habitat potential is very high and could be improved in the lower segment with reforestation and planting projects. The area with historical channel straightening mid-segment where the bedform is plane bed had limited habitat and slightly lowered the overall score (RHA score = "Good"). Large woody debris was common (LWD/Mile = 62). The lower segment lacks woody buffer in some areas, which has led to some moderate erosion on the outside of meander bends. Shifting planform is the dominant geomorphic adjustment observed in this segment. The overall geomorphic score was influenced because of a neck-cutoffs and other areas of possible avulsion (RGA score = "Fair"). Evidence of historic incision and some widening are good indicators of stage III of the CEM.

Figure 4.54 Pool and undercut bank located in the upper segment

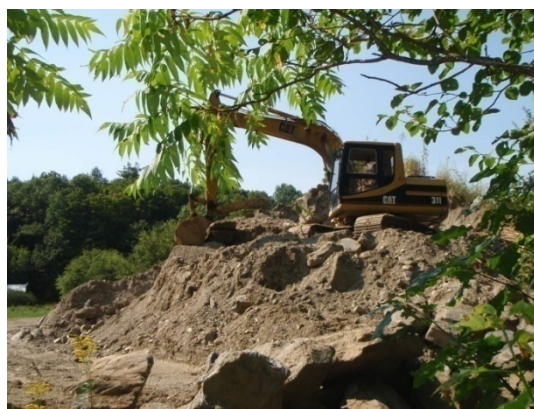
Geomorphically, this reach is nearly stable but responding to the increase in sediment from upslope sources. The reach is in stage II of the F model CEM and the RGA score is “Fair”. The lower part of this reach had good habitat features despite the increase in fine sediment from the mass failure and breached beaver dams. (LWD/mile = 75; pools/mile = 28) The quality of habitat in the lower reach can be attributed to the adequate bank and buffer vegetation, as well as accessible floodplain (RHA score = “Fair”). However, the upper reach had some extensive development in the left corridor. The land was cleared there, exposing surficial material and fill. At the time of the Phase 2 survey no silt fences or sediment management practices were in place to protect the channel from sedimentation (Figure 4.57). Upstream, a pile of fill soil was within 25 feet of the channel, again with no management practices in place (Figure 4.58).

**Figure 4.58** Fill and excavator within 25 feet of channel

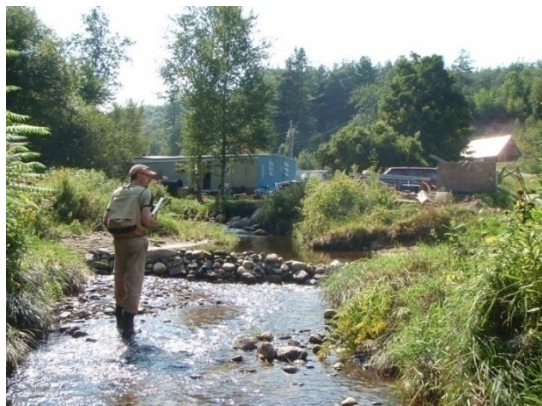
The upstream end of this reach has extensive impacts to the banks and riparian zone because of development within the stream corridor. A trailer park straddles the channel and many trailers are within the floodprone area, sitting very close to the bankfull channel elevation (Figure 4.59). Structures in this area are at risk during flood events and the low buffer width has impacted the channels banks. One stream crossing in the upper reach is acting as a bankfull channel constriction. The clearance of this structure is also very low and could pose a problem during high flow events and washout (Figure 4.60).

Figure 4.59 Development and low buffer width in upper reach

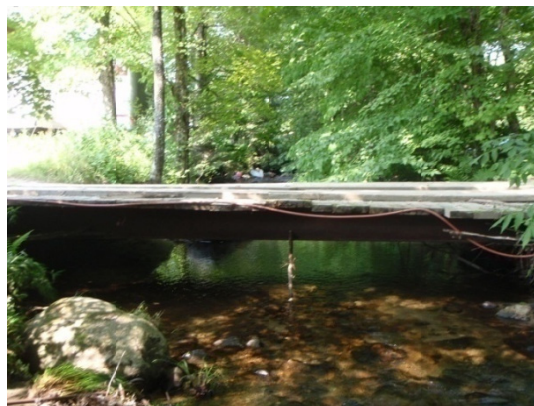
Figure 4.60 Bridge with low clearance; 22 ft construction

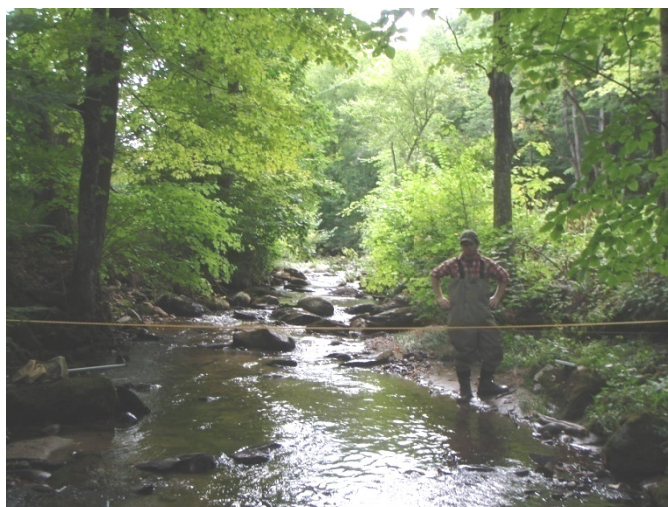
Figure 4.61 Cross-section looking upstream with Brookline Road in the left corridor (Photo Right)

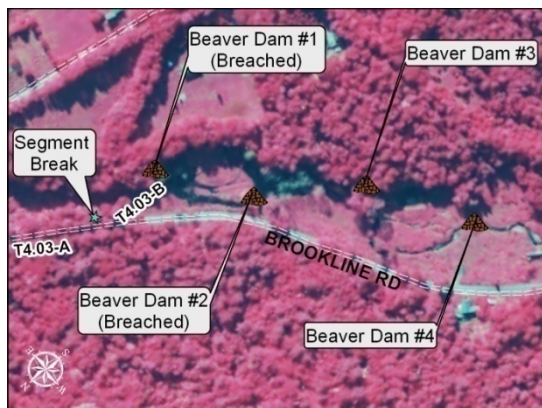
In total, T4.03-B has 4 beaver dams (Figure 4.62). Two of them have been breached by humans or have been blown out during a large storm event (Figure 4.63). The other two dams are intact and trapping extensive amounts of sediment upstream. The channel is responding to the base water level drop following the loss of the two major dams. The changes in channel state have occurred rapidly, because in 2008 both lower dams were intact.

Figure 4.62 Infrared aerial imagery of the beaver dam area

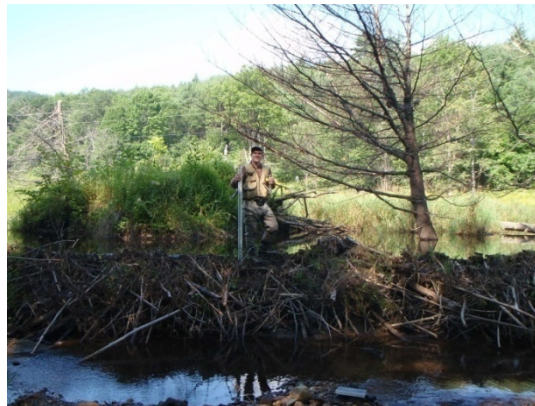
Figure 4.65 3rd beaver dam causing extensive ponding

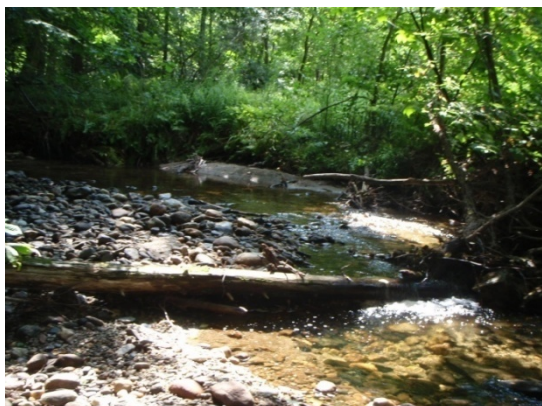
Segment C is 0.7 miles long and extends up to the reach break with T4.04 just upstream of the Brookline Road crossing. T4.03-C has Cb-type geometry with width-to-depth, entrenchment, and incision ratios of 17.0, 2.4, and 1.6, respectively. The segment is set in an unconfined, very broad valley but does not have any impacts associated with beaver activity. The slope is approximately 2.6%, giving the segment a subclass slope (b). The substrate is predominately cobble (45%) and gravel (41%) with a median substrate size of 60mm (gravel). The dominate bedform was riffle-pool, but areas in the upper reach had step-pool features (Figure 4.66).

Figure 4.66 The start of well-formed riffle-pool in stage IV CEM

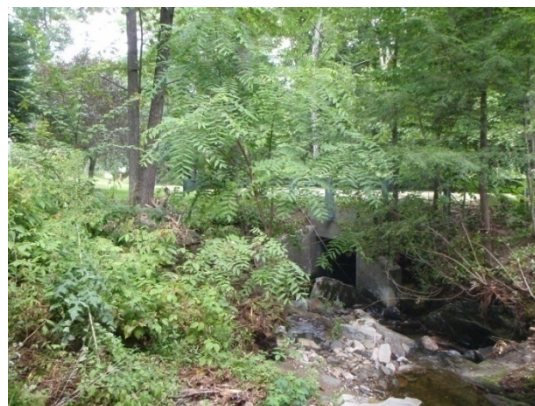
Figure 4.67 Area where channel crossed Brookline Road

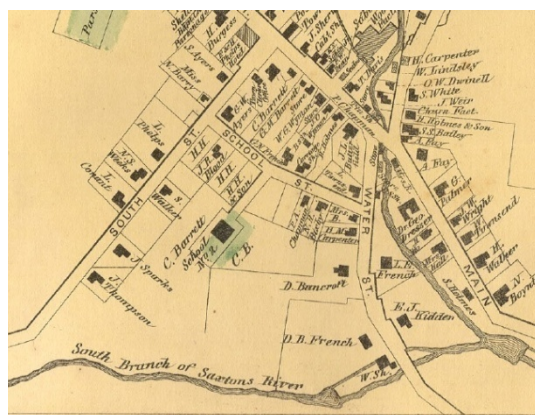
Figure 4.69 1869 Beer's Atlas showing dam and sluiceway

A section of a breached dam remains in place in the lower reach approximately 300 feet upstream of the covered bridge at the Kidder Hill Road crossing (Figure 4.68). This structure was part of a raceway diversion to a mill located along the north bank (Figure 4.69) just west of Kidder Hill Road (previously called Water Street). The structure was constructed on a grade control that spans at least half of the channel. Although the structure is partially breached, the concentration of flow and debris around the structure may limit the passage of juvenile fish into the upper reaches of the South Branch. In addition, sediment deposition occurring upstream of the structure is causing minor bank instability on the left bank. The removal of this structure to improve fish passage and channel stability is explored further in the project development summary in Appendix F.

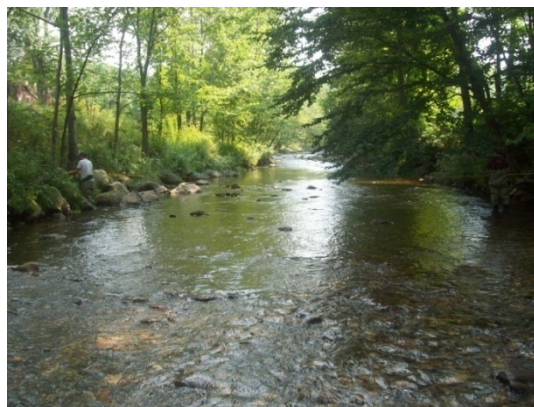
severe channel incision ( $HEIR = 2.8$ ;  $IR = 2.2$ ) resulting from straightening, bank armoring and encroachment of the road along the river corridor (Figure 4.70), a stream type departure was noted from C to F-type geometry ( $WDR = 13.1$ ;  $ER = 1.5$ ; Figure 4.71). The bed substrate is dominated by cobble (43%) and coarse gravel (34%), with limited fining noted in the riffles.

Figure 4.71 Cross-section location looking upstream

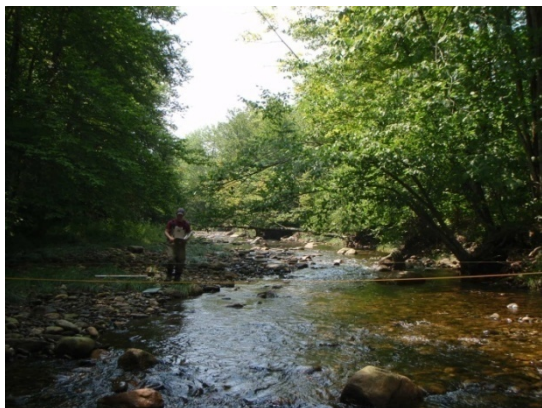
**Figure 4.72** Cross-section location looking upstream

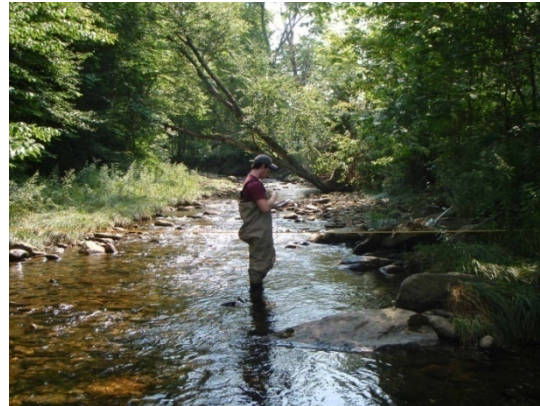
Reach T6.03 is 0.9 miles in length and begins at the confluence with Howe Brook (T6.S1.01) and ends at the confluence with Willie Brook (T6.S2.01). The reach is very similar to that of T6.02; it is almost entirely encroached upon by Townshend road and has a slope of 1.1% (Figure 4.75). The upslope drainage area is smaller because Howe Brook has a watershed area of 5.1 square miles. By reference T6.03 would be a meandering C-type channel with riffle-pool bedform, but impacts from encroachments and straightening have caused a stream type departure. T6.03 now exhibits Bc-type channel geometry with a width-to-depth ratio of 20.4 and an entrenchment ratio of 2.1 (Figure 4.76). The substrates are predominately cobble (42%) and gravel (33%) and the median particle size

**Figure 4.76** Cross-section location looking upstream

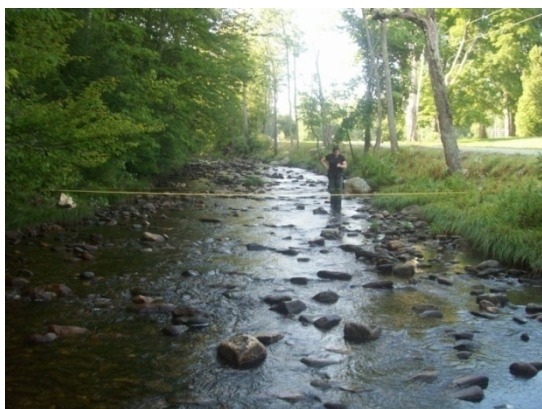
Figure 4.78 Cross-section mid-segment in T6.04-A

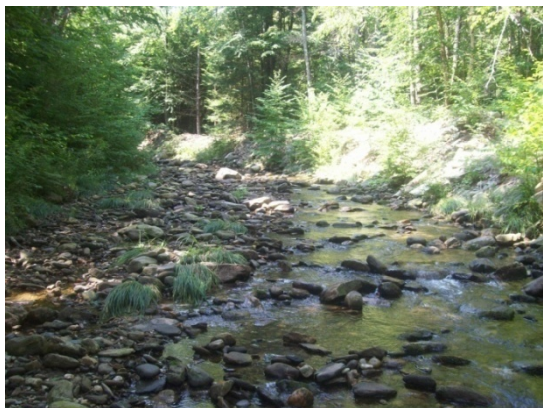
Figure 4.80 Old stone walls along the left bank of Styles Brook

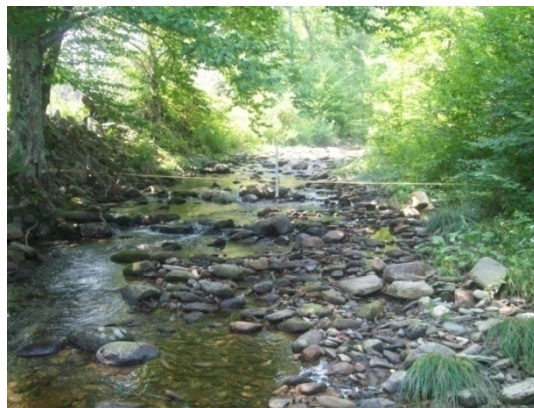
Figure 4.81 Cross-section mid-segment on T6.04-B

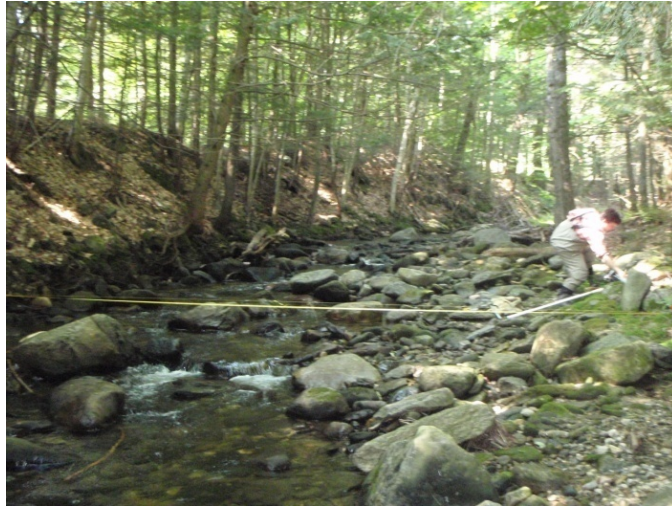
Howe Brook, reach T6.S1.01 is a long reach (6.2 miles) that extends up to the northwest toward Burt Hill. The high slope of the reach transitioning into the flat valley of the South Branch of the Saxtons River made it a probable location for an alluvial fan. For our Phase 2 assessments only the portion of the reach considered to be an alluvial fan was assessed. This area was segmented to distinguish it from the upslope channel that was not assessed. This segment has had significant dredging and straightening throughout the alluvial fan; the channel bed elevation is likely much lower than the pre-straightened elevation. Segment T6.S1.01-A is 0.4 miles long and has a slope of 3.7%. The current channel geometry for this segment is indicative of B-type channel morphology (Figure 4.83).

The width-to-depth, entrenchment, and incision ratios are 16.2, 1.5, and 2.0 respectively. The abandoned floodplain is high above the active channel, occurring at the same elevation of the hay field to the south. The substrate is predominately cobble (42%) with a median substrate size of 95mm (cobble). Bedform in T6.S1.01-A is plane bed, and the valley is semi-confined. Reference conditions were kept as B-type, because the alluvial fan must have been straightened so long ago that no visible remains of historical channels and floodchutes were observed.

**Figure 4.83** Cross-section with B-type channel geometry looking upstream

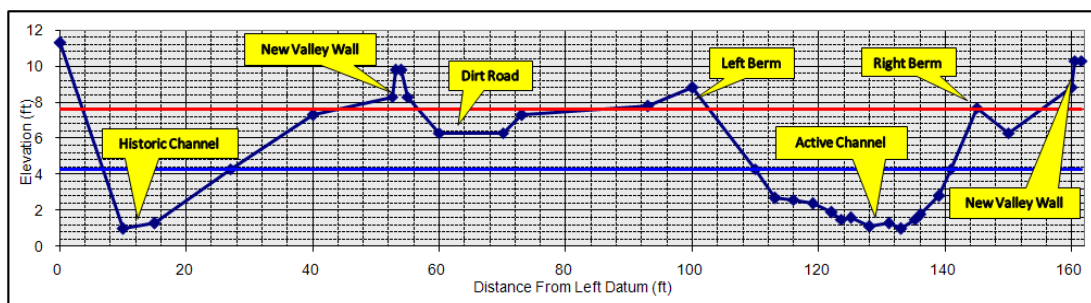
Willie Brook, reach T6.S2.01 is a long reach (4.5 miles) that extends up to the northwest toward Burt Hill. The high slope of the reach transitioning into the flat valley of the South Branch of the Saxtons River made it a probable location for an alluvial fan. For Phase 2 analysis only the portion of the reach impacted by the alluvial fan was assessed. This area was segmented to distinguish it from the upslope channel that was not assessed. This segment has significant dredging and straightening throughout the alluvial fan; the channel bed elevation is likely much lower than the pre-straightened elevation. The lower portion of Willie Brook has extensive evidence of previous channels that suggest a past history as an alluvial fan (Figure 4.86). The segment is 0.3 miles in length and as a channel slope of approximately 4.0%. Currently, T6.S2.01-A exhibits F-type channel morphology with width-to-depth and entrenchment ratios of 14.0 and 1.3, respectively. Incision from the natural floodplain to the right of the right berm is 1.6. The median substrate size is 110mm with 53% cobble and the bedform is plane bed. By reference this segment would be a braided D-type channel with an unconfined setting. However, the modifications to the channel have reduced the valley width to 107 feet, which is a semi-confined valley.

Figure 4.86 Cross-section of Willie Brook, showing historic channel and modified valley width

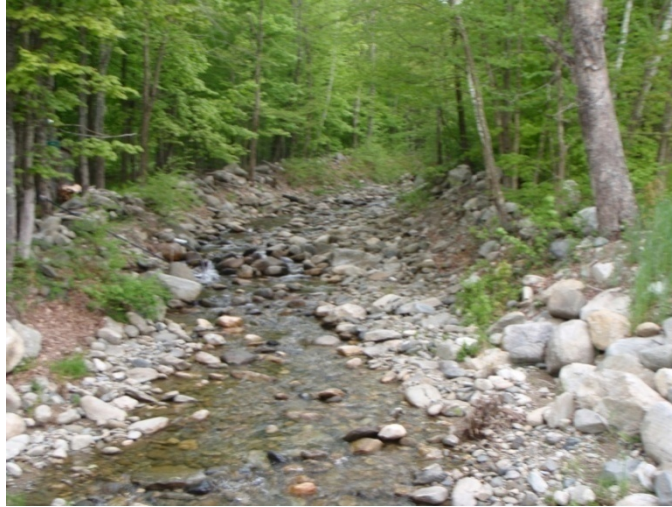
Human modification through straightening and berming has increased transport capacity and made the Townshend Road crossing in the lower reach a problematic area for debris jams during flooding events. Field observations and interviews with local land owners indicate that the bridge is undersized and was problematic during the large floods in the late 1990's. Following the flood, the bridge was completely clogged with sediment and the channel was extensively dredged (Figure 4.87). Stone pilings from the dredging remain on either side of the channel downstream of the crossing (Figure 4.88; Figure 4.89)

**Figure 4.87** Looking upstream from the Townshend Road crossing at the dredged and straightened channel

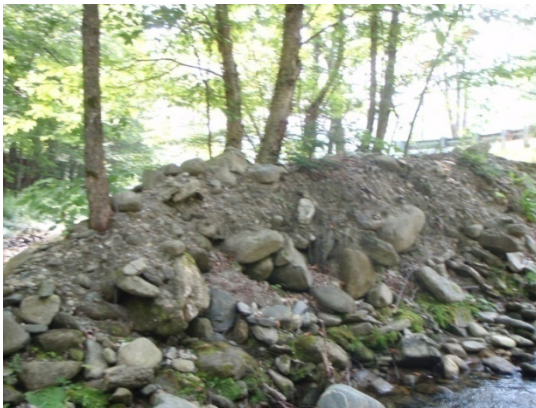
**Figure 4.88** Dredging pilings on the right bank

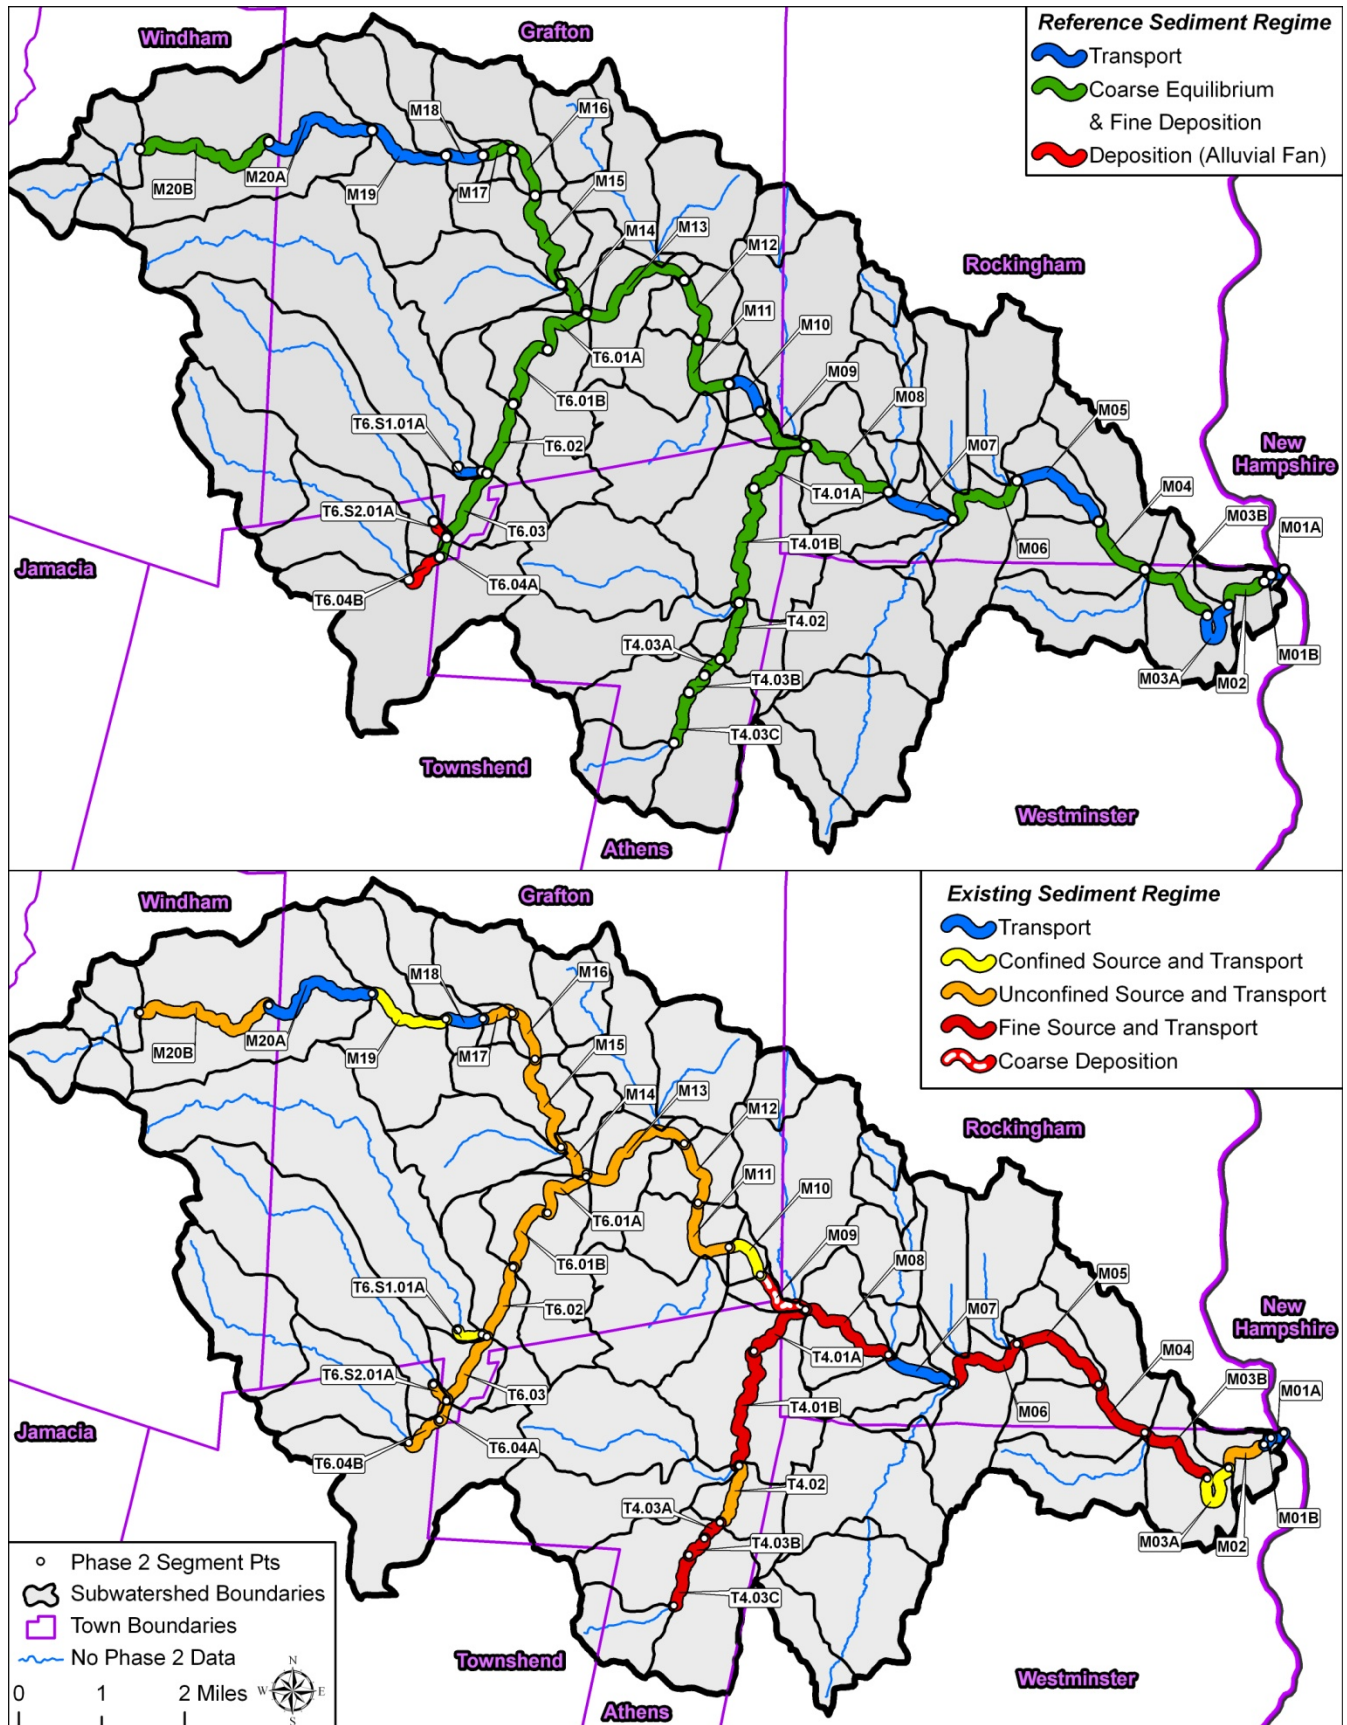
The reference and existing sediment regime types have been mapped using data from the Phase 1 and 2 assessments (Figure 4.90). Many segments have undergone a departure in sediment regime type due to channel incision and/or widening as a result of: 1) historical land uses, 2) encroachments or development in the river corridor, or 3) extensive straightening and bank armoring. Reach stream type departures are summarized below to help better describe the

Figure 4.90 Reference and Existing Sediment Regime Maps for the Saxtons River
