# Saxtons River Phase 1 Stream Geomorphic Assessment Summary

June 26, 2008  
**DRAFT**

**Fitzgerald Environmental Associates, LLC.**

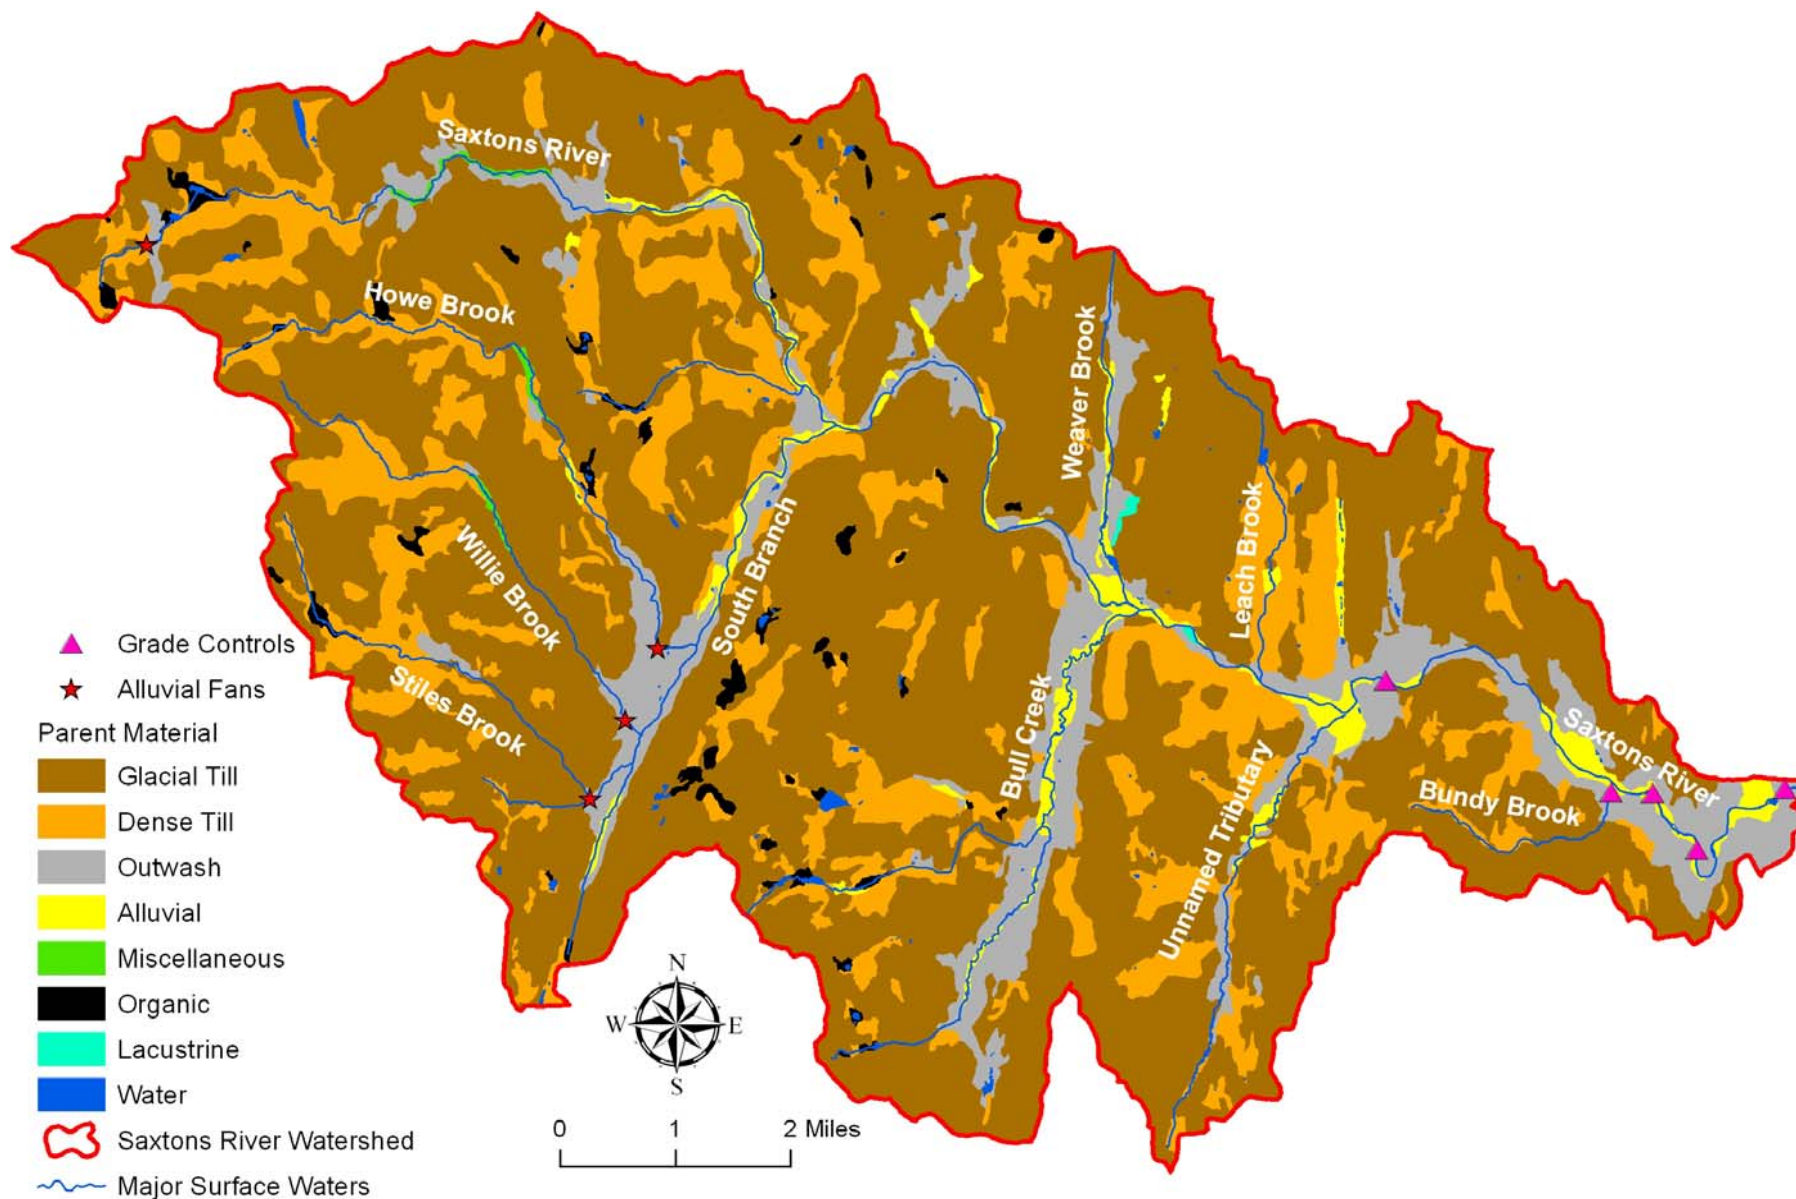
Four alluvial fan locations have been noted in the watershed, with three of these located where steep tributary reaches meet the South Branch valley floor along its western toe. In these locations, there is an abrupt change in channel slope and the topography and outwash parent material facilitates sediment deposition. Alluvial fans are characterized by highly active channels with a propensity for lateral migration and avulsion, even where they have been historically managed (e.g., dredged and straightened).

Figure 6. Parent Materials, Alluvial Fans, and Grade Controls within the Saxtons River watershed.

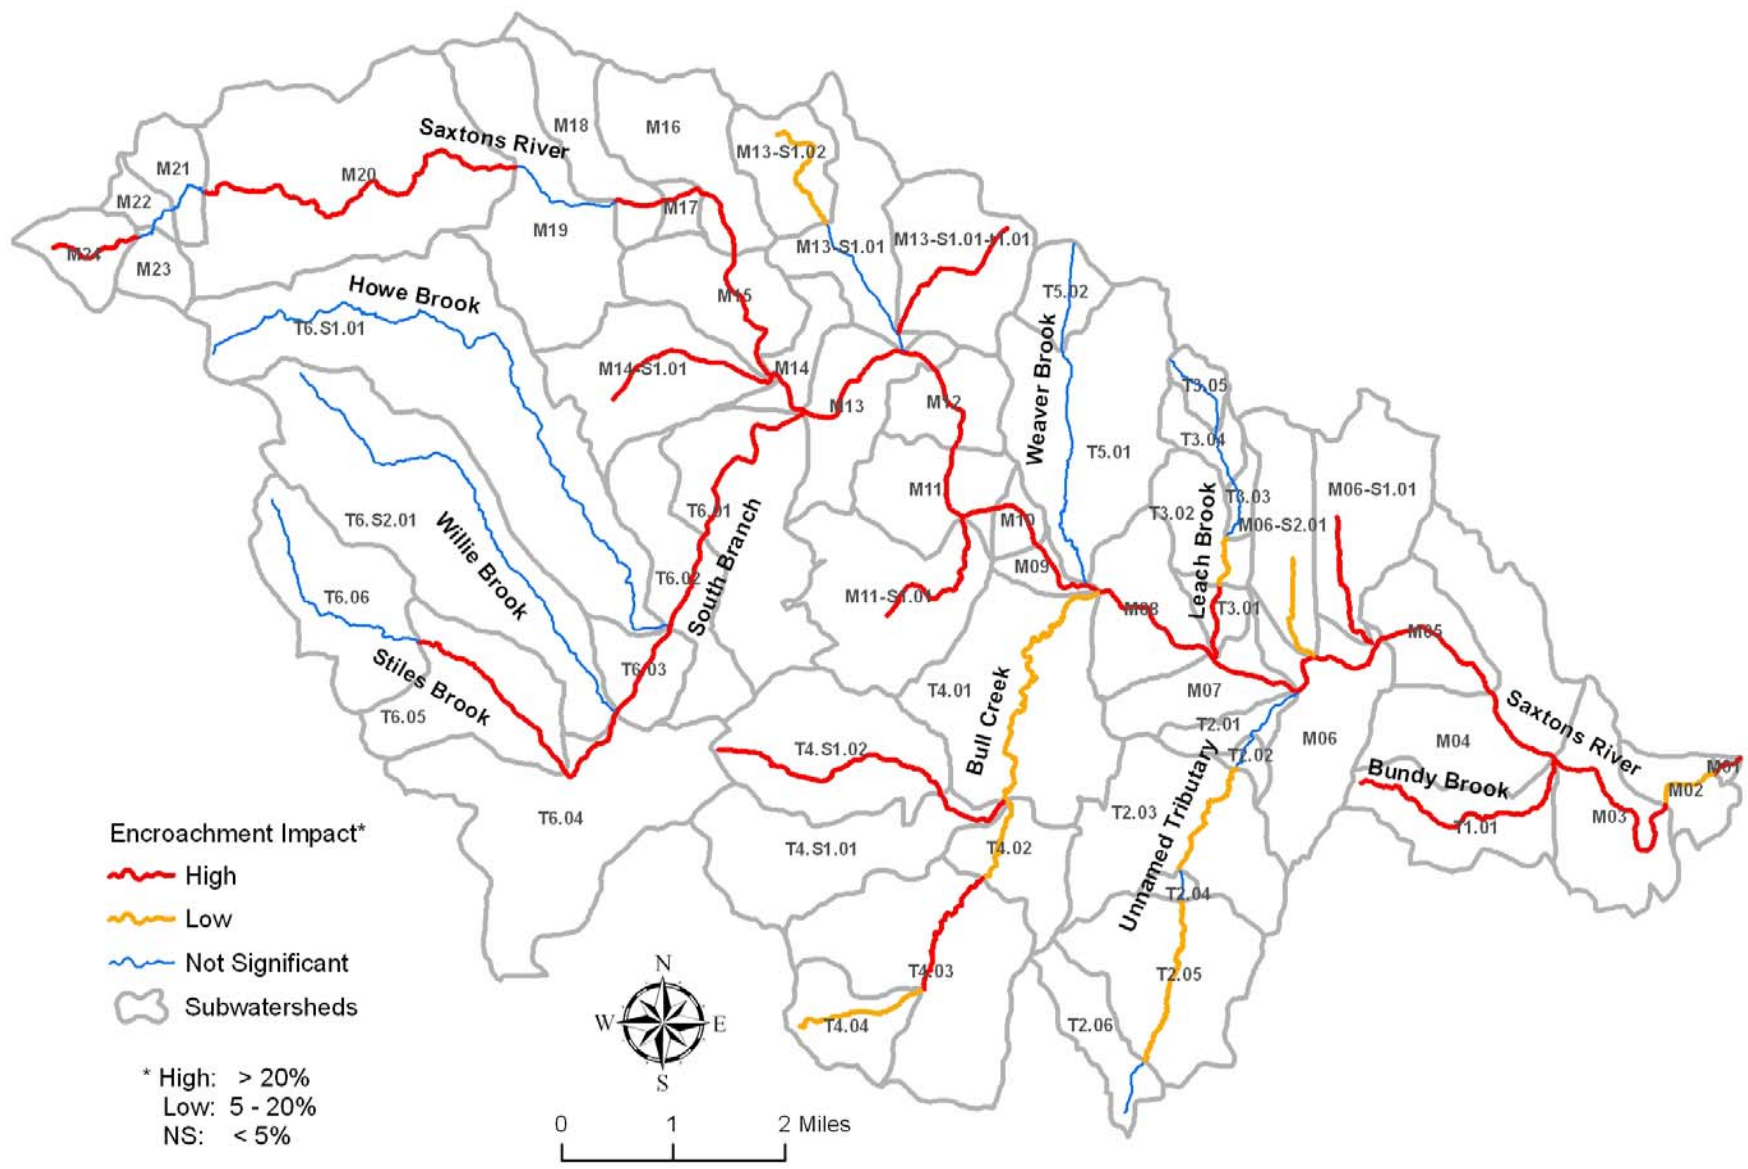
Figure 16. Impacts from corridor encroachments in the Saxtons River watershed.

Following the Phase 1 protocol, any berms, roads, driveways, railroads and/or improved paths found within the stream corridor were indexed using the FIT. These areas were identified using the 2003 NAIP aerial imagery, and were confirmed and/or refined during the field observations. Figure 16 depicts the reaches where encroachment has significantly impacted the stream corridor, with ratings based on the percentage of the reach length that was impacted as indicated in Table 9. All encroachments noted in the watershed were from roads, however further Phase 2 assessments may reveal additional berm encroachments that were not observed remotely or during the coarse field surveys.

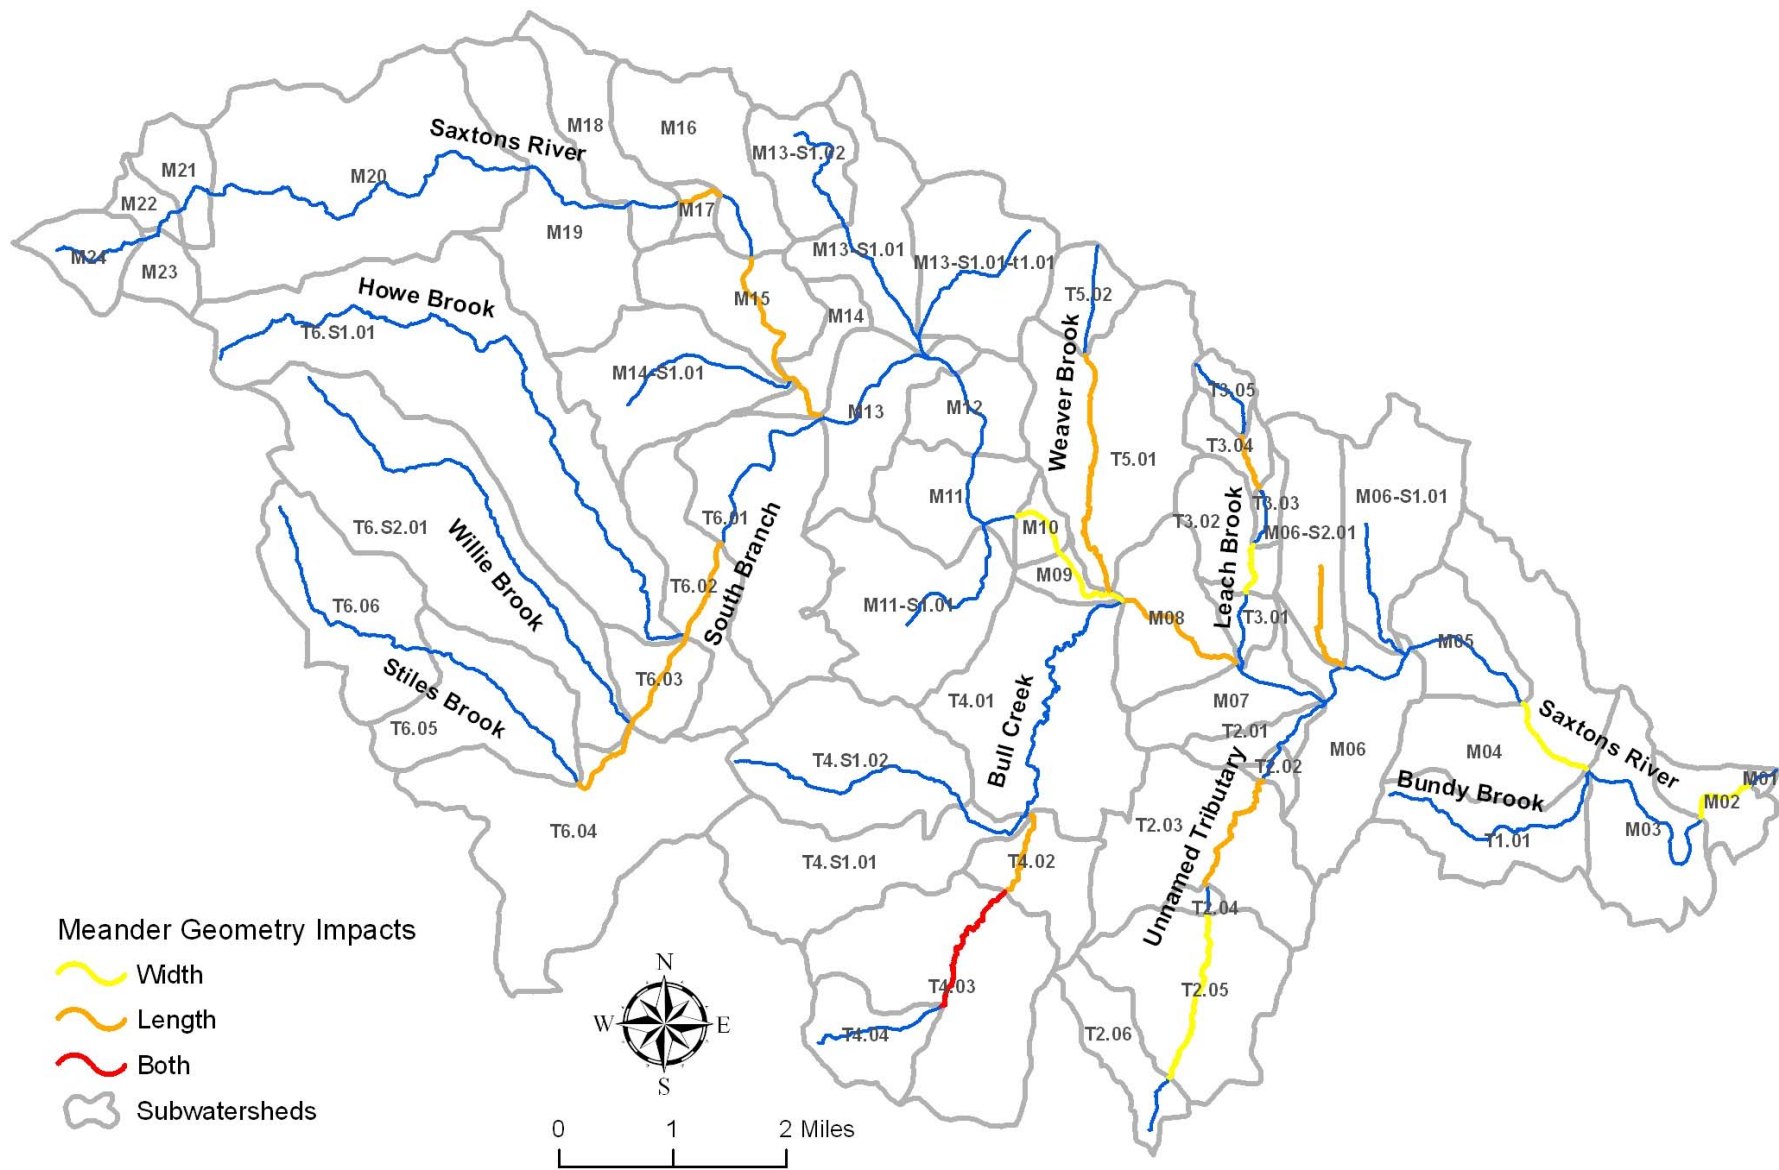
Figure 20. Meander geometry departures in the Saxtons River watershed.

For reaches characterized within unconfined valley settings (C or E-type channels), meander geometry was reviewed following the Phase 1 protocols. Thirty-one (31) of the 59 reaches had meandering profiles suitable for assessment of meander width and wavelength. Shapefiles were developed to indicate the areas where meander width and wavelength was measured. In some cases, multiple meanders were measured and an average of the measurements was entered in the DMS. Where the meander wavelengths and widths fell outside of the range of expected values relative to the predicted channel width, impact ratings of high or low were assigned according to the degree of departure (VTANR, 2007b). Twenty (20) of the 59 reaches had high impact ratings for either meander width or wavelengths, and these impact ratings are stored in the DMS. Highly impacted reaches are depicted for the watershed in Figure 20.

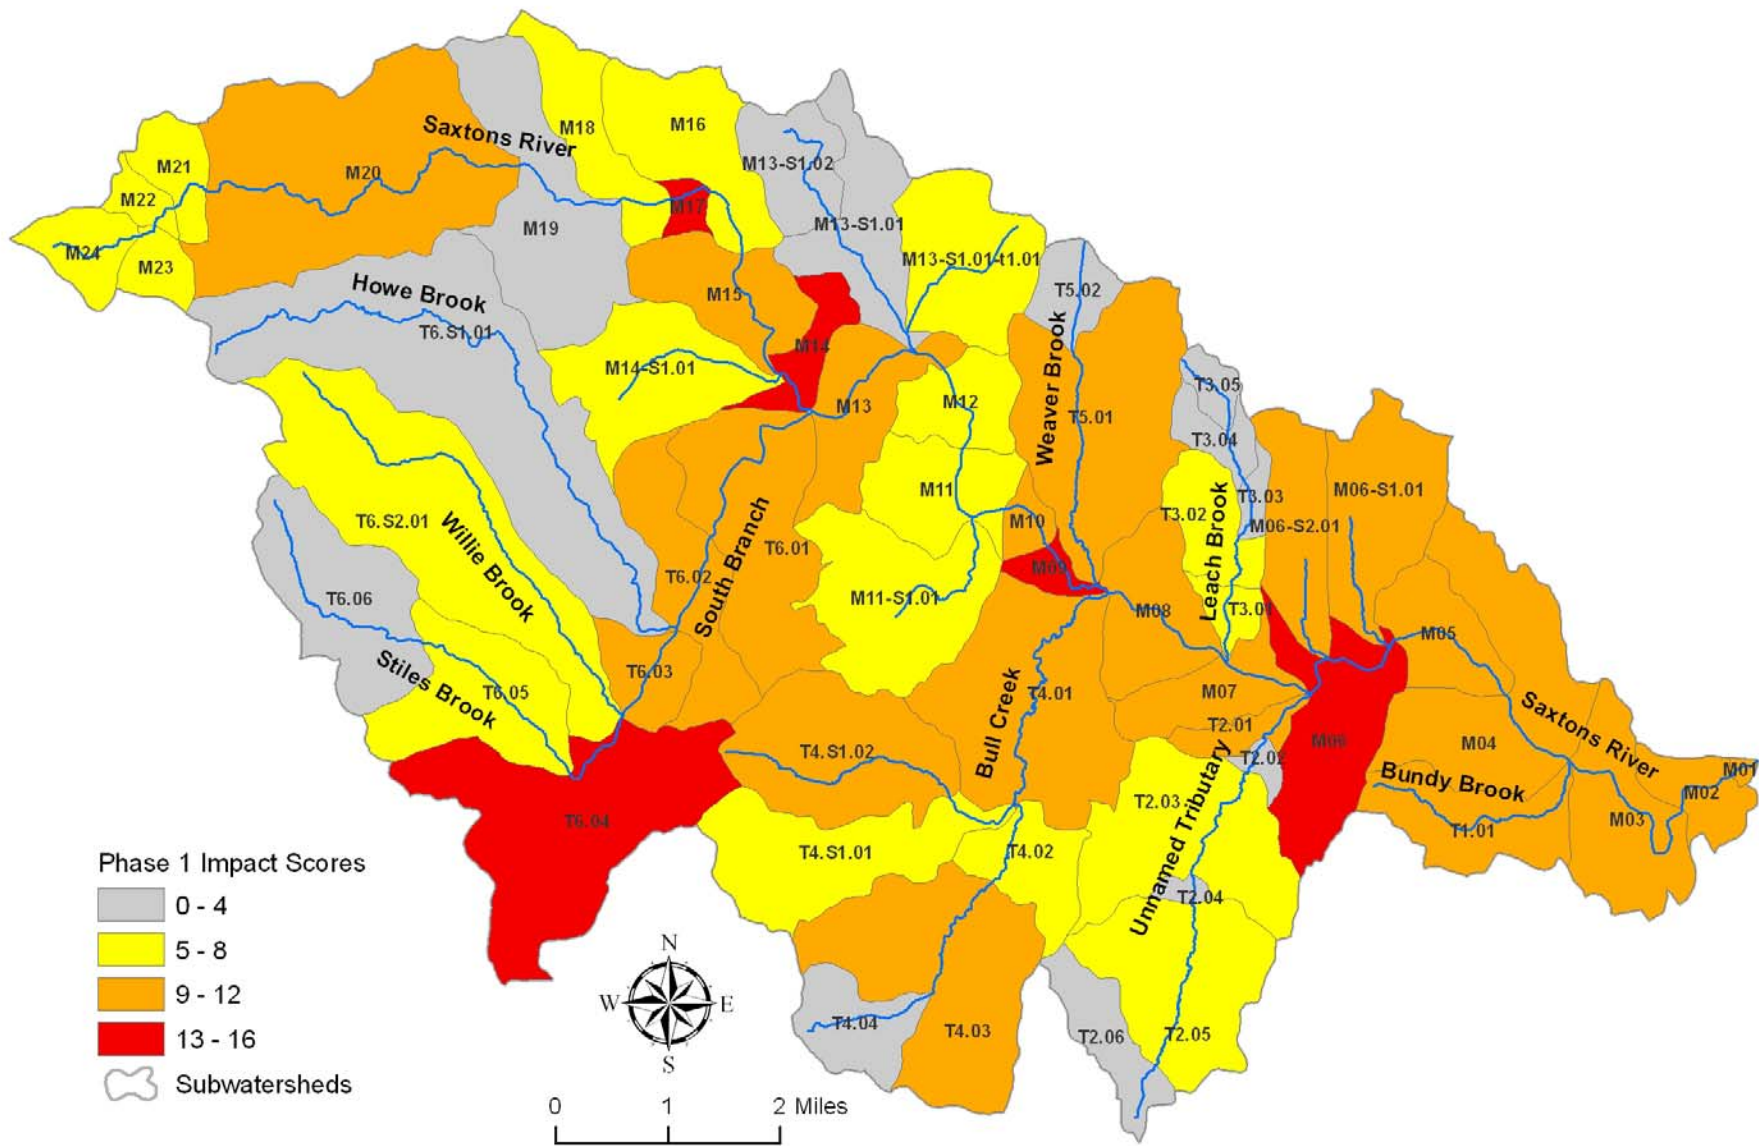
Impact scores have been generated for each of the Phase 1 steps for the 59 study reaches. The Phase 1 dataset in the DMS summarizes these scores under 4 separate impact categories as summarized in Table 11. Impact scores range from zero ("Not Significant") to 2 ("High") depending on the degree of impact recorded for each parameter. The 16 parameters evaluated for impacts and summarized for each study reach are presented in Table 11. Figure 21 presents the impact scores for each study reach, with the scores organized by quartiles. An additional table in Appendix A summarizes the impact scores by reach, as well as priority rankings used for recommendations for further Phase 2 assessment.

Figure 21. Phase 1 final impact scores for the Saxtons River watershed.

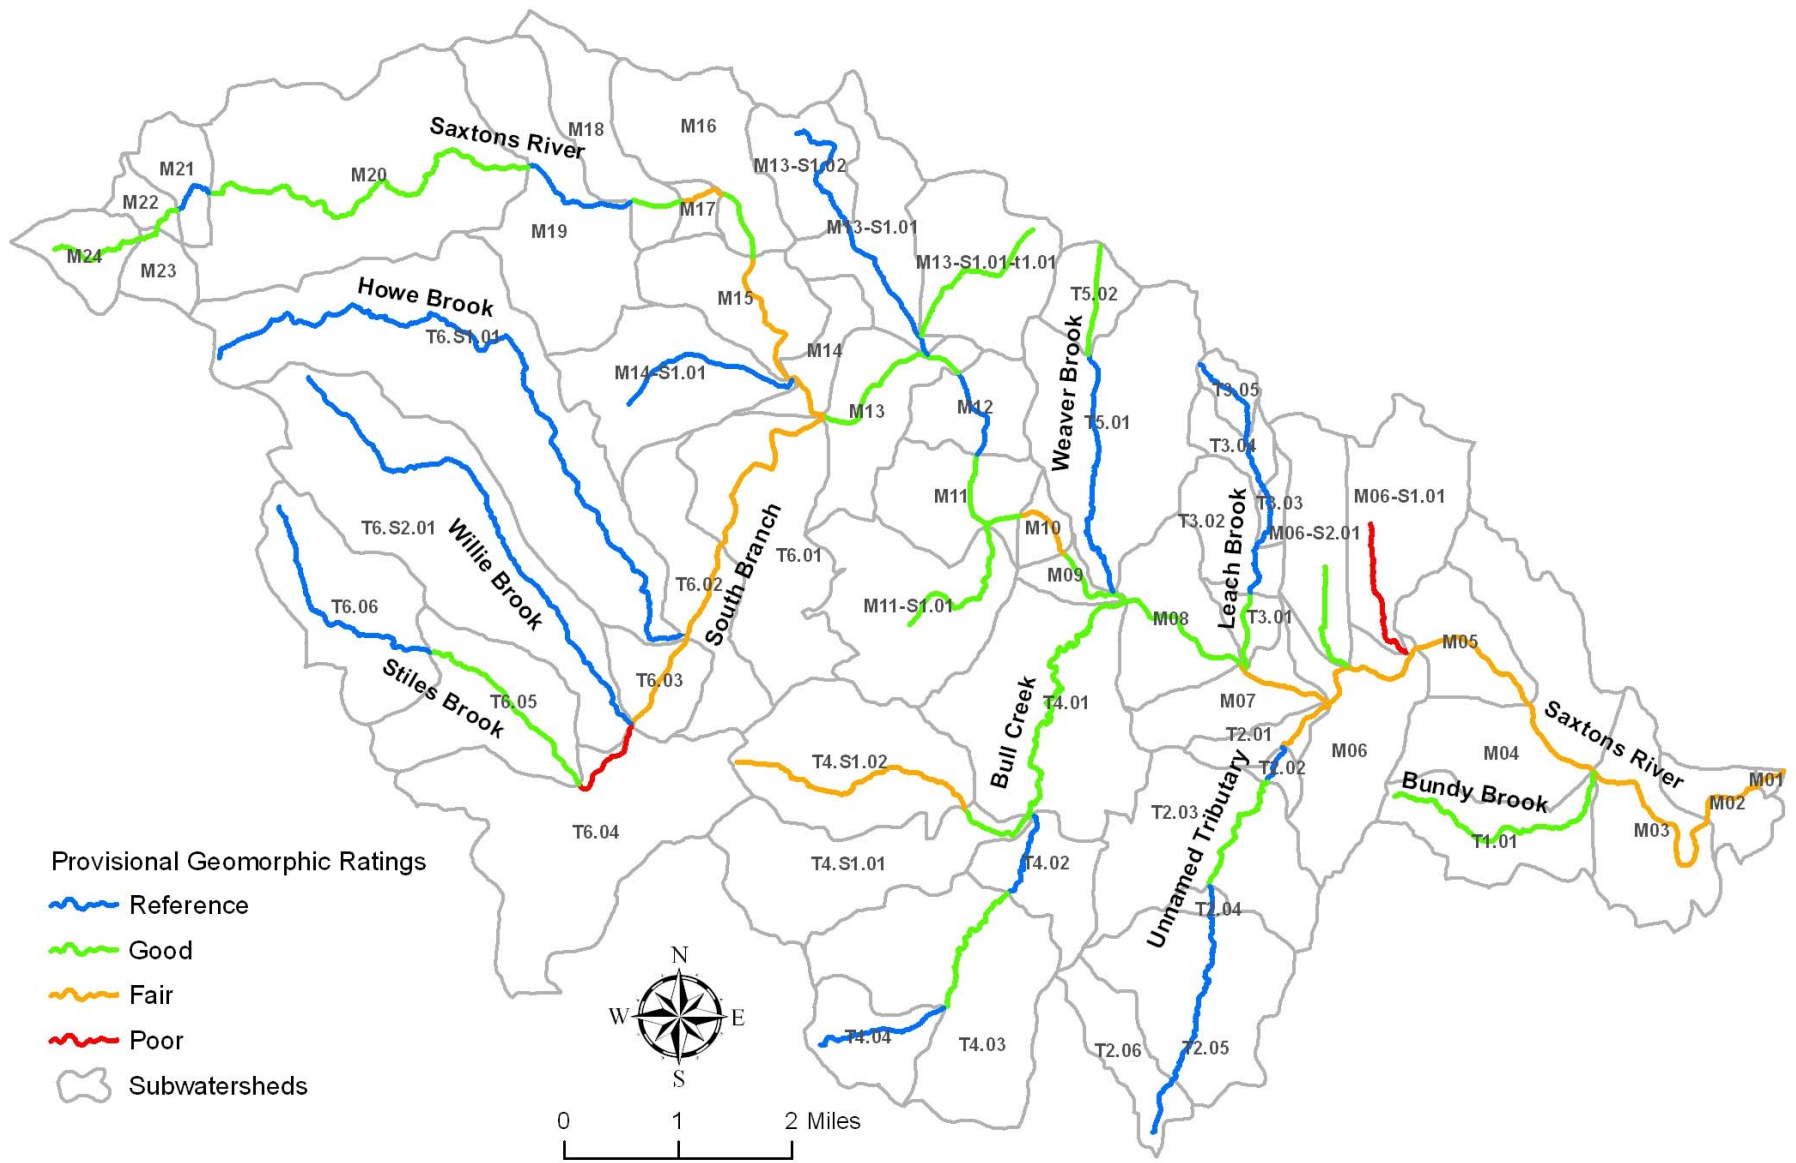
Based on the Phase 1 impact scores, the DMS also develops predictions for channel adjustment processes (VTANR, 2007b). These predictions are based on the dominant impacts recorded for each reach, and are categorized based on the impacts typically associated with the following four channel adjustment processes: 1) Degradation (e.g., channel incision); 2) Aggradation (e.g., increased sediment deposition); 3) Channel widening (e.g., increased bank erosion); 4) Planform Changes (e.g., irregular meander patterns). Using the channel adjustment process ratings, a provisional geomorphic rating is developed for each reach based on the methods outlined in the SGA Phase 1 protocols (page 76; VTANR, 2007b). Table 12 outlines the four possible geomorphic ratings based on the SGA methods, and Figure 22 presents the provisional geomorphic condition for all study reaches. An additional table in Appendix A summarizes the predicted reach adjustment processes, as well as stream sensitivity ratings. Both of these parameters have been used in conjunction with the overall impact scores in developing recommendations for further Phase 2 assessment.

Figure 22. Provisional geomorphic ratings for the Saxtons River watershed.

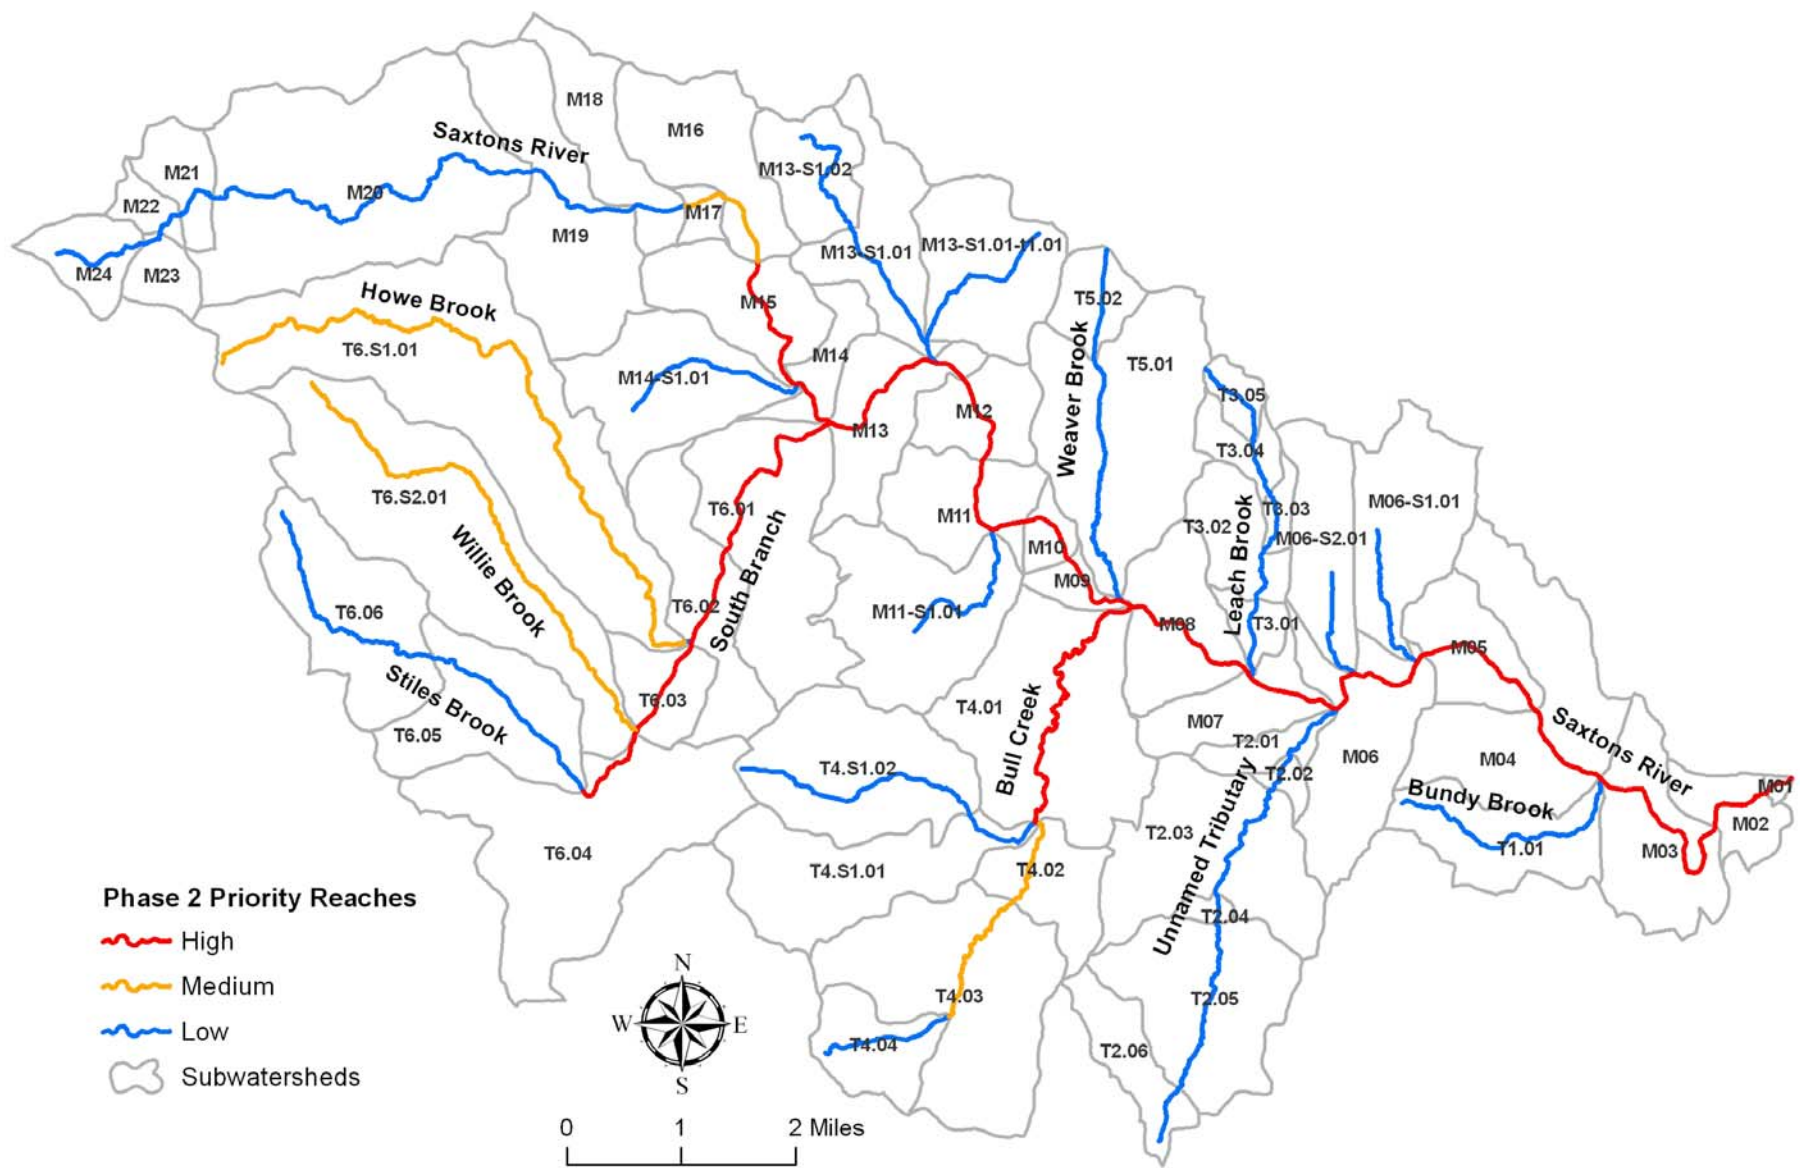
Twenty (20) reaches are considered high-priority for assessment, including 15 reaches on the mainstem, one reach on Bull Creek, and four reaches on the South Branch. The total channel length for the selected reaches is 22.7 miles. Within the list of 20 high-priority reaches, only three reaches had impact ratings that ranked higher than 20. These mainstem reaches, M10, M11 and M12, are located in between the Saxtons River and Grafton villages where fewer impacts from corridor encroachment, development, and straightening have been noted. These reaches have been included on the high-priority list due to the importance of understanding the channel adjustment processes along the entire mainstem channel network. Assessment of these reaches will help evaluate their potential as restoration areas to meet the overarching RMP objectives of fluvial erosion hazard mitigation, sediment and nutrient load reduction, and aquatic and riparian habitat protection and restoration.

Figure 23. Selected reaches for Phase 2 assessments.

Using the Phase 1 Impact Ratings as the primary basis for reach selection, a list of high and medium-priority reaches has been compiled for further Phase 2 surveys. Figure 23 presents the selected reaches by location in the watershed. Table 13 summarizes the selected reaches based on watershed location, channel length, and preliminary reference stream type. The total impact scores have been ranked for all 59 study reaches, with the lowest values representing the highest scores and impacts.
