Bear Creek **Environmental**

Phase I Stream Geomorphic Assessment
Neshobe River
Town of Goshen
Addison County, Vermont

DRAFT

June 10, 2004

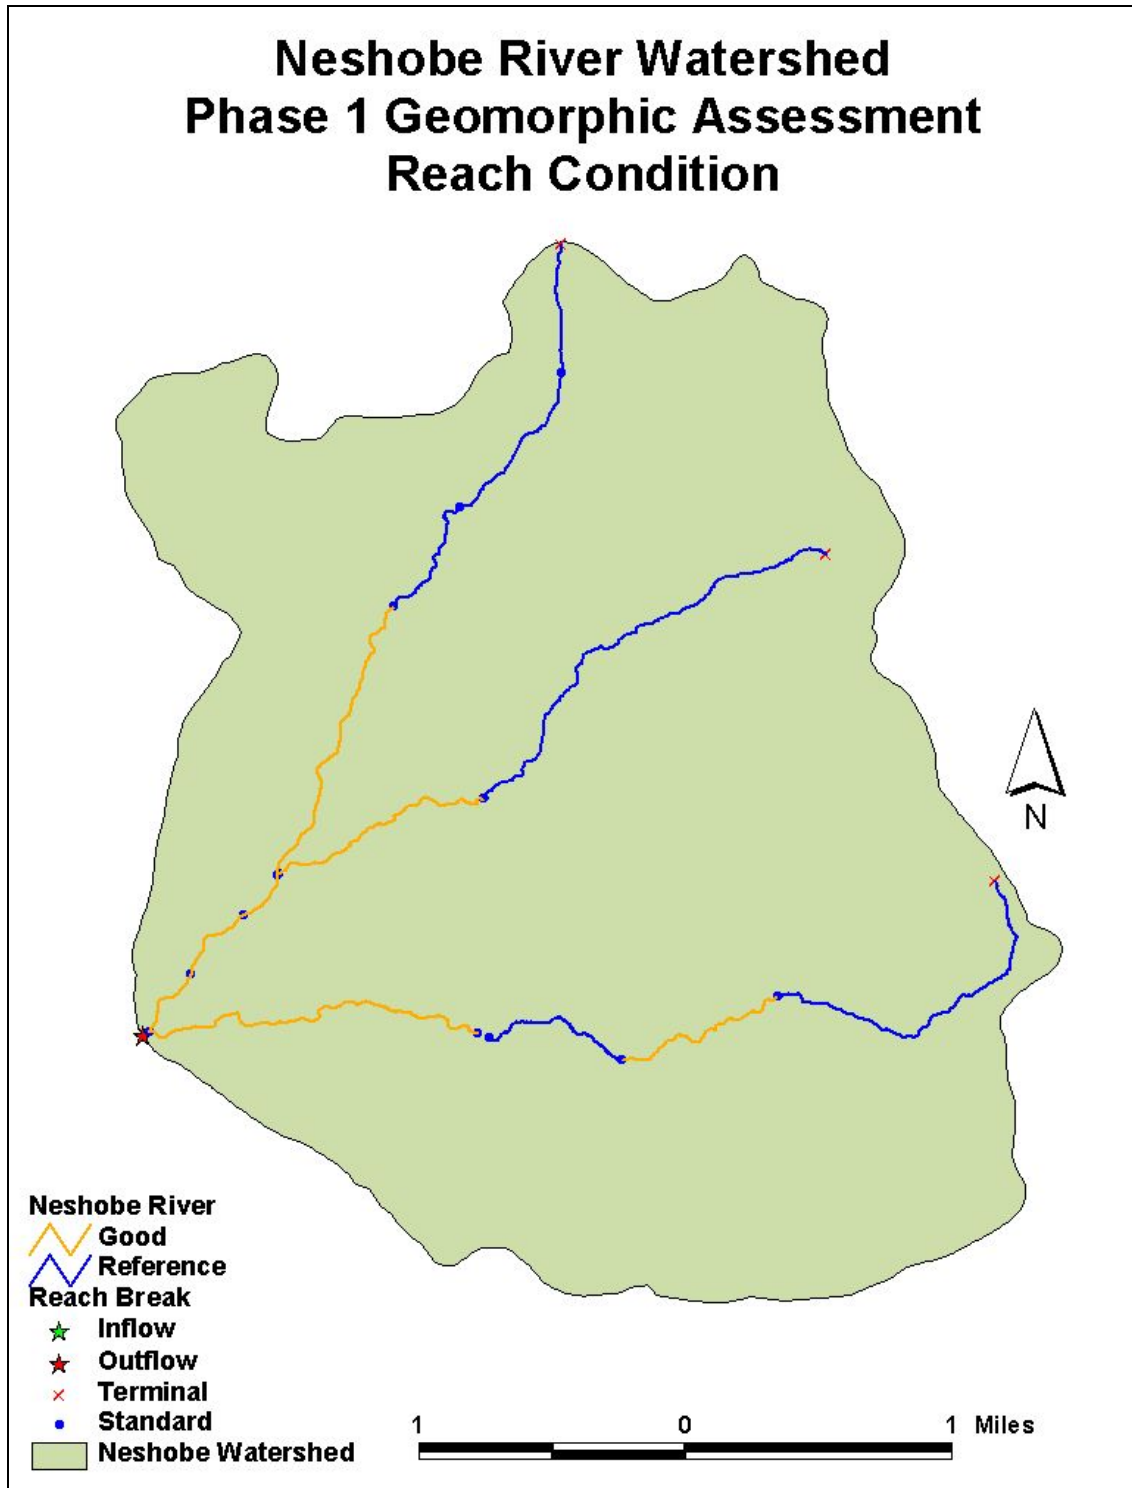
Figure 9. Reach Condition

The total impact scores for the Phase I assessment are provided in Report 8, on page 13 of the Appendix and are mapped below in Figure 8. As shown in Table 3, the within watershed condition generated from the Phase I database was generally similar to the reach condition based on professional judgment and observations during the Phase I windshield survey. The largest difference was noted for reaches, which were rated in poor or fair condition by the database. Based on the windshield survey, none of the reaches were considered in fair or poor condition. Streams in fair condition are fully in adjustment and are experiencing major and rapid changes due to recent floodplain and channel modifications, land cover changes, and/or loss of riparian buffer. None of the reaches appeared to be undergoing active incision (i.e. headcutting), widening, or rapid lateral movement.

Seven of the thirteen reaches were placed in the good category based on professional judgment. The streams in the good category had experienced some degree of human-induced change to their watershed, floodplain and/or channel and appeared to be undergoing only minor adjustments. The stream reaches in good condition all had at least one parameter from the instream channel modifications or floodplain modifications that was rated as a high impact. These high impacts appeared to have occurred many decades ago and were associated with floodplain and channel modifications.

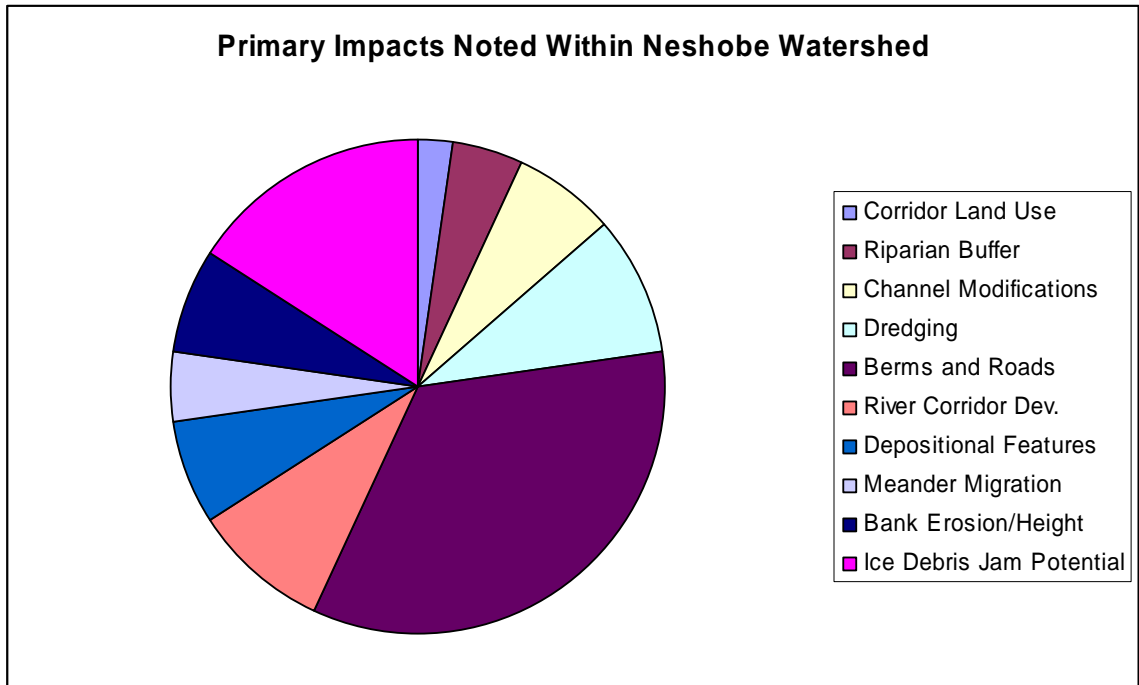
Figure 10. Impacts identified as part of remote sensing and the windshield survey

As shown in Figure 10 below, the primary floodplain modification is encroachment from berms and roads. Seven of the 13 reaches received a high impact score in the berms and roads category. River corridor development was rated as a low or high impact for five of the reaches. Instream modifications identified as possibly having a significant impact included channel modifications such as windrowing. It is likely that dredging and channel straightening occurred at the same time as the berms were constructed along the banks.
