**Restoring Water Quality in the Lake Memphremagog Basin:
River Corridor Plan for the Barton and Johns Rivers**

Melissa Dyer
December 19, 2008

Final Report for the 2007-2008 River Corridor Grant

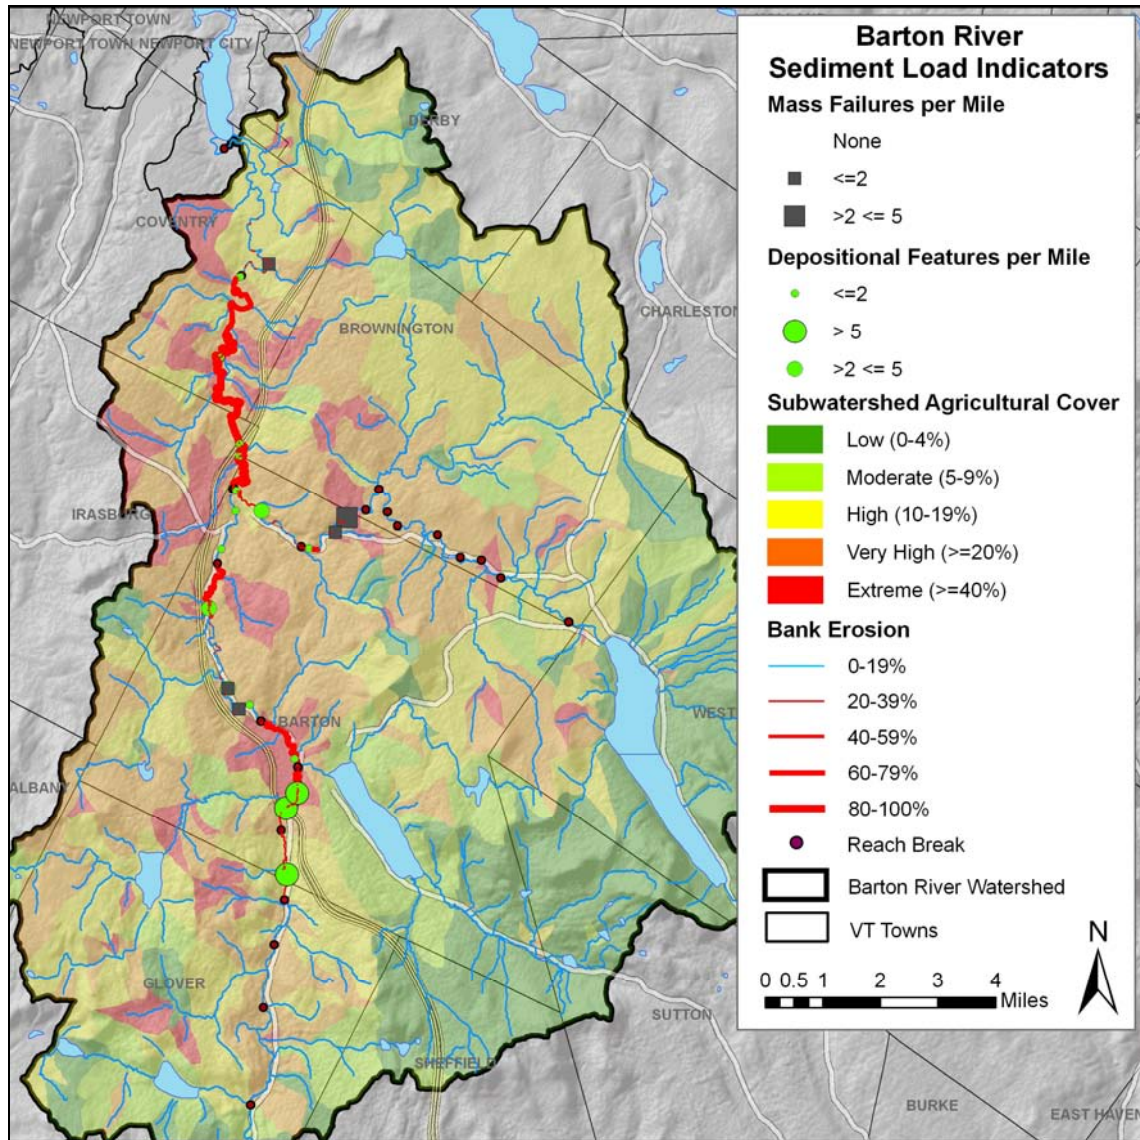
Figure 8. Sediment load indicators in the Barton River Watershed. Mass failures, bank erosion, and depositional features are for Phase 2 Reaches only.

Indicators and sources of the sediment load within the Barton River watershed are displayed in Figure 8. Bank erosion has been displayed for all assessed Phase 2 reaches and was common throughout the Barton River with the exception of South Bay WMA (Reach M02). Erosion was uncommon on the Willoughby River, except in the Willoughby Falls WMA and some isolated areas upstream. Mass failures, which occur when a river erodes a hillside, are large sources of sediment and are displayed in Figure 8 as normalized values for each stream reach (number of features per river-mile). They were very commonly observed along the Willoughby River, and smaller failures were occasionally observed on the Barton River. These large sediment sources may explain the dynamic nature of the Willoughby River observed just upstream of its confluence with

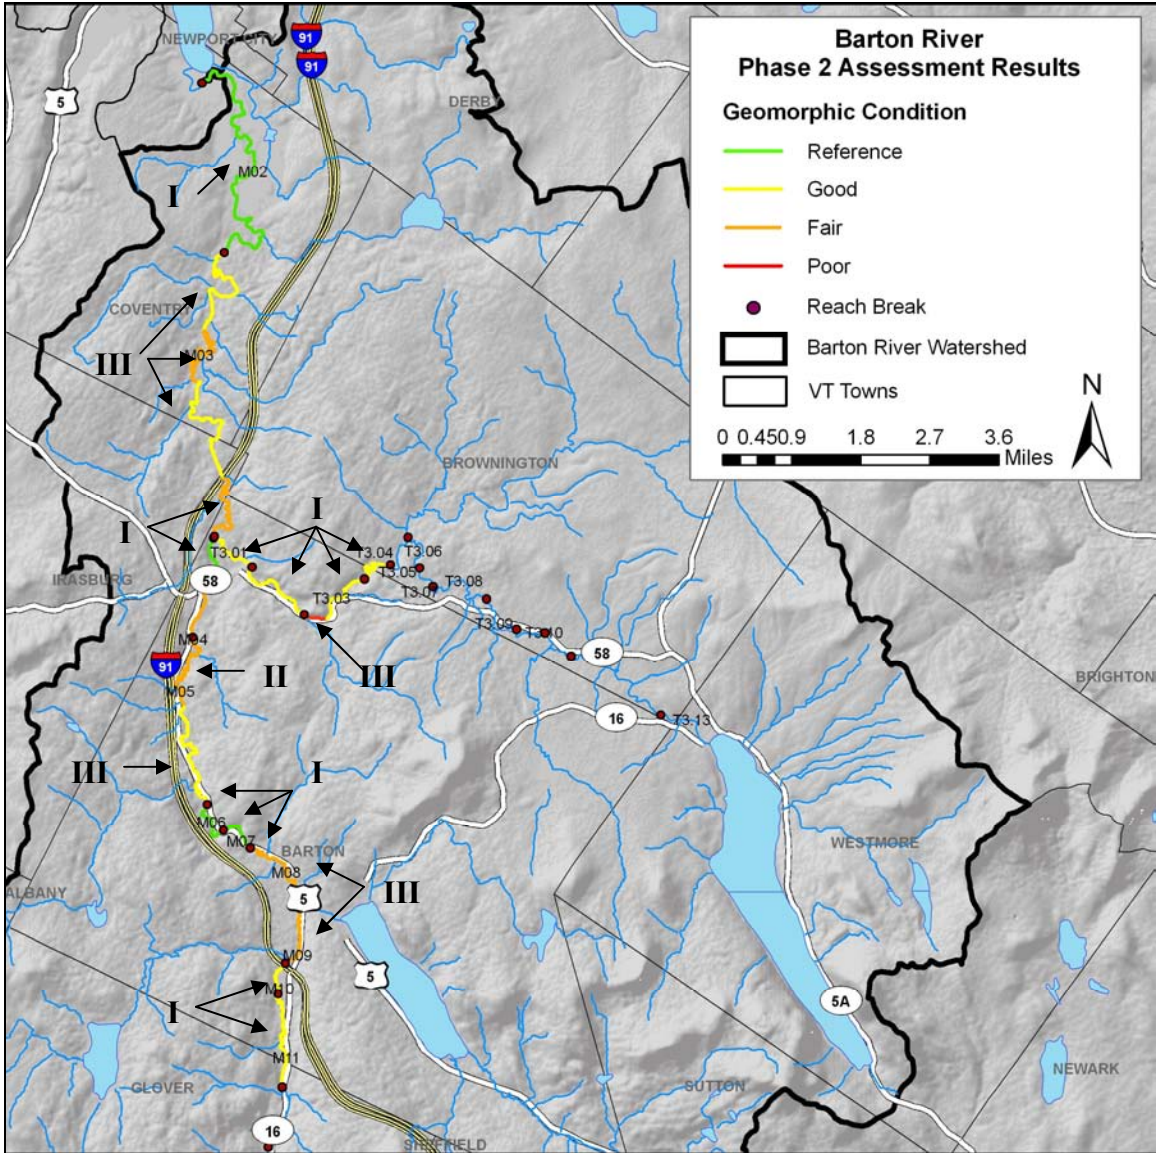
Along the Barton River, 28% of assessed reaches are in reference condition, 35% are in good condition, and 37% are in fair condition (Figure 11). Most reaches are either in Stage I or Stage III of channel evolution; those in Stage III are incised and reacting to modifications to the channel and watershed. Along the Willoughby River, 92% of assessed reaches are in good condition and 8% are in poor condition. All reaches are in Stage I of channel evolution except for a single Stage III segment. Man-made stressors to the Willoughby River watershed are minimal, but the river does receive large sediment inputs from multiple mass failure sites.

Figure 11. Map of geomorphic conditions in the Barton River Watershed. Channel evolution stages are in black.

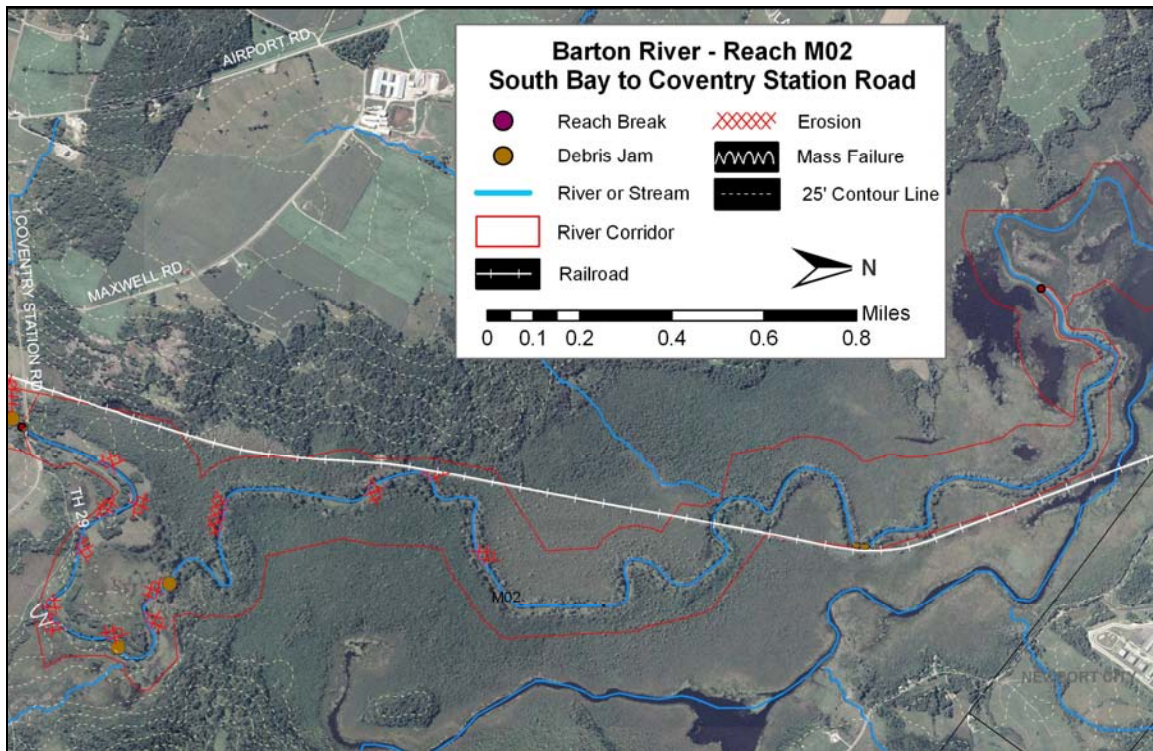
Barton River Reach M02 – South Bay to Coventry Station Road

Reference Stream Type: E dune-ripple, sand
Geomorphic Condition: Reference
Channel Evolution Stage: I (stable)
Habitat Condition: Reference
Stream Sensitivity: High

Figure 12: Results for Barton River reach M02, which traveled through the South Bay Wildlife Management Area before entering Lake Memphremagog.

Reach M02 is a long, slow, and sandy portion of the Barton River which flows entirely through the South Bay Wildlife Management Area. Riparian habitat here is notably intact and excellent. Aquatic plants, mussels, and schools of fish were observed throughout the reach. Most of the corridor is forested with native floodplain tree species; the only exception being the abandoned fields in the vicinity of Coventry Station Road.

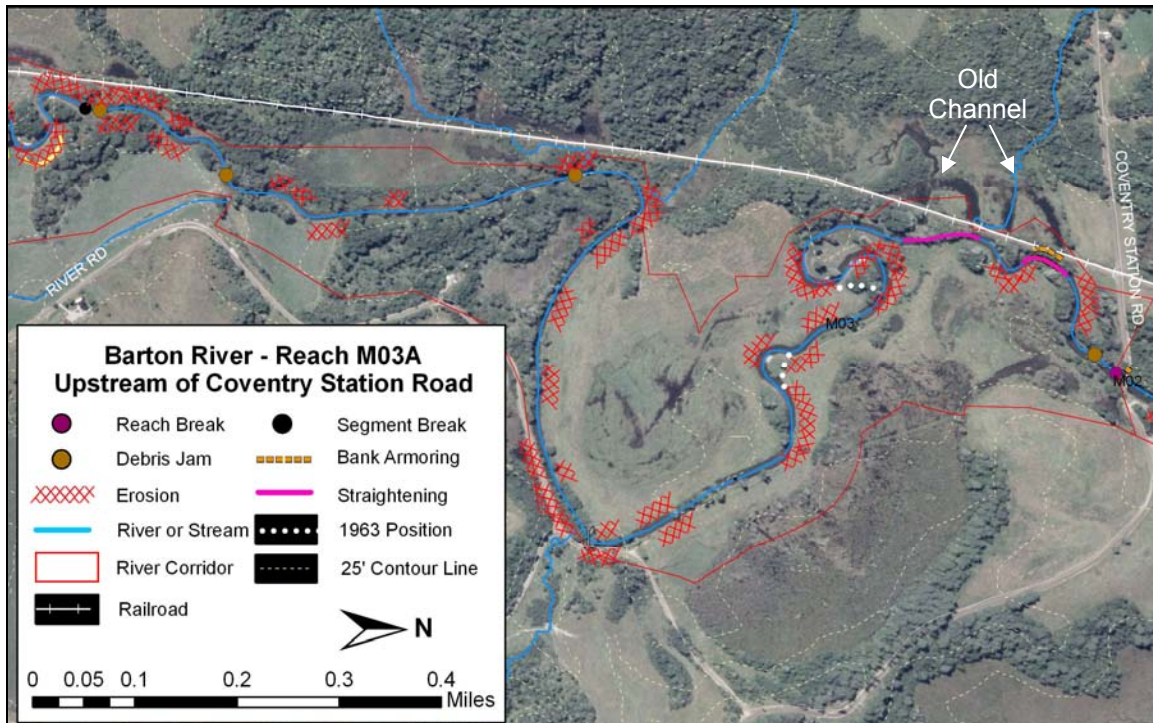
Barton River Reach M03A – Upstream of Coventry Station Road

Reference Stream Type: E dune-ripple, sand
 Geomorphic Condition: Good
 Channel Evolution Stage: III (widening)
 Habitat Condition: Good
 Stream Sensitivity: High

Figure 13: Phase 2 results for Barton River reach M03A in Coventry.

Reach M03A flows slowly through forests and fallow fields between River Road and the railroad in Coventry (Figure 13). Although two meanders were cut off since the construction of the railroad, most of the channel remains undisturbed. Some channel migration has occurred since the 1960s, but the channel is largely stable. The river is incised (incision ratio 1.5) and appears to be widening. Woody riparian vegetation is uncommon along the stream banks in the northern half of the segment. Bank erosion and leaning trees are found along 60% of this segment. Since the majority of the erosion

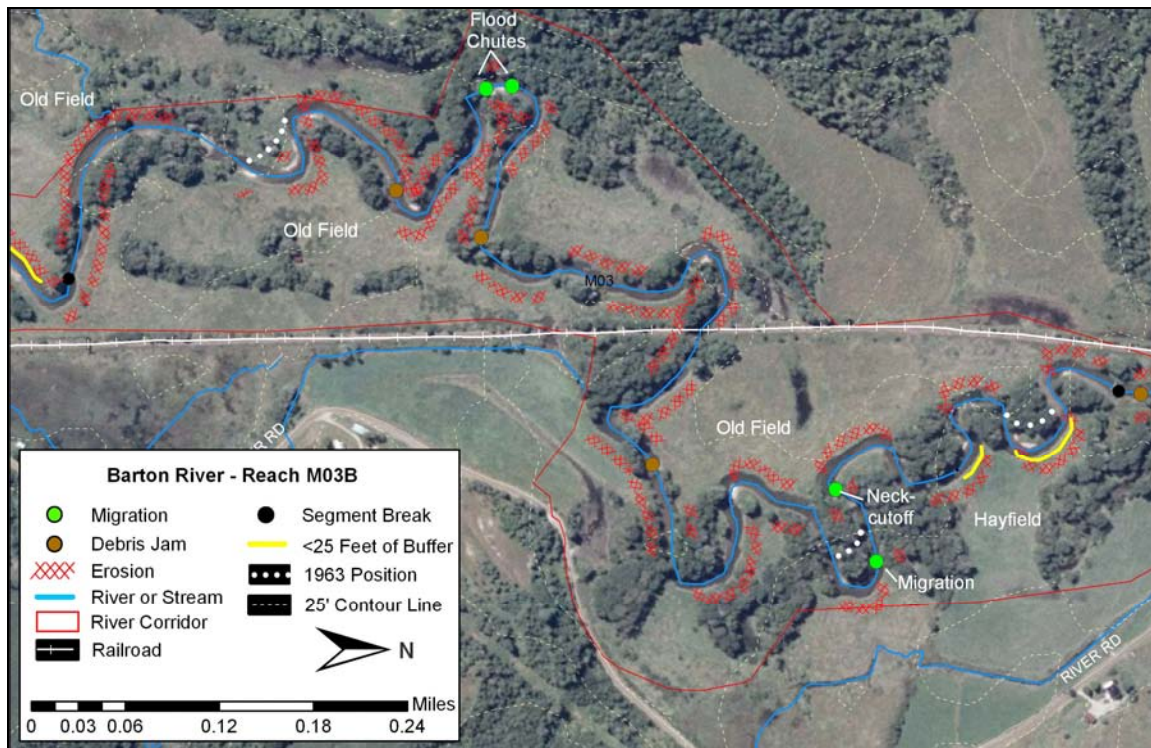
Figure 15. Results for Barton River Reach M03B

Most of the river corridor along reach M03B (Figure 15) consists of unmanaged fields with pockets of natural deciduous vegetation. This reach is slightly incised (incision ratio 1.3) and is migrating (note the river's 1963 position), as evidenced by the multiple migration and erosion features observed throughout the reach. Normally erosion occurs on the outside of meander bends, while sediment deposits on point bars on the inside of meander bends. On this reach there are several eroding point bars, particularly in the middle section. Excessive sediment inputs from upstream and in-reach combined with the lack of stabilizing woody vegetation (note that erosion is predominantly along stream banks that lacked trees) are likely causing the channel's migration.

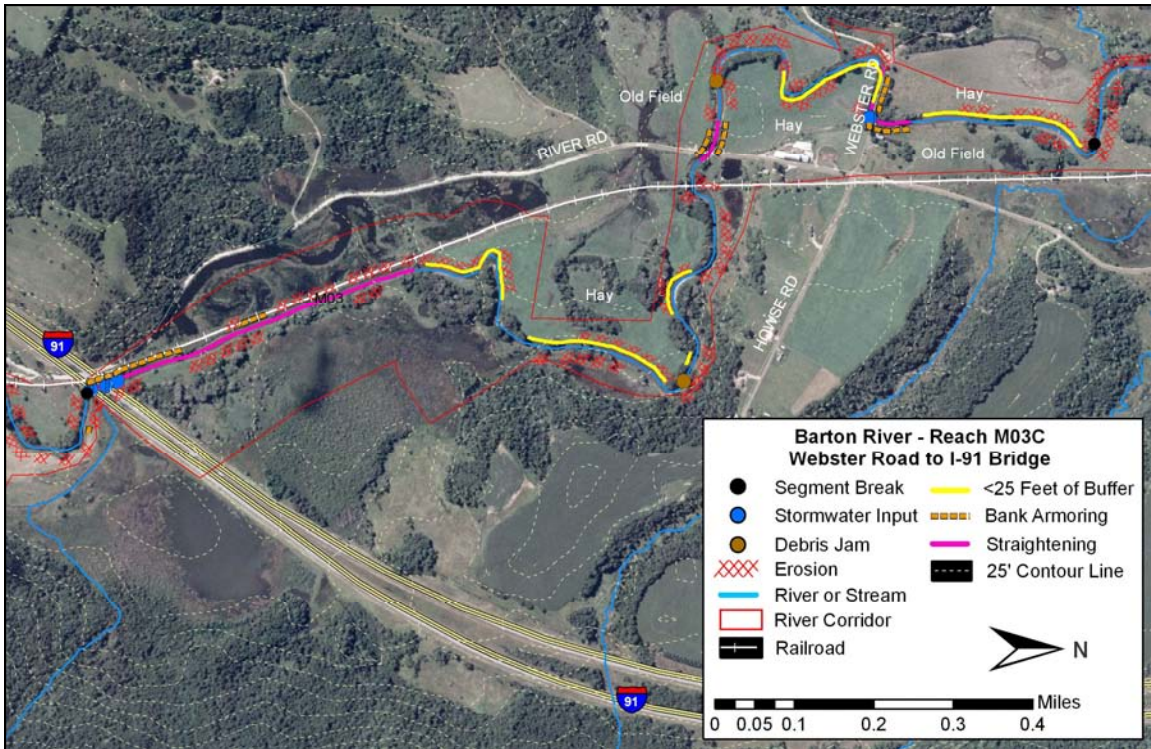
Barton River Reach M03C – Webster Road to I-91 Bridge

Reference Stream Type: E dune-ripple, sand
Geomorphic Condition: Good
Channel Evolution Stage: III (widening)
Habitat Condition: Fair
Stream Sensitivity: High

Figure 16. Results for Barton River Reach M03C.

Much of the river corridor along Reach M03C (Figure 16) is Class 2 wetland based upon the Vermont Significant Wetland Inventory. Much of this wetland has been altered, however, due to haying and filling of the floodplain to accommodate the railroad. Thirty percent of the reach has been straightened (note old river channel cut off by the railroad) and armored, though portions of the bank armoring along the railroad are failing. This reach is slightly incised (incision ratio 1.3) and erosion was observed along most outside bends, though less severe than in the adjacent upstream reach.

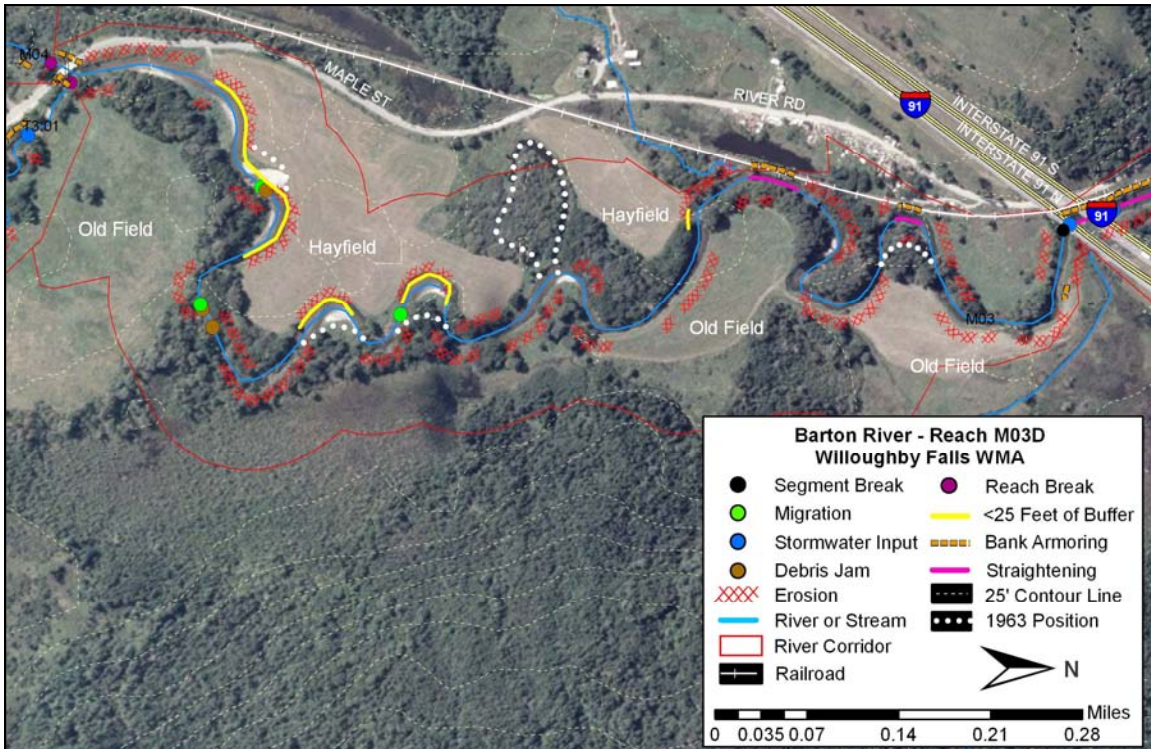
Barton River Reach M03D – Willoughby Falls Wildlife Management Area

Reference Stream Type: E dune-ripple, sand
 Geomorphic Condition: Fair
 Channel Evolution Stage: I (stable)
 Habitat Condition: Good
 Stream Sensitivity: Very High

Figure 17. Results for Barton River Reach M03D, which flows through the Willoughby Falls Wildlife Management Area.

Reach M03D flows in its entirety through the Willoughby Falls Wildlife Management Area (WMA). It is naturally dynamic due to receiving flows and sediment from the Willoughby River, the Barton River’s largest tributary. This reach is slightly incised (incision ratio 1.2) and abundant sediment deposition was noted on both the bars and the stream bed. While bank erosion and leaning trees are present throughout the reach on outside meander bends, erosion is more severe near the Willoughby River confluence.

The land along the left bank is mowed to the river’s edge, leaving no vegetated buffer to keep 12’ high banks from eroding into the channel (Figure 17). We anticipate this reach to be dynamic in the future, and recommend that the existing hayfield be reduced or retired within the river corridor to accommodate changes in the river planform. Additionally we recommend planting a wide buffer (>50’) of native trees found in the area such as willow, silver maple, and ash to protect the riverbanks and improve wildlife habitat.

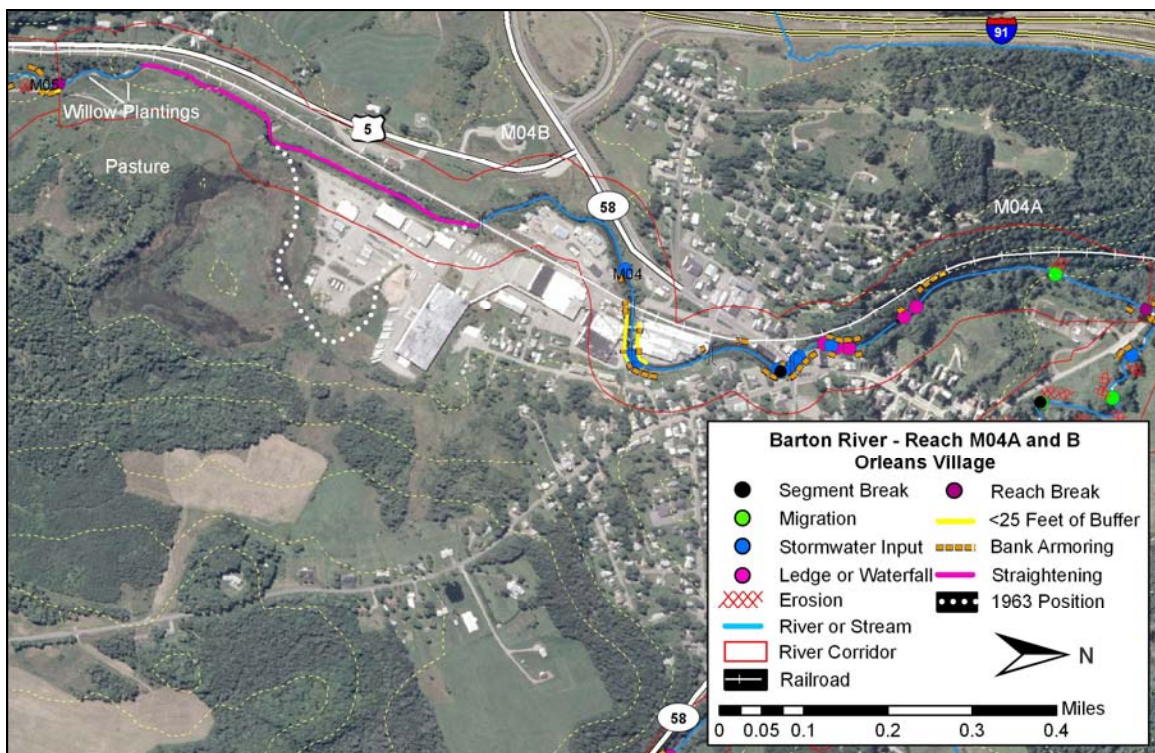
Figure 19: Phase 2 results for Barton River Reach M04A and B, which flows through Orleans Village.

M04A is a confined, bedrock-dominated segment with several bedrock ledges and waterfalls (Figures 19 and 20). Concerns with this reach are minimal due to the non-erosive bed and bank sediments. Steep slopes and the railroad along the left bank discouraged development and buffers >100' wide dominate that side; Willoughby Falls WMA lies along the right bank. M04B is a slow, deep, and highly-altered segment that flowed through the Ethan Allen furniture plant as it passes through Orleans Village. Much of the reach is straightened, and an entire meander has been cut off to make room for part of the Ethan Allen plant (note 1963 position). Additionally, much of the floodplain area has been cut-off due to railroad and road encroachments. One portion of this straightened section contains banks exceeding 15' in height, however this is not the case for the overwhelming majority of the reach, which is only slightly incised (incision ratio 1.3). Depositional features are rare in this segment; straightening, berms, and development activities have eliminated the reach's ability to meander and develop gravel bars. Instead, sediment generated within the reach and upstream of it is transported to the already dynamic Reach M03.

Because most of the river corridor is already developed, options to improve river morphology and habitat conditions are limited. Willow plantings and tree revetments were implemented on the upstream portion of this reach by Lake Region High School teacher Greg Hennemuth several years ago and have stabilized those banks well.

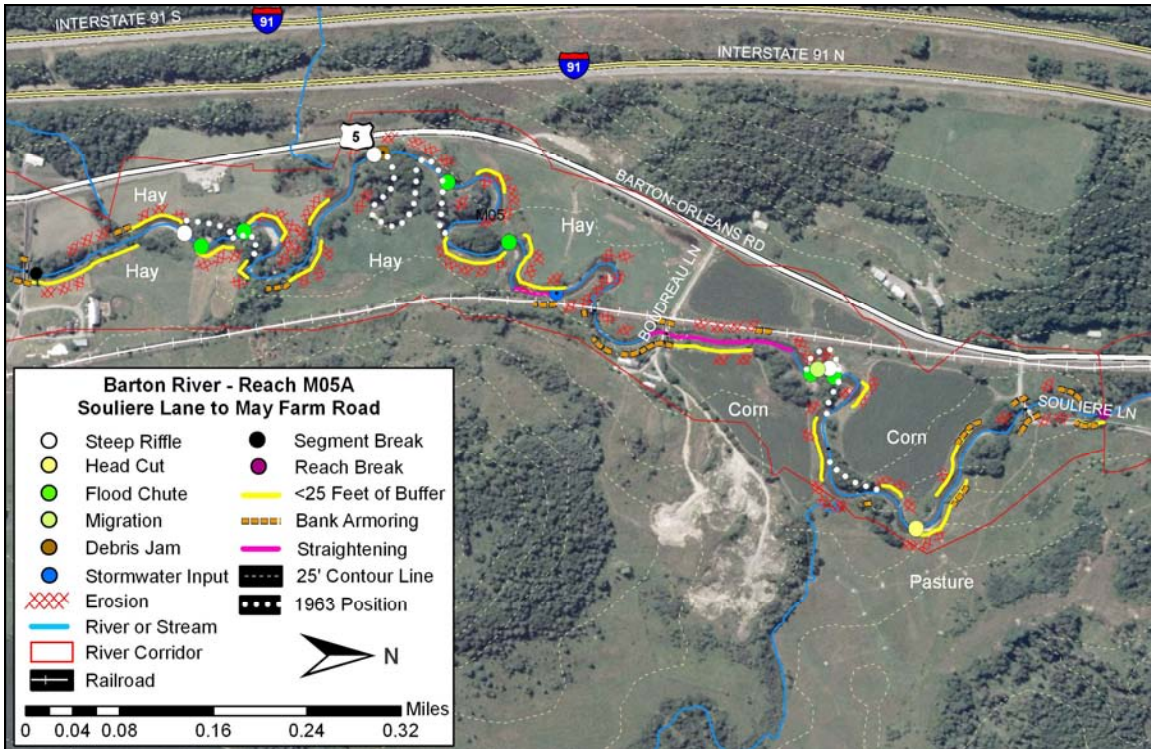
Figure 21: Results for Barton River reach M05A. High levels of erosion were observed on most outer meander bends.

The corridor is almost entirely in agricultural use and the river lacks a buffer in many areas (Figure 21). Erosion is occurring throughout the reach, with high slumping banks common. One 30’ high mass failure is present in the vicinity of Boudreau Lane. The streambed is very soft throughout most of the reach and large gravel bars are common. The channel is incised (incision ratio 1.6) and unstable. Several significant migrations have occurred during the past few decades, and the current condition of the segment indicates that this pattern will likely continue. Tree revetments were installed several years ago along the northern portion of the reach to stabilize the banks there. Most have succeeded but several sections have not.

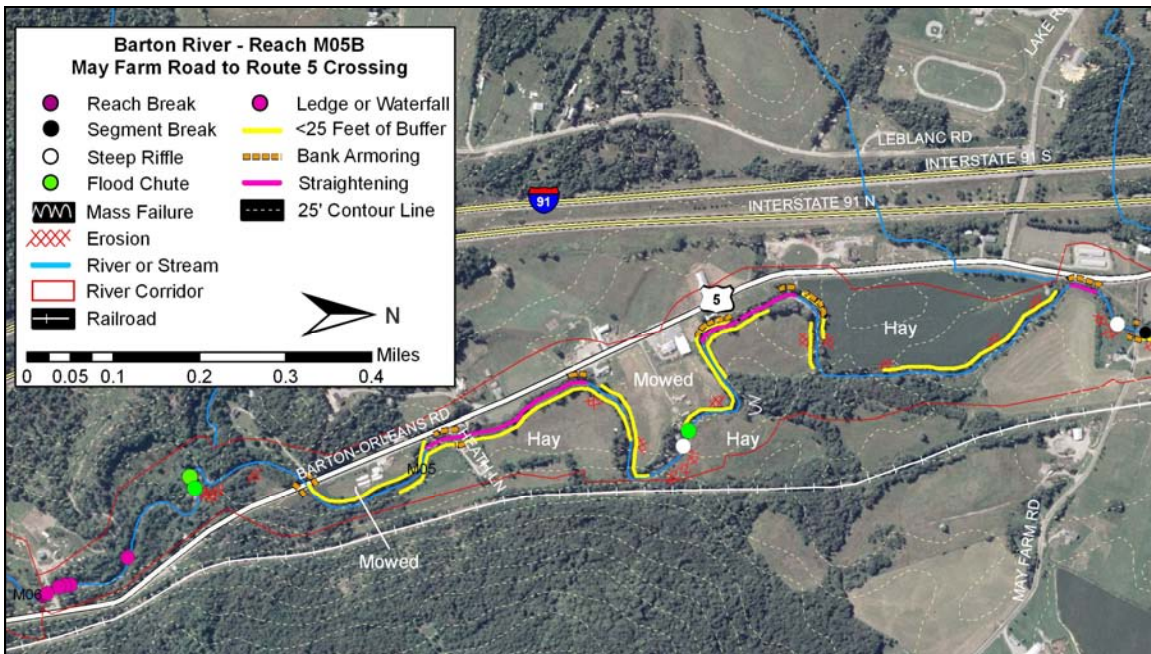
Figure 23: Results for Barton River reach M05B. Although erosion is low, most of the banks are mowed to within 25' of the river.

Like M05A, reach M05B's corridor is almost entirely devoted to agricultural use and lacks a wide riparian buffer for most of its length (Figure 23). However, M05B appears much more stable and is not incised like many of the Barton River reaches. Bank erosion is much less frequent. Most banks are covered in woody vegetation which stabilizes the banks well (Figure 24), but riparian habitat is limited. Ideally, mowing should cease within 50' of the river in order to improve habitat conditions.

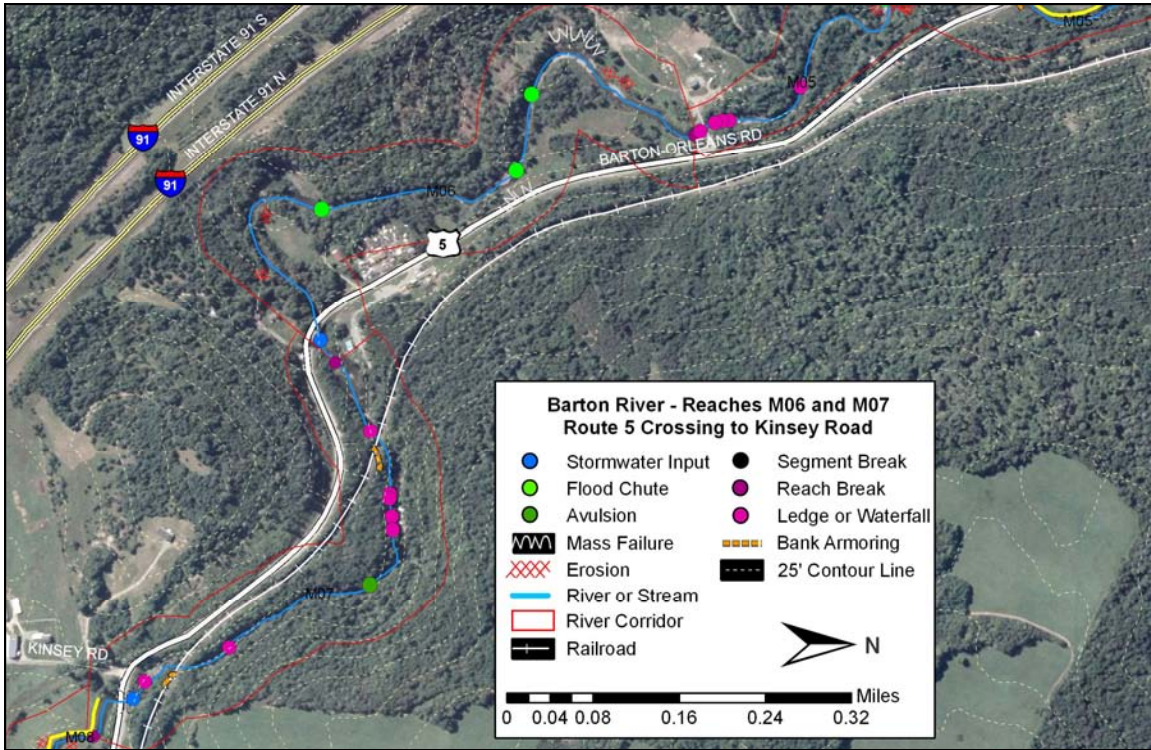
Figure 25: Results for Barton River reaches M06 and M07. Steeper slopes have limited development along the corridors here.

M06 and M07 (Figure 25) are excellent, reference-quality reaches located in a steep valley between Barton and Orleans. Both contain sections of quickwater and deep pools which provide excellent fish habitat. M06 contains cobbles and gravel as its bed sediments, while M07 is mostly bedrock with many ledges and waterfalls (Figure 26) scattered throughout the reach. Development along the corridors is limited by steep slopes and, in the case of M07, bedrock. The corridors should be protected against any future development in order to protect the uniquely intact habitats and aesthetics of the area.

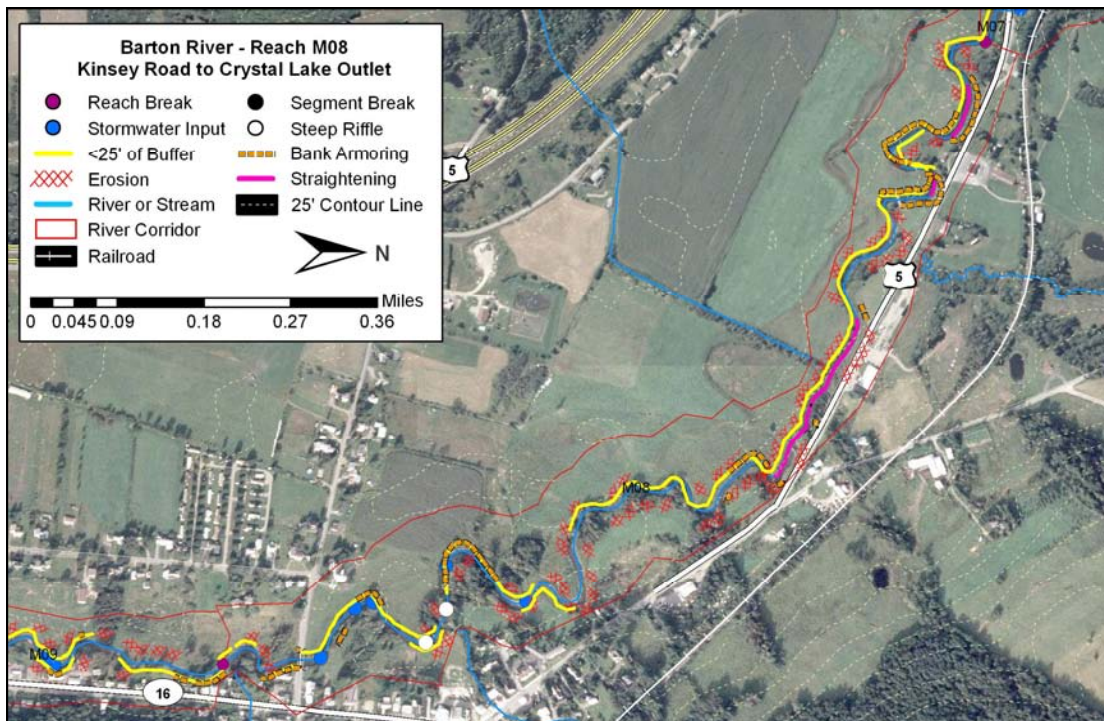
Figure 27: Results for Barton River reach M08.

Reach M08 flows through pasture for nearly its entire length. Forty-two percent of the reach has been rip-rapped, sometimes along both banks. The bank armoring is failing in many places. In areas where the rip-rap is intact, erosion is occurring along the opposite bank. Erosion is found along 77% of the reach, often along both sides. Bed sediments are very soft and the river appears very deep and slow-moving. The reach is incised (ratio 1.5) and appears to be aggrading and widening, except in places where it is fixed in place by rip-rap.

Fencing the entire corridor (which is also the entire floodplain) and establishing a forested buffer is recommended along this reach. This will greatly improve water quality, as most of the corridor is pasture and cattle are accessing the river. Portions of the reach are migrating (Figure 28), while others are fixed in place by rip-rap. An active restoration approach could include removal of the rip-rap to help the river establish an equilibrium state.

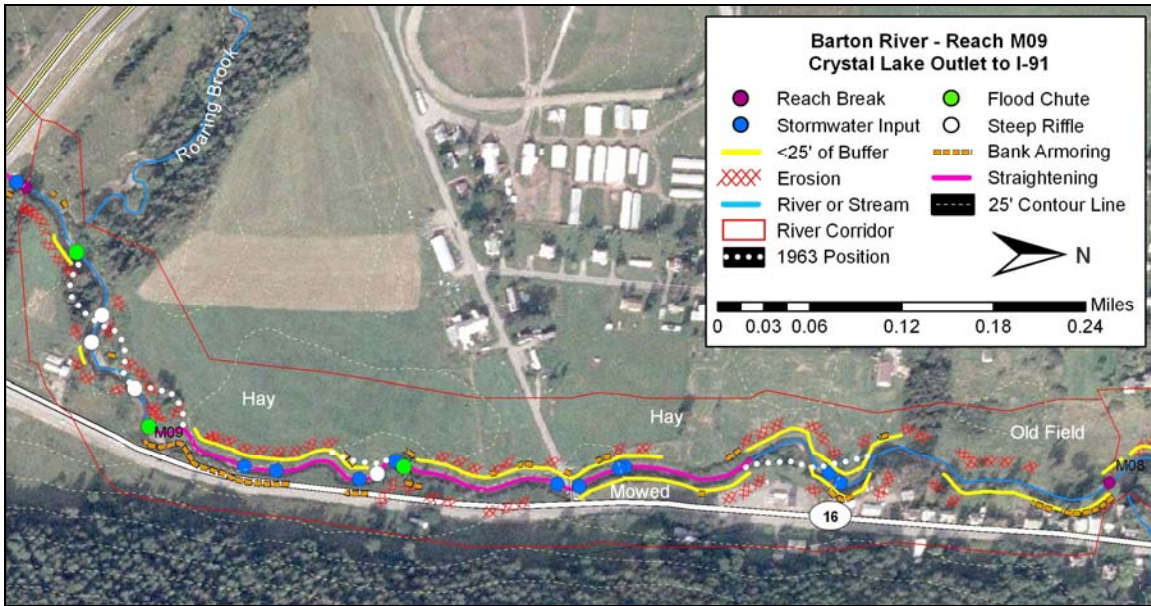
Figure 29: Results for Barton River reach M09.

Most of the northern three-quarters of reach M09 (Figure 29) appears to have been straightened historically and remnants of rip-rap are found along the reach. Multiple stormwater inputs are also found along the reach. The river is incised (incision ratio 1.5) and appears to be widening and eroding to eventually develop a more meandering planform (Figure 30). The corridor is encroached upon by Route 16 and residential development on the right side. The left corridor is managed as hay field and is mowed to within 25' of the stream banks. The left banks are covered by herbaceous vegetation and woody vegetation is rare.

Establishment of a wide strip of natural woody vegetation along the left corridor will be necessary to improve habitat and water quality conditions along this reach. It should be kept in mind that the river will likely transition to a more meandering planform in future decades. The area in the vicinity of Roaring Brook will probably always be dynamic as it reacts to the sediment and flows originating from that tributary; development and agricultural practices should be kept as far from this area as possible.

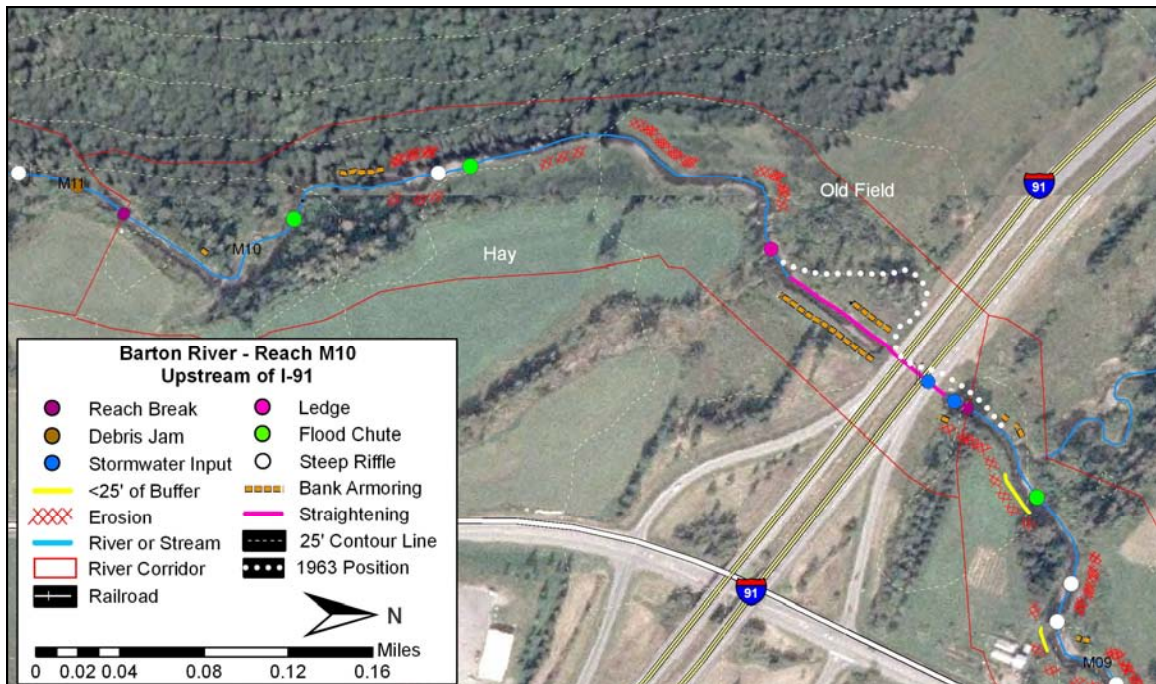
Figure 31: Results for Barton River reach M10.

Reach M10 flows through old fields and young forest. Overall, the reach is in good condition; it does not appear incised and erosion is infrequent. A portion is straightened to accommodate the I-91 bridge (Figure 31) but other human alterations of the river and its corridor are minimal. Given enough time, a forested buffer on the northern half of the reach will likely regenerate on its own. Protection of the corridor will be the key strategy to keep this portion of the river in good condition.

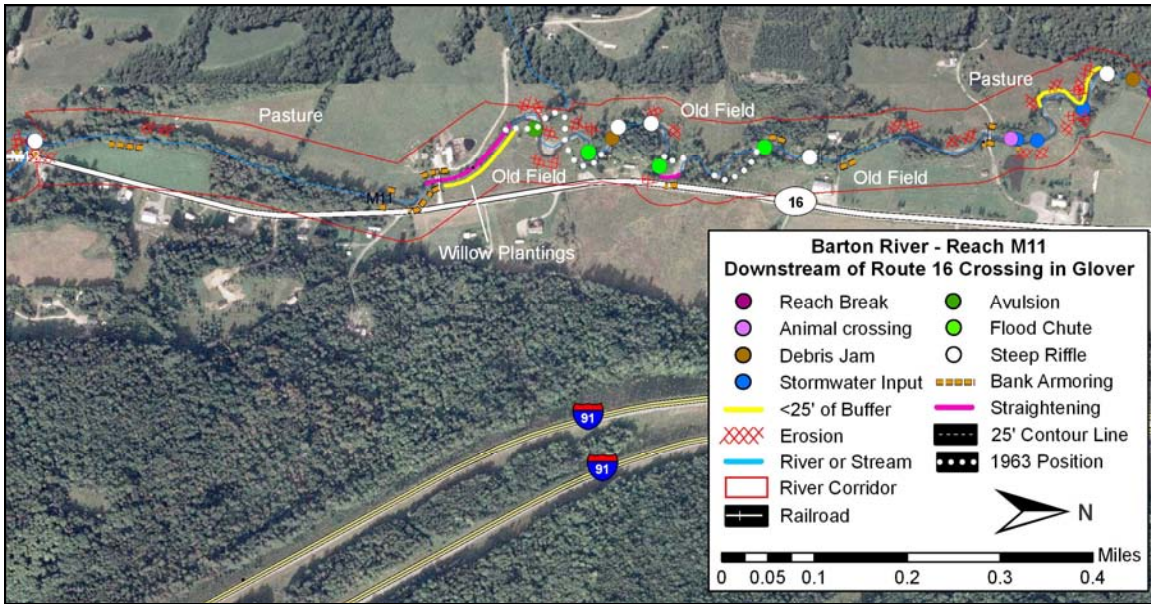
Figure 32. Results for Barton River reach M11.

Starting just below Glover Village as a fast flowing river over a cobble bed, Reach M11 (Figure 32) quickly transitions to become sinuous and dynamic. The reach has changed position in several locations since the 1963 aerial photographs were taken, and continued migration is evident, including numerous aggradational features (steep riffles, flood chutes, and an avulsion). Significant sequences of erosion and deposition were observed as well.

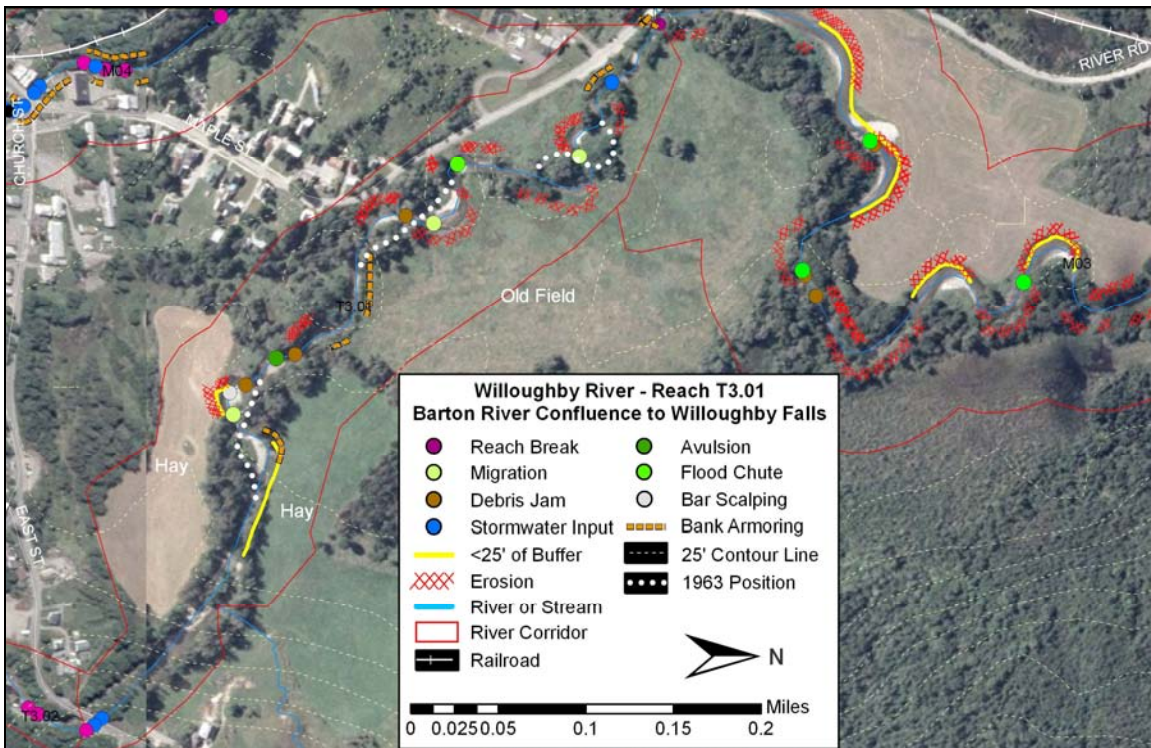
Figure 34. Results for Willoughby River reach T3.01. Note the river's 1963 position (white dotted line).

A popular fishing area, Reach T3.01 (Figures 34 and 35) is at the receiving end of several miles of fast-flowing river that has carried and deposited a significant amount of sediment originating from multiple large mass failures located several miles upstream. The river levels out at reach T3.01, and it is clear that large amounts of sediment are working through this section. This is particularly evident in segment A where sand and silt deposits are very deep. The river has migrated at several points since the 1963 aerial photos. This process seems to be ongoing, as large trees are leaning in a few areas and there are several sections with high, slumping banks. Some portions have been ripped, but it appears that these efforts have only deflected the flows to erode the downstream banks.

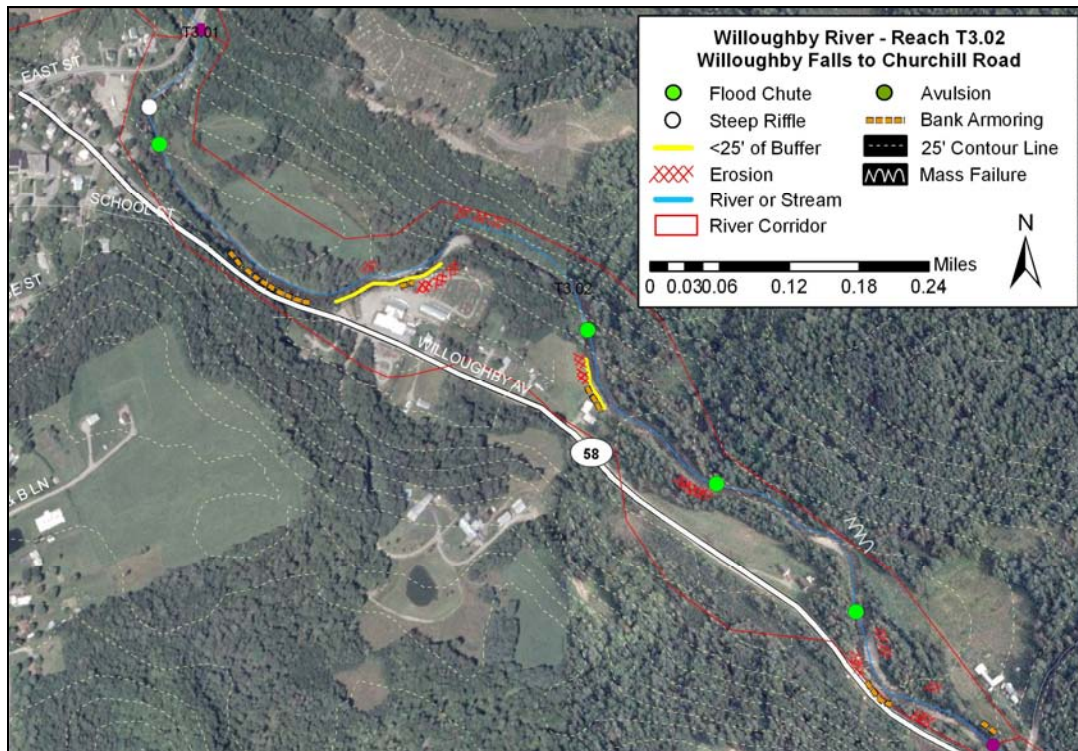
Figure 36: Results for Willoughby River reach T3.02

Reach T3.02, which includes Willoughby Falls, is in good condition overall (Figure 36). It contains many gravel bars and flood chutes due to the large amount of sediment introduced to the reach from sources upstream. Mowing has occurred up to the top of the left bank in places, but development is sparse, particularly along the steep right corridor. Typical of much of the Willoughby River, the majority of the corridor is forested and the water is swift and clear.

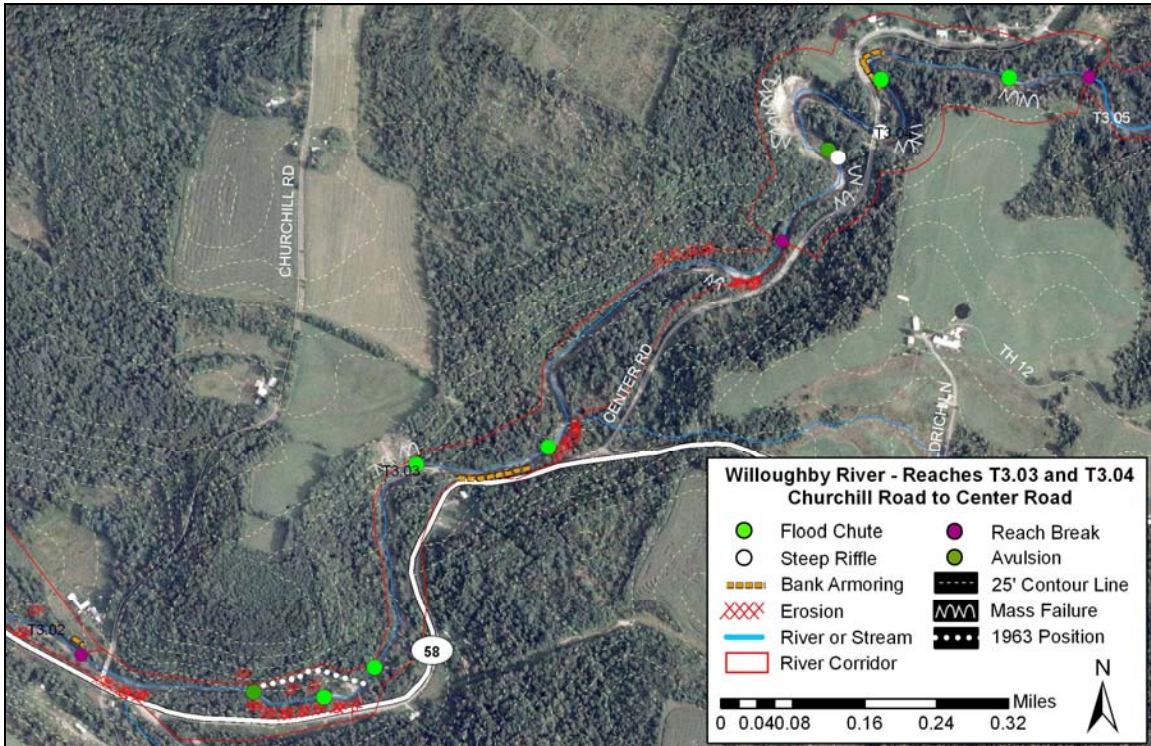
Figure 37: Results for Willoughby River reaches T3.03 and T3.04.

Reach T3.03 flows swiftly over boulders and cobbles in a mostly forested corridor (Figure 37). Reach T3.03A has avulsed; the river has abandoned its old channel (utilized in 1963) and has formed a new channel approximately 600ft in length. This section is very incised (incision ratio 2.2), with flooding only possible during very high flows. Development within this corridor is not advisable, as it is in poor geomorphic condition and further erosion and widening are anticipated. Reach T3.03B passes through two mass failure sites, which serve as large sediment sources for reaches downstream.

Another swift and boulder-dominated reach, Reach T3.04 passes through four large mass failure sites (Figure 38). Large sediment inputs manifest themselves as the multiple steep riffles and flood chutes seen along both this reach and the downstream reaches as it attempts to transport the sediment downstream. One of the steep riffles is located just upstream of the Center Road bridge and has directed the majority of the flow against the left bridge abutment.

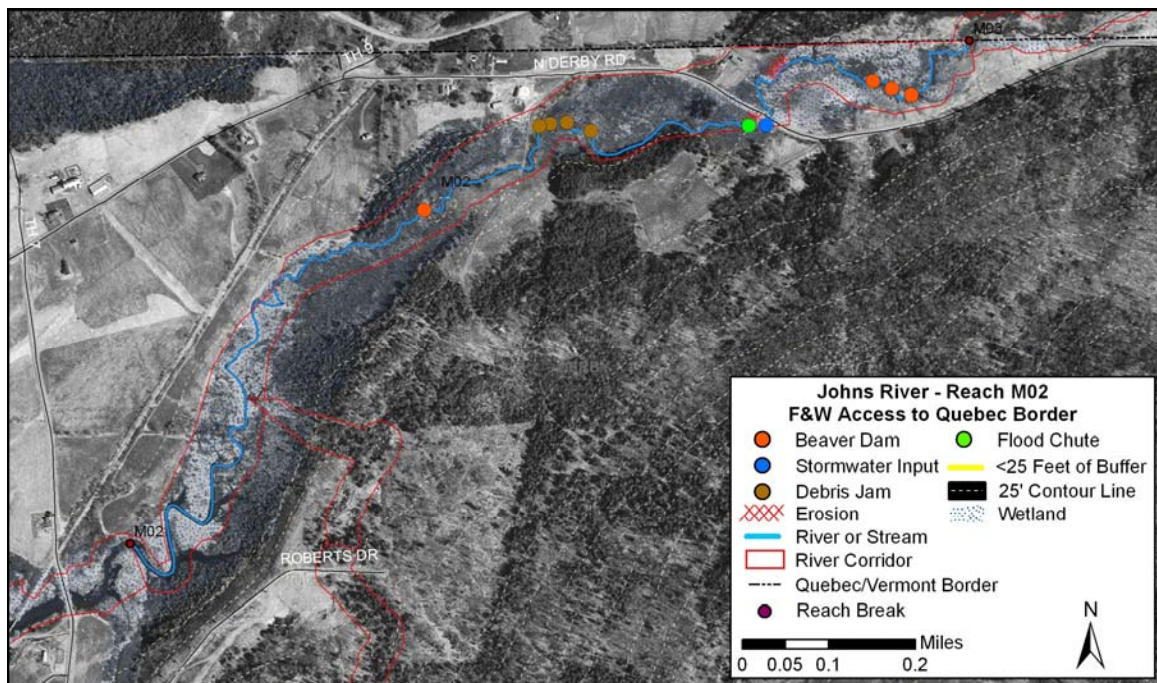
Figure 45: Results for Johns River Reach M02.

The overwhelming majority of Reach M02 is an alder wetland with minimal human impact within the channel's corridor. Most hay fields along the western portion of the reach begin at least 50 feet from the channel, due to very wet and swamp-like conditions caused by nearby Lake Memphremagog. Since the 1999 photograph shown in Figure 45, several land-use changes have occurred. A field south of North Derby Road has been abandoned and stream bank vegetation should re-establish itself well. A fenced horse pasture has been added just south of the Quebec/Vermont border but is located at least 50 feet from the river.

Reach M02 is in excellent geomorphic condition and contains excellent aquatic habitat. Restoration projects should not be necessary here, but protection of the wetlands

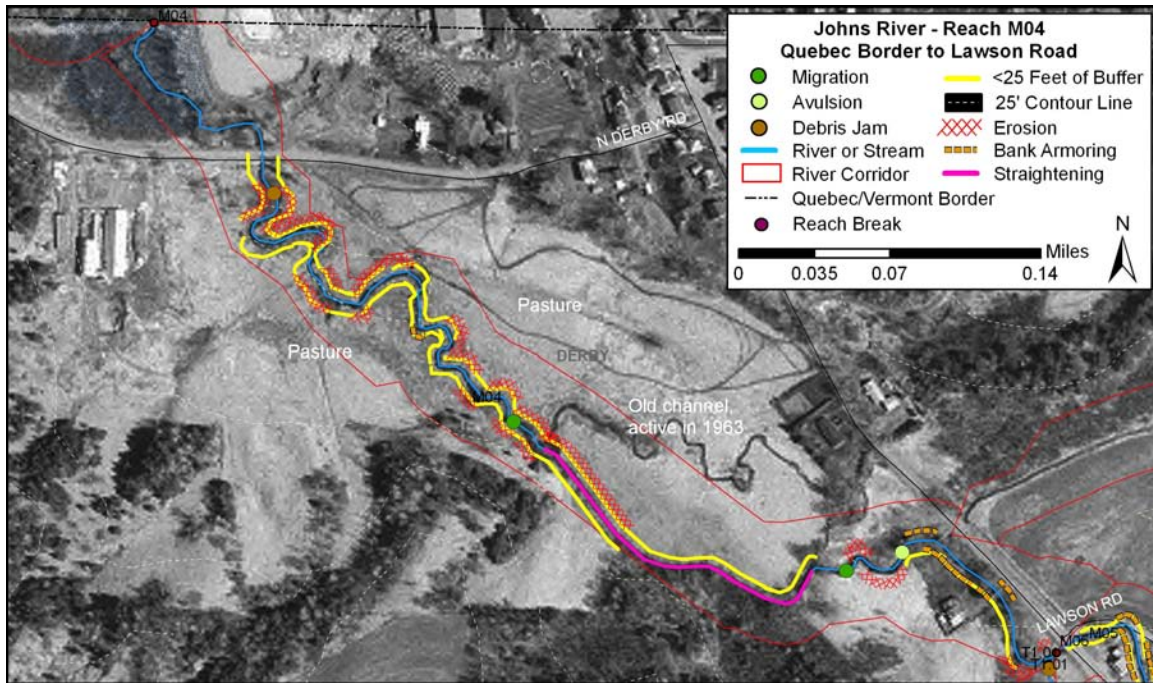
Figure 46: Results for Johns River Reach M04.

Reach M04 flows through an active pasture for nearly its entire length. An old channel (seen in Figure 46) meanders through the pasture while the river now occupies a straightened channel located against a hillside to the south of the pasture. Fencing is located along one bank in the straightened portion, set back about five feet from the river, but is absent along the remainder of the reach. Eroding banks are present throughout most of the reach, and grazing clearly occurs along most banks (Figure 47). It appears that cattle utilize the river both as a water source and to access the pasture located to the northeast of the river. Numerous drainage ditches exist in the pasture which appears to flood regularly, and was likely a wetland prior to being ditched and drained. Although these issues exist, the reach is still in good geomorphic condition because the channel is not incised and most stressors are local. Water quality would likely improve in this area if the entire northeast side of the pasture was restored. Fencing should be installed along the left corridor to allow woody vegetation to flourish and to prevent cattle from accessing the river.
