**Restoring Water Quality in the Lake Memphremagog Basin:
River Corridor Plan for the Barton and Johns Rivers**

Melissa Dyer
December 19, 2008

Final Report for the 2007-2008 River Corridor Grant

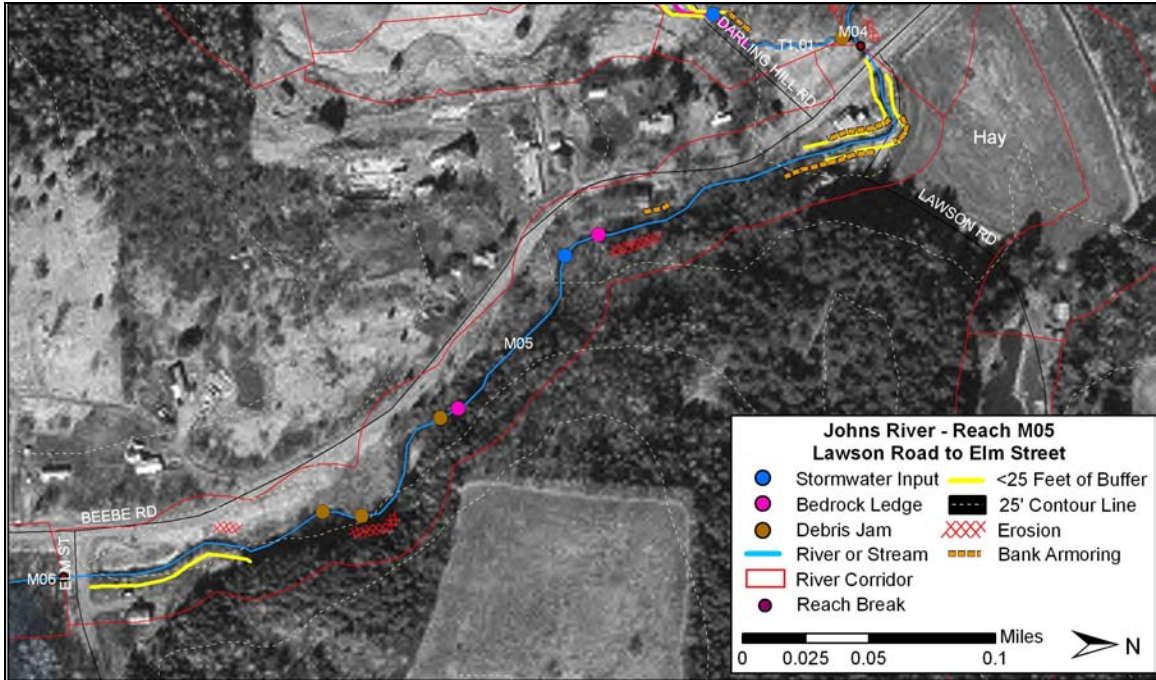
Figure 48: Results for Johns River Reach M05.

Reach M05 parallels Beebe Road, beginning and ending in residential areas (Figure 48). Development in this area is hindered by steep topography along the right bank and the road along the left. A brief section in the middle of the reach flowed between bedrock and a steep forested hillside, cascading over two bedrock ledges. Overall the reach is in excellent condition, though lawns are mowed to the bank edges near the end of the reach (Figure 49).

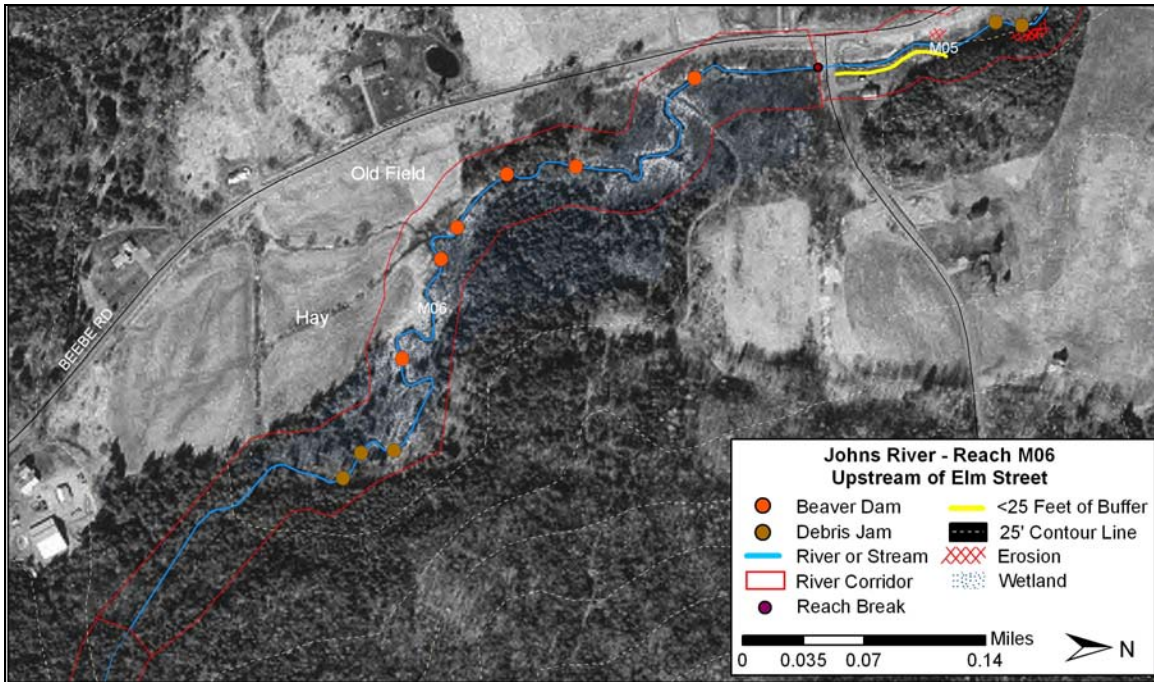
Johns River Reach M06 – Upstream of Elm Street

Reference Stream Type: E dune-ripple, sand
Geomorphic Condition: Reference
Channel Evolution Stage: I (stable)
Habitat Condition: Good
Stream Sensitivity: High

Figure 50: Results for Johns River Reach M06.

Beginning as crystal-clear water amidst a beautiful cedar forest, Reach M06 quickly becomes a multi-channeled beaver wetland. Fallen trees and debris are present throughout the reach. The entire section is affected by beaver activity and contains several dams (Figure 50) that have backed up silt for several hundred feet upstream, rendering the river un-walkable in those areas. Several of these dams have breached, resulting in silt being washed downstream. Breached beaver dams may help explain the high sediment levels observed in downstream portions of the Johns River; however this effect may be balanced by the remaining intact dams which allow sediment from upstream to settle out within the reach.

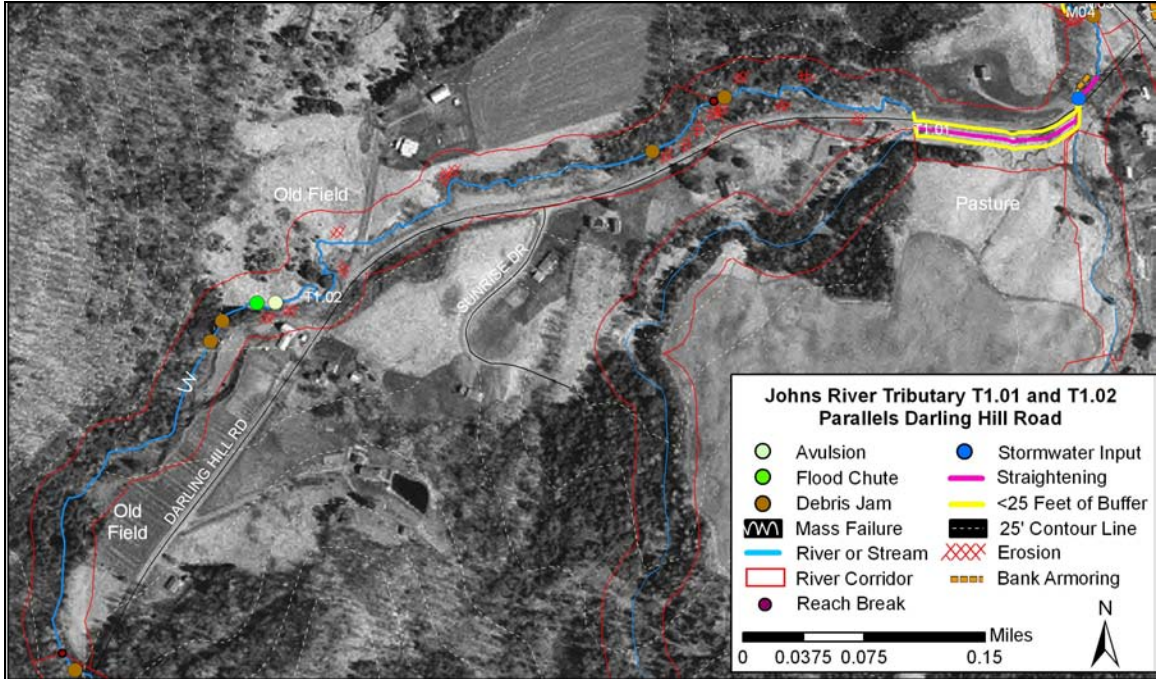
Un-named Tributary to Johns River, Reach T1.01 and T1.02
 Parallels Darling Hill Road

<u>Reach T1.01:</u>	<u>Reach T1.02:</u>
Reference Stream Type:	E dune-ripple, sand	E riffle-pool, gravel
Geomorphic Condition:	Good	Reference
Channel Evolution Stage:	I (stable)	I (stable)
Habitat Condition:	Good	Reference
Stream Sensitivity:	High	Moderate

Figure 51: Results for an un-named tributary to the Johns River, Reaches T1.01 and T1.02.

Reaches T1.01 and T1.02 (Figure 51) are portions of a small tributary which parallels Darling Hill Road before joining the Johns River. Both flow through forests and old fields, and a small portion flows along and active pasture near North Derby Road. Though high nutrient levels afflict this tributary (Dyer and Gerhardt 2007), no clear sources were observed to explain these levels in the vicinity of the stream during this assessment. These inputs likely originate from farmland along an upstream reach and runoff from elsewhere in the watershed. One culvert, at the second North Derby Road crossing, needs to be replaced or realigned, as it is more than halfway plugged with sand.
