# **Elmore Branch River Corridor Plan**

**Wolcott and Elmore, Vermont**  
**October 30, 2009**

Bear Creek Environmental, LLC

The Lamoille County Planning Commission

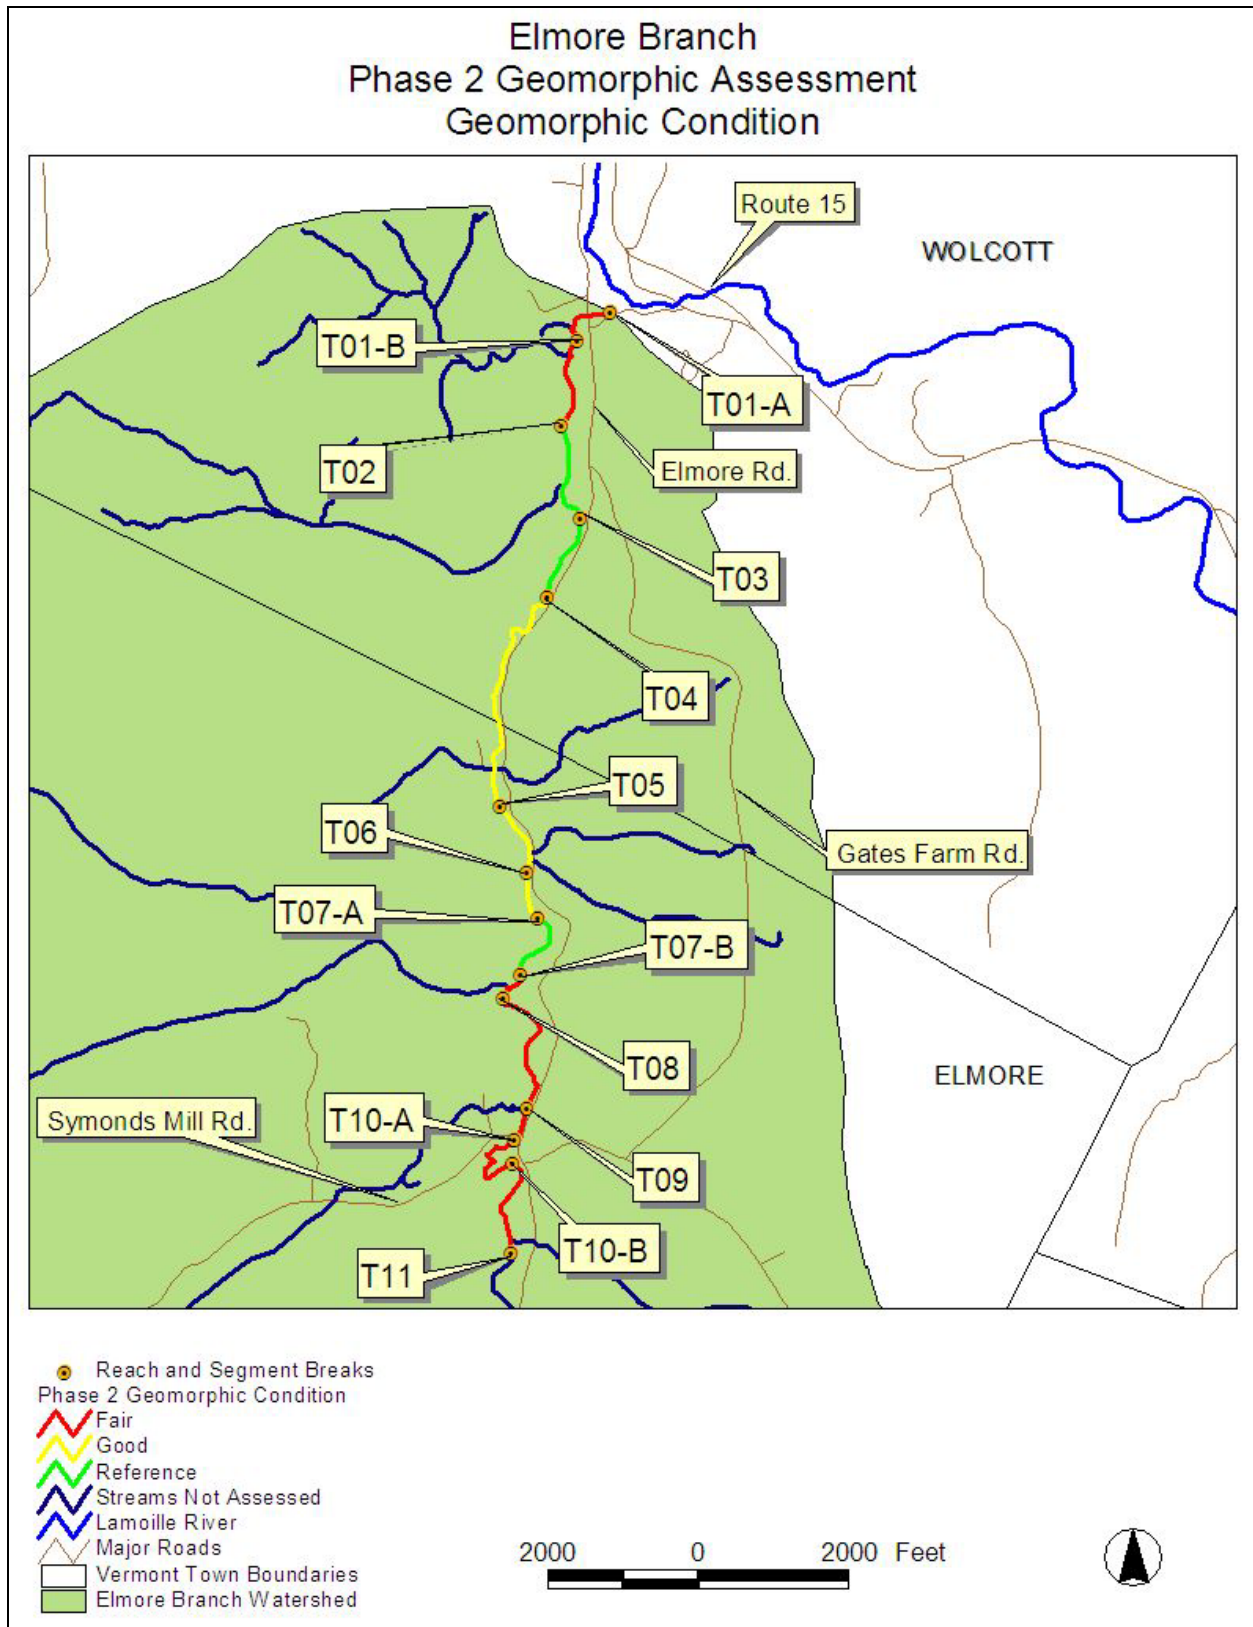
**Figure 8: Phase 2 Geomorphic Condition of the Elmore Branch Watershed**

Summary reports of the Phase 2 data are provided in Appendix A. Figure 7 is a map presenting the existing stream types found in the Elmore Branch watershed. Most of the reaches are Rosgen (1996) "C" channels by reference. C channels have wide valleys and moderate to gentle gradients. B channels have moderate to steep slopes and have narrower valleys than E or C channels. The reach condition for the Rapid Phase 2 Stream Geomorphic Assessment (RGA) is depicted in Figure 8. The bedrock grade controls are playing an important role in the vertical stability and condition of the Elmore Branch. Ryan (2001) noted that. "Much of the Elmore Branch is unstable with several areas of bedrock control restricting a total system head cutting". The lower reach is historically incised and received a reach condition of fair in both segments. Reaches T02, T03 and segments T07-A and T10-A are in reference condition and are stable, bedrock dominated sections. Between the bedrock dominated sections in the lower and mid portions of the study area, reaches T04 through T06 have not incised and are in good condition largely because of the bedrock grade controls on either end. The upper end of the study area (T07-B through T09) is in fair condition. It is not clear why this section has incised with the bedrock grade controls on each end. Segment T10-B is also in fair condition and appears to have been influenced by the former mill dams.

The RGA for the Elmore Branch indicate that several of the reaches are actively, or have historically, undergone a process of minor or major geomorphic adjustment. In a 2001 study, (Ryan 2001) it was noted that, "The East Elmore Road is responsible for much of the Elmore Branch's instability. The road acts as a major flood plain encroachment reducing the river's flood prone width, therefore reducing the stream's entrenchment ratio. The East Elmore Road runs parallel, and in some areas immediately adjacent, to the Elmore Branch". According to research conducted by Jim Ryan (2001 and 2007), review of USDA aerial photos revealed what looked to be like an intentional channel straightening near a farmhouse on Eagle Ledge Road that likely took place somewhere between 1960 and 1990. Additionally, Ryan observed that the Elmore Branch was relocated and channelized immediately below Brown Hill Road along the East Elmore Road. The channel relocation has contributed to some channel incision but it still has access to its active flood plain.

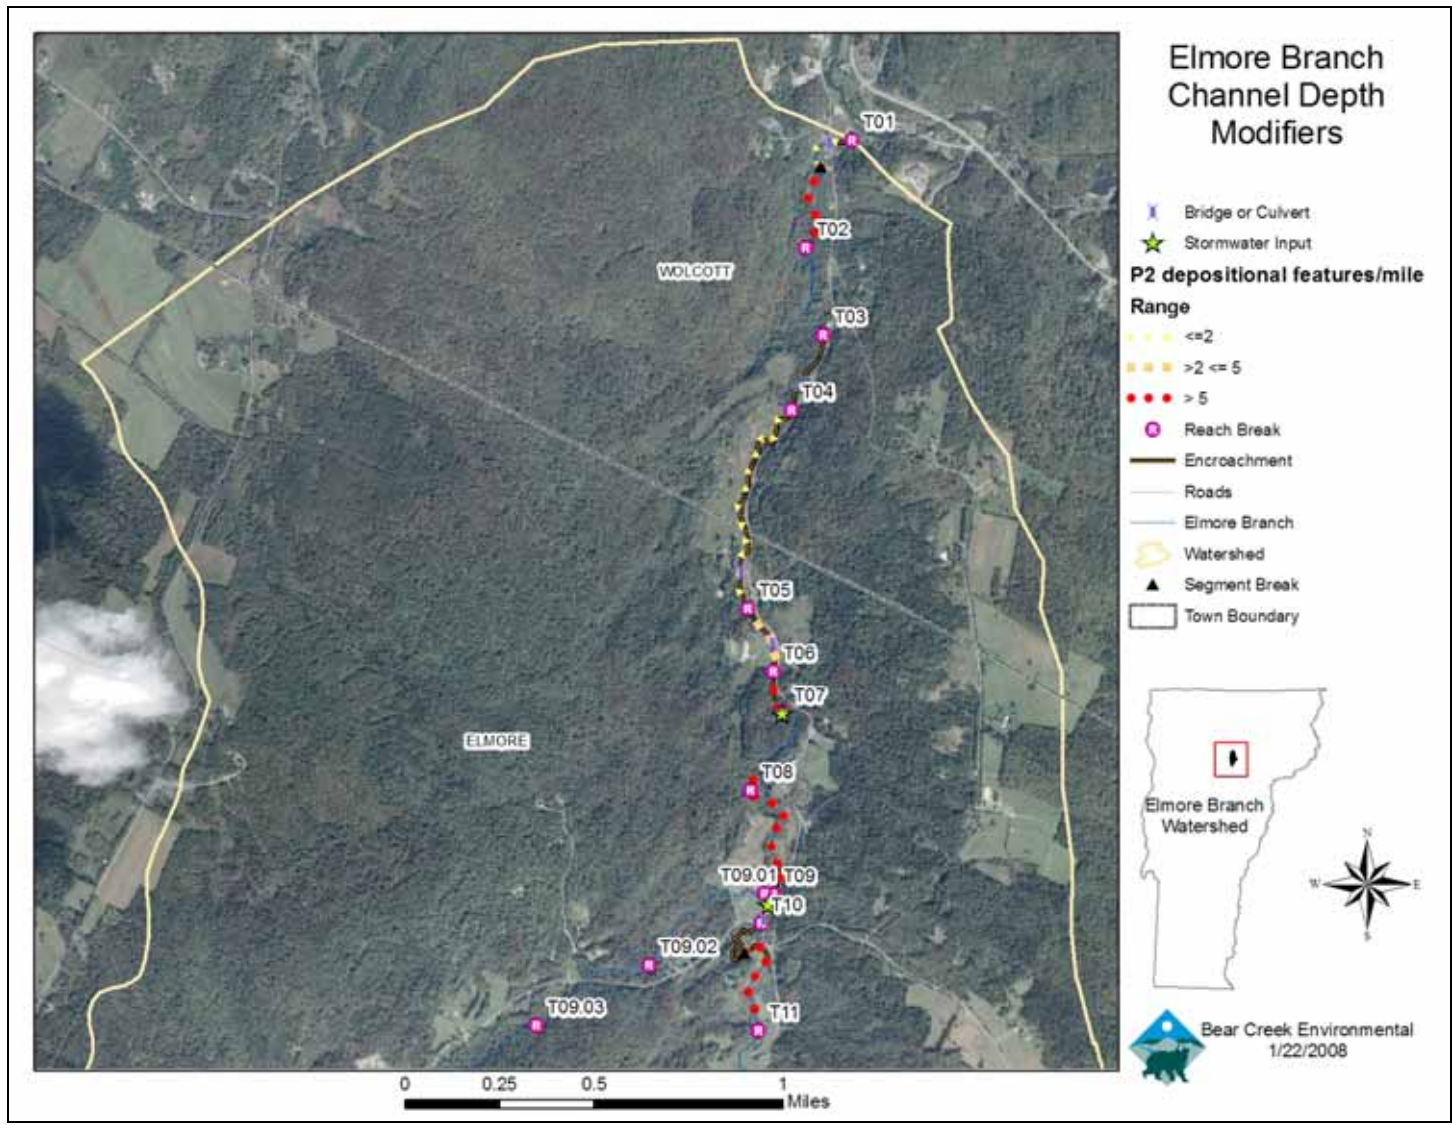
Figure 12. Channel depth modifiers showing encroachments, depositional features per mile, stormwater inputs and bridge locations.

Results from the Elmore Branch watershed indicate that primary stressors include extensive straightening of the channel along with road crossings and encroachments (see Figures 12 and 13). The majority of the channel straightening within the Elmore Branch watershed was associated with roads that run parallel to the stream and farm fields within the river corridor. In particular, straightening is evident in reaches T04, T05, T09, and T10 that runs parallel to East Elmore Road.

There are no records at the Vermont Agency of Natural Resources regarding dredging of the channel. Likewise, no existing data indicates that dredging has occurred within the stream network of concern in this study. However, where the channel has been straightened, it is likely that some dredging that may have occurred during the straightening process.

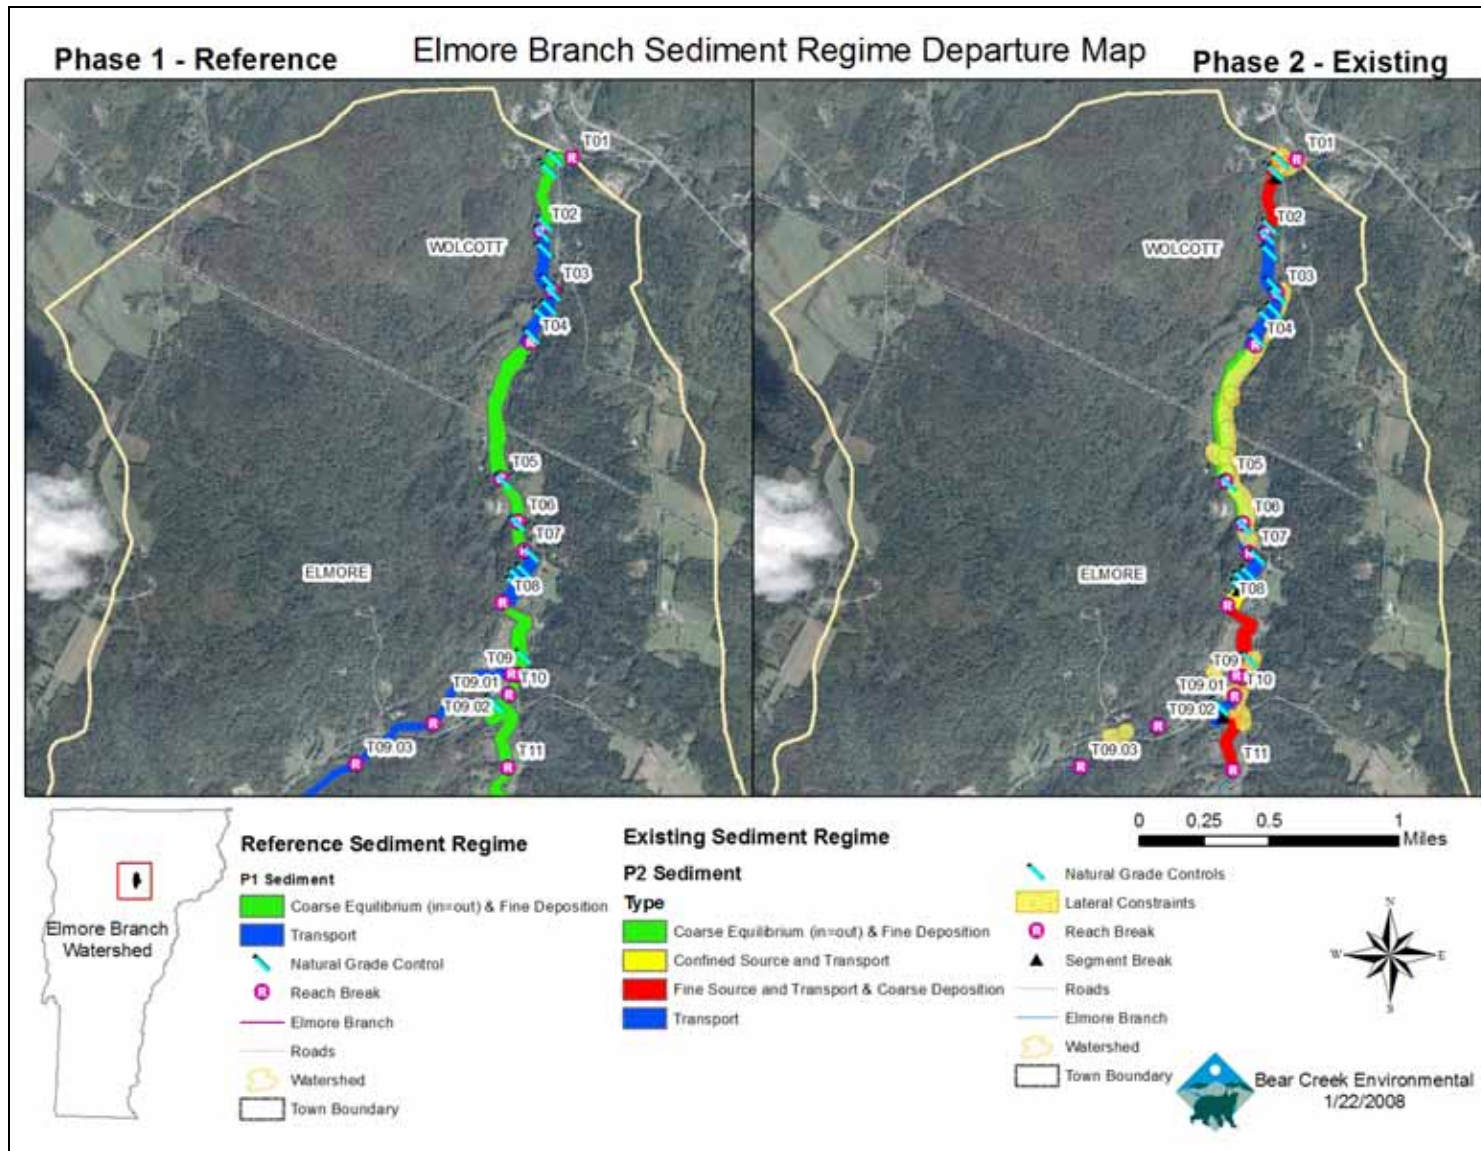
Figure 15. Sediment Regime Departure Map

The sediment regime departure map (Figure 15) shows the Phase 1 reference stream sediment conditions for each reach within the stream network. These reference type streams use available floodplain access as a means to store sediment within the watershed. The majority of the stream network has a reference sediment regime of a *Coarse Equilibrium (in=out) & Fine Deposition*. The bedrock dominated reaches have a *Transport* sediment regime.

Changes in hydrology (such as development and agriculture within the riparian corridor) and sediment storage within the watershed have altered the reference sediment regime types for some reach segments. Reach T01 near the confluence with the Lamoille, and reaches T08, T09, and T10-B were *Coarse Equilibrium (in=out) & Fine Deposition* type segments by reference have been converted to *Fine Source and Transport & Coarse Deposition* sediment regimes based on the Phase 2 Stream Geomorphic Assessment data. This means that most fine sediment entering the stream is either being transported through without being deposited, as a result of channel incision and reduced floodplain access. Additionally coarse sediment storage is increased due to increased load, along with lower transport capacity. One segment (T07-B) that was *Coarse Equilibrium (in=out) & Fine Deposition* by reference has been converted to a *Confined Source and Transport* sediment regime due to increased transport capacity derived from the gradient and/or entrenchment of the channel.

The existing sediment regime for the Elmore Branch watershed includes reduced floodplain access, increased stream power, reduced boundary resistance, and lateral constraints at various locations throughout the stream network. Watersheds which have lost attenuation or sediment storage areas, due to human related constraints, are generally more sensitive to erosion hazards, transport greater quantities of sediment and nutrients to receiving waters, and lack the sediment storage and distribution processes that create and maintain habitat (Vermont Agency of Natural Resources, 2007a). Segments and reaches of the Elmore Branch watershed that can act as attenuation assets are identified below to help in designing stream corridor protection and restoration projects within the stream network. These segments include:

- T01-B
- T04 (downstream end)
- T08
- T10-B

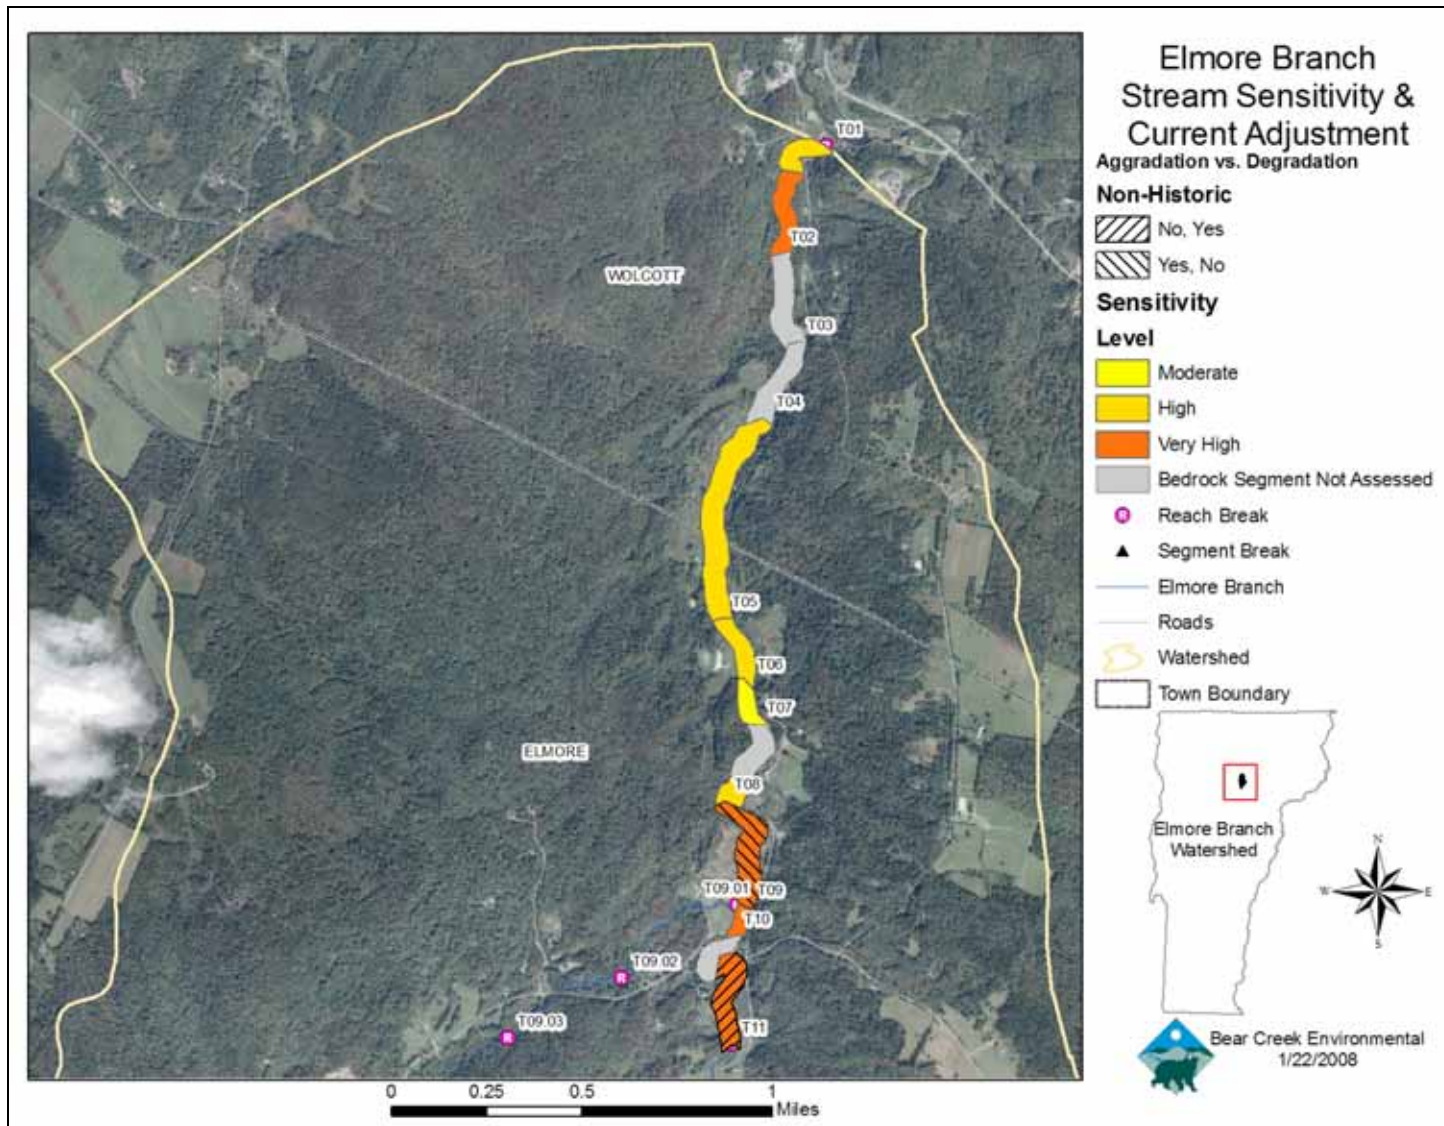
Figure 16. Elmore Branch Watershed Stream Sensitivity and Current Adjustment

The stream sensitivity map also documents vertical channel adjustments currently going on within a reach segment. Major degradation or aggradation adjustment processes are displayed on the sensitivity corridors where they were found to be actively occurring and they were not evaluated as historic. This information is helpful in prioritizing the implementation of the projects identified in section 7 of this report, as certain management actions may be influenced by these active adjustment processes. Vertical channel adjustments exist in the following segments:

Segment ID	Current Major Adjustment Process
T08	Aggradation
T10-B	Degradation (possible localized)

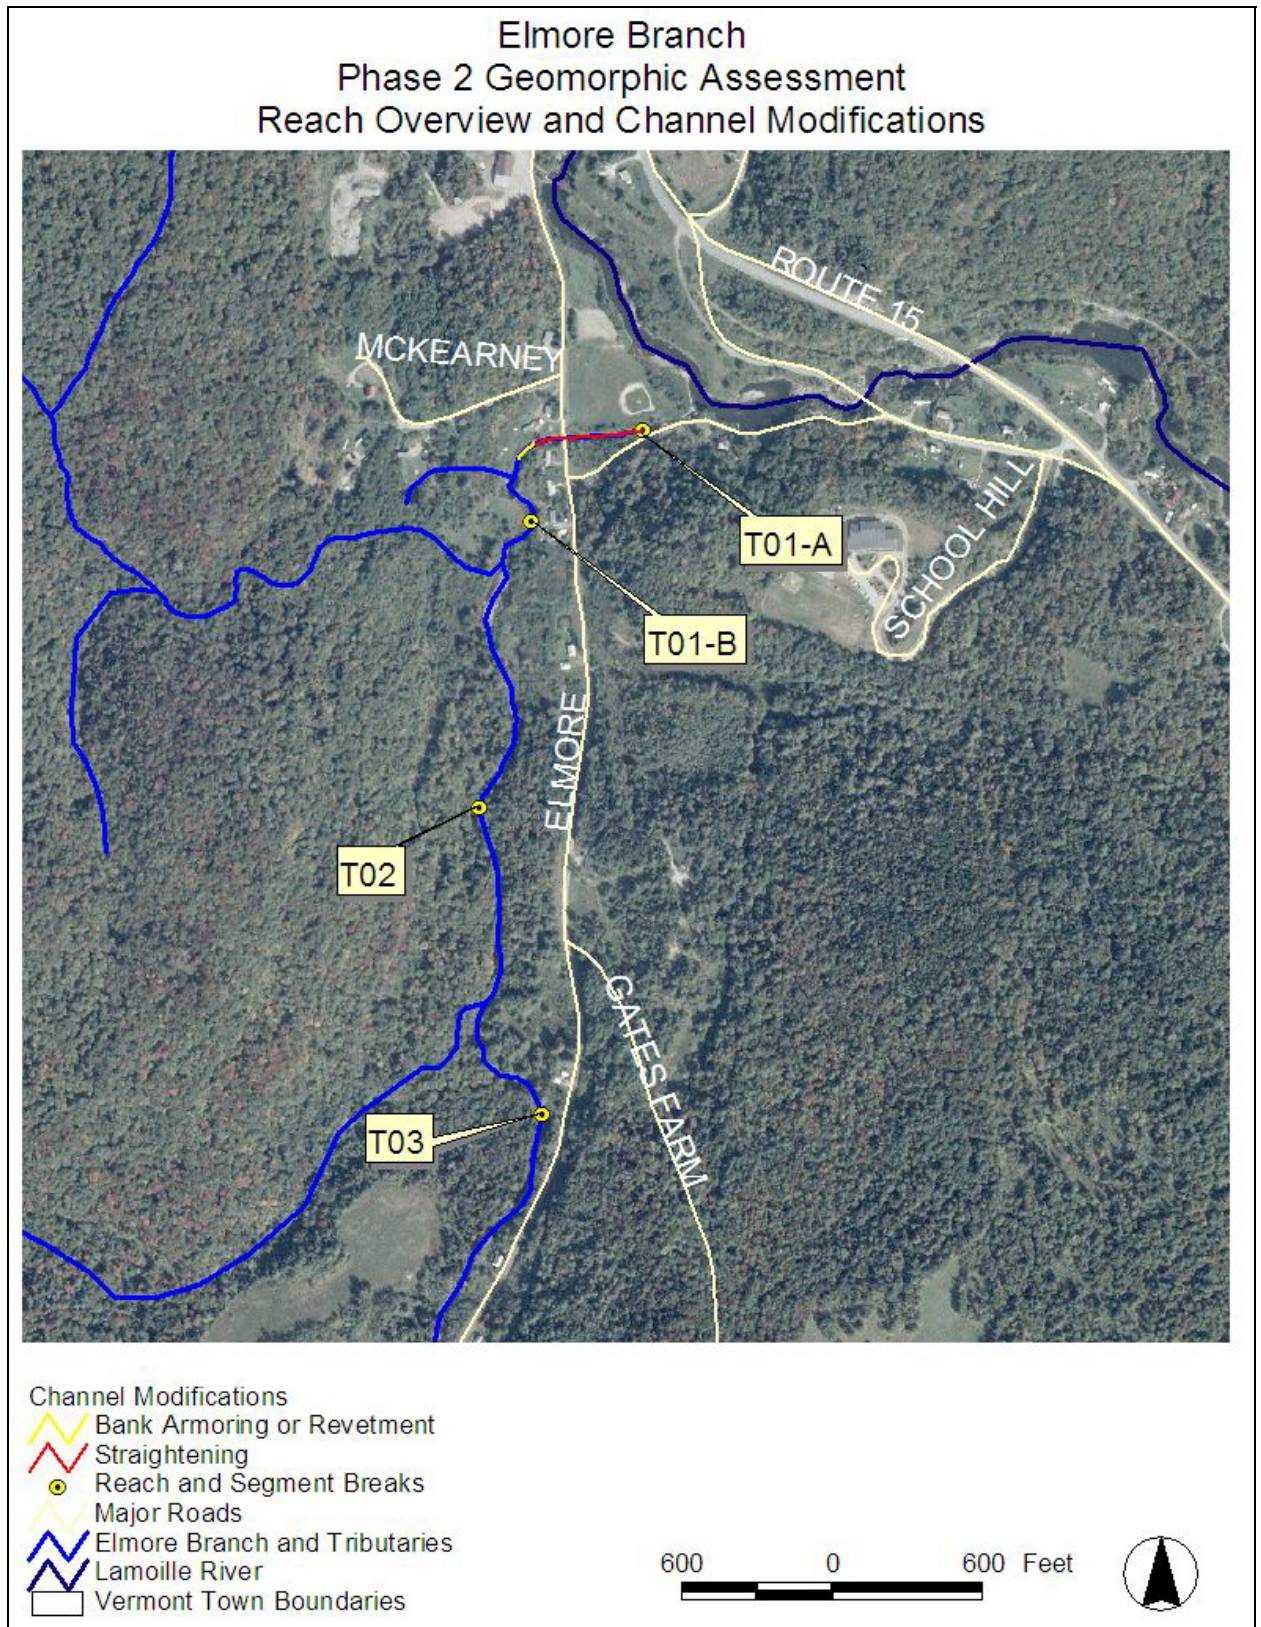
Figure 17. Overview of reaches T01 through T03 and channel straightening and armoring.

The lower section of the Elmore Branch begins at T03 and continues downstream to the confluence with the Lamoille River (Figure 17). This section is dominated by forested banks and bedrock grade controls until near the end of the river where residences of Wolcott Village, roads, and a town ball field all start to encroach on the stream corridor. Most of the final segment T01-A has been channelized.

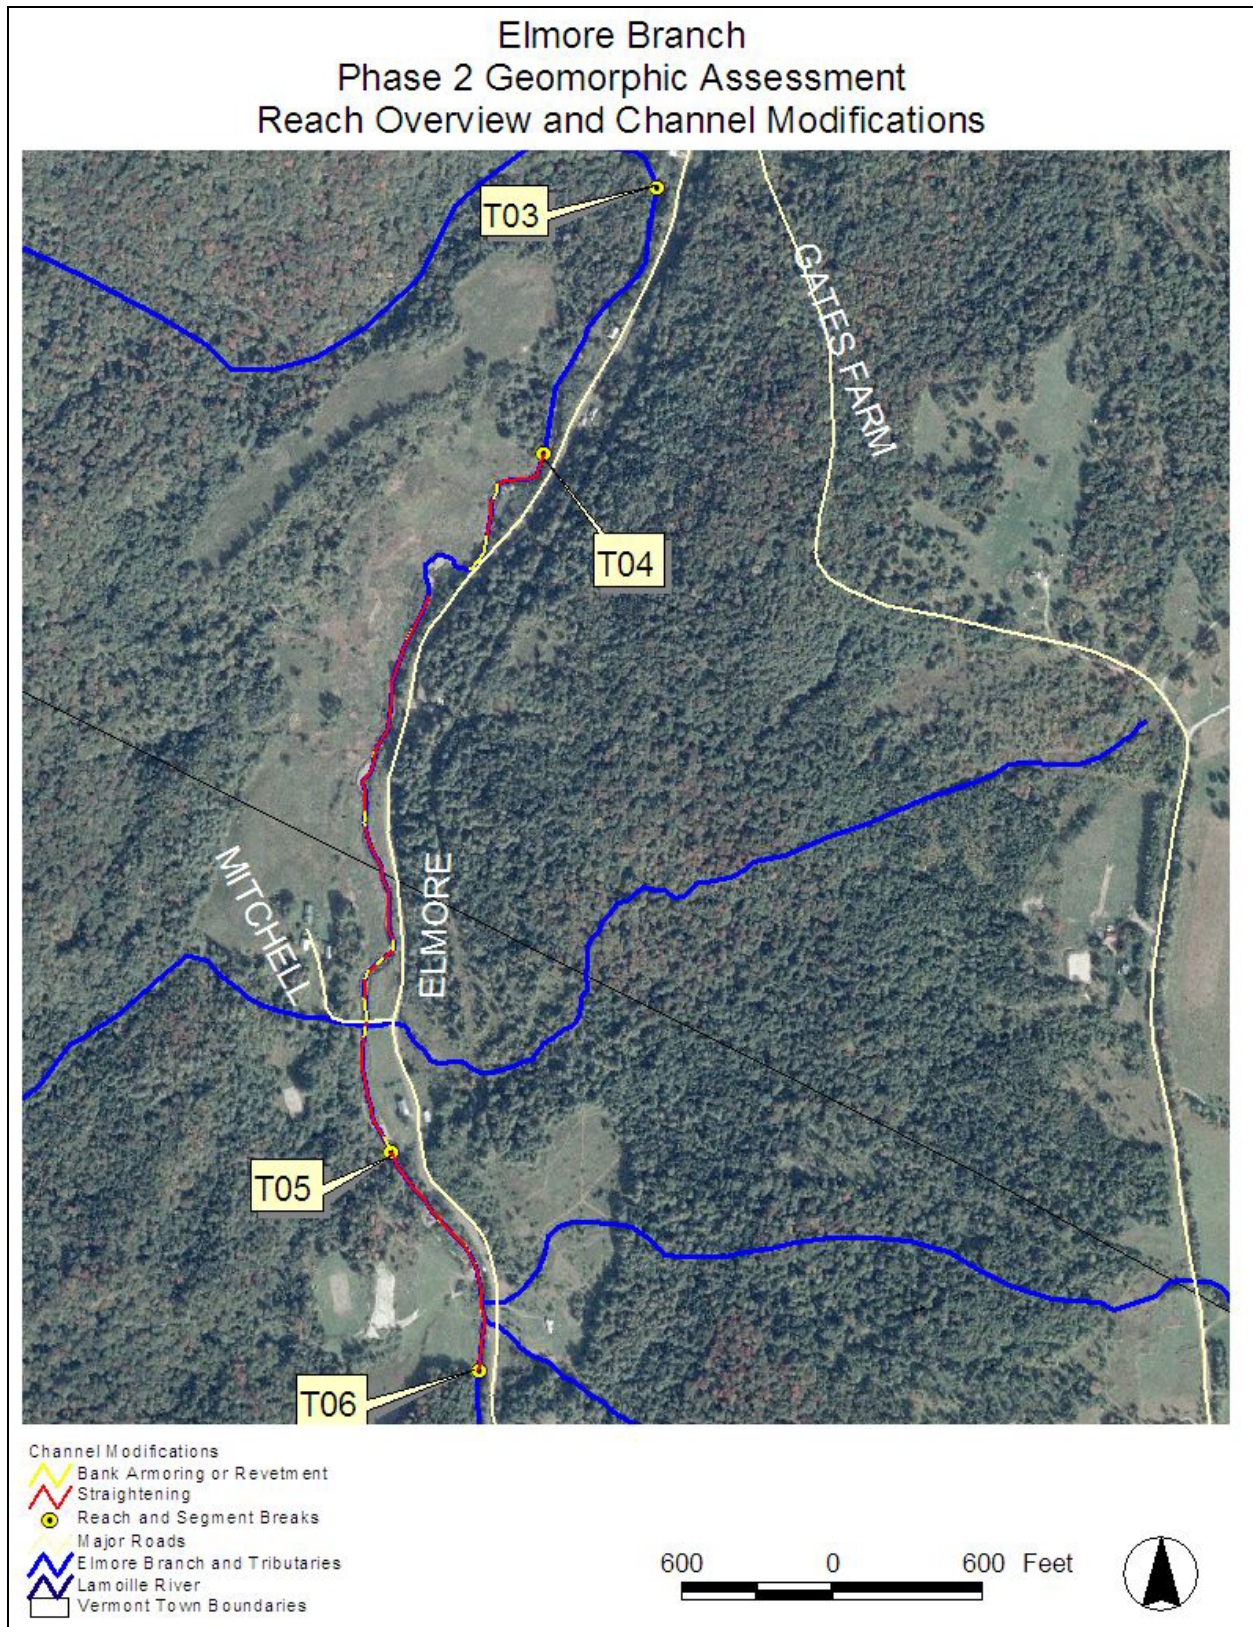
Figure 18. Overview of reaches T06 through T04 and channel straightening and armoring.

The next section of the Elmore Branch begins at T06 and continues downstream to reach T04 (Figure 18). The westbank of this section is predominately old farm field and pasture. The east bank of the section has several residences and the East Elmore Road along almost its entire corridor. The bridge at Mitchell Lane is a channel constriction.

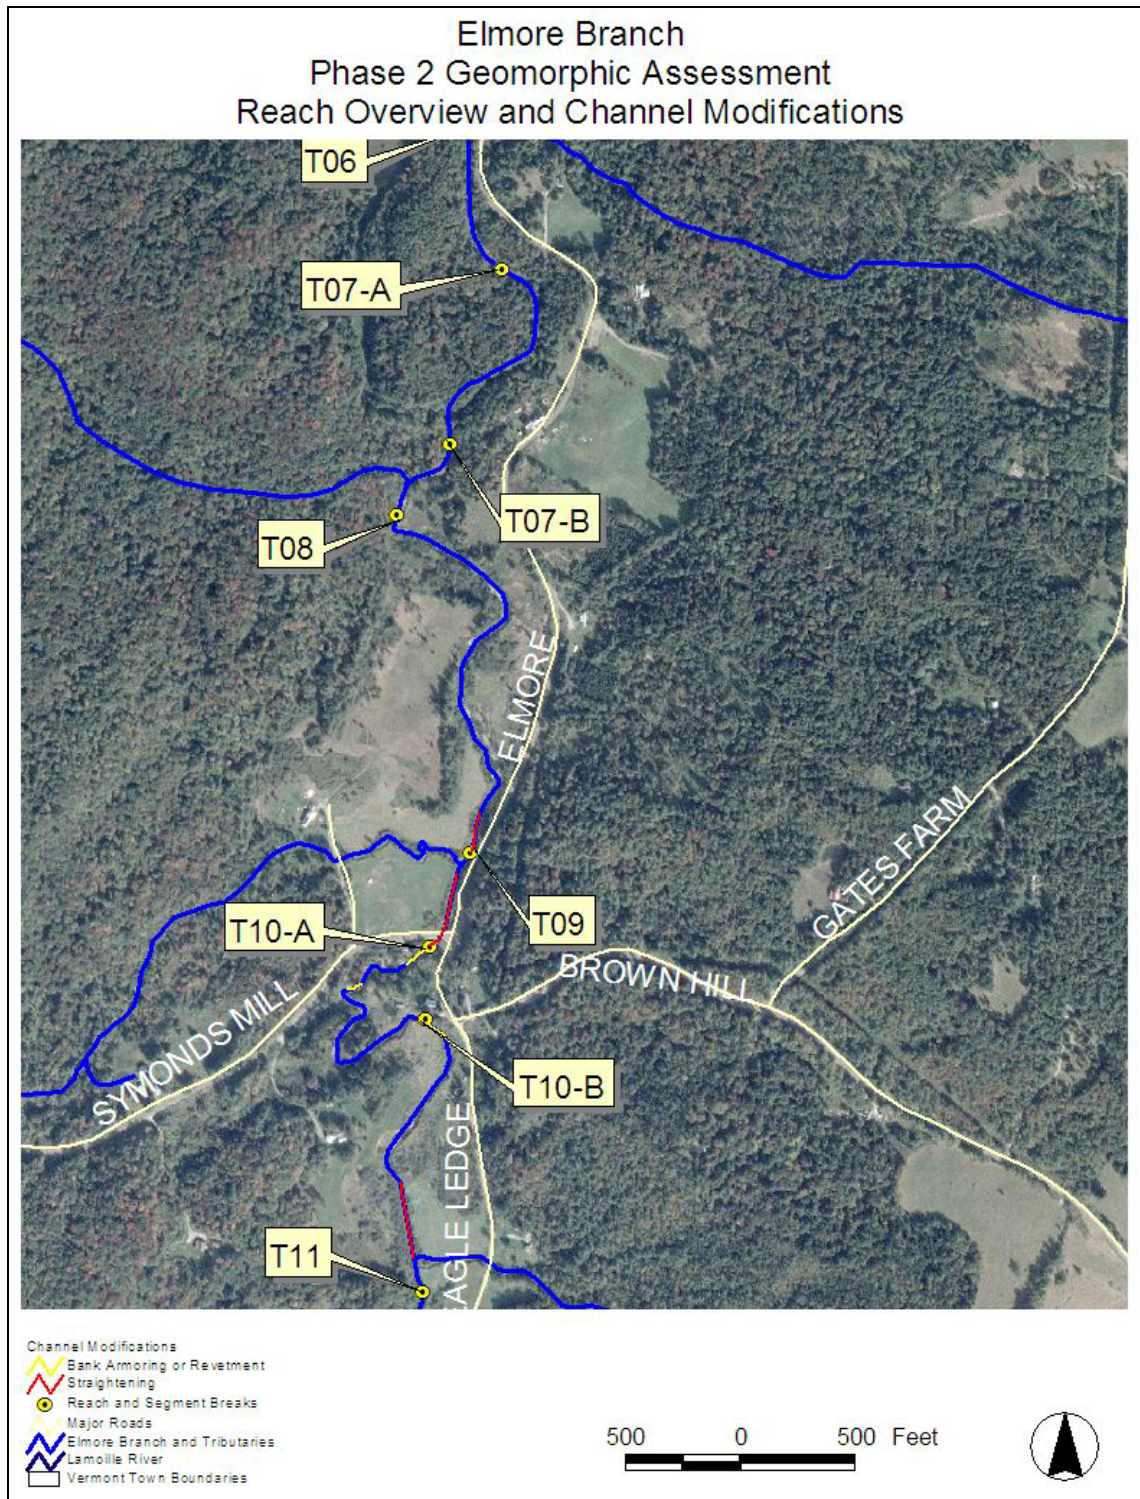
Figure 19: Overview of reaches T07 through T10

The last section of stream (illustrated in Figure 19) begins off Eagle Ledge Road in the town of Elmore near where the stream emerges from its heavily wooded upper watershed. From here down to reach T06, the Elmore Branch flows through predominately old pasture and agricultural fields. Major significant impacts in this section include historic removal of riparian vegetation, an old mill dam (no longer in operation), an undersized culvert under Symonds Mill Road, and channel straightening downstream of this culvert.

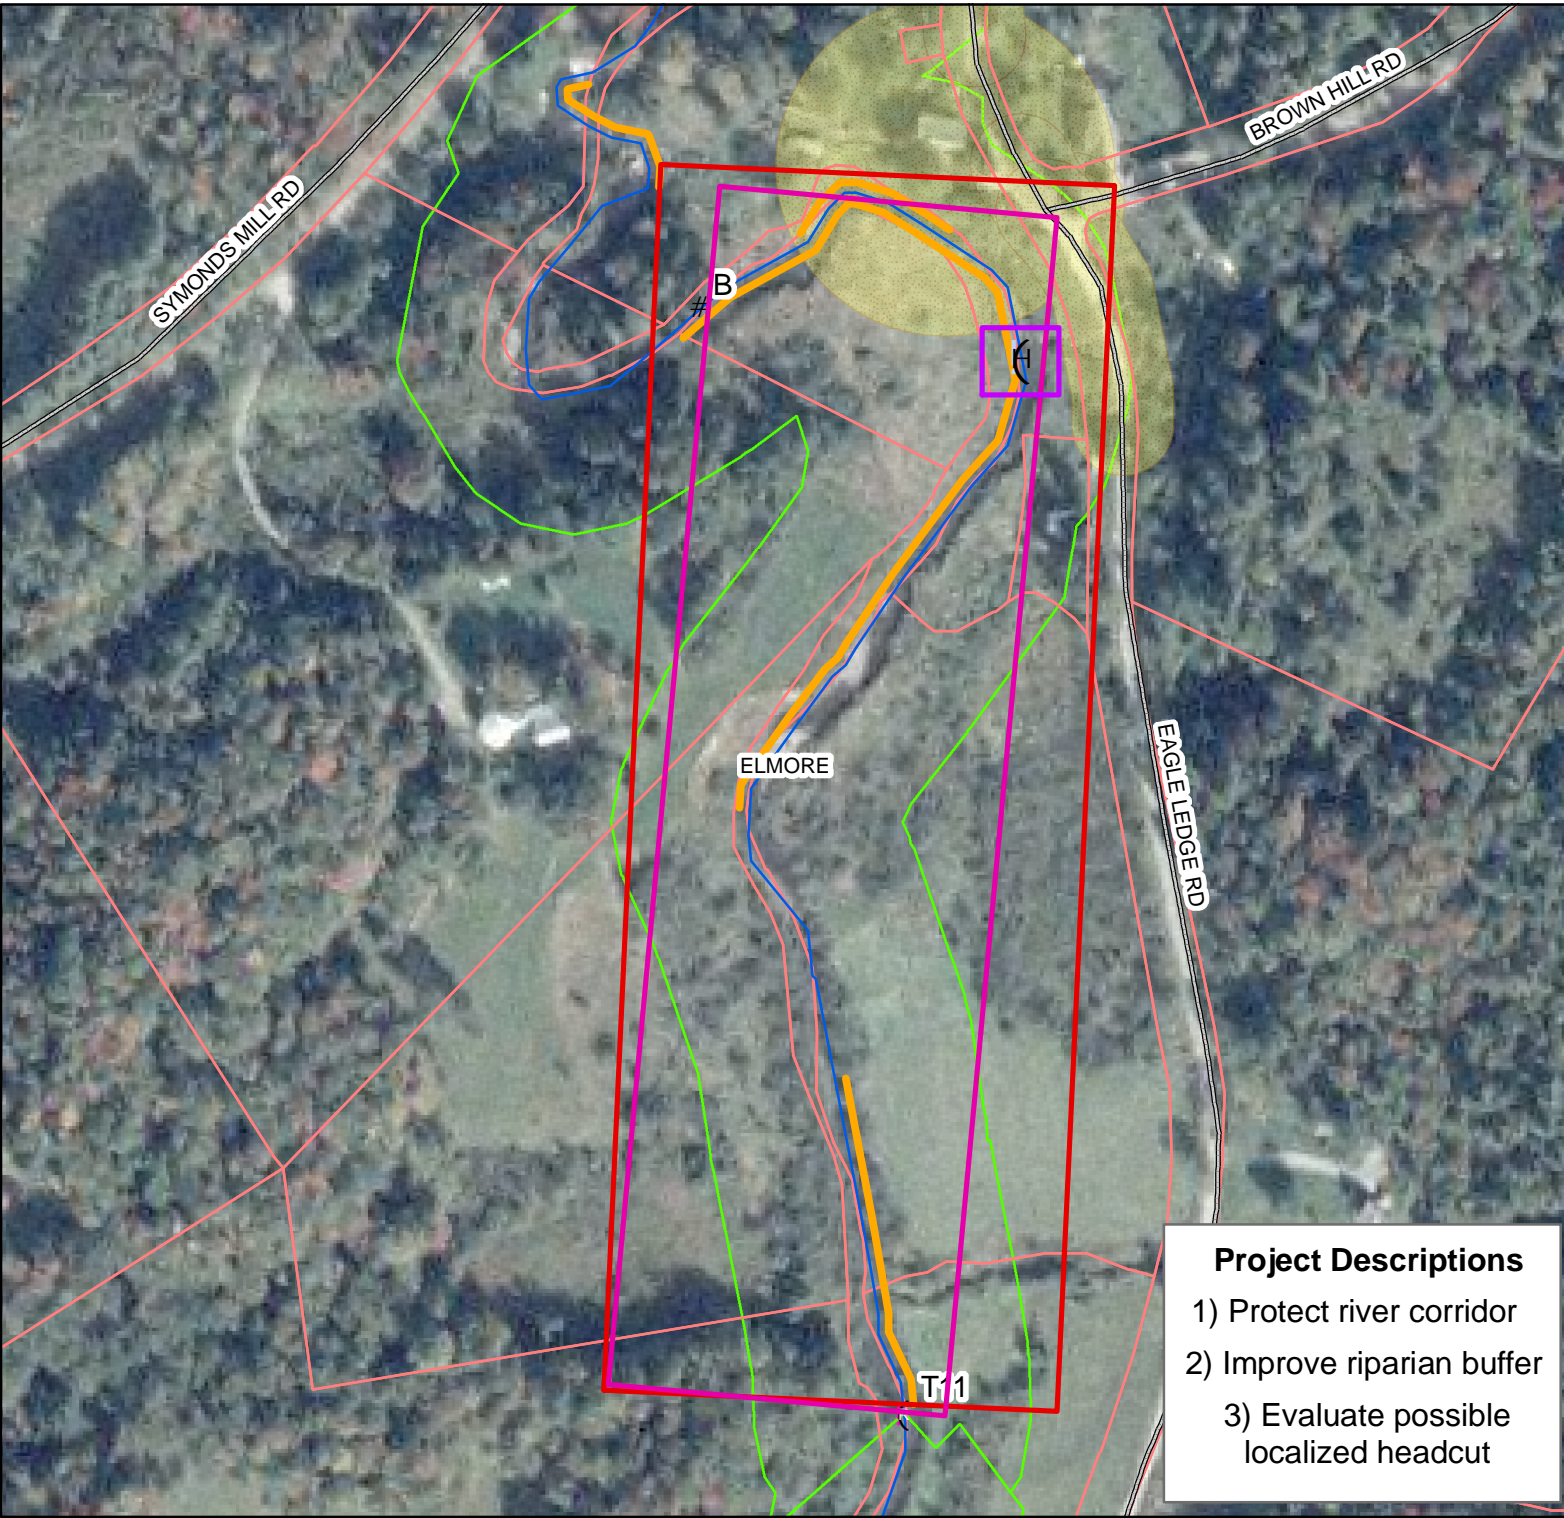
## Project Descriptions

- 1) Protect river corridor
- 2) Improve riparian buffer
- 3) Evaluate possible localized headcut
