# Dishmill Brook Watershed River Corridor Plan Burke, Vermont February 12, 2014

Prepared by:  
Bear Creek Environmental, LLC  
149 State Street, Suite 3  
Montpelier, Vermont 05602

Prepared under contract to:  
Caledonia County Natural Resources Conservation District  
481 Summer Street, Suite 202  
St. Johnsbury, Vermont 05819

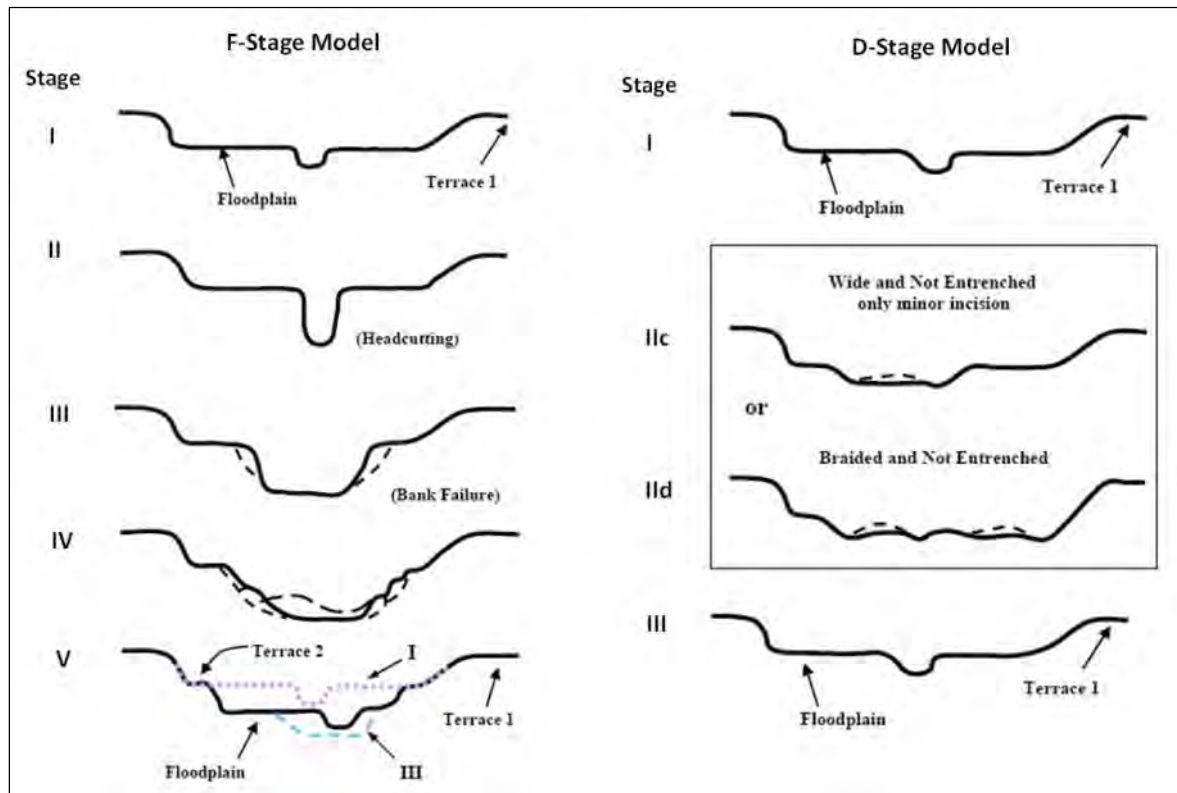
Figure 5.1 Typical channel evolution models for F-Stage and D-Stage  
(Vermont Agency of Natural Resources, 2009b)

Both the “D” and “F” stage channel evolution models (Vermont Agency of Natural Resources, 2009b; Vermont Agency of Natural Resources, 2004) are helpful for explaining the channel adjustment processes underway in the Dishmill Brook watershed. The “F” stage channel evolution model is used to understand the process that occurs when a stream degrades (*incises*). The common stages of the “F” channel evolution stage, as depicted in Figure 5.1 include:

- Stable (F-I) - a pre-disturbance period
- Incision (F-II) – channel degradation (head cutting)
- Widening (F-III) – bank failure
- Stabilizing (F-IV) – channel narrows through sediment build up and moves laterally building juvenile floodplain
- Stable (F-V) - gradual formation of a stable channel with access to its floodplain at a lower elevation

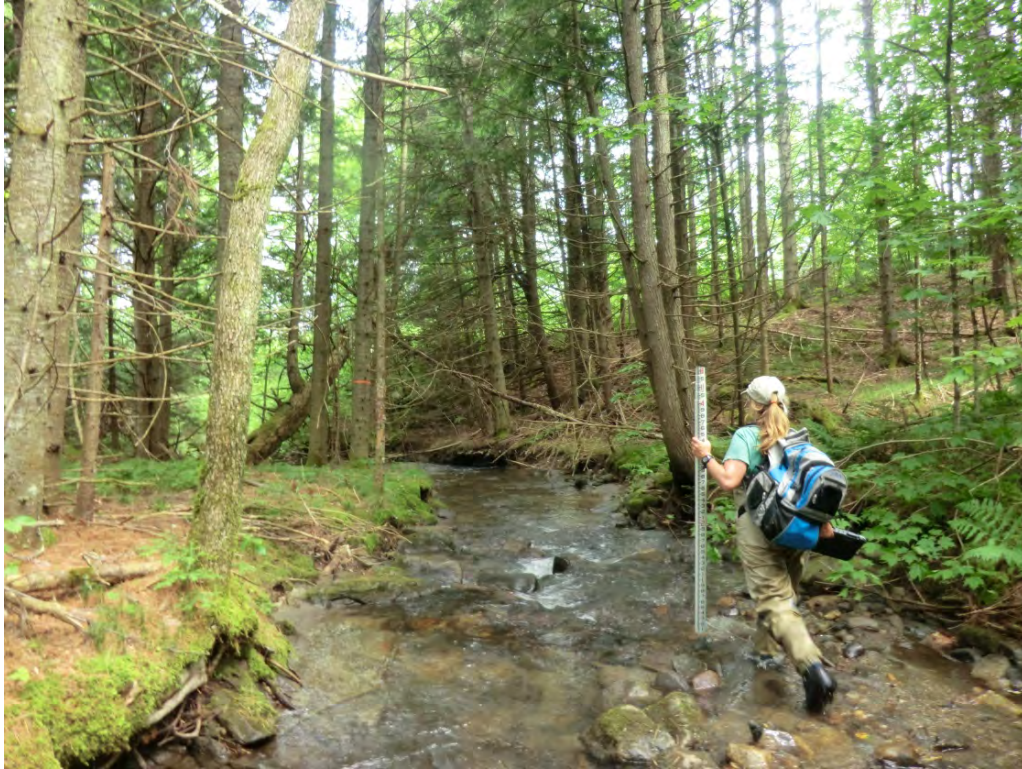
Figure 5.28. Nice floodplain access on southern bank in reach T1.01.

Reach T1.01 is in **fair** geomorphic condition with **aggradation** as a major process where there are debris jams or the valley walls open up. Debris jams have resulted in adjustments to the channel **planform** (Figure 5.27). Floodplain access is good in this reach indicating that the channel has not incised (Figure 5.28). Although the geomorphic condition is compromised by increased sediment load and planform adjustment, the habitat condition is **good**. Abundant large woody debris, nice pools, and some undercut banks have contributed to the good condition.

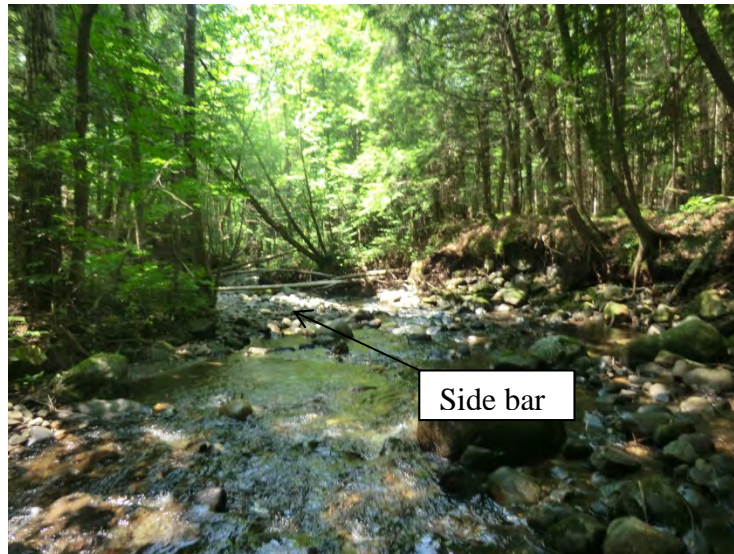
- Step 7.2 (Row 2) Step 7.3 (Row 4). Both in Good “single to multiple mid- channel side bars....”. Seems like this could be in “fair” as there are multiple bars and flood chutes. Thoughts?

M105-A was much more aggradational than this segment despite the number of bars. The good category is appropriate for this segment when compared to the upstream one. There were mostly larger side bars as shown in this photo and a few small mid-channel bars, but I think it was more natural for this segment. - ok

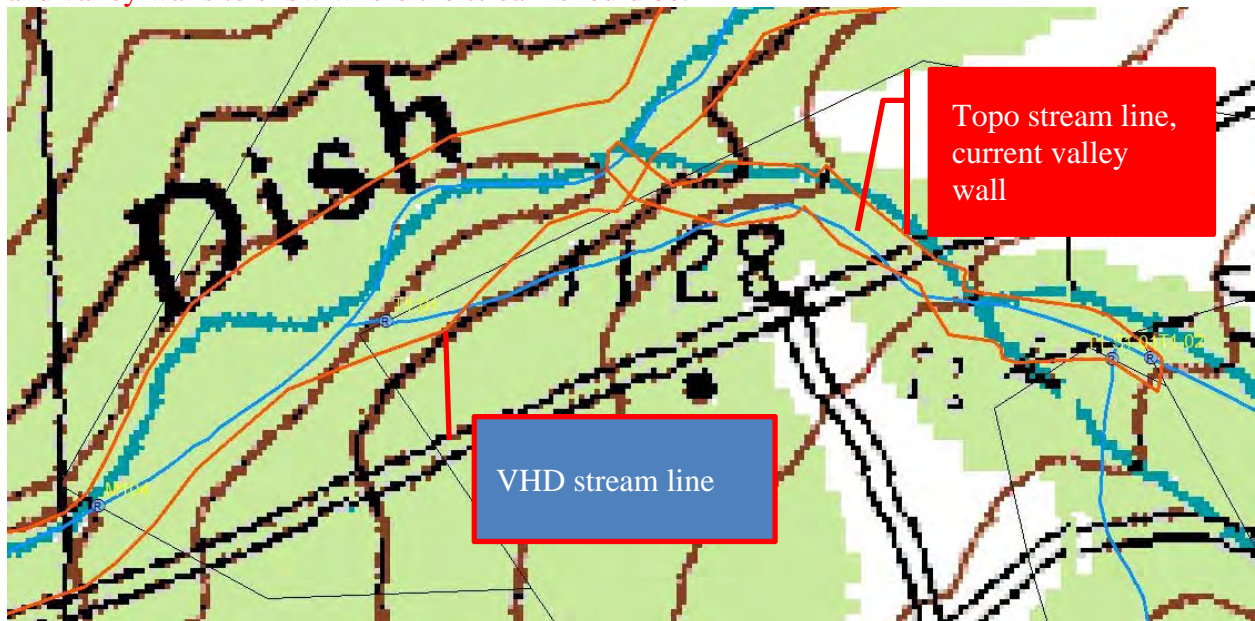
- Discussion note – question on the Phase 2 valley wall. It does not line up with the current VHD stream line; it looks like it lines up with the topo stream line, which enters further upstream. Is the stream located as the VHD has it or as the topo has it?

The VHD is off. I can provide you with the GPS points we took in the field for line and point impacts and valley walls to show where the stream should be.

This could represent a difference in stream and valley length –changes in slope as well. As we are tied to the VHD at the moment and SGAT has been run with this configuration; this will need to be documented in the Phase 1 notes if the VHD stream line is not correct. Corrections in stream and valley length may be able to manually corrected in the DMS or updated in the notes for correct length/slopes.

There is a change in stream length as a result. The stream length should be about 940 feet and the valley length about 920 feet. I added a note in the phase 1 data and I updated the stream and valley lengths in the Phase 1 and 2 DMS. – ok, thank you

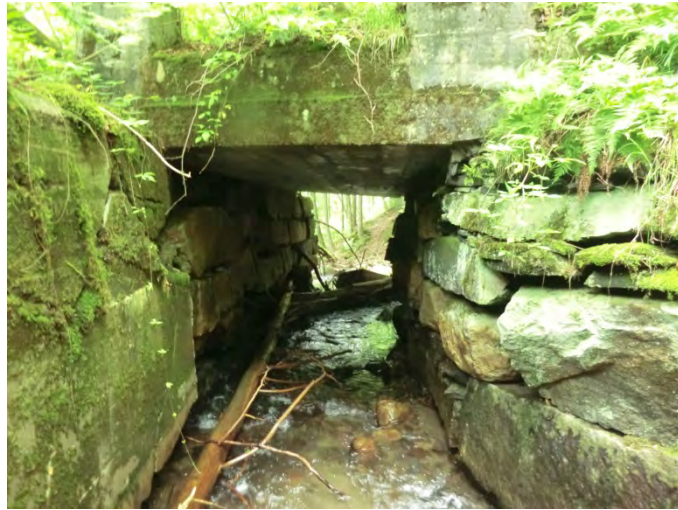
- Step 4.8 – Bridge is noted as channel constriction. Width is 26 ft. Channel width is 17. What other indicators are there that the bridge is a channel constrictor with a width wider than bankfull?  
Below is a photo of the bridge crossing. The channel is wider both upstream and downstream of the crossing and this is a major channel constriction. The road width was inadvertently entered as the structure width and vice-versa. This has been corrected in the DMS. – ok. Yikes that is a tight squeeze☺

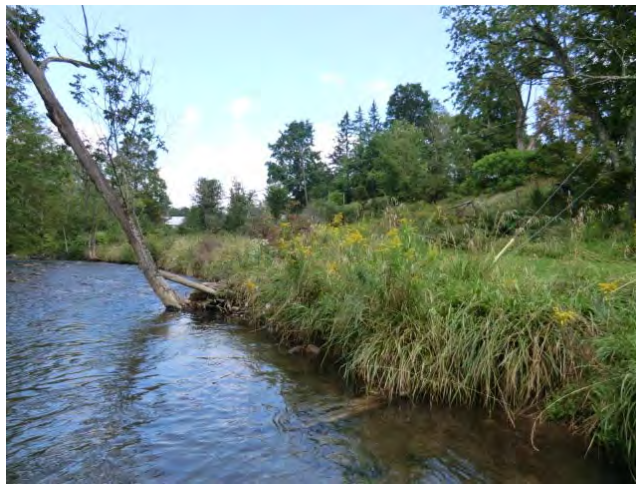
that the channel has widened. The tree in the following photograph used to be on the bank according to him. I changed the reference width to 30 feet to reflect this information considering that the channel is now about 40 feet wide. The channel was not straightened in the upstream reach and the channel width was also narrower than reference, so I don't think straightening had to do with the narrower actual channel width. While the curves do not always predict exact measures; a difference of ~23' in expected width raises questions. Given that this is a C stream type the width would be expected to be reasonably close to the expected curve estimate. Were there soils, slopes, valley constraints, etc. that would have caused the widths to be that much narrower than expected? What clues did you see that led you to 30' or a reference width, was it only based on the landowner's comments?

Both T3.11 (613' out of 939') and T3.12A (1,013' out of 1,400') were identified as straightened segments. Perhaps when it was straightened it may have been narrowed? There were dams noted in the T3.12 reach, perhaps this has also influenced the widths in these reaches? It is likely the landowner is seeing the channel become wider if given the watershed size and other factors; the expected width would be wider. Given all factors, would we expect to be trying to manage this channel back to a width of 30ft?
