# Stream Geomorphic Assessment of City Stream and Bolles Brook *Woodford, VT*

## **FINAL REPORT** *December 2007*

**Bennington County Conservation District**

**GOMEZ AND SULLIVAN**  
Engineers, P.C.

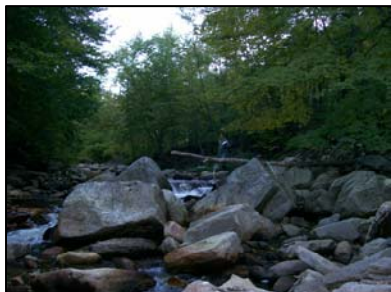
#### M06T3.05S1.02B

Segment M06T3.05S1.02B (S1.02B) of City Stream is a reference B2 step-pool stream that was classified during Phase 2 as a type B3a. It is slightly more entrenched (ER=1.21) than typical B-type stream, but its ER is within the allowance of  $\pm 0.2$  units (Rosgen, 1996). The segment could also have been classified as a type F, but its high slope (4.4%) is not characteristic of F-type streams. This relatively short segment (899 feet) was separated from Segment A due to a sharp change in slope and a shift to significantly coarser bed material (see Photo #100\_1013). Also, although its valley is narrow (CR=5.1), this

segment is unconfined. Moving upstream from Segment A to Segment B, the river left valley wall crosses to the far side of Notch Road, and the river right valley wall veers 50-100 feet away from the bank to accommodate a small floodplain. The upstream reach break is marked by the entrance of Stamford Stream, which is actually the larger stream at the confluence. Stamford Stream seems to provide more influence on the downstream system, with its larger flow and sediment inputs. The banks and buffers on both sides of the stream are fairly well vegetated with mixed trees and shrubs/saplings, although the left bank is badly eroded along most of the upper half of the segment, and there is a small section of right bank erosion near the top of the segment as well. The W/D ratio is moderately high (26.4). The IR, based on the river right RAF, is 1.84. The segment is in good RHA condition and fair RGA condition. Because the stream has lost access to some of its floodplain due to degradation and historic floodplain filling, it was determined to be in Stage II of the CEM. The major adjustment process is degradation, and the stream sensitivity is high.

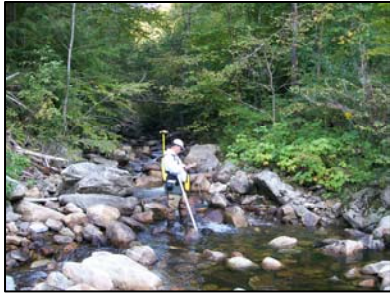
#### M06T3.05S1.03

Reach M06T3.05S1.03 (S1.03) of City Stream was not assessed because it is very steep ( $>6\%$ ), and is narrowly confined by both State Route 9 on the right and the natural valley wall on the left.

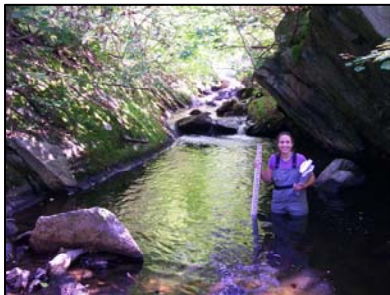
#### M06T3.05S1.04A

Segment M06T3.05S1.04A (S1.04A) of City Stream was not assessed during Phase 2 because it is a bedrock gorge. Several bedrock constrictions, ledges, and waterfalls were observed along its relatively short length.

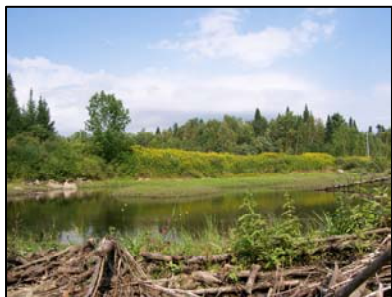
#### M06T3.05S1.04C

Segment M06T3.05S1.04C (S1.04C) of City Stream was not assessed because it is an impoundment formed by a beaver dam at the segment break between Segments B and C. Note that although the aerial imagery depicts a distinct channel and pond in Segment C, these features have merged to form one large wetland/impoundment area and no distinct channel exists.

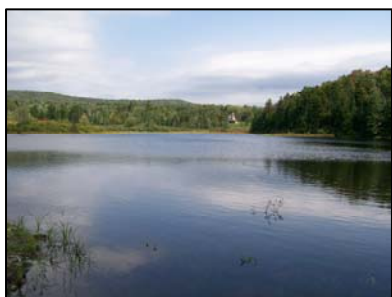
#### M06T3.05S1.05

Reach M06T3.05S1.05 (S1.05) of City Stream was not assessed because it is an impoundment known as Bugbee Mill Pond.

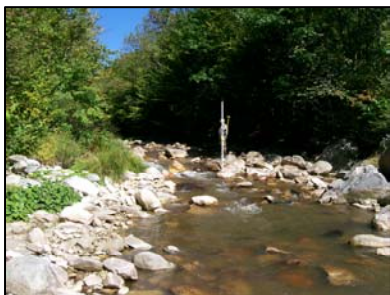
#### M06T3.05A

Data collected along Segment M06T3.05A (T3.05A) of Bolles Brook indicated that this segment is a reference and existing B3 step-pool type stream. However, the segment has been exposed to new development (four new buildings and a large addition have been built within the river corridor since the aerial photographs were taken), which now encroaches 87% of the segment. In several of the developed areas, the buffer is less than 25 feet. The stream is also encroached by Harbour Road, which is gravel, for 43% of the segment. As a result of these encroachments and the associated loss of bank and buffer vegetation, erosion, scour, and mass failures were observed

along much of the banks. Two head cuts and a flood chute are also present. The segment is approximately 2,043 feet long with a slope of about 2.0%. Its natural valley is broad (CR=9.3) but, even though Harbour Road is not a truly confining feature, it will certainly continue to have a confining effect on the stream as long as it is maintained. The valley is defined by steep mountainsides (behind Harbour Road on the left and on the bank or within one bankfull width on the right). This segment is moderately entrenched (ER=1.80) with a moderate W/D ratio (22.0). The IR, based on the river left top of bank, is 2.38. Bank and buffer vegetation, where present, is mostly shrub/sapling or mixed trees. There are several mowed lawn areas where the buffer is less than 25 feet. Therefore, the RHA score of 0.65 was adjusted from “good” to “fair.” The RGA score is also “fair.” Because the stream has lost access to the

majority of its floodplain through bed degradation and floodplain build-up (development), but is starting to widen, it was determined to be in Stage III of the CEM. The stream sensitivity is high.

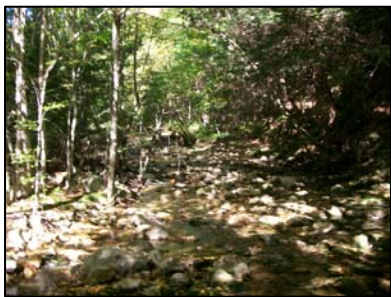
#### M06T3.07

Reach M06T3.07 (T3.07) of Bolles Brook was not assessed because it is a steep first-order stream that flows through the undeveloped Green Mountain Nation Forest.

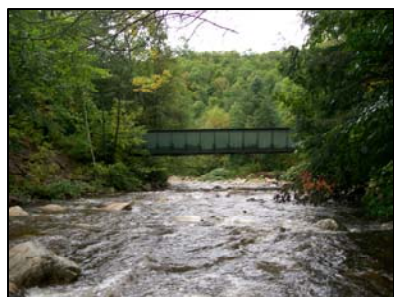
### S1.01A Harbour Road Bridge

The most downstream bridge on City Stream is located on Harbour Road, which is gravel, in segment S1.01A. The bridge width is 150% of the channel width, and does not confine the stream any more than the left bank berm already does. An adequate buffer of mixed trees surrounds the bridge in all directions except the downstream right bank, where there has been recent lot clearing and fill for the construction of a new house. Sediment deposits downstream of the bridge are more likely due to the confluence with Bolles Brook than the bridge itself. Overall, the bridge seems to be in relatively good condition with a low potential to fail or to have future significant impacts on the stream.

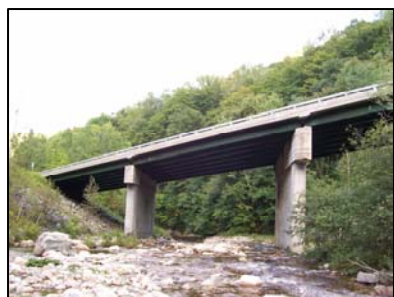
### S1.02A Route 9 Bridge

This bridge is located in segment S1.02A of City Stream on Route 9 at its intersection with Notch Road (old Route 9). With a 250-foot span, this concrete and steel bridge was by far the largest structure assessed. The bridge width is over 500% of the channel width, and does not appear to confine the stream. Contrarily, alterations made to the stream during the re-routing of Route 9 and the construction of the bridge seem to have drastically over-widened the channel through the bridge opening as well as upstream. Because of this, the sediment loads from the high-gradient tributary Stamford Stream (which is actually the larger stream) just upstream do not have enough velocity to be carried through the reach, and have formed large deposits above, underneath, and just below the bridge. The high banks in all directions except downstream right are heavily armored with rip-rap and have minimal herbaceous or shrub/sapling vegetation. The structure itself does not appear to be affecting the stream or have the potential to fail, but the extensive fill and channel alterations to accommodate both Route 9 and Notch Road have certainly impacted this reach.

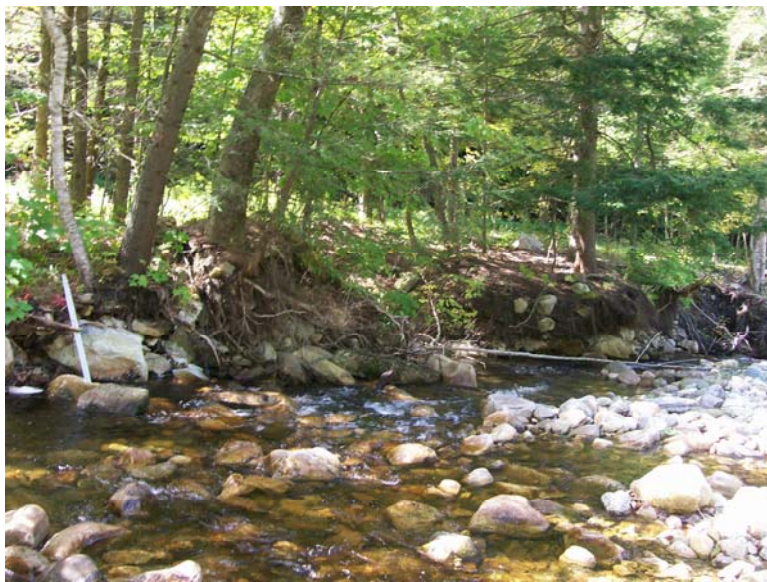
| <b>View:</b> US | <b>Description:</b> Close-up of bedrock wall and steep riffle | | | <b>View:</b> DS | <b>Description:</b> Left bank erosion along Rt. 9 | | |

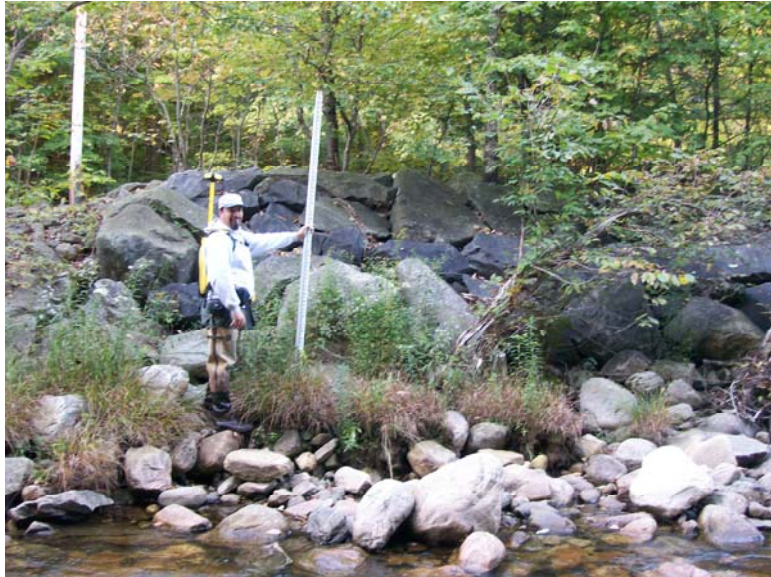
| Segment ID: S1.01B | | Photo #: 100_0995 | | Date: 9/18/2007 | |

| View: LB | | Description: Rip-rap on berm | | | |

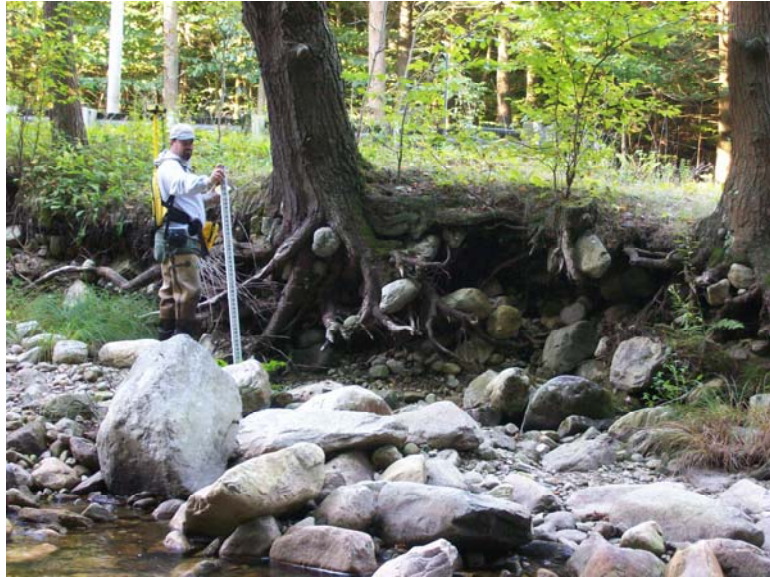
| Segment ID: S1.01B | | Photo #: 100_0997 | | Date: 9/18/2007 | |

| View: LB | | Description: Bank erosion along Rt. 9 (near cross-section) | | | |

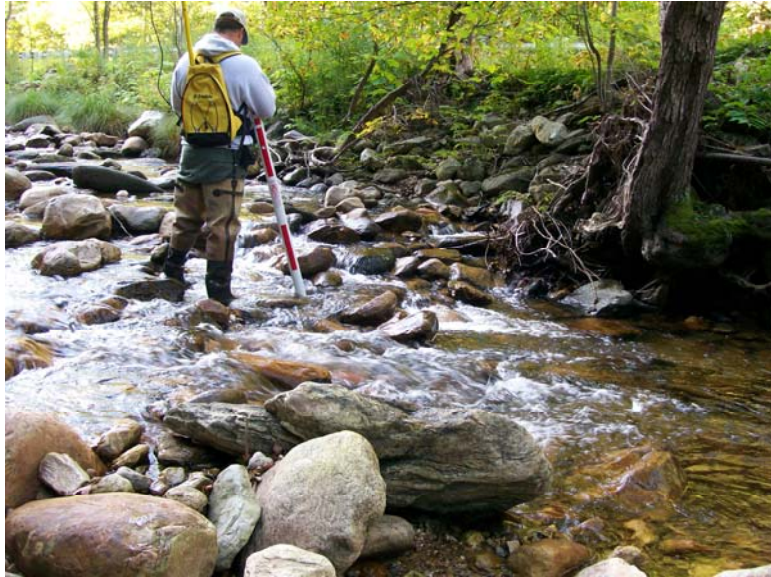
| Segment ID: S1.01B | | Photo #: 100_0998 | | Date: 9/18/2007 | |

| View: US | | Description: Head cut | | | |

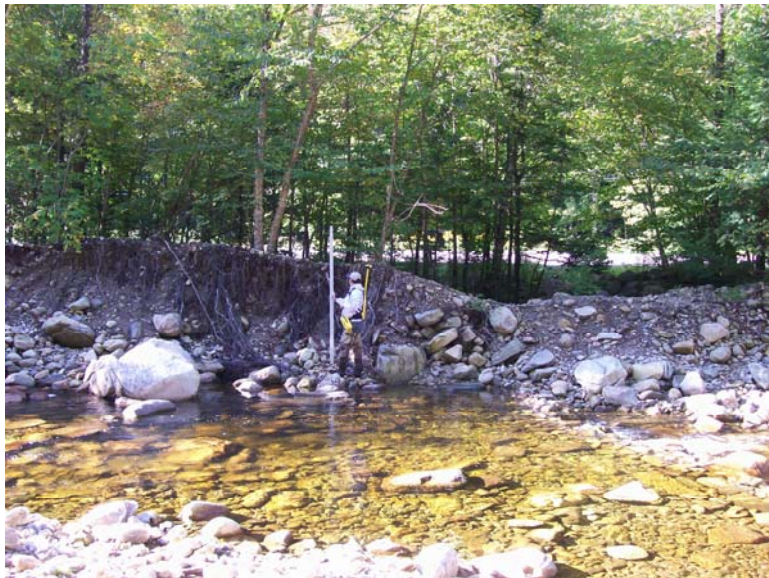
| View: DS | Description: Cross-section of segment S1.01B | | View: LB | Description: Berm erosion | |

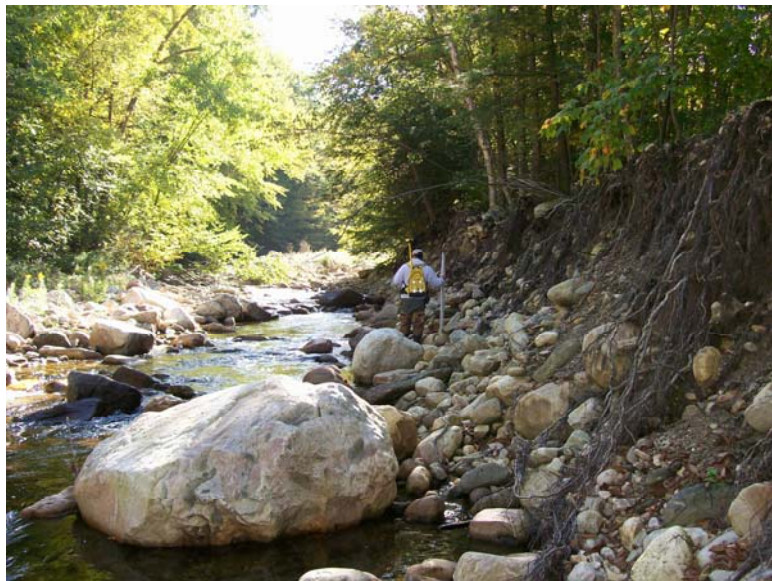
| Segment ID: S1.01C | | Photo #: 100_1004 | | Date: 9/18/2007 | |

| View: US | | Description: Berm erosion and sedimentation upstream | | | |

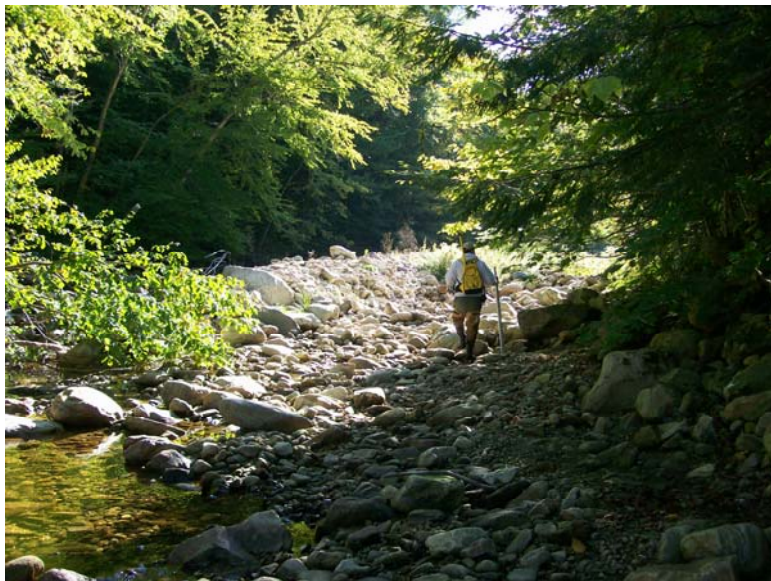
| Segment ID: S1.01C | | Photo #: 100_1005 | | Date: 9/18/2007 | |

| View: US | | Description: Large mid-channel bar upstream of berm erosion | | | |

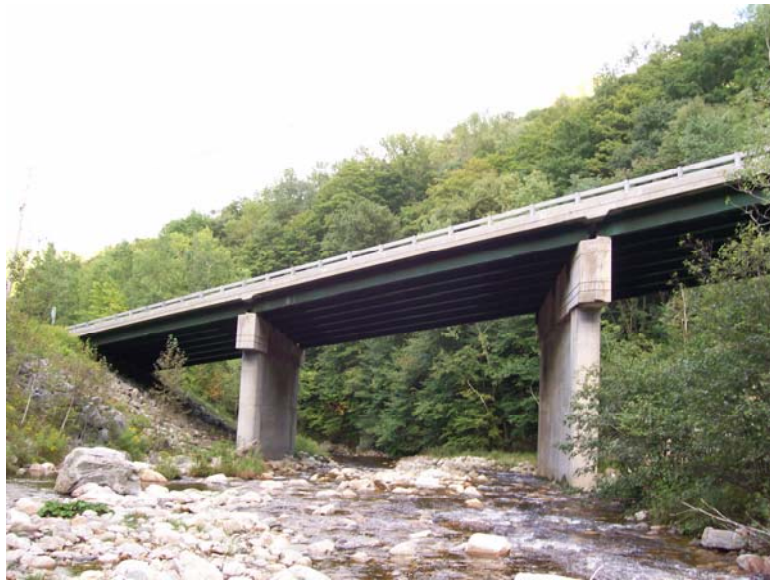
| Segment ID: S1.02A | | Photo #: 100_0919 | | Date: 9/12/2007 | |

| View: DS | | Description: Sedimentation above Rt. 9 bridge | | | |

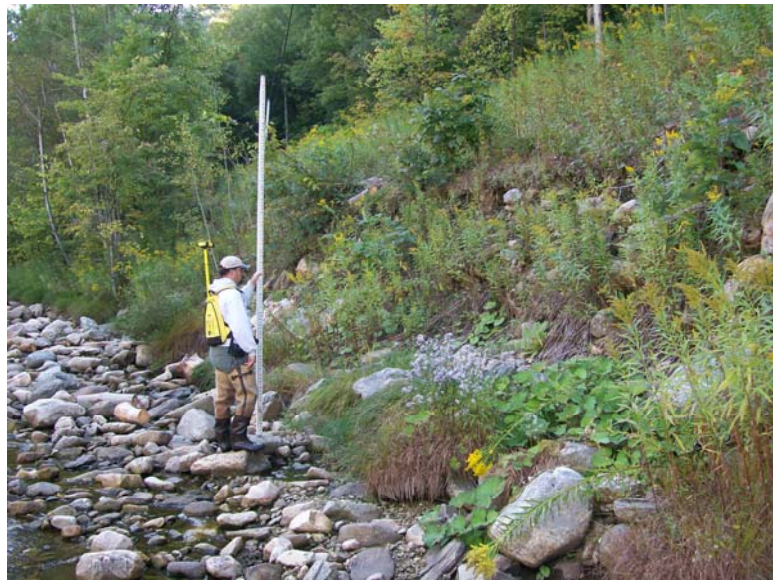
| Segment ID: S1.02A | | Photo #: 100_1012 | | Date: 9/18/2007 | |

| View: US | | Description: Left bank erosion upstream of Rt. 9 bridge | | | |

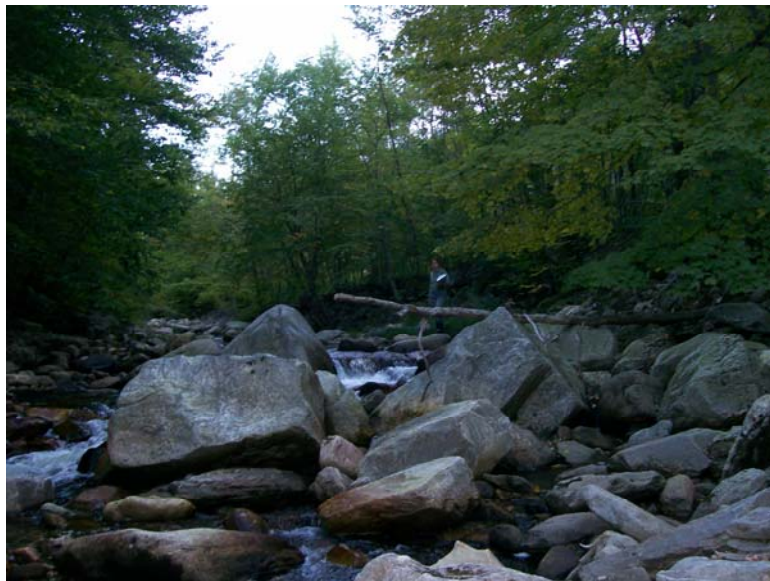
| <b>View:</b> US | <b>Description:</b> Enlargement of bed material at reach break | | | <b>View:</b> LB | <b>Description:</b> Piled dredging material along left bank | | |

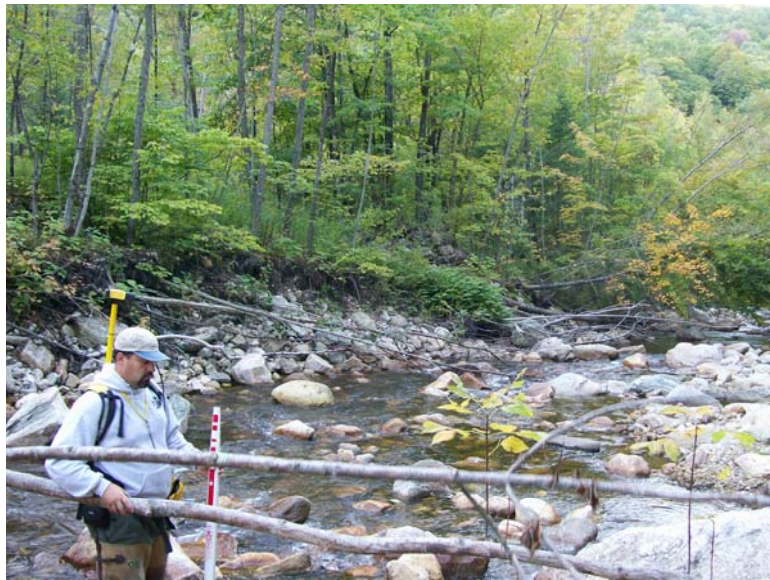
| <b>View:</b> DS | <b>Description:</b> Left bank erosion and leaning trees | | | <b>View:</b> US | <b>Description:</b> Left bank erosion | | |

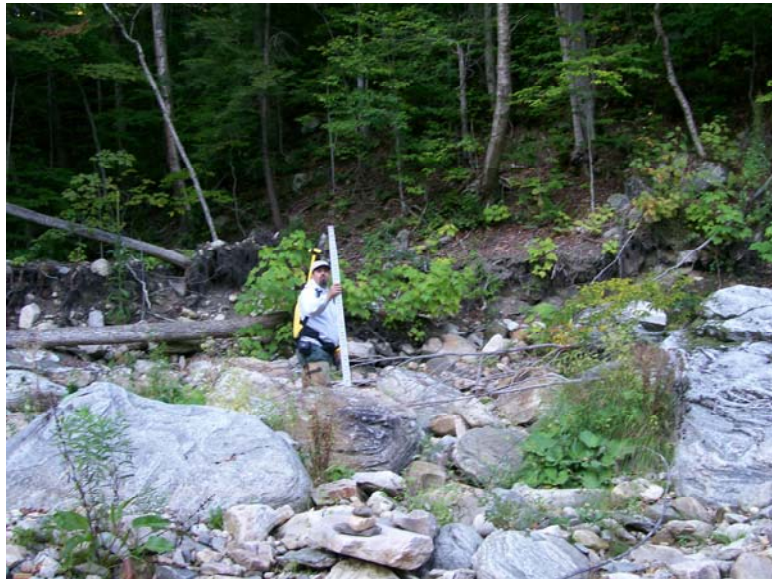
| <b>Segment ID:</b> S1.02B | | <b>Photo #:</b> 100_1020 | | <b>Date:</b> 9/18/2007 | |

| <b>View:</b> RB | | <b>Description:</b> Right bank erosion where valley wall meets bank | | | |

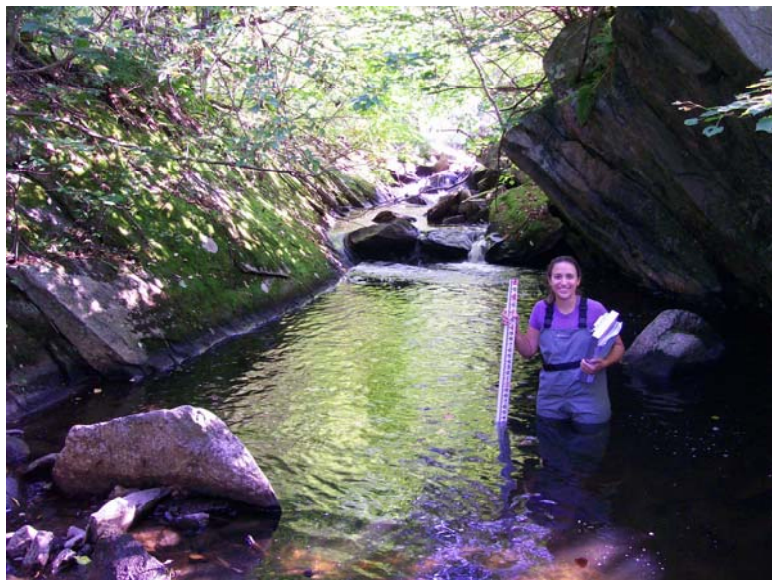
| <b>View:</b> US | <b>Description:</b> Bedrock outcrops causing channel constriction | | | <b>View:</b> DS | <b>Description:</b> Bedrock outcrops causing channel constriction | | |

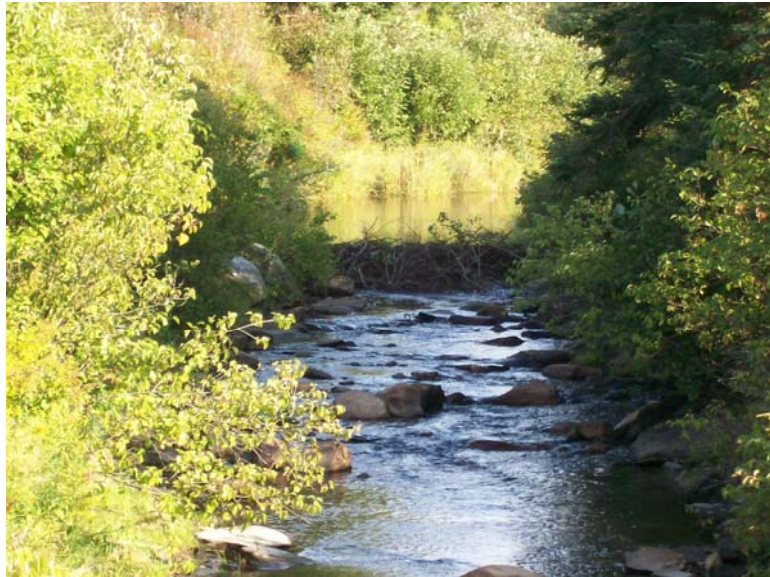
| Segment ID: S1.04D | | Photo #: 100_0945 | | Date: 9/14/2007 | |

| View: US | | Description: New beaver dam near bottom of segment S1.04D | | | |

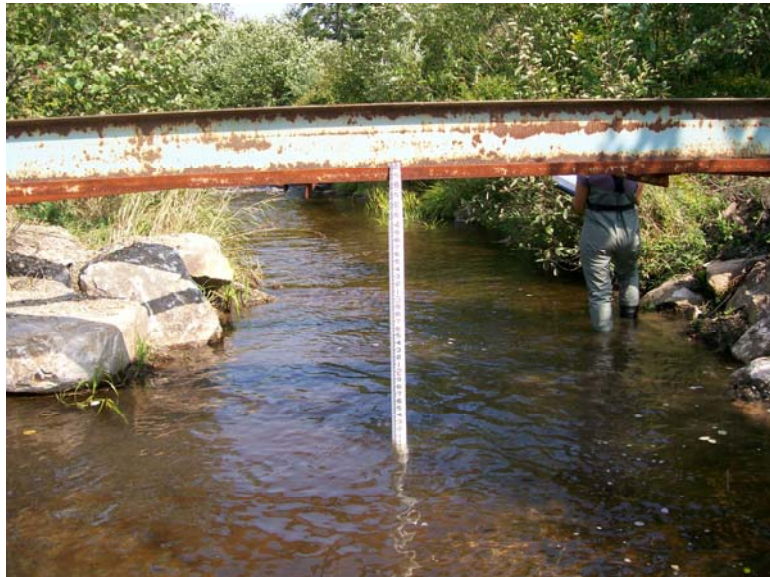
| Segment ID: S1.04D | | Photo #: 100_0966 | | Date: 9/14/2007 | |

| View: US | | Description: Steel bridge support (no deck) | | | |

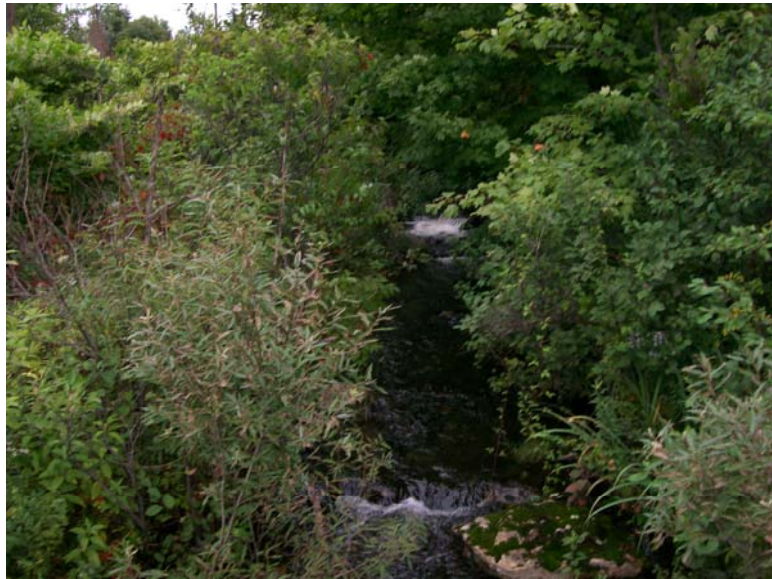
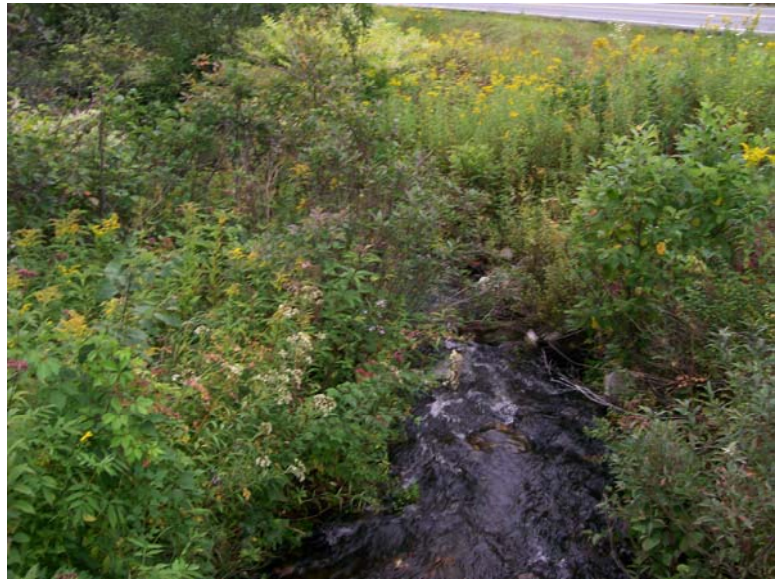
This bridge is on a snowmobile trail that crosses Route 9 in reach S1.06 of City Stream. The bridge's light timber deck, with a span 300% of the channel width, does not appear to confine the stream. Rip-rap armoring is intact. The left bank is buffered with shrub/sapling vegetation, whereas the right is the Route 9 embankment. The structure seems to be in good condition with a low potential to fail or impact the stream.

| <b>View:</b> US | <b>Description:</b> Upstream of snowmobile bridge | | | <b>View:</b> DS | <b>Description:</b> Downstream of snowmobile bridge | | |

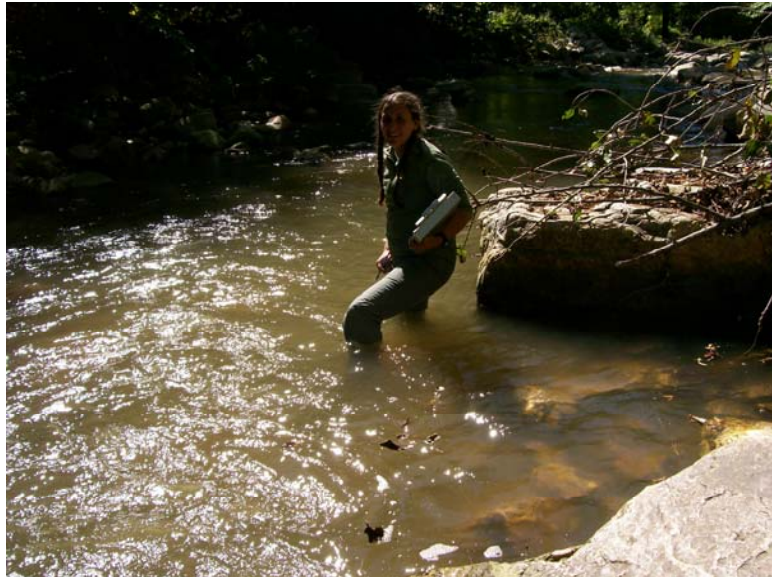
| Segment ID: T3.05A | Photo #: 100_1034 | Date: 9/19/2007 | Segment ID: T3.05A | Photo #: 100_1035 | Date: 9/19/2007 |

| View: DS | Description: Muddy water from dredging above dam | | View: US | Description: Left bank erosion | |

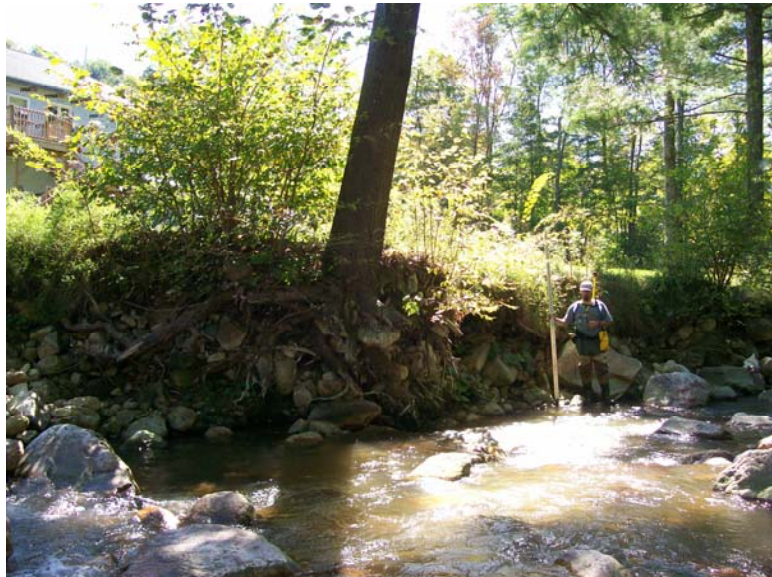
| Segment ID: T3.05A | Photo #: 100_1036 | Date: 9/19/2007 | Segment ID: T3.05A | Photo #: 100_1037 | Date: 9/19/2007 |

| View: DS | Description: Left bank erosion and development | | View: US | Description: Head cut | |

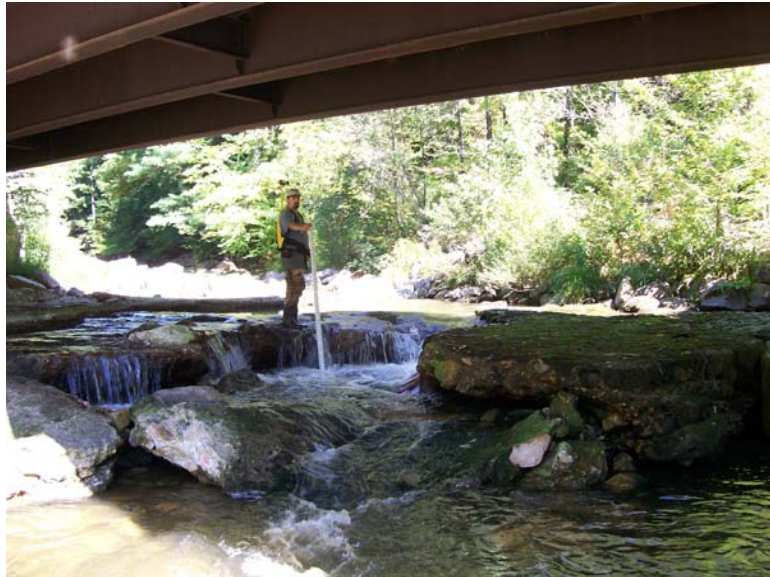
| Segment ID: T3.05B | | Photo #: 100_1043 | | Date: 9/19/2007 | |

| View: US | | Description: Old concrete slabs under bridge (grade control) | | | |

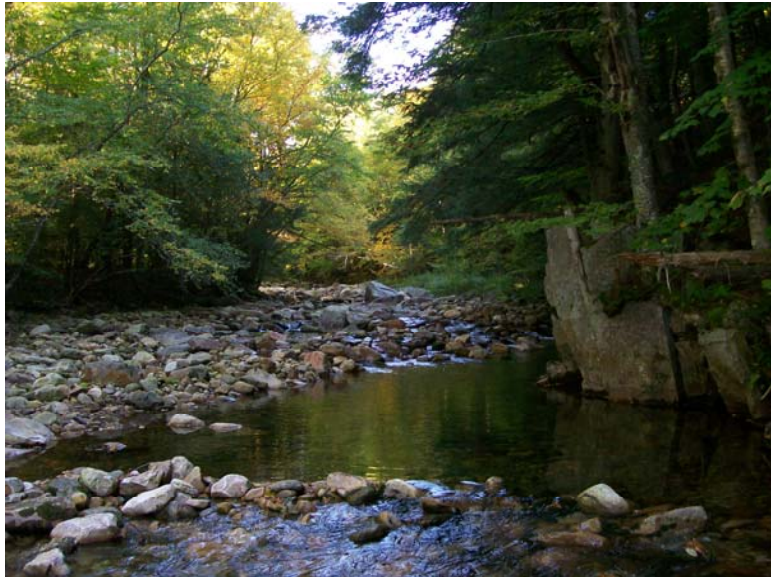
| Segment ID: T3.05B | | Photo #: 100_1044 | | Date: 9/24/2007 | |

| View: US | | Description: Bedrock outcrop and steep riffle/diagonal bar | | | |

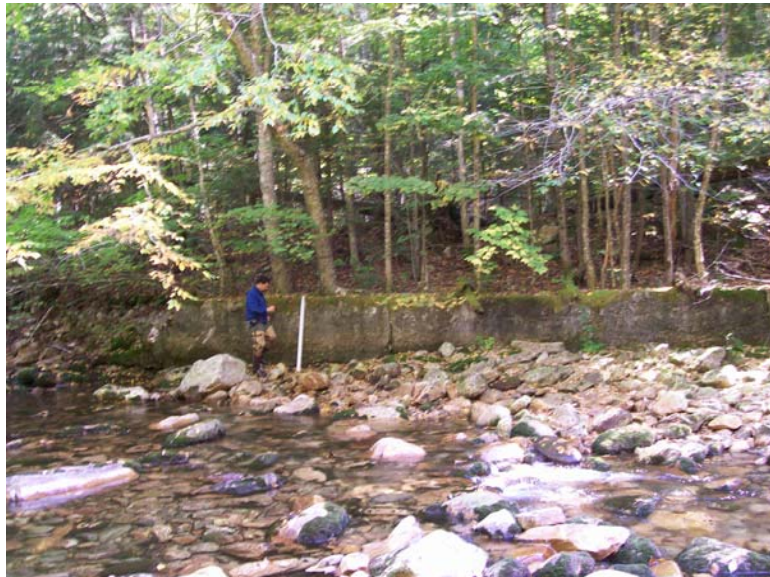
| Segment ID: T3.05B | | Photo #: 100_1046 | | Date: 9/24/2007 | |

| View: LB | | Description: Old concrete slab bank revetment | | | |

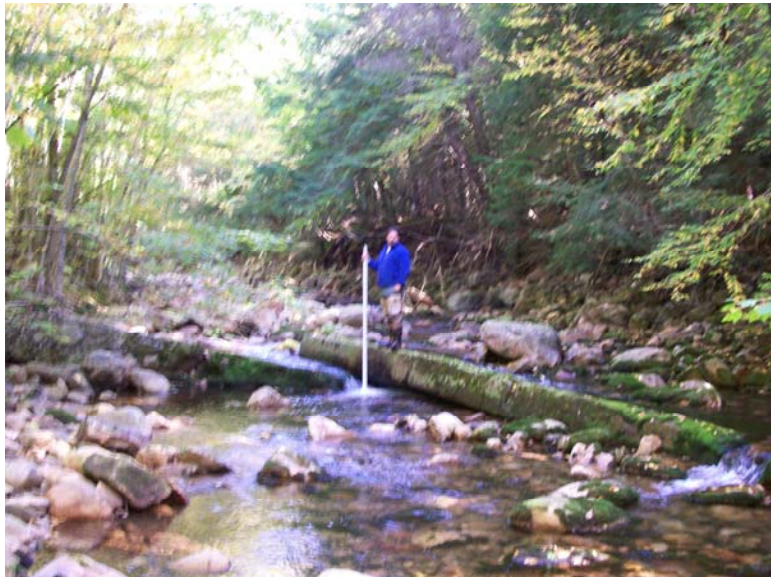
| Segment ID: T3.05B | | Photo #: 100_1049 | | Date: 9/24/2007 | |

| View: US | | Description: Old concrete slabs in channel (grade control) | | | |

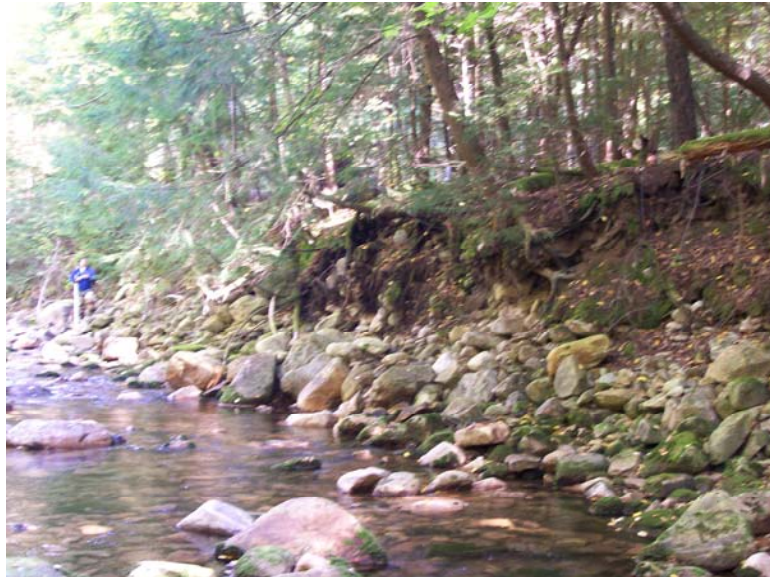
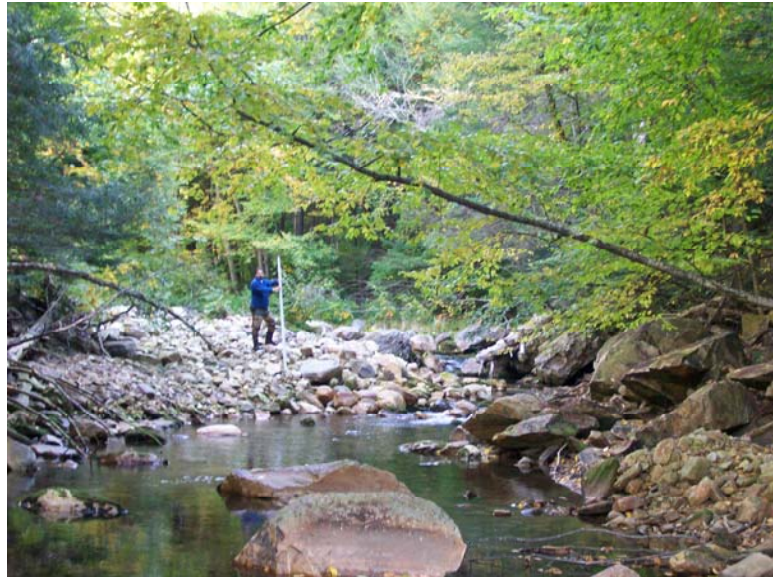
| <b>View:</b> US | <b>Description:</b> Left bank erosion | | | <b>View:</b> US | <b>Description:</b> Large point bar, steep riffle, and bedrock outcrop | | |

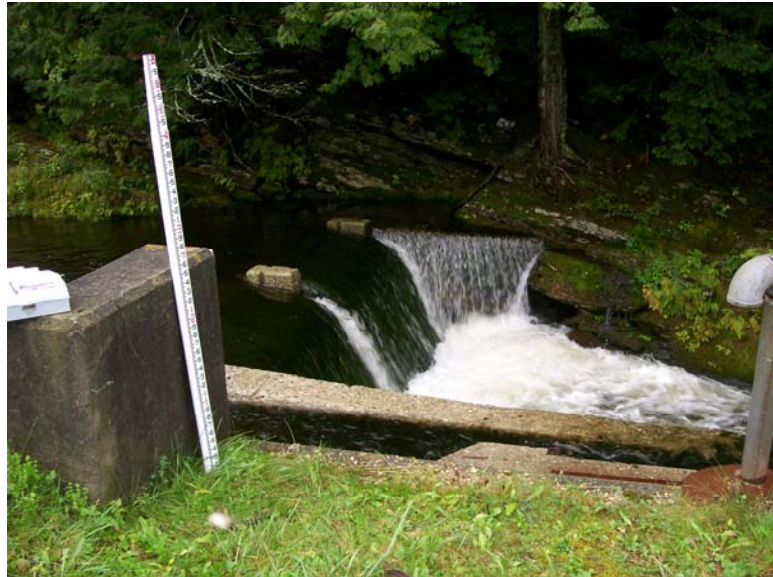
| <b>View:</b> LB | | <b>Description:</b> Cross section | | | <b>View:</b> LB | | <b>Description:</b> Small dam and drinking water withdrawal | | |

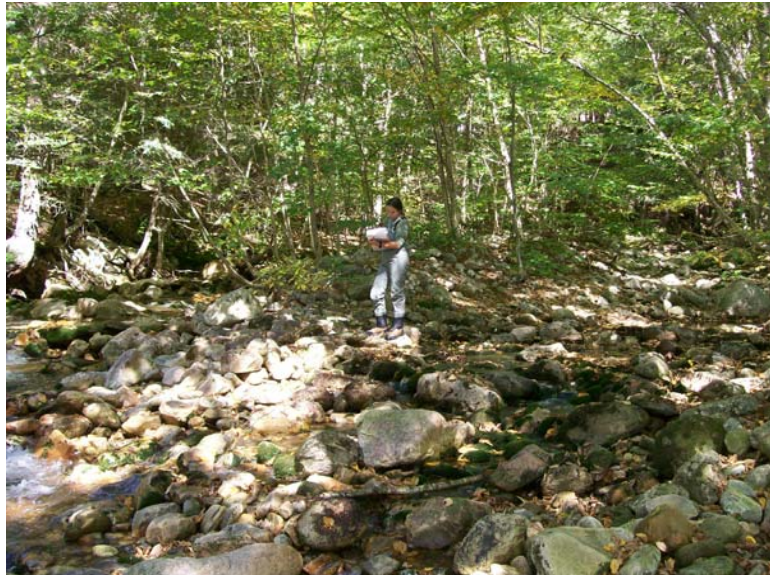
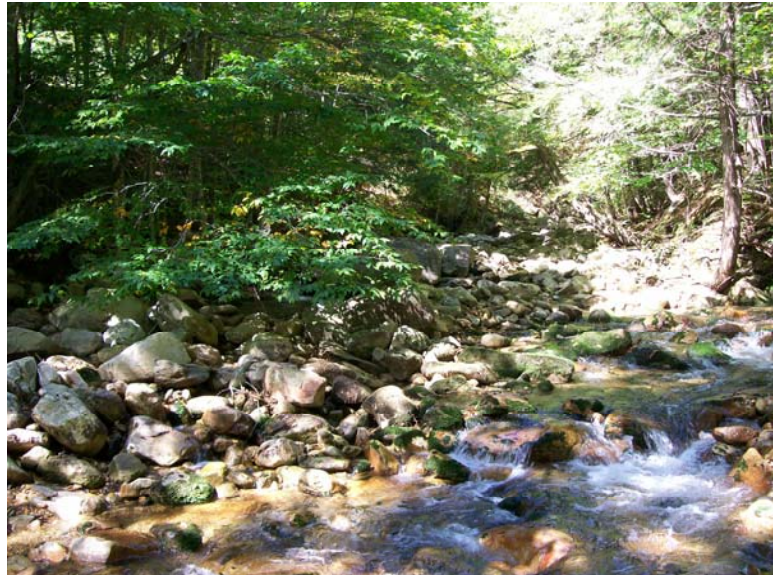
| <b>View:</b> US | <b>Description:</b> Bottom of reach (braiding, islands) | | | <b>View:</b> US | <b>Description:</b> Mouth of Bickford Hollow Brook at reach break | | |

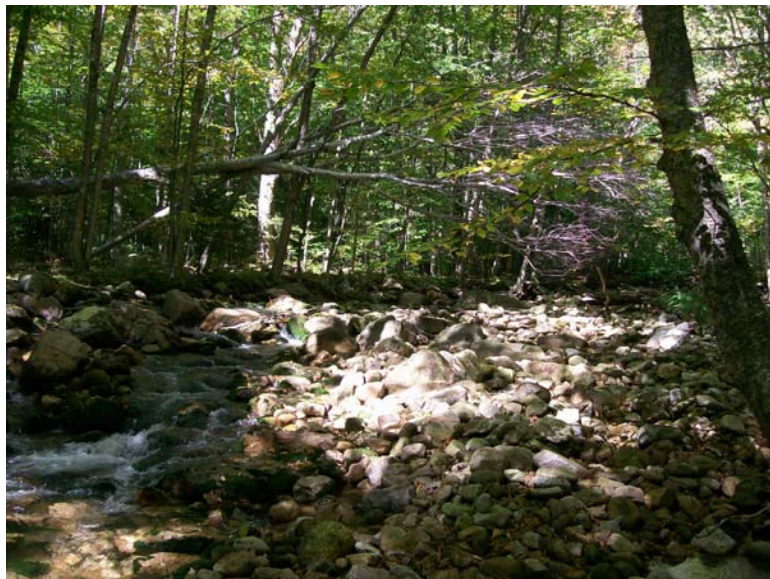
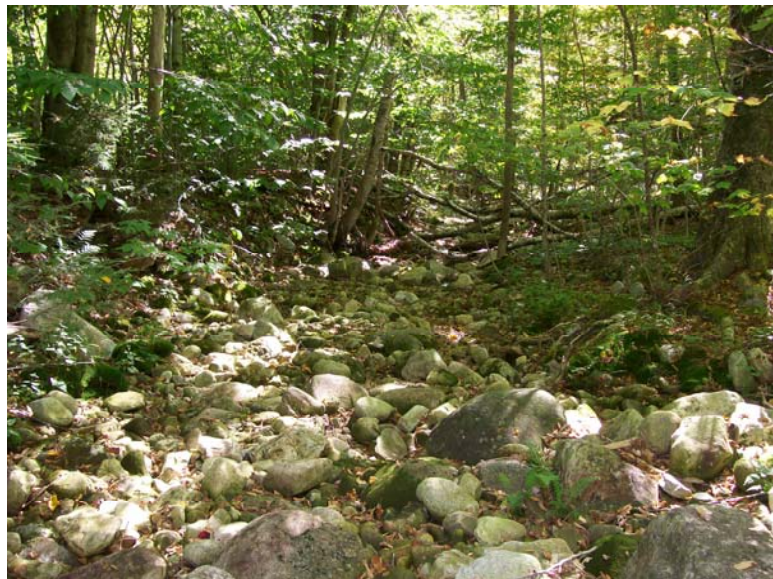
| <b>View:</b> US | <b>Description:</b> Steep riffle and large deposition | | | <b>View:</b> DS | <b>Description:</b> Top of characteristic dry side channel | | |

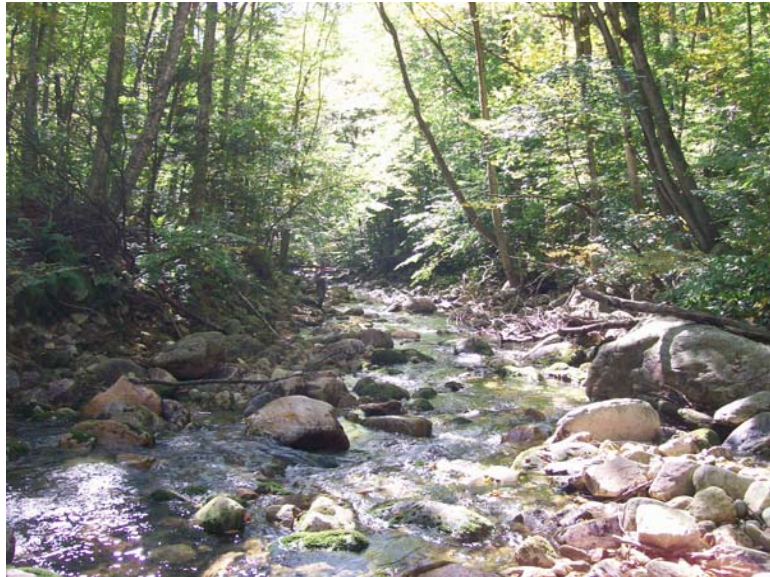
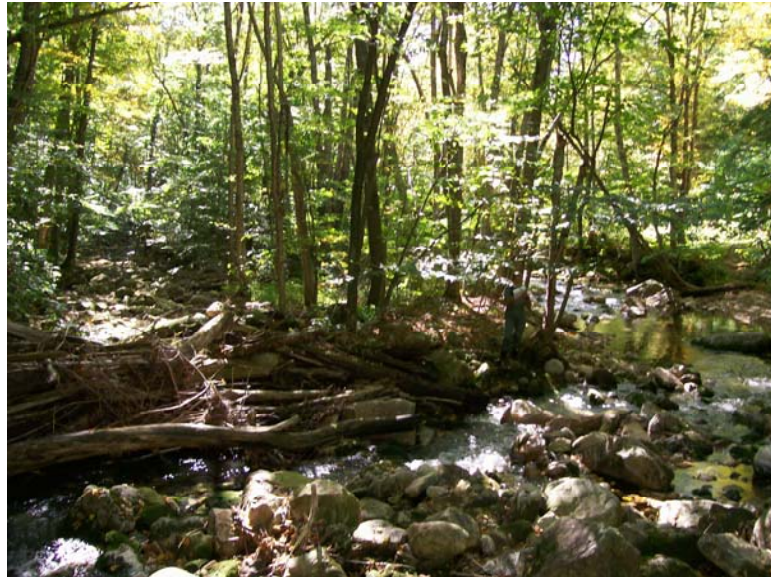
| <b>View:</b> DS | <b>Description:</b> Incising section with right bank erosion | | | <b>View:</b> DS | <b>Description:</b> Debris jam blocking side channel above x-section | | |

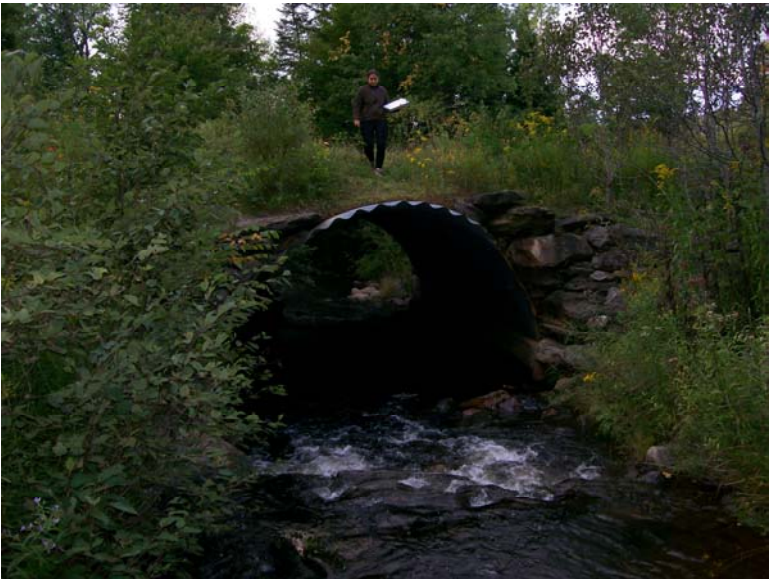
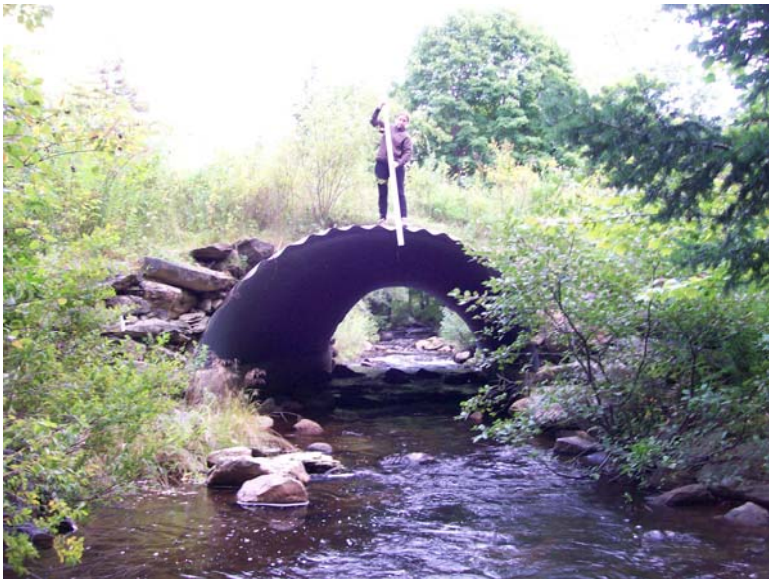
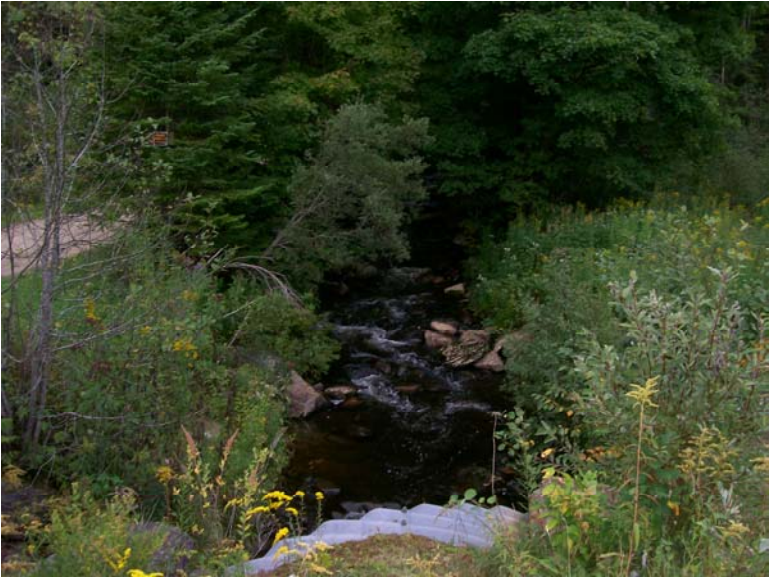
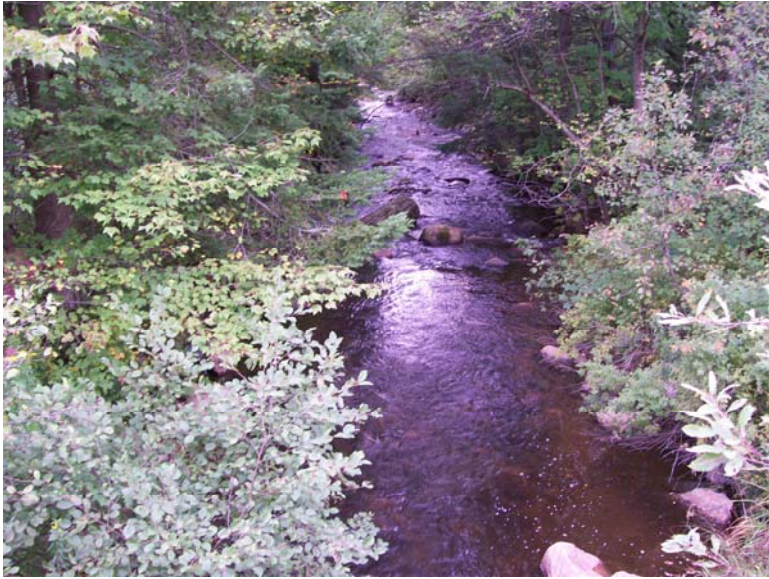
This structure is a small arch near the top of reach S1.03 of City Stream, just off Route 9 on City Stream Road (gravel). With a width 59% of the channel width, this structure acts as both a channel and floodplain confinement. Shrub/sapling vegetation lines both upstream and downstream banks, more densely on the left side. The arch seems to be in relatively good condition with a low potential to fail, although it does confine the stream somewhat.

| View: DS | | Description: Inlet of arch on City Stream Rd. | | | | View: US | | Description: Outlet of arch on City Stream Rd. | | | |

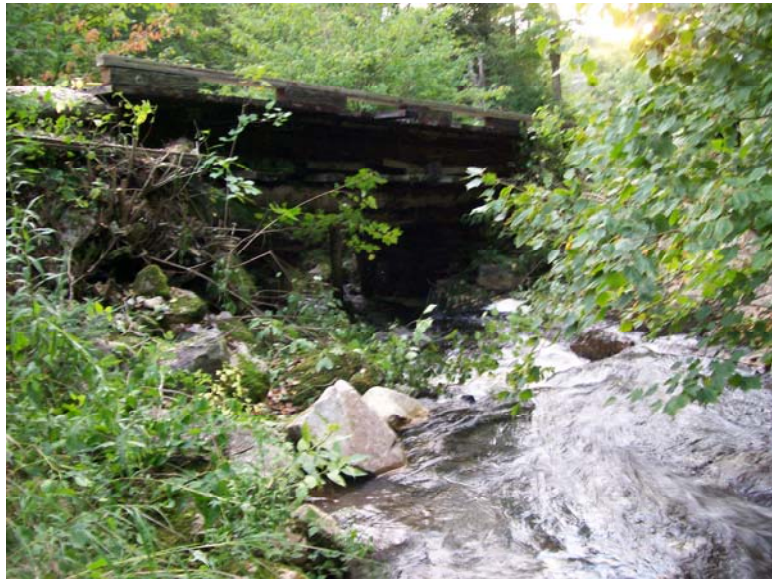
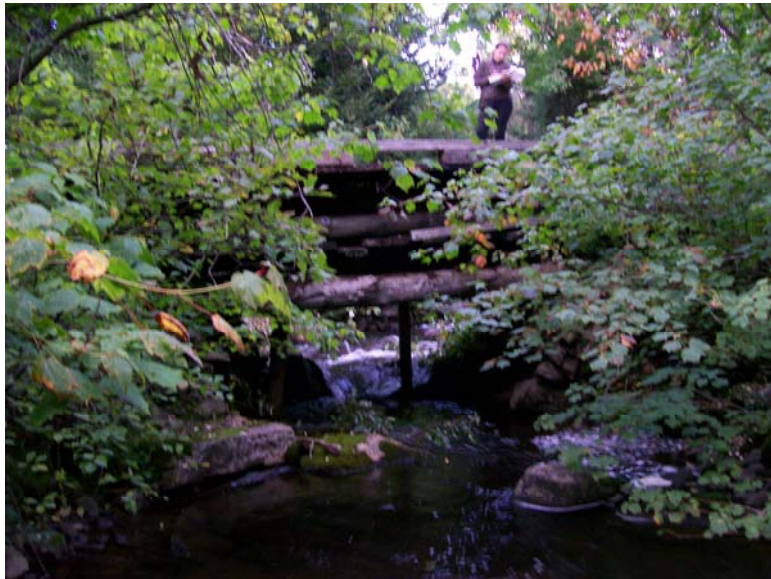
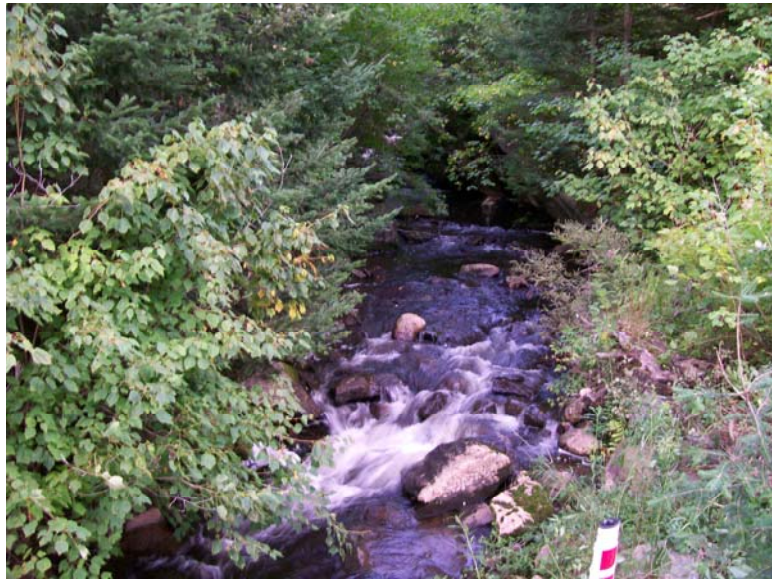
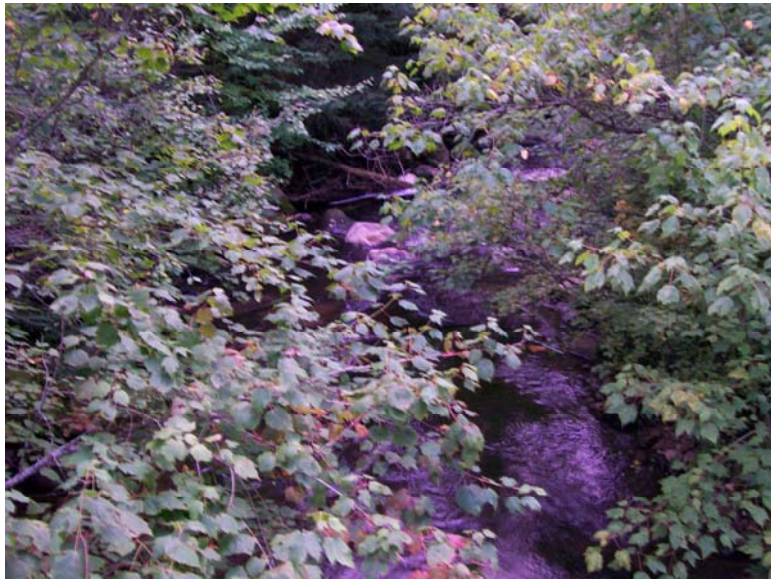
This structure is a small wooden bridge across a driveway just upstream at the break between reaches S1.03 and S1.04 of City Stream. A new bridge with steel beams and a timber deck was recently built over top of the old, failing bridge by its private owner. The bridge is located at the base of a bedrock gorge at a bend in the stream, and the effect of the high stream power is evidenced by failing bank armoring on the upstream side of the bridge. The banks and buffers are well-forested in all directions. Now that the bridge has been reinforced and rebuilt, it appears to

have a low potential to fail, but the remaining old bridge materials may soon fail and impede the stream flow.

| View: DS | | Description: Inlet of bridge on driveway off City Stream Rd. | | View: US | | Description: Outlet of bridge on driveway off City Stream Rd. | |
