# Stream Geomorphic Assessment of City Stream and Bolles Brook *Woodford, VT*

## **FINAL REPORT** *December 2007*

**Bennington County Conservation District**

**GOMEZ AND SULLIVAN**  
Engineers, P.C.

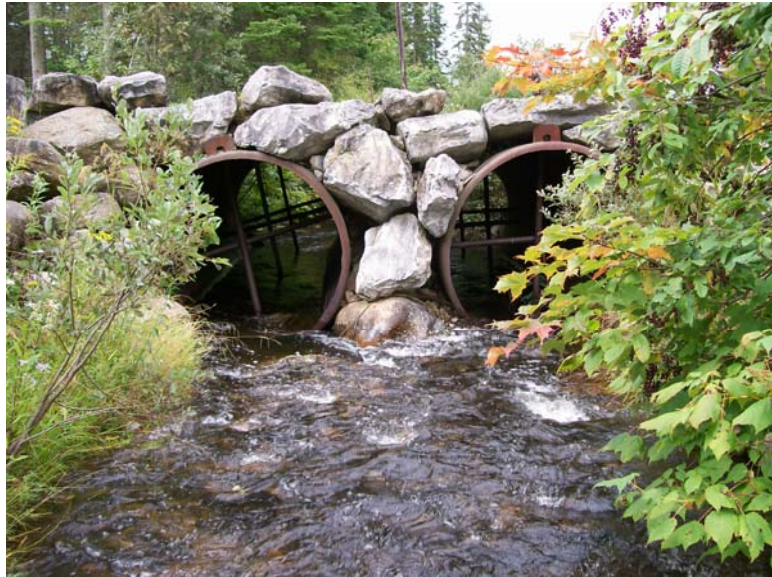
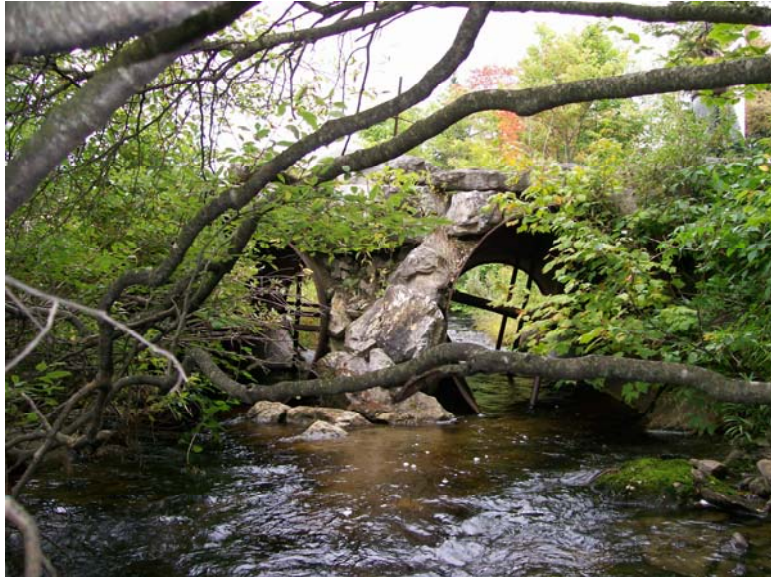
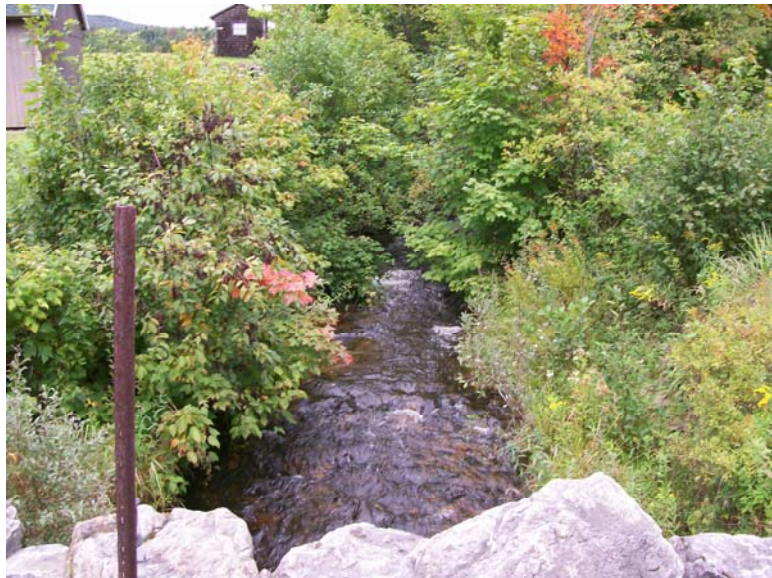
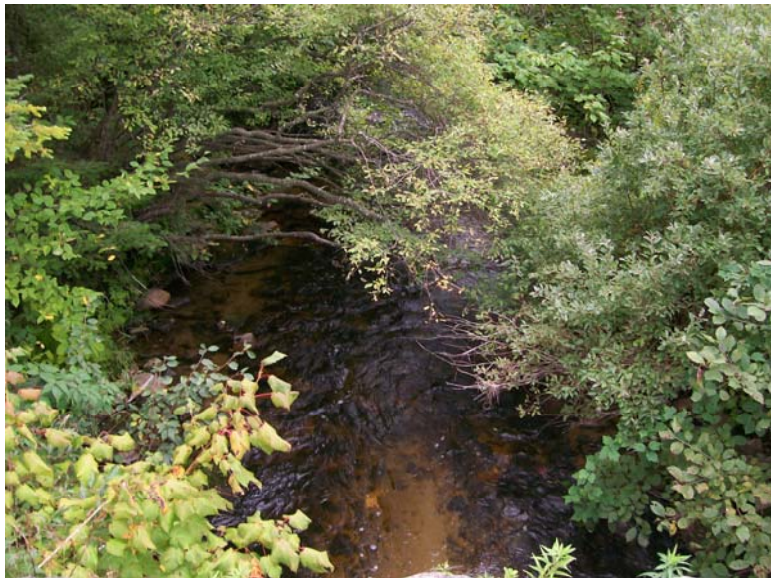
| <b>Segment ID:</b> S1.04D | | <b>Photo #:</b> 100_0912 | | <b>Date:</b> 9/12/2007 | |

This culvert is located just below the outlet of Bugbee Mill Pond near the top of segment S1.04D on Greenwood Drive. It has two openings with a combined width 67% of the channel width. Herbaceous and shrub vegetation lines both banks, although just downstream a new dirt road is being cut on the left and a gravel lot is on the right. Both of these developments are contributing to heavy sediment runoff and deposition in the channel downstream. The structure itself appears to be in good condition with little potential to fail, although it does confine the stream.

| <b>View:</b> DS | | <b>Description:</b> Inlet of culvert below Bugbee Mill Pond | | | |
| <b>View:</b> US | | <b>Description:</b> Outlet of culvert below Bugbee Mill Pond | | | |
| <b>View:</b> US | | <b>Description:</b> Upstream of culvert below Bugbee Mill Pond | | | |
| <b>View:</b> DS | | <b>Description:</b> Downstream of culvert below Bugbee Mill Pond | | | |

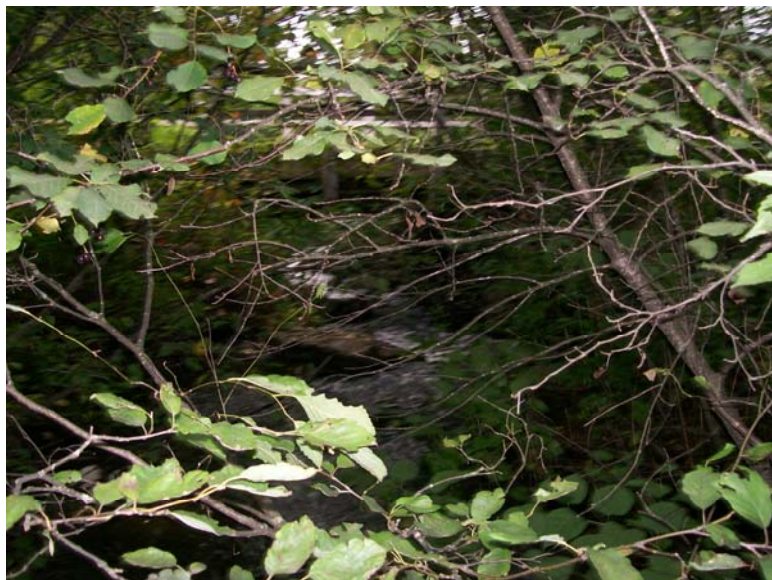
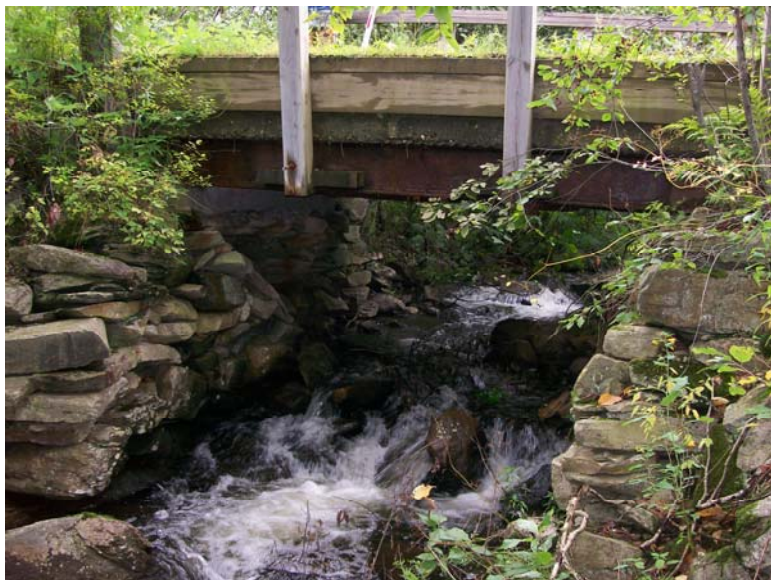
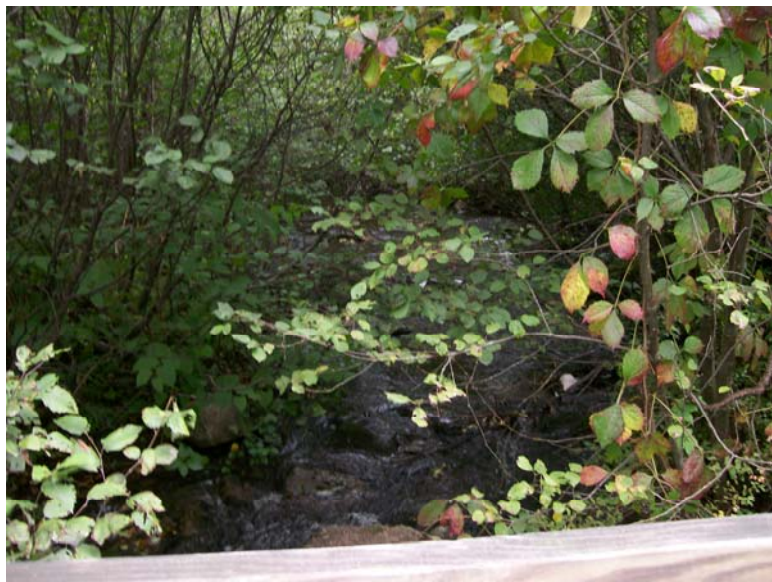
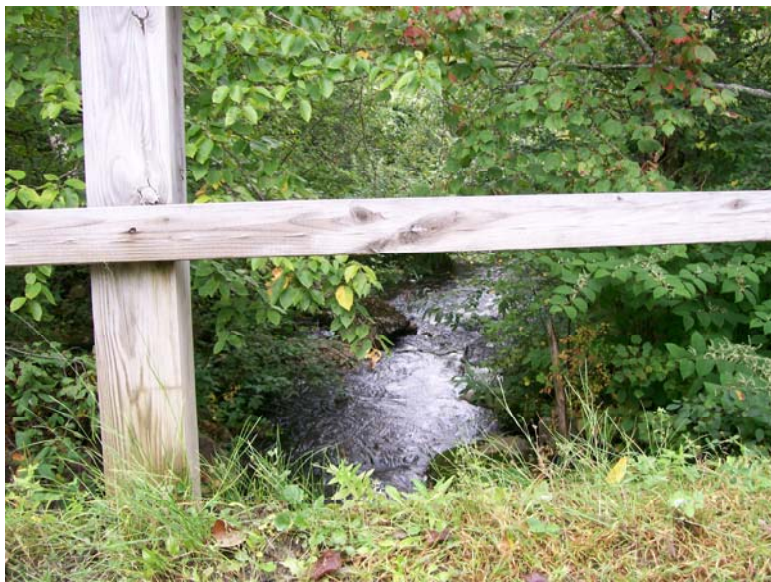
This bridge is located on a driveway just off Route 9 in reach S1.06 of City Stream. Although the structure span is as wide as the channel, large stone abutments beneath the bridge confine the stream. Shrub/sapling vegetation lines both banks, more extensively in the left corridor. The stone abutments do not appear to be in the best condition and could possibly fail during a flood event.

| <b>View:</b> DS | <b>Description:</b> Inlet of bridge on driveway off Rt. 9 | | | <b>View:</b> US | <b>Description:</b> Outlet of bridge on driveway off Rt. 9 | | |
| <b>View:</b> US | <b>Description:</b> Upstream of bridge on driveway off Rt. 9 | | | <b>View:</b> DS | <b>Description:</b> Downstream of bridge on driveway off Rt. 9 | | |

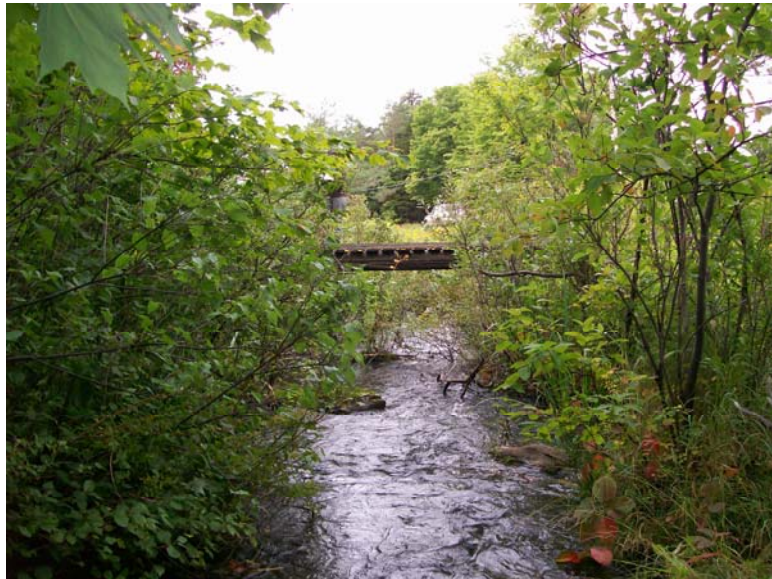
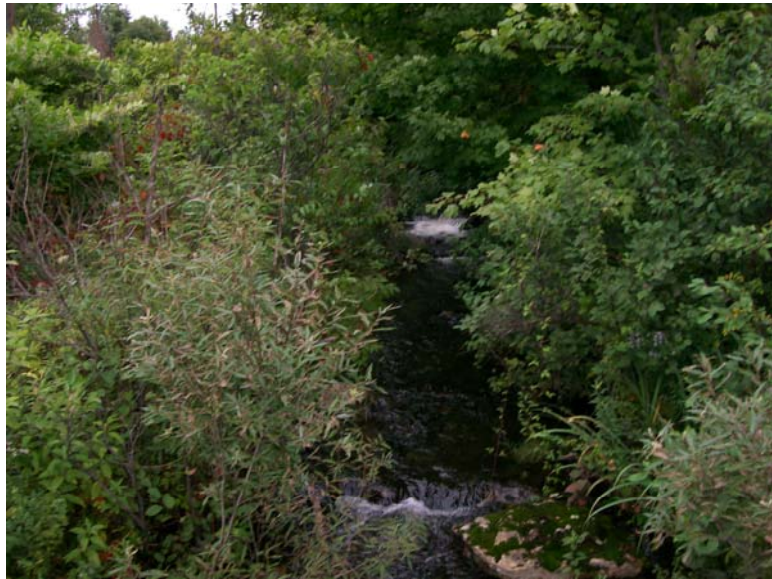
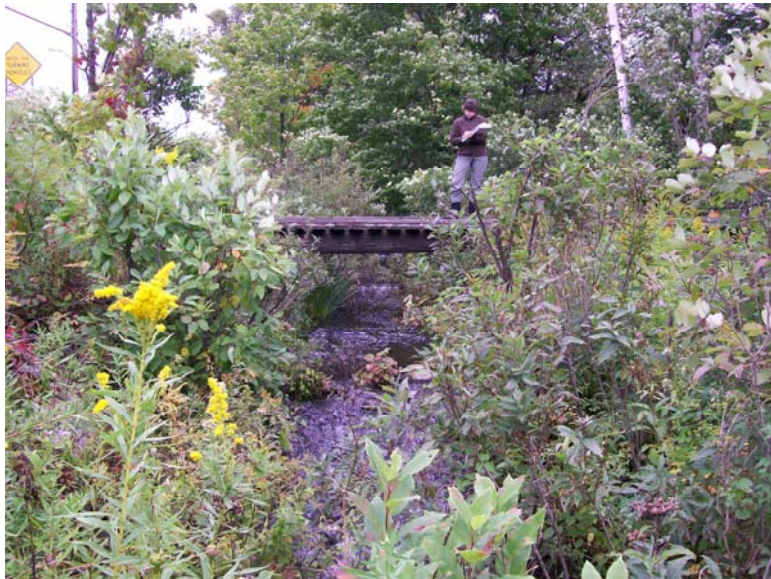
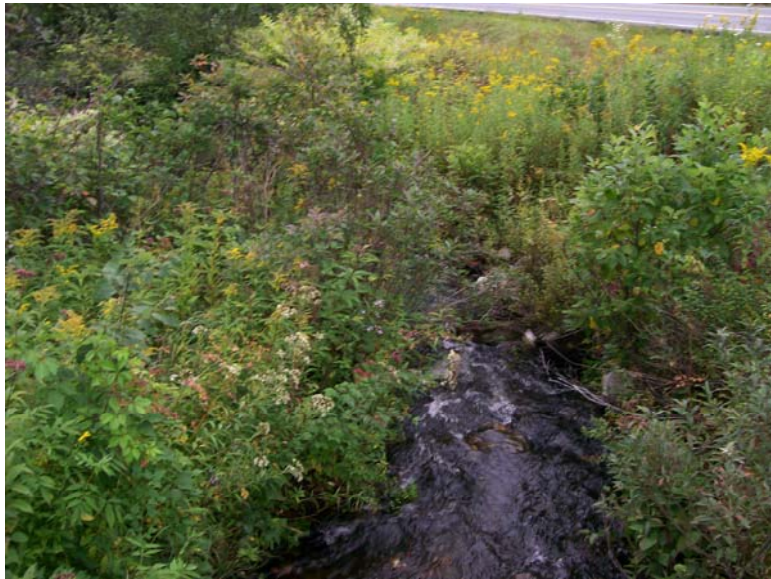
| Segment ID: S1.06 | | Photo #: 100_0903 | | Date: 9/12/2007 | |

This bridge is on a snowmobile trail that crosses Route 9 in reach S1.06 of City Stream. The bridge's light timber deck, with a span 300% of the channel width, does not appear to confine the stream. Rip-rap armoring is intact. The left bank is buffered with shrub/sapling vegetation, whereas the right is the Route 9 embankment. The structure seems to be in good condition with a low potential to fail or impact the stream.

| View: DS | | Description: Inlet of snowmobile bridge | | | |
| View: US | | Description: Upstream of snowmobile bridge | | | |

| View: US | | Description: Outlet of snowmobile bridge | | | |
| View: DS | | Description: Downstream of snowmobile bridge | | | |

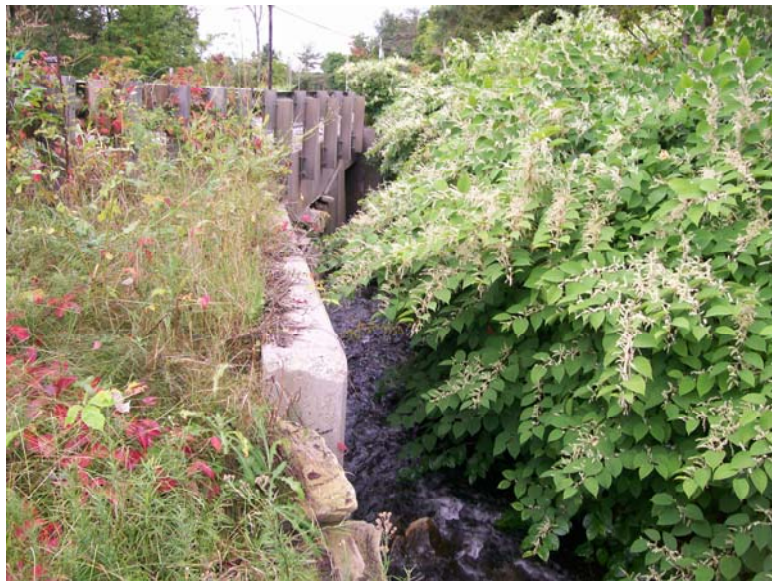
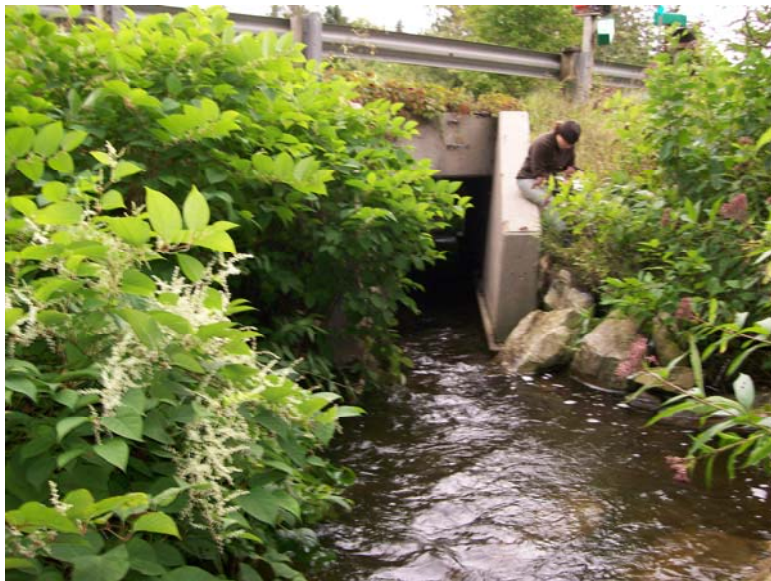
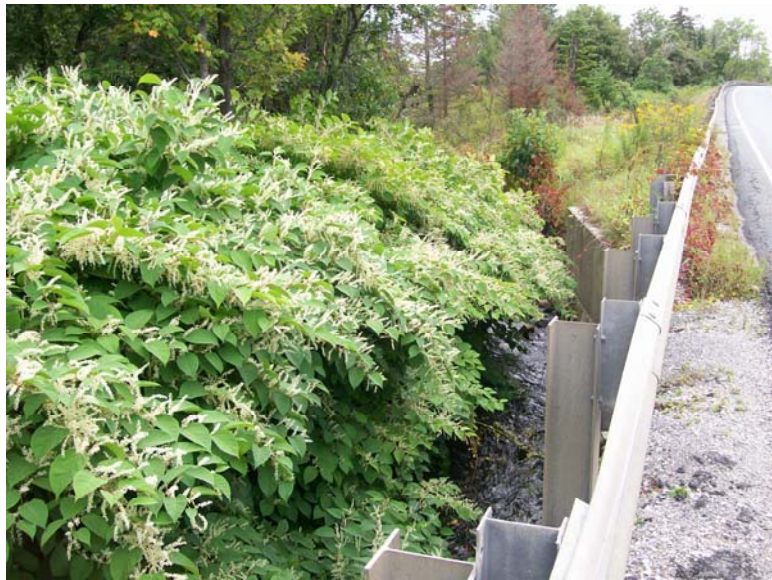
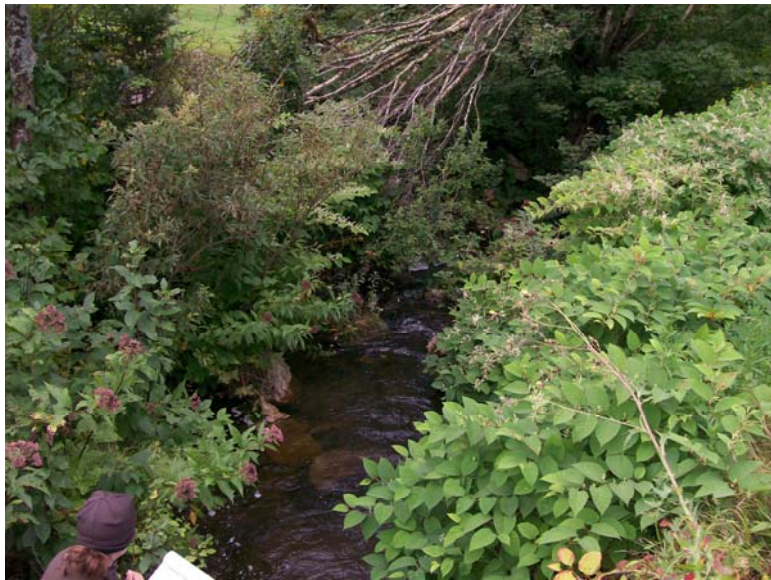
| Segment ID: S1.06 | | Photo #: 100_0897 | | Date: 9/12/2007 | |

This structure is a culvert across Route 9 near the upper end of reach S1.06 of City Stream. The structure is skewed to the roadway to accommodate the sharp angle of the stream. With a width of only 3.2 feet (18% of the channel width), this culvert is the most confining structure assessed on either City Stream or Bolles Brook. The stream is highly channelized in this area, especially above the culvert where concrete wingwalls extend upstream. Still, the structure seems to be in good condition with little potential to fail. It is likely that the small dam and impoundment just upstream of the culvert (at the reach break) provide some flow regulation to protect the structure.

| View: DS | | Description: Inlet of culvert across Rt. 9 | | | |

| View: US | | Description: Outlet of culvert across Rt. 9 | | | |

| View: US | | Description: Upstream of culvert across Rt. 9 | | | |

| View: DS | | Description: Downstream of culvert across Rt. 9 | | | |

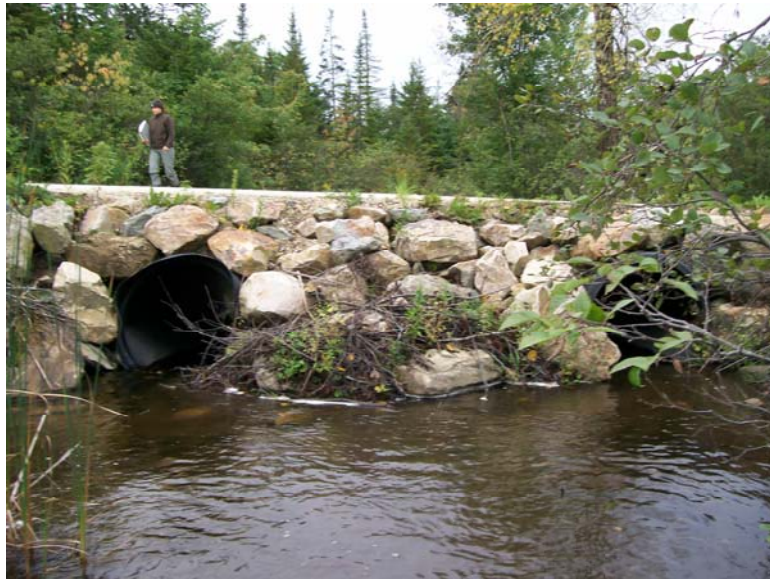
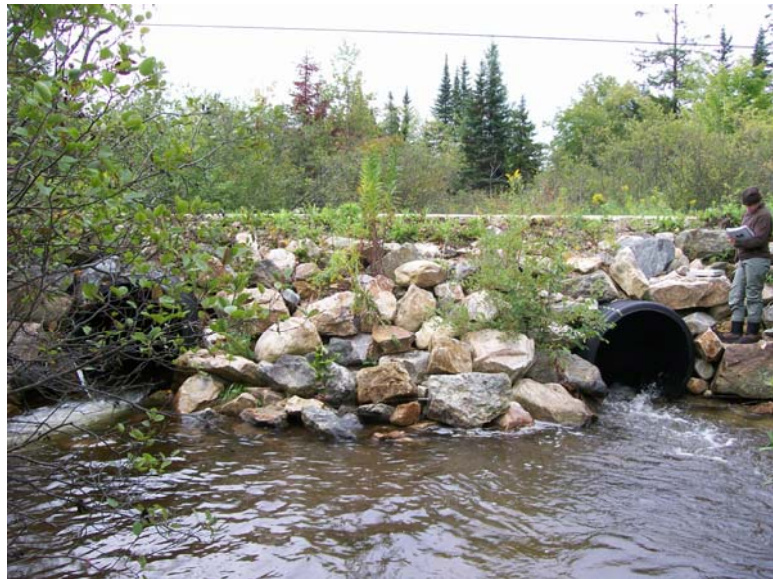
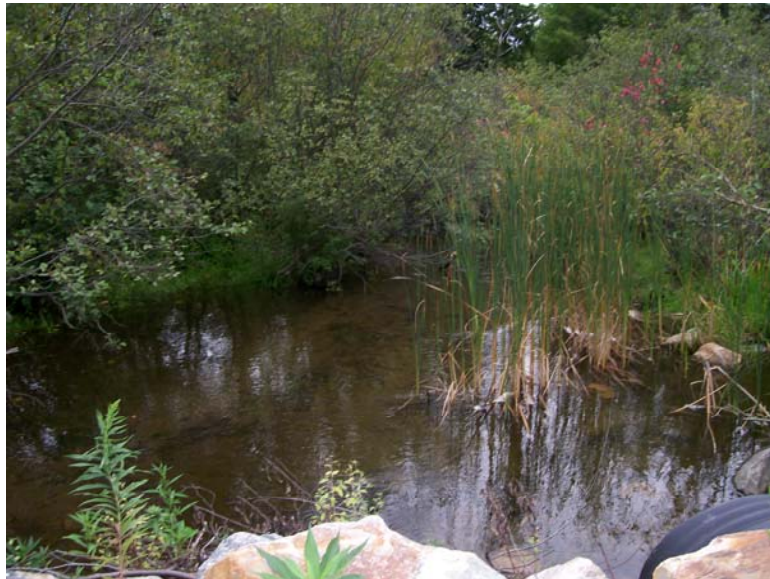
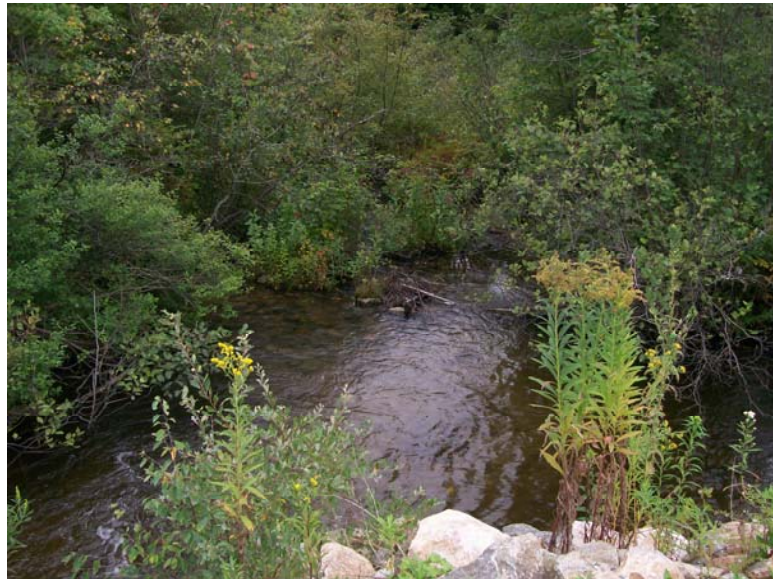
| Segment ID: S1.06 | | Photo #: 100_0895 | | Date: 9/12/2007 | |

The most upstream structure on City Stream is a culvert across Evergreen Lane below Woodford Lake (Big Pond) on reach S1.07. Two corrugated plastic culverts have a combined width that is 48% of the channel width. Shrub/sapling vegetation lines the banks in both directions. The structure seems to be in good condition with a low potential to fail or impact the stream, although it does confine the stream.

| View: DS | | Description: Inlet of culvert below Big Pond | | | |

| View: US | | Description: Outlet of culvert below Big Pond | | | |

| View: US | | Description: Upstream of culvert below Big Pond | | | |

| View: DS | | Description: Downstream of culvert below Big Pond | | | |

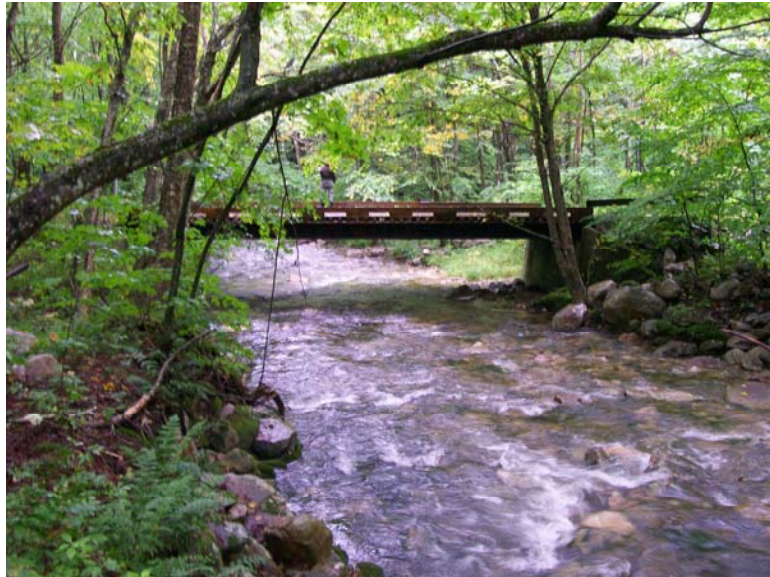
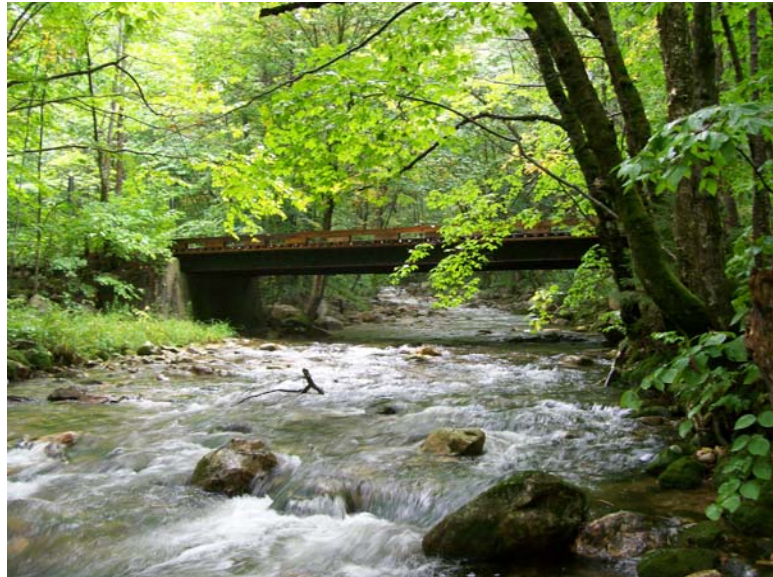
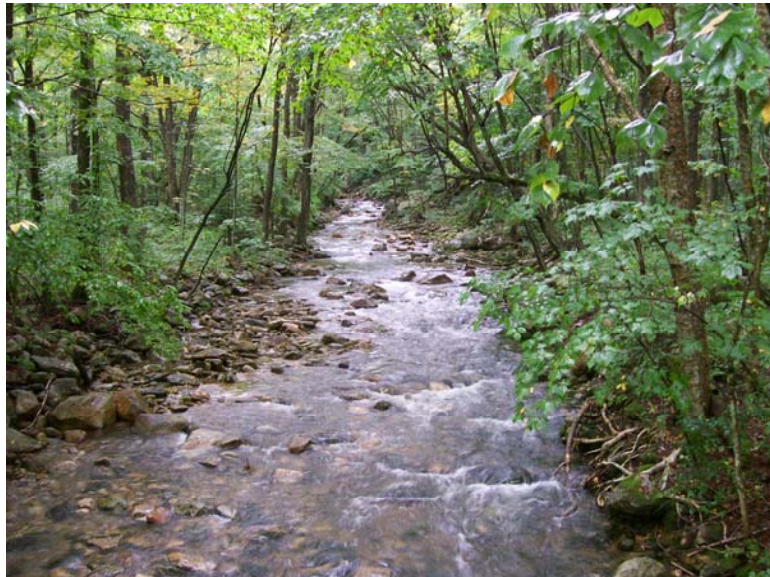
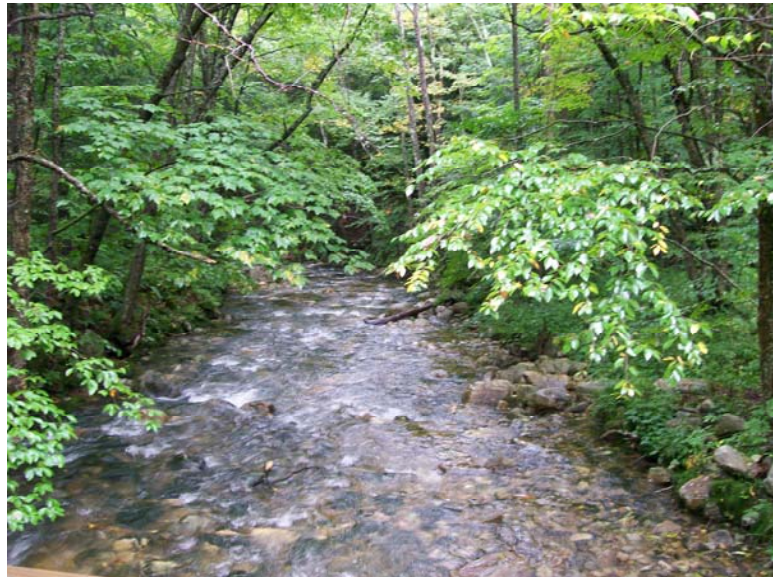
| <b>Segment ID:</b> T3.06 | | <b>Photo #:</b> 100_0880 | | <b>Date:</b> 9/11/2007 | |

The most upstream structure on Bolles Brook is a timber bridge near the top of reach T3.06 on the Green Mountain National Forest dirt road that continues from Harbour Road. This bridge spans approximately the same width as the channel, and does not seem to confine the stream. Mixed forest vegetation provides adequate buffer on both sides. The bridge is in good condition with a low potential to fail or impact the stream.

| <b>View:</b> DS | | <b>Description:</b> Inlet of bridge on National Forest road | | | |
| <b>View:</b> US | | <b>Description:</b> Outlet of bridge on National Forest road | | | |
| <b>View:</b> US | | <b>Description:</b> Upstream of bridge on National Forest road | | | |
| <b>View:</b> DS | | <b>Description:</b> Downstream of bridge on National Forest road | | | |
