Wild Branch Corridor Plan

Wolcott, Craftsbury and Eden, Vermont

March 18, 2010

Wild Branch Corridor Plan Wolcott, Craftsbury and Eden, Vermont

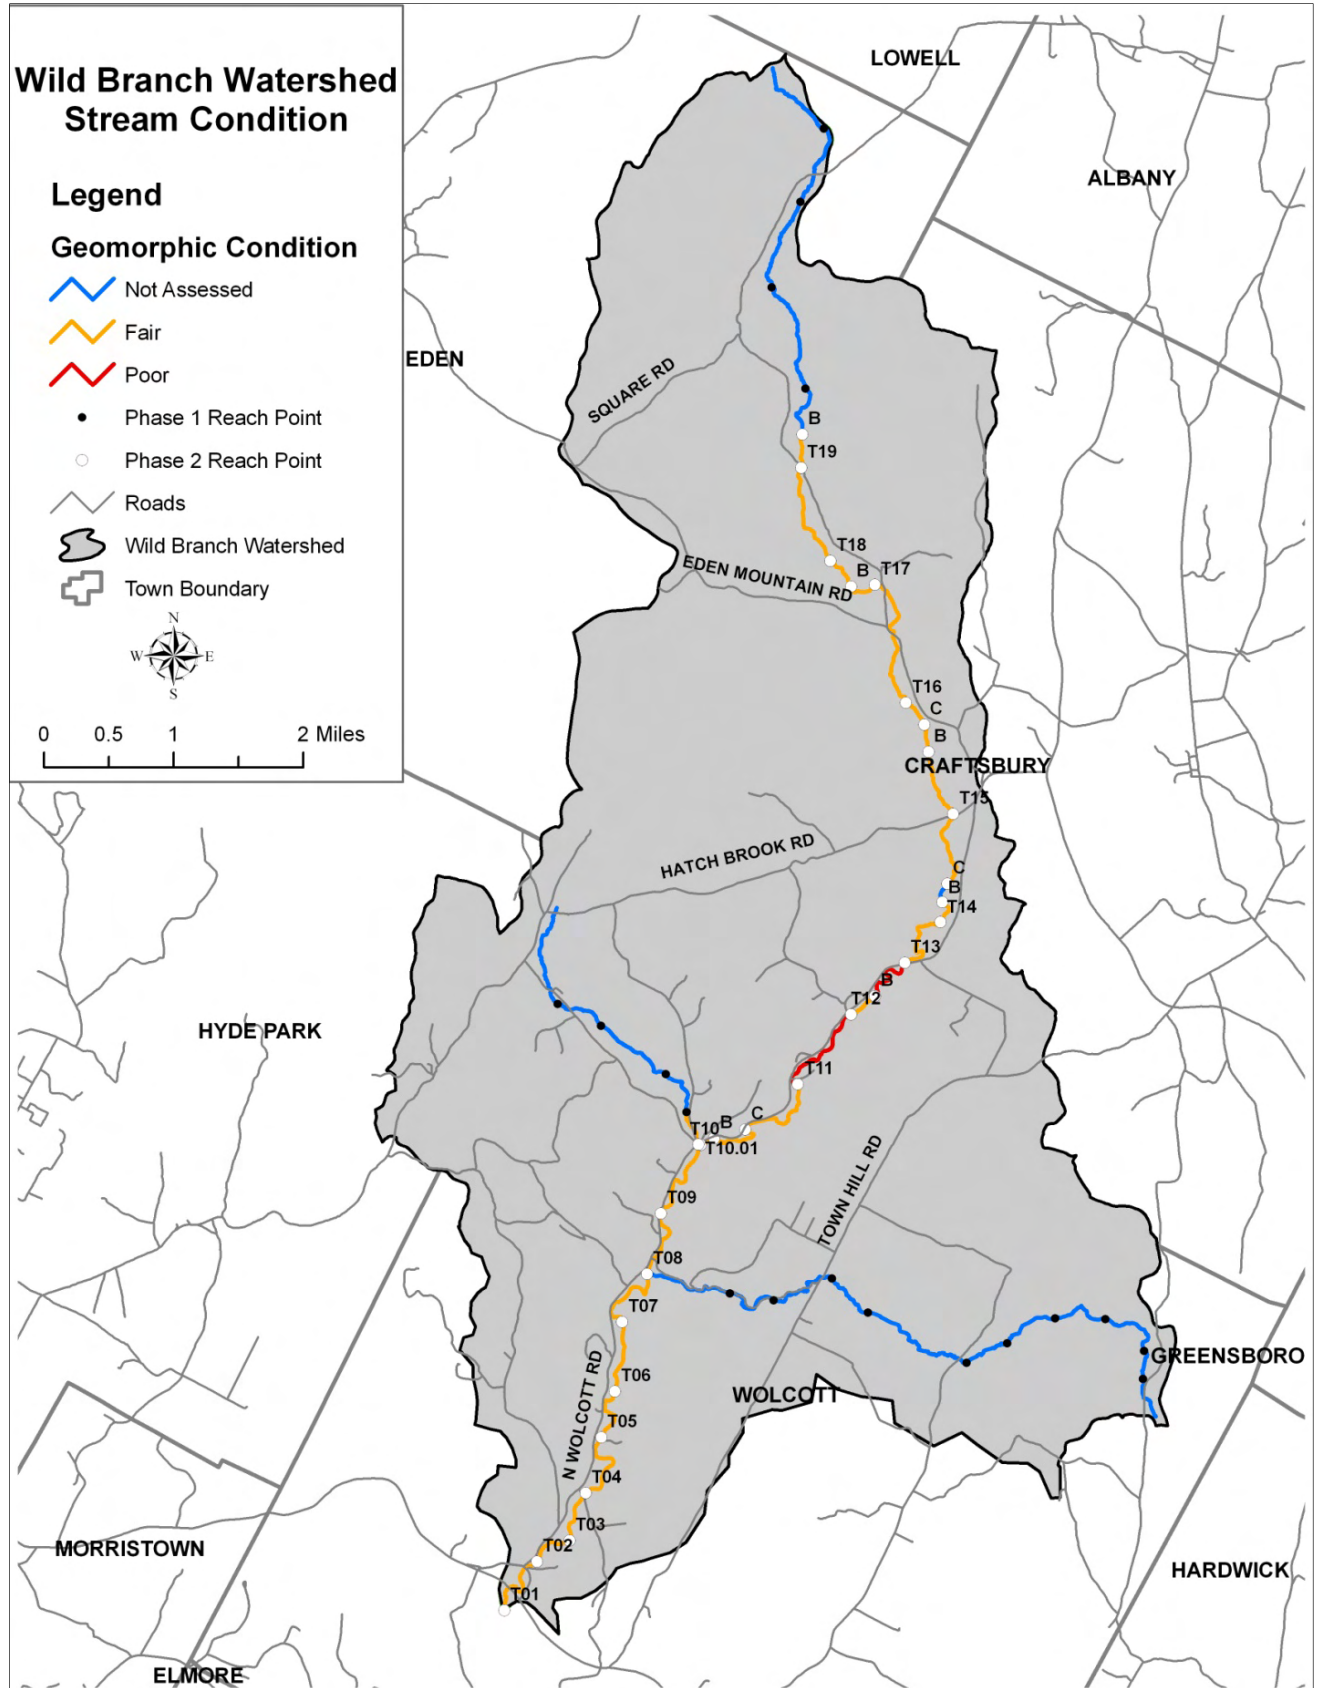
The existing geomorphic condition is depicted in Figure 5.2. The assessed segments and reaches in the Wild Branch watershed were found to be in “fair” and “poor” geomorphic condition. Geomorphic condition is determined based on the degree (if any) of channel degradation, aggradation, widening and planform adjustment. Two segments (T14-B and T19-B) were not assessed because they were heavily influenced by beaver dams.

The reach condition ratings of the Wild Branch indicate that most of the reaches are actively, or have historically, undergone a process of minor, major or even extreme geomorphic adjustment. All of the reaches studied in the Wild Branch watershed are undergoing a channel evolution process in response to large scale changes in its sediment, slope, and/or discharge associated with the human influences on the watershed. Table 3 below summarizes the channel evolution stage of each study reach and the primary adjustment processes that are occurring.

Figure 5.2. Phase 2 Geomorphic condition of the Wild Branch Watershed

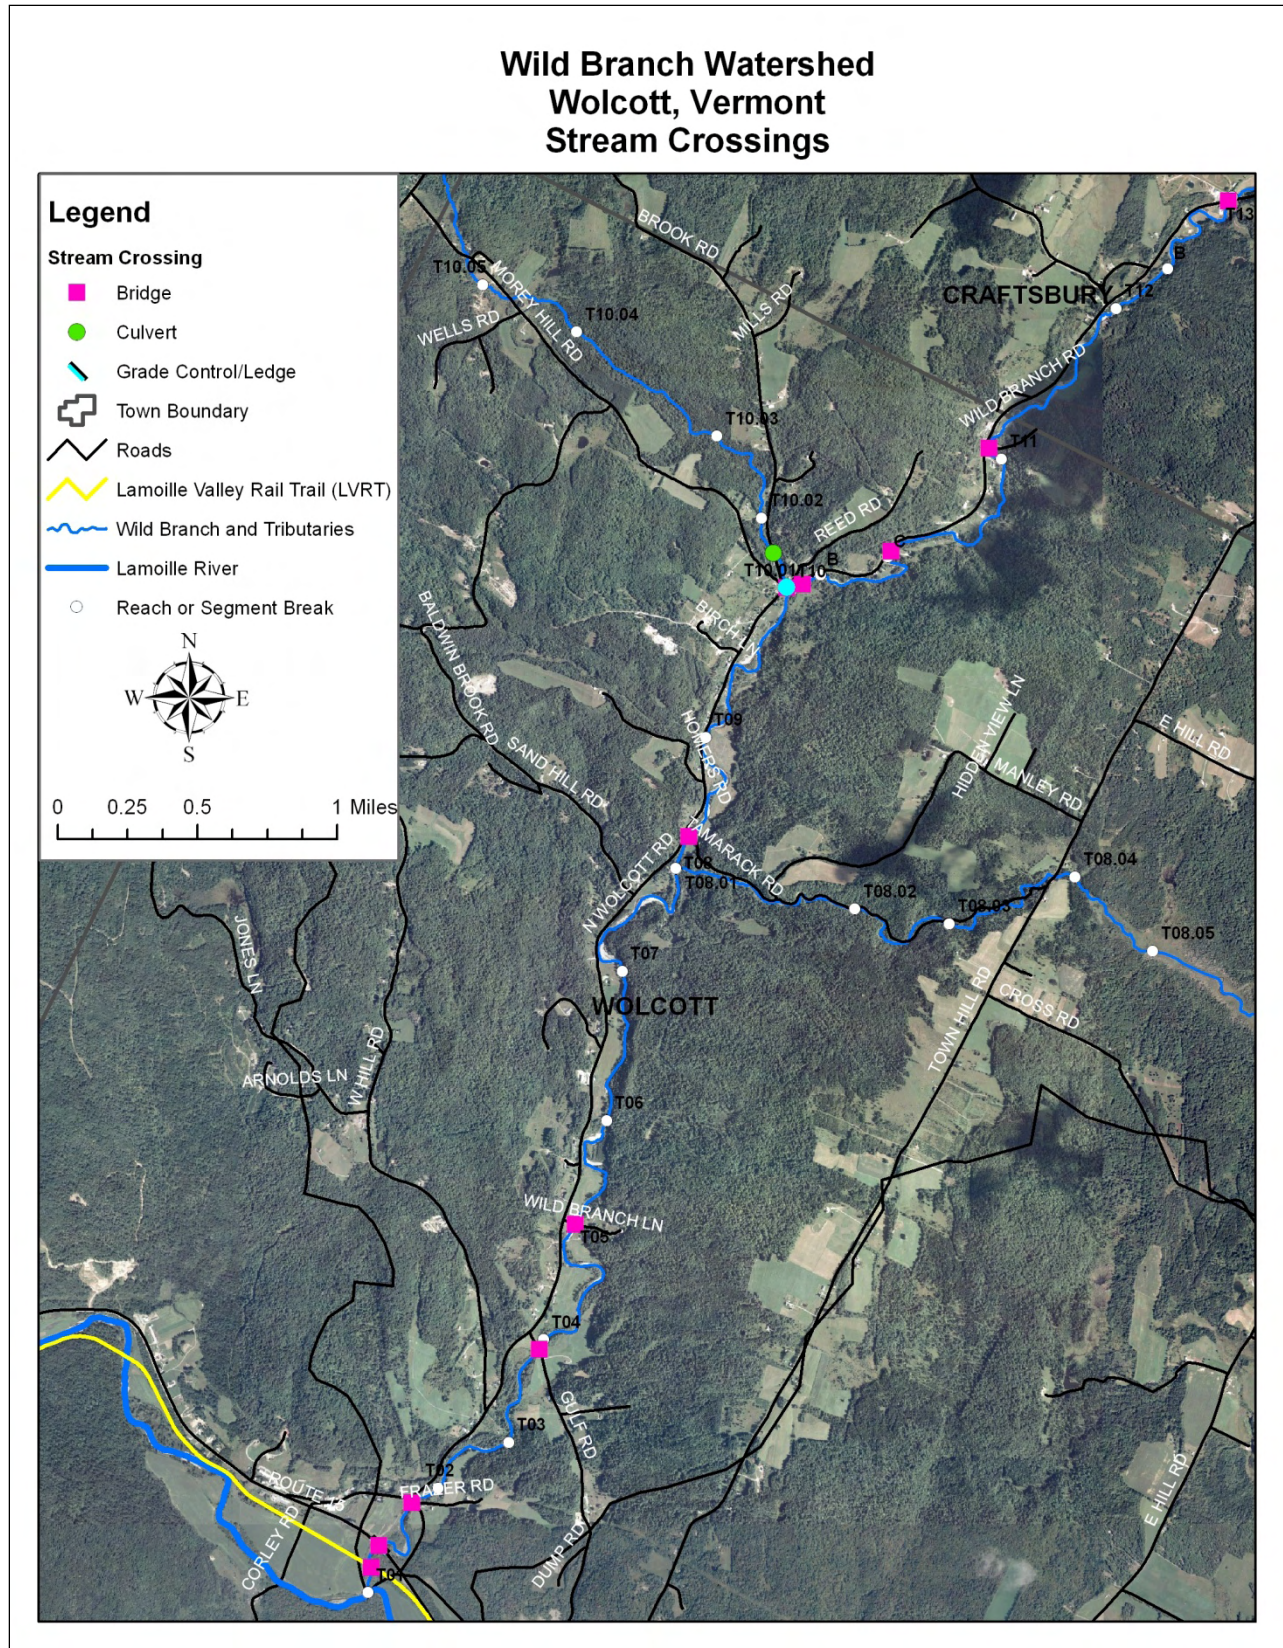
A total of 18 structures (17 bridges and 1 culvert) are located within the study area of Wild Branch where Phase 2 assessments were conducted in 2007 (see Figure 5.4 and Figure 5.5). The LCPC assessed one of these structures (the culvert on a tributary to the Wild Branch) during fall 2004 using the ANR Bridge and Culvert Assessment Protocol. General notes during the Phase 2 assessment were taken of the 17 bridges. A list of resources for towns regarding funding, planning and design for replacement and retrofit of stream crossings is available on the Vermont River Management and the Vermont Department of Fish and Wildlife's web sites:

Figure 5.4. Stream Crossings within the Wild Branch Watershed in Wolcott, VT

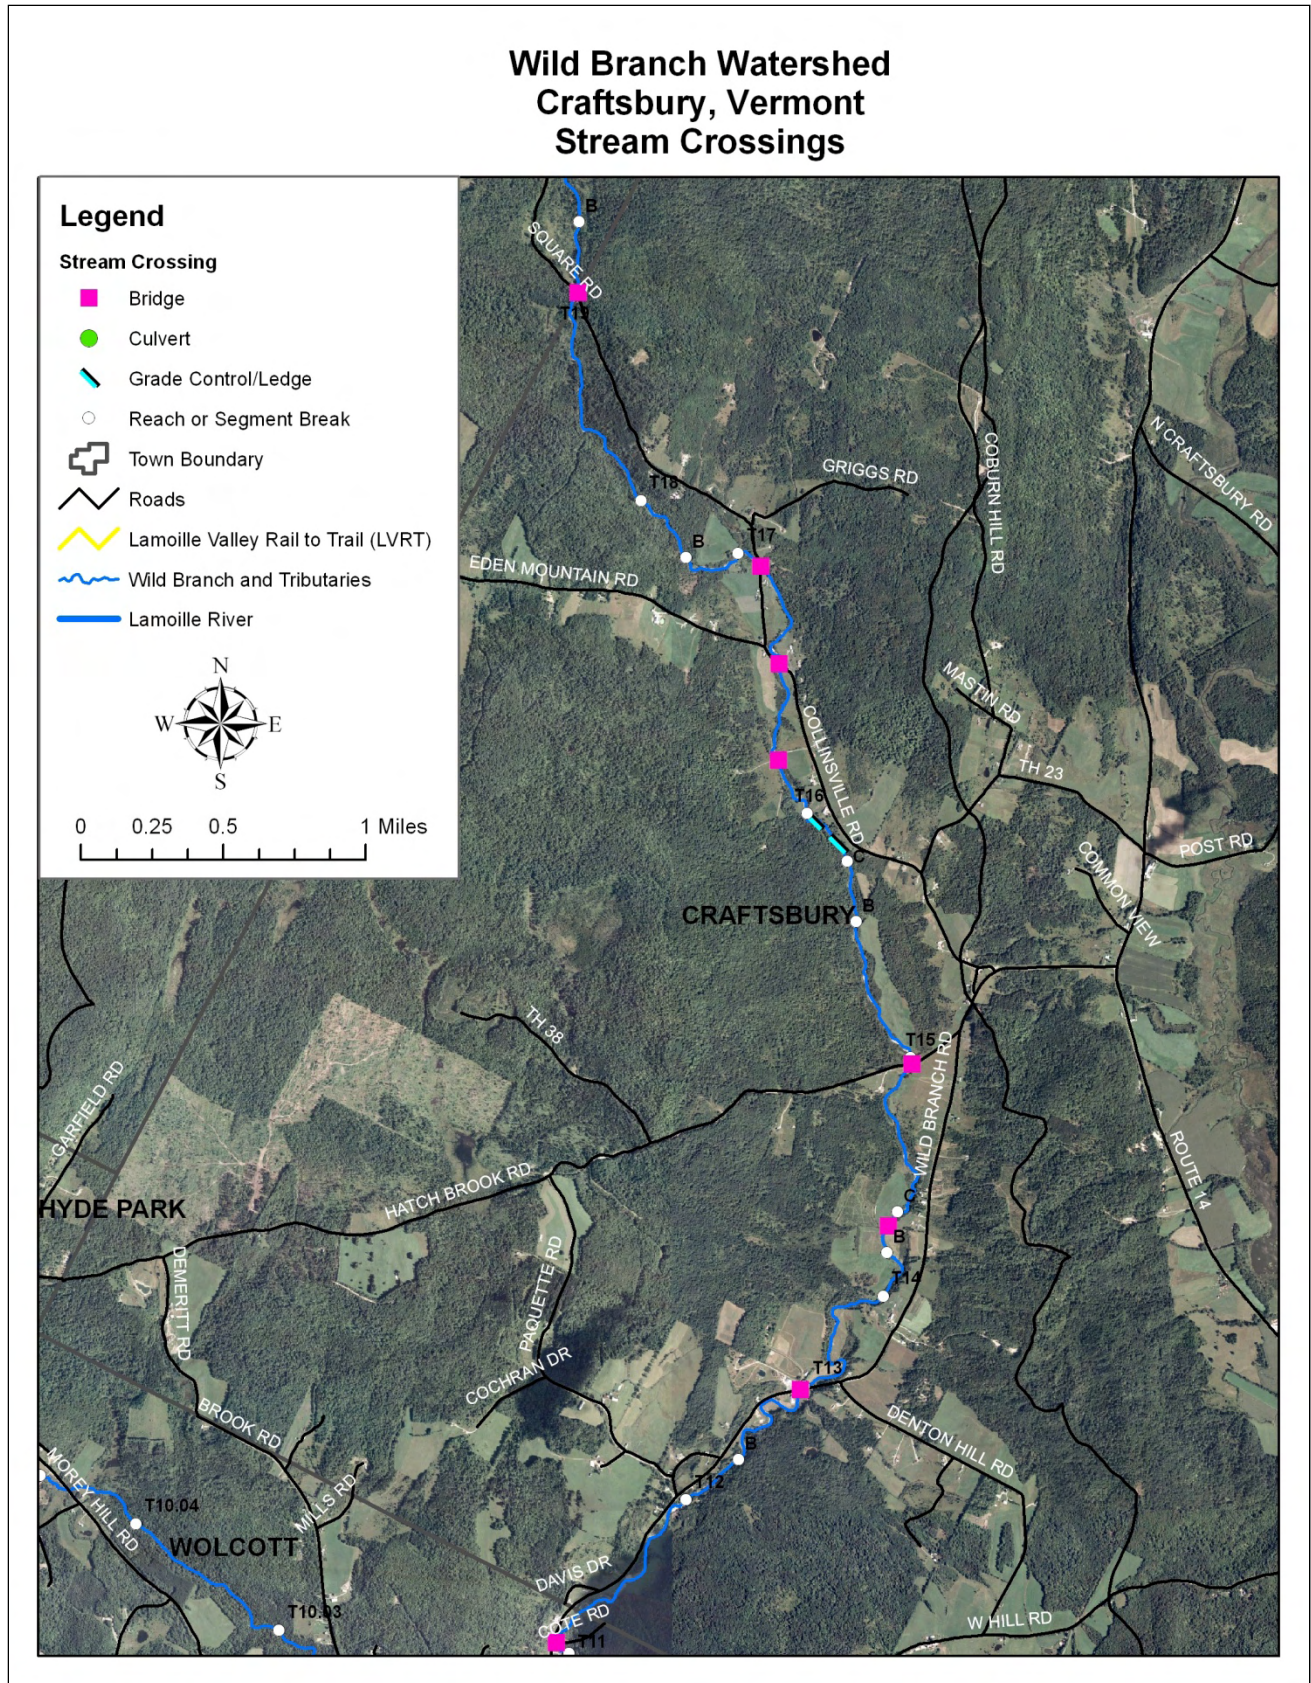
Figure 5.5. Stream Crossings within the Wild Branch Watershed in Craftsbury, Vermont

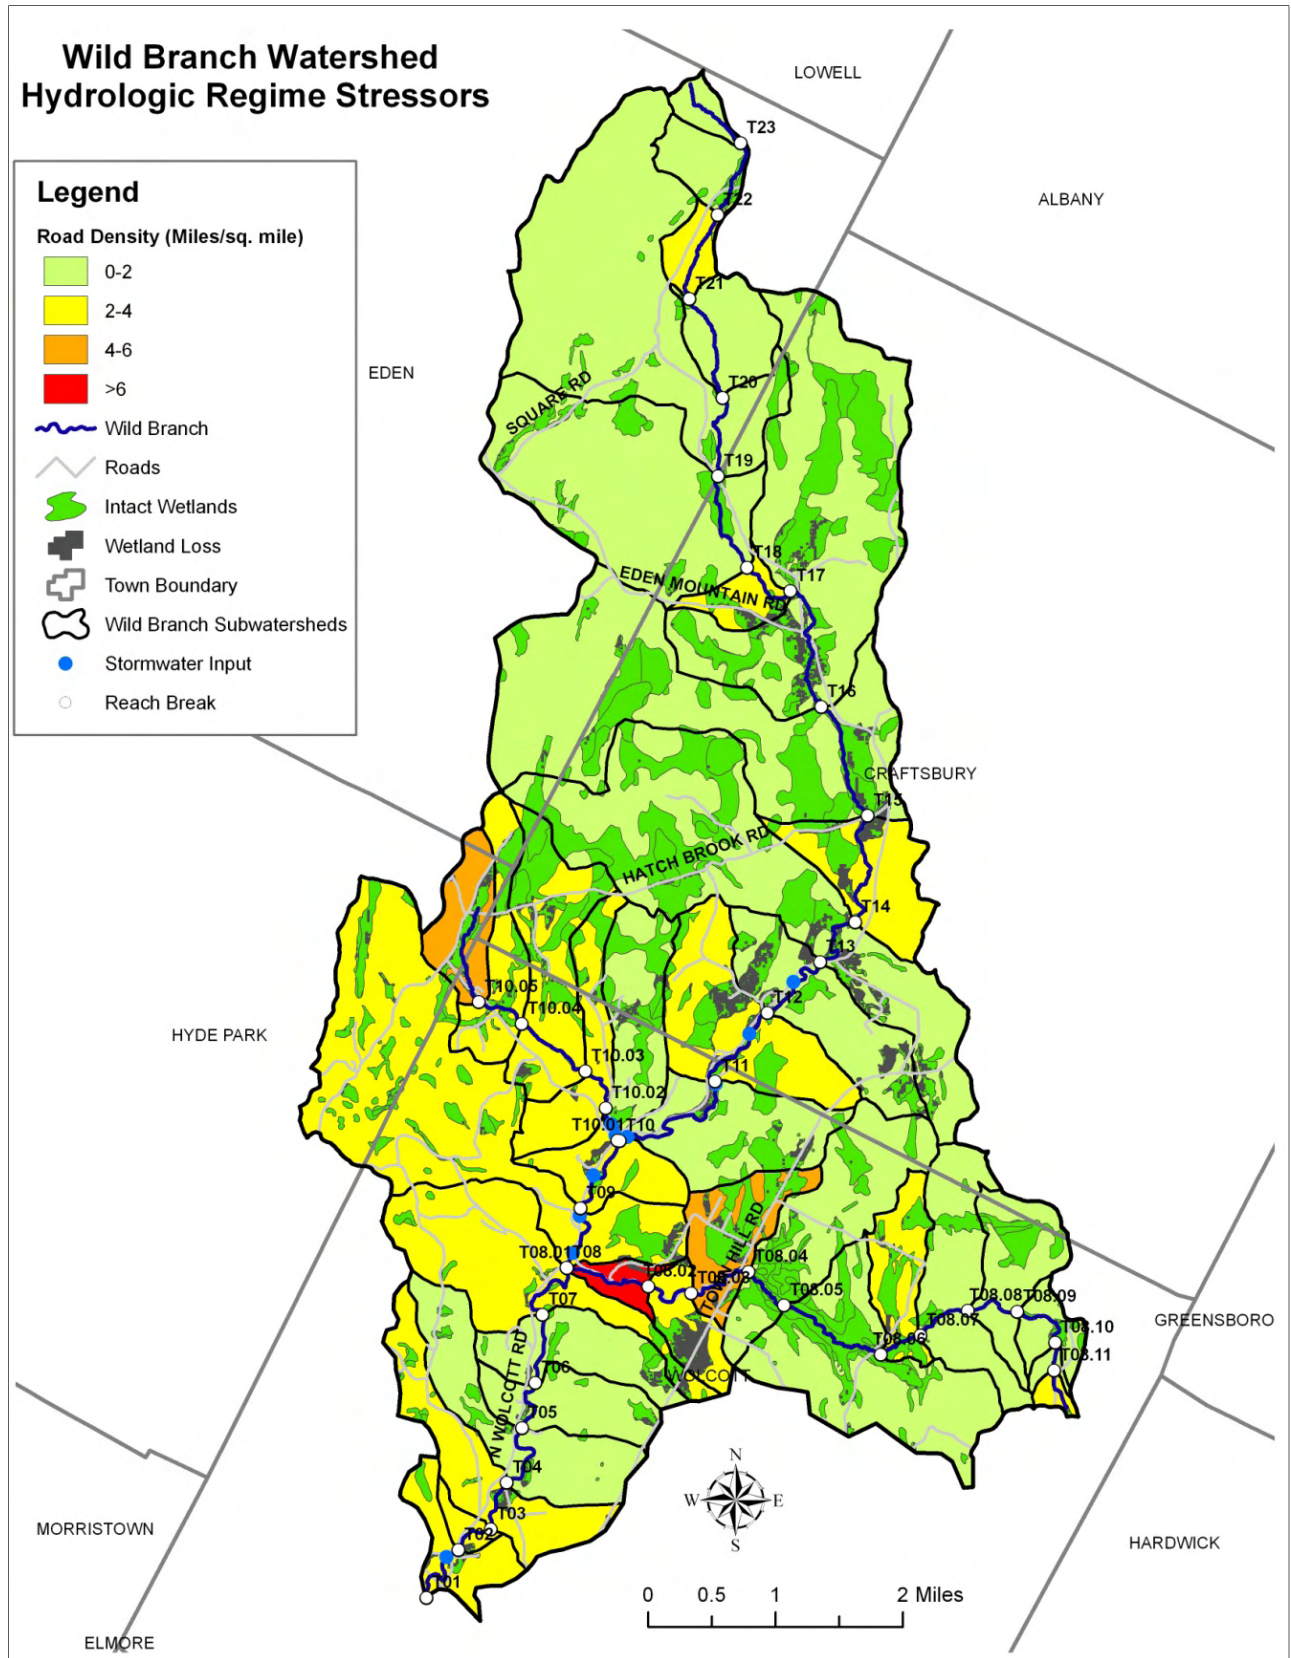
The Wild Branch watershed has a modest network of roads as shown in Figure 6.1. Extensive road networks can contribute significantly to increased flows within a river resulting both from increased runoff and stormwater ditching. According to Foreman and Alexander (1998), increased peak flows in streams may be evident at road densities of 3.2 miles/square mile. Subwatersheds with road densities of greater than 3.2 miles/square mile account for only about 6 percent of the Wild Branch watershed. The highest road densities are along the lower end of Tamarack Brook and in the headwaters of an unnamed tributary to the Wild Branch.

Figure 6.1. Land use map showing cumulative percent of urban land use, road density and lost wetland.

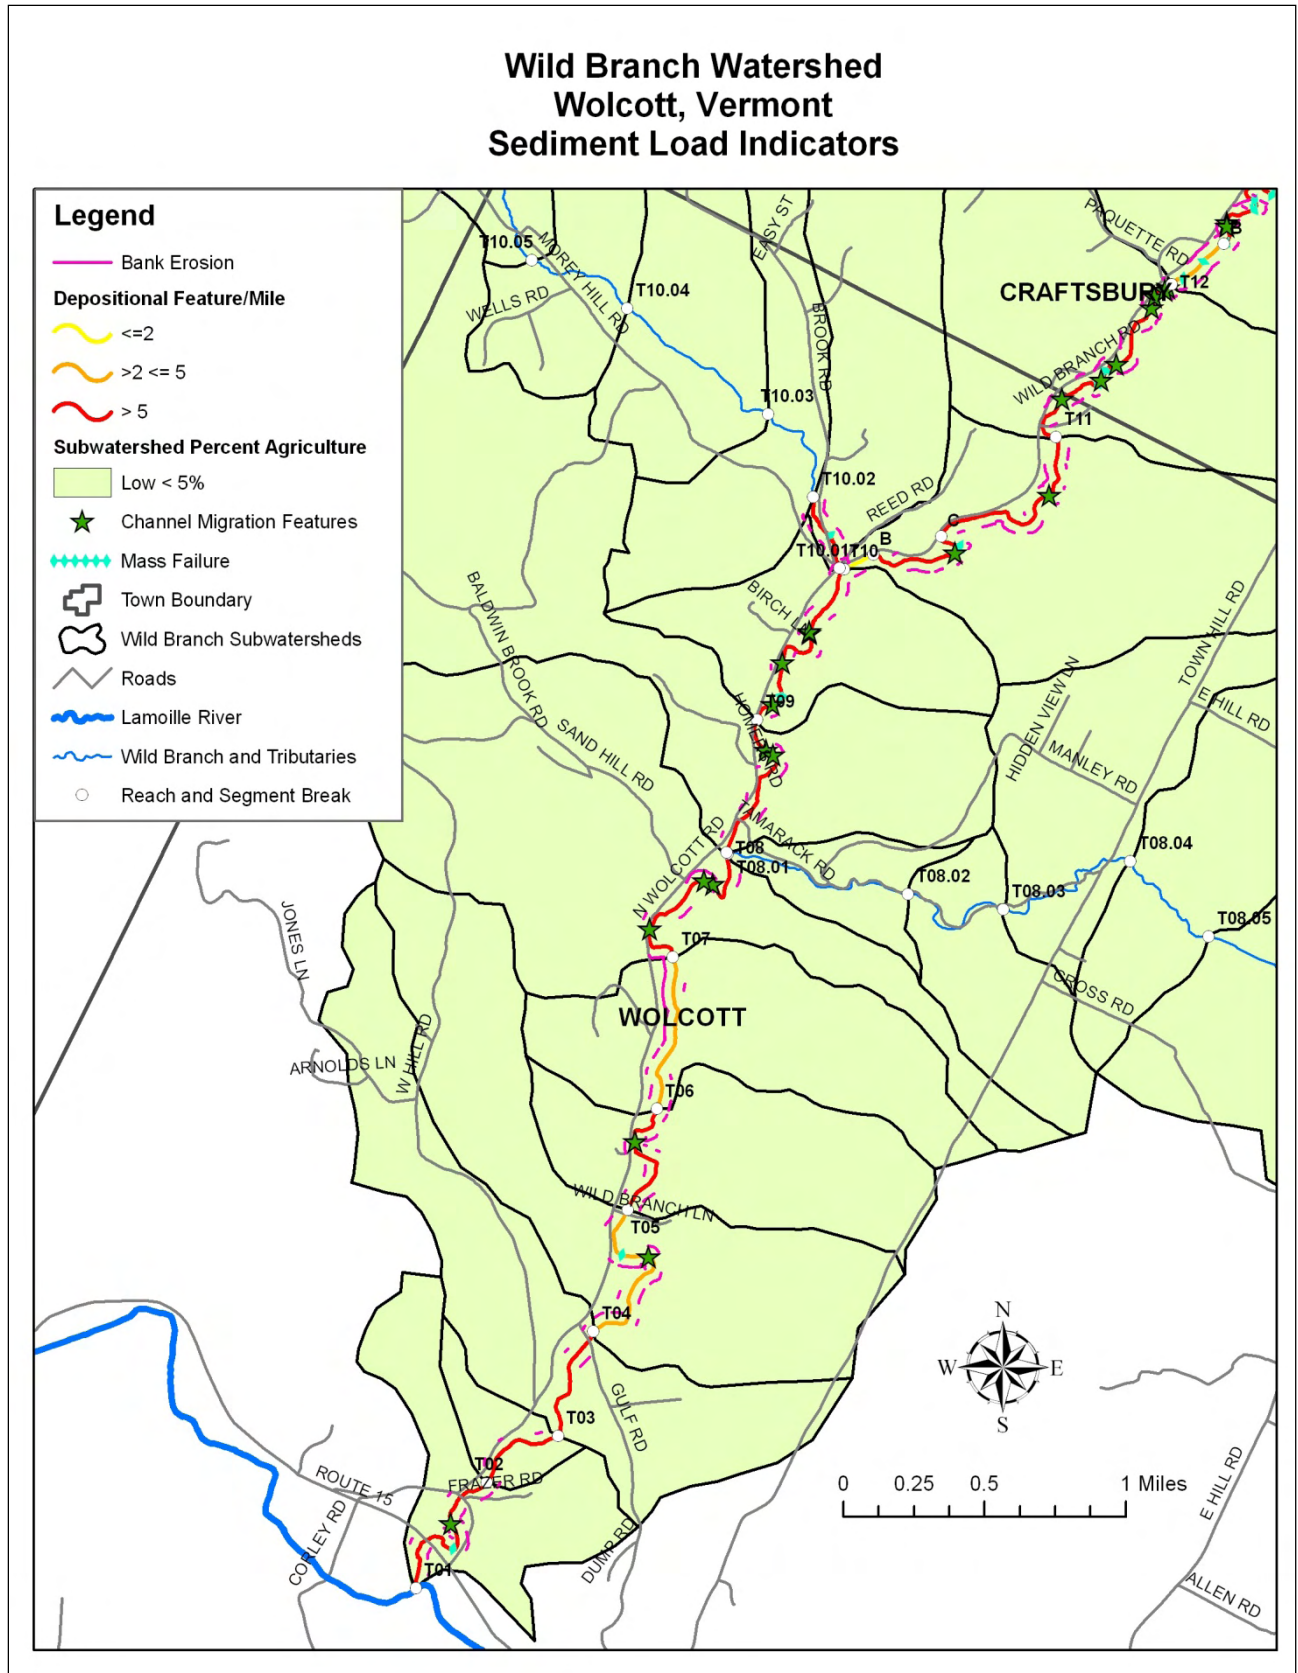
The high bank erosion and the prevalent mass failures illustrate the Wild Branch has a high source of sediment input. This is resulting in the channel being overwhelmed by sediment, thereby exceeding the sediment transport capability. The high level of aggradation is especially evident in the lower five reaches of the main stem.

Figure 6.2. Sediment load indicators map for the Wild Branch in Wolcott.

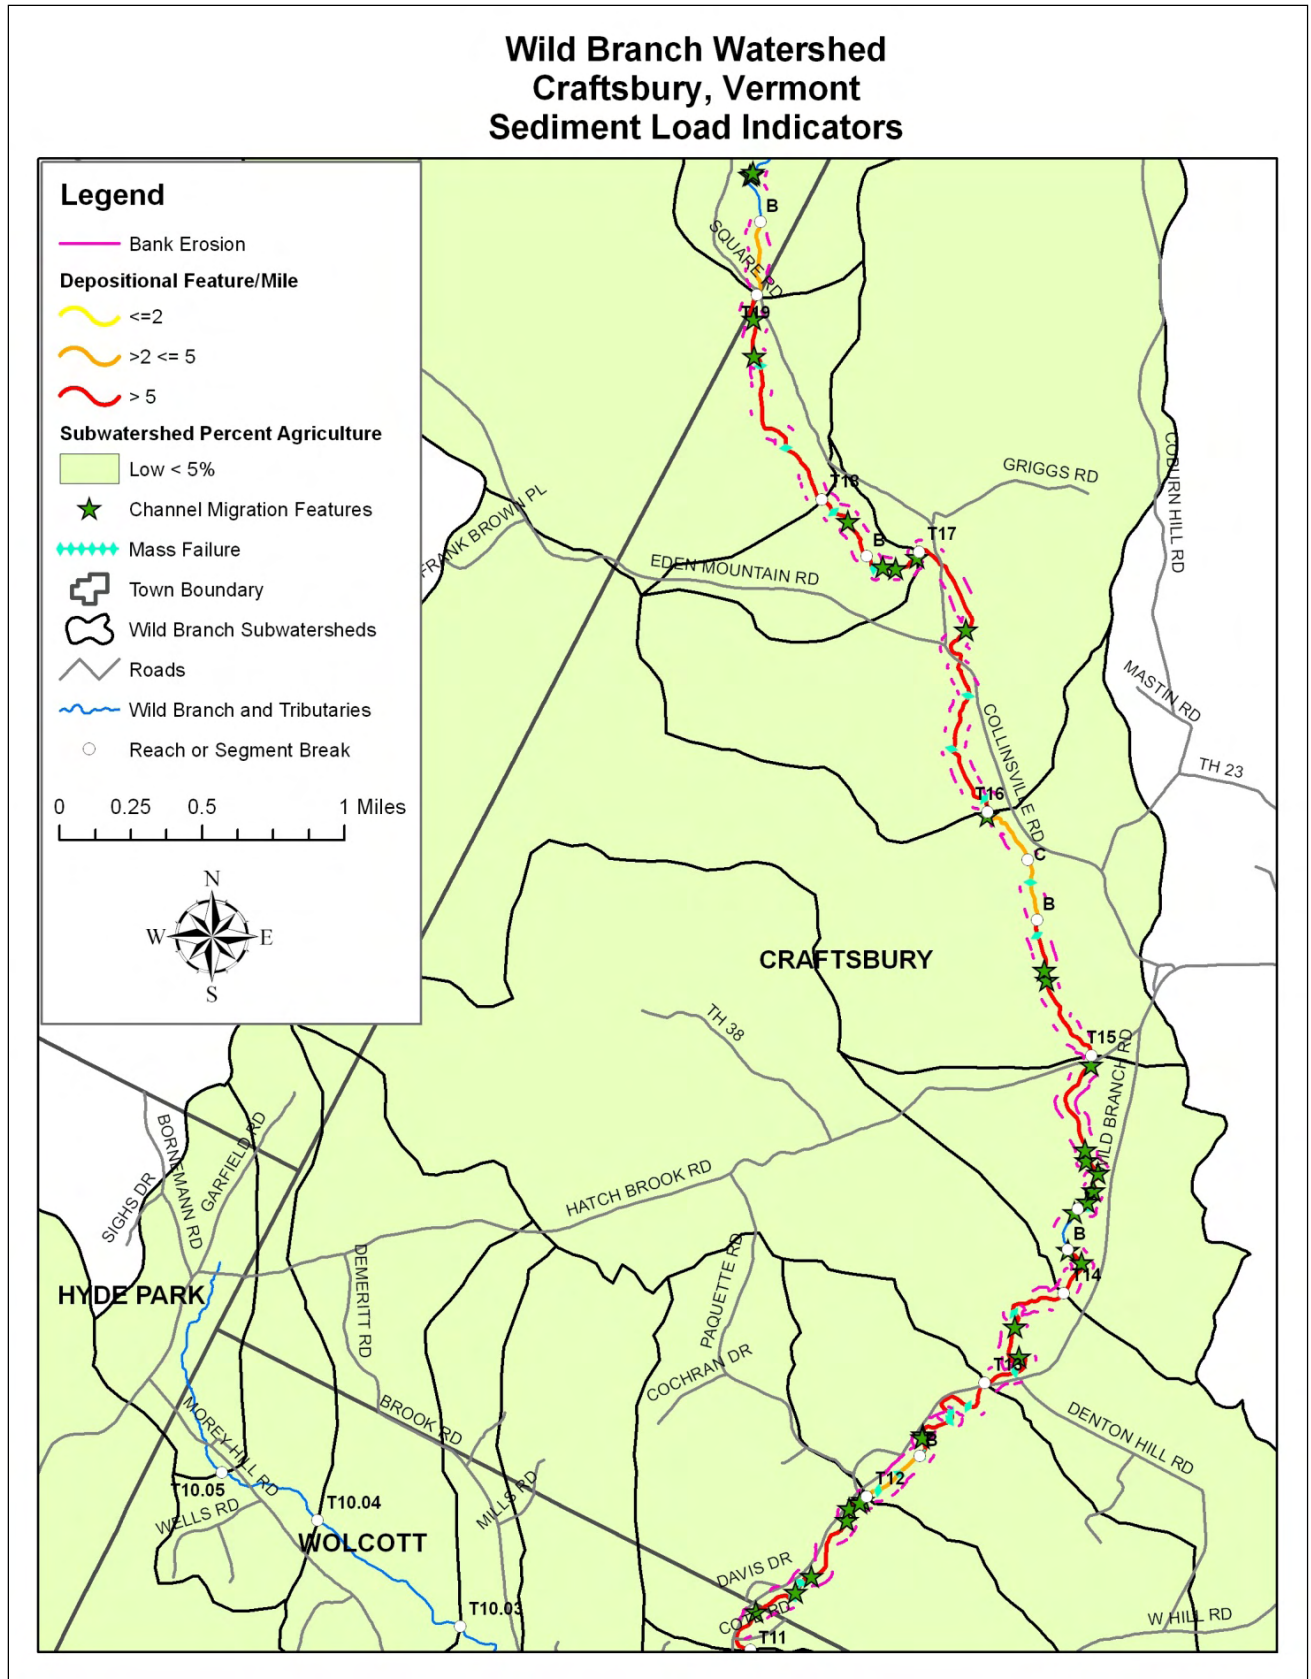
Figure 6.3. Sediment load indicators map for the Wild Branch in Craftsbury.

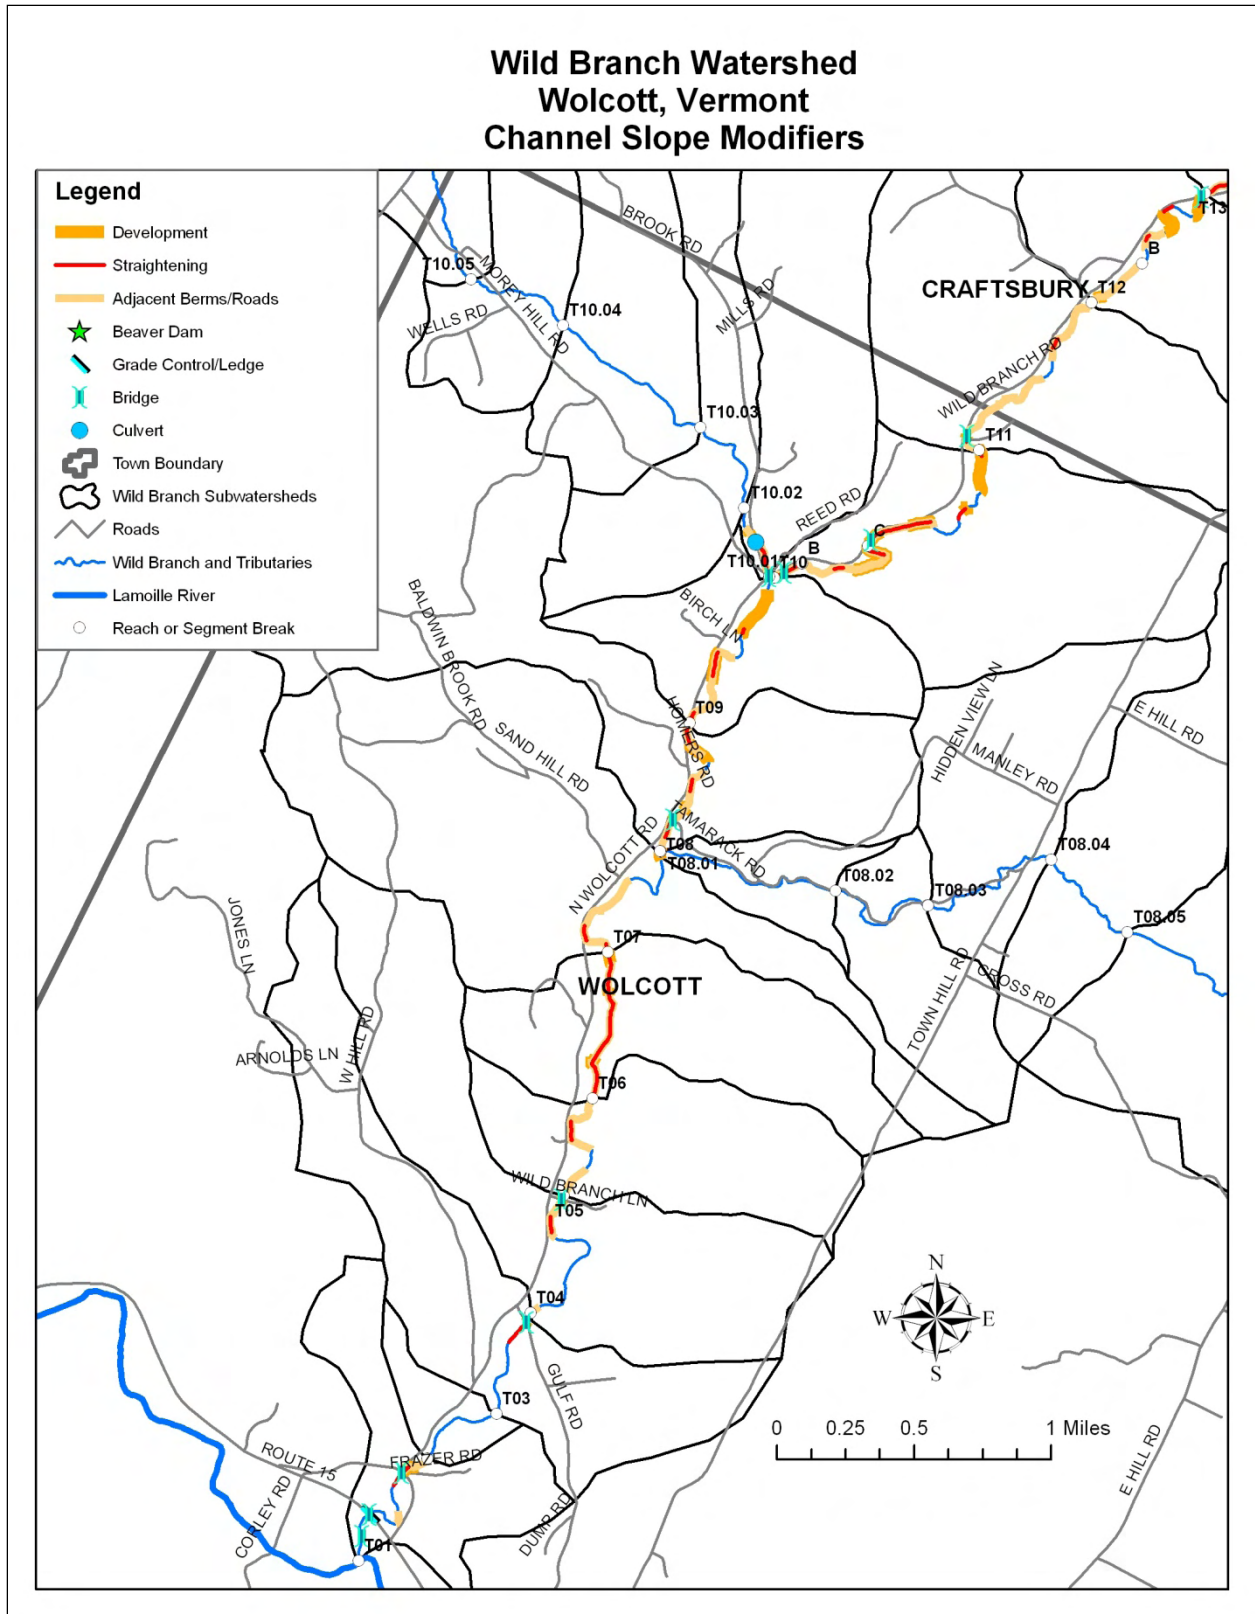
Channel straightening, floodplain encroachment, and berms and roads can increase the slope of a channel resulting in increased stream power. Increases in stream power (shown in red or orange in Figures 6.4 and 6.5) can initiate streambed erosion resulting in incision. The most extensive areas of channel straightening and floodplain encroachment (both development and adjacent berms and roads) are in the middle of the watershed between reaches T05 and T12. The channel within the middle reaches run predominantly along North Wolcott Road and Wild Branch Road. The majority of the channel straightening within the Wild Branch watershed is associated with roads that run parallel to the stream. The extensive areas with increases in stream power explain the high degree of channel adjustment that is occurring within the watershed.

Figure 6.4. Channel slope modifiers map for Wolcott showing parameters contributing to increases (red and orange) or decreases (blue and green) in slope.

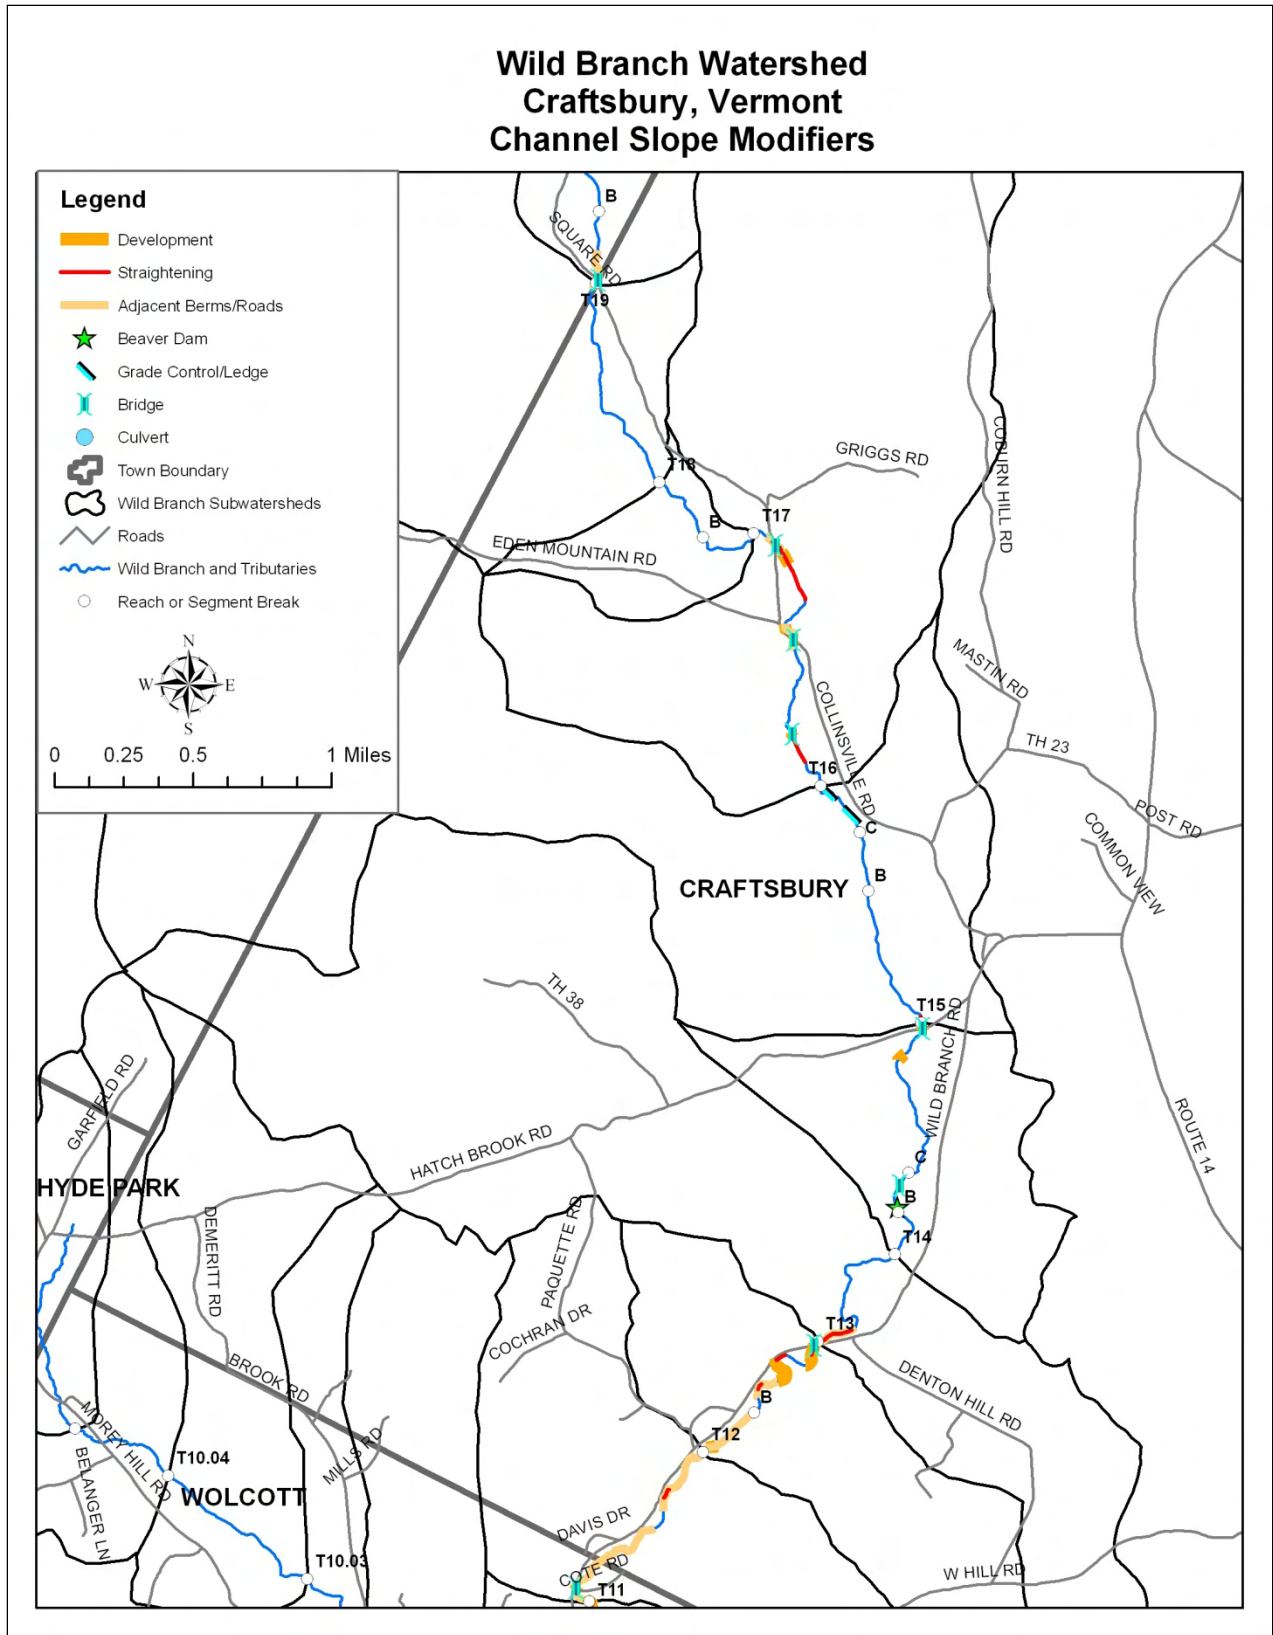
Figure 6.5. Channel slope modifiers map for Craftsbury showing parameters contributing to increases (red and orange) or decreases (blue and green) in slope.

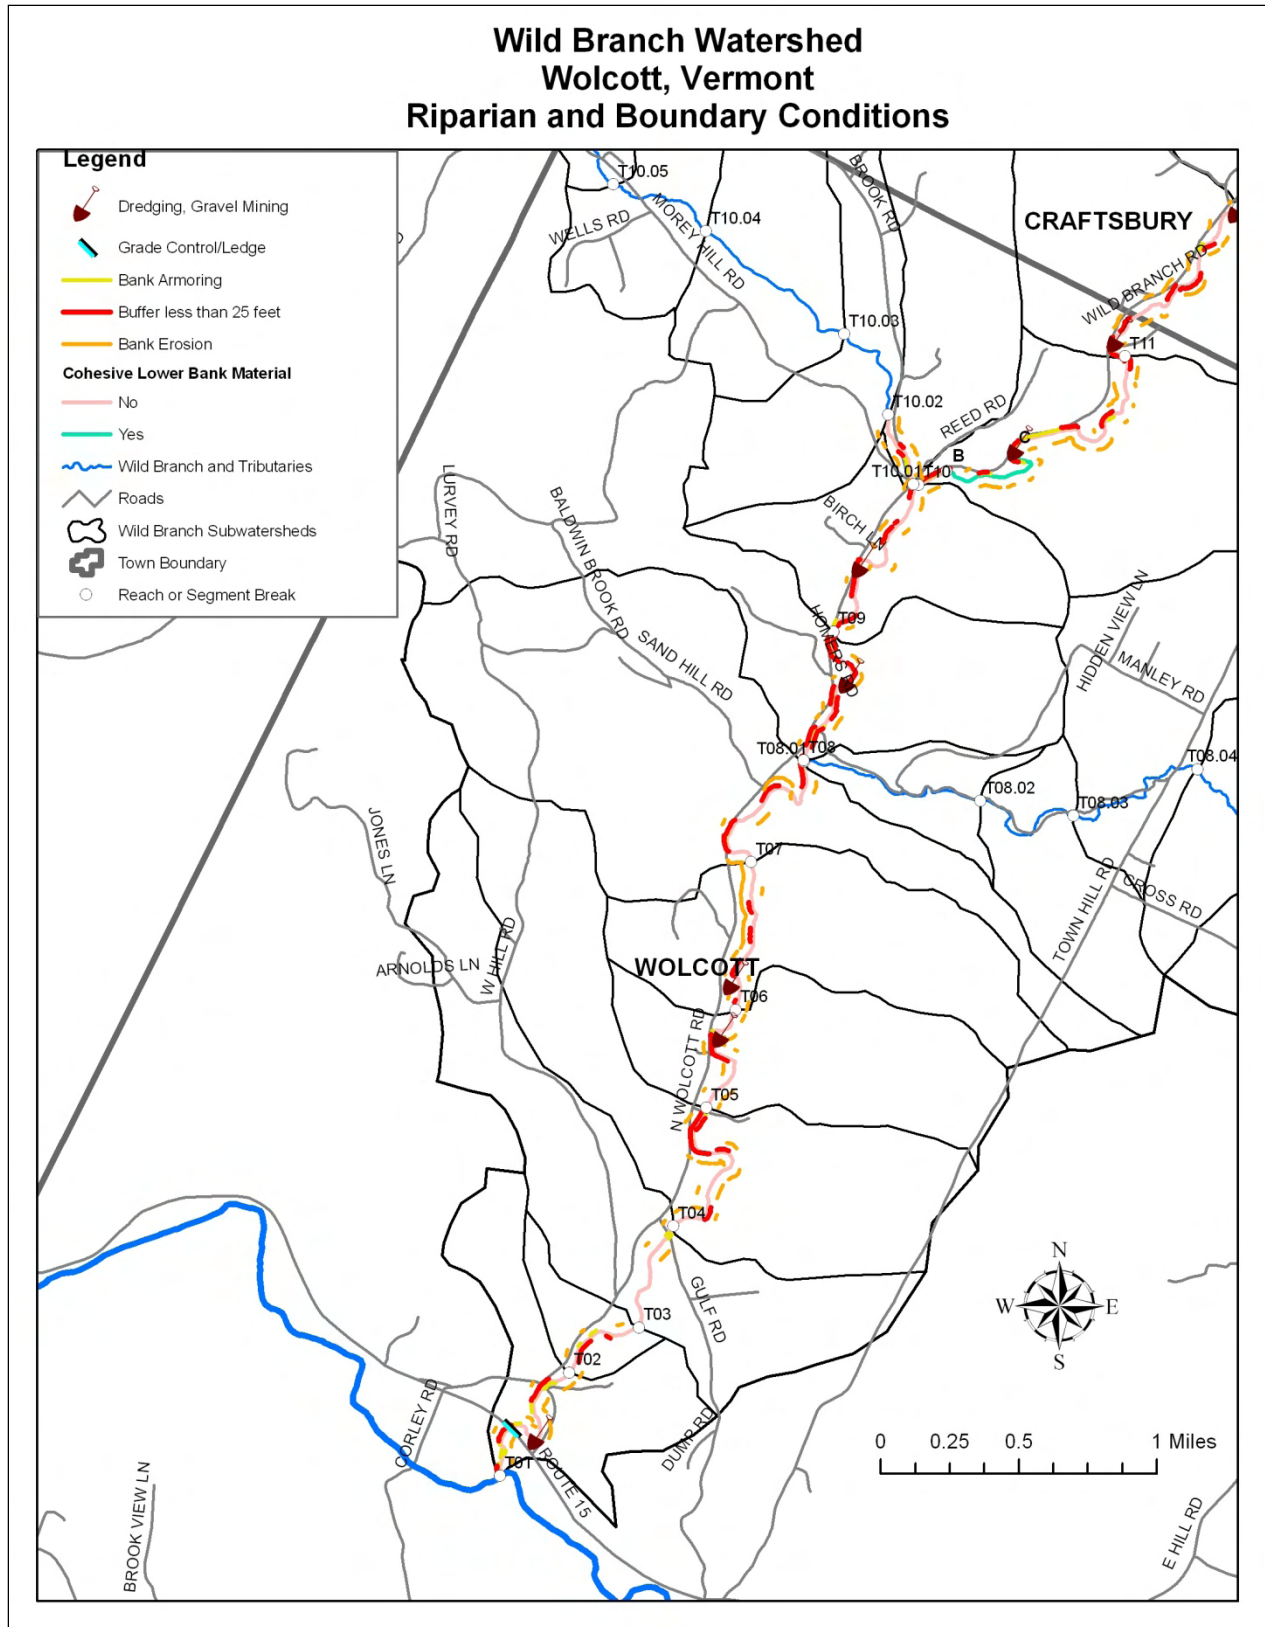
Parameters which are indicative of a decrease in boundary condition are shown in red and orange in Figures 6.6 and 6.7. While bank armoring may temporarily increase the boundary condition, it is indicative of where the stream power has resulted in bank erosion or widening of the channel. Extensive bank armoring may increase the stream power, resulting in erosion of banks located downstream. Areas where woody debris, bed substrate and plant material were removed from the channel also result in increased stream power. Gravel mining is a practice that can significantly decrease the boundary resistance. General areas where gravel mining has taken place were mapped by the LCPC during the Phase I portion of the study based on information provided by VANR.

Figure 6.6. Boundary conditions and riparian modifications map for Wolcott showing areas of decreased boundary condition (red and orange) and increased boundary condition (aqua).
