Wild Branch Corridor Plan

Wolcott, Craftsbury and Eden, Vermont

March 18, 2010

Wild Branch Corridor Plan Wolcott, Craftsbury and Eden, Vermont

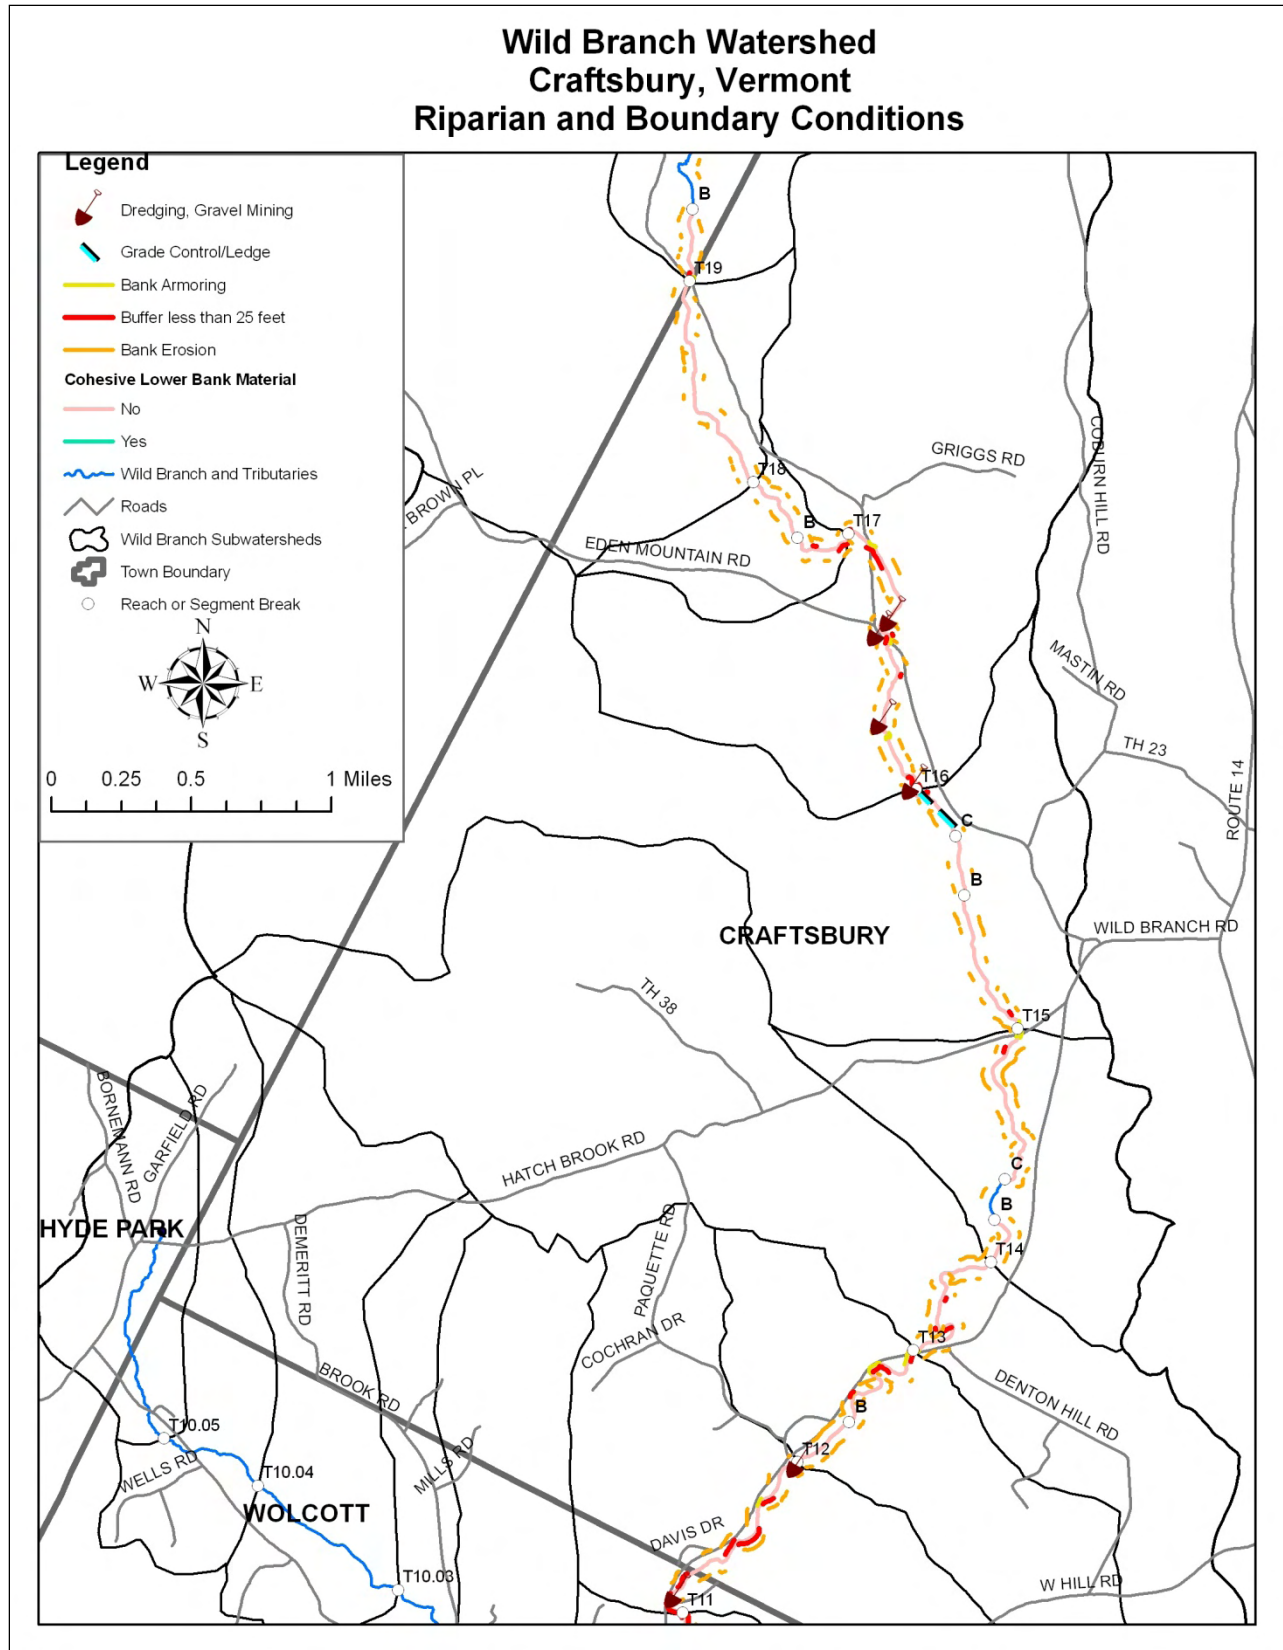
Parameters which are indicative of a decrease in boundary condition are shown in red and orange in Figures 6.6 and 6.7. While bank armoring may temporarily increase the boundary condition, it is indicative of where the stream power has resulted in bank erosion or widening of the channel. Extensive bank armoring may increase the stream power, resulting in erosion of banks located downstream. Areas where woody debris, bed substrate and plant material were removed from the channel also result in increased stream power. Gravel mining is a practice that can significantly decrease the boundary resistance. General areas where gravel mining has taken place were mapped by the LCPC during the Phase I portion of the study based on information provided by VANR.

Important factors that result in an increase in boundary condition are included in Figures 6.6 and 6.7 with aqua colored symbols. Natural and man-made grade controls increase the resistance of the bed to erosion. There were only two areas on the Wild Branch mainstem where natural grade controls (ledge) were mapped as channel spanning based on the Phase 2 fieldwork. The lower area of ledge is located on reach T01 just upstream of the confluence with the Lamoille River in Wolcott (Figure 6.6). The second area of ledge is located at the top of Reach 15 that starts at the Hatch Brook crossing in the Town of Craftsbury. The lack of natural grade controls may be one reason the Wild Branch watershed has undergone so much incision and channel adjustment. The cohesiveness of the lower bank materials is another factor that was considered in evaluating boundary resistance. Cohesive bank material can increase the boundary condition. Reach T10 in the northern part of Wolcott was the only reach that had cohesive lower banks.

Figure 6.6. Boundary conditions and riparian modifications map for Wolcott showing areas of decreased boundary condition (red and orange) and increased boundary condition (aqua).

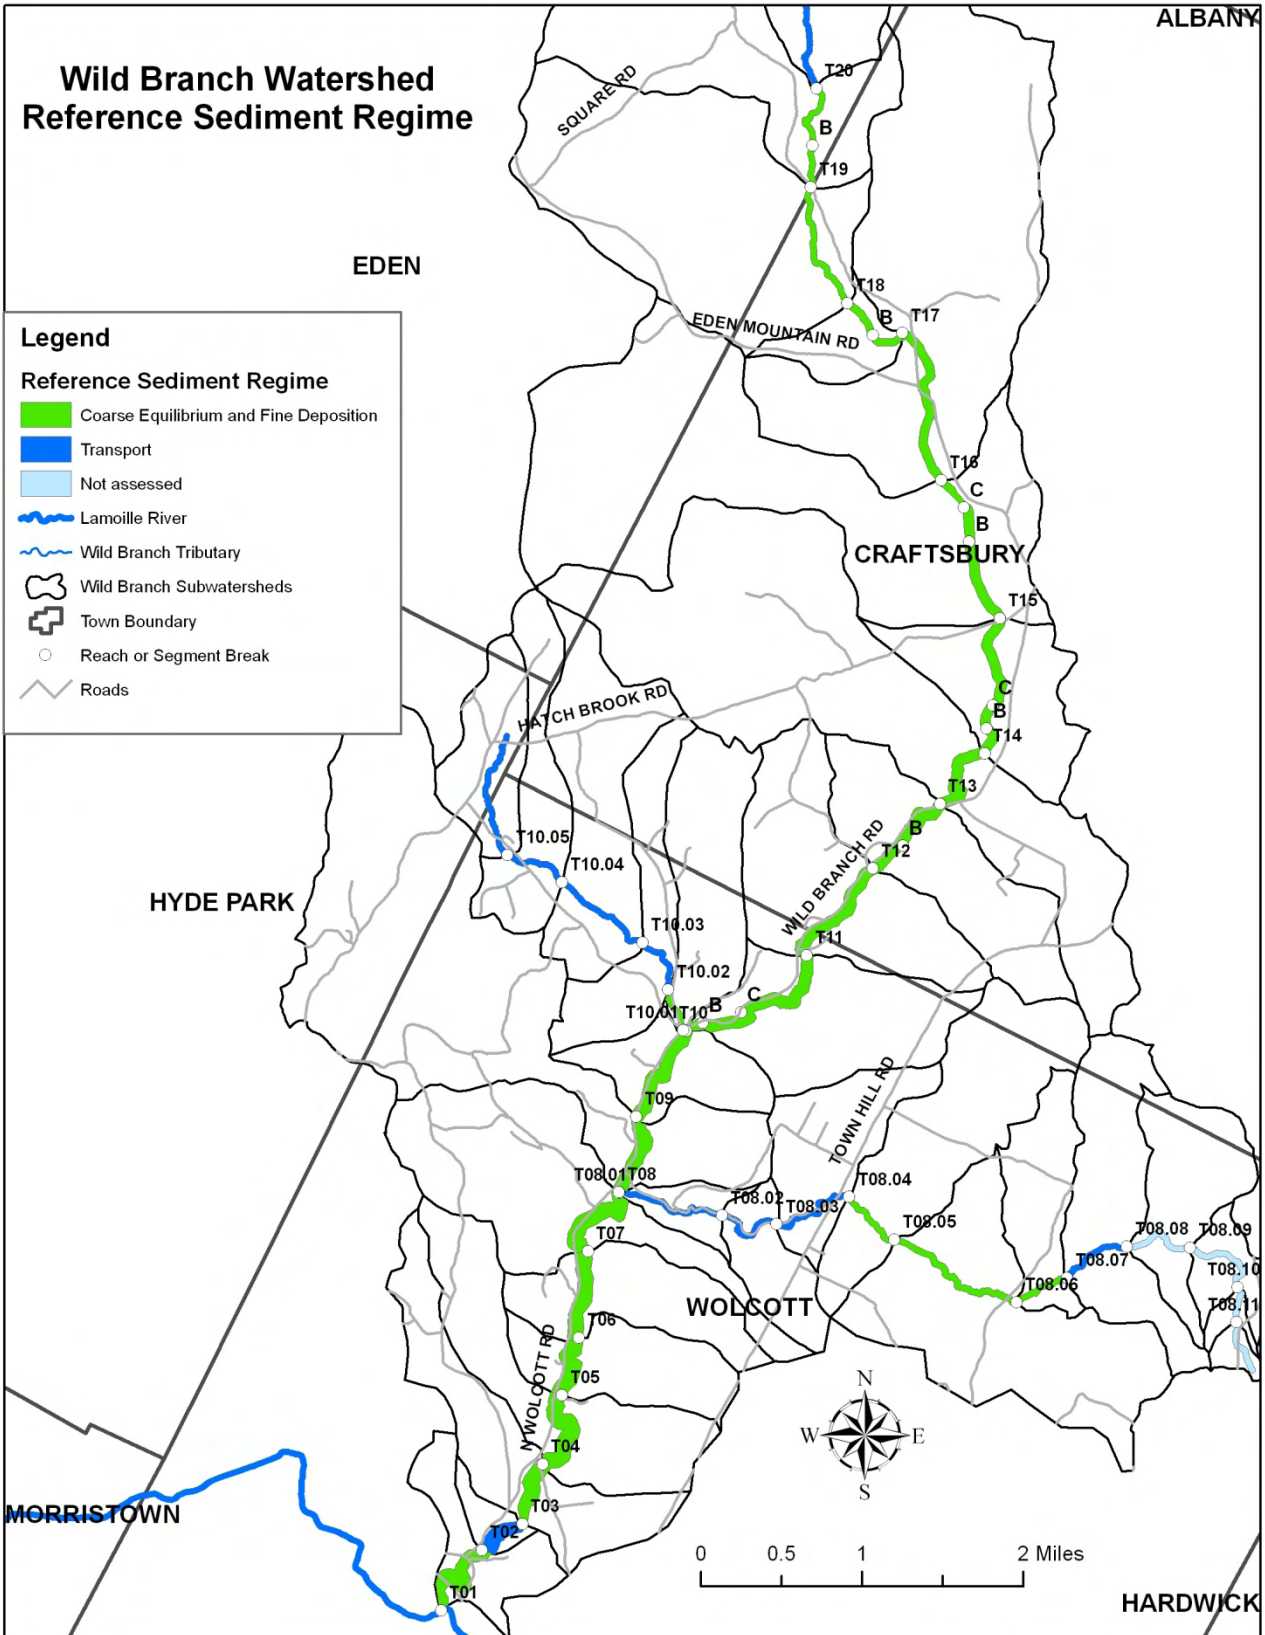
The reference sediment regime map (Figure 6.8) shows the Phase I reference stream sediment conditions for each reach within the stream network. In the reference condition, streams use available floodplain access as a means to store sediment within the watershed. All segments of the Phase 2 study area have a reference sediment regime of *Coarse Equilibrium (in=out) & Fine Deposition (Equilibrium) or Transport*. The majority of the stream network has a reference sediment regime of *Equilibrium*. *Equilibrium* channels are unconfined on at least one side, and they transport and deposit sediment in equilibrium, wherein the stream power is balanced by the sediment load, sediment size, and channel boundary resistance. *Transport* channels, on the other hand, are steep, dominated by bedrock and boulder/cobble substrates, and are typically in confined valleys. Transport channels do not supply appreciable quantities of sediments to downstream reaches. [Vermont Agency of Natural Resources, 2007a VANR, 2007a)].

Figure 6.8. Existing Sediment Regime Departure Map showing areas of coarse equilibrium and fine deposition and transport reaches.

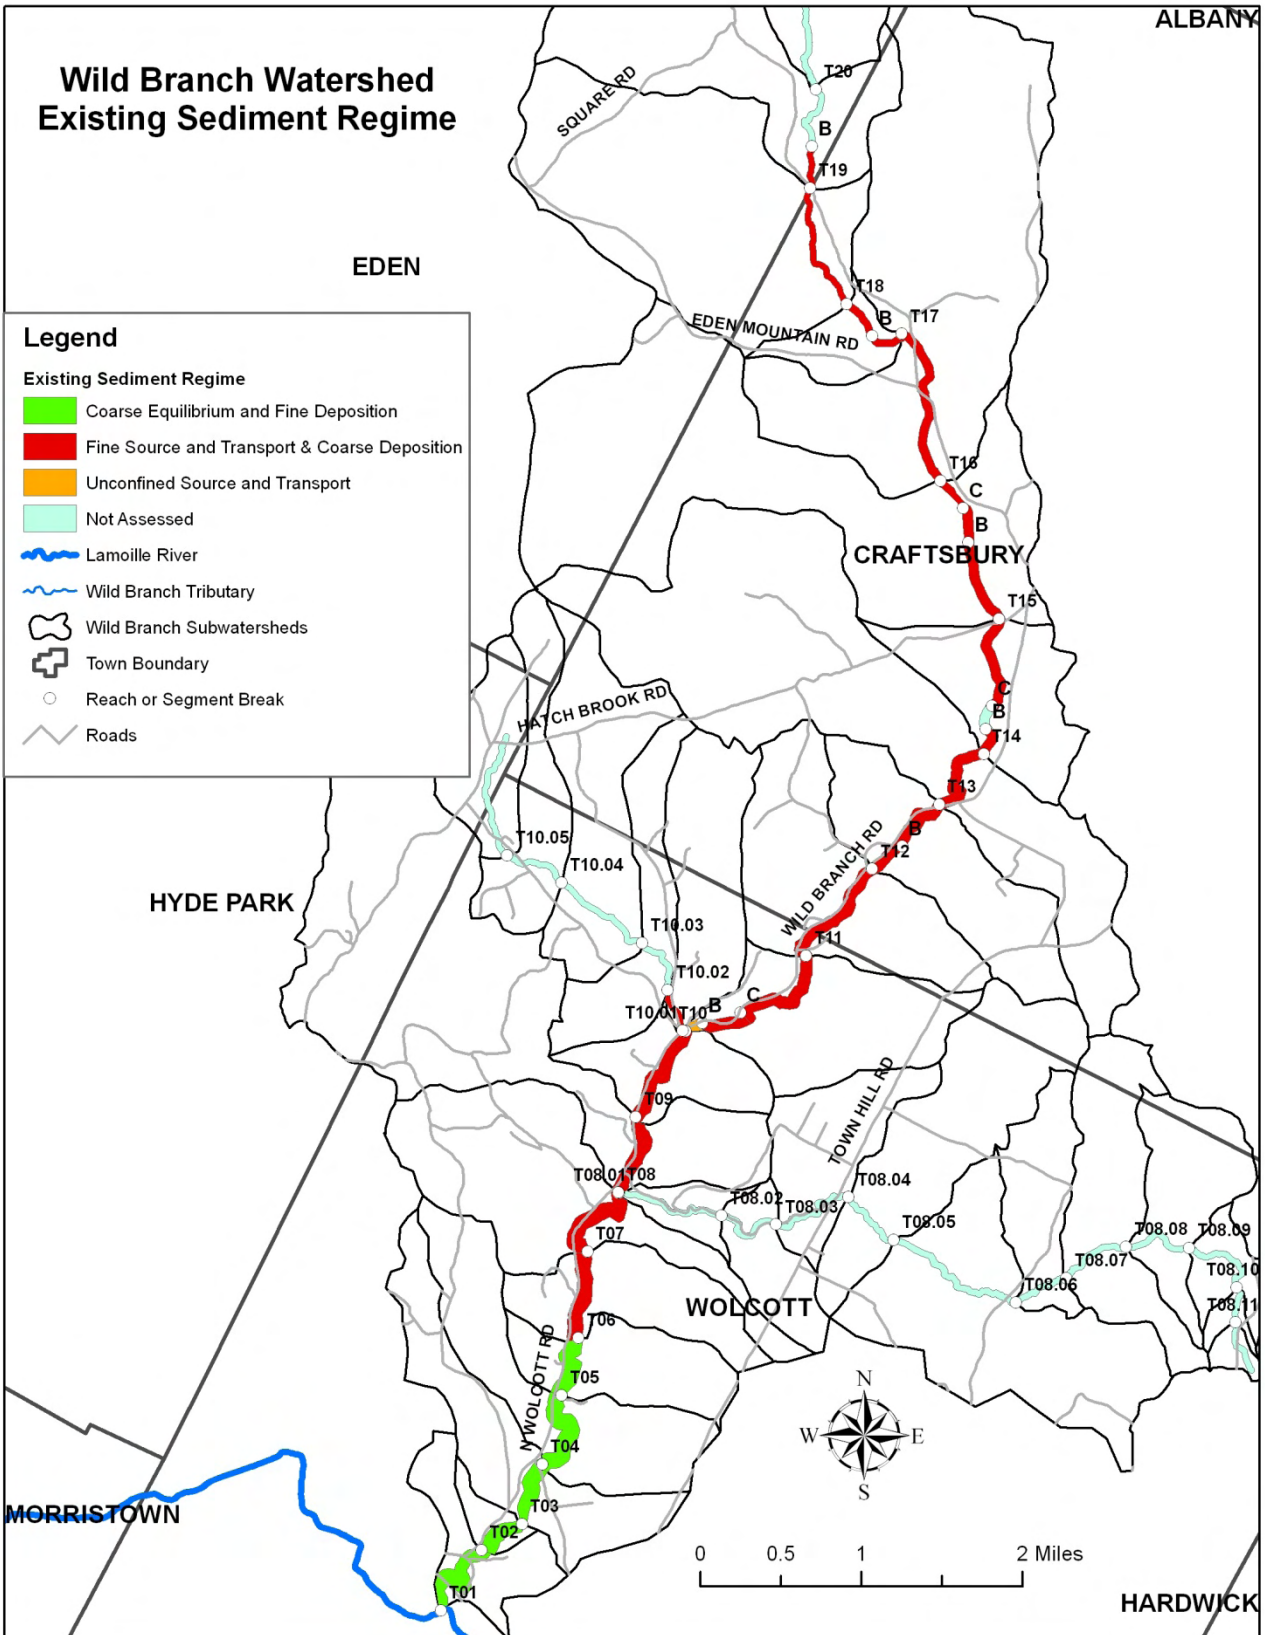
Phase 2 Stream Geomorphic Assessment data (Figure 6.9). This means that most fine sediment entering the stream is transported through without being deposited as a result of channel incision and reduced floodplain access. Additionally, coarse sediment storage is increased due to increased load along with lower transport capacity.

Figure 6.9. Existing Sediment Regime Departure Map showing areas of coarse equilibrium and fine deposition and transport reaches.

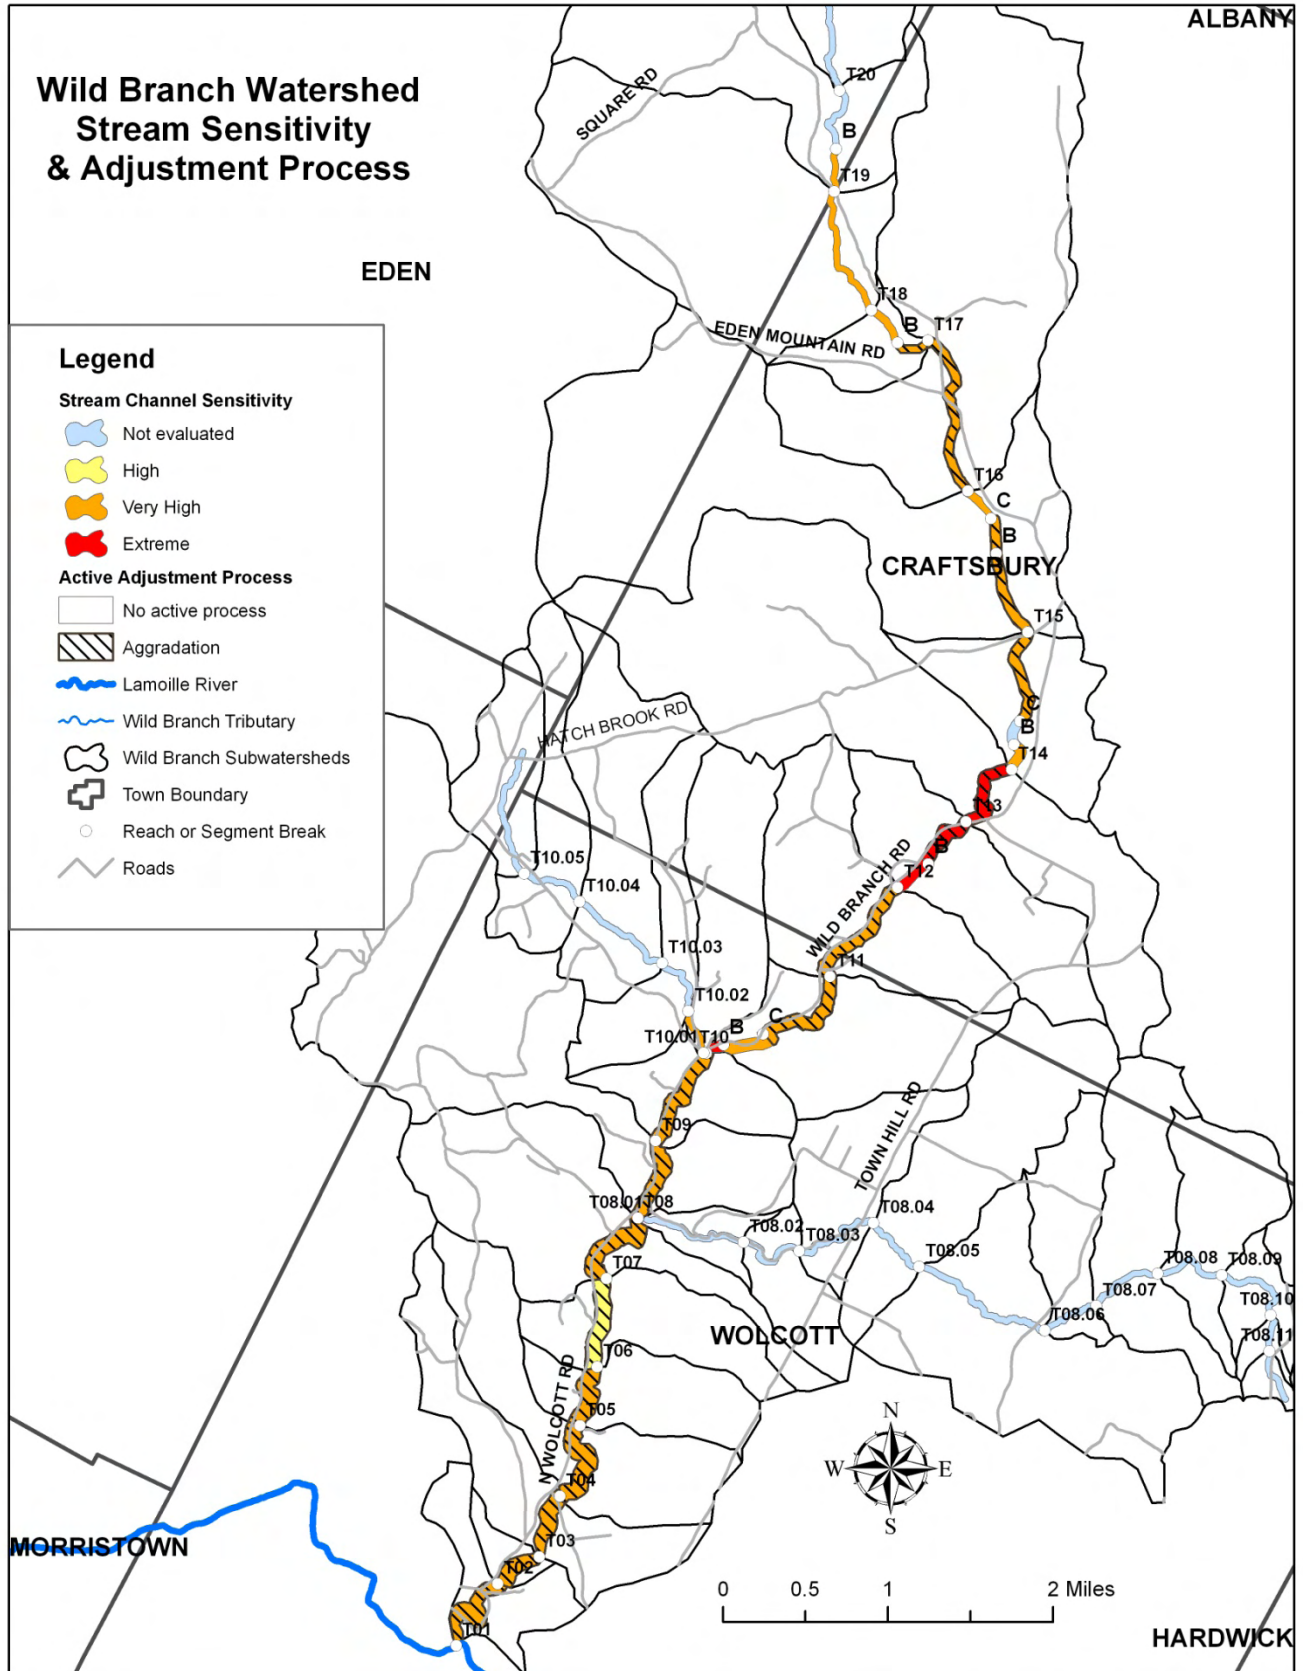
Figure 6.10 is a map presenting the stream sensitivity, generalized according to stream type and condition as per the VANR protocol, and current adjustments for each reach segment in the Wild Branch watershed. Sensitivity ratings have not been assigned for bedrock dominated segments and impounded segments that were not assessed. Segments T12-A, T12-B, T13 are gravel dominated segments that have undergone a stream type departure from a reference "C" channel to an "F" channel. This has resulted in a change in sensitivity from high to extreme (Figure 6.10). Segment T10-A, a cobble dominated segment, has also undergone a sensitivity change (moderate to extreme) because of a stream type departure from a "C" channel to an "F" channel. These stream type departures are attributed to historic incision. No vertical channel adjustments were noted to be actively occurring within the watershed during the 2007 Phase 2 assessment. However, both Jim Ryan (personal communication, 2010) and South Mountain Research & Consulting (2002) have noted active incision in the form of head cutting in the past in Reach T12 between Denton Hill Road and Paquette Road.

Major aggradation adjustment processes are displayed on the corridor where they were found to be actively occurring and not evaluated as historic. Aggradation is a current major active process for the majority of Wild Branch mainstem reaches. This information is useful in prioritizing the implementation of the projects identified in Section 7 of this report, as certain management actions may be influenced by these active adjustment processes.

Figure 6.10. Stream sensitivity and current adjustment of the Wild Branch.

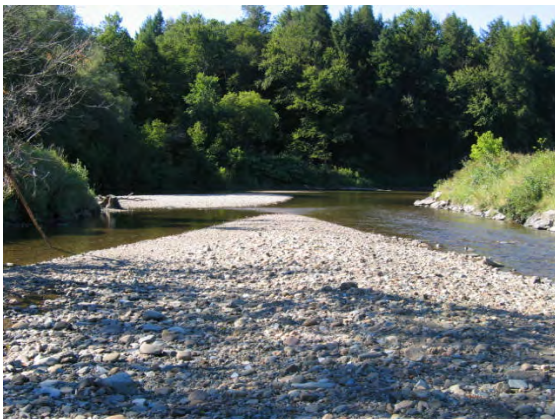
Wild Branch reach T01 is 3,374 feet in length and begins at the confluence of the Lamoille River and the Wild Branch. It continues north to about 250 feet south of the intersection of Frazer Road and North Wolcott Road. T01 has a very broad valley. As shown in Figure 7.1, this reach is very depositional and has multiple mid channel bars. Erosion is common along the east bank. About 15 percent of the reach has been straightened along roads within the corridor. Hay is the sub-dominant land use within the west corridor, and approximately one-third of the west bank was mapped as having a buffer width of less than 25 feet.

Figure 7.1. Mid channel bar near confluence with the Lamoille River in Reach T01

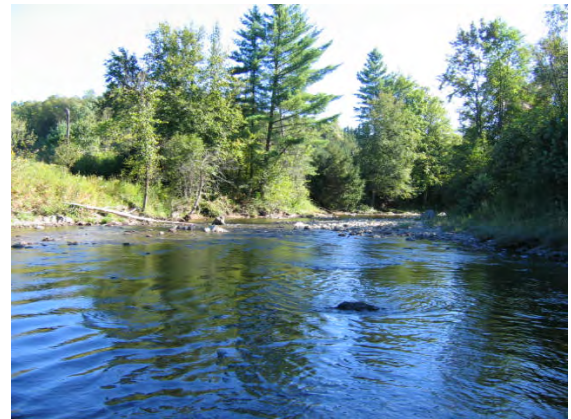
Figure 7.5. Reach T03 has a dominant buffer width of greater than 100 feet.

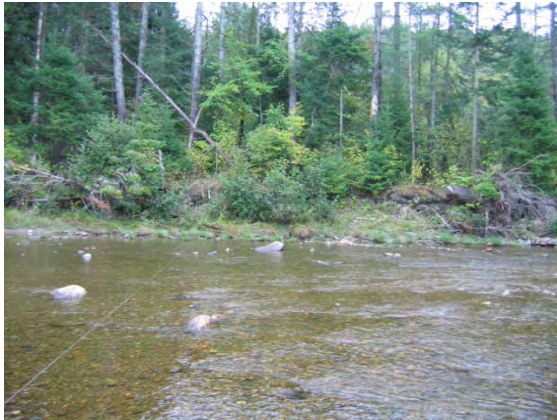
Large depositional features and flood chutes are common within reach T07. The channel bankfull width measured at the cross section (94.9 feet) is substantially wider than the reference bankfull channel width of 63.1 feet as shown in Figure 7.10. The channel

Figure 7.10. Typical wide cross section in reach T07.

dimensions suggest widening is occurring and explains why the stream channel is aggrading. Historic degradation, current aggradation, widening and planform adjustment are all major processes in reach T07. The geomorphic stream condition was rated as “fair”. The channel is just beginning to create a juvenile floodplain at a lower elevation. The RHA was also rated as “fair”. Fair substrate embeddedness, and sediment deposition, bank stability (west bank) and riparian buffer zone (west side) are contributing to the “fair” RHA score.

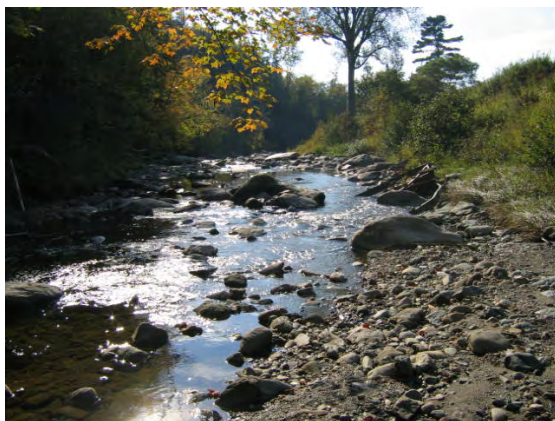
Figure 7.15. Stream channel in the vicinity of the cross section within segment T10-B.

segment B, as it is in segment A. However, there is still a stream type departure from a “C” channel to a “Bc” channel. The channel in the vicinity of the T10-B cross section is shown in Figure 7.15.

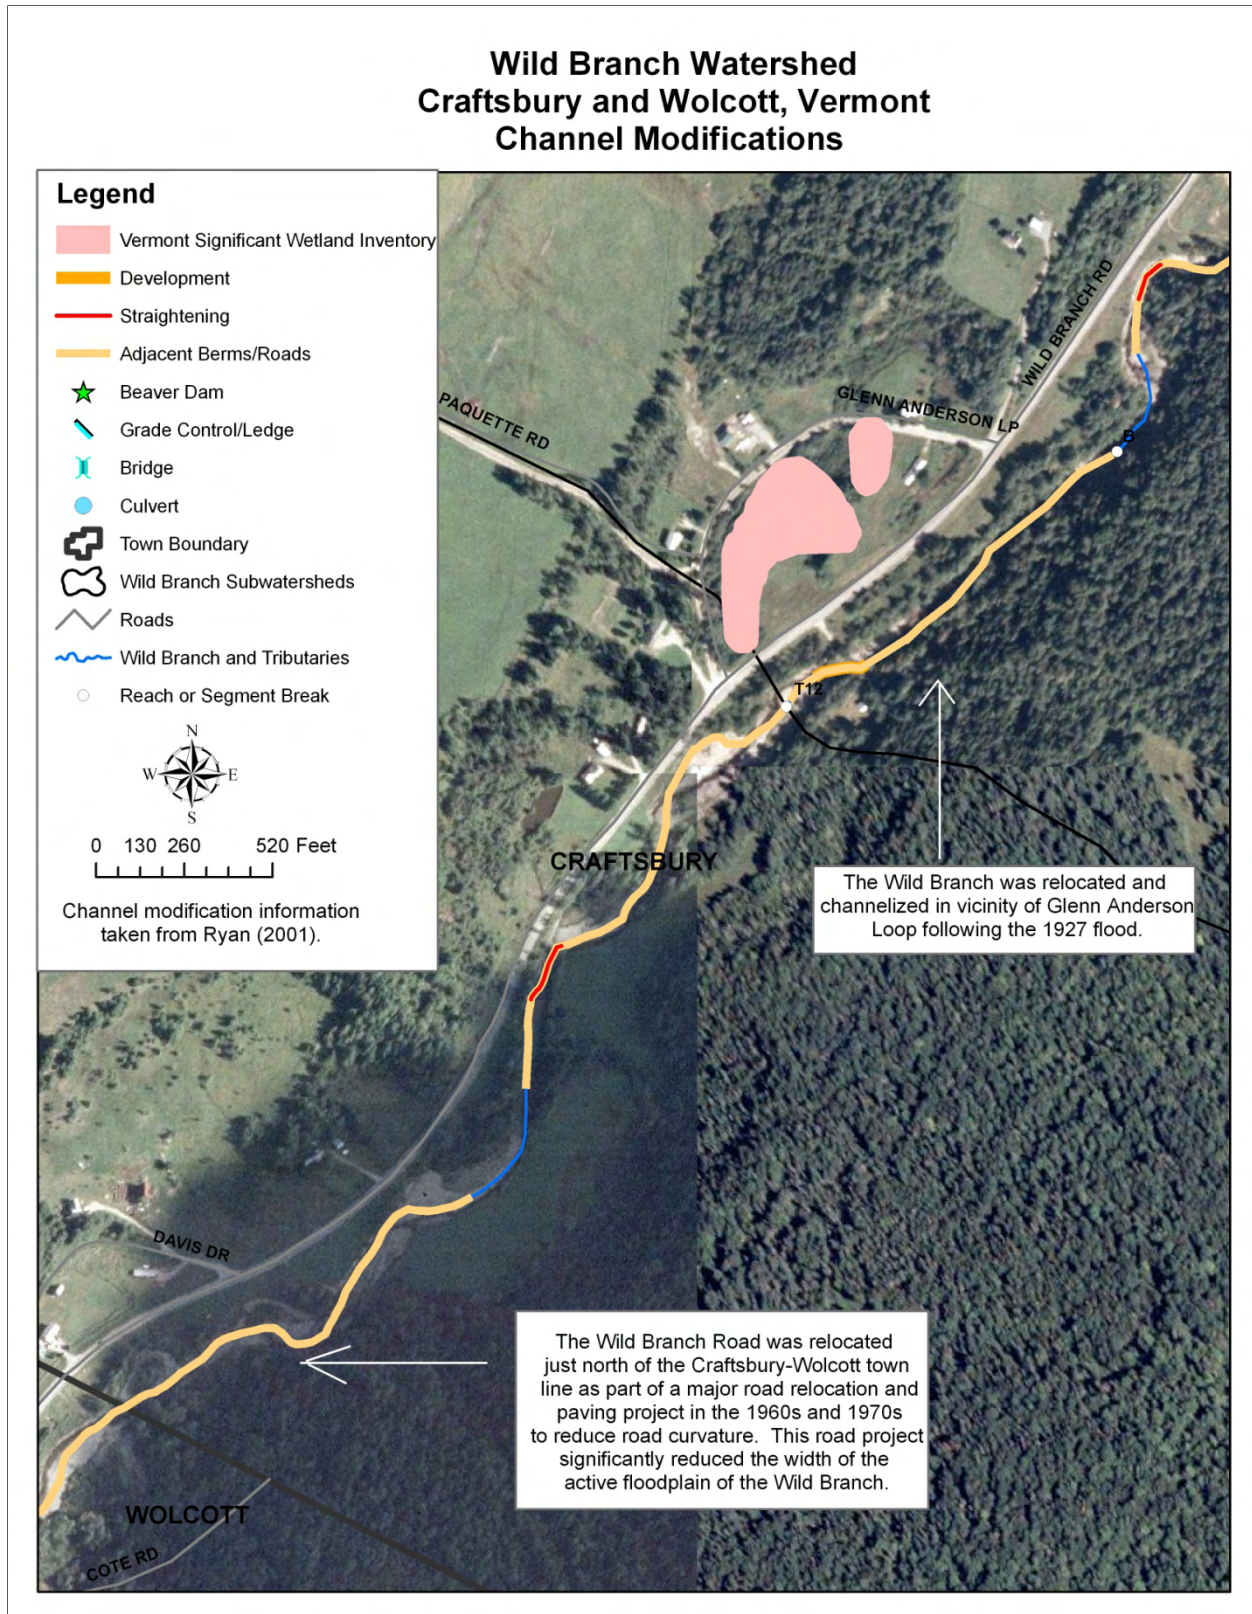
Figure 7.17. Historic channel modifications and the relocation of the Wild Branch Road in Craftsbury and Wolcott have significantly reduced the width of the active floodplain.

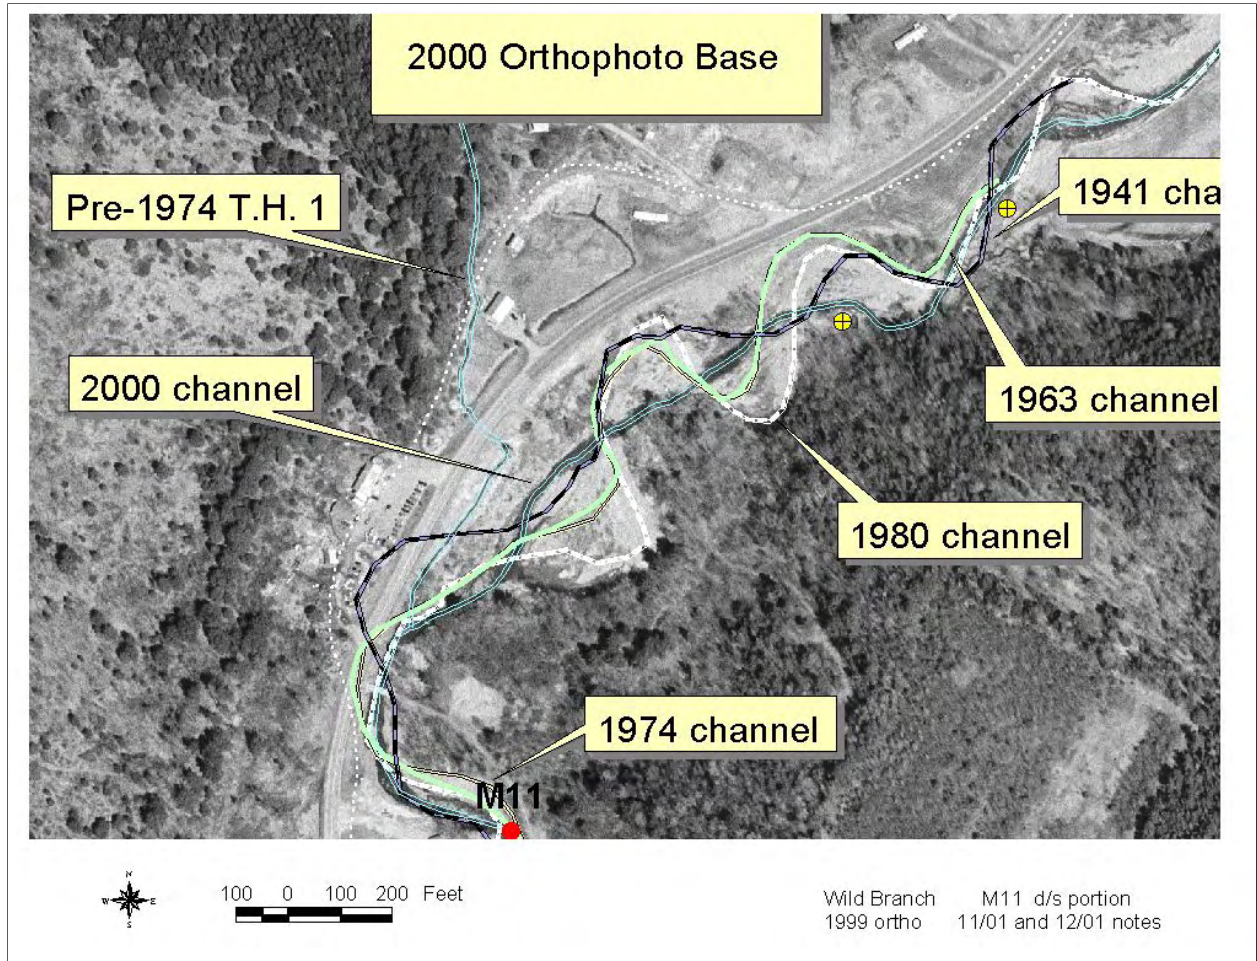
significant human-caused change in channel confinement from a very broad to a broad valley. Riprap is found for 600 feet along the west bank where the Wild Branch and North Wolcott Road are in close proximity to each other. According to Ryan (2001), the Wild Branch Road was relocated just north of the Craftsbury-Wolcott Town line as part of a major road relocation and paving project in the 1960s and 1970s to reduce road curvature (Figure 7.17). The road project significantly reduced the width of the active floodplain of the Wild Branch as shown in the historical orthophoto analysis (see Figure 7.18) conducted by South Mountain Research & Consulting Services.

Figure 7.18. The active floodplain of the Wild Branch was significantly reduced by the road relocation that occurred in the 1960s and 1970s. The location of the Wild Branch has changed considerably over time. This image is provided courtesy of South Mountain Research & Consulting Services.

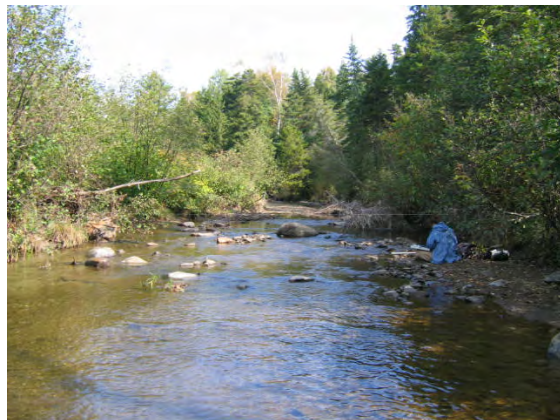
T14-A, the most downstream segment, has a remnant beaver dam at the upstream end of the segment that is no longer impounding the channel. There are no corridor encroachments and no buffers less than 25 feet in width. Bank erosion is found along about 1/3 of the length of the channel on both sides of the brook. Forest dominates the east corridor while hay is the dominant corridor land type on the west side. As shown in Figure 7.24, trees are the dominant buffer vegetation on both sides of the channel.

Figure 7.24. Wooded buffer adjacent to channel in reach T14-A. Dominant buffer widths are greater than 100 feet on the east bank and 26-50 feet on the west side.

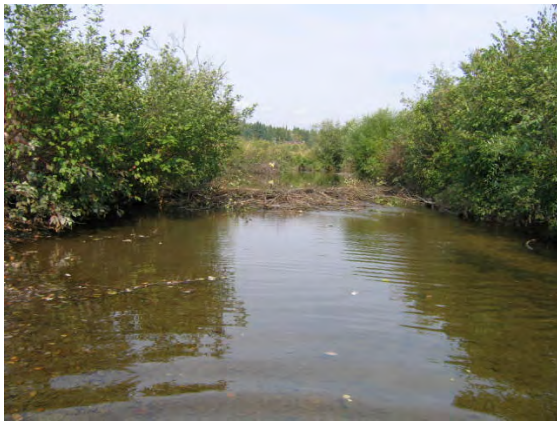
Segment T14-B was not assessed due to a beaver dam that was impounding the channel (Figure 7.25). This segment was too deep to be able to wade in the stream, and water backed up for the length of the segment. There is farm land on both sides of the Wild Branch. A private farm bridge is a stream crossing within this segment (Figure 7.25).

Figure 7.25. This beaver dam is impounding the channel in segment T14-B.

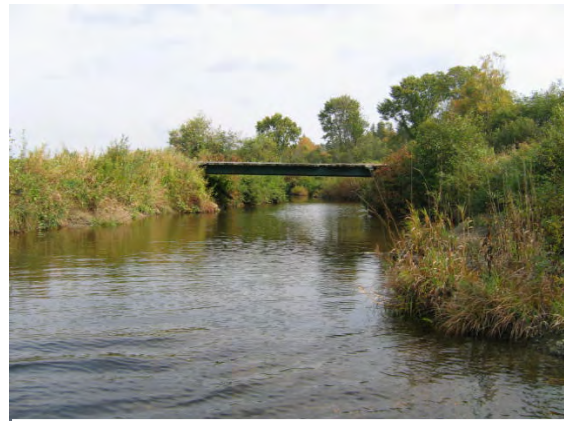
Figure 7.26. Farm bridge in T14-B with a span of 25 feet and a clearance of 5 feet.

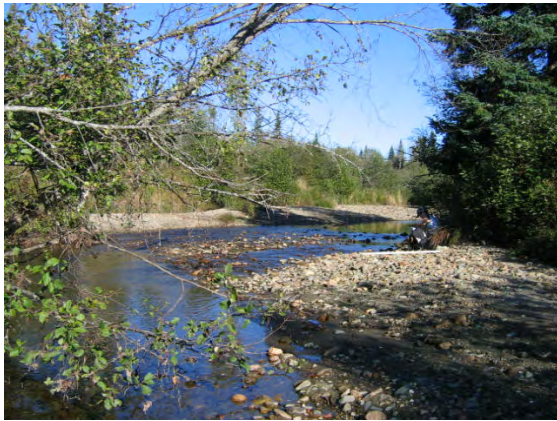
Figure 7.28. Segment T15-A has multiple diagonal bars and large depositional features.

also has multiple diagonal bars and steep riffles suggesting aggradation is a major process in this segment (Figure 7.28). Generally, buffers are good within segment T15-A. The dominant buffer width on the west bank is greater than 100 feet. The dominant and subdominant buffer widths on the east side are 26-50 feet and greater than 100 feet, respectively. The west corridor is primarily forested, while the east bank has a dominant corridor land use of pasture.

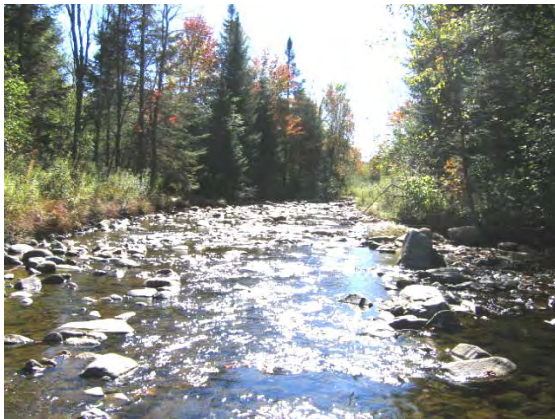
T15-B is a very short (1,152 foot) segment that appears to be naturally straight (Figure 7.29). There are no roads within the corridor and no evidence of channel straightening. No bank revetments were noted in the field to suggest historic or recent channel straightening had taken place. Stream buffers are generally greater than 100 feet along both banks and the dominant buffer vegetation is mixed trees, making for a healthy riparian buffer. In a few areas, the buffer width on the east side of the channel is 51 to 100 feet. Forest dominates both the east and west corridor, and hay is the subdominant corridor land use within the east corridor.

Figure 7.29. Segment T15-B is naturally straight.

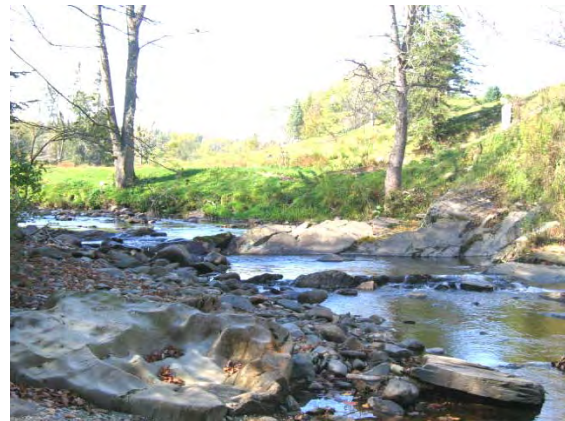
Segment T15-C differs from the lower two segments in reach T15 because of the narrow valley confinement and ledge grade control structures. There is evidence of two old dam abutments near the ledge grade controls (Figures 7.30 and 7.31)

Figure 7.31. Ledge in segment T15-C is acting as a grade control.

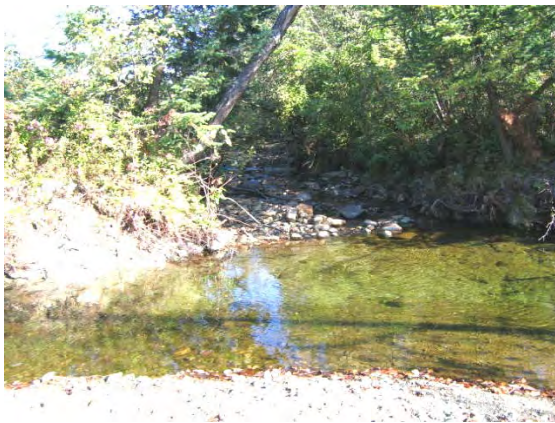
widening are the primary adjustment processes within the reach. Tributaries are also affected by the lowering of the bed of the Wild Branch. As the bed of the main stem is lowered, head cuts begin at the mouth of the tributary thereby “rejuvenating” the tributary. As shown in Figure 7.32, a tributary to the Wild Branch is rejuvenating following the historic incision of the mainstem. Also shown in the photo is the presence of clay on the mainstem in reach T16.

Figure 7.32. A tributary that enters the Wild Branch within reach T16 is rejuvenating following historic incision of the main stem.

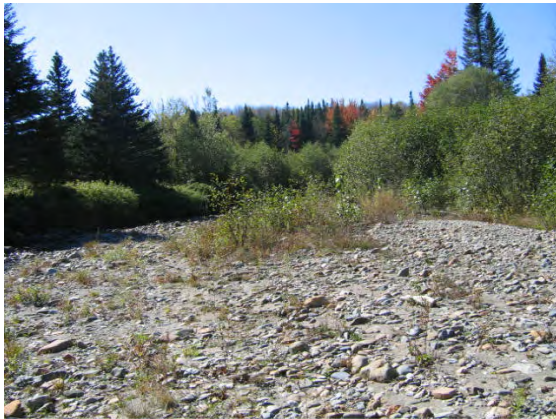
The lower segment, T17-A, begins about 500 feet upstream of the northern Collinsville Road crossing and is 1,285 feet in length. The segment is currently undergoing major aggradation (see large gravel bar in Figure 7.33), major planform adjustment with minor widening. As shown in Figure 7.34, there is a weak riffle-pool bedform due to significant filling of pools with sediment. Planform adjustment was evident from the active flood chutes crossing inside of meander bends.

Figure 7.33. A large unvegetated gravel bar in segment T17-A reflects the major aggradation that is occurring in the Wild Branch.

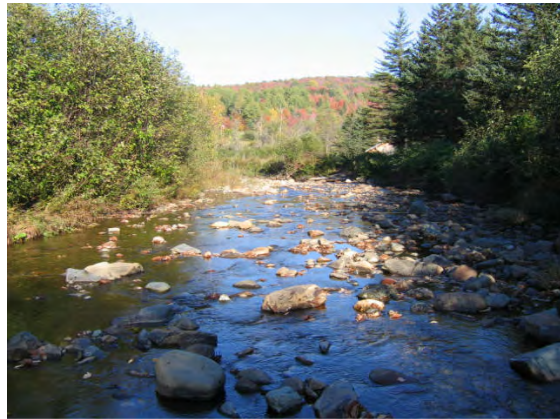
Figure 7.34. Segment T17-A has a weak riffle-pool bedform and lacks deep pools.

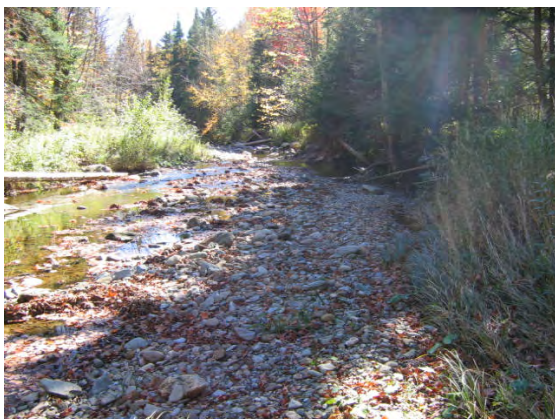
Segment T17-B is 1,460 feet in length. As previously mentioned, there is a stream type departure from the reference stream type. Some areas of the segment are more depositional (as shown in Figure 7.35) than where the cross section was measured and are wider and shallower, but have better floodplain access. The RGA scored as “fair”, while the habitat was in RHA was in the “good” category. The high quality riparian zones (Figure 7.36) and the lack of channel modifications in this segment were factors that helped bring the overall habitat score into the “good” range.

Figure 7.35. Some sections of T17-B were more depositional than the cross section location. This is a large diagonal bar near the lower end of the segment

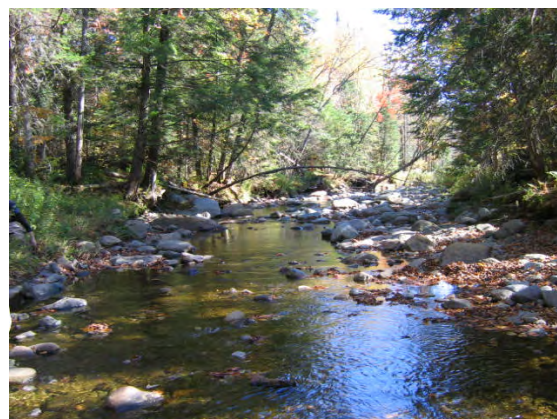
Figure 7.36. Segment T17-B has a high quality riparian zone along both banks. This photo was taken downstream of the cross section location.

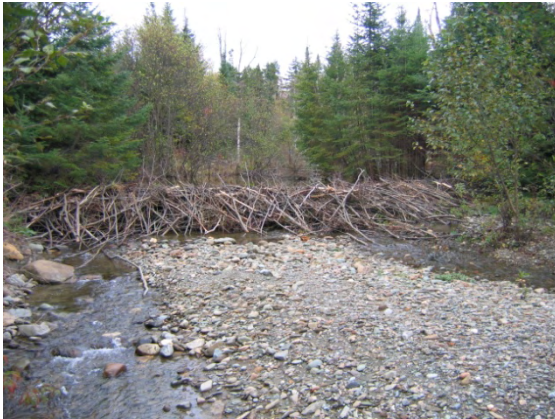
Segment T19-B was partially assessed due to the influence of beaver dams (Figure 7.40). Huge depositional features and multiple channels made this segment difficult to map and assess. The upper most 450 feet of the 2,430 foot segment could not be mapped due to beaver ponds. The upper end of the segment is fairly remote and the closest road (Square Road) is approximately 700 feet to the west of the Wild Branch channel near the reach break between T19 and T20. The lower part of segment T19-B appears to be influenced by upstream beaver dams. While the lower part of this segment was not impounded by beavers, it was heavily influenced by their presence upstream, to the point that the main channel was not always evident. Multiple islands and a channel avulsion within the segment are a result of flow entering the channel from beaver ponds (Figure 7.41). The Phase 2 assessment of the main channel ended at Reach 19.

Figure 7.40. A partial assessment of segment T19-B was conducted due to the influence of beaver dams.

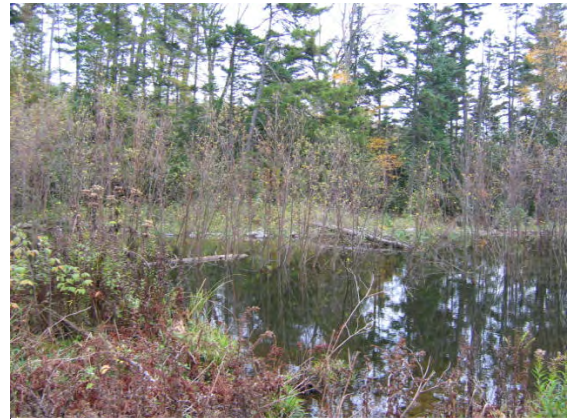
Figure 7.41. The upper 450 feet of segment T19-B could not be mapped due to the presence of beaver ponds.

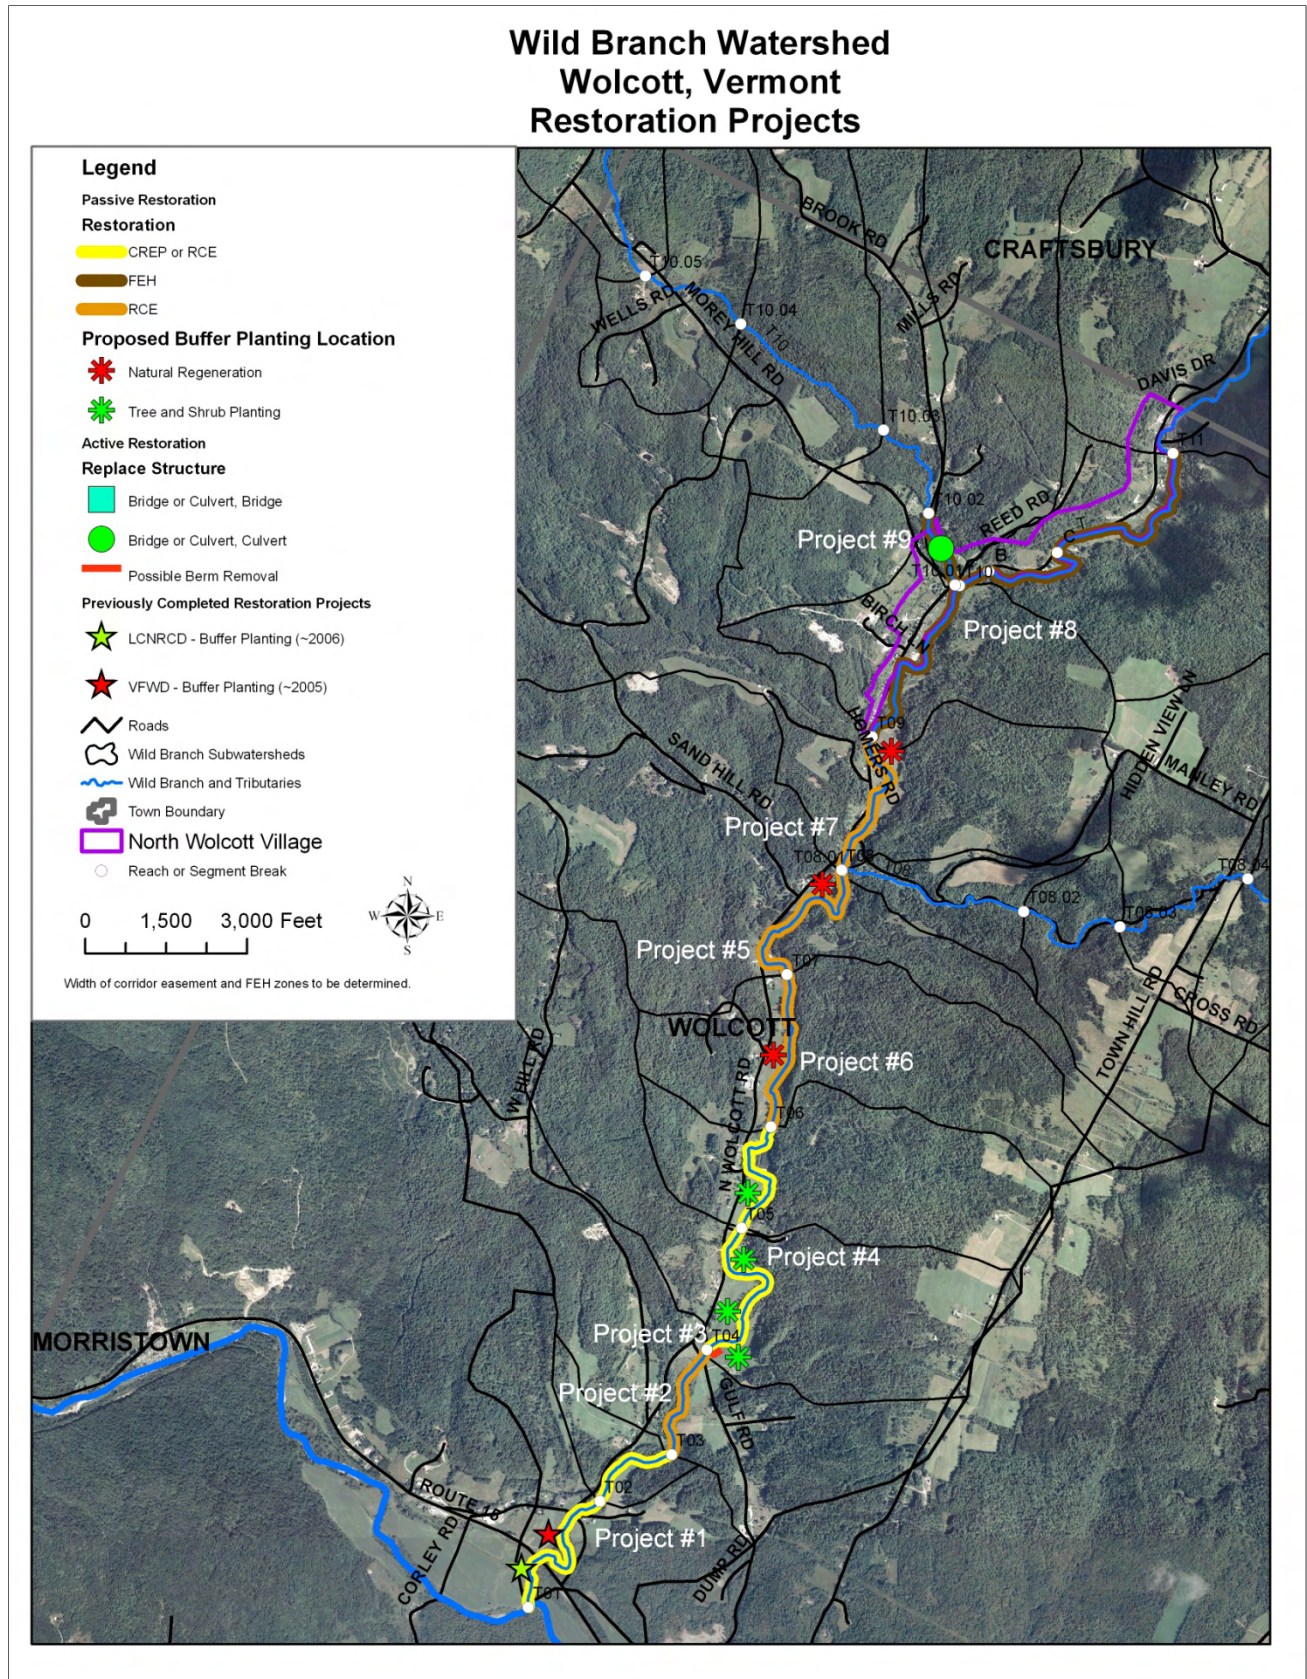
Figure 7.45. Proposed restoration and protection projects for Wild Branch in Wolcott, Vermont

- **Passive Restoration** of riparian buffer through natural regeneration or low cost plantings in vicinity of Tamarack Road (project #7).
- **Passive Restoration** of river corridor through natural development and implementation of fluvial erosion hazard (FEH) zones in North Wolcott Village (project #8).

- **Active Restoration** to arrest active incision by installing rock weirs or other restoration measures to stabilize the bed. Additional assessment work, as well as an alternatives analysis, is recommended to determine if project should go to design stage (project #10).

#8 North Wolcott T09, T10, T10.01	Passive Restoration	The North Wolcott Village has multiple property owners along the Wild Branch mainstem and major tributary and is well suited for the adoption of a fluvial erosion overlay district.	Fluvial Erosion Hazard (FEH) overlay district	High priority for corridor protection as FEH overlay district due to multiple landowners	Reduce fluvial erosion hazard and property damage	Unknown	No new structures in corridor	Town of Wolcott, ANR, LCPC

# 9 Brook Road Crossing on Unnamed Tributary Wolcott, VT T10.01	Active Restoration	The Brook Road culvert is undersized and was found to be mostly incompatible using the geomorphic screening tool. The structure is reducing aquatic organism passage.	Culvert Replacement	High priority	Improved geomorphic stability	Moderate cost of replacement	Unknown	Town of Wolcott, ANR, LCPC
