Wild Branch Corridor Plan

Wolcott, Craftsbury and Eden, Vermont

March 18, 2010

Wild Branch Corridor Plan Wolcott, Craftsbury and Eden, Vermont

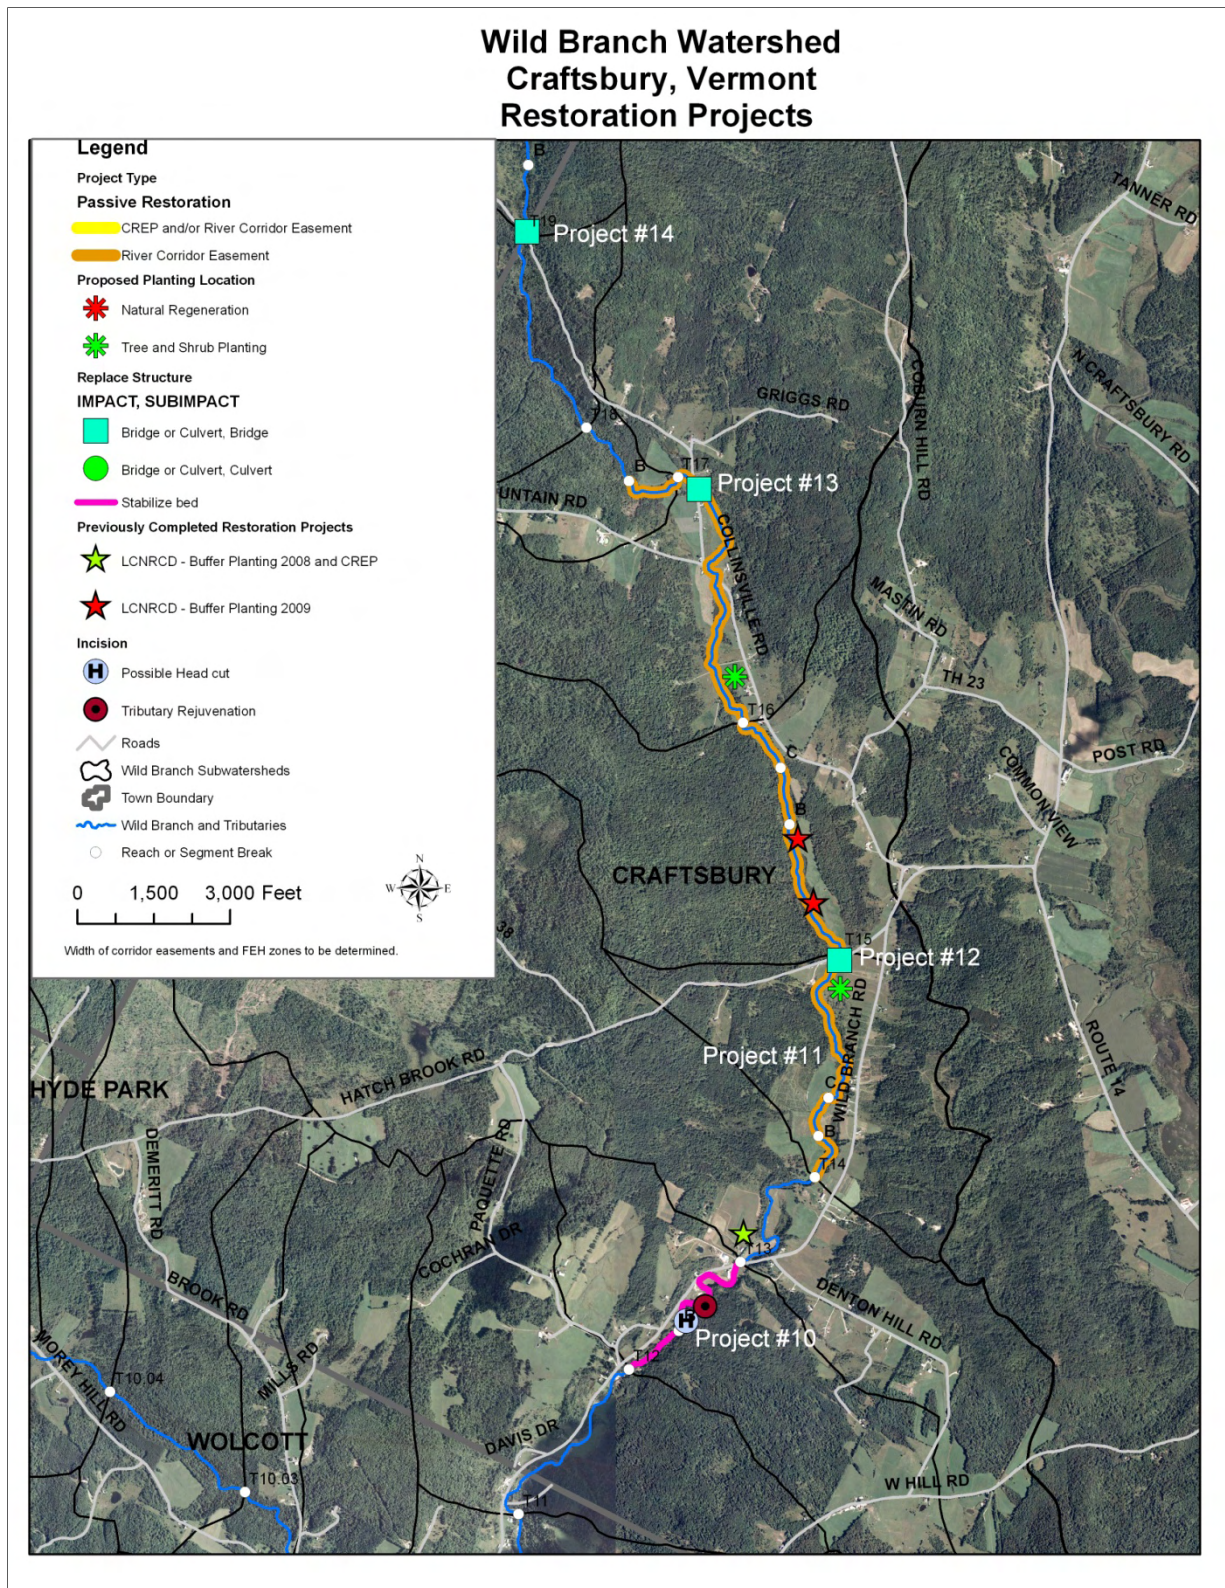
Figure 7.46. Proposed restoration and protection projects for the Wild Branch in Craftsbury, Vermont

- **Active Restoration** by possibly replacing the Hatch Brook Road Bridge. An assessment following the Vermont River Management's most current version of the Bridge and Culvert Assessment Protocol is recommended to confirm the need for replacement (project #12).

- **Active Restoration** by possibly replacing the northern Collinsville Road Bridge. An assessment following the Vermont River Management's most current version of the Bridge and Culvert Assessment Protocol is recommended to confirm the need for replacement (project #13).

- **Active Restoration** by possibly replacing the Square Road Bridge. An assessment following the Vermont River Management's most current version of the Bridge and Culvert Assessment Protocol is recommended to confirm the need for replacement (project #14).

#13 Northern Collinsville Road Bridge Craftsbury, VT T16	Active Restoration	Northern Collinsville Road Bridge is undersized and is causing localized geomorphic instability due to sediment transport and alignment.	Assess the crossing using the ANR bridge and culvert assessment protocol. Consider replacing if further assessment work confirms this is a problem.	High priority for replacement	Improved geomorphic stability	High cost for bridge replacement	Unknown	Town of Craftsbury, ANR, LCPC

#14 Square Road Crossing Eden, VT T19-A	Active Restoration	The Square Road Bridge is undersized relative to bankfull width. Sediment transport and alignment were problems noted during the Phase 2 assessment.	Assess the crossing using the ANR bridge and culvert assessment protocol. Consider replacing if further assessment work confirms this is a problem.	High priority	Improved geomorphic stability	High cost of replacement	Unknown	Town of Eden, ANR, LCPC
