# Muddy Brook Phase 1 and 2 Stream Geomorphic Assessment Summary

February 2, 2009

**Fitzgerald Environmental Associates, LLC.**

Vermont River Management Program

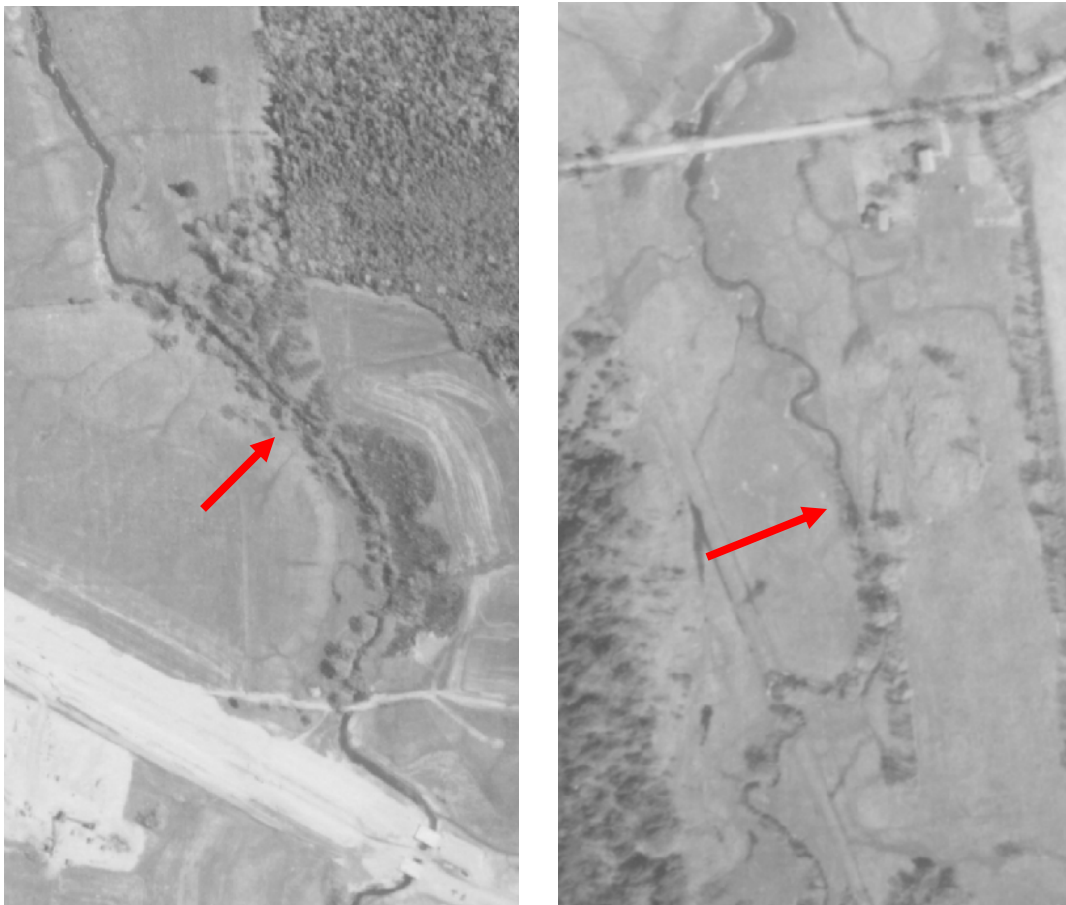
A review of historic aerial photography reveals that channel straightening occurred within many reaches, especially in the upper watershed upstream of Shelburne Pond. Below Shelburne Pond there are few areas where obvious channel straightening had occurred, despite the land being cleared for agriculture right up to the channel banks in many reaches. Channel straightening and bank armoring in this area may have been limited by the ongoing presence of beavers and the wet meadows adjacent the channel that would have made these lands marginal for tilling and agriculture. Areas of the channel below Shelburne Pond where channel straightening was clearly associated with agriculture include Reach M07 and M10 (Figure 9).

Figure 9. Historical channel straightening north of I-89 (left) and south of Van Sicklen Road (right) as seen in aerial photography from 1962.

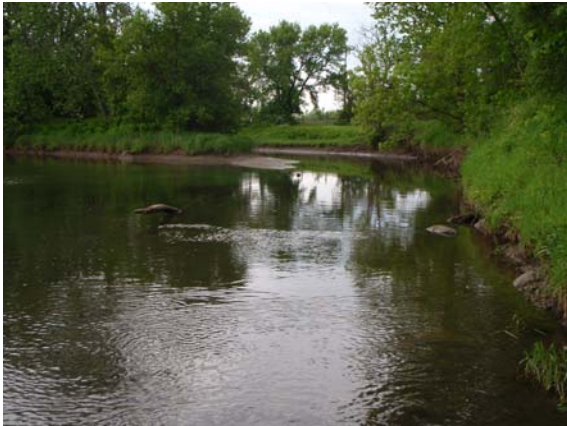
Figure 13. The confluence of Muddy Bk. with the Winooski

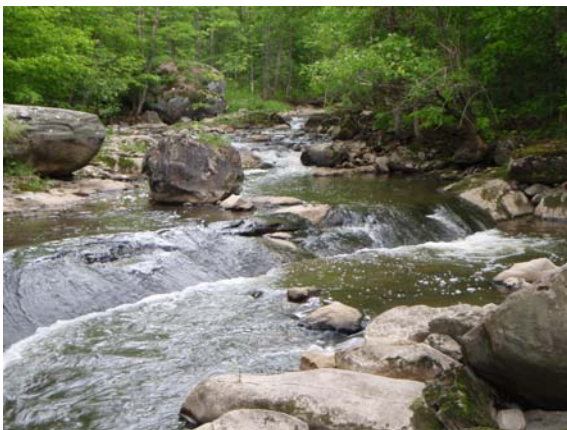
Figure 17. Step-pool bedform with grade control

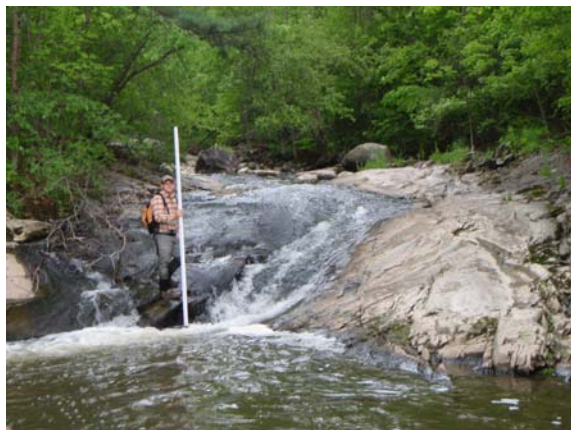
M03 begins at a sharp change in confinement southeast of the Burlington Airport and extends upstream until the reach break at the Williston Road culvert. The channel is 2,578 feet in length and it has the highest slope of all the mainstem reaches on Muddy Brook (3.0%). Given the high slope the geomorphic processes are largely transport-based. The entrenchment ( $ER = 2.1$ ) and width-to-depth ratios ( $WDR = 20.5$ ) indicate B-type channel geometry with step-pool bedform features. The reach is set in a semi-confined valley, well buffered on both sides by mixed forests. However, the texture of the steep banks is mostly sand in the lower reach, making erosion risks high. Two large bedrock cascades are found mid-reach one after the other (Figure 17). Each grade control rise approximately 8 feet above the height of water. These grade controls, along with the coarse substrate make this channel stable with limited vertical channel adjustments (Figure 18).

Figure 18. The first of two bedrock grade controls

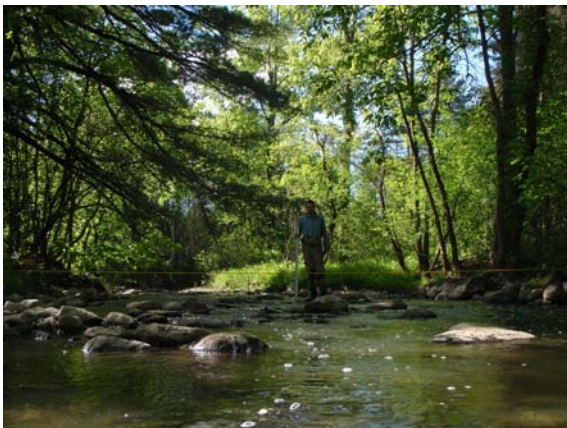
Figure 19. Cross section with typical C-type geometry

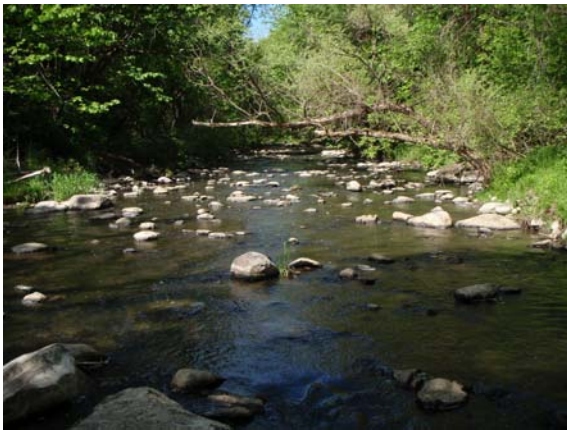
Figure 21. Plane bed channel bedform

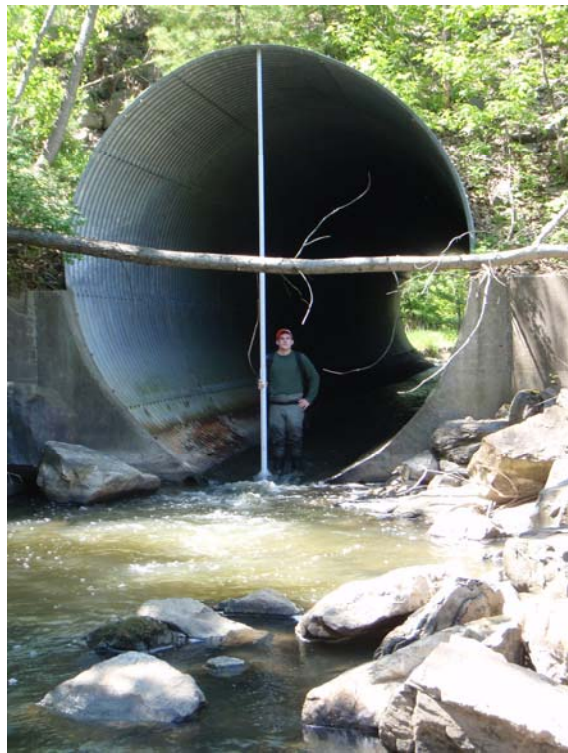
buffered along both sides with dense mixed tree and herbaceous cover. The reach has one culvert crossing where the channel passes under Marshall Ave (Figure 22). This structure is at grade and is amply sized

Figure 22. Culvert crossing at Marshall Ave.

to accommodate large storm events. The input of Tributary 2 is directly upstream of the culvert. The tributary's down-cutting and incision supply fine sediments to the upper reach. Several bar features were observed (15 features/mile), including a large island bar. The confined setting and low slope has made aggradation the primary geomorphic process in this reach. The substrate depositing on side and mid-channel bars was large in size, 5.0 and 9.0 inches respectively. This suggests that the channel still generates enough stream power to transport coarser substrate in high flow events. The pebble count histogram shows cobble to be the dominant substrate, with 53% of the distribution within that size class. Woody debris was common through the reach, often getting snagged on boulders protruding from the channel (LWD = 50 pieces/mile). The channel's potential to form large bar features, aggrade substrate, and change its planform without any areas of incision suggests stage IV of the CEM (RGA condition "fair"). The plane bed morphology has limited the velocity and depth patterns in the reach, greatly reducing the habitat (RHA condition "fair").

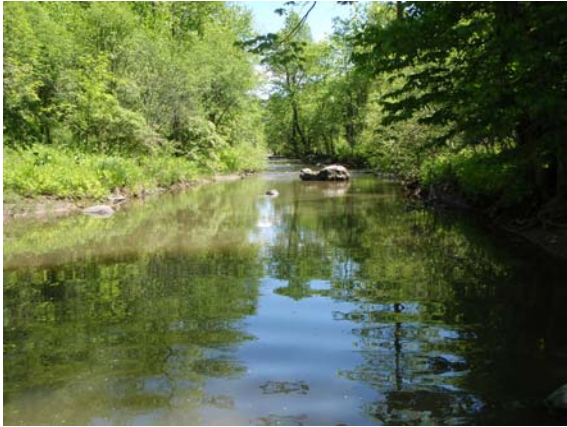
Figure 25. Plane morphology with coarse substrate

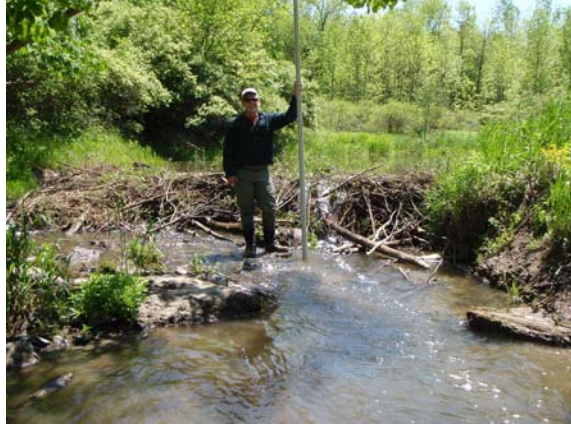
Figure 28. Beaver pond on the upstream end of the reach

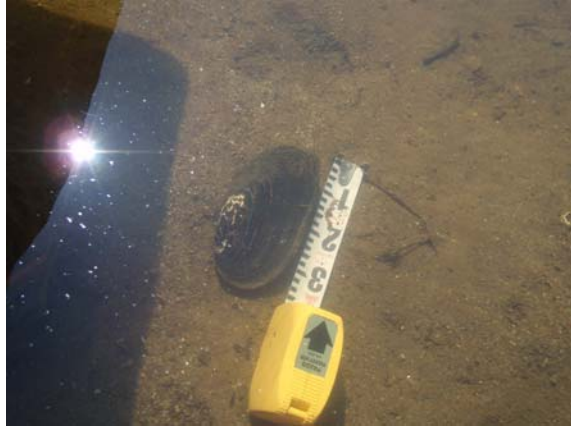
Figure 30. A native mussel *Elliptio complanata*

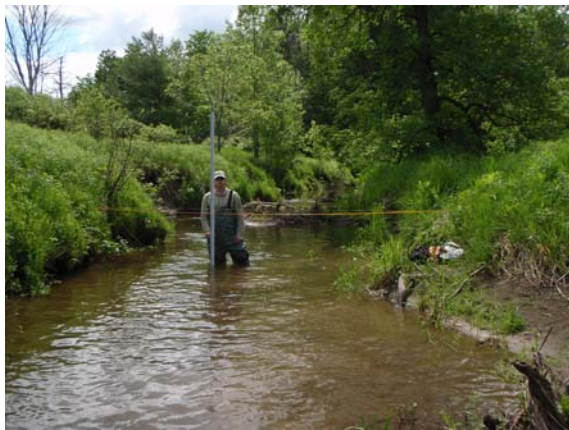
Figure 32. Cross-section in M10

Channel incision was noted in the cross-section (IR = 1.4; Figure 32) and the bankfull indicators at this level were very consistent throughout the reach. Incision is likely a result of the combined impacts of channel straightening and removal of riparian vegetation. Limited large woody debris observed in the channel (LWD = 45 pieces/mile) is leading to decreased fine sediment attenuation (e.g., bar formation), leading to further incision. However, the cohesive lower clay banks and bed limit the rate of further channel incision, causing the channel to be held in stage II of CEM. Due to the reduced floodplain access and moderate degree of bank erosion, the reach received an RGA rating of “Fair”. Quality habitat in the reach is limited by the lack of a healthy riparian buffer, the areas of straightened channel which lack pool formation, and increased sedimentation from bank erosion. The reach received an RHA score of “Fair”.

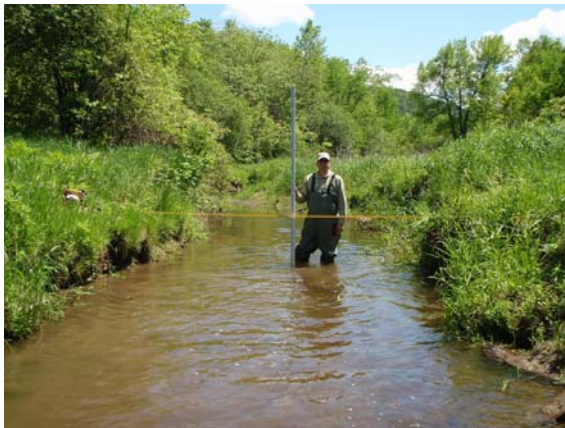
Figure 33. Cross-section in M11-A.

A level of channel incision consistent with that observed in M10 was noted in the cross-section ( $IR = 1.4$ ; Figure 33). As in M10, incision may have resulted from the removal of riparian vegetation, among other impacts when the adjacent floodplain was used for agriculture. The cohesive lower clay banks and bed limit the rate of further channel incision; however a high degree of slumping on the outer bends was noted on the upper banks which are composed of non-cohesive sands. Due to the reduced floodplain access and moderate degree of bank erosion and widening, the reach received an RGA rating of “Fair”. Biological habitat in M11-A is reduced due to the lack of a healthy riparian buffer and increased sedimentation from bank erosion ( $RHA = \text{“Fair”}$ ).

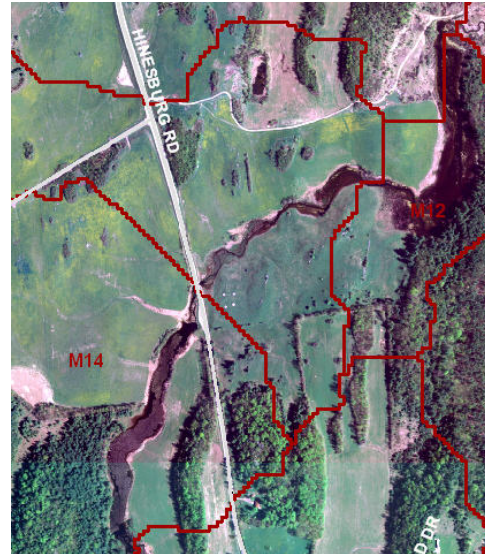
These reaches were not assessed following the complete SGA Phase 2 protocol because they were extensively impounded by beaver activity. The “gentle gradient” conditions extend from the segment break at M11B upstream until M18 the first reach above Shelburne Pond (Figure 35). However, the riparian banks, buffers, and corridor analyses were conducted for these reaches using a combination of field observations (entire corridor walked or canoed where possible) and the 2004 high resolution aerial photographs. M16 and M17 were not assessed because they are found within Shelburne Pond and are not part of the fluvial system.

Figure 35. Extent of ponding on M12-M14

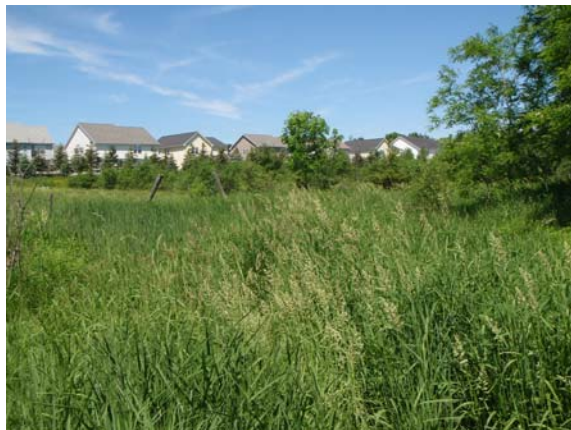
Figure 39. Channel downstream of confluence with T9

The channel is largely stable in between Cheese Factory Road and Dorset Street and the dominant processes at work in the reach are natural changes in planform (CEM stage I; RGA condition “good”). The habitat condition in this reach is “good”. There is a wide variety of pool sizes, steep banks that have overhanging vegetation, and ample baseflow. However, woody debris (20 pieces/ mile) is not regularly abundant in this channel because the surrounding corridor is mostly herbaceous vegetation or a mixture of shrubs and samplings. Most of the debris was noted in the small stretch of the channel that goes through a more developed forest.

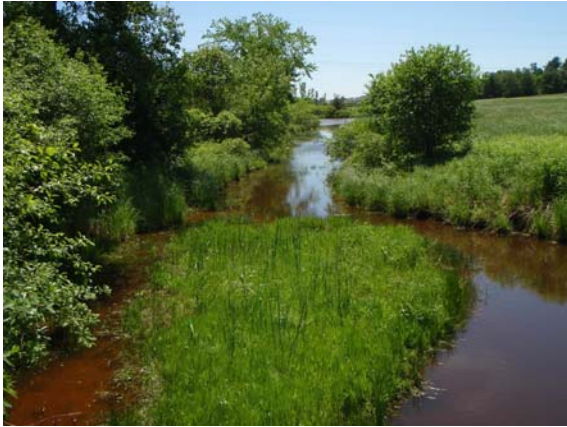
Figure 40. Ponded area downstream of a driveway

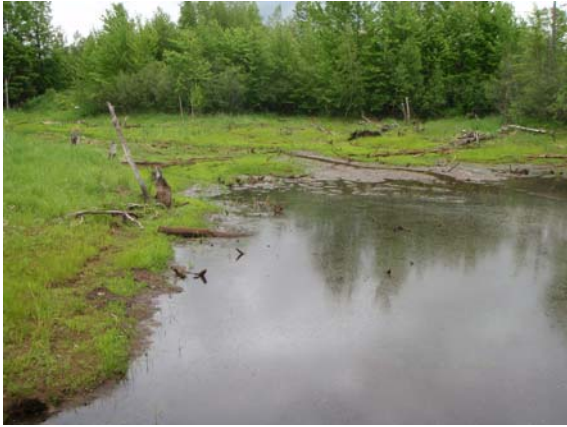
Figure 42. Ponding behind beaver dam at segment break.

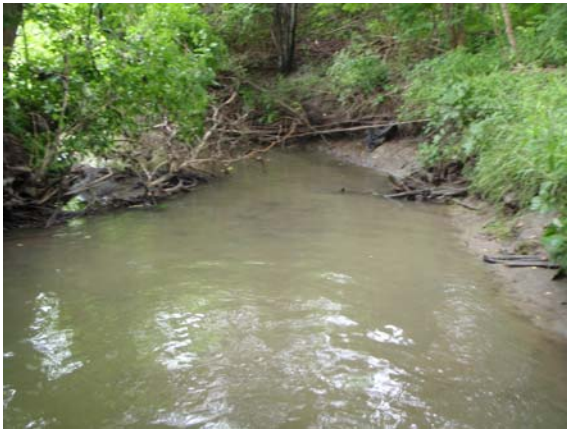
Figure 44. E-type channel with plane bed morphology

The substrate found in this segment is predominately fine, with silt and clay comprising 76% of the pebble count. The encroachment and straightening associated with the interstate has caused the channel to be in stage II of the CEM. The geomorphic condition rating is “fair,” because large storm events are able to push aggraded sediment through the channel, readily shifting the thalweg. Only in areas where woody debris has been lodged are changes in planform occurring. As more debris gets lodged securely in the channel, the planform could begin to shift and the channel could move through the evolution process. There were few viable habitat features observed in this reach. The “fair” habitat is indicative of the plane bed morphology and lack of riffle-pool features expected in a channel in this setting.

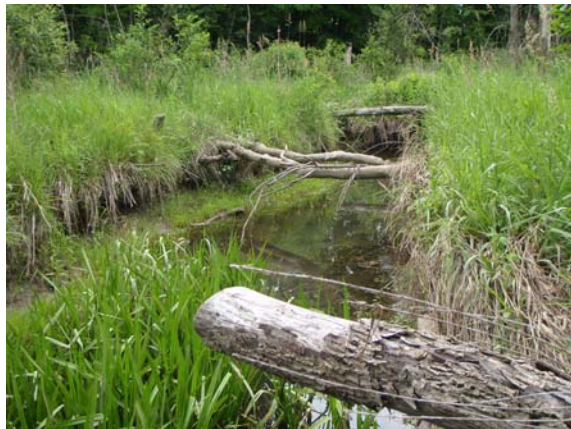
Figure 47. E-type channel with lots of woody debris

The reach was composed mostly of silt (60%) and sand (35%), forming excellent dune-ripple features spaced approximately every 90 feet. The abundance of large woody debris (107 pieces/mile), undercut banks, and refuge areas made habitat readily available (Figure 47; RHA condition “good”). The channel is greatly stabilized by the abundance of woody debris and does not have any signs of incision, indicating stage I of the CEM. The channel has some alterations in planform (i.e. an active flood chute off the left bank resulting from past beaver activity) but its geomorphic state is stable (RGA condition “good”). However, it is likely that this channel may be occupied by beavers in the future since the low gradient segment upstream has been dammed recently.

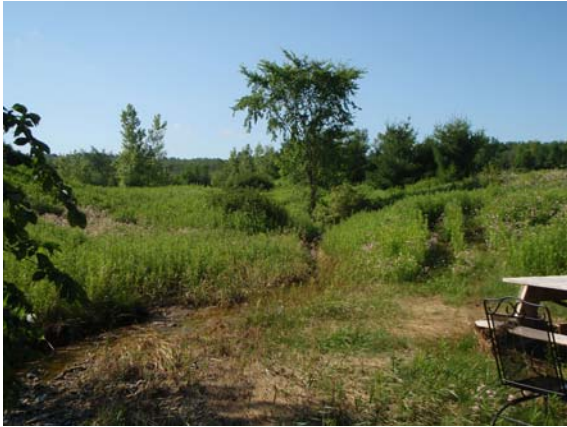
Figure 53. Wide unconfined valley type

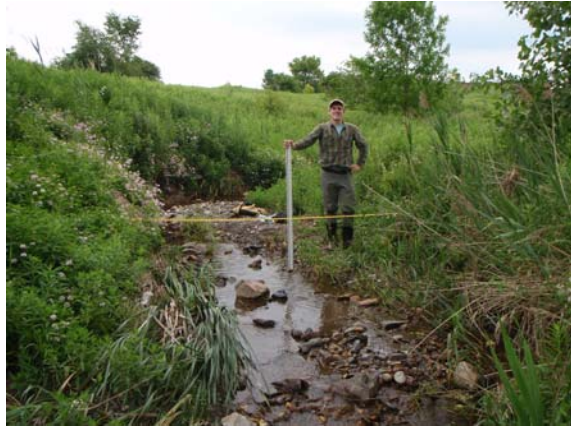
Figure 54. Cross-section showing C<sub>b</sub>-type geometry

This segment has a much higher slope than any of the segments in T3.01 and the coarser substrate size directly reflects that change. The bed substrate was comprised of coarse gravel (33%) and cobble (31%). The potential for woody debris to accumulate is low (LWD = 8 pieces/mile) because the surrounding vegetation is mostly shrubs, saplings, and herbaceous material. No major adjustment process stands out in this reach and its “fair” condition rating can be attributed to some degradation, aggradation, and changes in planform. The channel has a stage I evolution state because evolution processes have not fully developed. There was a good variety of epifaunal substrate small pools making the habitat condition “good”.
