# **Ompompanoosuc River Corridor Plan**

**West Fairlee to Thetford, Vermont**

**April 28, 2011**

**Bear Creek Environmental, LLC**

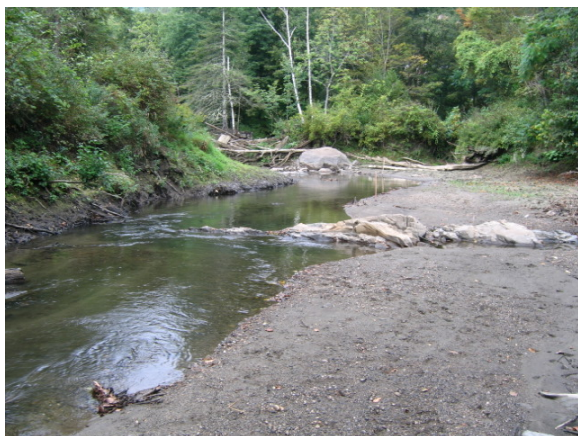
**Figure 4.5** Sediment deposition upstream of dam

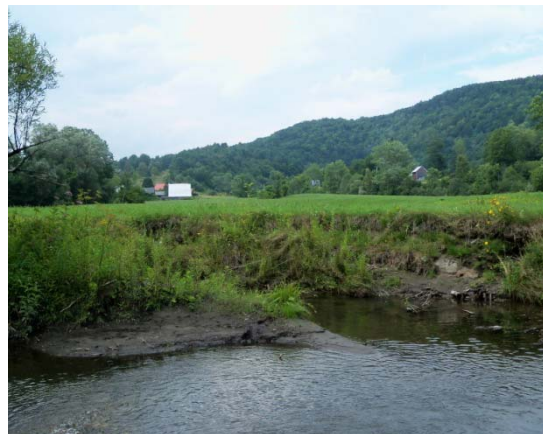
The lack of a high quality riparian buffer is one factor contributing to the “fair” habitat condition of R19-A. Approximately 80 percent of the east bank has buffer widths of less than 25 feet (Figure 4.13). The east bank has a riparian corridor that is primarily hay fields. The west bank has a dominant buffer width of greater than 100 feet and a sub-dominant buffer width of 51-100 feet. Forest is the primary land use in the western river corridor. Not surprisingly, 65 percent of the east bank has bank erosion compared with 25 percent of the west bank.

**Figure 4.13** Lack of buffer along hay field

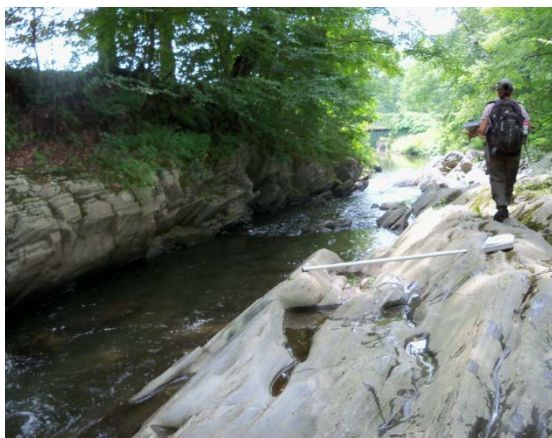
Segment R19-B is about a mile in length and contains five areas with ledge that are providing a natural grade control for the channel (Figure 4.14). The Geer dam, a man made grade control, was originally built to generate hydroelectric power (Figure 4.15). According to DEC records, the dam is no longer in service. The dam is holding back sediment, and is a barrier to aquatic organism passage. The dam has a total height of 6.7 feet, and it was 3.6 feet from the water surface to the top of the dam at the time of the Phase 2 assessment on July 28, 2010.

**Figure 4.14** Ledge grade control above Geer dam

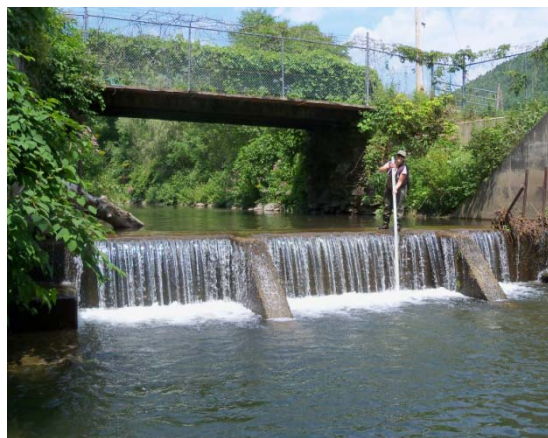
**Figure 4.15** Geer dam in segment R19-B

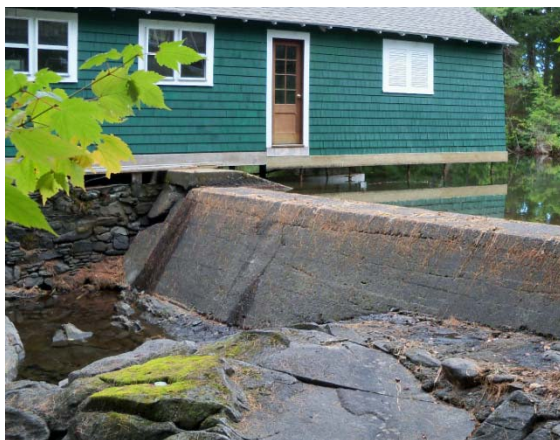
The habitat condition for R16T2.02 is at the high end of the “fair” range. Woody debris cover was outstanding, with logs and debris jams creating cover (Figure 4.27). Coarse particulate organic material (CPOM), which is an important source of food and cover for aquatic insects, was present both in the margins and channel. There is a high percentage of silt (30%) making the substrate less suitable for the colonization by water quality sensitive species and for trout reproduction. Connectivity of habitat scored low, because of the man-made obstruction (Lake Fairlee Dam). The dam is fourteen feet in height and is creating a system obstruction for movement of fish and other aquatic species (Figures 4.28 and 4.29).

**Figure 4.28** Lake Fairlee Dam from downstream

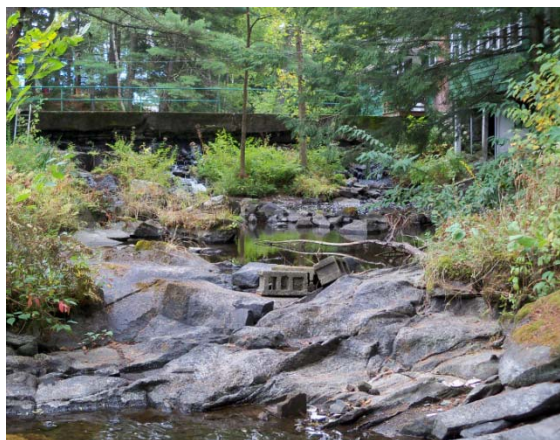
**Figure 4.29** Looking upstream at natural ledge & Dam

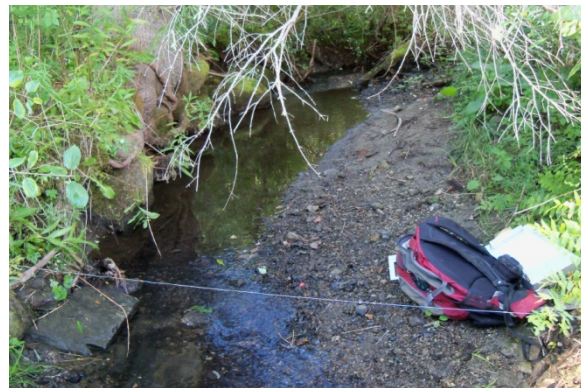
Wetlands are extensive in the riparian buffer and corridor (Figure 4.46). The high quality buffers are contributing to the habitat condition of “good”, although the habitat score was at the low end of the range. The dominant buffer width on each side of the channel is 100 feet, and there is less than 200 feet of channel length with buffers less than 25 feet on the east bank. The subdominant buffer width on the west bank is 26-50 feet. All of the habitat parameters were rated in the good category with the exception of Channel Morphology. Channel morphology was rated fair because of the channel straightening (Figure 4.47) and the limited floodplain access.

**Figure 4.47** Channel straightening and bank armoring

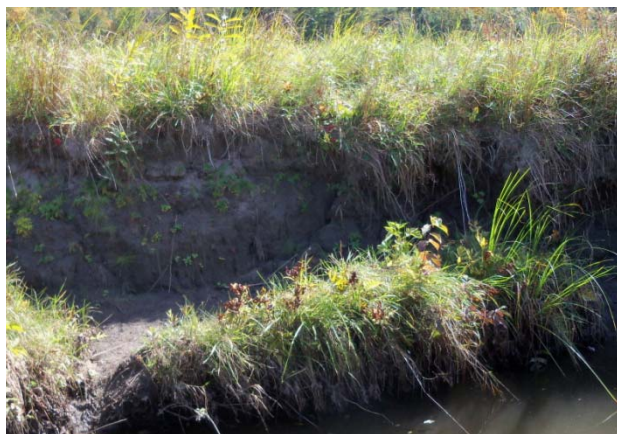
Segment RI6T2.03SI.02-A is about 2750 feet in length. The channel has a reference and existing and stream type of “E”. The dominant substrate material is sand. The bedform is predominantly dune-ripple, yet some portions have distinct riffles and pools. The downstream end of the segment (last 350 feet) is impounded by a beaver dam. Segment A is in “fair” geomorphic condition, and is undergoing major adjustment processes in terms of aggradation, widening, and planform change. The wetland adjacent to the channel on the west side is about one foot higher than the bankfull elevation. An active head cut in clay soils (Figures 4.56 and 4.57) was observed on a small drainage that enters the channel from the west side in the middle of the segment. It is not clear whether the channel historically incised in this segment. Nonetheless, given the extent of the aggradation, widening, and planform adjustment that is occurring, the channel appears to be in the stabilizing stage of the channel evolution model. There is a well defined floodplain on both sides of the channel. Based on the inspection of orthophotos, the channel has moved laterally over time. Planform adjustment is evident in the field from the moderate to high lateral bank erosion on most outside bands, *neck cutoffs* (places where the channel crosses and cuts off a meander), active flood chutes crossing inside of meander bends, and islands. There are numerous bars, which are uncharacteristic of the reference “E” channel. These bars are indicative of aggradation within the channel. Channel widening has occurred, and approximately seventy percent of both banks are eroded (Figure 4.58 and 4.59).

**Figure 4.58** Bank erosion and lack of buffer

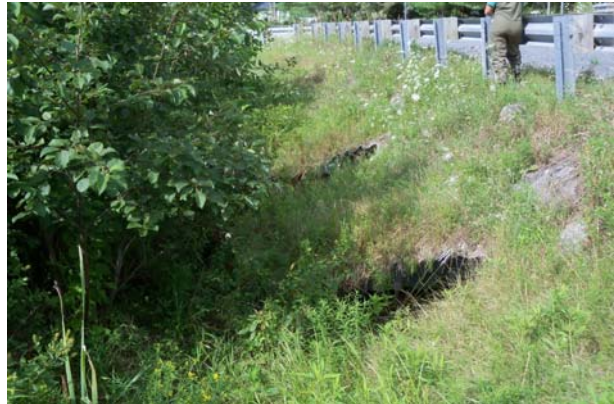
The Route 244 crossing on Blood Brook consists of three small culverts ranging between 6 and 6.5 feet in width (Figure 4.76). The culvert bottoms are steel corrugated pipe; the pipes do not have a natural stream bed with sediment and are reducing aquatic organism passage. For this reason the Route 244 crossing was assigned a moderate priority for replacement.

**Figure 4.76.** Three culverts at Route 244 Crossing

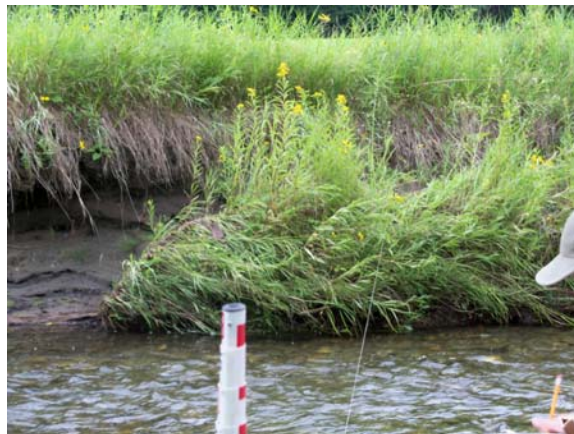
Project #7- Buffer improvement

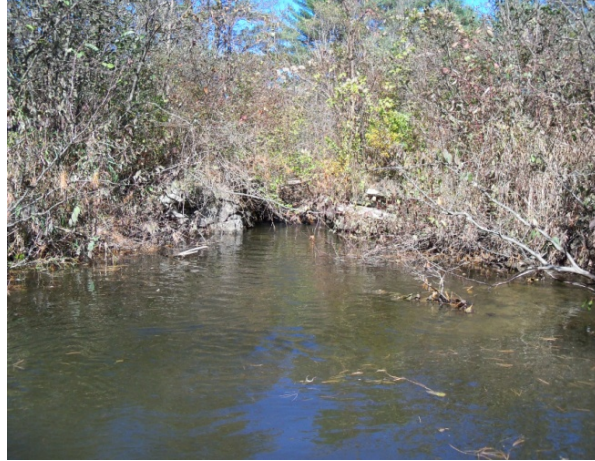
Project #2 – Remove old abutment
