Ompompanoosuc River Corridor Plan

Thetford to Norwich, Vermont

January 10, 2014

Bear Creek Environmental, LLC
149 State Street, Suite 3
Montpelier, Vermont 05602

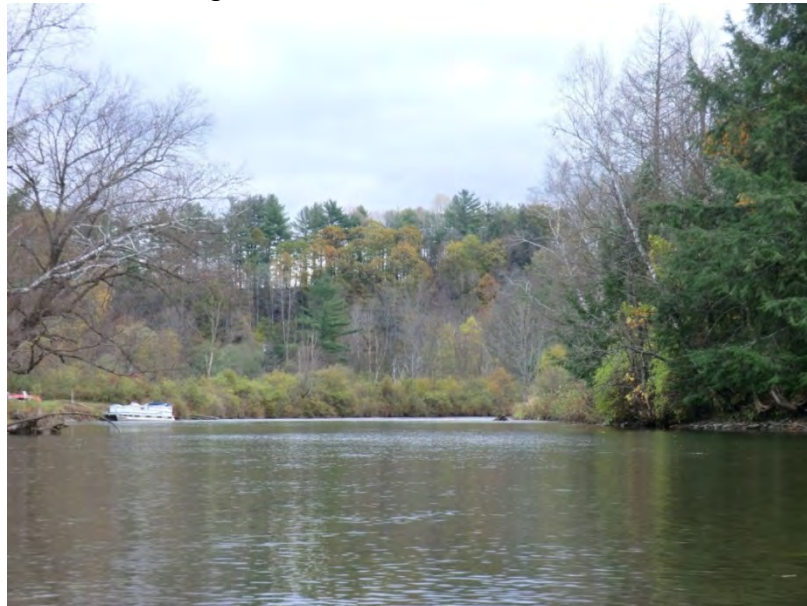
Figure 5.4. Typical channel in segment R03-A, which is impounded by the Wilder Dam

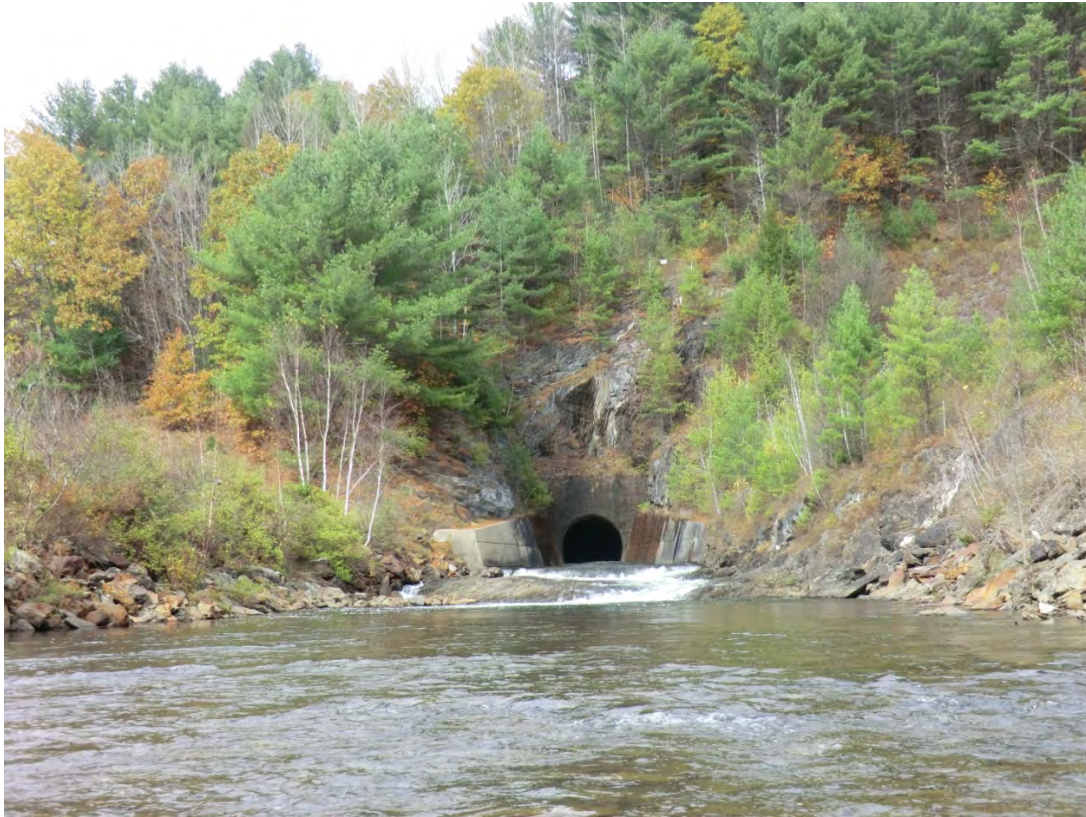
Figure 5.10. Outflow of the Union Village Dam.

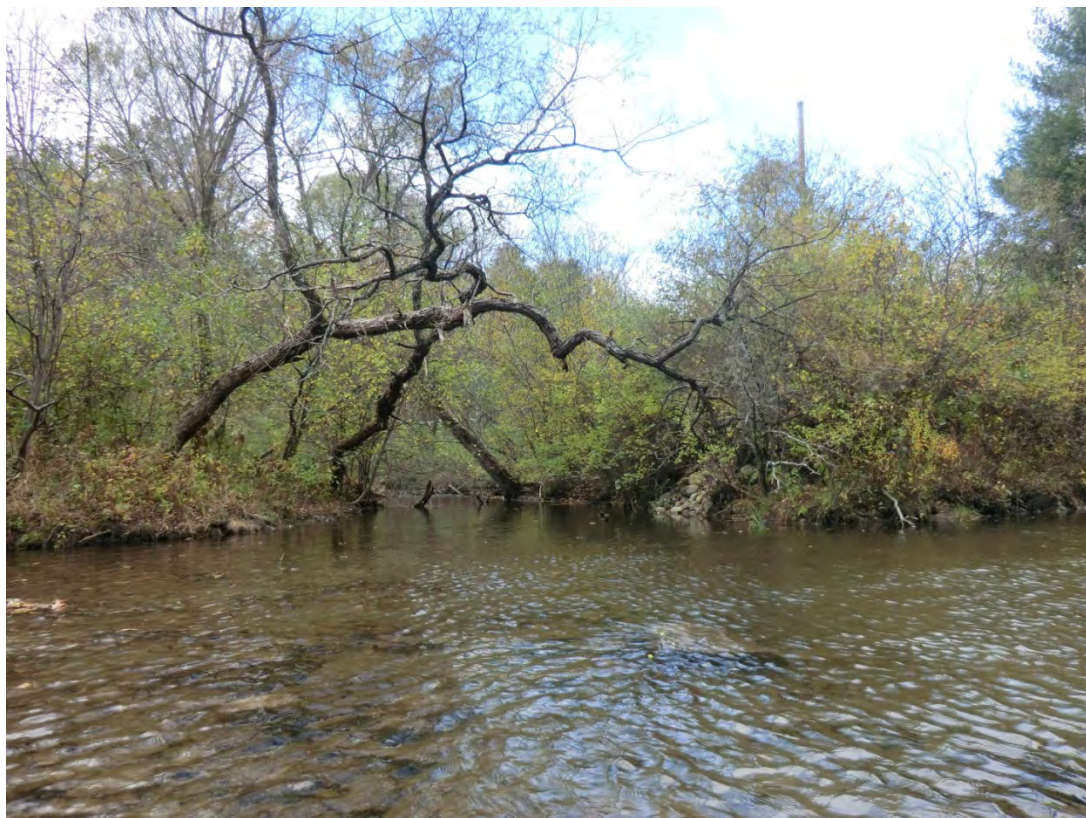
Figure 5.11. Avery Brook enters the Ompompanoosuc River from the west in segment R06-A.

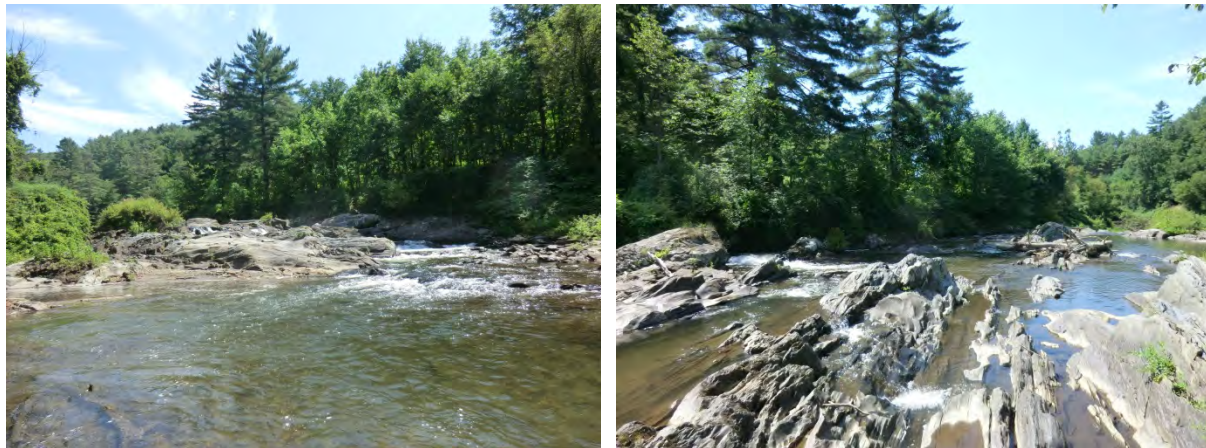
Figure 5.12. Bedrock grade controls in segment R08-A.

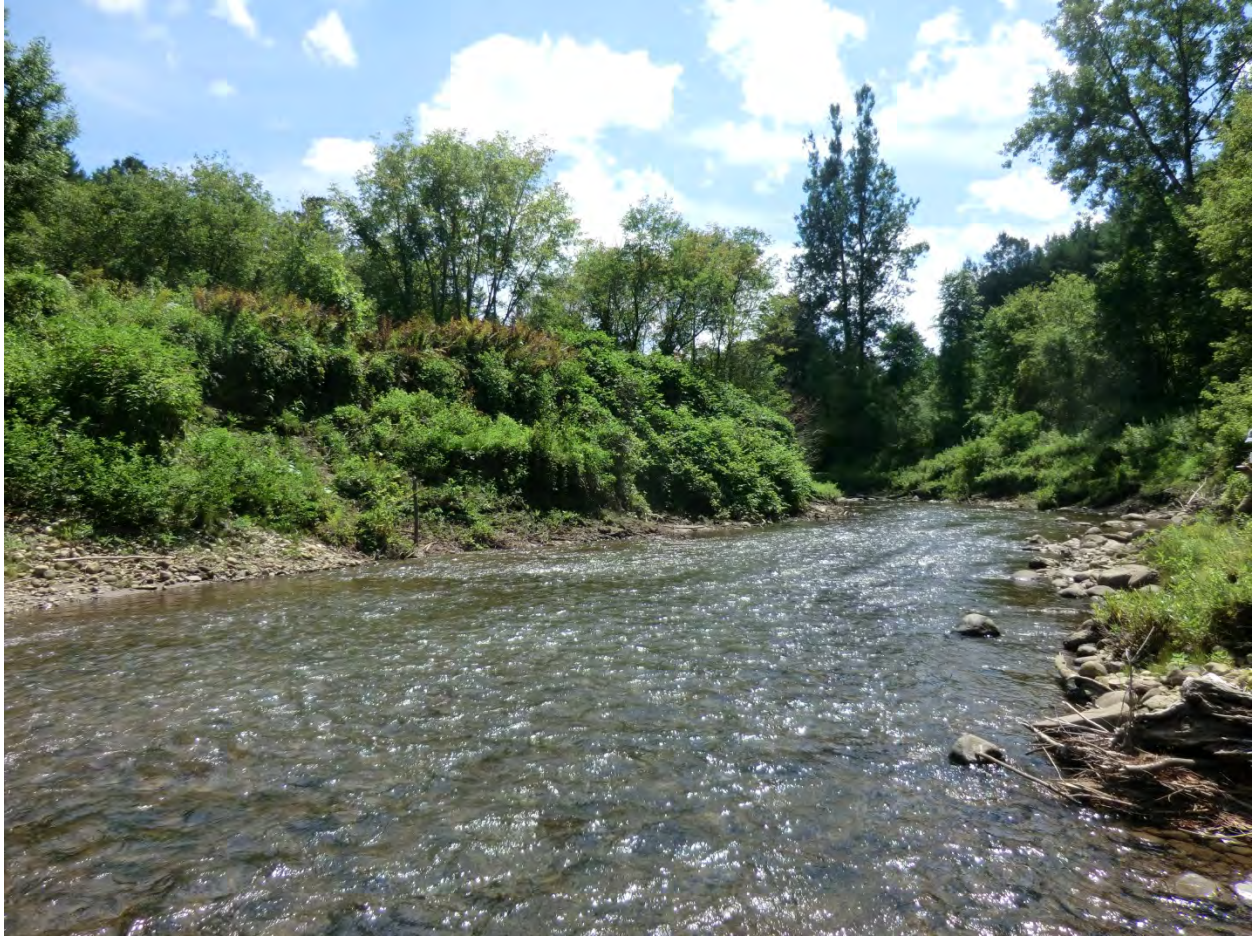
This segment begins at the confluence with the West Branch of the Ompompanoosuc River and continues about 1,200 feet upstream through an area with numerous bedrock grade controls. In the short areas that did not have bedrock grade controls, the banks were extremely high and eroded. Figures 5.12 and 5.13 show typical views of the channel in R08-A. This segment was not fully assessed as a result of the significant amount of grade controls. Administrative judgment was used to determine reference and existing stream type, bed material, and bedform.

Figure 5.13. High banks in short sections of R08-A.

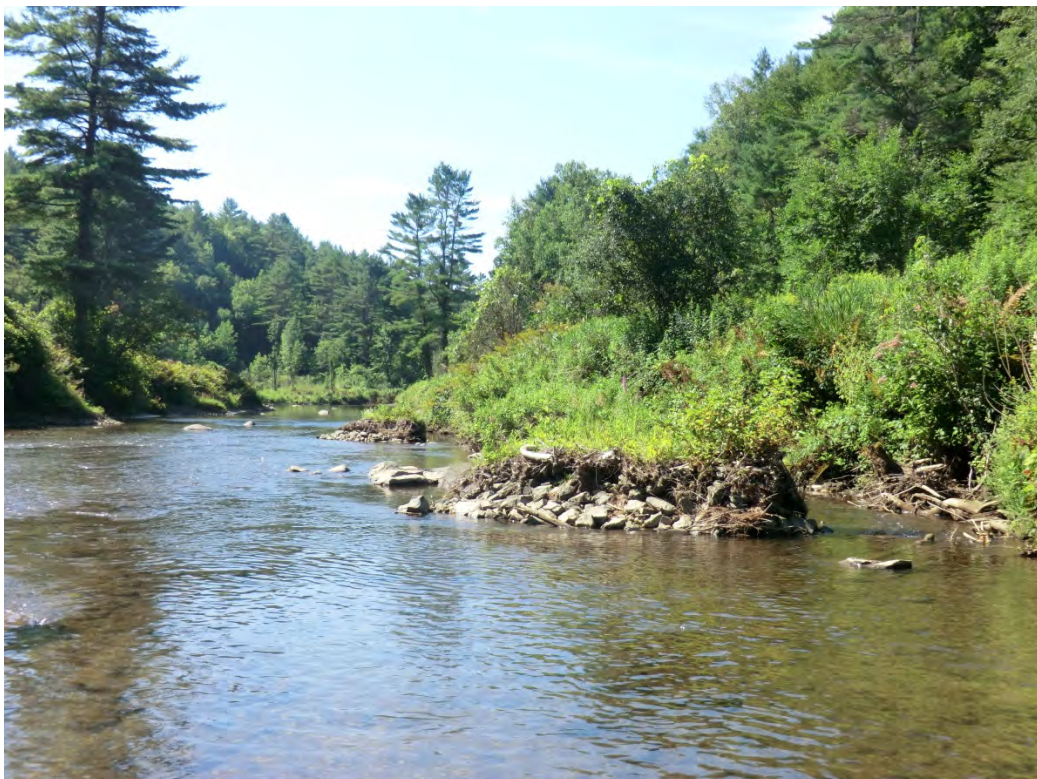
Segment R08-B begins at the upstream end of the largest bedrock grade control in R08-A and continues 2,400 feet upstream until the valley narrows. This segment has likely been historically straightened as evident by several old gabions found in the channel. Gabions are wire cages filled with rocks that are often used along rivers as an erosion control measure. In many places the river has outflanked the gabions and they are no longer serving their original purpose (See Figures 5.14 and 5.15).

Figure 5.15. In some areas the river has outflanked the gabions and the channel flows on either side of them.

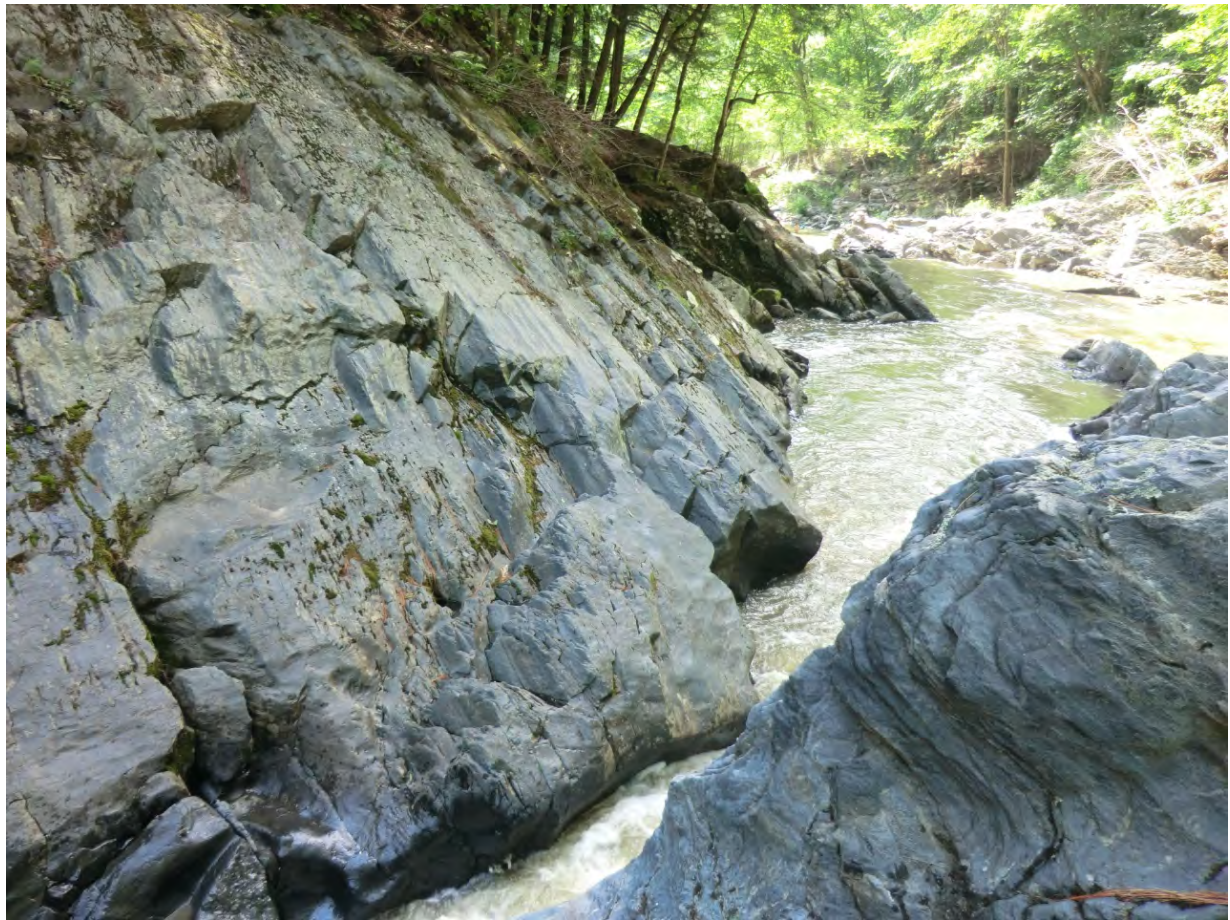
Figure 5.17. A portion of the upstream end of the large bedrock grade control in R08-D.

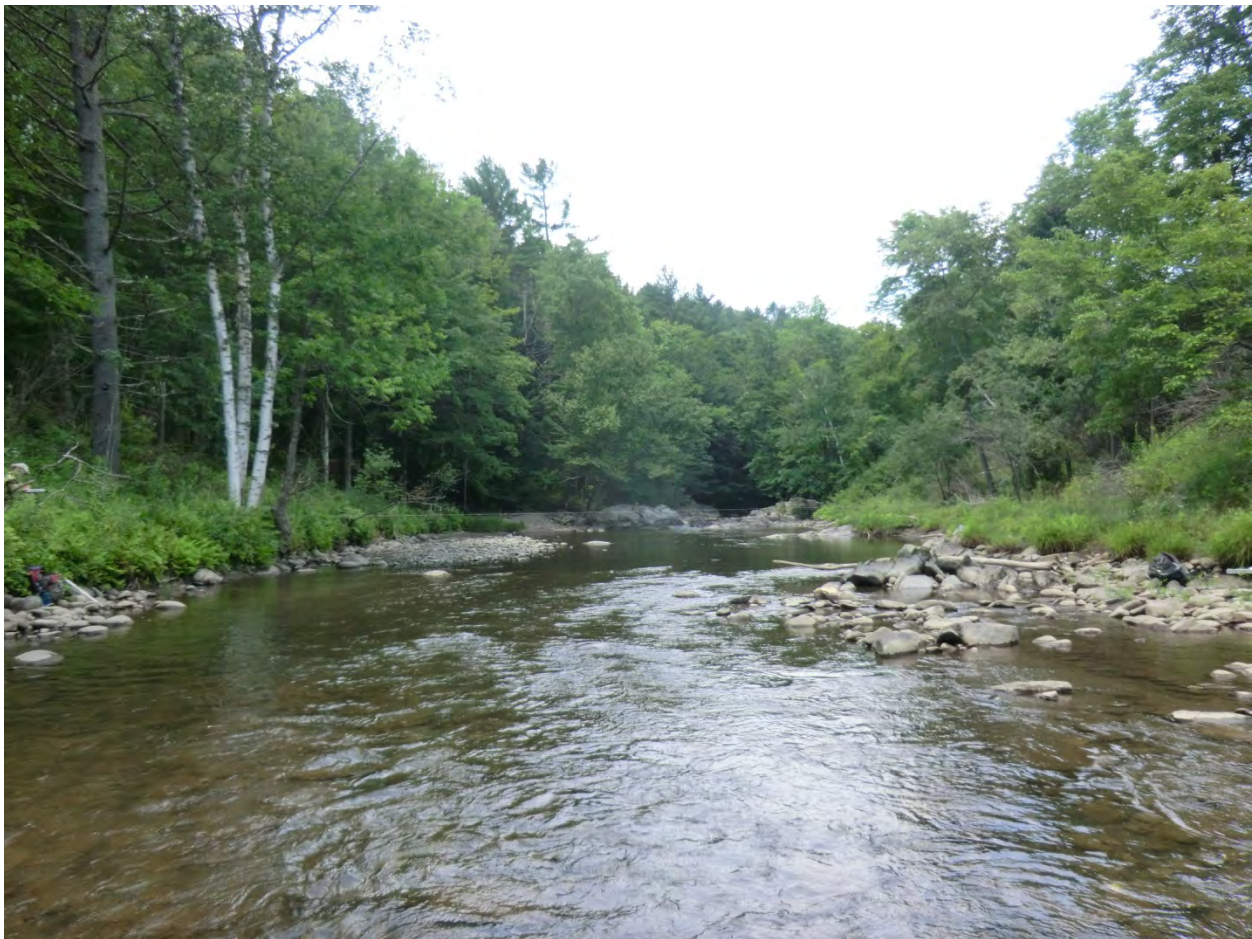
Figure 5.20. Typical channel in R10-A.

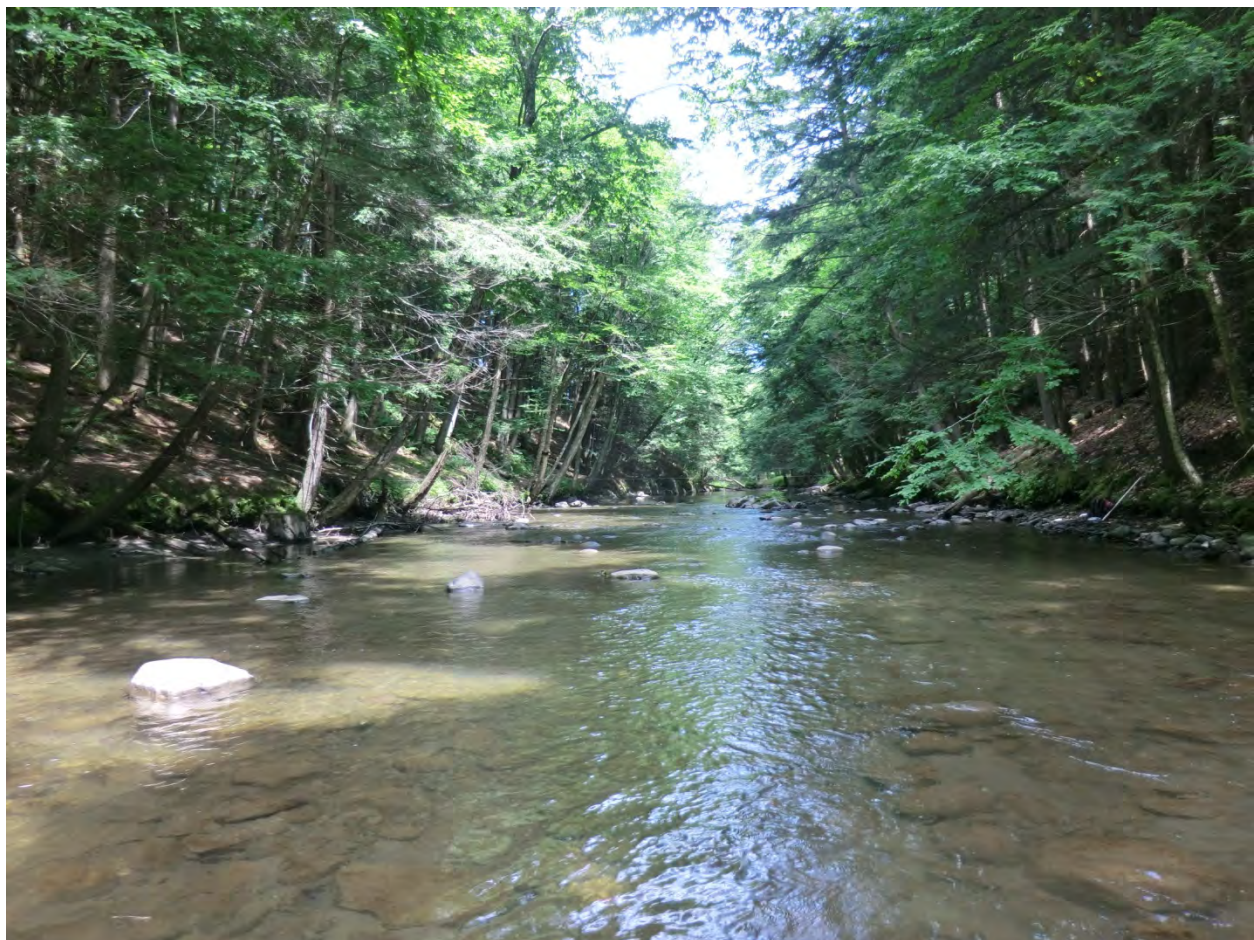
Figure 5.21. Typical channel in R10-B has a Semi-confined valley with excellent bank and buffer vegetation. Segment R10-B is in **good** geomorphic condition with minor aggradation, widening, and planform adjustment occurring here. This segment is in **good** habitat condition as well. The

excellent bank and buffer vegetation and wide buffer widths are contributing to this as well as good canopy cover and the presence of several aquatic organism refuge areas.

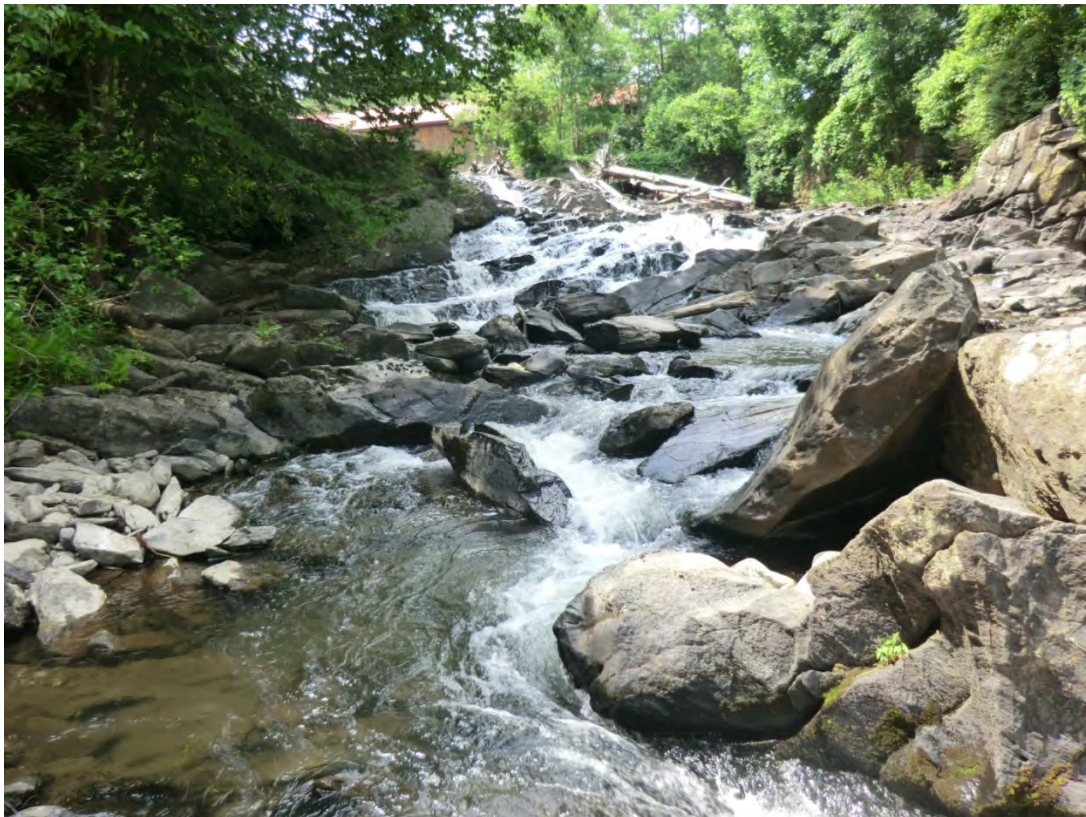
Figure 5.22. Looking upstream at a section of grade controls in R10-C.

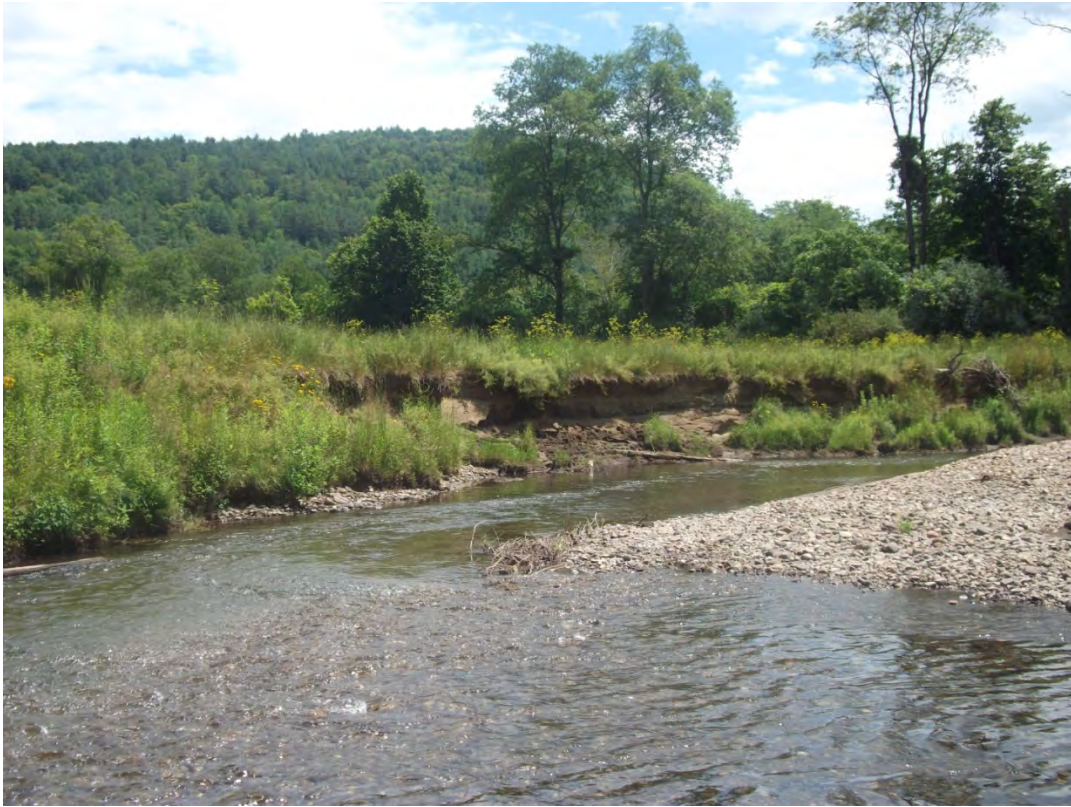
Figure 5.25. Erosion on outside of bend and aggradation on inside of bend in R11-B.

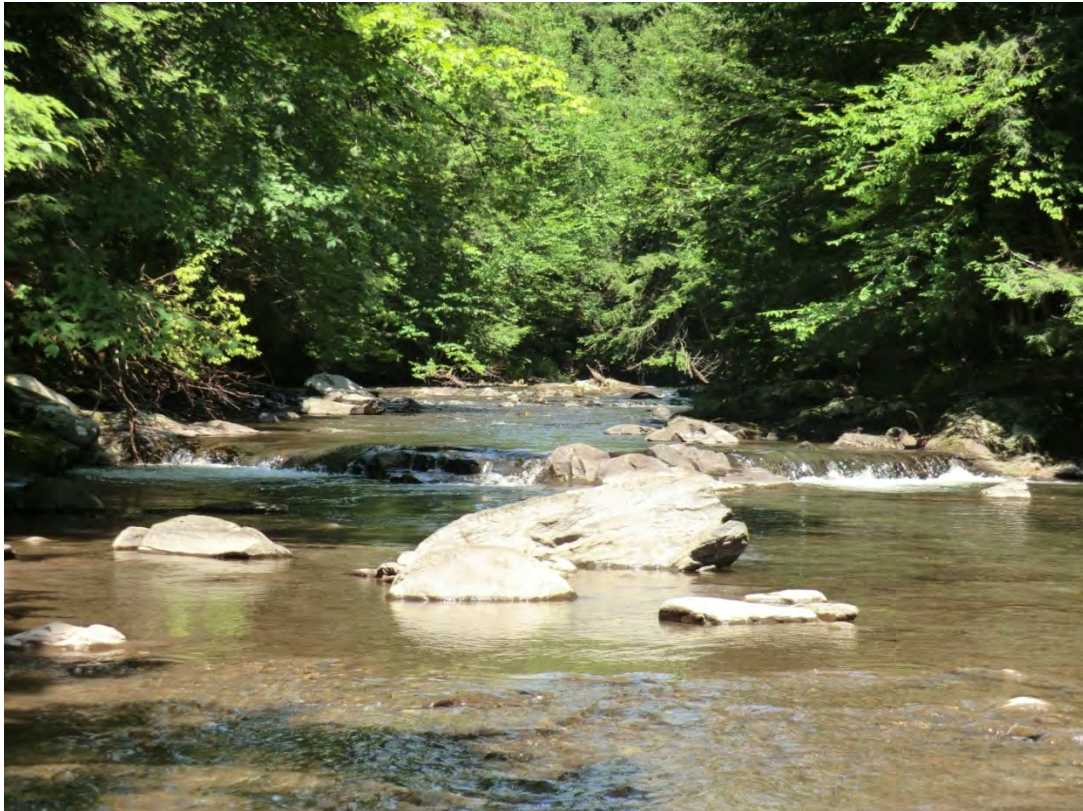
Figure 5.30. Grade controls are abundant in R12-A.

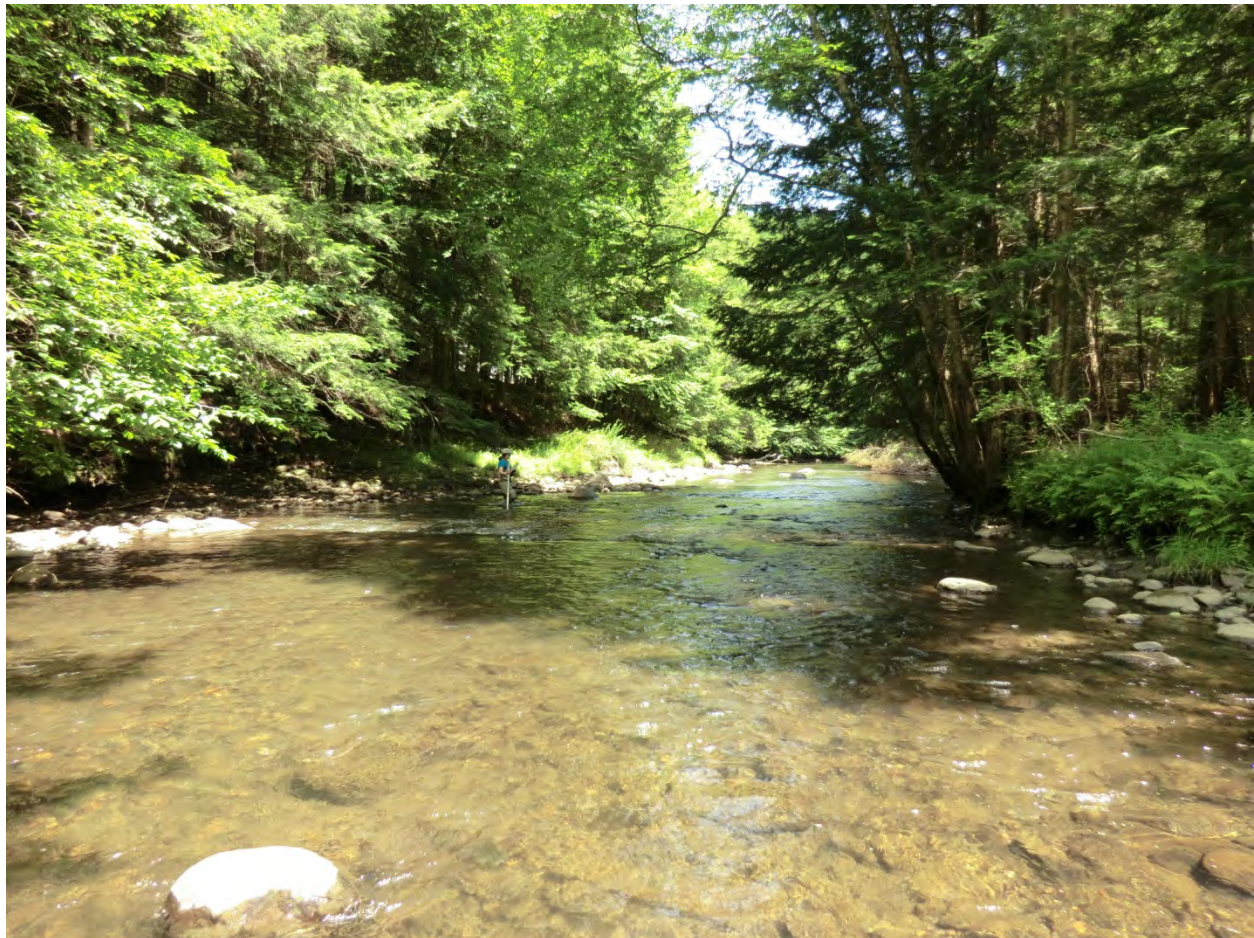
Figure 5.32. R13 is a generally stable reach with minor aggradation occurring and excellent bank vegetation.

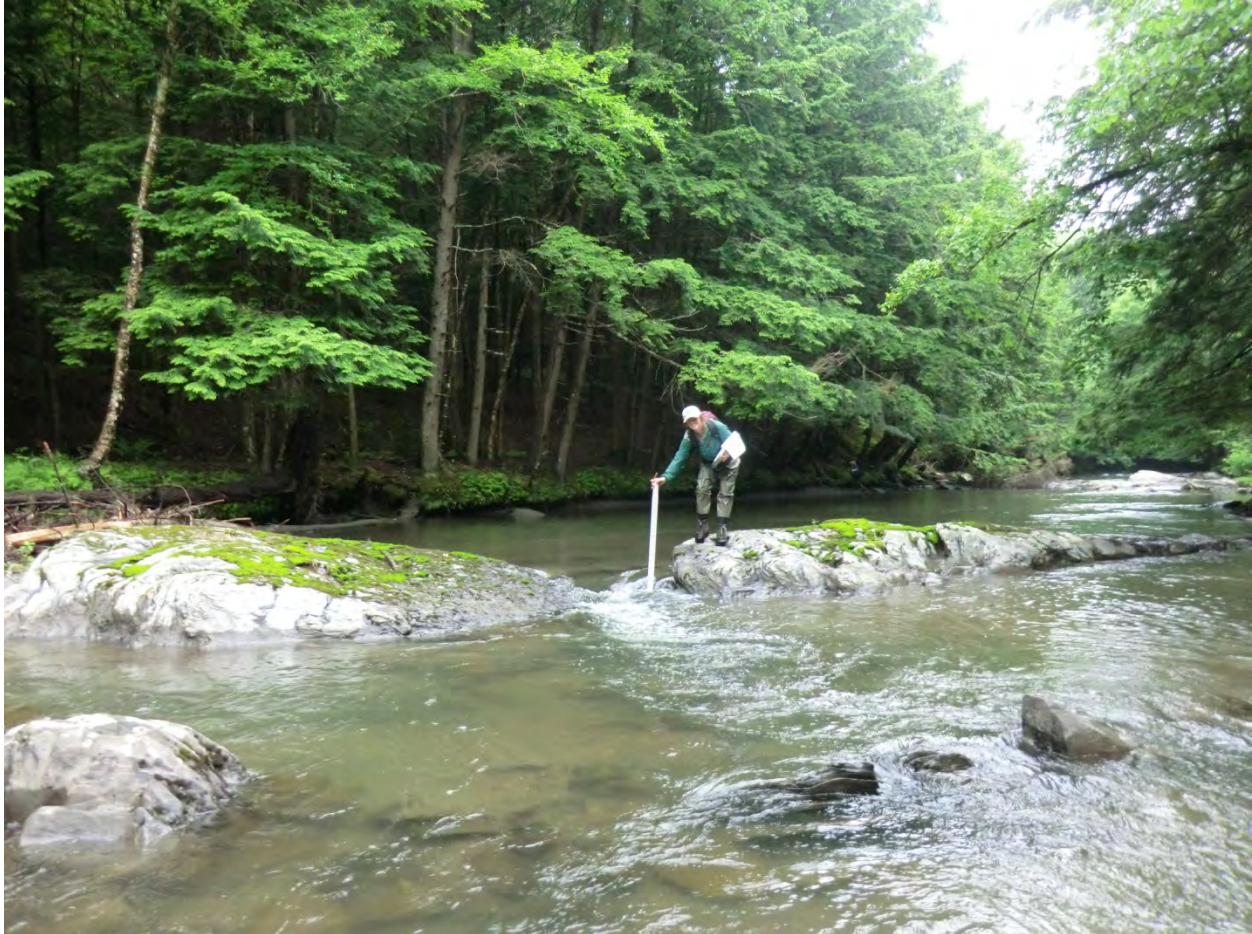
Figure 5.33. Bedrock grade controls in R14-A help to keep this segment in a stable geomorphic condition.

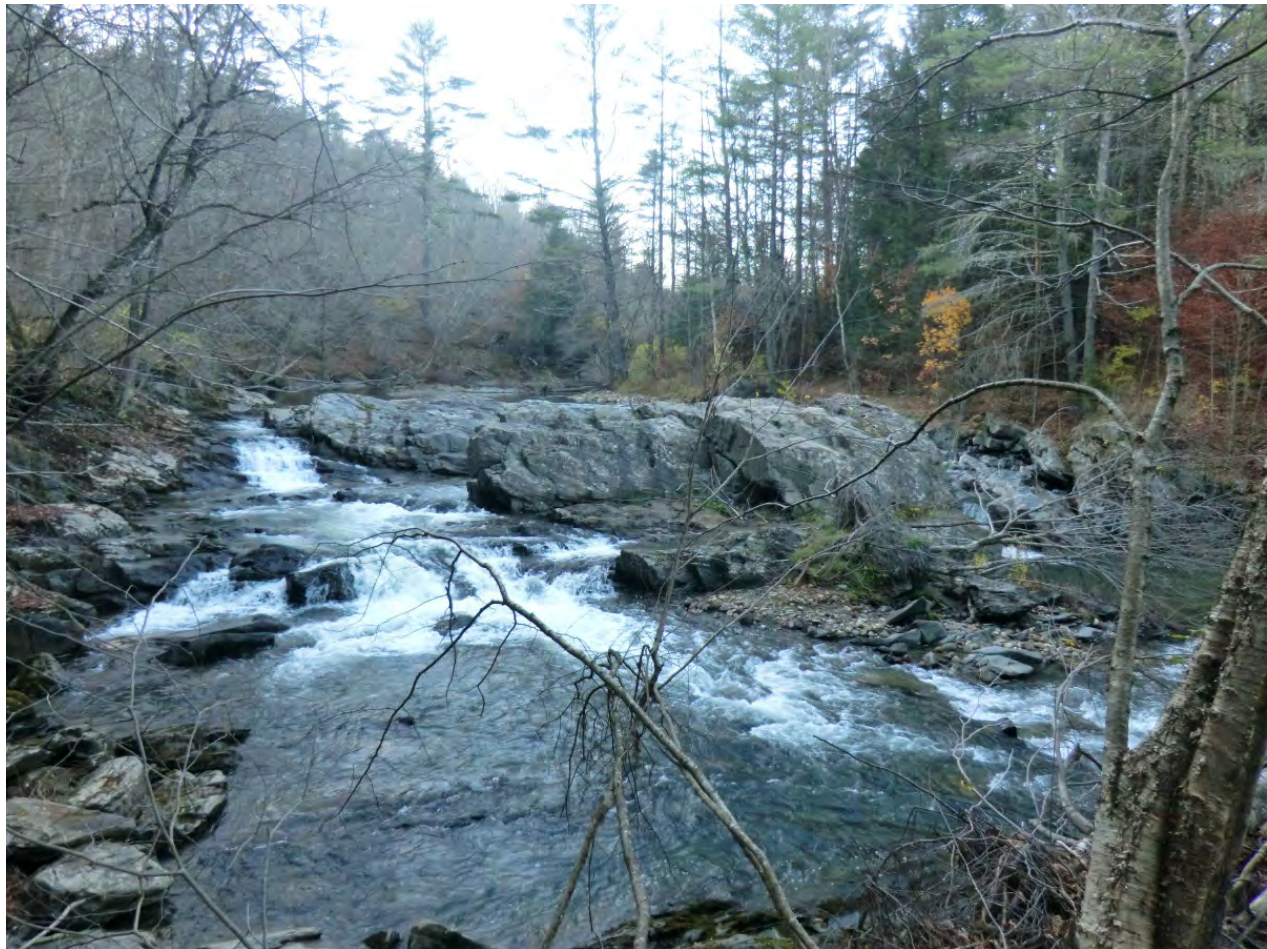
Figure 5.37. Downstream end of M01-B is a large bedrock grade control.

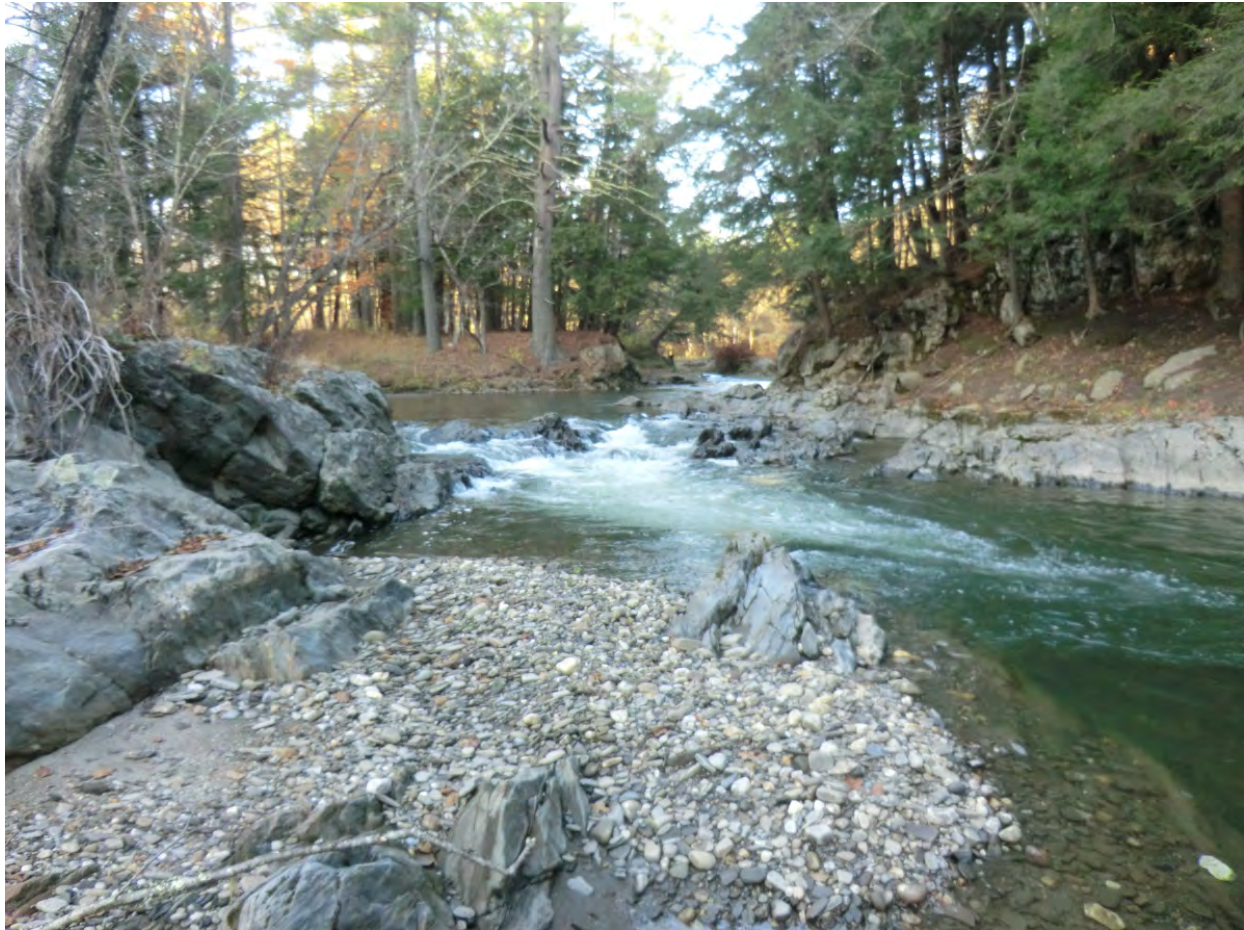
Figure 5.38. Upstream end of segment M01-B.

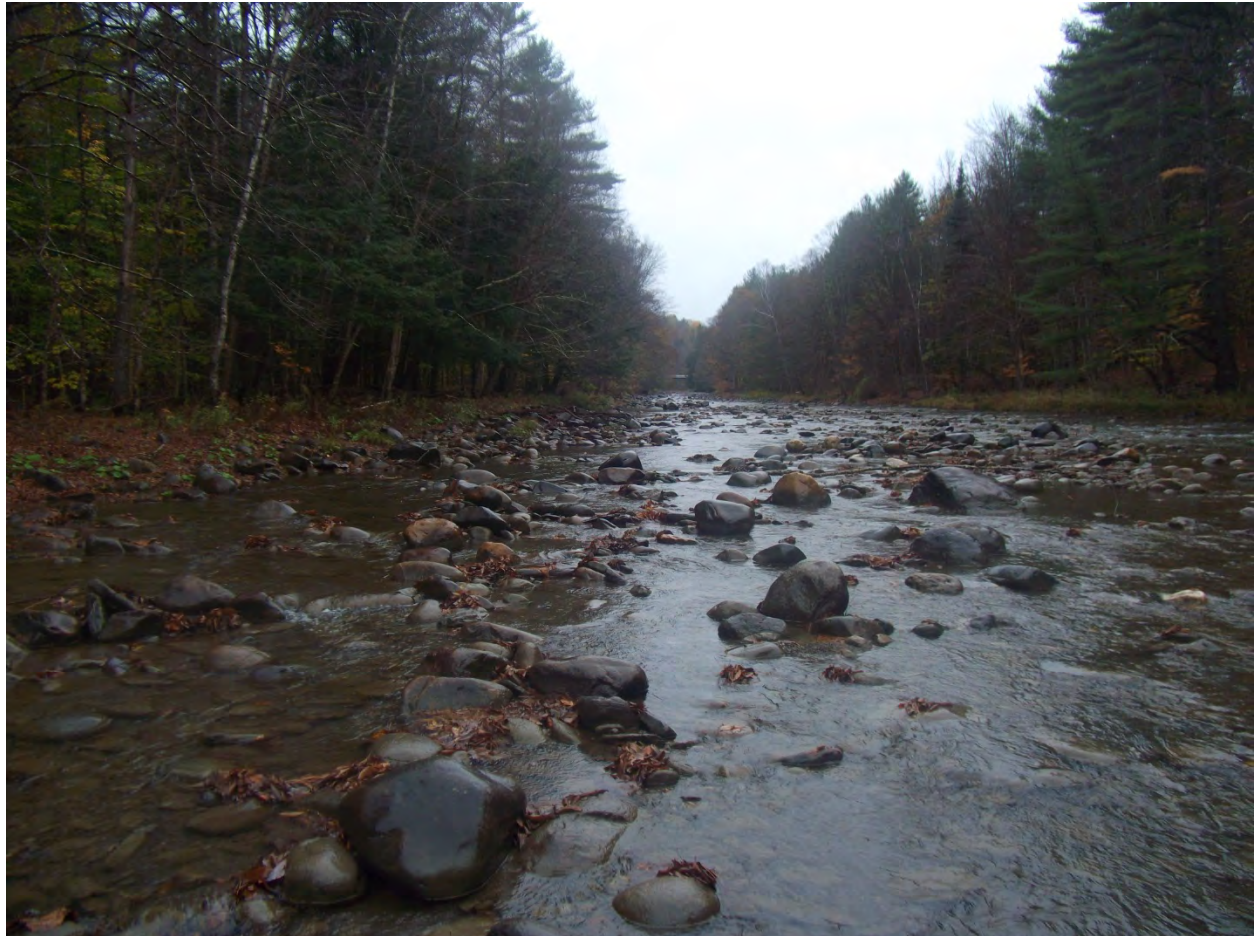
Figure 5.44. Excellent floodplain access in M01-H.

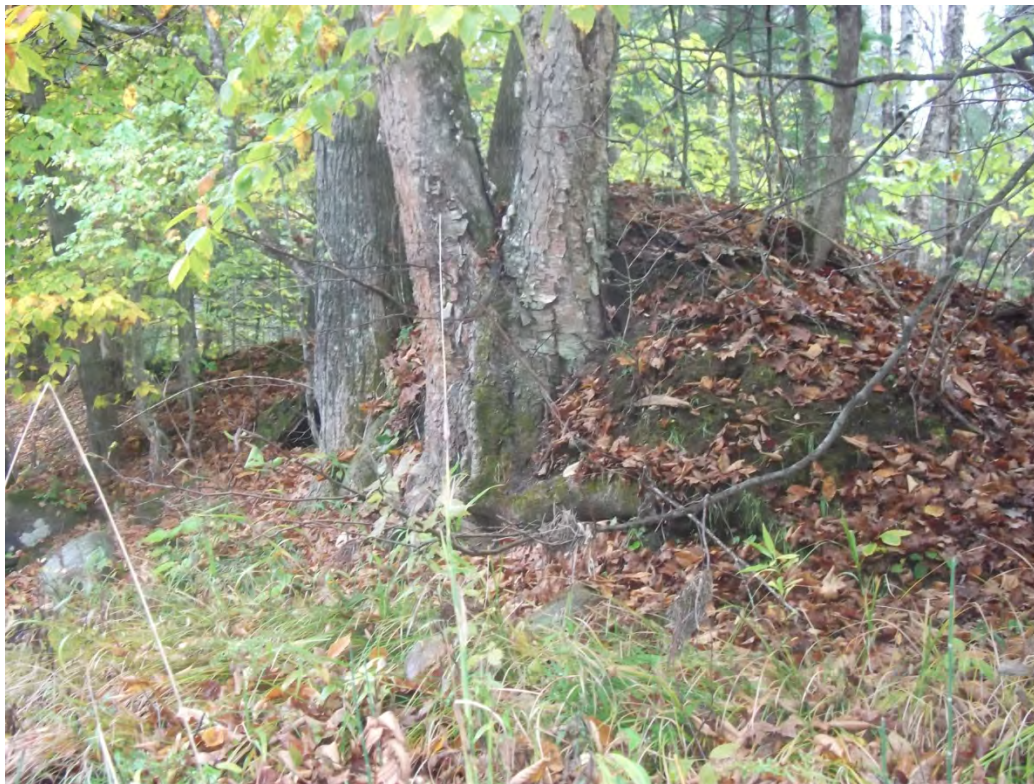
Segment M01-I is in **fair** geomorphic condition. Extreme **historic incision** as a result of channel straightening has led to a stream type departure from the reference C stream type to the existing F stream type. The influence from the berm (See Figure 5.46) is also contributing to the departure. **Widening** is a major process, while aggradation and planform adjustment are minor

Figure 5.46. Material has been pushed up near the northern bank to create a berm.

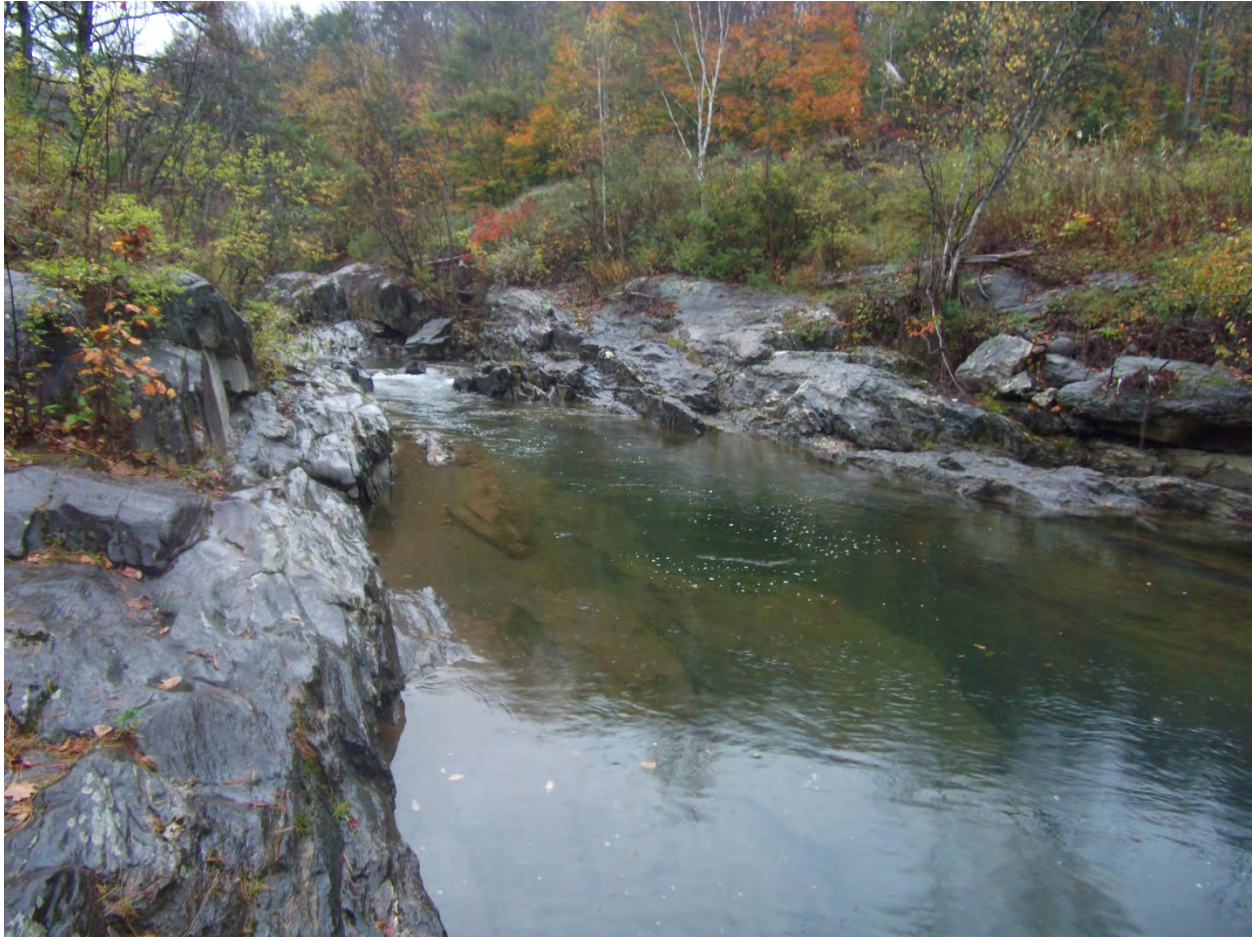
Figure 5.47. Bedrock grade control at the upper end of segment M01-J.

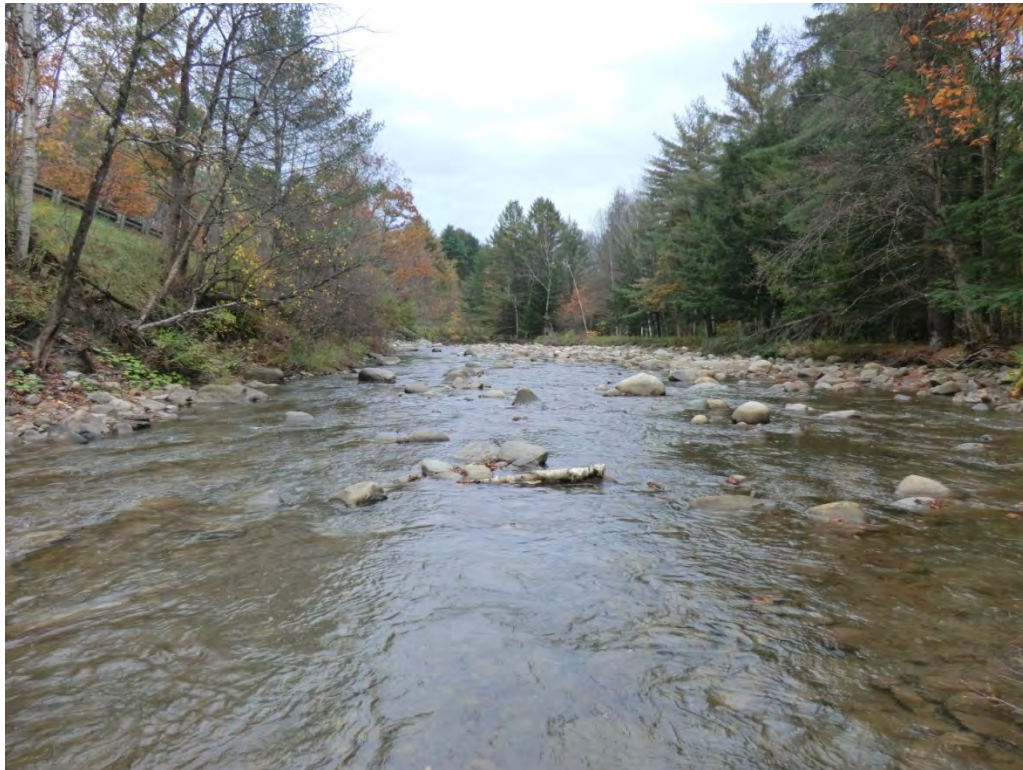
Figure 5.48. Route 132 (left) runs along the channel in M02 to the north, sometimes very close to the channel. The southern corridor (right) generally has good floodplain access and good buffer widths.

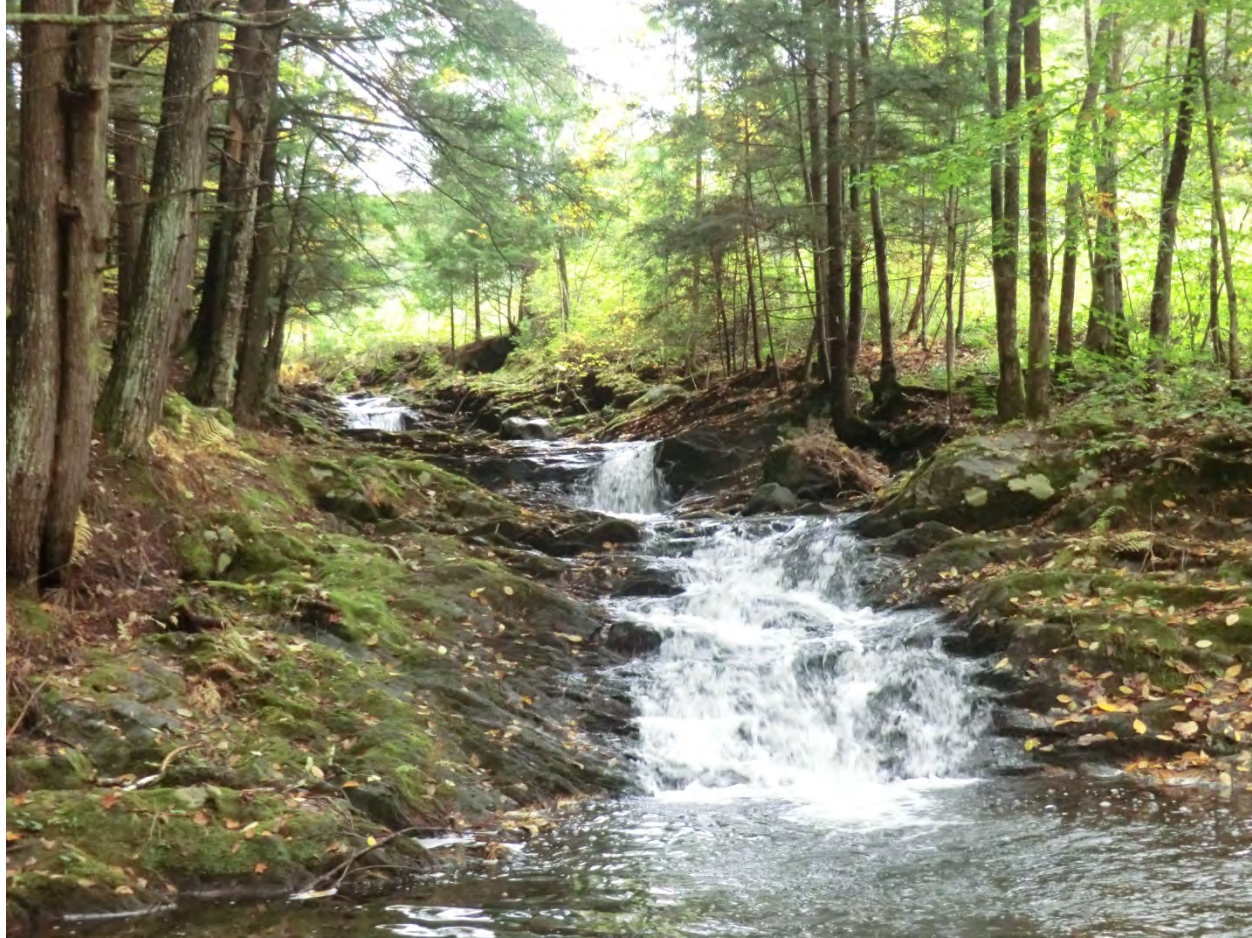
Figure 5.51. A large bedrock grade control dominates segment R06.S1.02-A.

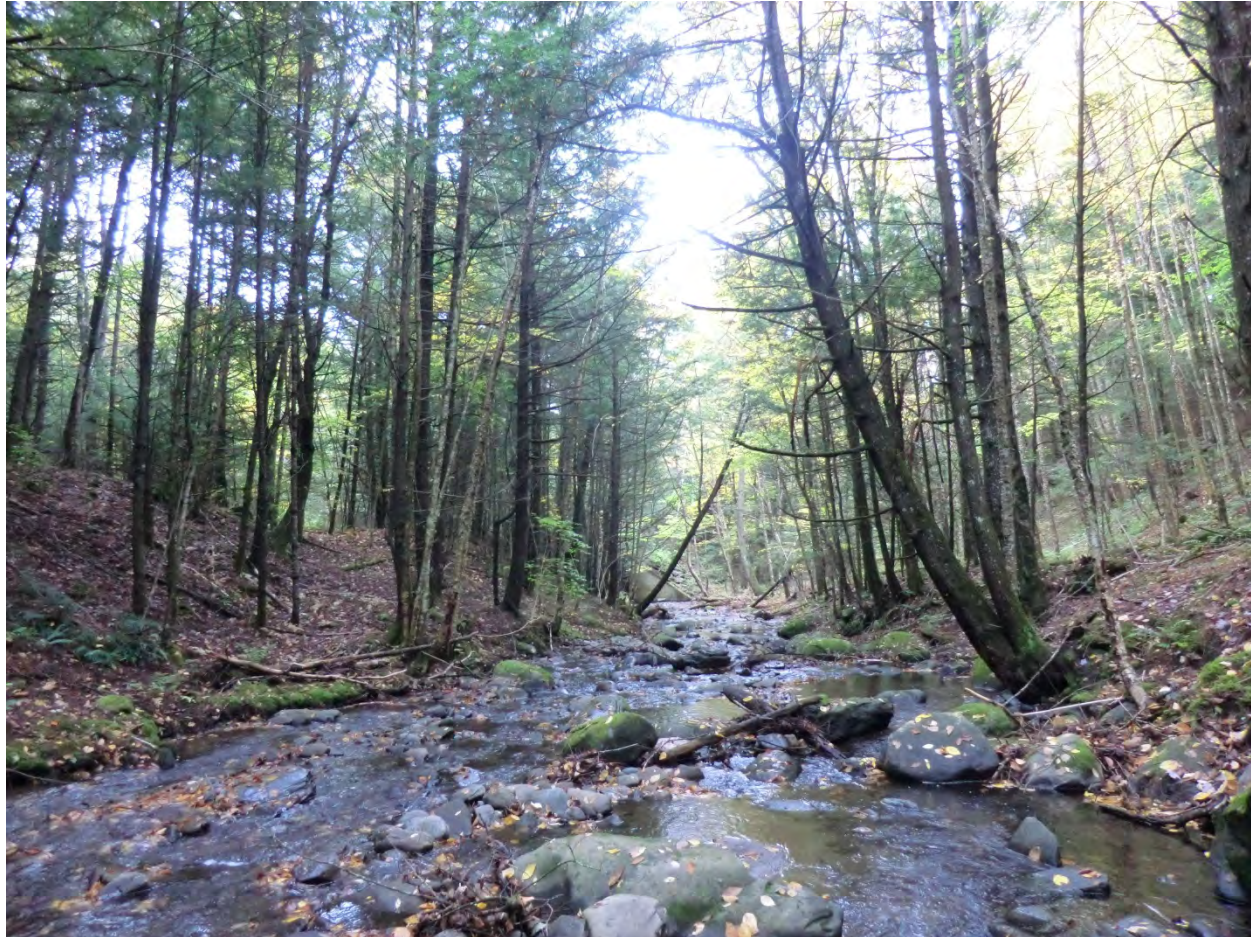
Segment B begins at the upstream end of the large grade control and continues about 1,000 feet upstream, ending about 400 feet upstream of a long box culvert that runs under Route 132. The channel is a “B” channel in a semi-confined valley and is stable. The segment is in **good** geomorphic condition with minor aggradation, widening, and planform adjustment in localized places. Several bedrock grade controls are limiting vertical adjustment in the majority of the segment. Overall, R06.S1.02-B is in **good** habitat condition because of an abundance of large woody debris in the channel as well as excellent vegetated stream banks and buffers. The major stressor to the segment is the 200-foot long box culvert located mid-segment. The

culvert is undersized, causing a channel constriction, and is impeding all aquatic organism passage based on the Milone & MacBroom AOP Screening Tool (2009) (See Section 5.5 for more information). Figure 5.52 shows a typical channel in R06.S1.02-B.

Figure 5.52. Stable segment R06.S1.02-B is located in a semi-confined valley and is geomorphically stable.
