Ompompanoosuc River Corridor Plan

Thetford to Norwich, Vermont

January 10, 2014

Bear Creek Environmental, LLC
149 State Street, Suite 3
Montpelier, Vermont 05602

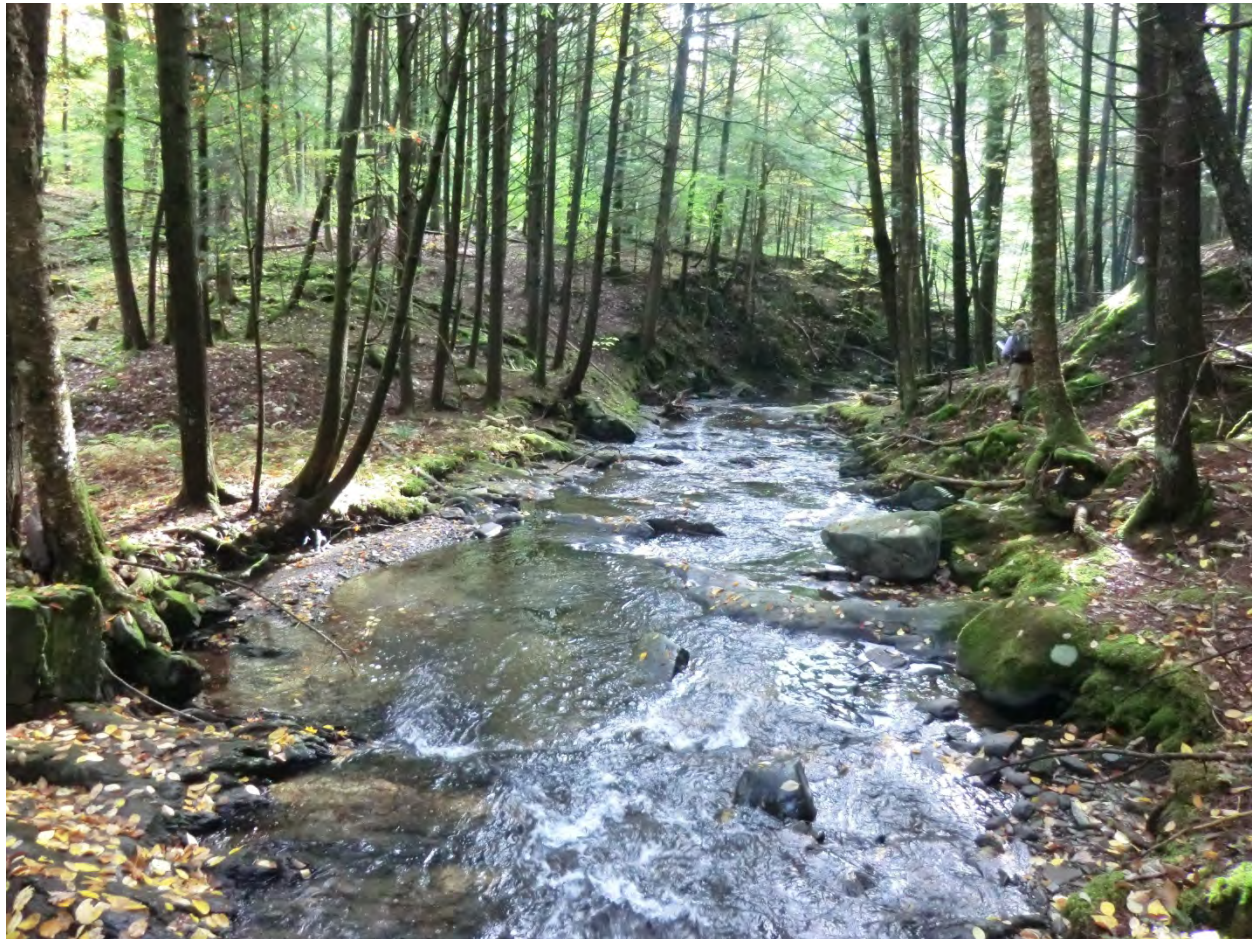
The most upstream segment assessed on Avery Brook is set in a semi-confined valley that is slightly narrower than the downstream segment. The 900-foot long segment has a reference stream type of F. The stable segment is in **good** geomorphic condition with minor aggradation and planform adjustment in localized areas. Multiple bedrock grade controls throughout the

segment are limiting vertical adjustment and contributing to the stability (Figure 5.53). R06.S1.02-C is in **good** habitat condition because of excellent vegetated stream banks and buffers as well as a variety of deep pools that are good for aquatic habitat.

Figure 5.53. Bedrock grade controls in R06.S1.02-C contribute to vertical stability.

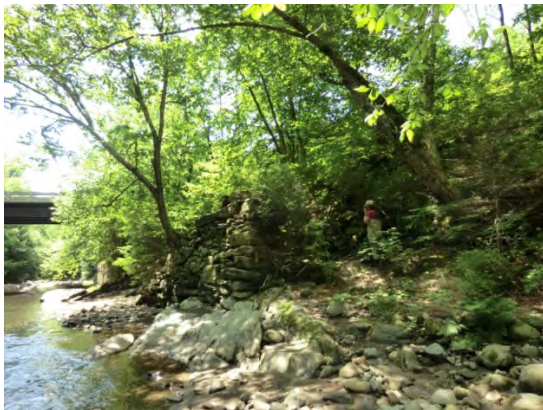
Project #5 – Remove Old Abutment, R12-A

Project # Segment	Type of Project	Site Description Including Stressors and Constraints	Project or Strategy Description	Technical Feasibility and Priority	Other Social Benefits	Potential Partners/Programs
Project #5 R12-A	Active Restoration	An old bridge abutment just upstream of the Sawnee Bean Road bridge is causing localized geomorphic instability. Access may be difficult – steep terrain.	Alternatives Analysis for the removal of the old abutment	Low Priority	Improved habitat, water quality, and geomorphic stability	Landowner, TCC, VANR, Town of Thetford ERP
Project #6 R12-A	Stormwater Management	Several stormwater inputs were identified along Sawnee Bean Road	Evaluate Stormwater Management	Low Priority	Improved water quality	Landowner, TCC, VANR, Town of Thetford ERP
Project #7 R12-A & R12-B	Passive Restoration	Valley wall close on east, western corridor has good floodplain access. Two tributaries enter main stem on this property.	Protect River Corridor through Easement , potential to extend easement to include tributaries	High Priority	Improved habitat and water quality	Landowners, TCC, VANR, Town of Thetford RCE

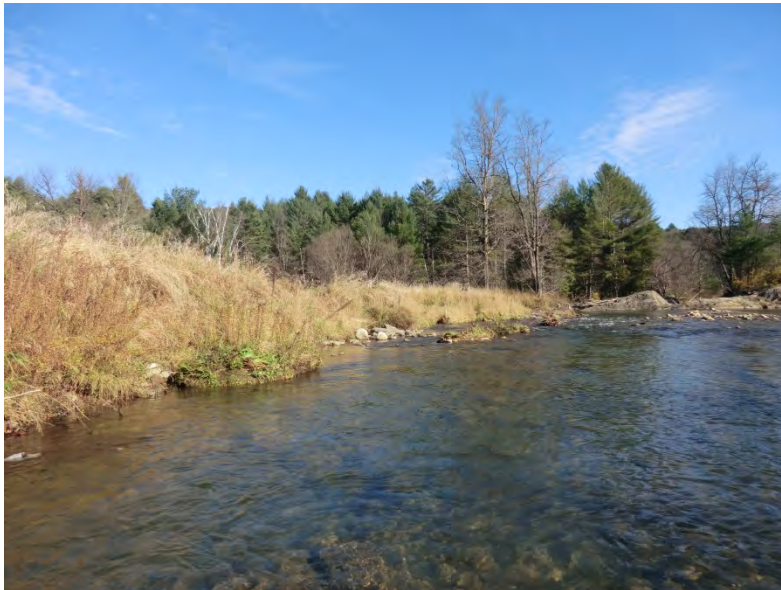
Project #1 – Streamside Plantings, M01-F

Project # Segment	Type of Project	Site Description Including Stressors and Constraints	Project or Strategy Description	Technical Feasibility and Priority	Other Social Benefits	Potential Partners/Programs
Project #1 M01-F	Passive Restoration	Area along northern bank has inadequate buffer. Bobolinks nest in the tall grass of the field adjacent to the river.	Buffer Improvement: Establish “no mow” zone and let buffer naturally reestablish	High Priority; ACOE has increased buffer width to about 20 feet on east side of channel south of bridge during 2013	Improved habitat and water quality	Landowner, TCC, VANR, Town of Thetford TFS, CRWC

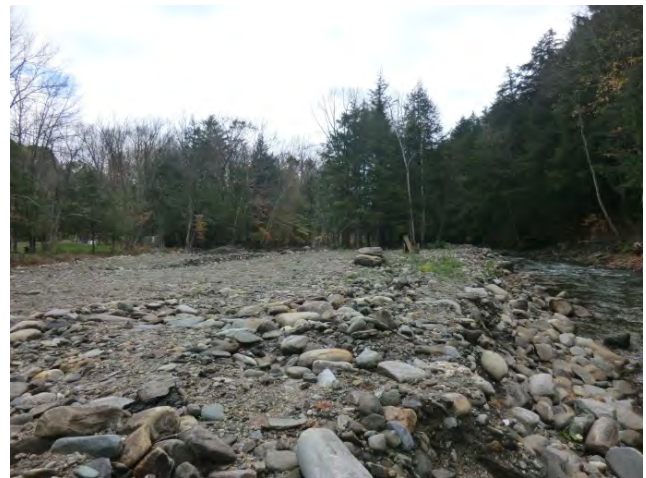
Project #3 – Restore Natural Channel, M02

Project #3 M02	Active Restoration	Material in channel was moved post TSI. Neighbor states flow was altered around an island.	Alternatives Analysis to determine if active restoration project is needed	Moderate Priority	Improved geomorphic stability	Landowner, TCC, VANR, Town of Thetford ERP
