Ottauquechee River Watershed Stream Geomorphic Assessment Bridgewater and Woodstock, Vermont January 29, 2013

Prepared by:
Bear Creek Environmental, LLC
297 East Bear Swamp Road
Middlesex, Vermont 05602

Prepared under contract to:
Two Rivers-Ottauquechee Regional Commission
128 King Farm Road
Woodstock, VT 05901

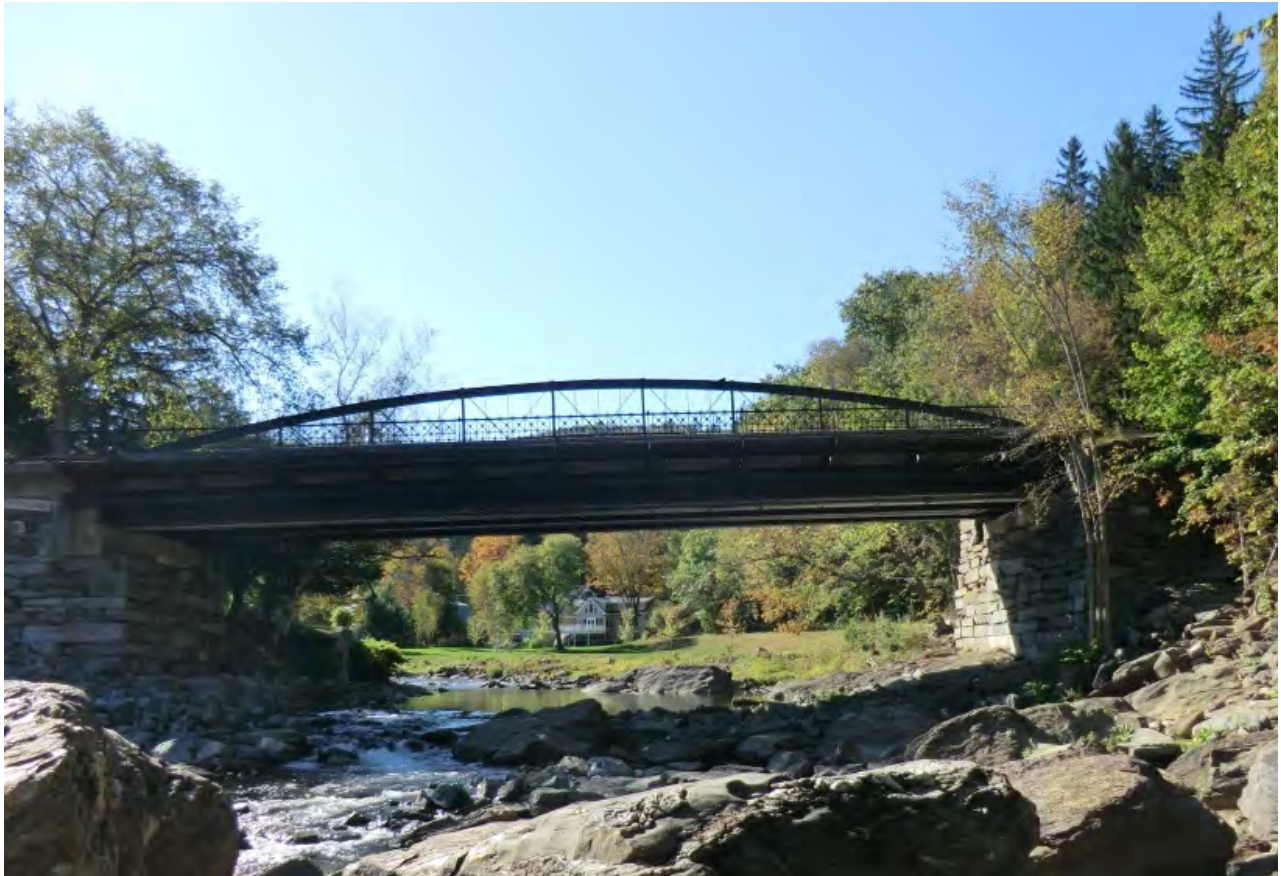
This reach was split into three segments to account for floodplain accessibility and stream type changes. This reach is located in an urban area (See Figure 5.7).

Figure 5.7. Human impacts are common in the vicinity of the Elm Street Bridge.

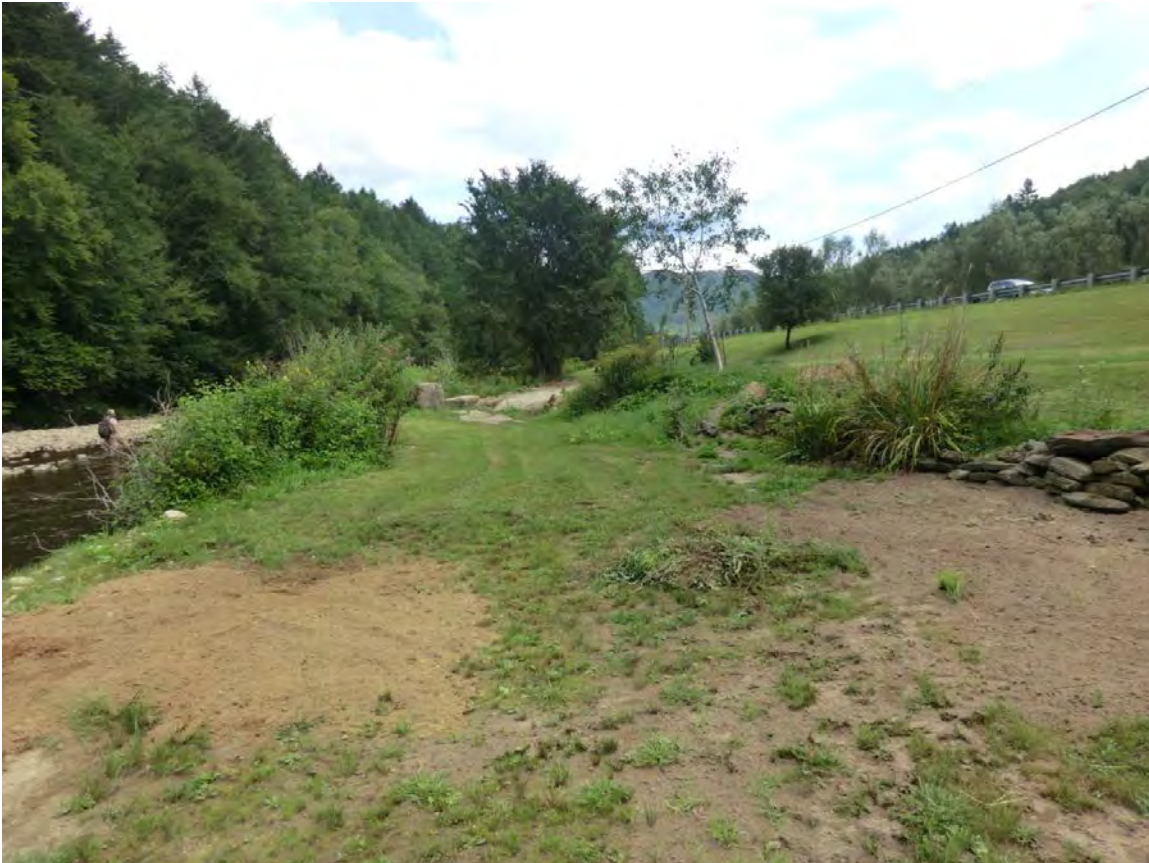
Figure 5.32. Floodplain access is not completely limited by Route 4 in M25-C. Sparse buffer on western bank.

- **Stream Clean-Up** by removing propane tank from channel in M25-A. (Map 5: Project #2)
- **Passive Restoration** by planting trees within the riparian corridor in areas where buffers are less than 25 feet wide. (Map 5: Project #3)

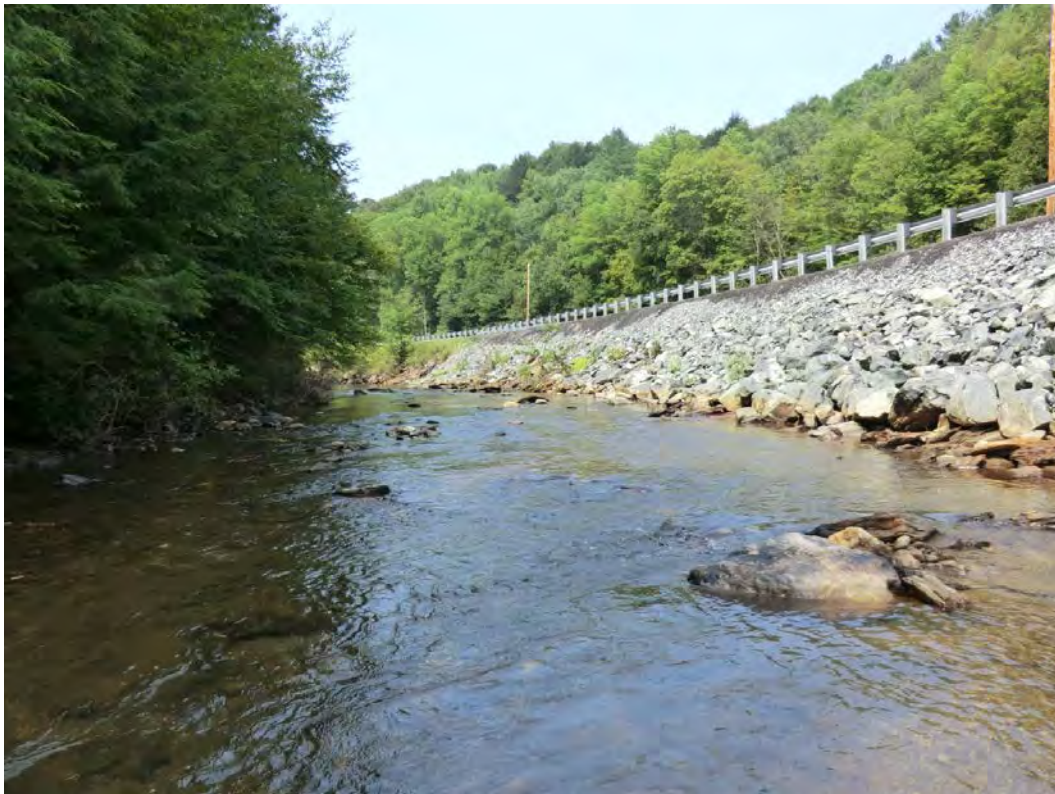
These segments are located where Route 4 runs directly adjacent to the Ottauquechee River. Figure 5.37, the cross section from M27-C, shows that Route 4 significantly cuts off the valley, changing from unconfined to confined, and limits floodplain access resulting in stream type departures. M27-A and M27-E are both in **fair** geomorphic condition and M27-C is in **poor** geomorphic condition. In general, these segments are seeing minor to major **widening** and **planform adjustment**. M27-E has **historically incised**. Extensive channel straightening with bank armoring limits widening in some places. These segments are all in **fair** habitat condition because of a lack of adequate bank and buffer vegetation and extensive riprap and erosion. Figures 8.38 and 8.39 shows a typical channels for all three segments.

Figure 5.38. Typical channel for segments M27-A, M27-C, and M27-E. (Photo from M27-E.)

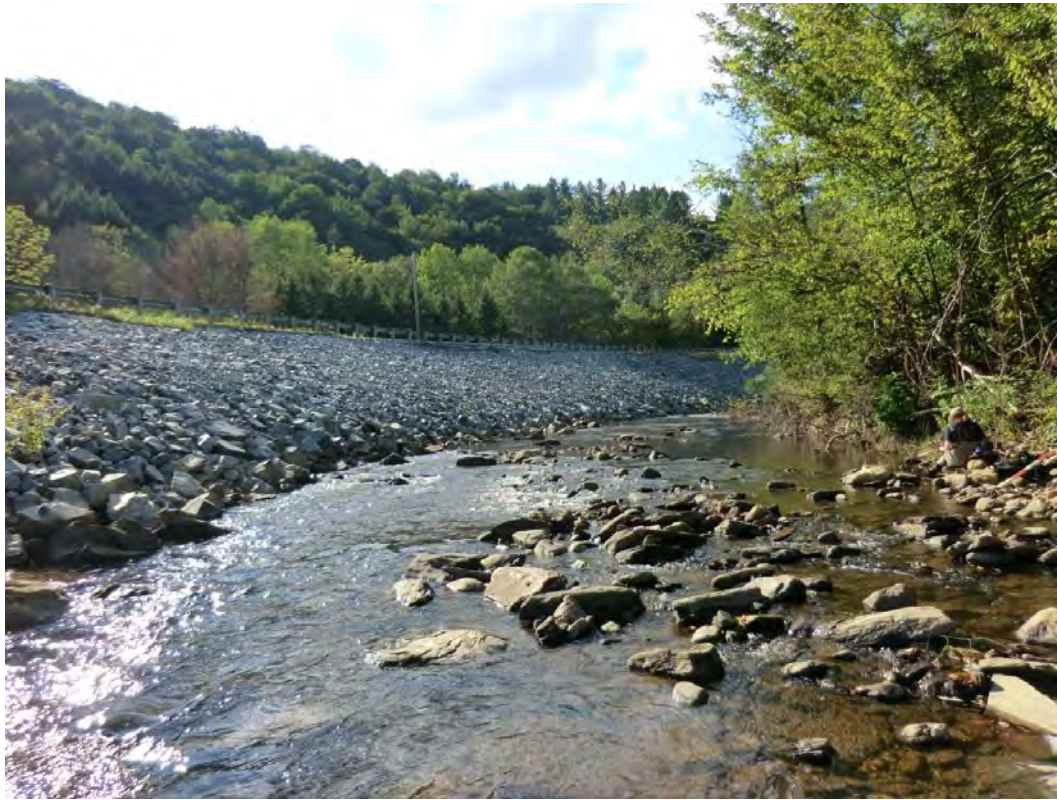
Figure 5.39. Typical channel for segments M27-A, M27-C, and M27-E. (Photo from M27-C.)

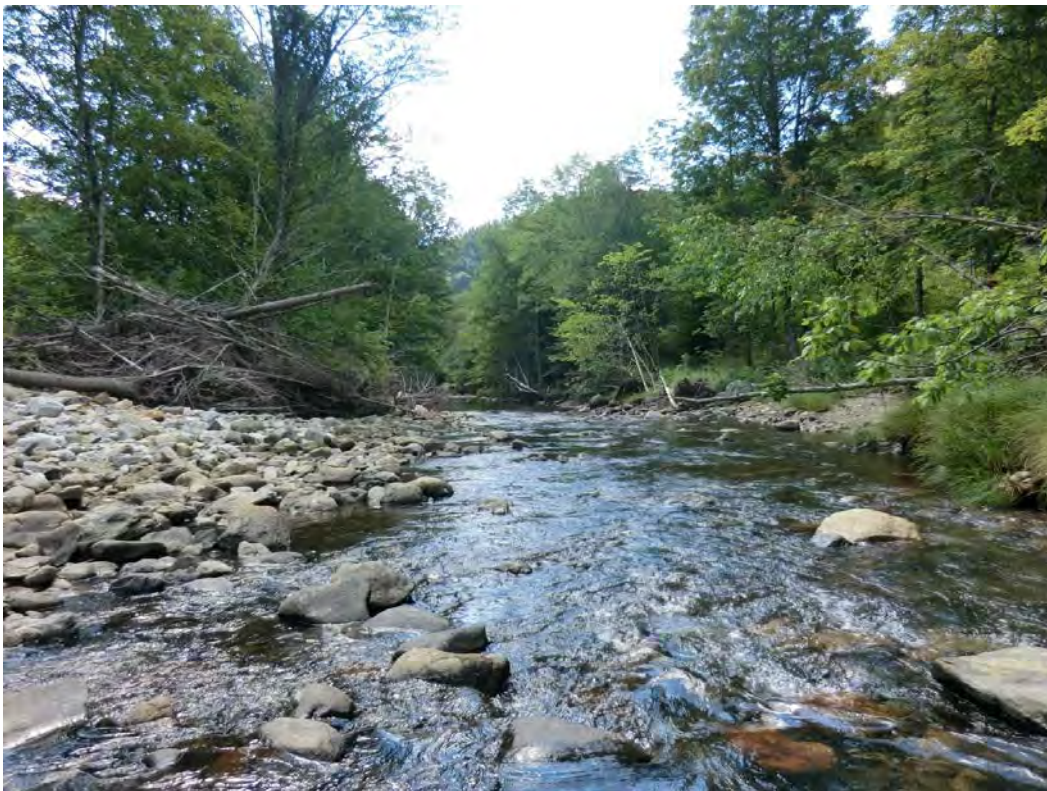
M27-B and M27-D are in **fair** habitat condition and M27-F is in **good** habitat condition. Each segment has adequate bank and buffer vegetation and deep pools. M27-F has more habitat refuge areas than the other two segments. Figure 5.41 shows good banks and buffers in M27-F.

Figure 5.41. Good buffers in M27-F. Major aggradation is seen in *side bars* on both banks.

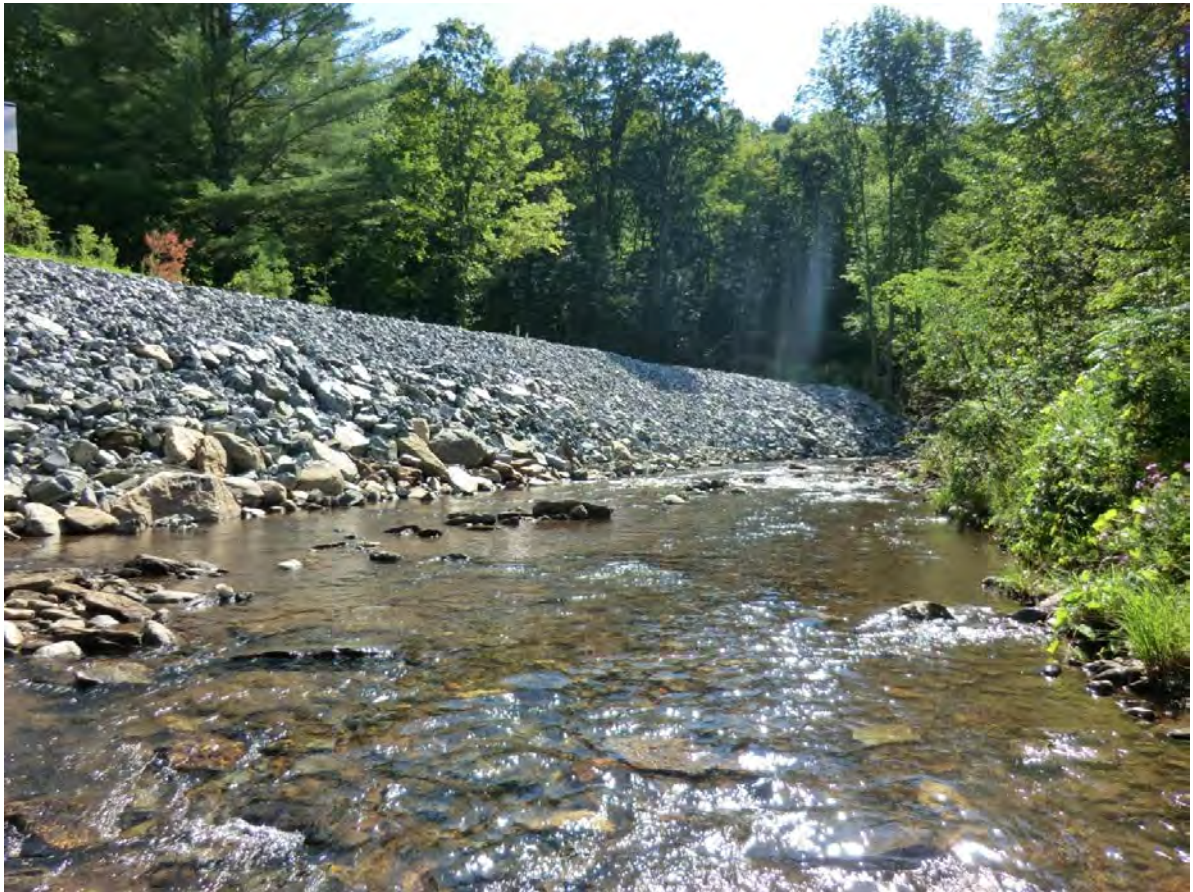
This segment begins just below the Route 4 crossing near where Standish Road intersects Route 4 and continues 2,600 feet upstream to where the river gains more floodplain access because it moves away from Route 4. This segment is in **fair** geomorphic condition. The placements of Route 4 and Standish Road have limited floodplain access, changed the confinement from unconfined to confined, and led to extreme **historic incision** (See Figure 5.42). This segment exhibits a stream type departure because of this. Abundant rip rap and channel straightening are limiting widening. **Aggradation** and **planform adjustment** are major. This segment is in **fair** habitat condition because of a lack of adequate northern bank and buffer vegetation, extensive erosion and riprap, and a low amount of large woody debris. Some areas exhibit a habitat departure from riffle-pool to plane bed. Figure 5.43 shows a rip rap near the Route 4 crossing and Figure 5.44 shows a stormwater input in M28-A.

Figure 5.43. Extensive riprap above Route 4 bridge crossing.

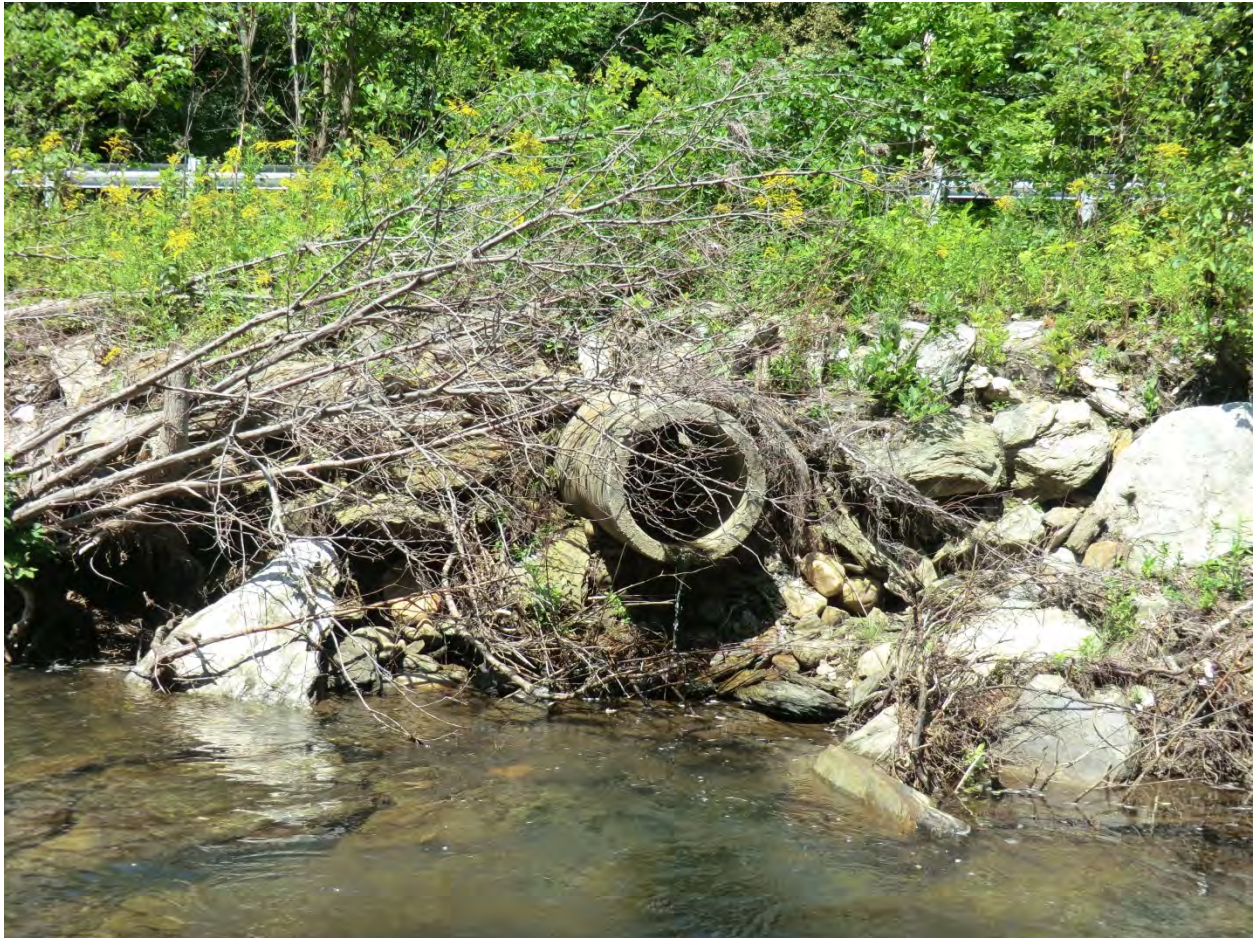
Figure 5.44. Storm water input along Route 4 in M28-A.

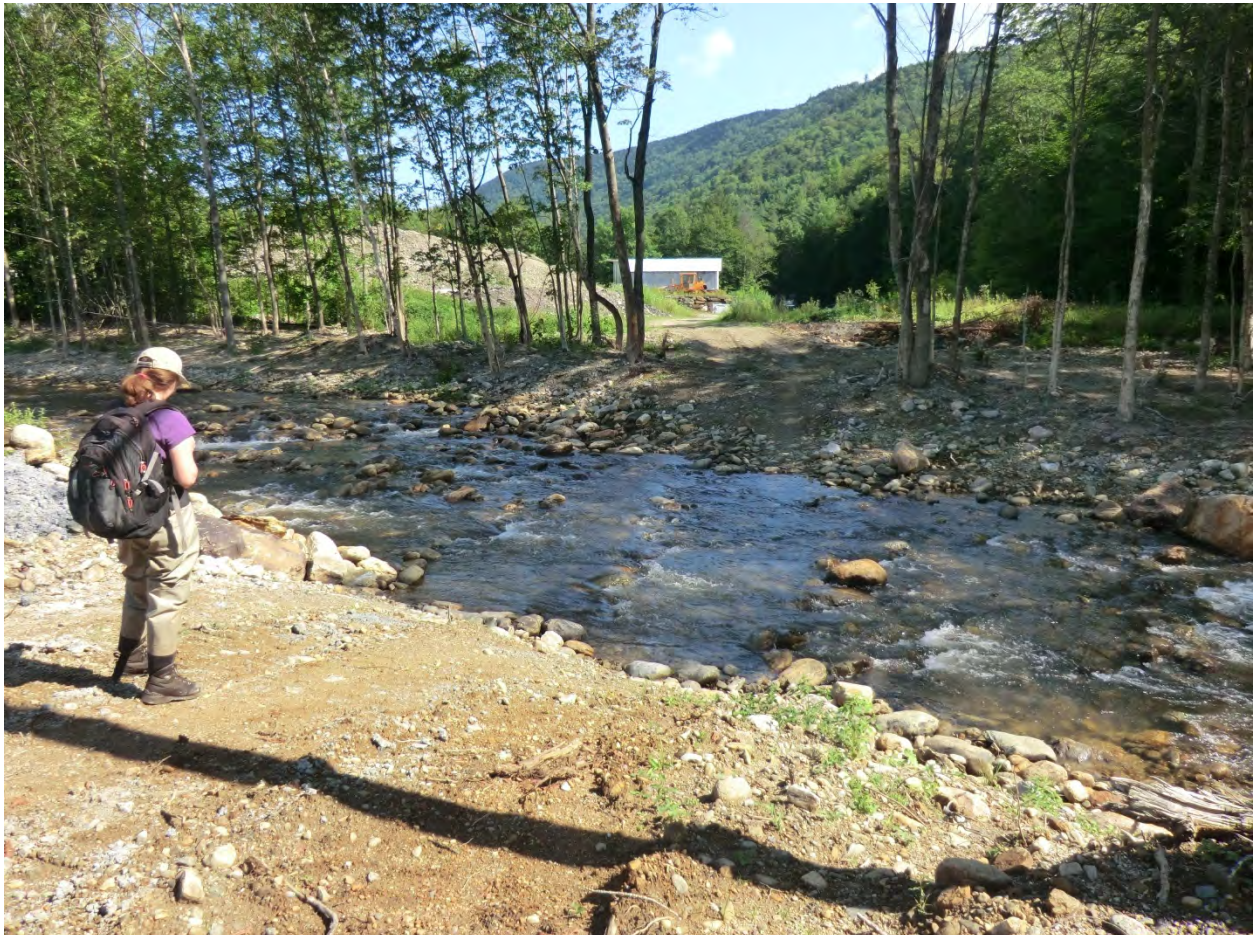
This reach begins at the confluence with Reservoir Brook in West Bridgewater and continues upstream 1,900 feet until the Route 4 bridge crossing near Hadley Hill Road. Route 4 has some effect on valley width, but does not change the confinement. This reach has been extensively straightened and altered. This reach is in **poor** geomorphic condition. Accurate channel data was not able to be determined because of significant flood damage and flood work alterations. Major **historic incision** has occurred here with extreme **aggradation** and major **planform adjustment** as the current processes. Widening is limited by rip rap in some places. Figure 5.48 shows that channel work has been done as well as a stream crossing for heavy machinery.

Figure 5.48. M29 exhibits channel alterations and a stream crossing for heavy machinery.

- **Active Restoration** by remediating an iron seep. (Map 6: Project #5)
- **Passive/Active Restoration** by creating floodplain and planting trees in areas with buffers less than 25 feet wide. (Map 6: Project 6)

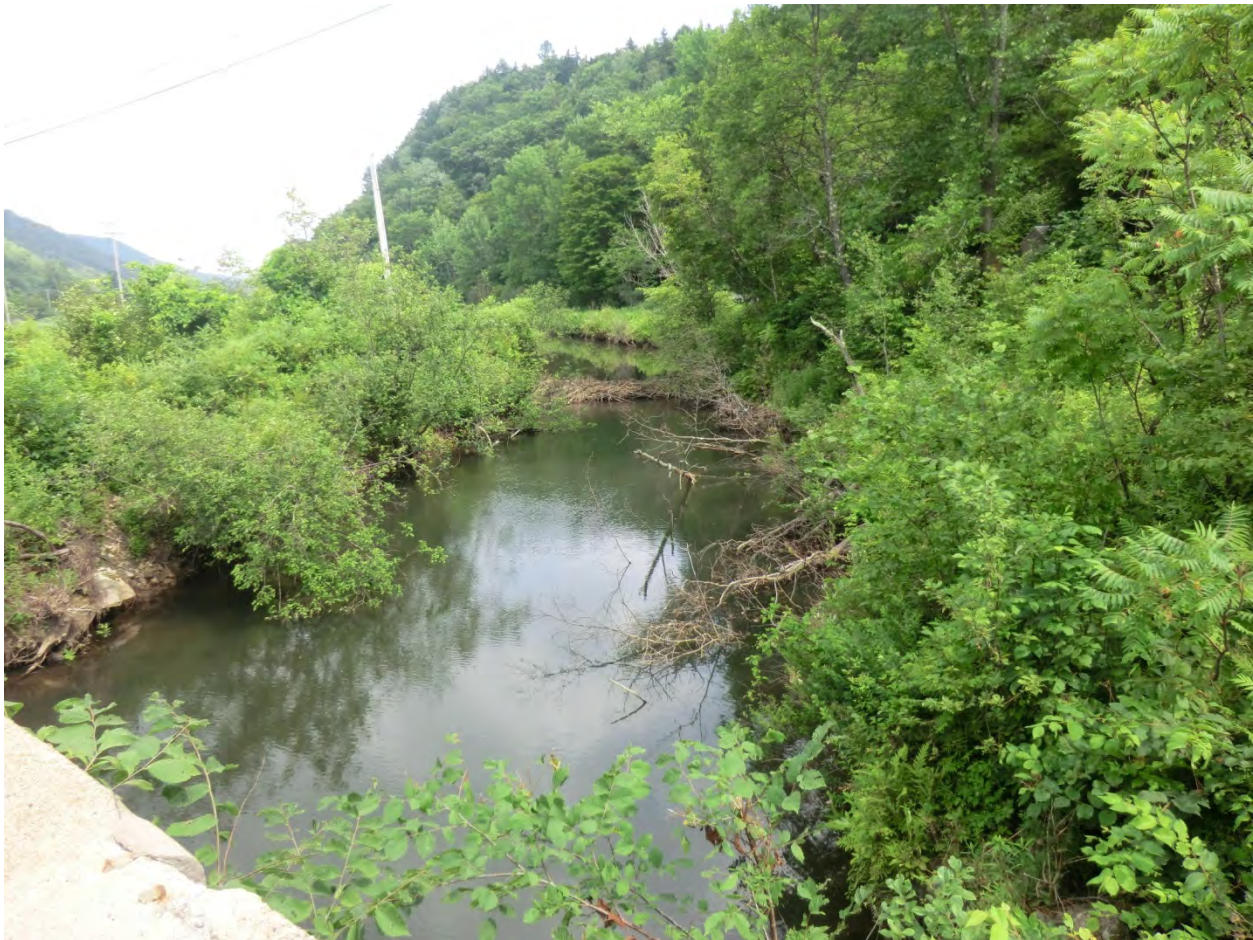
This segment begins about 300 feet below the Route 4 bridge crossing near where East Mountain Road intersects Route 4 at the Skyeship Base and continues about 900 feet upstream. This segment was not fully assessed because it is currently impounded by a beaver dam located 100 feet above the bridge. Figure 5.52 shows the beaver dam.

Figure 5.52. Beaver dam upstream of Route 4 bridge crossing.
