Town of Springfield, Vermont

Phase 2 Stream Geomorphic Assessment

Unnamed Tributary to Black River Along Valley Street

September 22, 2017

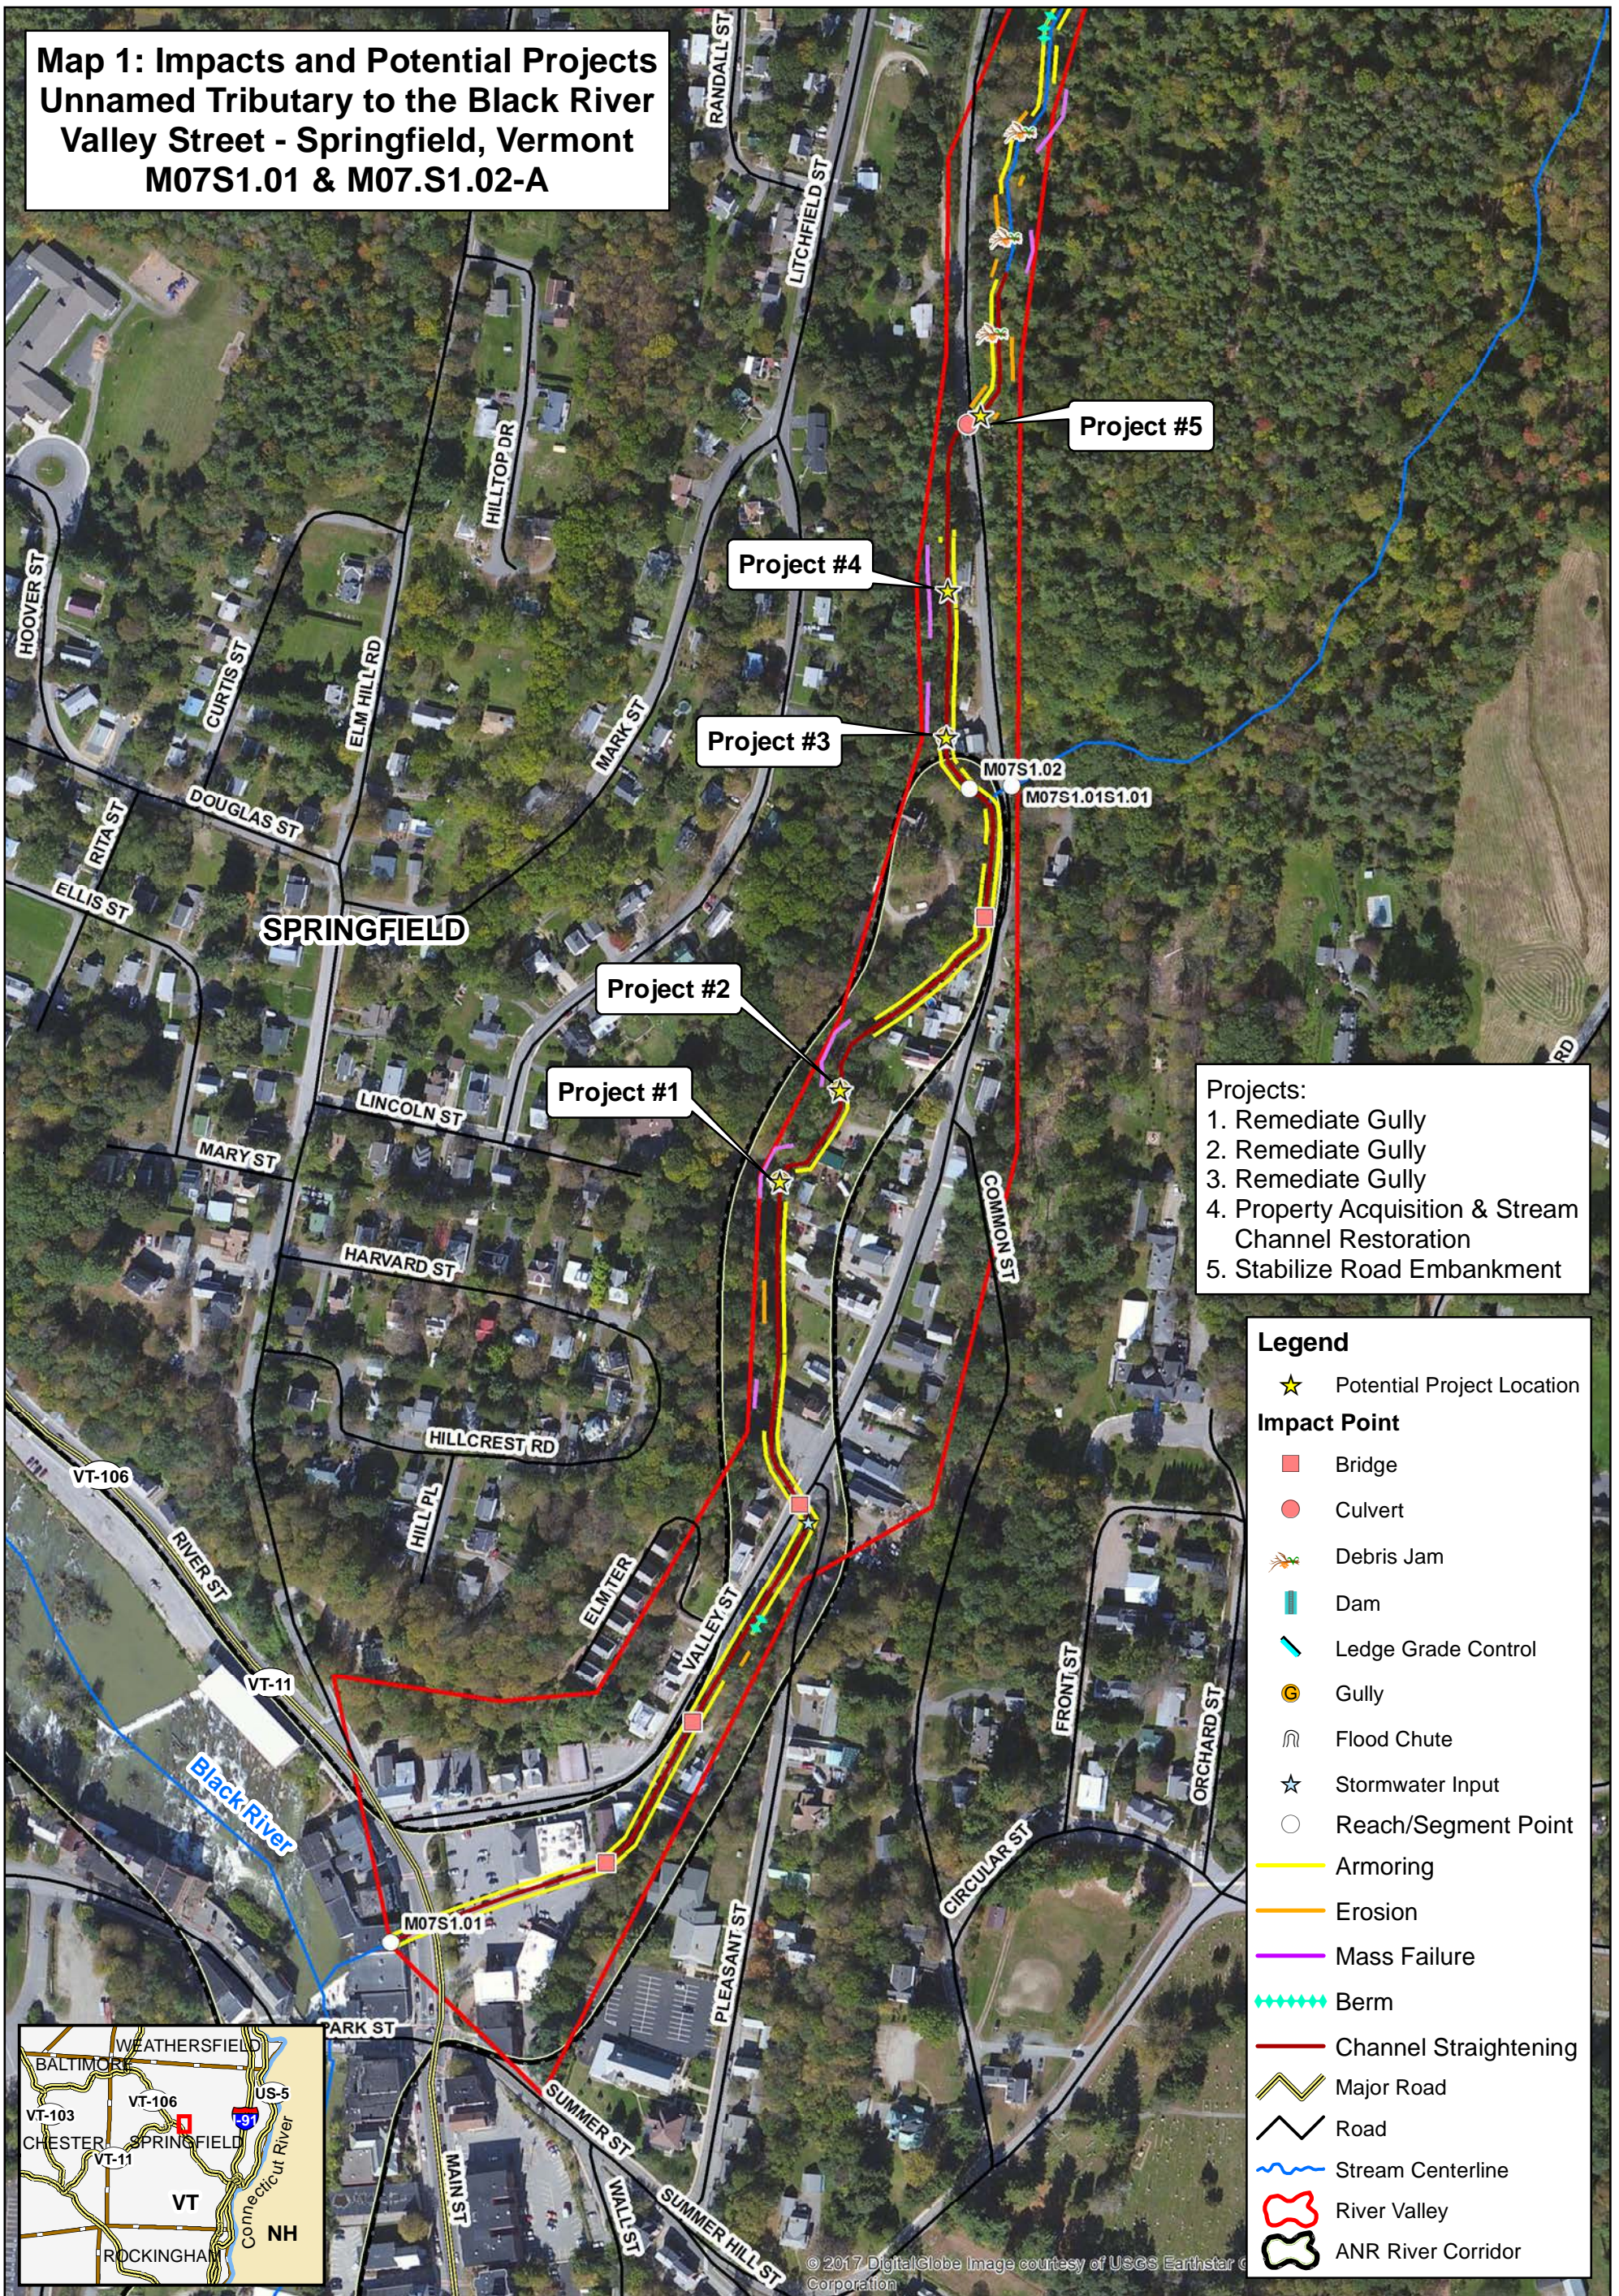
**Map 1: Impacts and Potential Projects
 Unnamed Tributary to the Black River
 Valley Street - Springfield, Vermont
 M07S1.01 & M07.S1.02-A**

- Projects:**
1. Remediate Gully
 2. Remediate Gully
 3. Remediate Gully
 4. Property Acquisition & Stream Channel Restoration
 5. Stabilize Road Embankment
