**East Creek Corridor Plan
East Creek Watershed
Addison and Rutland Counties, Vermont
May 25, 2011**

Prepared for:
Vermont Agency of Natural Resources
River Management Program

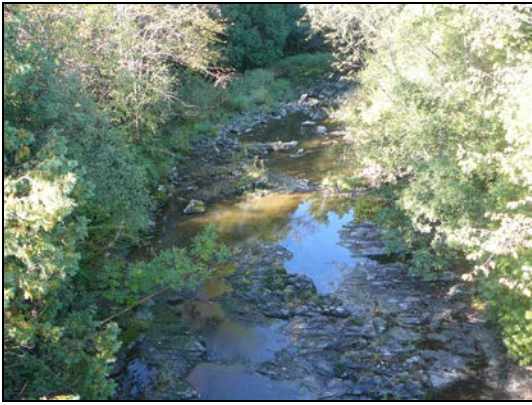
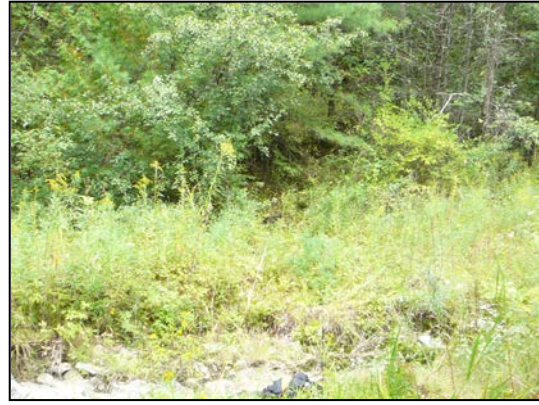
Segment T4.02-B has a nice step pool formation within a limestone bedrock setting. There are several nice, deep pools (Pools/Mile=28). This segment also has a nice intact forested buffer and corridor for the majority of its length. The upper 700' of this segment, both upstream and downstream of the Route 73 bridge, has a narrower buffer width in the vicinity of some residential structures. The Route 73 bridge is slightly undersized with a width only large enough to support 91% of a bankfull flow event. Scour was observed at both the upstream and downstream end of this structure. There are ledge grade controls both immediately upstream and downstream of this structure limiting any immediate channel adjustment potential from the undersized condition. Two mass failures and a short section of erosion (~125') are located just upstream of the T4.02-A segment break. The habitat condition of the segment is only Fair. Habitat conditions are reduced as a result of low flow conditions in the channel, continuous algae mats on the substrate and relative lack of large woody debris in the channel.

While the channel morphology scored low in the Rapid Habitat Assessment (RHA), F3 stream types are typically characterized by entrenched, meandering channels with high to very high width/depth ratios (WDRs) as is seen in this system (Rosgen and Silvey, 1996). Due to an RGA of Reference and little observable adjustment in the channel, the channel has been classified as CEM stage I.

Figure 9. Photos at Route 73 bridge looking downstream and representative right bank with good riparian vegetation

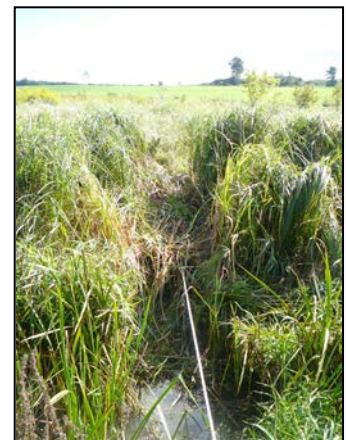
Reach T4.07 is a relatively short reach located to the east of Rte 22A. The valley setting is very broad with no structural encroachments in the river corridor. This reach falls within an agricultural setting but does not evidence historic straightening or dredging. The reach is characterized as a shallow slope (0.10%), narrow, meandering channel with plane bed bedform. The channel exhibits E type geometry with WDR of 9.7 and ER of 14.3. No incision was observed at the cross-section location (IR=1.0). The

Figure 18. Channel at cross section

substrate is predominated by silt. Due to an RGA of Reference and little observable adjustment in the channel, the channel has been classified as CEM stage I.

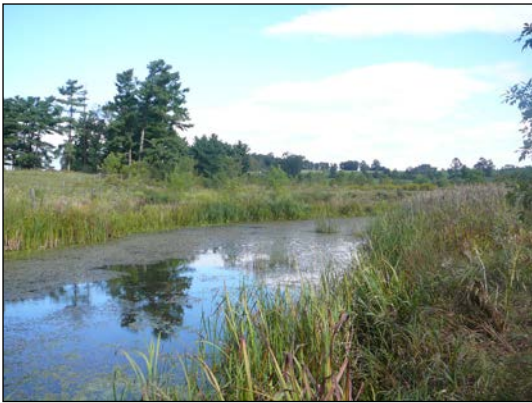
Figure 19. Nice wetland along channel

The downstream start of the reach is impounded from the beaver dam observed in reach T4.06. This has resulted in a nice open water area fringed by a cattail marsh and old oxbow backwater area. The habitat condition of the reach overall though, is only Fair due to virtually no large woody debris, substantial fine deposition throughout the channel resulting in filling of pools, and poor river bank vegetation. The channel alternates between being full at the downstream section

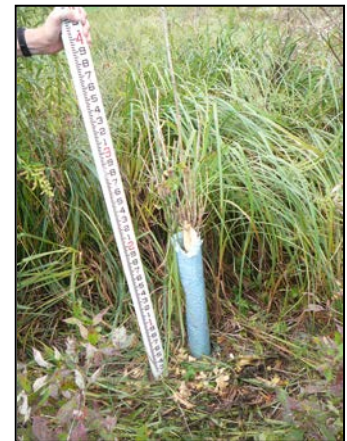
There is evidence on both the left and right banks along the entire length of the reach of a major planting effort. The project appears to have involved planting of shrub and tree species within the newly established buffer. At this time, the vegetation is not substantial enough to improve the habitat ranking but is expected to be so in the future.

Figure 20. Planting project underway

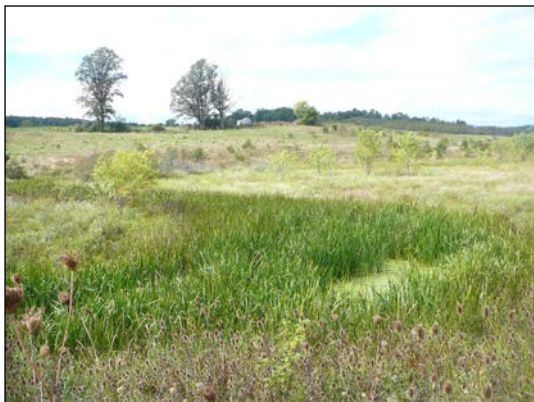
There is evidence on both the left and right banks along the entire length of the reach of a major planting effort. The project appears to have involved planting of shrub and tree species within the newly established buffer. At this time, the vegetation is not substantial enough to improve the habitat ranking but is expected to be so in the future.

Figure 23. Buffer plantings in the background

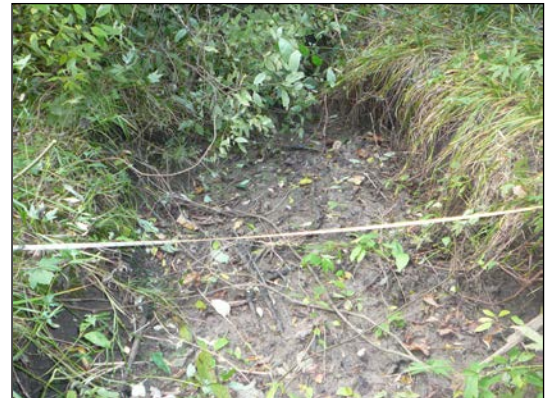
Subreach T5.01-B begins just upstream of the farm road at the T5.01-A segment break and extends upstream to North Orwell Road. The valley setting is very broad (slightly broader than segment A) with no structural encroachments in the river corridor. This reach falls within an agricultural setting but does not evidence historic straightening or dredging. The subreach is characterized as a moderate slope (2.6%), narrow (slightly wider than segment A), meandering channel with plane bed bedform. The channel exhibits G type geometry with WDR of 10 and ER of 1.2. Significant incision was observed throughout the segment (IR=2.8), and bank erosion was common. The substrate is predominated by silt. There appear to be significant flows moving through this segment, and with a lack of natural grade controls, the channel has responded by incising its bed. The high degree of silt in the bed substrate is likely from the ongoing bank erosion. Due to the incision with extensive erosion (RGA=Poor) the CEM has been classified as stage III. The subreach has an “extreme” sensitivity to future impacts, and will likely undergo significant lateral adjustments in the future. The subreach has undergone a stream channel departure converting this stream segment to a G (entrenched) from B (moderately entrenched).

Figure 28. Channel at cross section

This departure indicates a loss of floodplain access that is contributing to extreme stream sensitivity in this segment.

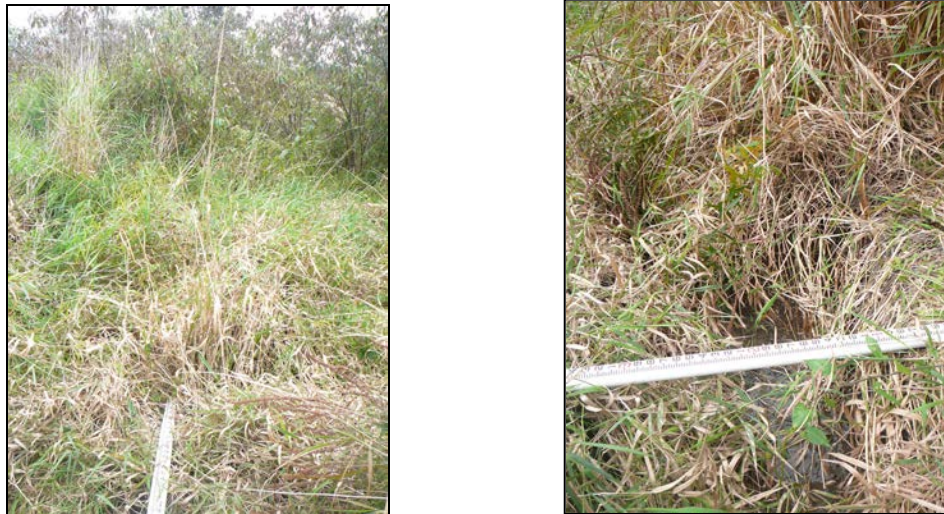
Segment T7.01-A begins at the downstream confluence with South Fork reach M06 and extends upstream approximately 900’. The valley setting is very broad with no structural encroachments in the river corridor. This reach falls within an agricultural setting and has evidence of significant historic straightening (approximately 500 linear feet). The reach segment is characterized as a shallow slope (1.5%), narrow (5’ bankfull width), low sinuosity channel with plane bed bedform. The channel exhibits E type geometry with WDR of 6.4 and ER of 90. Incision was not observed at the cross section and bank erosion was not present. Due to the lack of incision or erosion and widening (RGA=Good) the CEM has been classified as stage I.

The habitat condition of this segment is only Fair due to virtually no large woody debris cover, substantial fine deposition throughout the channel resulting in filling of pools, and poor river bank vegetation. The channel alternates between being dry and having areas of ponded water along the course of the reach. The reach has generally good buffer widths of greater than 100' for both the right and left banks. The invasive purple loosestrife was identified throughout the downstream half of the segment.

Figure 30. Photos at the cross section

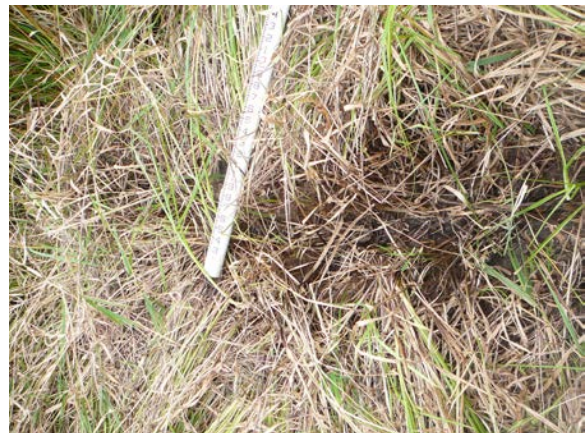
The stream channel, which is generally dry, comes in and out of wetland marsh areas. The stream corridor on both banks upstream of the Old Stage Road crossing is managed by the current property owners as grassland bird habitat. The overall habitat condition of this segment is only Fair due to virtually no large woody debris cover, poor hydrologic conditions, absence of pools and substantial fine deposition throughout the channel, and poor river bank vegetation. The channel alternates between being dry and having areas of ponded water along the course of the reach. The reach has generally poor buffer widths of less than 50' and in many places less than 25' for both the right and left banks. The invasive purple loosestrife was identified just upstream of the Old Stage Road culvert. There is very little erosion present within this segment.

Figure 31. Channel at the cross section

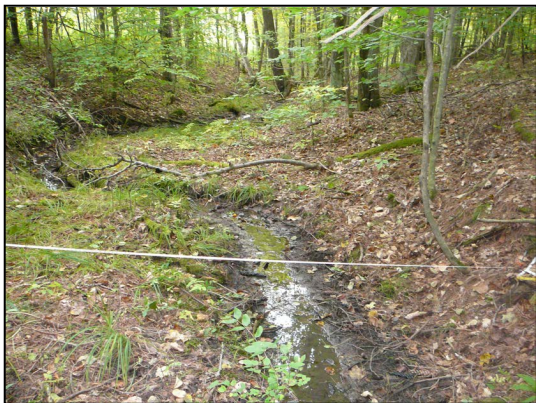
Subreach T7.01-D begins at the downstream segment break with T7.01-C and extends upstream approximately 775'. This subreach is the headwaters for the Doughty Hill Tributary. The valley setting is narrow with no structural encroachments in the river corridor. This reach falls within a forested landscape. The reach is characterized as a steep slope (9%), wide (16' bankfull width as compared to downstream segments), and low sinuosity channel with step-pool bedform. The channel exhibits F type geometry with WDR of 21.2 and ER of 1.3. Incision was not observed at the cross section (IR=1), and bank erosion was not common (~80' section on the left bank). The substrate is predominated by sand. The high degree of sand in the bed substrate is likely sourced from multiple stream inputs from the upslope watershed.

Figure 33. Channel at cross section

Due to the channel aggradation and widening (RGA=Poor) the CEM has been classified as stage III. The segment has an “extreme” sensitivity to future impacts, and will likely undergo significant lateral adjustments in the future. The segment has undergone a stream channel departure converting this stream segment to an F (moderate to high width/depth ratio) from an A (low width/depth ratio). This departure indicates an over-widening of the channel.

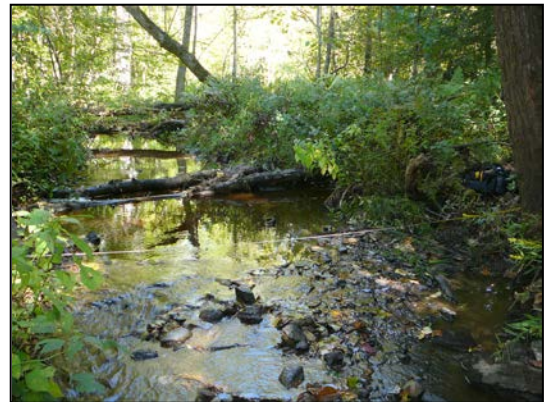
Segment T9.01-B begins at the T9.01-A segment break and extends 880' upstream of the Rte 22A crossing. The valley setting is very broad with significant structural encroachments in the river corridor, approximately 706 linear feet of development. The reach is characterized as a steep slope (4.6%), wide (16' bankfull channel), and moderate sinuosity channel with step-pool bedform.

Figure 34. Channel at cross section

The channel exhibits C type geometry with WDR of 21.1 and ER of 21.1. Incision was not observed at the cross section (IR=1), and bank erosion was not common (~100' section on the left bank and 62' section on the right bank). The substrate is predominated by gravel, with a high percentage of sand. The high degree of sand in the bed substrate is likely sourced from the upstream beaver dams. Due to the relative channel stability (RGA=Good), with only a few areas of erosion, the CEM has been classified as stage I.
