Malletts Creek & Allen (Petty) Brook Phase 1 & Phase 2 Stream Geomorphic Assessment Summary Report

February 23, 2011

Fitzgerald Environmental Associates, LLC.
316 River Road
Colchester, VT 05446

Chittenden County Regional Planning
Commission
110 West Canal Street, Suite 202
Winooski, VT 05404

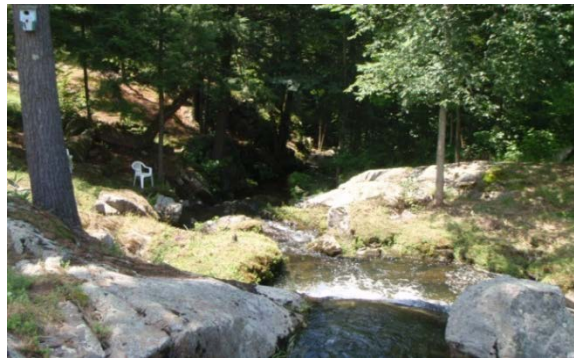
Figure 4.2 Bedrock cascade in reach M19

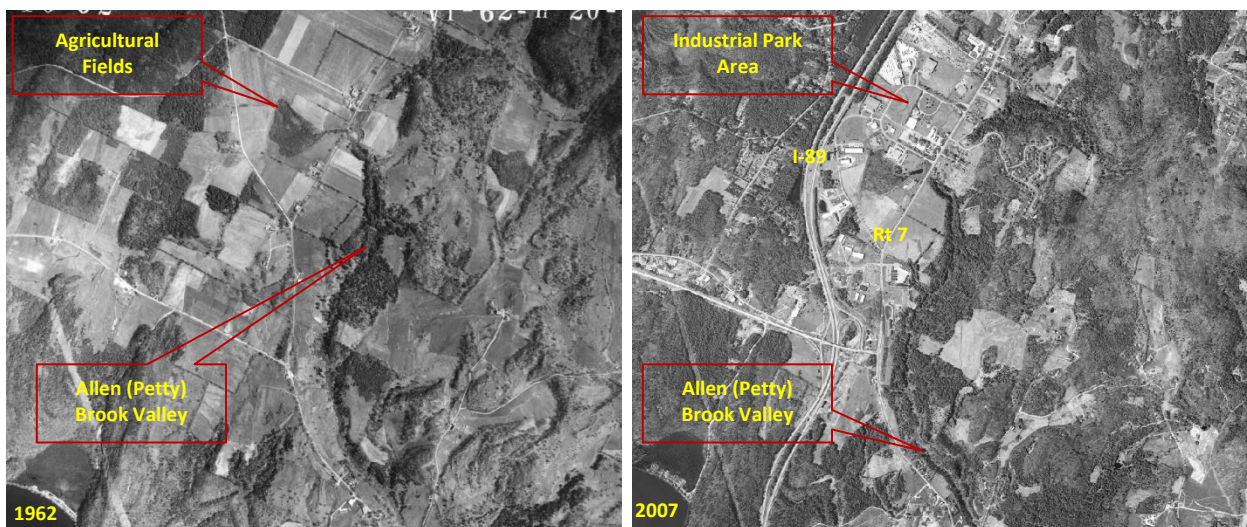
Figure 4.7 Change in land use from 1962 to 2007 in Allen (Petty) Brook upper watershed

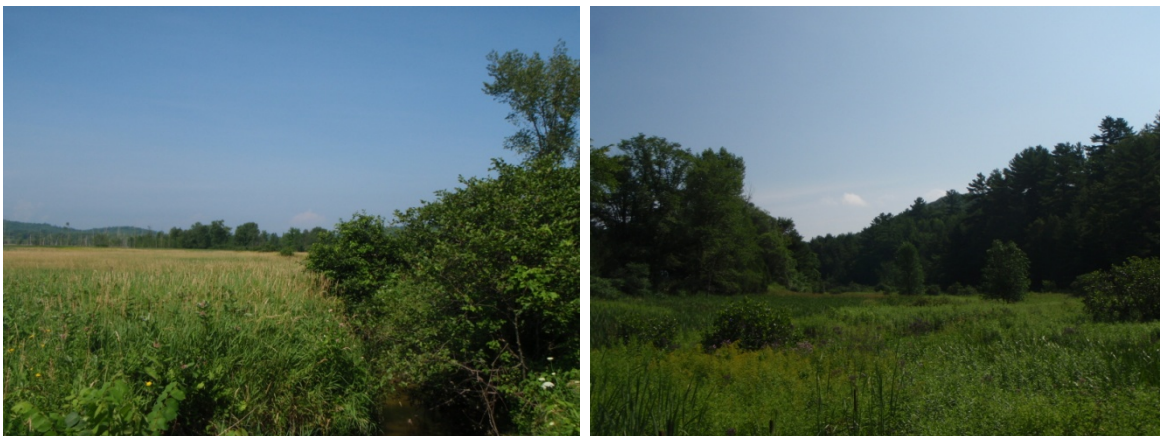
Groundwater and small tributary inputs were reviewed for each reach using the National Wetlands Inventory (NWI, 2004) and the Vermont Hydrography Dataset. The very large wetland complex between Lake Champlain and the Route 7 crossings of Petty Brook and Malletts creek covers over 350 acres (Figure 4.9). This contiguous wetland and others like it in the watershed offer recharge to the ground water and consistent flow during the dry months. Additional detailed information about each Step 4 parameter for all reaches is found in the watershed summary data and reach reports found in Appendix A.

Figure 4.9 Looking West (left) and East (right) from the crossing of T1.01 into the large wetland area east of Lake Champlain

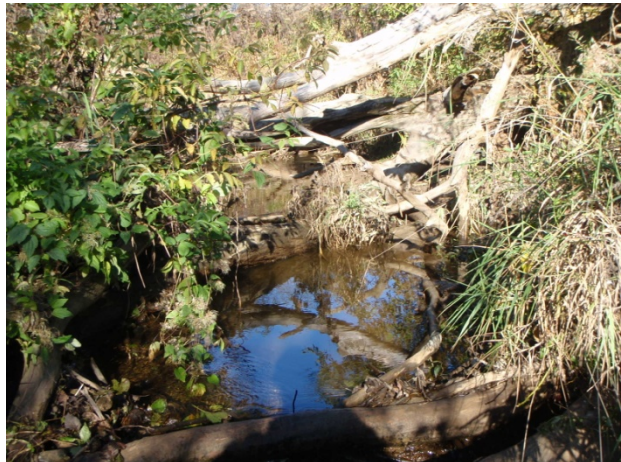
Habitat in segment M14-A is abundant (RHA score = "Good"). Both the woody debris and pool densities are in "reference" condition with 343 LWD/Mile and 81 Pools/Mile, respectively (Figure 5.2). One nice undercut was observed upstream of the cross-section location. Geomorphically, the segment has some minor impacts associated with the beaver dam. These impacts are natural, so the overall RGA score remains in "Good" condition. The channel evolution model (CEM) does not do a great job characterizing channels affected by so much beaver activity. Incision and widening was not present in the segment, but beaver activity has led to extensive shifts in planform. Because of the natural planform shifts, but also the relatively stable setting, stage I of the F-model CEM was chosen.

Figure 5.2 Great habitat feature with LWD and undercut bank

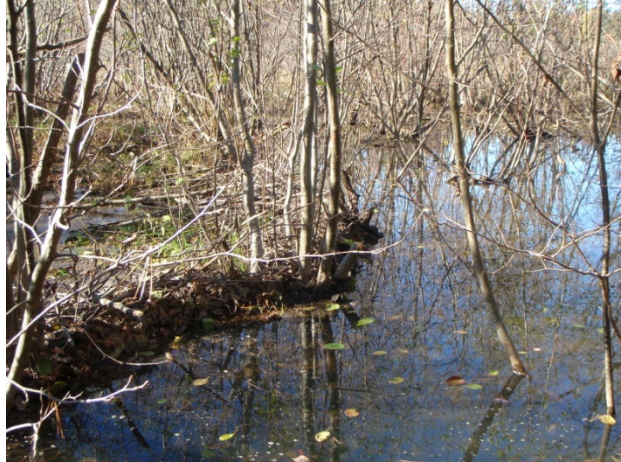
This segment was only assessed for bank and buffer conditions because extensive beaver activity impounds the entire channel length of 2,518 ft (Figure 5.3). The very broad valley and abundance of alders and other fast growing woody species makes this segment ideal for beaver inhabitation (Figure 5.4). Under reference conditions the channel was probably very similar to its current impounded state. Beaver activity greatly increases the time it takes for water to flow downstream, and the dams act as sediment sinks allowing fine silts and sands to settle out and aggrade. The channel is extremely well buffered because of the abundance of wetlands in the wide valley. Professional judgment was used to determine the RGA score as “Good” and E5-type channel morphology with dune-ripple bedform.

Figure 5.4 Typical impounded setting with many alders

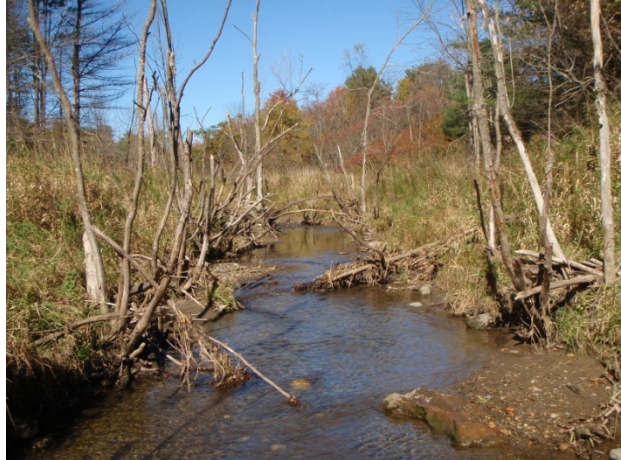
Figure 5.9 Well-spaced riffle-pool sequence located mid-reach

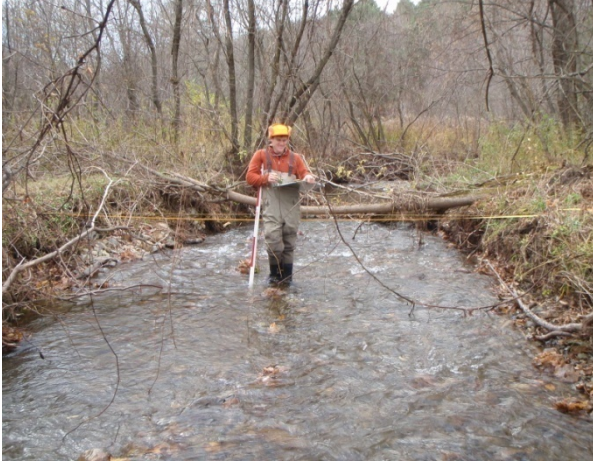
Figure 5.11 E-type channel morphology at cross-section

The impacts to the natural planform of the channel have also impacted the habitat condition of this segment. M17-A has limited wood (LWD/Mile = 40), pools (Pools/Mile = 28), and undercut banks (UCB/Mile = 17), which reduced the overall habitat score to “Fair” condition. It is evident in Figure 5.11 that the banks and buffers in the lower portion of the segment have been recovering from previous deforestation. The plant assemblages are typical of old field succession occurring in a wet environment. Boxelder (*Acer negundo*), speckled alder (*Alnus rugosa*), and black willow (*Salix nigra*) are the dominant woody species in the lower segment. The geomorphic condition of M17-A has been reduced as a result of several adjustment processes (RGA score = “Fair”). The straightening which occurred sometime between 1962 and the present likely caused the channel to degrade and down-cut. However, vertical changes in the channel were not observed in the cross-section; only minor incision (IR = 1.1) was noted upstream and downstream. The lack of incision suggests that the bed elevation might be aggrading sediment from upslope. Several large sediment deposits were observed at the upstream end of reach M16, indicative of a high sediment load (Figure 5.13). As more coarse sediment spills into this segment, widening and planform adjustments are likely to recreate a similar sinuous setting as observed in 1962. Stage I of the CEM describes the state of this segment, because no active incision associated with historical straightening was noted. Widening and shifts in planform will likely be more prominent adjustment processes in the future.

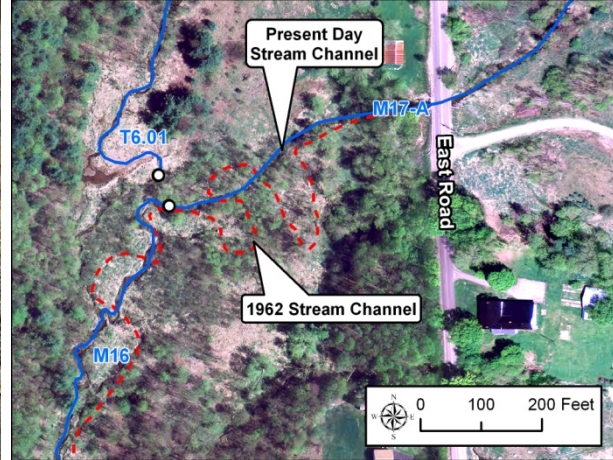
Figure 5.12 Historical channel planform in segment M17-A

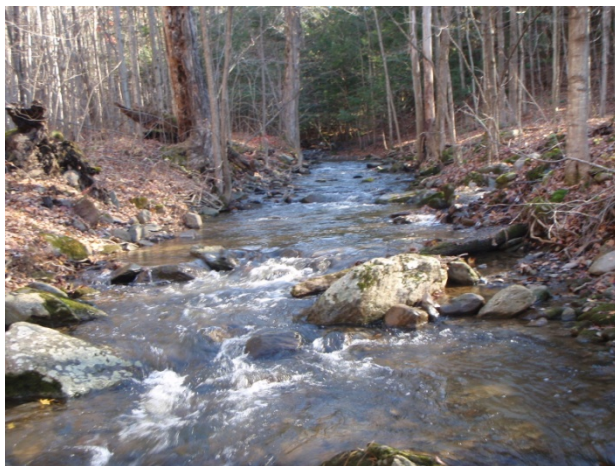
Figure 5.14 Excellent B-Type channel with step-pool bedform

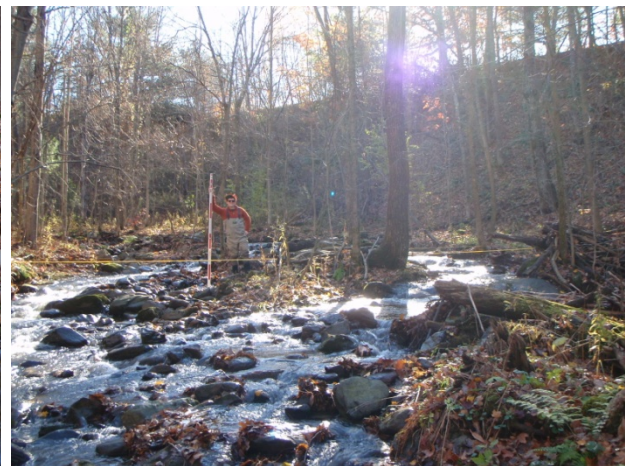
Figure 5.15 Unconfined valley with braided bedform

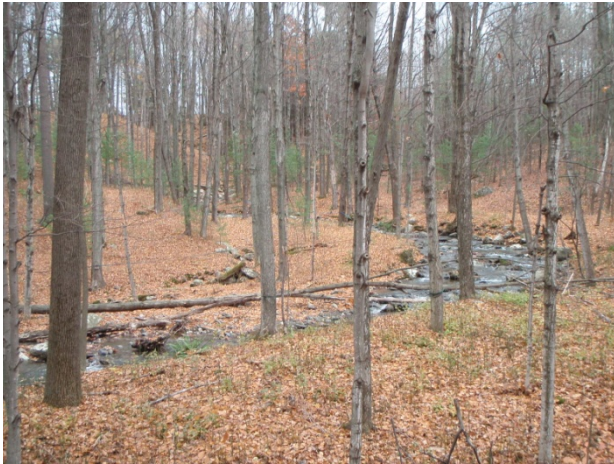
The habitat in this segment was in “Good” condition. Woody debris density was reference (LWD/Mile = 212) and pools were abundant and well-spaced (Pools/Mile = 64). The only major impact to the habitat condition was some lack of buffer plant diversity in the lower reach where the understory was cleared

as a sugarbush (Figure 5.16). Many brook trout (*Salvelinus fontinalis*) and other fish were observed while assessing this segment. High amounts of coarse particulate organic matter provide the necessary resources for healthy benthic communities. Geomorphically, the segment is stable, with few notable adjustments (RGA score = "Good"). This segment is in stage I of the CEM. The upstream end of the segment has two large cascades that control any vertical adjustment (Figure 5.17). These features may inhibit fish passage, but overall channel connectivity is good.

Figure 5.16 Upstream view of channel and valley in sugarbush

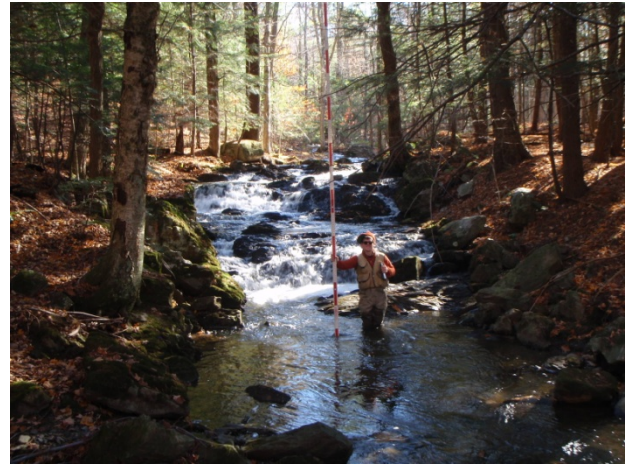
Figure 5.17 Cascade grade control in upper segment

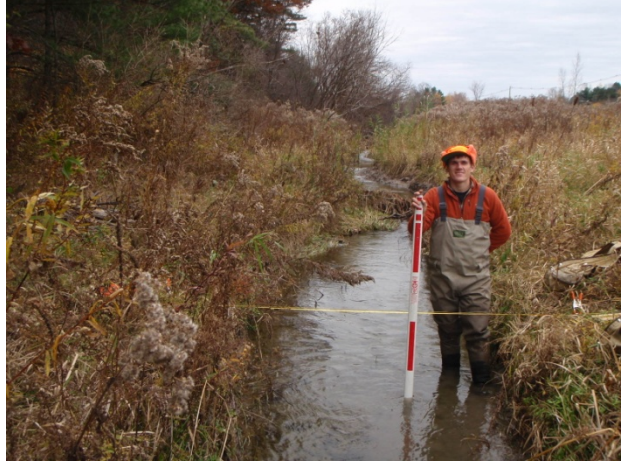
Reach T6.01 was segmented twice to best characterize the diversity in channel characteristics and impacts associated with beaver and anthropogenic activities. Segment T6.01-A begins at the confluence with the main stem at the upper end of M16 and ends at a large beaver dam observed under the utility line right-of-way. In total, the segment is 994 feet in length with an average channel slope of 0.9%. The segment has an unconfined valley setting with a very broad valley type. Like many of the lower-sloped reaches on Malletts Creek, beaver activity has been a constant factor in the geomorphic conditions observed (Figure 5.18). On T6.01-A, no active beaver dams were observed at the time of survey, but many relic structures were present. The channel exhibits E-type morphology with minor incision and dune-ripple bedform (WDR = 5.4, ER = 39.4; IR = 1.2; Figure 5.19).

Figure 5.19 Cross-section with E-type morphology

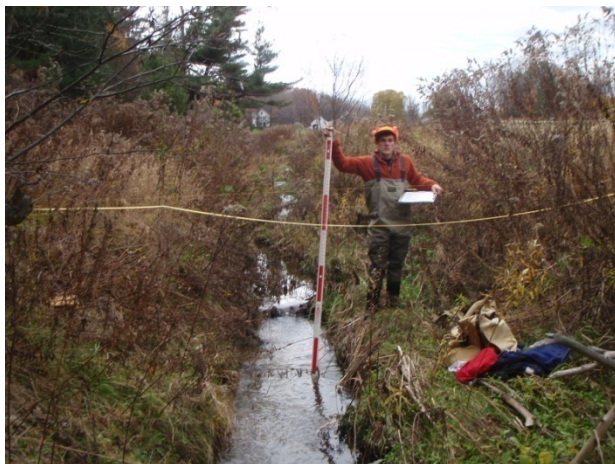
Figure 5.22 Cross-section with G-type channel morphology

The extensive dredging and channel straightening with little buffer resistance has led to a highly incised G-type channel. Three small headcuts were observed downstream of the Main Street crossing. These features were armored with coarse material to prevent any additional migration upstream (Figure 5.23).

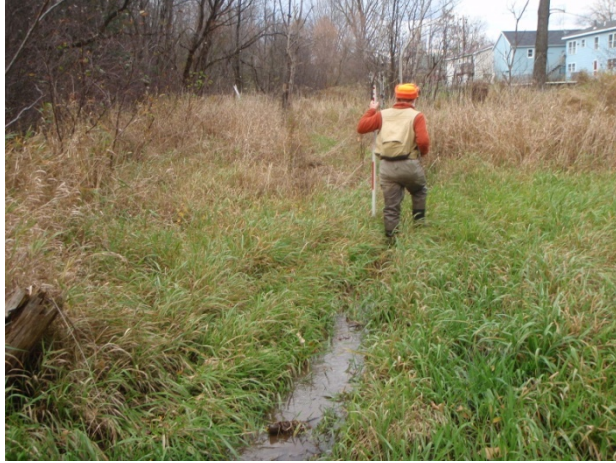
T6.02 is a reach, 609 feet in length, that begins just upstream of the Main Street crossing and ends approximately 600 feet downstream of a driveway crossing off North Road. The hydrological condition of this reach has changed because of an influx of stormwater runoff from the Hunting Ridge Development. The development, built around the turn of the millennia, lacks sufficient stormwater best management practices to reduce the large volume of water which surge off the impervious surfaces and down the steep slope into the tributary. The channel has E-type morphology with dune-ripple bedform. The width-to-depth and entrenchment ratios are 9.0 and 19.3, respectively. Much of the very broad valley is occupied by wetlands. The primary thread of the channel dissipates into a wetland for a brief extent where the vegetation is herbaceous (Figure 5.24).

Figure 5.24 Area of channel that dissipates into wetland

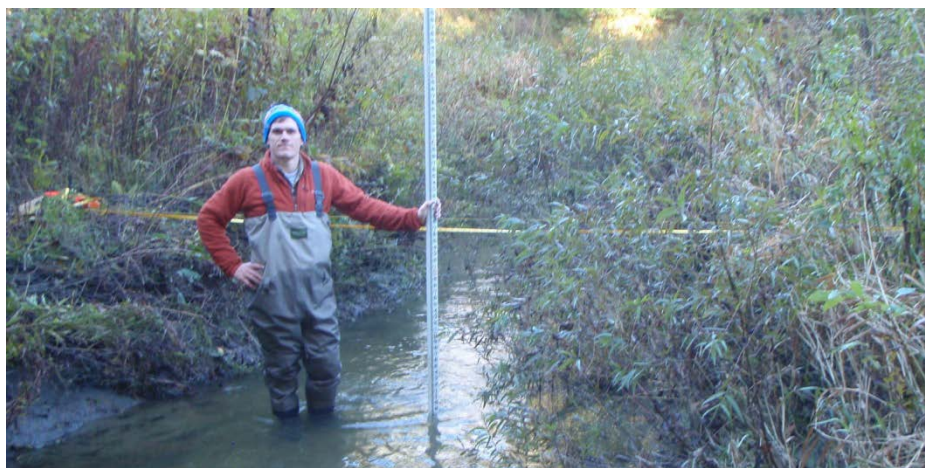
Figure 5.26 T1.02 cross-section with E-type morphology

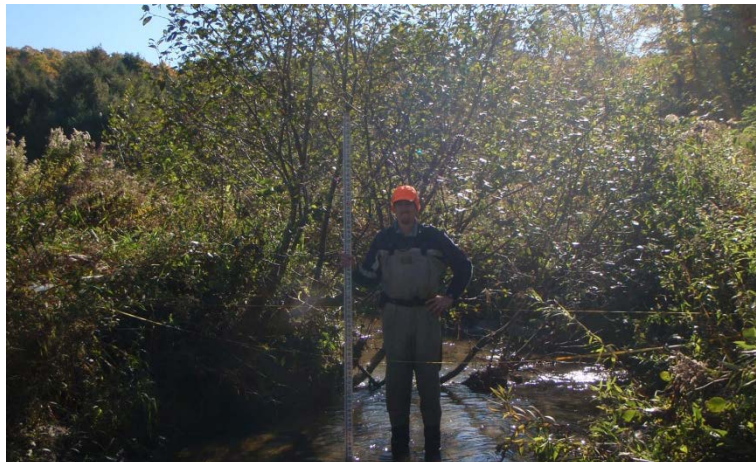
Figure 5.27 T1.02 cross-section with E-type morphology

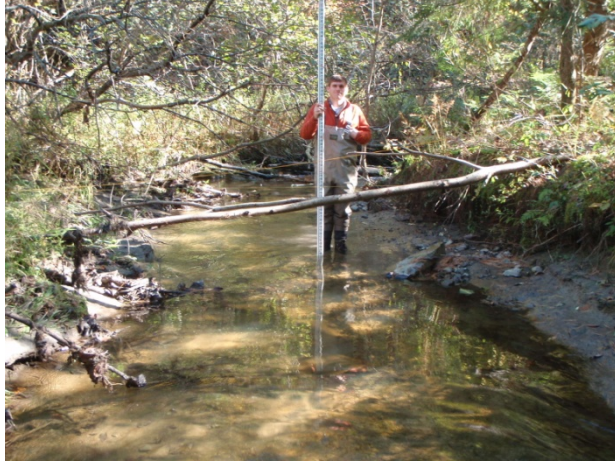
Figure 5.30 Cross-section with E-type morphology

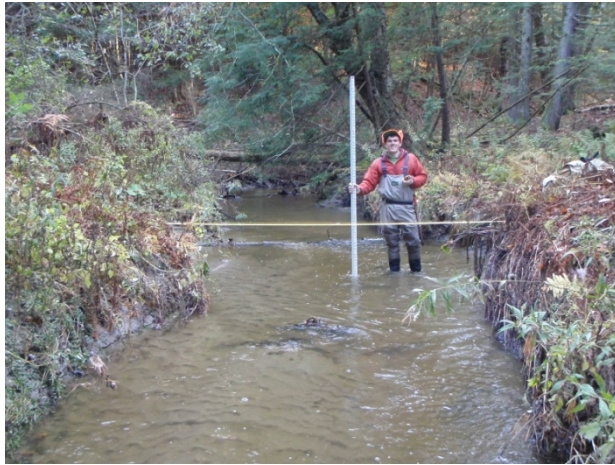
Figure 5.32 Cross-section with reference E-type morphology

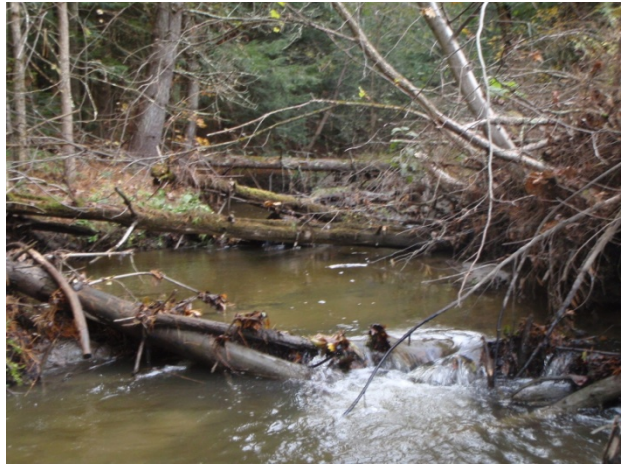
The habitat score in reach T1.05 is in “Reference” condition. Woody debris density was extremely high (LWD/Mile = 332) and debris jams were abundant (DJ/Mile = 28). Pool density was slightly lower than expected (Pools/Mile = 22; Figure 5.33). The high volume of non-cohesive sand substrate limited pool formation to areas of localized hydraulic variability, such as areas where large debris jams created scour pools. The bank and buffer conditions reflect several decades free of management or clearing. The extent of the riparian buffer observed in the 1962 aerial images are very similar to the buffer observed today. The buffer is primarily composed of eastern hemlocks (*T. canadensis*) with some large, sporadic hardwoods. Geomorphically, the reach is stable, with few adjustments noted (RGA Score = “Reference”). Some minor shifts in planform and migration were caused by the many debris jams noted, but these

Figure 5.33 Excellent habitat with abundant LWD and DJs

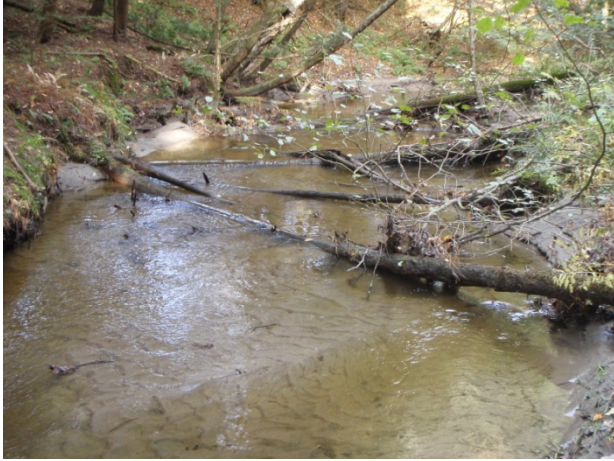
Figure 5.34 Well-formed dune-ripple bedform

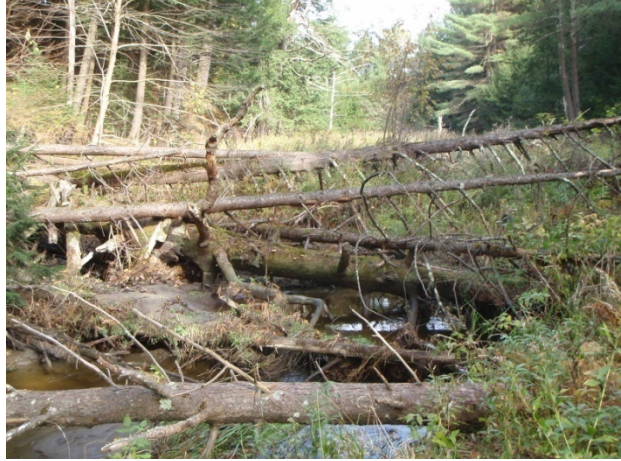
The ecological setting and habitat condition of this segment is very similar to T1.05. Woody debris density and debris jam density were extremely high, with 442 LWD/Mile and 31 DJ/Mile, respectively (Figure 5.35). Pool density was high as well with 123 Pools/Mile observed. The excellent condition of the riparian buffer and near banks has helped preserve this segment's habitat integrity (RHA Score = "Reference"). Like T1.05, limited clearing was observed in T1.06-A over the last 50 years. Many trees had a diameter at breast height that exceeded 30 inches. The sub-tributary located at the upper end of this segment is highly managed. The channel on the western side of Route 7 drains into a very large stormwater detention basin, the outlet of which crosses under the highway and becomes T1.06.s1.01. The stormwater inputs and other road drainage ditches that enter sub-tributary T1.06.s1.01 have created some geomorphic instability in the upper portion of segment T1.06-A. Migration and neck cutoff potential are the most common impacts observed. The overall RGA score is in "Good" condition. Despite minor impacts in the upper segment the channel remains in stage I of the CEM.

Figure 5.35 Very large debris jam with abundant LWD

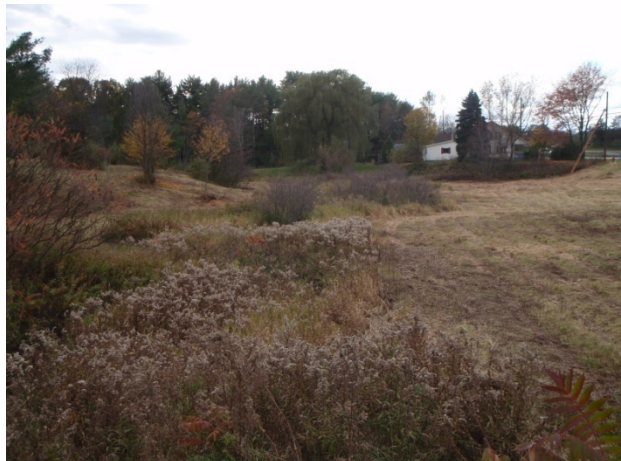
Segment T1.06-B was parsed out because of property restrictions and changes to the bank and buffer condition. The segment, 1,009 feet in length, begins just upstream of the confluence with sub-tributary T1.06.s1.01 and ends about 110 feet upstream of the Sweeny Farm Road (Figure 5.36). The segment is set in a very broad valley, with some human caused change in the valley width. Bank and buffer conditions were assessed using aerial imagery and the corridor was walked along route 7. Professional judgment was used to determine a geomorphic condition (RGA score = "Fair"). The channel observed from the road exhibits E-type morphology with plane bedform. Bank and buffer impacts, channel straightening and the undersized culvert at Sweeny Farm Road were considered in this decision (Figure 5.37).

Figure 5.37 Buffer <25ft and channel straightening in T1.06-B

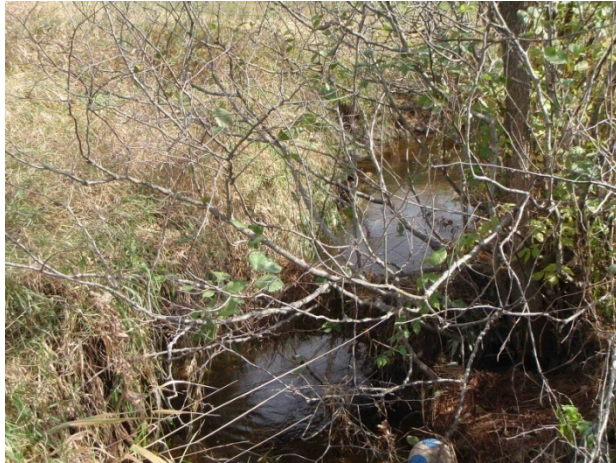
type morphology with plane bedform (Figure 5.38). The width-to-depth and entrenchment ratios are 7.9 and 12.2, respectively. Minor incision was observed in segment T1.06-C, the channel had impacts associated with historical channel alteration and straightening (IR = 1.2). The median substrate size observed was sand (71%), with some fining of silts (15%). The Allen Brook Drive crossing had significant impacts on the channel condition. The culvert is a constriction to the bankfull channel width and the structure occupies approximately 20% of the total segment length. Extensive fill was placed in the valley to create the road footing (Figure 5.39) for the development to the east and two stormwater inputs were observed on the upstream end of the structure.

Figure 5.38 Plane bedform with E-type morphology
