# Lower Passumpsic River Tributaries Phase 1 Stream Geomorphic Assessment Report

September 27, 2013

**Fitzgerald Environmental Associates, LLC.**  
18 Severance Green, Suite 203  
Colchester, VT 05446

**Caledonia Country Natural  
Resources Conservation District**  
481 Summer Street, Suite 202  
St. Johnsbury, VT 05819

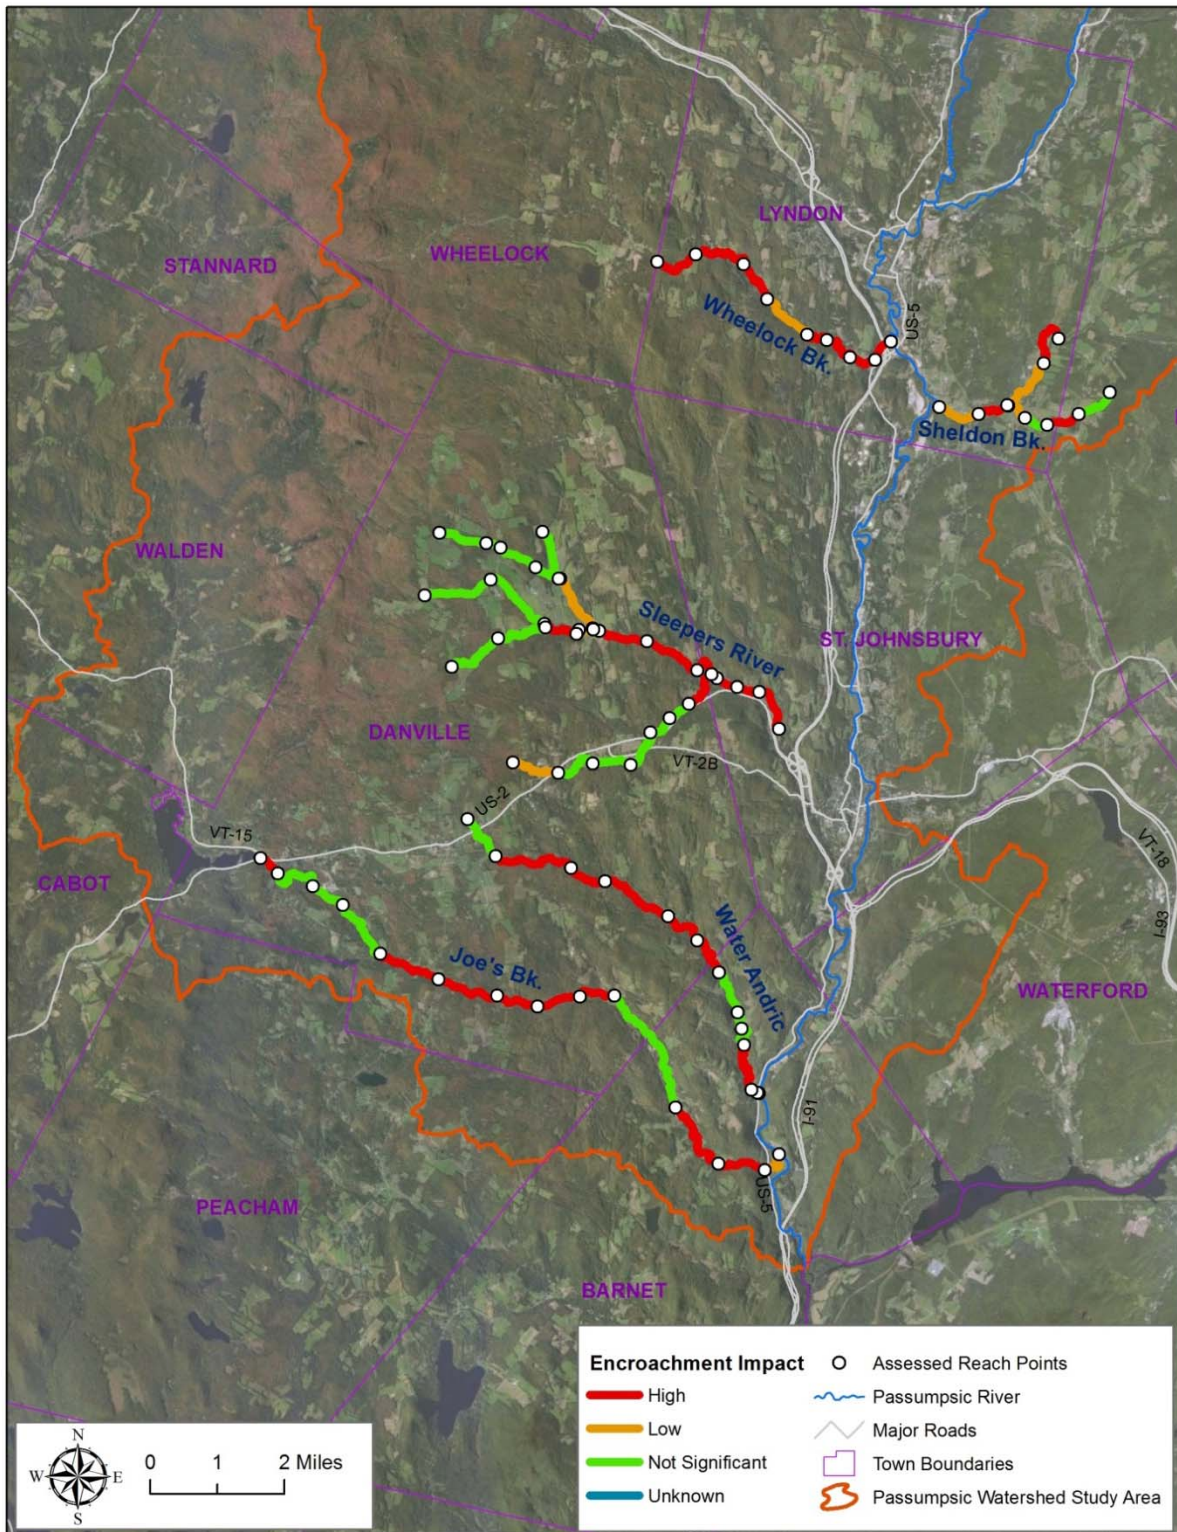
Following the Phase 1 protocol, any berms, roads, driveways, railroads and/or improved paths found within the stream corridor were indexed using the FIT (Figure 15). These areas were identified using current aerial imagery, and were confirmed and/or refined during the field observations. Figure 16 depicts the reaches where encroachment has significantly impacted the stream corridor, with ratings based on the percentage of the reach length that was impacted as indicated in Table 10. Impacts classified as "High" from corridor encroachment were found in reaches along much of Joe's Brook, Water Andric, Sleepers River (mainstem), and Wheelock Brook. A total of 29 reaches have "high" encroachment impacts and 6 reaches have "low" impacts.

**Figure 16:** Impacts from corridor encroachments from roads, berms, and development in the Lower Passumpsic River tributary watersheds

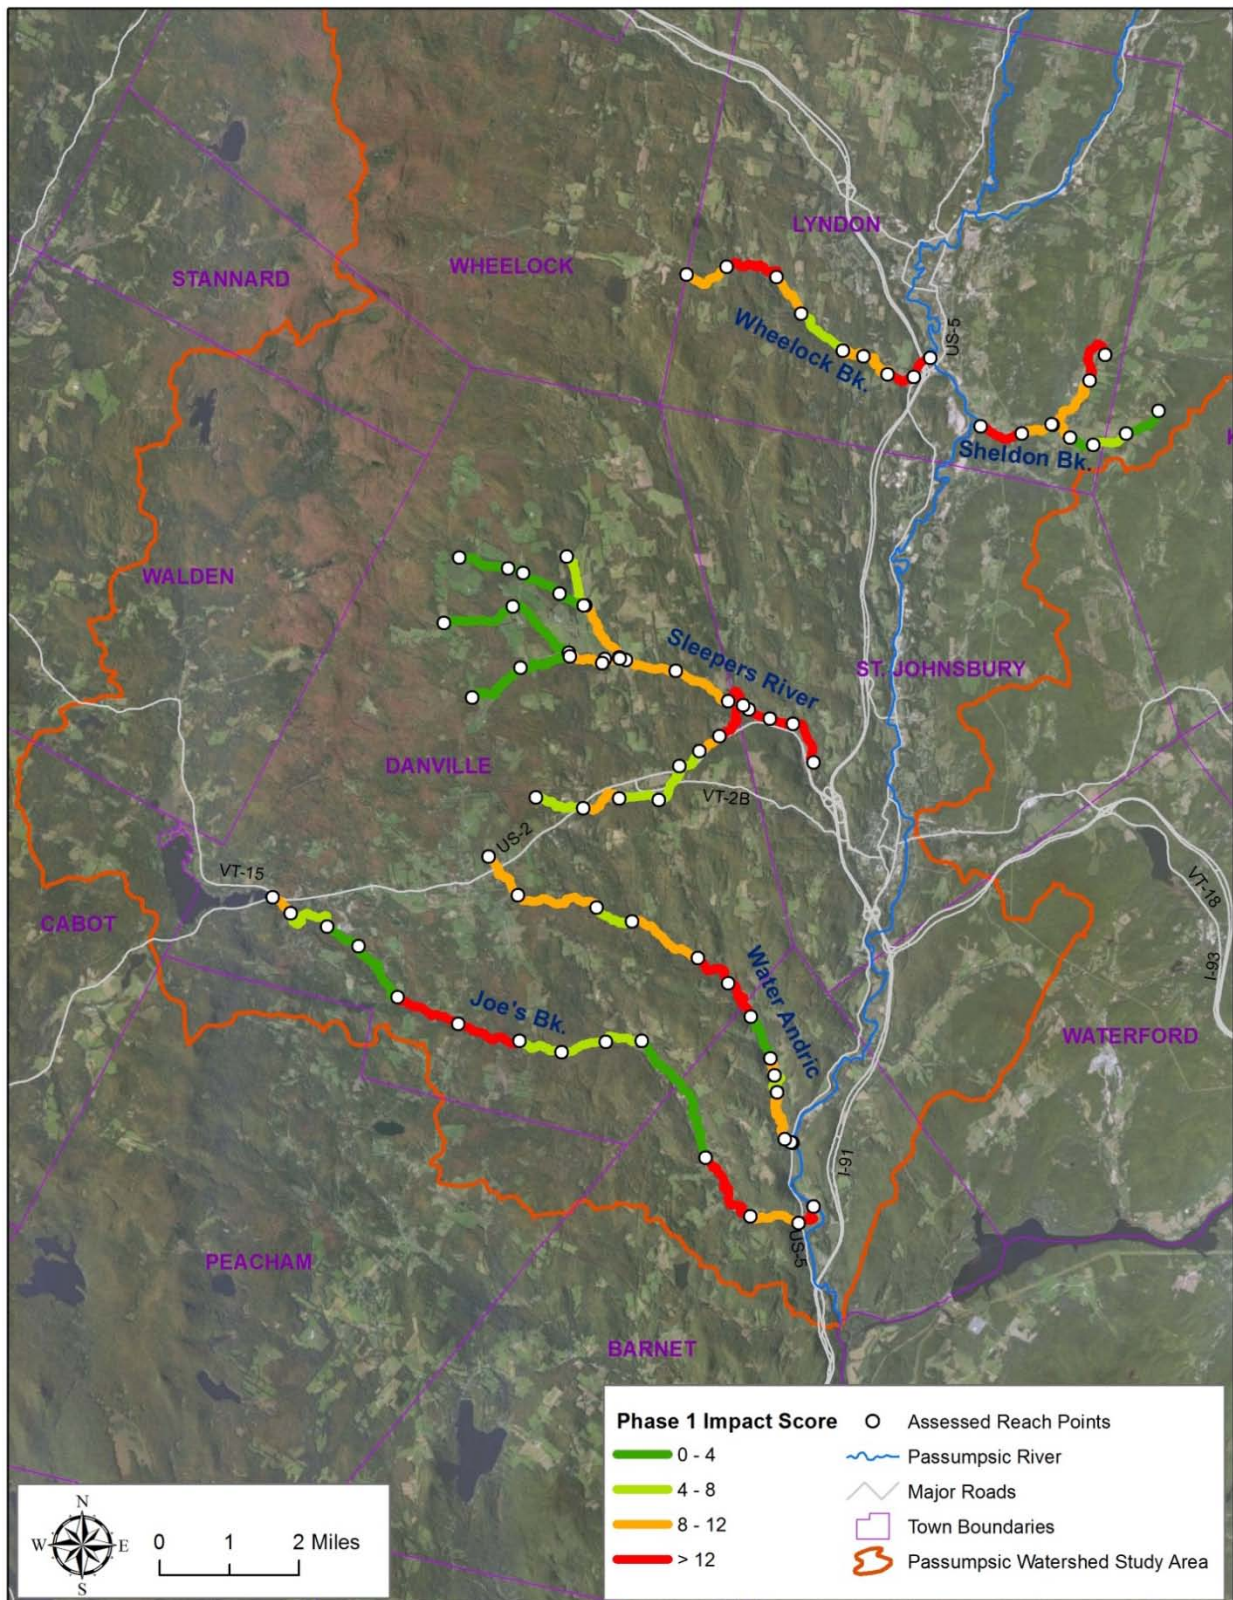
- Impact ratings were developed for each reach using the Phase 1 parameters representing four classes of watershed and reach-scale impacts: 1) Land Cover and Reach Hydrology; 2) Channel Modifications; 3) Floodplain Modifications and Planform Changes; 4) Bed and Bank Conditions. Out of a total possible impact score of 32, the average rating for all reaches was 8.9, with a maximum score of 18 and a minimum score of 1.

**Figure 22.** Phase 1 impact scores for the Lower Passumpsic River Tributaries

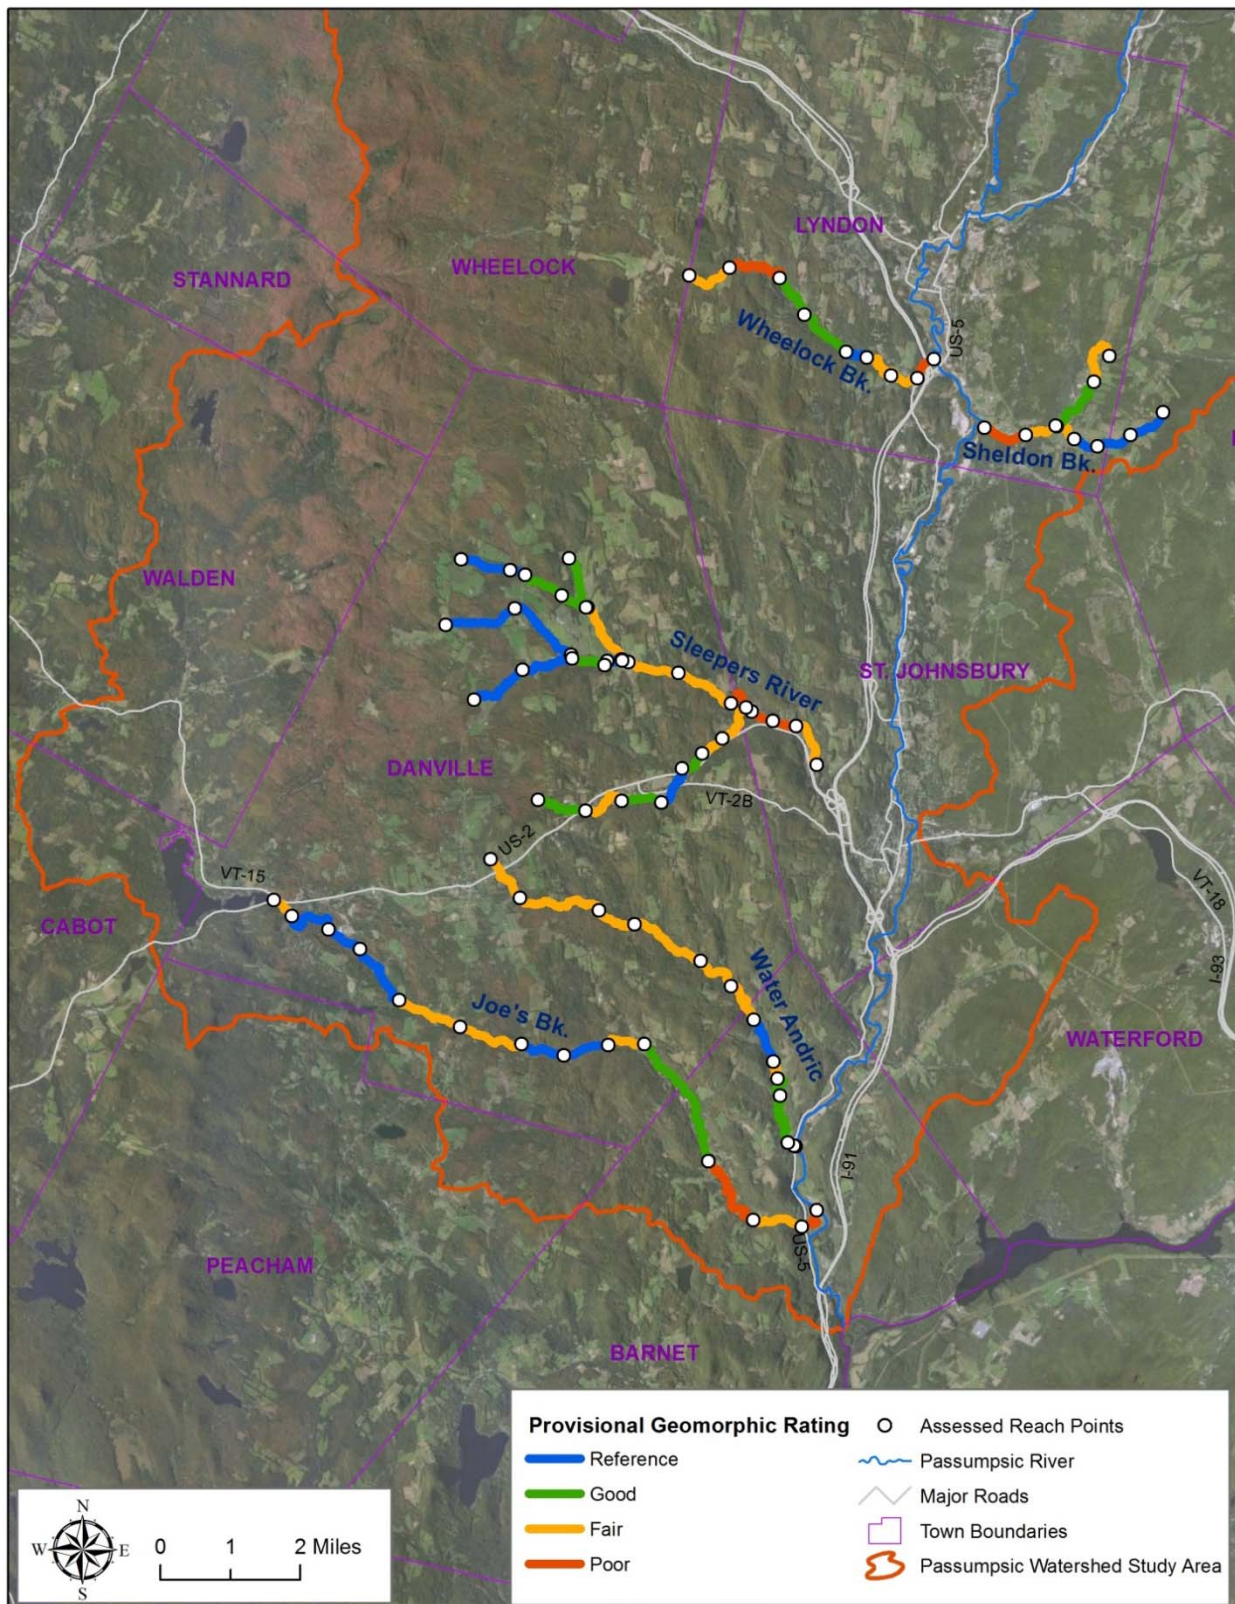
Based on the Phase 1 impact scores, the DMS also develops predictions for channel adjustment processes (VTDEC, 2009). These predictions are based on the dominant impacts recorded for each reach, and are categorized based on the impacts typically associated with the following four channel adjustment processes: 1) Degradation (e.g., channel incision); 2) Aggradation (e.g., increased sediment deposition); 3) Channel widening (e.g., increased bank erosion); 4) Planform Changes (e.g., irregular meander patterns) (Table 10 and Figure 22). Using the channel adjustment process ratings, a provisional geomorphic rating is developed for each reach based on the methods outlined in the SGA Phase 1 protocols (VTDEC, 2009). Table 11 outlines the four possible geomorphic ratings based on the SGA methods, and Figure 23 presents the provisional geomorphic condition for all study reaches.

**Figure 23:** Provisional geomorphic ratings for the Lower Passumpsic River Tributaries
